## **Inspection Report**

**Property Address:**  
780 Nutfield Way  
Richmond KY 40475

<b>Date:</b> 7/15/2018	<b>Time:</b> 09:00 AM till 03:00 PM	<b>Report ID:</b> 180715BETHAM
<b>Property:</b> 780 Nutfield Way Richmond KY 40475	<b>Customer:</b> Mrs. Gail Schneider	<b>Real Estate Professional:</b>

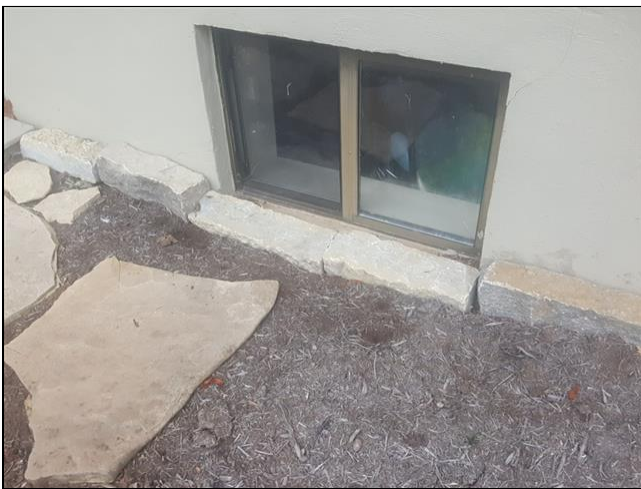
1.7 Item 1(Picture)

**1.7** The basement window at the rear right side of the home is at or near ground level. This can allow water entry into the basement. Water intrusion in a basement can lead to more costly repairs and cause mildew or mold to form. Recommend a half-round window well be installed where needed. The dirt inside the well should be replaced with approximately four inches of gravel. A couple of inches clearance between the gravel and window opening is recommended. Recommend a general contractor correct as needed.

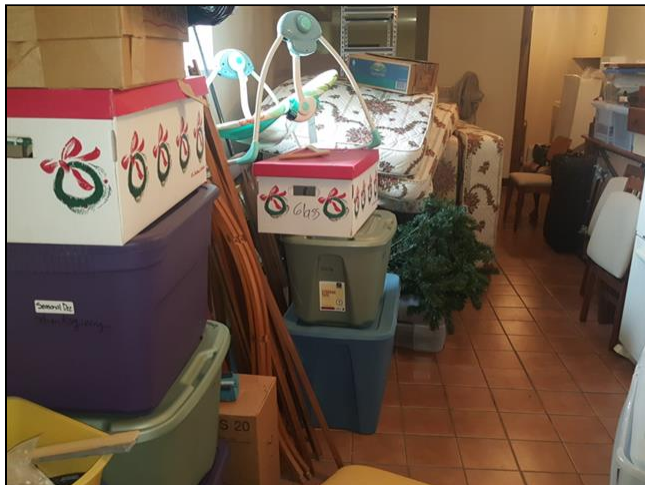
**1.8 (1)** Due to the personal stored items in the basement, we were unable to perform a proper visual examination and assessment of portions of the basement walls and floor at this time. Be sure to review these areas during the final walk through after the stored items have been removed. If you suspect further investigation is needed, recommend either myself or a certified home inspector conduct a more thorough inspection of the basement walls and floor.

1.8 Item 1(Picture) basement kitchen

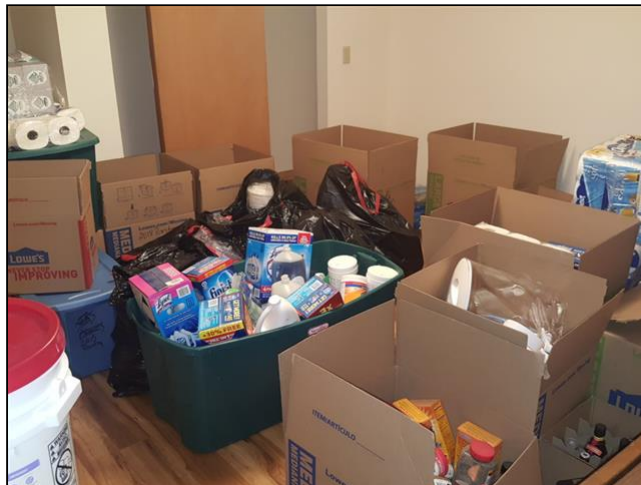
1.8 Item 2(Picture) basement bonus room

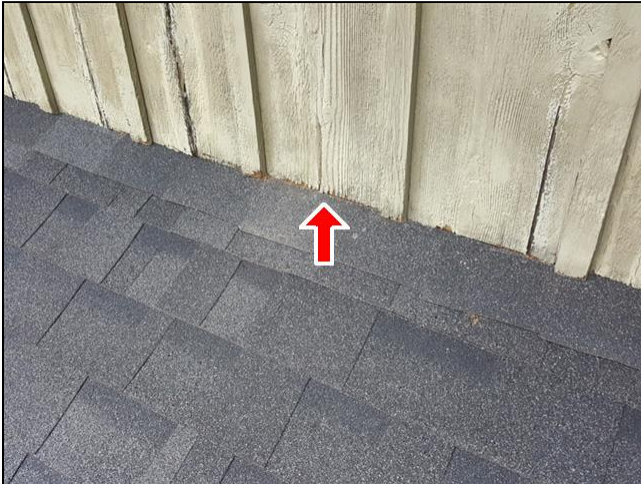
**2.1** (2) Where the wall and roof intersects at the top level of the home it is recommended that a 2 inch gap is needed between the siding and the roof to prevent water absorption to prevent the ends of the wood siding from deterioration. Cannot determine if a metal flashing has been installed. This area is more prone for water leakage which can lead to the deterioration of the wood structure and framing of the roof and damage to the wall framing if a flashing is not installed. Recommend a qualified roofing contractor further evaluate, correct and repair as needed to ensure water leakage does not occur and to prevent the wood siding from rotting underneath.

2.1 Item 1(Picture) front of home

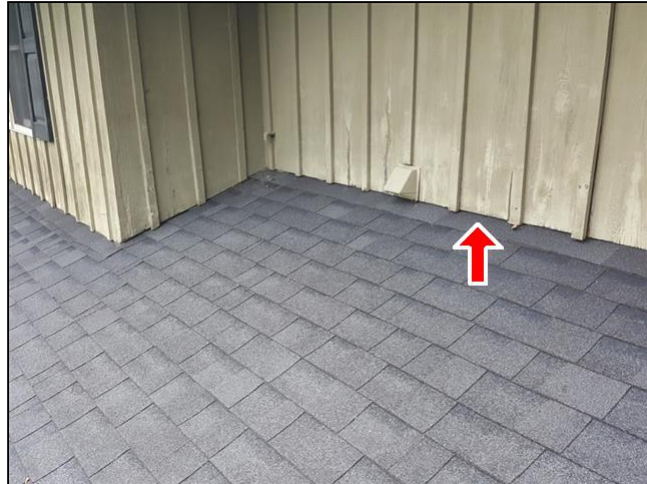
2.1 Item 2(Picture) front of home

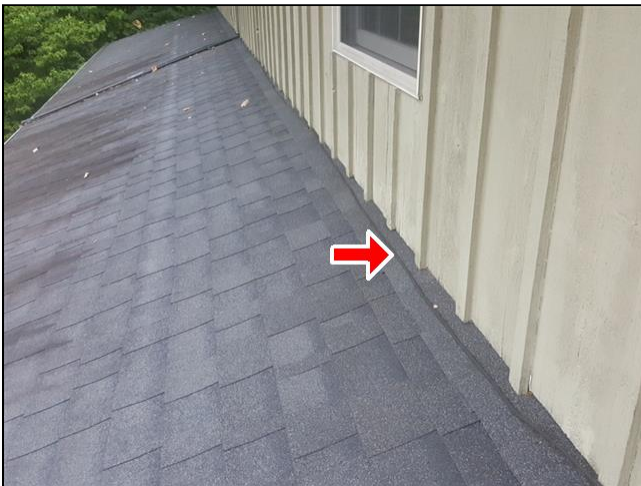
2.1 Item 3(Picture) rear of home

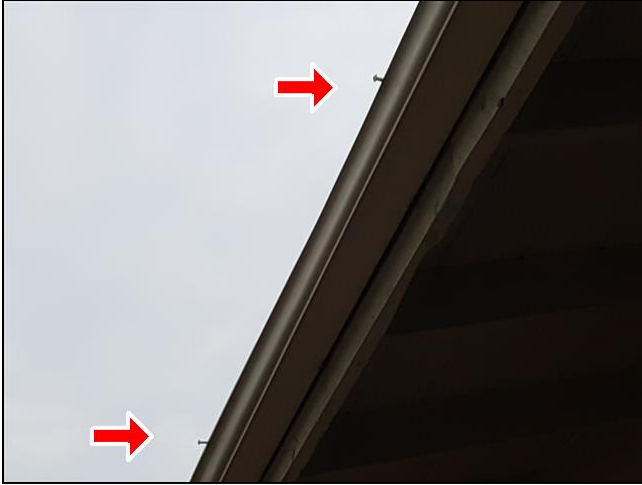
2.4 Item 1(Picture)

**2.4** (1) The gutters where indicated in photos have mounting bolts that are loose at the left side of the home. If not corrected gutters can become detached from the fascia and also water can enter the soffits which can lead to wood rot. Recommend a qualified contractor repair loose gutters to avoid spilling roof runoff around perimeter of home.

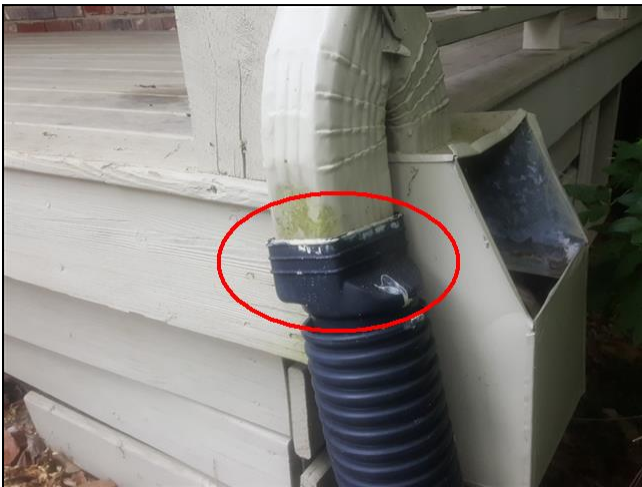
2.4 Item 2(Picture)

**2.4** (2) Recommend the downspout extension(s) be attached to the downspout at the front right corner of the home by placing a screw at the top and bottom where it connects to the downspout to ensure the extension(s) does not pull away from the downspout(s). Failing to do this may create future problems to the foundation around the home due to soil erosion and water entering the basement which may result in the foundation settlement if the extension detaches from the downspout.

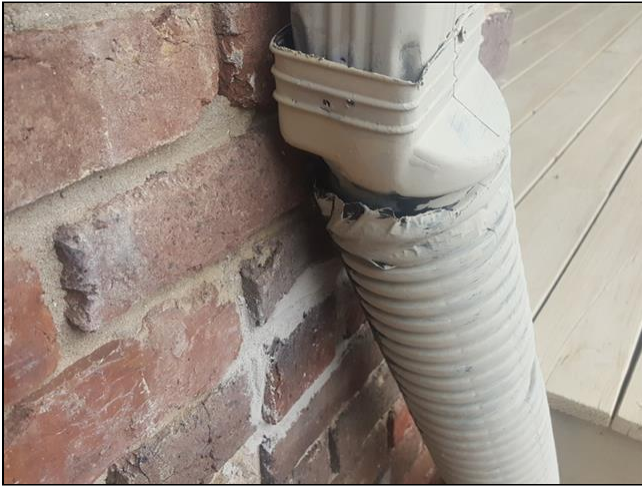
2.4 (3) The downspout extension has deteriorated at the join at the front center of the home. Leakage maybe be experienced here when it rains which could lead to basement leakage. Recommend replacement as needed.

2.4 Item 3(Picture) front center of home

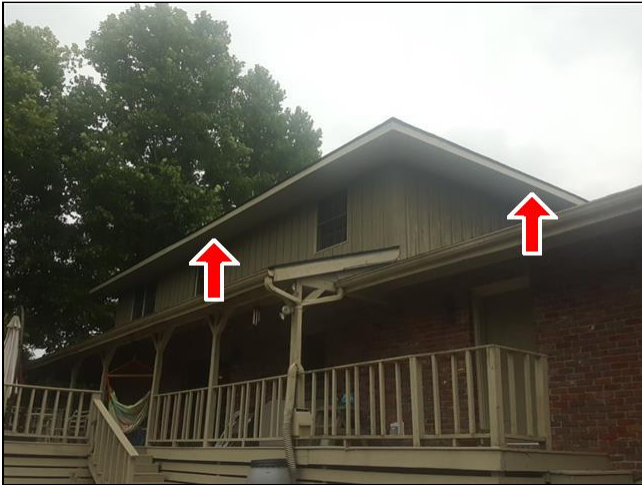
2.4 Item 4(Picture)

2.4 (4) Gutters and downspouts are missing at the top roof of the home and should be installed to prevent deterioration of the roof shingles below and to avoid spilling roof runoff around the building if current downspouts cannot adequately drain roof runoff efficiently- a potential source of water entry into the basement or water damage. Recommend a qualified contractor install a gutter system at the top level of the home. Ensure that the downspouts drain directly into the lower gutter and not on the roof.

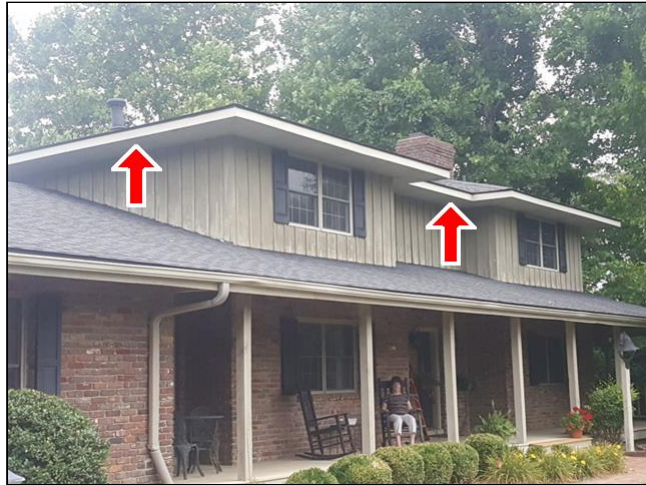
2.4 Item 5(Picture) front of home

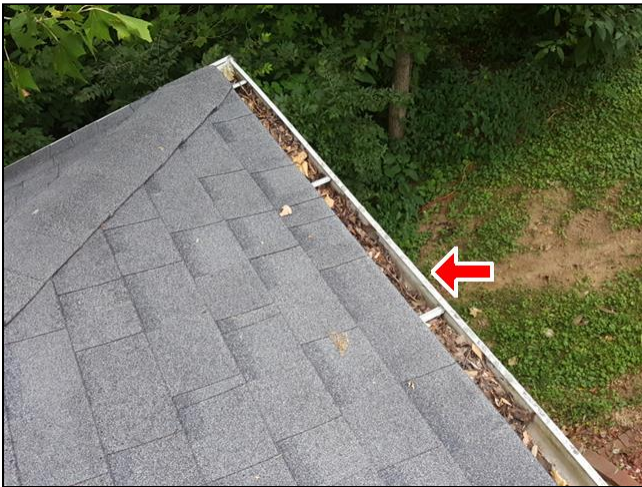
**2.4** (5) The gutter(s) where indicated in the photos, especially where they drain into the downspouts, are full of debris and need to be cleaned. The debris in gutters can also conceal rust, deterioration or leaks that are not visible until cleaned, and I am unable to determine if such conditions exist. Gutters require cleaning to avoid spilling roof runoff around the building - a potential source of water entry or water damage, and/or the fascia could become damaged. Recommend cleaning the gutters as needed. You may wish to consider installing gutter guards due to trees surrounding the home.

2.4 Item 6(Picture) front right corner of home

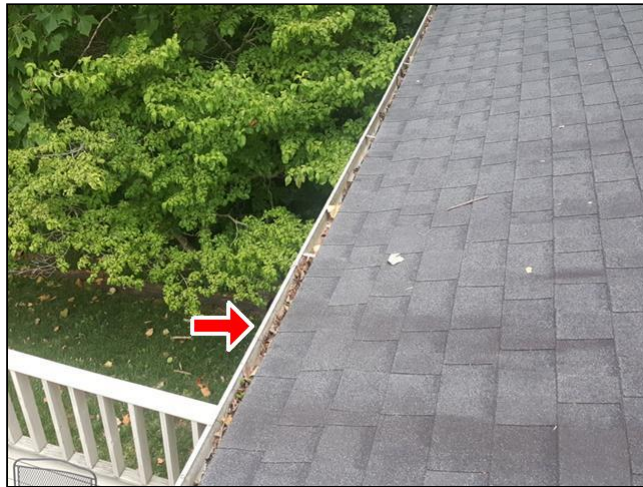
2.4 Item 7(Picture) rear left side of home

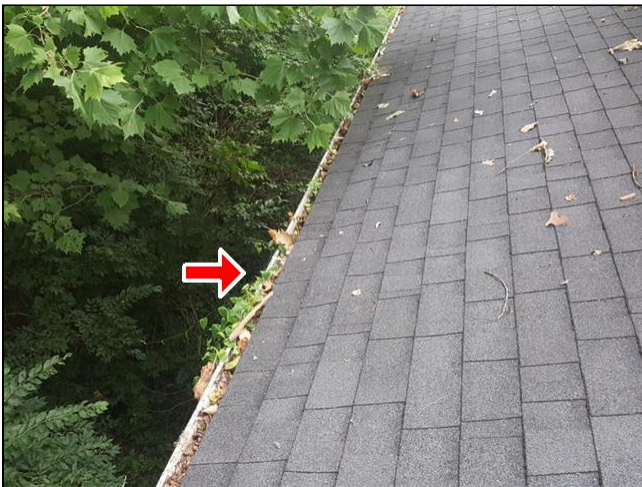
2.4 Item 8(Picture) right side of home

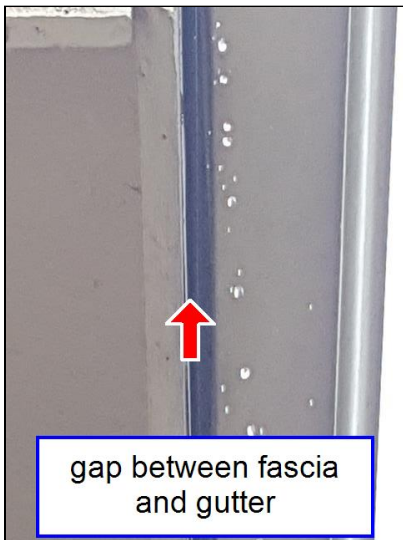
2.4 Item 11(Picture)

2.4 (6) The gutter needs to be tightened against fascia and sealed at the front left side of the home. This may cause water to pool in this area and may cause the gutter to pull away and detach from the fascia. Recommend a general contractor repair as needed.

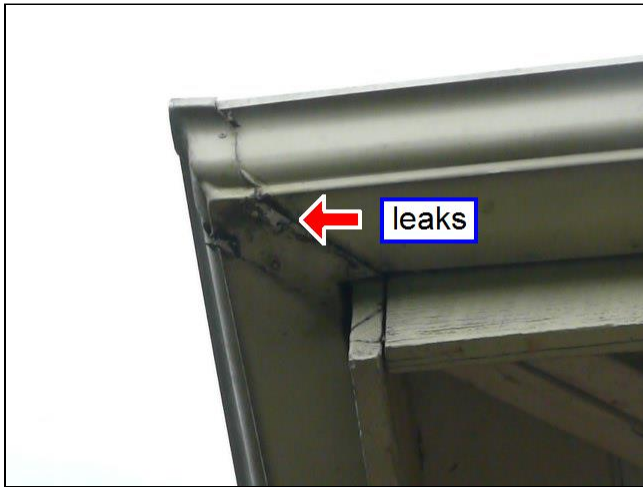
2.4 (7) The gutter leaks at the seam where indicated in the photos. Evidence of minor leakage was observed in this area during the inspection. Repairs are needed to prevent possible deterioration of the fascia and/or soffit via water intrusion. Recommend a general contractor repair as needed.

2.4 Item 13(Picture) rear right corner of home

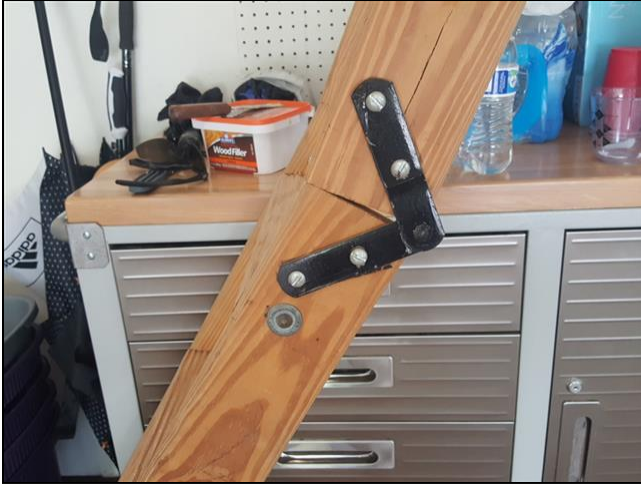
2.5 Item 1(Picture)

2.5 (1) The pull down ladder in the garage is not assembled properly at the bottom stile, leaving the bottom stile unstable and not sitting flush against the mid stile for support against the floor. This is a safety issue. If it were to fail when someone is using it they could be severely hurt. Recommend that the stairs be repaired or replaced to prevent injuries.

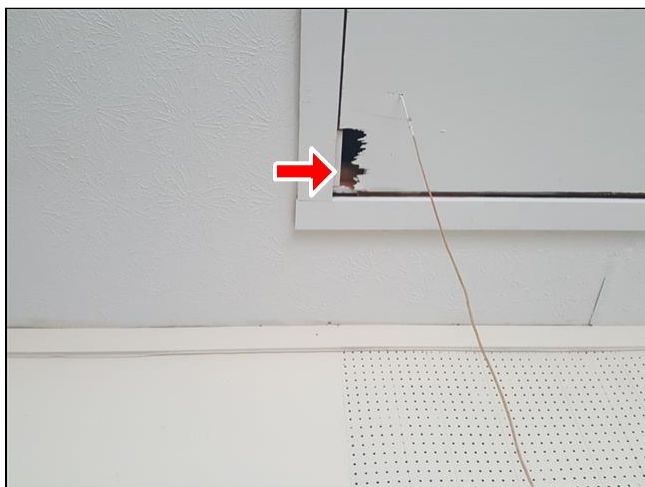
2.5 Item 4(Picture)

2.5 (2) Recommend repairing the hole in the pull down ladder door.

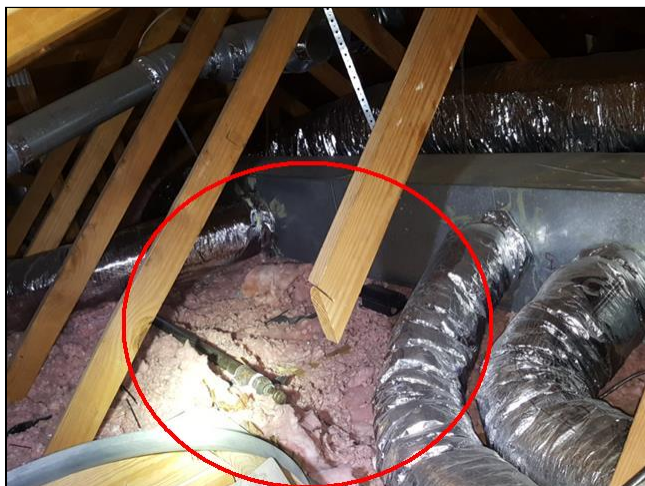
2.6 Item 1(Picture)

2.6 The 2x4 truss above the attic house fan has been cut/modified in the master bedroom attic area. The truss may fail if not repaired correctly. Excess loads on the roof like snow can cause separation if not reinforced. Truss repairs should be approved by an engineer or qualified architect before performing the work involved. Some reinforcement may be recommended by an engineer. For this reason, I **strongly** recommend you contact an engineer or qualified person for a second opinion before closing.

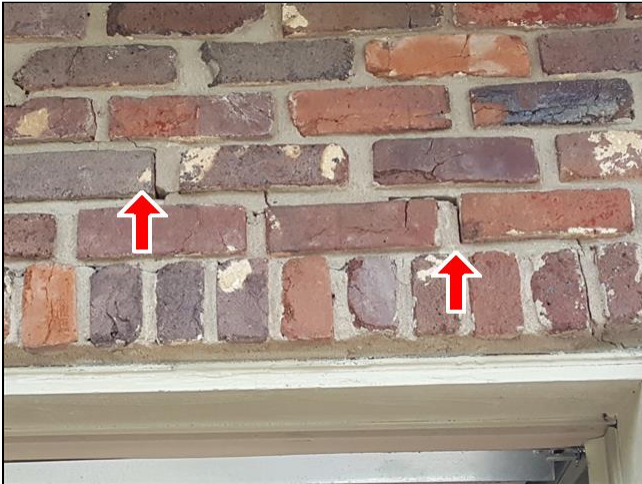
**3.0** Typical stair step cracks at the mortar joint in the brick siding at the right side of the home above the garage was observed. These cracks imply that the lintel may be rusting or expanding. A lintel is a metal beam supporting the masonry above an opening in a wall. It also may imply that minor settlement of the home has occurred. While the rate of movement cannot be predicted during a one-time inspection it is likely that repairs are needed. These cracks do not appear significant at this stage from a structural concern due to the width of the crack. Due to freeze/thaw (water entering), the cracks should be sealed to minimize further chipping away, flaking or deterioration. The lintel is covered. Recommend these cracks be sealed to prevent further cracking and possible deterioration of the brick work. A skilled masonry contractor should perform the repairs via re-pointing mortar. It is recommended that you monitor periodically and if cracks reappear further investigation by a structural engineer is recommend. Ensure the lintel is sealed so that water intrusion does not occur to prevent rusting of the lintel.

3.0 Item 1(Picture) right side of garage

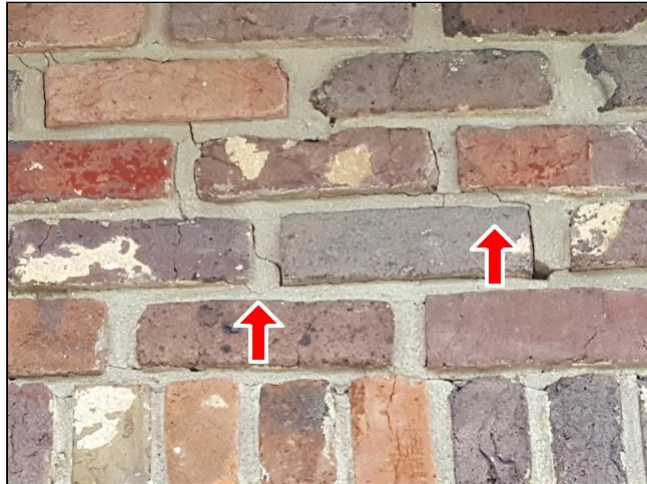
3.0 Item 2(Picture) right side

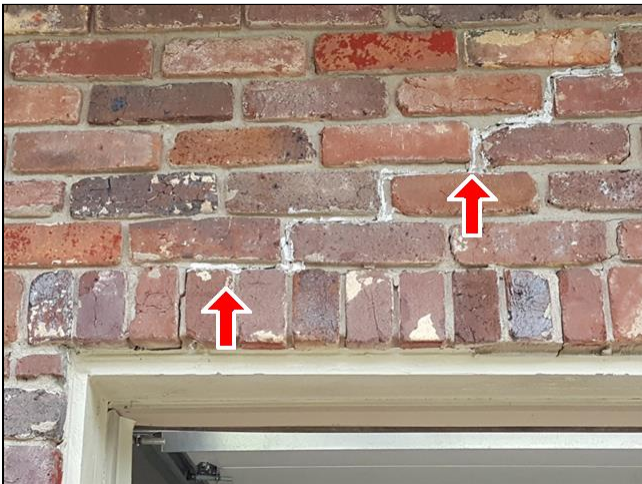
3.0 Item 3(Picture) left side

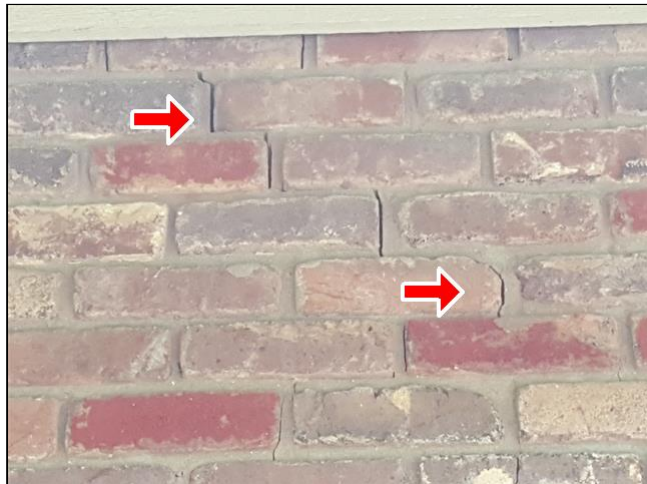
3.0 Item 4(Picture) left side

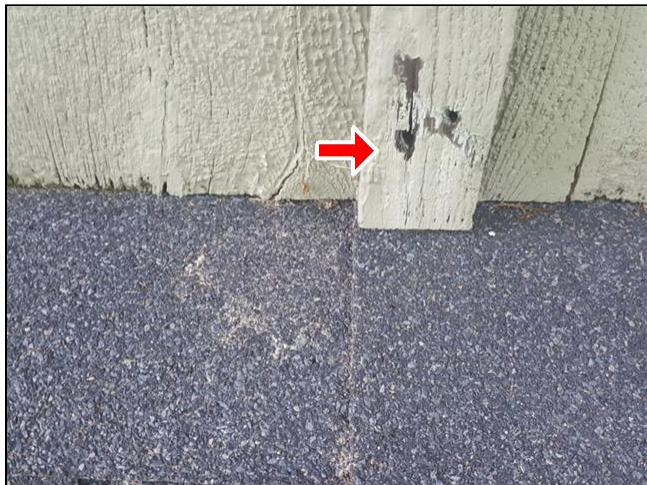
3.1 Item 1(Picture)

**3.1** (1) There is evidence of recent carpenter bee damage to the wood siding in some areas of the home. Carpenter bees have the ability to tunnel into the wood which can compromise the structure and cause damage via water intrusion. Recommend sealing holes where found around the perimeter of the home with the appropriate sealer, then consult a pest control specialist for advice on a possible treatment to prevent further damage and deterioration of the wood siding around the home. [Carpenter Bee Treatment and Repair](#)

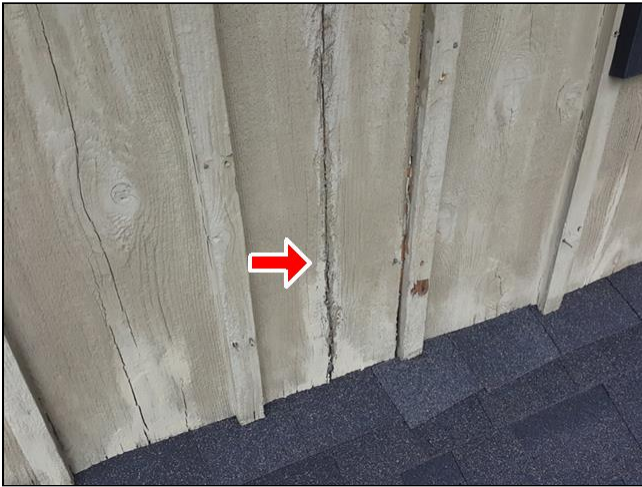
**3.1** (3) The wood siding has cracked and is loose in some areas at the front of the home. See photos for location. These areas need to be repaired or replaced to prevent further water intrusion which will lead to further deterioration of the siding and possible rotting. Over time deterioration of the wall sheathing and/or framing may occur and possible mold may occur. Recommend a qualified contractor further access damaged areas and repair or replace as needed.

3.1 Item 2(Picture) front right side of home

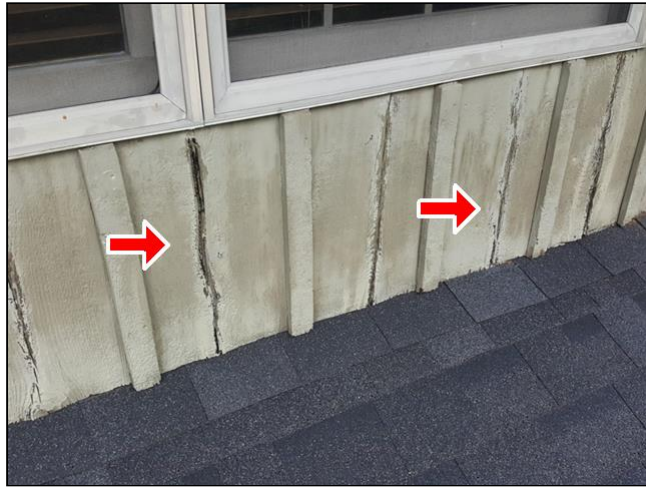
3.1 Item 3(Picture) front right side of home

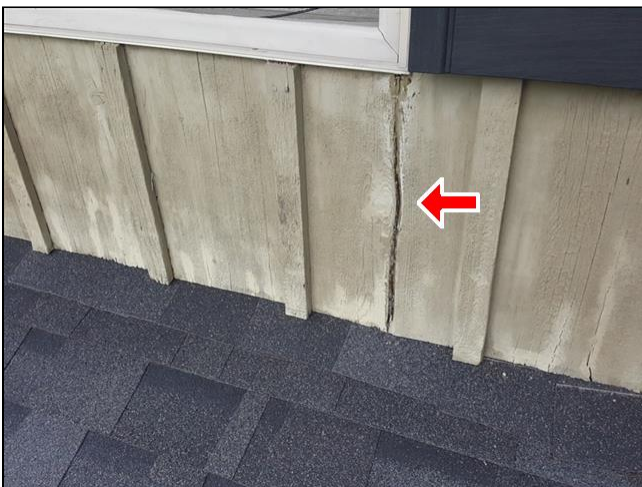
3.1 Item 4(Picture) front left side of home

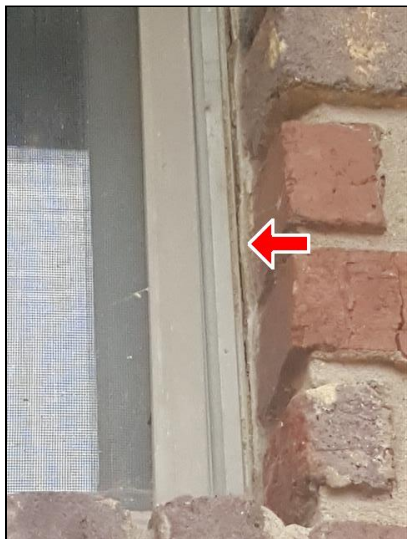
3.4 Item 3(Picture)

**3.4** (2) The window frame at the rear right side of the home has cracked sealant between the siding and the window frame. Water and/or insects may enter and deterioration may occur behind the wall cavity and siding. This is a small repair. Recommend re-caulking as needed. [Which caulk to use](#)

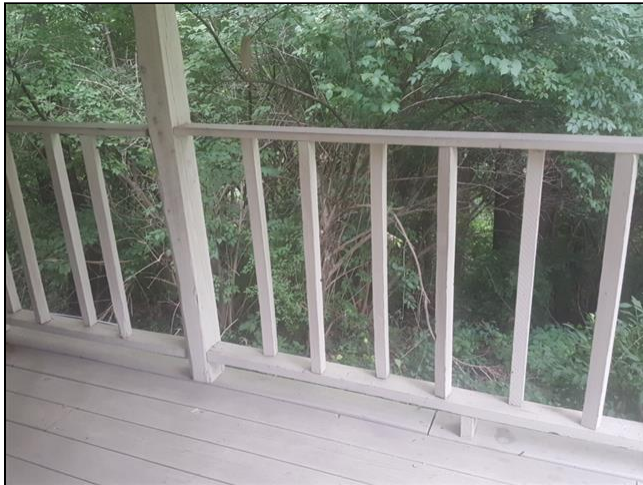
3.5 Item 1(Picture)

3.5 (1) The guard rail for the balcony porch on the right side of the home have large spaces between the ballusters. This is a safety issue. A fall or injury could occur if not corrected as this condition could allow a child or pet to fall through which may result in a death. The current recommendations are for spacing to be no more than 4" to prevent these accidents. A qualified contractor should make the necessary repairs and corrections where needed for safety.

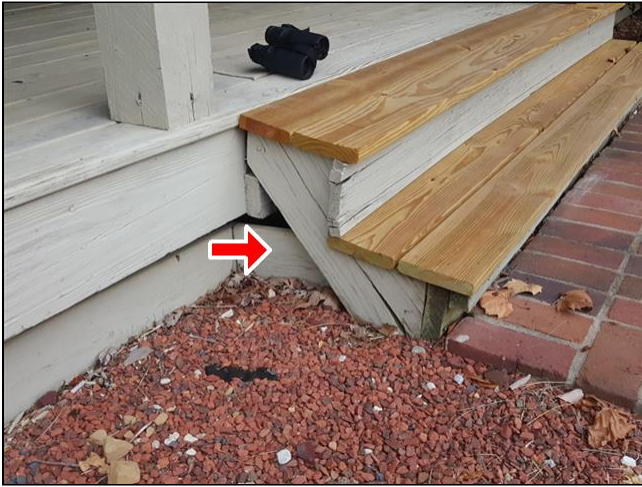
3.5 Item 6(Picture)

**3.5** (4) The staircase at the front porch has sunken on the left side. The staircase may be in contact with the ground. This may become a possible safety issue if further settlement occurs. Recommend replacement or repair as needed by a qualified contractor.

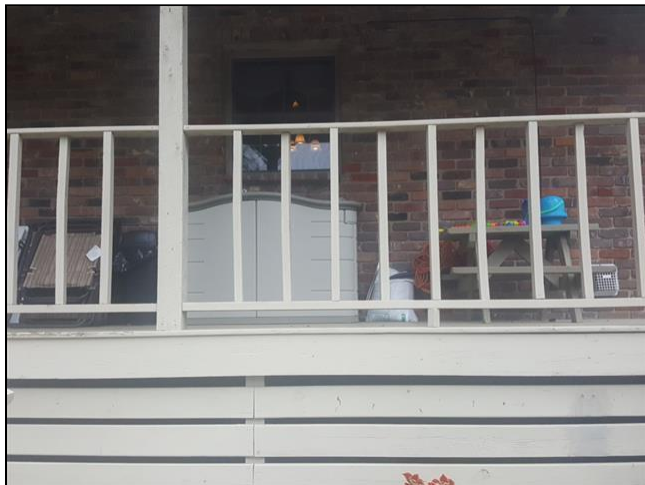
3.6 Item 1(Picture)

**3.6** (1) The guard rail for the rear deck and the staircase have large spaces between the ballusters. This is a safety issue. A fall or injury could occur if not corrected as this condition could allow a child or pet to fall through which may result in a death. The current recommendations are for spacing to be no more than 4" to prevent these accidents. A qualified contractor should make the necessary repairs and corrections where needed for safety.

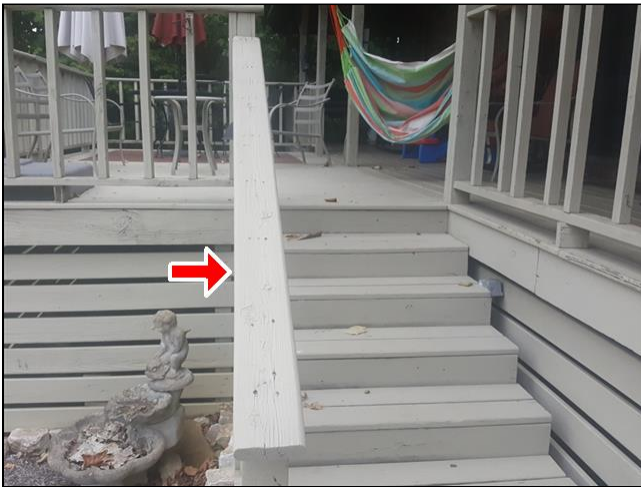
3.6 Item 4(Picture)

**3.6 (2)** 2x4s are installed for handrails for the deck staircase and are not considered "gripable" by industry standards. This is a safety issue and an injury could occur if not corrected. Recommend that a standard approved handrail be installed for safety by a general contractor.

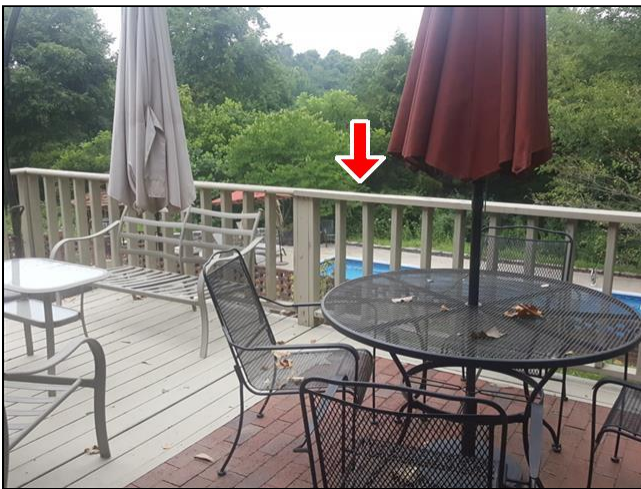
3.6 Item 5(Picture)

**3.6 (3)** The guard rail for rear deck is loose, unstable and not secured properly. This is extremely dangerous and is a major safety concern. It may fail under a medium or heavy force or if someone was pushed against or was leaning on the railing. For your safety it should be strengthened and secured. Recommend a qualified contractor repair as needed before closing.

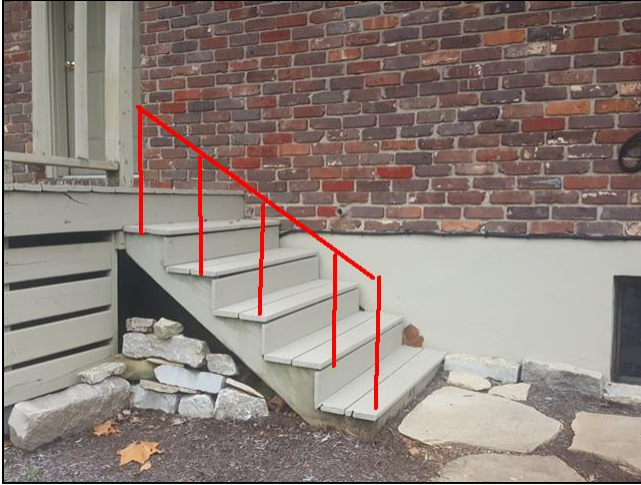
3.6 Item 7(Picture)

3.6 (4) Recommend a guard rail be installed for the staircase at the rear right side of the home to prevent a fall from occurring which may result in an injury of a person. This is a potential safety issue. The railing needs to be at least 36 inches high and balusters need spacing to be at least 4 inches. Recommend a qualified contractor install one for safety.

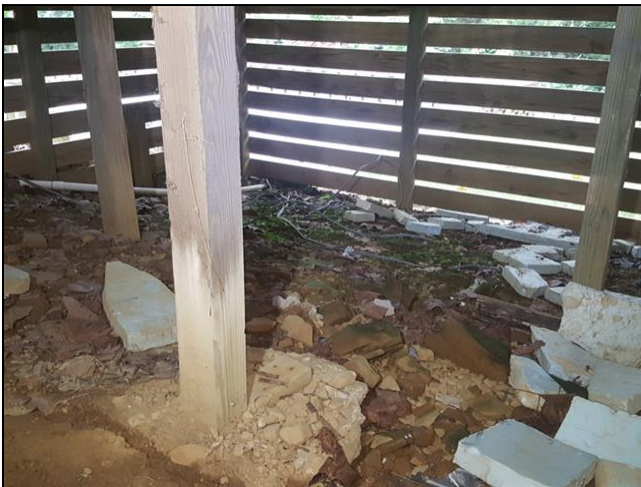
3.6 Item 8(Picture)

3.6 (5) The support posts for the deck/balcony are 4x4s. This was common when this home was built. 6x6 posts are now recommended for structural support for decks and balconies. There were no issues noted during the inspection, however I would recommend monitoring posts annually and at the first sign of posts leaning, strongly recommend a qualified contractor repair or replace post to ensure structural integrity of the deck/balcony. This is for your information.

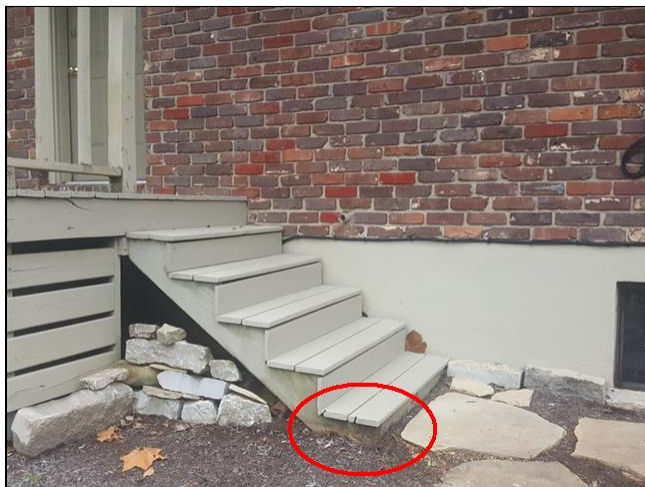
3.6 Item 10(Picture)

**3.6** (6) The bottom of the deck steps are in contact with the soil at the rear right side of the home. The stairs need to be resting on a concrete landing. Over time the soil will erode away and weaken the bottom of the staircase and will not be supported. In the future this will result in being a safety issue and an injury could occur. Recommend correcting as needed by a general contractor or qualified person.

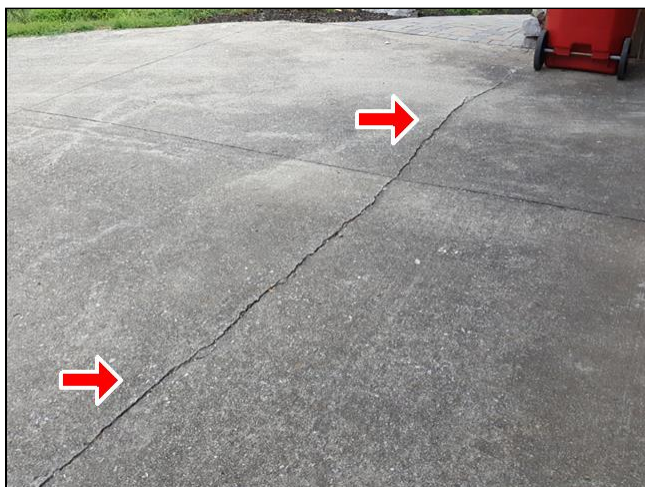
3.7 Item 1(Picture)

**3.7** Common settlement crack(s) were noted at the concrete drive. This is not a tripping hazard as yet at this time. I also do not see these small cracks as an indication of a structural issue. Further deterioration and/or settlement can occur to the driveway via water intrusion if not repaired. Recommend repairs via a masonry caulk as needed then monitor annually. Here is a link for [Sealing Concrete Cracks](#)

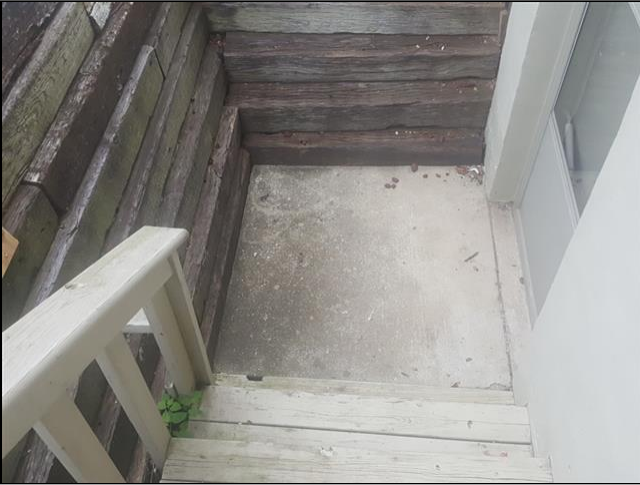
3.10 Item 1(Picture)

**3.10** The installation of a drain is recommended for the basement entry door at the left side of the home. The drain should be arranged to effectively drain water from the basement door while resisting clogging. Basement entry runoff must be directed away from the building to avoid water entry/damage to the basement and to prevent water entering the foundation perimeter. You may wish to consult a qualified contractor for advice on how to achieve this.

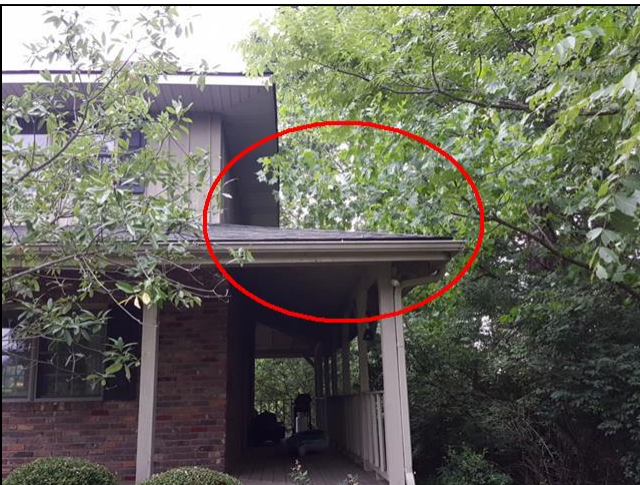
3.11 Item 1(Picture)

**3.11** (2) There are tree branches that overhang over the roof at the front right corner of the home. Be observant. Tree limbs should be cut as needed to prevent damage to the shingles and from scraping on the roof surface. They will also clog gutters which will cause water run off problems around the home. Recommend cutting back tree branches as needed.

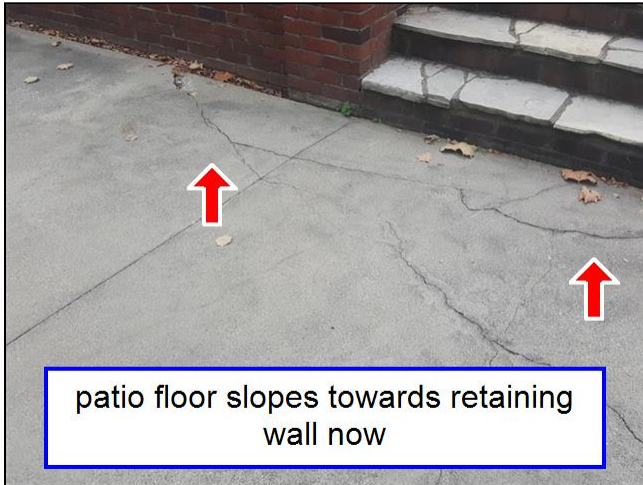
3.14 Item 4(Picture)

**3.14** (2) Common settlement crack(s) were noted at the patio floor near the pool area. This has caused a slope which allows water to pool and not drain correctly. Water pooling here can lead to the retaining wall to settle or lean in the future. Recommend a qualified masonry contractor repair as needed. Consideration for improving drainage in this area is also recommended. Further deterioration and/or settlement can occur to the concrete floor via water intrusion if not repaired.

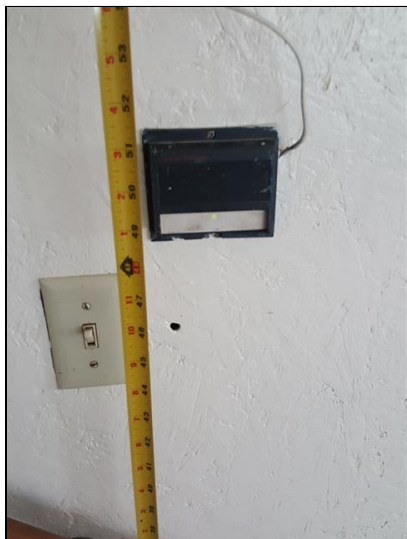
4.3 Item 1(Picture)

4.3 (1) The door button is lower than the manufacturers recommended 5 feet above the floor. This is a safety issue. Recommend this be raised to prevent unauthorized use by children as an injury may occur or damage to a motor vehicle when the door is opened or closed automatically. A qualified licensed electrician is recommended for correcting.

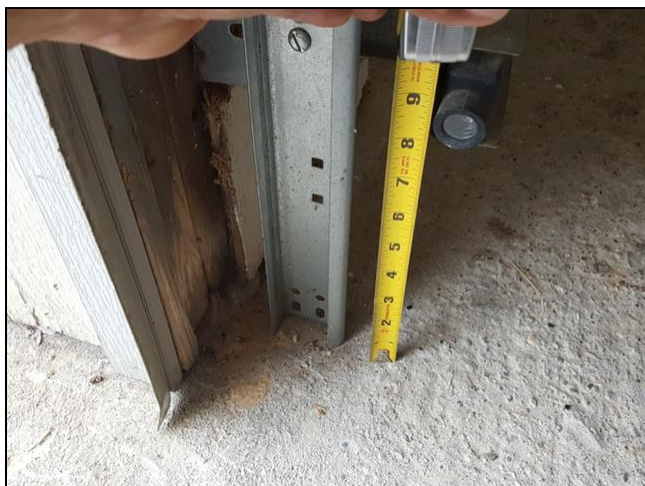
4.3 Item 3(Picture)

4.3 (2) The garage door opener electric eyes are installed too high. There is a serious risk of injury, particularly to children or pets, under this condition. The eyes should be placed 4" to 6" off the floor or as otherwise indicated in the installation manual. This should be dealt with immediately by a qualified garage installer.

Note: the door does reverse when eyes are interrupted and under resistance.

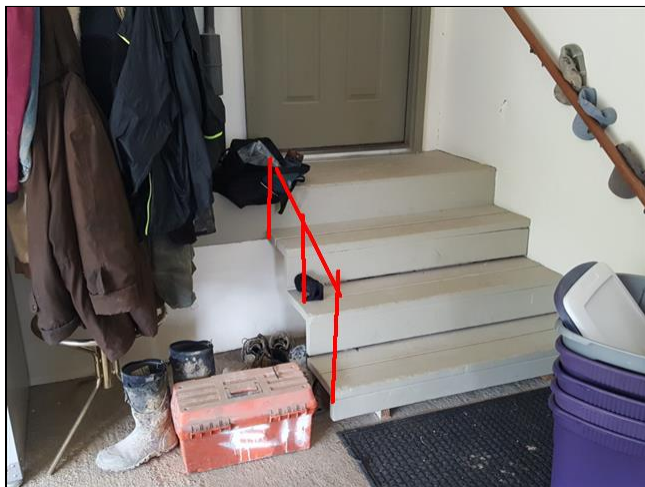
4.7 Item 1(Picture)

**4.7** Recommend a guard rail be installed at the staircase in the garage to prevent a fall from occurring which may result in an injury of a person. This is a potential safety issue. The railing needs to be at least 36 inches high and balusters need spacing to be at least 4 inches. Recommend a qualified contractor install one for safety.

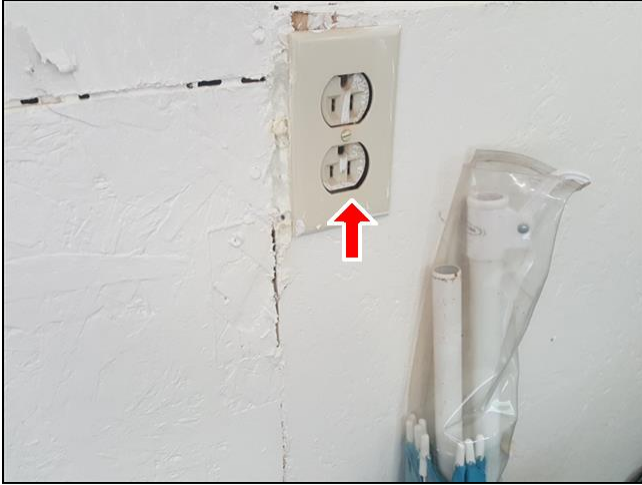
4.8 Item 1(Picture)

**4.8** (1) The outlets in the garage are not GFCI protected. GFCI (Ground fault circuit interrupters) outlets should be considered for installation as a safety upgrade in all locations where water is present if the outlets are not presently connected to a GFCI. They are now required in all bathrooms, kitchen, unfinished basements, garages, exterior outlets, or other locations within 6' of a water source or sink. GFCI outlets may not have been required when this house was built but should be considered for safety. This is for your information. Personally recommend a licensed electrician replace as needed.

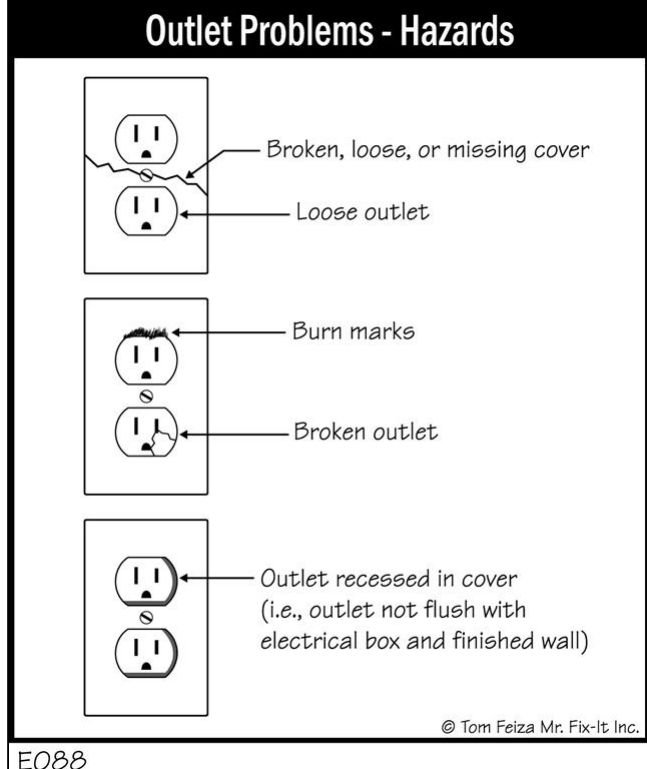
4.8 Item 2(Picture)

4.8 (2) Openings between the outlet and the cover plate in the garage where indicated in the photo is a serious safety issue. A child or person may place an object inside opening which may contact the connecting wires causing an electrical shock which could lead to a serious injury or death. Recommend a qualified electrician repair as needed for your safety before moving into home.

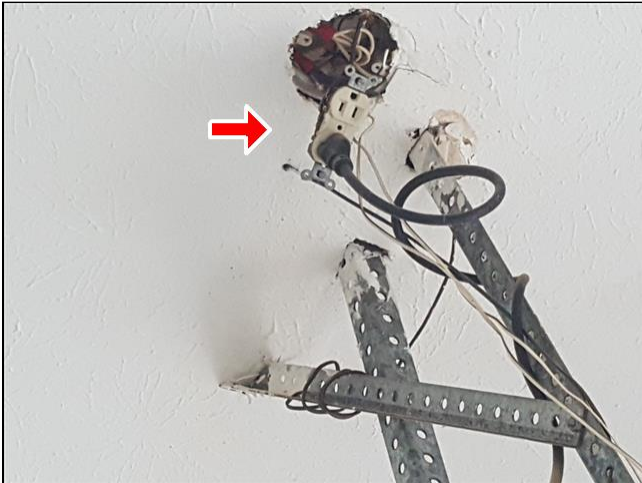
4.8 Item 3(Picture)

4.8 (3) The outlet(s) in the garage where indicated in the photo(s) are loose in the ceiling and is missing a cover plate. Electrical issues are considered a hazard until repaired. This is a safety issue that needs to be corrected due to an electric shock or fire from loose connections could occur if not repaired. Recommend a qualified licensed electrical contractor correct as needed.

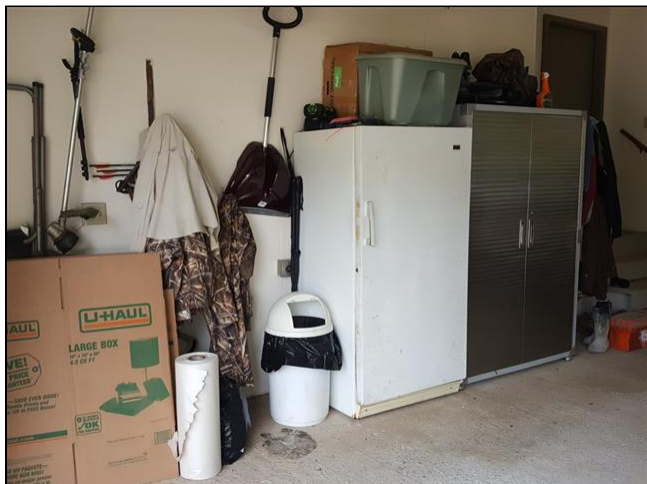
4.9 Item 1(Picture)

**4.9 Note:** Limited Inspection of the garage was performed due to excessive personal property, unable to view most of the walls, slab and access switches and outlets. Recommend further inspection of these item(s) / areas prior to closing.

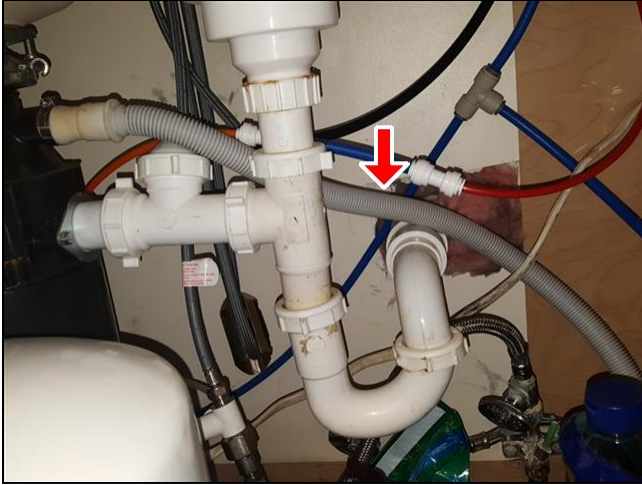
5.2.A Item 1(Picture)

**5.2.A** The dishwasher drain hose did not perform a loop to create a trap under the sink. The current recommendations for the dishwasher drain lines are for them to be installed as close to the bottom of the countertop as possible. This creates a water blockage to prevent sewer gases entering the house through the dishwasher. Recommend repair or replace as necessary.

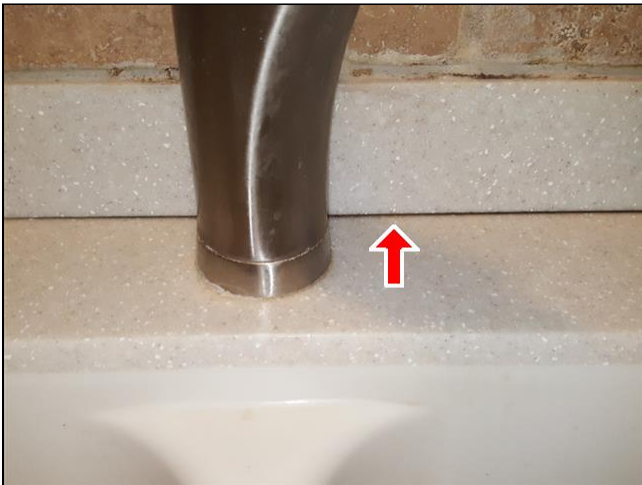
5.9.A Item 1(Picture)

**5.9.A** Recommend caulking around the counter top in the kitchen to seal the gap/crack in front of the sink. Water may enter which can cause damage to the drywall and cabinets, then result in possible mold forming. Repair using a quality caulk that is resistant to moisture and is expandable. Here is a link on [How to Choose the right Caulk](#)

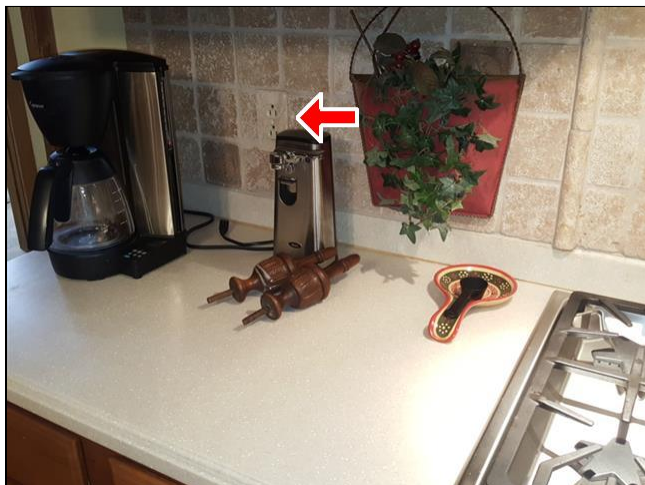
5.10.A Item 1(Picture)

**5.10.A (3)** The outlet(s) in the kitchen where indicated in the photo(s) are loose at the wall or in the outlet box. Electrical issues are considered a hazard until repaired. This is a safety issue that needs to be corrected due to an electric shock or fire from loose connections could occur if not repaired. Recommend a qualified licensed electrical contractor correct as needed.

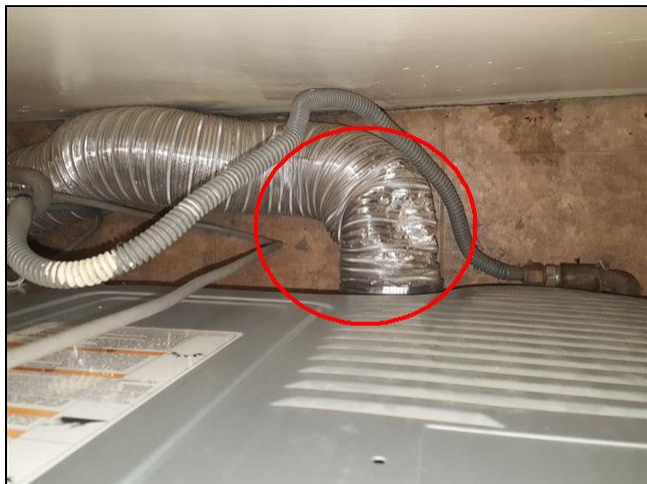
5.11.A Item 2(Picture)

**5.11.A** (2) The dryer vent piping is damaged. This can cause an obstruction of lint that has a possibility to create a fire hazard. Recommend replacing flexible line prior to using dryer.

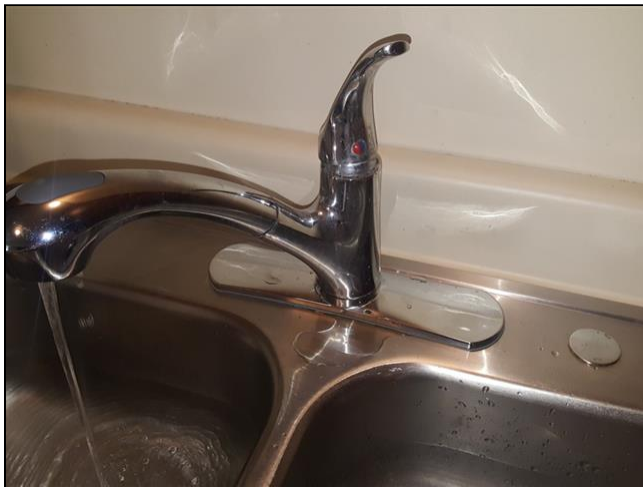
5.0.B Item 1(Picture)

**5.0.B (1)** The hot and cold water lines are connected to the faucets at the sink in reverse from there normal positions in the basement kitchen. This could result in scalding burns. Recommend they be changed to the accepted normal locations with the cold water valve on the right side of the fixture. Recommend a licensed plumber correct as needed.

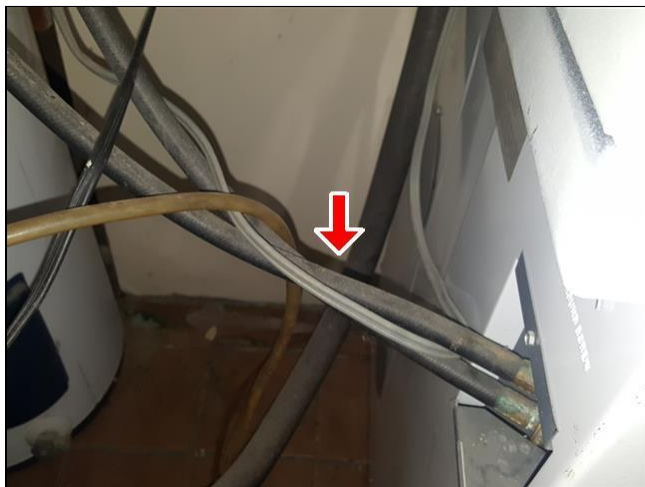
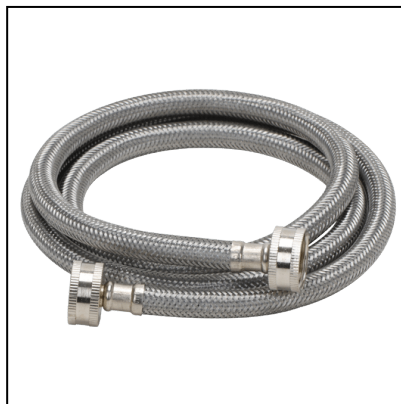
**5.0.B** (2) Your washing machine is connected to rubber hoses. These hoses are under constant water pressure and are prone to leaks or even bursting overtime. This will cause damage to your home. You may wish to convert hoses to "No-burst hoses" which are encased in a woven metal sleeve that prevents weak spots in the rubber from developing into leaks. This is for your information.

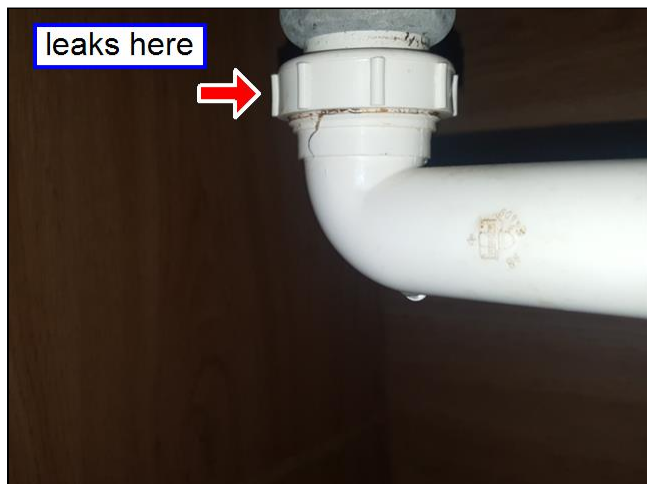
5.1.B Item 1(Picture)

**5.1.B** The waste line is leaking at the connection underneath the left sink in the basement kitchen. Repairs are needed to stop leaking water from damaging the cabinet bottom or to eliminate moisture that may contribute to fungi growth. A qualified licensed plumber is recommended for repairs as needed.
