## **Inspection Report**

**Property Address:**  
780 Nutfield Way  
Richmond KY 40475

<b>Date:</b> 7/15/2018	<b>Time:</b> 09:00 AM till 03:00 PM	<b>Report ID:</b> 180715BETHAM
<b>Property:</b> 780 Nutfield Way Richmond KY 40475	<b>Customer:</b> Mrs. Gail Schneider	<b>Real Estate Professional:</b>

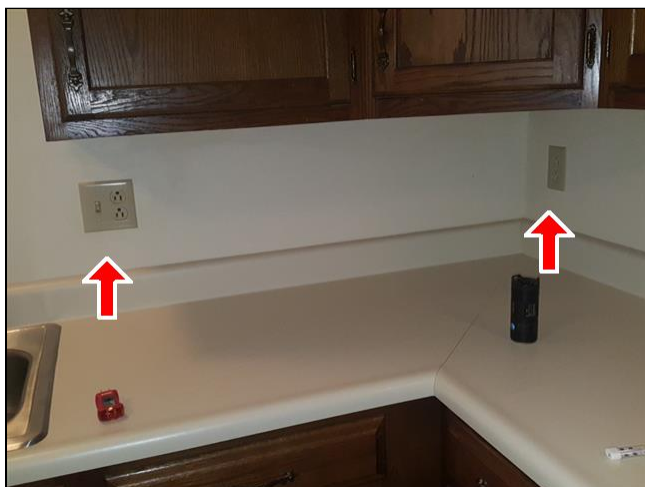
5.6.B Item 1(Picture)

**5.6.B** (2) The outlets in the basement kitchen are not GFCI protected. GFCI (Ground fault circuit interrupters) outlets should be considered for installation as a safety upgrade in all locations where water is present if the outlets are not presently connected to a GFCI. They are now required in all bathrooms, kitchen, unfinished basements, garages, exterior outlets, or other locations within 6' of a water source or sink. GFCI outlets may not have been required when this house was built but should be considered for safety. Personally recommend a licensed electrician replace as needed.

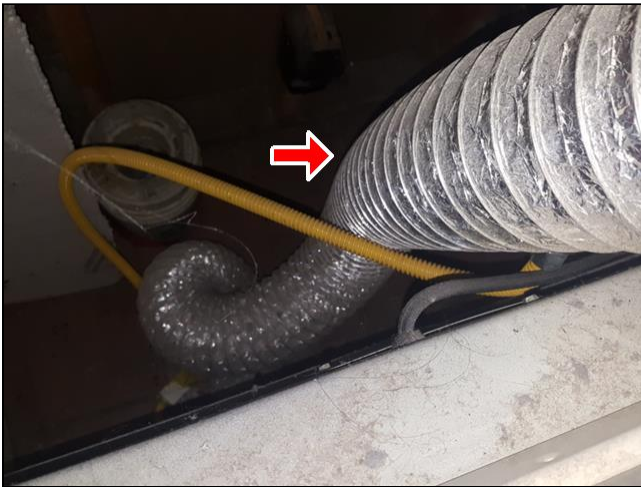
5.7.B Item 1(Picture)

**5.7.B** (1) A pleated Foil flex pipe is currently installed from the dryer to the exhaust vent. The current recommendations are for dryer vents to be heavy flexible or solid metal to help prevent crushing and damage from fires. Dryer lint fires are reported to be the third leading cause of fires. Exhaust ducts should be constructed of minimum 0.016 inch thick rigid metal ducts, having smooth interior surfaces with joints running in the direction of air flow. Exhaust ducts shall not be connected with sheet metal screws or fastening means which extend into the duct. All dryer vents should be disconnected and cleaned twice a year. This is a very common cause of fires. Recommend replacing duct for proper operation and for your safety using a qualified contractor.

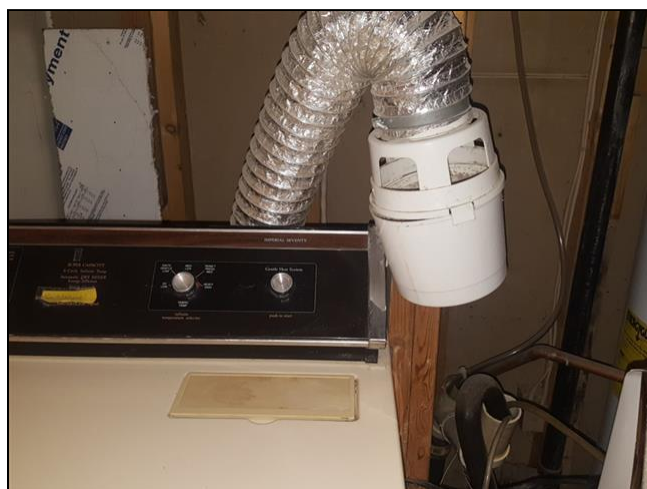
5.7.B Item 5(Picture)

**5.7.B (2)** The dryer vent piping uses a "lint trap kit" and does not vent to the outside in the basement. Recommend checking owners manual to see if this is recommended for this brand appliance. Ideally the dryer should be vented to the outside. Ensure that you clean the trap regularly to prevent a fire from occurring.

Note: Indoor dryer vent buckets are not recommended because of safety reasons, and they may be fire hazards as well.

1. Indoor dryer vent buckets contain water in a bucket, to which the dryer vent is attached. As the dryer is operating, the lint, moisture and heat are vented into the bucket. As the lint accumulates, it can constitute a fire hazard. If the dryer vent is blocked, the dryer operates at higher temperatures. The heat emanated to the vent bucket may be too hot. The lint, which is highly inflammable, can catch fire. The fire can quickly spread to other combustible materials and can lead to disaster.

Another risk factor is the constant presence of moisture, by way of water in the vent bucket. Over time, the moisture from the dryer and the water together can cause problems such as mold and mildew in your home. I would recommend having it corrected by a qualified contractor if possible.

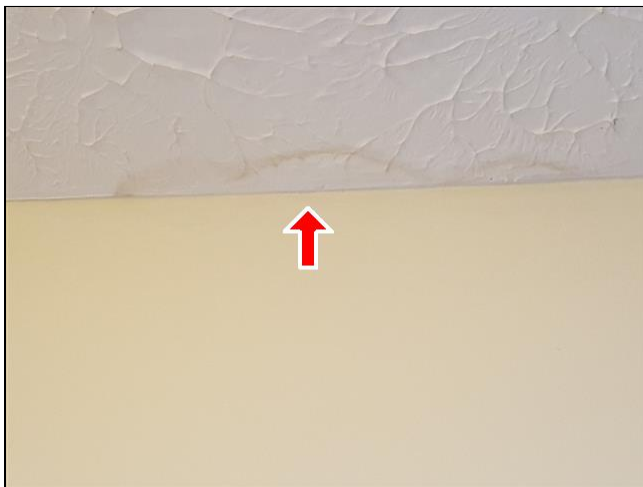
6.0 Item 1(Picture)

**6.0** (1) The drywall at the ceiling in the guest bathroom above the roof intersection reveals an old water stain indicating a leak did or still exists where indicated by the photo(s). Although there was no leaking or elevated moisture content found at this time, I could not determine how the stain existed. Perhaps ask the owner of the home to explain cause of the stain. Inspections are limited and destructive inspections are excluded. Recommend cleaning the drywall then monitor this area to see if a leak is active and if a leak does exist, recommend further investigation and repair as needed. The repair work will likely involve the removal of the covering in order to determine where the leak is coming from and if it still exists.

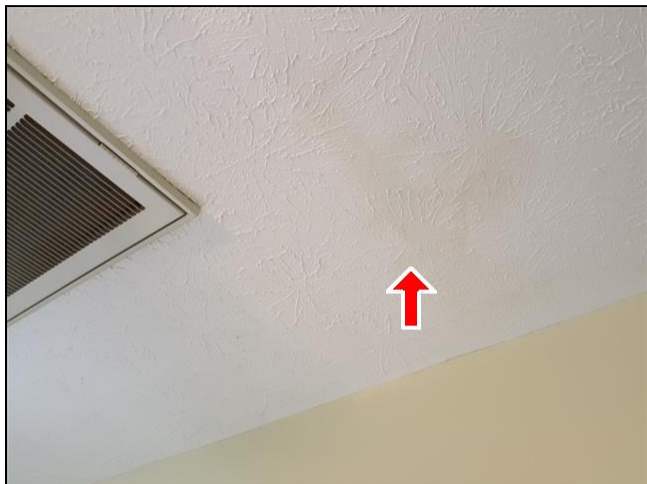
6.0 Item 2(Picture)

**6.0** (2) The drywall on the ceiling in the master bedroom reveals a water stain indicating a leak did or still exists. It is positioned directly above the large suction line from the heat pump to the air handler in the attic. Although there was no leaking or elevated moisture content found at this time, future leaks may develop via condensation. Inspections are limited and destructive inspections are excluded. Recommend cleaning the drywall then monitor this area to see if leak is active and if leak does exist recommend further investigation and repair as needed. A qualified HVAC contractor may also be needed to repair leak if it is caused by the large suction line via a missing or deteriorated insulation sleeve.

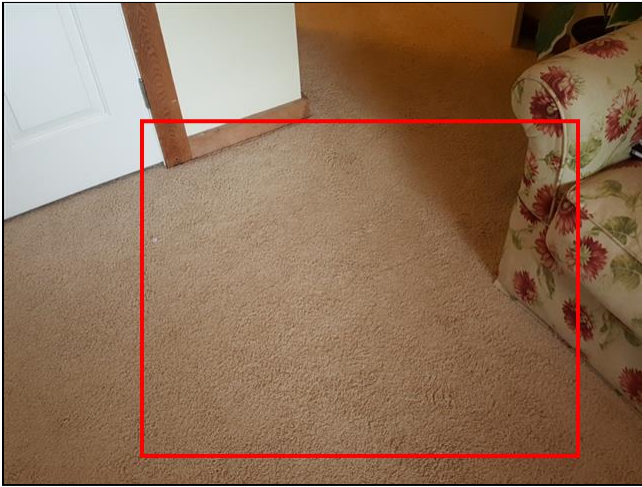
6.2 Item 2(Picture)

6.2 (2) The floor squeaks in the master bedroom sitting room as indicated in the photo(s) (nuisance only). This is for your information and is of no concern from a structural perspective. A qualified carpenter should know how to eliminate or reduce squeaks in the flooring. This will likely involve the removal of the floor covering to repair the squeak in the floor. Repair as desired.

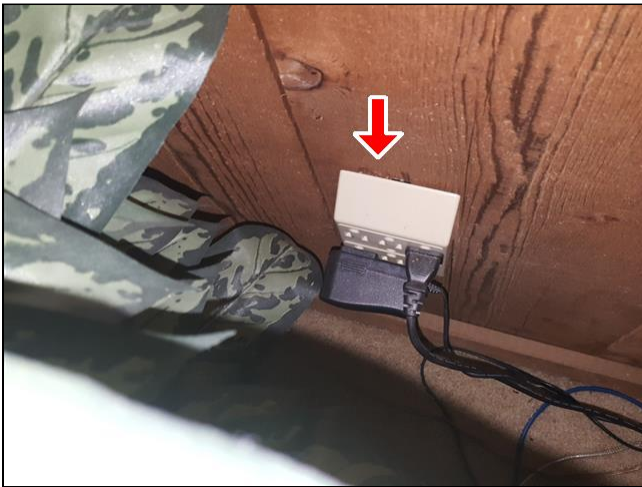
6.7 Item 1(Picture) living room

6.7 (1) It is not recommended that these adapters be used in the outlets as they can overheat and cause a fire. This is for your safety. Especially in areas like kitchens where numerous appliances can be connected. If additional outlets are required, recommend a qualified electrician install them as needed.

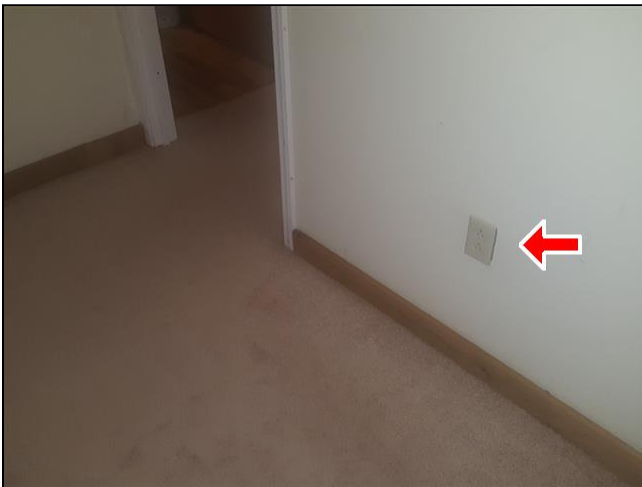
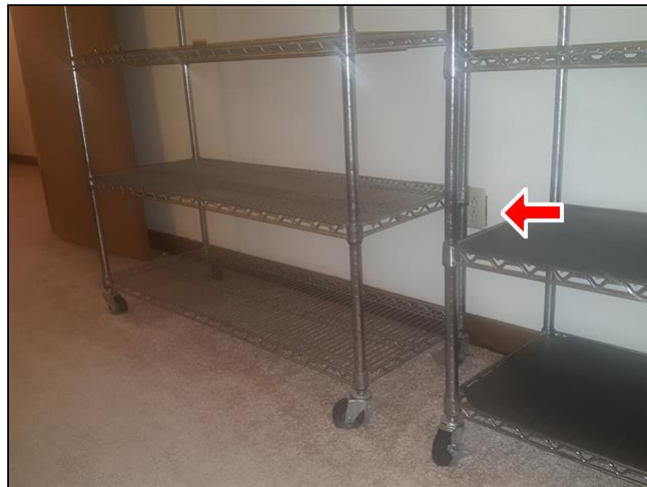
6.7 (2) The outlet(s) in the basement hallway where indicated in the photo(s) are loose at the wall or in the outlet box. Electrical issues are considered a hazard until repaired. This is a safety issue that needs to be corrected due to an electric shock or fire from loose connections could occur if not repaired. Recommend a qualified licensed electrical contractor correct as needed.

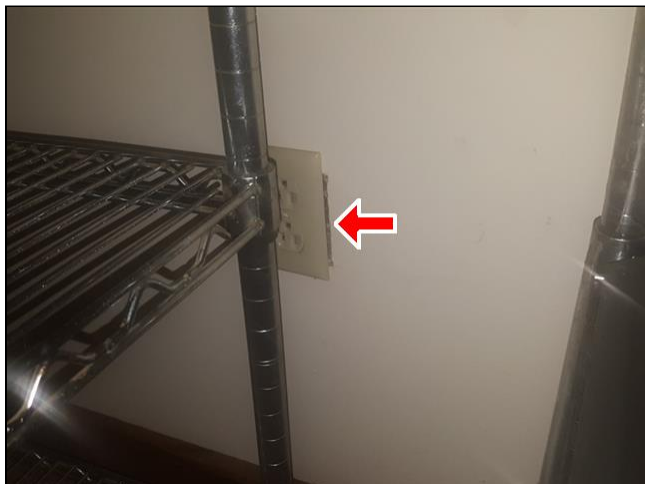
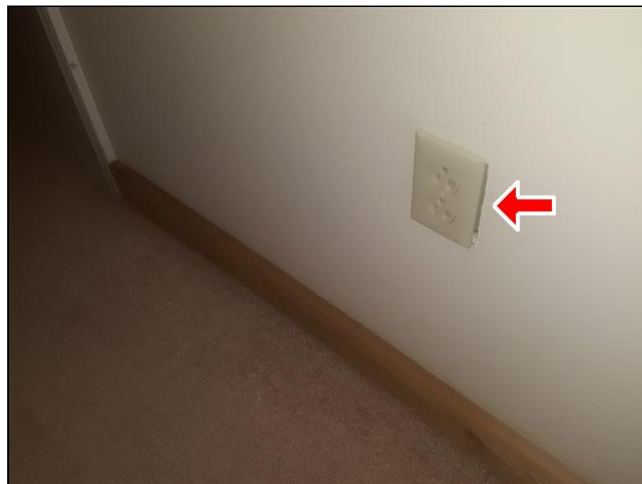
**6.7 (3)** Recommend sealing the gap between the wall and the outlet in the basement hallway where indicated in the photo(s) to prevent children being electrocuted by placing objects inside the opening. This is a serious safety issue. Recommend a qualified electrician and/or a general contractor repair as needed.

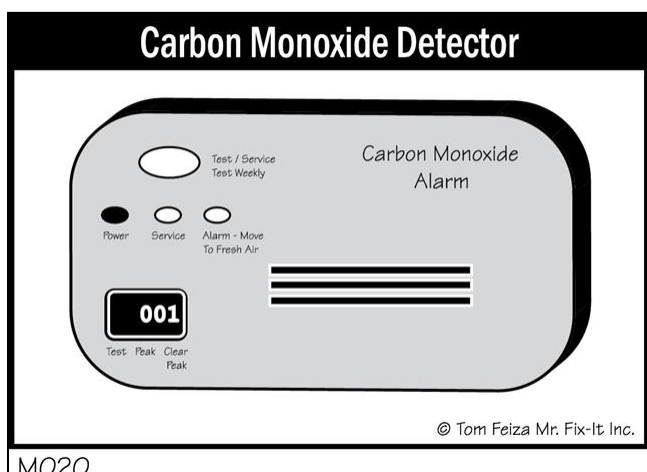
6.8 Item 1(Picture)

**6.8 (3)** There is no visible permanent carbon monoxide detector found in the home. It is recommended that one be installed according to the manufacturer's instructions for safety and to prevent a death from carbon monoxide poisoning due to the water heater located at the upstairs closet.

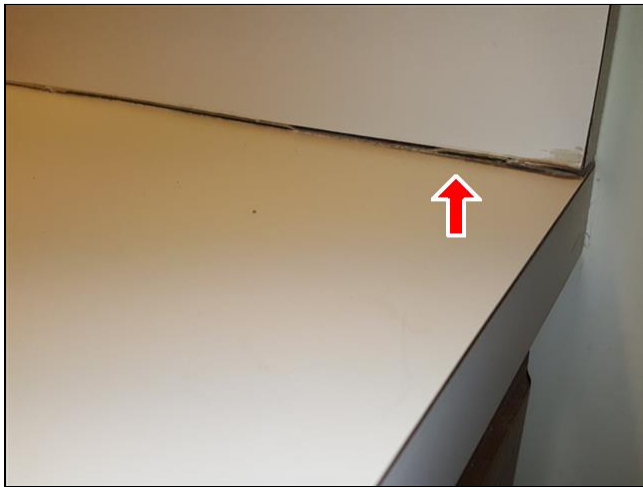
7.1 Item 1(Picture)

**7.1** Recommend caulking around the counter top in the guest bathroom to seal the gap/crack. Water may enter which can cause damage to the drywall and cabinets, then result in possible mold forming. Repair using a quality caulk that is resistant to moisture and is expandable. Here is a link on [How to Choose the right Caulk](#)

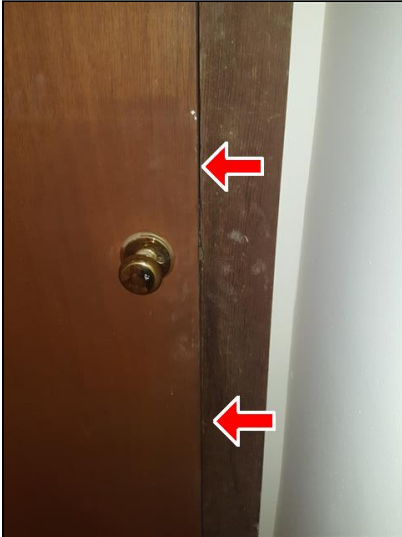
7.2 Item 1(Picture)

**7.2** The entry door in the basement bathroom where indicated in the photo does close properly, however it rubs at the door jamb when closing where indicated in photos. This is a maintenance issue and is for your information. Sometimes correcting the door opening can require the door trim to be removed then touch up painting or doors will need to be rehung or trimmed down. Recommend a qualified contractor repair as needed.

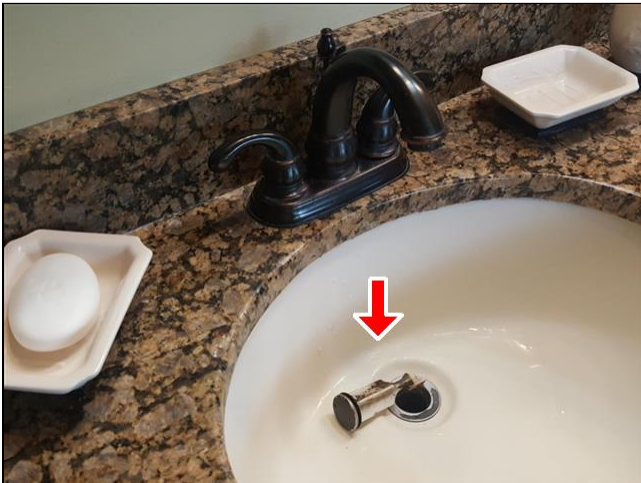
7.4 Item 1(Picture)

**7.4 (2)** The drain control stopper is not connected at the left sink and does not function in the master bathroom. Recommend correcting to allow easy use of the drain lever and to ensure it functions properly. Repair or correct as needed.

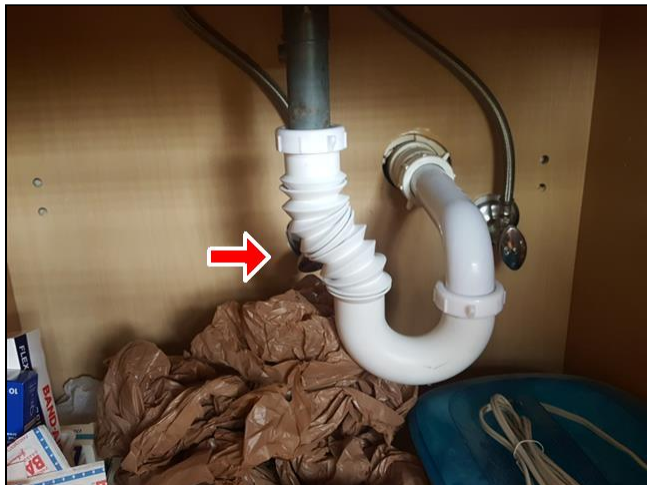
7.5 Item 1(Picture)

**7.5 (1)** Flexible ridged pipe is being used for the connection to the drain line under the sink in the master bathroom. The pipe ridges will hold and trap debris which could clog the drain. Plan on cleaning the drain from time to time. Smooth pipe would be better but may be difficult to fit to the existing drain lines. Recommend you seek a qualified licensed plumber to evaluate and correct if needed as this type of work is not to standard workman like practices.

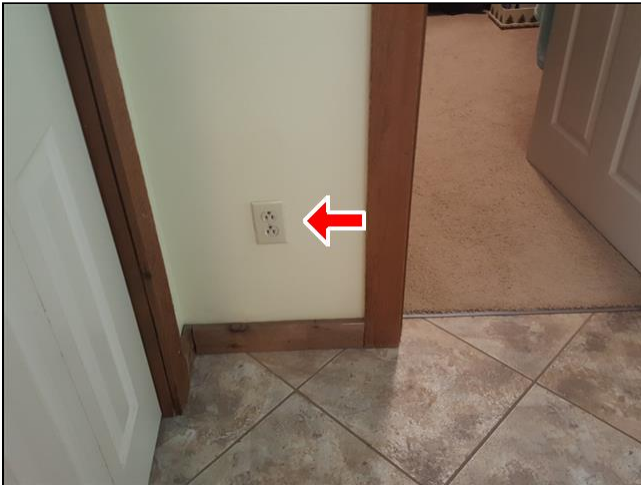
7.6 Item 1(Picture) master bathroom

7.6 (3) The outlet(s) are not GFCI protected in the Master and basement bathrooms where indicated in the photos. Although GFCIs may not have been required at the time that this house was built, these are now required and recommended for safety within any water source as a safety feature when any changes to the outlets are made. GFCI outlet offers protection from shock or electrocution. Recommend a licensed electrician correct as needed prior to moving in.

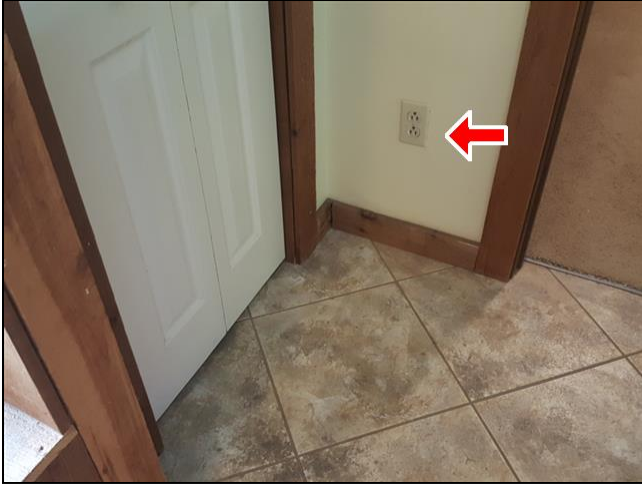
7.6 Item 5(Picture)

**7.6** (4) The outlet in the master bathroom where indicated in the photo is loose at the wall or at the outlet box. Electrical issues are considered a hazard until repaired. This is a safety issue that needs to be corrected due to an electric shock or fire from loose connections could occur if not repaired. Recommend a qualified licensed electrical contractor correct as needed.

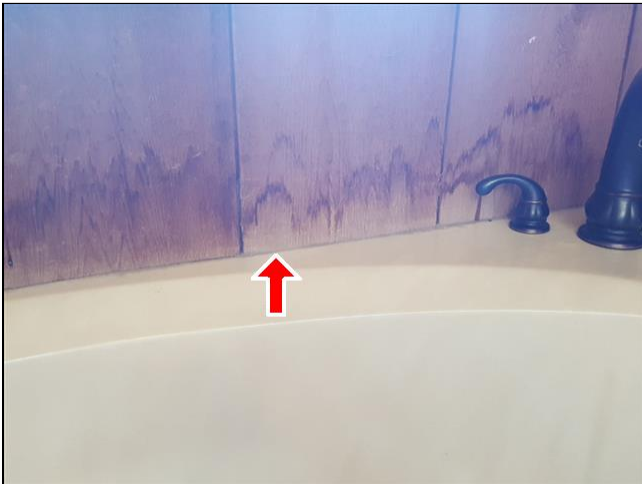
7.7 Item 1(Picture)

**7.7** (1) Water stains on the wood paneling at the bathtub in the master bathroom was noted. Recommend changing the wall covering to prevent mold and deterioration of the wall covering in the future.

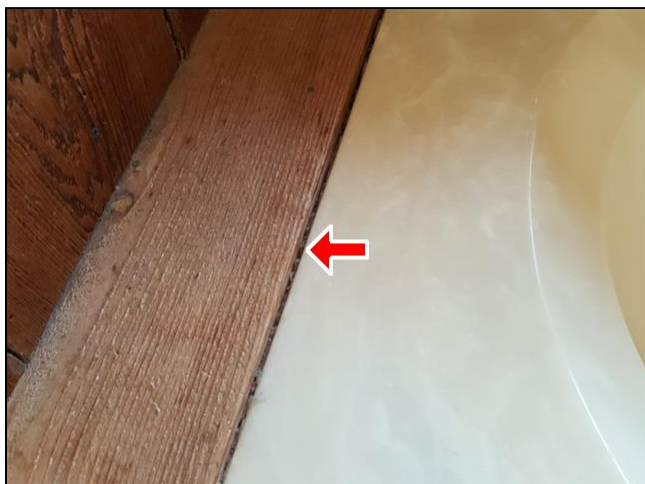
7.7 Item 2(Picture)

7.7 (2) Recommend a quality caulk that is expandable and moisture resistant along the top of the threshold of the bath tub so moisture or water cannot penetrate in the master bathroom. [Choosing the right caulk](#)

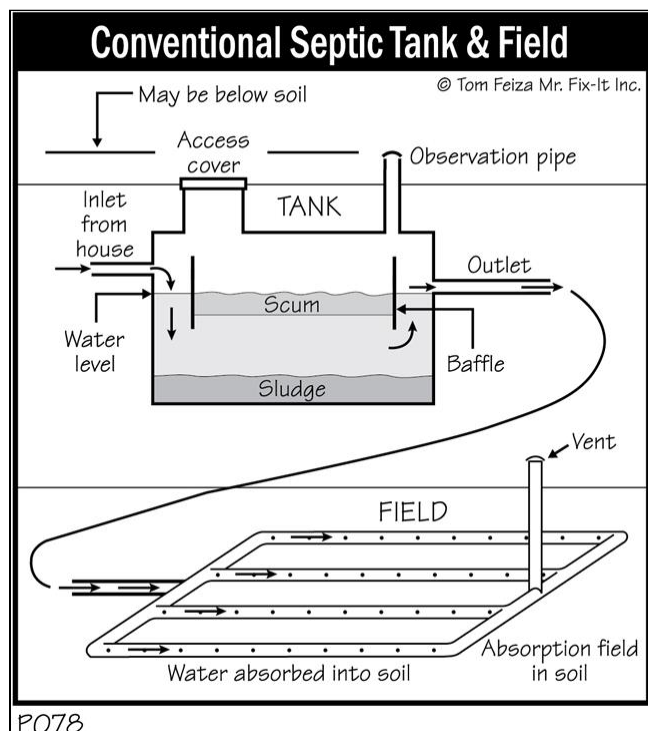
8.0 Item 1(Picture)

**8.0 (1)** This inspection did not access the septic tank or determine its location. I did not visually locate the septic nor did I inspect the tank and drain lines for size or condition. Changes in water volume use can sometimes have an impact on septic tanks that before were working properly. Most septic contractors recommend that if the septic tank hasn't been pumped and inspected in the last 4-5 years, you should have it pumped and inspected visually during the inspection process to determine its true condition. For a more detailed inspection, recommend you contact a septic pumping company.

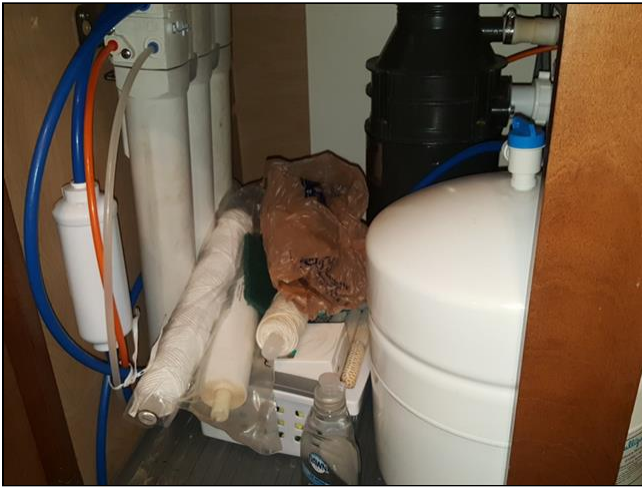
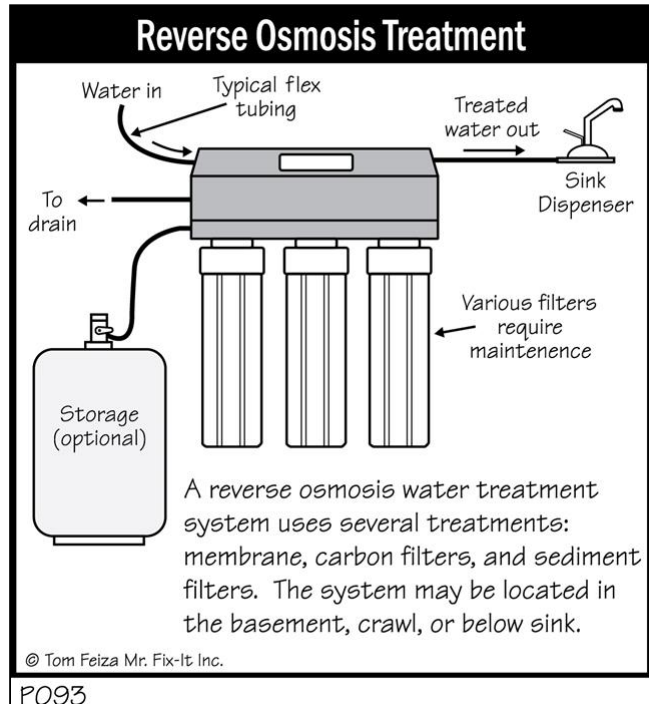
**8.1 (1)** This house has a water softener unit under the kitchen sink. I did not inspect any water filtration units. Filters should be changed on a regular basis to prevent pressure loss and to keep the water cleaner. This is for your information. Recommend consulting with owner for operation and maintenance instructions for the unit. I would also recommend contacting the installer or qualified contractor for information on life expectancy and/or condition.

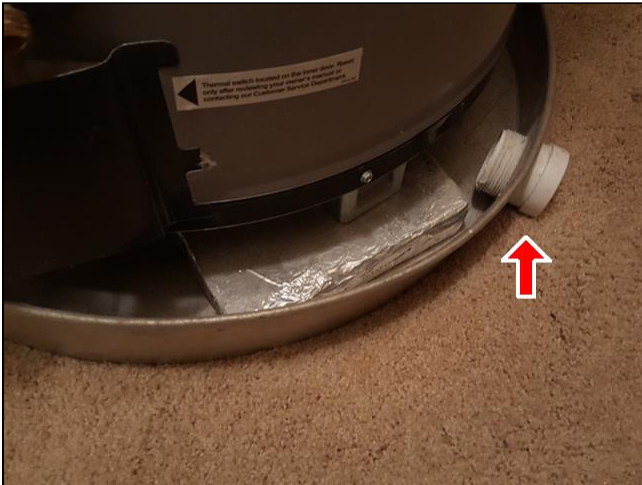
8.2 Item 2(Picture)

**8.2 (4)** The drain pan installed under the water heater in the upstairs closet is missing a drain line to the exterior. If the water heater leaks it has the potential to cause severe damage if a leak should develop which will result in costly repairs to the floor and ceiling below if a drain line is not connected. As an inexpensive safe-guard a drain pan with a moisture alarm can easily be installed as another option. Recommend a qualified plumber install a drain line at the pan that leads to the exterior of home.

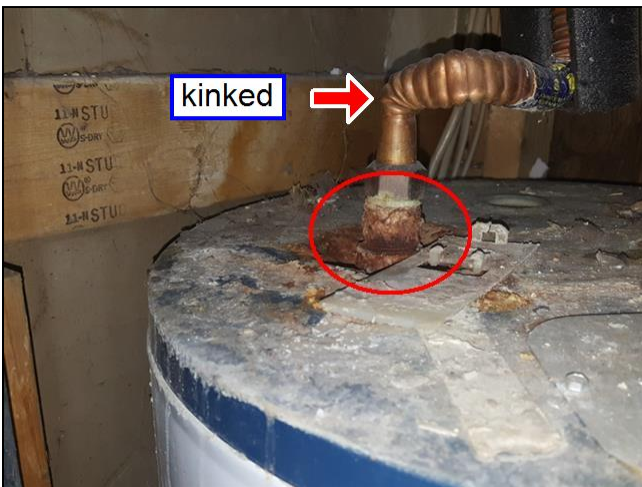
8.2 Item 3(Picture)

**8.2 (5)** Corrosion and a kink at the hot water supply inlet at the top of the water heater was noted in the basement washer dryer room. This usually occurs when two different types of metals are in contact with each other. This area will eventually leak water. Recommend a qualified plumber further investigate and repair as needed. Due to the age of unit, consideration in replacing unit would be wise before a major leak occurs.

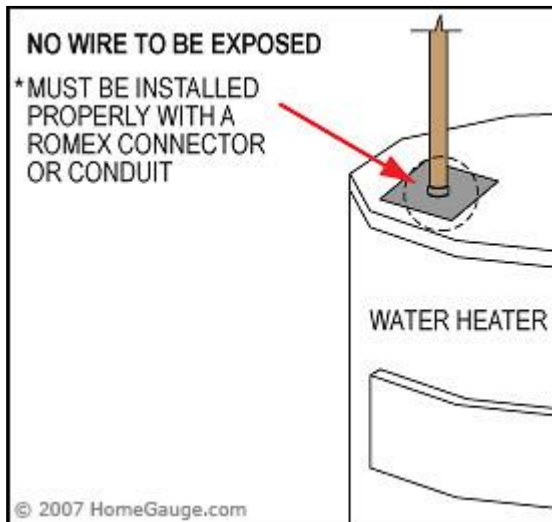
8.2 Item 7(Picture)

8.2 (8) There is no strain-relief clamp on the wire where it enters the top of the water heater in the basement. This is a safety issue. A child or person could easily pull the wire out of the heater, touch an energized conductor, and be electrocuted causing possible death. Recommend a qualified licensed electrician repair as needed for safety.

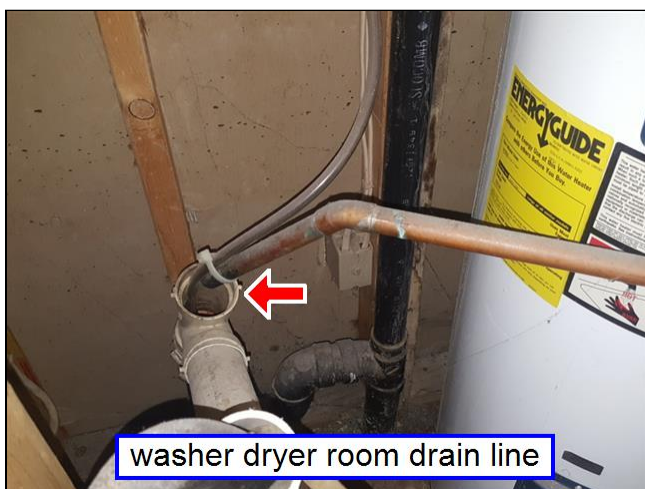
8.3 Item 1(Picture)

8.3 (1) Location of the TPR (temperature pressure relief) drain line to exterior. (see picture)

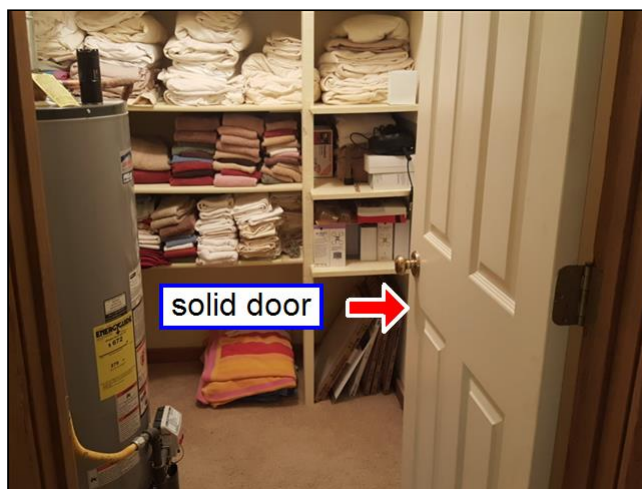
8.4 Item 2(Picture)

**8.4** The water heater is located in the closet upstairs. This is a safety issue and can be hazardous to your health. When a gas appliance is located in a small enclosed room it requires combustion air. If the closet doors are closed, there will be inadequate combustion air for the water heater due to only one vent was found. Inadequate combustion can result in excessive amounts of CO (carbon monoxide) being produced and has been known to cause sickness or death. When a gas appliance is placed in a small confined enclosure, it requires proper ventilation. The easiest remedy is to install two metal 6" pipes to obtain air from the attic or the outside. The two openings located high and low with 144 square inches of free space each, or a louvered door with free space of 288 square inches is required. Recommend a qualified plumber further evaluate and make the necessary corrections for your safety prior to closing.

Note: Vent screens that are used for combustion air for a gas appliance **must not have any damper or closing device**. This is a serious safety issue. Recommend replacing vents that are not adjustable.

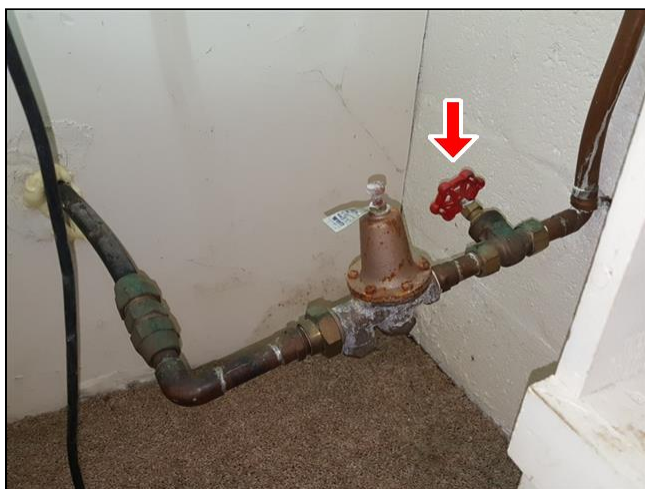
8.5 Item 1(Picture)

**8.5** (1) The main water shut off is the red knob located in the basement under the living room area. This is for your information.

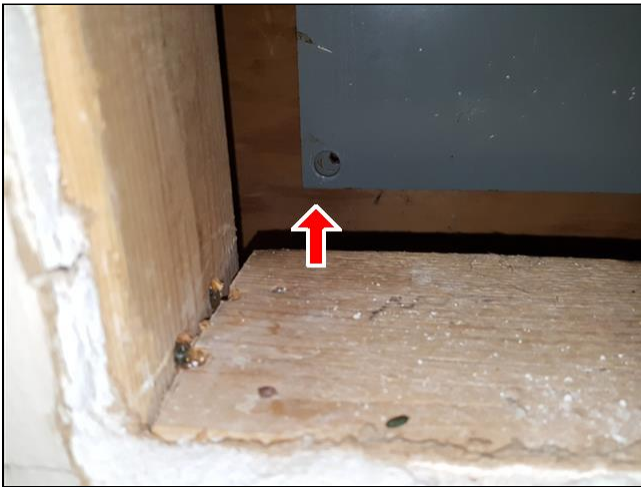
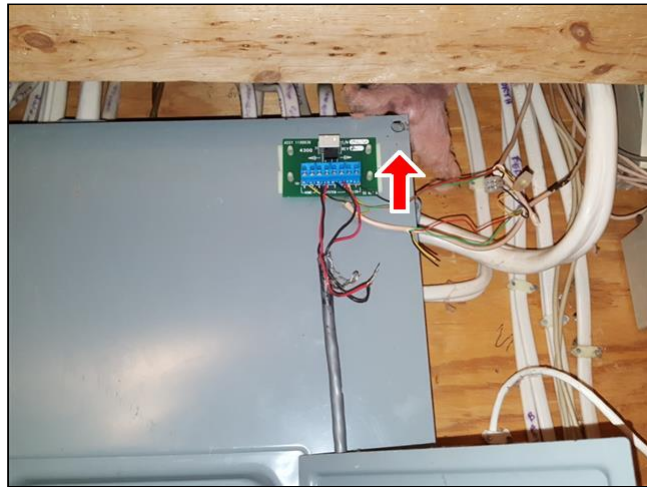
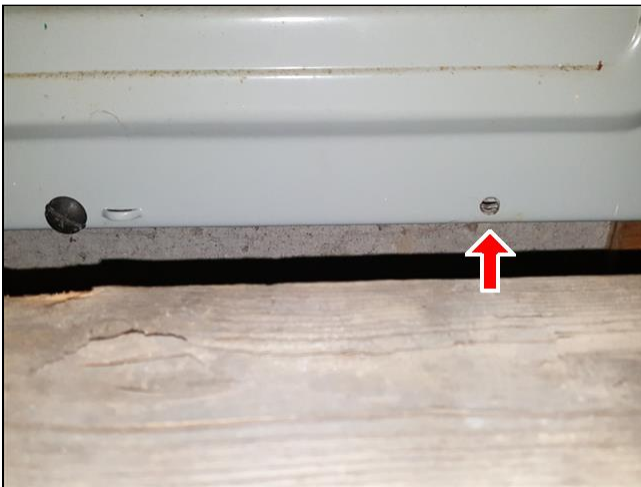
9.2 (2) There are screws missing from the cover for both the electric panels where indicated in photos. This is a safety issue. The missing cover screws should be installed to prevent easy entry and to prevent moisture from entering the panel box. Recommend an licensed electrician correct as needed for your safety.

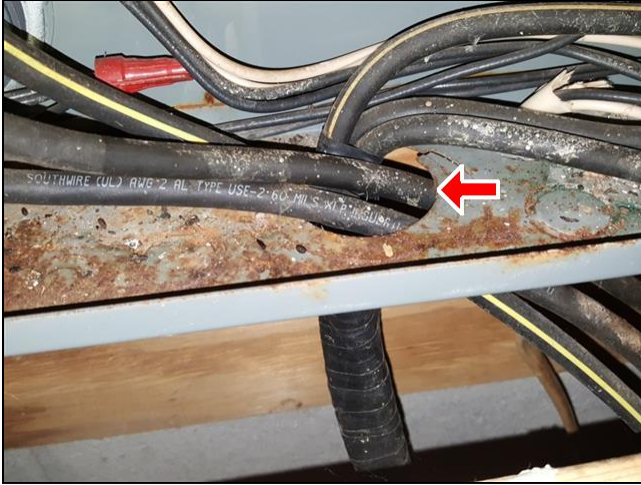
9.2 Item 4(Picture)

9.2 (3) Cable clamps (sometimes referred to as bushings or grommets) are required where wiring passes into the electrical main panel box. Cable clamps serve to protect the wiring from the metal edges of the panel box to prevent a short from occurring or from the panel box becoming energized which can result in a death via electric shock. This is a safety issue. Recommend a qualified licensed electrician repair as needed.

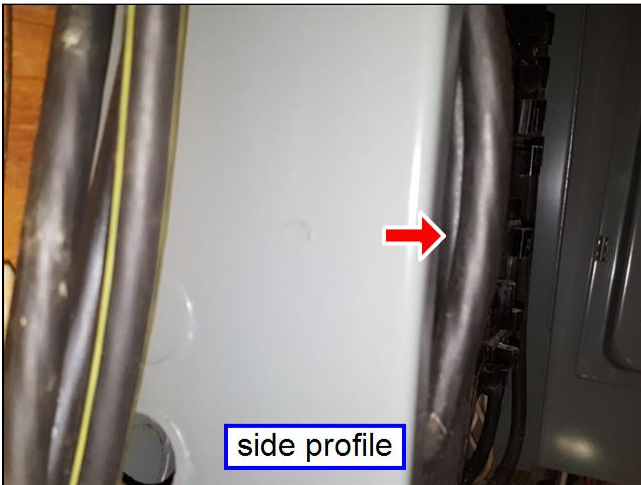
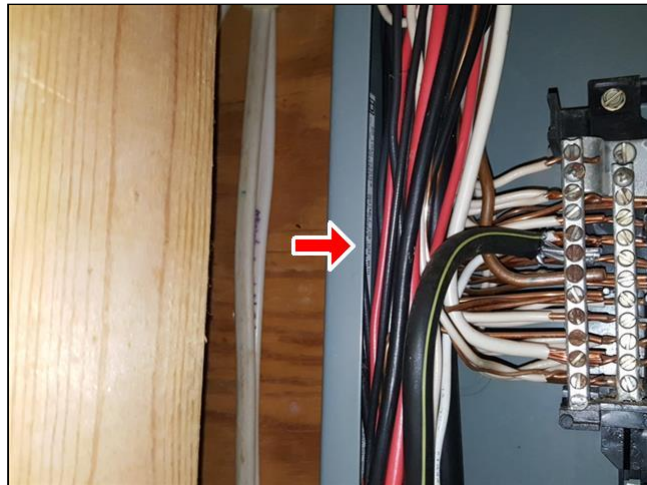
9.2 (4) The wiring in the main panel box is near or on top of the panel under where the cover is attached on both sides. This is a serious safety issue. If the panel cover were to be secured with screws on this side it could crush wires which may cause the box to energize resulting in a death via electrocution if the panel box is touched. Recommend a qualified licensed electrician correct for safety as needed.

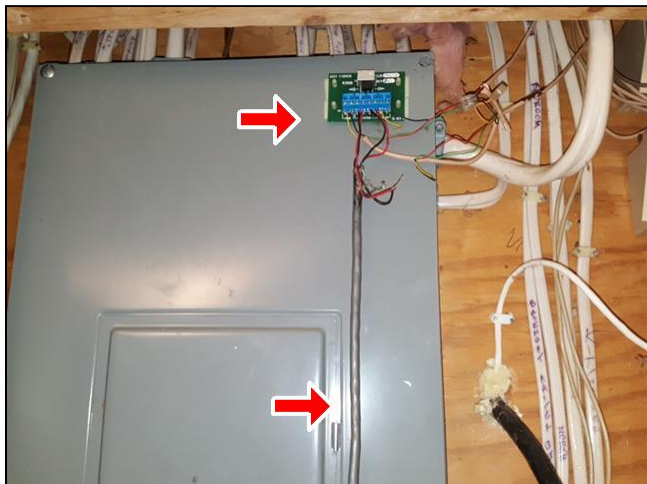
9.2 Item 7(Picture)

9.2 (5) No wires should be attached to the panel cover. This makes it difficult to have it removed for inspection and repairs when needed. Recommend an electrician correct as needed.

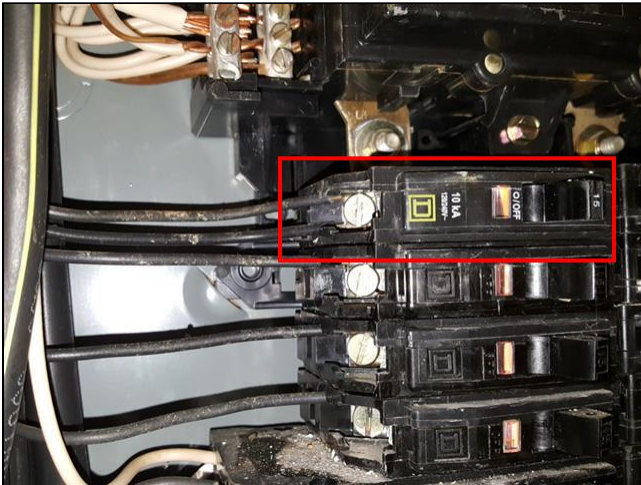
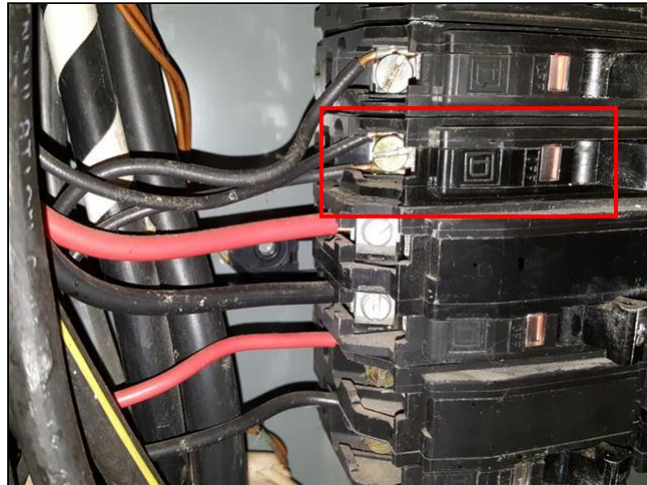
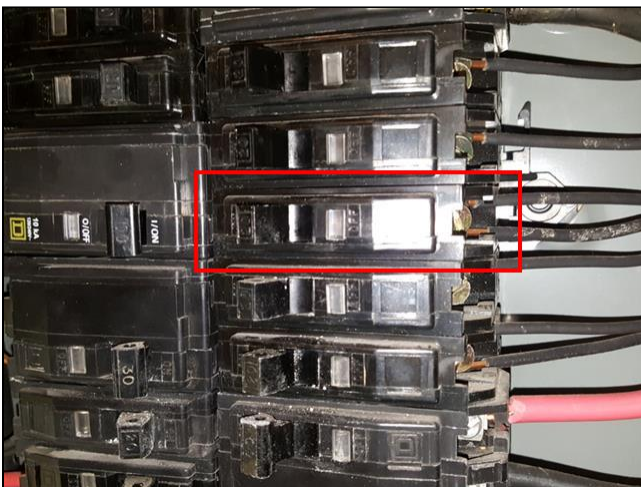
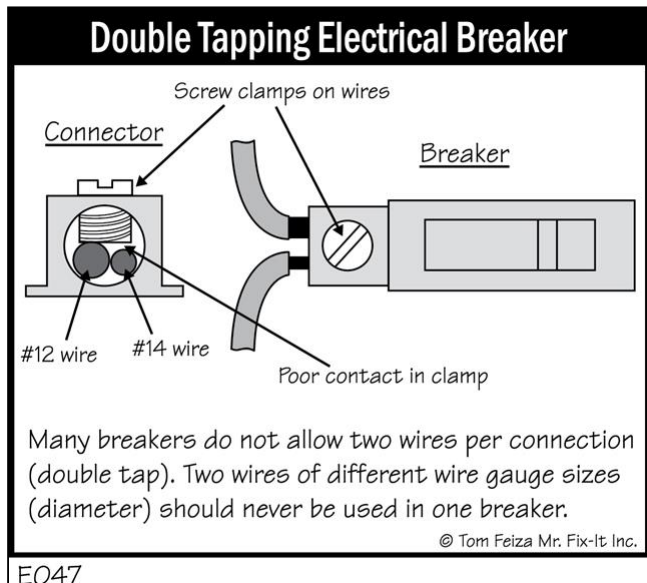
9.3 (3) Multiple tap wiring (more than one hot wire attached to the same breaker) was found in the main panel. This panel and breakers are NOT MADE or DESIGNED to provide adequate holding power for multiple wires on a single breaker. A separate breaker should serve each circuit. This is a very hazardous and is a safety issue. May cause a fire or short. Recommend a qualified electrician further evaluate the panel box for further issues and repair and correct as needed.

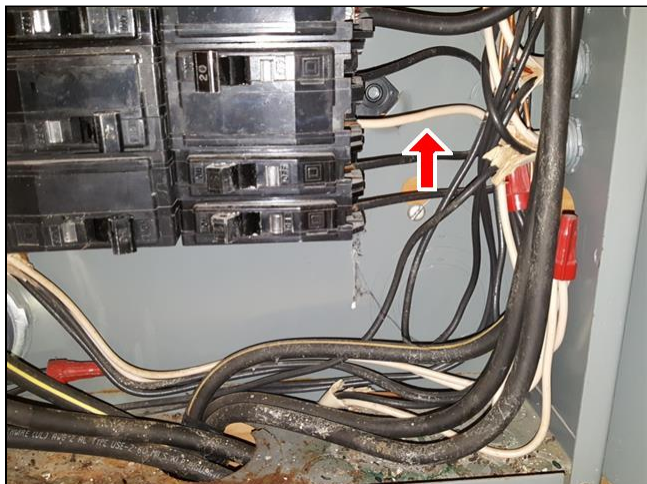
9.3 Item 6(Picture)

9.3 (4) The white wire(s) that are connected to the circuit breaker(s) in the main panel should be marked black to indicate that they are live (hot wires) and are being used for the flow of electricity to travel. Recommend an electrician correct due to safety.

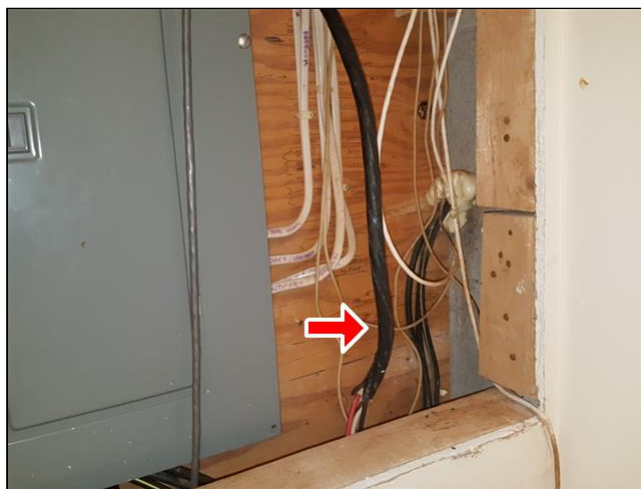
9.3 Item 9(Picture)

**9.3** (6) Wires that are not in use or connected to a breaker in the panel box should have a twist cap to protect the wire from possibly being energized if it comes in contact with current. If not corrected this could lead to a possible short creating a fire or it may energize the panel box creating an electrical shock when the box is touched. This is a serious safety issue. Recommend a qualified electrician repair as needed and further inspect panel to determine any other additional issues that could not be found within the panel box for your safety.

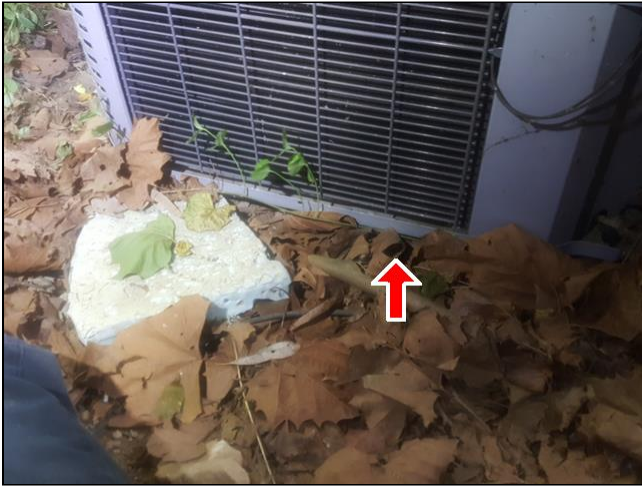
10.0.A Item 1(Picture)

**10.0.A** (2) The heat pump should be raised of the ground for better efficiency and proper drainage. Blocked fins via snow coverage can harm the unit and increase energy costs. Recommend a qualified HVAC contractor correct if desired. Ensure when a new unit is installed that this is done on new installation.

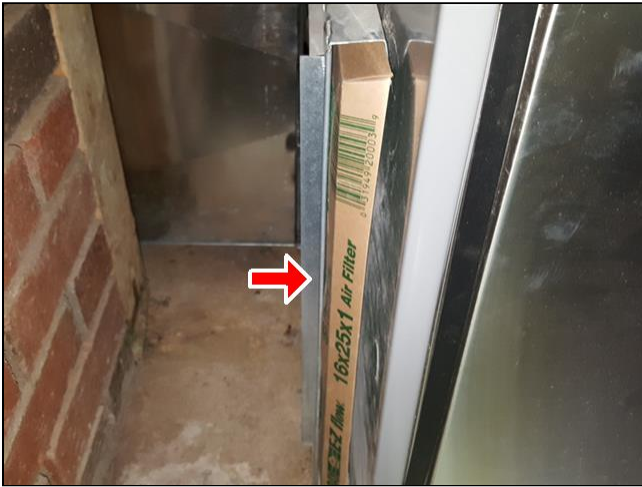
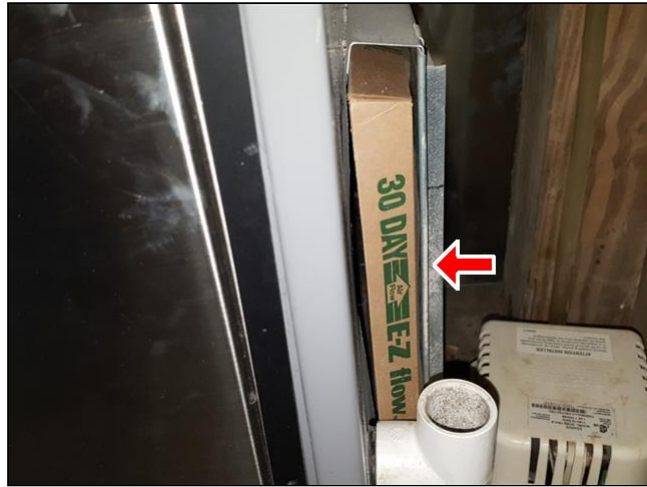
**10.1.A** (1) Filter location (see photo). The arrow on the filter should always point towards the blower.

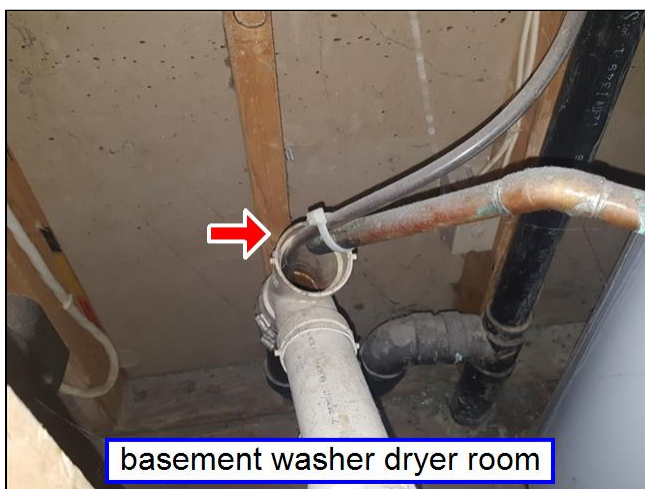
10.4.A Item 1(Picture)

**10.4.A** (1) Location of the condensate drain line to exterior. (see photo)

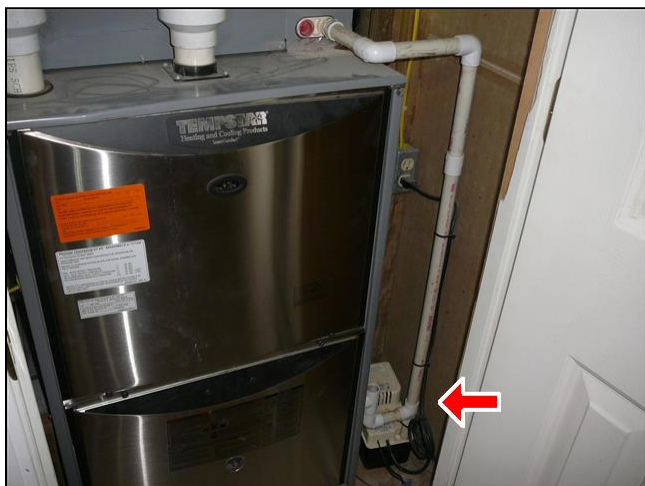
10.4.A Item 2(Picture)

**10.4.A** (2) The condensate pump was tested and was working at time of inspection.

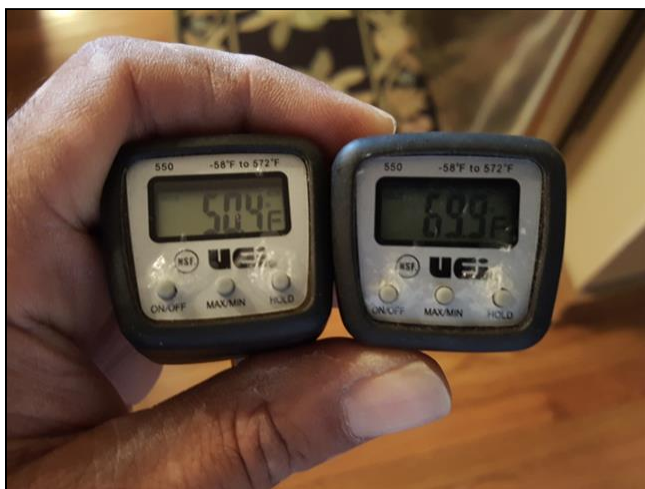
10.8.A Item 1(Picture)

**10.8.A** The ambient air test was performed by using thermometers at the registers closest to the blower to determine if the difference in temperatures of the supply and return air are between 14 degrees and 22 degrees which indicates that the unit is cooling as intended. The supply air temperature on your system read 50 degrees, and the return air temperature was 70 degrees. This indicates the range in temperature drop is normal.

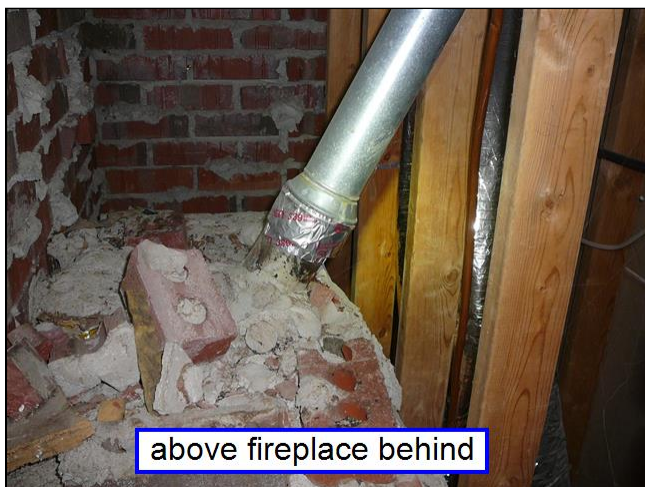
10.10.A Item 1(Picture)

10.10.A (2) The fireplace in the basement is not suited for wood burning. This is for your information.

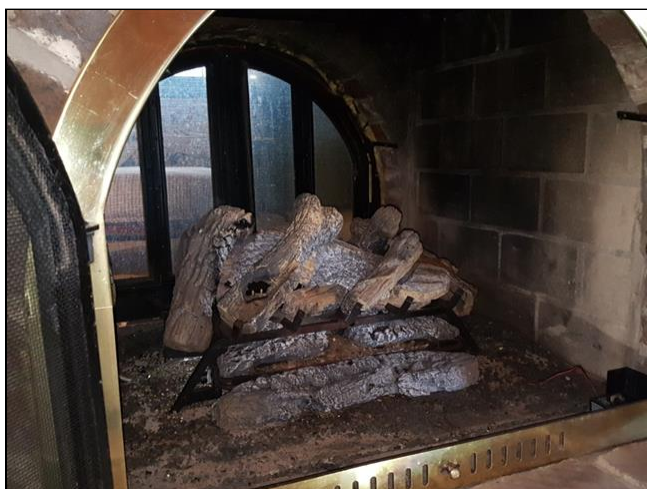
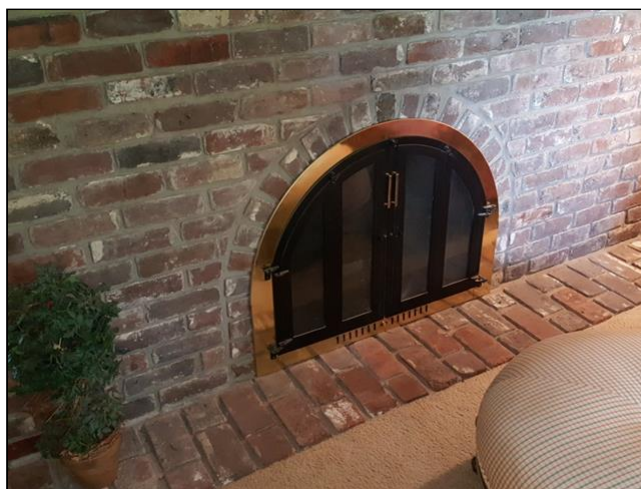
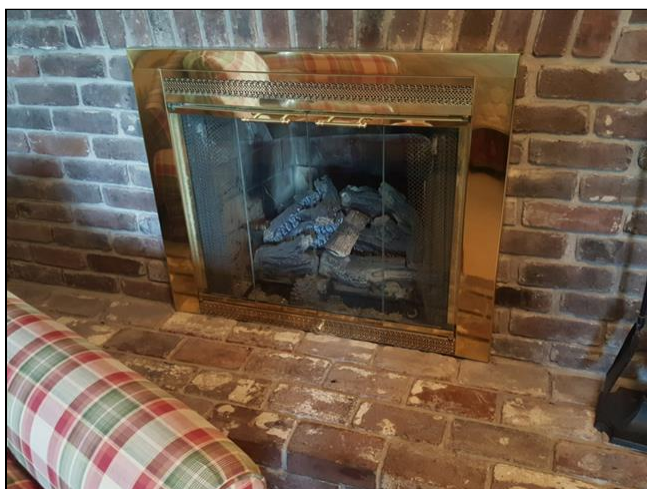
**10.11.A (1)** The fireplace in the living room, sitting room, and master bedroom is equipped with a gas log insert with the pilot light turned off. The inspector is **NOT** required to light pilot lights and operate these fixtures. Reason why we do not light pilot lights is for safety. As such we suggest that the pilot be lit and the fireplace operation be verified with the current owner during the final walk-through to insure continued good operating conditions. If the owner is unsure or if the gas fireplace has not been used for some time, we strongly recommend a qualified fireplace contractor further evaluate and inspect to ensure safety and operation of the gas fireplace prior to moving in.

Note: when the gas fireplace is being operated you **MUST** have the damper fully opened in order to prevent carbon monoxide entering the home which is a poisonous gas that can lead to a death.

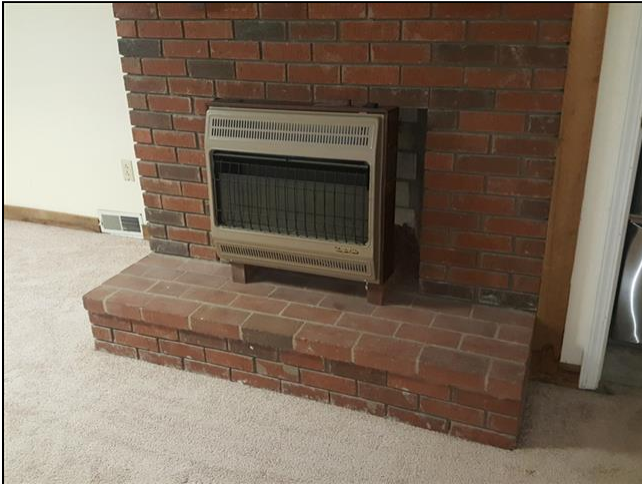
10.11.A Item 4(Picture)

**10.11.A** (3) The non vented gas fireplace at the basement family room was not inspected for operation. There was no pilot light lit. The inspector is **NOT** required to light pilot lights and operate these fixtures. Reason why we do not light pilot lights is for safety. As such we suggest that the pilot be lit and the fireplace operation be verified with the current owner during the final walk-through to insure continued good operating conditions. If owner is unsure or gas fireplace has not been used for some time, we strongly recommend a qualified fireplace contractor further evaluate and inspect to ensure safety and operation of the gas fireplace prior to moving in.
