## **Inspection Report**

**Property Address:**  
780 Nutfield Way  
Richmond KY 40475

<b>Date:</b> 7/15/2018	<b>Time:</b> 09:00 AM till 03:00 PM	<b>Report ID:</b> 180715BETHAM
<b>Property:</b> 780 Nutfield Way Richmond KY 40475	<b>Customer:</b> Mrs. Gail Schneider	<b>Real Estate Professional:</b>

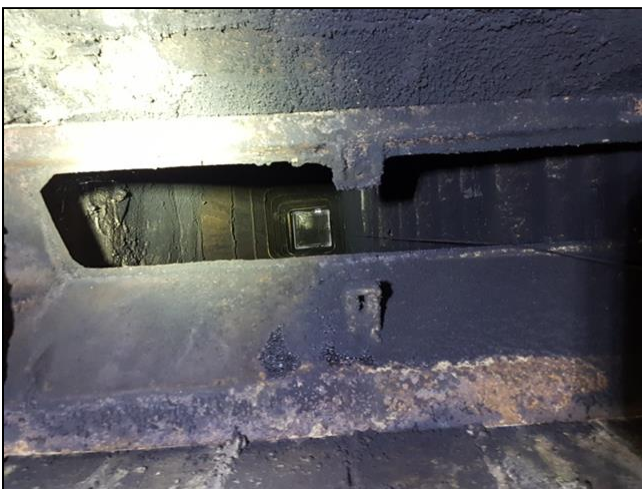
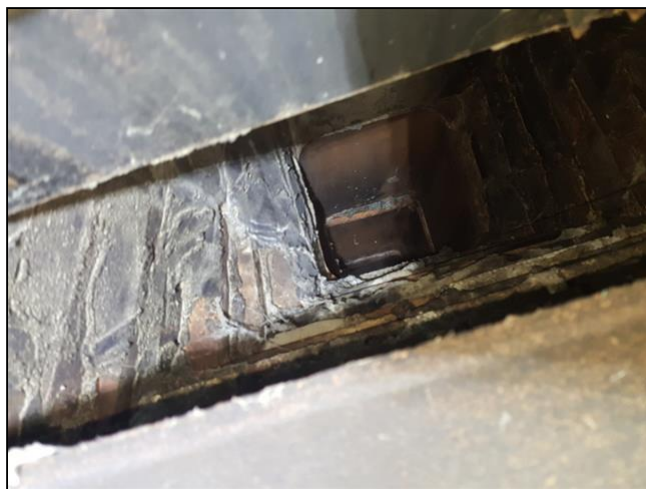
**10.12.A** Our inspection of the chimney is limited to the readily visible portions only. The inner reaches of the flue is relatively inaccessible. Our restricted view from the top or bottom is not adequate to discover possible deficiencies or damage, even with a strong light. For safe and efficient operation we recommend annual inspections by a qualified fireplace professional. A qualified fireplace professional will clean the interior if necessary, use specialized tools, testing procedures, mirrors and video cameras as needed to evaluate the fireplace system. If the chimney/flue has not been inspected or cleaned by a qualified fireplace professional within the past year we recommend this be done prior to use.

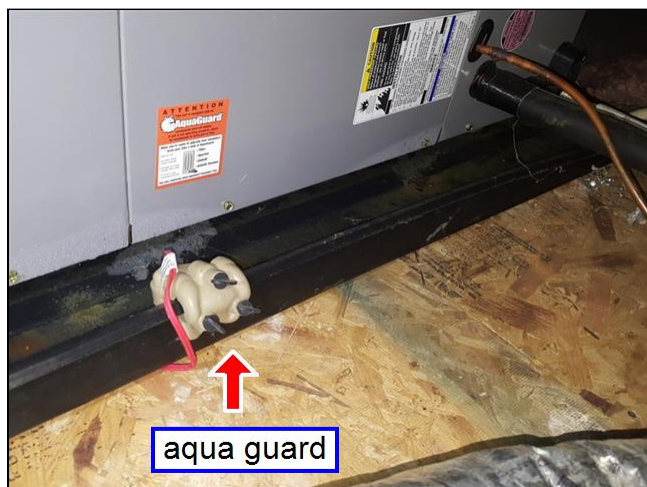
10.0.B Item 1(Picture)

**10.0.B (2)** The Air Handler in the attic has a condensate drip tray with an aqua guard shut off switch installed. In the event that condensate malfunctions or water overflows into the tray the float switch will sense there is excess water in the tray and will shut down the system. This may be inconvenient in hot weather, but the installer or owner have chosen to protect the building against a potentially costly mold or water damage to the attic. This is for your information.

Please note: If your HVAC system seems okay but won't turn on, this switch could be one of the items to check. Recommend checking the tray each quarter for water as it has no where to drain away.

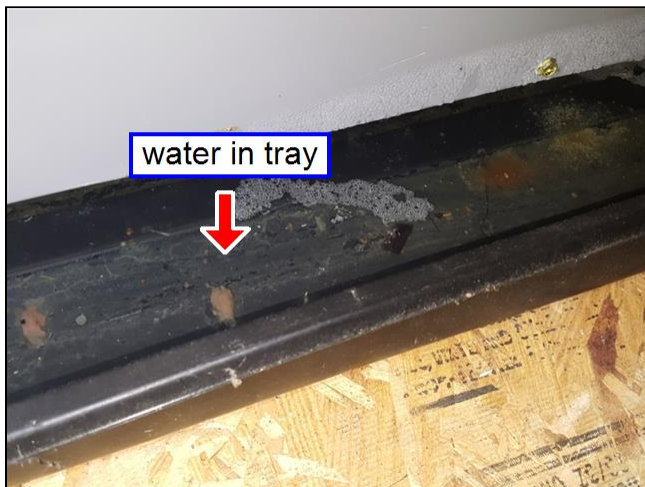
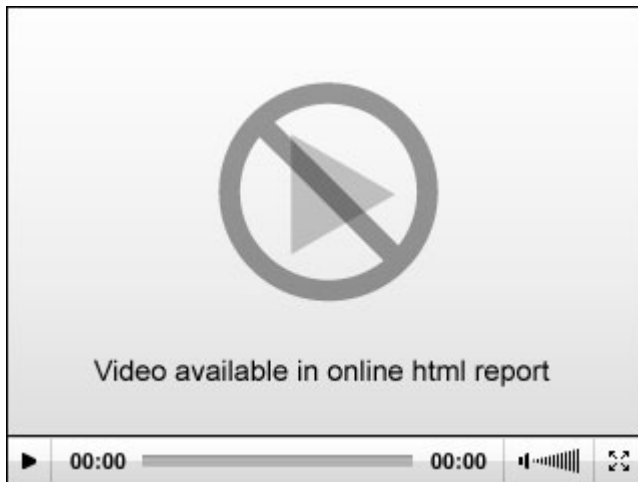
**10.0.B** (3) Water was found in the condensate drain pan under the air handler in the attic. This water may be leaking from the evaporative coil or maybe caused by condensation from the large suction line leading into the unit. **Strongly** recommend a qualified HVAC contractor further investigate for cause and make any needed repairs that may be necessary prior to closing. Also recommend the Aqua guard condensate shut off switch be checked to see if it is working as the unit remained on during the inspection.

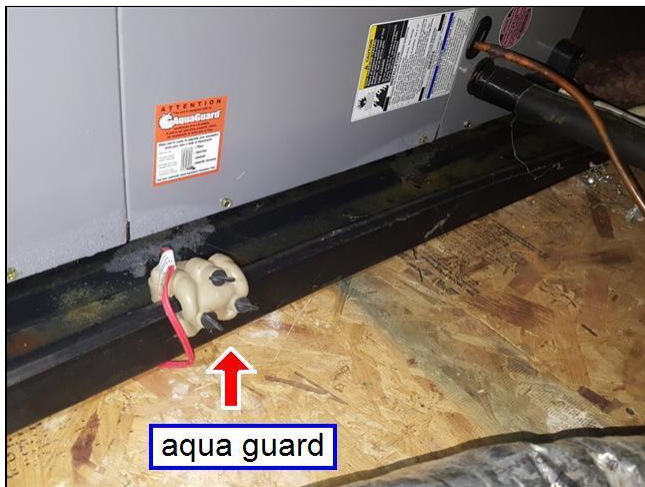
10.2.B Item 3(Picture)

**10.2.B (3)** The aqua guard safety switch does not appear to be working. Water was in the tray and the switch was in contact with the water, yet the unit remained on. Recommend a qualified HVAC contractor repair or replace as needed to prevent a water leak occurring in the attic which will damage ceiling and insulation in the attic. Also refer to note 10.0.B(3).

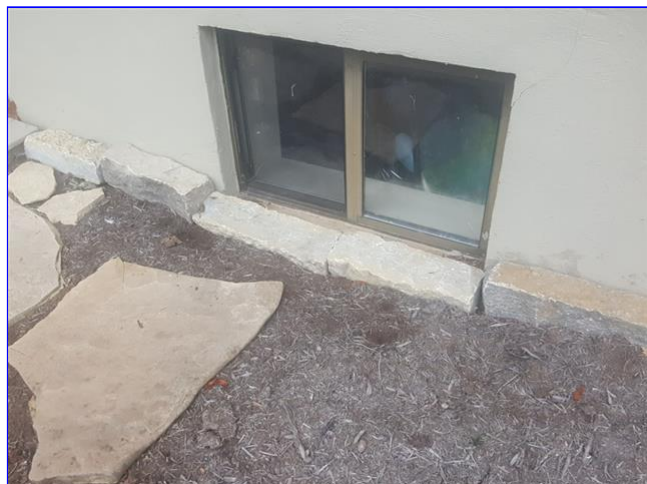
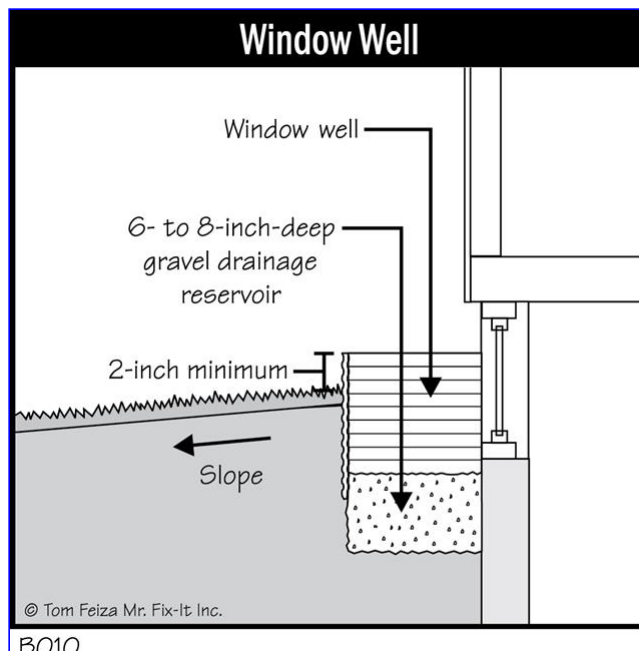
The basement window at the rear right side of the home is at or near ground level. This can allow water entry into the basement. Water intrusion in a basement can lead to more costly repairs and cause mildew or mold to form. Recommend a half-round window well be installed where needed. The dirt inside the well should be replaced with approximately four inches of gravel. A couple of inches clearance between the gravel and window opening is recommended. Recommend a general contractor correct as needed.

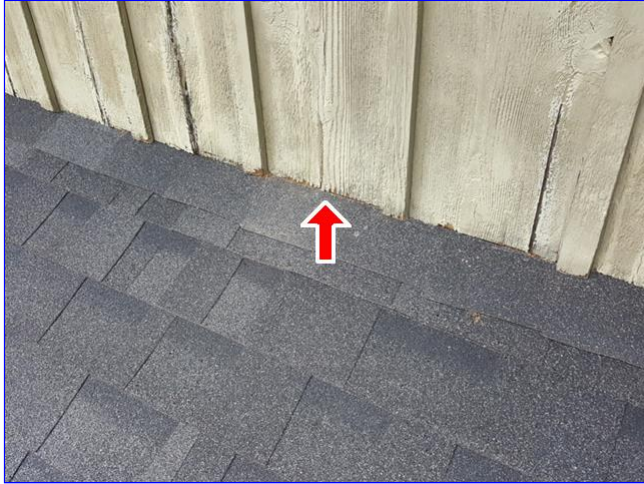
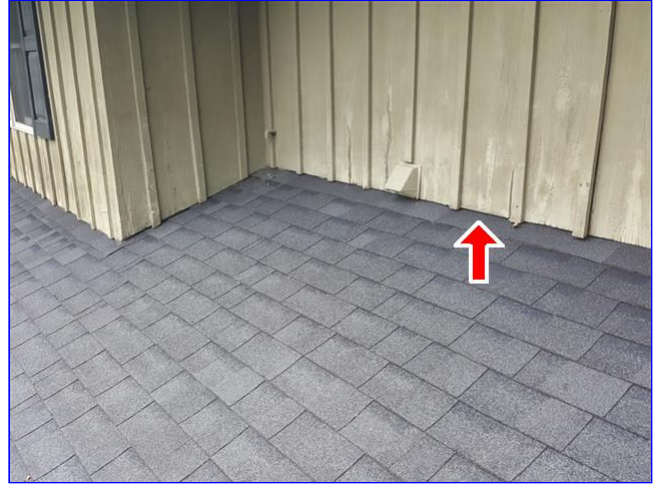
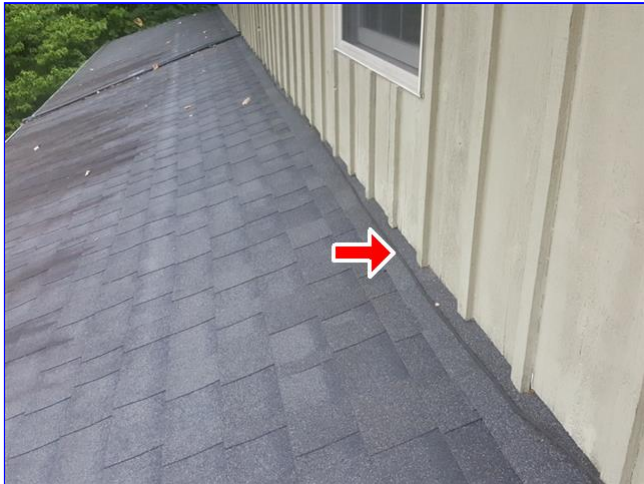
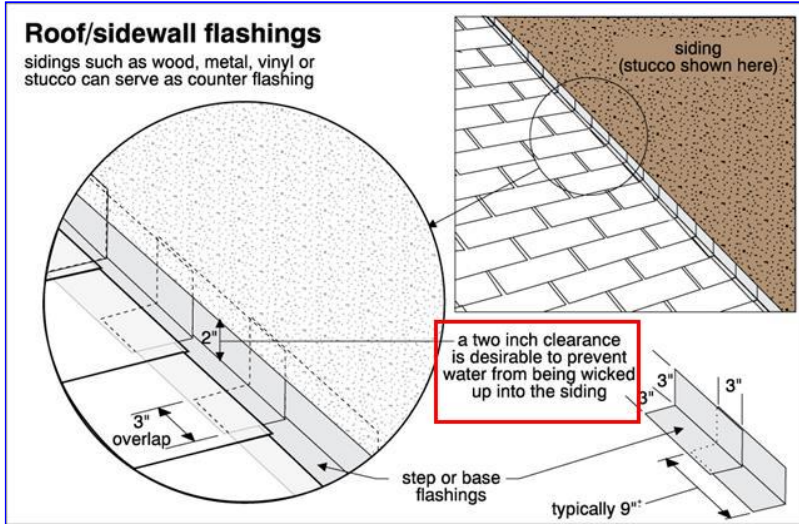
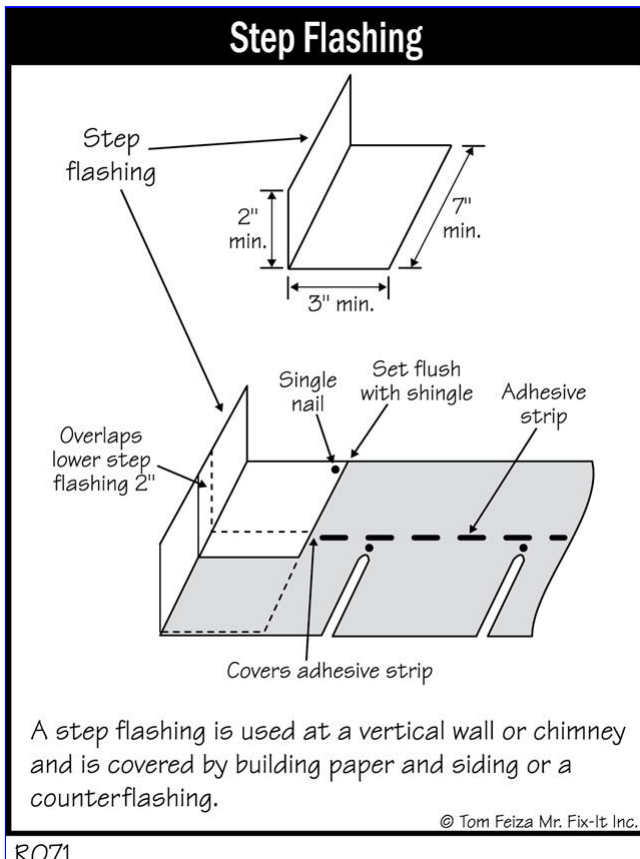
(2) Where the wall and roof intersects at the top level of the home it is recommended that a 2 inch gap is needed between the siding and the roof to prevent water absorption to prevent the ends of the wood siding from deterioration. Cannot determine if a metal flashing has been installed. This area is more prone for water leakage which can lead to the deterioration of the wood structure and framing of the roof and damage to the wall framing if a flashing is not installed. Recommend a qualified roofing contractor further evaluate, correct and repair as needed to ensure water leakage does not occur and to prevent the wood siding from rotting underneath.

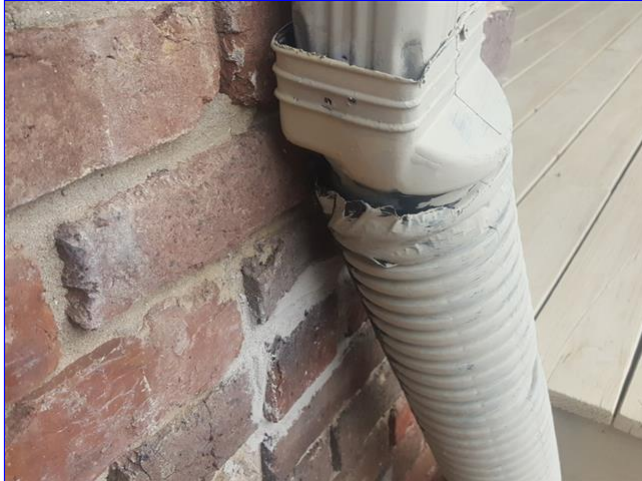
2.4 Item 3(Picture) front center of home

(3) The downspout extension has deteriorated at the join at the front center of the home. Leakage maybe be experienced here when it rains which could lead to basement leakage. Recommend replacement as needed.

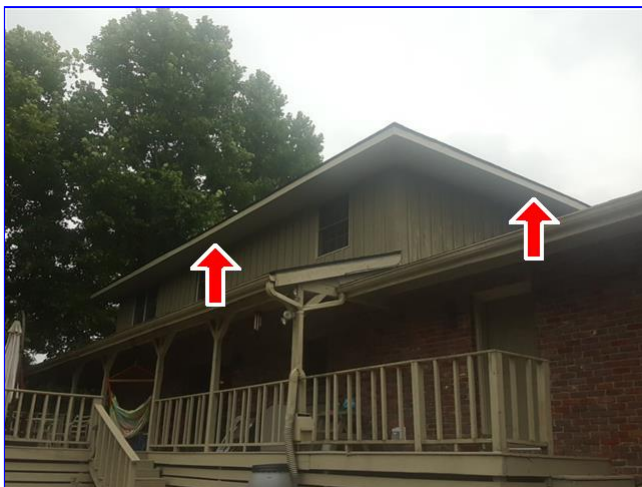
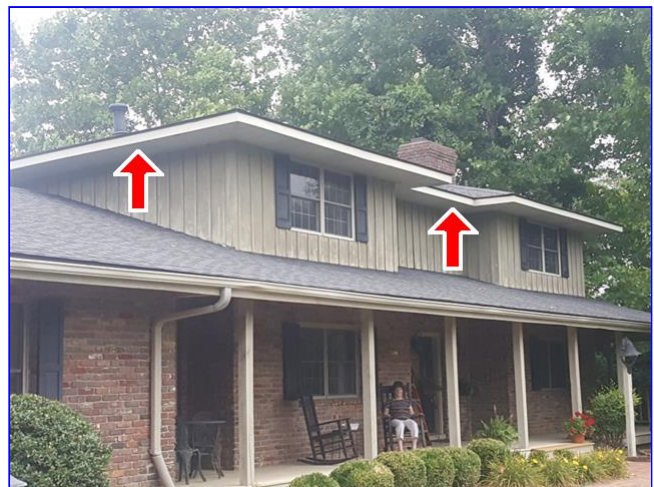
(4) Gutters and downspouts are missing at the top roof of the home and should be installed to prevent deterioration of the roof shingles below and to avoid spilling roof runoff around the building if current downspouts cannot adequately drain roof runoff efficiently- a potential source of water entry into the basement or water damage. Recommend a qualified contractor install a gutter system at the top level of the home. Ensure that the downspouts drain directly into the lower gutter and not on the roof.

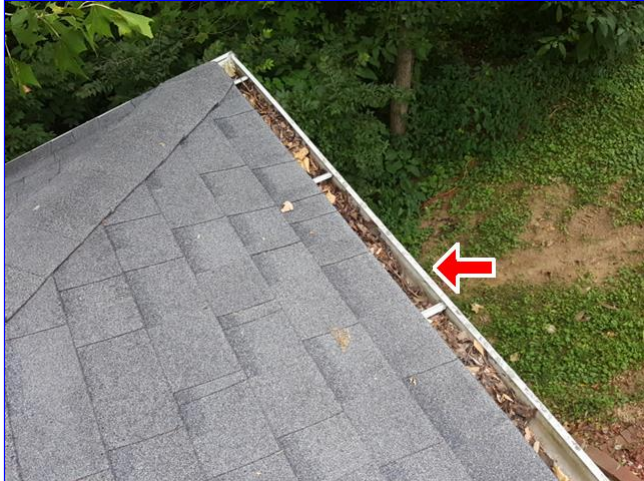
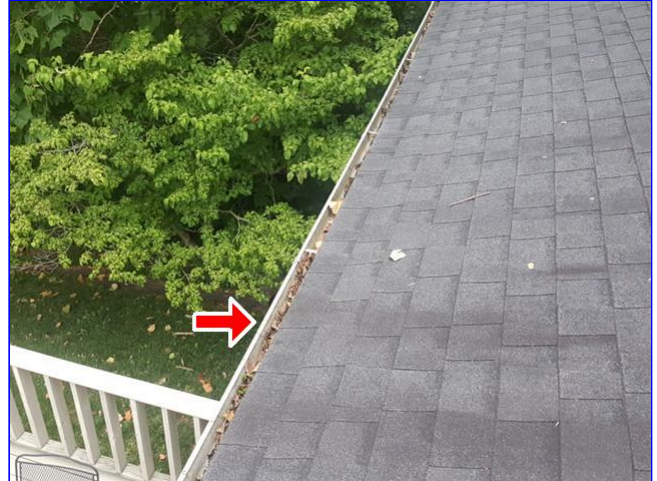
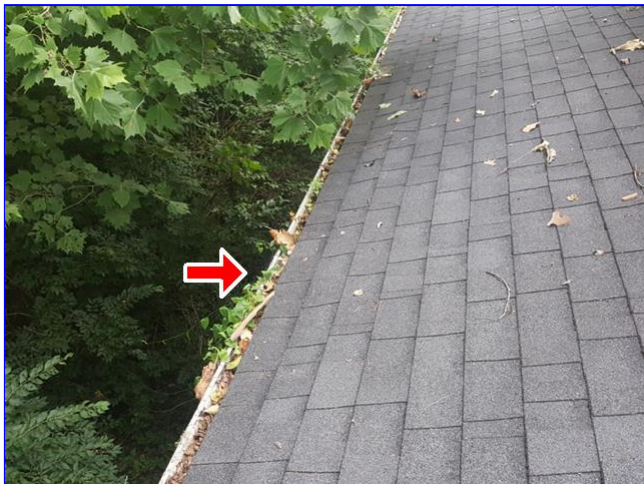
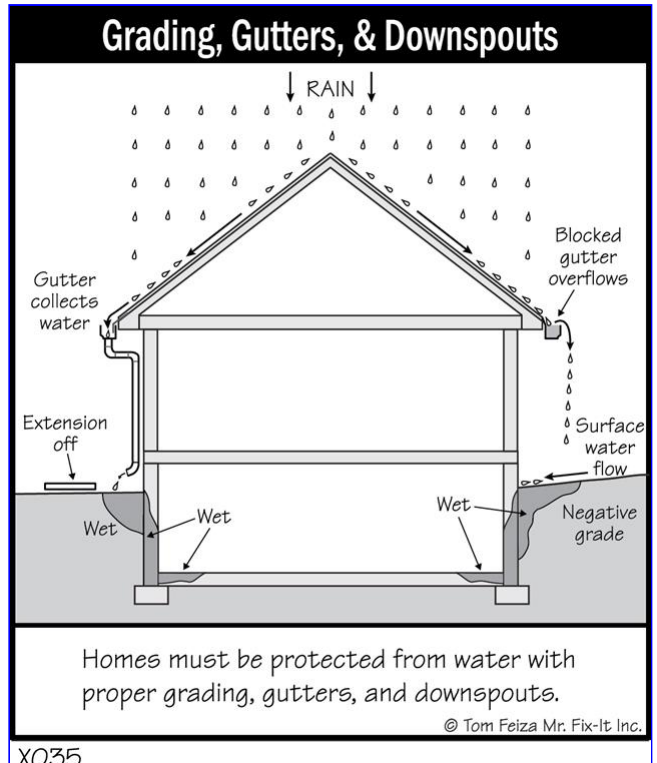
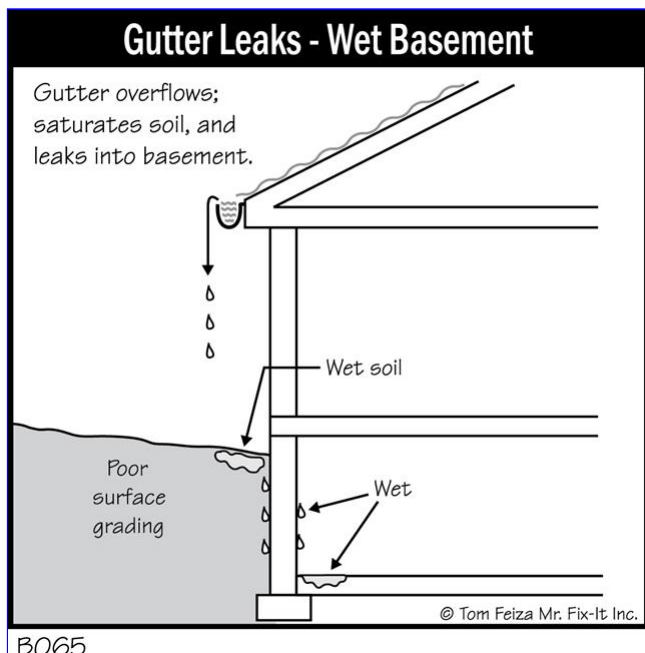
(5) The gutter(s) where indicated in the photos, especially where they drain into the downspouts, are full of debris and need to be cleaned. The debris in gutters can also conceal rust, deterioration or leaks that are not visible until cleaned, and I am unable to determine if such conditions exist. Gutters require cleaning to avoid spilling roof runoff around the building - a potential source of water entry or water damage, and/or the fascia could become damaged. Recommend cleaning the gutters as needed. You may wish to consider installing gutter guards due to trees surrounding the home.

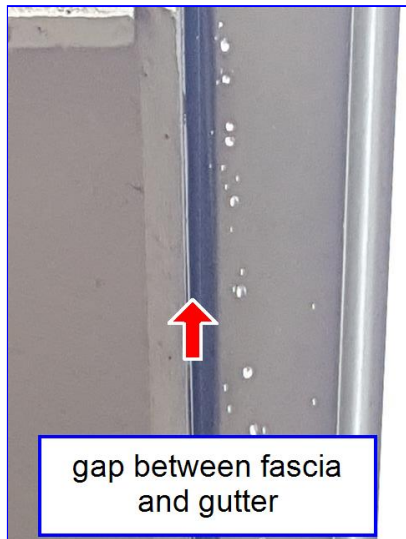
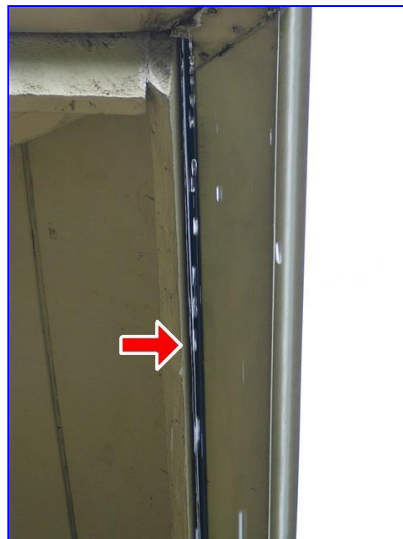
(6) The gutter needs to be tightened against fascia and sealed at the front left side of the home. This may cause water to pool in this area and may cause the gutter to pull away and detach from the fascia. Recommend a general contractor repair as needed.

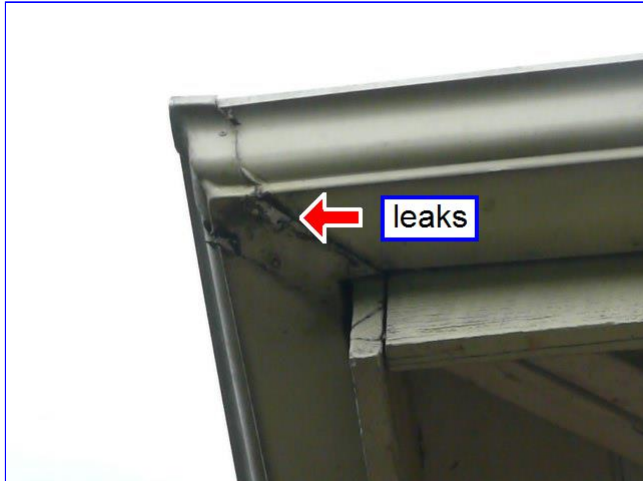
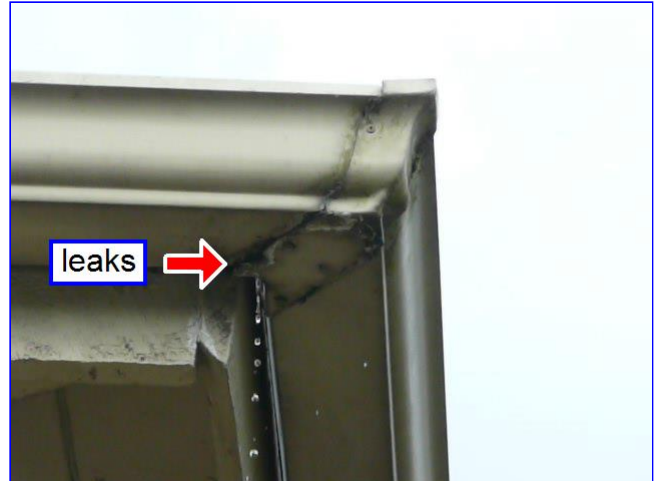
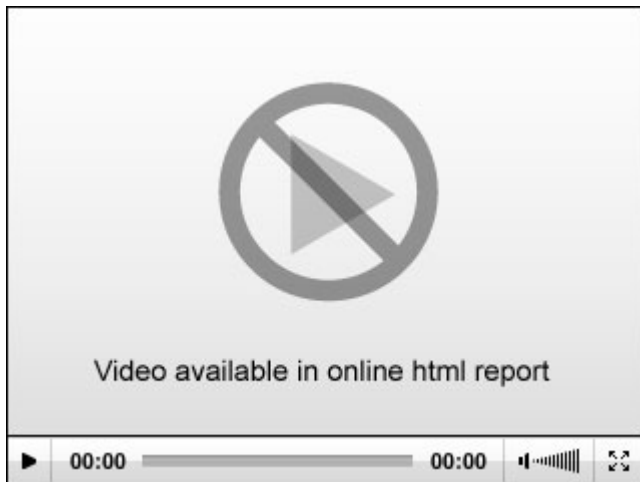
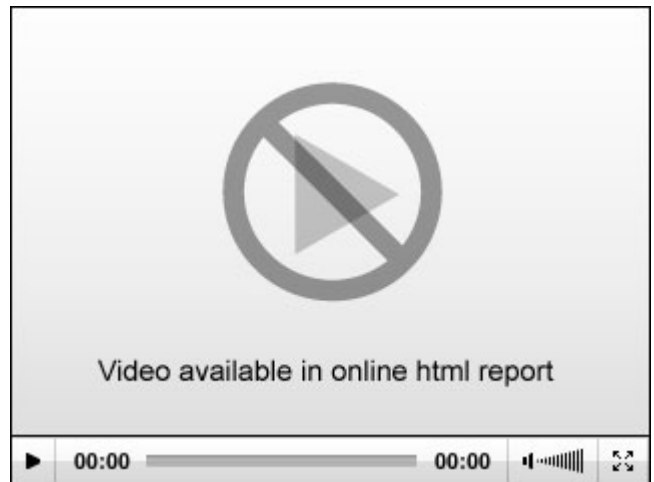
(7) The gutter leaks at the seam where indicated in the photos. Evidence of minor leakage was observed in this area during the inspection. Repairs are needed to prevent possible deterioration of the fascia and/or soffit via water intrusion. Recommend a general contractor repair as needed.

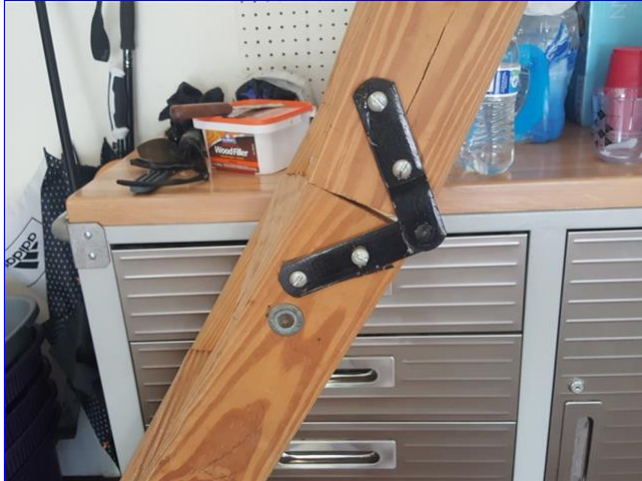
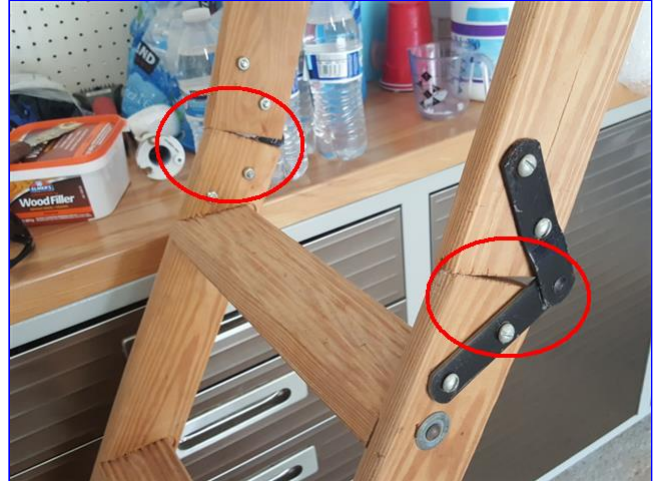
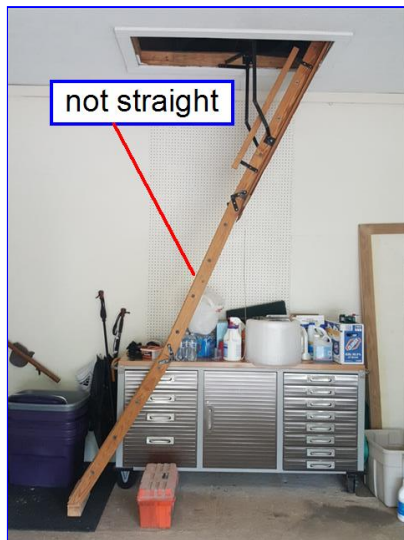
(1) The pull down ladder in the garage is not assembled properly at the bottom stile, leaving the bottom stile unstable and not sitting flush against the mid stile for support against the floor. This is a safety issue. If it were to fail when someone is using it they could be severely hurt. Recommend that the stairs be repaired or replaced to prevent injuries.

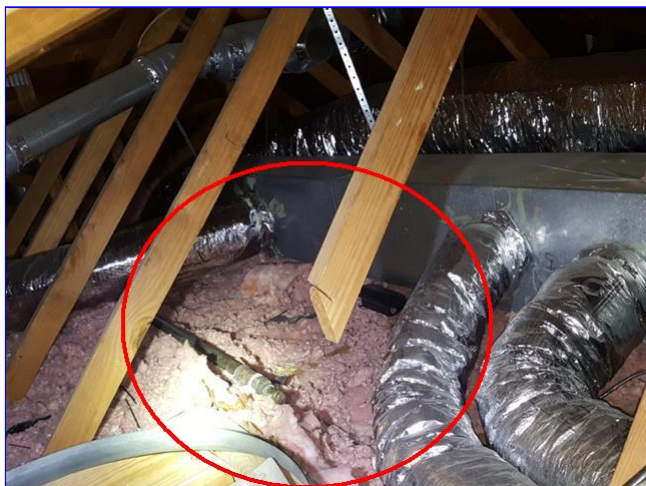
2.6 Item 1(Picture)

The 2x4 truss above the attic house fan has been cut/modified in the master bedroom attic area. The truss may fail if not repaired correctly. Excess loads on the roof like snow can cause separation if not reinforced. Truss repairs should be approved by an engineer or qualified architect before performing the work involved. Some reinforcement may be recommended by an engineer. For this reason, I **strongly** recommend you contact an engineer or qualified person for a second opinion before closing.

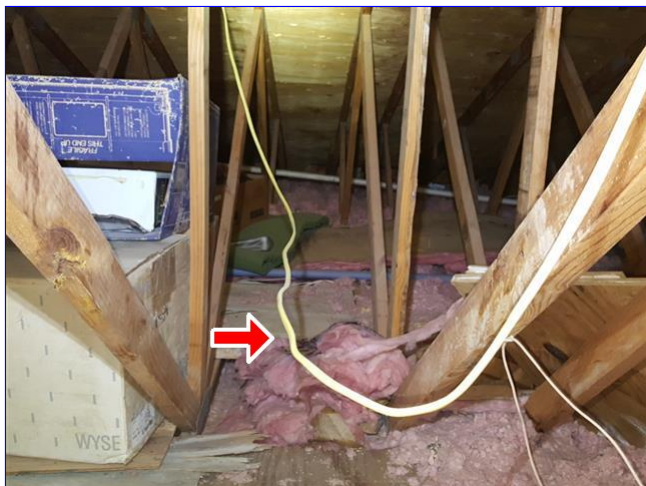
2.10 Item 1(Picture) garage

(1) Loose wiring in the garage attic should be secured to prevent tripping accidents. This is a safety issue. Recommend a licensed electrician secure where needed.

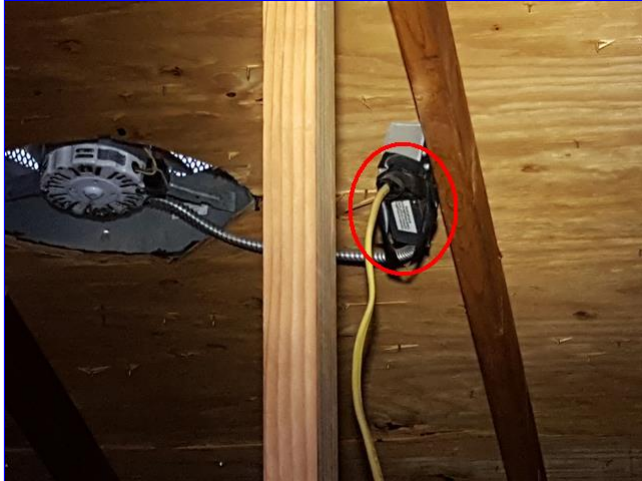
2.10 Item 2(Picture)

(2) The wiring installation of the power vent in the garage attic is non-standard. It is suspected that an amateur, rather than a licensed electrician performed the installation. Splices in electrical wiring should be enclosed in junction boxes and fitted with cover plates, not covered in insulation tape. This is a safety issue. Recommend a licensed electrician repair as needed to prevent accidental electric shocks.

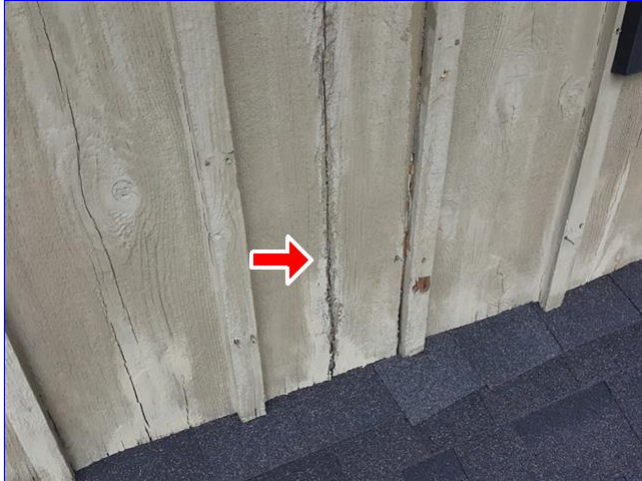
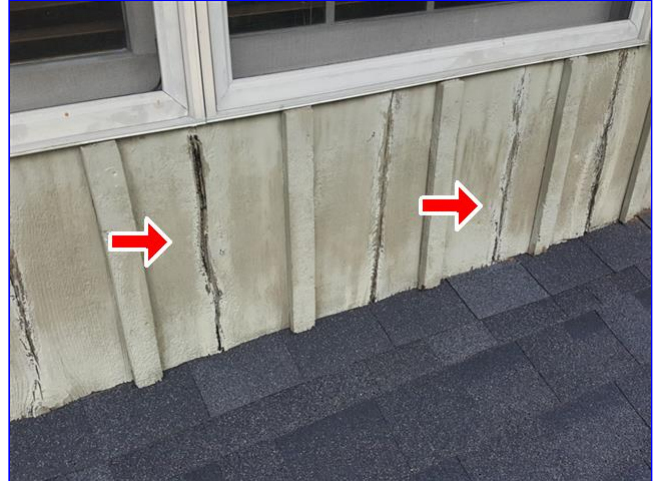
(3) The wood siding has cracked and is loose in some areas at the front of the home. See photos for location. These areas need to be repaired or replaced to prevent further water intrusion which will lead to further deterioration of the siding and possible rotting. Over time deterioration of the wall sheathing and/or framing may occur and possible mold may occur. Recommend a qualified contractor further access damaged areas and repair or replace as needed.

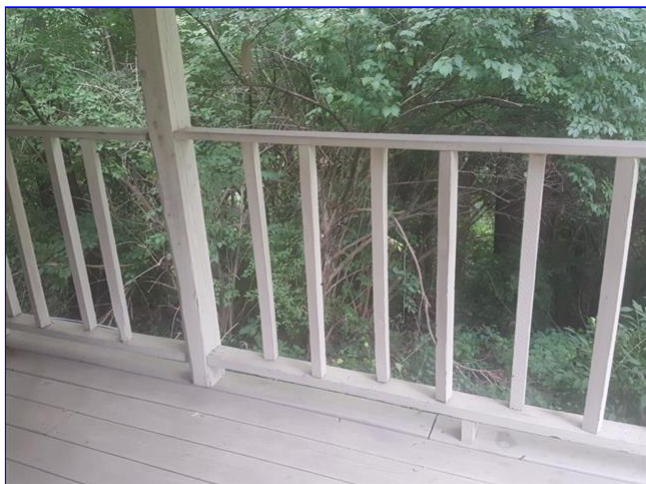
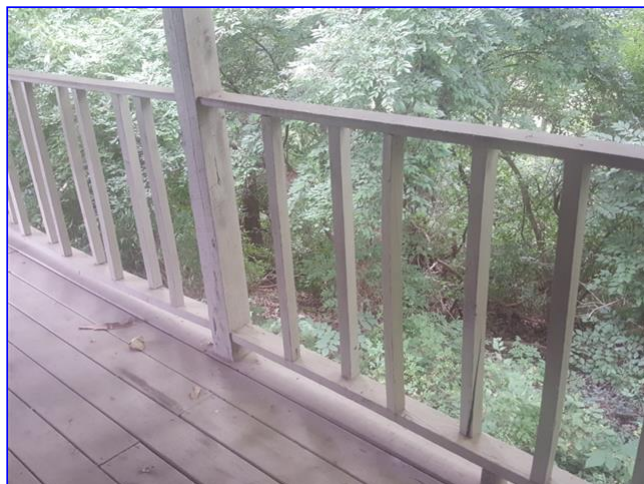
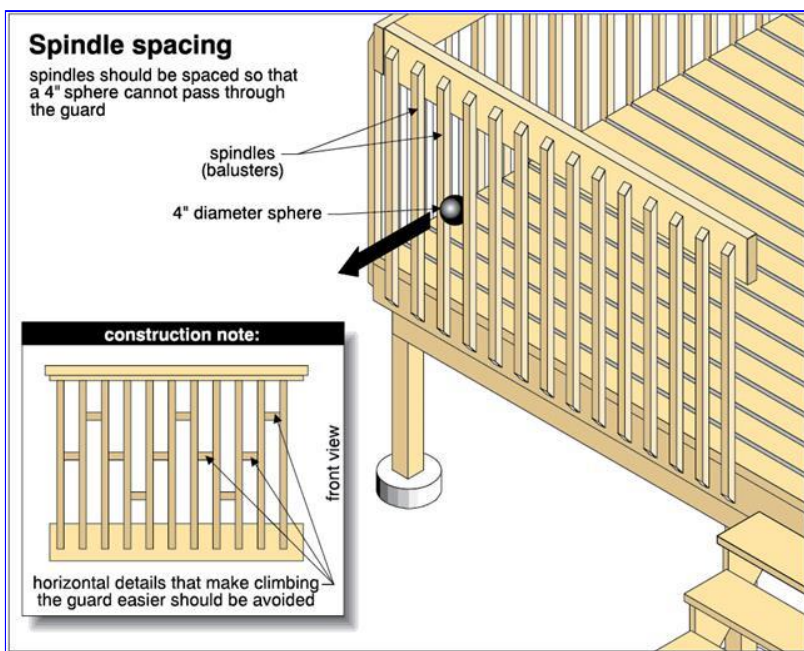
(1) The guard rail for the balcony porch on the right side of the home have large spaces between the ballusters. This is a safety issue. A fall or injury could occur if not corrected as this condition could allow a child or pet to fall through which may result in a death. The current recommendations are for spacing to be no more than 4" to prevent these accidents. A qualified contractor should make the necessary repairs and corrections where needed for safety.

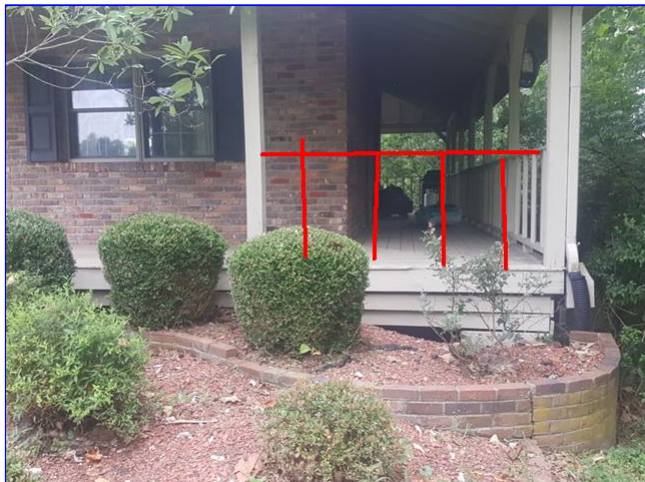
3.5 Item 4(Picture) front right side of home

(2) Recommend a guard rail be installed at the front porch on the right side to prevent a fall from occurring which may result in an injury of a person. This is a potential safety issue. The railing needs to be at least 36 inches high and balusters need spacing to be at least 4 inches. Recommend a qualified contractor install one for safety.

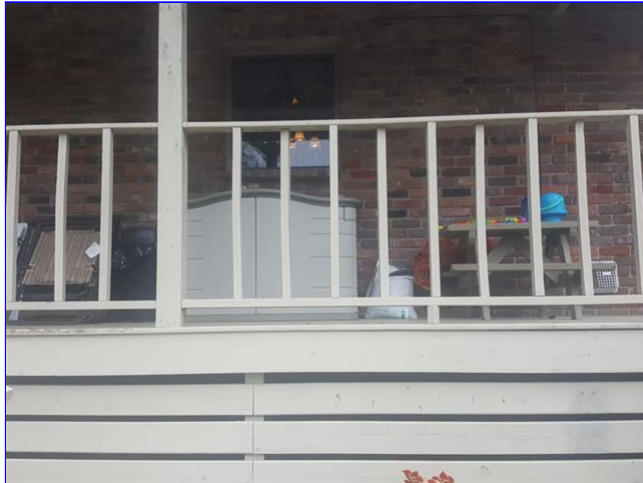
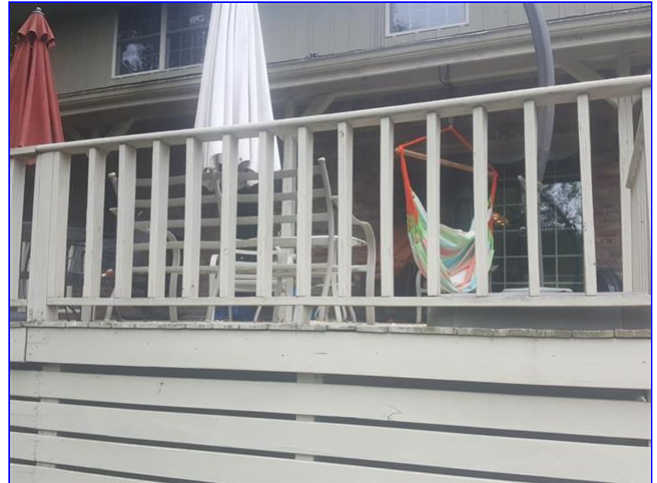
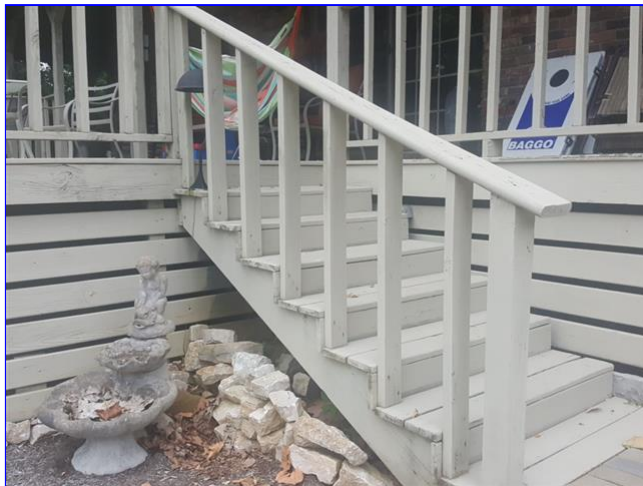
(1) The guard rail for the rear deck and the staircase have large spaces between the ballusters. This is a safety issue. A fall or injury could occur if not corrected as this condition could allow a child or pet to fall through which may result in a death. The current recommendations are for spacing to be no more than 4" to prevent these accidents. A qualified contractor should make the necessary repairs and corrections where needed for safety.

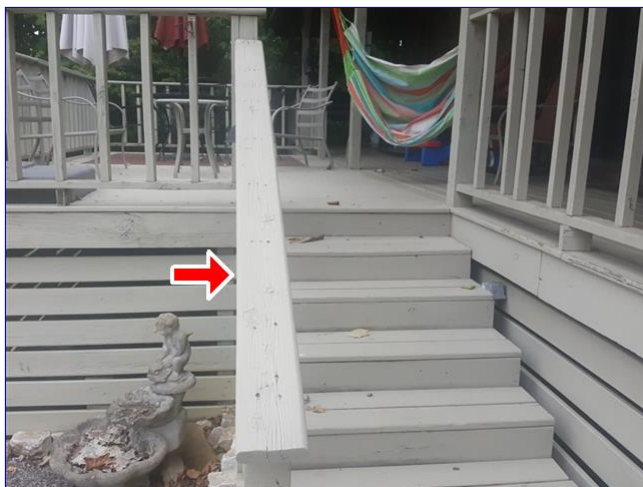
3.6 Item 4(Picture)

(2) 2x4s are installed for handrails for the deck staircase and are not considered "gripable" by industry standards. This is a safety issue and an injury could occur if not corrected. Recommend that a standard approved handrail be installed for safety by a general contractor.

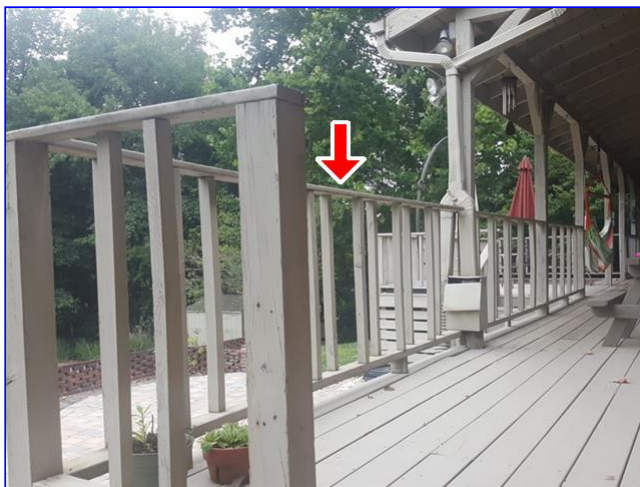
3.6 Item 6(Picture)

(3) The guard rail for rear deck is loose, unstable and not secured properly. This is extremely dangerous and is a major safety concern. It may fail under a medium or heavy force or if someone was pushed against or was leaning on the railing. For your safety it should be strengthened and secured. Recommend a qualified contractor repair as needed before closing.

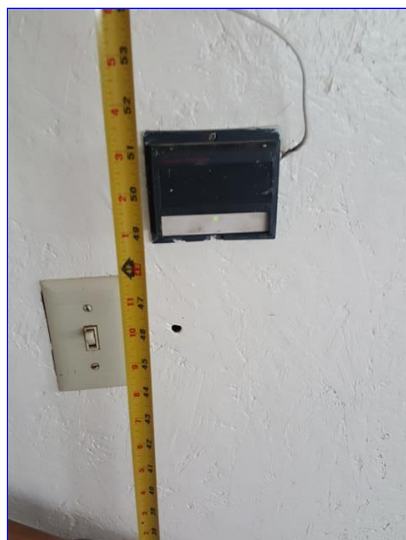
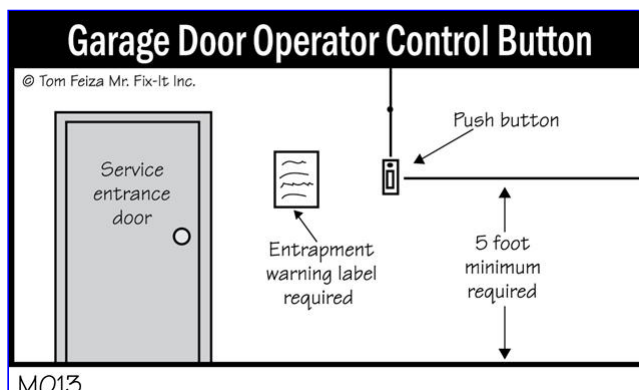
(1) The door button is lower than the manufacturers recommended 5 feet above the floor. This is a safety issue. Recommend this be raised to prevent unauthorized use by children as an injury may occur or damage to a motor vehicle when the door is opened or closed automatically. A qualified licensed electrician is recommended for correcting.

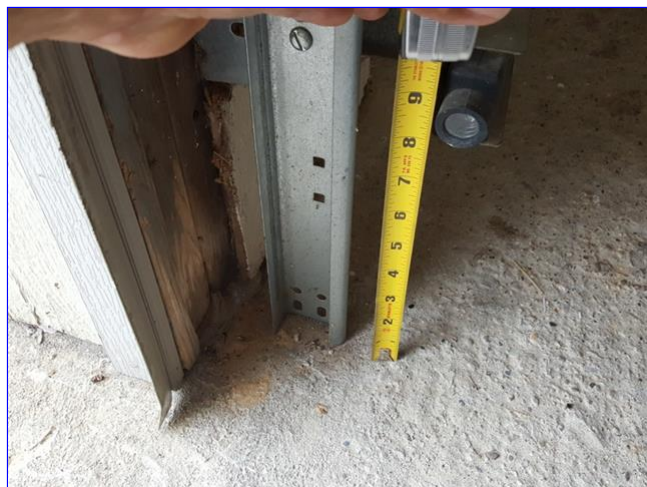
4.3 Item 3(Picture)

(2) The garage door opener electric eyes are installed too high. There is a serious risk of injury, particularly to children or pets, under this condition. The eyes should be placed 4" to 6" off the floor or as otherwise indicated in the installation manual. This should be dealt with immediately by a qualified garage installer.

Note: the door does reverse when eyes are interrupted and under resistance.

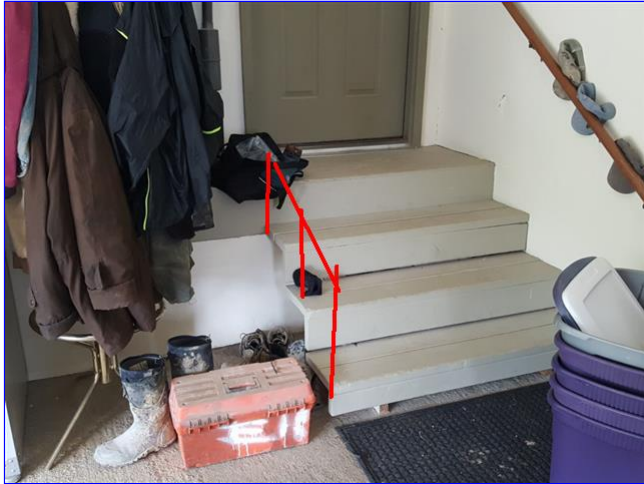
4.7 Item 1(Picture)

Recommend a guard rail be installed at the staircase in the garage to prevent a fall from occurring which may result in an injury of a person. This is a potential safety issue. The railing needs to be at least 36 inches high and balusters need spacing to be at least 4 inches. Recommend a qualified contractor install one for safety.

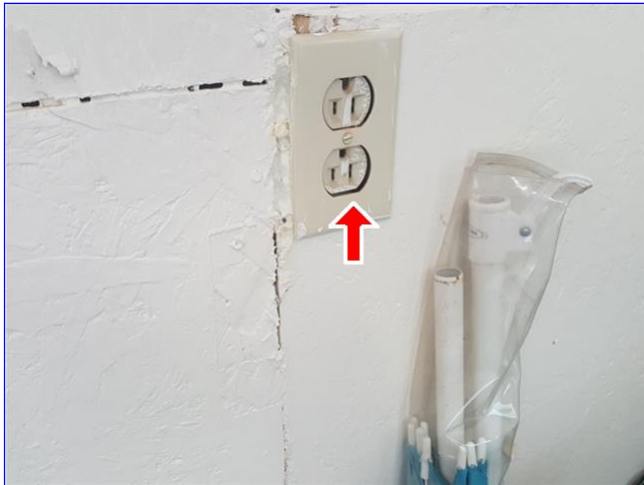
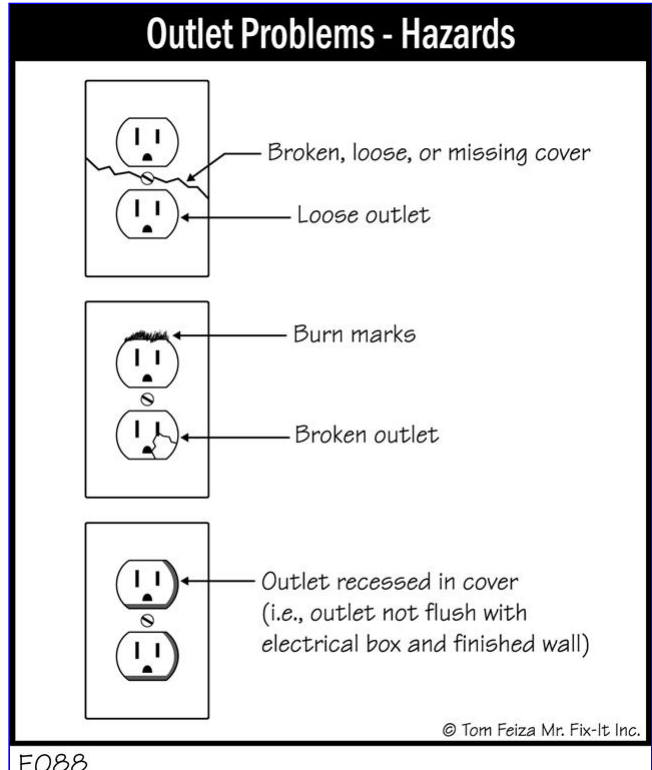
(2) Openings between the outlet and the cover plate in the garage where indicated in the photo is a serious safety issue. A child or person may place an object inside opening which may contact the connecting wires causing an electrical shock which could lead to a serious injury or death. Recommend a qualified electrician repair as needed for your safety before moving into home.

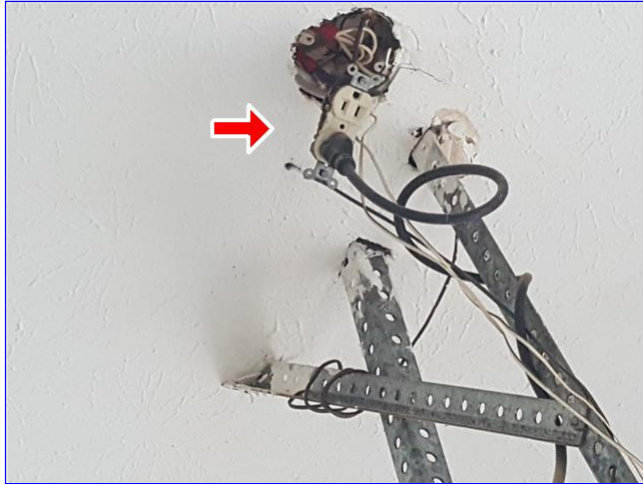
4.8 Item 3(Picture)

(3) The outlet(s) in the garage where indicated in the photo(s) are loose in the ceiling and is missing a cover plate. Electrical issues are considered a hazard until repaired. This is a safety issue that needs to be corrected due to an electric shock or fire from loose connections could occur if not repaired. Recommend a qualified licensed electrical contractor correct as needed.

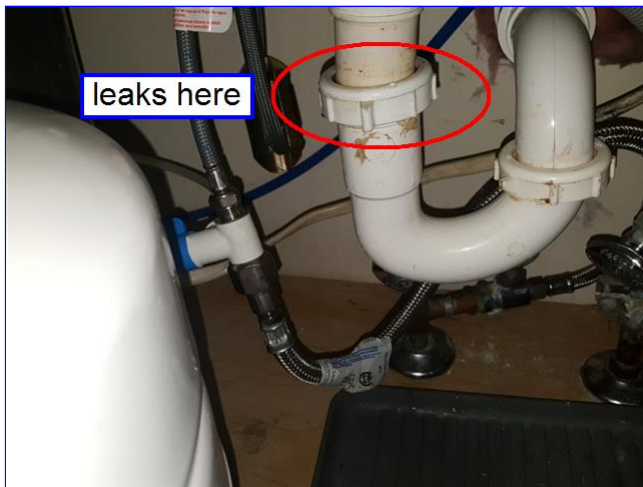
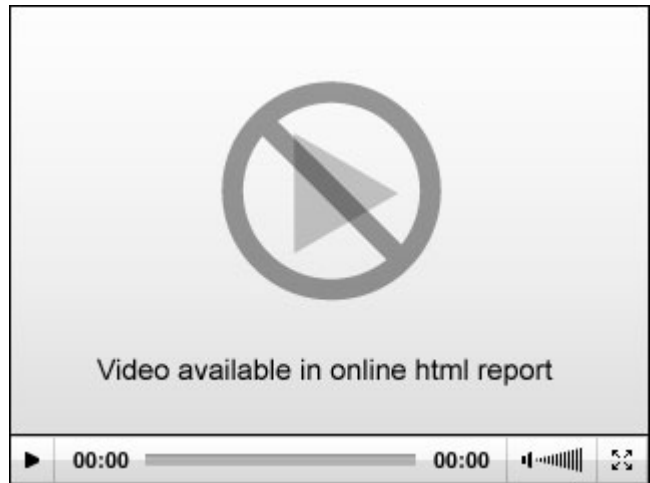
The p-trap on the waste line is leaking at the connection underneath the sink in the kitchen. Repairs are needed to stop leaking water from damaging the cabinet bottom or to eliminate moisture that may contribute to fungi growth. A qualified licensed plumber is recommended for repairs as needed.

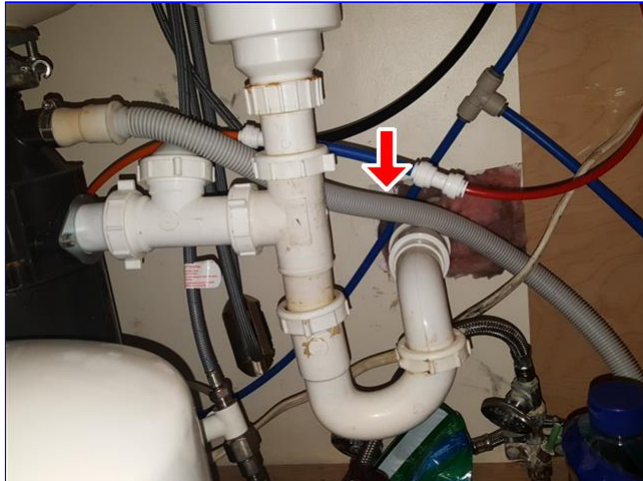
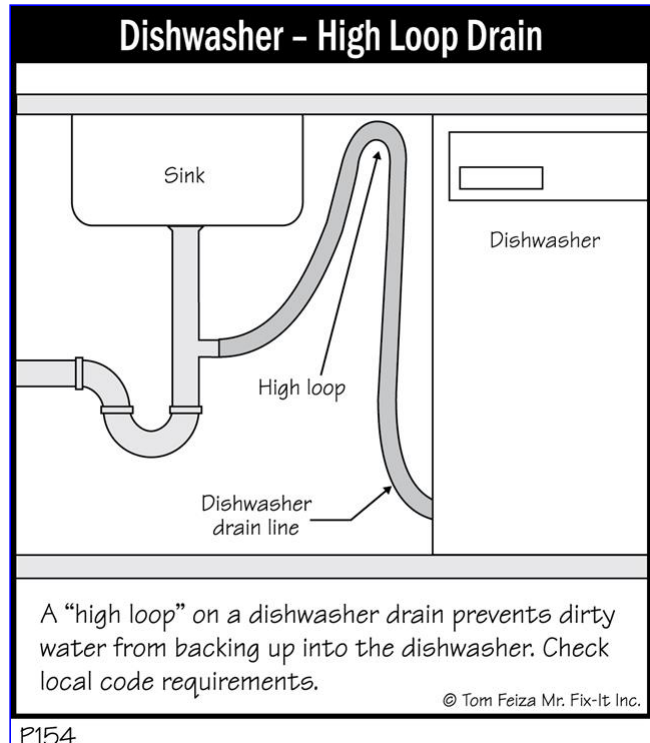
The dishwasher drain hose did not perform a loop to create a trap under the sink. The current recommendations for the dishwasher drain lines are for them to be installed as close to the bottom of the countertop as possible. This creates a water blockage to prevent sewer gases entering the house through the dishwasher. Recommend repair or replace as necessary.

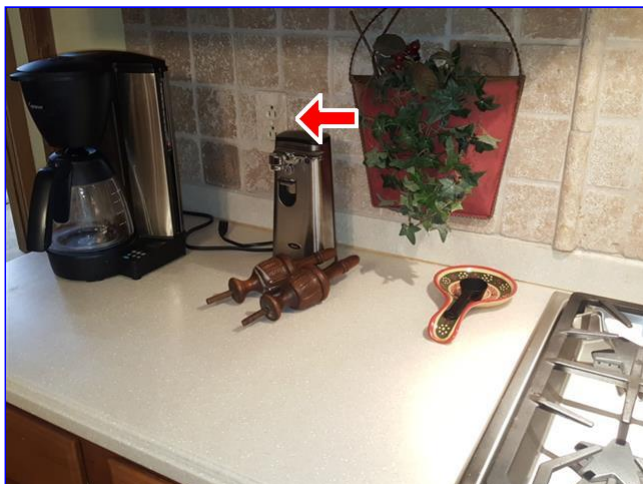
5.10.A Item 1(Picture)

(3) The outlet(s) in the kitchen where indicated in the photo(s) are loose at the wall or in the outlet box. Electrical issues are considered a hazard until repaired. This is a safety issue that needs to be corrected due to an electric shock or fire from loose connections could occur if not repaired. Recommend a qualified licensed electrical contractor correct as needed.

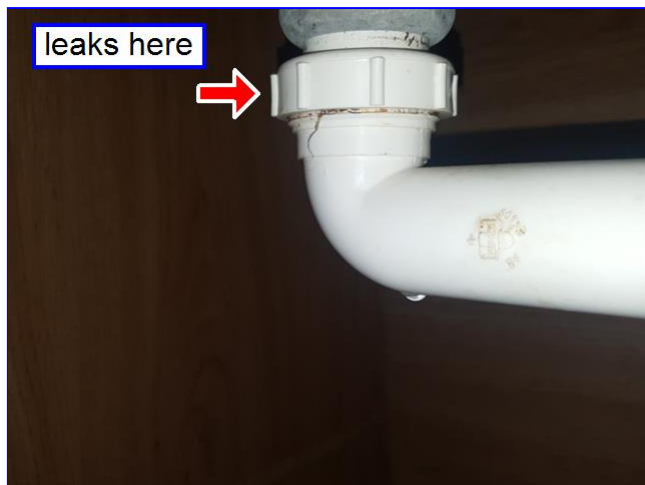
The waste line is leaking at the connection underneath the left sink in the basement kitchen. Repairs are needed to stop leaking water from damaging the cabinet bottom or to eliminate moisture that may contribute to fungi growth. A qualified licensed plumber is recommended for repairs as needed.

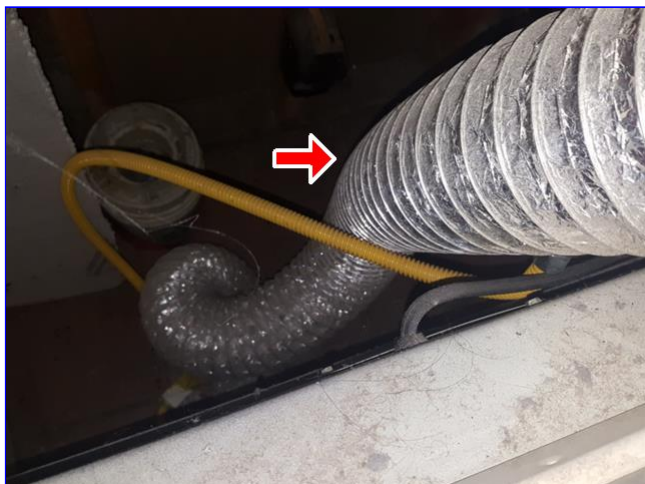
5.7.B Item 1(Picture)

(1) A pleated Foil flex pipe is currently installed from the dryer to the exhaust vent. The current recommendations are for dryer vents to be heavy flexible or solid metal to help prevent crushing and damage from fires. Dryer lint fires are reported to be the third leading cause of fires. Exhaust ducts should be constructed of minimum 0.016 inch thick rigid metal ducts, having smooth interior surfaces with joints running in the direction of air flow. Exhaust ducts shall not be connected with sheet metal screws or fastening means which extend into the duct. All dryer vents should be disconnected and cleaned twice a year. This is a very common cause of fires. Recommend replacing duct for proper operation and for your safety using a qualified contractor.
