## **Inspection Report**

**Property Address:**  
780 Nutfield Way  
Richmond KY 40475

<b>Date:</b> 7/15/2018	<b>Time:</b> 09:00 AM till 03:00 PM	<b>Report ID:</b> 180715BETHAM
<b>Property:</b> 780 Nutfield Way Richmond KY 40475	<b>Customer:</b> Mrs. Gail Schneider	<b>Real Estate Professional:</b>

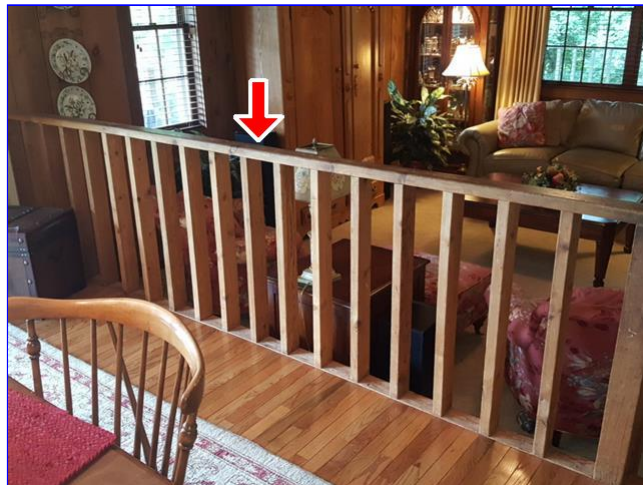
(1) The balcony railing is loose/unstable between the dining and living room. This is extremely dangerous and is a safety concern. This could collapse if someone was pushed against or was leaning on the railing. Recommend repair by a qualified contractor before closing.

6.3 Item 1(Picture) dining room

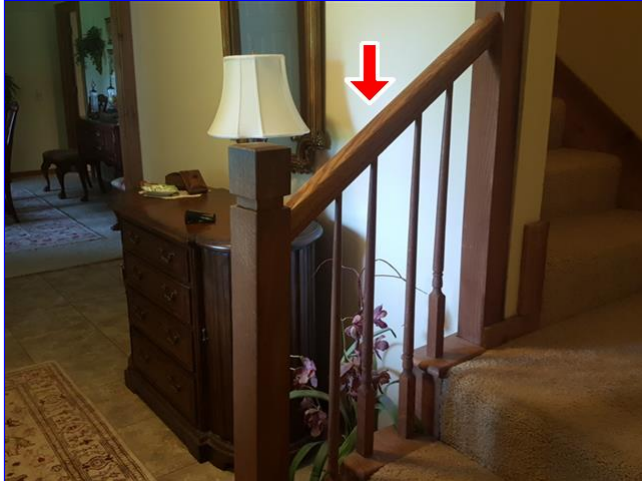
6.3 Item 2(Picture)

(2) The stair case rail on the on the left side leading to the upstairs is unstable and not secured properly. This is extremely dangerous and is a safety concern. It may fail under a medium or heavy force or if someone was pushed against or was leaning on the railing. For your safety it should be strengthened and secured. Recommend a qualified contractor repair as needed before closing.

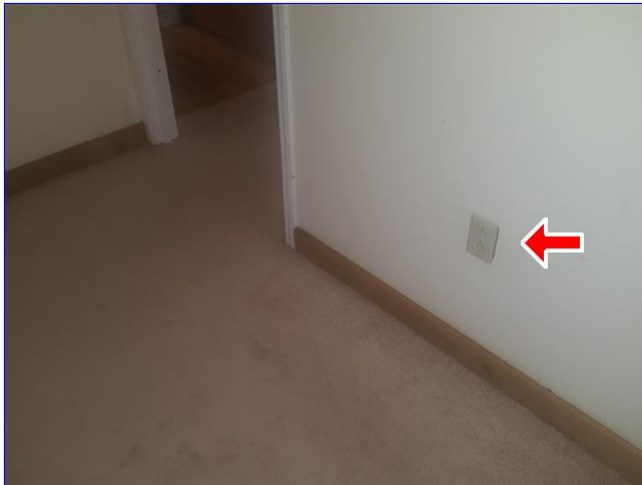
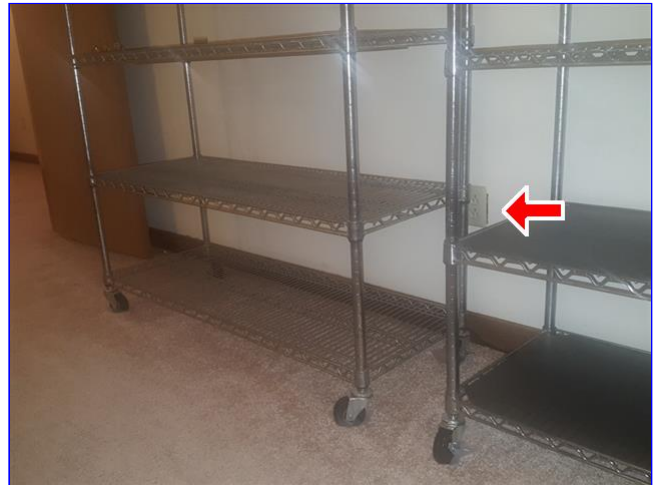
(2) The outlet(s) in the basement hallway where indicated in the photo(s) are loose at the wall or in the outlet box. Electrical issues are considered a hazard until repaired. This is a safety issue that needs to be corrected due to an electric shock or fire from loose connections could occur if not repaired. Recommend a qualified licensed electrical contractor correct as needed.

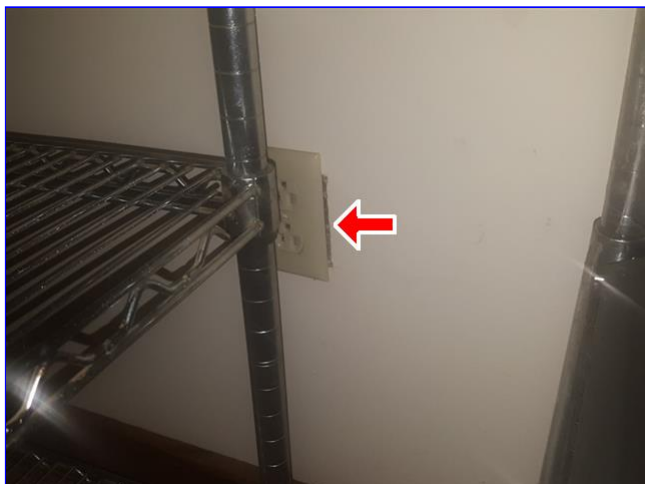
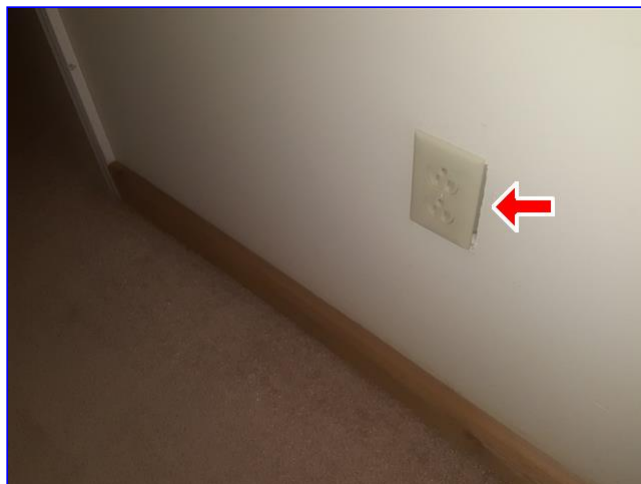
(3) Recommend sealing the gap between the wall and the outlet in the basement hallway where indicated in the photo(s) to prevent children being electrocuted by placing objects inside the opening. This is a serious safety issue. Recommend a qualified electrician and/or a general contractor repair as needed.

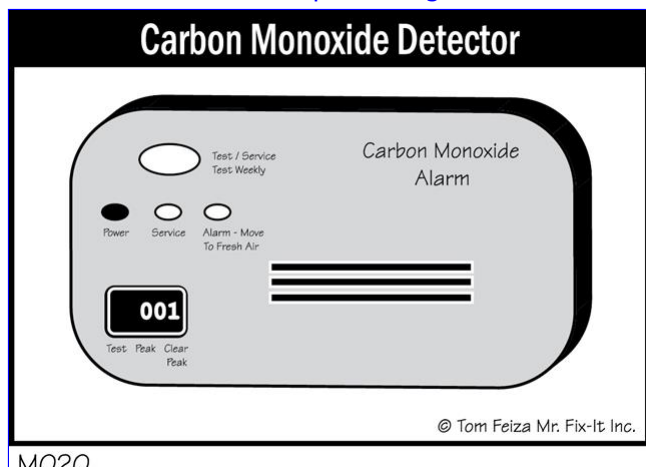
6.8 Item 1(Picture)

(3) There is no visible permanent carbon monoxide detector found in the home. It is recommended that one be installed according to the manufacturer's instructions for safety and to prevent a death from carbon monoxide poisoning due to the water heater located at the upstairs closet.

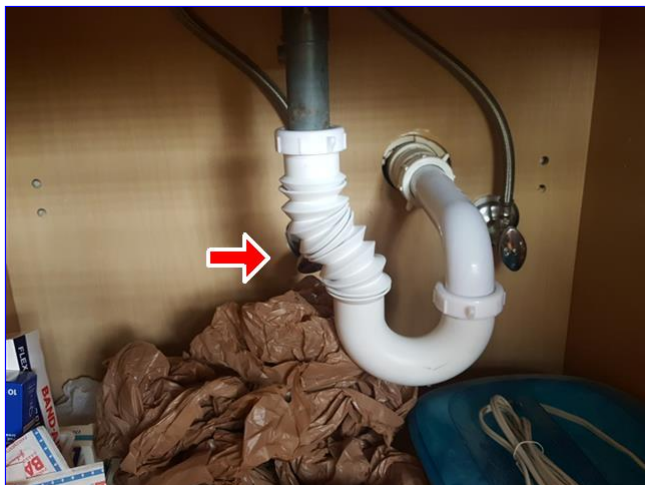
7.5 Item 1(Picture)

(1) Flexible ridged pipe is being used for the connection to the drain line under the sink in the master bathroom. The pipe ridges will hold and trap debris which could clog the drain. Plan on cleaning the drain from time to time. Smooth pipe would be better but may be difficult to fit to the existing drain lines. Recommend you seek a qualified licensed plumber to evaluate and correct if needed as this type of work is not to standard workman like practices.

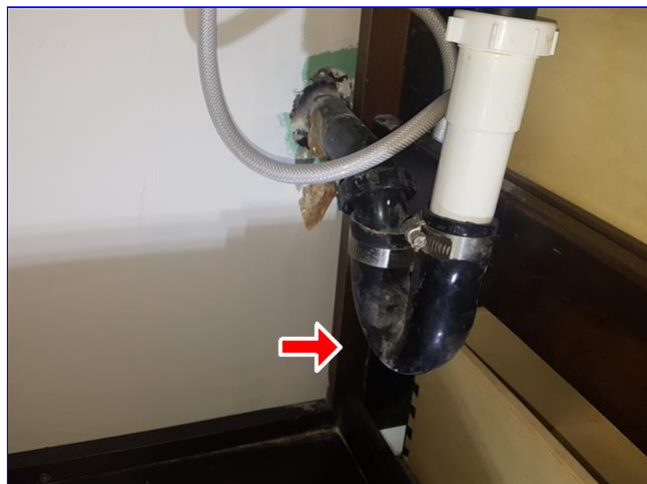
7.5 Item 2(Picture)

(2) Rubber hose pipe is being used for the connection to the drain line under the sink in the basement bathroom. The pipe connections may leak in the future. Recommend you seek a qualified licensed plumber to correct as needed as this type of work is not to standard workman like practices.

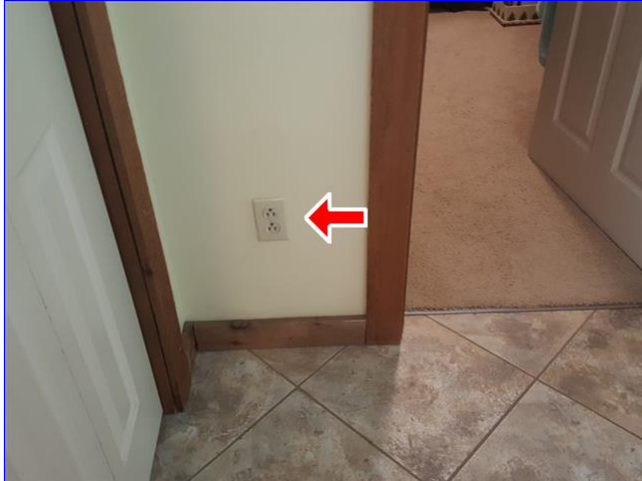
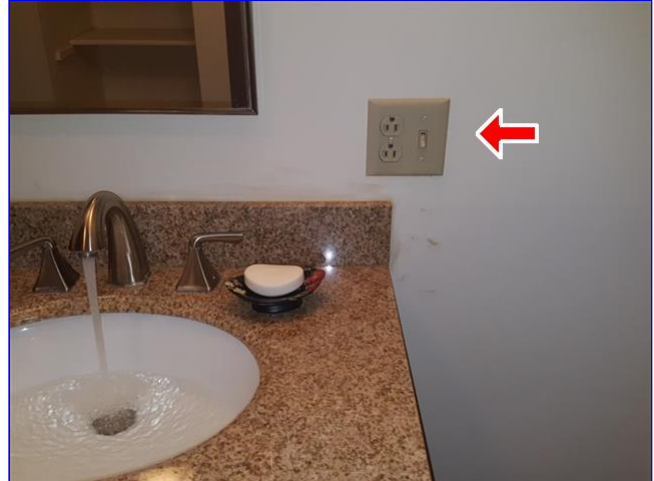
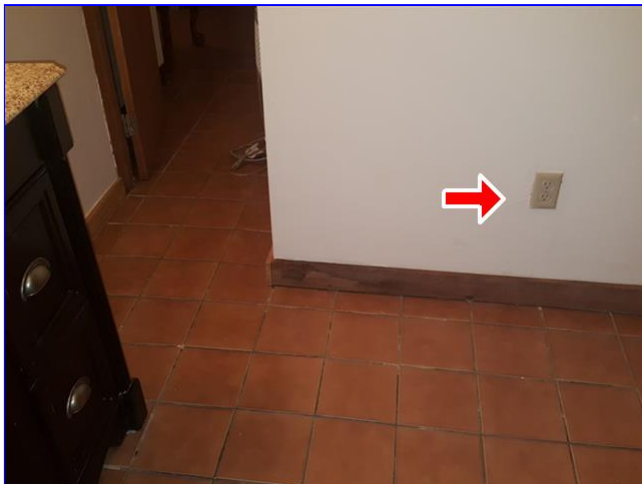
(3) The outlet(s) are not GFCI protected in the Master and basement bathrooms where indicated in the photos. Although GFCIs may not have been required at the time that this house was built, these are now required and recommended for safety within any water source as a safety feature when any changes to the outlets are made. GFCI outlet offers protection from shock or electrocution. Recommend a licensed electrician correct as needed prior to moving in.

7.6 Item 1(Picture) master bathroom

7.6 Item 2(Picture) basement bathroom

7.6 Item 3(Picture) basement bathroom

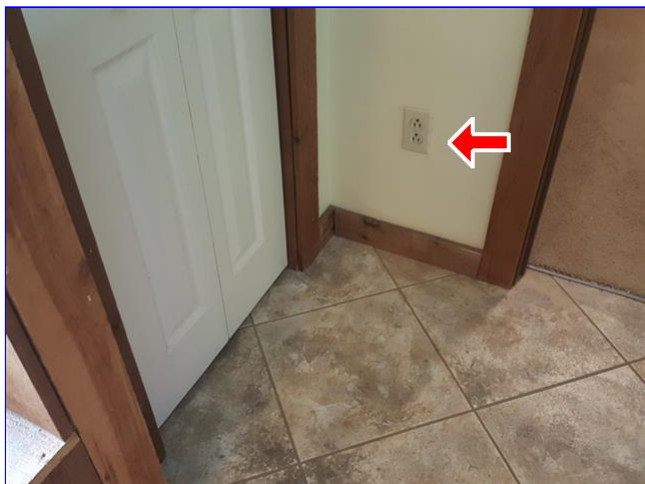
7.6 Item 5(Picture)

(4) The outlet in the master bathroom where indicated in the photo is loose at the wall or at the outlet box. Electrical issues are considered a hazard until repaired. This is a safety issue that needs to be corrected due to an electric shock or fire from loose connections could occur if not repaired. Recommend a qualified licensed electrical contractor correct as needed.

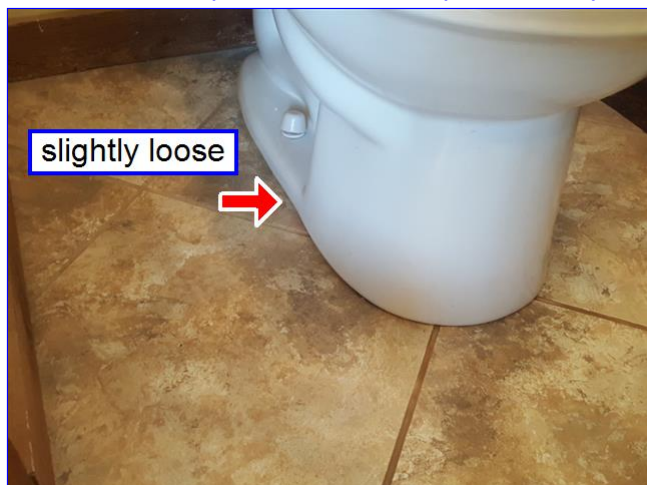
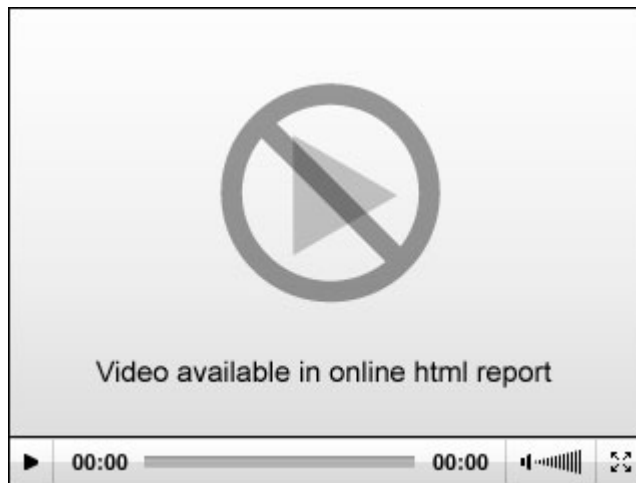
7.8 Item 1(Picture)

The toilet tank base is loose at the floor in the master bathroom. The screws may need tightening to secure the toilet base to the floor to prevent a water leak between the toilet and the drain line connection. If tightening the screws at the base of the toilet does not secure the toilet, repairs may involve re-setting the toilet on a new wax seal and/or repairs to the floor may be required. Recommend a qualified licensed plumber repair or correct as needed.

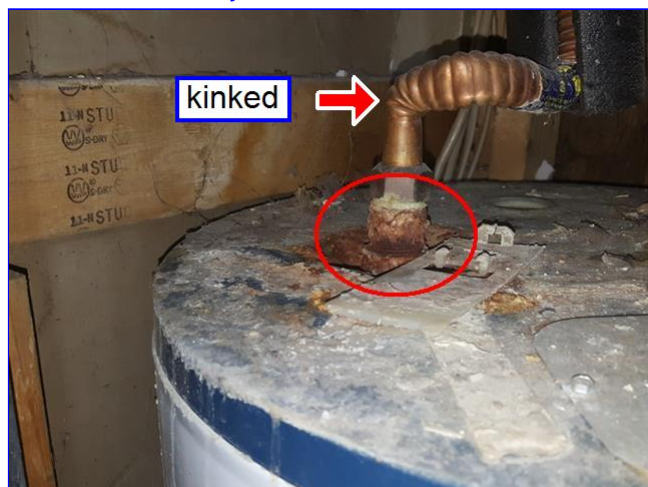
8.2 Item 3(Picture)

(5) Corrosion and a kink at the hot water supply inlet at the top of the water heater was noted in the basement washer dryer room. This usually occurs when two different types of metals are in contact with each other. This area will eventually leak water. Recommend a qualified plumber further investigate and repair as needed. Due to the age of unit, consideration in replacing unit would be wise before a major leak occurs.

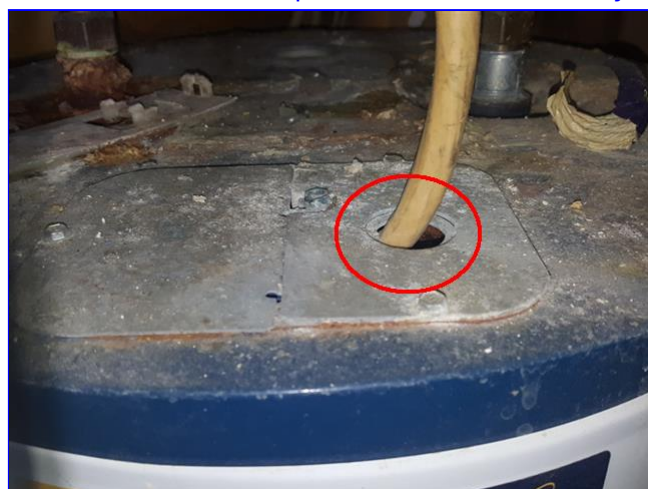
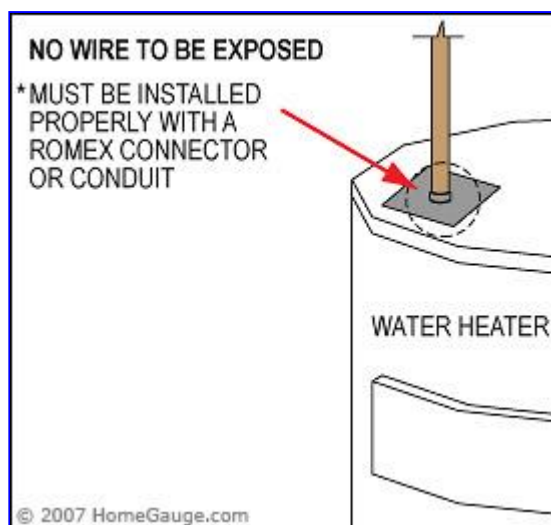
(8) There is no strain-relief clamp on the wire where it enters the top of the water heater in the basement. This is a safety issue. A child or person could easily pull the wire out of the heater, touch an energized conductor, and be electrocuted causing possible death. Recommend a qualified licensed electrician repair as needed for safety.

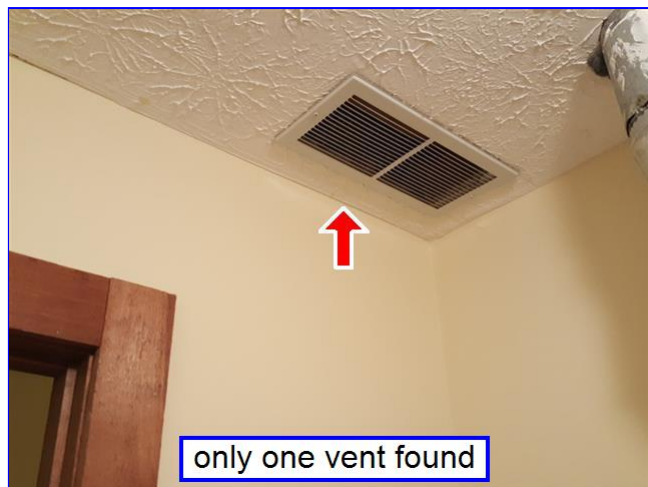
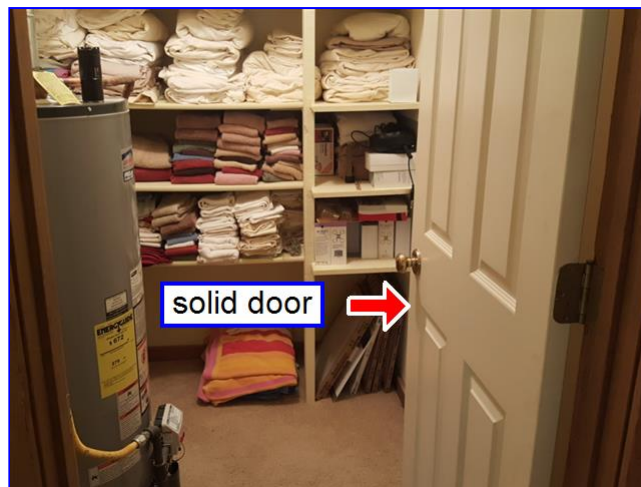
The water heater is located in the closet upstairs. This is a safety issue and can be hazardous to your health. When a gas appliance is located in a small enclosed room it requires combustion air. If the closet doors are closed, there will be inadequate combustion air for the water heater due to only one vent was found. Inadequate combustion can result in excessive amounts of CO (carbon monoxide) being produced and has been known to cause sickness or death. When a gas appliance is placed in a small confined enclosure, it requires proper ventilation. The easiest remedy is to install two metal 6" pipes to obtain air from the attic or the outside. The two openings located high and low with 144 square inches of free space each, or a louvered door with free space of 288 square inches is required.

Recommend a qualified plumber further evaluate and make the necessary corrections for your safety prior to closing.

Note: Vent screens that are used for combustion air for a gas appliance **must not have any damper or closing device**. This is a serious safety issue. Recommend replacing vents that are not adjustable.

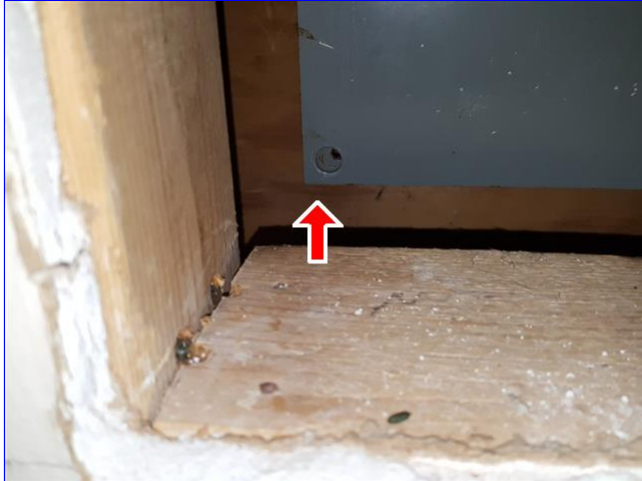
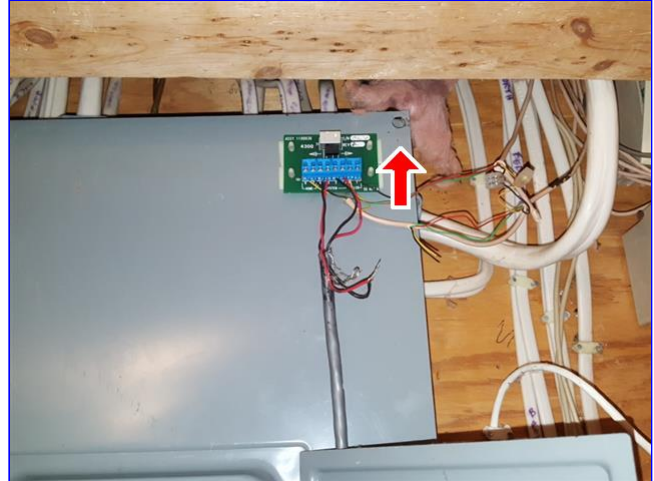
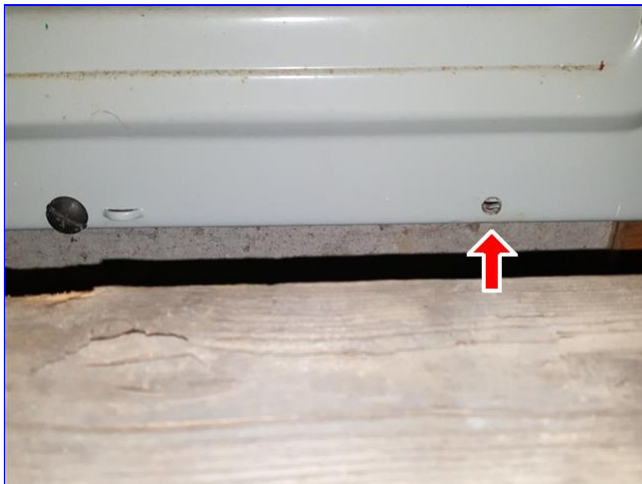
(2) There are screws missing from the cover for both the electric panels where indicated in photos. This is a safety issue. The missing cover screws should be installed to prevent easy entry and to prevent moisture from entering the panel box. Recommend a licensed electrician correct as needed for your safety.

9.2 Item 1(Picture) main panel

9.2 Item 2(Picture) main panel

9.2 Item 3(Picture) sub panel

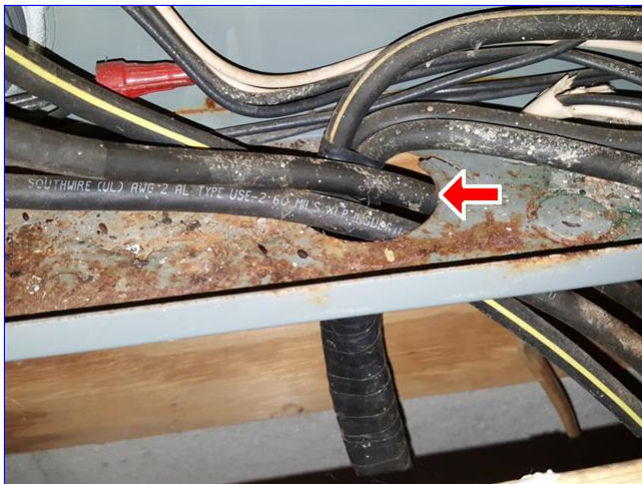
9.2 Item 4(Picture)

(3) Cable clamps (sometimes referred to as bushings or grommets) are required where wiring passes into the electrical main panel box. Cable clamps serve to protect the wiring from the metal edges of the panel box to prevent a short from occurring or from the panel box becoming energized which can result in a death via electric shock. This is a safety issue. Recommend a qualified licensed electrician repair as needed.

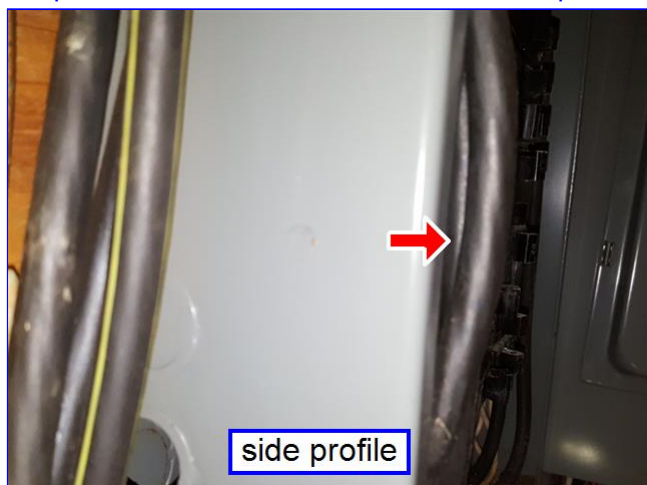
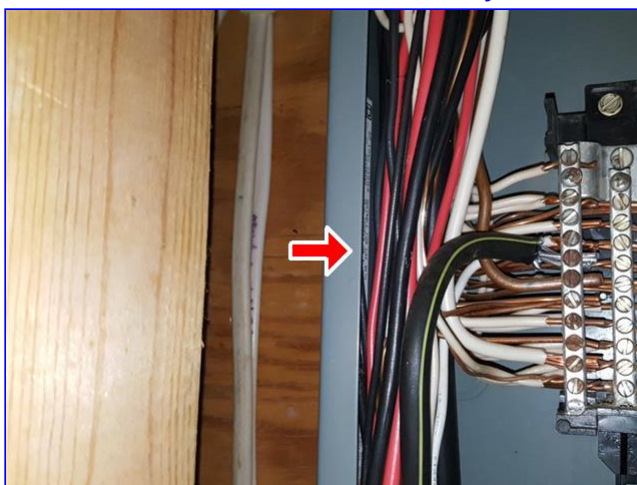
(4) The wiring in the main panel box is near or on top of the panel under where the cover is attached on both sides. This is a serious safety issue. If the panel cover were to be secured with screws on this side it could crush wires which may cause the box to energize resulting in a death via electrocution if the panel box is touched. Recommend a qualified licensed electrician correct for safety as needed.

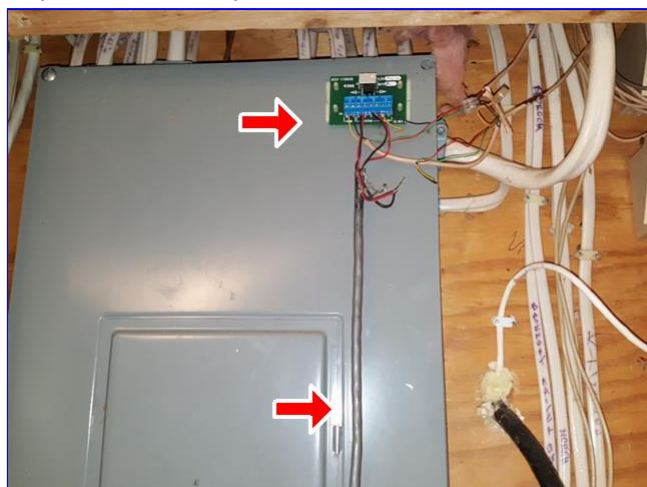
9.2 Item 7(Picture)

(5) No wires should be attached to the panel cover. This makes it difficult to have it removed for inspection and repairs when needed. Recommend an electrician correct as needed.

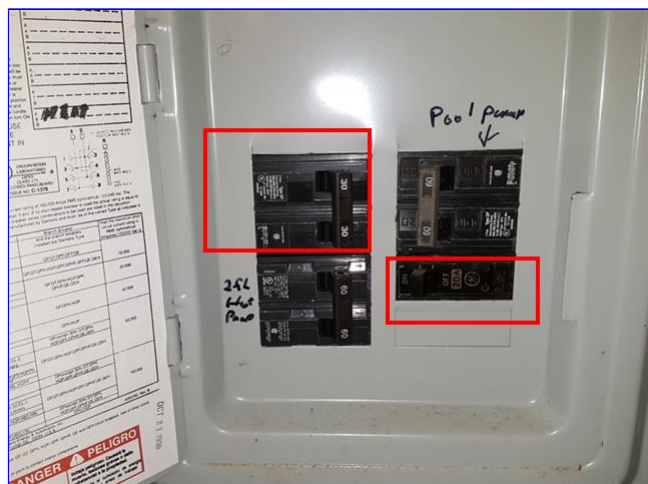
9.2 Item 8(Picture)

(6) Some of the circuit breakers are not labelled at the sub panel cover. This is a safety issue. Could not check if breakers may be overloaded with appliances in the home. The electrical panel should be indexed, identifying each circuit breaker. This will allow for quick de-energizing of a circuit under emergency situations. Recommend the panel be fully labelled to facilitate turning off breakers to circuits. A licensed electrician is recommended to correct as needed.

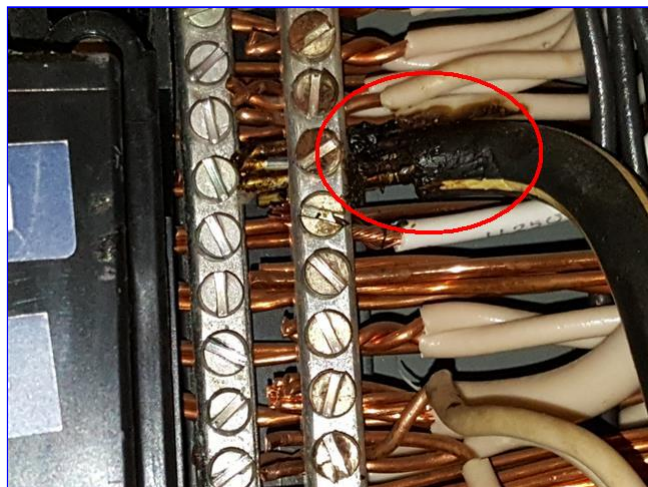
9.3 Item 1(Picture)

(1) Evidence of scorched wires was noted on the bus bar in the main panel. This indicates that a short is happening and a fire could develop if not repaired or corrected. Strongly recommend a qualified licensed electrician further investigate all wiring in the panel box and correct problems found as needed for your safety.

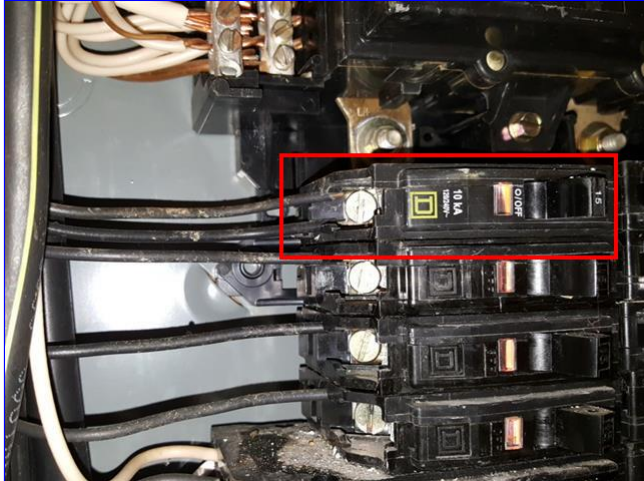
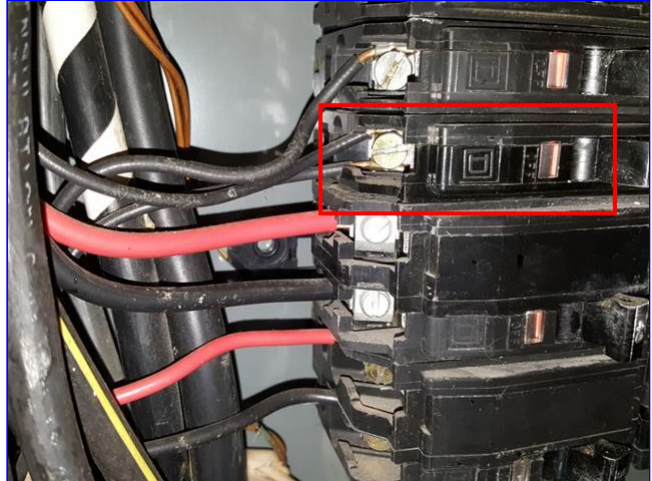
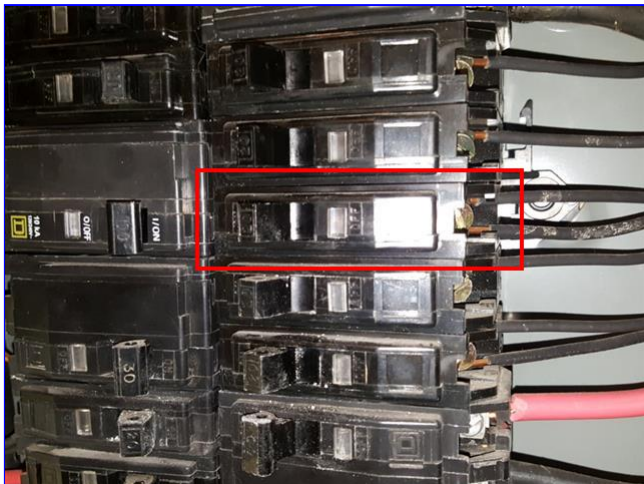
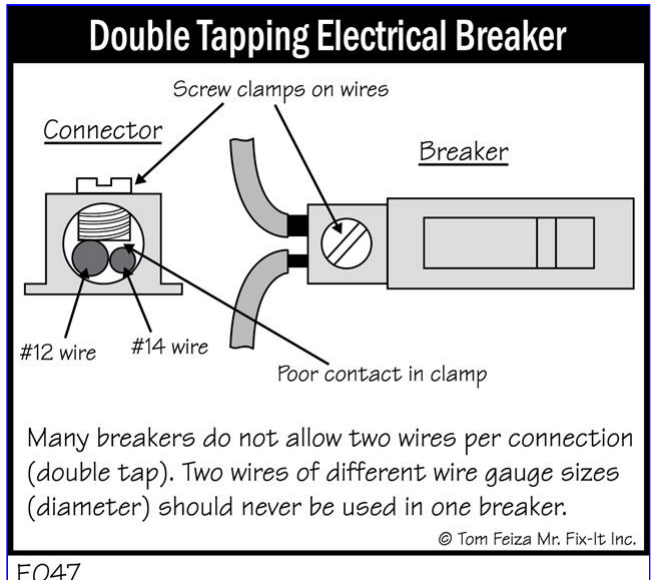
(2) The breaker for the Heat Pump on the ground level is oversized in the panel box. Currently it has a 40 amp breaker installed, whereas the data plate on the Heat Pump specifies maximum breaker of 35 amps. The concern with an oversized breaker is typically causing possible damage to the equipment, and if the unit pulls more than 35 amps it could cause the insulation on the wires to start to melt. This will void warranty on the unit. Recommend a qualified HVAC contractor and/or electrician further evaluate to determine if correction is needed.

(3) Multiple tap wiring (more than one hot wire attached to the same breaker) was found in the main panel. This panel and breakers are NOT MADE or DESIGNED to provide adequate holding power for multiple wires on a single breaker. A separate breaker should serve each circuit. This is a very hazardous and is a safety issue. May cause a fire or short. Recommend a qualified electrician further evaluate the panel box for further issues and repair and correct as needed.

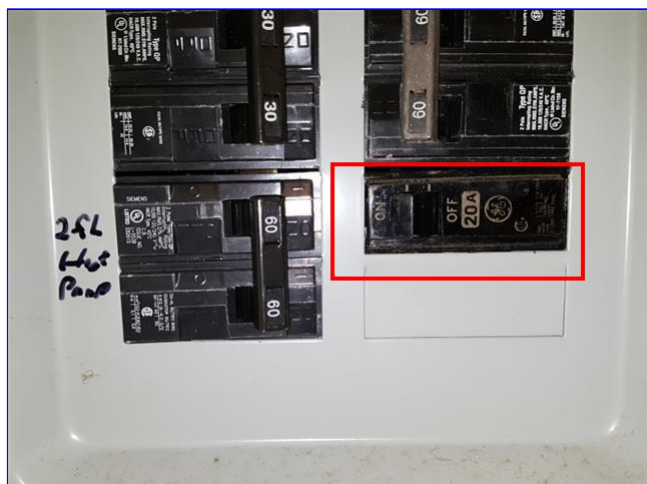
9.3 Item 7(Picture)

(5) Some of the breakers are not manufactured by the maker of the sub panel. Most mismatched breakers are normally not allowed because the connections may be loose or tight which can result in an electrical fire or short. This is a potential safety hazard. Recommend a qualified electrician verify that these breakers are compatible with this panel prior to closing.

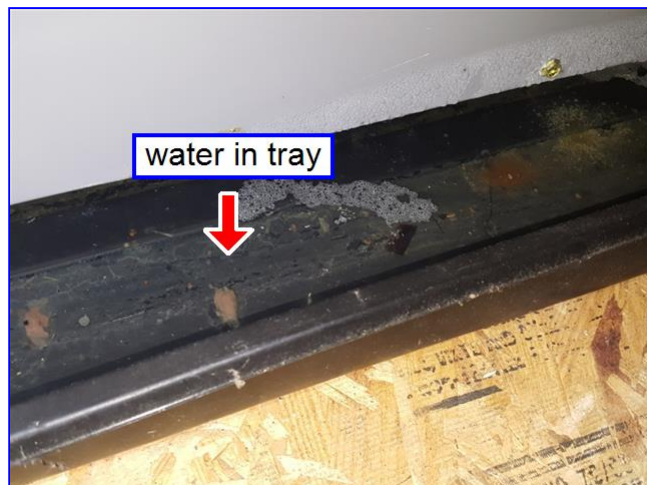
(3) Water was found in the condensate drain pan under the air handler in the attic. This water may be leaking from the evaporative coil or maybe caused by condensation from the large suction line leading into the unit. **Strongly** recommend a qualified HVAC contractor further investigate for cause and make any needed repairs that may be necessary prior to closing. Also recommend the Aqua guard condensate shut off switch be checked to see if it is working as the unit remained on during the inspection.

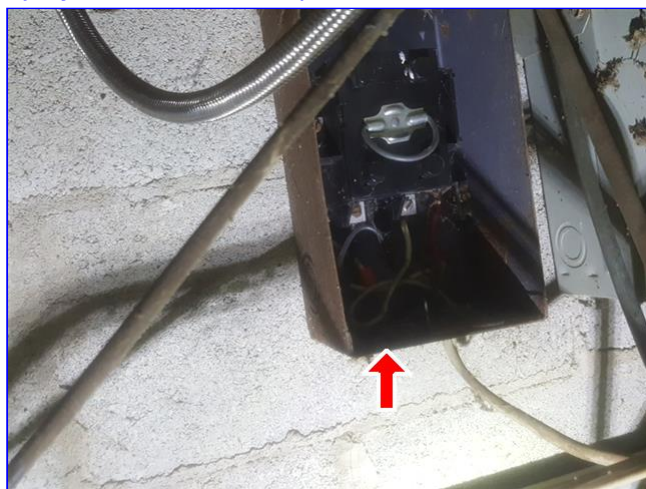
10.2.B Item 2(Picture)

(2) The disconnect for the Heat Pump at the right side of the home is missing a cover inside the box to protect the wiring. This is a safety issue especially due to no lock on the box cover. The wires are exposed. A child or person can be shocked if wires are tampered with which may result in a death or injury. Recommend a qualified electrician correct and repair for safety.

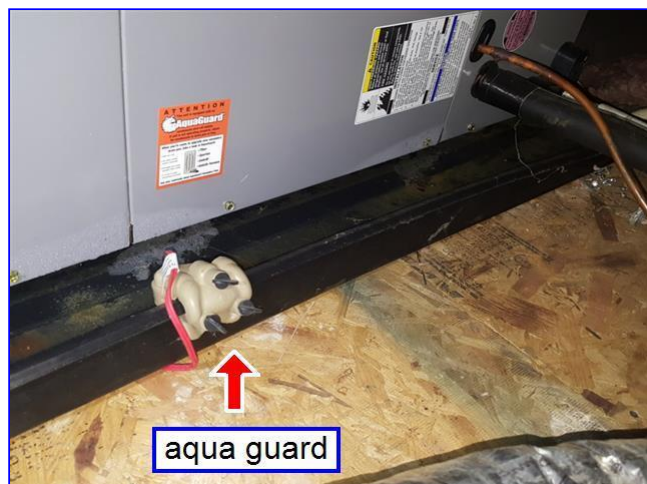
10.2.B Item 3(Picture)

(3) The aqua guard safety switch does not appear to be working. Water was in the tray and the switch was in contact with the water, yet the unit remained on. Recommend a qualified HVAC contractor repair or replace as needed to prevent a water leak occurring in the attic which will damage ceiling and insulation in the attic. **Also refer to note 10.0.B(3).**

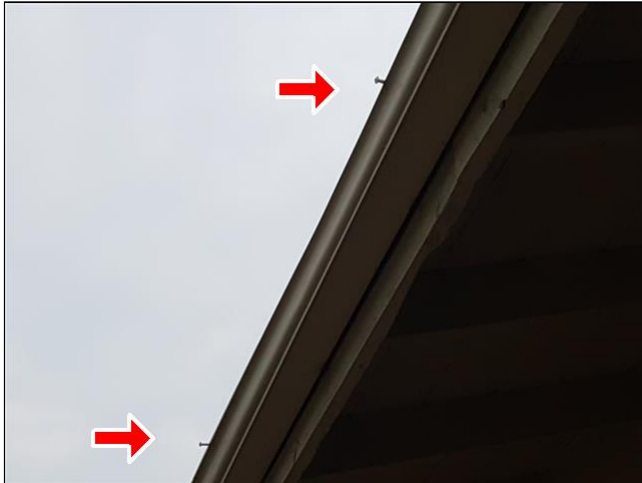
2.4 Item 1(Picture)

(1) The gutters where indicated in photos have mounting bolts that are loose at the left side of the home. If not corrected gutters can become detached from the fascia and also water can enter the soffits which can lead to wood rot. Recommend a qualified contractor repair loose gutters to avoid spilling roof runoff around perimeter of home.

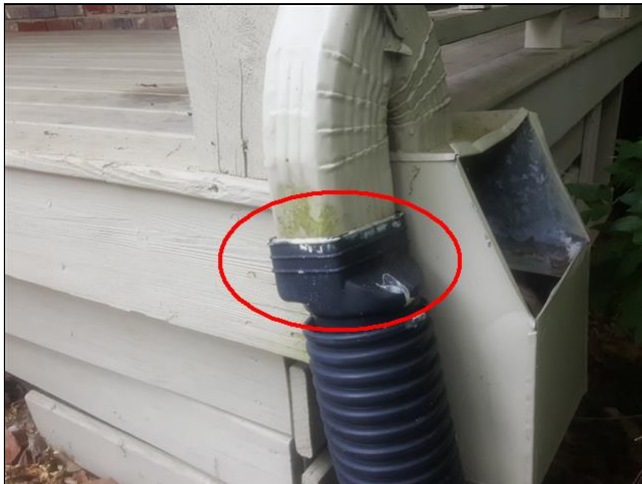
2.4 Item 2(Picture)

(2) Recommend the downspout extension(s) be attached to the downspout at the front right corner of the home by placing a screw at the top and bottom where it connects to the downspout to ensure the extension(s) does not pull away from the downspout(s). Failing to do this may create future problems to the foundation around the home due to soil erosion and water entering the basement which may result in the foundation settlement if the extension detaches from the downspout.

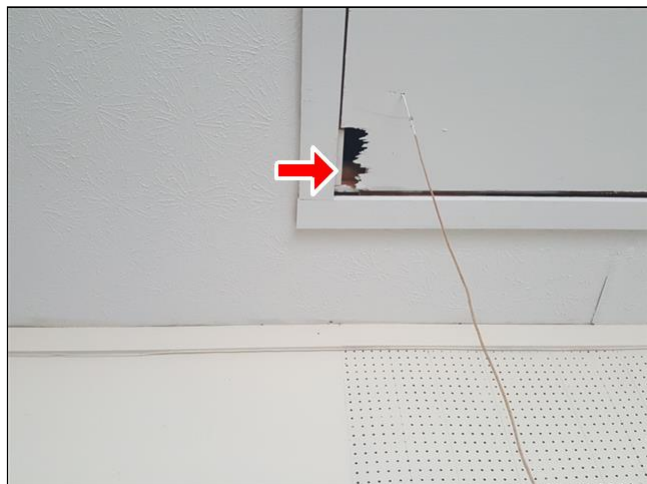
2.5 Item 4(Picture)

(2) Recommend repairing the hole in the pull down ladder door.

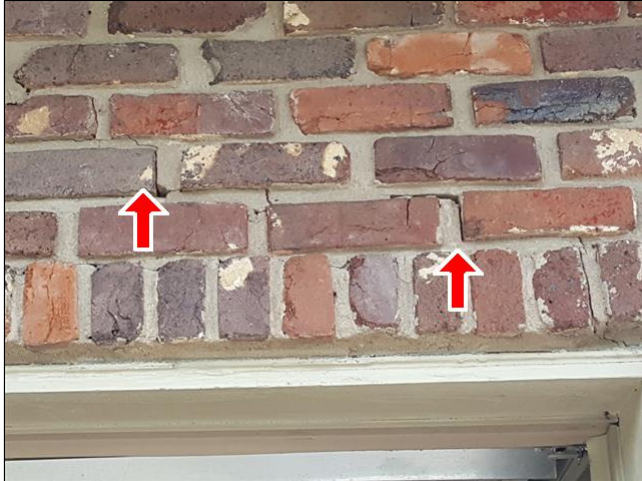
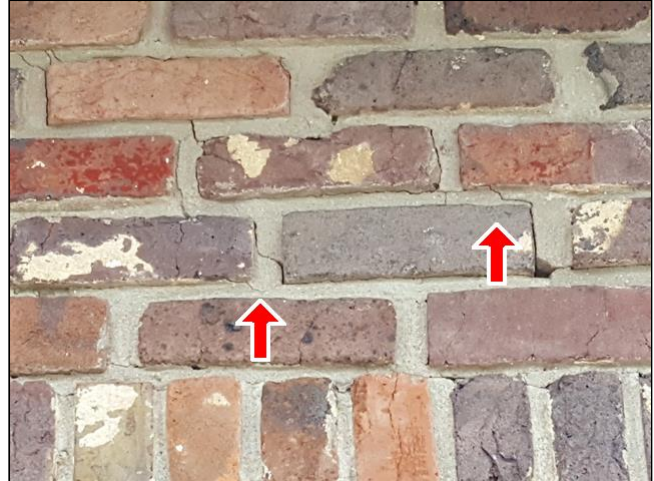
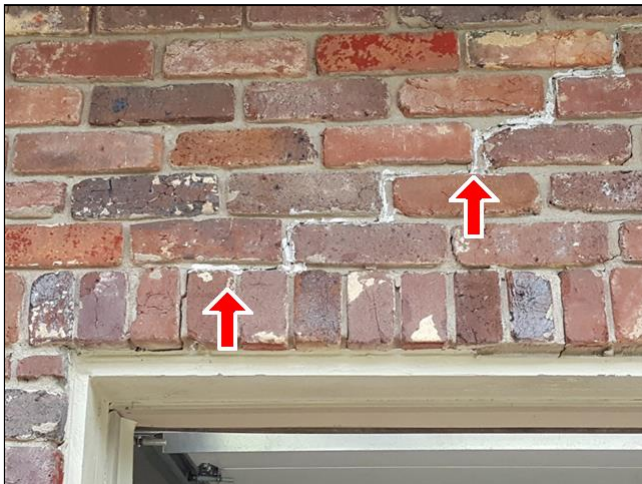
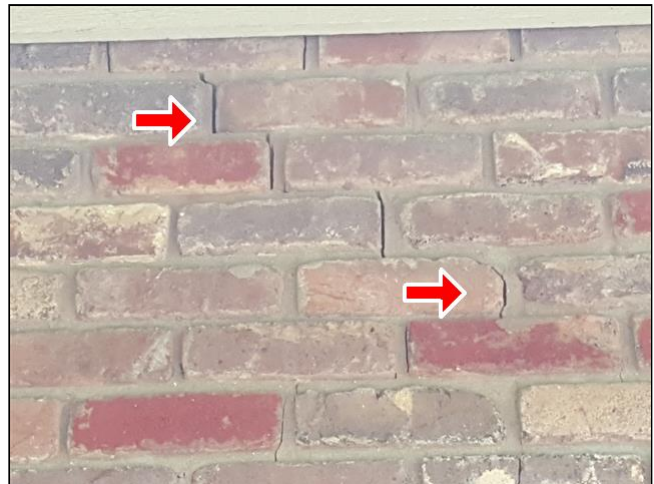
Typical stair step cracks at the mortar joint in the brick siding at the right side of the home above the garage was observed. These cracks imply that the lintel may be rusting or expanding. A lintel is a metal beam supporting the masonry above an opening in a wall. It also may imply that minor settlement of the home has occurred. While the rate of movement cannot be predicted during a one-time inspection it is likely that repairs are needed. These cracks do not appear significant at this stage from a structural concern due to the width of the crack. Due to freeze/thaw (water entering), the cracks should be sealed to minimize further chipping away, flaking or deterioration. The lintel is covered. Recommend these cracks be sealed to prevent further cracking and possible deterioration of the brick work. A skilled masonry contractor should perform the repairs via re-pointing mortar. It is recommended that you monitor periodically and if cracks reappear further investigation by a structural engineer is recommend. Ensure the lintel is sealed so that water intrusion does not occur to prevent rusting of the lintel.

3.0 Item 1(Picture) right side of garage

3.0 Item 2(Picture) right side

3.0 Item 3(Picture) left side

3.0 Item 4(Picture) left side

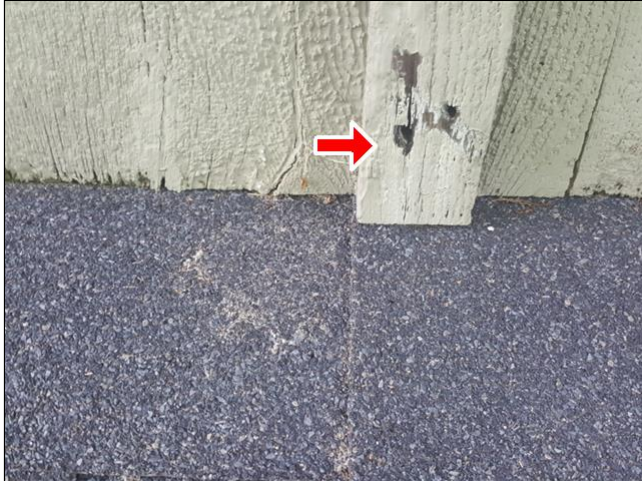
3.1 Item 1(Picture)

(1) There is evidence of recent carpenter bee damage to the wood siding in some areas of the home. Carpenter bees have the ability to tunnel into the wood which can compromise the structure and cause damage via water intrusion. Recommend sealing holes where found around the perimeter of the home with the appropriate sealer, then consult a pest control specialist for advice on a possible treatment to prevent further damage and deterioration of the wood siding around the home.

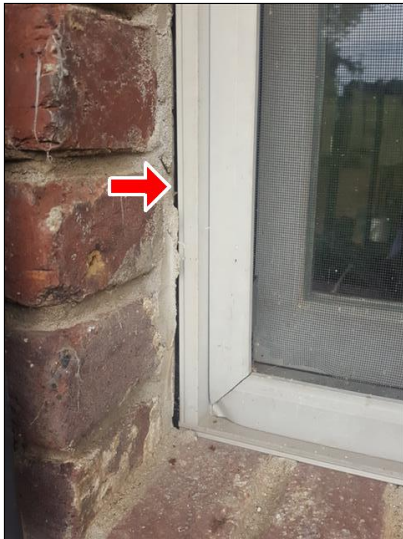
3.4 Item 1(Picture)

(1) The gaps between the window frames and the siding around the home need to be sealed correctly to prevent water intrusion. Water entering here can lead to deterioration of the wall siding and potential leaks inside the wall cavity. Recommend caulking these areas with a quality moisture resistant caulk that expands and contracts. [Choosing the right caulk](#)

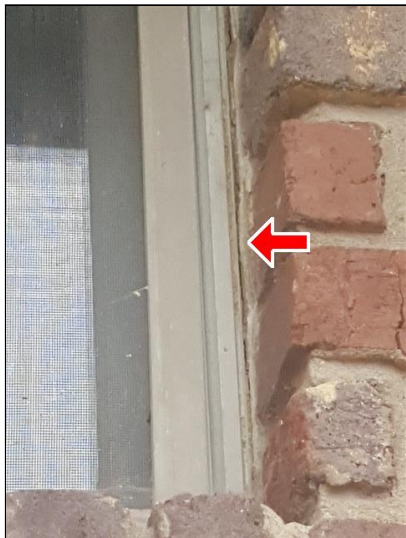
3.4 Item 3(Picture)

(2) The window frame at the rear right side of the home has cracked sealant between the siding and the window frame. Water and/or insects may enter and deterioration may occur behind the wall cavity and siding. This is a small repair. Recommend re-caulking as needed. [Which caulk to use](#)

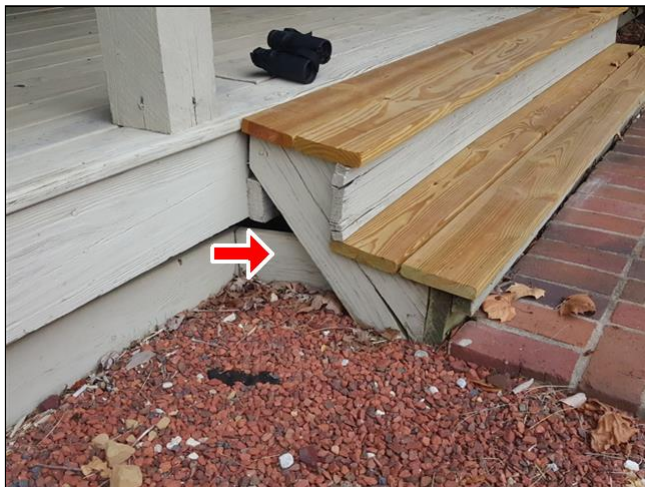
3.5 Item 6(Picture)

(4) The staircase at the front porch has sunken on the left side. The staircase may be in contact with the ground. This may become a possible safety issue if further settlement occurs. Recommend replacement or repair as needed by a qualified contractor.

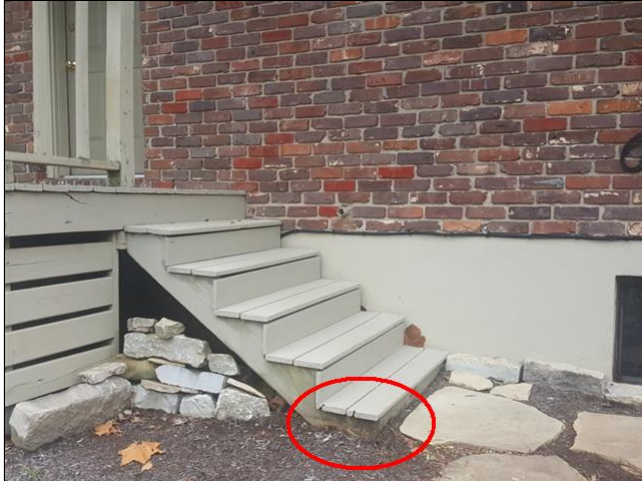
3.6 Item 10(Picture)

(6) The bottom of the deck steps are in contact with the soil at the rear right side of the home. The stairs need to be resting on a concrete landing. Over time the soil will erode away and weaken the bottom of the staircase and will not be supported. In the future this will result in being a safety issue and an injury could occur. Recommend correcting as needed by a general contractor or qualified person.

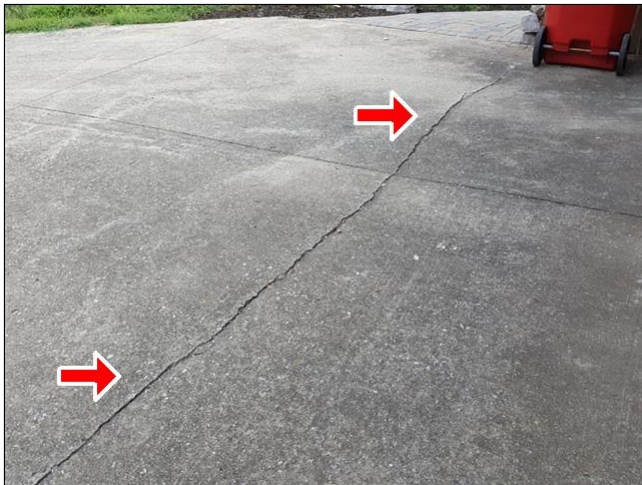
3.7 Item 1(Picture)

Common settlement crack(s) were noted at the concrete drive. This is not a tripping hazard as yet at this time. I also do not see these small cracks as an indication of a structural issue. Further deterioration and/or settlement can occur to the driveway via water intrusion if not repaired. Recommend repairs via a masonry caulk as needed then monitor annually. Here is a link for [Sealing Concrete Cracks](#)

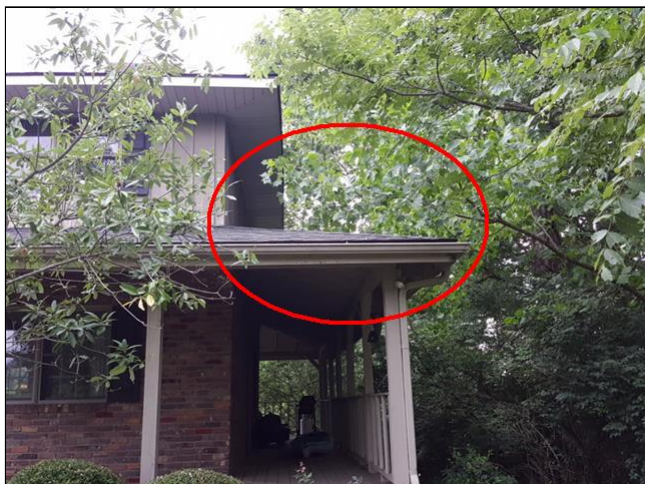
3.11 Item 1(Picture)

(2) There are tree branches that overhang over the roof at the front right corner of the home. Be observant. Tree limbs should be cut as needed to prevent damage to the shingles and from scraping on the roof surface. They will also clog gutters which will cause water run off problems around the home. Recommend cutting back tree branches as needed.

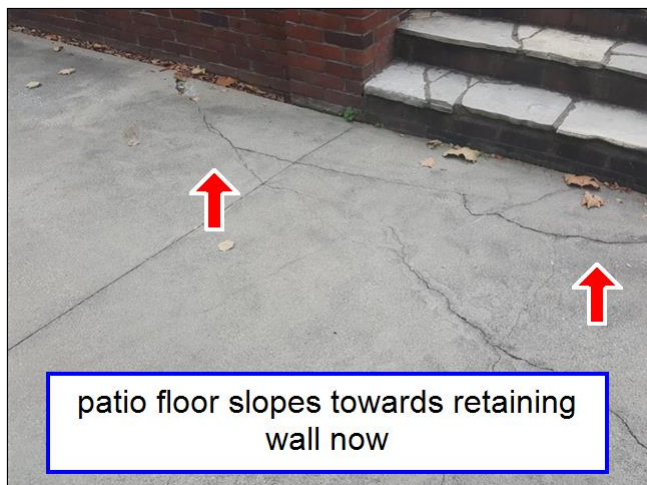
3.14 Item 4(Picture)

(2) Common settlement crack(s) were noted at the patio floor near the pool area. This has caused a slope which allows water to pool and not drain correctly. Water pooling here can lead to the retaining wall to settle or lean in the future. Recommend a qualified masonry contractor repair as needed. Consideration for improving drainage in this area is also recommended. Further deterioration and/or settlement can occur to the concrete floor via water intrusion if not repaired.

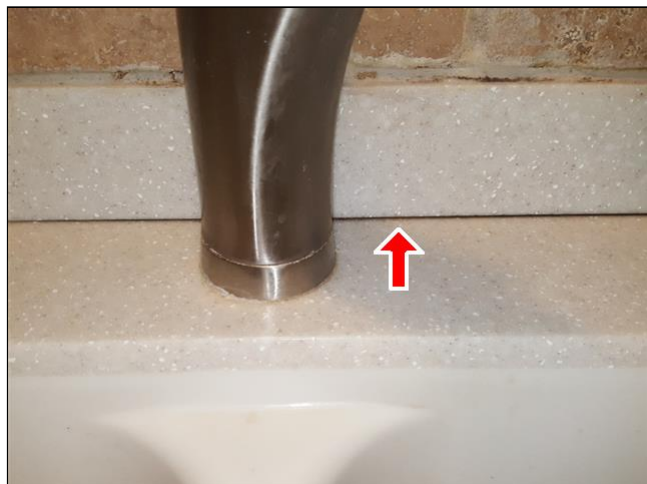
5.9.A Item 1(Picture)

Recommend caulking around the counter top in the kitchen to seal the gap/crack in front of the sink. Water may enter which can cause damage to the drywall and cabinets, then result in possible mold forming. Repair using a quality caulk that is resistant to moisture and is expandable. Here is a link on [How to Choose the right Caulk](#)

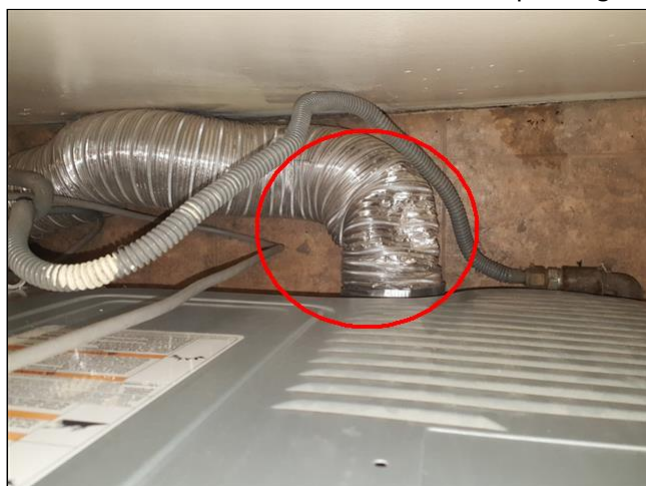
5.11.A Item 2(Picture)

(2) The dryer vent piping is damaged. This can cause an obstruction of lint that has a possibility to create a fire hazard. Recommend replacing flexible line prior to using dryer.

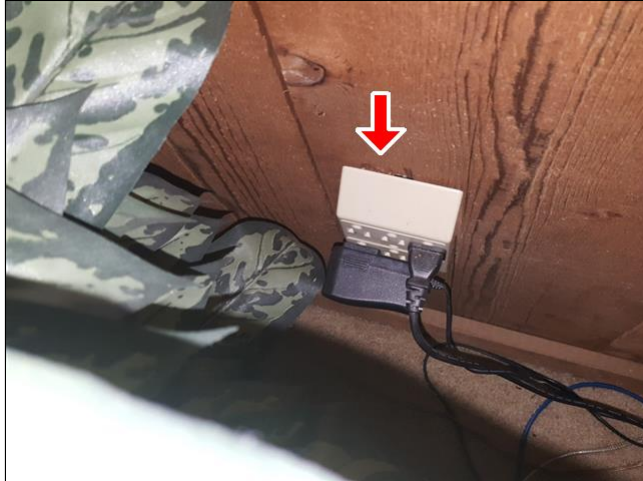
(1) It is not recommended that these adapters be used in the outlets as they can overheat and cause a fire. This is for your safety. Especially in areas like kitchens where numerous appliances can be connected. If additional outlets are required, recommend a qualified electrician install them as needed.

6.7 Item 1(Picture) living room

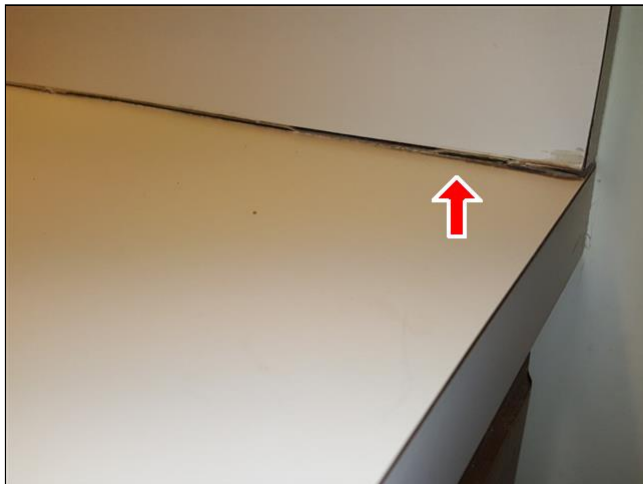
7.1 Item 1(Picture)

Recommend caulking around the counter top in the guest bathroom to seal the gap/crack. Water may enter which can cause damage to the drywall and cabinets, then result in possible mold forming.

Repair using a quality caulk that is resistant to moisture and is expandable. Here is a link on [How to Choose the right Caulk](#)

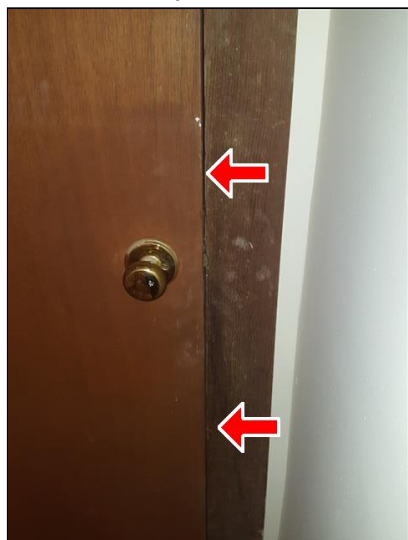
7.2 Item 1(Picture)

then touch up painting or doors will need to be rehung or trimmed down. Recommend a qualified contractor repair as needed.
