## **Inspection Report**

**Property Address:**  
780 Nutfield Way  
Richmond KY 40475

<b>Date:</b> 7/15/2018	<b>Time:</b> 09:00 AM till 03:00 PM	<b>Report ID:</b> 180715BETHAM
<b>Property:</b> 780 Nutfield Way Richmond KY 40475	<b>Customer:</b> Mrs. Gail Schneider	<b>Real Estate Professional:</b>

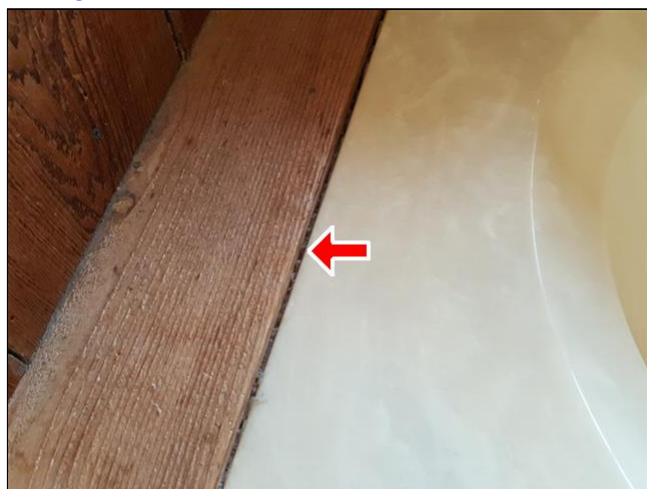
7.7 Item 2(Picture)

(2) Recommend a quality caulk that is expandable and moisture resistant along the top of the threshold of the bath tub so moisture or water cannot penetrate in the master bathroom. [Choosing the right caulk](#)

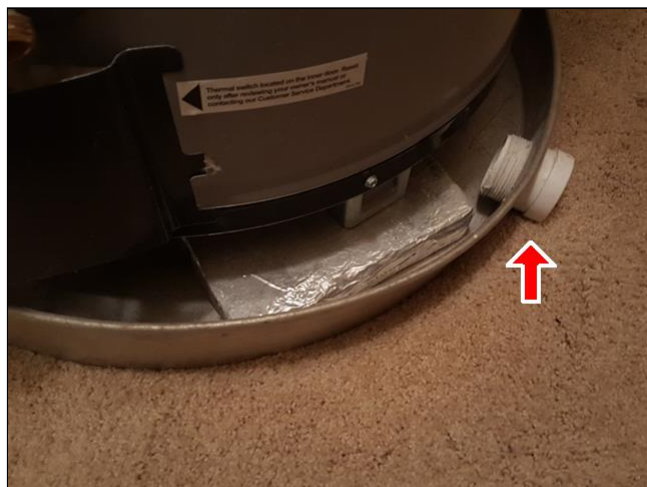
8.2 Item 2(Picture)

(4) The drain pan installed under the water heater in the upstairs closet is missing a drain line to the exterior. If the water heater leaks it has the potential to cause severe damage if a leak should develop which will result in costly repairs to the floor and ceiling below if a drain line is not connected. As an inexpensive safe-guard a drain pan with a moisture alarm can easily be installed as

another option. Recommend a qualified plumber install a drain line at the pan that leads to the exterior of home.

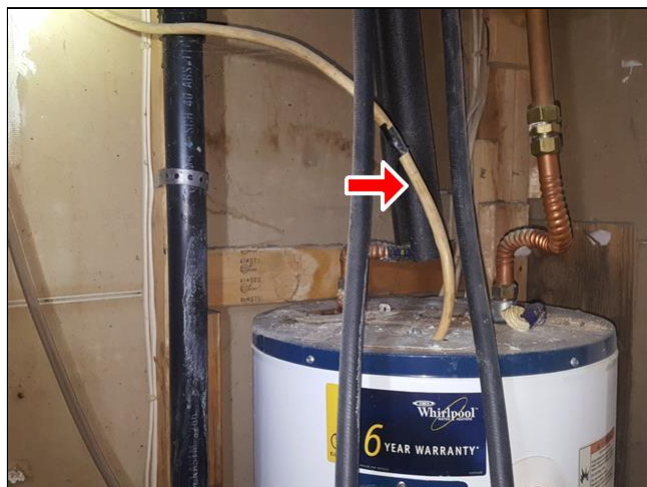
8.2 Item 8(Picture)

(9) Unprotected electrical wiring leading into the water heater in the basement is susceptible to being damaged and should be covered or protected by a rigid conduit. This is a potential safety issue. This will protect the wire jacket from possible melting if it comes in contact with the hot water line which could energize the unit and cause an electric shock if any water or metal surface is touched. Recommend a qualified electrician install a conduit to make the connection safer and protect the wire from being damaged.

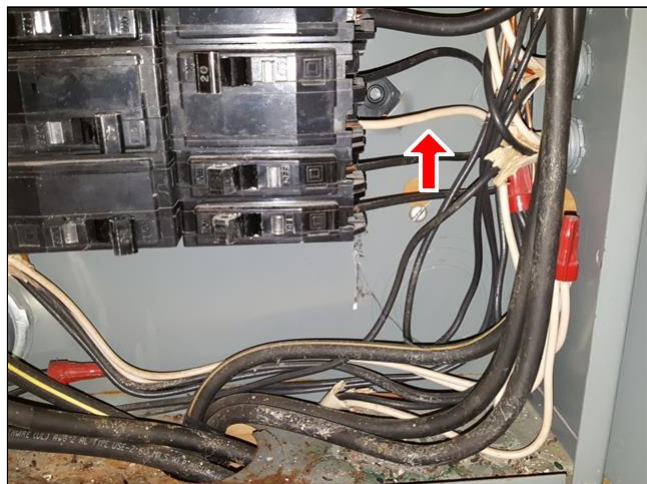
9.3 Item 6(Picture)

(4) The white wire(s) that are connected to the circuit breaker(s) in the main panel should be marked black to indicate that they are live (hot wires) and are being used for the flow of electricity to travel. Recommend an electrician correct due to safety.

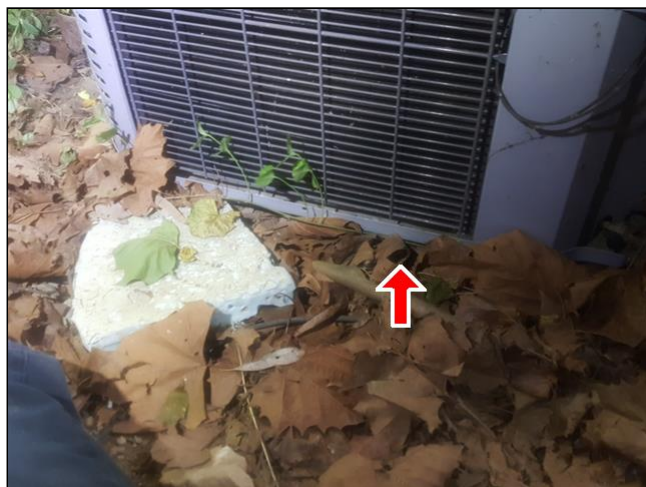
10.0.A Item 1(Picture)

(2) The heat pump should be raised of the ground for better efficiency and proper drainage. Blocked fins via snow coverage can harm the unit and increase energy costs. Recommend a qualified HVAC contractor correct if desired. Ensure when a new unit is installed that this is done on new installation.

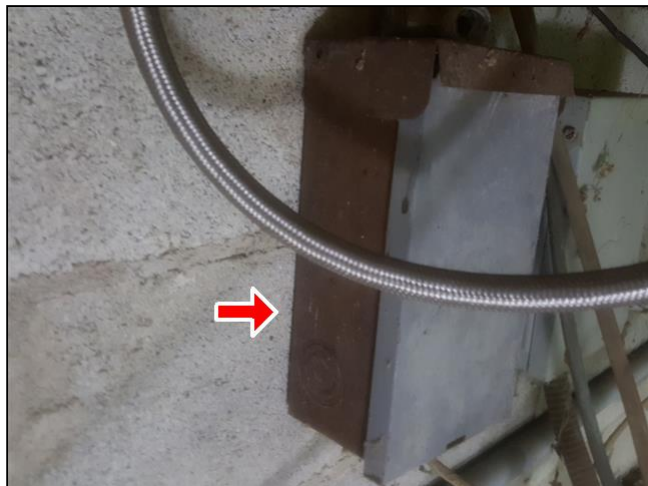
10.2.B Item 1(Picture)

(1) The exterior electrical box for the Heat Pump is rusted on the outside and on the inside. Recommend it be painted or replaced to prevent further rusting. If replaced a qualified electrician should perform replacement.
