Sand Dollar Home Inspections

Your Property Inspection Report

1234 Main St, Anywhere, FL 33767 Inspection prepared for: Steve Miller Date of Inspection: 4/28/2016 Time: 9am Age of Home: 25 Weather: 70 degrees, Dry

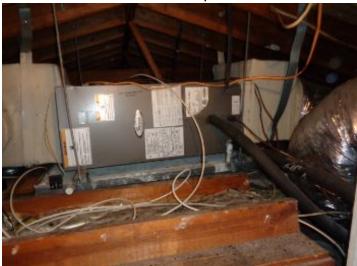
Page 7 Item: 2	HVAC Unit	• Burn marks on the outside of unit, have a licensed HVAC Technician further evaluate.
Page 9 Item: 3	Water Heater	• Temperature – Pressure drain line is missing. One should be installed to terminate within six inches of the floor to minimize personal injury which may be caused by scalding water, in the event of a pressure blow-off.

HVAC exterior burning

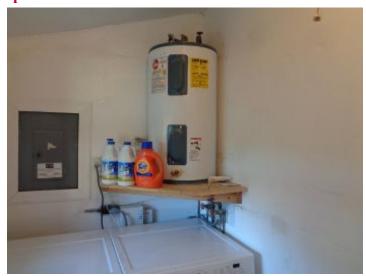
• Temperature – Pressure drain line is missing. One should be installed to terminate within six inches of the floor to minimize personal injury which may be caused by scalding water, in the event of a pressure blow-off.

Missing Drain Pipe
