MINIMUM INSPECTION PROCEDURAL GUIDELINES FOR BUILDING ELECTRICAL RECERTIFICATION

Table with 1 column and 13 rows containing structure details: a. Name on Title: Village at Dadeland Condominiums (K), b. Street Address: 7400 SW 82nd St. Miami, Florida 33143, c. Legal Description: Village at Dadeland Condominiums, d. Owner's Name: Village at Dadeland Condominiums, e. Owner's Mailing Address: 7400 SW 82nd St. Miami, Florida 33143, f. Folio Number of Property on which Building is Located: 30-4035-047-XXXX, g. Building Code Occupancy Classification: R2 - Residential, h. Present Use: Condominium, Residential, i. General Description, Type of Construction, Size, Number of Stories, and Special Features. Additional Comments: The condominium building was built in 1970. The 4-story twenty-four unit building at the Village at Dadeland Condominium has an approximate footprint of 175ftx50ft. Building 7400 is 1 of 2 buildings that comprise the VILLA "K" area of the community. Buildings 7410 and 7400 are linked at their east and west ends respectively and have an approximate combined footprint of 350ftx50ft. Two stair/elevator towers are located on their south front elevation and provide access to

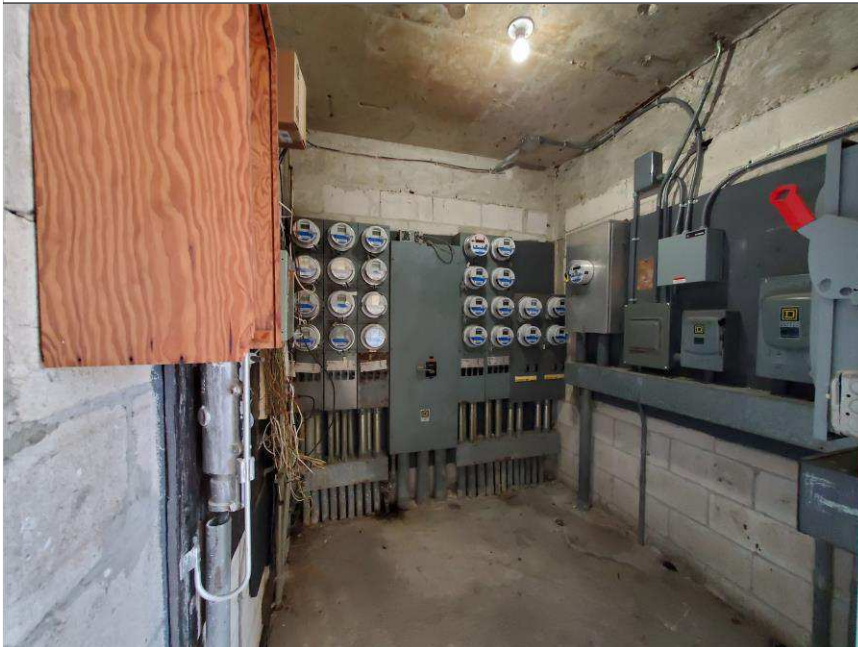
Photo 2 – Village at Dadeland Condominium Association

Existing Electrical Room - 1st FL
Main Switches for Apartments,
Meters, House Main Switch,
Fire Alarm Panel, and Gutters.

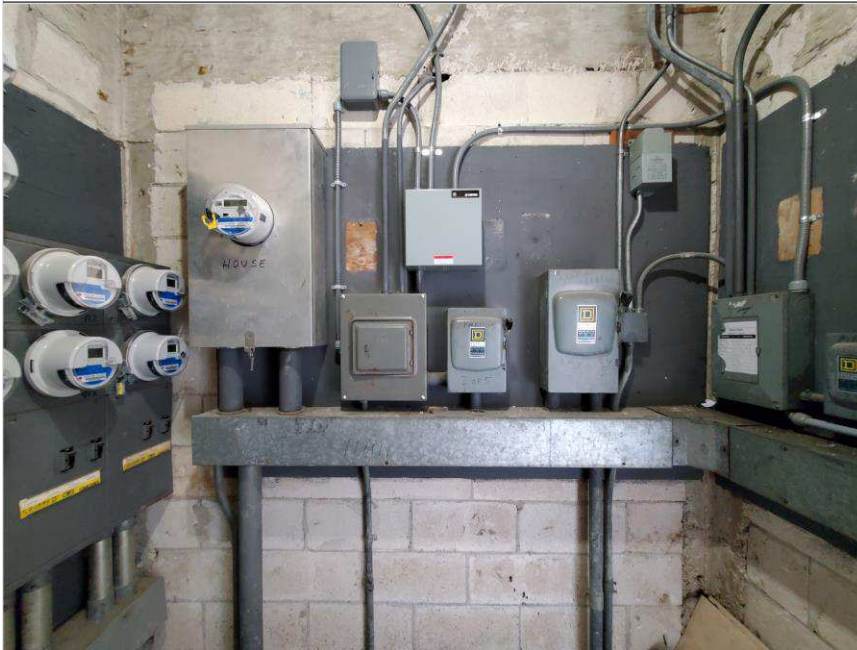
Photo 3 – Village at Dadeland Condominium Association

Existing Electrical Room - 1st FL
House Main Disconnect
Switches, and House Meter

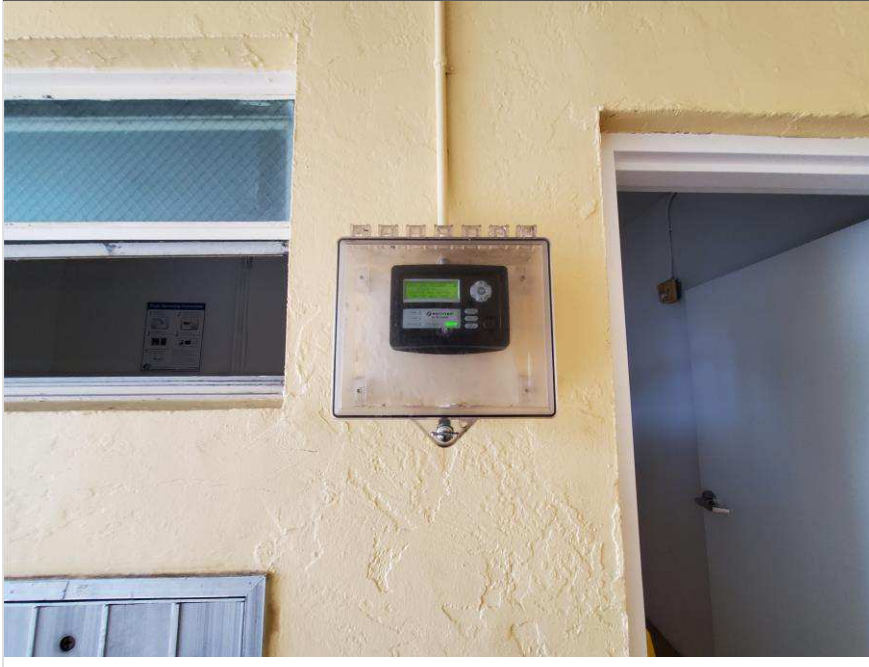
Photo 15 – Village at Dadeland Condominium Association

Level 1
Fire Alarm Annunciator

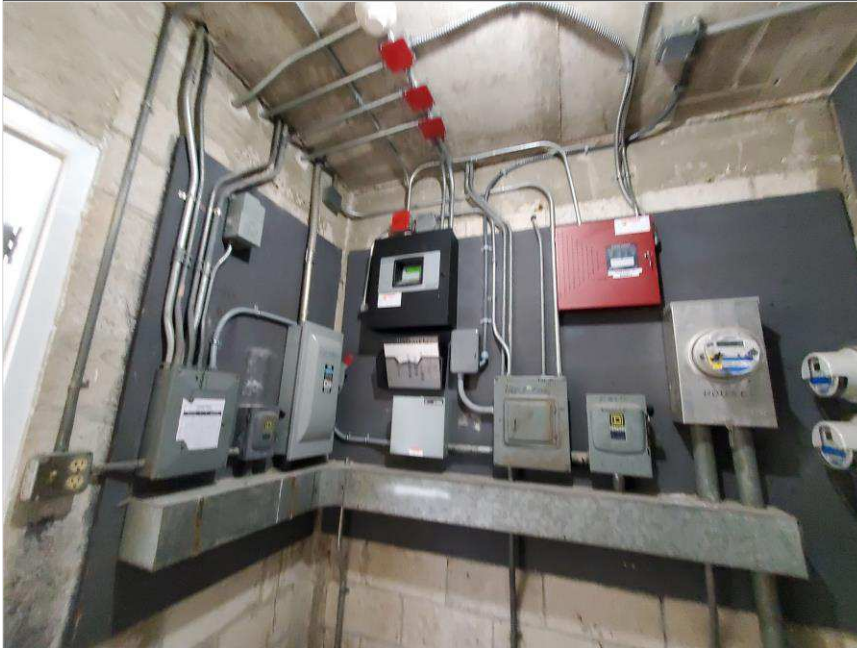
Photo 3 – Village at Dadeland Condominium Association

Existing Electrical Room - 1st FL
House Main Disconnect
Switches, House Meter, and
Fire Alarm Panel

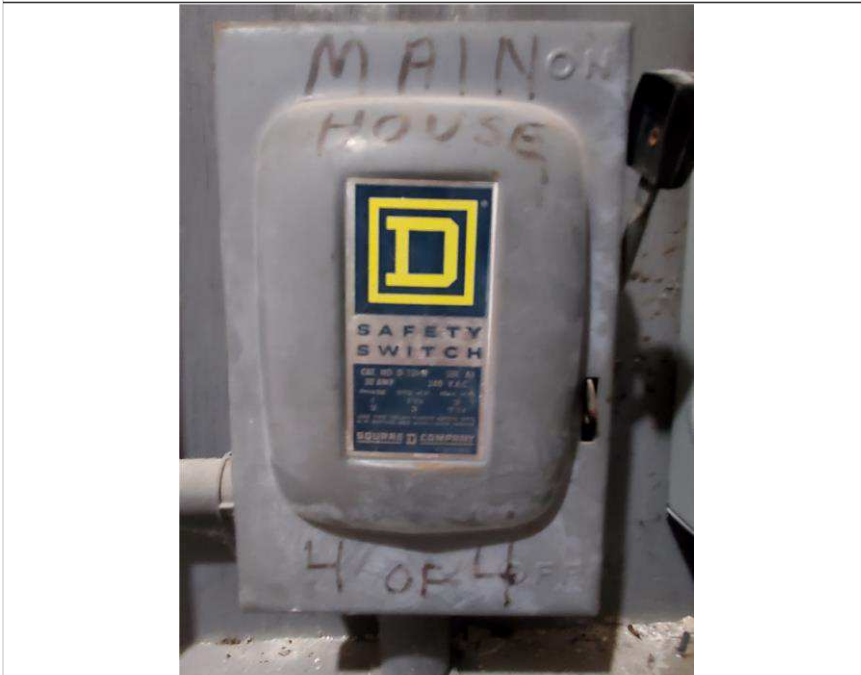
Photo 6 – Village at Dadeland Condominium Association

Existing Electrical Room - 1st FL
House Panel Board

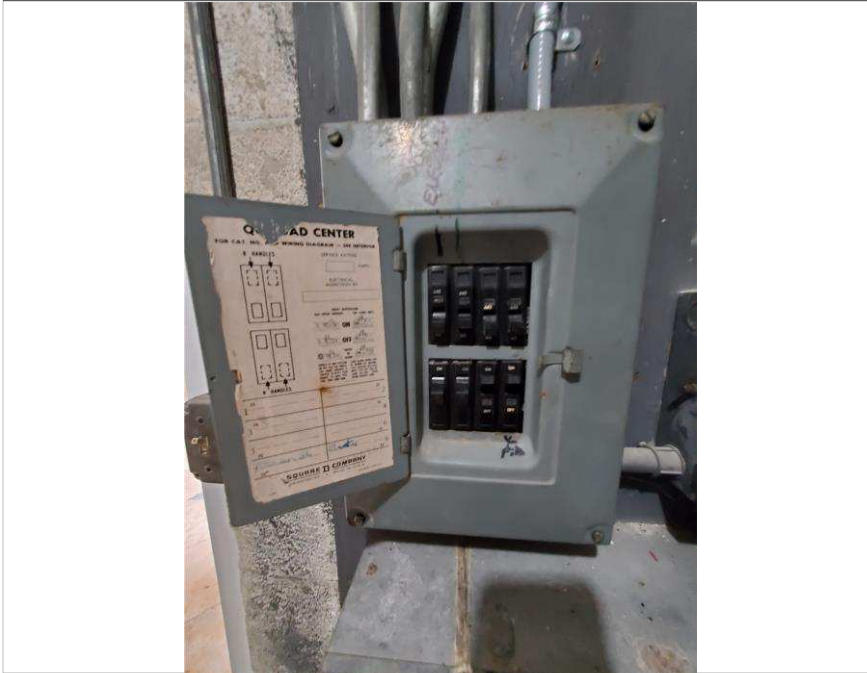
Photo 7 – Village at Dadeland Condominium Association

Existing Electrical Room - 1st FL
House Panel Board #2.

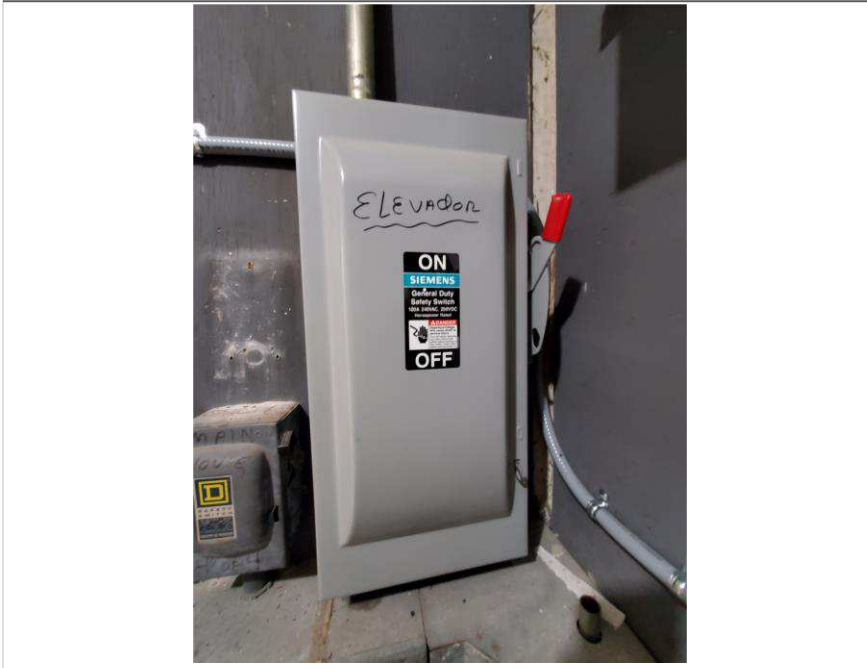
Photo 8 – Village at Dadeland Condominium Association

Existing Electrical Room - 1st FL
Elevator Disconnect Switch

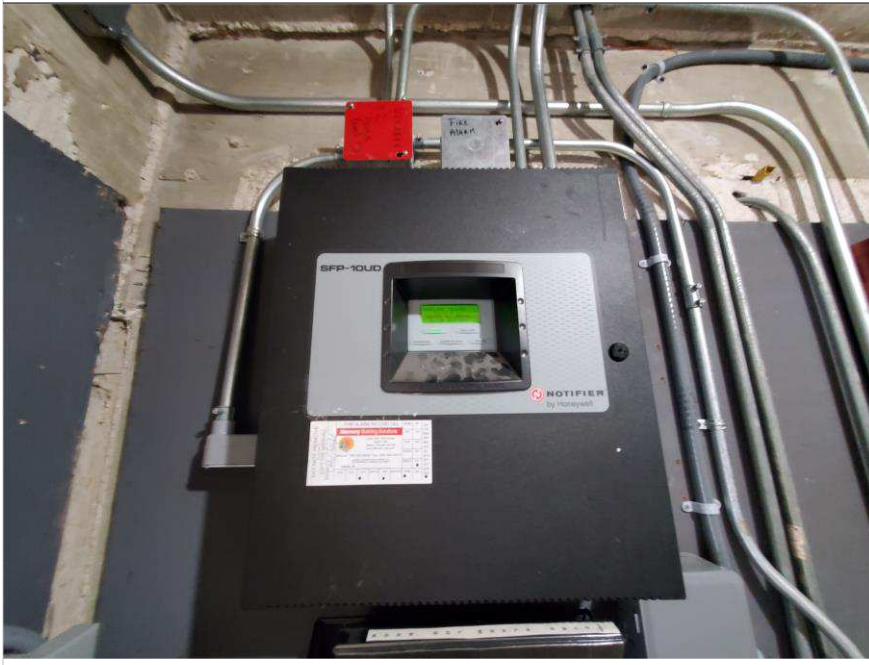
Photo 14 – Village at Dadeland Condominium Association

Existing Electrical Room - 1st FL
Fire Alarm Panel

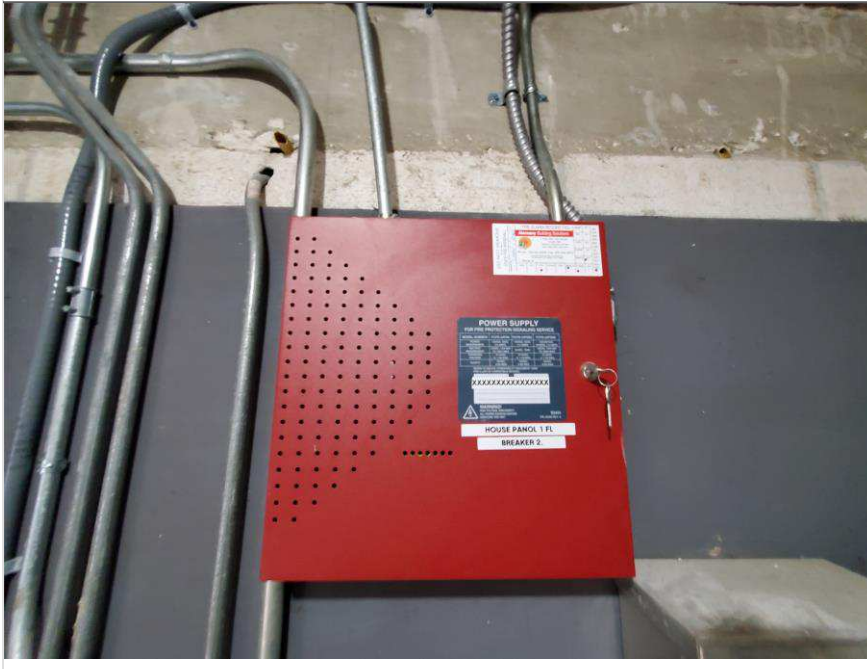
Photo 15 – Village at Dadeland Condominium Association

Existing Electrical Room - 1st FL
Fire Alarm Power Supply

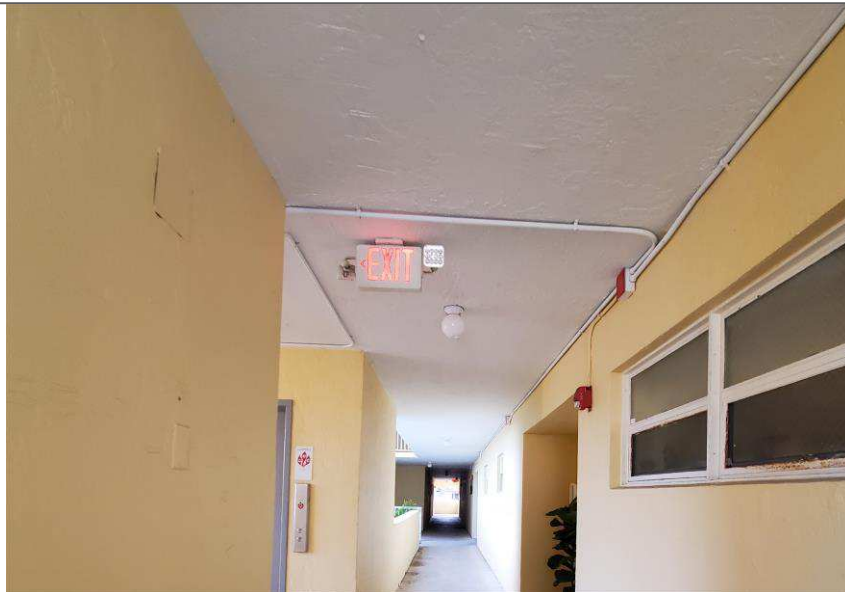
Photo 18 – Village at Dadeland Condominium Association

Comments: Old combination Emergency Lights/Exit Lights. Broken EM Light at 2nd Floor West Stair.

EM Lights/Exit Lights -
Old Combination EM Light and
Exit Light/Sign
