Superior LawnCare

Tree Report

Woodwind Lakes

Photo Sampler

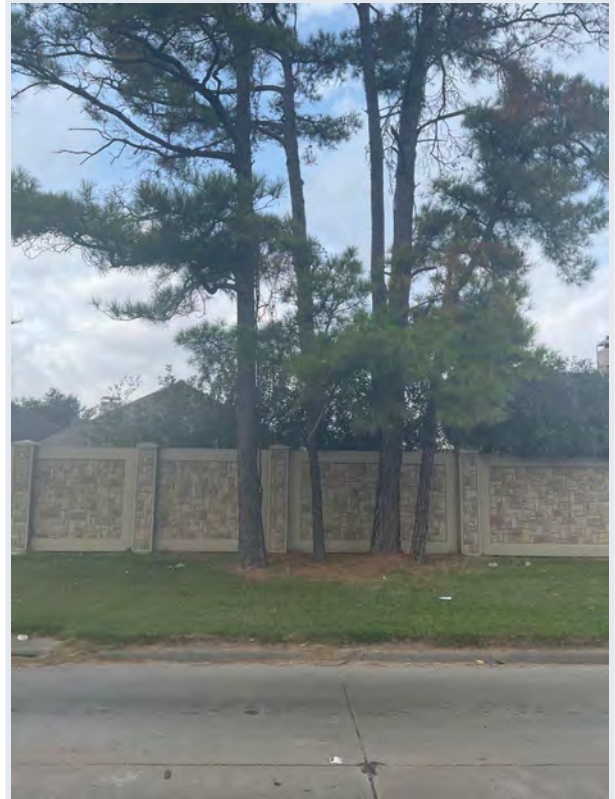
Loblolly pine Tree ID #51

Condition: Poor

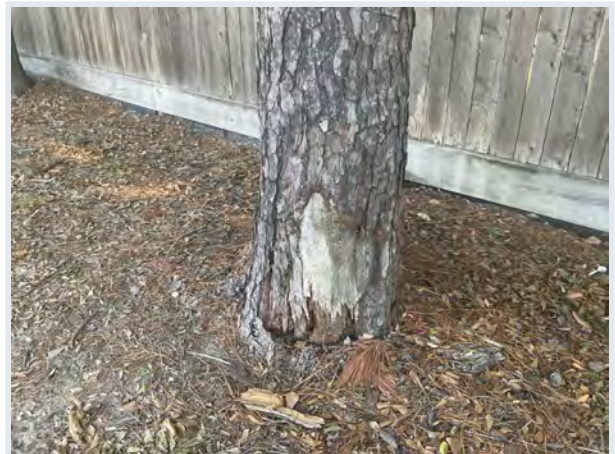
Loblolly pine Tree ID #99

Scientific Name:	Pinus taeda
Common Name:	Loblolly pine
Genus:	Pinus
Condition:	Fair
Status:	Alive
Number of Stems (Multi Calc):	1
Trimming Class:	B (Moderate)
DBH Range:	6-12in
Height Range:	30ft-50ft
Risk Rating:	
Priority:	High
Crown Spread:	
Canopy Shape:	
Observations-Characteristics:	Leaning trunk, Deadwood
Observations-Biotic Pest:	Boring Insect
Observations-Abiotic:	None
Observation Comments:	
Tree Work-PHC:	Chemical Systemic
Tree Work-Other:	Not Needed
Last Modified:	12/30/2025
Notes:

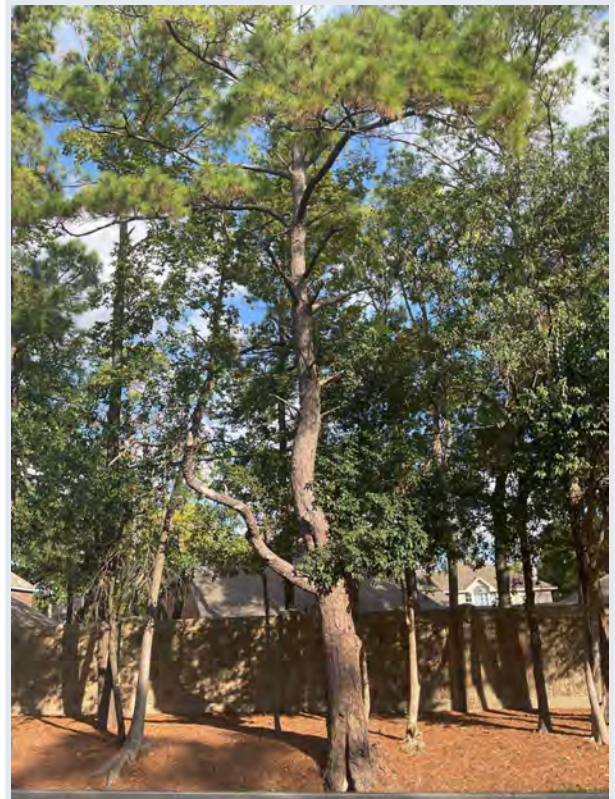
Loblolly pine Tree ID #281

Scientific Name:	Pinus taeda
Common Name:	Loblolly pine
Genus:	Pinus
Condition:	Poor
Status:	Alive
Number of Stems (Multi Calc):	1
Trimming Class:	B (Moderate)
DBH Range:	12-18in
Height Range:	50ft-75ft
Risk Rating:	
Priority:	High
Crown Spread:	
Canopy Shape:	
Observations- Characteristics:	Deadwood
Observations-Biotic Pest:	Boring Insect
Observations-Abiotic:	None
Observation Comments:	
Tree Work-PHC:	Chemical Systemic
Tree Work-Other:	Not Needed
Last Modified:	12/30/2025

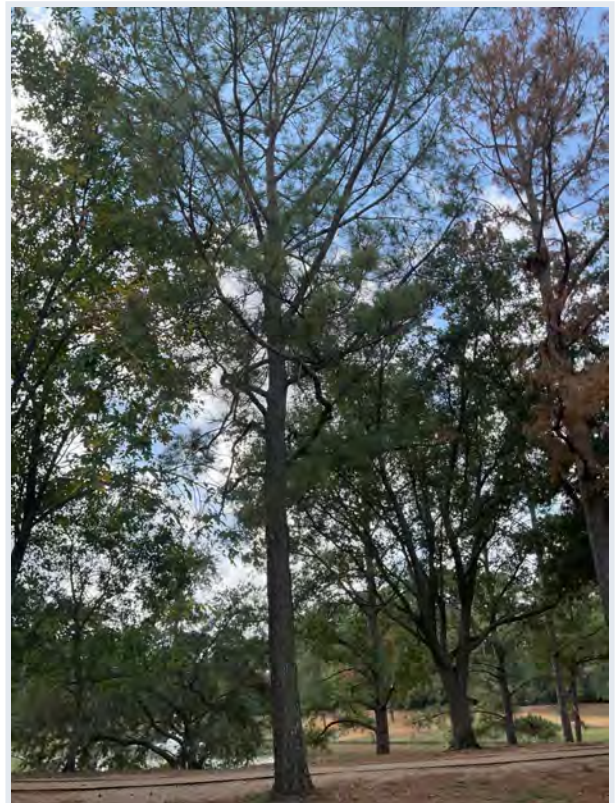
Tallowtree Tree ID #296

Condition: Good

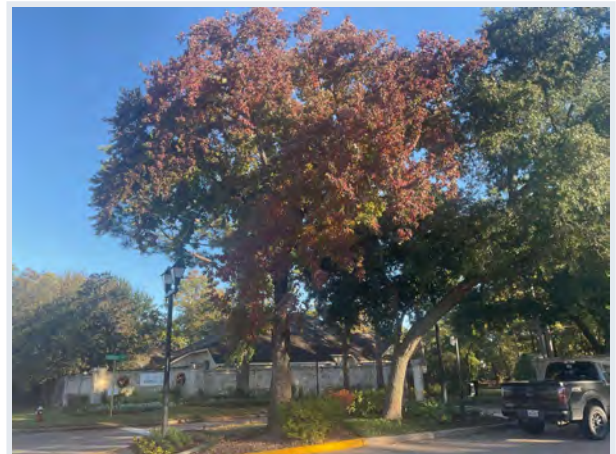
Live oak Tree ID #297

Condition: Good

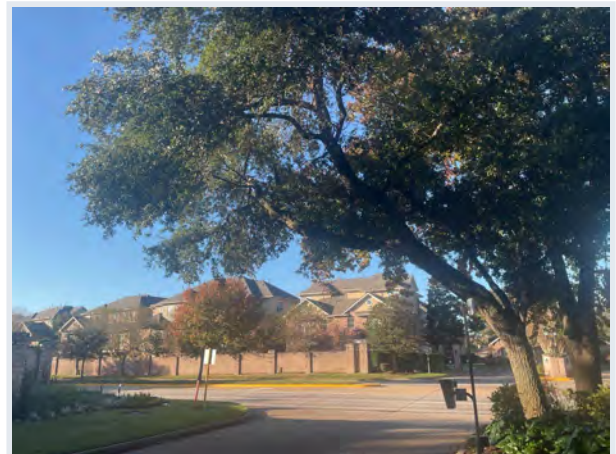
Tallowtree Tree ID #299

Condition: Dead

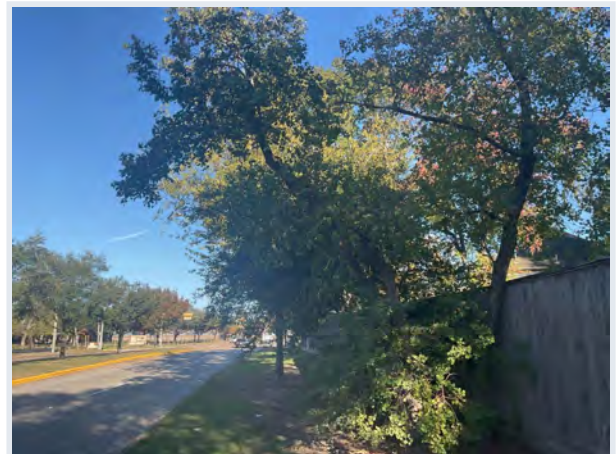
American elm Tree ID #311

Scientific Name:	Ulmus americana
Common Name:	American elm
Genus:	Ulmus
Condition:	Poor
Status:	Alive
Number of Stems (Multi Calc):	Multiple Stems
Trimming Class:	Not Needed
DBH Range:	6-12in
Height Range:	15ft-30ft
Risk Rating:	
Priority:	Medium
Crown Spread:	
Canopy Shape:	
Observations-Characteristics:	Deadwood, Cavity
Observations-Biotic Pest:	Fungus
Observations-Abiotic:	None
Observation Comments:	
Tree Work-PHC:	Not Needed
Tree Work-Other:	Remove
Last Modified:	12/30/2025
Notes:	Hypoxylon Canker

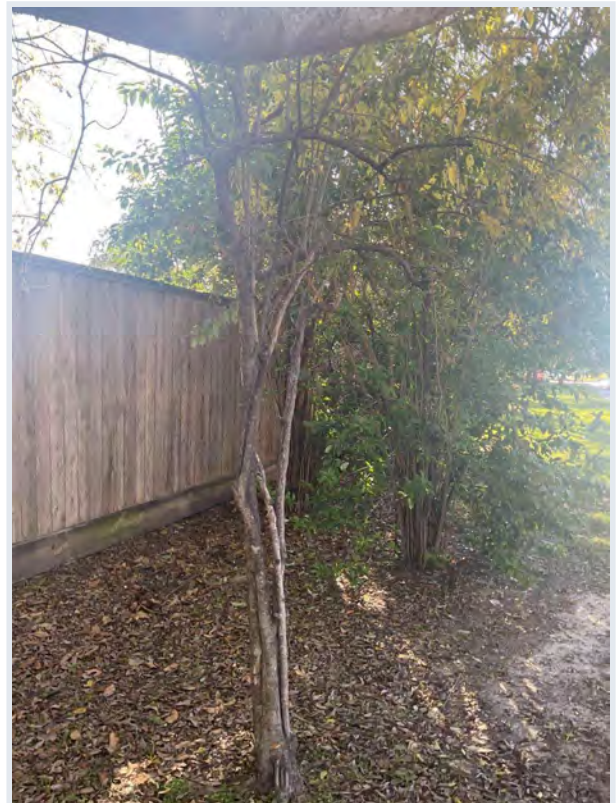
Yaupon Tree ID #353

Scientific Name:	Ilex vomitoria
Common Name:	Yaupon
Genus:	Ilex
Condition:	Dead
Status:	Dead
Number of Stems (Multi Calc):	Multiple Stems
Trimming Class:	Not Needed
DBH Range:	3-6in
Height Range:	<15ft
Risk Rating:	
Priority:	Medium
Crown Spread:	
Canopy Shape:	
Observations-Characteristics:	
Observations-Biotic Pest:	Little to No Pest Pressure
Observations-Abiotic:	None
Observation Comments:	
Tree Work-PHC:	Not Needed
Tree Work-Other:	Remove
Last Modified:	12/30/2025
Notes:

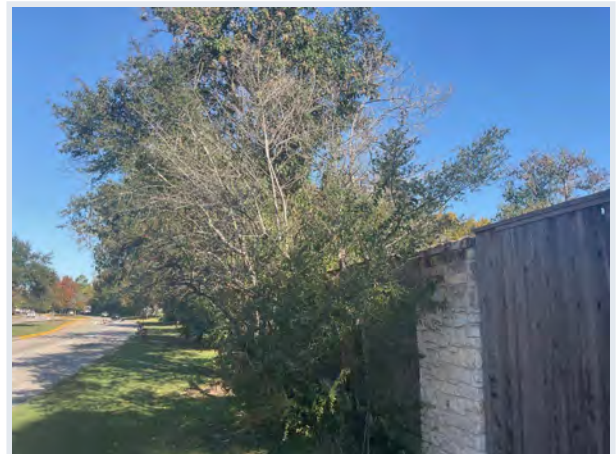
Live oak Tree ID #370

Scientific Name:	Quercus virginiana
Common Name:	Live oak
Genus:	Quercus
Condition:	Poor
Status:	Alive
Number of Stems (Multi Calc):	1
Trimming Class:	Not Needed
DBH Range:	3-6in
Height Range:	15ft-30ft
Risk Rating:	
Priority:	High
Crown Spread:	
Canopy Shape:	
Observations-Characteristics:	Deadwood, Compacted Soil
Observations-Biotic Pest:	Fungus
Observations-Abiotic:	Nutrient Deficiency
Observation Comments:	
Tree Work-PHC:	Not Needed
Tree Work-Other:	Remove
Last Modified:	12/30/2025
Notes:

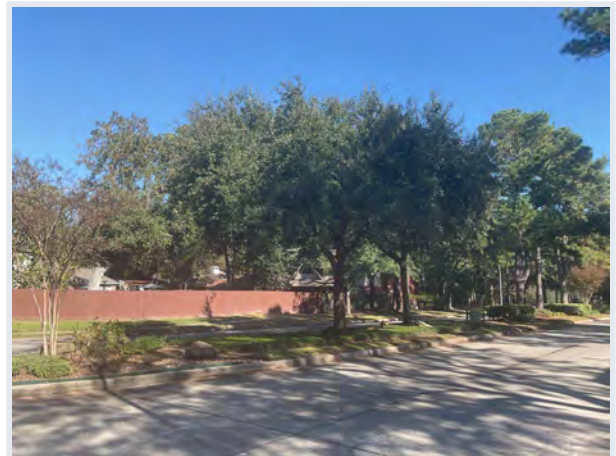
Water oak Tree ID #440
9303 Woodwind Lakes Drive

Scientific Name:	Quercus nigra
Common Name:	Water oak
Genus:	Quercus
Condition:	Good
Status:	Alive
Number of Stems (Multi Calc):	1
Trimming Class:	B (Moderate)
DBH Range:	12-18in
Height Range:	30ft-50ft
Risk Rating:	
Priority:	High
Crown Spread:	
Canopy Shape:	
Observations-Characteristics:	Broken Limb, Deadwood
Observations-Biotic Pest:	Little to No Pest Pressure
Observations-Abiotic:	None
Observation Comments:	
Tree Work-PHC:	Not Needed
Tree Work-Other:	Not Needed
Last Modified:	12/30/2025
Notes:

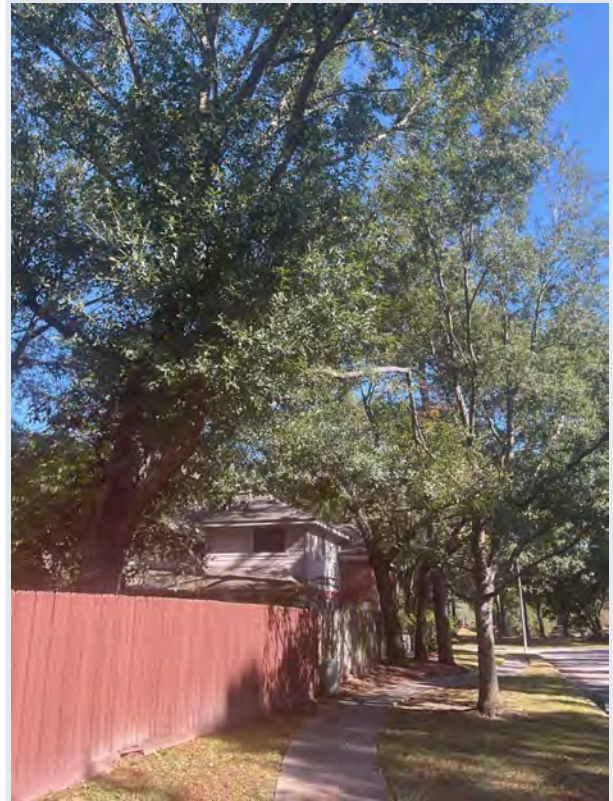
Water oak Tree ID #450

Scientific Name:	Quercus nigra
Common Name:	Water oak
Genus:	Quercus
Condition:	Fair
Status:	Alive
Number of Stems (Multi Calc):	1
Trimming Class:	B (Moderate)
DBH Range:	12-18in
Height Range:	30ft-50ft
Risk Rating:	
Priority:	High
Crown Spread:	
Canopy Shape:	
Observations-Characteristics:	Deadwood
Observations-Biotic Pest:	Little to No Pest Pressure
Observations-Abiotic:	None
Observation Comments:	
Tree Work-PHC:	Not Needed
Tree Work-Other:	Not Needed
Last Modified:	12/30/2025
Notes:	Cable clearance

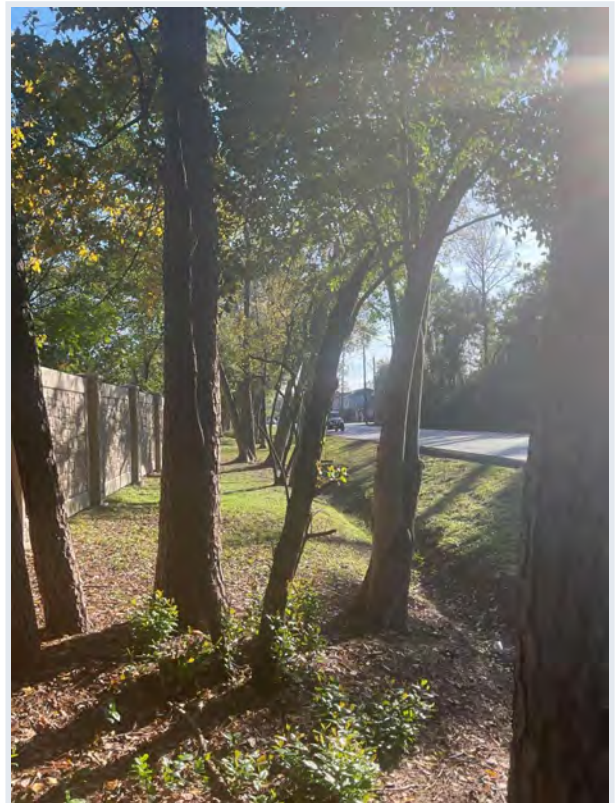
Chinaberry Tree ID #502

Scientific Name:	Melia azedarach
Common Name:	Chinaberry
Genus:	Melia
Condition:	Fair
Status:	Alive
Number of Stems (Multi Calc):	1
Trimming Class:	Not Needed
DBH Range:	12-18in
Height Range:	30ft-50ft
Risk Rating:	
Priority:	Medium
Crown Spread:	
Canopy Shape:	
Observations-Characteristics:	
Observations-Biotic Pest:	Little to No Pest Pressure
Observations-Abiotic:	None
Observation Comments:	
Tree Work-PHC:	Not Needed
Tree Work-Other:	Remove
Last Modified:	12/30/2025
Notes:	Caution tape wrap

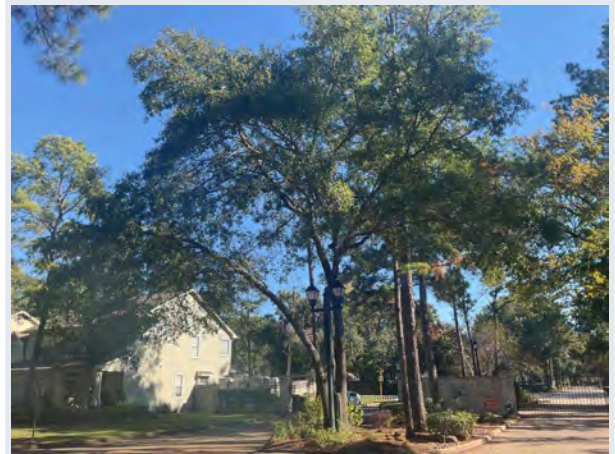
Eastern cottonwood Tree ID #680

Scientific Name:	Populus deltoides
Common Name:	Eastern cottonwood
Genus:	Populus
Condition:	Fair
Status:	Alive
Number of Stems (Multi Calc):	1
Trimming Class:	B (Moderate)
DBH Range:	24-30in
Height Range:	50ft-75ft
Risk Rating:	
Priority:	High
Crown Spread:	
Canopy Shape:	
Observations-Characteristics:	Deadwood, Weak attachments, Compacted Soil
Observations-Biotic Pest:	Little to No Pest Pressure
Observations-Abiotic:	Mechanical Damage
Observation Comments:	
Tree Work-PHC:	Not Needed
Tree Work-Other:	Not Needed
Last Modified:	12/30/2025
Notes:

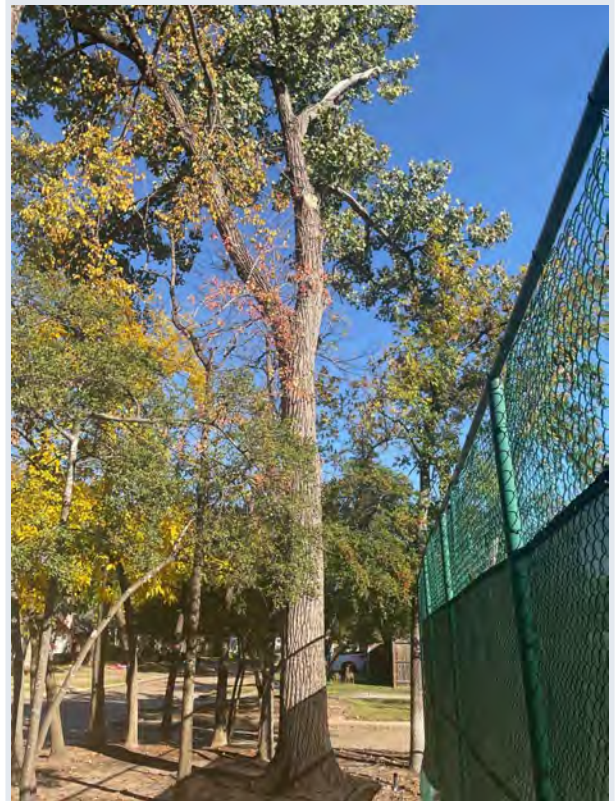
Water oak Tree ID #694

Scientific Name:	Quercus nigra
Common Name:	Water oak
Genus:	Quercus
Condition:	Dead
Status:	Dead
Number of Stems (Multi Calc):	1
Trimming Class:	Not Needed
DBH Range:	3-6in
Height Range:	<15ft
Risk Rating:	
Priority:	Medium
Crown Spread:	
Canopy Shape:	
Observations-Characteristics:	
Observations-Biotic Pest:	Little to No Pest Pressure
Observations-Abiotic:	None
Observation Comments:	
Tree Work-PHC:	Not Needed
Tree Work-Other:	Remove
Last Modified:	12/30/2025
Notes:

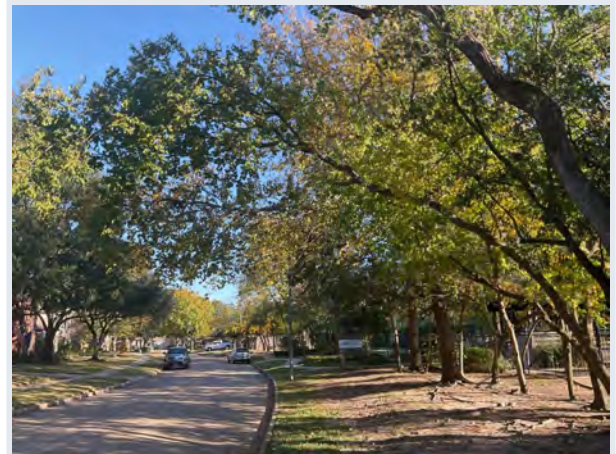
Carolina laurelcherry Tree ID #707

Scientific Name:	Prunus caroliniana
Common Name:	Carolina laurelcherry
Genus:	Prunus
Condition:	Poor
Status:	Alive
Number of Stems (Multi Calc):	Multiple Stems
Trimming Class:	B (Moderate)
DBH Range:	6-12in
Height Range:	15ft-30ft
Risk Rating:	
Priority:	High
Crown Spread:	
Canopy Shape:	
Observations-Characteristics:	Deadwood, Cavity
Observations-Biotic Pest:	Fungus, Boring Insect
Observations-Abiotic:	None
Observation Comments:	
Tree Work-PHC:	Chemical Spray
Tree Work-Other:	Not Needed
Last Modified:	12/30/2025
Notes:

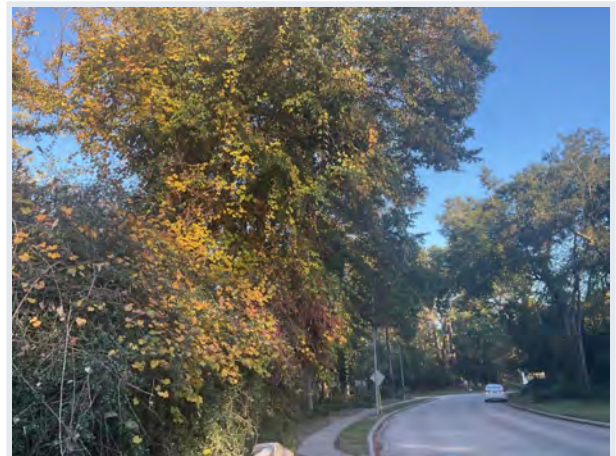
Water oak Tree ID #760

Scientific Name:	Quercus nigra
Common Name:	Water oak
Genus:	Quercus
Condition:	Fair
Status:	Alive
Number of Stems (Multi Calc):	1
Trimming Class:	B (Moderate)
DBH Range:	12-18in
Height Range:	30ft-50ft
Risk Rating:	
Priority:	High
Crown Spread:	
Canopy Shape:	
Observations-Characteristics:	Compacted Soil
Observations-Biotic Pest:	Little to No Pest Pressure
Observations-Abiotic:	None
Observation Comments:	
Tree Work-PHC:	Not Needed
Tree Work-Other:	Not Needed
Last Modified:	12/30/2025
Notes:	Streetlight Clearance

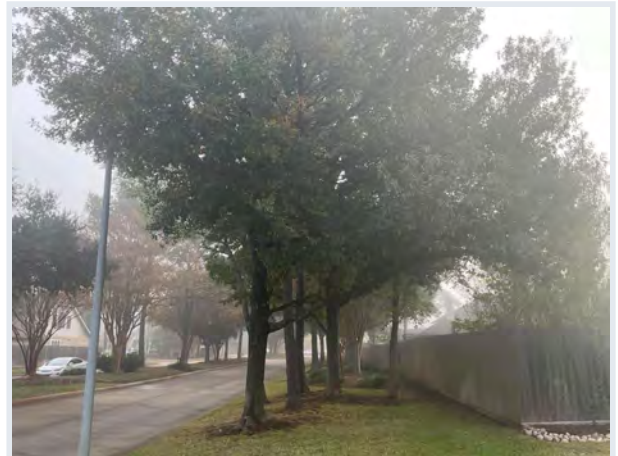
Water oak Tree ID #840

Scientific Name:	Quercus nigra
Common Name:	Water oak
Genus:	Quercus
Condition:	Fair
Status:	Alive
Number of Stems (Multi Calc):	1
Trimming Class:	B (Moderate)
DBH Range:	12-18in
Height Range:	30ft-50ft
Risk Rating:	
Priority:	High
Crown Spread:	
Canopy Shape:	
Observations-Characteristics:	Leaning trunk
Observations-Biotic Pest:	Little to No Pest Pressure
Observations-Abiotic:	None
Observation Comments:	
Tree Work-PHC:	Not Needed
Tree Work-Other:	Not Needed
Last Modified:	12/30/2025
Notes:

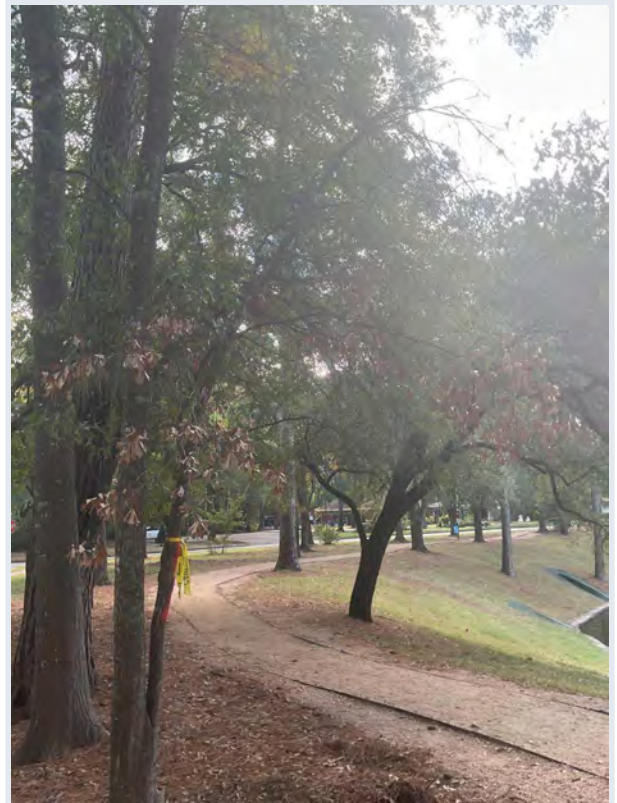
Water oak Tree ID #888

Scientific Name:	Quercus nigra
Common Name:	Water oak
Genus:	Quercus
Condition:	Fair
Status:	Alive
Number of Stems (Multi Calc):	1
Trimming Class:	A (Aggressive)
DBH Range:	12-18in
Height Range:	30ft-50ft
Risk Rating:	
Priority:	High
Crown Spread:	
Canopy Shape:	
Observations-Characteristics:	Crack, Broken Limb, Deadwood
Observations-Biotic Pest:	Boring Insect
Observations-Abiotic:	None
Observation Comments:	
Tree Work-PHC:	Chemical Spray
Tree Work-Other:	Not Needed
Last Modified:	12/30/2025
Notes:	Big broken branch above trail.

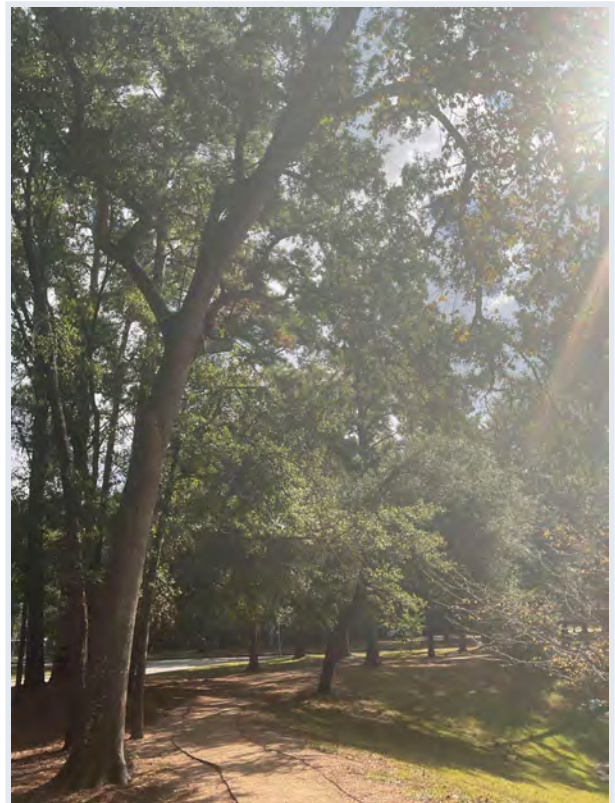
Water oak Tree ID #894

Scientific Name:	Quercus nigra
Common Name:	Water oak
Genus:	Quercus
Condition:	Poor
Status:	Alive
Number of Stems (Multi Calc):	1
Trimming Class:	Not Needed
DBH Range:	3-6in
Height Range:	<15ft
Risk Rating:	
Priority:	Medium
Crown Spread:	
Canopy Shape:	
Observations-Characteristics:	Deadwood, Cavity
Observations-Biotic Pest:	Boring Insect, Fungus
Observations-Abiotic:	None
Observation Comments:	
Tree Work-PHC:	Not Needed
Tree Work-Other:	Remove
Last Modified:	12/30/2025
Notes:

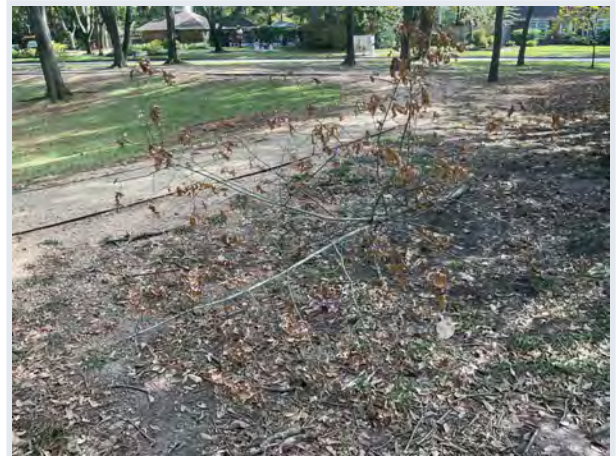
Water oak Tree ID #930
9102 Woodwind Lakes Drive

Tree Details	
Scientific Name:	Quercus nigra
Common Name:	Water oak
Genus:	Quercus
Condition:	Fair
Status:	Alive
Number of Stems (Multi Calc):	1
Trimming Class:	B (Moderate)
DBH Range:	12-18in
Height Range:	30ft-50ft
Risk Rating:	
Priority:	High
Crown Spread:	
Canopy Shape:	
Observations-Characteristics:	Broken Limb, Deadwood
Observations-Biotic Pest:	Little to No Pest Pressure
Observations-Abiotic:	None
Observation Comments:	
Tree Work-PHC:	Not Needed
Tree Work-Other:	Not Needed
Last Modified:	12/30/2025
Notes:

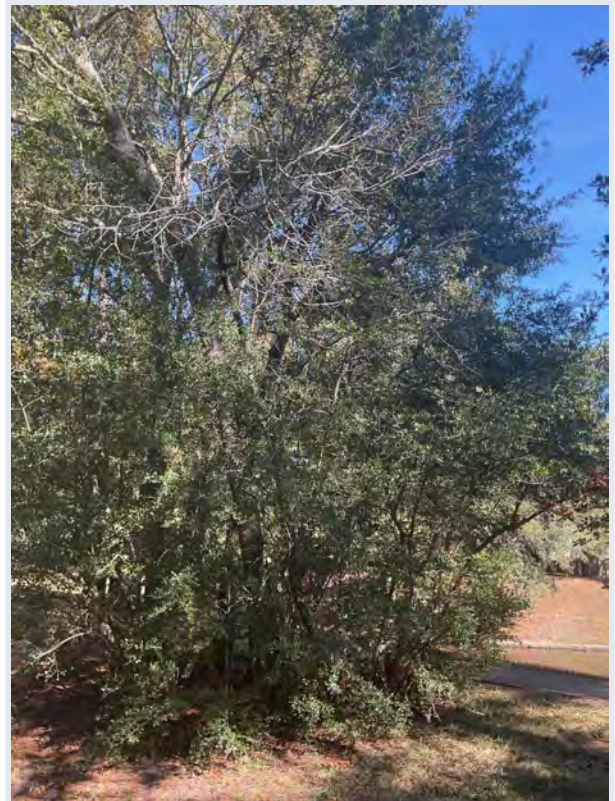
Water oak Tree ID #975

Scientific Name:	Quercus nigra
Common Name:	Water oak
Genus:	Quercus
Condition:	Fair
Status:	Alive
Number of Stems (Multi Calc):	1
Trimming Class:	B (Moderate)
DBH Range:	6-12in
Height Range:	30ft-50ft
Risk Rating:	
Priority:	High
Crown Spread:	
Canopy Shape:	
Observations-Characteristics:	Deadwood, Cavity, Broken Limb, Compacted Soil
Observations-Biotic Pest:	Boring Insect
Observations-Abiotic:	None
Observation Comments:	
Tree Work-PHC:	Chemical Spray
Tree Work-Other:	Not Needed
Last Modified:	12/30/2025
Notes:

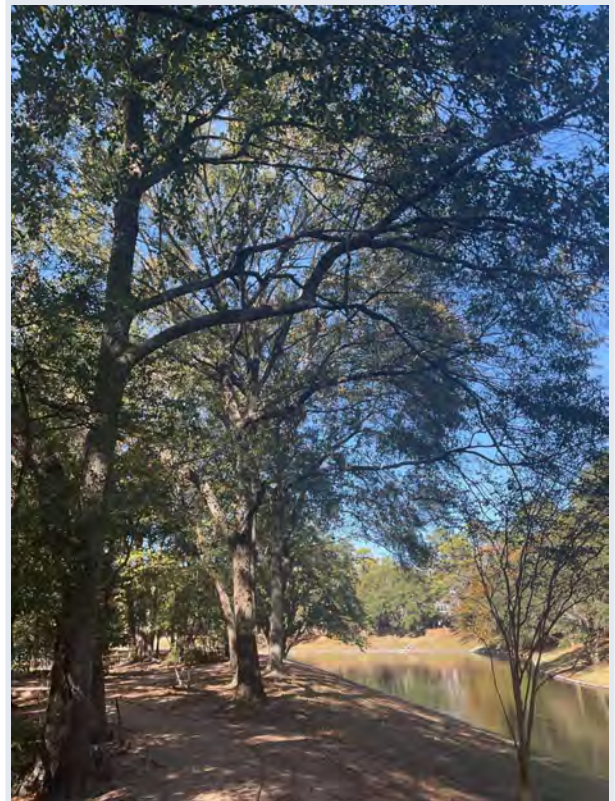
Water oak Tree ID #1093
9219 Woodwind Lakes Drive

Scientific Name:	Quercus nigra
Common Name:	Water oak
Genus:	Quercus
Condition:	Poor
Status:	Alive
Number of Stems (Multi Calc):	1
Trimming Class:	A (Aggressive)
DBH Range:	12-18in
Height Range:	30ft-50ft
Risk Rating:	
Priority:	High
Crown Spread:	
Canopy Shape:	
Observations-Characteristics:	Deadwood, Cavity
Observations-Biotic Pest:	Boring Insect
Observations-Abiotic:	None
Observation Comments:	
Tree Work-PHC:	Not Needed
Tree Work-Other:	Not Needed
Last Modified:	12/30/2025
Notes:

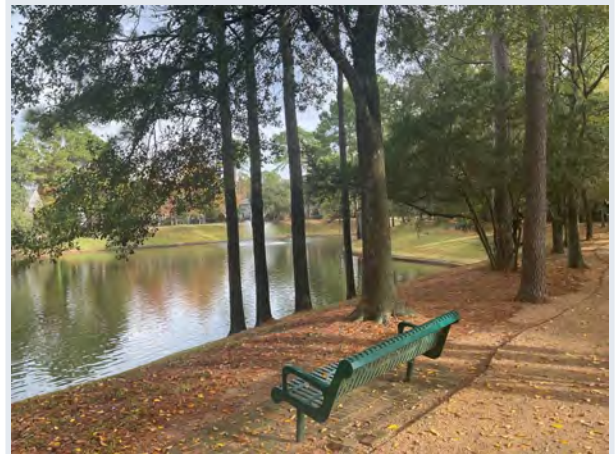
Scientific Name:	Quercus nigra
Common Name:	Water oak
Genus:	Quercus
Condition:	Fair
Status:	Alive
Number of Stems (Multi Calc):	1
Trimming Class:	B (Moderate)
DBH Range:	12-18in
Height Range:	30ft-50ft
Risk Rating:	
Priority:	High
Crown Spread:	
Canopy Shape:	
Observations-Characteristics:	Deadwood, Compacted Soil
Observations-Biotic Pest:	Boring Insect
Observations-Abiotic:	None
Observation Comments:	
Tree Work-PHC:	Chemical Spray
Tree Work-Other:	Not Needed
Last Modified:	12/30/2025
Notes:

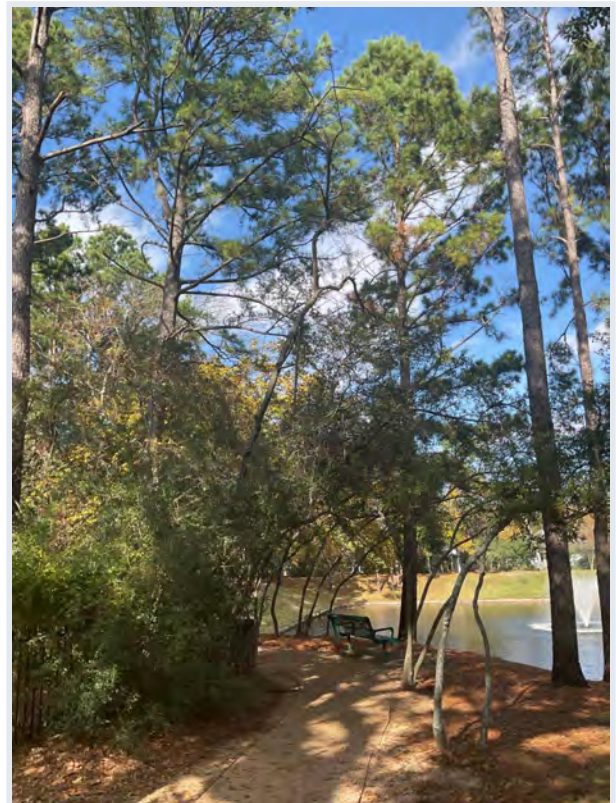
Yaupon Tree ID #1570

Scientific Name:	Ilex vomitoria
Common Name:	Yaupon
Genus:	Ilex
Condition:	Poor
Status:	Alive
Number of Stems (Multi Calc):	1
Trimming Class:	Not Needed
DBH Range:	3-6in
Height Range:	15ft-30ft
Risk Rating:	
Priority:	Medium
Crown Spread:	
Canopy Shape:	
Observations-Characteristics:	Cavity, Deadwood
Observations-Biotic Pest:	Fungus
Observations-Abiotic:	None
Observation Comments:	
Tree Work-PHC:	Not Needed
Tree Work-Other:	Remove
Last Modified:	12/30/2025
Notes:

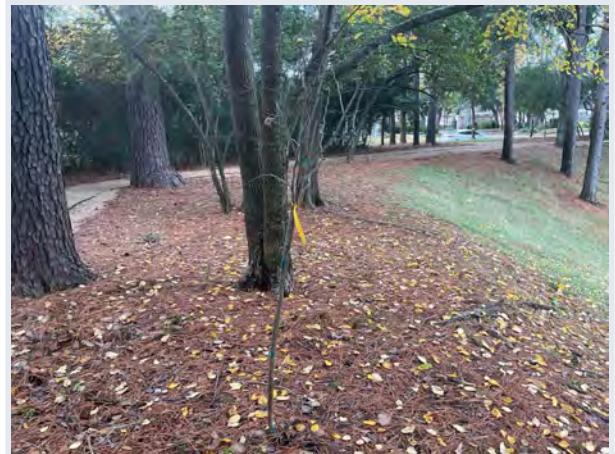
Eastern redbud Tree ID #1585

Condition: Fair

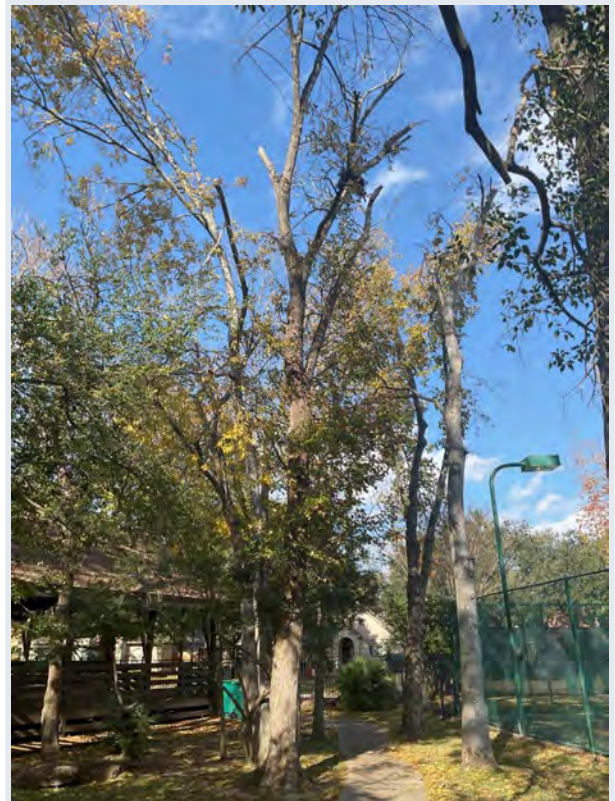
American elm Tree ID #1624

Condition: Poor

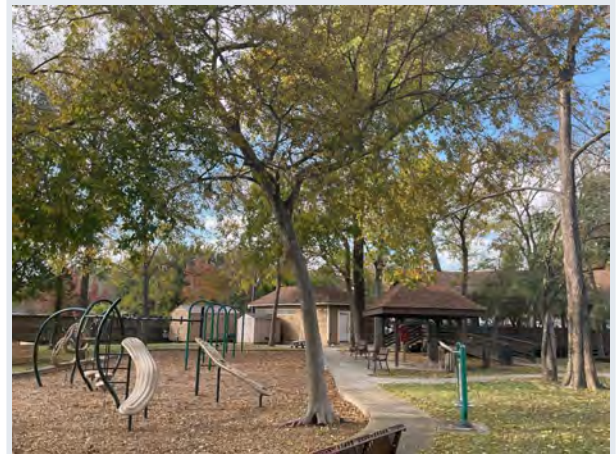
Sugarberry Tree ID #1626

Condition: Fair

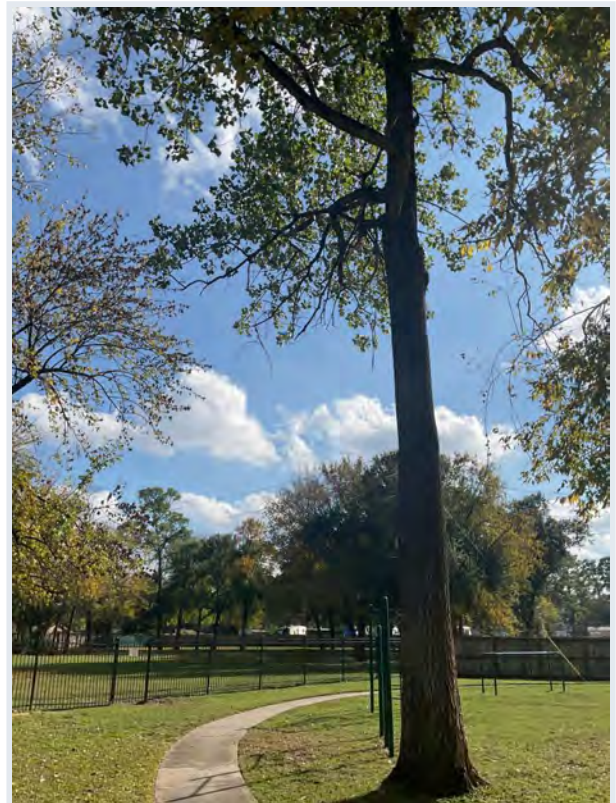
Eastern cottonwood Tree ID #1628

Scientific Name:	Populus deltoides
Common Name:	Eastern cottonwood
Genus:	Populus
Condition:	Fair
Status:	Alive
Number of Stems (Multi Calc):	1
Trimming Class:	B (Moderate)
DBH Range:	24-30in
Height Range:	50ft-75ft
Risk Rating:	
Priority:	High
Crown Spread:	
Canopy Shape:	
Observations-Characteristics:	Compacted Soil, Broken Limb, Deadwood
Observations-Biotic Pest:	Little to No Pest Pressure
Observations-Abiotic:	None
Observation Comments:	
Tree Work-PHC:	Not Needed
Tree Work-Other:	Not Needed
Last Modified:	12/30/2025
Notes:

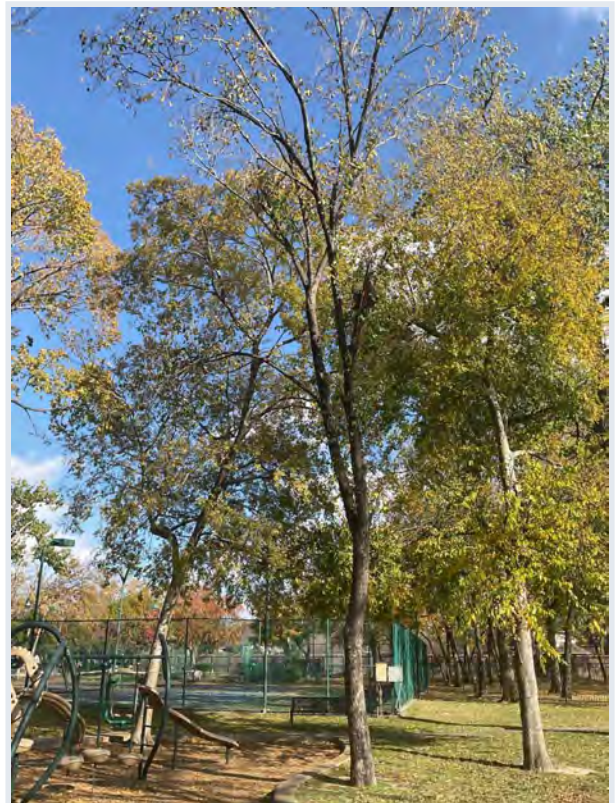
American elm Tree ID #1630

Condition: Fair

Observations-
Characteristics: Compacted Soil,
Broken Limb,
Deadwood, Crack

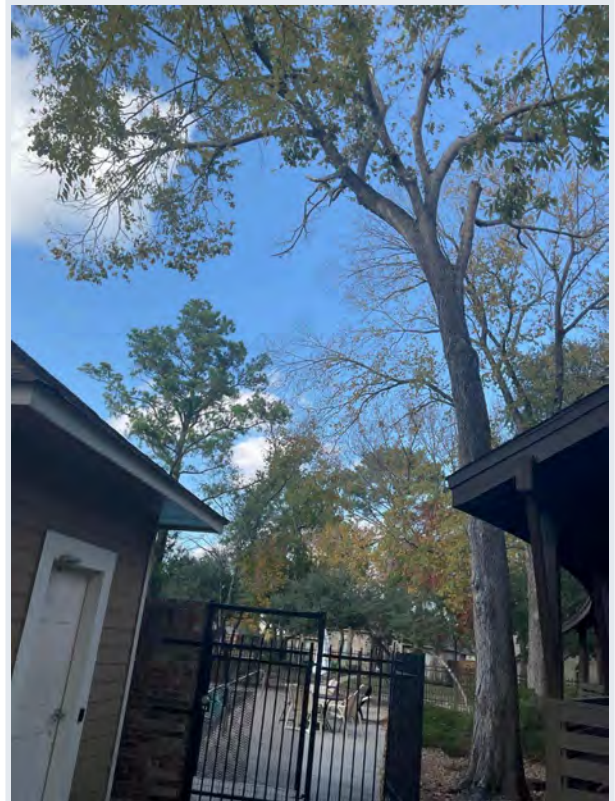
American elm Tree ID #1644

Scientific Name:	Ulmus americana
Common Name:	American elm
Genus:	Ulmus
Condition:	Poor
Status:	Alive
Number of Stems (Multi Calc):	1
Trimming Class:	B (Moderate)
DBH Range:	24-30in
Height Range:	50ft-75ft
Risk Rating:	
Priority:	High
Crown Spread:	
Canopy Shape:	
Observations-Characteristics:	Deadwood, Compacted Soil, Cavity, Broken Limb
Observations-Biotic Pest:	Boring Insect
Observations-Abiotic:	None
Observation Comments:	
Tree Work-PHC:	Chemical Spray
Tree Work-Other:	Not Needed
Last Modified:	12/30/2025
Notes:

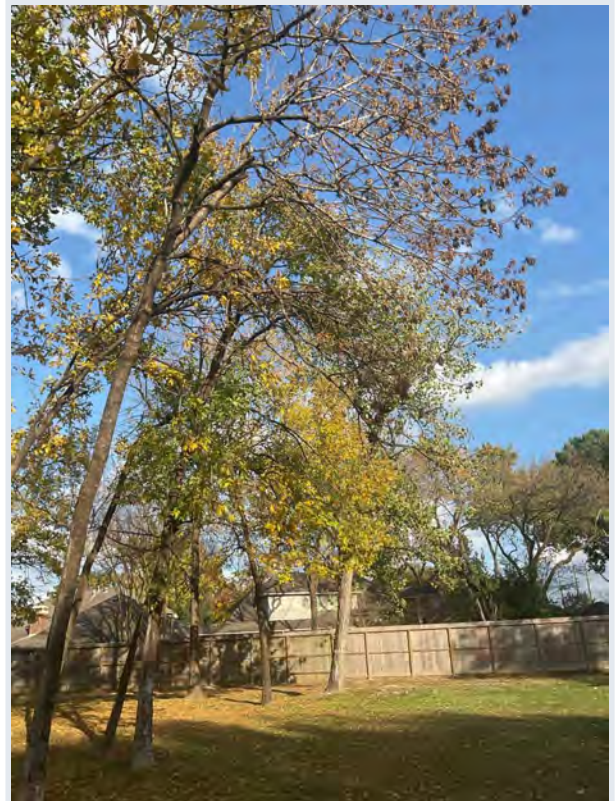
Green ash Tree ID #1660

Scientific Name:	Fraxinus pennsylvanica
Common Name:	Green ash
Genus:	Fraxinus
Condition:	Fair
Status:	Alive
Number of Stems (Multi Calc):	1
Trimming Class:	C (Light)
DBH Range:	6-12in
Height Range:	30ft-50ft
Risk Rating:	
Priority:	Medium
Crown Spread:	
Canopy Shape:	
Observations-Characteristics:	Leaning trunk
Observations-Biotic Pest:	Little to No Pest Pressure
Observations-Abiotic:	None
Observation Comments:	
Tree Work-PHC:	Not Needed
Tree Work-Other:	Not Needed
Last Modified:	12/30/2025
Notes:	Leaves fell first

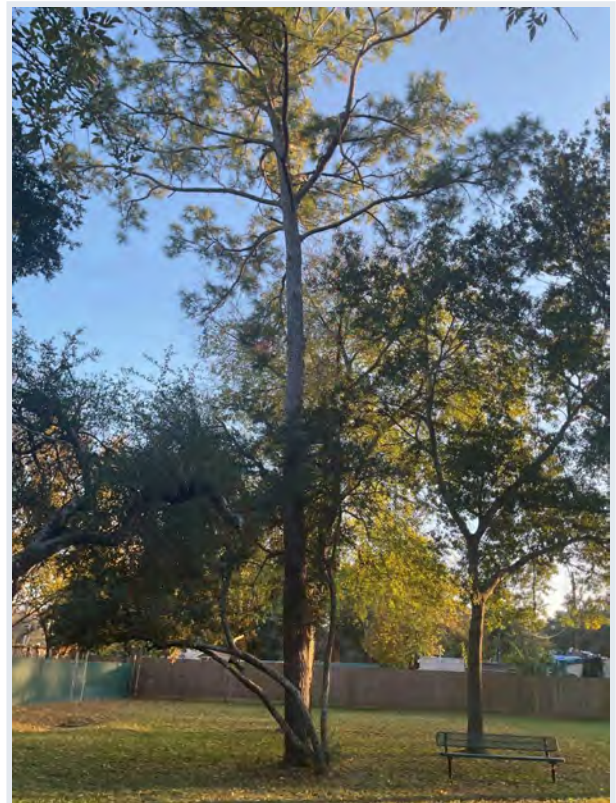
Loblolly pine Tree ID #1698

Scientific Name:	Pinus taeda
Common Name:	Loblolly pine
Genus:	Pinus
Condition:	Fair
Status:	Alive
Number of Stems (Multi Calc):	1
Trimming Class:	B (Moderate)
DBH Range:	18-24in
Height Range:	50ft-75ft
Risk Rating:	
Priority:	High
Crown Spread:	
Canopy Shape:	
Observations-Characteristics:	Broken Limb, Deadwood, Crack
Observations-Biotic Pest:	Little to No Pest Pressure
Observations-Abiotic:	None
Observation Comments:	
Tree Work-PHC:	Not Needed
Tree Work-Other:	Not Needed
Last Modified:	12/30/2025
Notes:	Broken branch above Bench

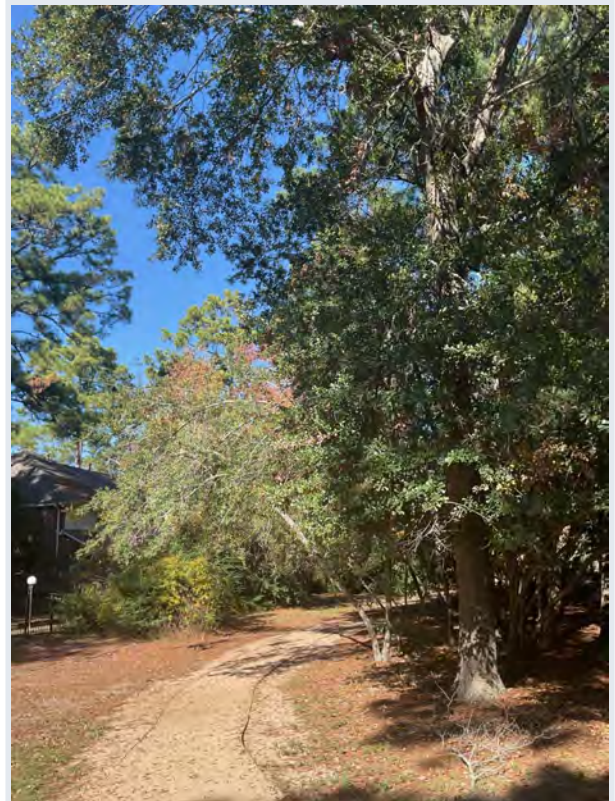
Water oak Tree ID #1893

Condition: Good

Observations-
Characteristics: Broken Limb,
Deadwood

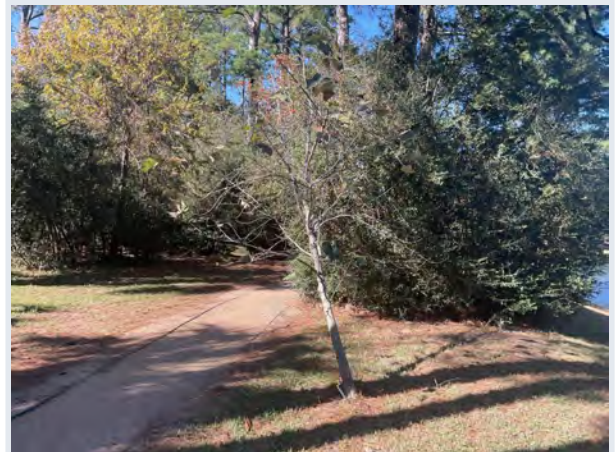
American sycamore Tree ID #1930

Condition: Poor

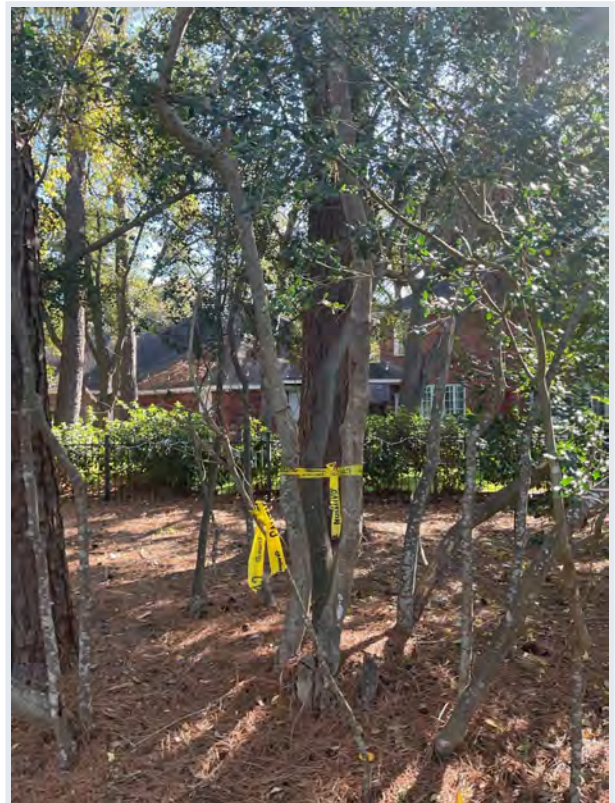
Yaupon Tree ID #1960

Scientific Name:	Ilex vomitoria
Common Name:	Yaupon
Genus:	Ilex
Condition:	Dead
Status:	Dead
Number of Stems (Multi Calc):	Multiple Stems
Trimming Class:	Not Needed
DBH Range:	6-12in
Height Range:	15ft-30ft
Risk Rating:	
Priority:	High
Crown Spread:	
Canopy Shape:	
Observations-Characteristics:	
Observations-Biotic Pest:	Little to No Pest Pressure
Observations-Abiotic:	None
Observation Comments:	
Tree Work-PHC:	Not Needed
Tree Work-Other:	Remove
Last Modified:	12/30/2025
Notes:	Caution tape wrapped

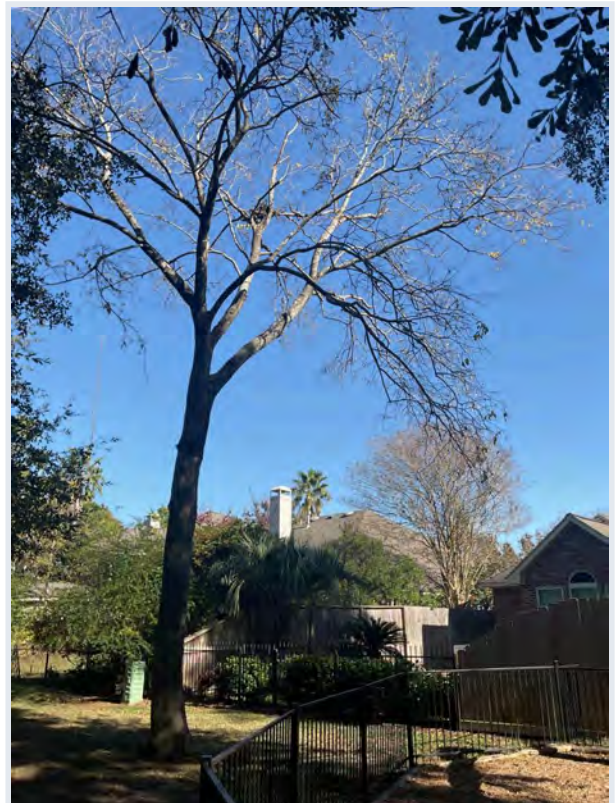
Sugarberry Tree ID #1990

Condition: Fair

Observations-
Characteristics: Deadwood, Broken
Limb, Compacted Soil

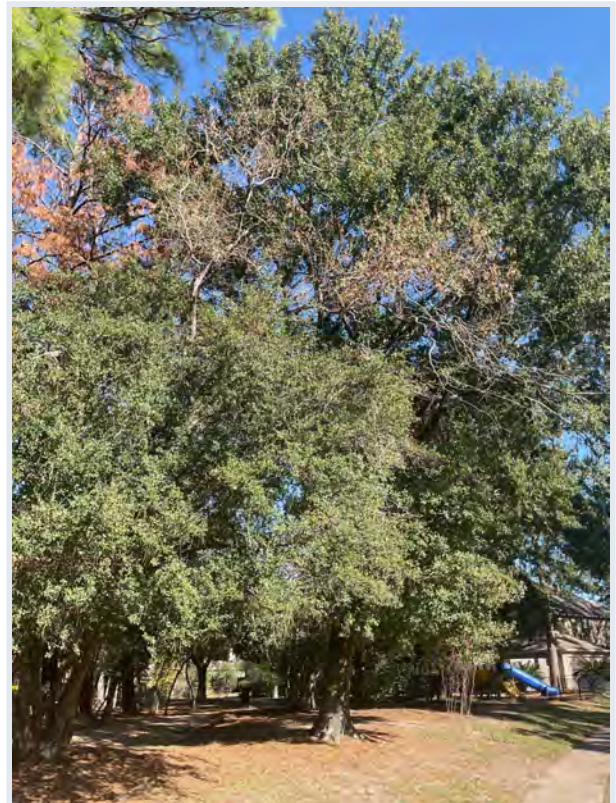
Tallowtree Tree ID #1997

Condition: Poor

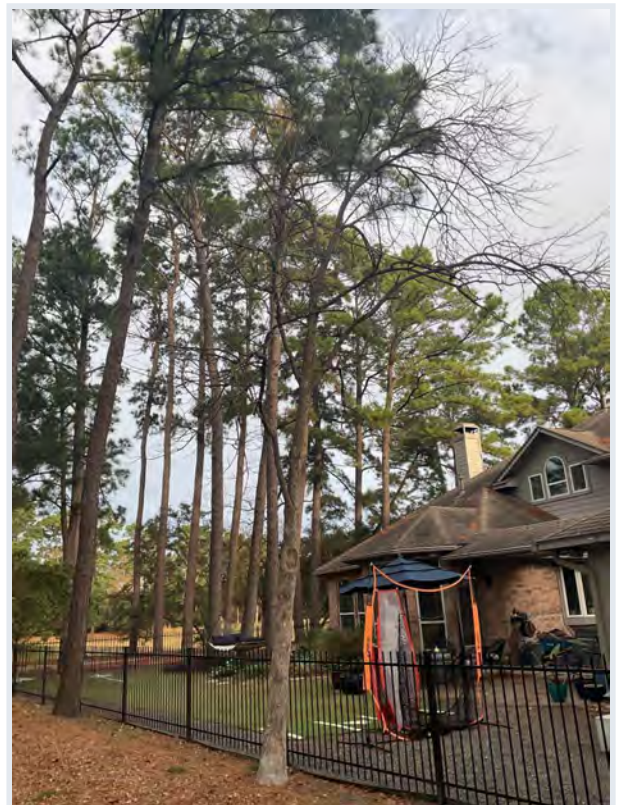
American elm Tree ID #2091

Scientific Name:	Ulmus americana
Common Name:	American elm
Genus:	Ulmus
Condition:	Fair
Status:	Alive
Number of Stems (Multi Calc):	1
Trimming Class:	Not Needed
DBH Range:	3-6in
Height Range:	30ft-50ft
Risk Rating:	
Priority:	Medium
Crown Spread:	
Canopy Shape:	
Observations-Characteristics:	Compacted Soil, Cavity
Observations-Biotic Pest:	Little to No Pest Pressure
Observations-Abiotic:	Mechanical Damage
Observation Comments:	
Tree Work-PHC:	Not Needed
Tree Work-Other:	Remove
Last Modified:	12/30/2025
Notes:	Bad place, growing into fence

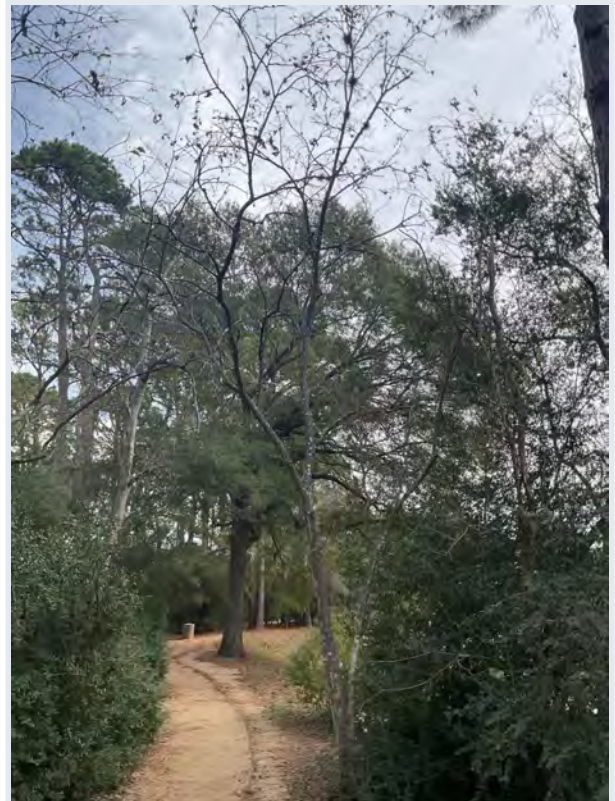
Sugarberry Tree ID #2155

Condition: Dead

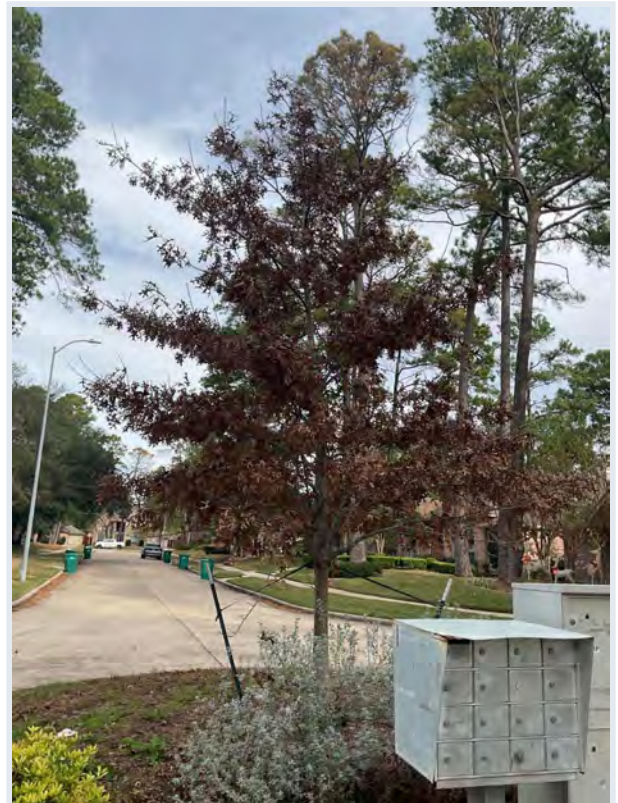
Shumard oak Tree ID #2173

Condition: Fair

Observations-Abiotic: Mechanical Damage

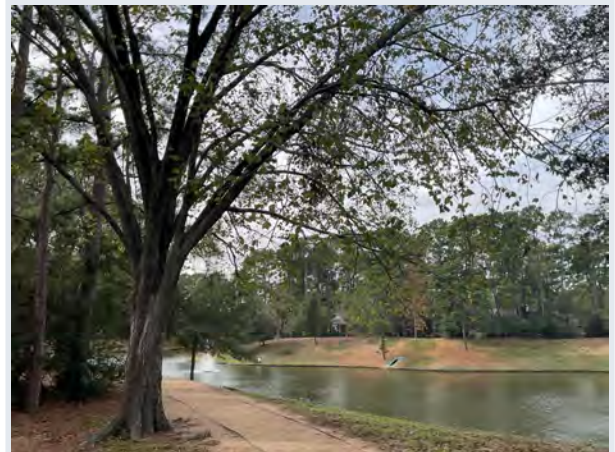
American elm Tree ID #2200

Scientific Name:	Ulmus americana
Common Name:	American elm
Genus:	Ulmus
Condition:	Fair
Status:	Alive
Number of Stems (Multi Calc):	1
Trimming Class:	B (Moderate)
DBH Range:	18-24in
Height Range:	50ft-75ft
Risk Rating:	
Priority:	High
Crown Spread:	
Canopy Shape:	
Observations-Characteristics:	Crack, Compacted Soil, Deadwood
Observations-Biotic Pest:	Little to No Pest Pressure
Observations-Abiotic:	None
Observation Comments:	
Tree Work-PHC:	Not Needed
Tree Work-Other:	Not Needed
Last Modified:	12/30/2025
Notes:	Crack forming in middle of tree.

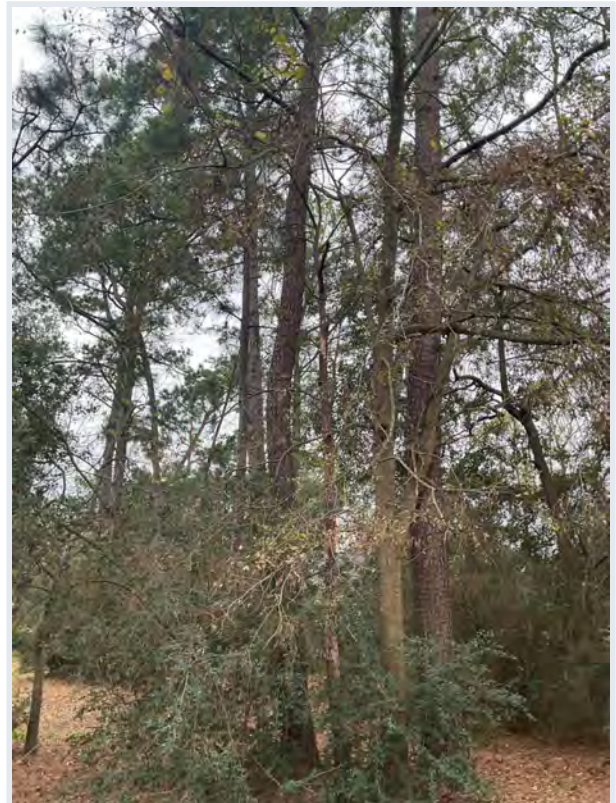
Loblolly pine Tree ID #2328

Scientific Name:	Pinus taeda
Common Name:	Loblolly pine
Genus:	Pinus
Condition:	Dead
Status:	Dead
Number of Stems (Multi Calc):	1
Trimming Class:	Not Needed
DBH Range:	3-6in
Height Range:	15ft-30ft
Risk Rating:	
Priority:	Medium
Crown Spread:	
Canopy Shape:	
Observations-Characteristics:	
Observations-Biotic Pest:	Little to No Pest Pressure
Observations-Abiotic:	None
Observation Comments:	
Tree Work-PHC:	Not Needed
Tree Work-Other:	Remove
Last Modified:	12/30/2025
Notes:
