Home Inspection Report

781 Castillo Street Santa Barbara, CA 93101

1234

Report Overview

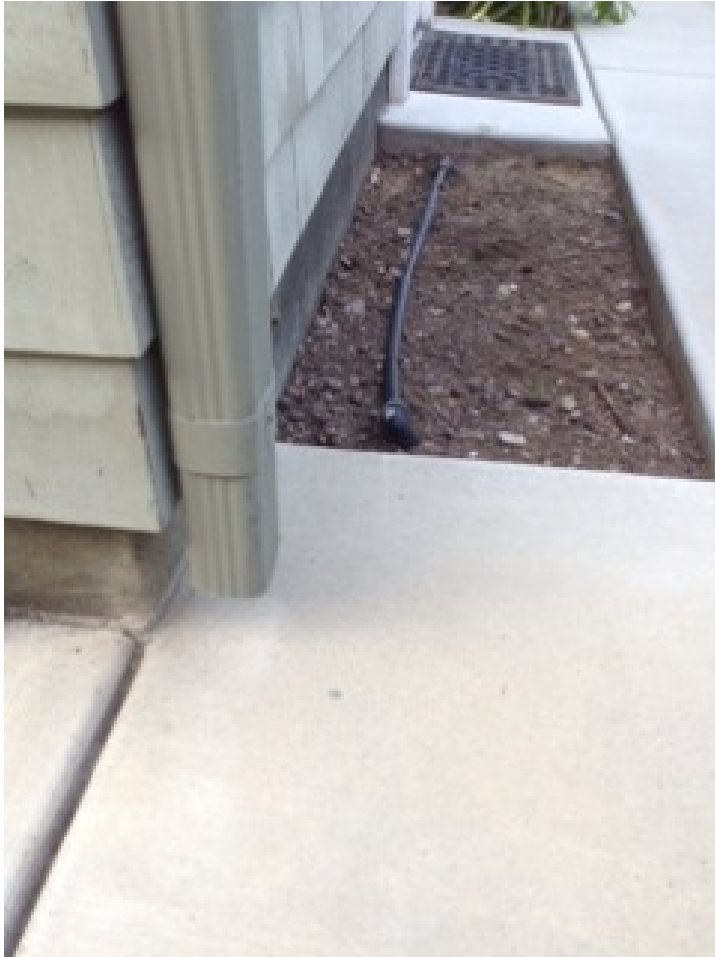
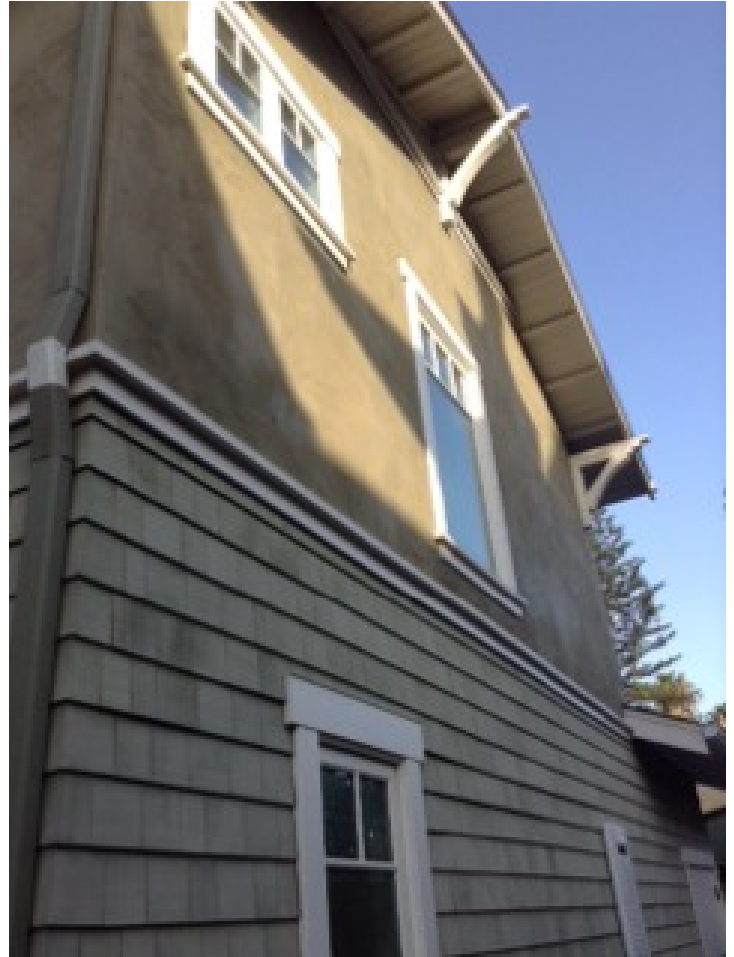
Not a fix, just best for down pipe to have elbow to divert water away from house. However there is a good slab and grade profile here.

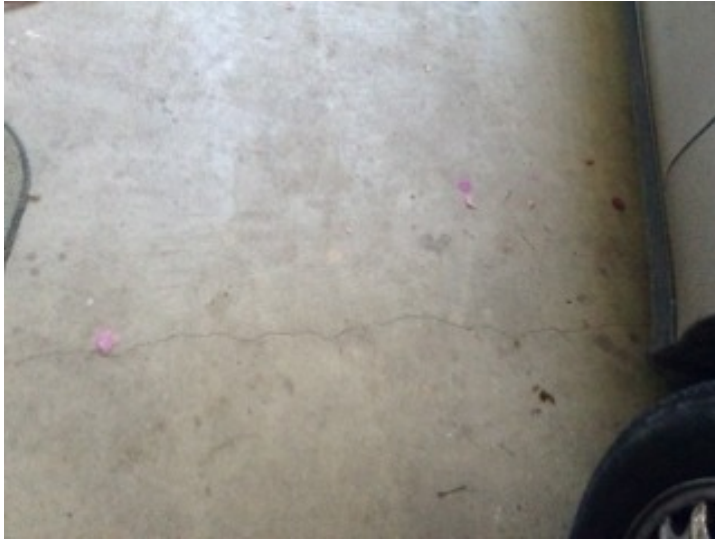
Very minor slab cracking
