Thermal Imaging - A Better Solution for Inspecting G10 Laminates

By Charles J. Hazouri,

Qualitative and Quantitative Infrared Thermography is a more informative and non-invasive inspection technique-making it the perfect tool for marine inspections of G10 as well as all Fiberglass Laminates.

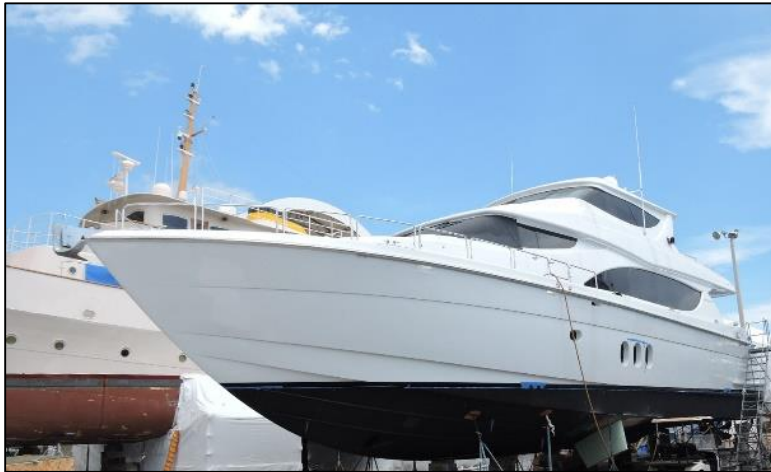
The vessel used in this thermographic inspection is an 80' Hatteras Motor Yacht. The test samples were .375" x 12" x 12" G10 Epoxyglas Sheets with 1708 Biaxial +/- 45 Degree Cloth and Adtech Epoxy Resin, which were then painted with Interlux White Polyurethane.
