SERVICE BULLETIN - AUCKLAND	0002
Date of Issue	08.09.2017
Issue Number	A-01
Customer	ORIX New Zealand Ltd
Component Affected	Skid Plate

### **T605Z Trailer Incident**

## Report into kingpin supporting structure failure:

2012 Maxicube Reefer 3 Axle Semi Trailer

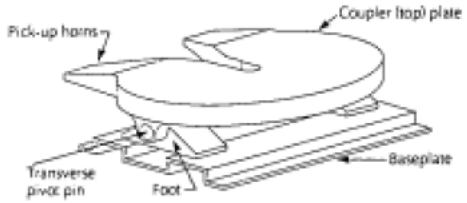
<p><b>Fig.1 SINGLE OSCILLATING</b></p>	<p>Generally used where the chassis is designed with a degree of torsional flexibility that will compensate for terrain irregularities. For general over the road use e.g. flat tops, dry vans, livestock, curtainsiders, tippers, etc.</p>	<p>The driver will be able to feel the trailer and its load swaying or rolling, during normal road travel, as the prime mover and trailer will tend to move as a single unit.</p>

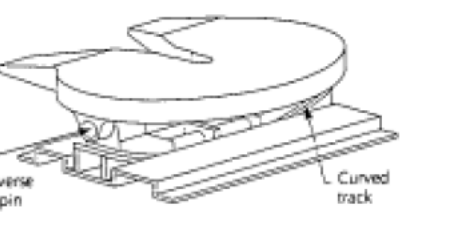
Figure 3  
Extract from NZS 5450:1989

<p><b>Fig 3 COMPENSATING</b> See note</p>	<p>Generally for applications where minimizing torque and twist of semi-trailer is desirable and where the centre-of-gravity of the loaded semi-trailer does not exceed approximately one metre above the fifth wheel height e.g. tankers and trailers with bodies that have some measure of torsional rigidity.</p>	<p>The driver will be able to feel the trailer and load tending to sway, but he will not receive any direct initial feel of a change of a tractor unit/trailer roll attitude. (See 2.7.3)</p>

As they are torsionally rigid, it is usually recommended to tow the trailer with a compensating 5th wheel. This allows some compliance between vehicles, but comes at the disadvantage of a higher 5th wheel height.
