TALON
Home Inspections

Inspection Report

Property Address:
2001 Crimea Street
Lawrenceburg KY 40324

Date: 12/17/2017	Time: 10:00 AM till 03:00 PM	Report ID: 171217PETERS
Property: 2001 Crimea Street Lawrenceburg KY 40324	Customer: Mr. Trevor Peters	Real Estate Professional:

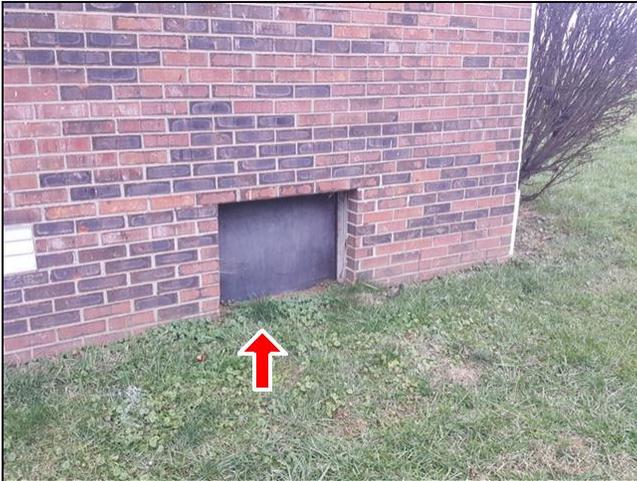
1.0 Item 1(Picture)

1.0 Access to the crawlspace is located at the right side of the home. For safety, recommend a lock be installed on the crawlspace access door to prevent a child entering which could result in a injury or death occurring.

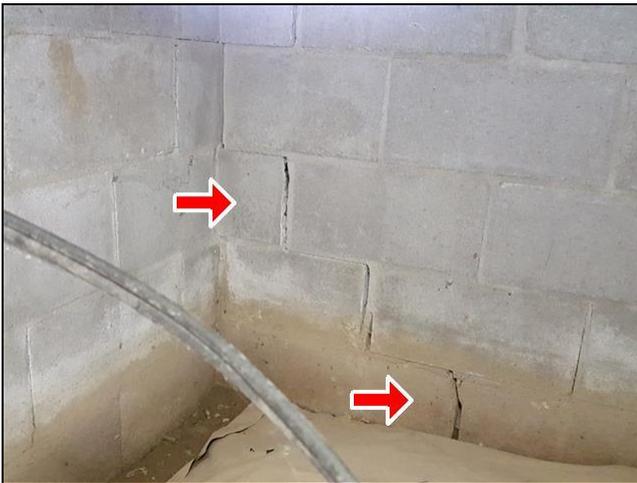
1.1 Item 1(Picture)

1.1 The stair step crack at the foundation wall on the front right corner of the home in the crawlspace was noted and is large enough for concern. Some degree of settlement has occurred. The size of the crack shown is 1/8 in width and is has bulged. This is cause for concern. The wall(s) may need reinforcement. Cannot tell if this movement is ongoing. While the rate of movement cannot be predicted during a one-time inspection it is likely that repairs maybe needed. Recommend a Foundation contractor be consulted to further evaluate this condition and the remedies available for correction prior to closing. These cracks need to be sealed to prevent further cracking due to freeze/thaw (water entering) and possible further deterioration via water intrusion in the crawlspace.

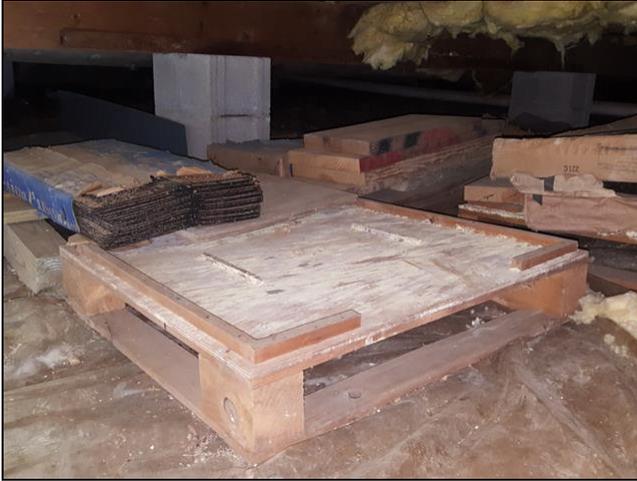
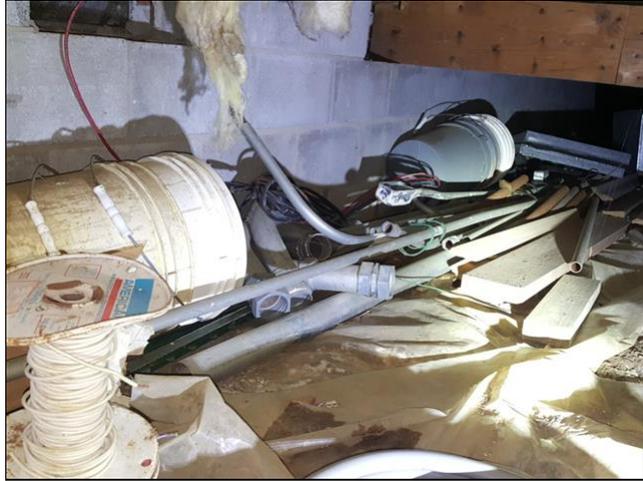
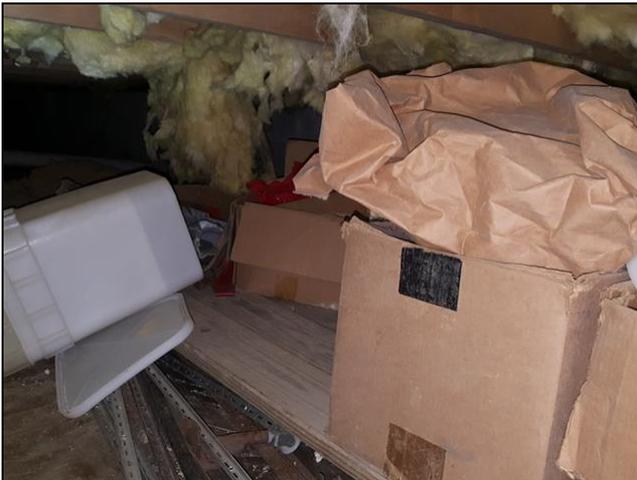
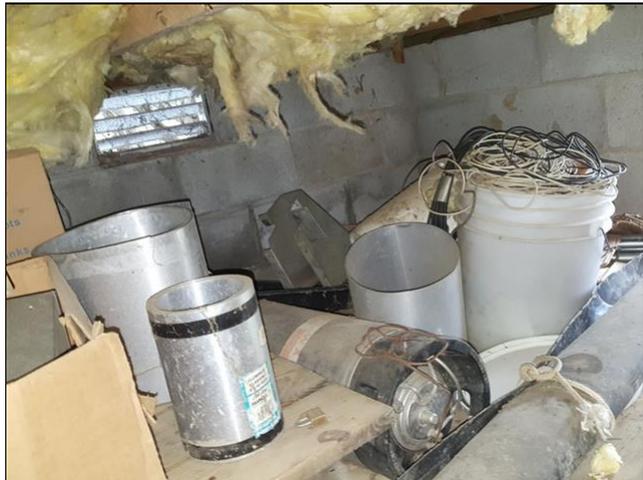
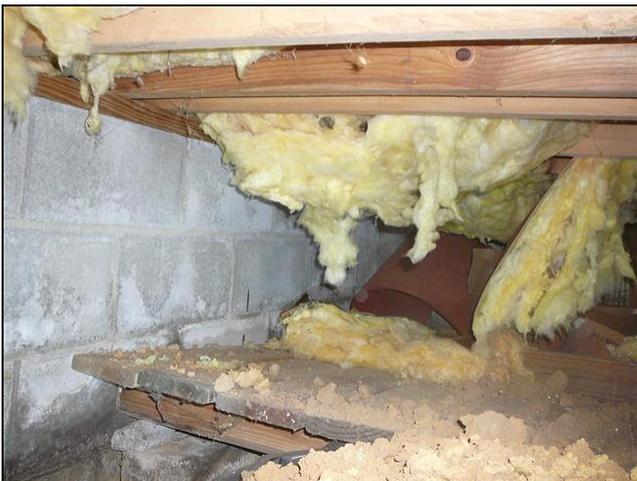
1.2 (1) All wood, insulation, unused building materials and junk should be removed from the crawlspace floor. The insulation will hold moisture creating condensation and possible mold growth on the wooden structure in the crawlspace. Wood debris risks rotting and can attract wood eating insects into the crawlspace which can lead to more costly repairs later. Recommend all types of debris resting on the crawlspace floor be removed to prevent damage to the wood/floor structure of the home.

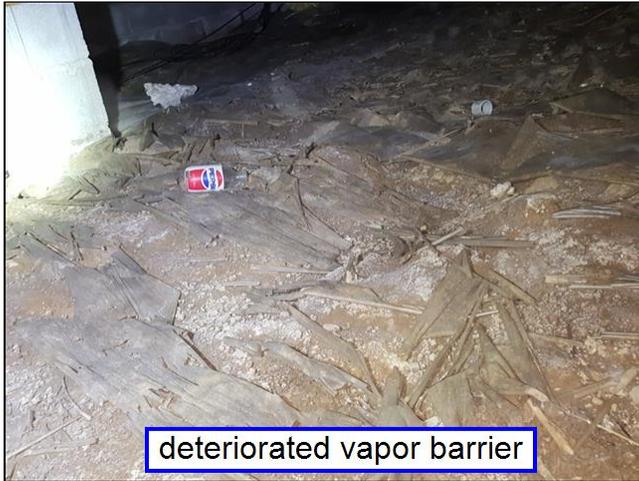
1.2 Item 7(Picture)

1.2 (2) The vapor barrier (plastic) on the crawlspace ground is deteriorated in various areas and is less than 9 mill thick. A vapor barrier provides added protection to the floor system from moisture or dampness that can enter from the ground. If this is not corrected wood rot, condensation and/or mold could develop in the crawlspace. Recommend a qualified contractor replace as needed prior to moving in.

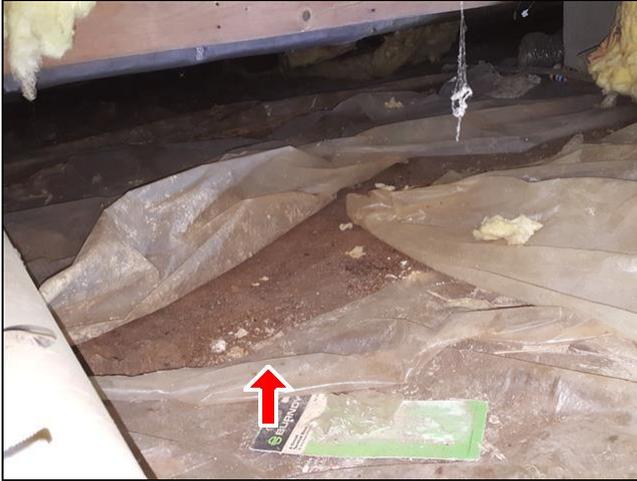
1.2 Item 10(Picture) under washer dryer room

1.2 (3) There are some gaps in the coverage of the vapour barrier in the crawl space floor. The vapor barrier in the crawl space floor should be adjusted to cover all areas of exposed soil. These gaps are allowing moisture vapor entry into the crawl space which promotes condensation, humidity and mold/mildew growth on the floor joists. The plastic vapour barrier should be a minimum of 9mil thick in Kentucky (recommend using 15 or 20 mil) straightened and/or added to as needed to cover the entire crawlspace floor to prevent excessive moisture entering. Recommend correcting and replacement using a qualified contractor.

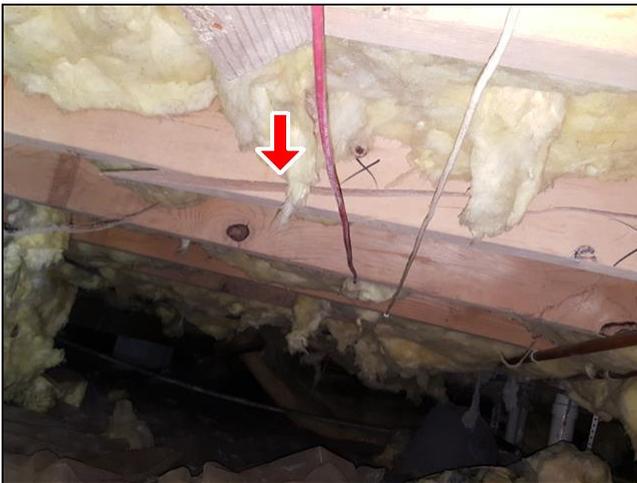
1.4 Item 1(Picture)

1.4 (1) One floor joist is severely split or cracked in the crawlspace under the master bathroom area. There may be more but due to the access and conditions in the crawlspace others may have been unnoticed at the time of inspection. Repairs are needed. Cracked joists are repaired by replacement , "sister" joists installed along side or additional support. Recommend a qualified licensed building contractor repair as needed and further access the floor structure under the living room and kitchen area once access is granted.

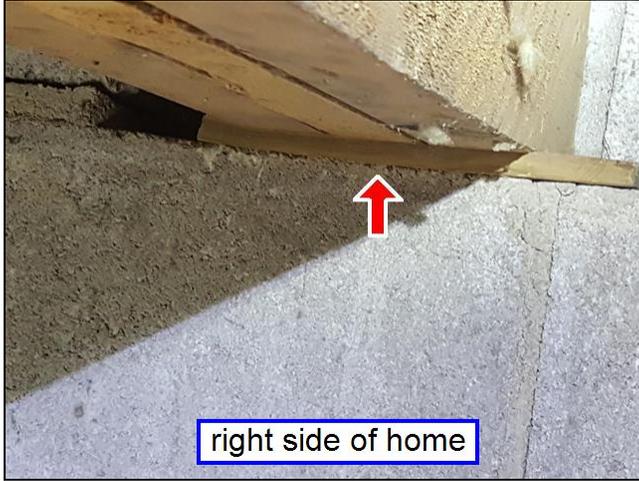
1.4 Item 3(Picture)

1.4 (2) Wood shims were placed under the beam (under 2nd bedroom area) to support and level beam resting on the masonry block wall foundation. Steel shims are recommended for this purpose. Wood will compress and allow the beam to sag resulting in the floor sloping and cracks in the drywall of the walls and ceilings. See note 6.1 Photo 1. Recommend a qualified structural engineer further evaluate to determine if corrections are needed.

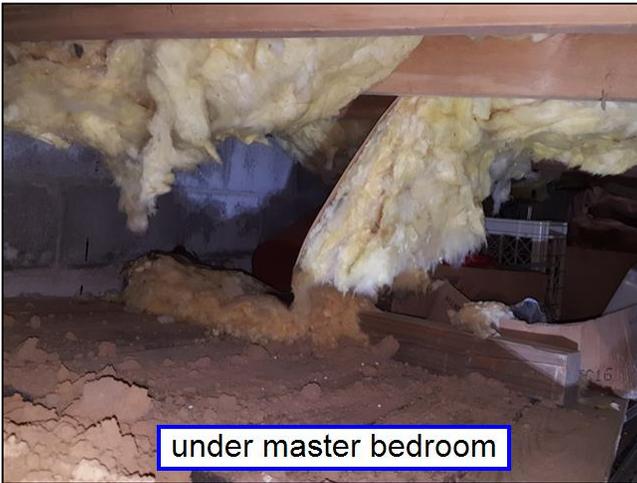
1.5 Item 1(Picture)

1.5 (1) The insulation is loose/fallen and is hanging loose in the crawlspace in various areas. Heat loss can occur more on this home than one that is properly insulated. Insulation that has fallen to the ground or has become damp from the ground or from condensation usually needs to be replaced with new insulation. Recommend repair or replacement as needed by a general contractor.

under master bedroom

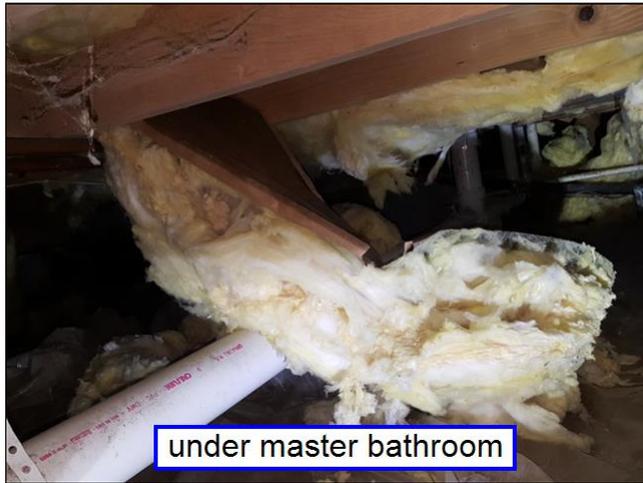
1.5 Item 2(Picture)

under master bathroom

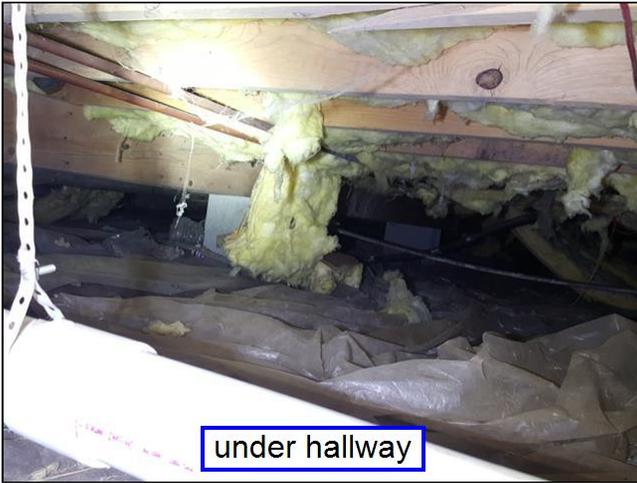
1.5 Item 3(Picture)

under hallway

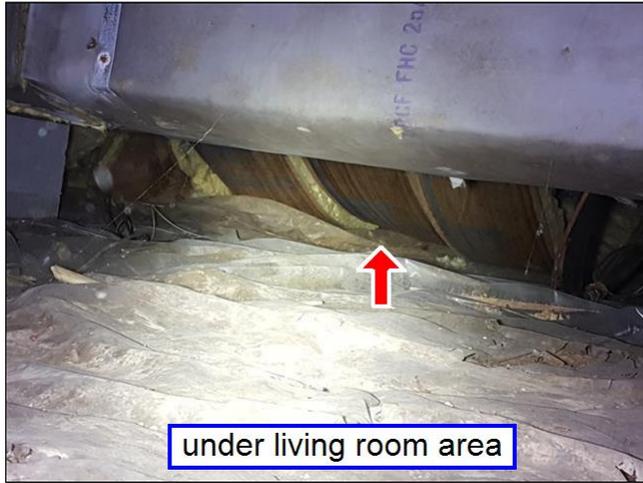
1.5 Item 4(Picture)

Note: Due to the majority of insulation that has fallen below the living room area this did not allow reasonable access to inspect the crawl in that part of the home.

under living room area

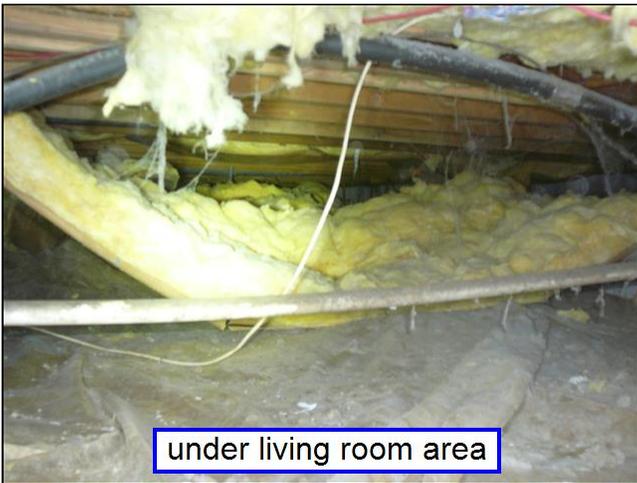
1.5 Item 5(Picture)

under living room area

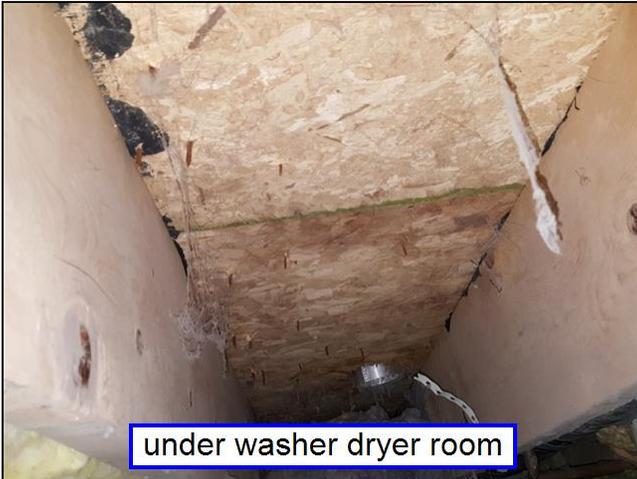
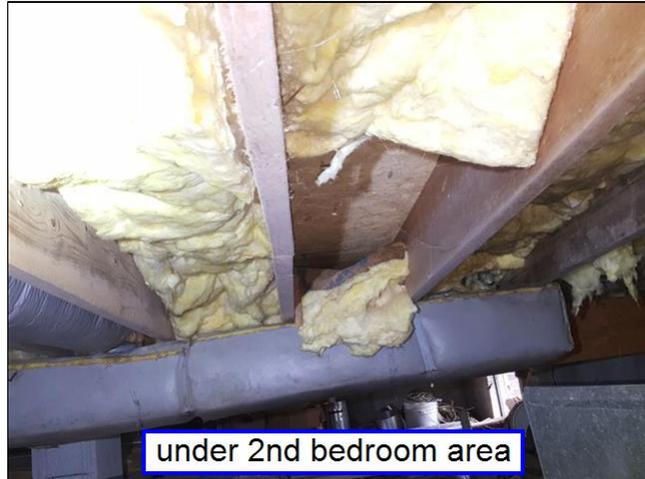
1.5 (2) The insulation is missing in some areas in the crawlspace. Heat loss can occur more on this home than one that is properly insulated. Recommend replacement as needed.

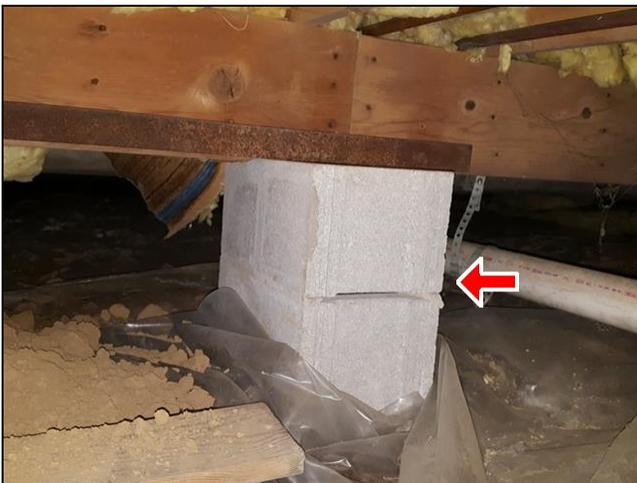
1.6 Item 1(Picture)

1.6 (1) All the piers that are supporting the main beam in the crawlspace maybe undersized and may not provide proper support for the beam. Normal building practices use a minimum sizing of 12 inch wide piers. The installed piers in question are 8x8x16 single pile piers. The floor is an integral part of the foundation system. Because of the various repairs to joists, additional steel screw posts installed in the crawl and issues found with exterior brick walls and foundation walls it is recommended prior to closing to have a structural engineer further evaluate to determine if corrections are needed.

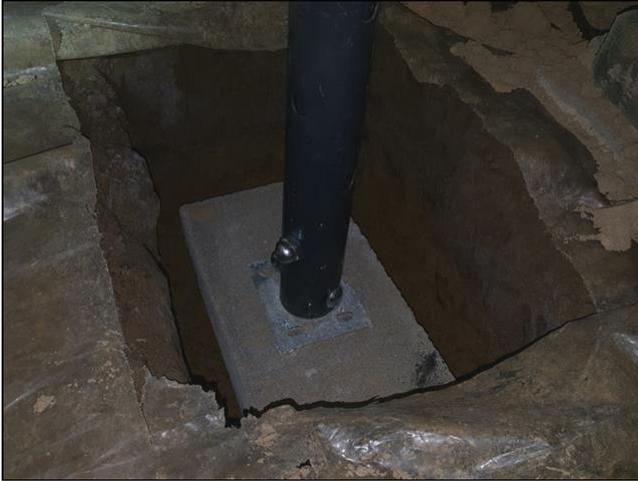
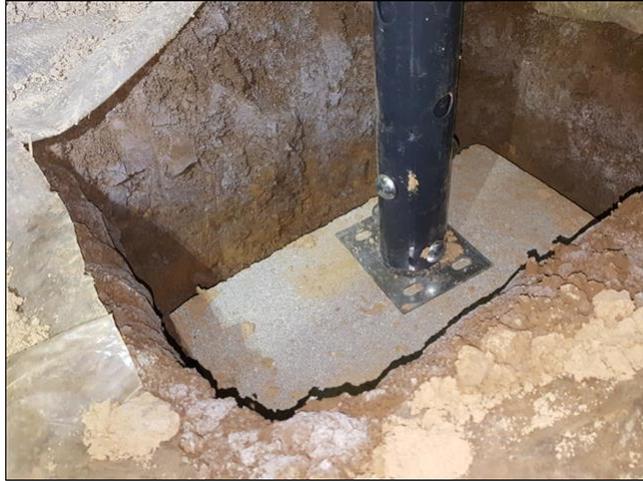
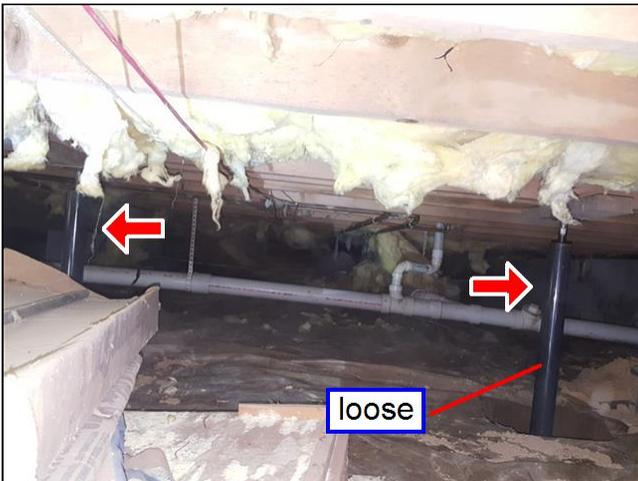
1.6 (2) Support posts are usually set on 3'x3'x12" thick footer pads. The posts are set on masonry blocks resting on the ground in the crawlspace under the master bathroom area. One of the posts is loose. When support posts are missing footers, they can settle which can result in settlement and possible failure of the floor structure over time. These posts are directly under the master bathroom area. Strongly recommend a qualified building contractor and/or a structural engineer further evaluate and repair/correct as needed. Also refer to note 6.1.

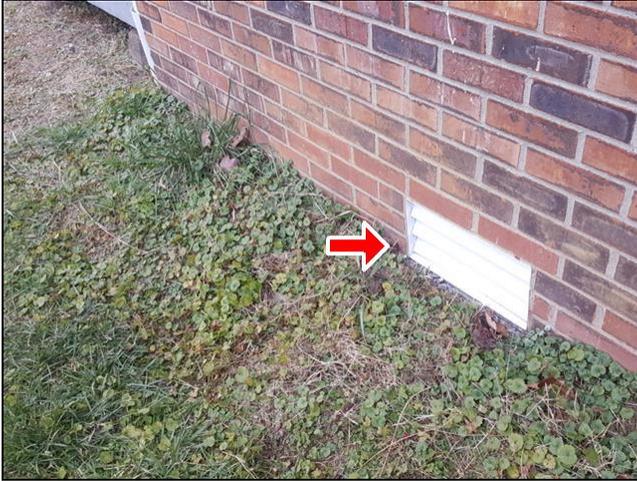
1.8 Item 1(Picture)

1.8 The foundation vent(s) is a little below ground level at left side of the home which can allow water to enter the crawlspace. A half-round window well should be installed. The dirt inside the well should be replaced with approximately four inches of gravel. A couple of inches clearance between the gravel and vent opening is recommended. Recommend a general contractor correct as needed.

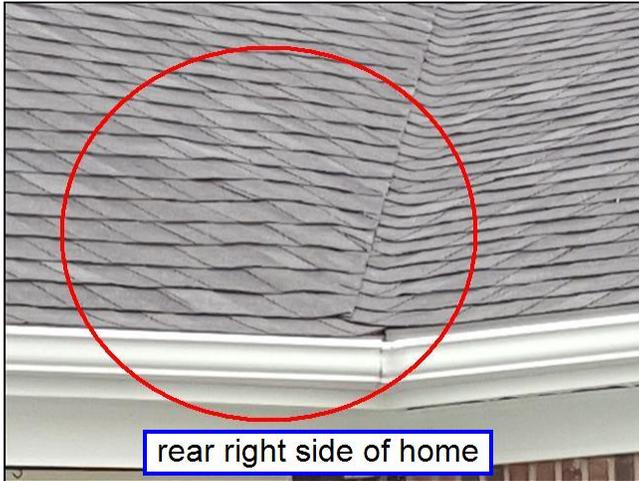
2.0 Item 1(Picture)

2.0 (1) The roof covering shows a mump-like appearance in some areas around the home, see photos for location. These small little bumps might be caused by hot weather, in which some air beneath the cover layer has become hot and has expanded, or due to poor installation. These areas will eventually or may blister creating a water leak and the roof area will need replacing. Recommend a qualified roofing contractor further investigate and repair as needed as these bumps may cause ruptures, and cause leakage later on.

rear right side of home

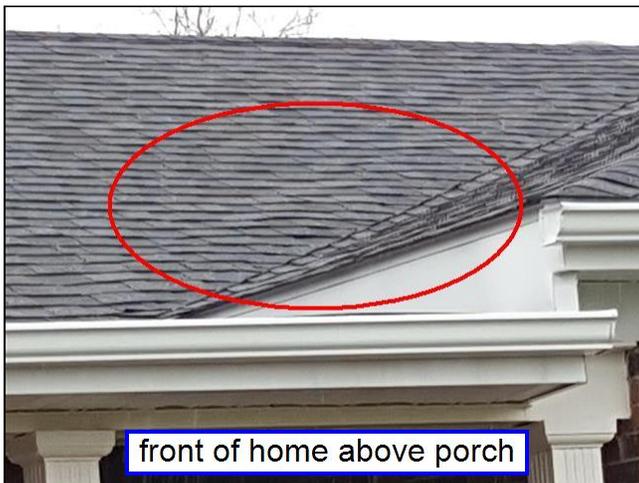
2.0 Item 3(Picture)

front of home above porch

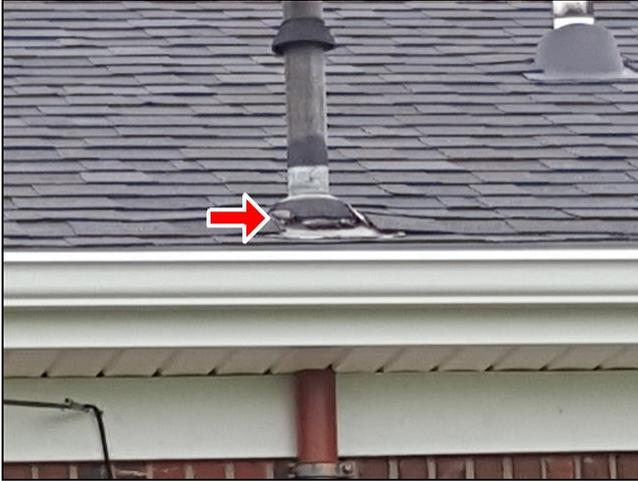
2.3 Item 1(Picture)

2.3 The rubber boot below the electric mast is starting to deteriorate and may be prone to leaks because it is split/cracked at the rear of the home. This may allow water to enter into the attic which may lead to deterioration of the roof and ceiling structure which can lead to mold within the attic. Sealing or replacing the rubber boot is recommended. Recommend a roofing contractor repair or replace as needed.

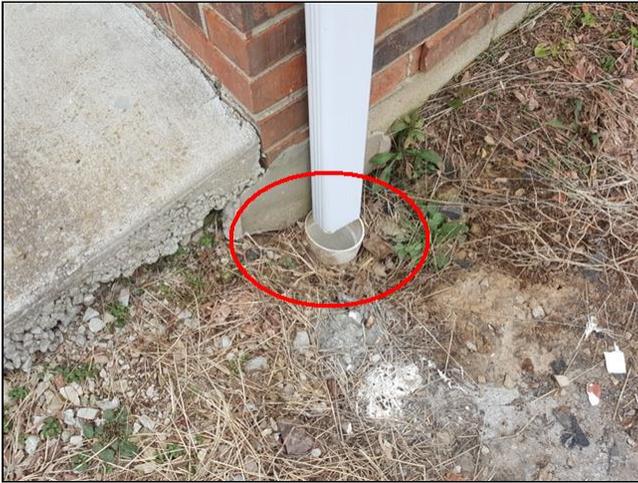
2.4 Item 1(Picture)

2.4 (1) The Down spout is dislodged at the joint leading into the extension at the front right corner of the garage. This allows water spilling and not being drained correctly at the downspout extension. This will cause soil erosion and possible settlement of the foundation wall or leakage under the slab. Recommend a general contractor repair or replace as needed.

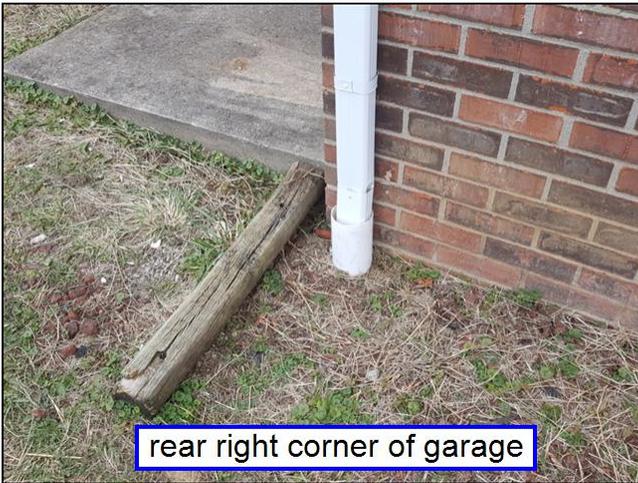
2.4 Item 3(Picture)

2.4 (2) Downspouts that discharge below grade level should be monitored. If they are ever suspected to be clogged or disconnected below grade, they should be redirected to discharge at least 10 feet from the building or into a storm sewer system. Foundation leakage adjacent to a downspout is an indication of a problem below grade.

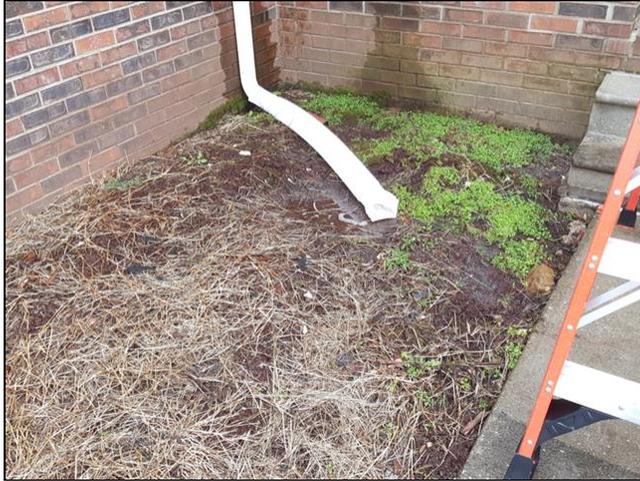
2.4 Item 9(Picture)

2.4 (3) Recommend the downspout(s) at the front left corner of the home near the porch where indicated in the photo(s) be extended and flow onto a splashblock. This will ensure water is kept away from the foundation perimeter, soil erosion does not occur and water cannot leak under the slab foundation area and be trapped between the front walkway which may cause settlement of the foundation of the home. Recommend a general contractor correct as needed.

Note: the extension will need to go underneath the front walkway.

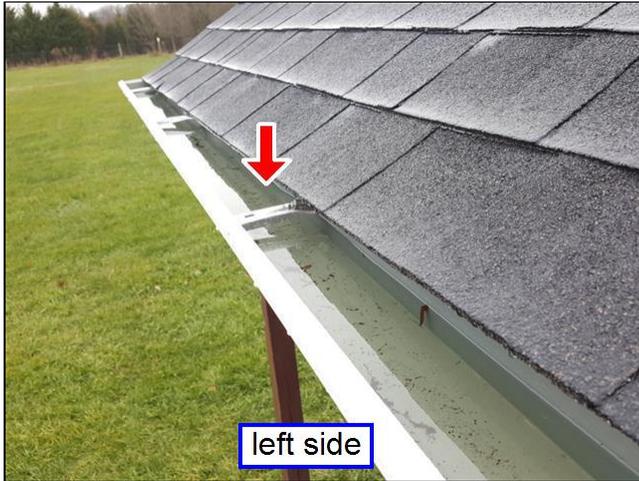
2.4 Item 10(Picture)

2.4 (4) The gutter is holding water at the rear left and the right side of the deck roof due to an incorrect slope towards the downspout. Gutters that drain poorly can lead to many costly problems such as deterioration of the fascia, soffit or roof edge. It can also cause gutters to pull loose and lead to possible water intrusion. Recommend the slope be adjusted by a qualified person as needed prior to closing.

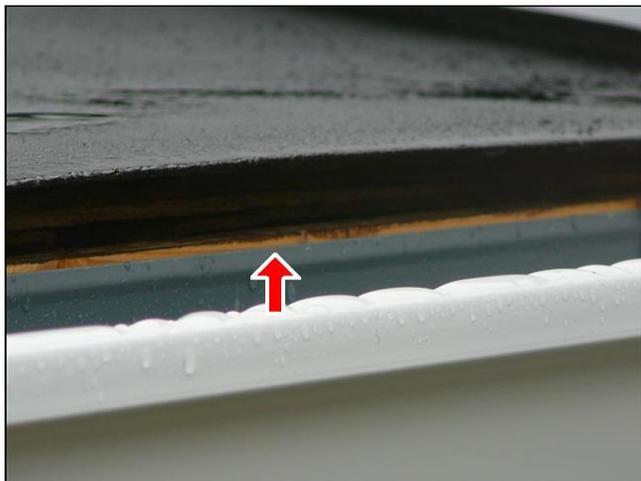
2.4 Item 15(Picture)

2.4 (5) The drip edge/flashing is missing at the front porch roof of the home. The drip edge/flashing protects the roof edge of the wood sheathing from water intrusion. Repairs are needed to prevent deterioration of the roof sheathing. Recommend a qualified roofing contractor repair as needed.

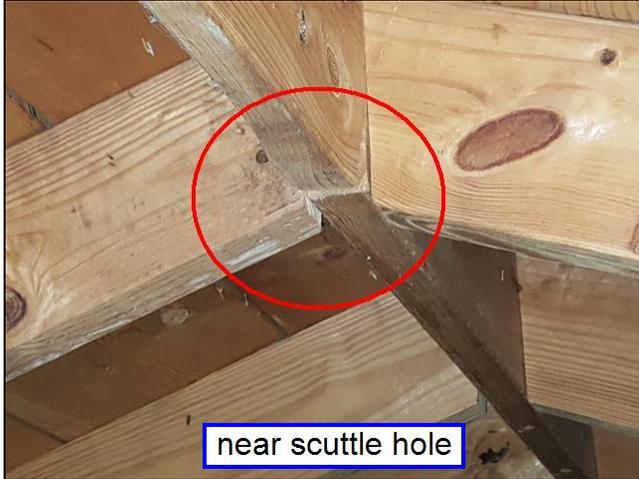
2.6 Item 1(Picture)

2.6 Recommend a vertical supports to the join in the ridge beam in the attic (garage area) to add extra support to the roof structure and to resist rafters and/or ridge beam from sagging and cracking in the future. The rafters are the primary support to the ridge beam only. Recommend a qualified framing/building contractor further evaluate and make the necessary repairs as needed.

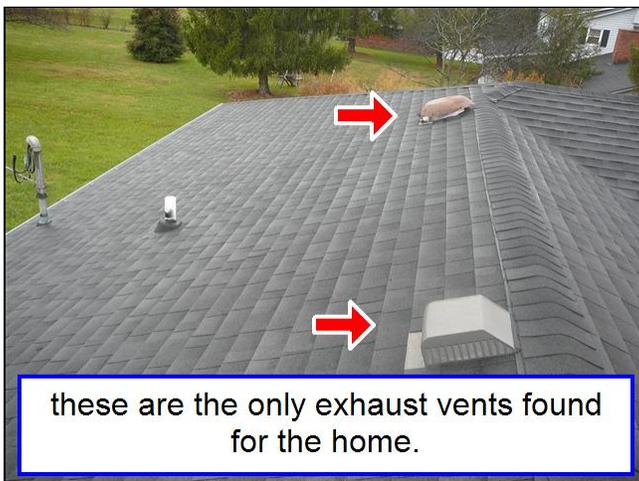
2.7 Item 1(Picture)

2.7 Additional ventilation was not added, when the most recent roof covering was installed. The level of ventilation is marginal and can be improved. It is generally recommended that one square foot of free vent area be provided for every one hundred and fifty square feet of ceiling area. Half of the ventilation should be at the ridge and the other half at the eaves. Proper ventilation will help to keep the house cooler during warm weather and extend the life of roofing materials. In the winter, it will help reduce the potential for ice dams on the roof and condensation within the attic. [Here is a link explaining ventilation.](#) Recommend a qualified roofing contractor further evaluate to determine if corrections are needed now or when the next replacement of the roof coverings is expected.

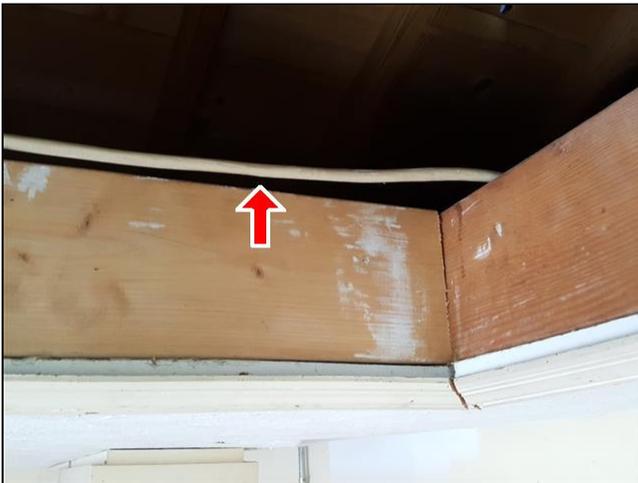
2.10 Item 1(Picture)

2.10 (1) The electrical wire above the attic access should be secured onto a rafter. This is a safety issue as when entering attic or falling from ladder someone may grab these wires and pull on them. This could result in a death via electrocution via wires being pulled from junction box. Recommend a licensed electrical contractor correct as needed.

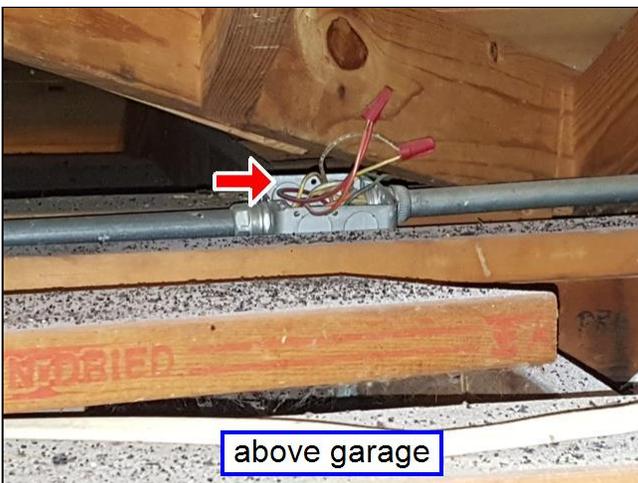
2.10 Item 2(Picture)

2.10 (2) All junction boxes in the attic space should have covers installed to prevent tampering, protect the wire connections, and for personal protection. This is a safety issue that needs to be corrected. If a leak was to occur it could result in a short then a fire in the home. Recommend a qualified licensed electrician correct as needed.

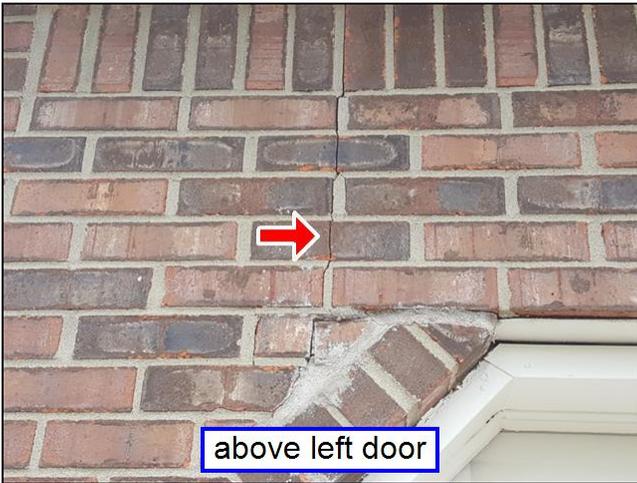
3.0 Item 1(Picture)

3.0 (1) Exterior wall vertical cracks at the mortar joints and through the brick siding was observed above the garage where indicated in the photos. The majority of these cracks were observed above the garage door frames where there were metal lintel's in the brick work. A lintel is a metal beam supporting masonry above an opening in a wall. These cracks may imply that the lintel may be rusting, expanding, or close to the lower limit of function and acceptability due to being undersized. While the rate of movement cannot be predicted during a one-time inspection it is likely that repairs are needed. These cracks do not appear significant at this stage. Recommend a qualified contractor seal all cracks to prevent further cracking and possible deterioration of the brick work and treat lintel's from rusting and exposure to moisture by painting lintel's. Also ensure they are sealed between the brickwork so water cannot enter behind or on top of lintel. If cracks reappear after repairs, then would recommend a qualified masonry further investigate to determine cause and repair or replace as necessary.

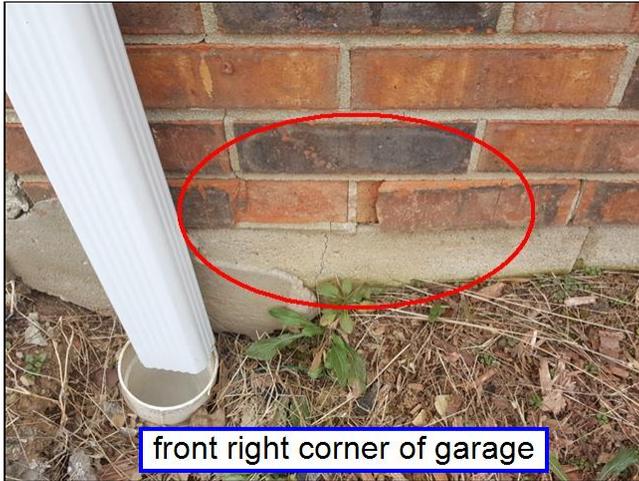
3.0 Item 6(Picture)

3.0 (2) Brick spalling observed at the front right corner of the garage near the downspout. Spalling is a result of water entering the concrete and masonry and forcing the surface to peel, pop out or flake off, due to moisture entering the foundation perimeter. Eventually, spalling can cause crumbling and destruction of a structure. Recommend repair and ensure water is drained away from the perimeter of the home. A skilled masonry contractor should perform the repairs.

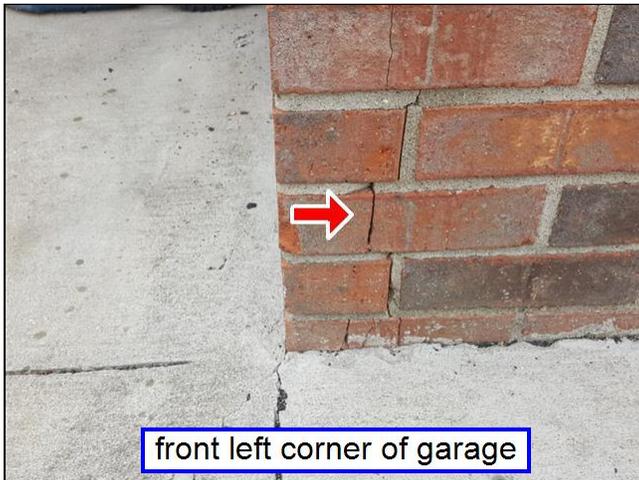
3.0 Item 7(Picture)

3.0 (3) The exterior brick wall has various vertical and stair step settlement cracks in various places around the home, see photos for location. This implies that minor structural movement has occurred. While the rate of movement cannot be predicted during a one-time inspection it is likely that repairs are needed. These cracks do not appear significant at this stage. Cracks that are greater than 1/8 inch are cause for concern. Due to freeze/thaw, the cracks should be sealed to minimize further chipping away, flaking or deterioration. Recommend these cracks be sealed to prevent further cracking via water intrusion. A qualified contractor or skilled masonry contractor should perform the repairs via tuck pointing mortar. It is recommended that you monitor periodically and if cracks reappear and become greater than 1/8", then a qualified structural engineer or masonry contractor should be consulted to determine cause and suggest repairs. This would indicate that the home is continually settling. Keep water away from the foundation: review the lot and roof drainage improvements in the Exterior and Roofing sections of this report. While the rate of movement cannot be predicted during a one-time inspection it is likely that repairs are needed.

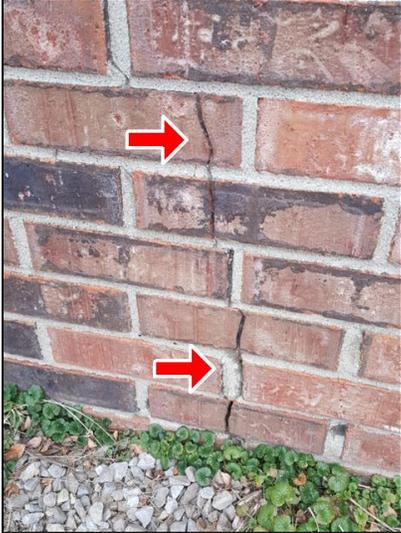
3.0 Item 12(Picture)

3.0 (5) The appearance of the settlement crack at the rear of the home below the master bedroom window right side is large enough for concern. Previous repairs have been performed from the outside to eliminate water intrusion. However the crack has reappeared. Some degree of settlement has and seems to be re-occurring. Cracks show sizes between 1/8 and 1/4 inch in width. This is cause for concern. Cannot tell if this movement is ongoing. While the rate of movement cannot be predicted during a one-time inspection it is likely that repairs are needed. Recommend a Structural engineer or Masonry contractor be consulted to further evaluate this condition and the remedies available for correction. These cracks need to be sealed to prevent further cracking due to freeze/thaw (water entering) and possible further deterioration of the brick work.

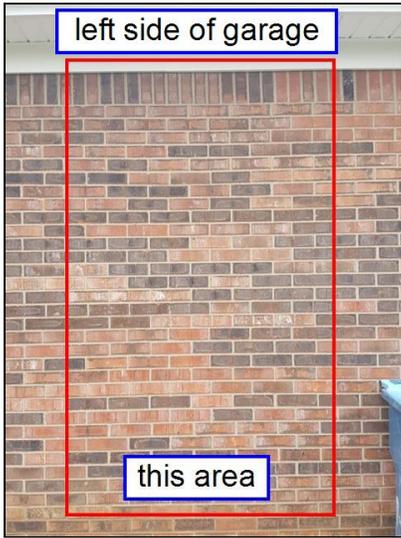
3.0 Item 14(Picture)

3.0 (6) The exterior brickwork has a vertical "V" shaped crack that has a large gap at the top then runs down to a smaller gap at the bottom at the right side of the home and at the left side of the garage. This implies that minor structural movement is occurring. While the rate of movement cannot be predicted during a one time inspection it is likely that additional repairs are needed and further investigation is required due to the shape of these cracks. "V" shaped cracks (wider on one end than the other), could be a signal that you have some foundation settling issues. When the foundation of your home settles in one direction, this causes the weight of the house to shift toward that settling, or sinking, area. There are numerous reasons that this could happen, but one of the signifiers is V shaped cracks appearing in your drywall or exterior brick siding. Strongly recommend a qualified foundation contractor and/or structural engineer further inspect and make the necessary repairs if needed to prevent possible further cracking of the brick wall and perhaps future settlement of the foundation. The cracks needs to be sealed to prevent water entering which can lead to further deterioration and possible damage to the wall structure.

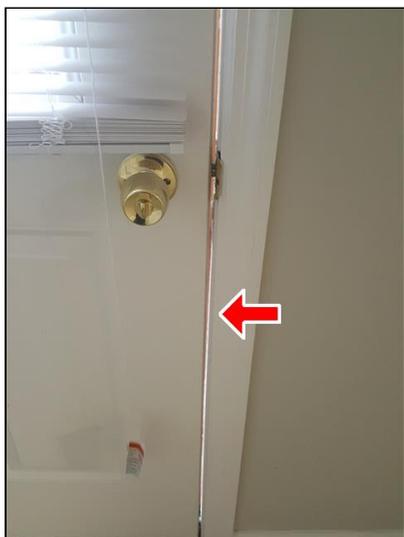
3.2 Item 1(Picture)

3.2 The side entry door at the dining room reveals daylight when latched at areas. It is missing weather-stripping. This can cause some heat loss in winter and loss of cool air in summer if not corrected which can cause condensation. Recommend repair as needed.

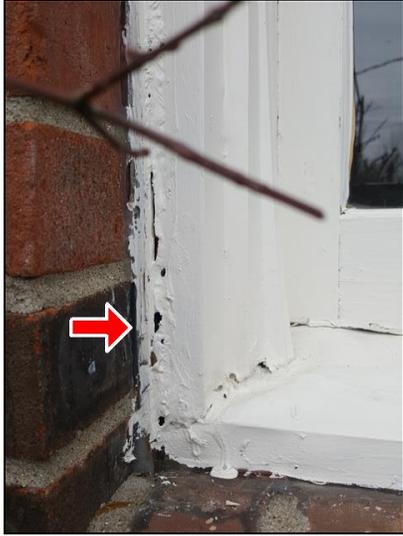
3.3 Item 2(Picture)

3.3 (2) The gaps between the window frames and the brick siding at the rear of the home (master bedroom windows) need to be sealed correctly to prevent water intrusion. Water entering here can lead to deterioration of the wall siding and potential leaks inside the wall cavity. Recommend caulking these areas with a quality moisture resistant caulk that expands and contracts. [Choosing the right caulk](#)

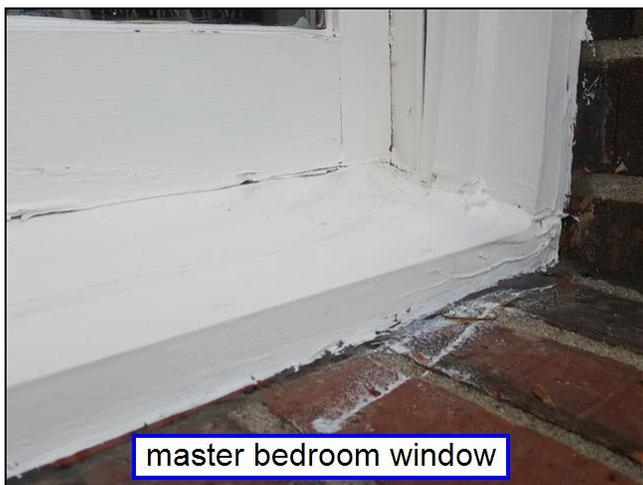
3.3 Item 6(Picture)

3.3 (3) The bottom of some of the window sills around the home are warped/buckled and show signs of previous repairs. The sills should be flat and sloped to ensure water drains away from the home. The openings may allow water to enter and cause poor seals allowing the outside air to enter if not sealed correctly. Recommend a qualified window contractor repair as needed.

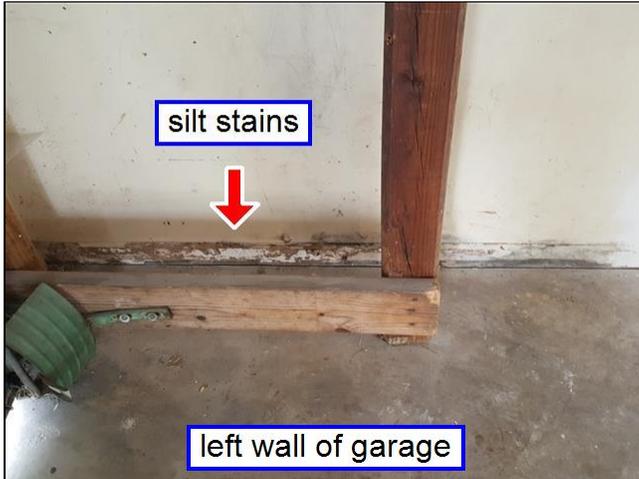
4.1 Item 1(Picture)

4.1 (1) Visible signs of water intrusion and/or evidence of past water penetration in the garage was present at time of inspection from silt stains observed on wall. It is evident that correction repairs are present. I am unable to determine if repair is successful Water intrusion can cause deterioration and excessive moisture on building components if not corrected. I am unable to determine the extent of intrusion or how often it occurs. Water intrusion can lead to more costly repairs and increase damage if not corrected. Inspections are limited and destructive inspections are excluded. The extent of possible damage behind repairs cannot be realized until the covering is removed. Recommend asking owner for possible explanation due to walls have been repaired. Also, recommend monitoring these areas when it rains to determine if water intrusion is still occurring and if so further investigation will be required by a qualified contractor to determine cause and remedy to prevent further water intrusion.

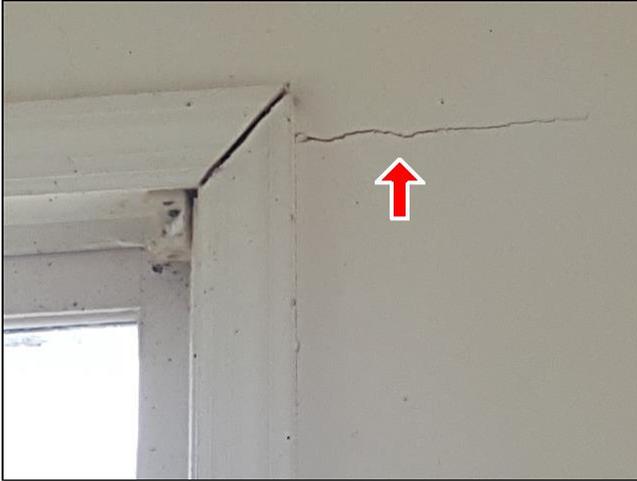
4.1 Item 5(Picture)

4.1 (2) The horizontal cracks in the walls in the garage at the right wall above the windows (see photos for location) appear to be common settlement cracks. Cracks larger than 1/8" are of concern only. Minor settlement of the home has occurred due to the age of the home and from perhaps framing shrinkage. Cracks of this nature are also caused by moisture and changing temperature. Recommend repairing cracks then paint and monitor. If cracks reappear and become larger than 1/8" then would recommend a structural engineer further investigate to determine cause and suggest repairs.

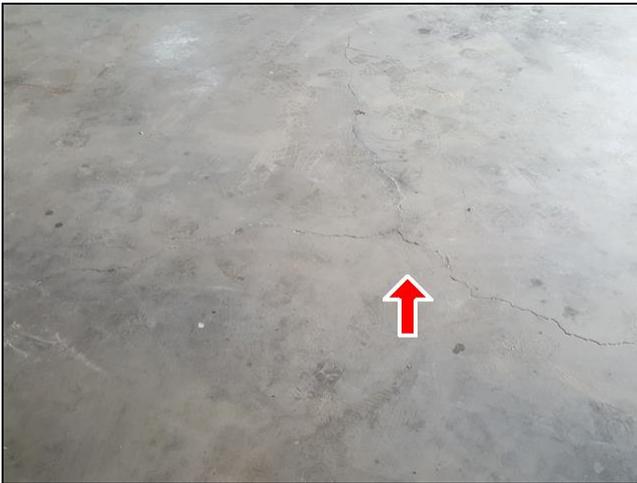
4.2 Item 1(Picture)

4.2 There are no control joints in the garage floor. All concrete cracks. Control joints allow poured concrete to crack at the joint to prevent large running cracks. The garage flooring has typical cracks in areas highlighted in photos. These cracks do not appear significant and seem typical. Cracks that are usually 1/8 inch or wider are need for concern. The cracks are usually the result of shrinkage and/or settling of the slab. Recommend these cracks be sealed then apply an epoxy coating on the floor to ensure water intrusion does not occur. It is recommended that you monitor annually after repairs. If these cracks should reoccur a masonry contractor who is familiar with foundation repair should be consulted. [Caulk for Concrete Cracks](#) This is for your information.

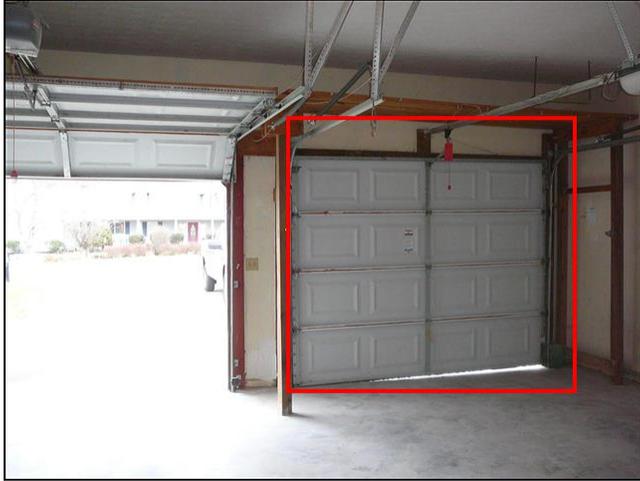
4.3 Item 1(Picture)

4.3 (1) The garage door, "left" door (from outside), does not open automatically and when opened manually it does not hold its position. The garage door openers are in place but are not operational. The door also appears to be misaligned due to the weather stripping at the bottom is not sealing against the flooring. Recommend a garage installer further inspect and repair or replace as needed prior to closing.

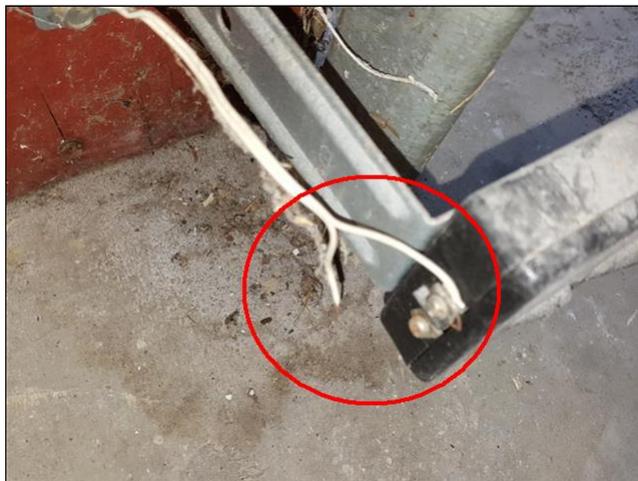
4.3 Item 4(Picture)

4.3 (2) The eye sensors for the garage "right" door (from outside) are not connected, hence possible reason why the door button needs to be depressed and held in order for the door to be closed. The sensors do not function. This is a safety issue. Recommend a qualified garage installer repair as needed prior to moving in.

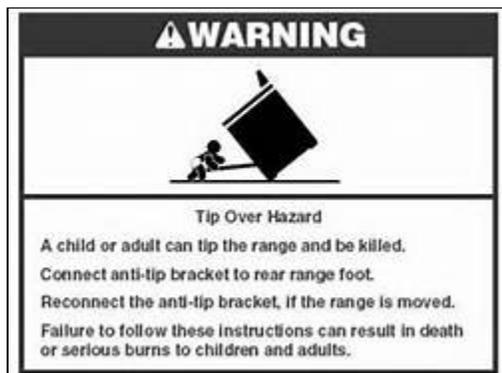
5.4 Item 1(Picture)

5.4 (1) The "Anti Tip" bracket for the range has not been installed as required by manufacturer's installation instructions. This could allow the range to tip if it is pulled or if the oven door is pushed down or stepped on. This is a safety issue. A tip over hazard exists for small children and a serious injury or death could occur. Strongly recommend the bracket be installed for safety around small children or others. [Information about "anti tip" bracket](#)

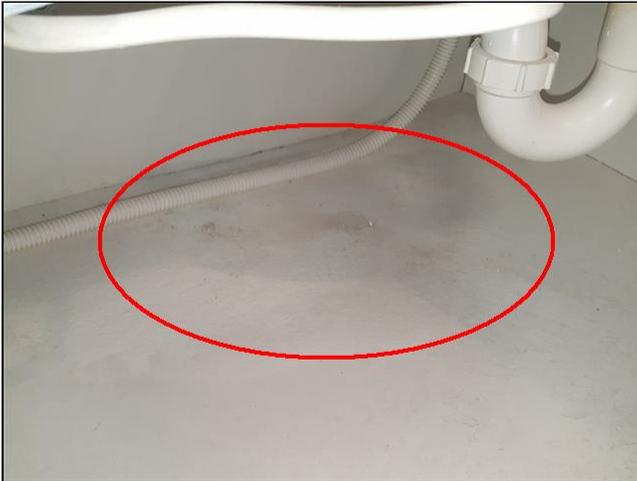
5.7 Item 1(Picture)

5.7 The bottom of the cabinet(s) in the kitchen under the sink where indicated in the photo(s) has very minor water damage. This indicates that a previous water leak existed at some stage. This is a cosmetic issue only. Check with the owner for possible cause and check for leaks once shut off valves are turned on. This is for your information.

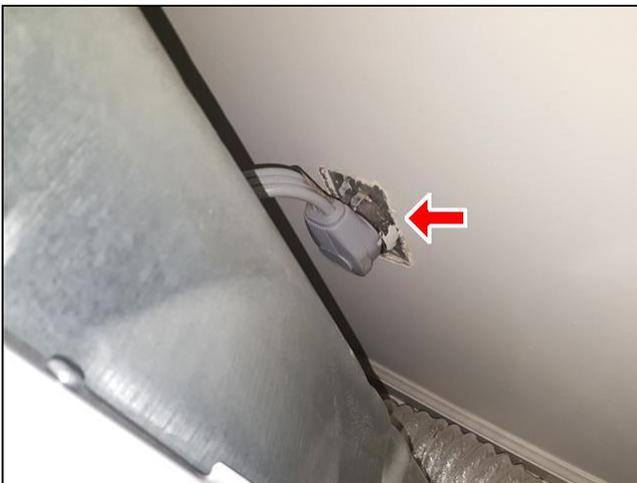
5.8 Item 1(Picture)

5.8 (1) The outlet(s) in the washer/dryer room for the dryer is missing a cover-plate. The outlet was not tested. All missing covers should be installed to prevent touching the sides of the devices to prevent an electric shock which can cause an injury or death. Electrical issues are considered a hazard until repaired, and this is considered to be unsafe. A qualified licensed electrical contractor should correct as needed prior to moving in.

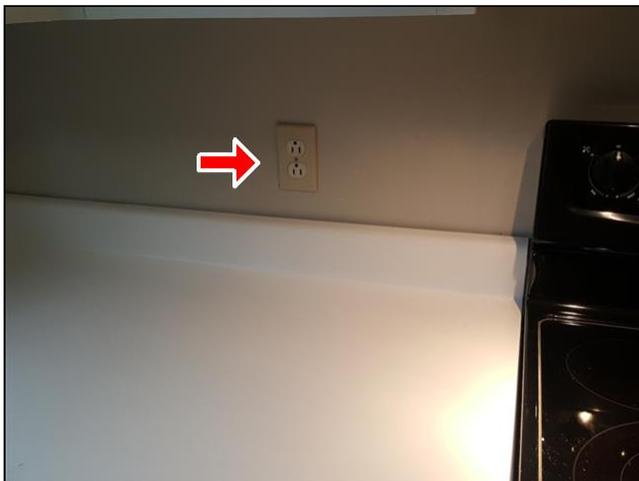
5.8 Item 3(Picture)

5.8 (3) The outlet(s) in the kitchen where indicated in the photo(s) are loose at the wall or in the outlet box. Electrical issues are considered a hazard until repaired. This is a safety issue that needs to be corrected due to an electric shock or fire from loose connections could occur if not repaired. Recommend a qualified licensed electrical contractor correct as needed.
