TALON
Home Inspections

Inspection Report

Property Address:
2001 Crimea Street
Lawrenceburg KY 40324

Date: 12/17/2017	Time: 10:00 AM till 03:00 PM	Report ID: 171217PETERS
Property: 2001 Crimea Street Lawrenceburg KY 40324	Customer: Mr. Trevor Peters	Real Estate Professional:

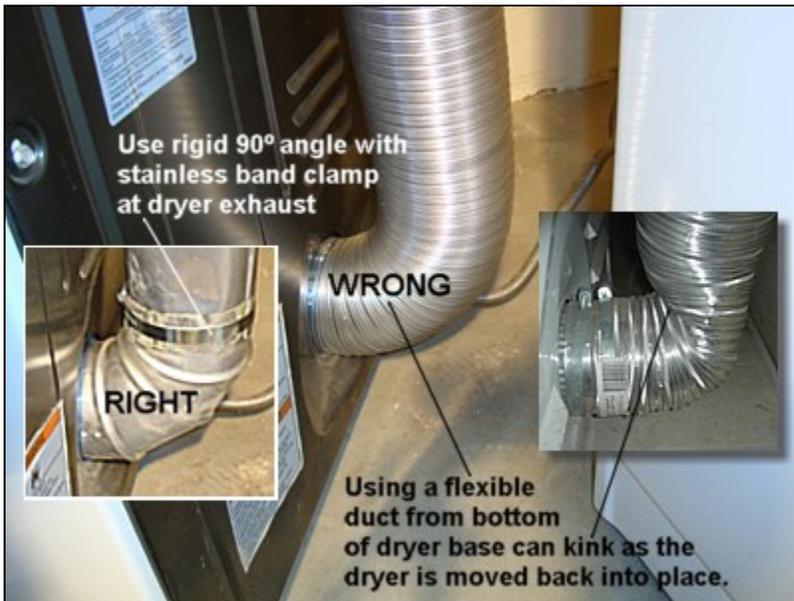
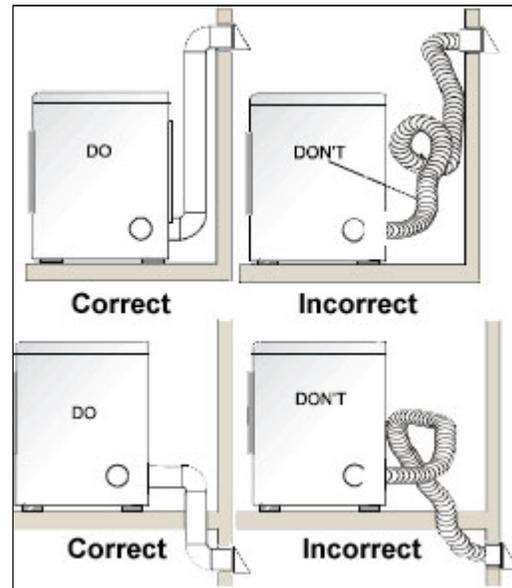
5.9 Item 3(Picture)

5.9 (1) A pleated Foil flex pipe is currently installed from the dryer to the exhaust vent. The current recommendations are for dryer vents to be heavy flexible or solid metal to help prevent crushing and damage from fires. Dryer lint fires are reported to be the third leading cause of fires. Exhaust ducts should be constructed of minimum 0.016 inch thick rigid metal ducts, having smooth interior surfaces with joints running in the direction of air flow. Exhaust ducts shall not be connected with sheet metal screws or fastening means which extend into the duct. All dryer vents should be disconnected and cleaned twice a year. This is a very common cause of fires. Recommend replacing duct for proper operation and for your safety using a qualified contractor.

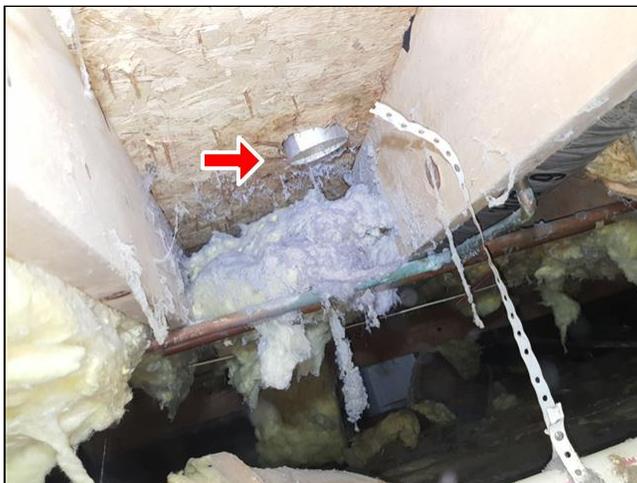
5.9 Item 5(Picture)

5.9 (2) The dryer is currently venting into the crawlspace which can result in various problems. Venting a dryer in a crawlspace can result in moisture problems which could lead to rot or mold in your crawl space, lint buildup on insulation, and damage to floor framing. The dryer should vent to the exterior. Recommend a qualified contractor correct as needed.

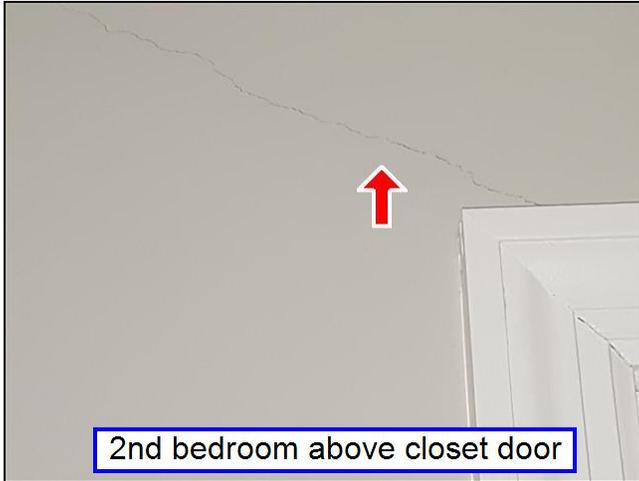
6.1 Item 1(Picture)

6.1 The crack(s) noted on the walls near the corners of the door frames in the home, (see photos for location) are common minor settlement diagonal crack(s). Cracks larger than 1/8" are of concern only. Minor settlement of the home has occurred. All the doors in the related room(s) do open and close without rubbing on door jambs. This damage is considered to be cosmetic and a small repair issue for your information. Recommend prep prime and paint as needed.

Note: After repairs, these areas should be monitored and if cracks reappear and become greater than 1/8 inch wide, then further evaluation is recommended by a qualified contractor to determine cause and repairs. (structural members are not visible) Also see note 1.6(2) and 1.4(2).

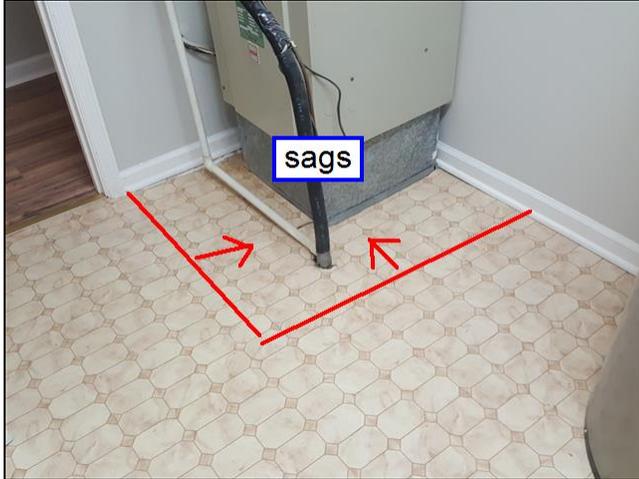
6.2 Item 1(Picture)

6.2 The floor is sagged underneath the air handler in the washer dryer room. I suspect that the joists maybe damaged or need additional support. Access to this area of the crawlspace was limited due to access from fallen insulation, ducts and plumbing pipes. Recommend a qualified contractor further inspect and evaluate to determine if repairs are needed prior to closing once easy access is granted. This maybe a structural issue.

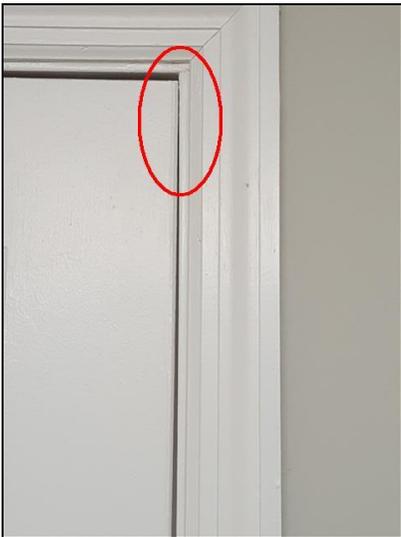
6.4 Item 1(Picture)

6.4 (1) The door in the Washer/Dryer room hits and rubs the door jamb at the top but does close shut. This maybe due to settlement of the home or sagging joists. Once the floor structure is inspected and repaired if needed, then recommend the door be repaired/corrected as needed by a general contractor. Sometimes correcting the door opening can require door trim to be removed and painting touch up, and/or door hinges may need reseating to ensure correct closure of door. **Also see note 7.2.**

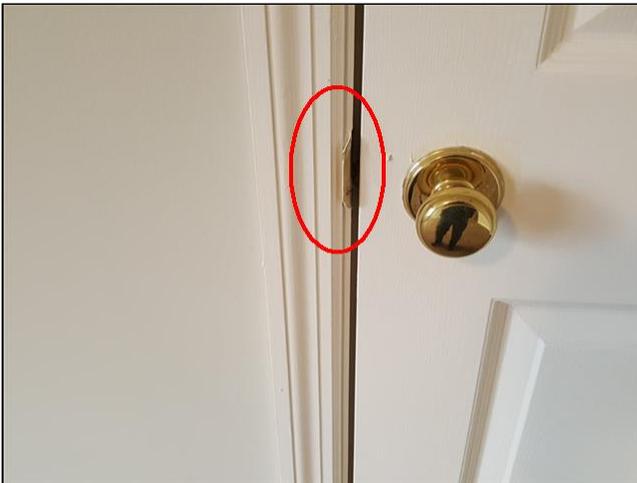
6.4 Item 2(Picture)

6.4 (2) The door knob hardware is not latching in the 3rd bedroom closet door where indicated in the photo. It requires an adjustment. The strike plate may need to be adjusted or trimmed to be able to lock/close the door. Recommend repair as needed.

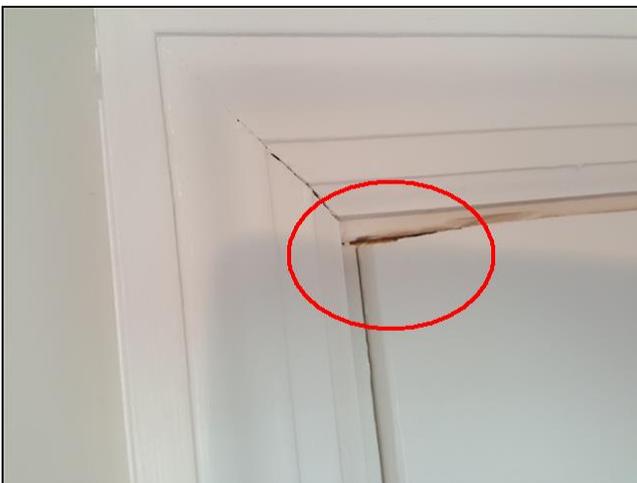
6.4 Item 4(Picture)

6.4 (3) The entry door in the 2nd Bedroom closet where indicated in the photo does close properly, however it rubs at the door jamb when closing where indicated in photo. This maybe due to minor settlement of the floor structure. Sometimes correcting the door opening can require the door trim to be removed then touch up painting or doors will need to be rehung or trimmed down. Recommend a qualified contractor repair as needed. **Also see notes 7.1 and 1.4(2).**

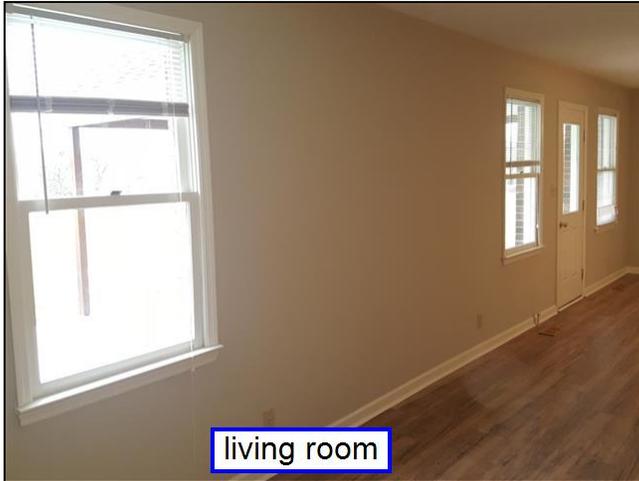
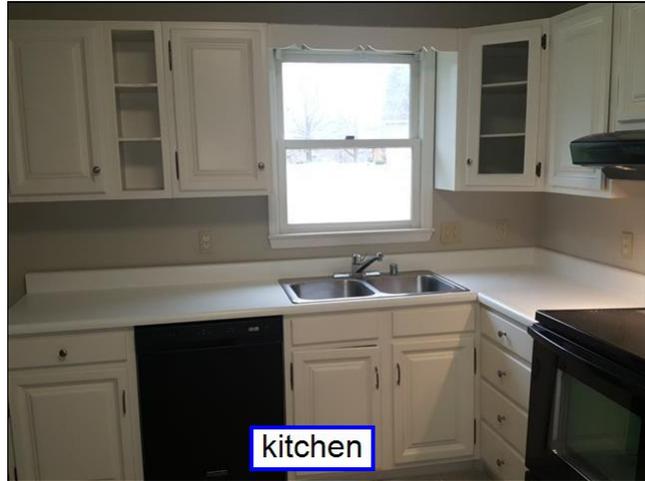
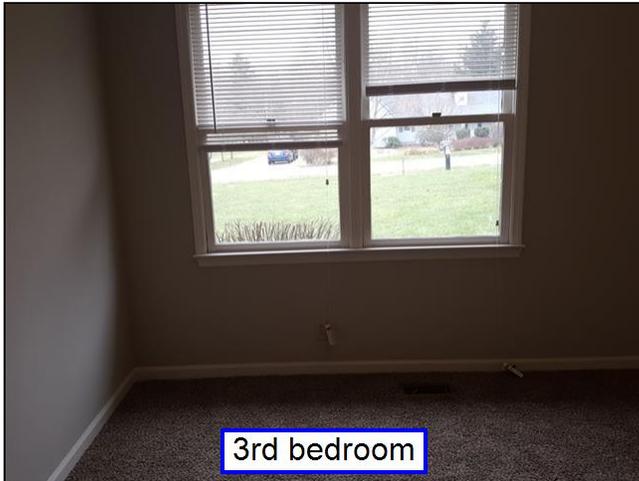
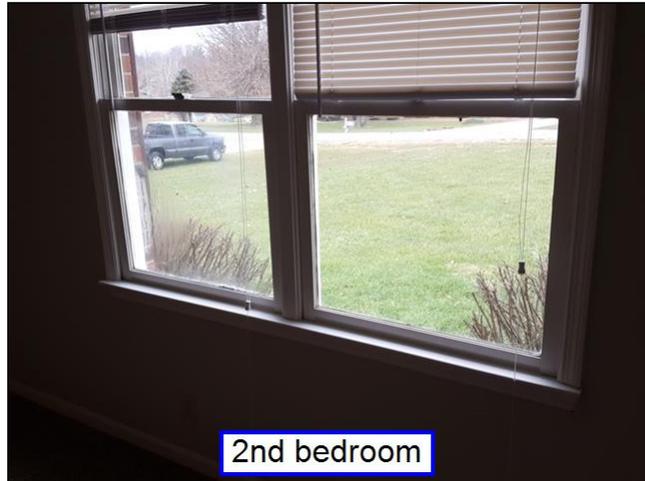
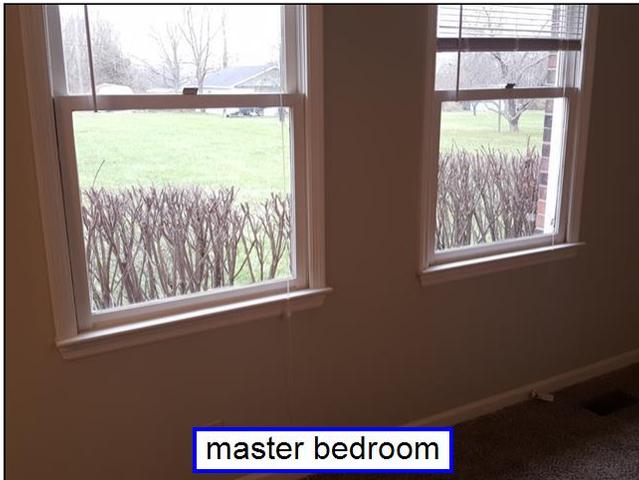
6.5 (1) All the windows in home are missing screens. Recommend these be installed to prevent insects entering the home when the window is opened. Replace as needed.

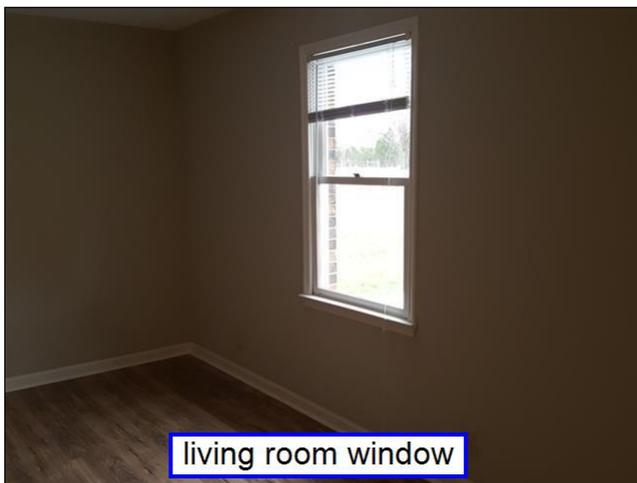
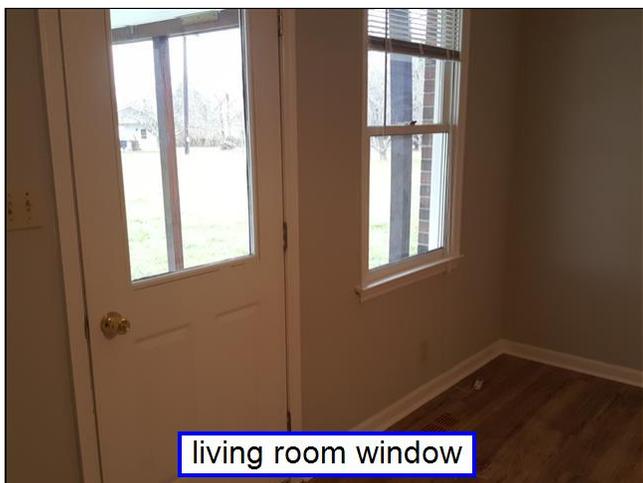
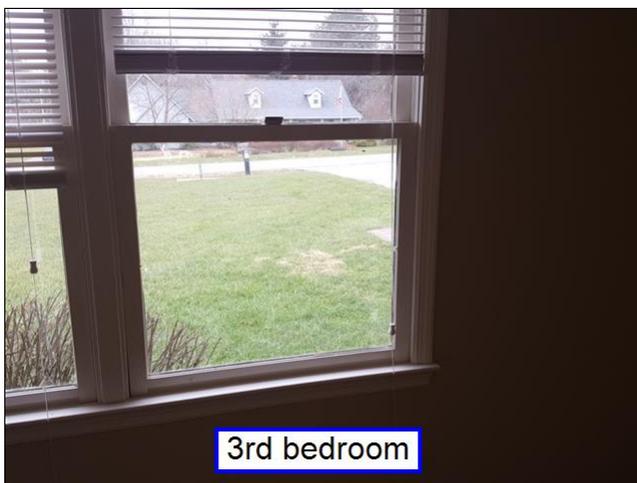
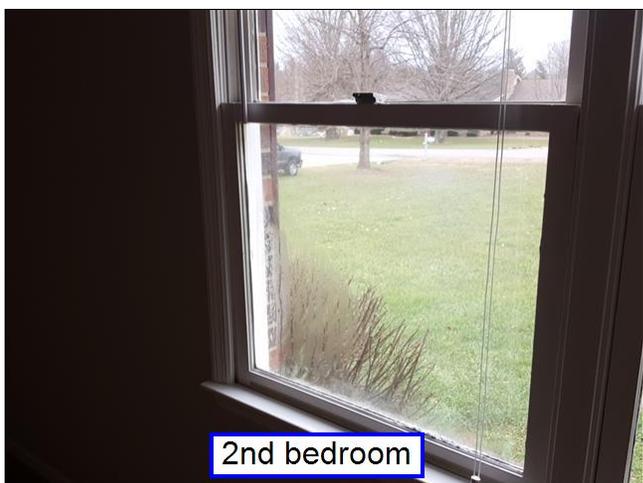
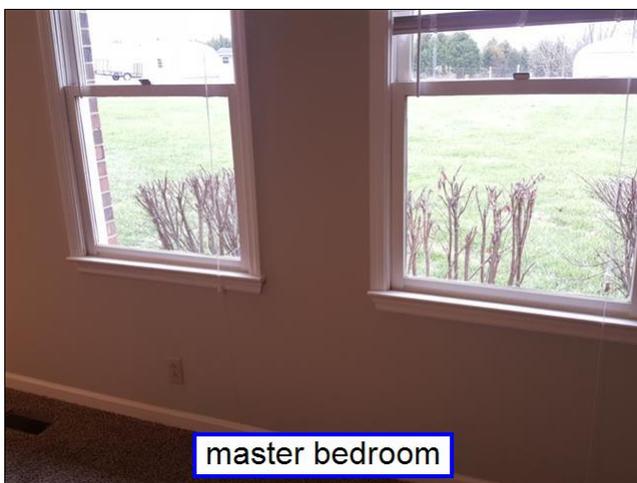
6.5 (2) The majority of the windows in the home will not open, see photos for location. These may be stuck or painted shut and/or may involve repair to sash cords. In the event a fire was to develop in the hallway in the home, person(s) or children have no means of exiting the master bedroom. This is a serious safety issue. Strongly recommend this be corrected prior to moving into home. Recommend unsticking the other window(s) to determine there functionality. If the problem persists, recommend either installing new windows or have a qualified window installer further investigate and repair as needed, which ever is cheaper.

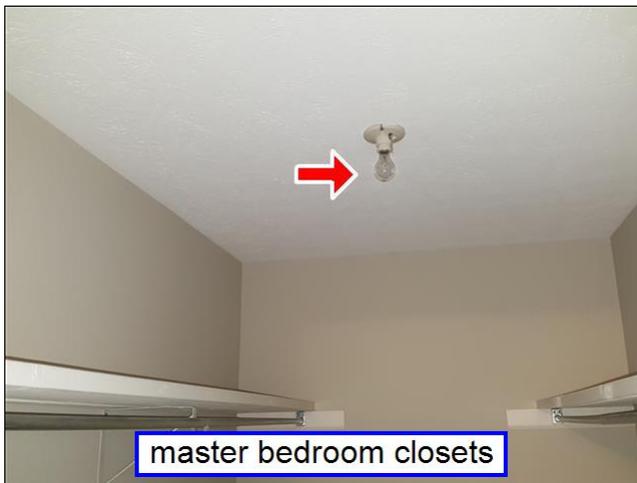
6.6 Item 2(Picture)

6.6 The light in the Master Bedroom and the 2nd Bedroom closet room is missing a fixture. Light bulbs in closets should have fixtures or be replaced with fluorescent bulbs to prevent fires from bulbs being in contact with clothing or storage items. This is a safety issue. Recommend correcting as needed.

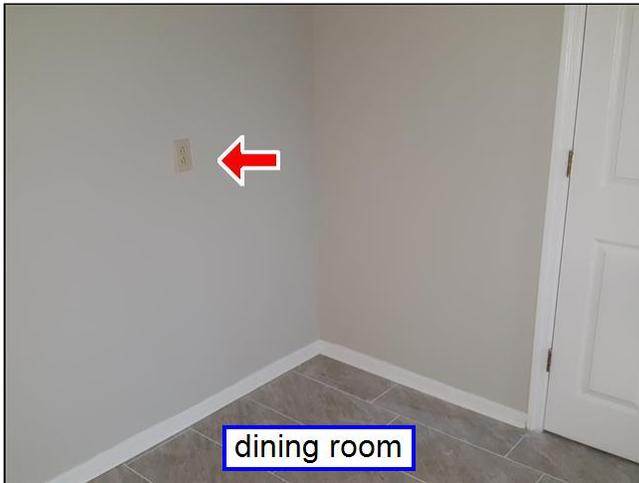
6.7 Item 1(Picture)

6.7 (1) The outlet(s) where indicated in the photo(s) are loose at the wall or in the outlet box. Electrical issues are considered a hazard until repaired. This is a safety issue that needs to be corrected due to an electric shock or fire from loose connections could occur if not repaired. Recommend a qualified licensed electrical contractor correct as needed.

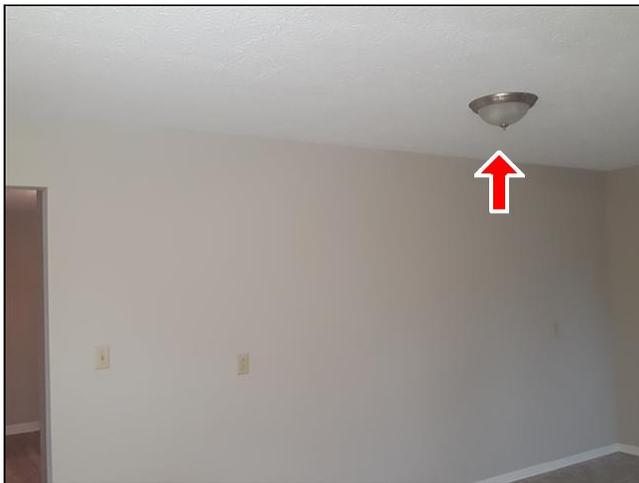
6.7 Item 3(Picture)

6.7 (2) The light fixture does not work (try bulb first) in the dining room. If the bulb is not burned out, the fixture or circuit should be repaired using a qualified electrician.

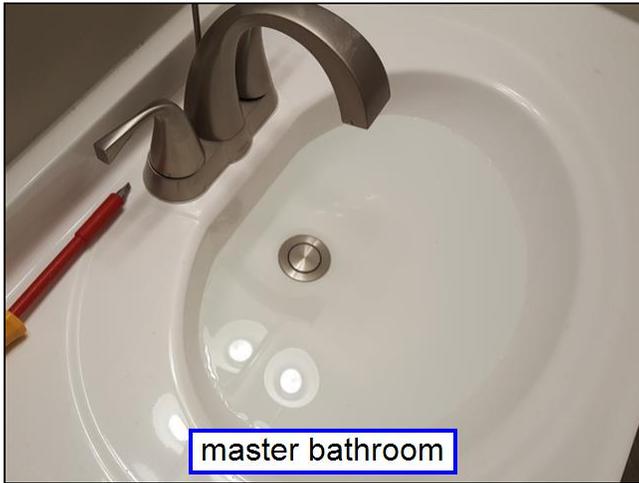
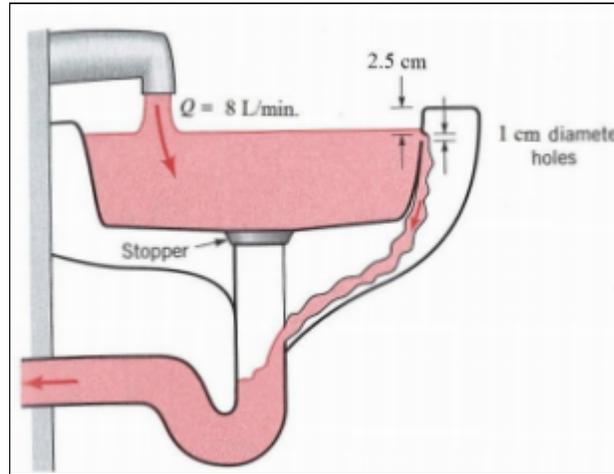
7.3 (1) The sink(s) in the all the bathrooms do not have overflow holes. Over flow holes are recommended at all sinks to prevent water spillage which can lead to damage cabinets or flooring. This is for your information.

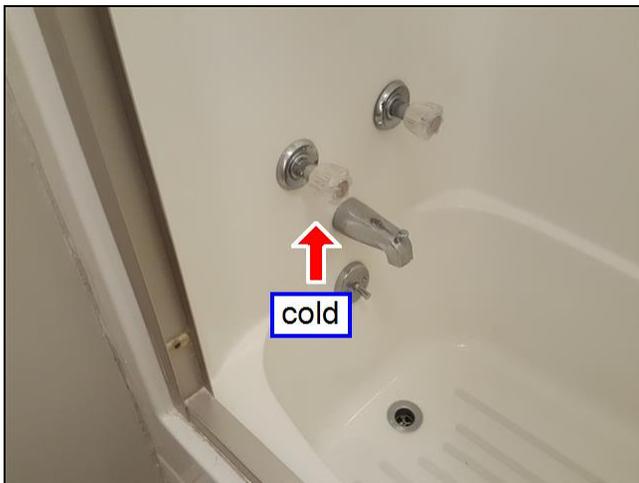
7.3 Item 3(Picture)

7.3 (2) The hot and cold water lines are connected in reverse from there normal positions in the Master bathroom at the shower. This could result in scalding burns of a person or child and is a safety issue. Recommend they be changed to the accepted normal locations with the cold water valve on the right side of the fixture. Recommend a licensed plumber correct as needed.

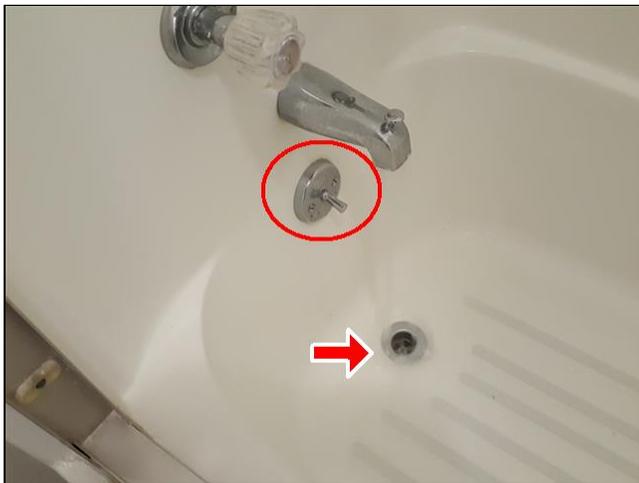
7.4 Item 1(Picture)

7.4 The drain stopper is not functioning at the tub in the master bathroom bath tub. Recommend a qualified licensed plumber install one so that bath tub can be filled with water without draining or a rubber stopper can be used.

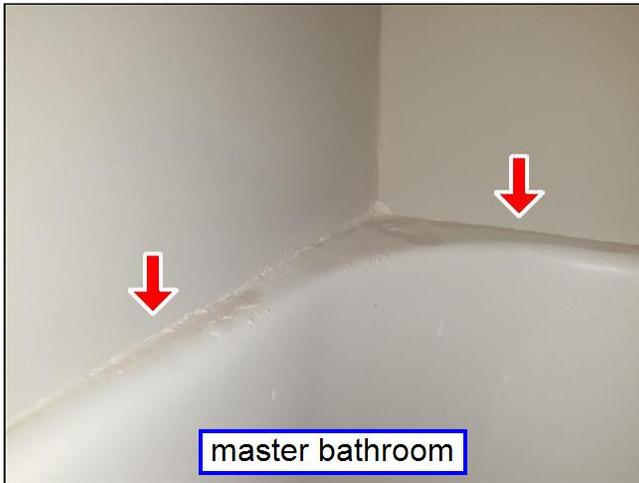
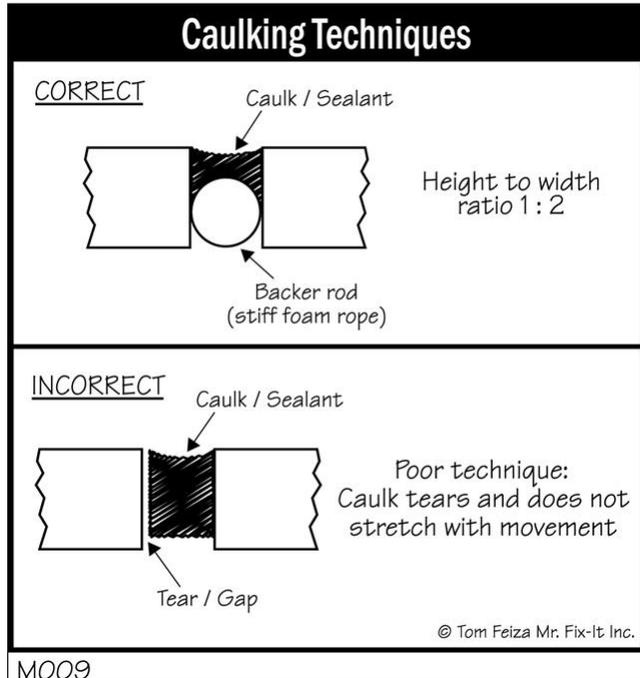
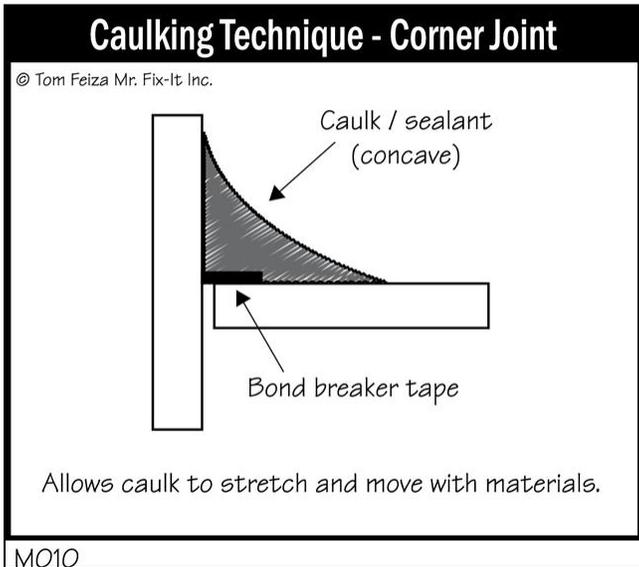
7.6 Recommend a quality caulk that is expandable and moisture resistant along the top of the threshold of the shower so moisture or water cannot penetrate between the drywall and the shower enclosure at all the bathrooms. [Choosing the right caulk](#)

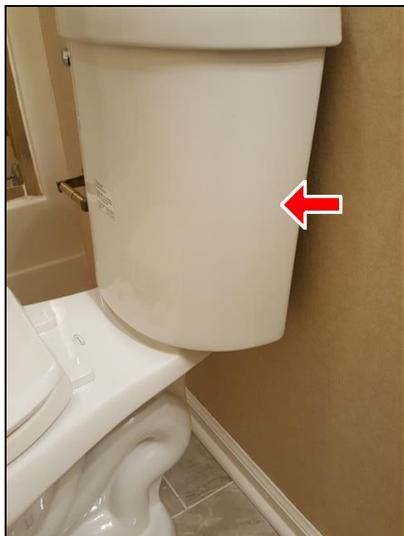
7.7 Item 1(Picture)

7.7 The toilet tank is loose in the 2nd bathroom. Recommend tightening the the toilet tank to the bowl to prevent a possible leak from occurring.

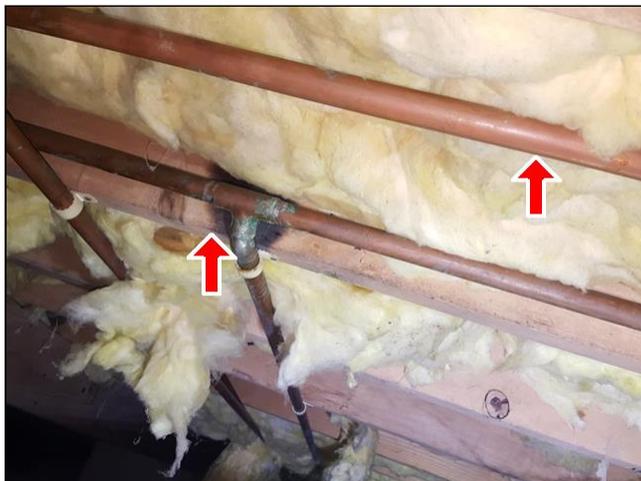
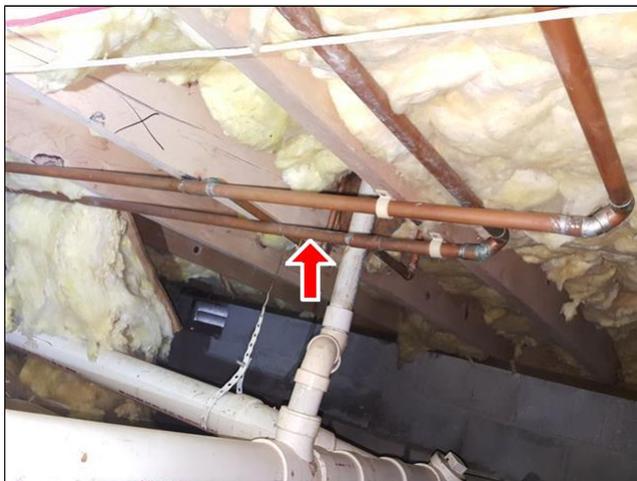
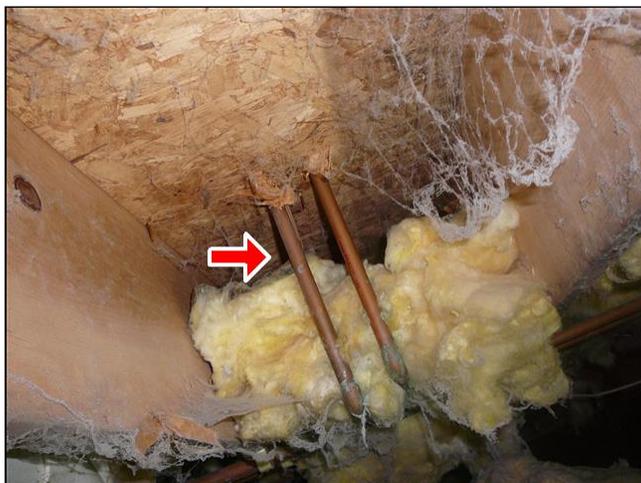
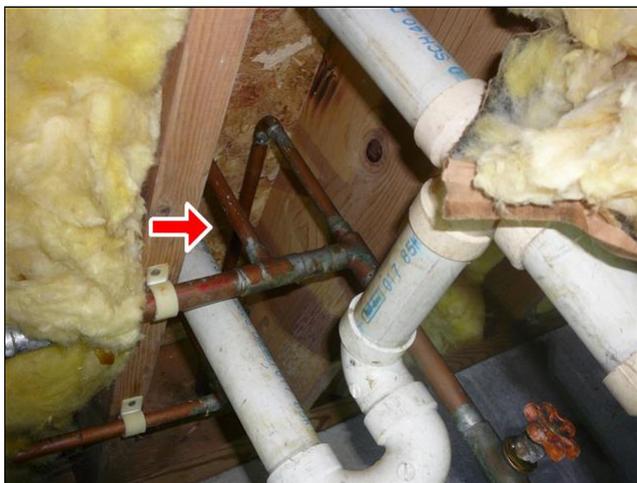
8.1 (2) Recommend insulating the water supply pipes underneath in the crawlspace (hot and cold) to ensure pipes do not freeze in winter which may cause a serious plumbing leak in the crawlspace, and to prevent heat loss of water when hot water is flowing into home. This will improve efficiency. This is for your information.

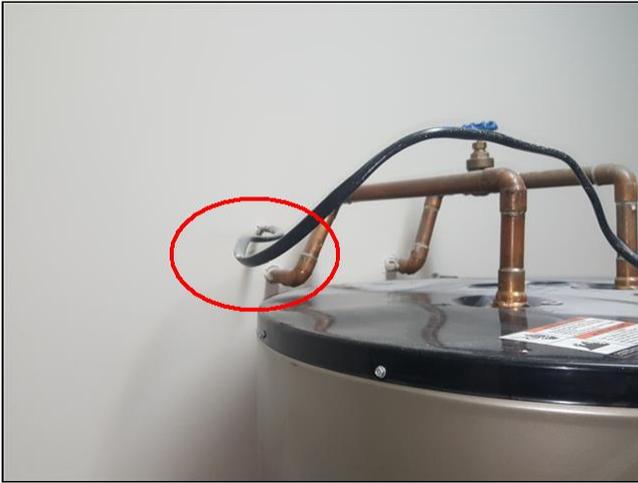
8.2 Item 1(Picture)

8.2 (3) There is no direct electrical disconnect for the water heater. The unit can only be turned off at the breaker in the panel box. Recommend one be installed when the water heater is replaced to provide ease of turning off the unit. This is for your information.

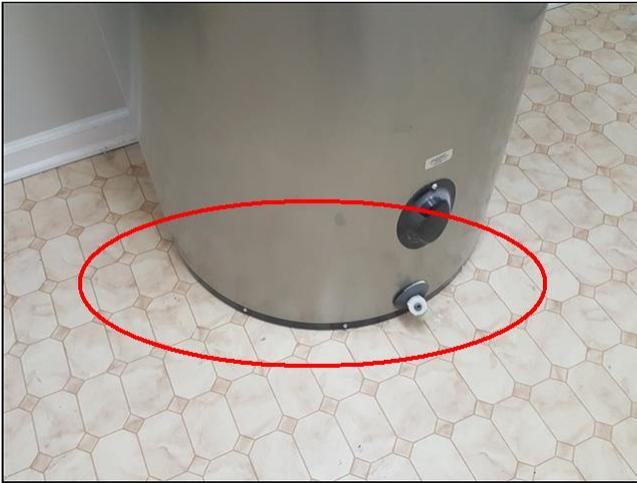
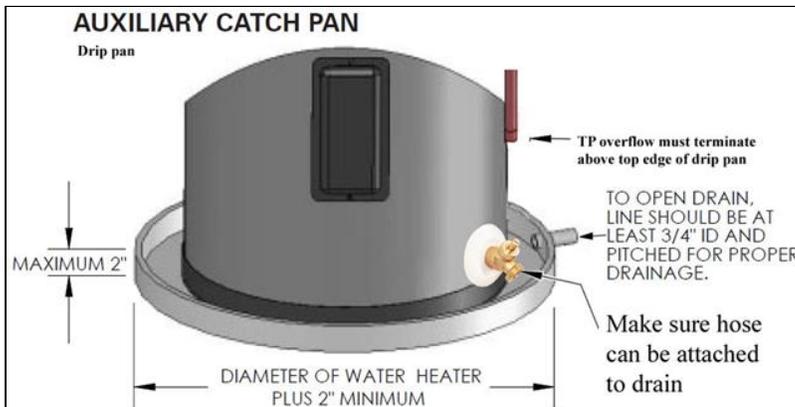
8.2 (4) The water heater on a finished floor has the potential to cause severe damage if a leak should develop. Consider installing a drain pan under the water heater to prevent damage to the home if a leak develops. This will allow any water leaks to safely drain without damaging the finished materials, floor or furnishings. A qualified plumber could examine and install the drain pan and drain line, but may need to install a drain line with a trap to the current drainage system. As an inexpensive safe-guard a drain pan with a moisture alarm can easily be installed as another option. Recommend a qualified plumber make the necessary corrections if desired.

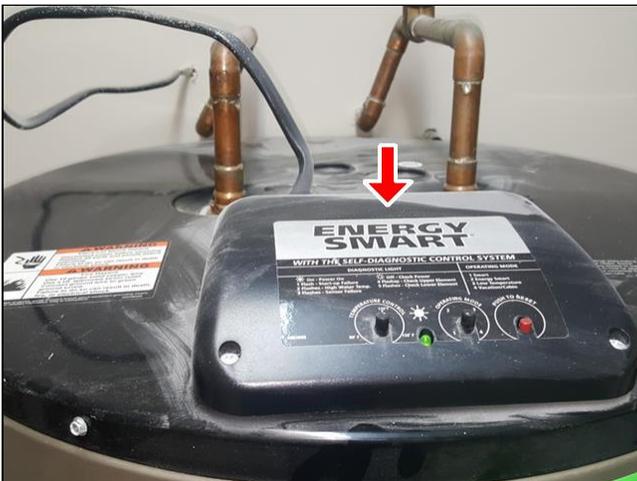
8.2 Item 4(Picture)

8.2 (5) The demand conservation switch (energy saver device) has been connected to the water heater. [What is a Demand Conservation switch?](#)

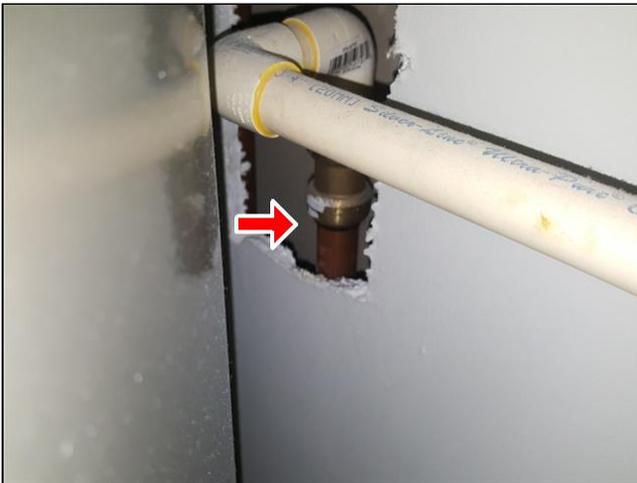
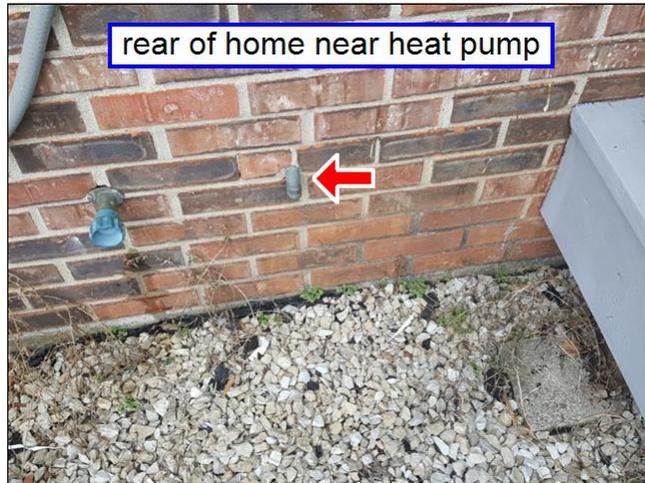
8.3 Location of the TPR (temperature pressure relief) drain line to exterior. (see picture)

Recommend installing a tray under the TP Drain line to prevent water entering the crawlspace and to prevent soil erosion.

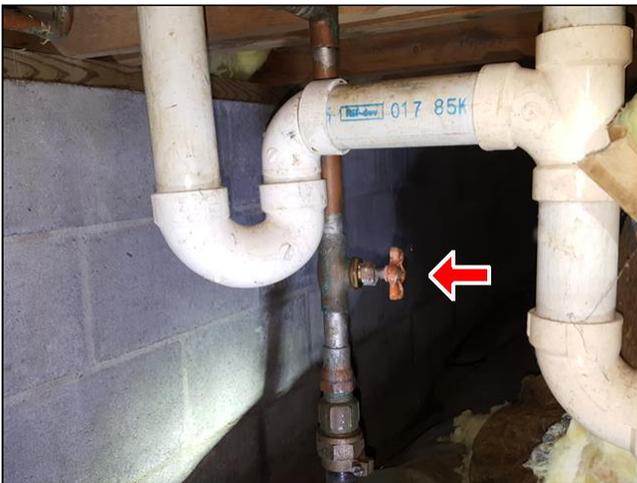
8.4 Item 1(Picture)

8.4 (1) The main water shut off is the orange knob located underneath in the crawlspace near the front wall under the 3rd bedroom area. This is for your information.

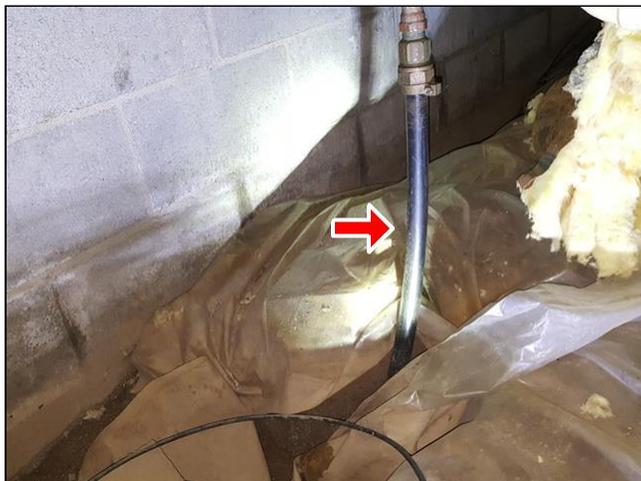
8.4 Item 2(Picture)

8.4 (2) Recommend insulating the main water supply line pipe in the crawlspace due to the pipe is located in an unconditioned area. This will ensure that the pipe does not freeze in winter which may cause a serious plumbing leak and prevent costly damage to the home. This is for your information.

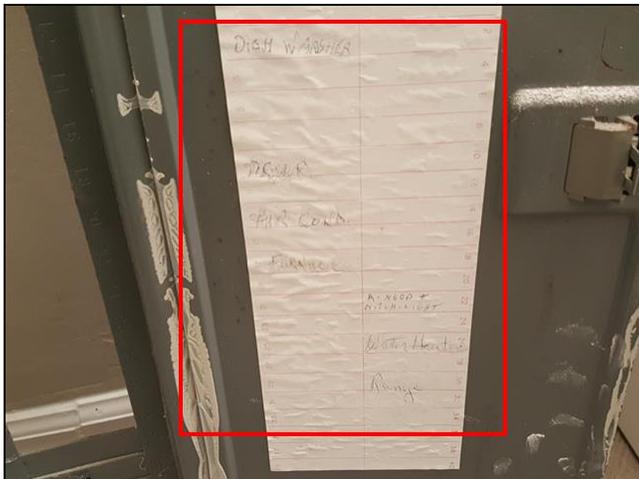
9.2 Item 1(Picture)

9.2 (1) Some of the circuit breakers are not labelled at the main panel cover in the master bathroom. This is a safety issue. Could not check if breakers may be overloaded with appliances in the home. (example: Heating and air conditioning cannot be on the same circuit breaker even though they are used at different times of the year). The electrical panel should be indexed, identifying each circuit breaker. This will allow for quick de-energizing of a circuit under emergency situations. Recommend the panel be fully labelled to facilitate turning off breakers to circuits. A licensed electrician is recommended to correct as needed.

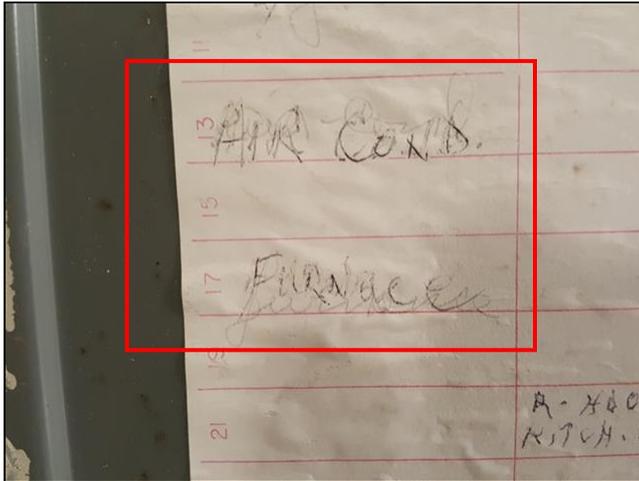
9.2 Item 2(Picture)

9.2 (2) The circuit breakers are not correctly labelled on the cover of the main electrical panel in the master bathroom. This is a safety issue. The panel indicates that the 100 amp breaker is for the furnace. The electrical panel should be indexed correctly, identifying each circuit breaker. This will allow for quick de-energizing of a circuit under emergency situations. Recommend the panel be correctly labelled to facilitate turning off breakers to circuits prior to moving in. A licensed electrician is recommended for this correction for safety.

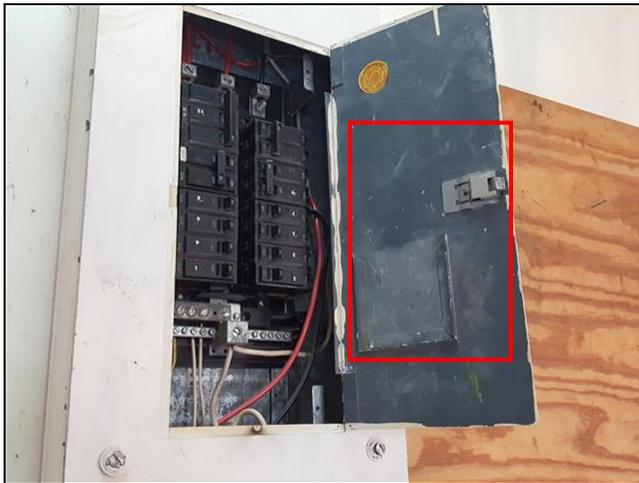
9.2 Item 4(Picture)

9.2 (3) The circuit breakers are not labelled on the cover of the electrical sub panel in the garage. This is a safety issue. The electrical panel should be indexed, identifying each circuit breaker. This will allow for quick de-energizing of a circuit under emergency situations. Recommend the panel be fully labelled to facilitate turning off breakers to circuits prior to moving in. A licensed electrician is recommended for this correction for safety.

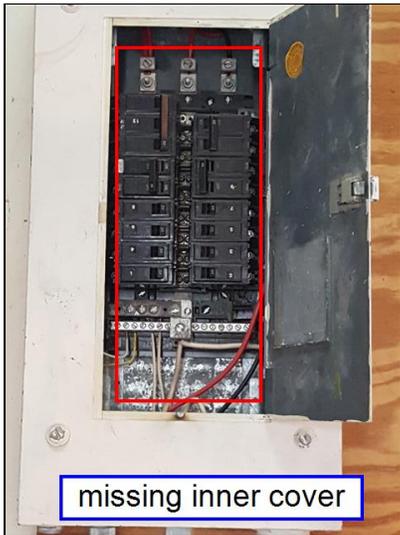
9.2 Item 5(Picture)

9.2 (4) The sub panel box inside cover is missing. This is exposing the wiring connected to the breakers inside the box. This is dangerous and is a safety hazard. The openings can allow someone to place an object inside which can cause a short or electrocution of a person which would result in a death. Recommend correction and replacement by a qualified licensed electrician as needed for occupant safety prior to closing and moving in.

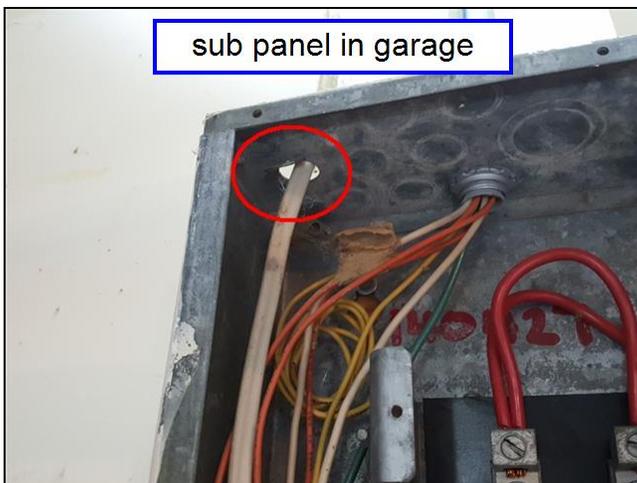
9.2 Item 6(Picture)

9.2 (5) Cable clamps (sometimes referred to as bushings or grommets) are required where wiring passes into the electrical panel box. Cable clamps serve to protect the wiring from the metal edges of the panel box to prevent a short from occurring or from the panel box becoming energized which can result in a death via electric shock. Also, if a water leak was to occur above the ceiling, water can enter the panel box which could cause a short or fire. This is a safety issue. Recommend a qualified licensed electrician repair as needed at the sub panel in the garage prior to closing.

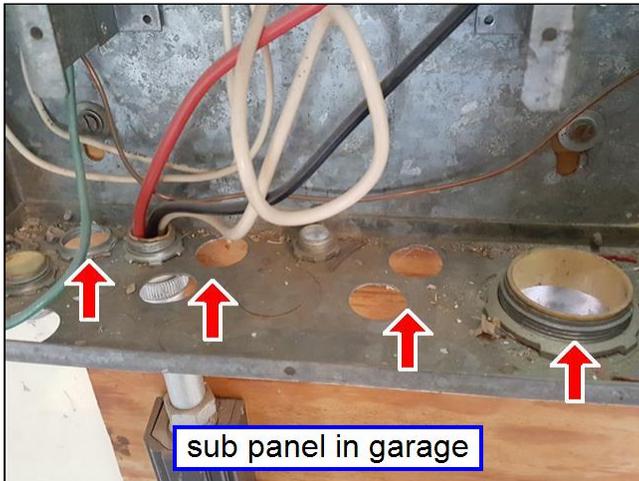
9.2 Item 7(Picture)

9.2 (6) Openings in the panel box which are for wires to enter that are not in use should be sealed to prevent moisture or rodents entering the sub panel box in the garage. These openings are considered hazardous. Recommend a licensed electrician correct as needed.

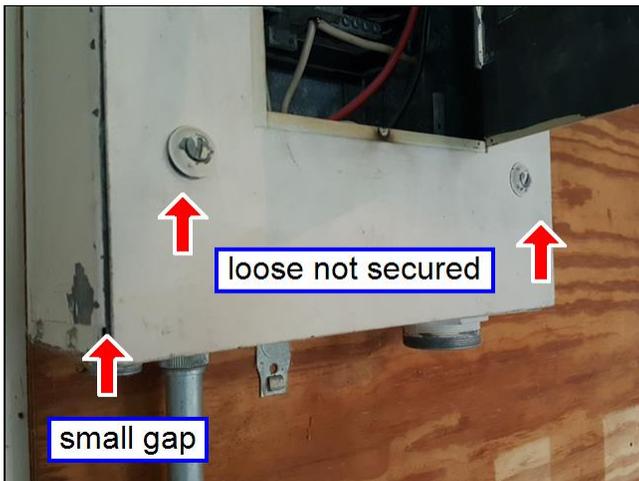
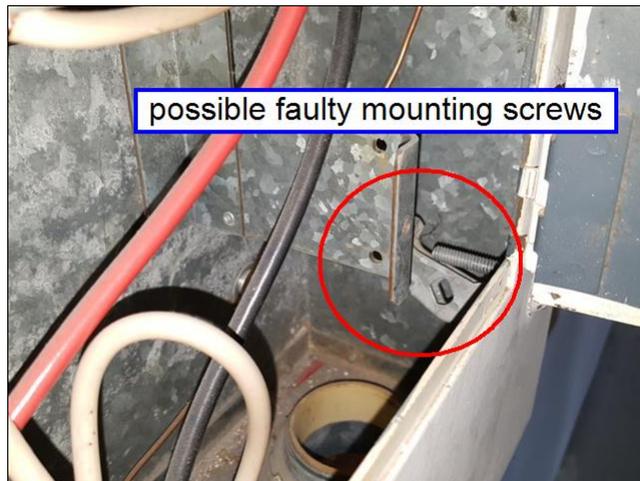
9.2 (7) The bottom of the panel cover is loose and not secured in the garage. This is a safety issue. The cover can be tilted allowing a person or child to place an object inside which would result in a death via an electric shock. Also moisture could enter due to the cover is not secured. This is a serious safety issue. Recommend a qualified electrician repair as needed.

Note the mounting screws at the bottom maybe faulty and need replacing.

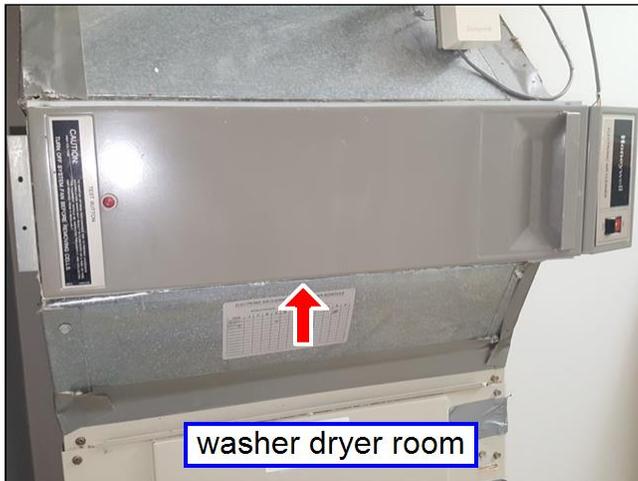
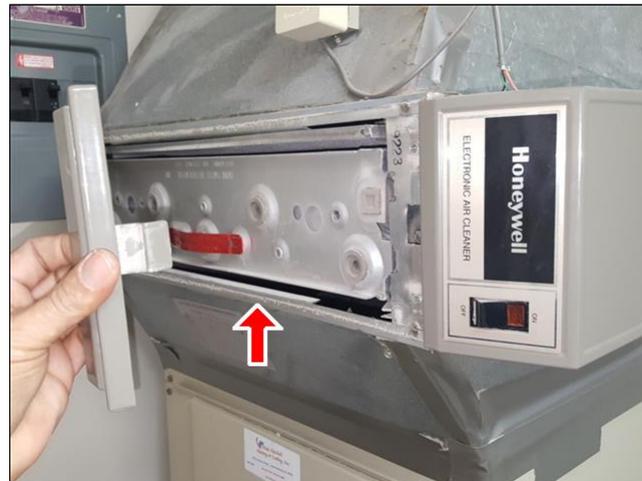
10.1 (1) Filter location (see photo). The arrow on the filter should always point towards the blower.

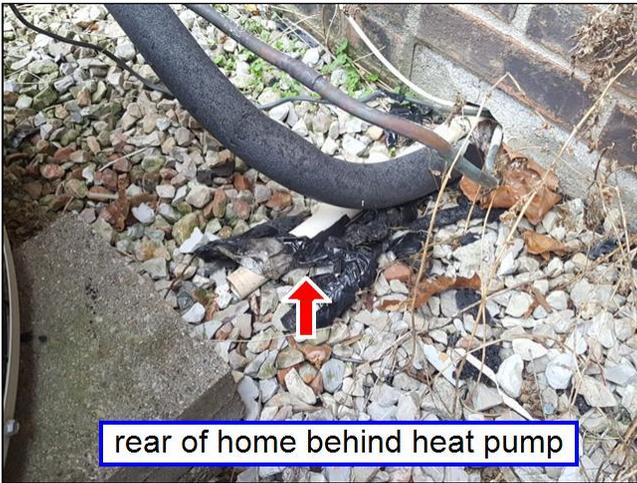
10.3 Item 1(Picture)

10.3 (1) Location of the condensate drain line to exterior. (see photo)

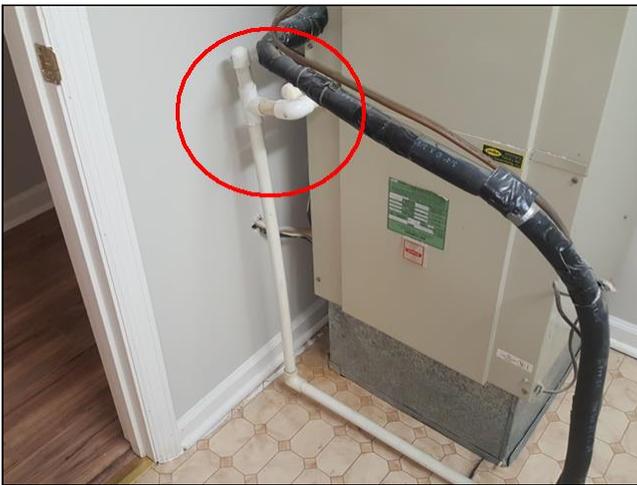
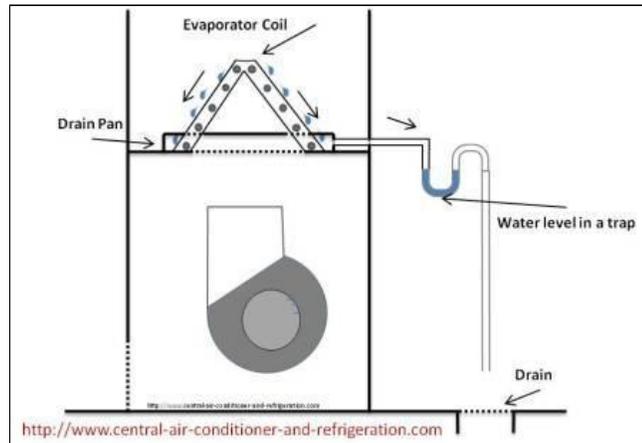
10.3 (2) There was no visible condensation trap installed at the condensate drain line for the Air Handler in the home. It is recommended by the manufacturer to have one. The purpose of the trap is to allow the water to drain freely, with out it air flowing in the drain line can cause the water to not flow (drain to the exterior). Recommend a qualified HVAC contractor correct as needed.

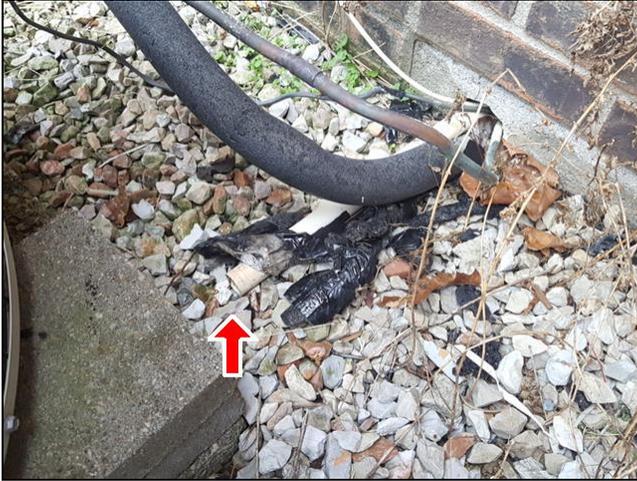
10.3 Item 5(Picture)

10.3 (3) Recommend the discharge for the condensate drain line be improved via installing a splash block and extending the drain line at the rear of the home. This will prevent water pooling near the foundation which could cause settlement of the foundation wall, soil erosion and water leakage into the crawlspace. Also to prevent possible settling of the platform for the Heat Pump. A qualified HVAC contractor is recommended for these repairs.

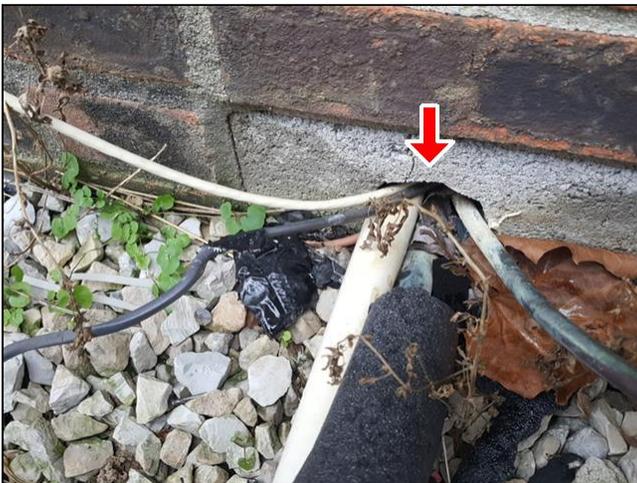
10.3 Item 6(Picture)

10.3 (4) The hole in the wall at the rear of the home which allows the Heat Pump lines to be connected to the Air Handler in the home is not sealed. Openings should be sealed to prevent entry of insects and weather into the wall cavity and into the crawlspace. Also to prevent deterioration of the foundation wall. Recommend sealing with cement or an appropriate filler.

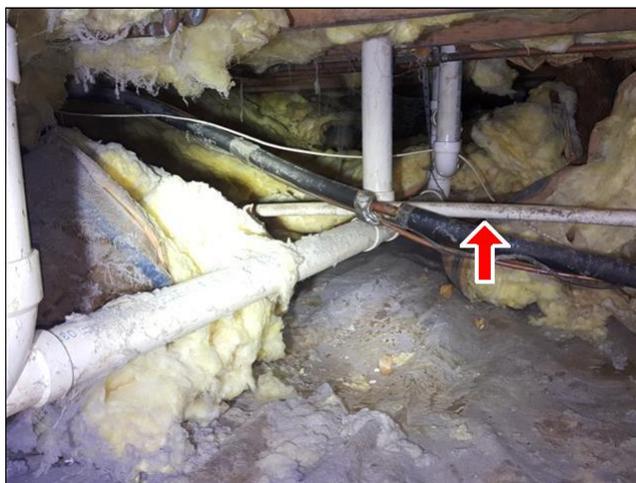
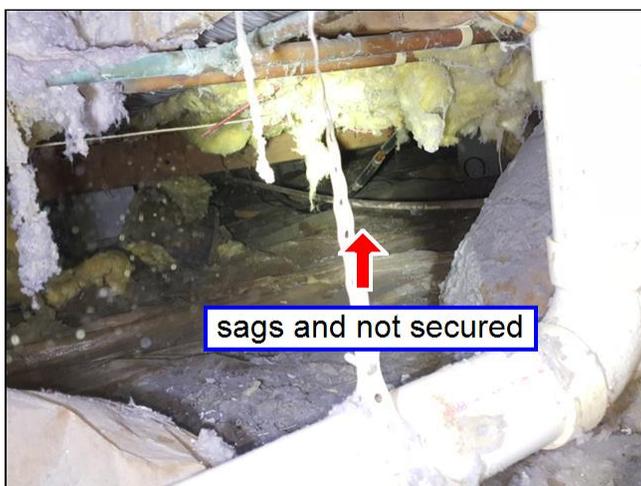
10.3 (5) The condensate drain line is not supported and sags leading to the exterior in the crawlspace. It also has an improper pitch for ease of draining. Poor drainage can lead to leakage or damage to the unit. Recommend a qualified contractor or HVAC contractor correct as needed.

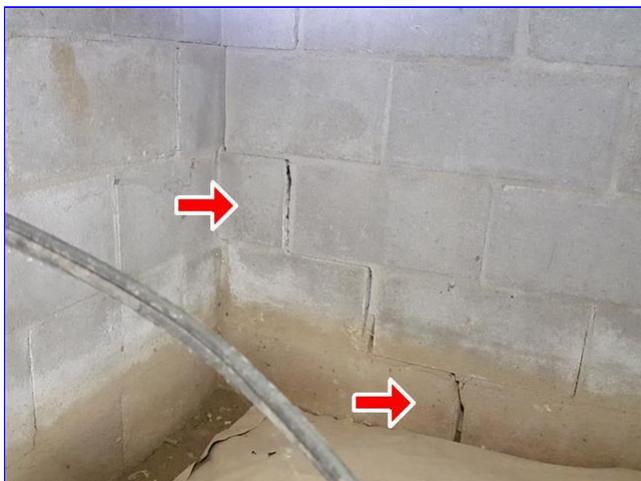
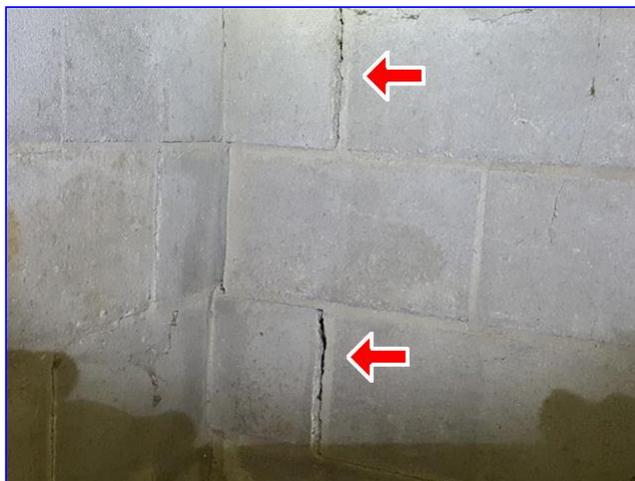
The stair step crack at the foundation wall on the front right corner of the home in the crawlspace was noted and is large enough for concern. Some degree of settlement has occurred. The size of the crack shown is 1/8 in width and is has bulged. This is cause for concern. The wall(s) may need reinforcement. Cannot tell if this movement is ongoing. While the rate of movement cannot be predicted during a one-time inspection it is likely that repairs maybe needed. Recommend a Foundation contractor be consulted to further evaluate this condition and the remedies available for correction prior to closing. These cracks need to be sealed to prevent further cracking due to freeze/ thaw (water entering) and possible further deterioration via water intrusion in the crawlspace.
