TALON
Home Inspections

Inspection Report

Property Address:
2001 Crimea Street
Lawrenceburg KY 40324

Date: 12/17/2017	Time: 10:00 AM till 03:00 PM	Report ID: 171217PETERS
Property: 2001 Crimea Street Lawrenceburg KY 40324	Customer: Mr. Trevor Peters	Real Estate Professional:

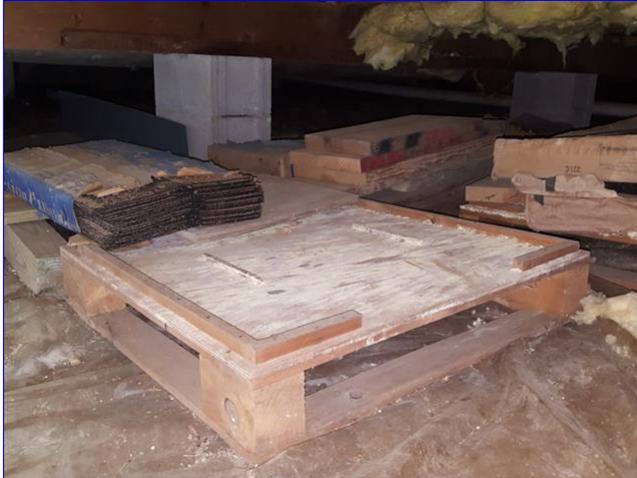
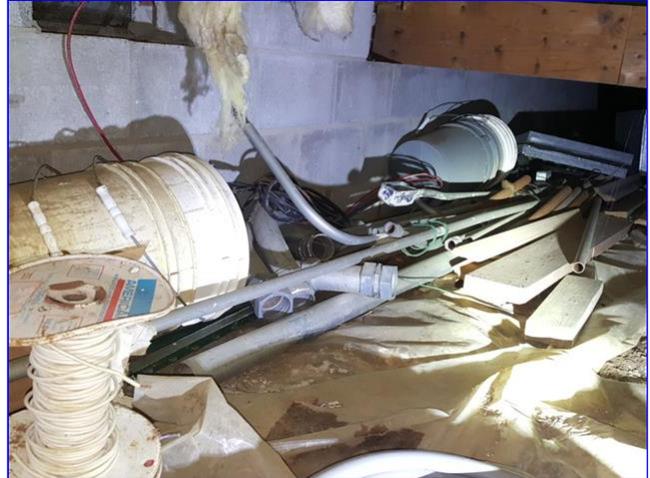
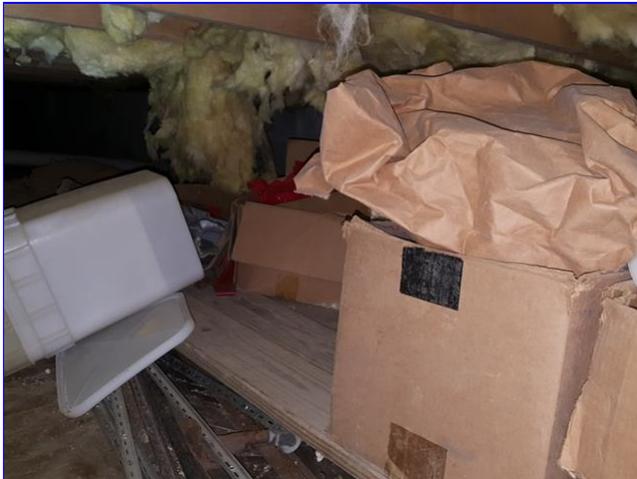
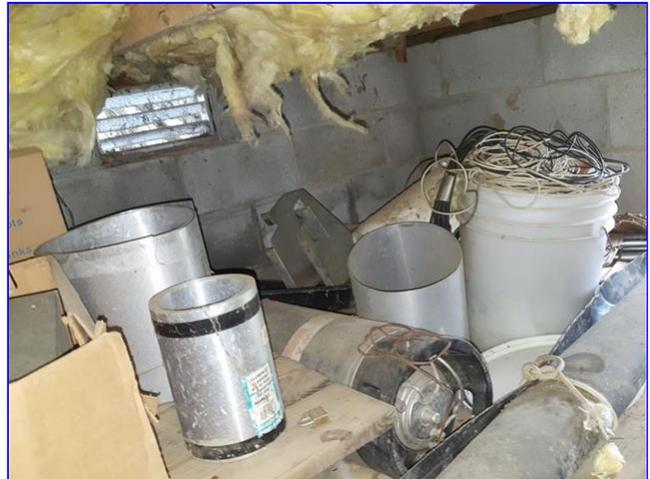
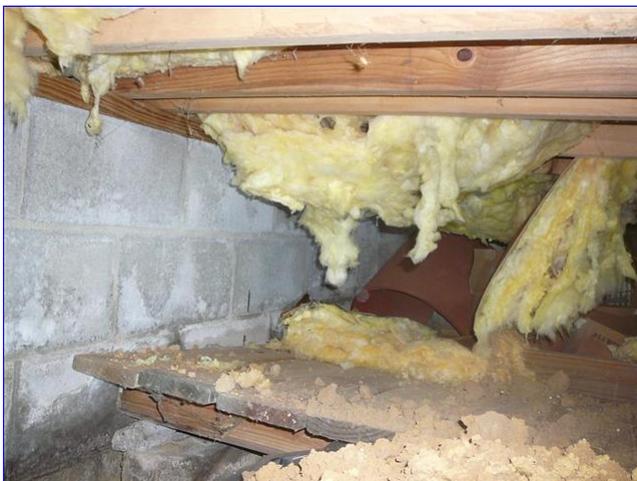
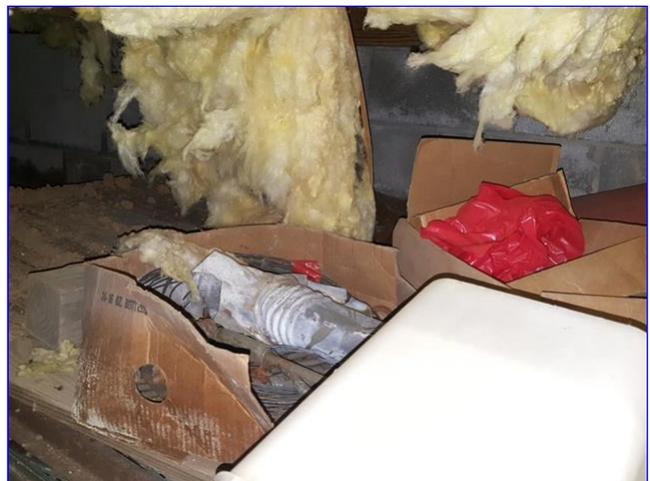
(1) All wood, insulation, unused building materials and junk should be removed from the crawlspace floor. The insulation will hold moisture creating condensation and possible mold growth on the wooden structure in the crawlspace. Wood debris risks rotting and can attract wood eating insects into the crawlspace which can lead to more costly repairs later. Recommend all types of debris resting on the crawlspace floor be removed to prevent damage to the wood/floor structure of the home.

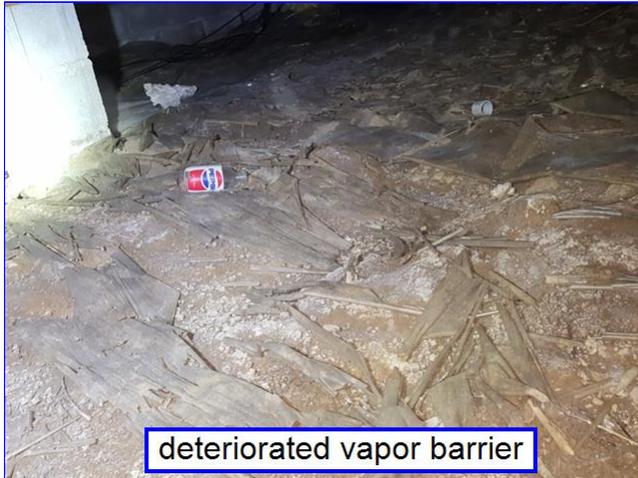
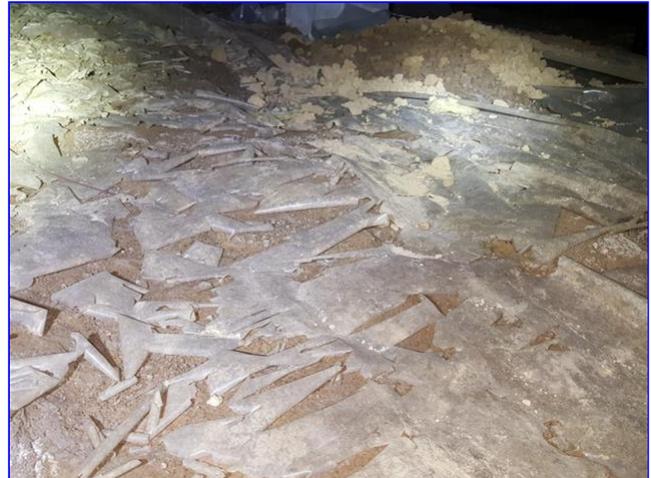
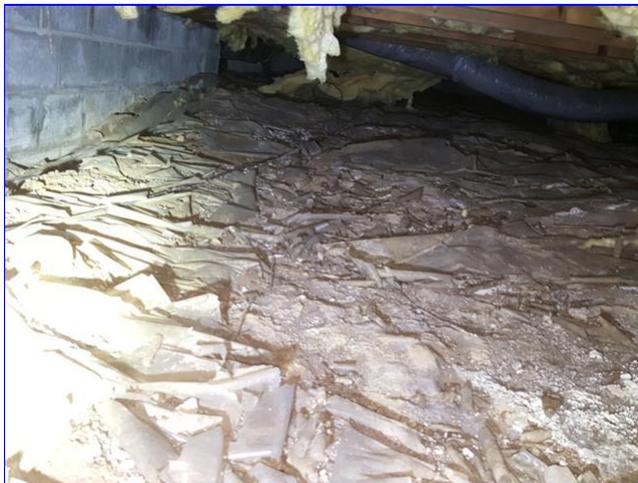
(2) The vapor barrier (plastic) on the crawlspace ground is deteriorated in various areas and is less than 9 mill thick. A vapor barrier provides added protection to the floor system from moisture or dampness that can enter from the ground. If this is not corrected wood rot, condensation and/or mold could develop in the crawlspace. Recommend a qualified contractor replace as needed prior to moving in.

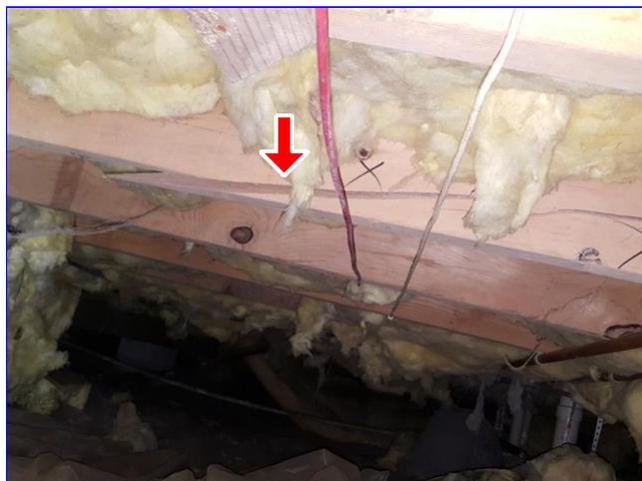
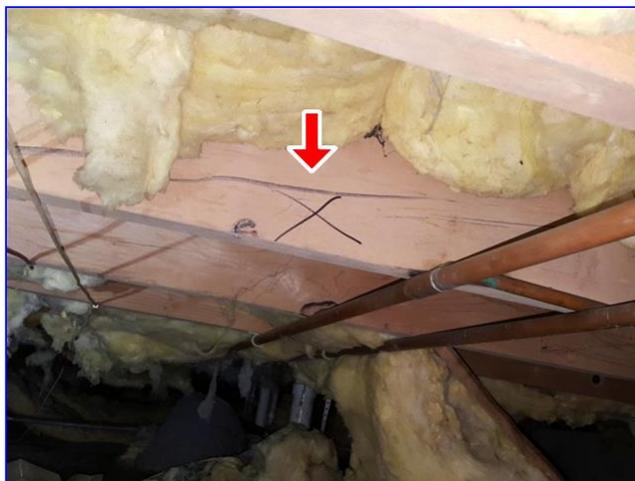
(1) One floor joist is severely split or cracked in the crawlspace under the master bathroom area. There may be more but due to the access and conditions in the crawlspace others may have been unnoticed at the time of inspection. Repairs are needed. Cracked joists are repaired by replacement , "sister" joists installed along side or additional support. Recommend a qualified licensed building contractor repair as needed and further access the floor structure under the living room and kitchen area once access is granted.

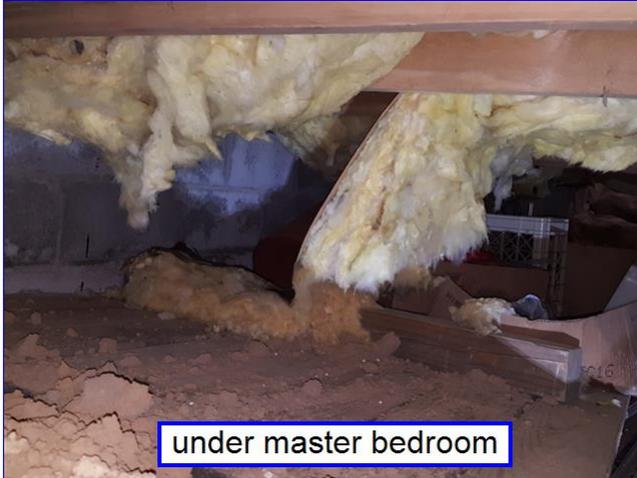
1.5 Item 1(Picture)

(1) The insulation is loose/fallen and is hanging loose in the crawlspace in various areas. Heat loss can occur more on this home than one that is properly insulated. Insulation that has fallen to the ground or has become damp from the ground or from condensation usually needs to be replaced with new insulation. Recommend repair or replacement as needed by a general contractor.

under master bedroom

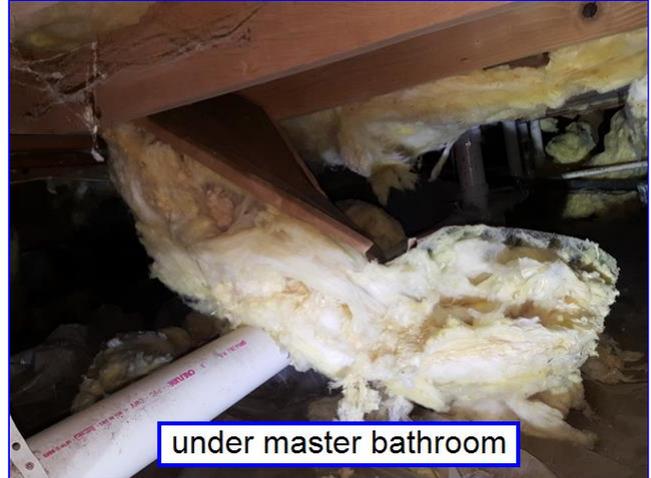
1.5 Item 2(Picture)

under master bathroom

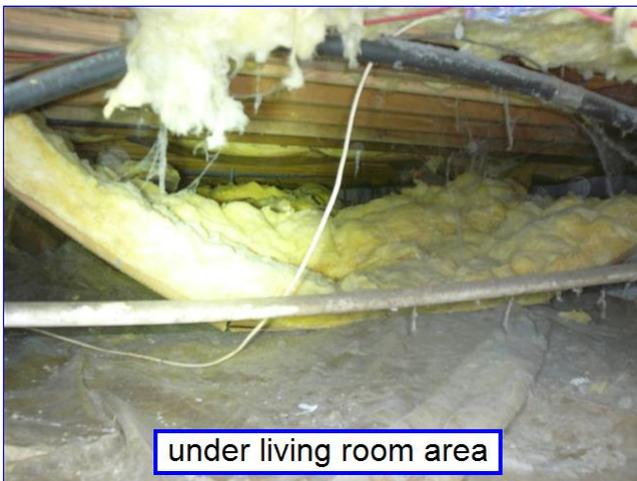
1.5 Item 4(Picture)

under living room area

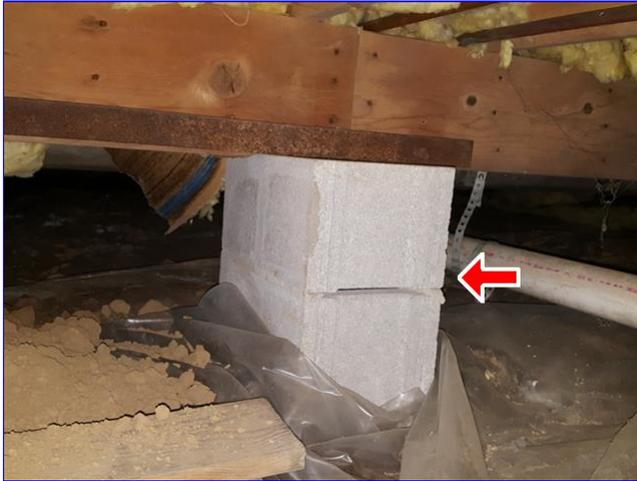
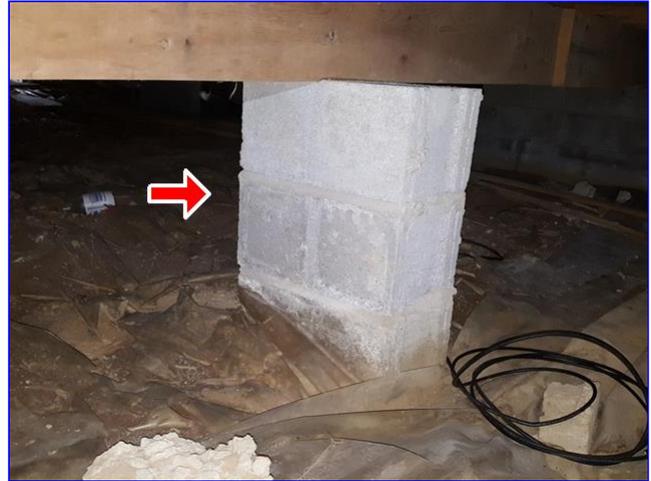
piers in question are 8x8x16 single pile piers. The floor is an integral part of the foundation system. Because of the various repairs to joists, additional steel screw posts installed in the crawl and issues found with exterior brick walls and foundation walls it is recommended prior to closing to have a structural engineer further evaluate to determine if corrections are needed.

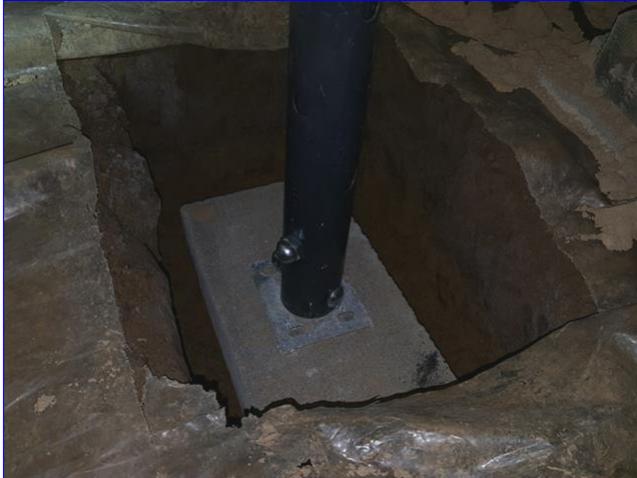
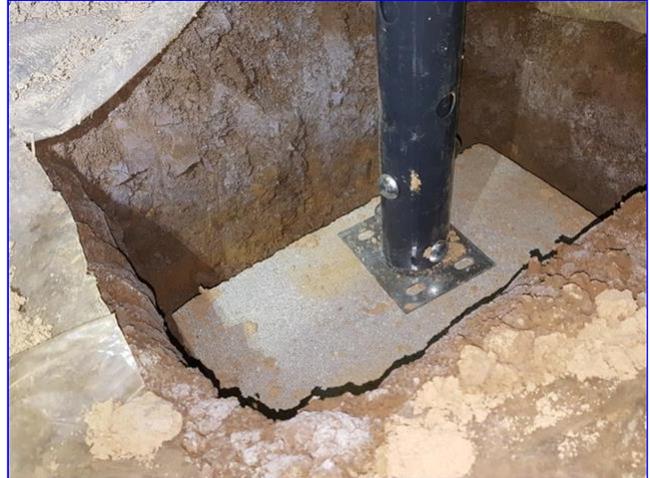
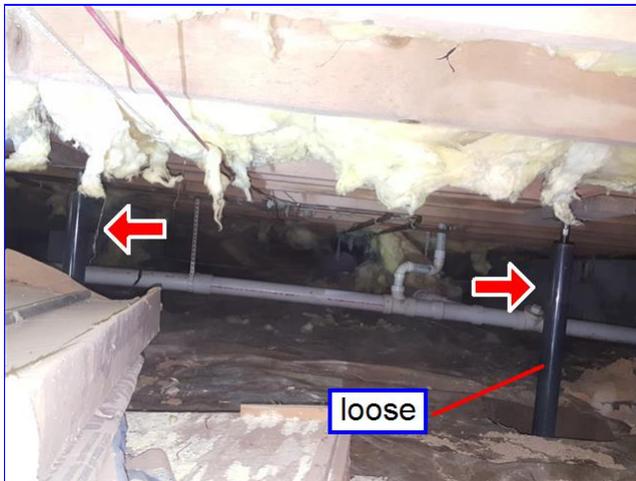
(2) Support posts are usually set on 3'x3'x12' thick footer pads. The posts are set on masonry blocks resting on the ground in the crawlspace under the master bathroom area. One of the posts is loose. When support posts are missing footers, they can settle which can result in settlement and possible failure of the floor structure over time. These posts are directly under the master bathroom area. Strongly recommend a qualified building contractor and/or a structural engineer further evaluate and repair/correct as needed. **Also refer to note 6.1.**

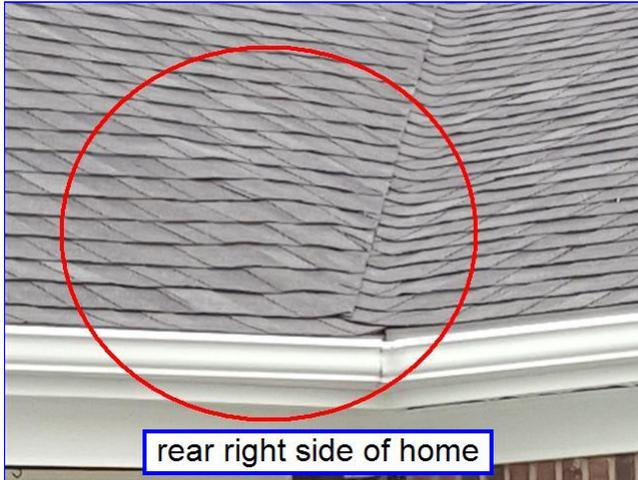
2.0 Item 1(Picture)

(1) The roof covering shows a mump-like appearance in some areas around the home, see photos for location. These small little bumps might be caused by hot weather, in which some air beneath the cover layer has become hot and has expanded, or due to poor installation. These areas will eventually or may blister creating a water leak and the roof area will need replacing. Recommend a qualified roofing contractor further investigate and repair as needed as these bumps may cause ruptures, and cause leakage later on.

rear right side of home

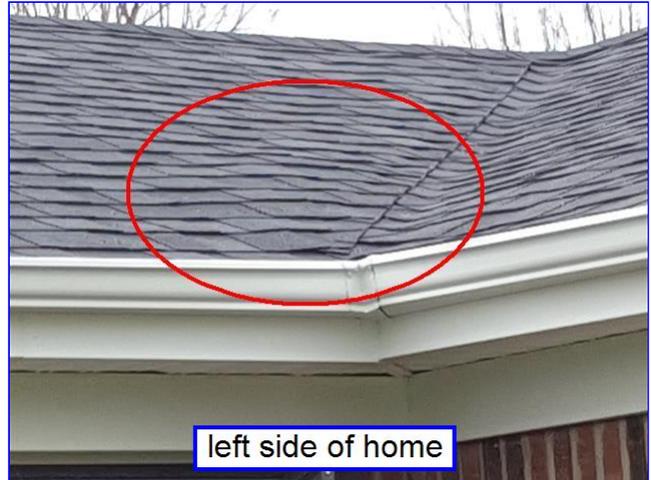
2.0 Item 2(Picture)

left side of home

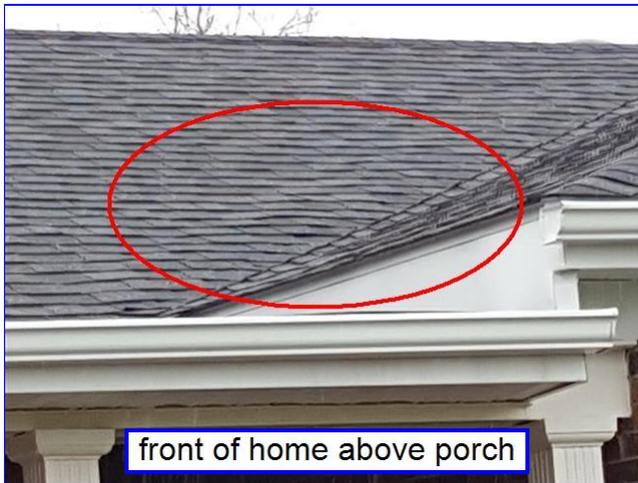
2.0 Item 3(Picture)

front of home above porch

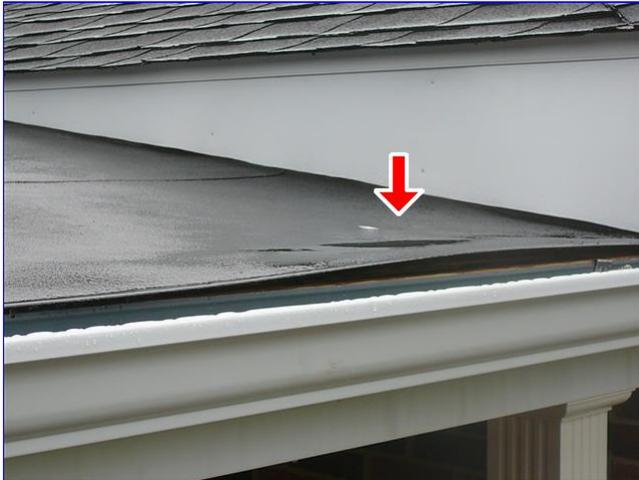
2.1 Item 1(Picture)

The flat roof roof covering is lifting at the front of the home above the covered porch right side. Unable to determine if this area will leak. However this needs to be repaired to prevent the wood sheathing from being damaged via water intrusion and to prevent possible water pooling in this area which could result in roof leakage. Recommend qualified roofing contractor should inspect further and correct/repair as needed

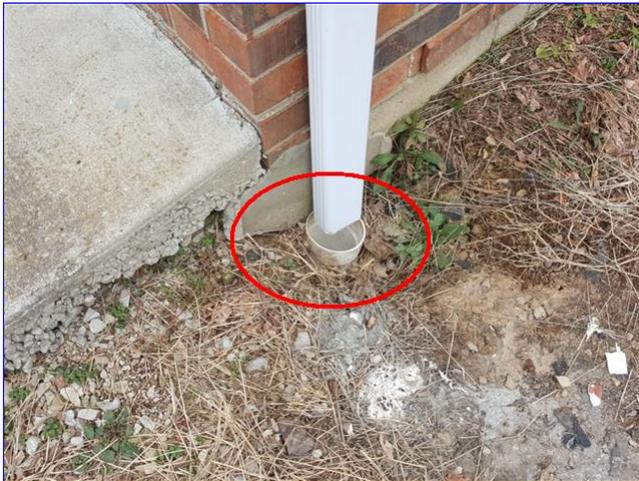
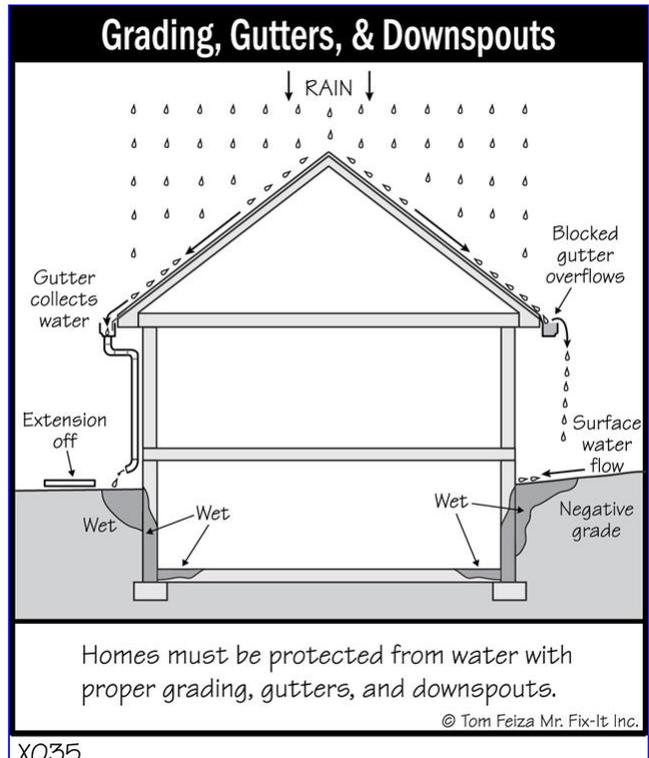
(1) The Down spout is dislodged at the joint leading into the extension at the front right corner of the garage. This allows water spilling and not being drained correctly at the downspout extension. This will cause soil erosion and possible settlement of the foundation wall or leakage under the slab. Recommend a general contractor repair or replace as needed.

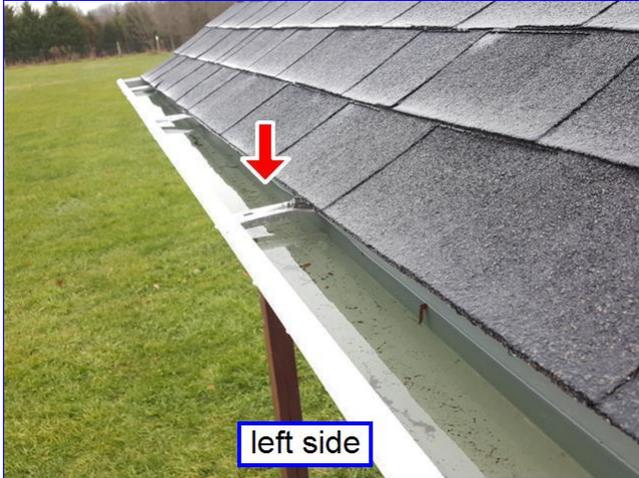
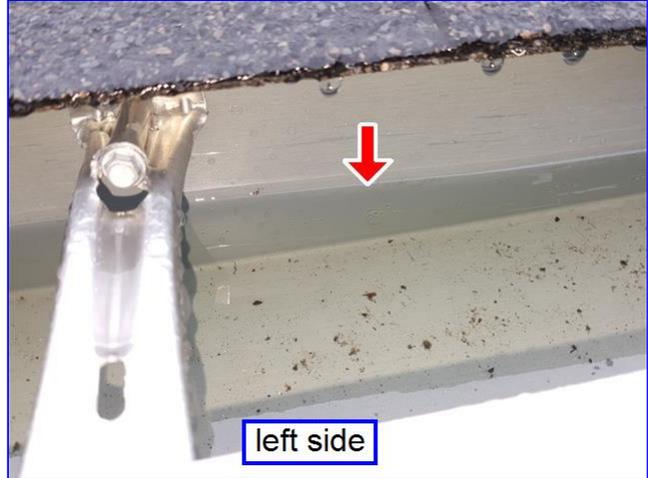
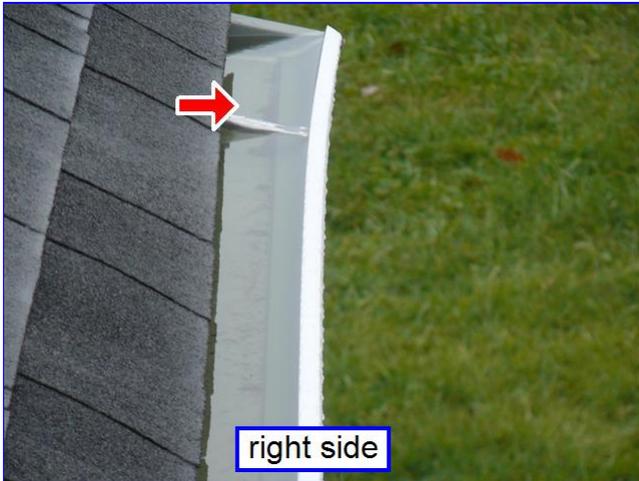
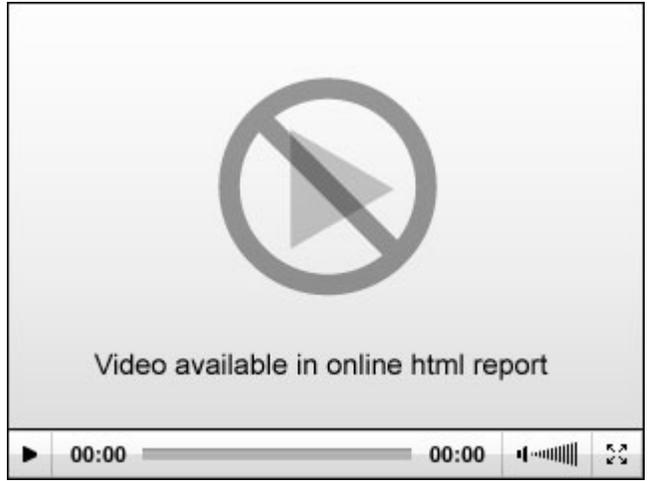
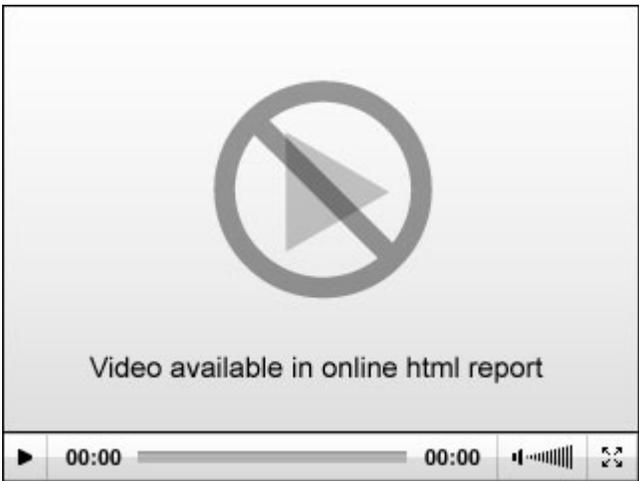
(4) The gutter is holding water at the rear left and the right side of the deck roof due to an incorrect slope towards the downspout. Gutters that drain poorly can lead to many costly problems such as deterioration of the fascia, soffit or roof edge. It can also cause gutters to pull loose and lead to possible water intrusion. Recommend the slope be adjusted by a qualified person as needed prior to closing.

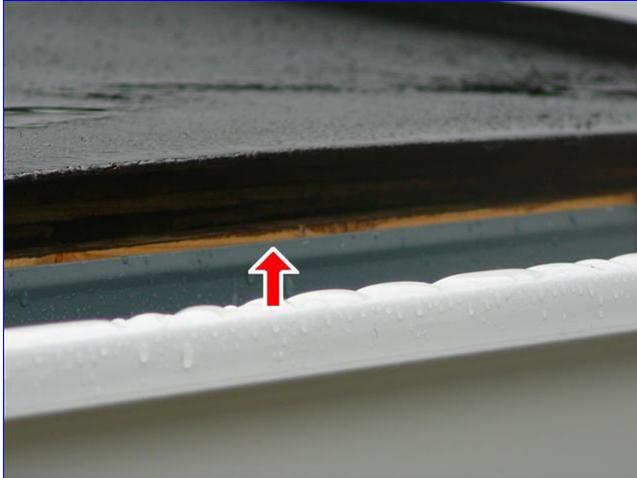
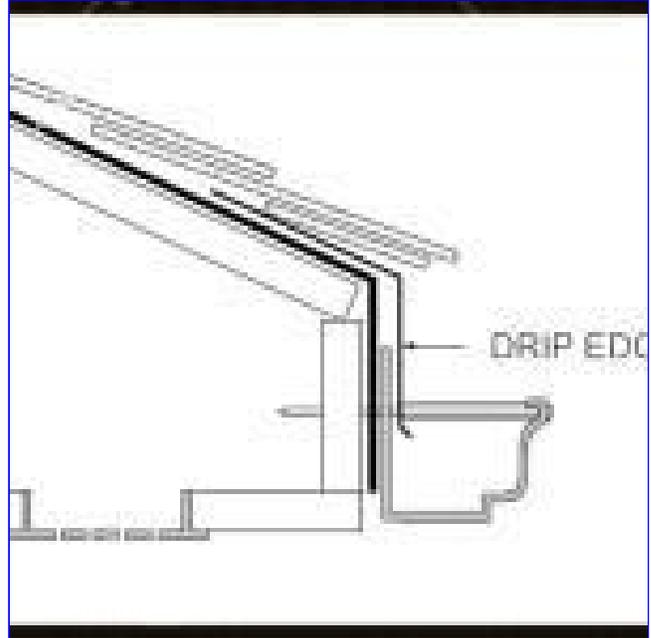
(5) The drip edge/flashing is missing at the front porch roof of the home. The drip edge/flashing protects the roof edge of the wood sheathing from water intrusion. Repairs are needed to prevent deterioration of the roof sheathing. Recommend a qualified roofing contractor repair as needed.

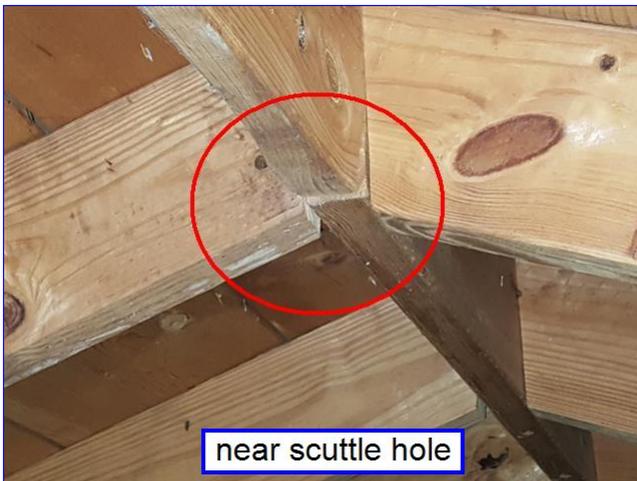
2.6 Item 1(Picture)

Recommend a vertical supports to the join in the ridge beam in the attic (garage area) to add extra support to the roof structure and to resist rafters and/or ridge beam from sagging and cracking in the future. The rafters are the primary support to the ridge beam only. Recommend a qualified framing/building contractor further evaluate and make the necessary repairs as needed.

near scuttle hole

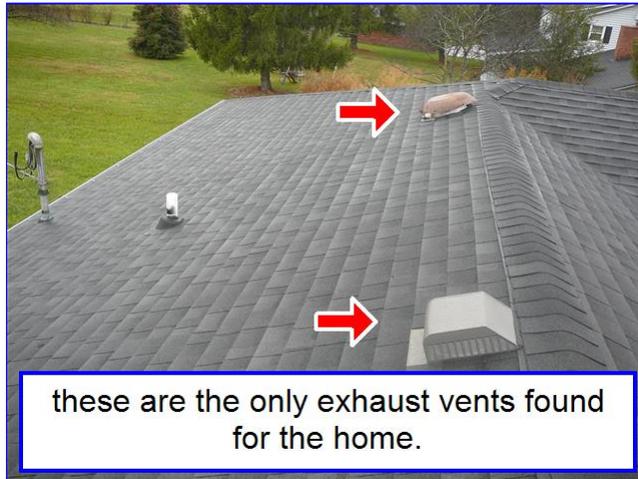
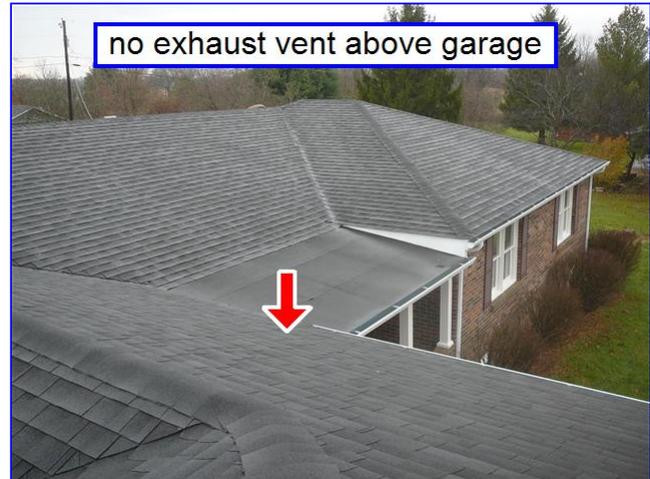
Additional ventilation was not added, when the most recent roof covering was installed. The level of ventilation is marginal and can be improved. It is generally recommended that one square foot of free vent area be provided for every one hundred and fifty square feet of ceiling area. Half of the ventilation should be at the ridge and the other half at the eaves. Proper ventilation will help to keep the house cooler during warm weather and extend the life of

roofing materials. In the winter, it will help reduce the potential for ice dams on the roof and condensation within the attic. [Here is a link explaining ventilation.](#) Recommend a qualified roofing contractor further evaluate to determine if corrections are needed now or when the next replacement of the roof coverings is expected.

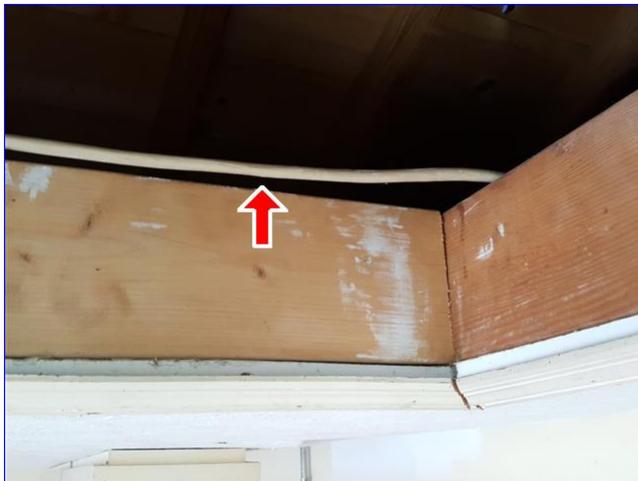
2.10 Item 1(Picture)

(1) The electrical wire above the attic access should be secured onto a rafter. This is a safety issue as when entering attic or falling from ladder someone may grab these wires and pull on them. This could result in a death via electrocution via wires being pulled from junction box. Recommend a licensed electrical contractor correct as needed.

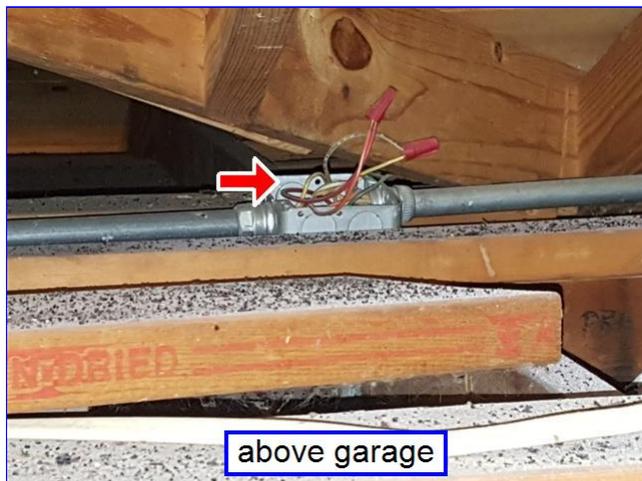
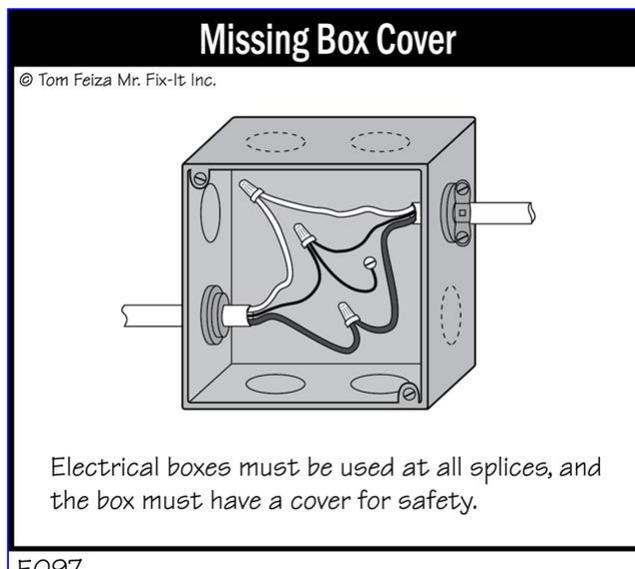
(2) All junction boxes in the attic space should have covers installed to prevent tampering, protect the wire connections, and for personal protection. This is a safety issue that needs to be corrected. If a leak was to occur it could result in a short then a fire in the home. Recommend a qualified licensed electrician correct as needed.

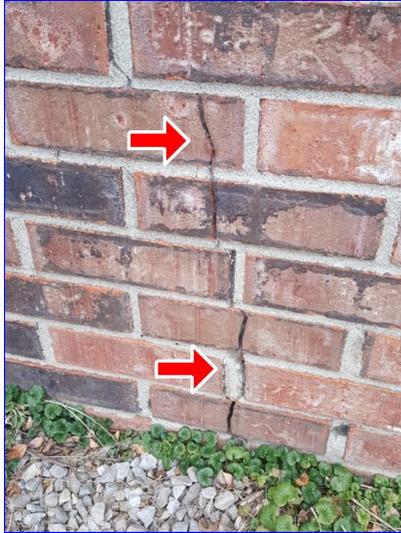
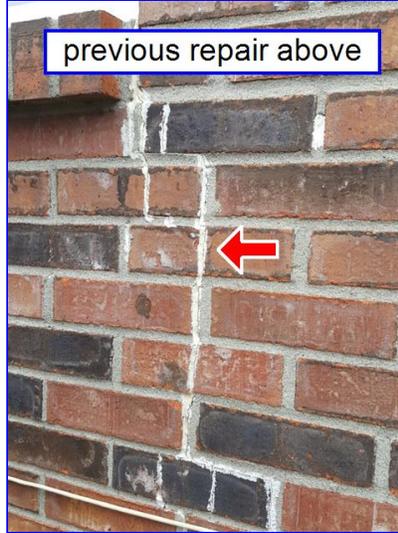
(5) The appearance of the settlement crack at the rear of the home below the master bedroom window right side is large enough for concern. Previous repairs have been performed from the outside to eliminate water intrusion. However the crack has reappeared. Some degree of settlement has and seems to be re-occurring. Cracks show sizes between 1/8 and 1/4 inch in width. This is cause for concern. Cannot tell if this movement is ongoing. While the rate of movement cannot be predicted during a one-time inspection it is likely that repairs are needed. Recommend a Structural engineer or Masonry contractor be consulted to further evaluate this condition and the remedies available for correction. These cracks need to be sealed to prevent further cracking due to freeze/thaw (water entering) and possible further deterioration of the brick work.

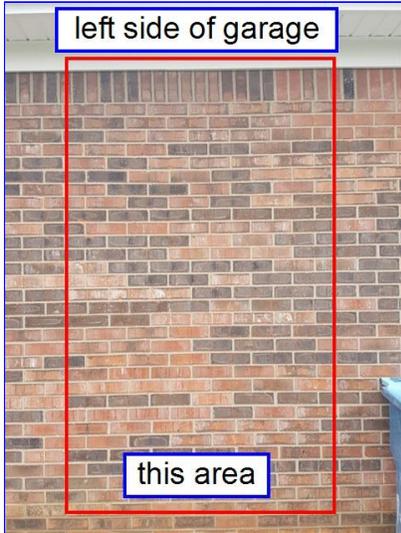
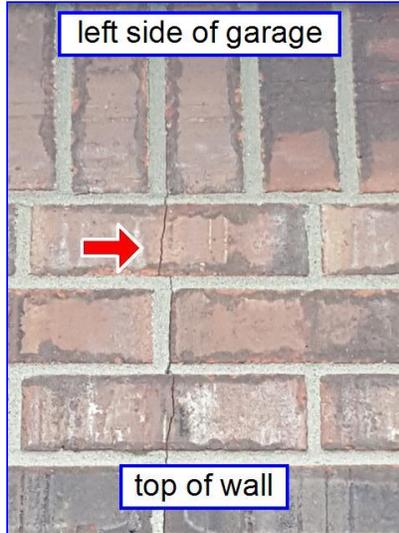
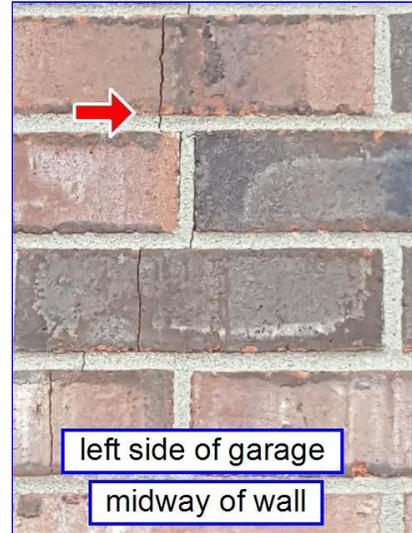
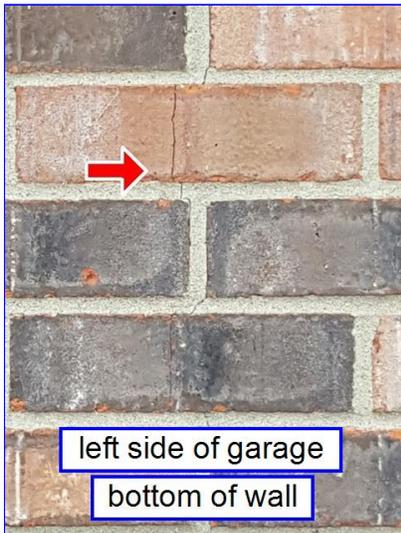
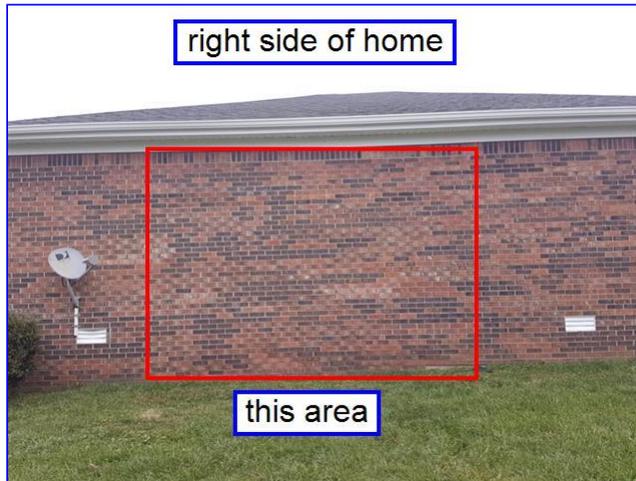
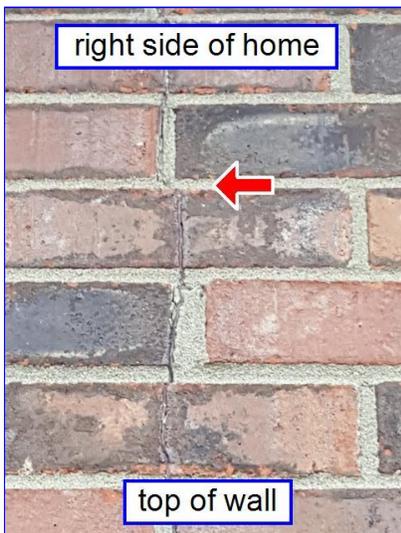
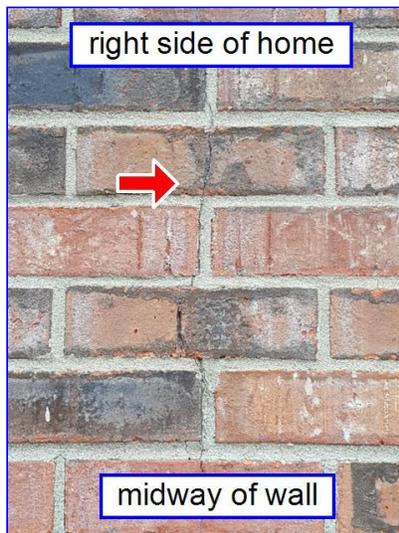
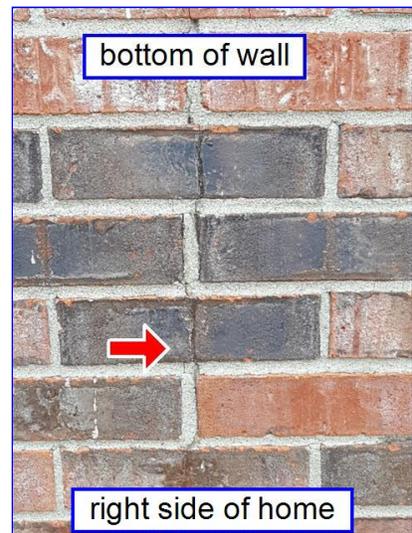
(6) The exterior brickwork has a vertical "V" shaped crack that has a large gap at the top then runs down to a smaller gap at the bottom at the right side of the home and at the left side of the garage. This implies that minor structural movement is occurring. While the rate of movement cannot be predicted during a one time inspection it is likely that additional repairs are needed and further investigation is required due to the shape of these cracks. "V" shaped cracks (wider on one end than the other), could be a signal that you have some foundation settling issues. When the foundation of your home settles in one direction, this causes the weight of the house to shift toward that settling, or sinking, area. There are numerous reasons that this could happen, but one of the signifiers is V shaped cracks appearing in your drywall or exterior brick siding. Strongly recommend a qualified foundation contractor and/or structural engineer further inspect and make the necessary repairs if needed to prevent possible further cracking of the brick wall and perhaps future settlement of the foundation. The cracks needs to be sealed to prevent water entering which can lead to further deterioration and possible damage to the wall structure.

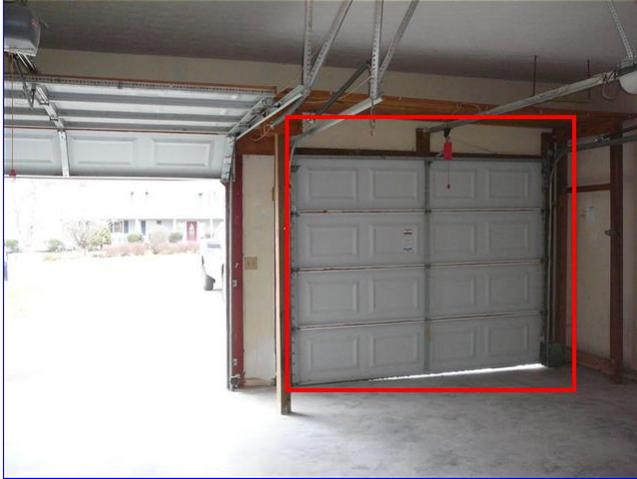
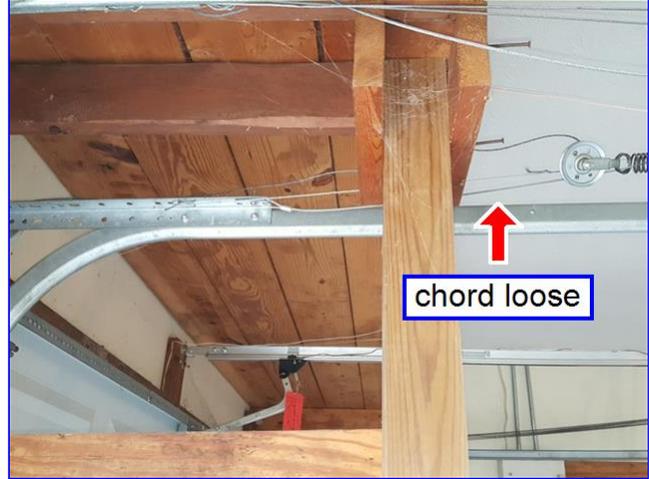
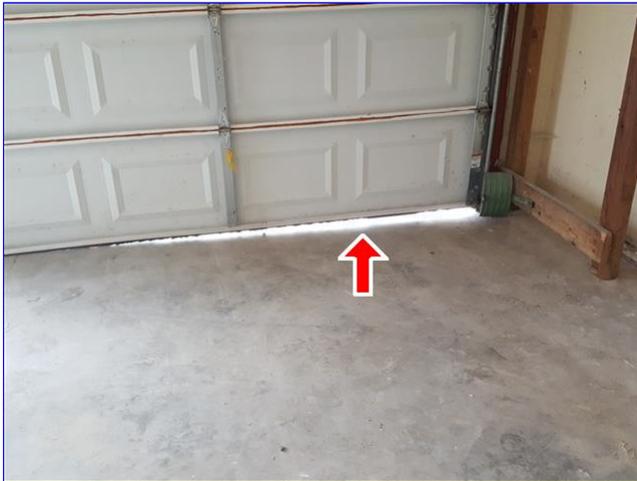
(1) The garage door, "left" door (from outside), does not open automatically and when opened manually it does not hold it's position. The garage door openers are in place but are not operational. The door also appears to be misaligned due to the weather stripping at the bottom is not sealing against the flooring. Recommend a garage installer further inspect and repair or replace as needed prior to closing.

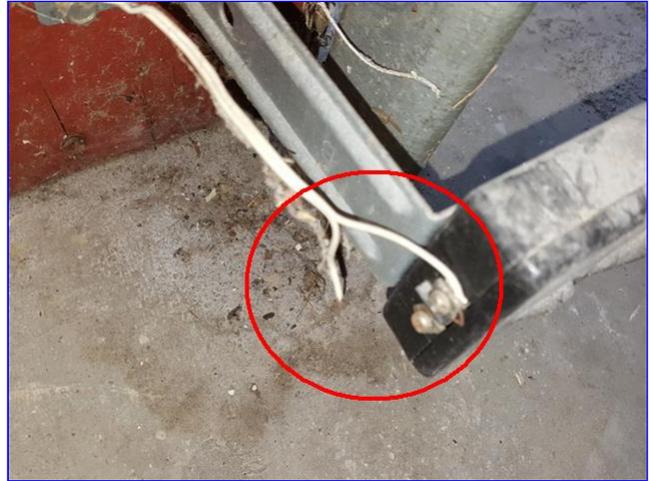
4.3 Item 5(Picture)

(4) The header block is pulling away from the wall and the bolt is not fastened correctly which may result in the garage "right" door (from outside) opener to fail. The header block should be mounted and secured to support the operation of the garage door opening and closing and to not place strain on the moving and supporting parts. Recommend a qualified garage door installer make the needed repairs and adjustments prior to moving in.

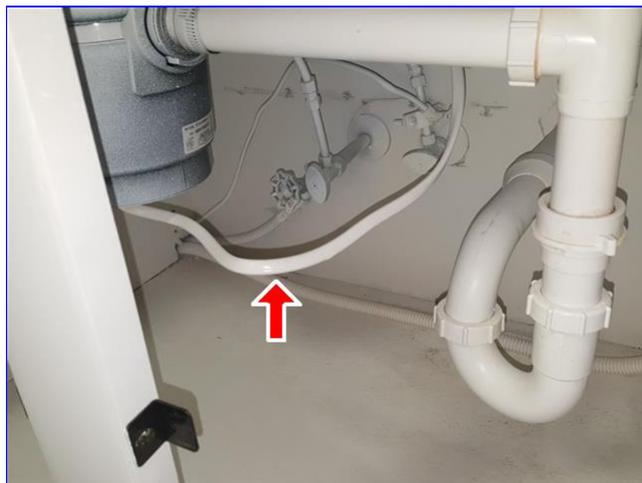
5.3 Item 2(Picture)

(2) Unprotected electrical wiring under the kitchen sink for the disposer is susceptible to being damage and should be relocated or protected by a rigid conduit. Recommend a qualified electrician repair as needed for safety of the occupants.

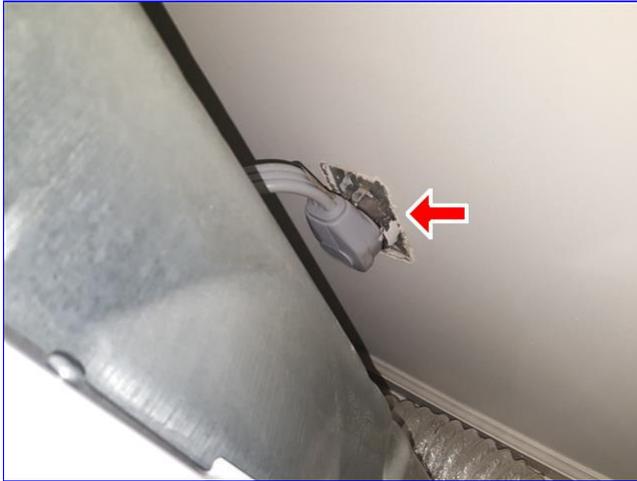
5.8 Item 1(Picture)

(1) The outlet(s) in the washer/dryer room for the dryer is missing a cover-plate. The outlet was not tested. All missing covers should be installed to prevent touching the sides of the devices to prevent an electric shock which can cause an injury or death. Electrical issues are considered a hazard until repaired, and this is considered to be unsafe. A qualified licensed electrical contractor should correct as needed prior to moving in.

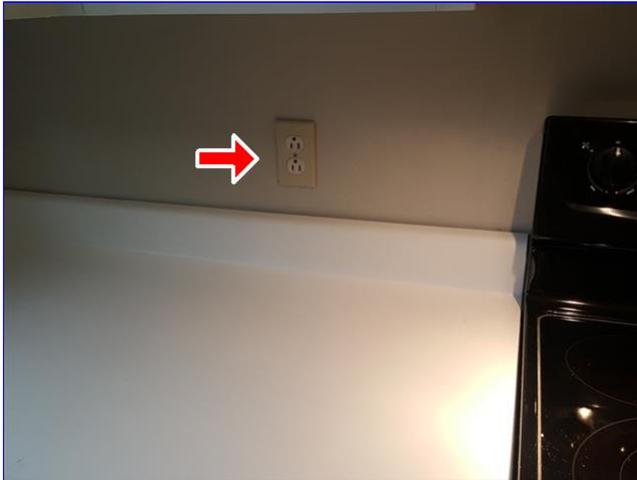
5.8 Item 3(Picture)

(3) The outlet(s) in the kitchen where indicated in the photo(s) are loose at the wall or in the outlet box. Electrical issues are considered a hazard until repaired. This is a safety issue that needs to be corrected due to an electric shock or fire from loose connections could occur if not repaired. Recommend a qualified licensed electrical contractor correct as needed.

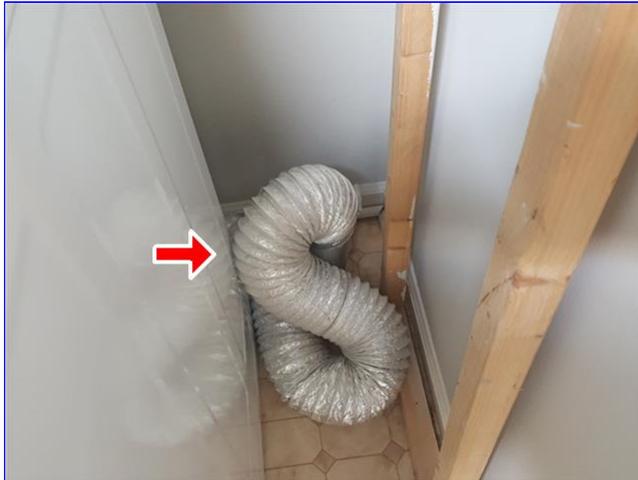
5.9 Item 1(Picture)

(1) A pleated Foil flex pipe is currently installed from the dryer to the exhaust vent. The current recommendations are for dryer vents to be heavy flexible or solid metal to help prevent crushing and damage from fires. Dryer lint fires are reported to be the third leading cause of fires. Exhaust ducts should be constructed of minimum 0.016 inch thick rigid metal ducts, having smooth interior surfaces with joints running in the direction of air flow. Exhaust ducts shall not be connected with sheet metal screws or fastening means which extend into the duct. All dryer vents should be disconnected and cleaned twice a year. This is a very common cause of fires. Recommend replacing duct for proper operation and for your safety using a qualified contractor.

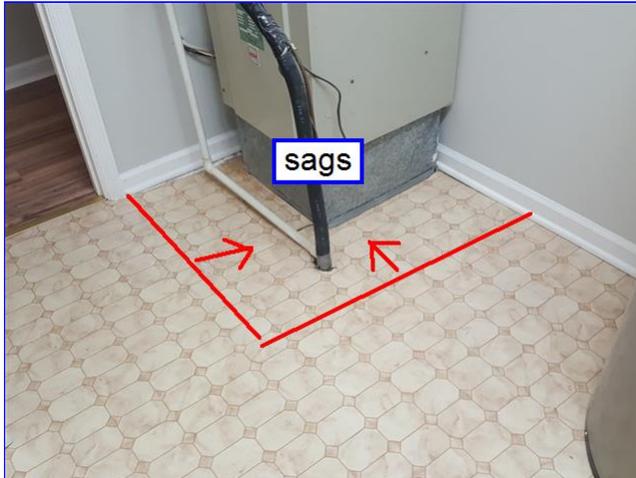
6.2 Item 1(Picture)

The floor is sagged underneath the air handler in the washer dryer room. I suspect that the joists maybe damaged or need additional support. Access to this area of the crawlspace was limited due to access from fallen insulation, ducts and plumbing pipes. Recommend a qualified contractor further inspect and evaluate to determine if repairs are needed prior to closing once easy access is granted. This maybe a structural issue.

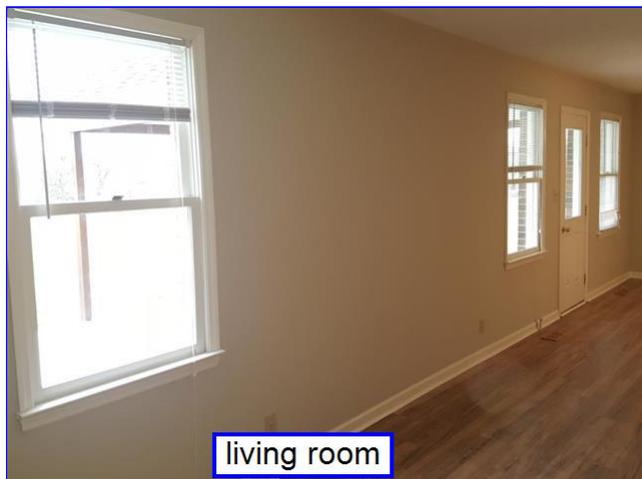
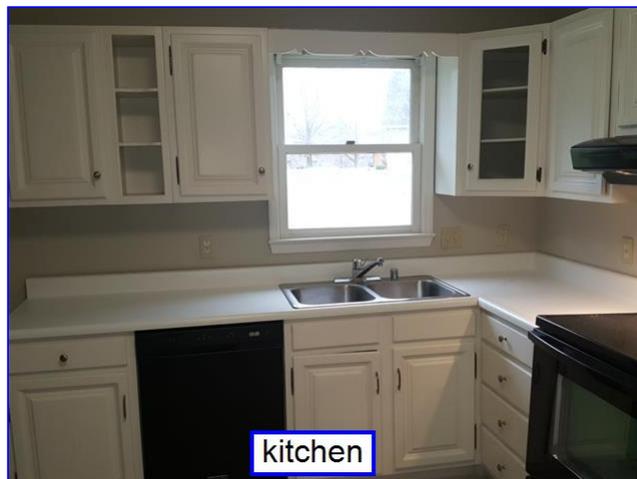
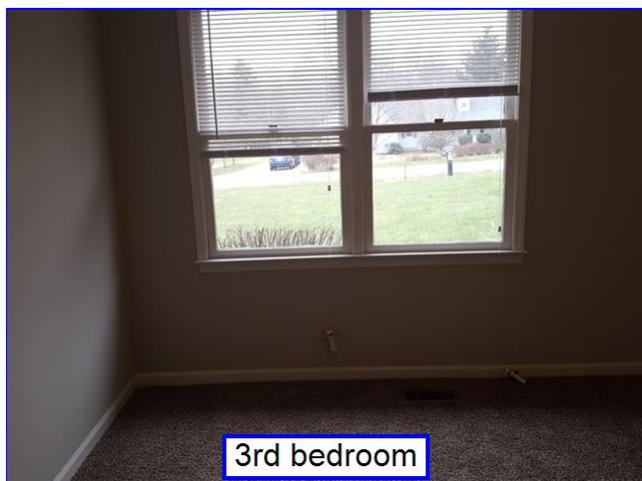
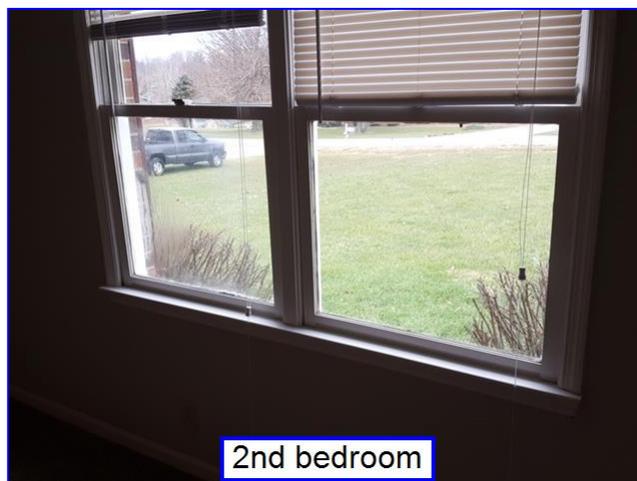
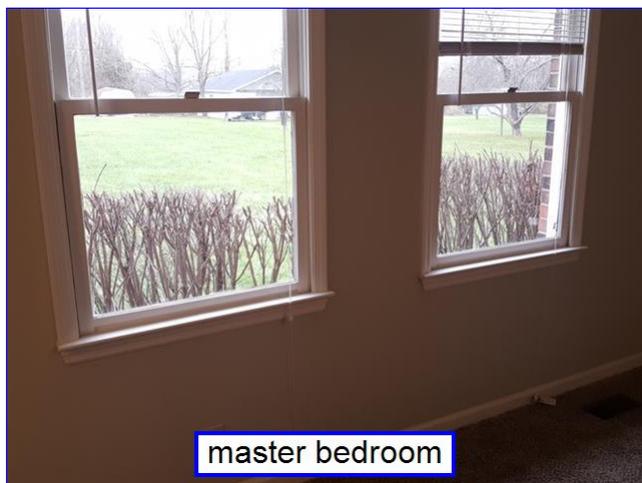
(1) All the windows in home are missing screens. Recommend these be installed to prevent insects entering the home when the window is opened. Replace as needed.

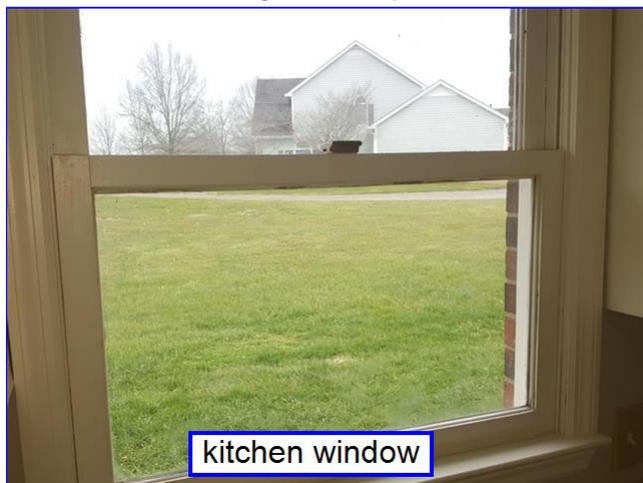
6.5 Item 6(Picture)

(2) The majority of the windows in the home will not open, see photos for location. These may be stuck or painted shut and/or may involve repair to sash cords. In the event a fire was to develop in the hallway in the home, person(s) or children have no means of exiting the master bedroom. This is a serious safety issue. Strongly recommend this be corrected prior to moving into home. Recommend unsticking the other window(s) to determine

kitchen window

there functionality. If the problem persists, recommend either installing new windows or have a qualified window installer further investigate and repair as needed, which ever is cheaper.
