TALON
Home Inspections

Inspection Report

Property Address:
2001 Crimea Street
Lawrenceburg KY 40324

Date: 12/17/2017	Time: 10:00 AM till 03:00 PM	Report ID: 171217PETERS
Property: 2001 Crimea Street Lawrenceburg KY 40324	Customer: Mr. Trevor Peters	Real Estate Professional:

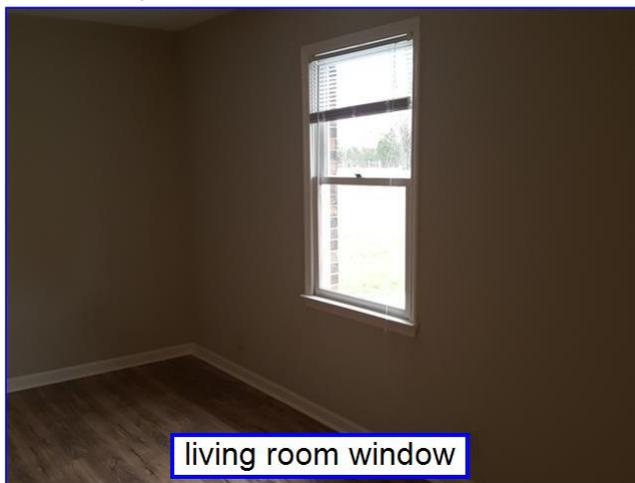
6.5 Item 7(Picture)

(2) The majority of the windows in the home will not open, see photos for location. These may be stuck or painted shut and/or may involve repair to sash cords. In the event a fire was to develop in the hallway in the home, person(s) or children have no means of exiting the master bedroom. This is a serious safety issue. Strongly recommend this be corrected prior to moving into home. Recommend unsticking the other window(s) to determine

living room window

there functionality. If the problem persists, recommend either installing new windows or have a qualified window installer further investigate and repair as needed, which ever is cheaper.

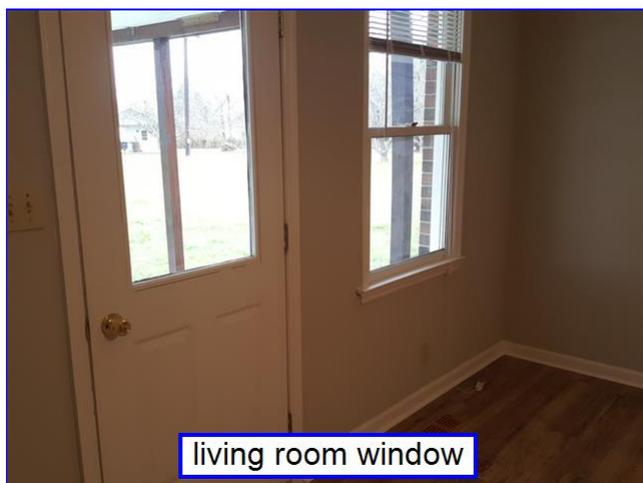
6.5 Item 8(Picture)

living room window

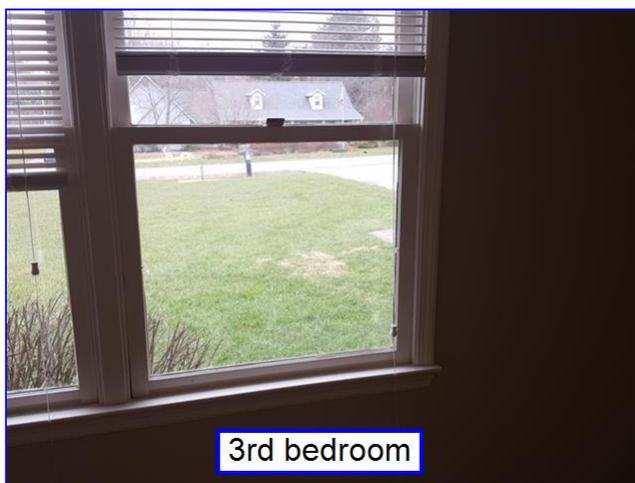
6.5 Item 9(Picture)

3rd bedroom

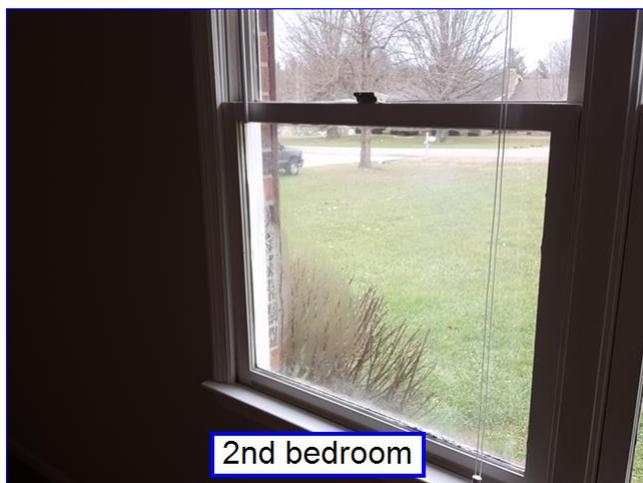
6.5 Item 10(Picture)

2nd bedroom

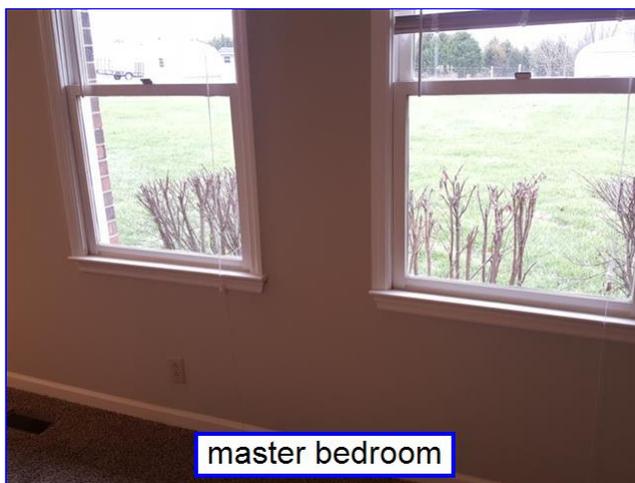
6.5 Item 11(Picture)

master bedroom

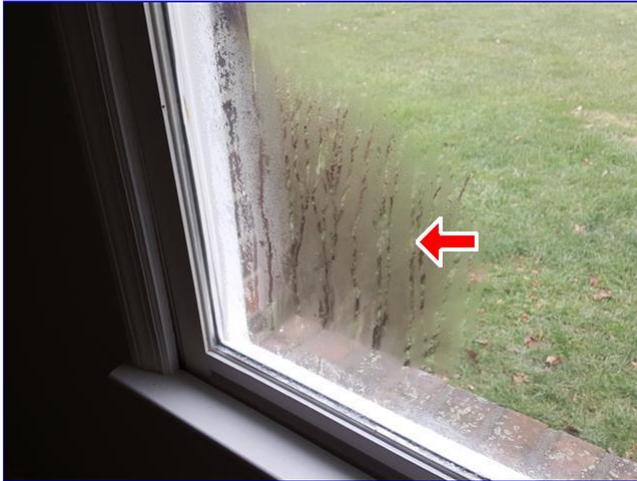
6.5 Item 12(Picture)

(3) The 2nd Bedroom window, left side at the home has deterioration at the seals between the panes of glass due to condensation was evident between the panes of glass. This can cause fogging between the window and the insulation/thermal ability of the window may be compromised. This can cause heat/cooling loss. Recommend a

qualified window installer further investigate and repair or replace as needed to ensure efficiency of windows. Some windows with lost seals may not have been evident at the time of this inspection. The windows were checked for condensation.

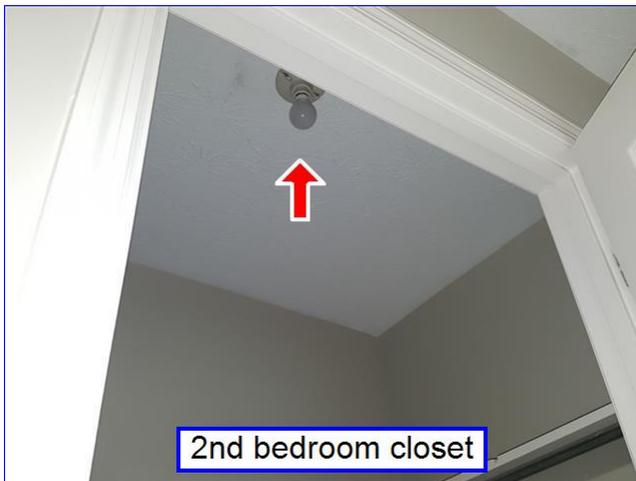
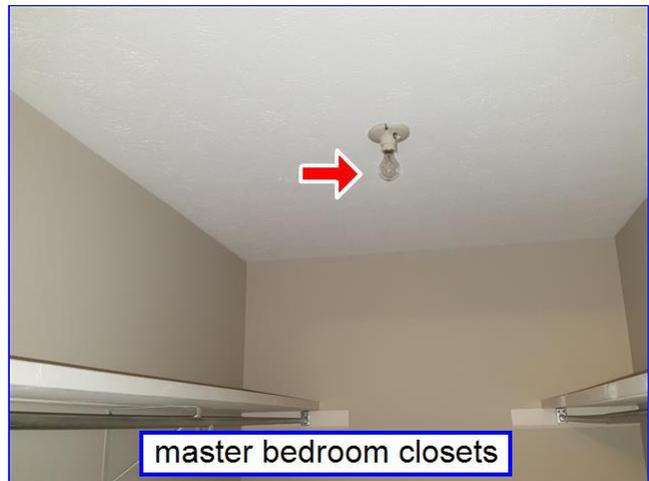
The light in the Master Bedroom and the 2nd Bedroom closet room is missing a fixture. Light bulbs in closets should have fixtures or be replaced with fluorescent bulbs to prevent fires from bulbs being in contact with clothing or storage items. This is a safety issue. Recommend correcting as needed.

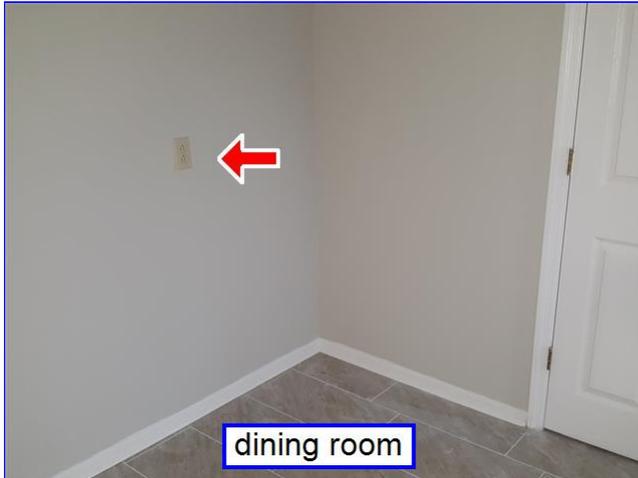
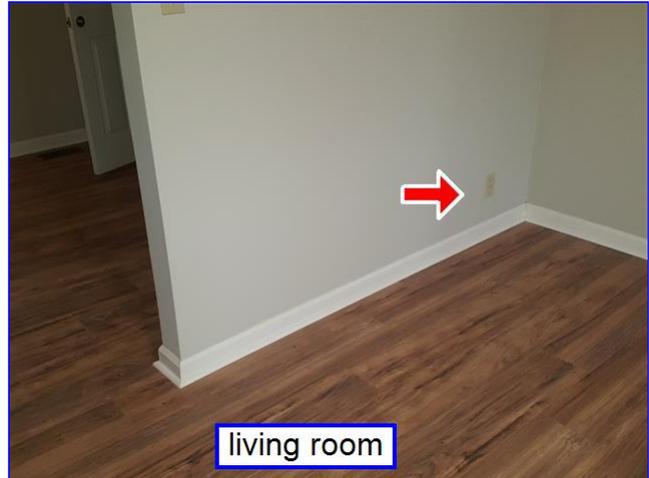
(1) The outlet(s) where indicated in the photo(s) are loose at the wall or in the outlet box. Electrical issues are considered a hazard until repaired. This is a safety issue that needs to be corrected due to an electric shock or fire from loose connections could occur if not repaired. Recommend a qualified licensed electrical contractor correct as needed.

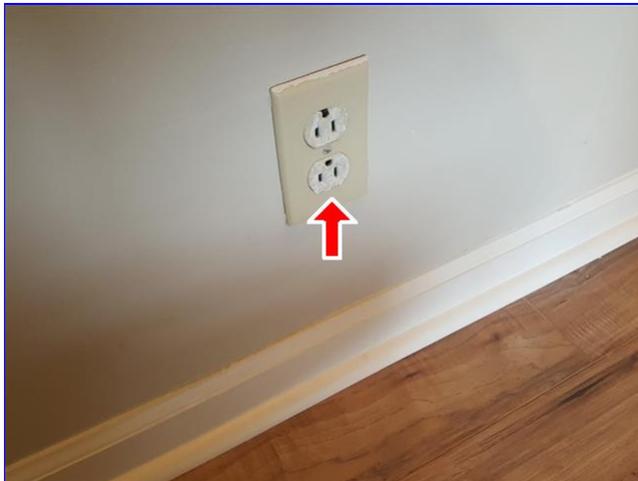
6.7 Item 4(Picture)

(3) The outlet in the hallway have been painted. Paint clumps in crevices can clog the openings in the outlet, making it difficult to insert the blades from the plug. Forcing the blades in may damage them and/or lead to a poor connection with the internal contacts creating a hazardous condition causing a fire. Additionally, paint chips can fall off the outlet or switch after repeated use creating a health hazard for young children and pets. Recommend replacing outlets and covers where necessary for safety by an electrician.

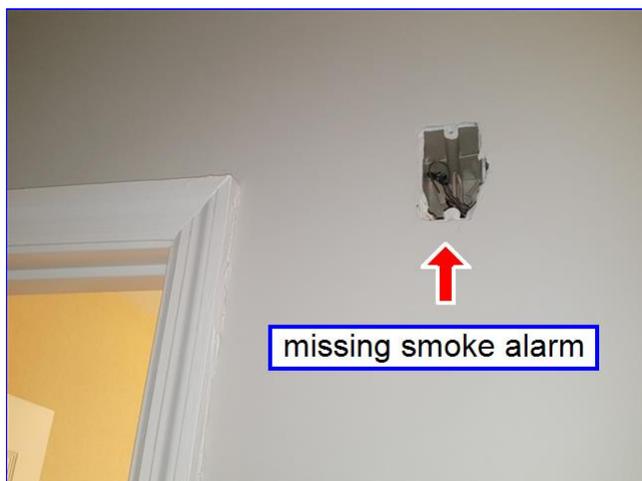
(2) The smoke detector has been disconnected intentionally and removed at the hallway. Without a working smoke detector in your home you have no first alert to a possible fire. This is a safety issue. Strongly recommend installing or replace the smoke detector for your safety in the home. Recommend a qualified contractor install one before closing and moving in. Note: Ensure the smoke alarm is a photoelectric type. Here is a link explaining type of alarm to use by the [Dept. of Fire and Emergency Services](#)

6.8 Item 1(Picture) hallway wall

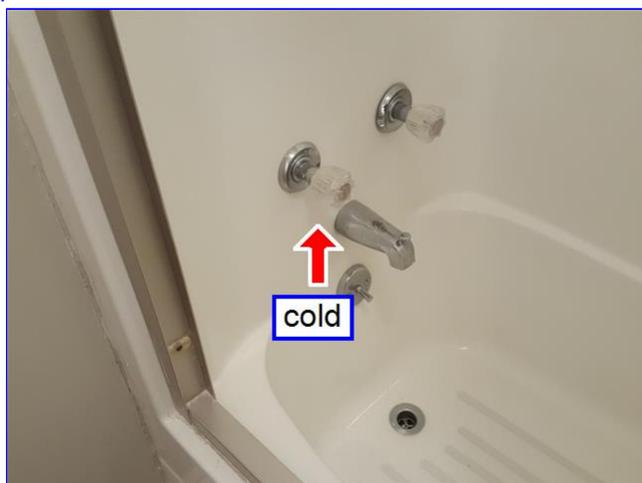
7.3 Item 3(Picture)

(2) The hot and cold water lines are connected in reverse from their normal positions in the Master bathroom at the shower. This could result in scalding burns of a person or child and is a safety issue. Recommend they be changed to the accepted normal locations with the cold water valve on the right side of the fixture. Recommend a licensed plumber correct as needed.

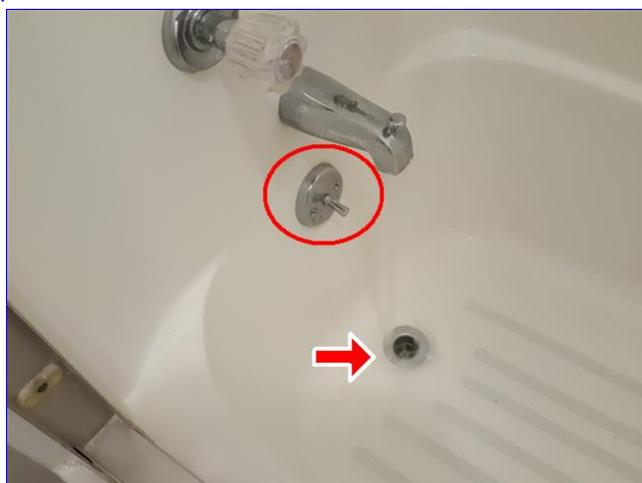
7.4 Item 1(Picture)

The drain stopper is not functioning at the tub in the master bathroom bath tub. Recommend a qualified licensed plumber install one so that bath tub can be filled with water without draining or a rubber stopper can be used.

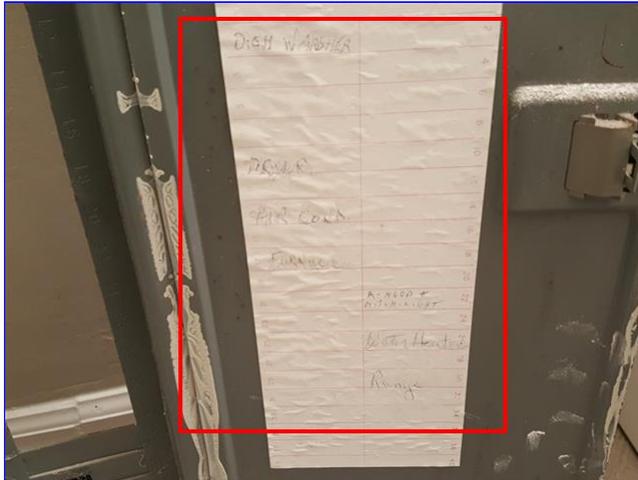
9.2 Item 1(Picture)

(1) Some of the circuit breakers are not labelled at the main panel cover in the master bathroom. This is a safety issue. Could not check if breakers may be overloaded with appliances in the home. (example: Heating and air conditioning cannot be on the same circuit breaker even though they are used at different times of the year). The electrical panel should be indexed, identifying each circuit breaker. This will allow for quick de-energizing of a circuit under emergency situations. Recommend the panel be fully labelled to facilitate turning off breakers to circuits. A licensed electrician is recommended to correct as needed.

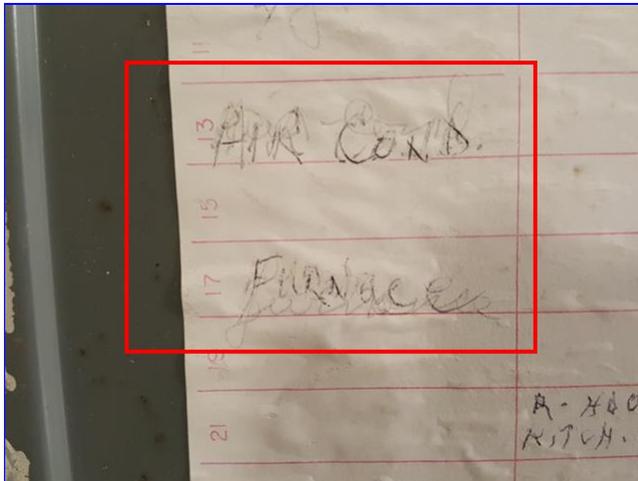
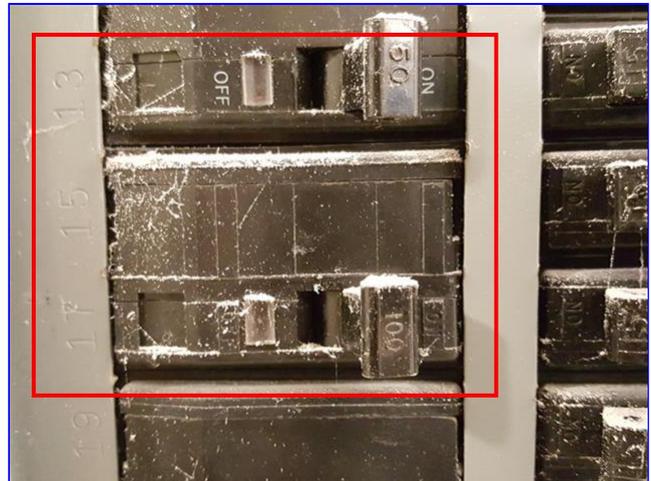
9.2 Item 2(Picture)

(2) The circuit breakers are not correctly labelled on the cover of the main electrical panel in the master bathroom. This is a safety issue. The panel indicates that the 100 amp breaker is for the furnace. The electrical panel should be indexed correctly, identifying each circuit breaker. This will allow for quick de-energizing of a circuit under emergency situations. Recommend the panel be correctly labelled to facilitate turning off breakers to circuits prior to moving in. A licensed electrician is recommended for this correction for safety.

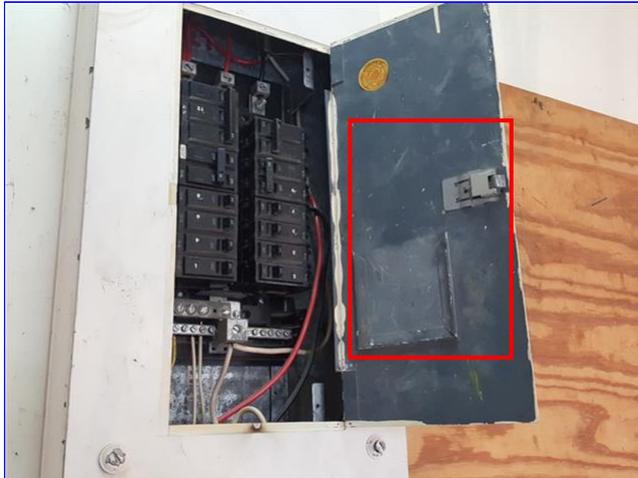
9.2 Item 4(Picture)

(3) The circuit breakers are not labelled on the cover of the electrical sub panel in the garage. This is a safety issue. The electrical panel should be indexed, identifying each circuit breaker. This will allow for quick de-energizing of a circuit under emergency situations. Recommend the panel be fully labelled to facilitate turning off breakers to circuits prior to moving in. A licensed electrician is recommended for this correction for safety.

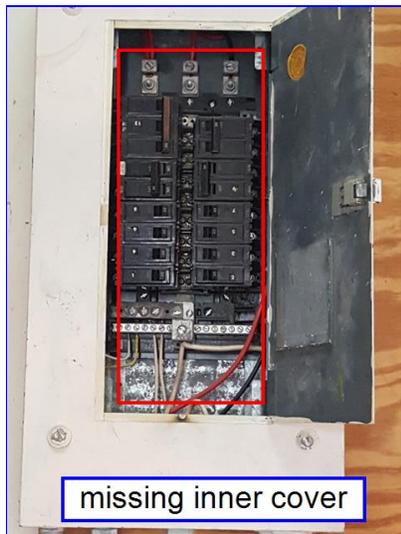
9.2 Item 5(Picture)

(4) The sub panel box inside cover is missing. This is exposing the wiring connected to the breakers inside the box. This is dangerous and is a safety hazard. The openings can allow someone to place an object inside which can cause a short or electrocution of a person which would result in a death. Recommend correction and replacement by a qualified licensed electrician as needed for occupant safety prior to closing and moving in.

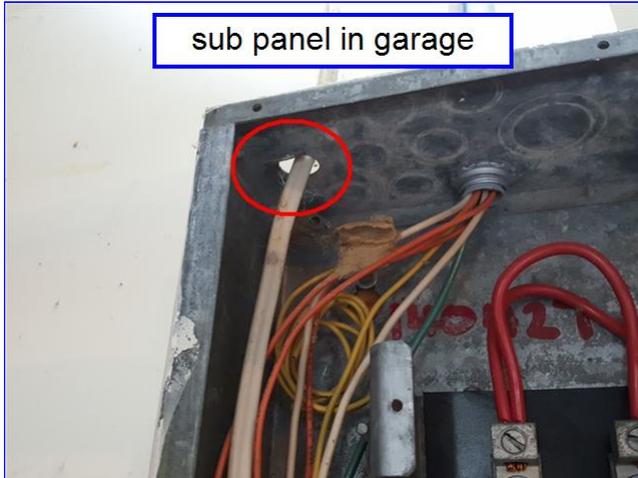
9.2 Item 6(Picture)

(5) Cable clamps (sometimes referred to as bushings or grommets) are required where wiring passes into the electrical panel box. Cable clamps serve to protect the wiring from the metal edges of the panel box to prevent a short from occurring or from the panel box becoming energized which can result in a death via electric shock. Also, if a water leak was to occur above the ceiling, water can enter the panel box which could cause a short or fire. This is a safety issue. Recommend a qualified licensed electrician repair as needed at the sub panel in the garage prior to closing.

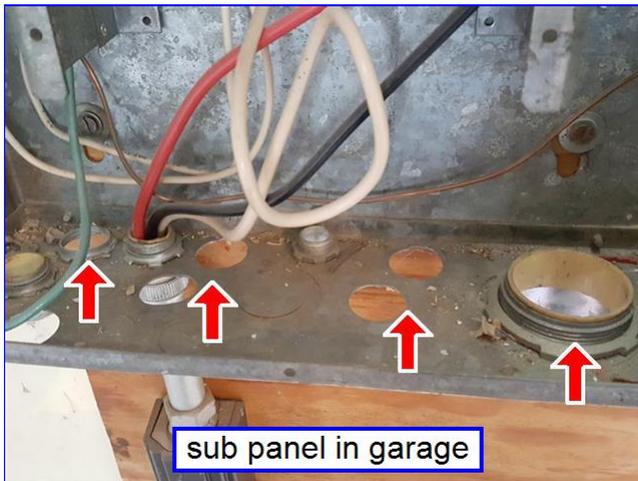
9.2 Item 7(Picture)

(6) Openings in the panel box which are for wires to enter that are not in use should be sealed to prevent moisture or rodents entering the sub panel box in the garage. These openings are considered hazardous. Recommend a licensed electrician correct as needed.

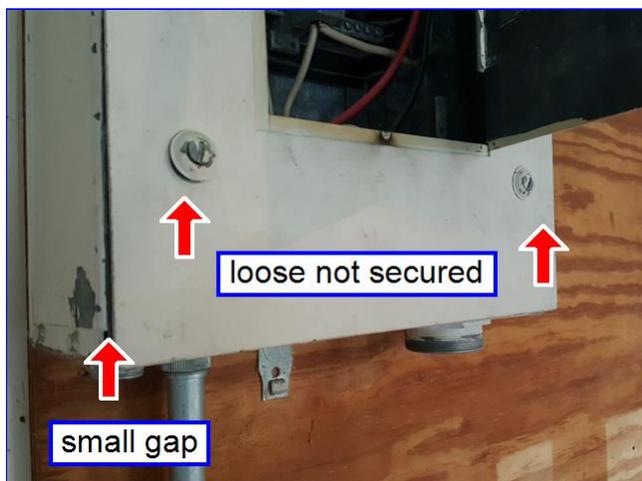
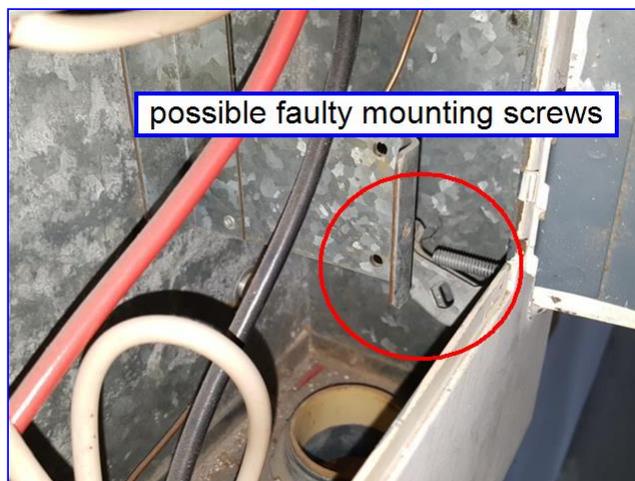
9.2 Item 8(Picture)

(7) The bottom of the panel cover is loose and not secured in the garage. This is a safety issue. The cover can be tilted allowing a person or child to place an object inside which would result in a death via an electric shock. Also moisture could enter due to the cover is not secured. This is a serious safety issue. Recommend a qualified electrician repair as needed.

Note the mounting screws at the bottom maybe faulty and need replacing.

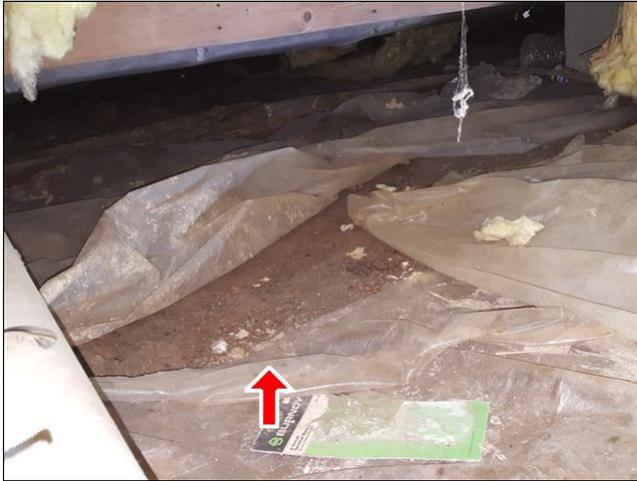
1.2 Item 10(Picture) under washer dryer room

(3) There are some gaps in the coverage of the vapour barrier in the crawl space floor. The vapor barrier in the crawl space floor should be adjusted to cover all areas of exposed soil. These gaps are allowing moisture vapor entry into the crawl space which promotes condensation, humidity and mold/mildew growth on the floor joists. The plastic vapour barrier should be a minimum of 9mil thick in Kentucky (recommend using 15 or 20 mil) straightened and/or added to as needed to cover the entire crawlspace floor to prevent excessive moisture entering. Recommend correcting and replacement using a qualified contractor.

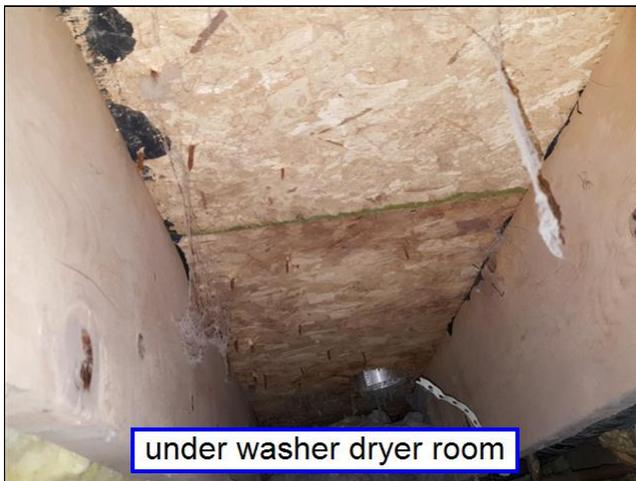
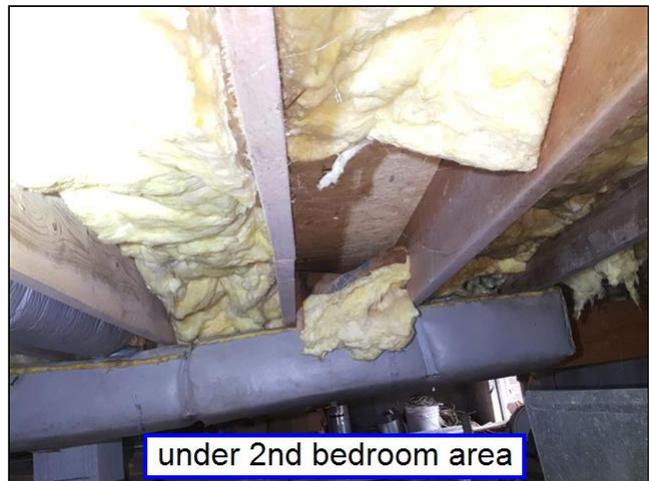
1.5 Item 6(Picture)

(2) The insulation is missing in some areas in the crawlspace. Heat loss can occur more on this home than one that is properly insulated. Recommend replacement as needed.

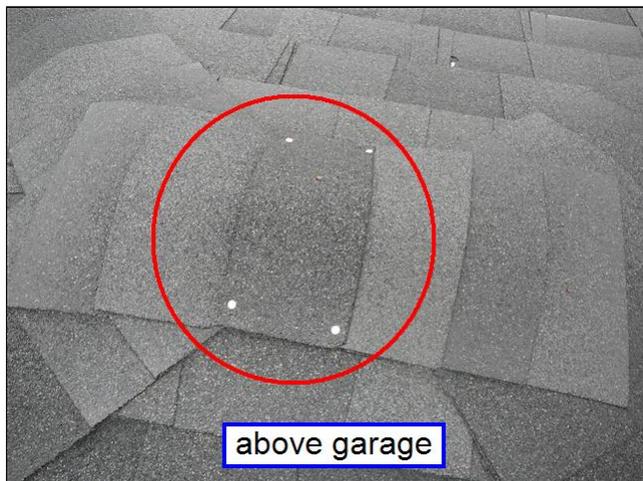
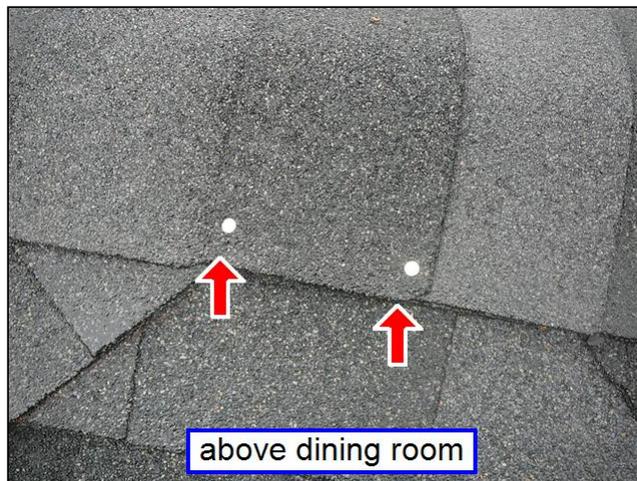
2.0 Item 4(Picture)

(2) Exposed nail heads were seen above the garage and dining room area at the roof. All exposed nails should be properly sealed by a qualified roofing contractor. A sealant compatible with the roofing or flashing material should be applied to the nail. This will prevent and reduce future water entry and/or leaks into the attic.

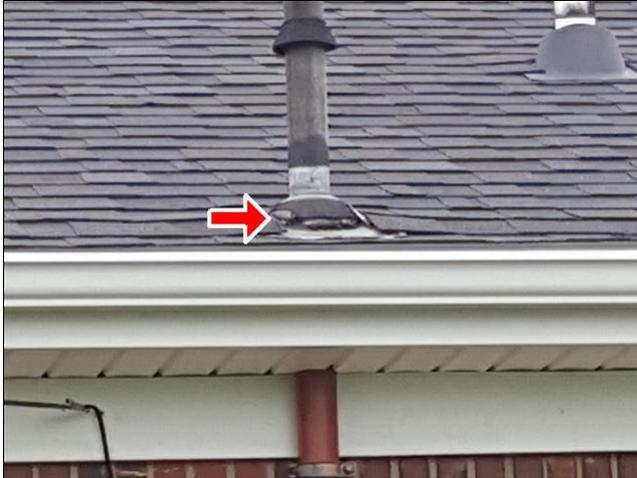
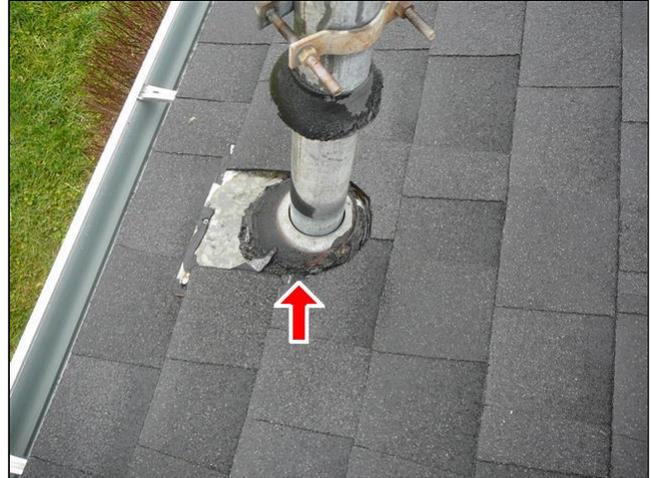
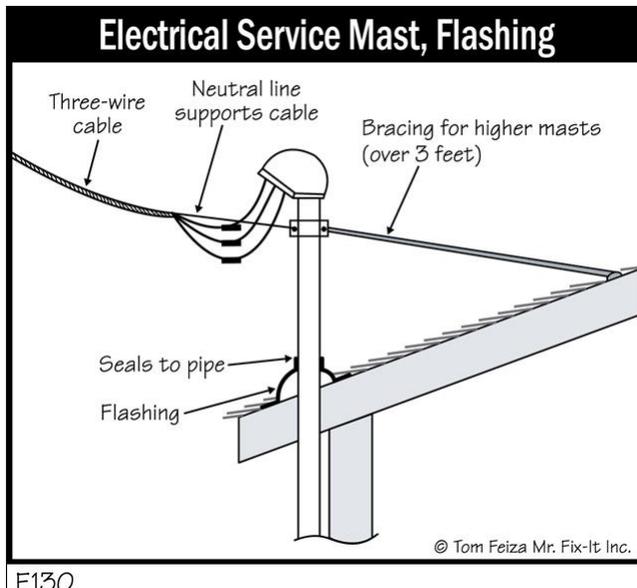
2.3 Item 1(Picture)

The rubber boot below the electric mast is starting to deteriorate and may be prone to leaks because it is split/cracked at the rear of the home. This may allow water to enter into the attic which may lead to deterioration of the roof and ceiling structure which can lead to mold within the attic. Sealing or replacing the rubber boot is recommended. Recommend a roofing contractor repair or replace as needed.

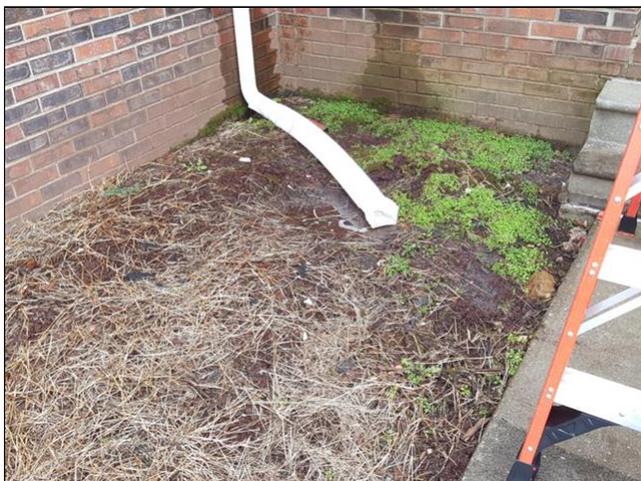
2.4 Item 9(Picture)

(3) Recommend the downspout(s) at the front left corner of the home near the porch where indicated in the photo(s) be extended and flow onto a splashblock. This will ensure water is kept away from the foundation perimeter, soil erosion does not occur and water cannot leak under the slab foundation area and be trapped between the front walkway which may cause settlement of the foundation of the home. Recommend a general contractor correct as needed.

Note: the extension will need to go underneath the front walkway.

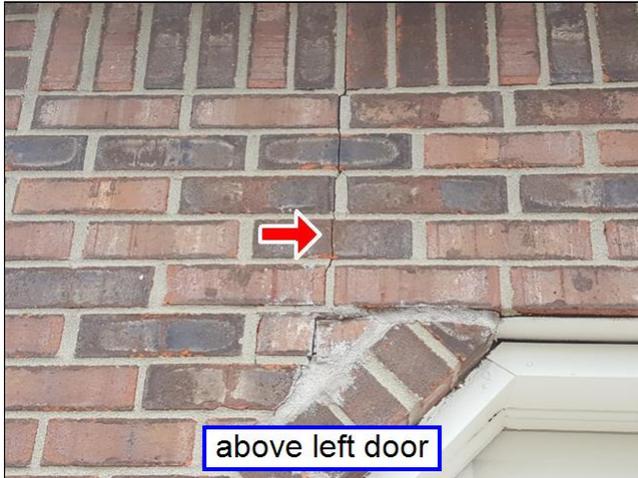
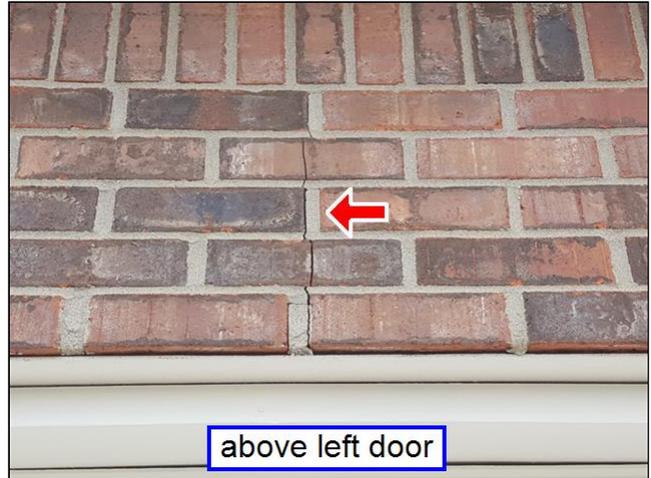
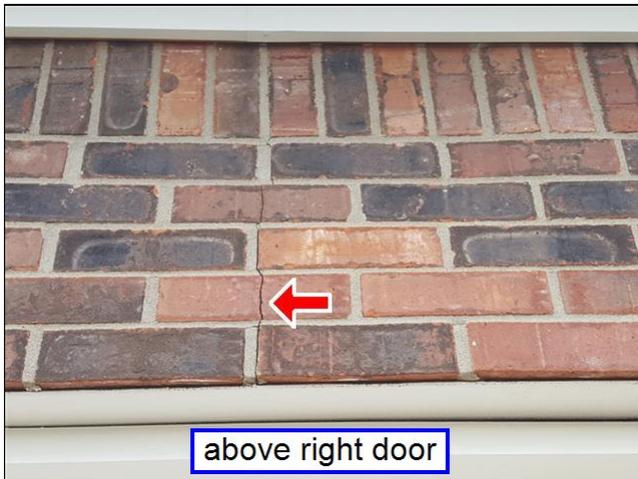
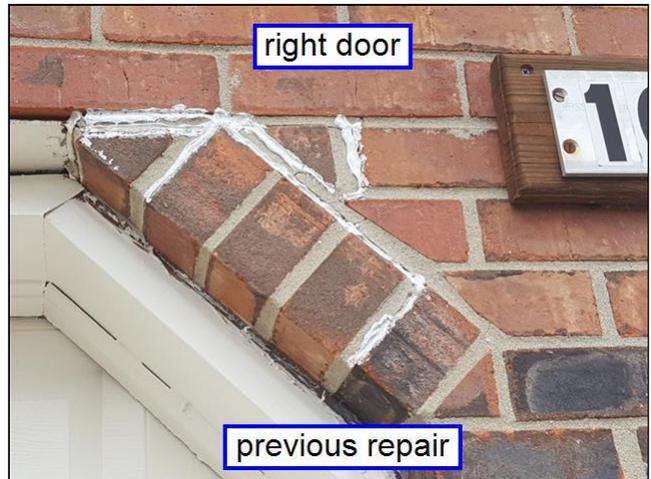
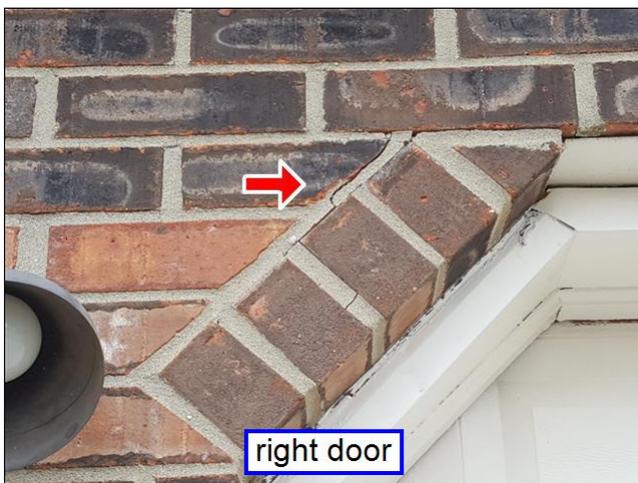
(1) Exterior wall vertical cracks at the mortar joints and through the brick siding was observed above the garage where indicated in the photos. The majority of these cracks were observed above the garage door frames where there were metal lintel's in the brick work. A lintel is a metal beam supporting masonry above an opening in a wall. These cracks may imply that the lintel may be rusting, expanding, or close to the lower limit of function and acceptability due to being undersized. While the rate of movement cannot be predicted during a one-time inspection it is likely that repairs are needed. These cracks do not appear significant at this stage. Recommend a qualified contractor seal all cracks to prevent further cracking and possible deterioration of the brick work and treat lintel's from rusting and exposure to moisture by painting lintel's. Also ensure they are sealed between the brickwork so water cannot enter behind or on top of lintel. If cracks reappear after repairs, then would recommend a qualified masonry further investigate to determine cause and repair or replace as necessary.

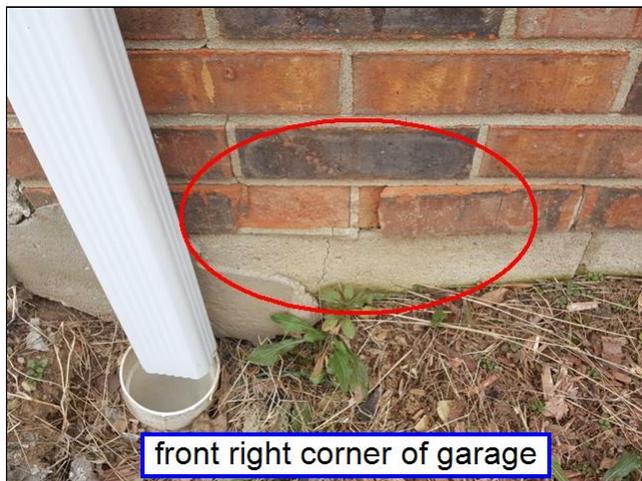
3.0 Item 6(Picture)

(2) Brick spalling observed at the front right corner of the garage near the downspout. Spalling is a result of water entering the concrete and masonry and forcing the surface to peel, pop out or flake off, due to moisture entering the foundation perimeter. Eventually, spalling can cause crumbling and destruction of a structure. Recommend repair and ensure water is drained away from the perimeter of the home. A skilled masonry contractor should perform the repairs.

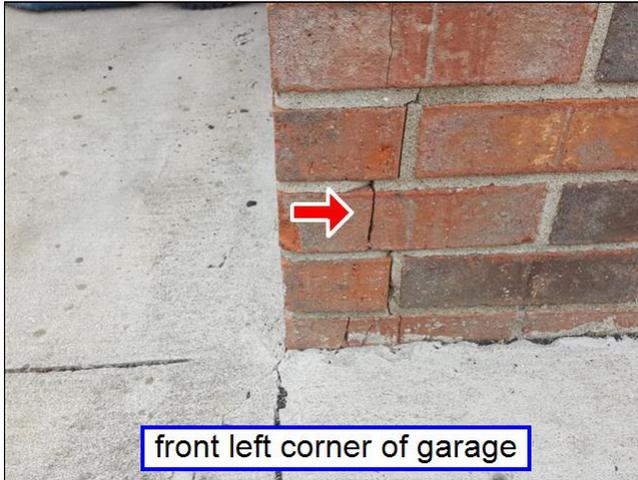
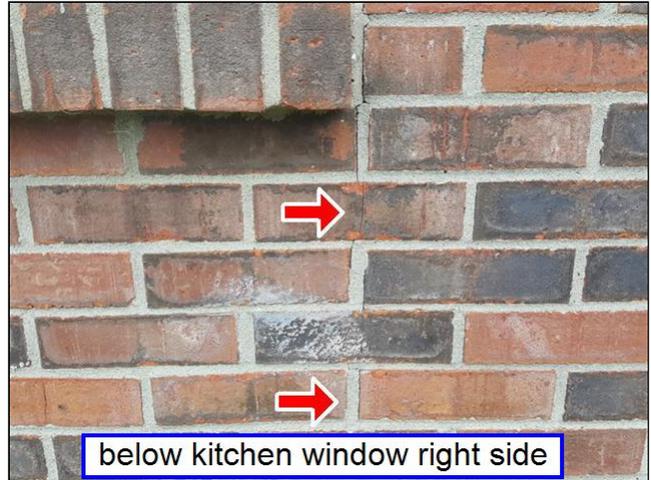
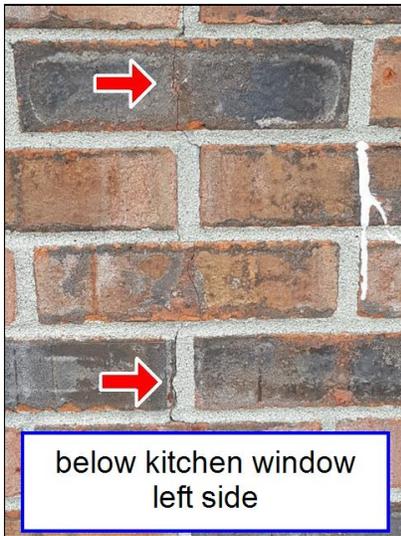
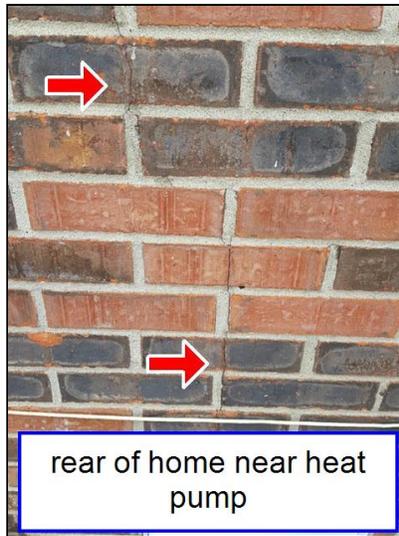
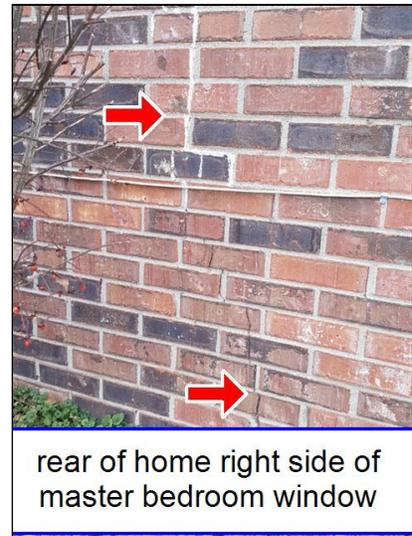
(3) The exterior brick wall has various vertical and stair step settlement cracks in various places around the home, see photos for location. This implies that minor structural movement has occurred. While the rate of movement cannot be predicted during a one-time inspection it is likely that repairs are needed. These cracks do not appear significant at this stage. Cracks that are greater than 1/8 inch are cause for concern. Due to freeze/thaw, the cracks should be sealed to minimize further chipping away, flaking or deterioration. Recommend these cracks be sealed to prevent further cracking via water intrusion. A qualified contractor or skilled masonry contractor should perform the repairs via tuck pointing mortar. It is recommended that you monitor periodically and if cracks reappear and become greater than 1/8", then a qualified structural engineer or masonry contractor should be consulted to determine cause and suggest repairs. This would indicate that the home is continually settling. Keep water away from the foundation: review the lot and roof drainage improvements in the Exterior and Roofing sections of this report. While the rate of movement cannot be predicted during a one-time inspection it is likely that repairs are needed.

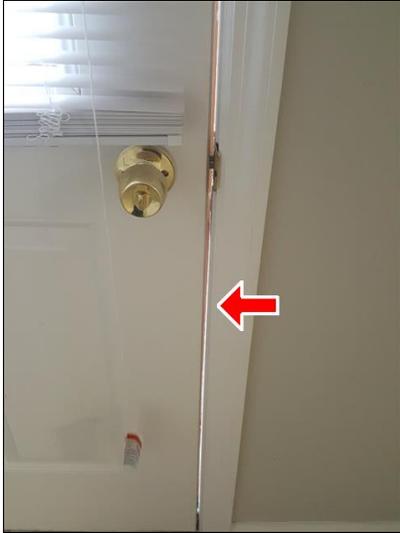
3.2 Item 1(Picture)

The side entry door at the dining room reveals daylight when latched at areas. It is missing weather-stripping. This can cause some heat loss in winter and loss of cool air in summer if not corrected which can cause condensation. Recommend repair as needed.

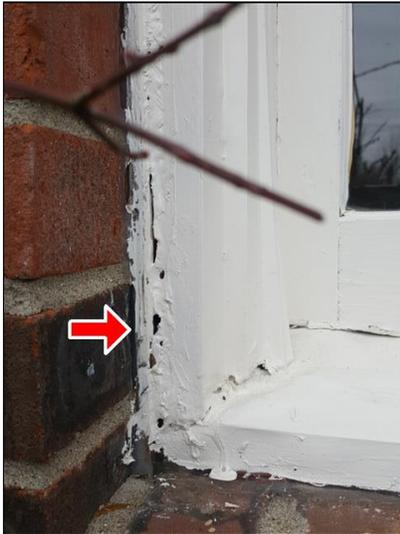
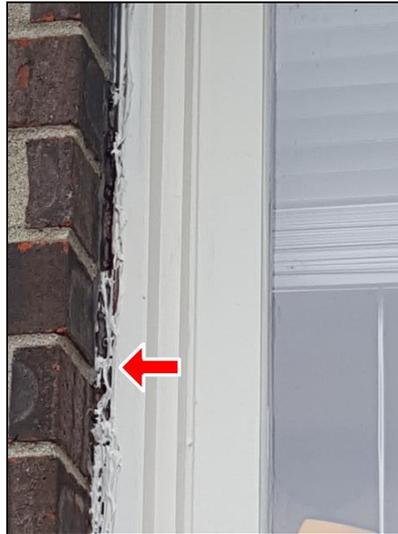
(2) The gaps between the window frames and the brick siding at the rear of the home (master bedroom windows) need to be sealed correctly to prevent water intrusion. Water entering here can lead to deterioration of the wall siding and potential leaks inside the wall cavity. Recommend caulking these areas with a quality moisture resistant caulk that expands and contracts. [Choosing the right caulk](#)

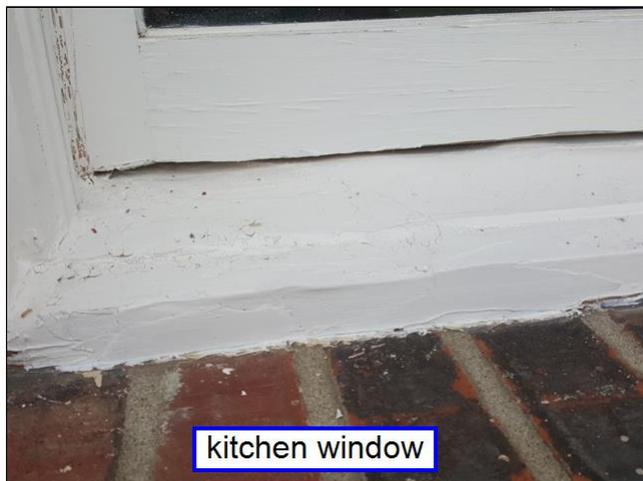
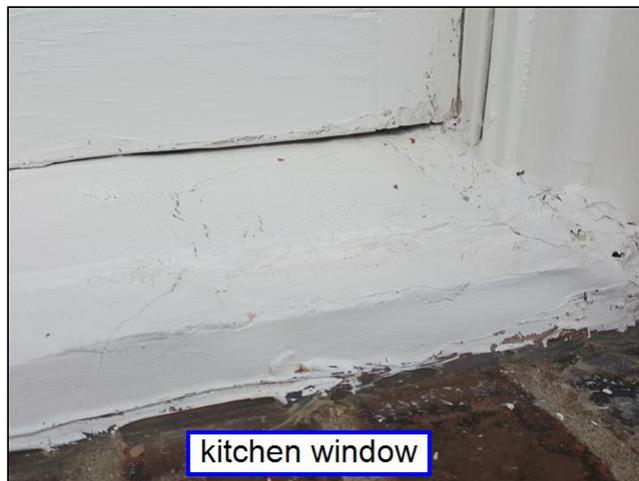
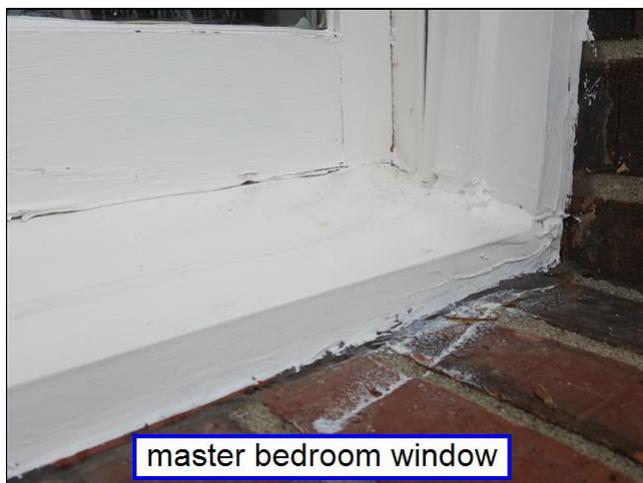
(3) The bottom of some of the window sills around the home are warped/buckled and show signs of previous repairs. The sills should be flat and sloped to ensure water drains away from the home. The openings may allow water to enter and cause poor seals allowing the outside air to enter if not sealed correctly. Recommend a qualified window contractor repair as needed.

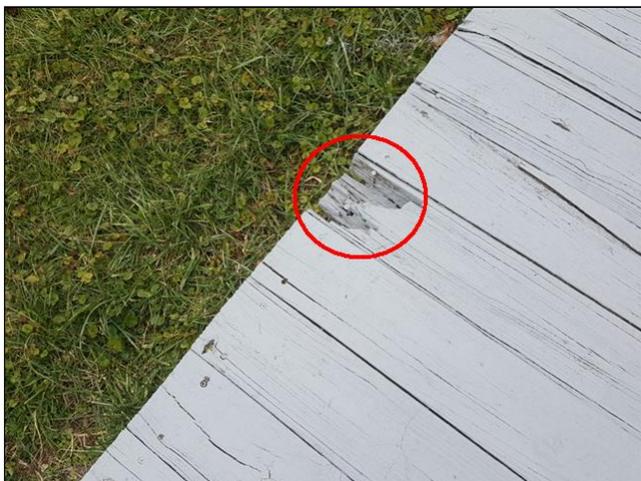
3.5 Item 2(Picture)

(2) The deck board at the some of the ends on the deck at the rear of the home have deteriorated at the end cuts. Further erosion or deterioration can occur if not corrected via water intrusion. Recommend repair or replace as needed.

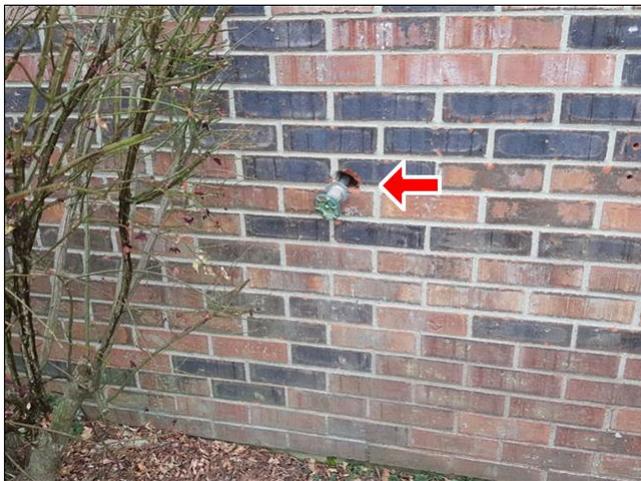
3.9 Item 1(Picture)

(2) The outside water faucet has an opening where the pipe protrudes the wall at the right side of the home. The opening can allow insects or water to enter which can cause deterioration of the wall structure. Recommend a general contractor repair as needed.

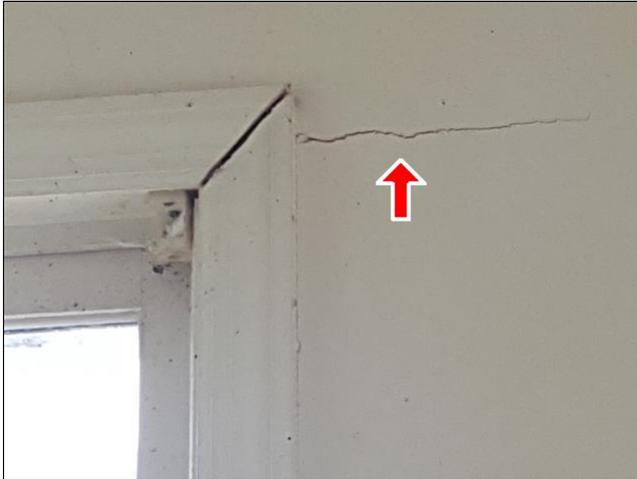
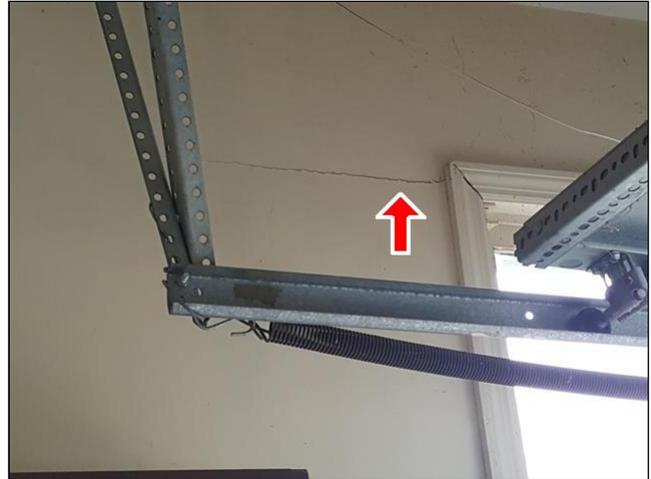
(2) The horizontal cracks in the walls in the garage at the right wall above the windows (see photos for location) appear to be common settlement cracks. Cracks larger than 1/8" are of concern only. Minor settlement of the home has occurred due to the age of the home and from perhaps framing shrinkage. Cracks of this nature are also caused by moisture and changing temperature. Recommend repairing cracks then paint and monitor. If cracks reappear and become larger than 1/8" then would recommend a structural engineer further investigate to determine cause and suggest repairs.

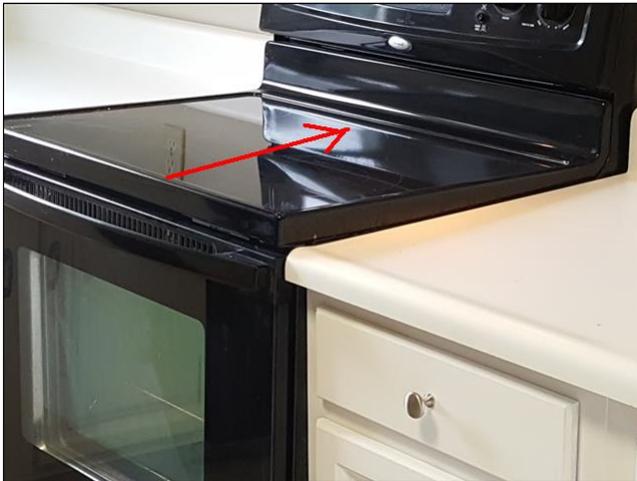
5.4 Item 2(Picture)

(2) The stove needs to be adjusted at the feet at the front. The stove top slopes severely to the back. Recommend adjusting the bottom feet to ensure stove top is stable and level on the floor. This can be a safety issue when boiling water on the stove top.

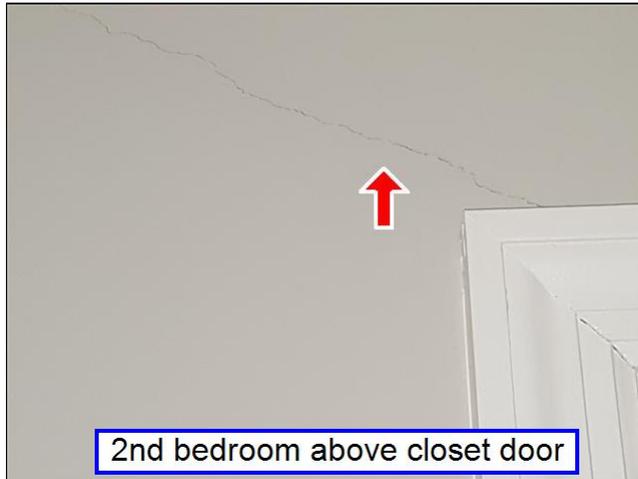
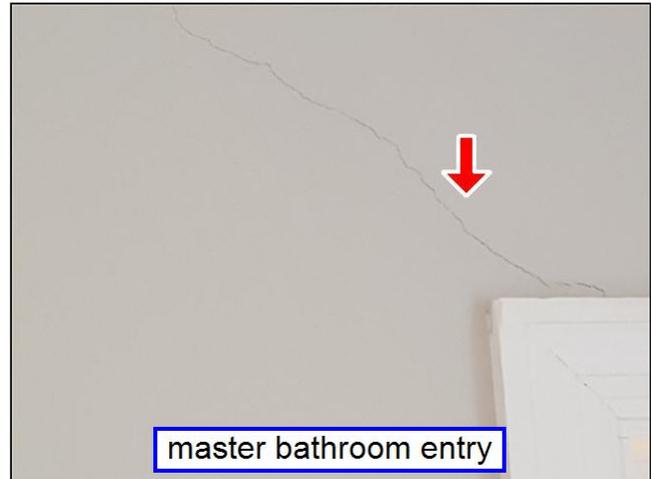
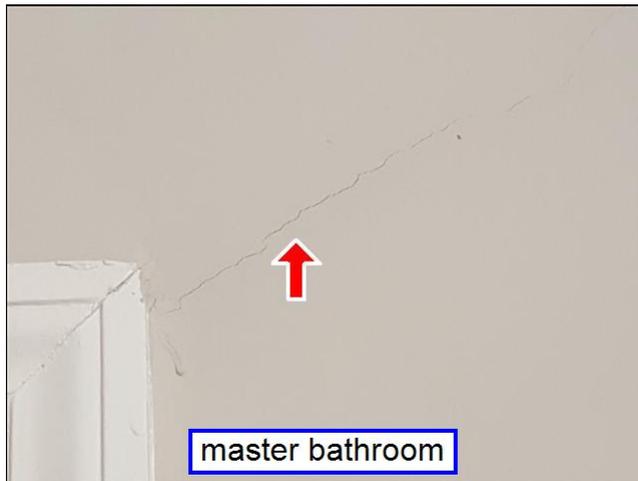
The crack(s) noted on the walls near the corners of the door frames in the home, (see photos for location) are common minor settlement diagonal crack(s). Cracks larger than 1/8" are of concern only. Minor settlement of the home has occurred. All the doors in the related room(s) do open and close without rubbing on door jambs. This damage is considered to be cosmetic and a small repair issue for your information. Recommend prep prime and paint as needed.

Note: After repairs, these areas should be monitored and if cracks reappear and become greater than 1/8 inch wide, then further evaluation is recommended by a qualified contractor to determine cause and repairs. (structural members are not visible) **Also see note 1.6(2) and 1.4(2).**

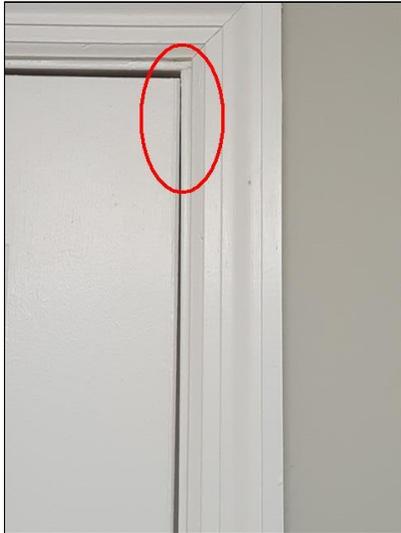
6.4 Item 1(Picture)

(1) The door in the Washer/Dryer room hits and rubs the door jamb at the top but does close shut. This maybe due to settlement of the home or sagging joists. Once the floor structure is inspected and repaired if needed, then recommend the door be repaired/corrected as needed by a general contractor. Sometimes correcting the door opening can require door trim to be removed and painting touch up, and/or door hinges may need reseating to ensure correct closure of door. **Also see note 7.2.**

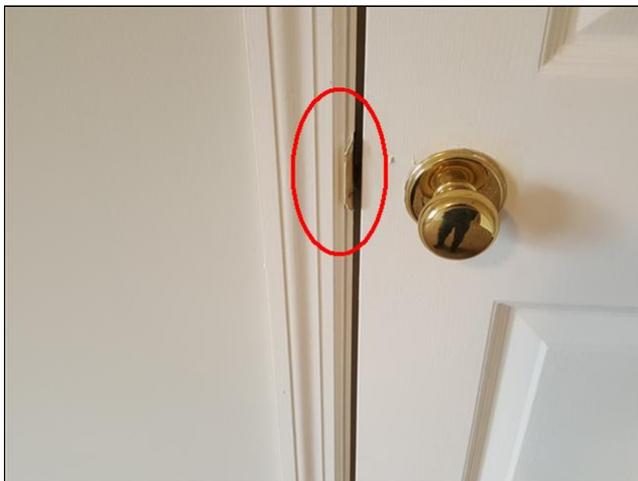
6.4 Item 2(Picture)

(2) The door knob hardware is not latching in the 3rd bedroom closet door where indicated in the photo. It requires an adjustment. The strike plate may need to be adjusted or trimmed to be able to lock/close the door. Recommend repair as needed.

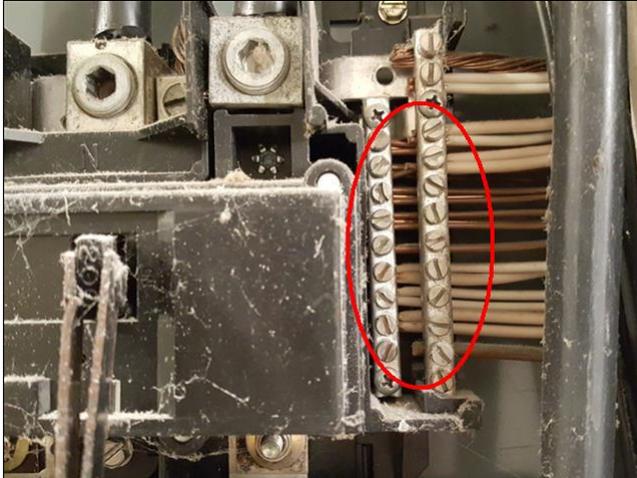
9.3 Item 1(Picture)

(1) More than one common (white wires) on a single lug of the neutral bar is not recommended but was found in the main panel in the master bathroom. Separation of these commons is recommended when any other electrical work is done by a qualified licensed electrician.
