TALON
Home Inspections

Inspection Report

Property Address:
2001 Crimea Street
Lawrenceburg KY 40324

Date: 12/17/2017	Time: 10:00 AM till 03:00 PM	Report ID: 171217PETERS
Property: 2001 Crimea Street Lawrenceburg KY 40324	Customer: Mr. Trevor Peters	Real Estate Professional:

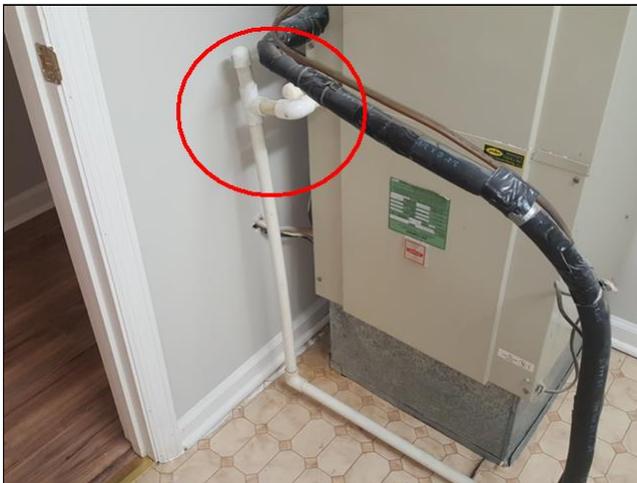
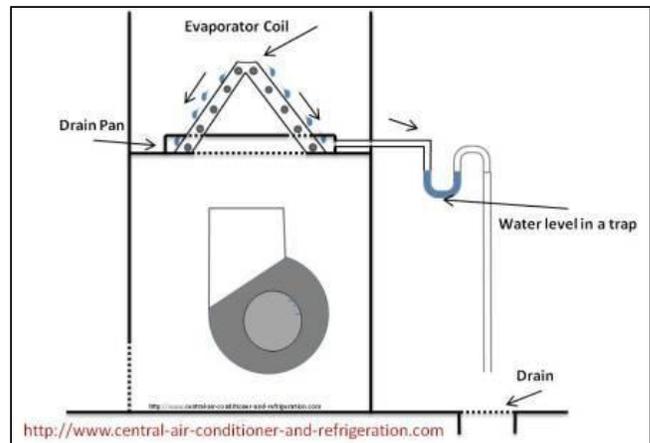
(2) There was no visible condensate trap installed at the condensate drain line for the Air Handler in the home. It is recommended by the manufacturer to have one. The purpose of the trap is to allow the water to drain freely, without air flowing in the drain line can cause the water to not flow (drain to the exterior). Recommend a qualified HVAC contractor correct as needed.

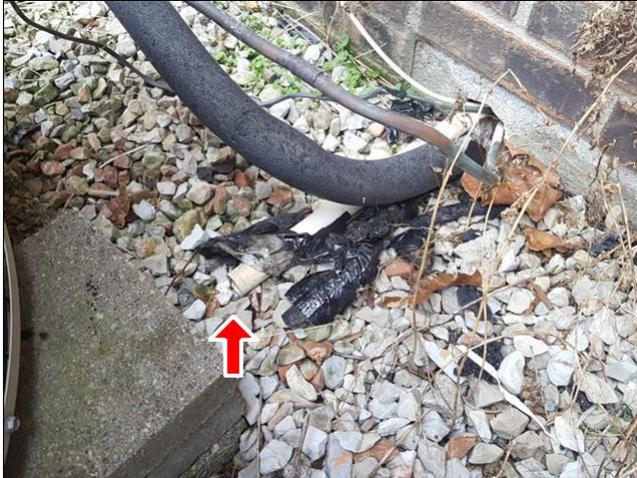
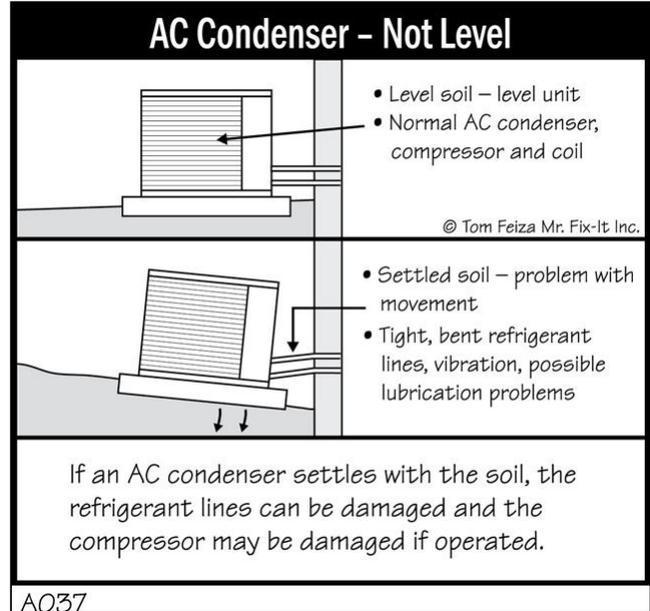
(3) Recommend the discharge for the condensate drain line be improved via installing a splash block and extending the drain line at the rear of the home. This will prevent water pooling near the foundation which could cause settlement of the foundation wall, soil erosion and water leakage into the crawlspace. Also to prevent possible settling of the platform for the Heat Pump. A qualified HVAC contractor is recommended for these repairs.

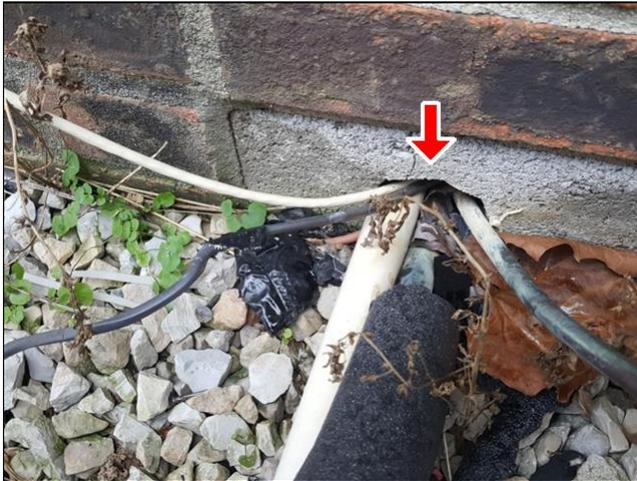
10.3 Item 6(Picture)

(4) The hole in the wall at the rear of the home which allows the Heat Pump lines to be connected to the Air Handler in the home is not sealed. Openings should be sealed to prevent entry of insects and weather into the wall cavity and into the crawlspace. Also to prevent deterioration of the foundation wall. Recommend sealing with cement or an appropriate filler.

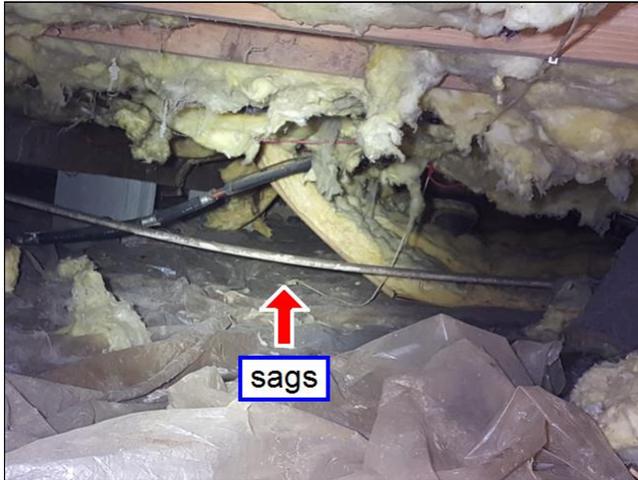
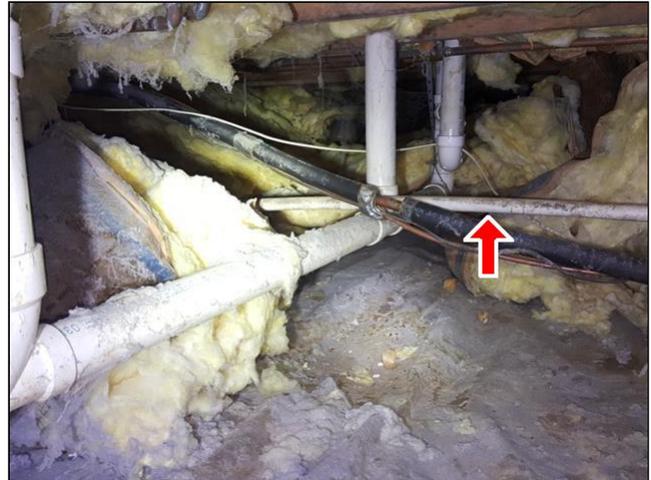
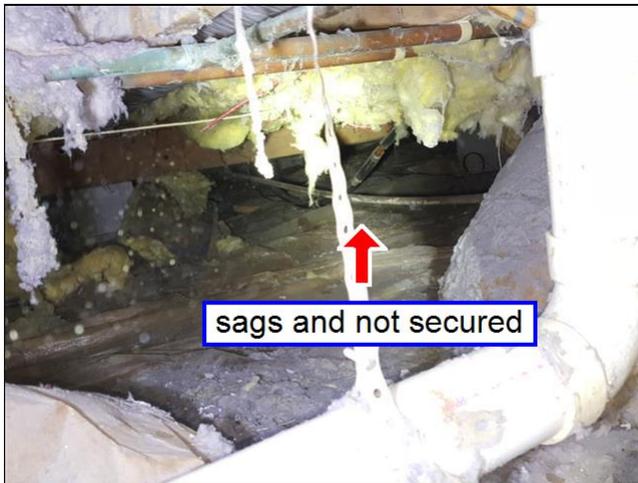
(5) The condensate drain line is not supported and sags leading to the exterior in the crawlspace. It also has an improper pitch for ease of draining. Poor drainage can lead to leakage or damage to the unit. Recommend a qualified contractor or HVAC contractor correct as needed.
