Report: 3443

Confidential Inspection Report

[REDACTED]
[REDACTED]
August 4, 2023

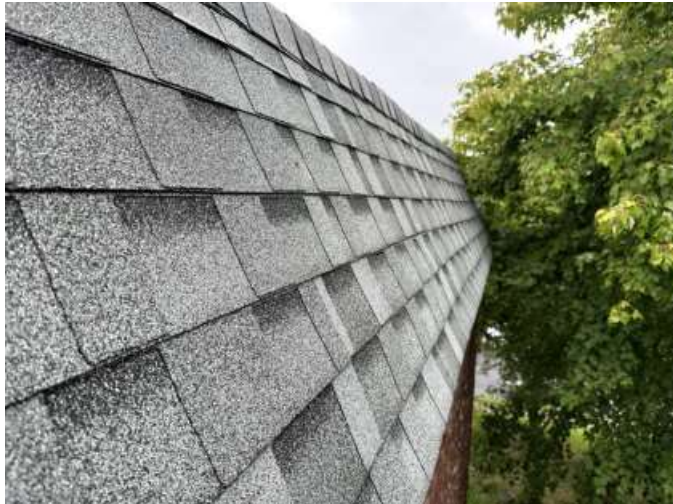
Roof #2:

Style: Mansard.

Approximate Roofing Age: Roofing material appears to be approximately 1-3 years old. Inquire with seller to confirm age and about any applicable warranty documentation.

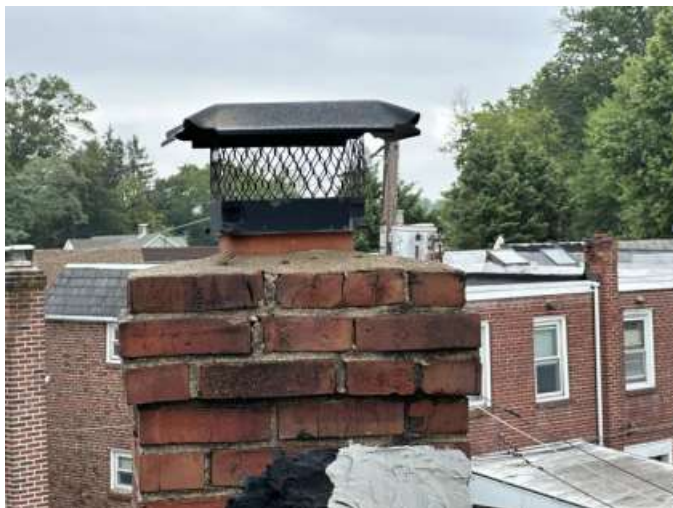
Chimney:

Chimney Exterior: Brick.

Flue: Heating appliance flue, Heater or boiler, Terra Cotta clay, A rain cap was noted at the top of the flue. This is essential to keep the rain and animals from entering the chimney.

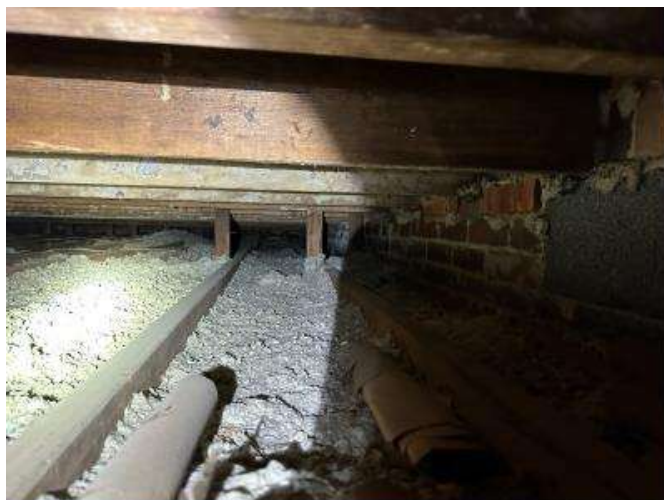
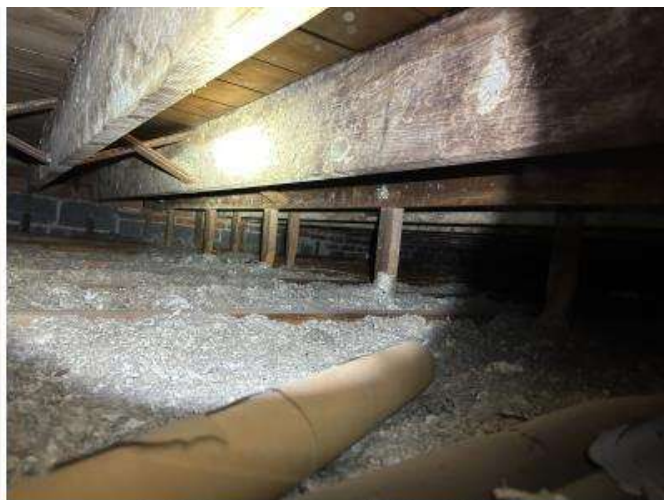
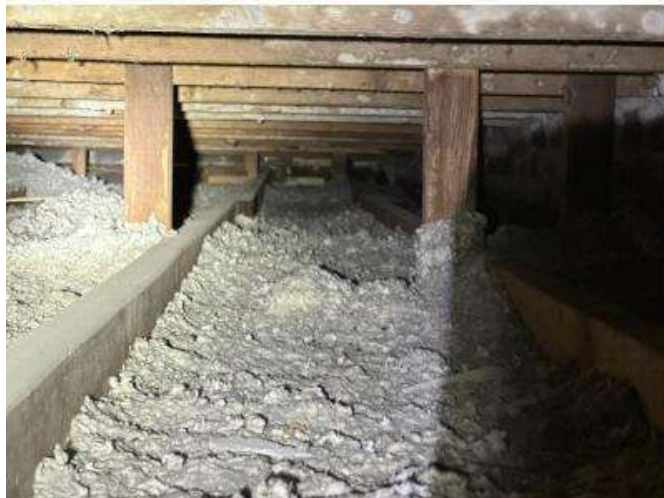
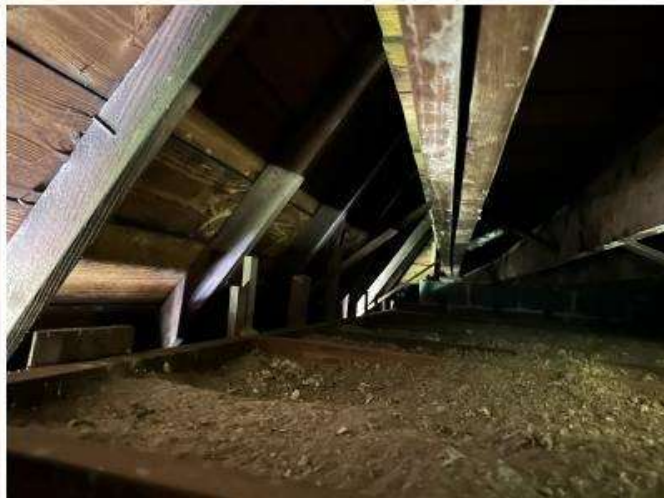
Access:

Attic inspected from hatch due to limited access/clearance.
