MINIMUM INSPECTION PROCEDURAL GUIDELINES  
FOR BUILDING ELECTRICAL RECERTIFICATION

INSPECTION MADE BY: FLORIN FLOREA P.E.

a. Name on Title: Village at Dadeland Condominiums (G)

b. Street Address: 7500 SW 82nd St. Miami, Florida 33143

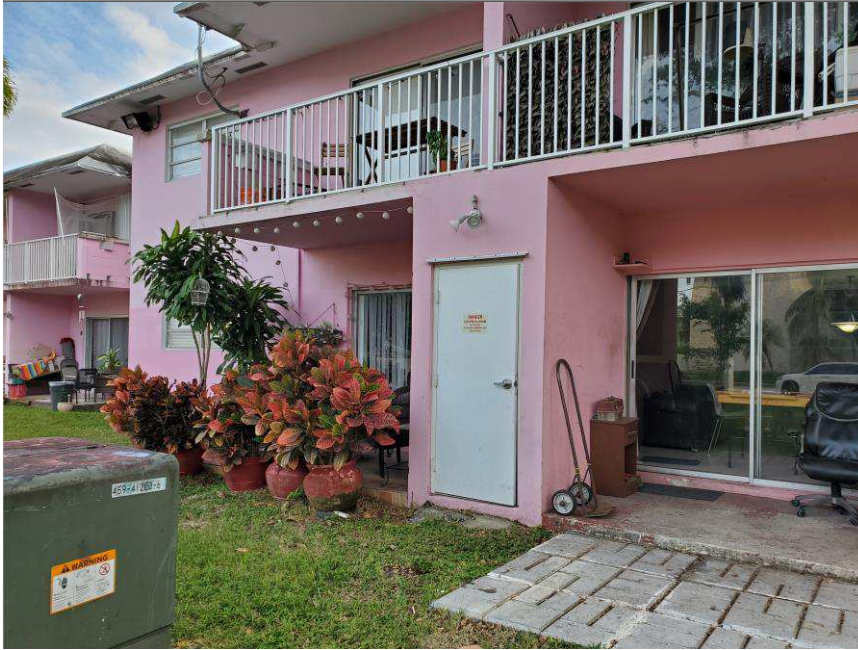
Photo 1 – Village of Dadeland Condominium Association

Existing Electrical Room - 1st FL  
No Storage Permitted

Missing sign with Room name  
and Building number.

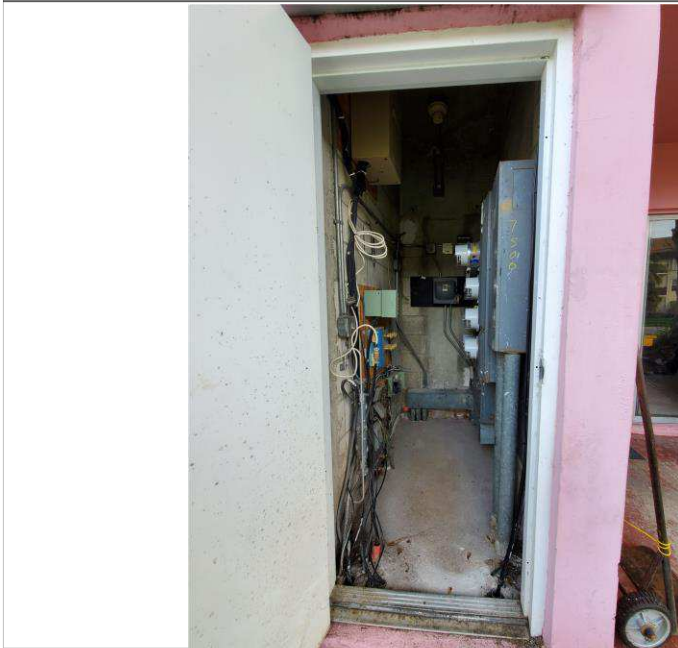
Photo 2 – Village of Dadeland Condominium Association

Existing Electrical Room - 1<sup>st</sup> FL  
Main Switches for Apartments,  
Meters, and Gutter.

Insufficient clearance in front of  
electrical components.

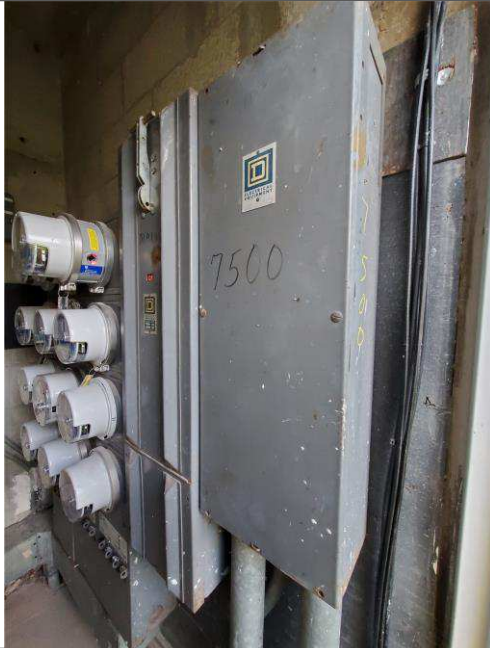
Photo 3 – Village of Dadeland Condominium Association

Existing Electrical Room - 1st FL  
Main Disconnect and Meter  
Stacks are corroded.  
50 year old electrical  
components.

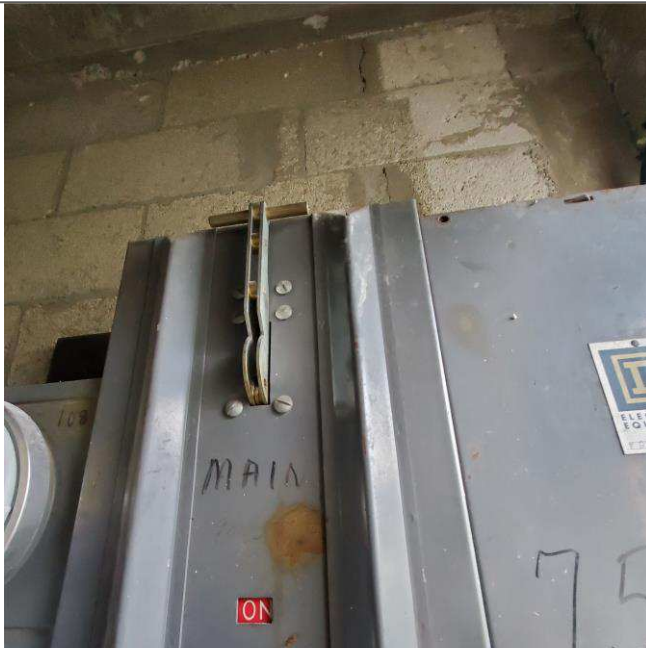
Photo 4 – Village of Dadeland Condominium Association

Existing Electrical Room - 1st FL  
Building Main Disconnect is  
corroded.  
50 year old electrical  
component.

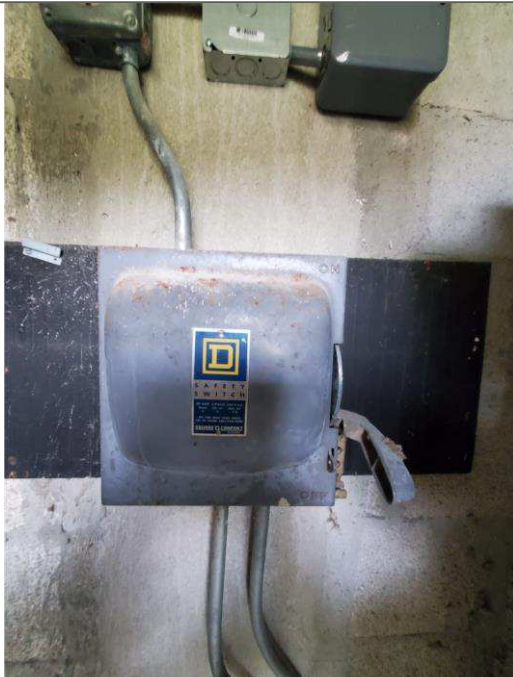
Photo 5 – Village of Dadeland Condominium Association

Existing Electrical Room - 1st FL  
House Panel Disconnect Switch  
is corroded.  
50 year old electrical  
component.

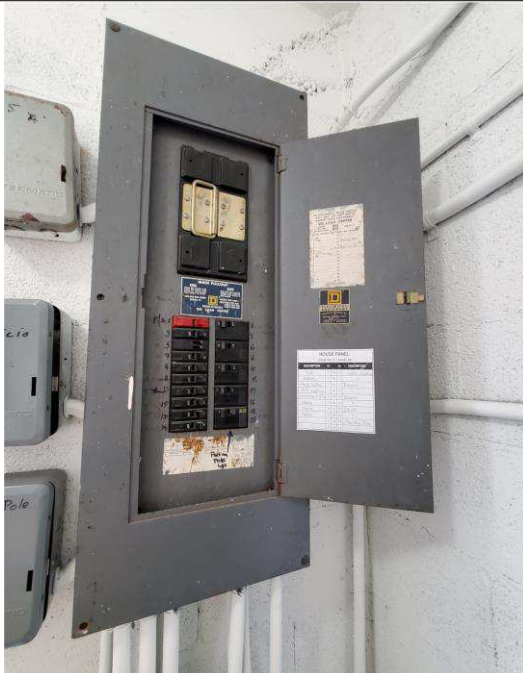
Photo 6 – Village of Dadeland Condominium Association

1st FL - Laundry/Water Heater  
Room  
House Main Panel Board

Old 50 year old electrical  
component

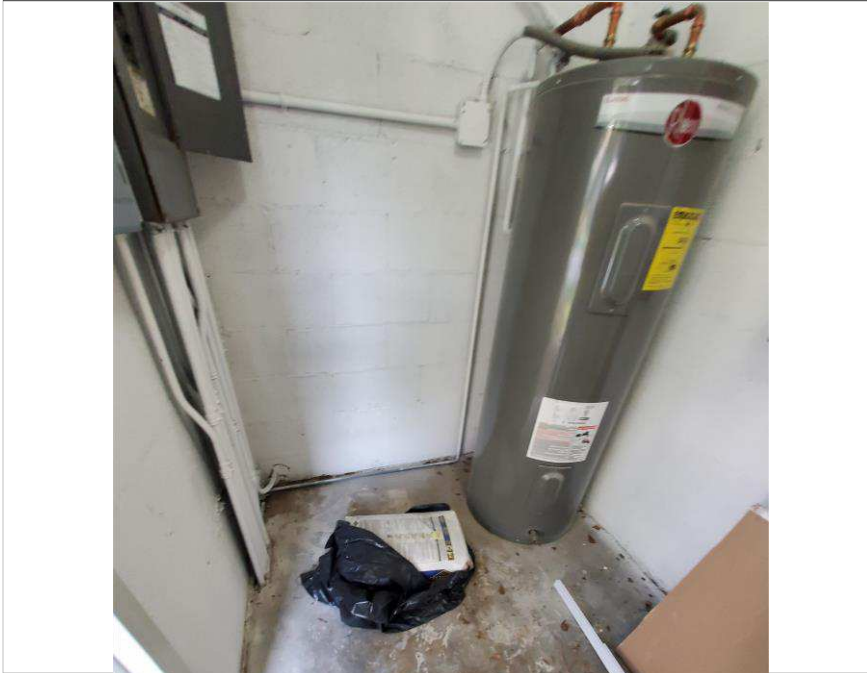
Photo 7 – Village of Dadeland Condominium Association

1st FL - Laundry/ Water Heater Room  
House Panel Board

House Panel Board installed in front of Water Heater.

There is insufficient clearance in front of panel.

17. Time clocks insufficient clearance, repairs required.

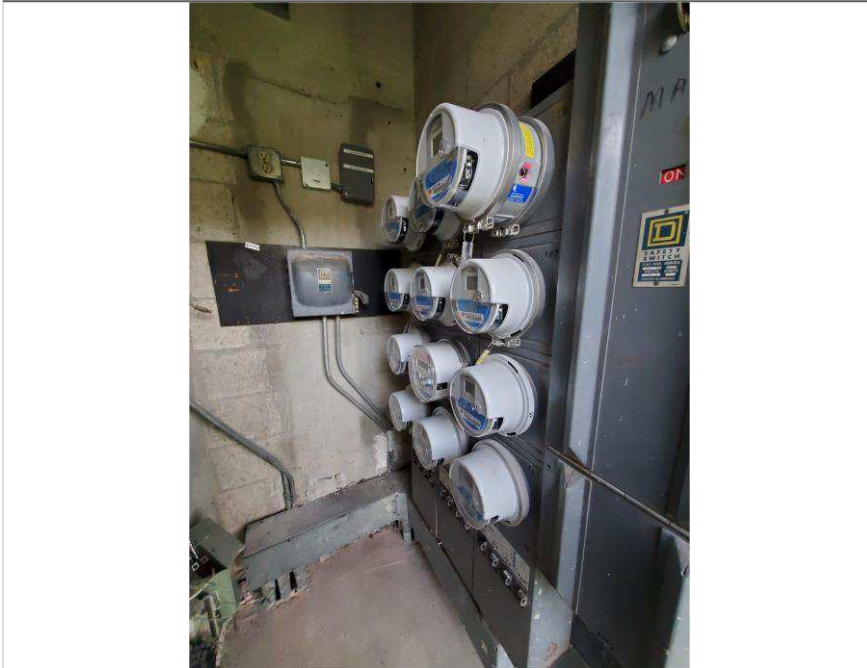
Photo 8 – Village of Dadeland Condominium Association

Existing Electrical Room - 1st FL  
Main Switches for Apartments, Meters, and Gutter.

Old and oxidized meter stacks.

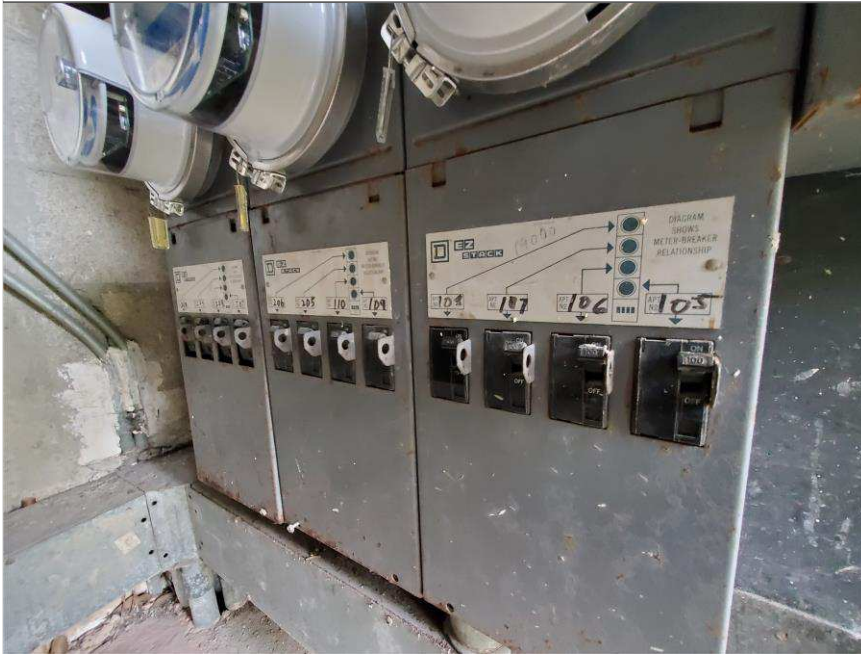
Photo 9 – Village of Dadeland Condominium Association

Existing Electrical Room - 1st FL  
Apartment Meters and Main  
Switches

Old and oxidized meter stacks  
and breakers.

House Meter not labeled.  
All meters to be clearly labeled.

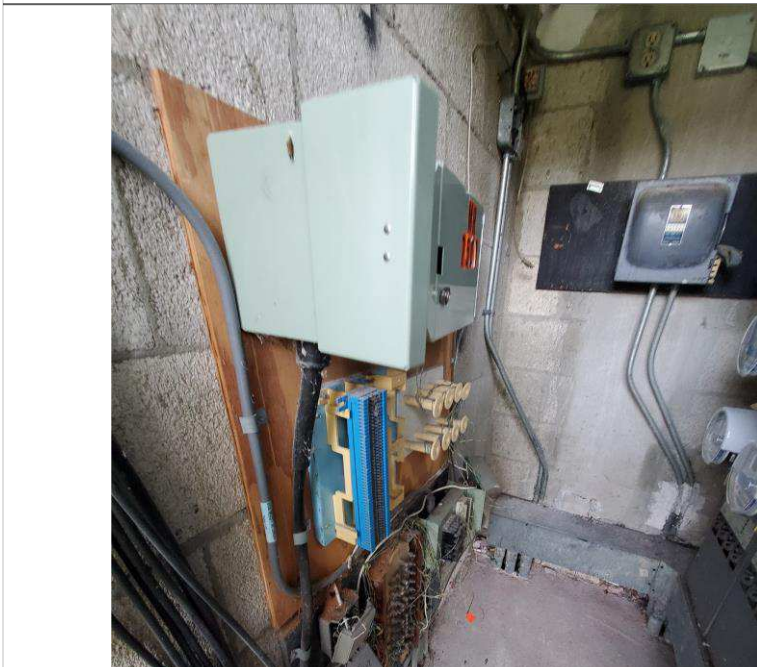
Photo 10 – Village of Dadeland Condominium Association

Existing Electrical Room - 1st FL

Oxidized conduits.

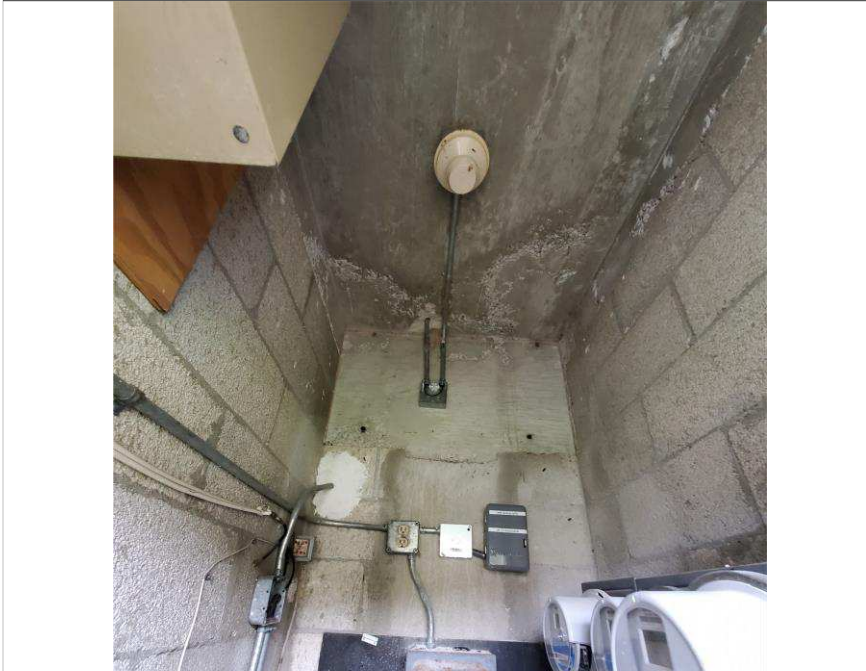
Photo 11 – Village of Dadeland Condominium Association

Existing Electrical Room - 1st FL

Old smoke detector.

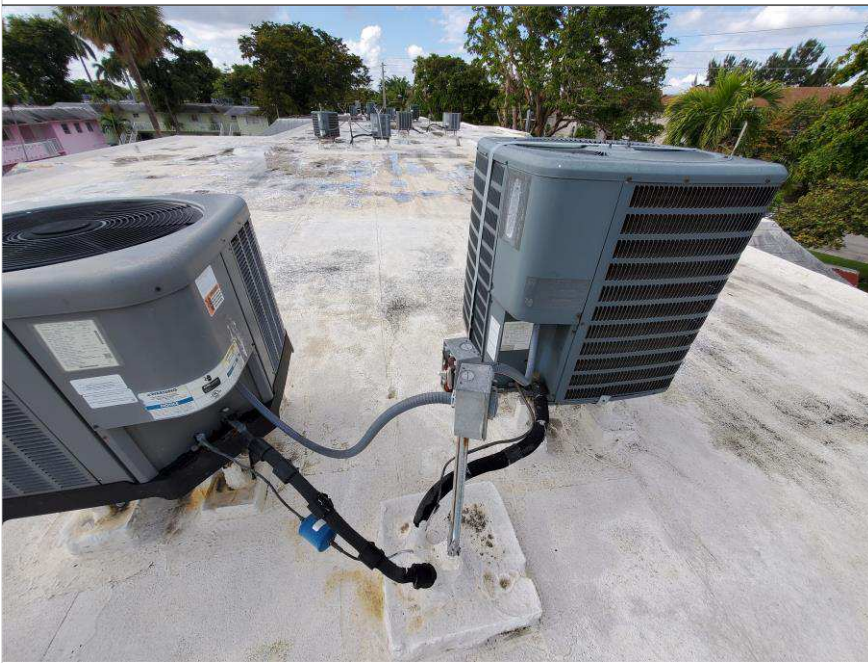
Photo 14 – Village of Dadeland Condominium Association

Rooftop Condenser Units -  
Oxidized junction boxes and  
conduits.

Junction boxes not properly  
supported.

Missing disconnect switches.

Open electrical boxes.

Comments: 1. Mechanical Rooftop Equipment - Repairs/Replacement Required at all oxidized electrical disconnect boxes, supports, and conduit. All disconnect switches are to be operable and inside electrical components rust free. 2. All Rooftop Mechanical Equipment and Disconnect Switches to be properly identified.

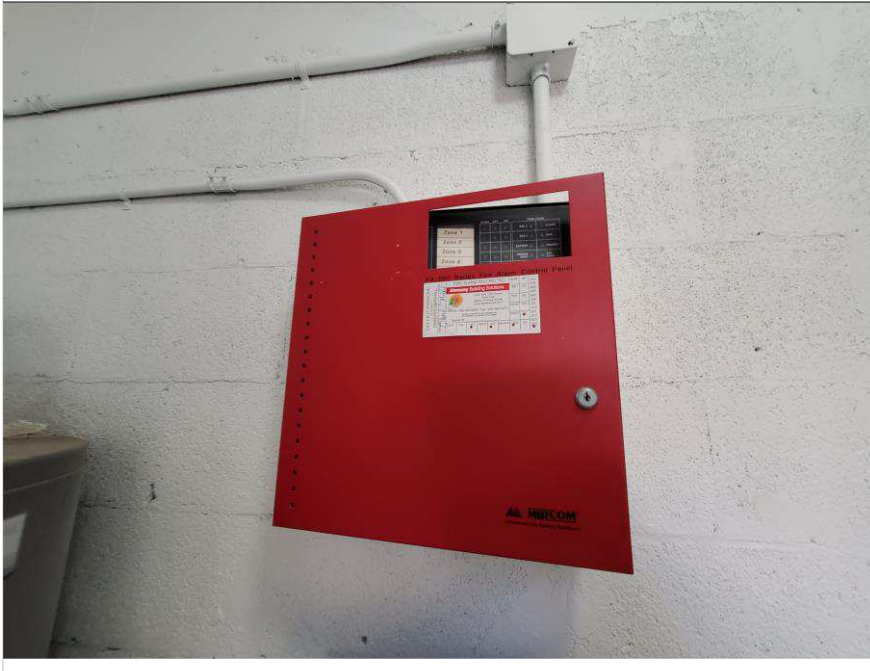
Photo 15 – Village of Dadeland Condominium Association

1st FL - Laundry/Water Heater  
Room  
Fire Alarm Panel

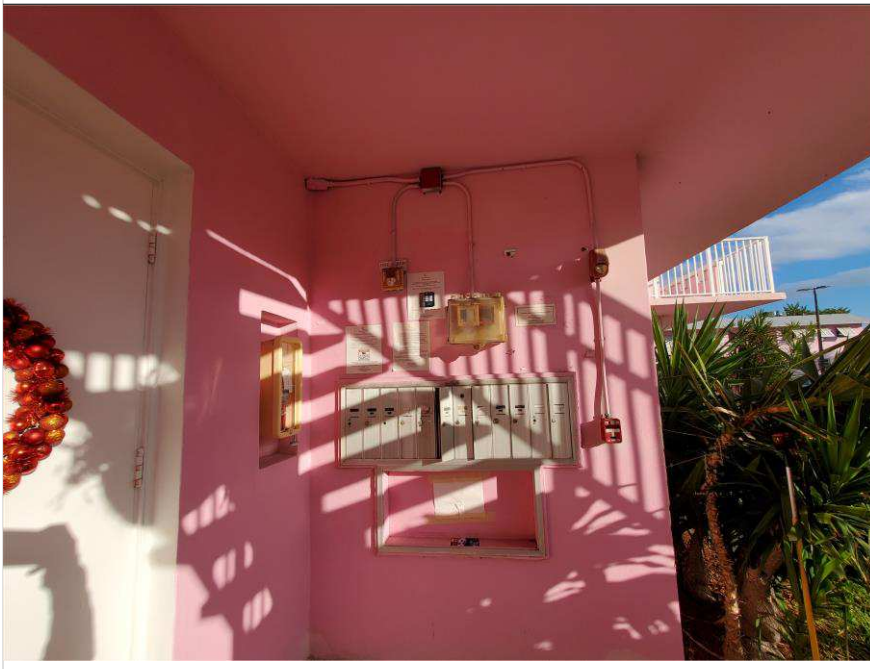
Photo 16 – Village of Dadeland Condominium Association

Level 1  
Fire Alarm - Old and Weathered  
Fire Alarm Devices and Control  
Center

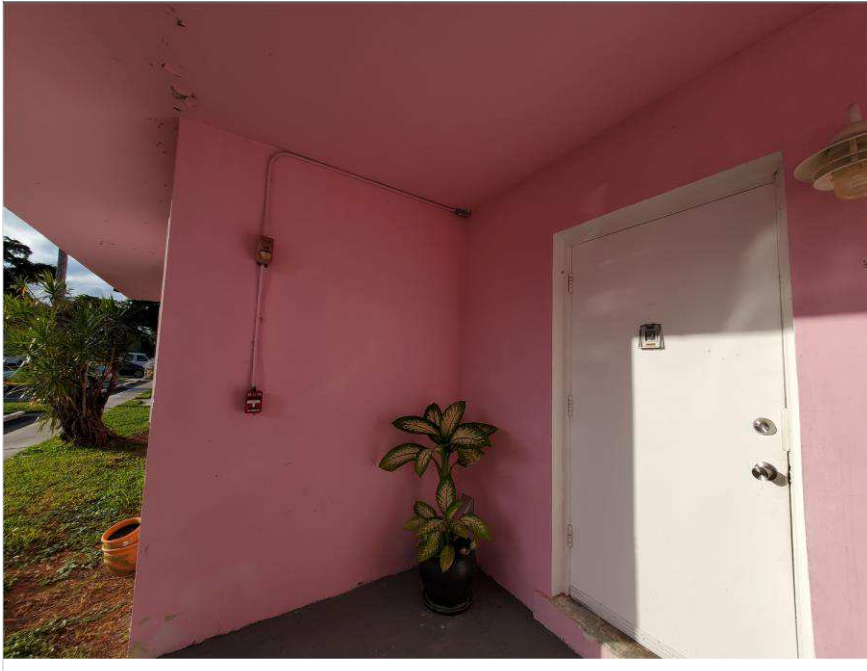
Photo 17 – Village of Dadeland Condominium Association

Level 1

Fire Alarm - Old and Weathered  
Fire Alarm Devices and Control  
Center

Old Strobe Horn/Strobe Device  
and Pull Stations

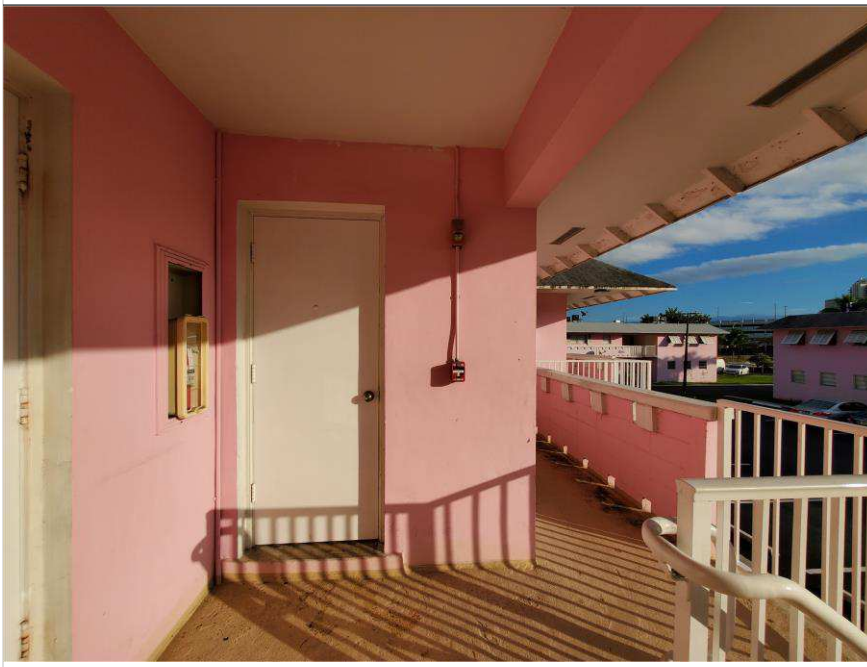
Photo 18 – Village of Dadeland Condominium Association

Level 2

Fire Alarm - Old and Weathered  
Fire Alarm Devices and Control  
Center

Old Strobe Horn/Strobe Device  
and Pull Stations

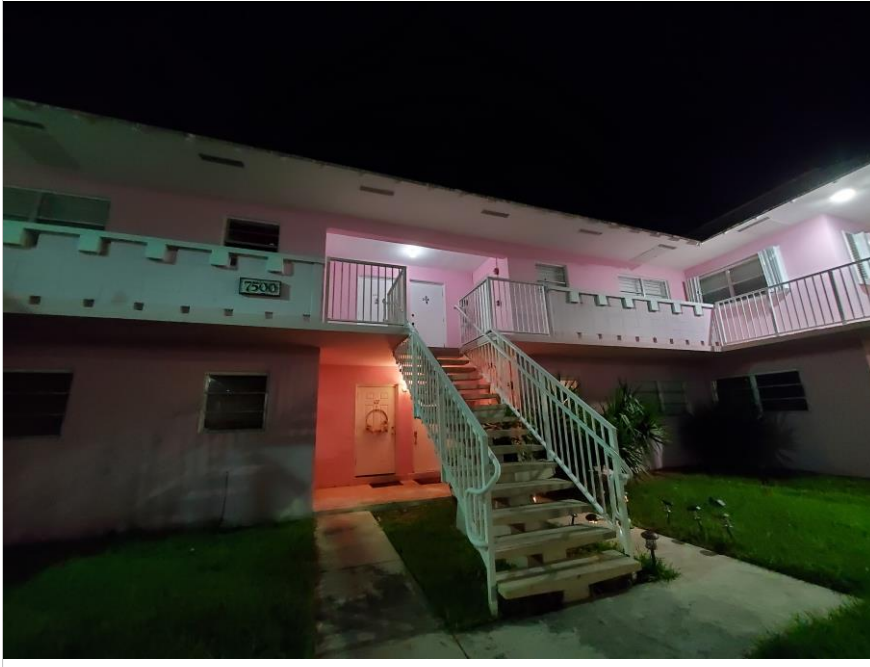
Photo 19 – Village of Dadeland Condominium Association

Egress Components  
Poorly illuminated Catwalks and  
Points of Egress.  
Exterior lights are not functional.

Insufficient illumination at Stairs  
sidewalk, and Catwalks.

Comments: Open parking areas have low illumination levels creating unsafe conditions and security concerns. Additional lighting is required to illuminate the parking walking surfaces for safety and security purposes. Parking light mounted on building is out - Repairs Required.

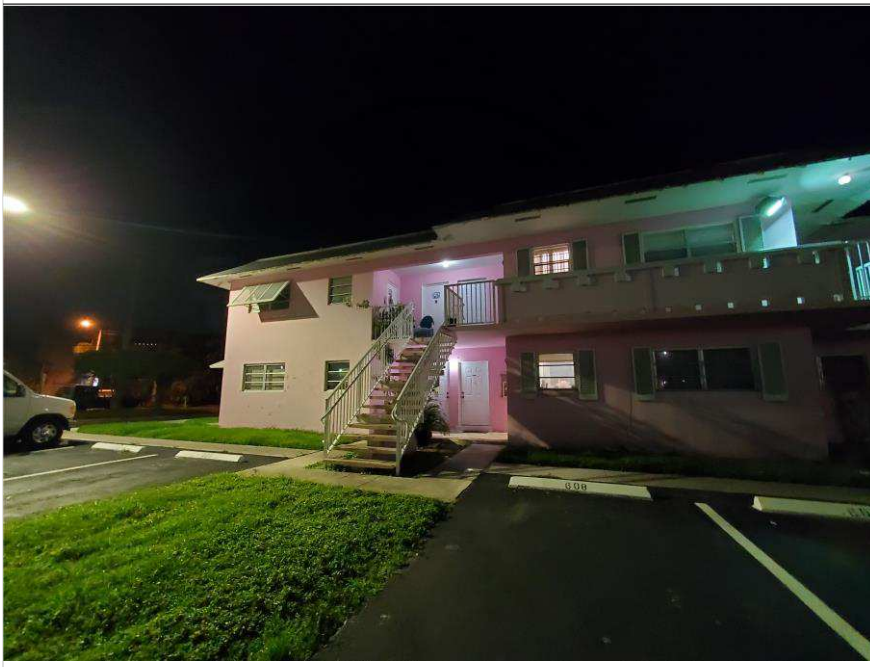
Photo 20 – Village of Dadeland Condominium Association

Egress Components  
Poorly illuminated Catwalks and  
Points of Egress.  
Exterior lights are not functional.

Insufficient illumination at Stairs  
sidewalk, and Catwalks.

Parking  
Insufficient illumination at  
sidewalks and parking areas.

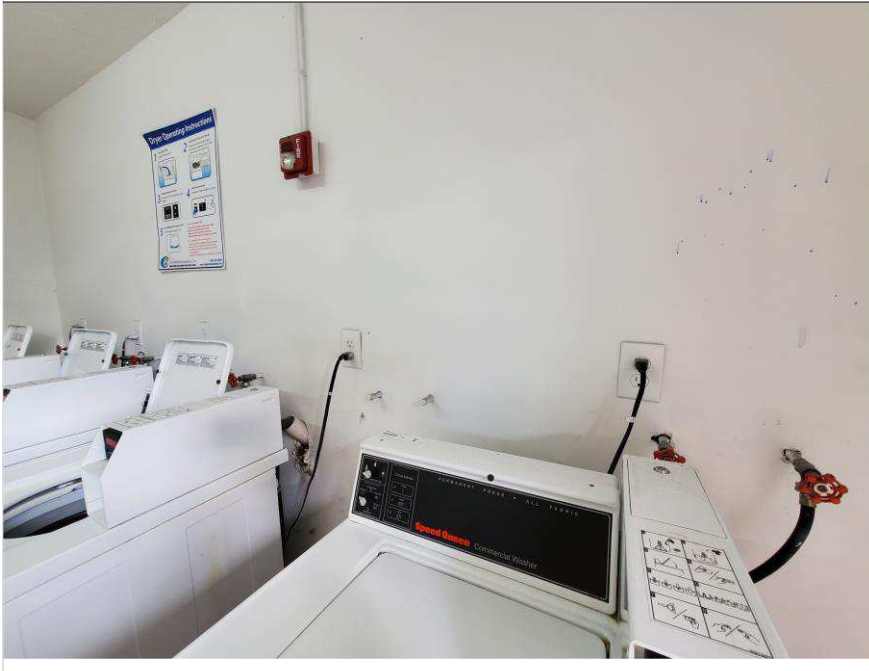
Photo 21 – Village of Dadeland Condominium Association

Laundry Room - Outlets are not GFCI type.

18. Outlets in laundry room and water heater room are not GFCI - Repairs Required.

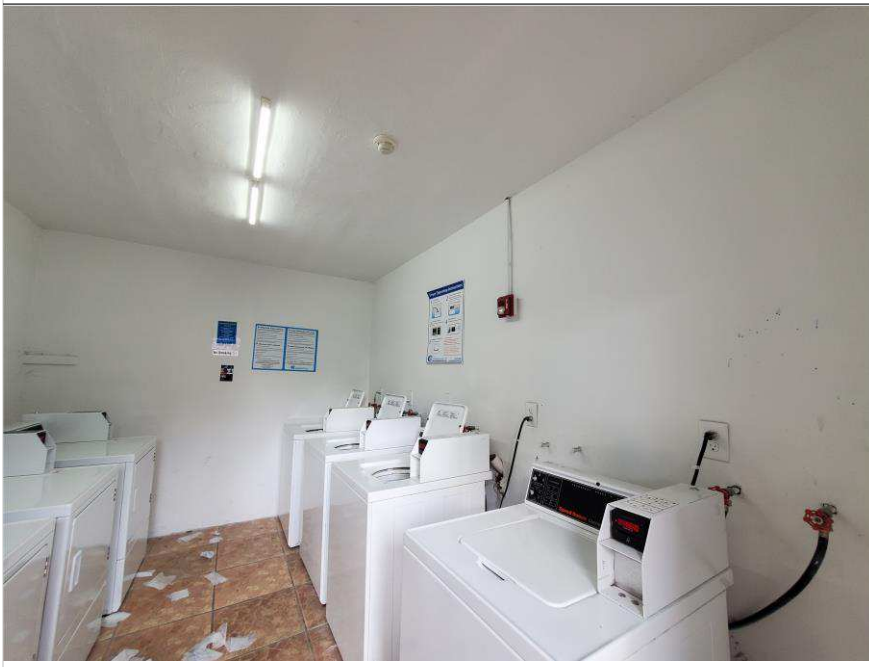
Photo 22 – Village of Dadeland Condominium Association

Laundry Room -  
Old smoke detector.

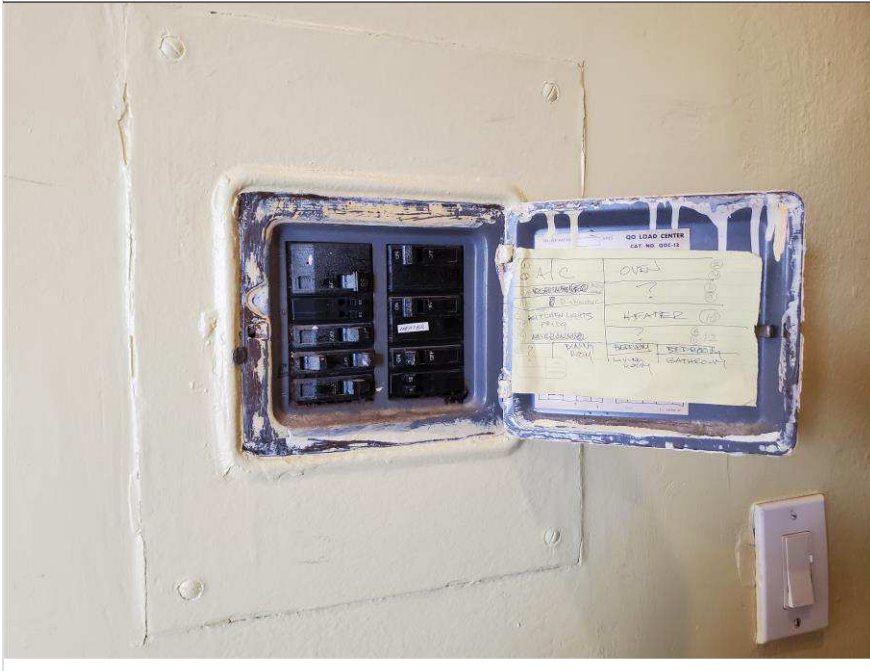
Photo 23 – Village of Dadeland Condominium Association

Apartments - Old Electrical Panels

8. Not all balcony and/or patio outlets are WP type, Repairs Required.
9. Electrical Panels in the apartments have considerable oxidation and are to be replaced.

14. All electrical panels installed 40 years or later, even though in good working order has passed its useful life and is recommended to be replaced.

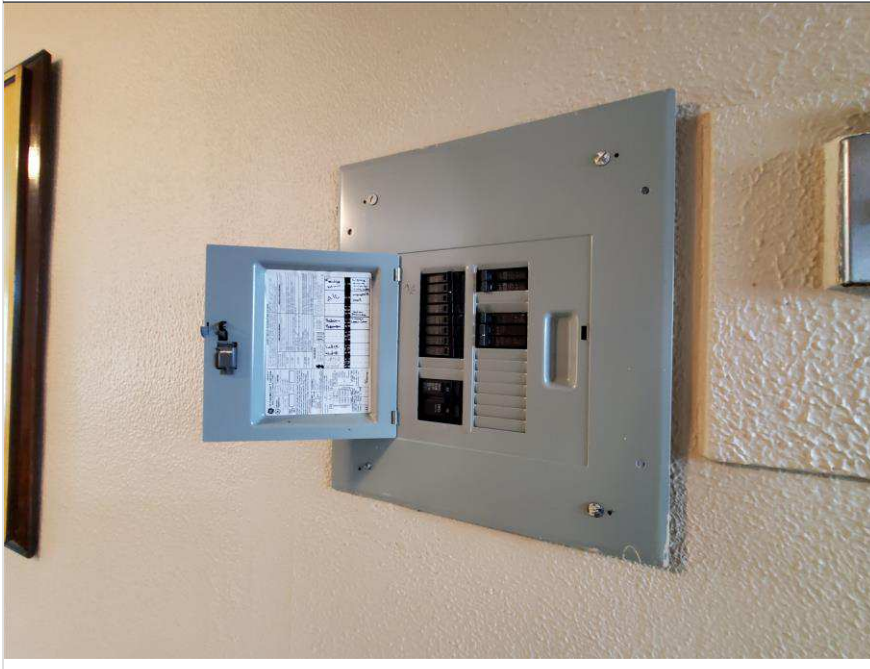
Photo 24 – Village of Dadeland Condominium Association

Apartments - Electrical Panels

Panel cover and panel box are not set properly leaving excessive space around breakers.

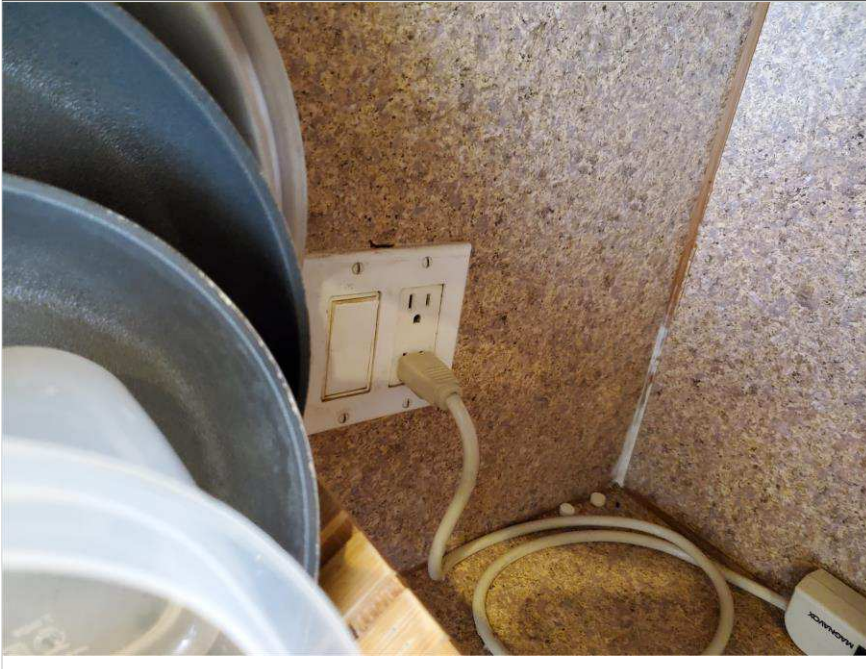
Photo 25 – Village of Dadeland Condominium Association

Apartments - Kitchen outlets  
not GFCI type.

3. Unit G207 - Kitchen outlets are not GFCI type, Repairs Required
4. All Kitchen Island outlets are to be GFCI type, Repairs Required
5. Electrical outlets that have an open ground and/or are hot are to be repaired.

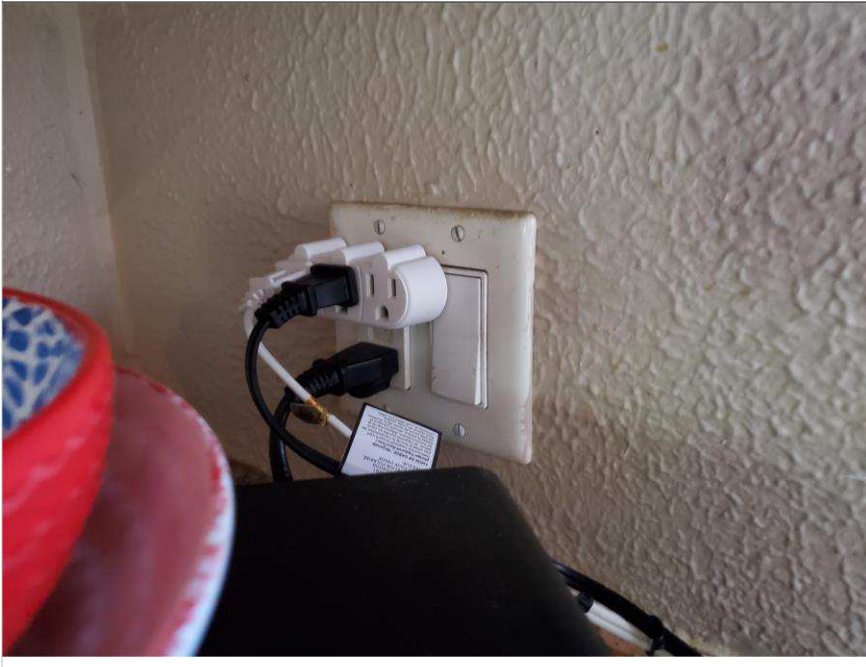
Photo 26 – Village of Dadeland Condominium Association

Apartments - Balcony/Patio  
outlets not GFCI type.

6. All Balcony and Patio outlets to be GFCI type and should be installed with a HD waterproof enclosure.
7. Not all balcony and/or patio outlets are GFCI type outlets, Repairs Required.

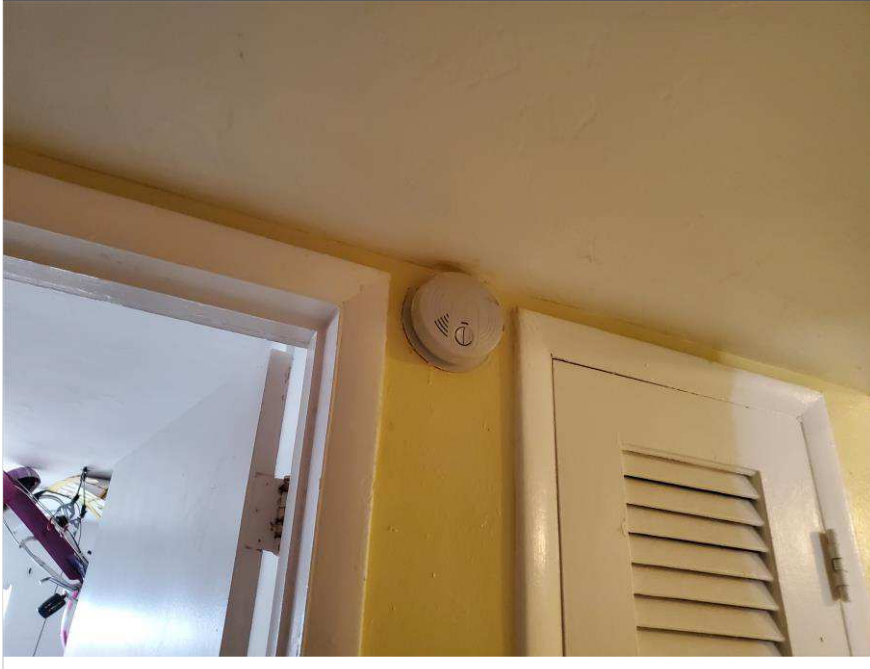
Photo 27 – Village of Dadeland Condominium Association

Apartments - Old Smoke  
Detectors

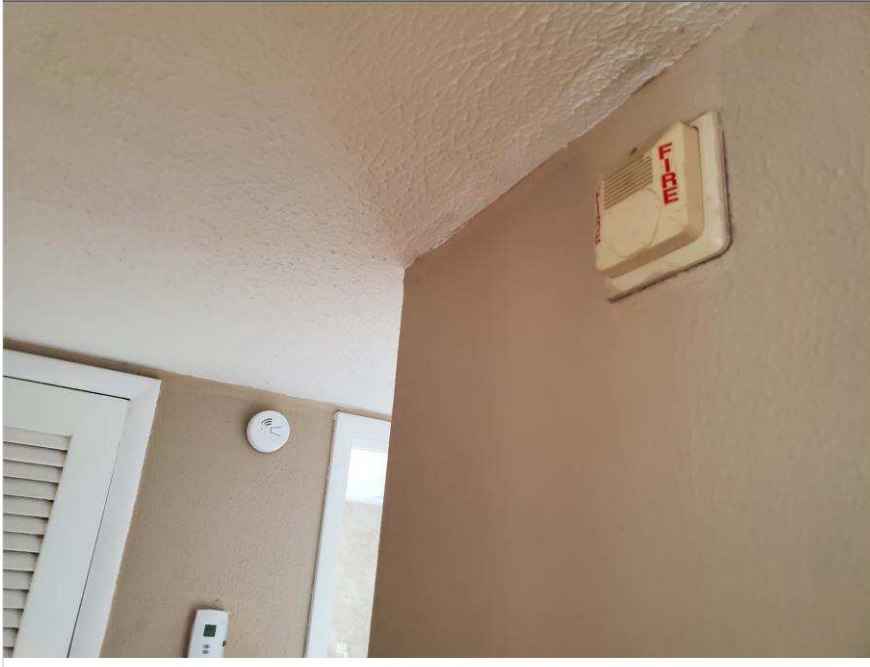
Photo 28 – Village of Dadeland Condominium Association

Apartments - Fire Alarm System

Old Devices exceeding useful  
life.

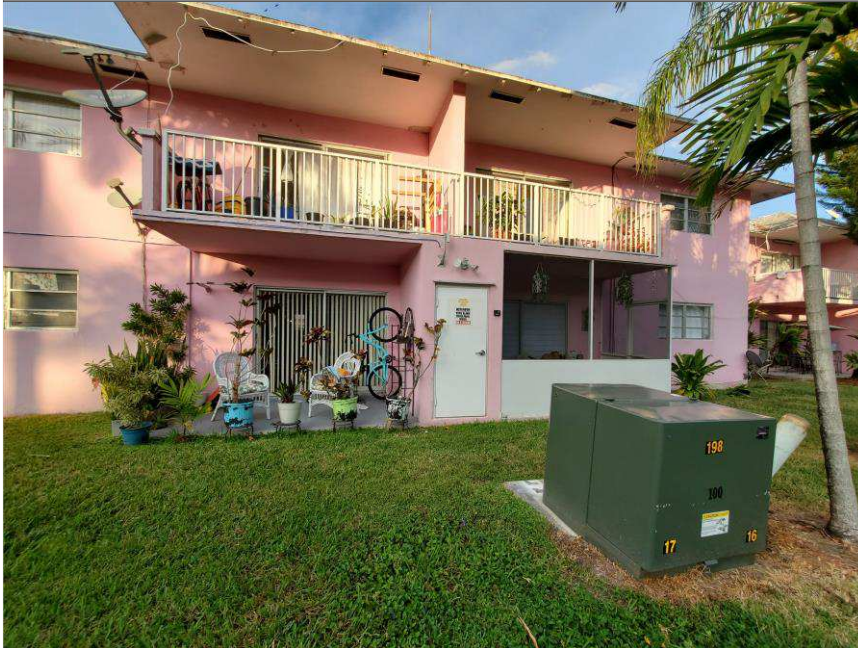
Photo 1 – Village of Dadeland Condominium Association

Existing Electrical Room - 1st FL  
Provide sign with Building  
Number

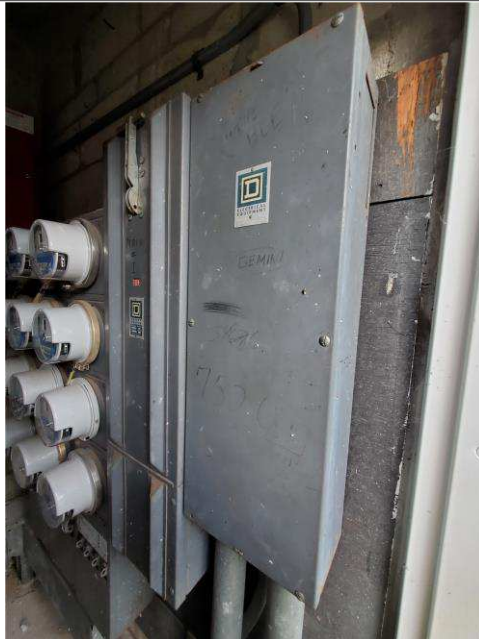
Photo 3 – Village of Dadeland Condominium Association

Existing Electrical Room - 1st FL  
Building Main Disconnect is  
corroded.  
50 year old electrical  
component.

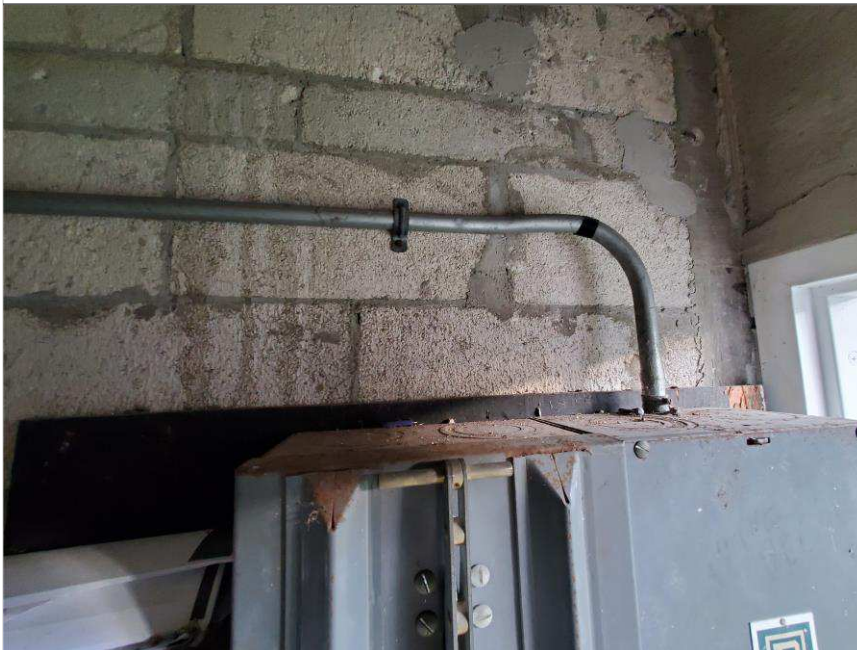
Photo 4 – Village of Dadeland Condominium Association

Existing Electrical Room - 1st FL  
Building Main Disconnect is  
corroded.  
50 year old electrical  
component.

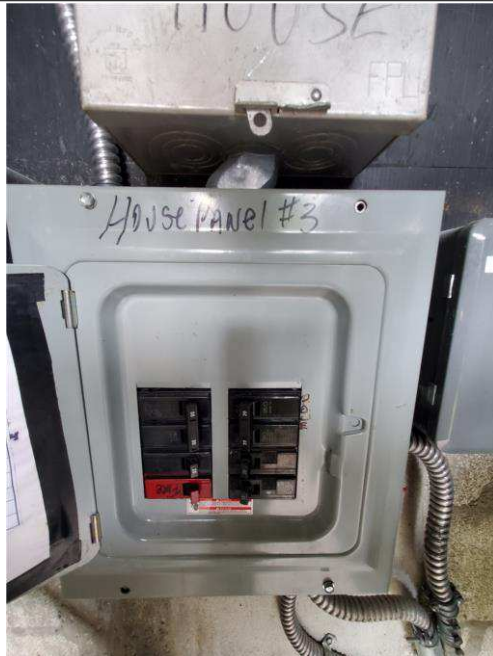
Photo 6 – Village of Dadeland Condominium Association

Existing Electrical Room - 1st FL  
House Panel Board and  
breakers.

Panel nameplate is covered.

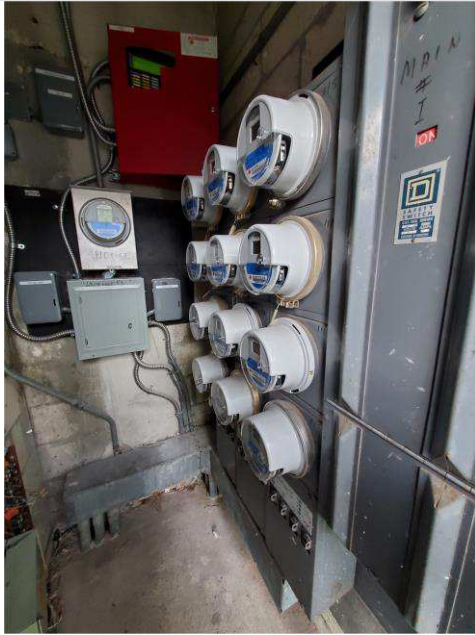
Photo 7 – Village of Dadeland Condominium Association

Existing Electrical Room - 1st FL  
Apartment Meters and Gutter

Old and corroded meter stacks.

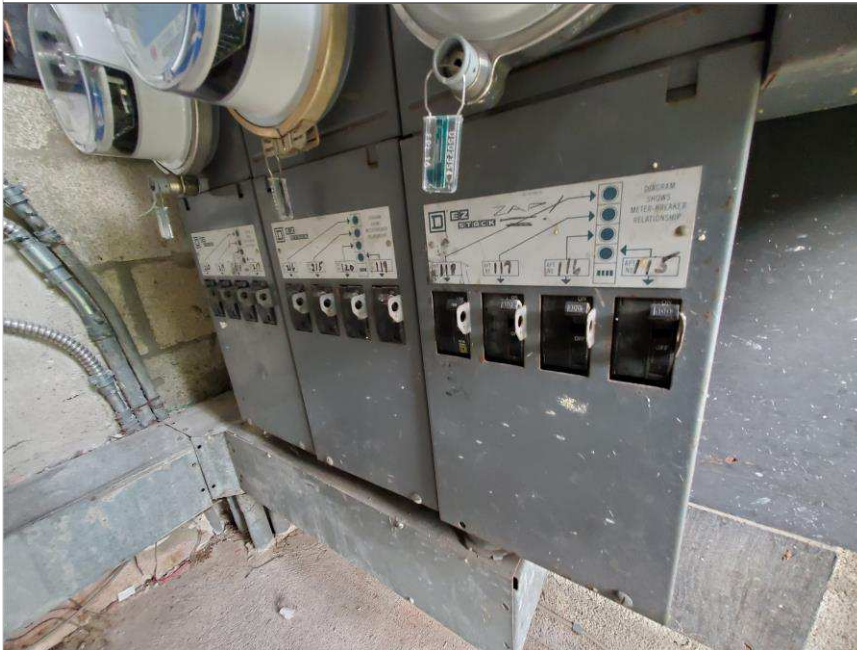
Photo 8 – Village of Dadeland Condominium Association

Existing Electrical Room - 1st FL  
Apartment Meters and Main  
Switches

Old and corroded meter stacks.

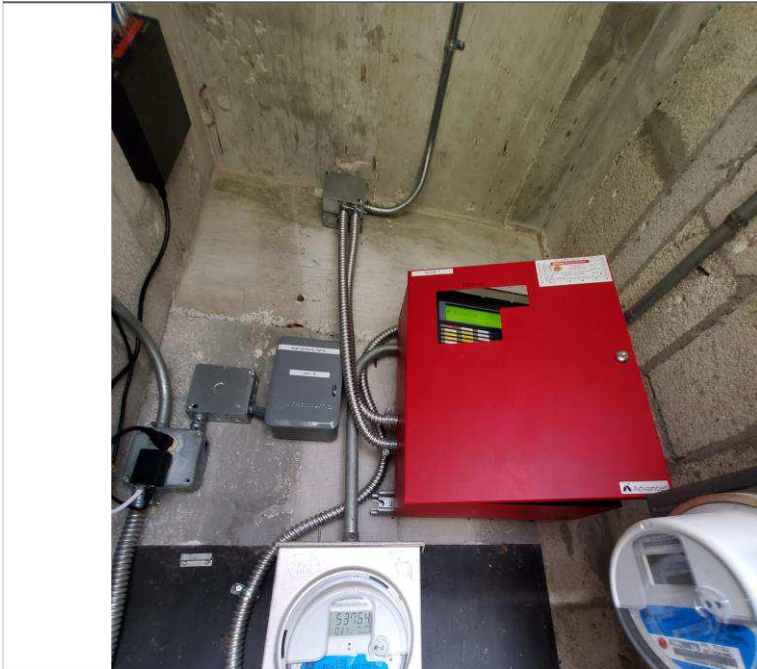
Photo 13 – Village of Dadeland Condominium Association

Existing Electrical Room - 1st FL  
Fire Alarm Panel

Panel is installed high.

All penetrations or openings in  
walls are to be fire caulked.

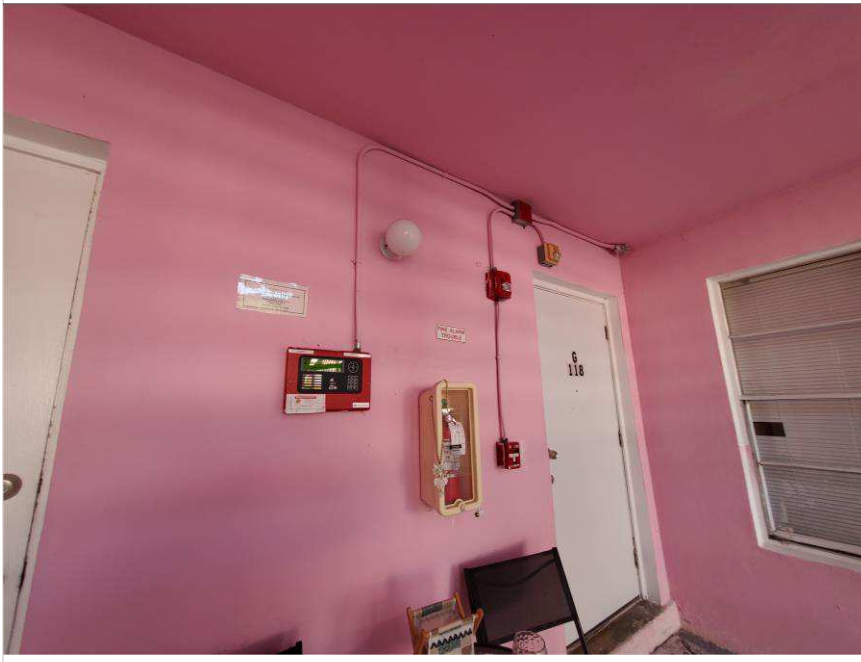
Photo 14 – Village of Dadeland Condominium Association

Level 1  
Fire Alarm - Old and Weathered  
Fire Alarm Devices

Old Strobe Horn/Strobe Device

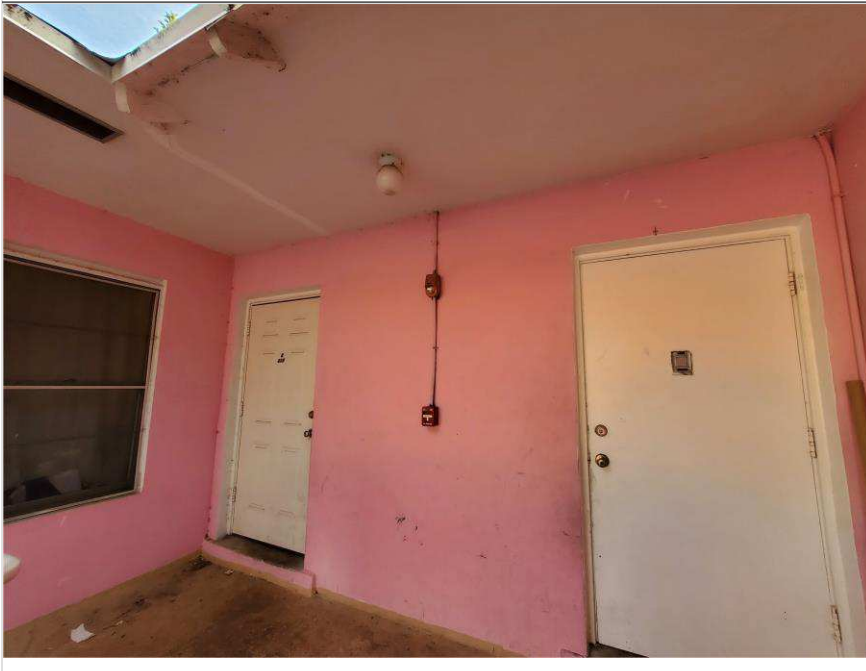
Photo 15 – Village of Dadeland Condominium Association

Level 2

Fire Alarm - Old and Weathered  
Fire Alarm Devices

Old Strobe Horn/Strobe Device  
and Pull Stations

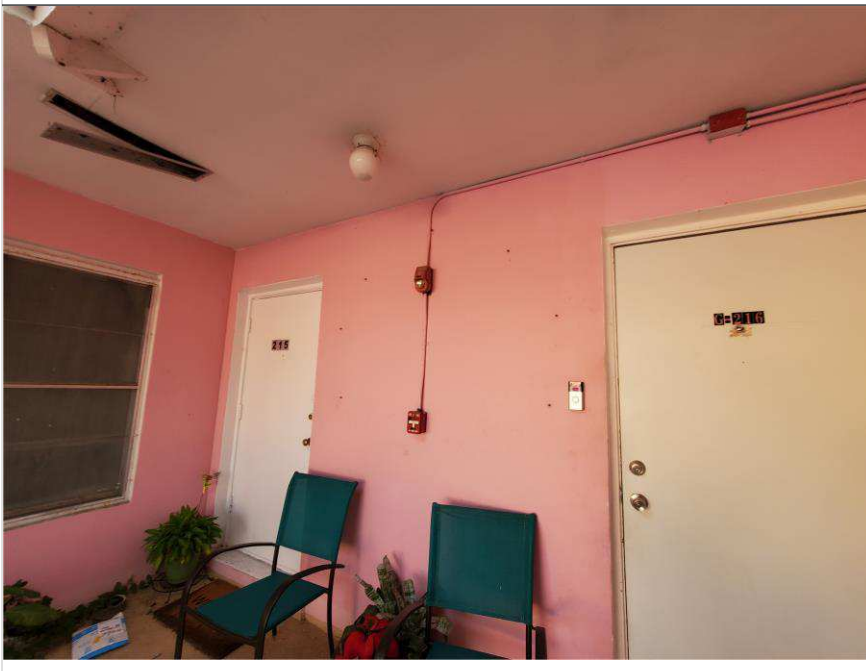
Photo 16 – Village of Dadeland Condominium Association

Level 2

Fire Alarm - Old and Weathered  
Fire Alarm Devices

Old Strobe Horn/Strobe Device  
and Pull Stations

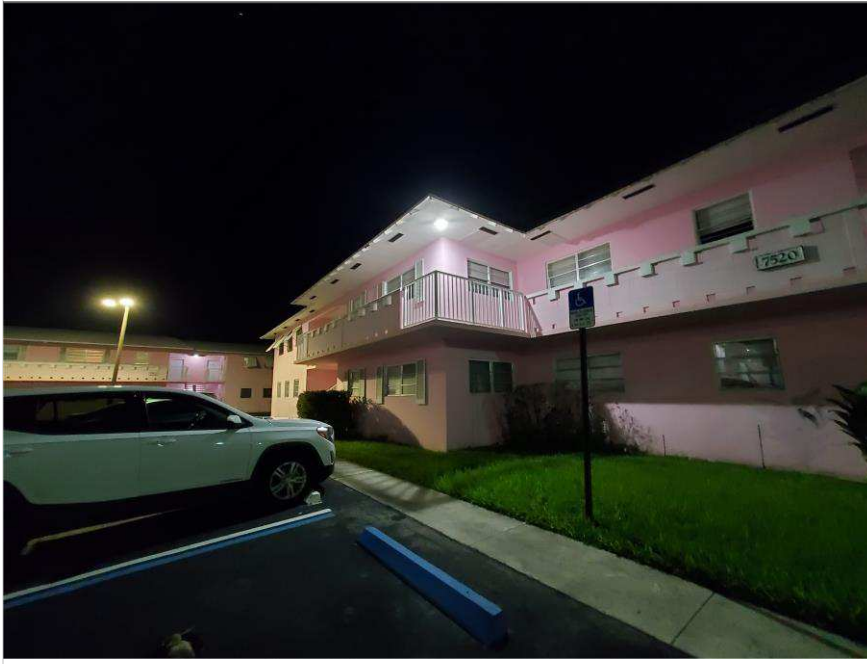
Photo 17 – Village of Dadeland Condominium Association

Parking/Catwalks -

Insufficient illumination at catwalks and sidewalks. Exterior lights are not functional.

Insufficient illumination at Parking Areas

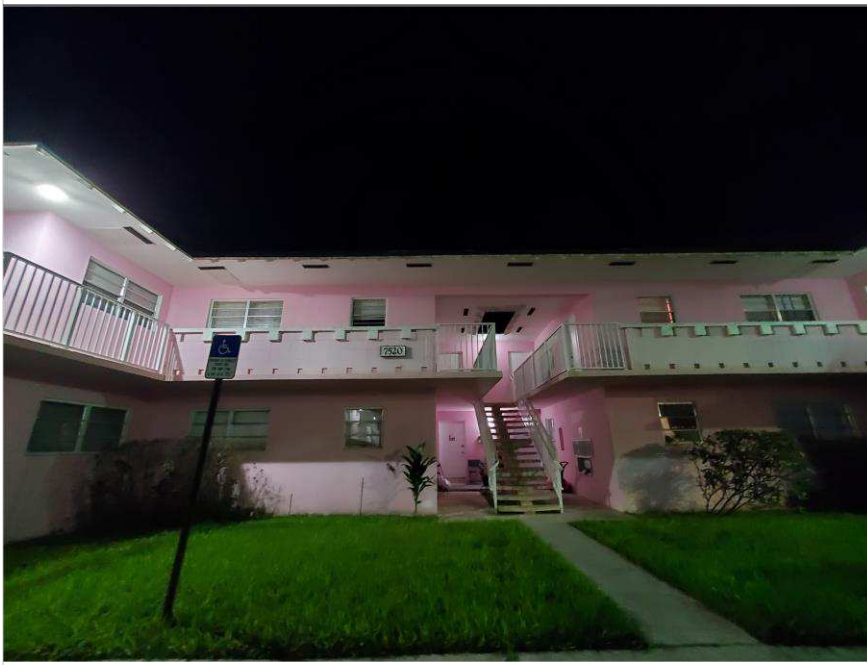
Photo 18 – Village of Dadeland Condominium Association

Points of Egress

Poorly illuminated Areas  
Exterior lights are not functional.

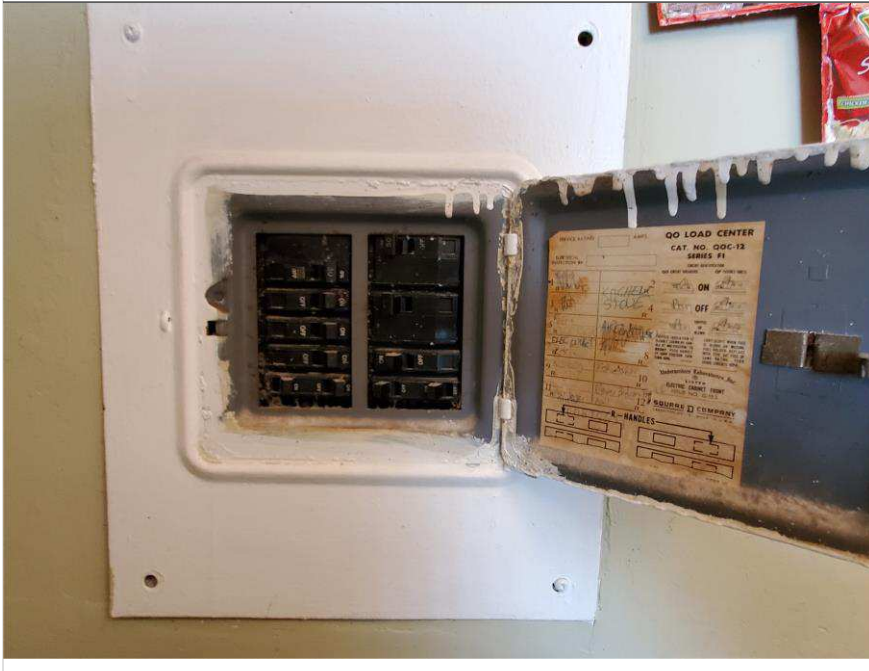
Photo 19 – Village of Dadeland Condominium Association

Apartments - Old Electrical Panels
