MINIMUM INSPECTION PROCEDURAL GUIDELINES  
FOR BUILDING ELECTRICAL RECERTIFICATION

INSPECTION MADE BY: FLORIN FLOREA P.E.

a. Name on Title: Village at Dadeland Condominiums (G)

b. Street Address: 7500 SW 82nd St. Miami, Florida 33143

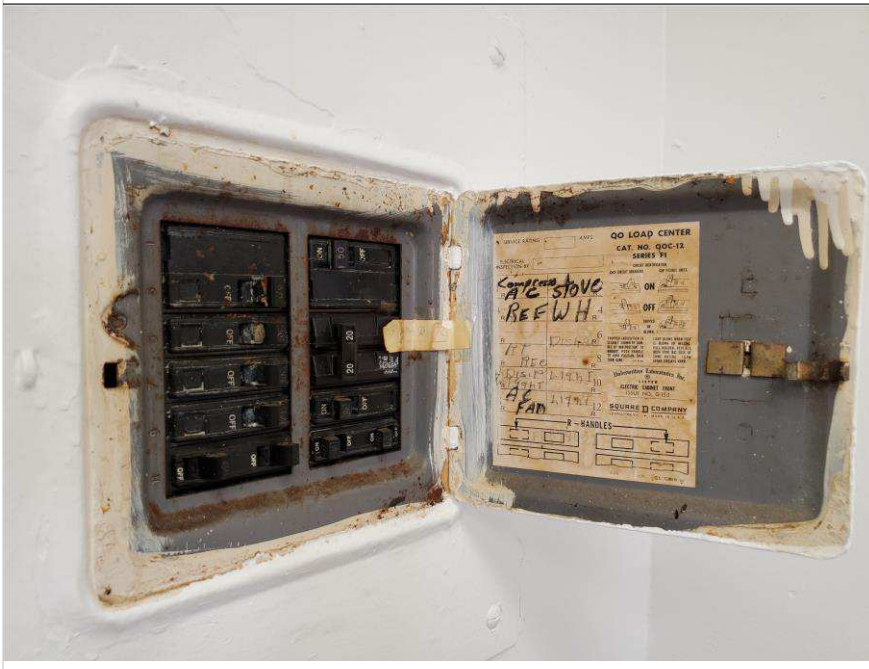
Photo 20 – Village of Dadeland Condominium Association

Apartments - Old Electrical Panels

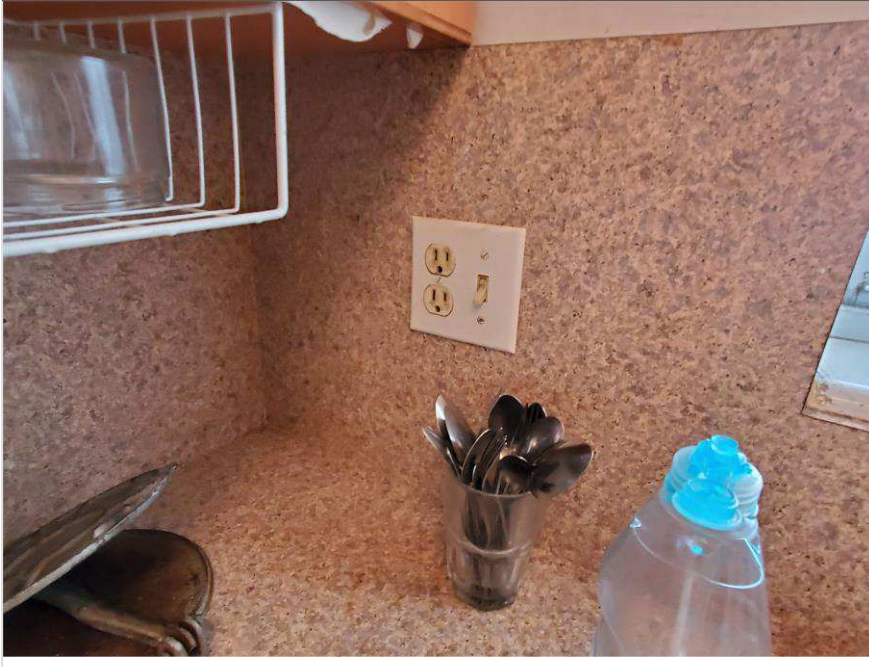
Photo 21 – Village of Dadeland Condominium Association

Apartments - Kitchen outlets  
not GFCI type.

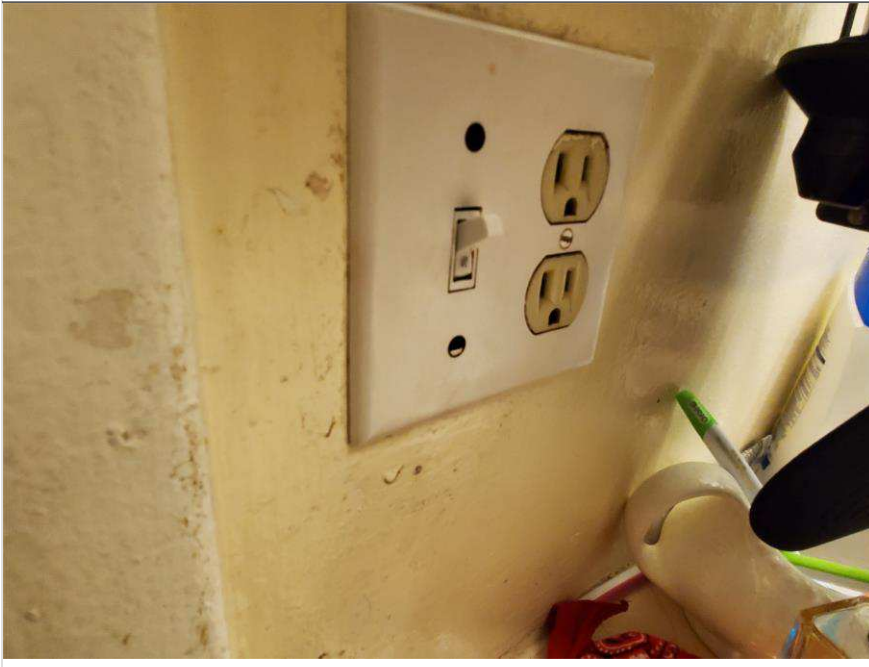
Photo 22 – Village of Dadeland Condominium Association

Apartments - Bathroom outlets  
not GFCI type.

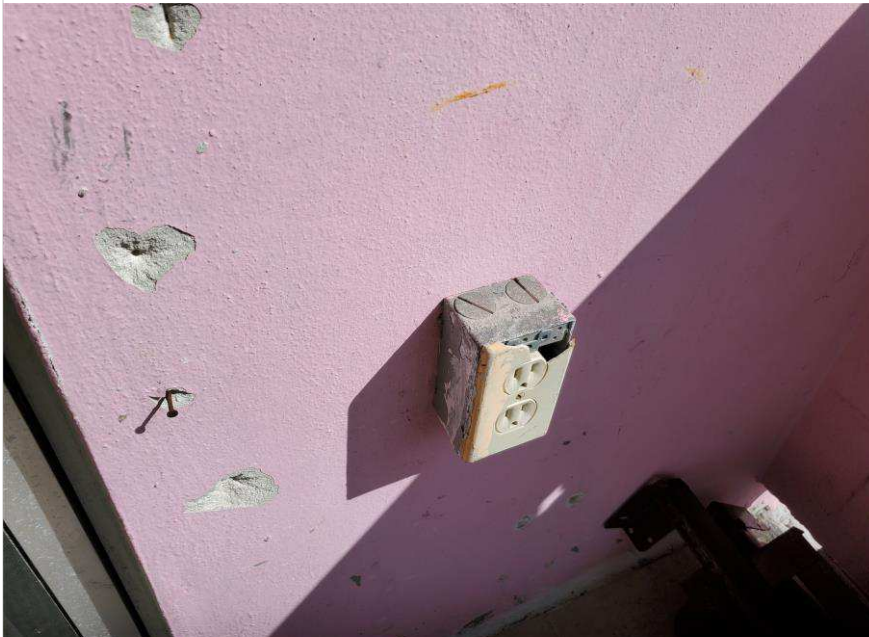
Photo 23 – Village of Dadeland Condominium Association

Apartments - Balcony/Patio outlets not GFCI type.

Outlet is not in a HD waterproof enclosure.

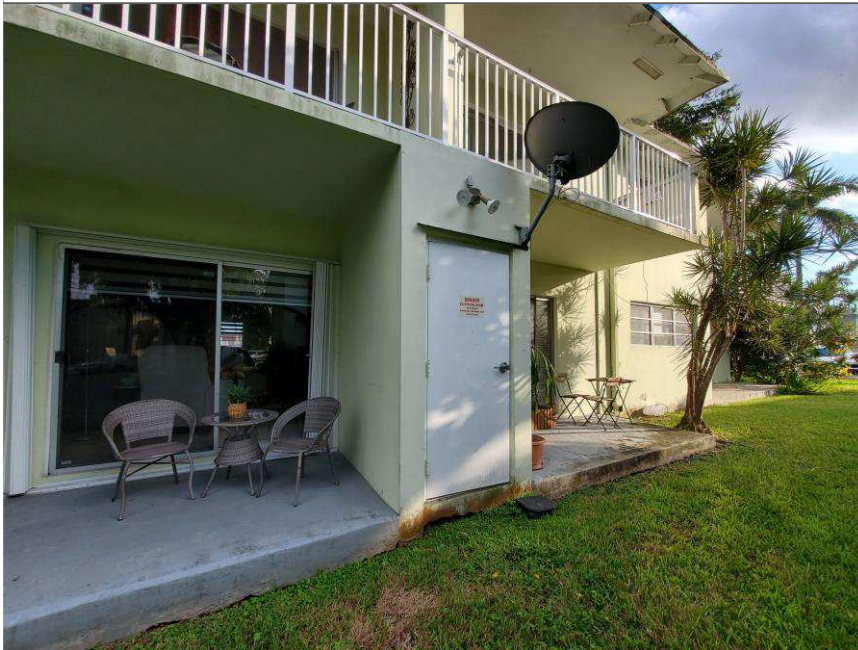
Photo 1 – Village of Dadeland Condominium Association

Existing Electrical Room - 1st FL  
No Storage Permitted

Missing sign with Room name  
and Building number.

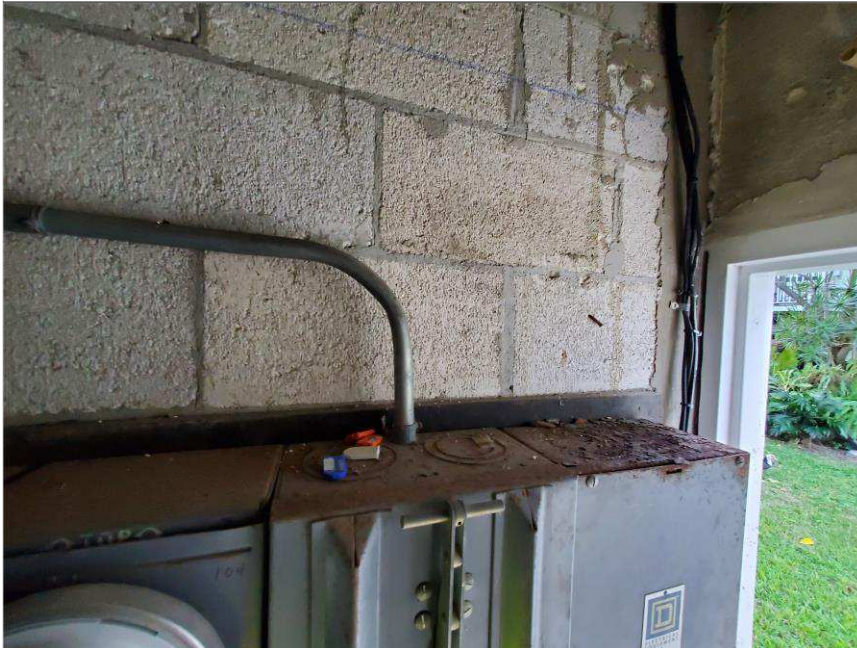
Photo 4 – Village of Dadeland Condominium Association

Existing Electrical Room - 1st FL  
Main Disconnect

Oxidized tops and taps of  
Electrical Components.

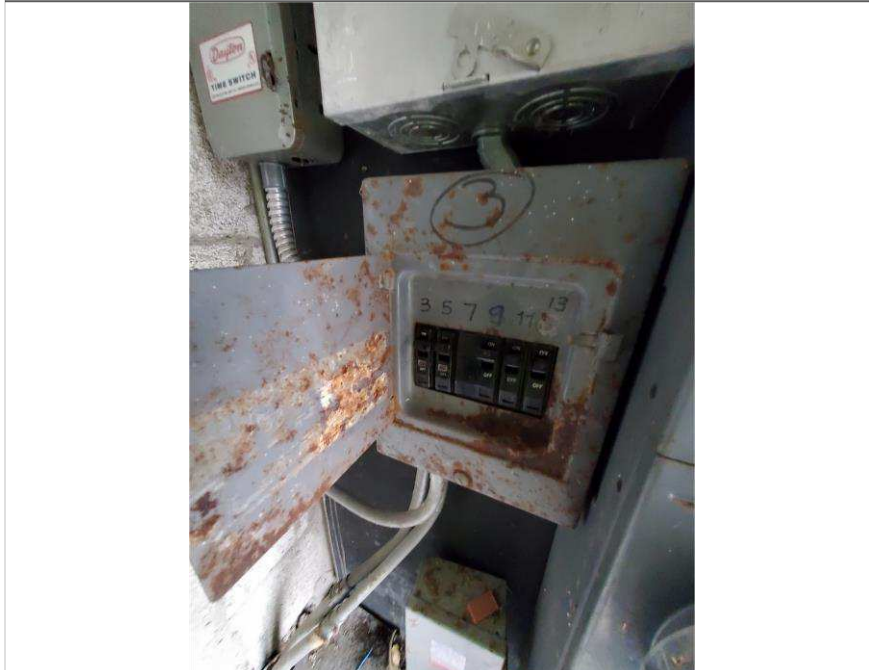
Photo 6 – Village of Dadeland Condominium Association

Existing Electrical Room - 1st FL  
House Panel Board and  
Breakers.

Old and oxidized panel.

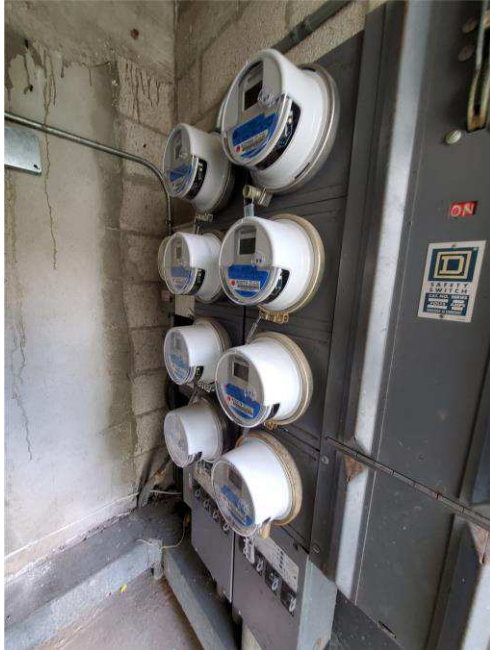
Photo 7 – Village of Dadeland Condominium Association

Existing Electrical Room - 1st FL  
Apartment Meters and Gutter.

Old and corroded meter stacks.

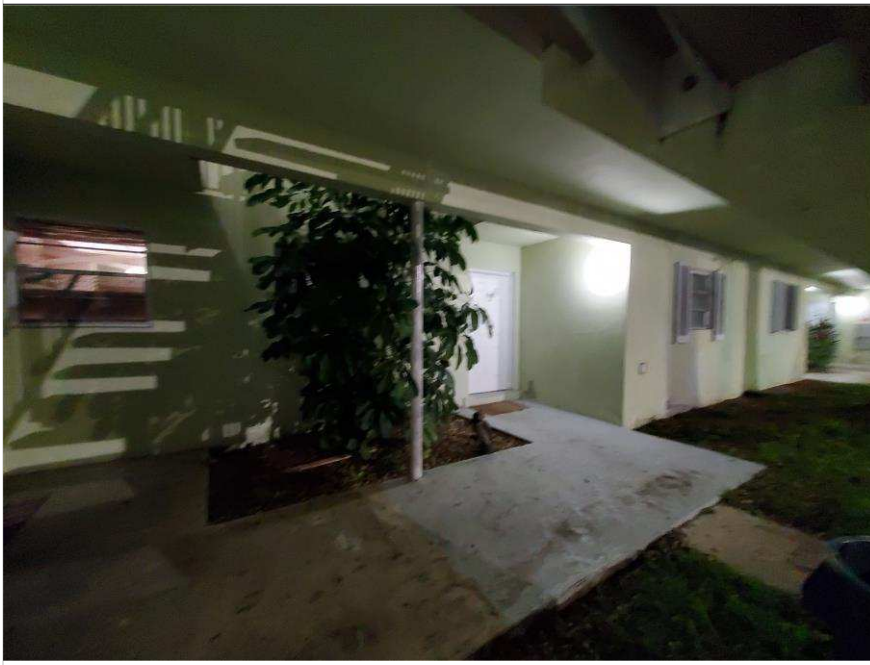
Photo 14 – Village of Dadeland Condominium Association

Points of Egress -  
Poorly illuminated sidewalks  
Exterior lights not functional

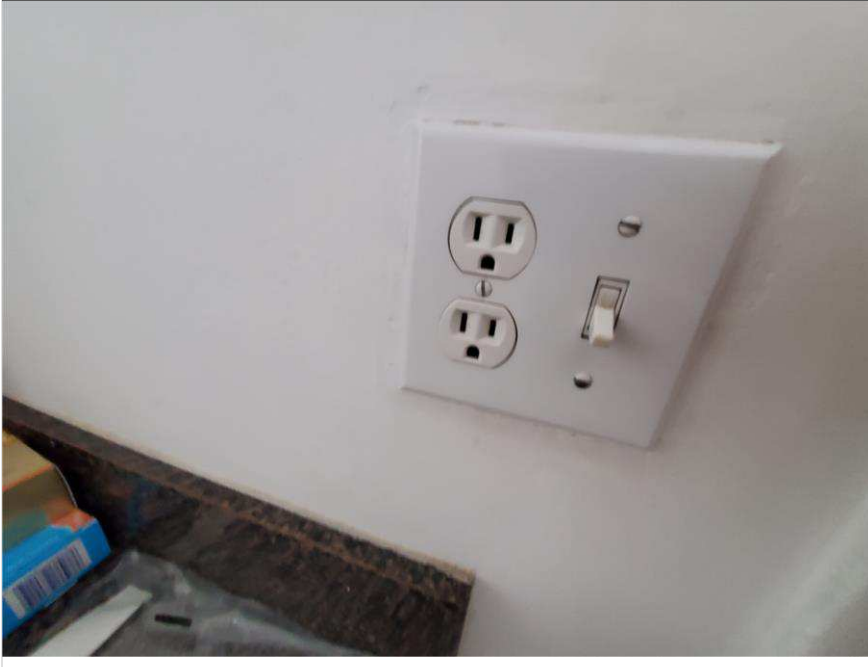
Photo 17 – Village of Dadeland Condominium Association

Apartments - Bathroom outlets  
are not GFCI type.

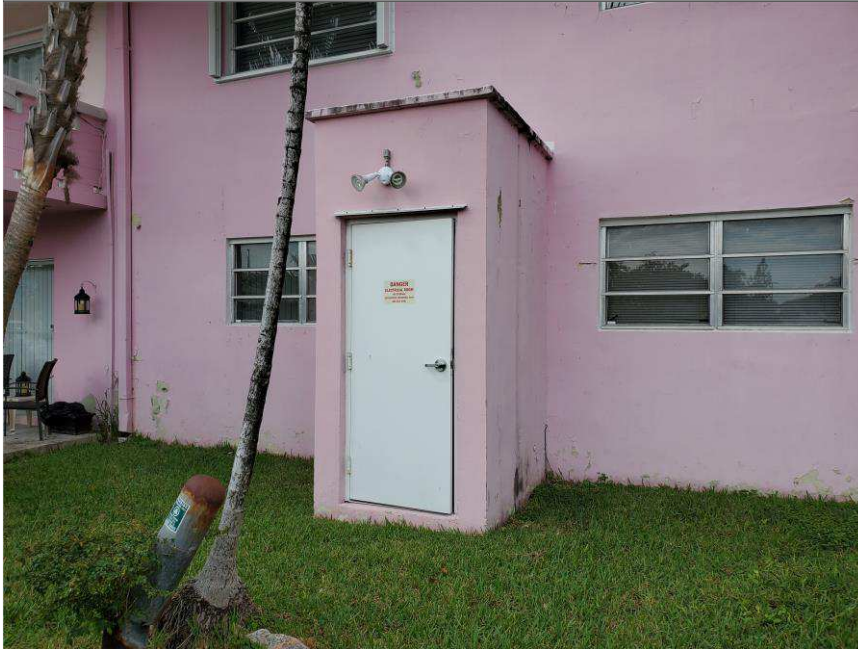
Photo 1 – Village of Dadeland Condominium Association

Existing Electrical Room - 1st FL  
No Storage Permitted

Missing sign with Room name  
and Building number.

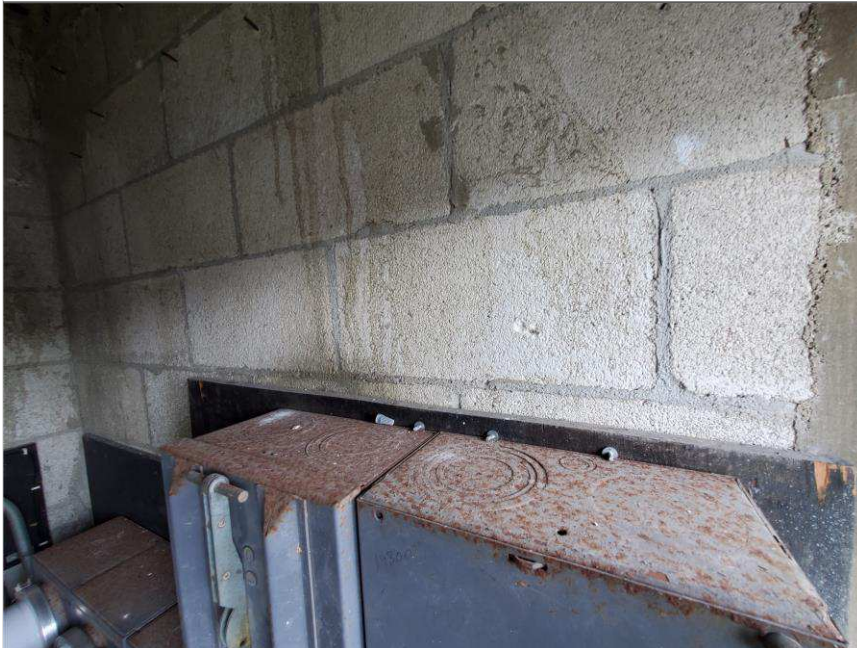
Photo 4 – Village of Dadeland Condominium Association

Existing Electrical Room - 1st FL  
Main Disconnect – Top View

Corroded tops and taps of  
electrical components.

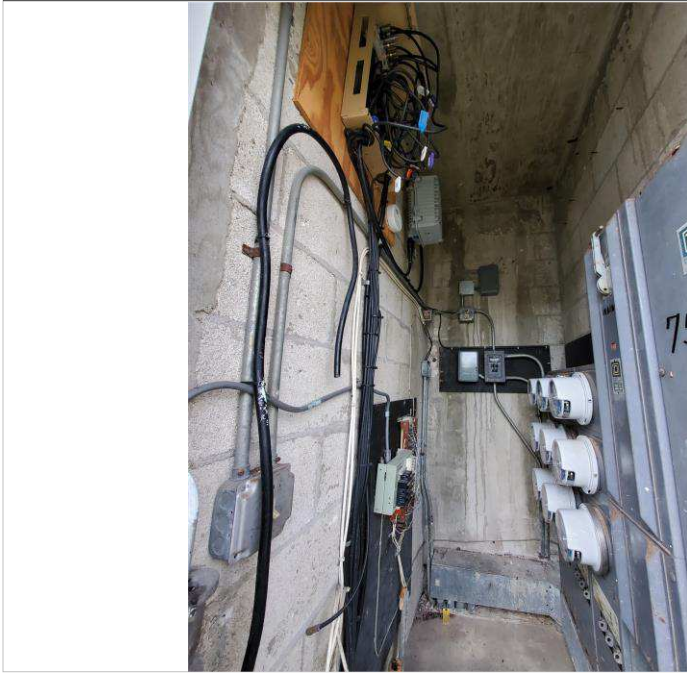
Photo 9 – Village of Dadeland Condominium Association

Existing Electrical Room - 1st FL  
Apartment Meters, Gutter and  
Main Disconnect Switch

Insufficient clearance at  
electrical components.

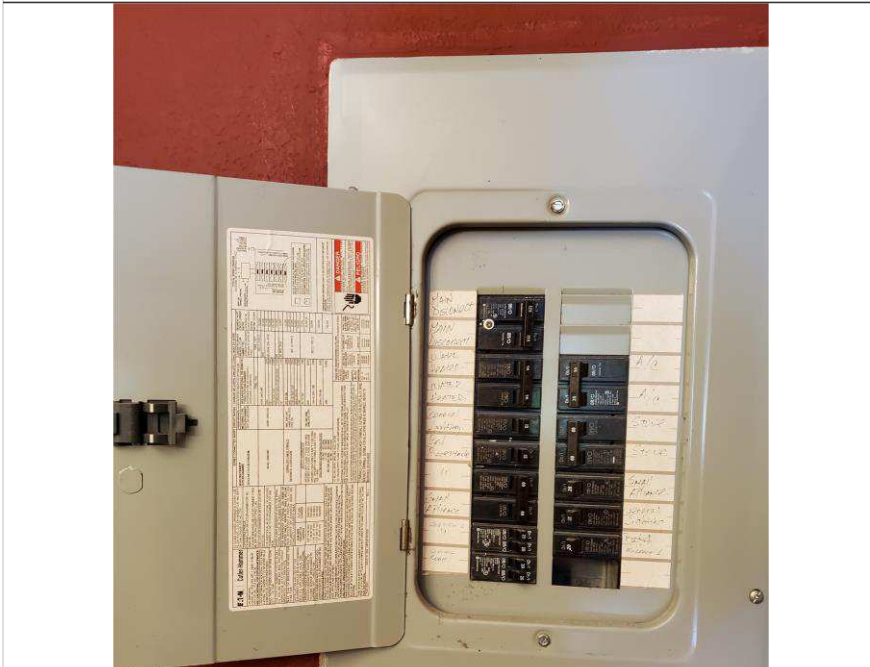
Photo 14 – Village of Dadeland Condominium Association

Apartments - Electrical Panels  
Open breaker slot.

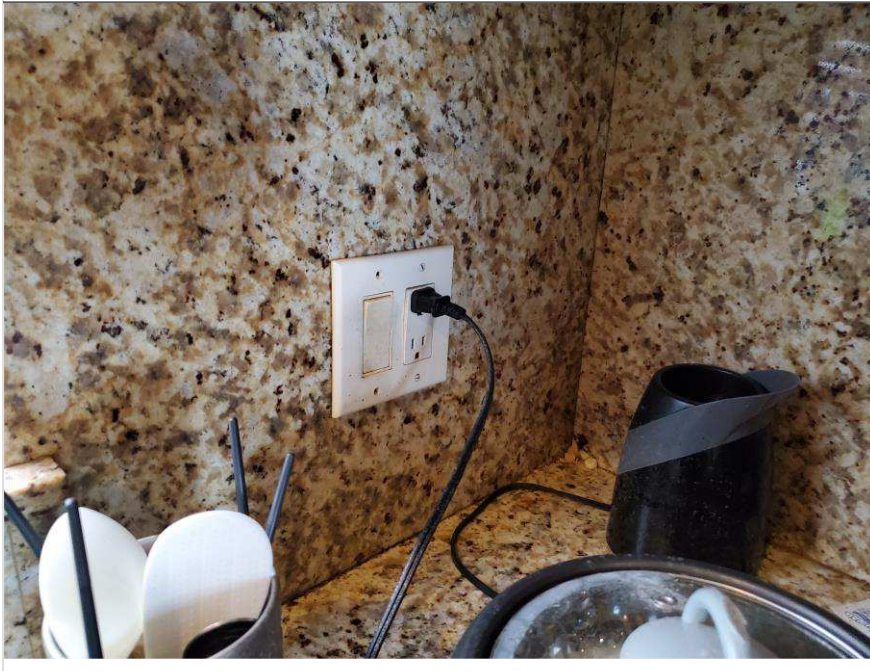
Photo 15 – Village of Dadeland Condominium Association

Apartments - Kitchen outlets are not GFCI type.

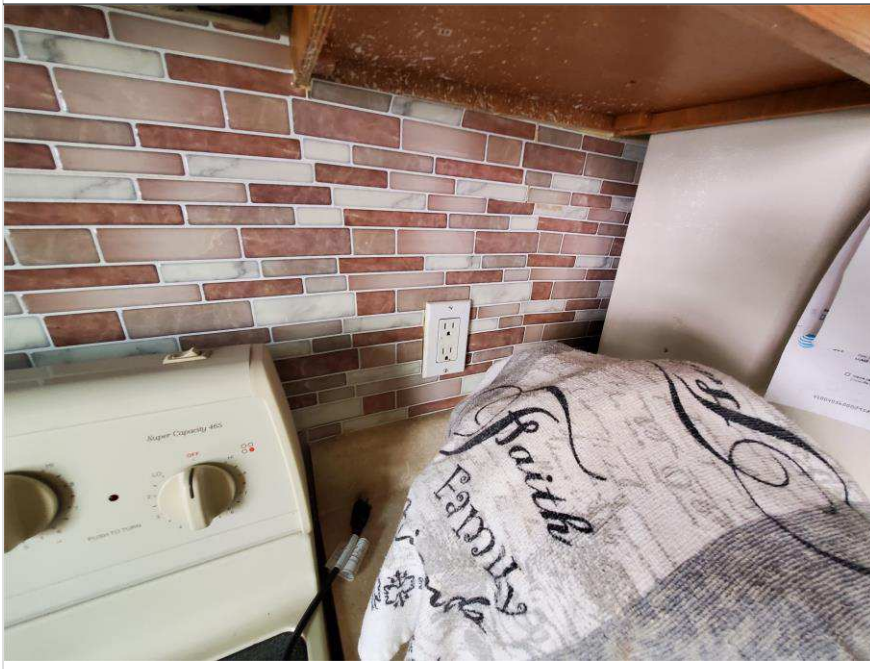
Photo 16 – Village of Dadeland Condominium Association

Apartments - Bathroom outlets are not GFCI type.

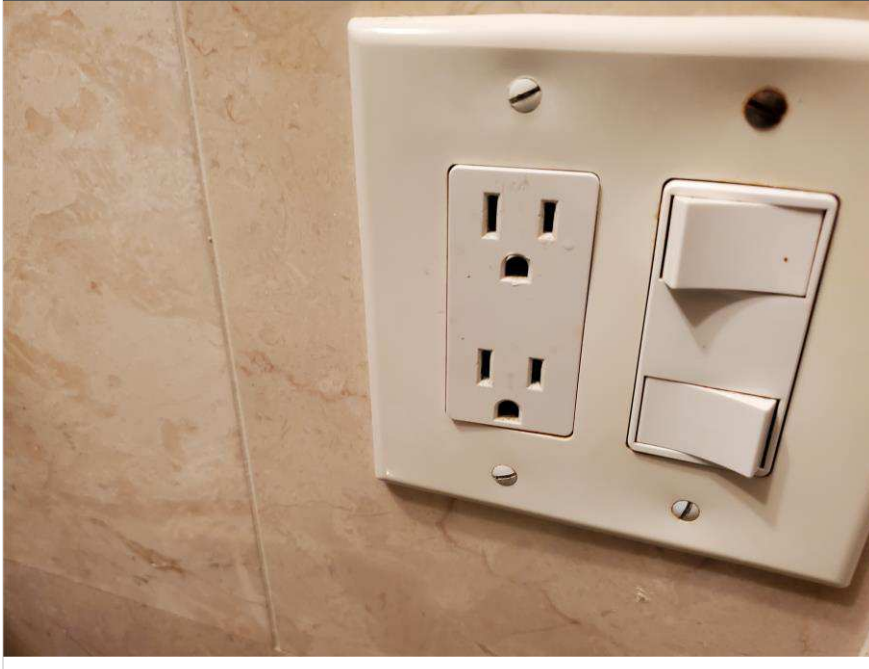
Photo 17 – Village of Dadeland Condominium Association

Apartments - Bathroom outlets are not GFCI type.

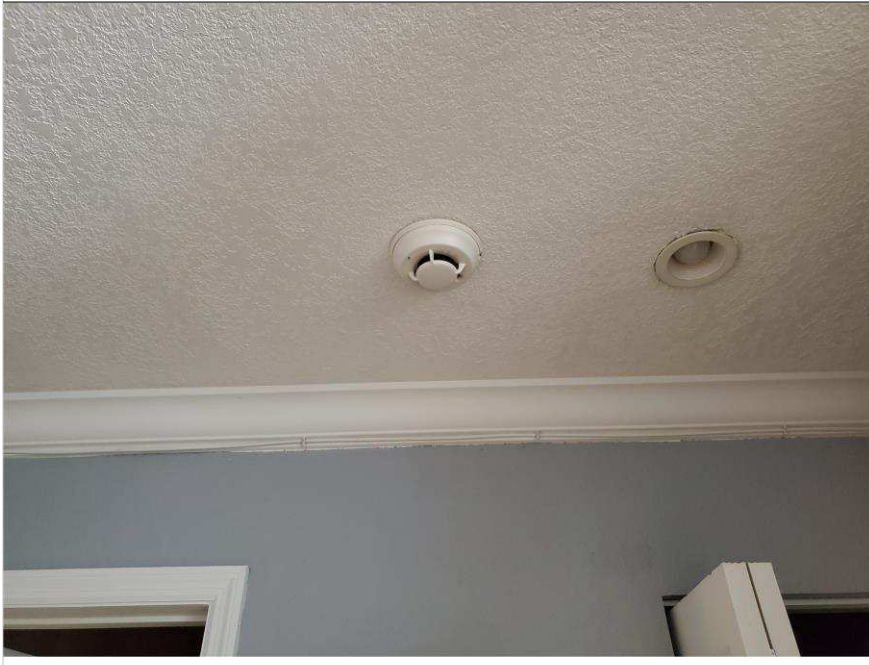
Photo 18 – Village of Dadeland Condominium Association

Apartments - Old Detectors

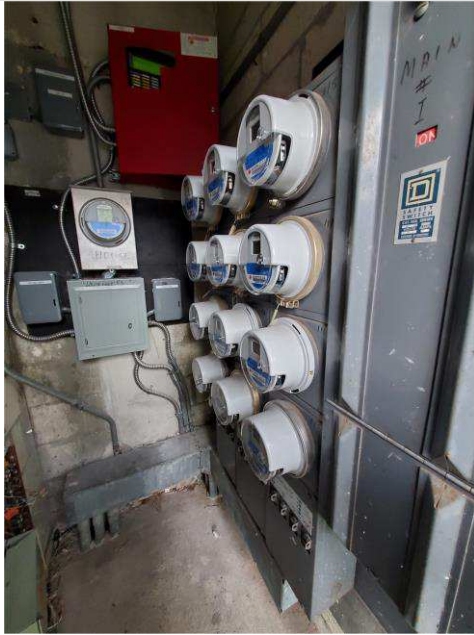
Photo 7 – Village of Dadeland Condominium Association

Existing Electrical Room - 1st FL  
Apartment Meters and Gutter

Old and corroded meter stacks.

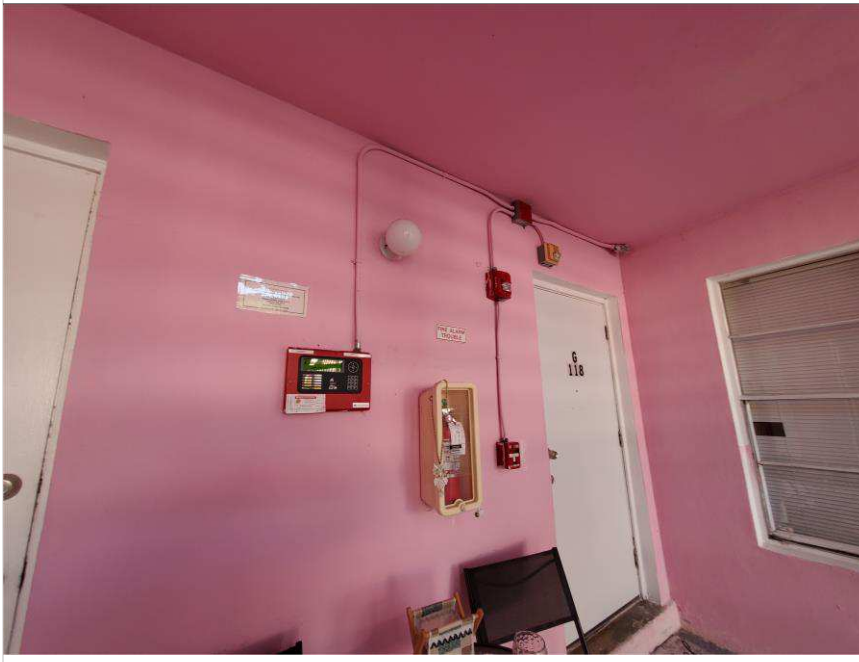
Photo 14 – Village of Dadeland Condominium Association

Level 1  
Fire Alarm - Old and Weathered  
Fire Alarm Devices

Old Strobe Horn/Strobe Device

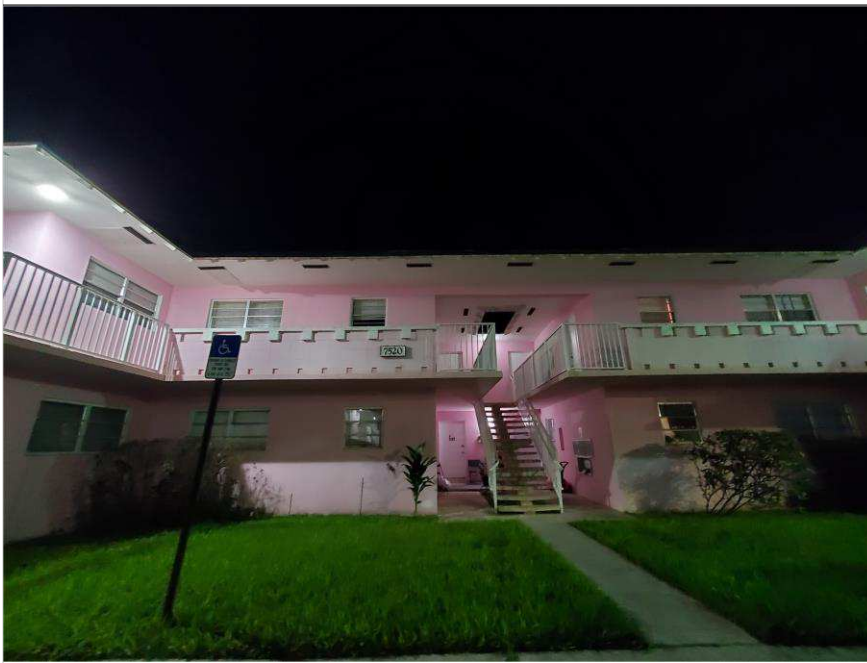
Photo 18 – Village of Dadeland Condominium Association

Points of Egress

Poorly illuminated Areas  
Exterior lights are not functional.

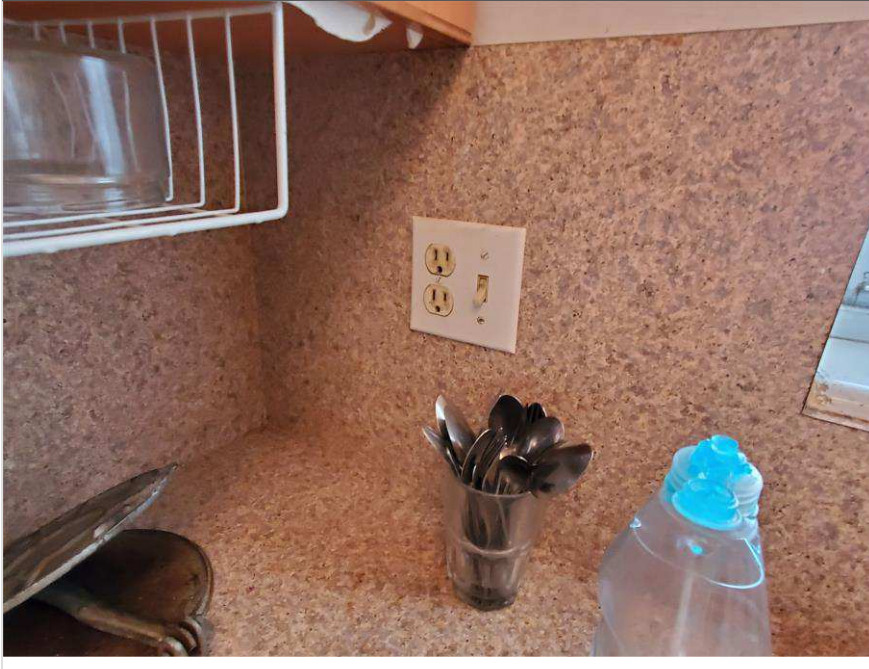
Photo 21 – Village of Dadeland Condominium Association

Apartments - Kitchen outlets  
not GFCI type.

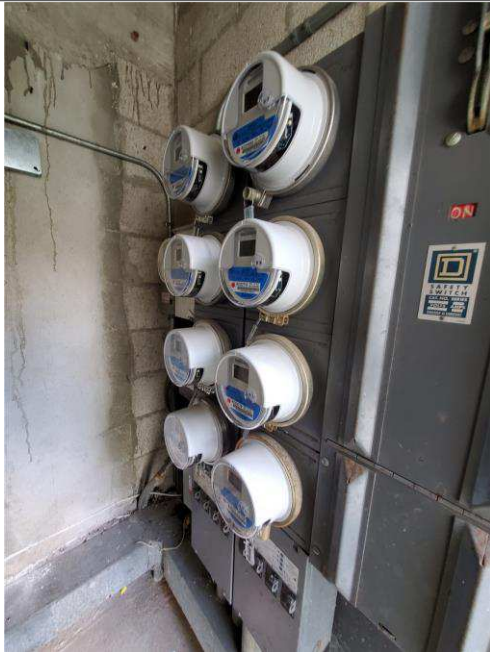
Photo 7 – Village of Dadeland Condominium Association

Existing Electrical Room - 1st FL  
Apartment Meters and Gutter.

Old and corroded meter stacks.

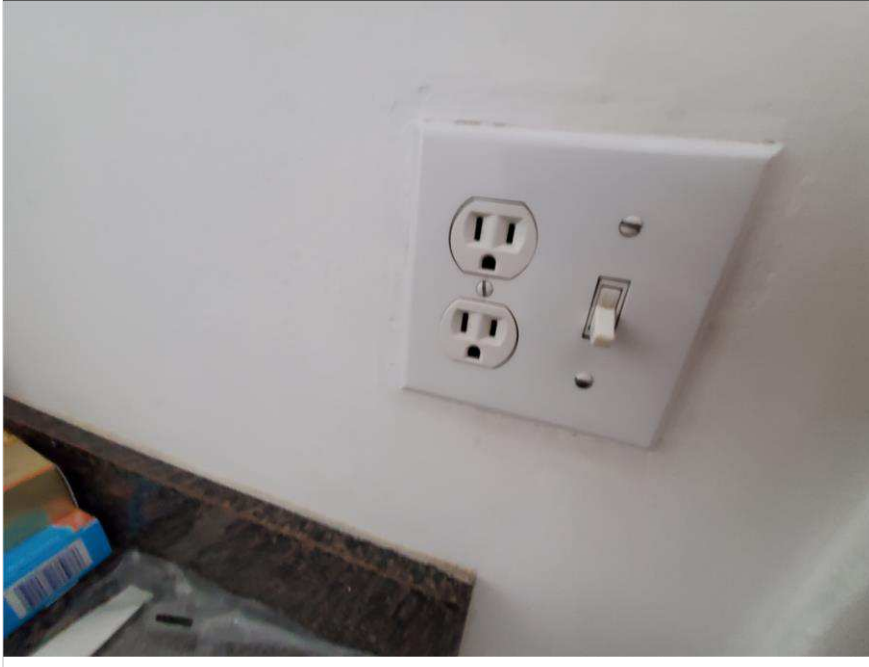
Photo 17 – Village of Dadeland Condominium Association

Apartments - Bathroom outlets  
are not GFCI type.

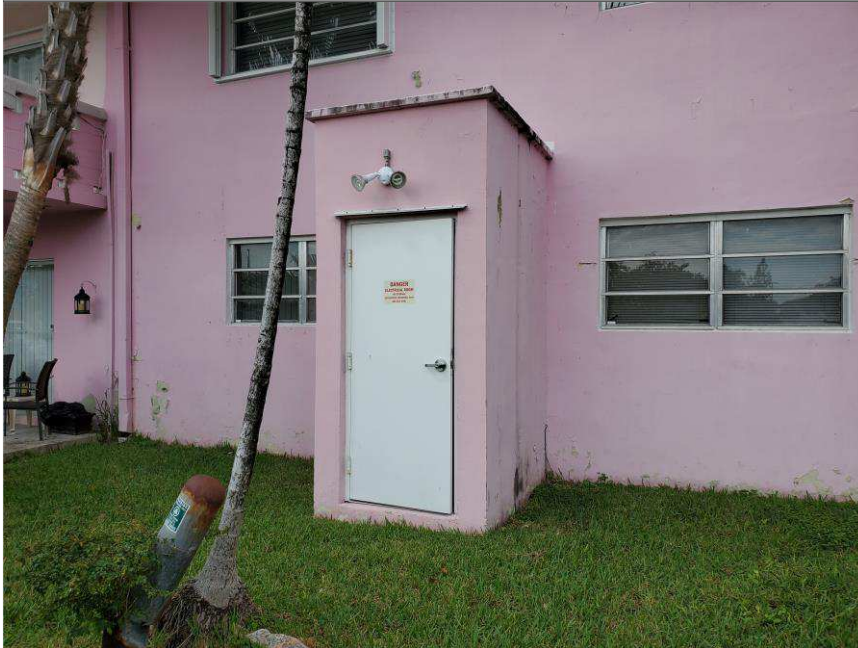
Photo 1 – Village of Dadeland Condominium Association

Existing Electrical Room - 1st FL  
No Storage Permitted

Missing sign with Room name  
and Building number.

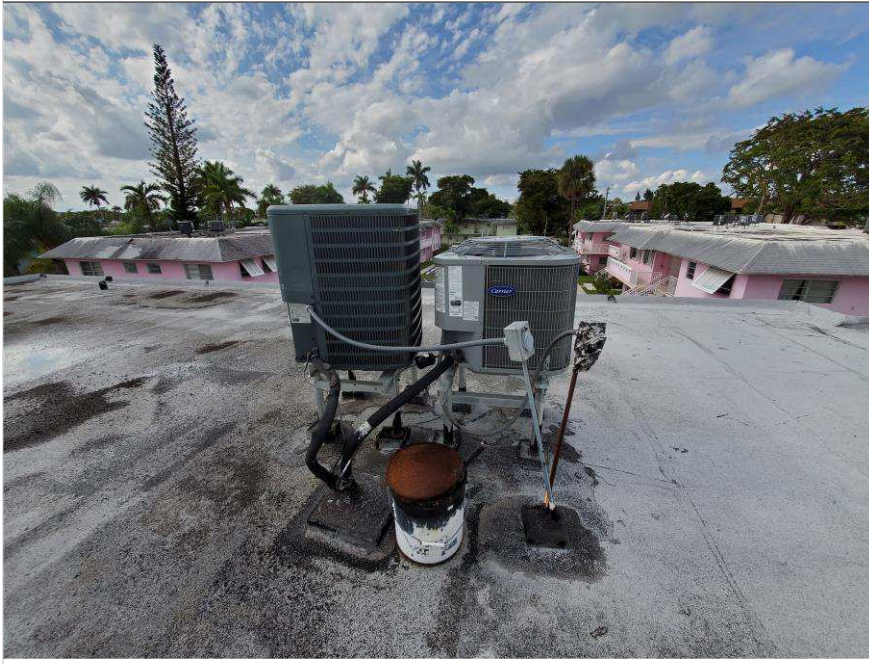
Photo 11 – Village of Dadeland Condominium Association

Rooftop Condenser Units -

Improperly supported switches.

Corroded conduits and boxes.

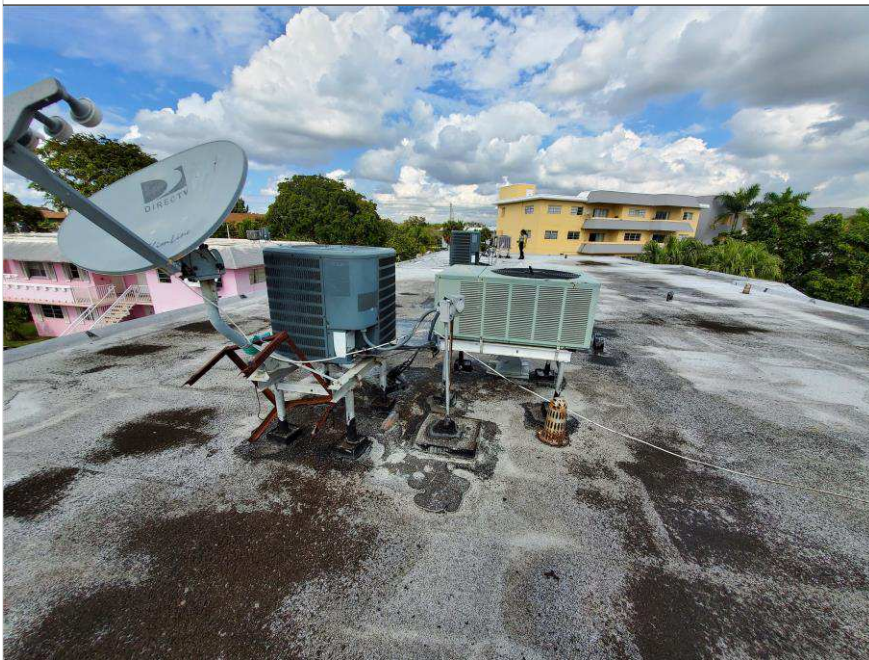
Photo 12 – Village of Dadeland Condominium Association

Rooftop Condenser Units -

Corroded junction boxes and conduits.

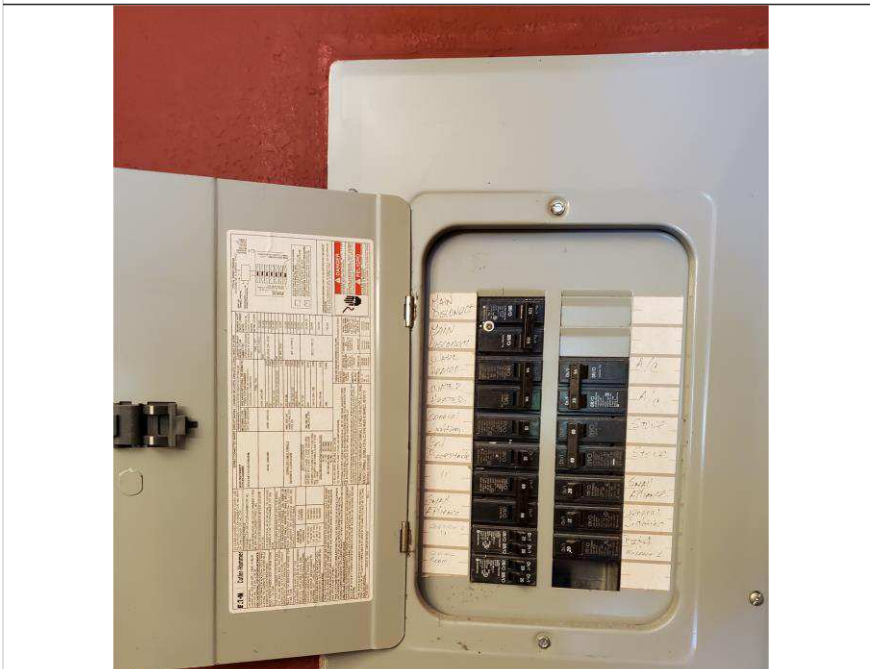
Photo 14 – Village of Dadeland Condominium Association

Apartments - Electrical Panels  
Open breaker slot.

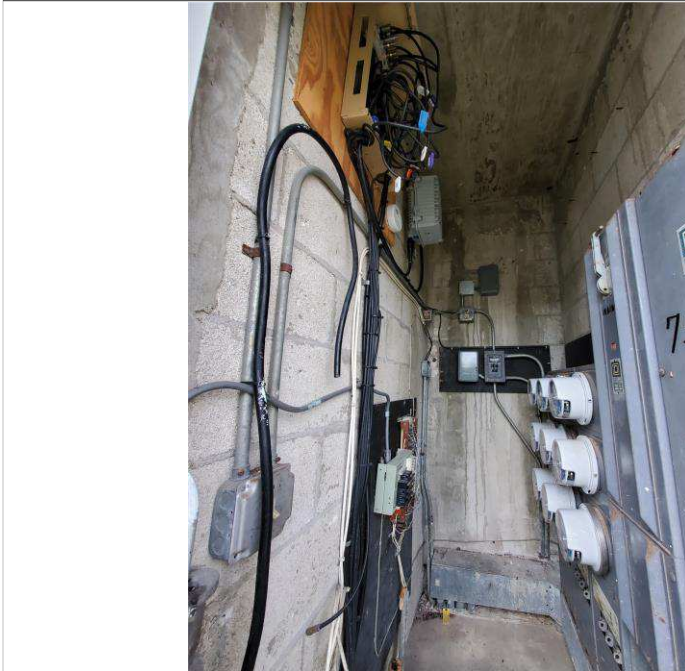
Photo 9 – Village of Dadeland Condominium Association

Existing Electrical Room - 1st FL  
Apartment Meters, Gutter and  
Main Disconnect Switch

Insufficient clearance at  
electrical components.

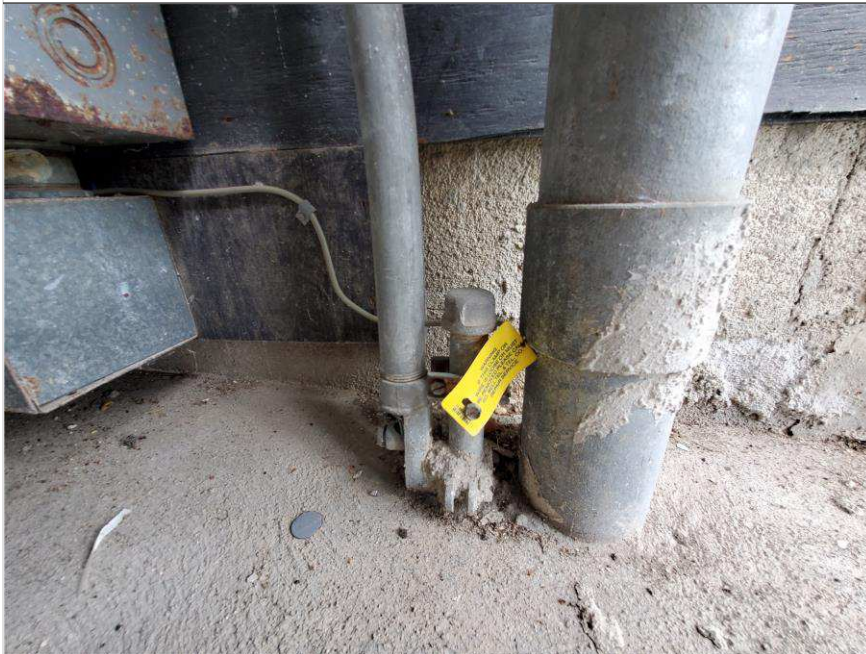
Photo 10 – Village of Dadeland Condominium Association

Existing Electrical Room - 1st FL  
Main Service - Grounding

Grounding resistance to be  
tested to determine if repairs  
and/or maintenance are  
required.

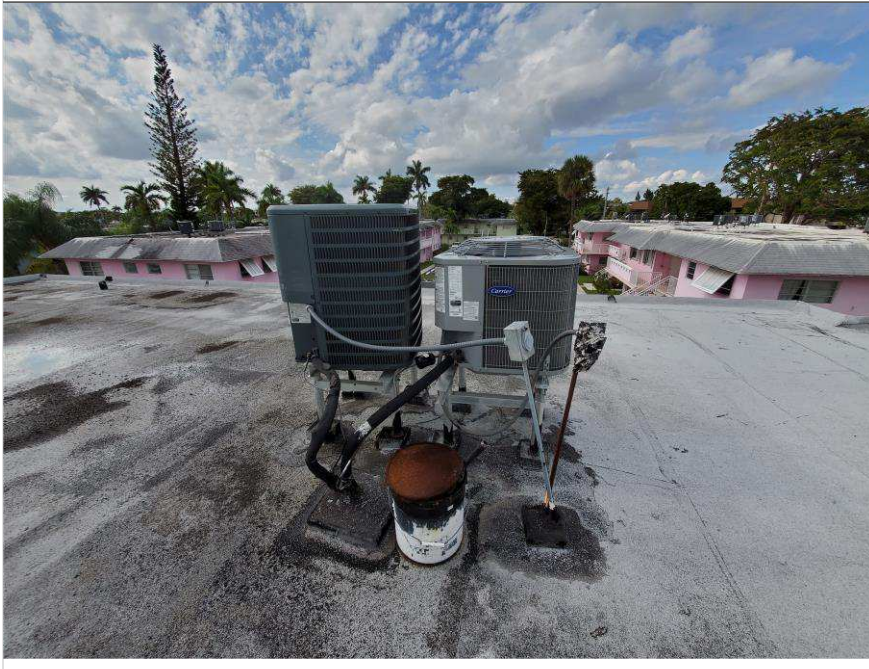
Photo 11 – Village of Dadeland Condominium Association

Rooftop Condenser Units -

Improperly supported switches.

Corroded conduits and boxes.

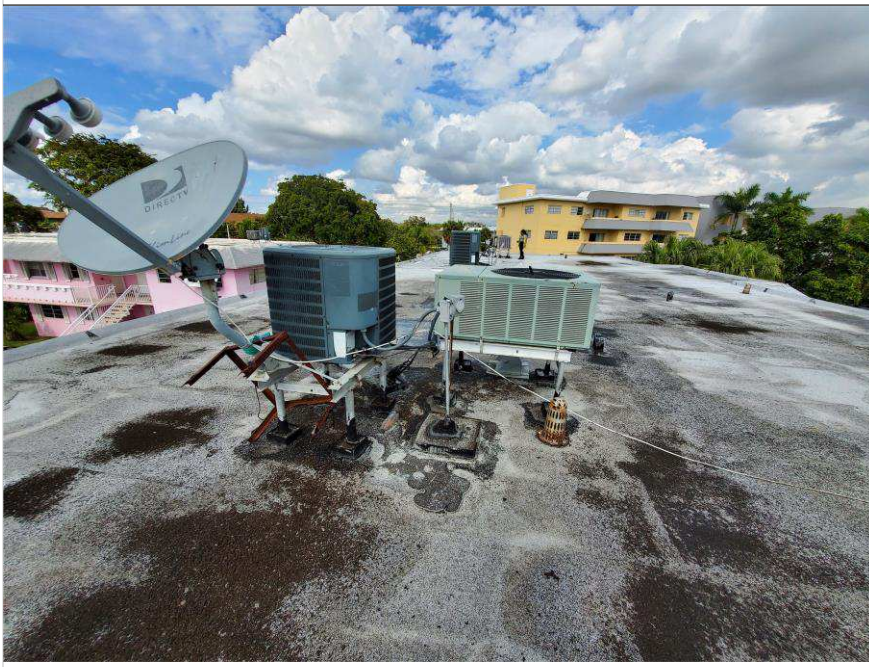
Photo 12 – Village of Dadeland Condominium Association

Rooftop Condenser Units -

Corroded junction boxes and conduits.
