***INSPECTION AND CLEANING (SEDIMENT REMOVAL) OF THE
120,000-GALLON ELEVATED RIVETED STEEL WATER STORAGE TANK***

***VILLAGE OF INTERLAKEN D.P.W.
INTERLAKEN, NEW YORK***

NOVEMBER 10, 2015

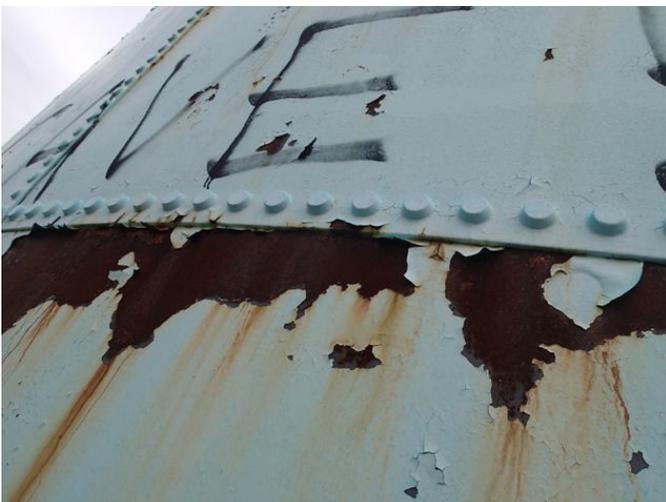
The protective coating applied to the exterior steel sidewalls was found having poor adhesion value and is nearing expiration. Cracking, lifting and peeling of the coating applied to the tank walls has resulted in exposure of the primary coating throughout approximately 20% of these wall surfaces, while complete coating loss and steel exposure exists throughout approximately 20% of these walls at this time.

No obvious fatigue (pitting) of the steel wall panels was evident, rather mild to moderate surface corrosion exists at this time.

5 *Exterior Wall With Coating Loss/Cracking/Lifting/Peeling, Exposed Primary Coating, Exposed Steel And Mild To Moderate Surface Corrosion (Nearing Expiration)*

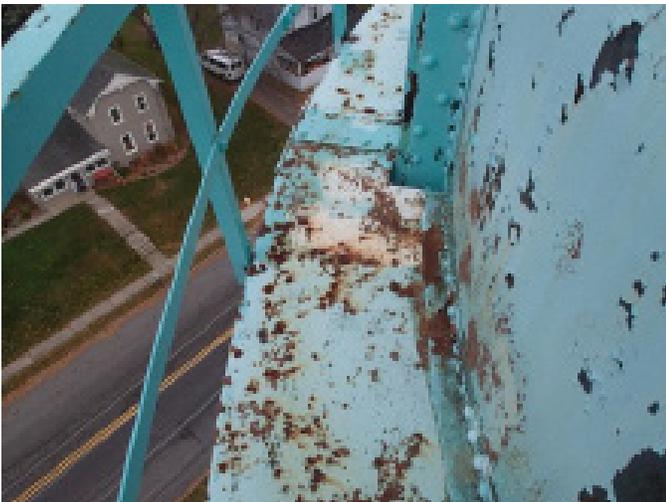
23 *Catwalk And Safety Railing With Coating Loss/Peeling, Exposed Underlying Steel And Mild To Moderate (Nearing Expiration)*

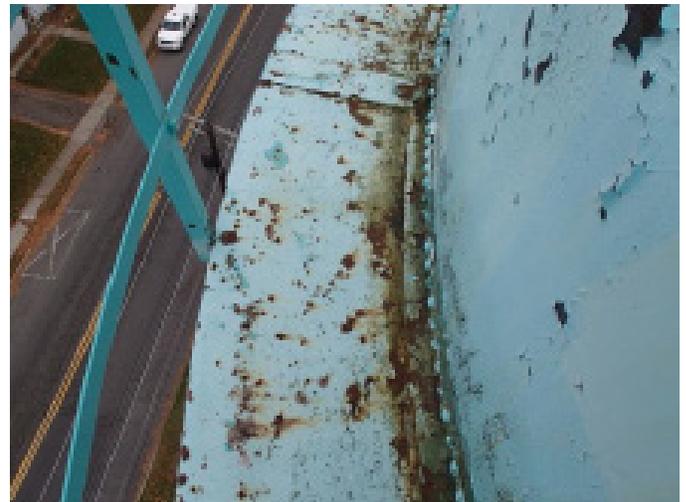
24 *Catwalk And Safety Railing With Coating Loss/Peeling, Exposed Underlying Steel And Mild To Moderate (Nearing Expiration)*

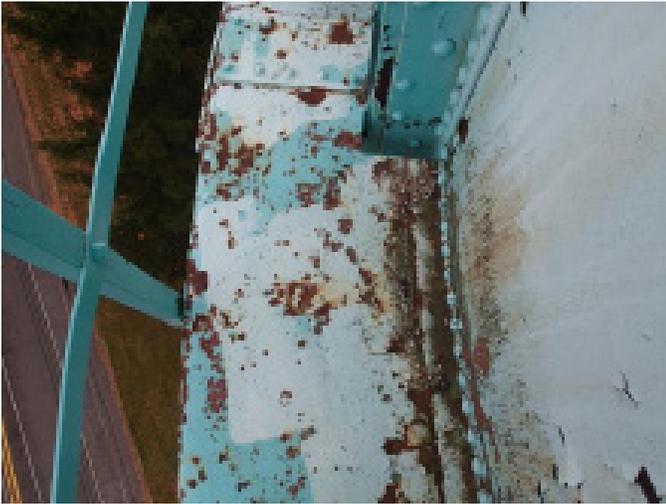
25 *Catwalk And Safety Railing With Coating Loss/Peeling, Exposed Underlying Steel And Mild To Moderate (Nearing Expiration)*

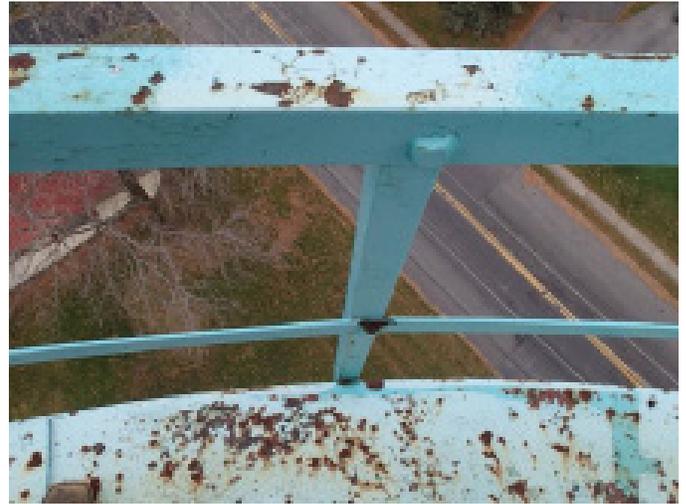
26 *Catwalk And Safety Railing With Coating Loss/Peeling, Exposed Underlying Steel And Mild To Moderate (Nearing Expiration)*

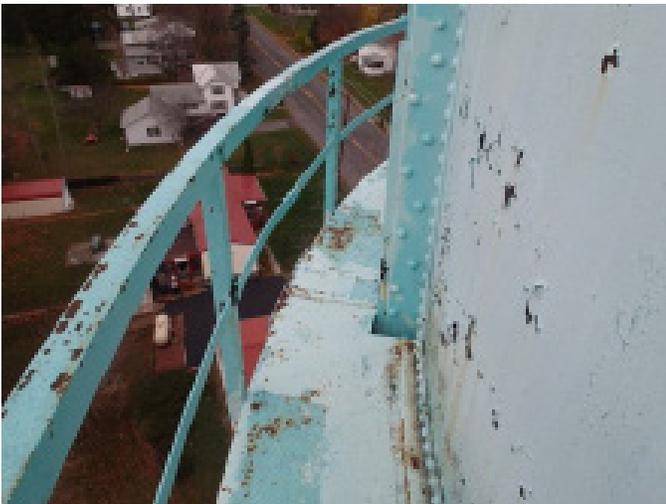
27 *Catwalk And Safety Railing With Coating Loss/Peeling, Exposed Underlying Steel And Mild To Moderate (Nearing Expiration)*

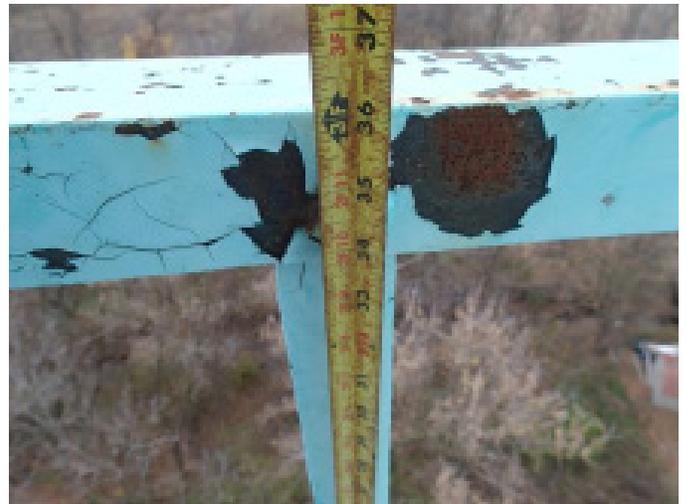
28 *Safety Railing With Coating Loss/Peeling, Exposed Underlying Steel And Mild To Moderate (Nearing Expiration)*

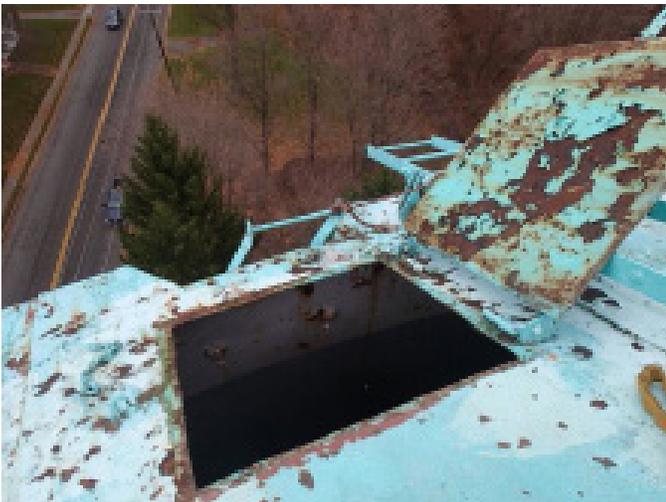
The protective coating applied to the interior and exterior surfaces of this steel hatch was found having poor adhesion value and is peeling. This condition has resulted in exposure of the underlying steel throughout approximately 10% of all surfaces of this hatch.

No obvious fatigue or deterioration of this steel hatch was evident, rather mild to moderate corrosion exists within the areas showing steel exposure at this time.

29 *Open Hatch With Coating Loss/Peeling, Exposed Underlying Steel And Mild To Moderate Corrosion*

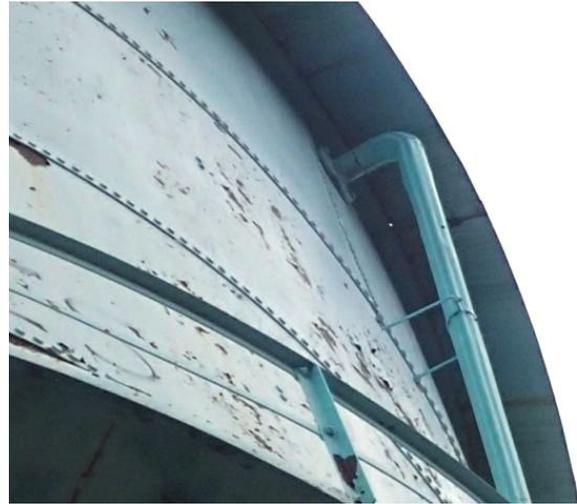
32 *Overflow Pipe*

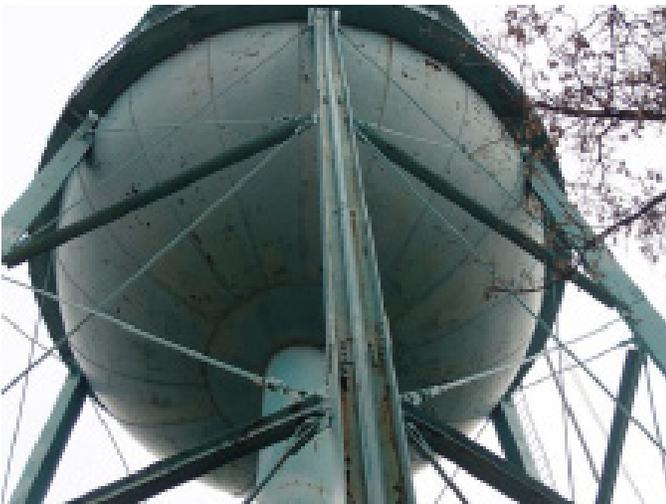
33 *Overflow Pipe*

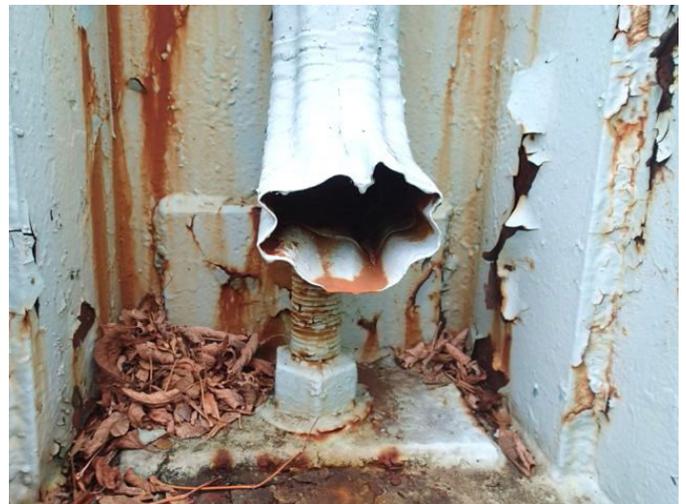
Although the outlet end of this pipe was found to be slightly compressed, it remains unobstructed, allowing for proper flow, while no screen found was installed at the end of this pipe at this time.

34 *Un-Secure Overflow Pipe (No Screen)*

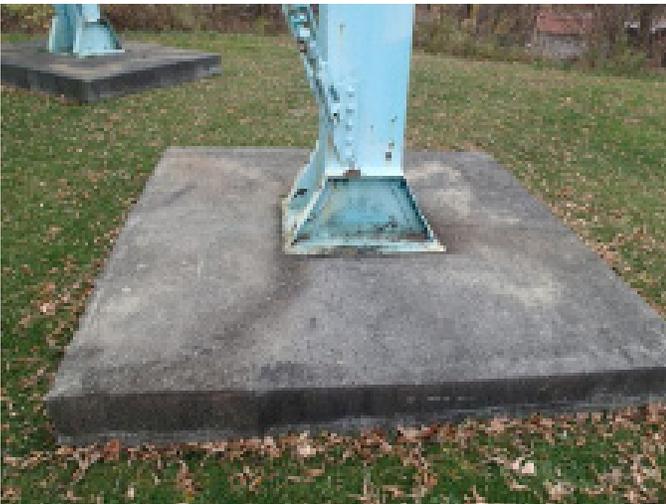
51 *Support Leg With Coating Loss/Peeling, Exposed Underlying Steel And Mild To Moderate Corrosion (Nearing Expiration)*

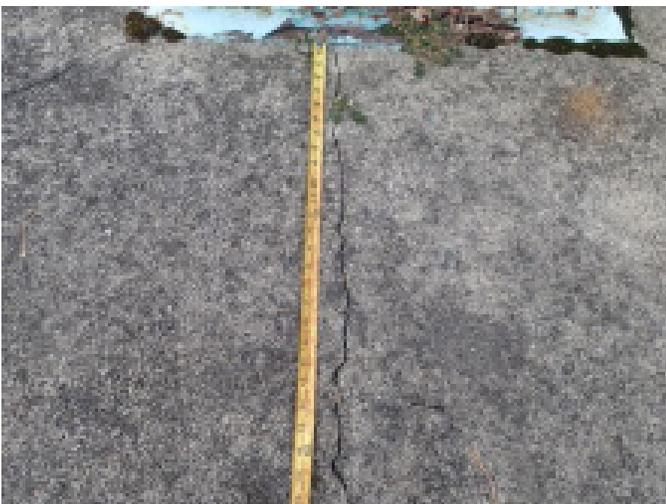
53 *Concrete Support Footer With Cracking*

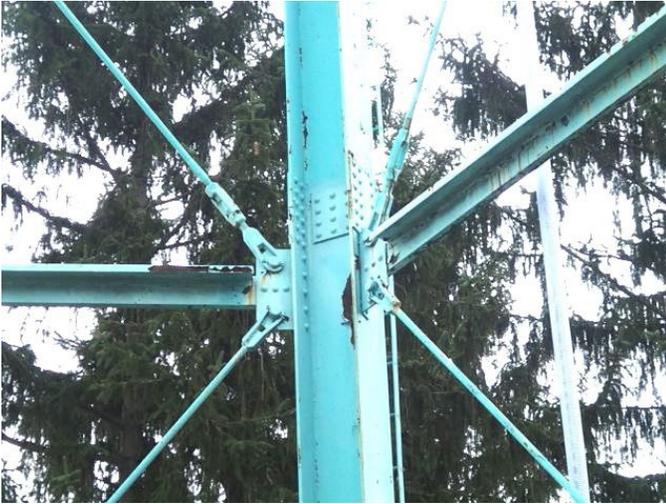
57 *Cross Member With Coating Loss/Peeling, Exposed Underlying Steel And Mild Surface Corrosion (Nearing Expiration)*

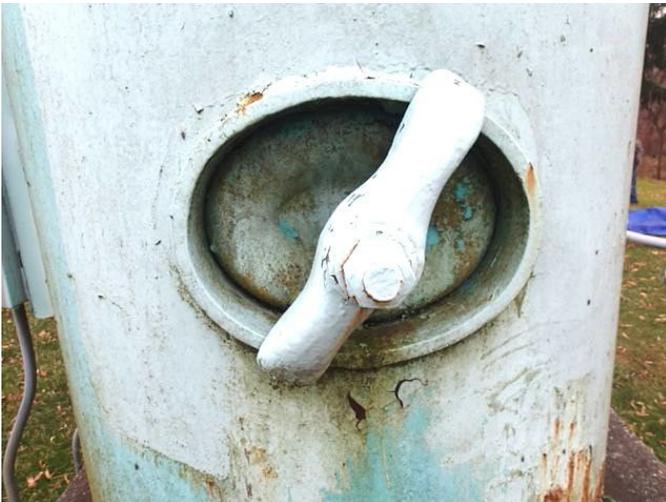
59 *Manway With Secondary Coating Loss, Exposed Underlying Primary Coating, Exposed Underlying Steel And Mild To Moderate Corrosion*

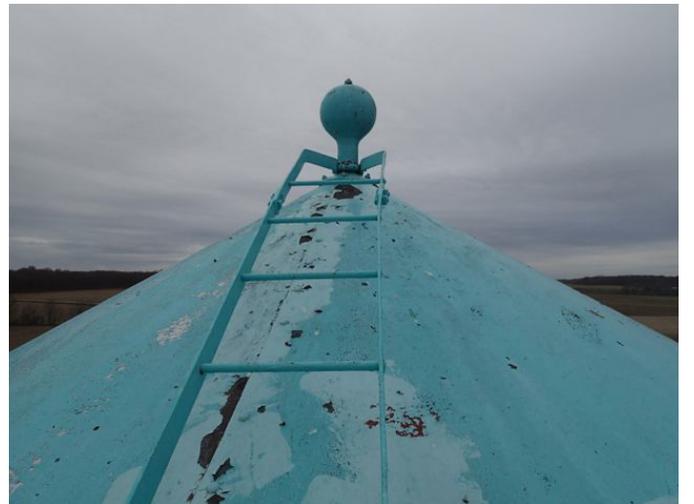
64 *Roof Access Ladder And Finial Ball*

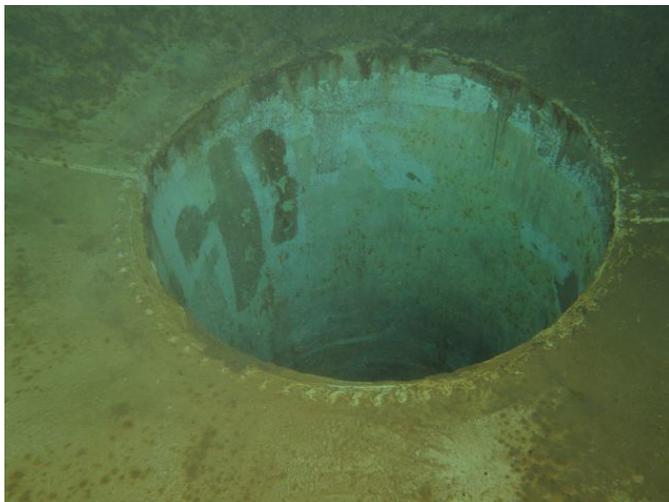
65 *Immeasurable Sediment*

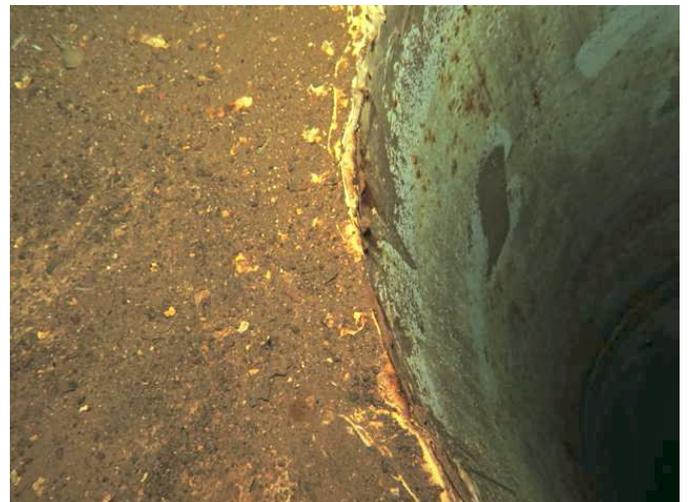
66 *Immeasurable Sediment*

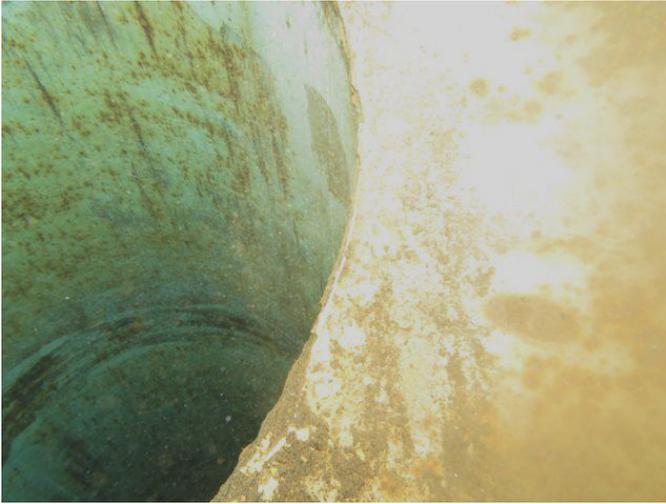
67 *Immeasurable Sediment*

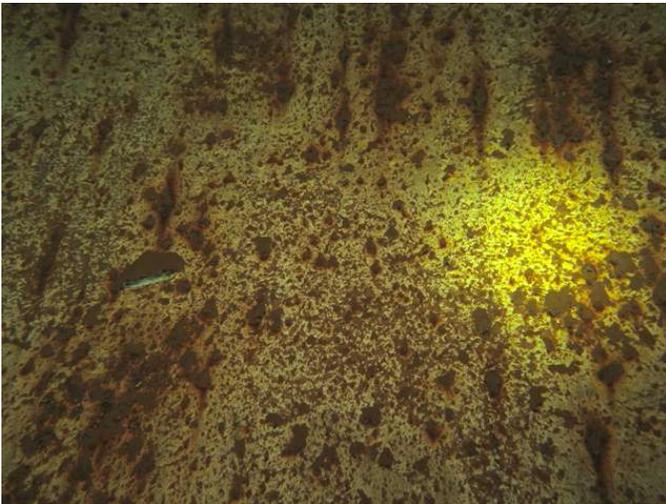
69 *Floor With Coating Loss, Ruptured Coating Blisters, Exposed Underlying Steel, Moderate To Heavy Corrosion And Mild Staining(Expired)*

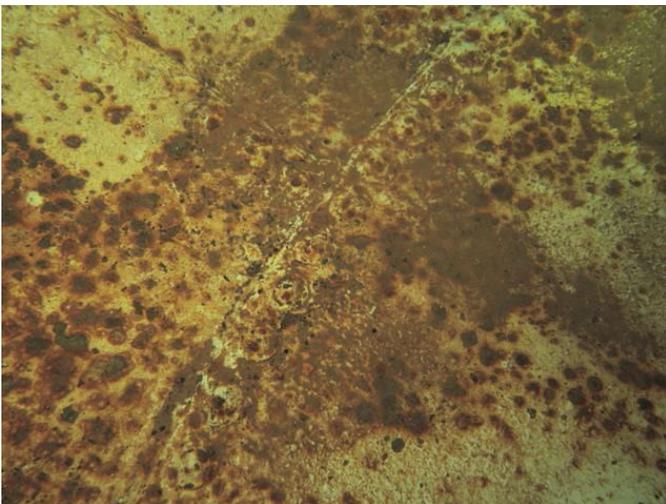
71 *Floor With Coating Loss, Ruptured Coating Blisters, Exposed Underlying Steel, Moderate To Heavy Corrosion And Mild Staining(Expired)*

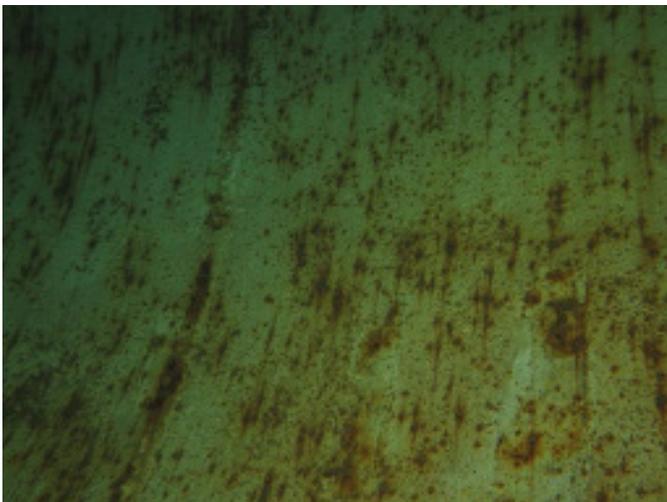
77 *Interior Wall With Coating Loss/Blistering/Peeling, Exposed Underlying Steel, Mild To Moderate Corrosion And Mild Staining (Expired)*

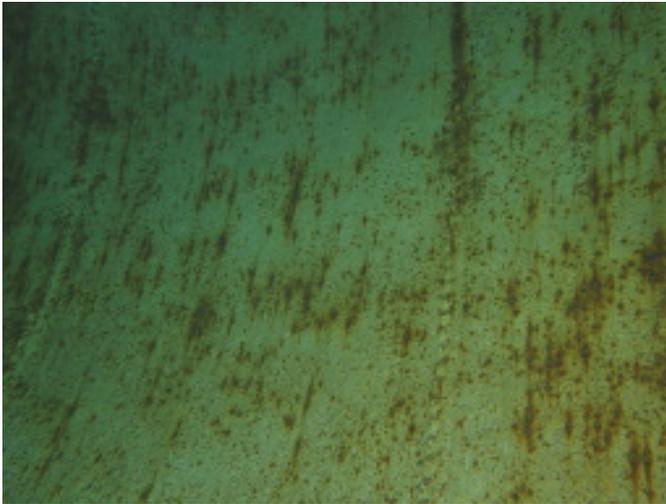
81 *Interior Wall With Coating Loss/Blistering/Peeling, Exposed Underlying Steel, Mild To Moderate Corrosion And Mild Staining (Expired)*

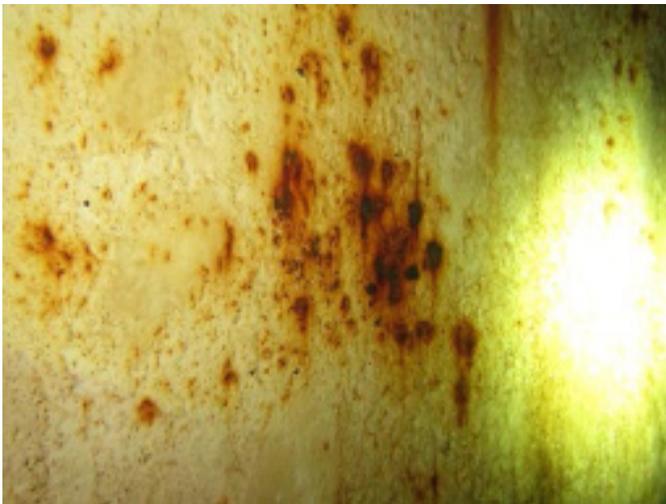
83 *Interior Wall With Coating Loss/Blistering/Peeling, Exposed Underlying Steel, Mild To Moderate Corrosion And Mild Staining (Expired)*

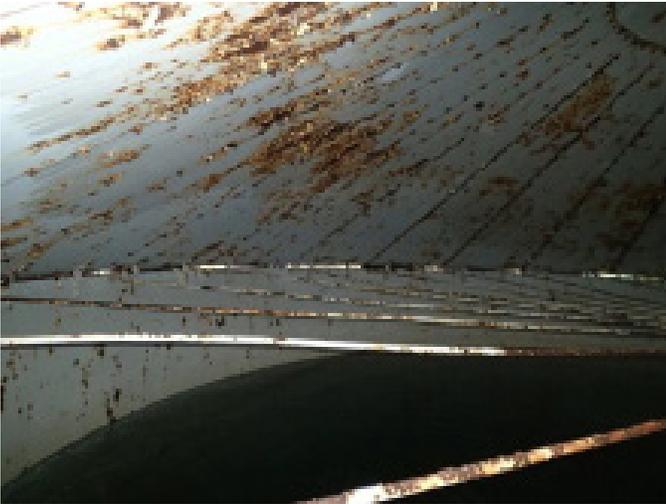
93 *Overhead With Coating Loss/Peeling, Exposed Underlying Steel, Blotch Rusting And Mild To Moderate Corrosion And Staining*

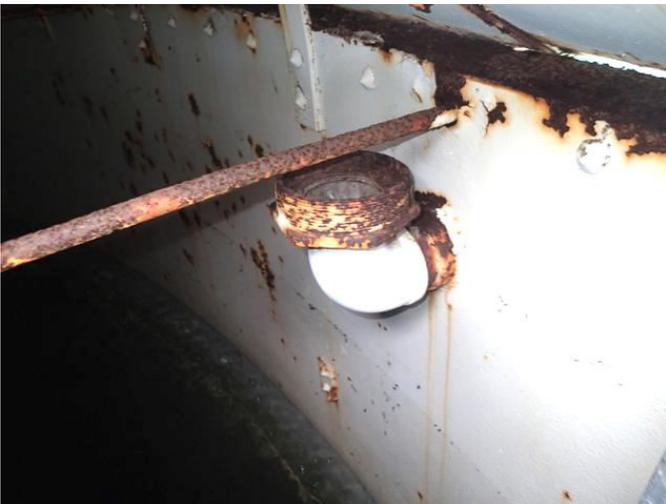
95 *Overflow Pipe*

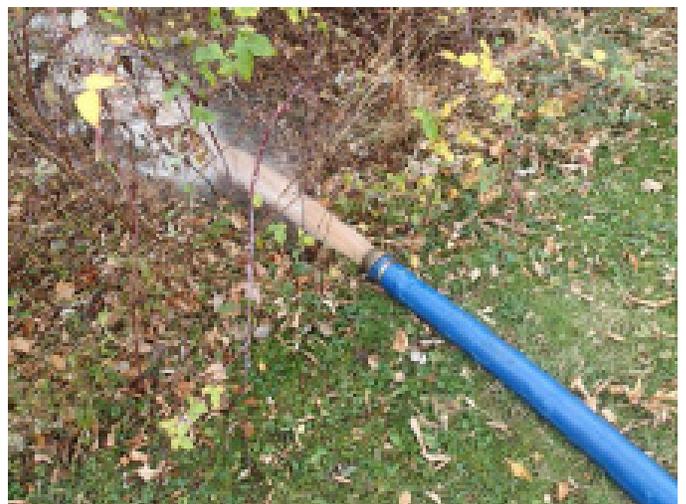
96 *Discharge During Cleaning*
