HAZARDOUS BUILDING MATERIALS SURVEY

CONDON GRADE SCHOOL
220 S. EAST STREET
CONDON, OREGON

Prepared for
CITY OF CONDON
May 17, 2022
Project No. M2053.01.002

Prepared by
Maul Foster & Alongi, Inc.
3140 NE Broadway Street, Portland, OR 97232

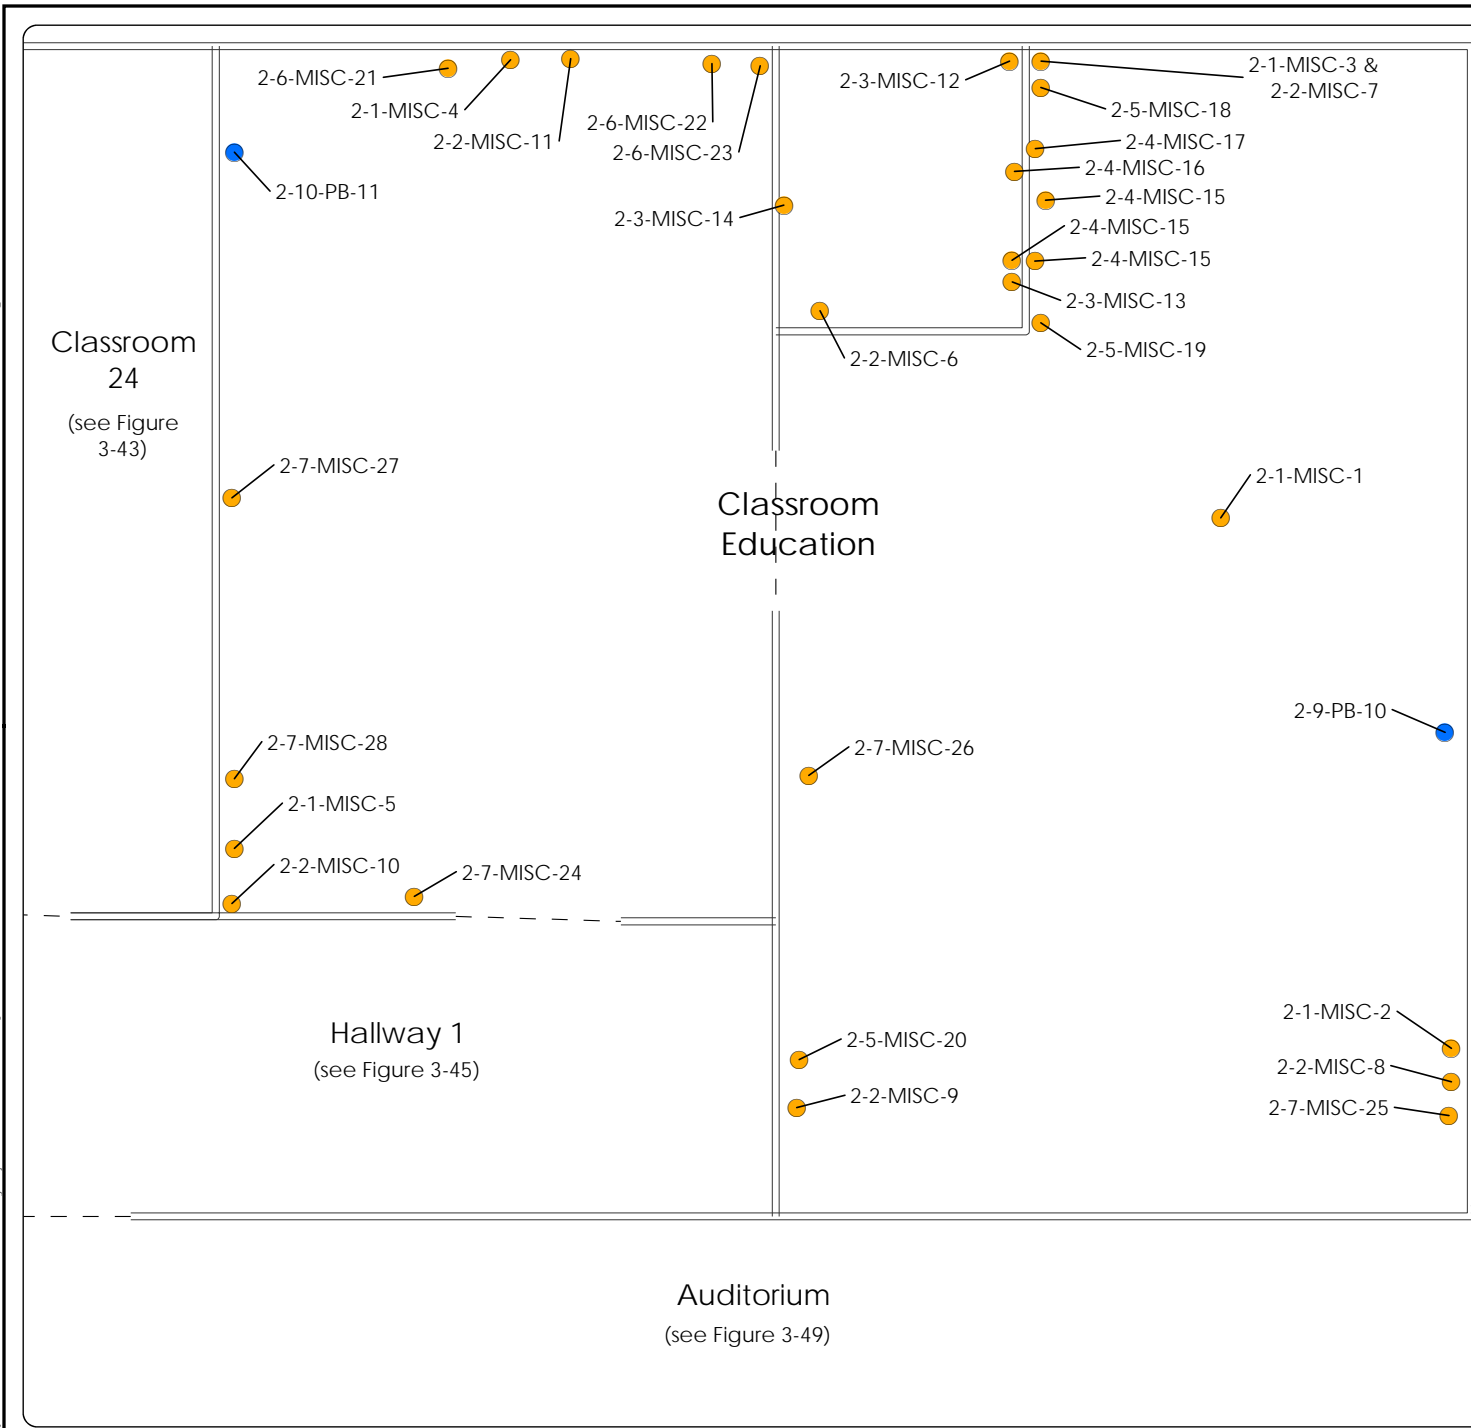
Figure 3-44
 Functional Area 2
 Second Floor:
 Classroom Education
 Condon HBM Report

Sample ID:	Sample Type:	
2-1-MISC-1	MISC	
Sample Location:	Detailed Sample Location:	
Classroom Education	East of shower	
Sample Quantity:	371 SF	
Misc Sample Material:	Sample Condition:	Sample Friable?:
Blue carpet with yellow mastic	Damaged or significantly damaged friable miscellaneous ACM	No

Additional Sample Notes:		
Sample ID:	Sample Type:	
2-1-MISC-3	MISC	
Sample Location:	Detailed Sample Location:	
Classroom Education	Southeast corner of the easternmost room	
Sample Quantity:	See 2-1-MISC-1	
Misc Sample Material:	Sample Condition:	Sample Friable?:
Blue carpet with yellow mastic	Damaged or significantly damaged friable miscellaneous ACM	No

Additional Sample Notes:		
Sample ID:	Sample Type:	
2-1-MISC-5	MISC	
Sample Location:	Detailed Sample Location:	
Classroom Education	West wall of westernmost room	
Sample Quantity:	See 2-1-MISC-1	
Misc Sample Material:	Sample Condition:	Sample Friable?:
Blue carpet with yellow mastic	Damaged or significantly damaged friable miscellaneous ACM	No

Additional Sample Notes:		
Sample ID:	Sample Type:	
2-2-MISC-6	MISC	
Sample Location:	Detailed Sample Location:	
Classroom education	South wall of shower	
Sample Quantity:	571 SF	
Misc Sample Material:	Sample Condition:	Sample Friable?:
Tan tile with gray grout	Damaged or significantly damaged friable miscellaneous ACM	No

Additional Sample Notes:		
Sample ID:	Sample Type:	
2-3-MISC-12	MISC	
Sample Location:	Detailed Sample Location:	
Classroom Education	Northeast wall of shower	
Sample Quantity:	122 SF	
Misc Sample Material:	Sample Condition:	Sample Friable?:
5"x5" oatmeal color tile with gray grout	Damaged or significantly damaged friable miscellaneous ACM	Yes
Sample Photo:

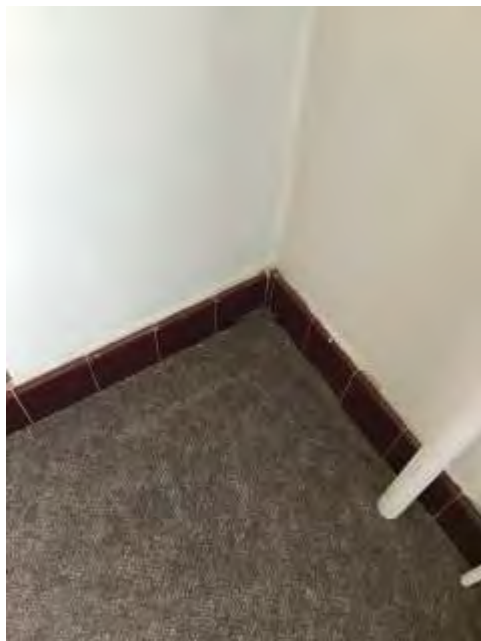
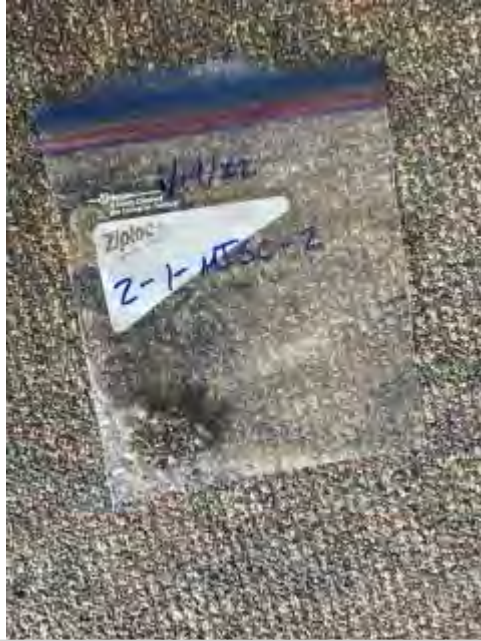
Damaged or significantly damaged friable miscellaneous ACM

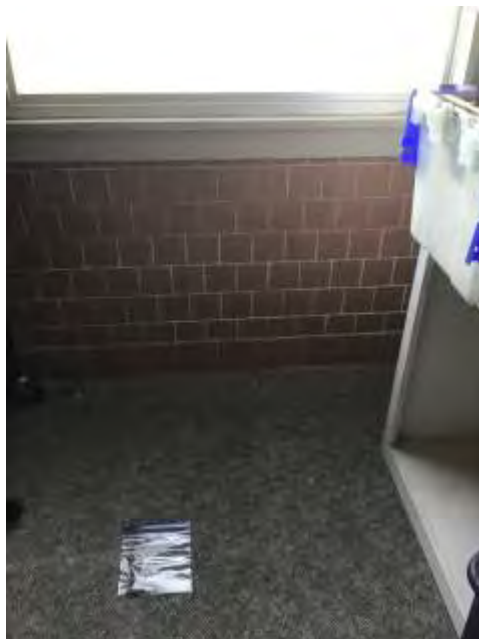
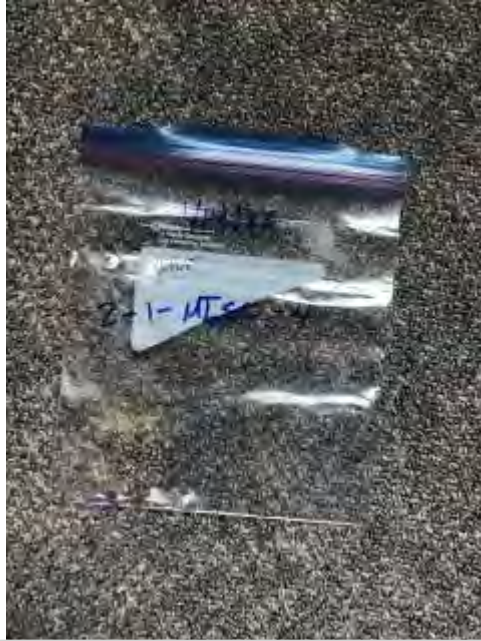
Damaged or significantly damaged friable miscellaneous ACM

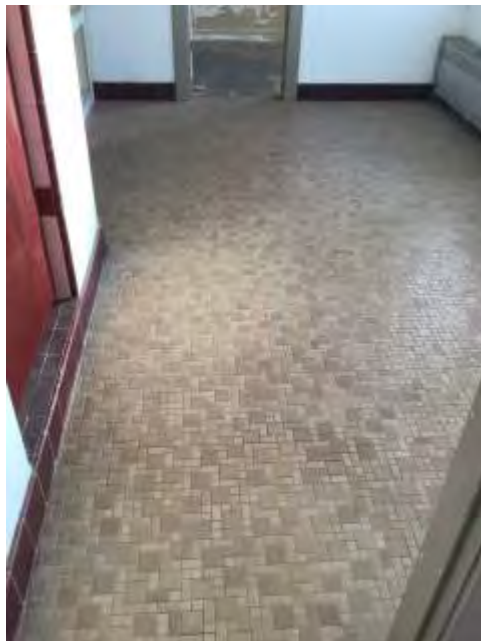
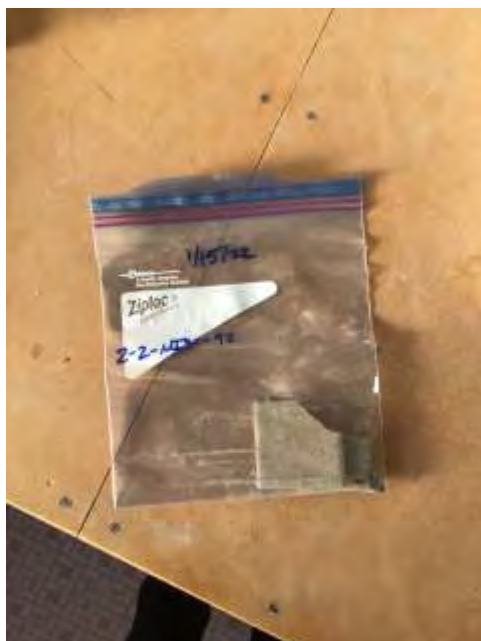
Additional Sample Notes:		
Sample ID:	Sample Type:	
2-2-MISC-92	MISC	
Sample Location:	Detailed Sample Location:	
Stage bathroom	South wall near window of shower room	
Sample Quantity:	See 2-2-MISC-6	
Misc Sample Material:	Sample Condition:	Sample Friable?:
Tan tile with gray grout	Damaged or significantly damaged friable miscellaneous ACM	No

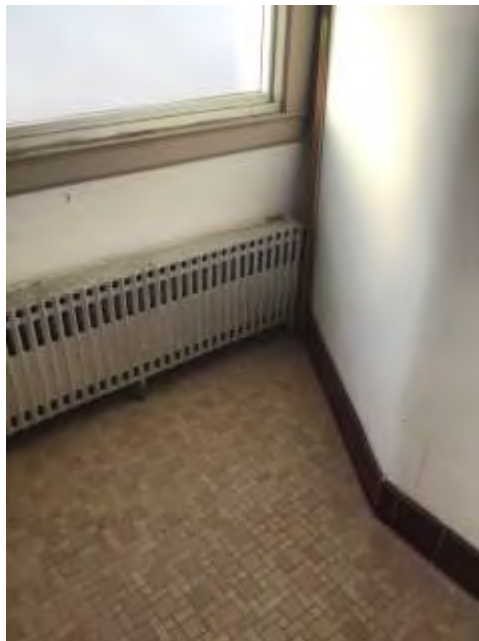
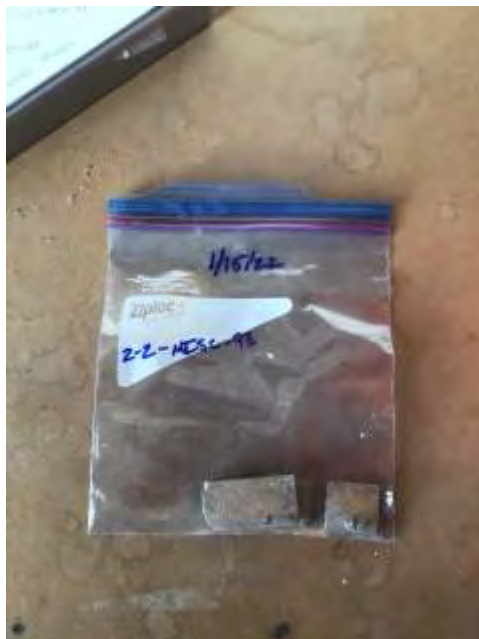
Additional Sample Notes:		
Sample ID:	Sample Type:	
2-2-MISC-93	MISC	
Sample Location:	Detailed Sample Location:	
Stage bathroom	South wall near radiator of shower room	
Sample Quantity:	See 2-2-MISC-6	
Misc Sample Material:	Sample Condition:	Sample Friable?:
Tan tile with gray grout	Damaged or significantly damaged friable miscellaneous ACM	No

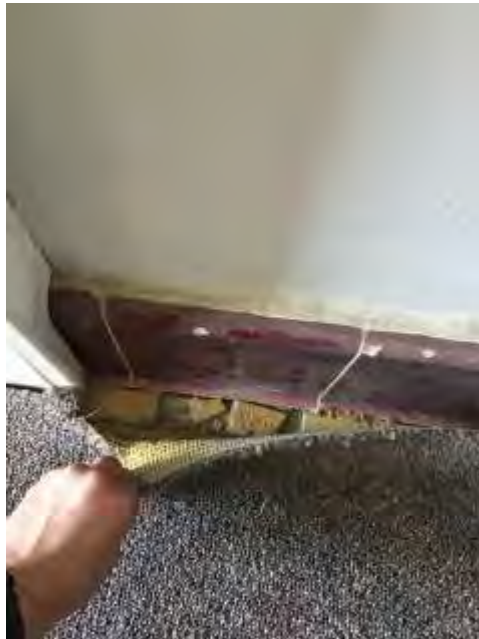
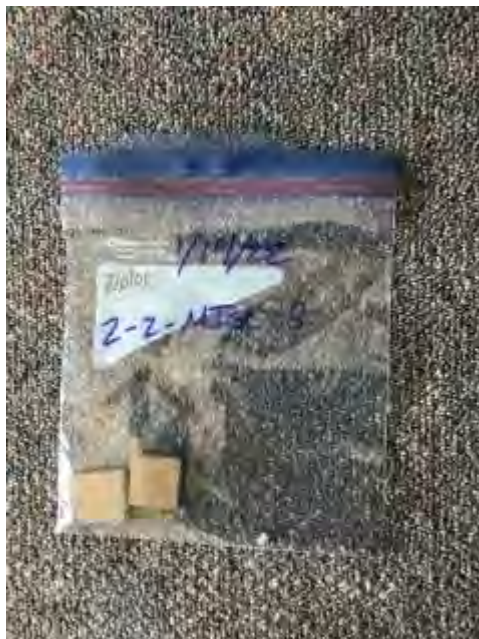
Additional Sample Notes:		
Sample ID:	Sample Type:	
2-2-MISC-8	MISC	
Sample Location:	Detailed Sample Location:	
Classroom Education	Southeast corner of easternmost room	
Sample Quantity:	See 2-2-MISC-6	
Misc Sample Material:	Sample Condition:	Sample Friable?:
Tan tile with yellow mastic and gray grout	Damaged or significantly damaged friable miscellaneous ACM	No

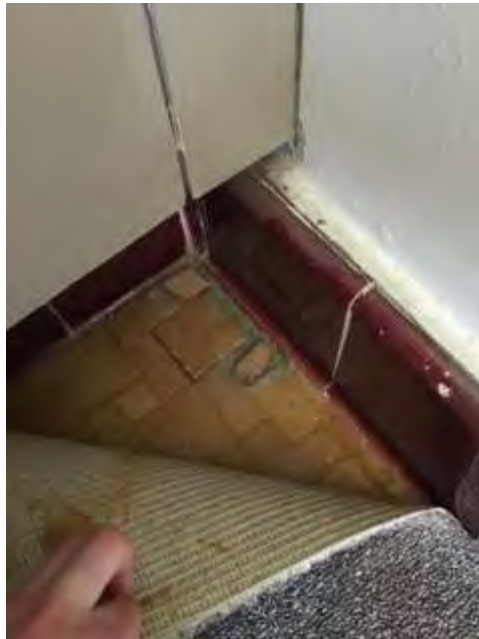
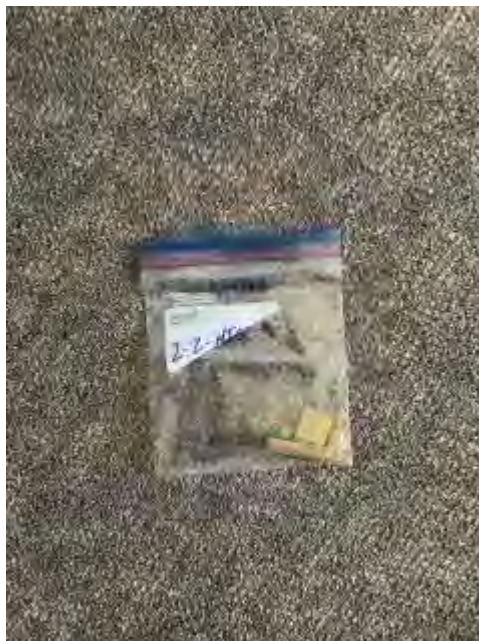
Additional Sample Notes:		
Sample ID:	Sample Type:	
2-2-MISC-9	MISC	
Sample Location:	Detailed Sample Location:	
Classroom Education	Southwest corner of easternmost room	
Sample Quantity:	See 2-2-MISC-6	
Misc Sample Material:	Sample Condition:	Sample Friable?:
Tan tile with yellow mastic and gray grout	Damaged or significantly damaged friable miscellaneous ACM	No

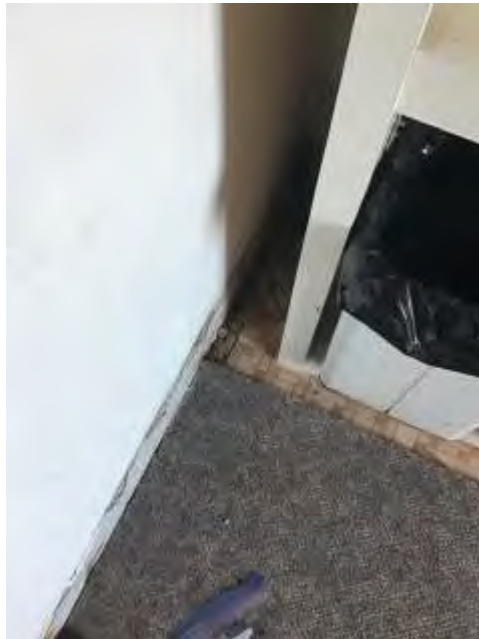
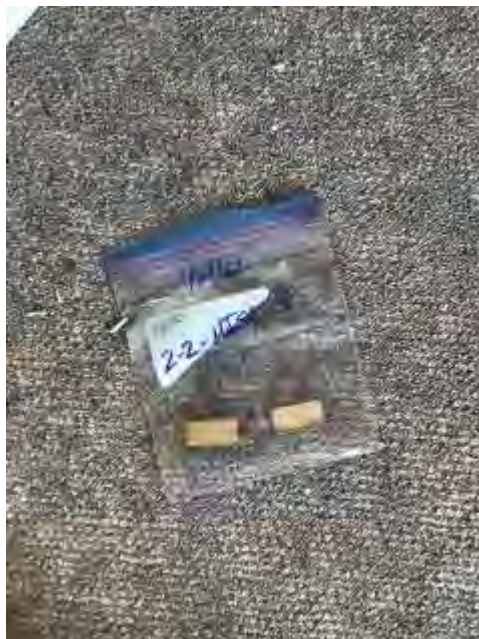
Additional Sample Notes:		
Sample ID:	Sample Type:	
2-2-MISC-10	MISC	
Sample Location:	Detailed Sample Location:	
Classroom Education	Southwest corner of westernmost room	
Sample Quantity:	See 2-2-MISC-6	
Misc Sample Material:	Sample Condition:	Sample Friable?:
Tan tile with yellow mastic and gray grout	Damaged or significantly damaged friable miscellaneous ACM	No

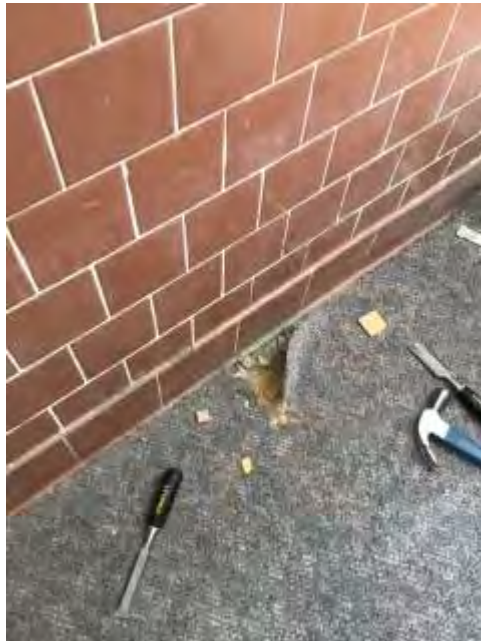
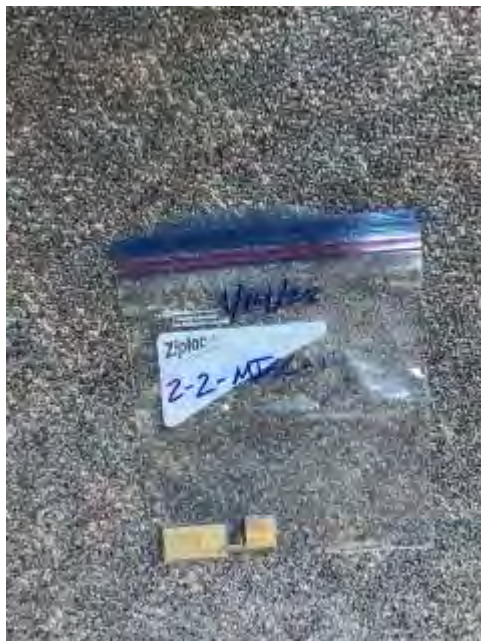
Additional Sample Notes:		
Sample ID:	Sample Type:	
2-2-MISC-11	MISC	
Sample Location:	Detailed Sample Location:	
Classroom Education	Northeast corner of easternmost room	
Sample Quantity:	See 2-2-MISC-6	
Misc Sample Material:	Sample Condition:	Sample Friable?:
Tan tile with yellow mastic and gray grout	Damaged or significantly damaged friable miscellaneous ACM	No

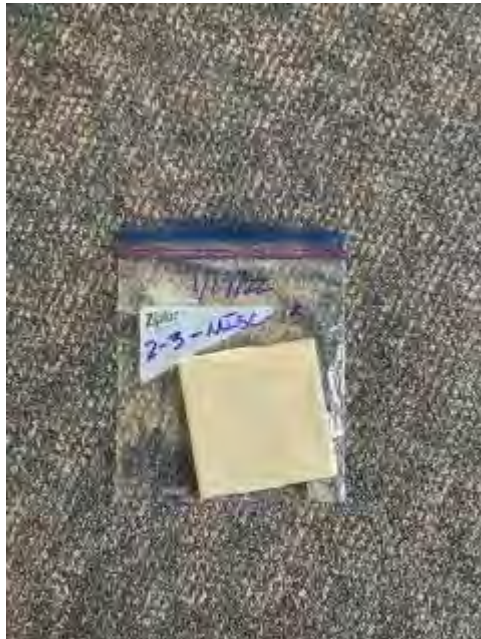
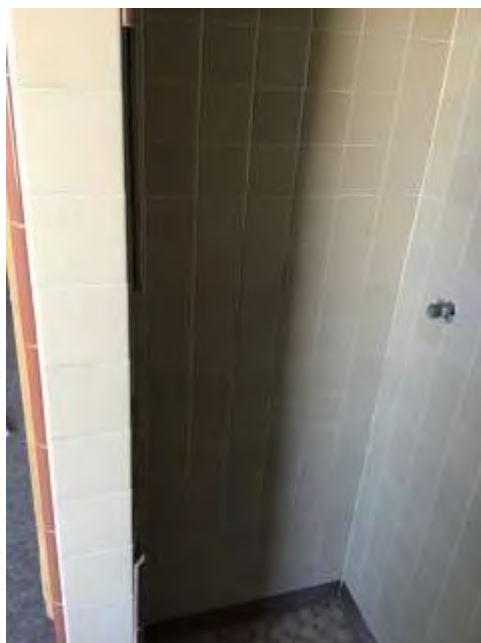
Additional Sample Notes:		
Sample ID:	Sample Type:	
2-3-MISC-13	MISC	
Sample Location:	Detailed Sample Location:	
Classroom Education	East wall of shower	
Sample Quantity:	See 2-3-MISC-12	
Misc Sample Material:	Sample Condition:	Sample Friable?:
5"x5" oatmeal color tile with gray grout	Damaged or significantly damaged friable miscellaneous ACM	No

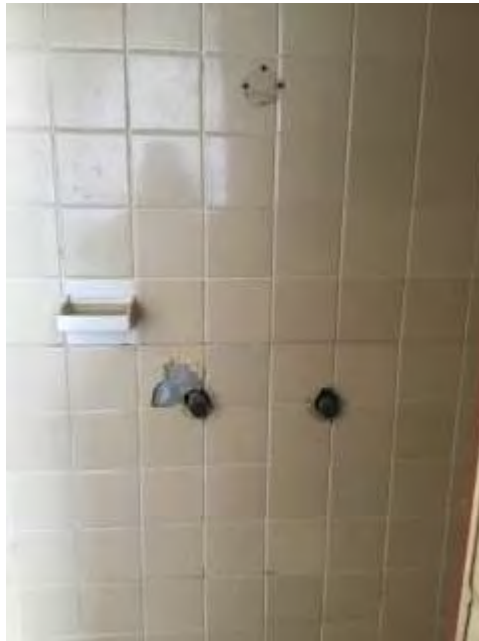
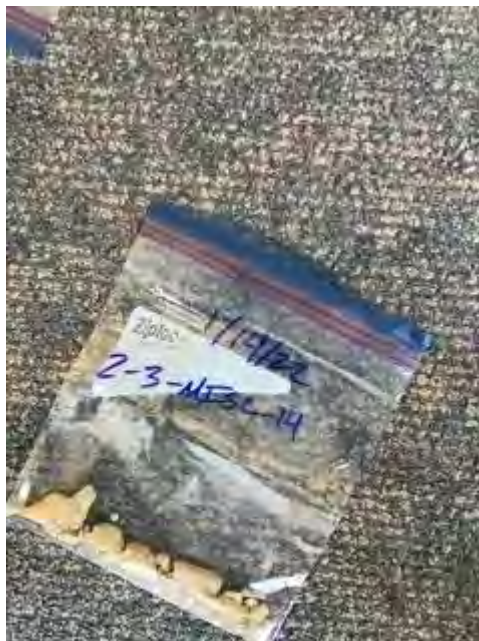
Additional Sample Notes:		
Sample ID:	Sample Type:	
2-3-MISC-14	MISC	
Sample Location:	Detailed Sample Location:	
Classroom Education	West wall of shower	
Sample Quantity:	See 2-3-MISC-12	
Misc Sample Material:	Sample Condition:	Sample Friable?:
5"x5" oatmeal color tile with gray grout	Damaged or significantly damaged friable miscellaneous ACM	No

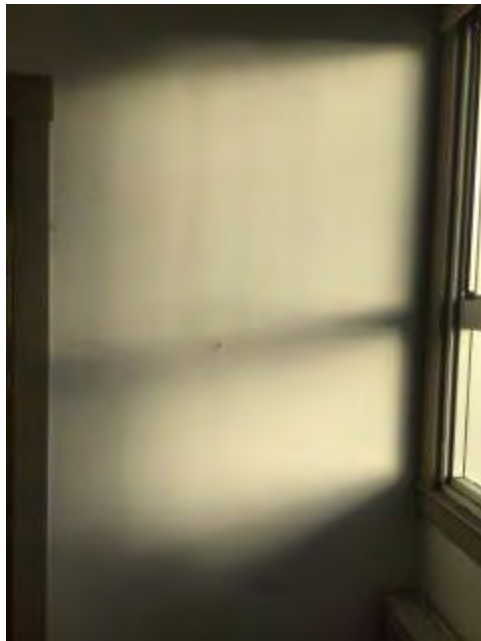
Sample ID:	Sample Type:
2-3-PB-3	PB
Sample Location:	Detailed Sample Location:
Stage bathroom	Throughout bathroom
Sample Quantity:	
Sample Color:	XRF:
White	0.08 mg/cm2

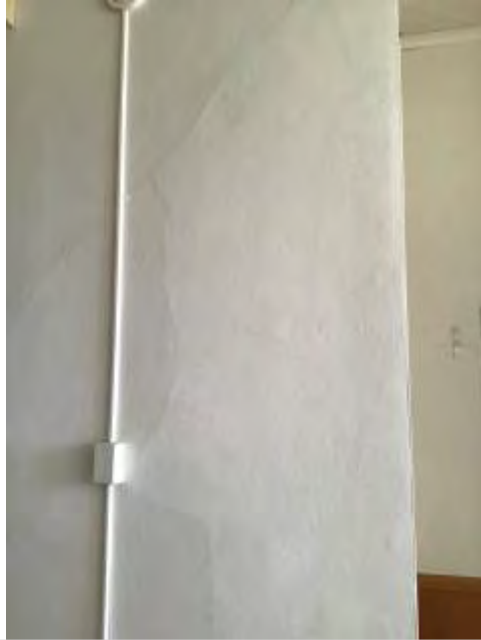
Sample ID:	Sample Type:
2-4-PB-4	PB
Sample Location:	Detailed Sample Location:
Hallway	Throughout hallway
Sample Quantity:	
Sample Color:	XRF:
White	0.05 mg/cm2

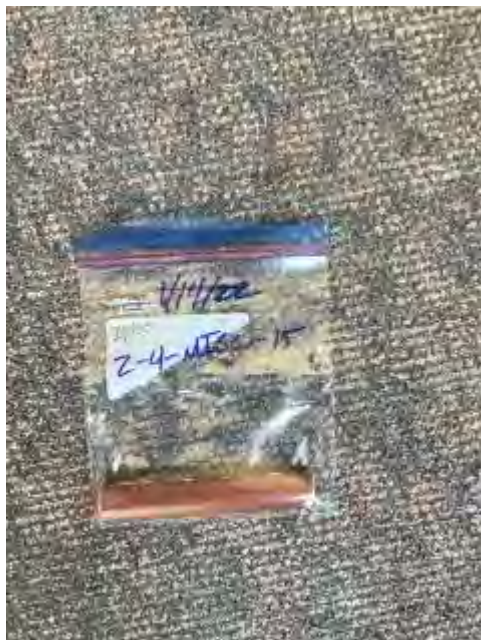
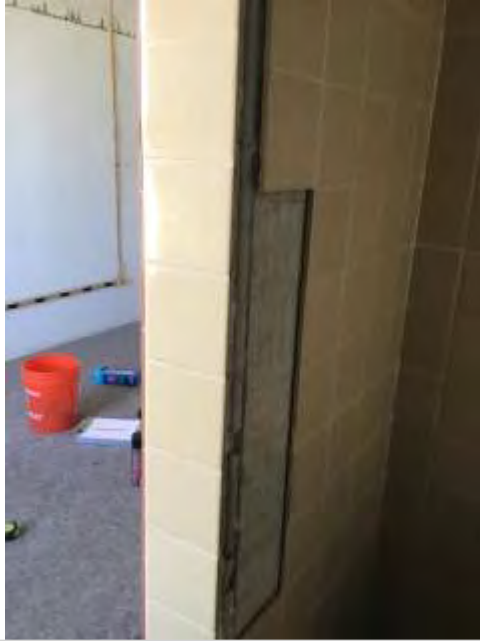
Sample ID:	Sample Type:	
2-4-MISC-15	MISC	
Sample Location:	Detailed Sample Location:	
Classroom education	East wall of shower	
Sample Quantity:	40 SF	
Misc Sample Material:	Sample Condition:	Sample Friable?:
Brown tile with gray grout	Damaged or significantly damaged friable miscellaneous ACM	No

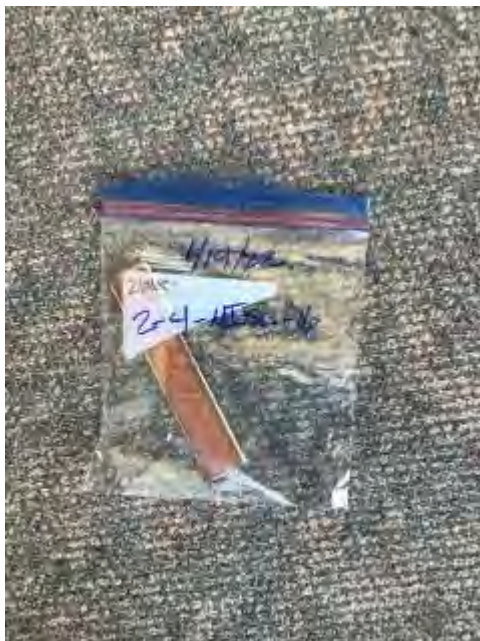
Additional Sample Notes:		
Sample ID:	Sample Type:	
2-4-MISC-16	MISC	
Sample Location:	Detailed Sample Location:	
Classroom Education	Northeast wall of shower	
Sample Quantity:	See 2-4-MISC-15	
Misc Sample Material:	Sample Condition:	Sample Friable?:
Brown tile with gray grout	Damaged or significantly damaged friable miscellaneous ACM	Yes

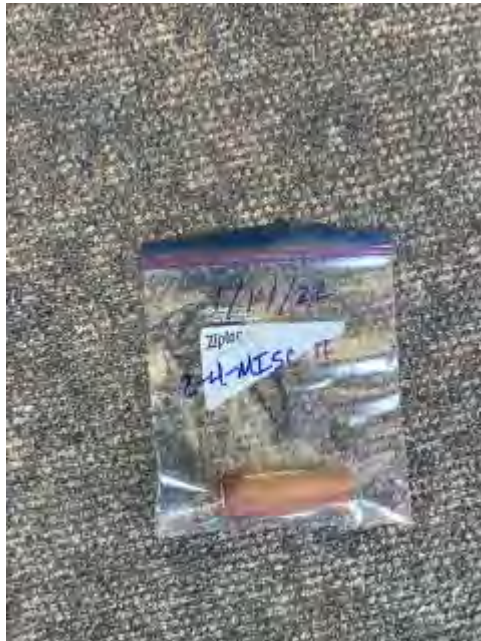
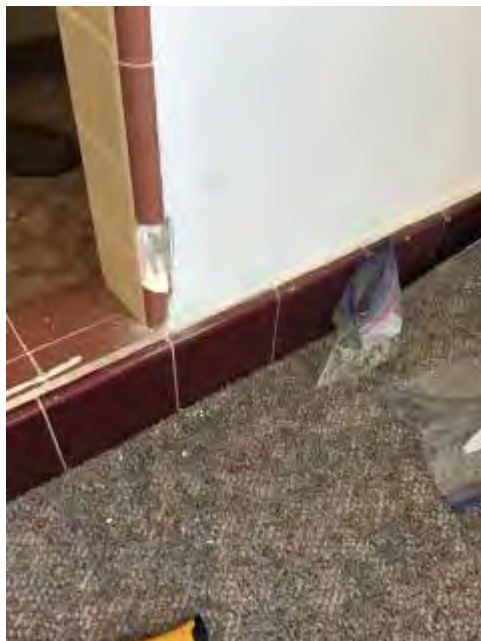
Additional Sample Notes:		
Sample ID:	Sample Type:	
2-4-MISC-17	MISC	
Sample Location:	Detailed Sample Location:	
Classroom Education	Northeast corner of shower	
Sample Quantity:	See 2-4-MISC-15	
Misc Sample Material:	Sample Condition:	Sample Friable?:
Brown tile with gray grout	Damaged or significantly damaged friable miscellaneous ACM	No

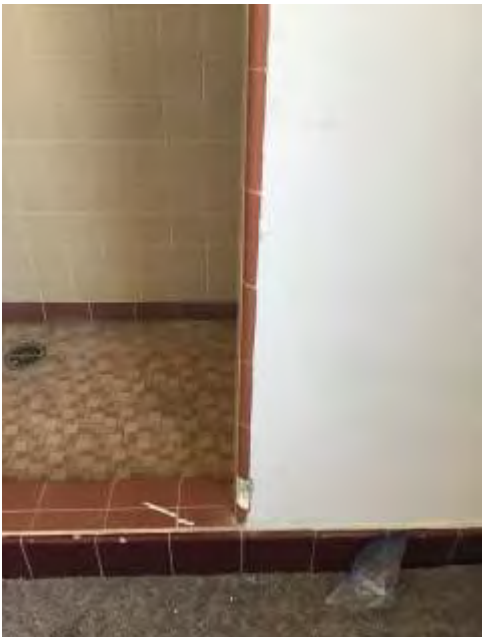
Additional Sample Notes:		
Sample ID:	Sample Type:	
2-5-MISC-18	MISC	
Sample Location:	Detailed Sample Location:	
Classroom Education	Northeast wall outside shower	
Sample Quantity:	140 LF	
Misc Sample Material:	Sample Condition:	Sample Friable?:
6"x6" maroon tile with gray grout	Damaged or significantly damaged friable miscellaneous ACM	No
Sample Photo:

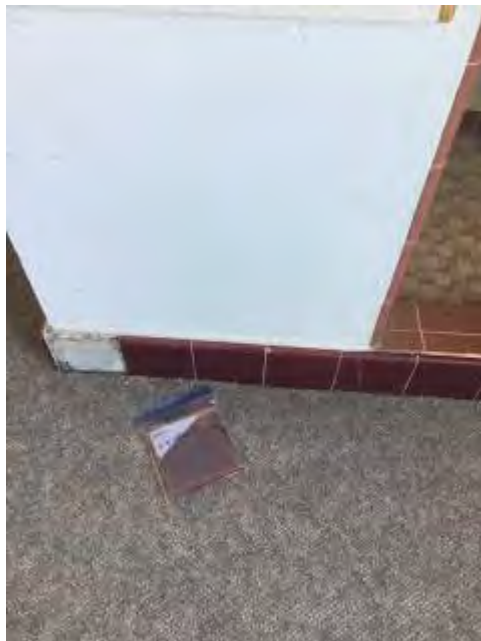
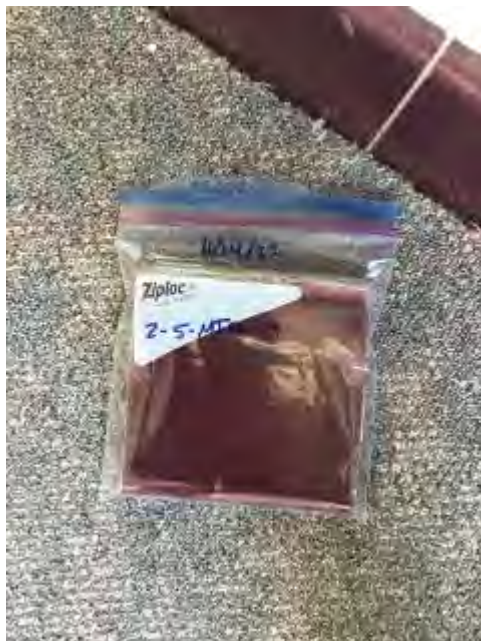
Additional Sample Notes:		
Sample ID:	Sample Type:	
2-5-MISC-19	MISC	
Sample Location:	Detailed Sample Location:	
Classroom Education	Southeast wall outside shower	
Sample Quantity:	See 2-5-MISC-18	
Misc Sample Material:	Sample Condition:	Sample Friable?:
6"x6" maroon tile with gray grout	Damaged or significantly damaged friable miscellaneous ACM	No

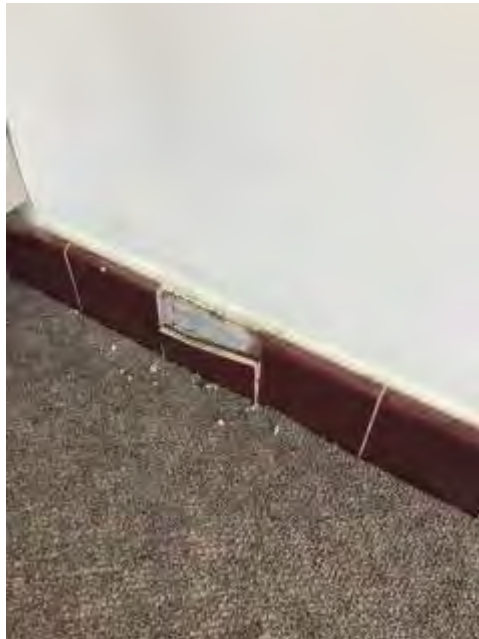
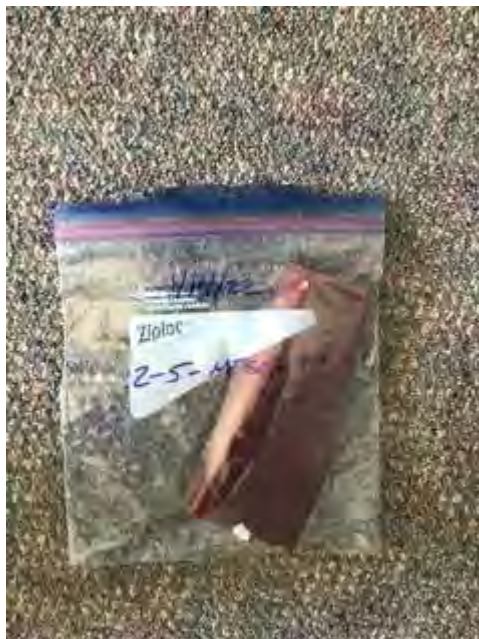
Additional Sample Notes:		
Sample ID:	Sample Type:	
2-5-MISC-20	MISC	
Sample Location:	Detailed Sample Location:	
Classroom Education	Southwest wall of easternmost room	
Sample Quantity:	See 2-5-MISC-18	
Misc Sample Material:	Sample Condition:	Sample Friable?:
6"x6" maroon tile with gray grout	Damaged or significantly damaged friable miscellaneous ACM	No

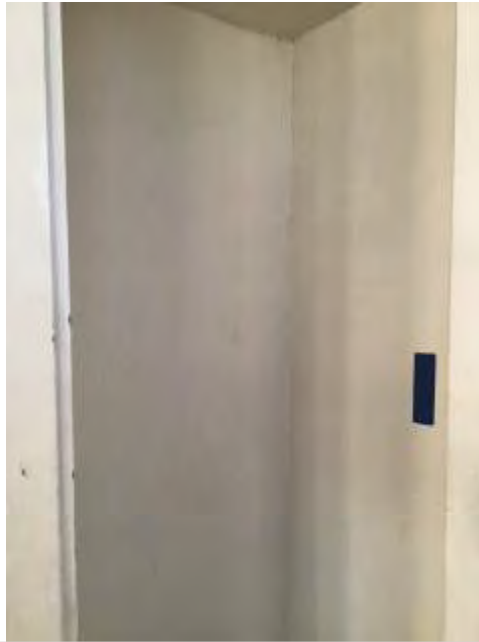
Sample ID:	Sample Type:
2-5-PB-5	PB
Sample Location:	Detailed Sample Location:
Classroom 29	Closet area between room 29 and 30
Sample Quantity:	1,950 SF
Sample Color:	XRF:
White	0.47 mg/cm2

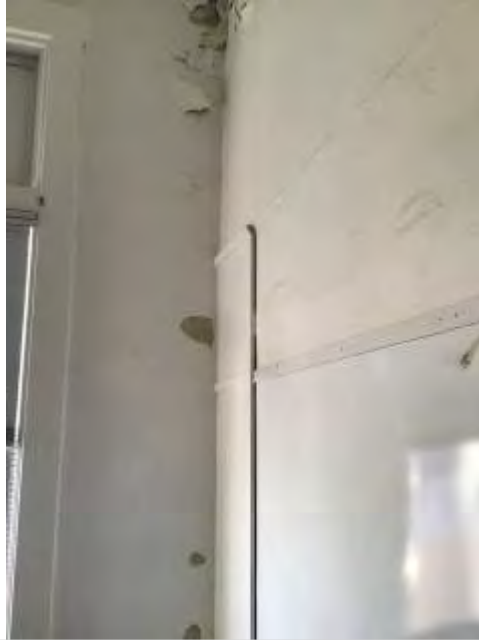
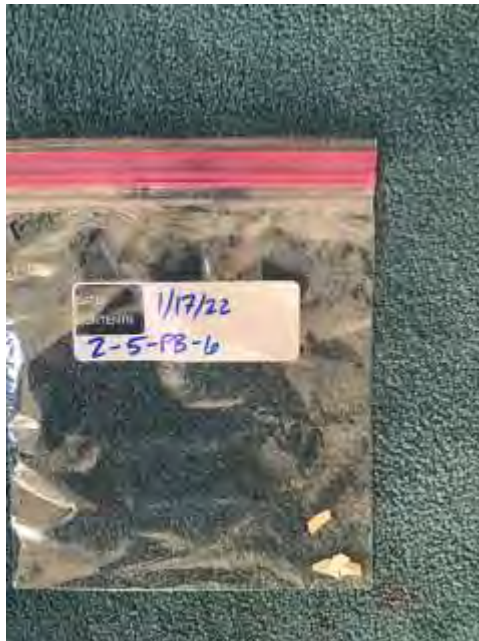
Sample ID:	Sample Type:
2-5-PB-6	PB
Sample Location:	Detailed Sample Location:
Classroom 30	Throughout room
Sample Quantity:	See 2-5-PB-5
Sample Color:	XRF:
White	0.05mg/cm2

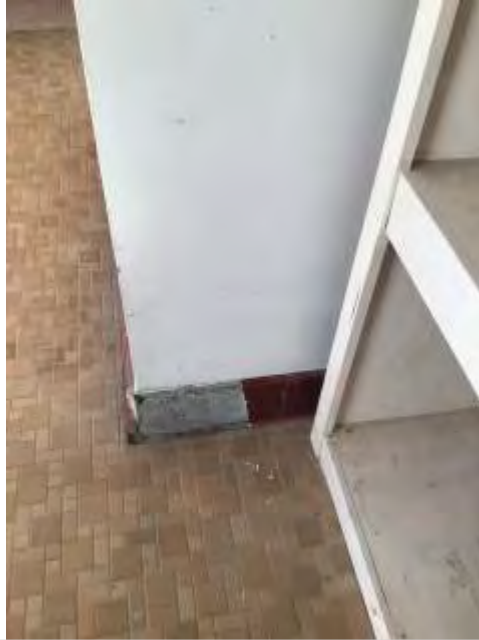
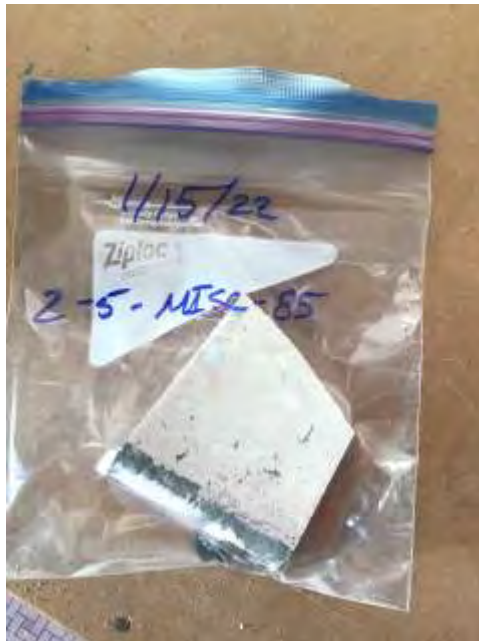
Additional Sample Notes:		
Sample ID:	Sample Type:	
2-5-MISC-85	MISC	
Sample Location:	Detailed Sample Location:	
Stage bathroom	Northwest wall of shower room	
Sample Quantity:	See 2-5-MISC-18	
Misc Sample Material:	Sample Condition:	Sample Friable?:
6"x6" maroon tile with gray grout	Damaged or significantly damaged friable miscellaneous ACM	No
Sample Photo:

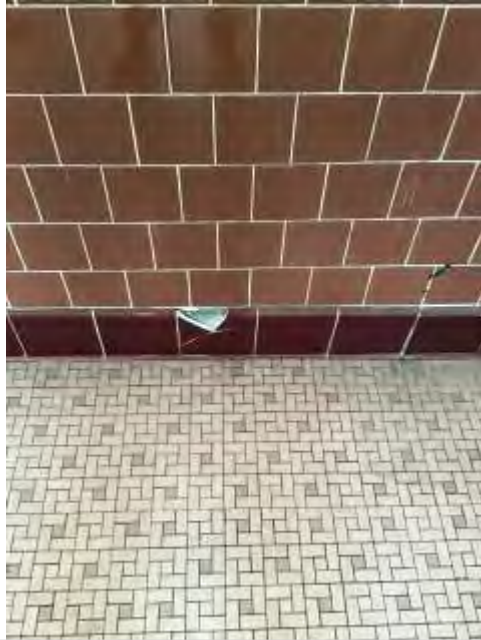
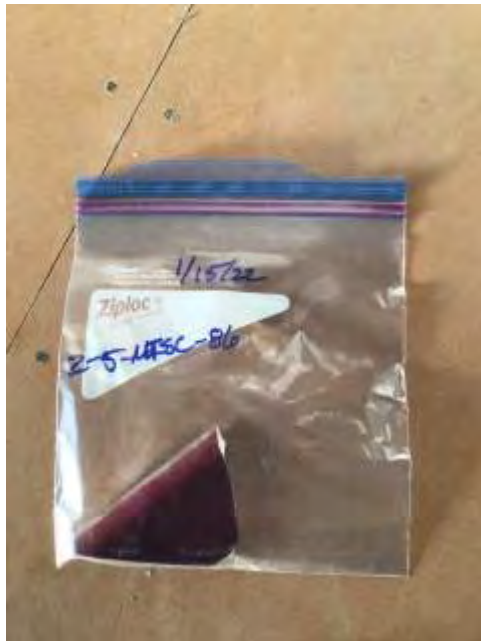
Additional Sample Notes:		
Sample ID:	Sample Type:	
2-5-MISC-86	MISC	
Sample Location:	Detailed Sample Location:	
Stage bathroom	North wall of changing room	
Sample Quantity:	See 2-5-MISC-18	
Misc Sample Material:	Sample Condition:	Sample Friable?:
6"x6" maroon tile with gray grout	Damaged or significantly damaged friable miscellaneous ACM	No
Sample Photo:

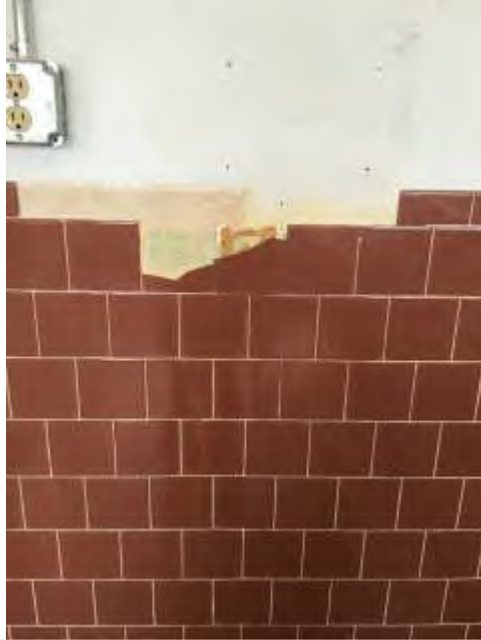
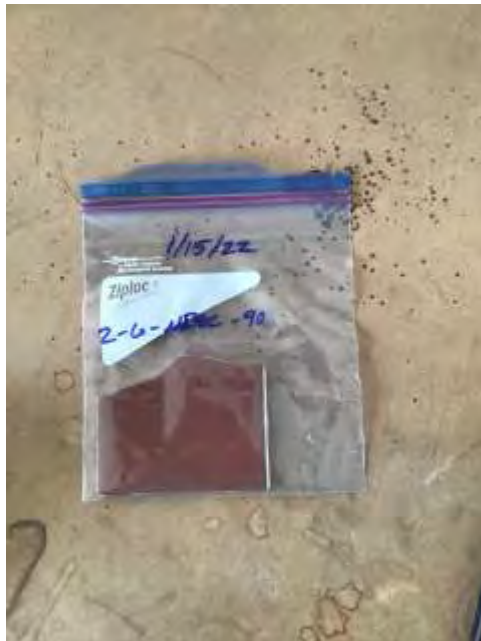
Additional Sample Notes:		
Sample ID:	Sample Type:	
2-6-MISC-90	MISC	
Sample Location:	Detailed Sample Location:	
Stage bathroom	North wall of changing area	
Sample Quantity:	See 2-6-MISC-21	
Misc Sample Material:	Sample Condition:	Sample Friable?:
Brown tile with gray grout	Damaged or significantly damaged friable miscellaneous ACM	No
Sample Photo:

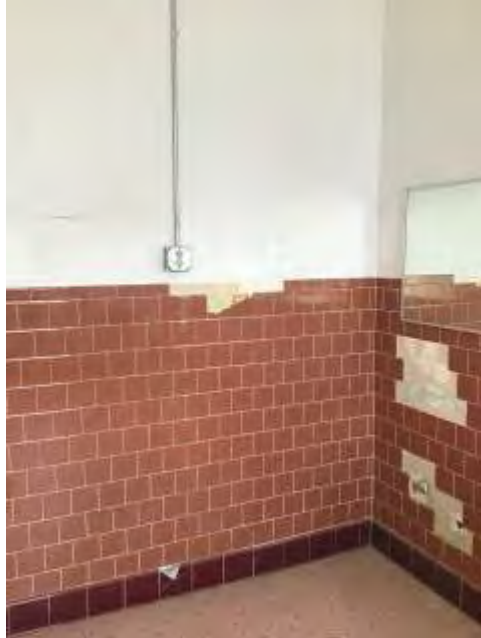
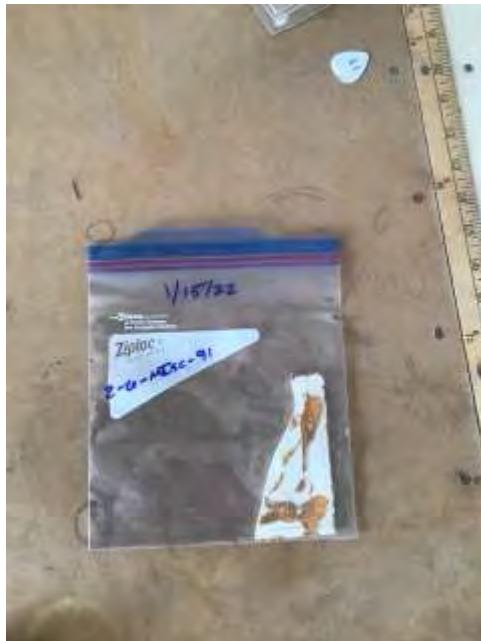
Additional Sample Notes:		
Sample ID:	Sample Type:	
2-6-MISC-91	MISC	
Sample Location:	Detailed Sample Location:	
Stage bathroom	North wall of changing area	
Sample Quantity:	See 2-6-MISC-21	
Misc Sample Material:	Sample Condition:	Sample Friable?:
Brown tile with gray grout and yellow mastic	Damaged or significantly damaged friable miscellaneous ACM	No
Sample Photo:

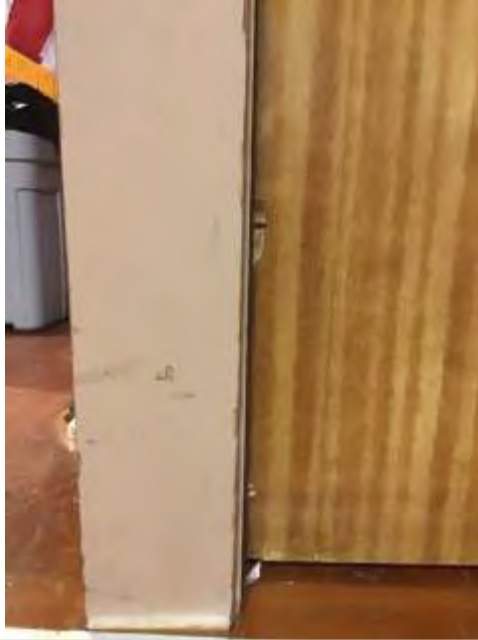
Additional Sample Notes:	
Sample ID:	Sample Type:
2-6-PB-7	PB
Sample Location:	Detailed Sample Location:
Auditorium	Beams throughout
Sample Quantity:	
Sample Color:	XRF:
Dark tan	0.03 mg/cm
Sample Photo:

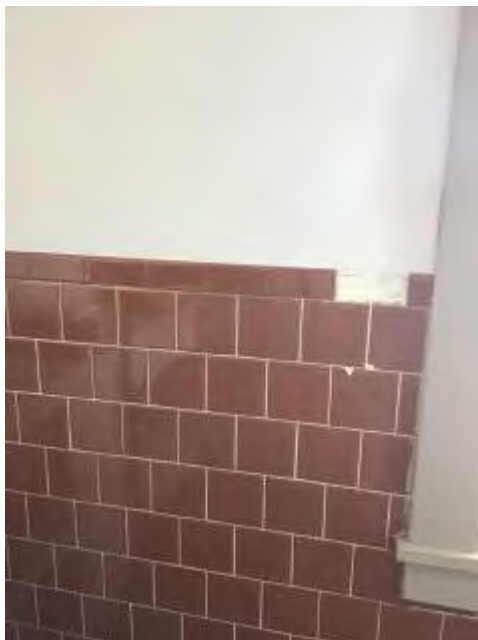
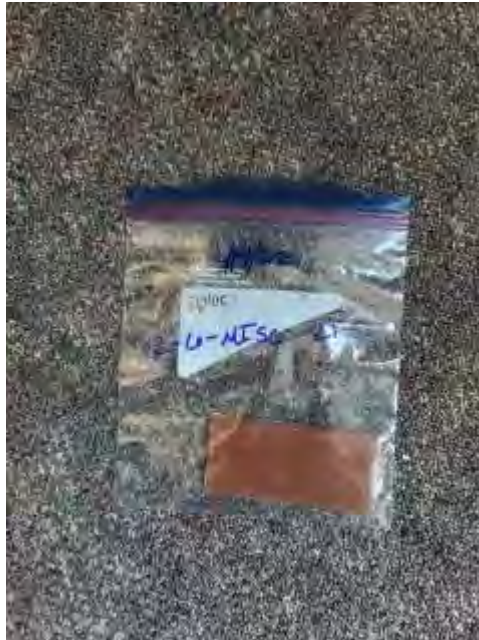
Additional Sample Notes:		
Sample ID:	Sample Type:	
2-6-MISC-21	MISC	
Sample Location:	Detailed Sample Location:	
Classroom Education	North wall of westernmost room	
Sample Quantity:	140 SF	
Misc Sample Material:	Sample Condition:	Sample Friable?:
Brown tile with yellow mastic and gray grout	Damaged or significantly damaged friable miscellaneous ACM	No

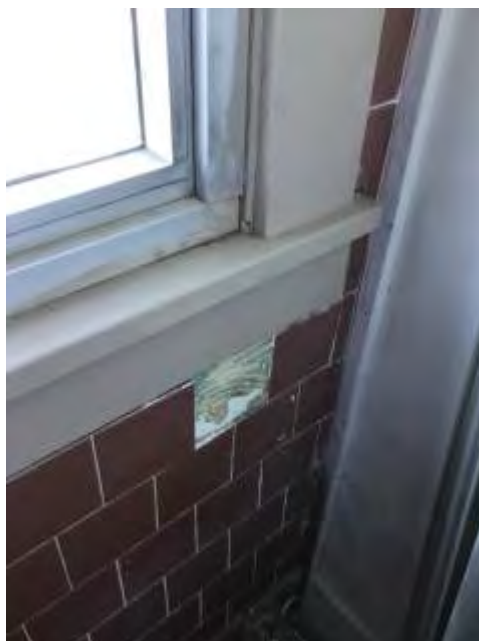
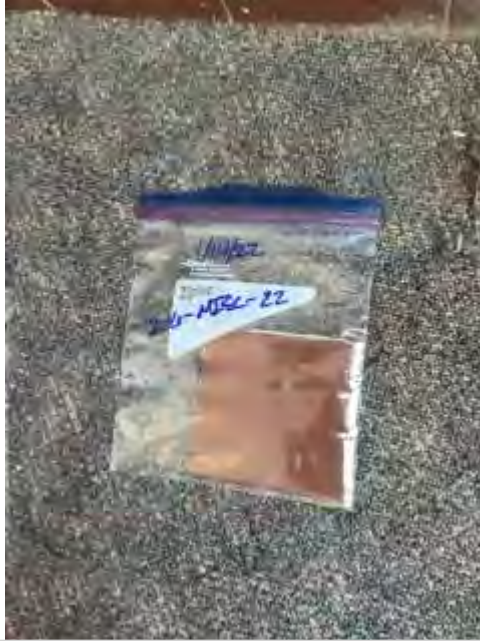
Additional Sample Notes:		
Sample ID:	Sample Type:	
2-6-MISC-22	MISC	
Sample Location:	Detailed Sample Location:	
Classroom Education	North wall of westernmost room	
Sample Quantity:	See 2-6-MISC-21	
Misc Sample Material:	Sample Condition:	Sample Friable?:
Brown tile with gray grout	Damaged or significantly damaged friable miscellaneous ACM	No

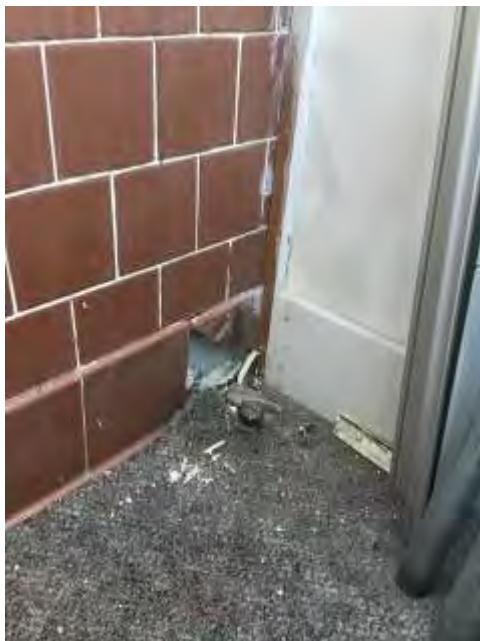
Additional Sample Notes:		
Sample ID:	Sample Type:	
2-6-MISC-23	MISC	
Sample Location:	Detailed Sample Location:	
Classroom Education	North wall of westernmost room	
Sample Quantity:	See 2-6-MISC-21	
Misc Sample Material:	Sample Condition:	Sample Friable?:
Brown tile with gray grout	Damaged or significantly damaged friable miscellaneous ACM	No

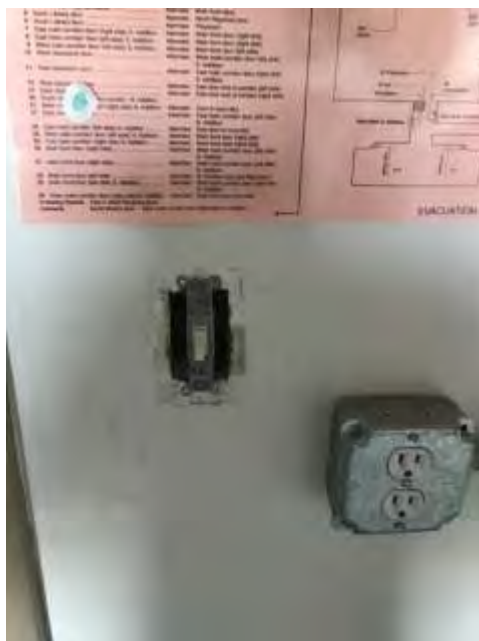
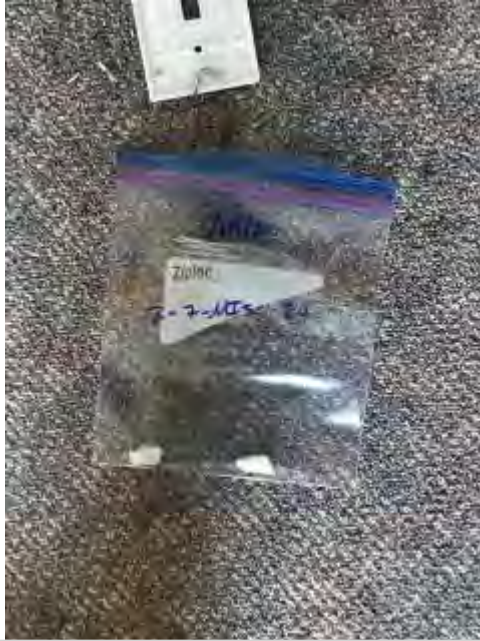
Damaged or significantly damaged friable miscellaneous ACM

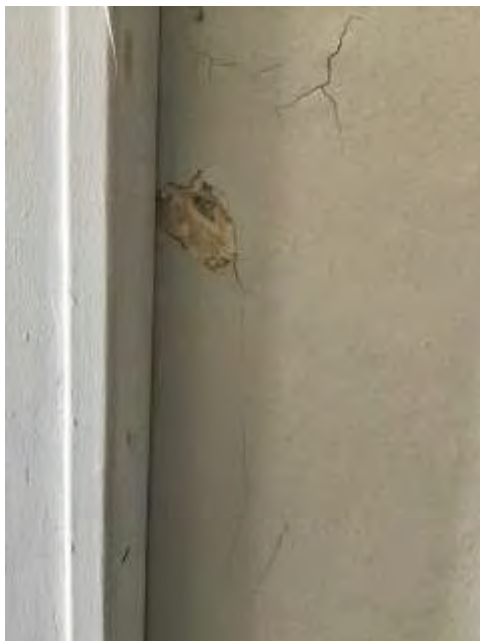
Additional Sample Notes:		
Sample ID:	Sample Type:	
2-7-MISC-25	MISC	
Sample Location:	Detailed Sample Location:	
Classroom Education	Southeast wall of easternmost room	
Sample Quantity:	See 2-7-MISC-24	
Misc Sample Material:	Sample Condition:	Sample Friable?:
White wallboard	Damaged or significantly damaged friable miscellaneous ACM	Yes

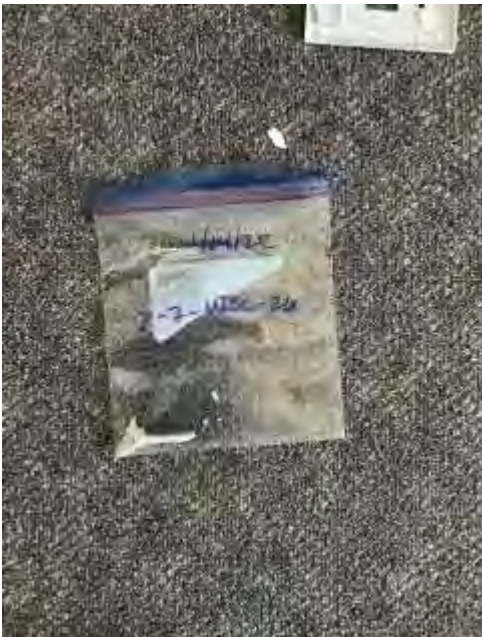
Additional Sample Notes:		
Sample ID:	Sample Type:	
2-7-MISC-26	MISC	
Sample Location:	Detailed Sample Location:	
Classroom Education	Southwest wall of easternmost room	
Sample Quantity:	See 2-7-MISC-24	
Misc Sample Material:	Sample Condition:	Sample Friable?:
White wallboard	Damaged or significantly damaged friable miscellaneous ACM	Yes
Sample Photo:

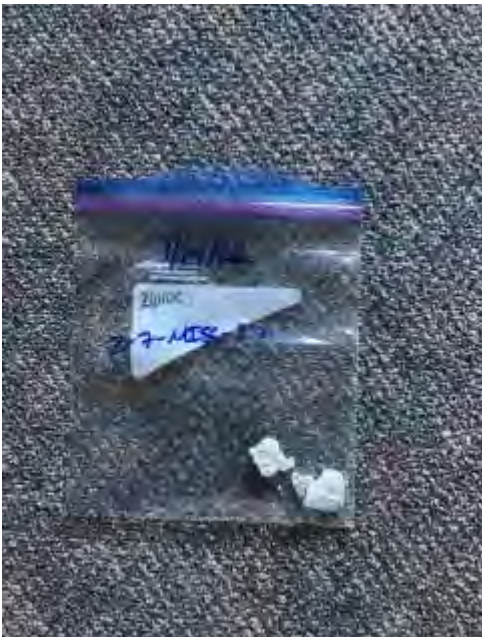
Additional Sample Notes:		
Sample ID:	Sample Type:	
2-7-MISC-27	MISC	
Sample Location:	Detailed Sample Location:	
Classroom Education	West wall of westernmost room	
Sample Quantity:	See 2-7-MISC-24	
Misc Sample Material:	Sample Condition:	Sample Friable?:
White wallboard	Damaged or significantly damaged friable miscellaneous ACM	Yes
Sample Photo:

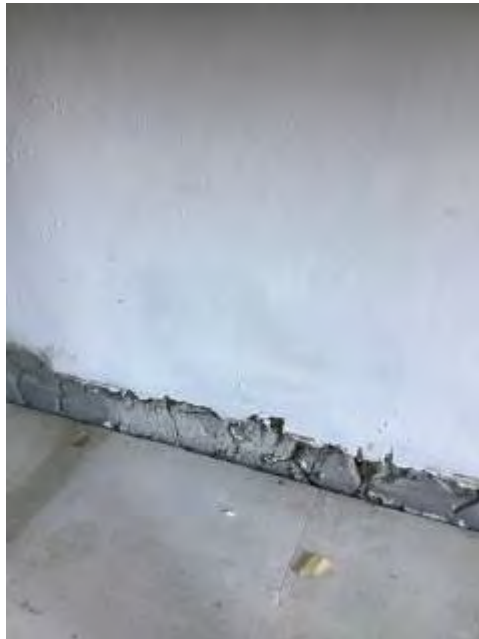
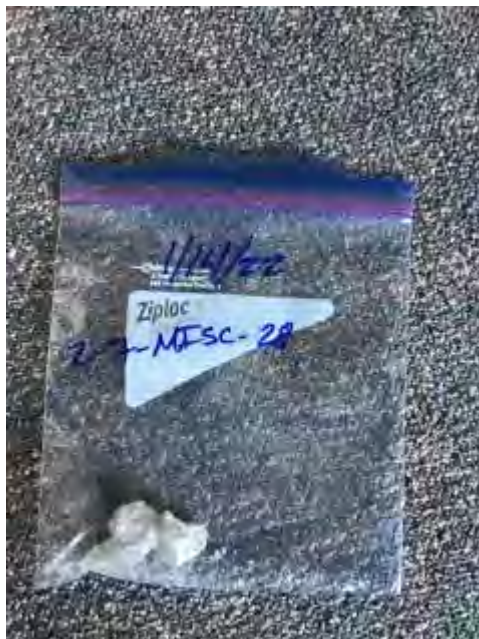
Sample ID:	Sample Type:	
2-7-MISC-28	MISC	
Sample Location:	Detailed Sample Location:	
Classroom Education	Northwest wall of westernmost room	
Sample Quantity:	See 2-7-MISC-24	
Misc Sample Material:	Sample Condition:	Sample Friable?:
White wallboard	Damaged or significantly damaged friable miscellaneous ACM	Yes

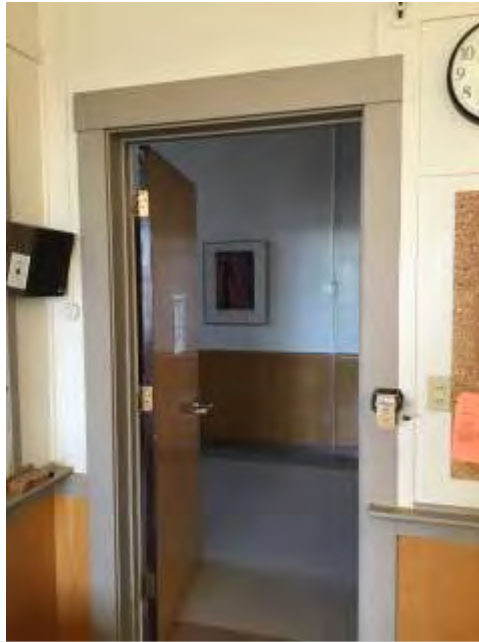
Sample ID:	Sample Type:
2-7-PB-8	PB
Sample Location:	Detailed Sample Location:
Classroom 26	Door frame
Sample Quantity:	
Sample Color:	XRF:
Gray	0.18 mg/cm2
