HAZARDOUS BUILDING MATERIALS SURVEY

CONDON GRADE SCHOOL
220 S. EAST STREET
CONDON, OREGON

Prepared for
CITY OF CONDON
May 17, 2022
Project No. M2053.01.002

Prepared by
Maul Foster & Alongi, Inc.
3140 NE Broadway Street, Portland, OR 97232

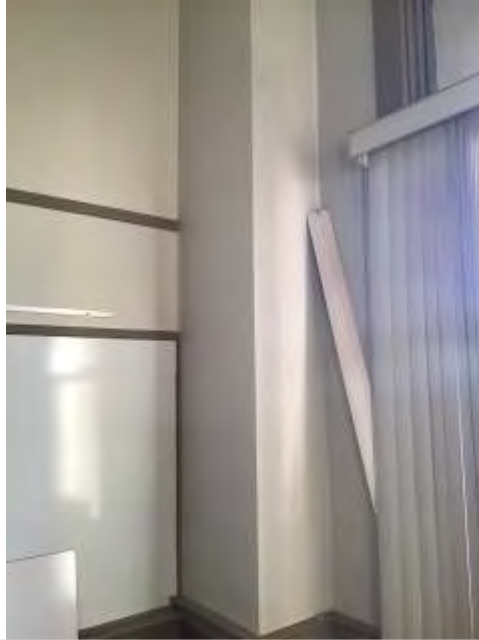
Sample ID:	Sample Type:
2-8-PB-9	PB
Sample Location:	Detailed Sample Location:
Classroom 26	Throughout
Sample Quantity:	
Sample Color:	XRF:
White	0.20 mg/cm

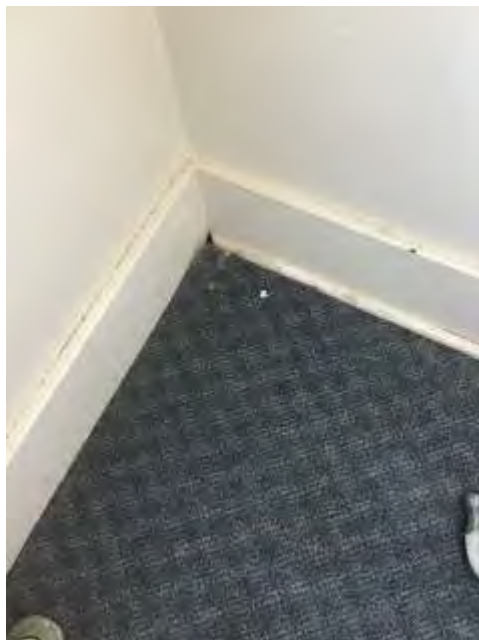
Sample ID:	Sample Type:	
2-8-MISC-29	MISC	
Sample Location:	Detailed Sample Location:	
Classroom 25	Northeast corner	
Sample Quantity:		
Misc Sample Material:	Sample Condition:	Sample Friable?:
Blue carpet with yellow mastic	Damaged or significantly damaged friable miscellaneous ACM	No

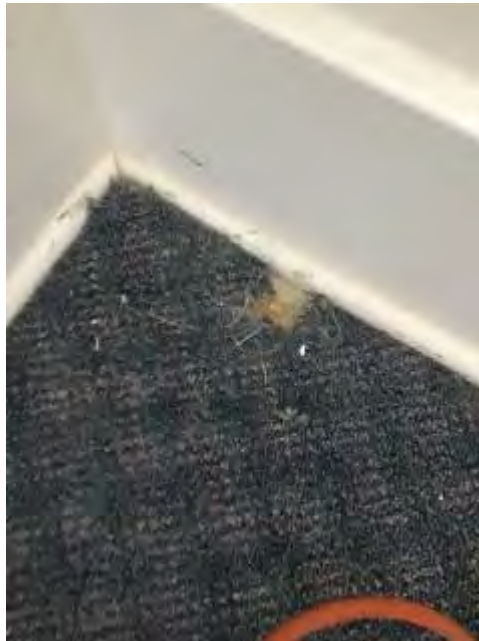
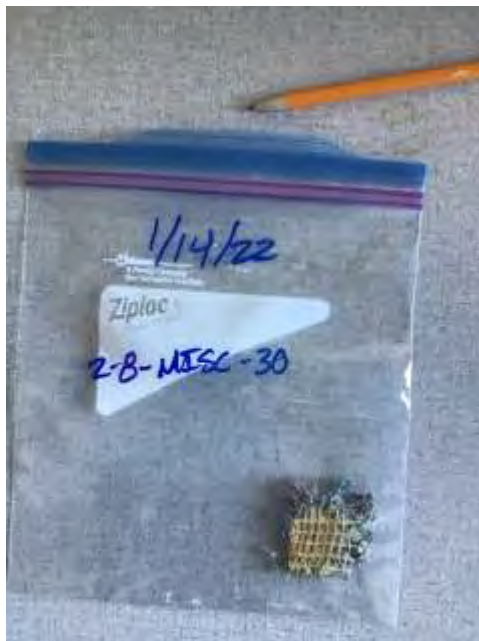
Additional Sample Notes:		
Sample ID:	Sample Type:	
2-8-MISC-30	MISC	
Sample Location:	Detailed Sample Location:	
Classroom 25	Southwest corner	
Sample Quantity:	See 2-8-MISC-29	
Misc Sample Material:	Sample Condition:	Sample Friable?:
Blue carpet with yellow mastic	Damaged or significantly damaged friable miscellaneous ACM	No

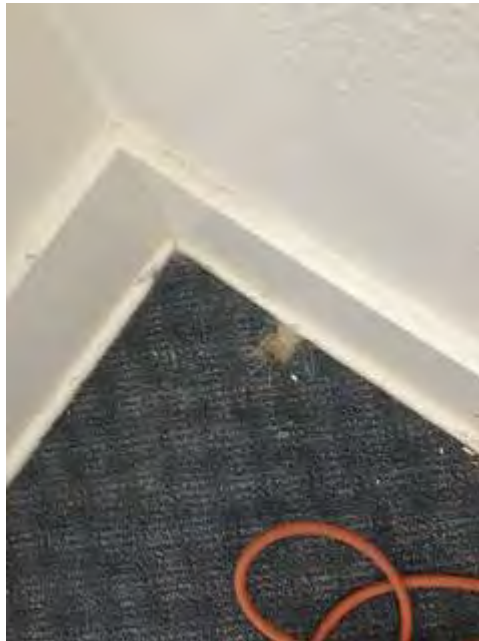
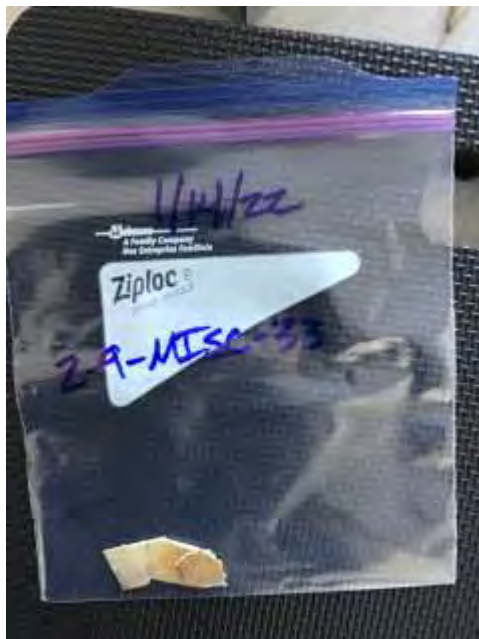
Additional Sample Notes:		
Sample ID:	Sample Type:	
2-9-MISC-33	MISC	
Sample Location:	Detailed Sample Location:	
Classroom 25	Southwest corner	
Sample Quantity:	See 2-9-MISC-32	
Misc Sample Material:	Sample Condition:	Sample Friable?:
Tan linoleum with black mastic	Damaged or significantly damaged friable miscellaneous ACM	Yes

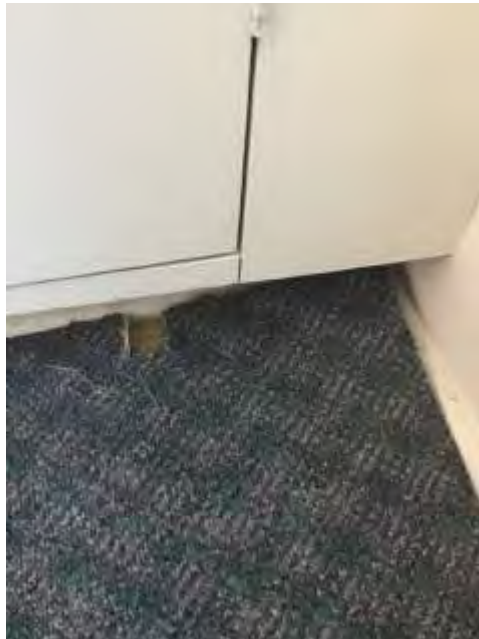
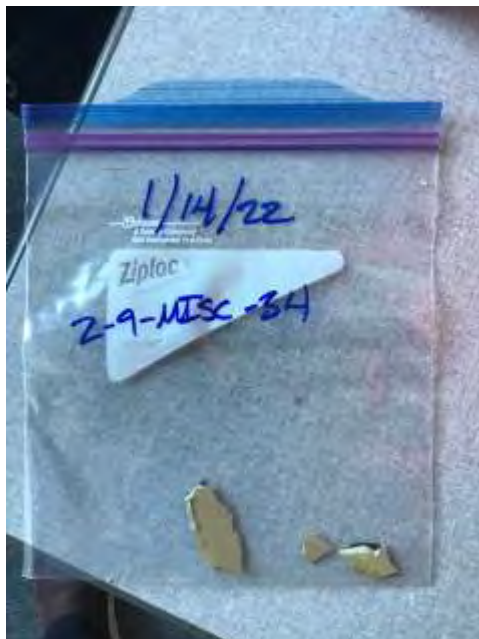
Additional Sample Notes:		
Sample ID:	Sample Type:	
2-9-MISC-34	MISC	
Sample Location:	Detailed Sample Location:	
Classroom 25	Northwest corner	
Sample Quantity:	See 2-9-MISC-32	
Misc Sample Material:	Sample Condition:	Sample Friable?:
Tan linoleum with black mastic	Damaged or significantly damaged friable miscellaneous ACM	Yes

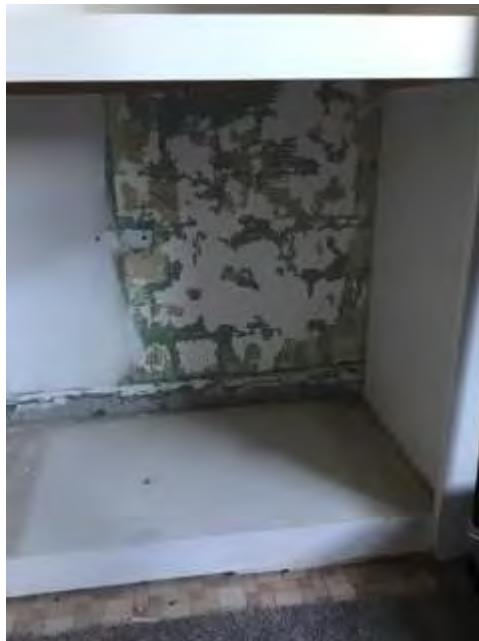
Sample ID:	Sample Type:
2-9-PB-10	PB
Sample Location:	Detailed Sample Location:
Classroom Education	Throughout
Sample Quantity:	
Sample Color:	XRF:
Green	0.34mg/cm2

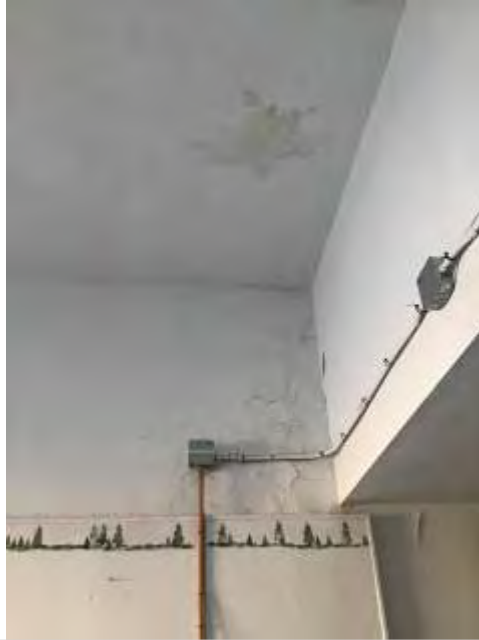
Sample ID:	Sample Type:
2-10-PB-11	PB
Sample Location:	Detailed Sample Location:
Classroom Education	Throughout
Sample Quantity:	
Sample Color:	XRF:
White	ND

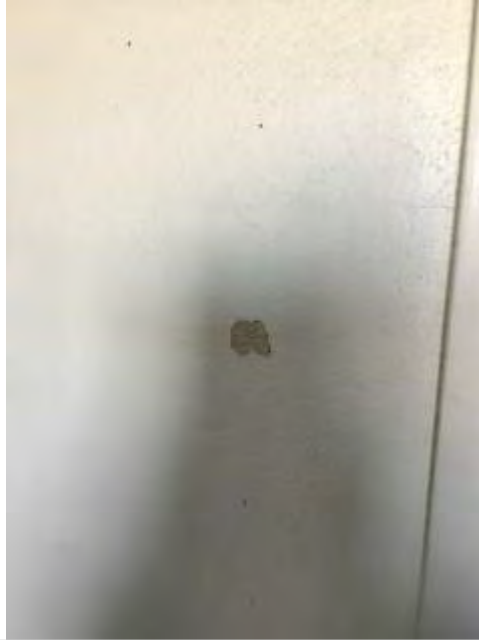
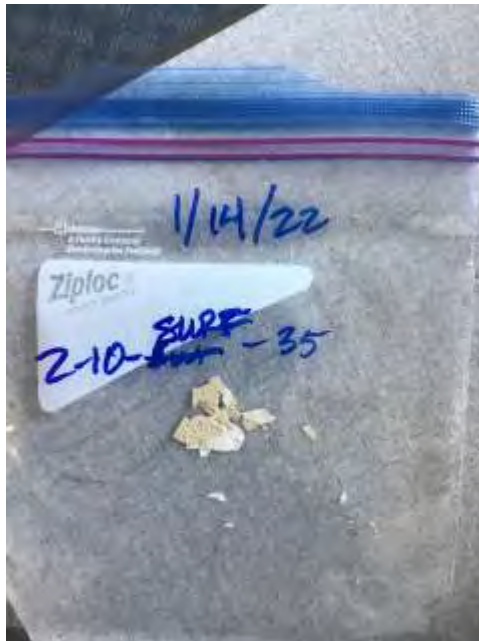
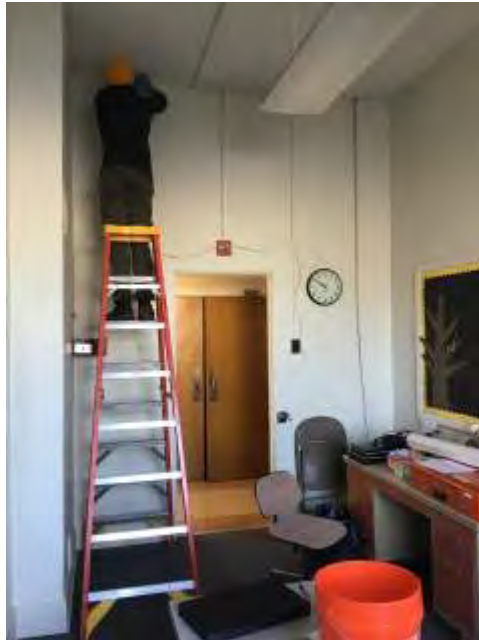
Additional Sample Notes:		
Sample ID:	Sample Type:	
2-10-SURF-35	SURF	
Sample Location:	Detailed Sample Location:	
Classroom 25	Southeast wall	
Sample Quantity:	452 SF	
Sample Color:	XRF:	
Misc Sample Material:	Sample Condition:	Sample Friable?:
	Damaged friable surfacing ACM	No
Sample Photo:

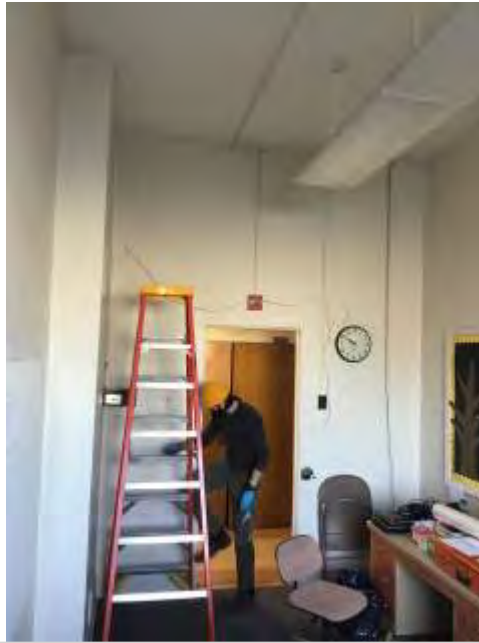
Additional Sample Notes:		This accounts for ceiling and south pop out wall.	
Sample ID:		Sample Type:	
2-10-SURF-36		SURF	
Sample Location:		Detailed Sample Location:	
Classroom 25		Southwest wall	
Sample Quantity:		See 2-10-SURF-35	
Sample Color:		XRF:	
Misc Sample Material:		Sample Condition:	Sample Friable?:
		Damaged friable surfacing ACM	No
Sample Photo:

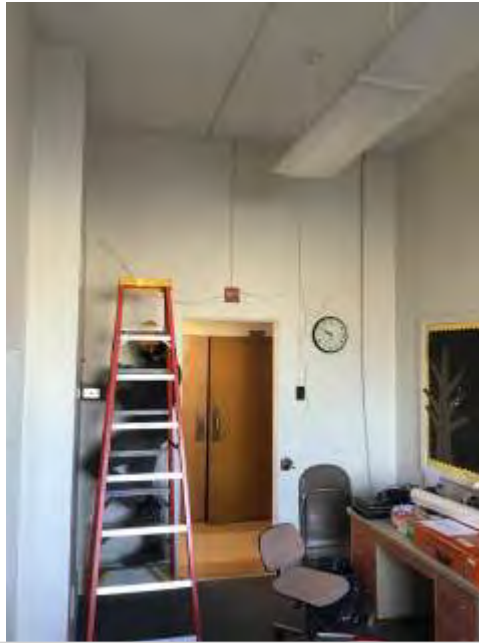
Additional Sample Notes:		This accounts for ceiling and south pop out wall	
Sample ID:		Sample Type:	
2-10-SURF-37		SURF	
Sample Location:		Detailed Sample Location:	
Classroom 25		South ceiling	
Sample Quantity:		See 2-10-SURF-35	
Sample Color:		XRF:	
Misc Sample Material:		Sample Condition:	Sample Friable?:
		Damaged friable surfacing ACM	No
Sample Photo:

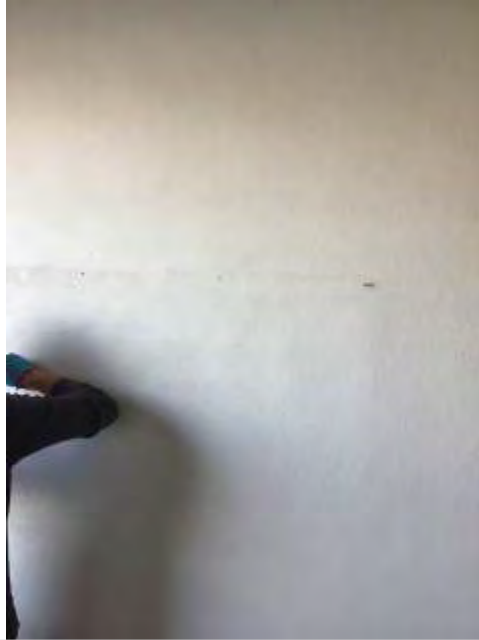
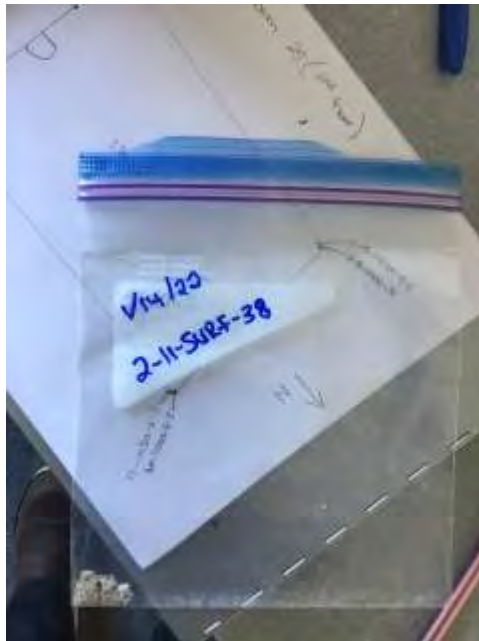
Additional Sample Notes:		This accounts for ceiling and south pop out wall	
Sample ID:		Sample Type:	
2-11-SURF-38		SURF	
Sample Location:		Detailed Sample Location:	
Classroom 25		East wall	
Sample Quantity:		144 SF	
Sample Color:		XRF:	
Misc Sample Material:		Sample Condition:	Sample Friable?:
		Damaged friable surfacing ACM	Yes
Sample Photo:

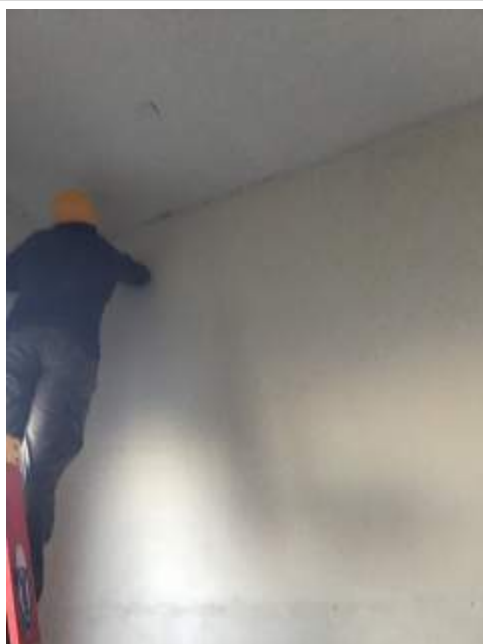
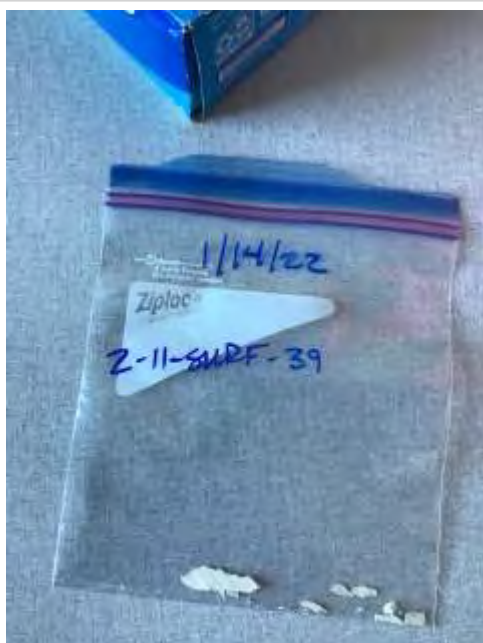
Additional Sample Notes:		Orange peel texture only on east wall	
Sample ID:		Sample Type:	
2-11-SURF-39		SURF	
Sample Location:		Detailed Sample Location:	
Classroom 25		East corner	
Sample Quantity:		See 2-11-SURF-38	
Sample Color:		XRF:	
Misc Sample Material:		Sample Condition:	Sample Friable?:
		Damaged friable surfacing ACM	Yes

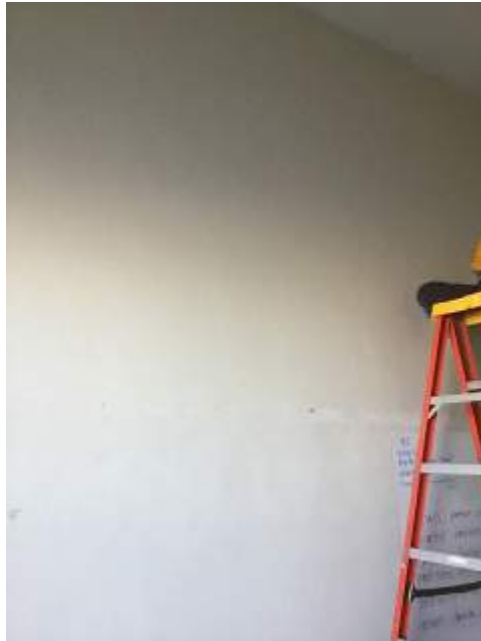
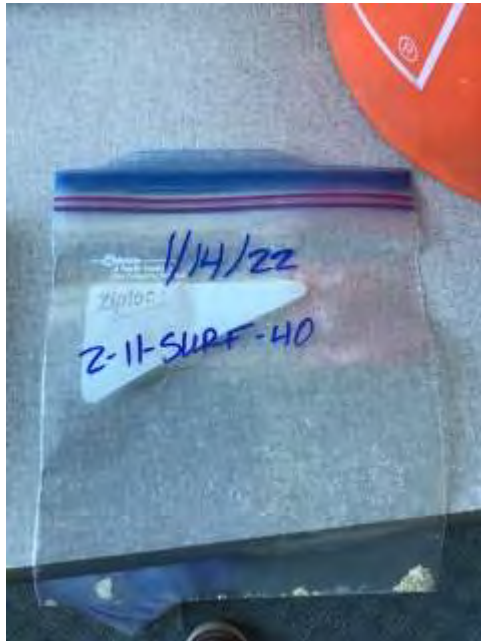
Misc Sample Material:	Sample Condition:	Sample Friable?:
	Damaged friable surfacing ACM	Yes

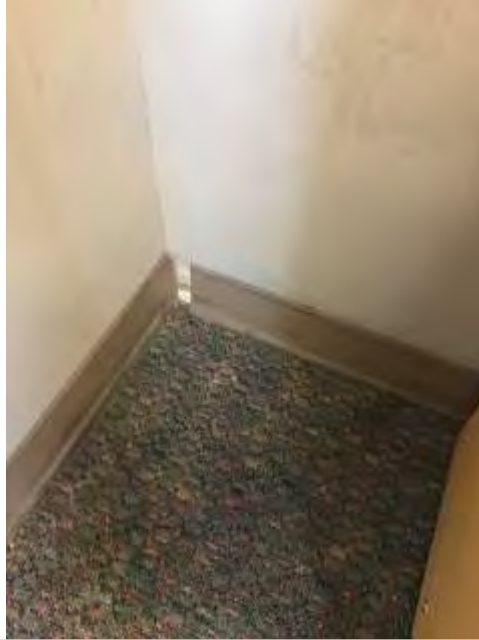
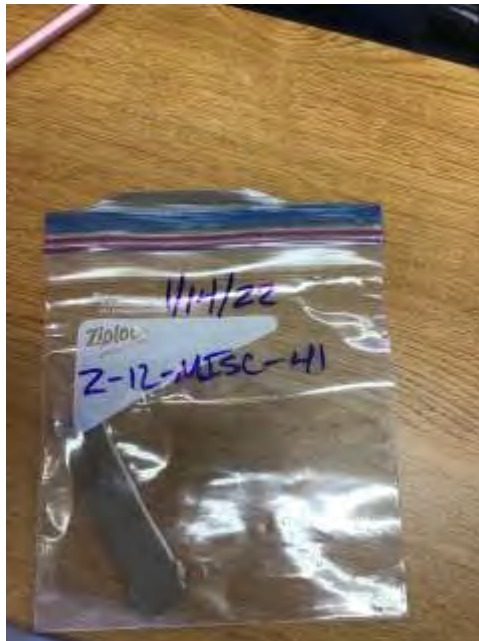
Additional Sample Notes:	Orange peel texture only on east wall
Sample ID:	Sample Type:
2-12-MISC-41	MISC
Sample Location:	Detailed Sample Location:
Classroom 24	East wall near doorway
Sample Quantity:	108 LF

Misc Sample Material:	Sample Condition:	Sample Friable?:
Tan base cove with tan mastic	Damaged or significantly damaged friable miscellaneous ACM	No

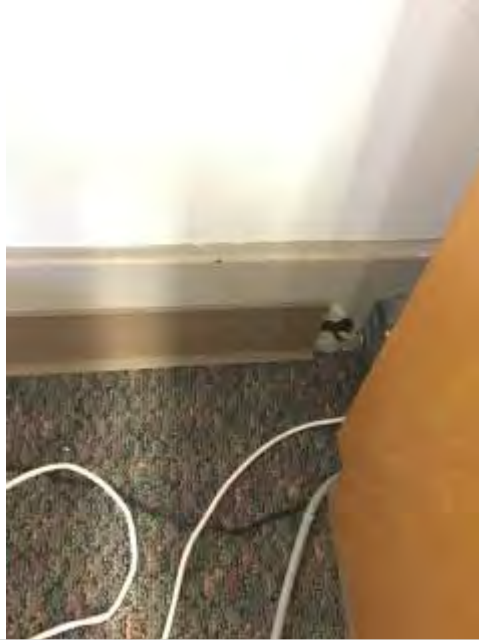
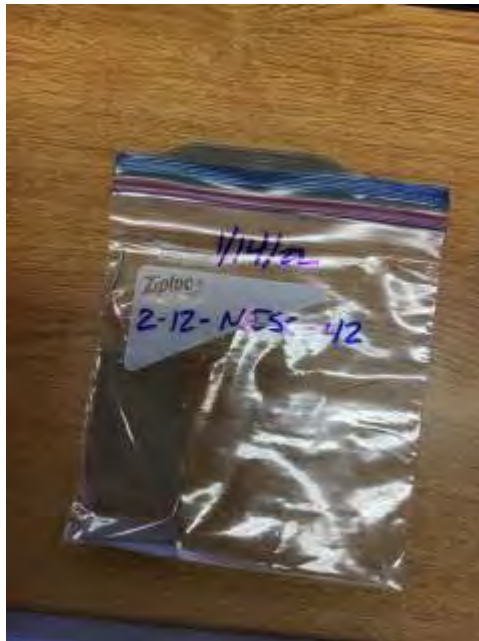
Sample ID:	Sample Type:
2-12-MISC-42	MISC
Sample Location:	Detailed Sample Location:
Classroom 24	Northeast corner wall
Sample Quantity:	See 2-12-MISC-41

Misc Sample Material:	Sample Condition:	Sample Friable?:
Tan base cove with tan mastic	Damaged or significantly damaged friable miscellaneous ACM	No

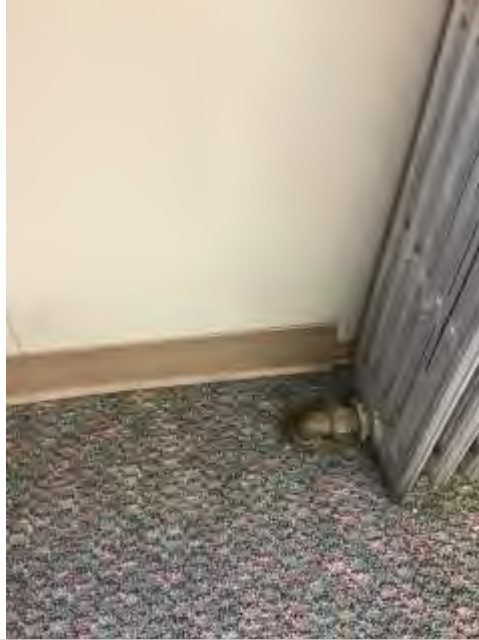
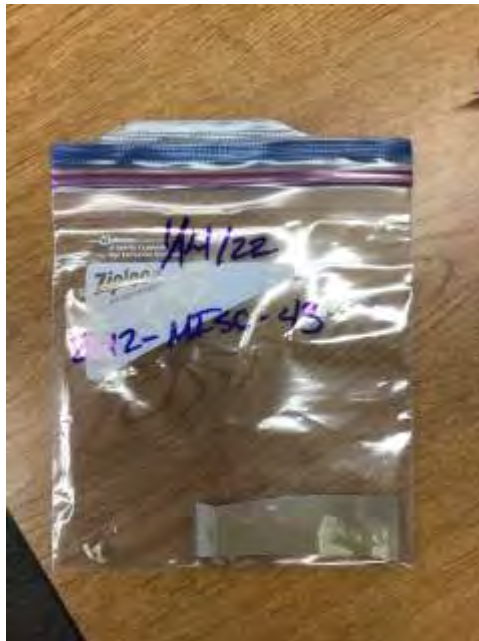
Sample ID:	Sample Type:
2-12-MISC-43	MISC
Sample Location:	Detailed Sample Location:
Classroom 24	Northwest wall
Sample Quantity:	See 2-12-MISC-41

Misc Sample Material:	Sample Condition:	Sample Friable?:
Tan base cove with tan mastic	Damaged or significantly damaged friable miscellaneous ACM	No

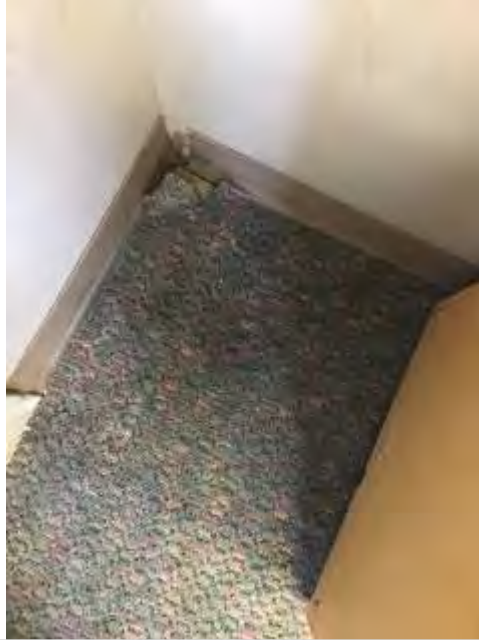
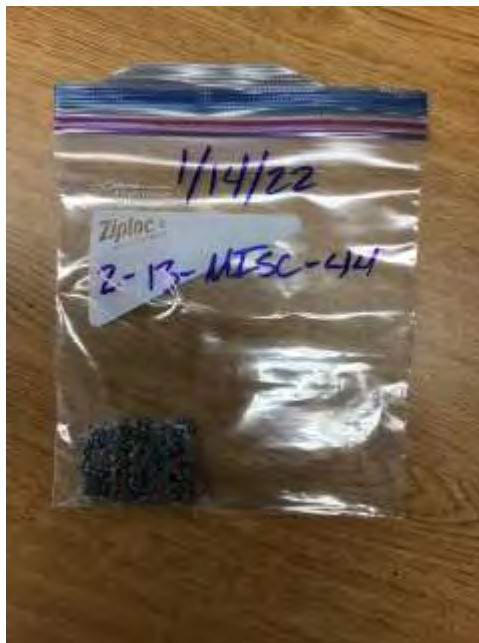
Additional Sample Notes:	
Sample ID:	Sample Type:
2-13-MISC-44	MISC
Sample Location:	Detailed Sample Location:
Classroom 24	East corner near doorway
Sample Quantity:	713 SF

Misc Sample Material:	Sample Condition:	Sample Friable?:
Green carpet with yellow mastic	Damaged or significantly damaged friable miscellaneous ACM	No

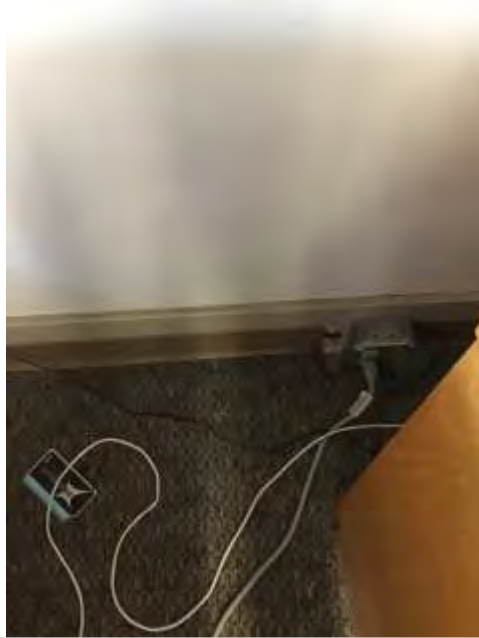
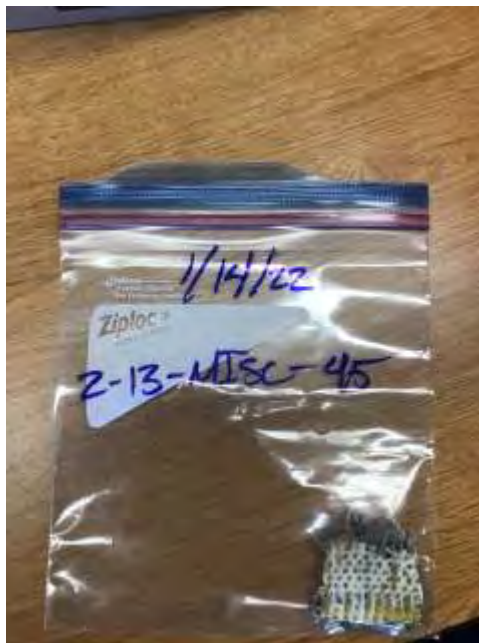
Misc Sample Material:	Sample Condition:	Sample Friable?:
Green carpet with yellow mastic	Damaged or significantly damaged friable miscellaneous ACM	No

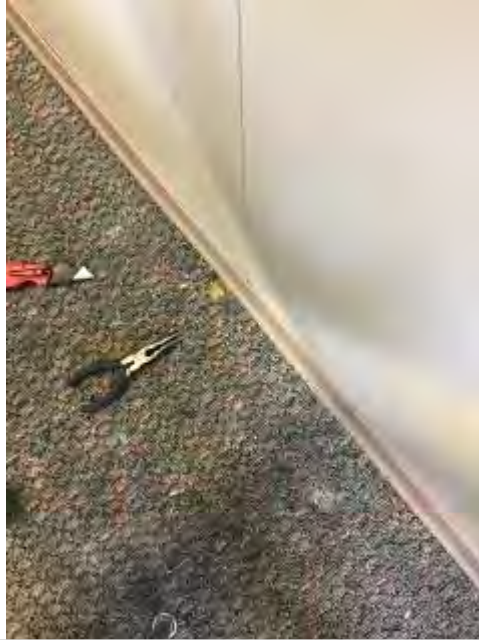
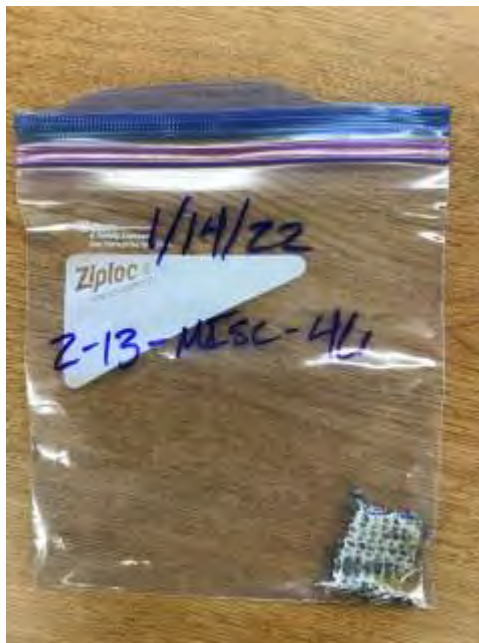
Additional Sample Notes:	
Sample ID:	Sample Type:
2-13-MISC-46	MISC
Sample Location:	Detailed Sample Location:
Classroom 24	West wall
Sample Quantity:	See 2-13-MISC-44

Misc Sample Material:	Sample Condition:	Sample Friable?:
Green carpet with yellow mastic	Damaged or significantly damaged friable miscellaneous ACM	No

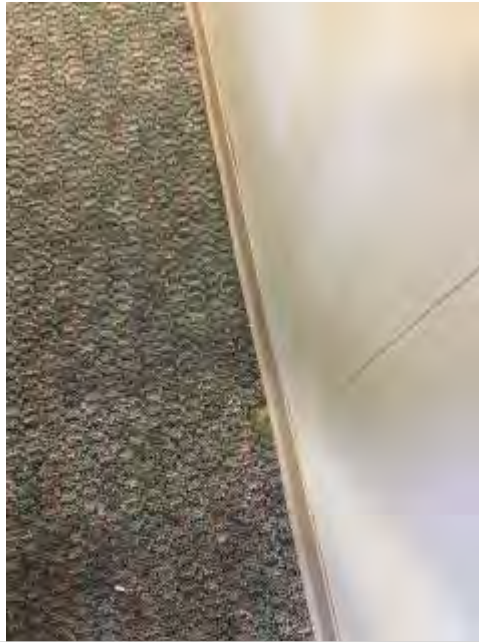
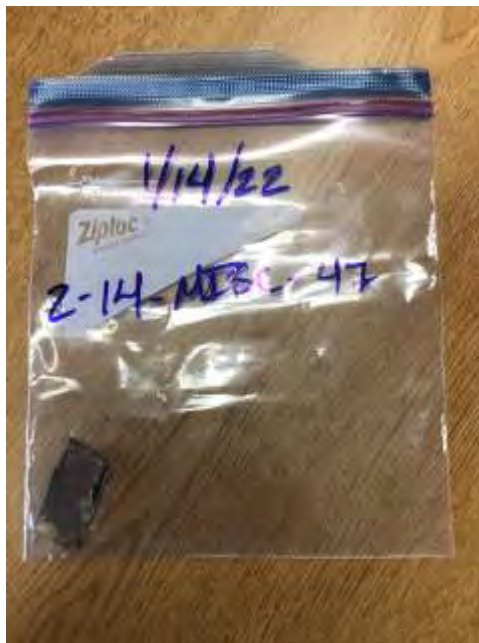
Additional Sample Notes:	
Sample ID:	Sample Type:
2-14-MISC-47	MISC
Sample Location:	Detailed Sample Location:
Classroom 24	West wall
Sample Quantity:	713 SF

Misc Sample Material:	Sample Condition:	Sample Friable?:
Linoleum with white black mastic	Damaged or significantly damaged friable miscellaneous ACM	Yes

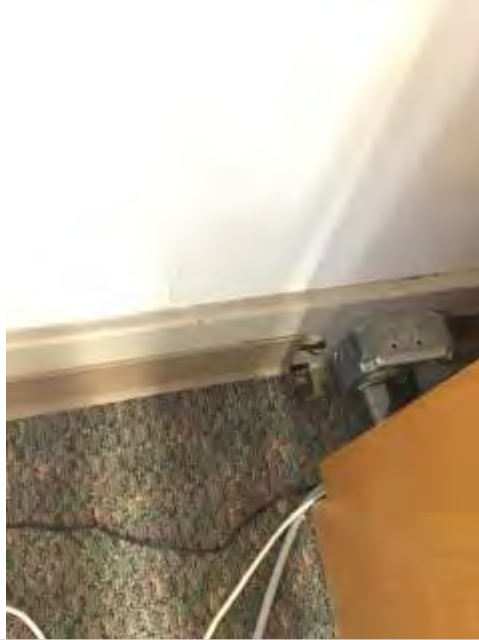
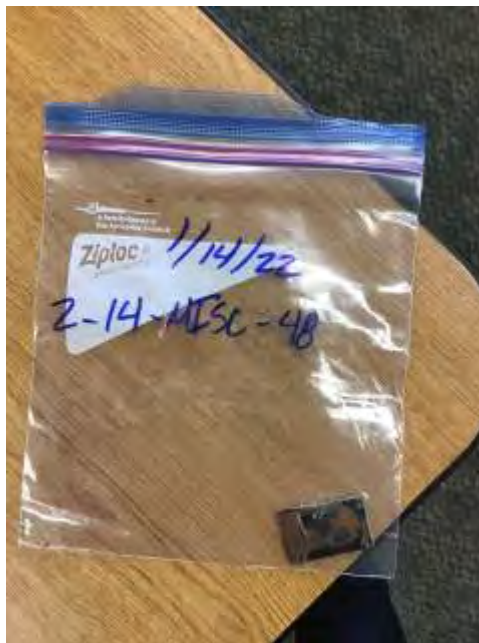
Additional Sample Notes:	
Sample ID:	Sample Type:
2-14-MISC-48	MISC
Sample Location:	Detailed Sample Location:
Classroom 24	Northeast corner
Sample Quantity:	See 2-14-MISC-47

Misc Sample Material:	Sample Condition:	Sample Friable?:
Linoleum with black and yellow mastic	Damaged or significantly damaged friable miscellaneous ACM	No

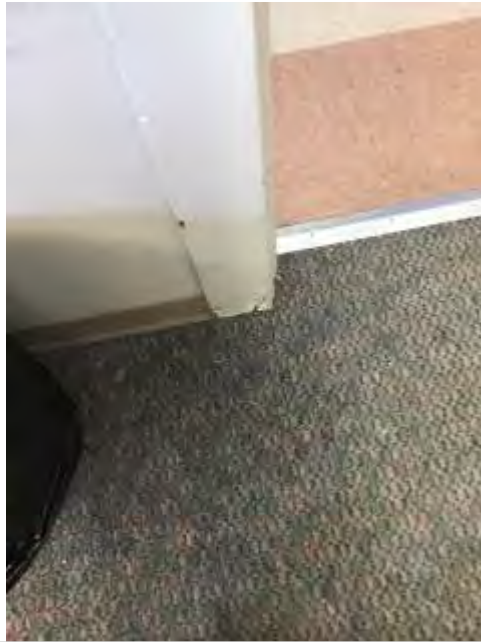
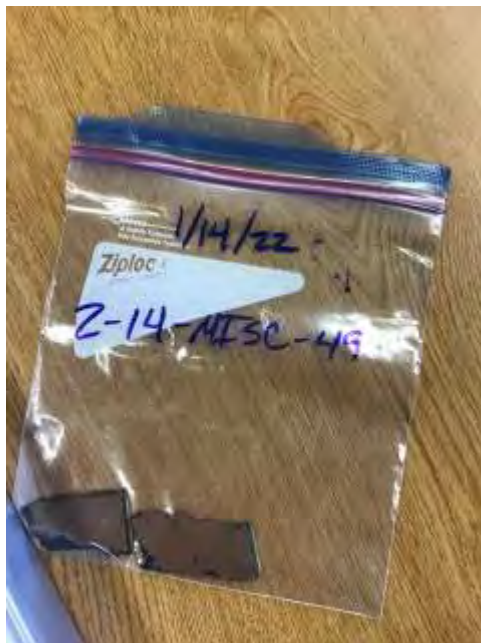
Additional Sample Notes:	
Sample ID:	Sample Type:
2-14-MISC-49	MISC
Sample Location:	Detailed Sample Location:
Classroom 24	Southeast wall near doorway
Sample Quantity:	See 2-14-MISC-47

Misc Sample Material:	Sample Condition:	Sample Friable?:
Linoleum with black and yellow mastic	Damaged or significantly damaged friable miscellaneous ACM	No

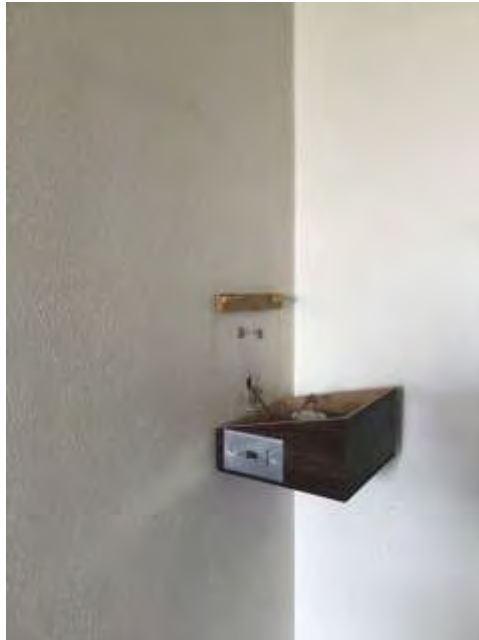
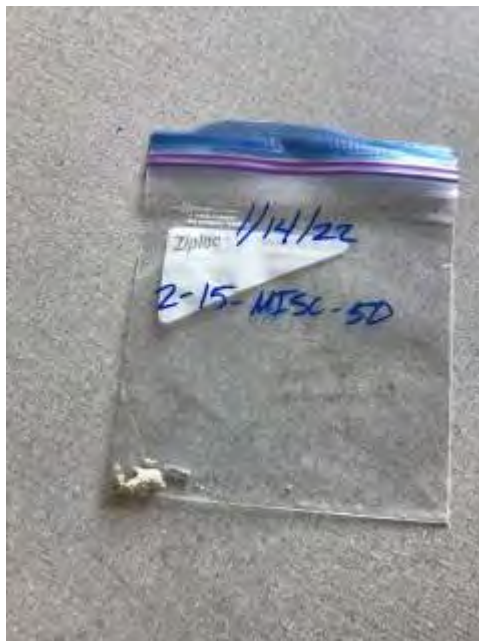
Additional Sample Notes:	
Sample ID:	Sample Type:
2-15-MISC-50	MISC
Sample Location:	Detailed Sample Location:
Classroom 25	South wall
Sample Quantity:	11,930 SF

Misc Sample Material:	Sample Condition:	Sample Friable?:
Cement board	Damaged or significantly damaged friable miscellaneous ACM	Yes

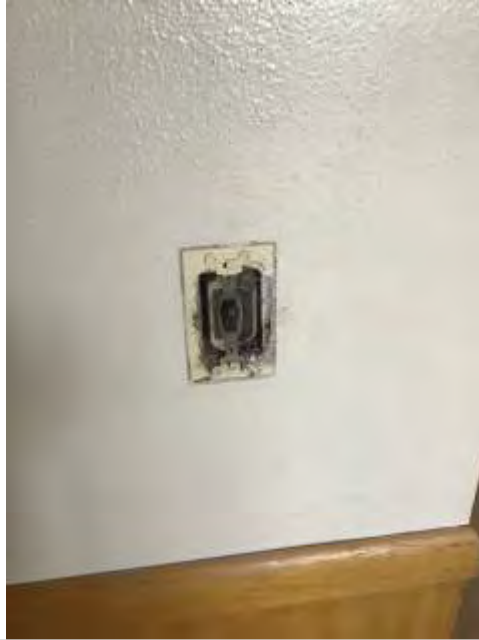
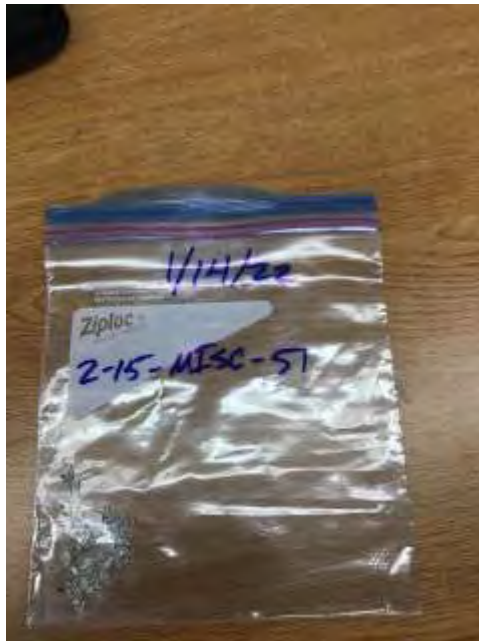
Additional Sample Notes:	
Sample ID:	Sample Type:
2-15-MISC-51	MISC
Sample Location:	Detailed Sample Location:
Second floor hallway	South wall across from Classroom 25
Sample Quantity:	See 2-15-MISC-50

Misc Sample Material:	Sample Condition:	Sample Friable?:
Cement board	Damaged or significantly damaged friable miscellaneous ACM	Yes

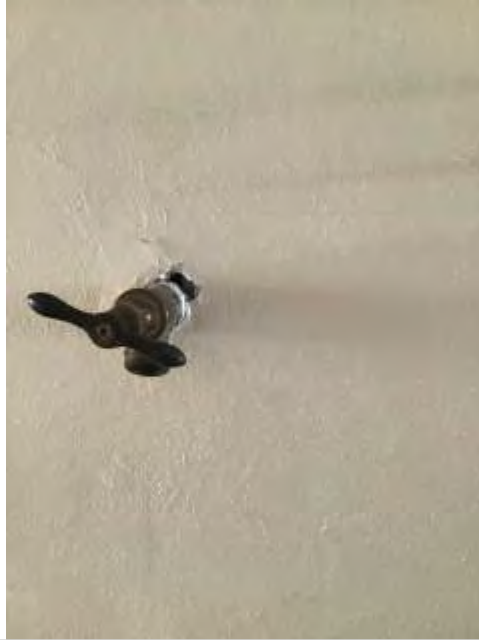
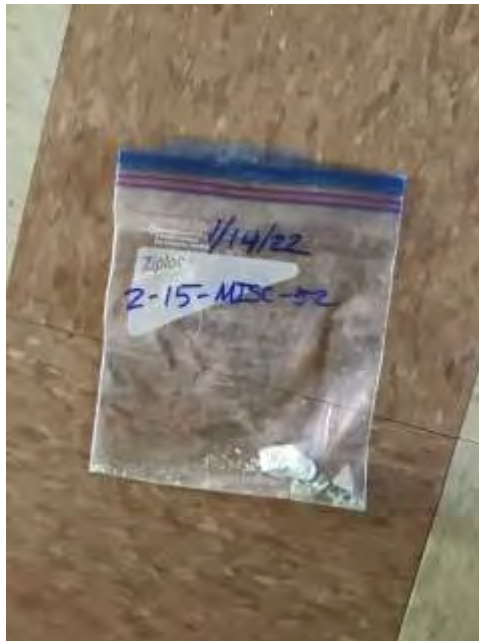
Additional Sample Notes:	
Sample ID:	Sample Type:
2-15-MISC-52	MISC
Sample Location:	Detailed Sample Location:
Second floor hallway	East wall near stairway to counselor's room
Sample Quantity:	See 2-15-MISC-50

Misc Sample Material:	Sample Condition:	Sample Friable?:
Cement board	Damaged or significantly damaged friable miscellaneous ACM	Yes

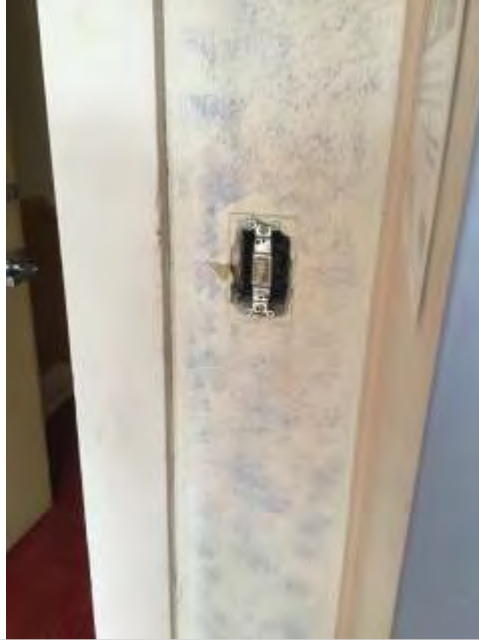
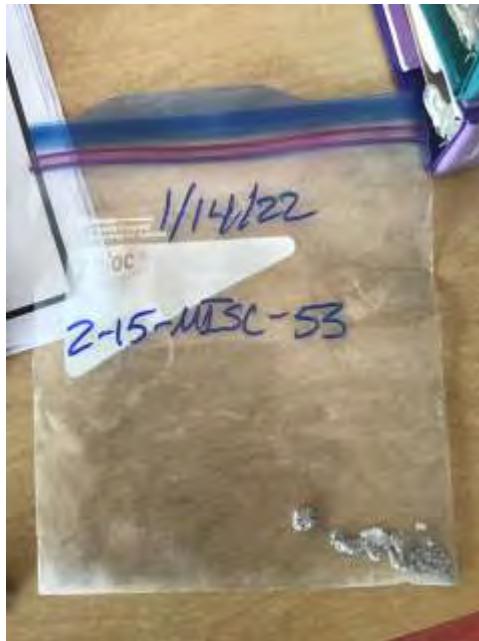
Additional Sample Notes:	
Sample ID:	Sample Type:
2-15-MISC-53	MISC
Sample Location:	Detailed Sample Location:
Counselor's room/Classroom 27	East wall
Sample Quantity:	See 2-15-MISC-50

Misc Sample Material:	Sample Condition:	Sample Friable?:
Cement board	Damaged or significantly damaged friable miscellaneous ACM	Yes

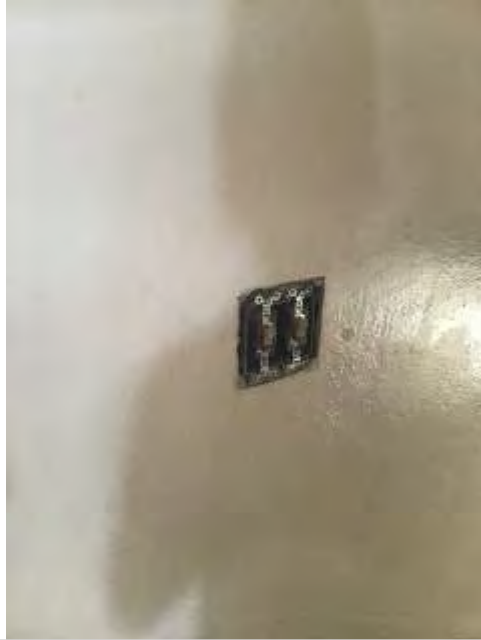
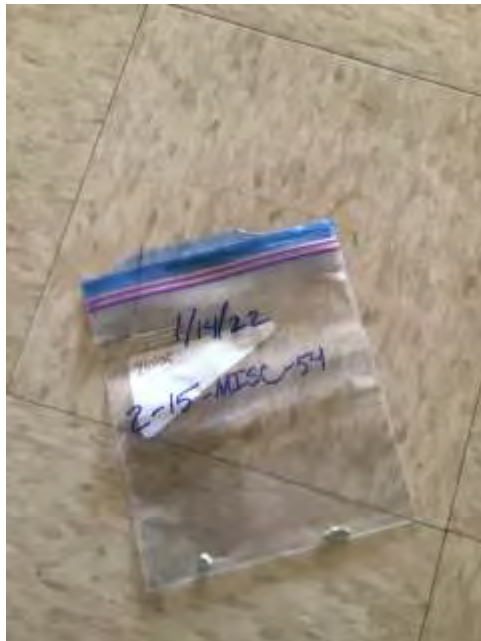
Sample ID:	Sample Type:
2-15-MISC-54	MISC
Sample Location:	Detailed Sample Location:
Second floor hallway	Stairway
Sample Quantity:	See 2-15-MISC-50

Misc Sample Material:	Sample Condition:	Sample Friable?:
Cement board	Damaged or significantly damaged friable miscellaneous ACM	Yes

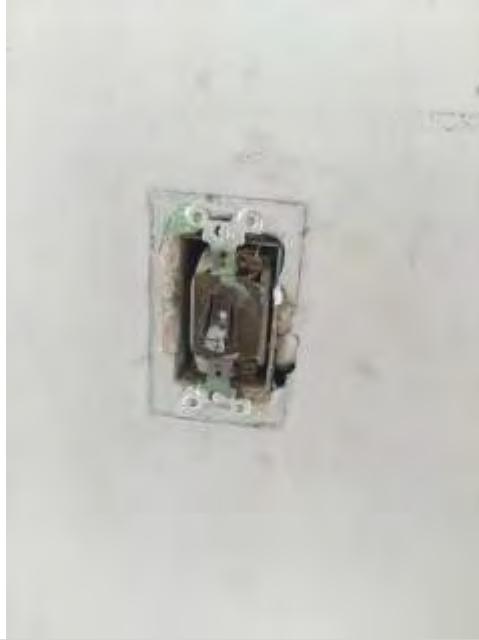
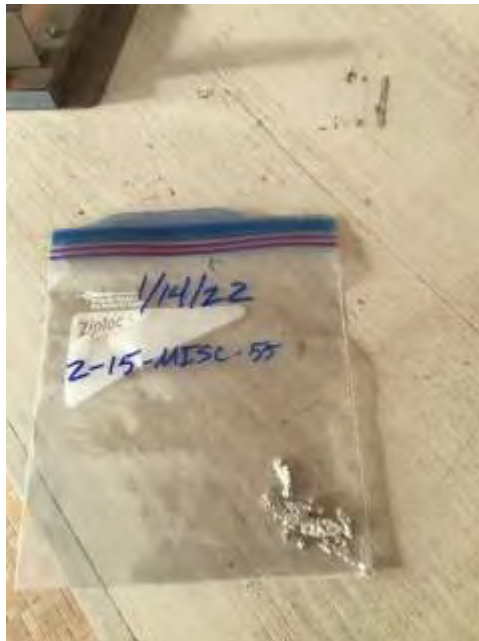
Sample ID:	Sample Type:
2-15-MISC-55	MISC
Sample Location:	Detailed Sample Location:
Hallway bathroom	North wall of shower room
Sample Quantity:	See 2-15-MISC-50

Misc Sample Material:	Sample Condition:	Sample Friable?:
Cement board and wallboard	Damaged or significantly damaged friable miscellaneous ACM	Yes

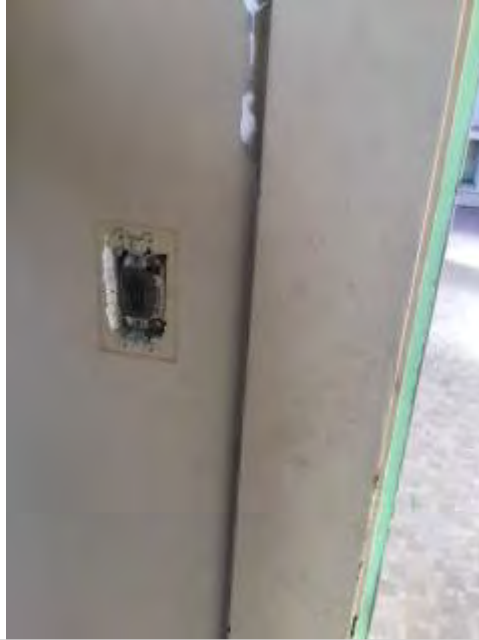
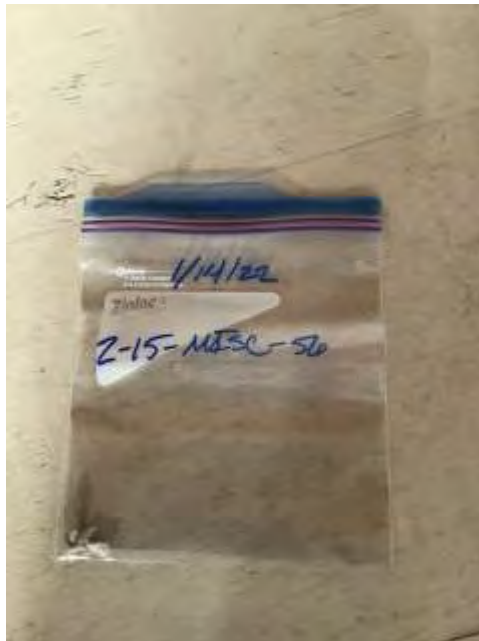
Additional Sample Notes:	
Sample ID:	Sample Type:
2-15-MISC-56	MISC
Sample Location:	Detailed Sample Location:
Hallway bathroom	North wall of back shower room
Sample Quantity:	See 2-15-MISC-50

Misc Sample Material:	Sample Condition:	Sample Friable?:
Cement board	Damaged or significantly damaged friable miscellaneous ACM	Yes

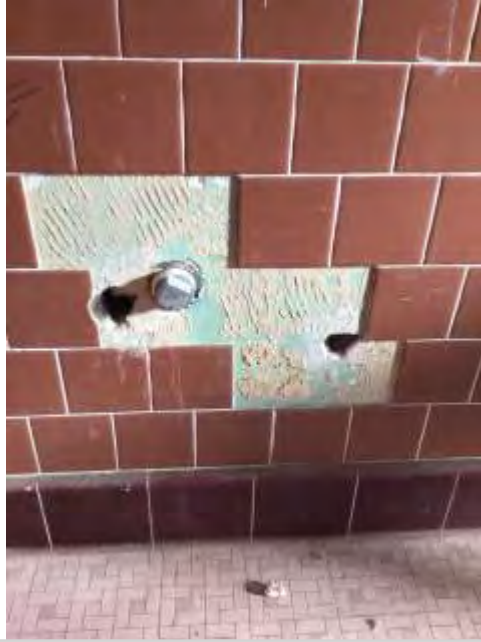
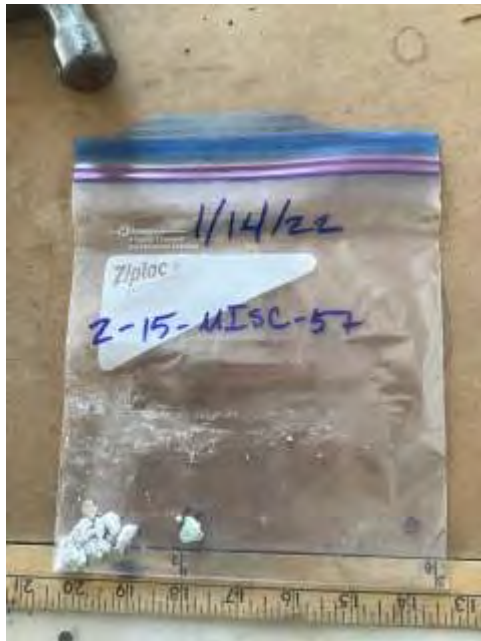
Sample ID:	Sample Type:
2-15-MISC-57	MISC
Sample Location:	Detailed Sample Location:
Hallway bathroom	North wall of back shower room
Sample Quantity:	See 2-15-MISC-50

Misc Sample Material:	Sample Condition:	Sample Friable?:
Cement board	Damaged or significantly damaged friable miscellaneous ACM	Yes

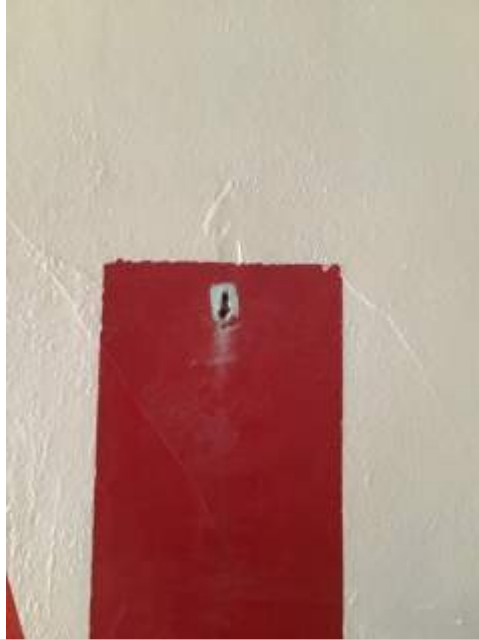
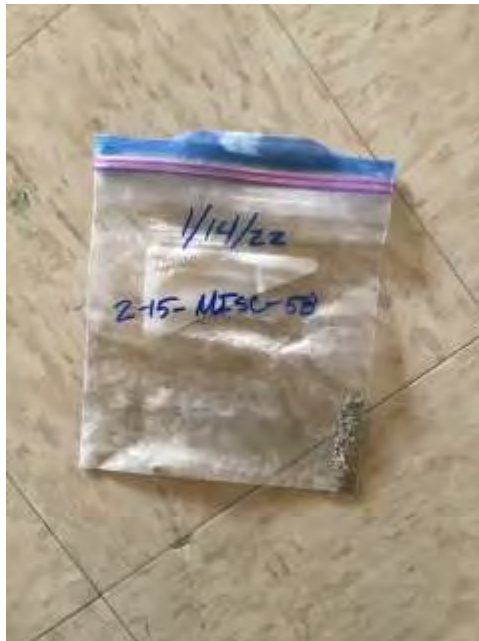
Additional Sample Notes:	
Sample ID:	Sample Type:
2-15-MISC-58	MISC
Sample Location:	Detailed Sample Location:
Hallway	East wall near stairway
Sample Quantity:	See 2-15-MISC-50

Misc Sample Material:	Sample Condition:	Sample Friable?:
Cement board	Damaged or significantly damaged friable miscellaneous ACM	Yes

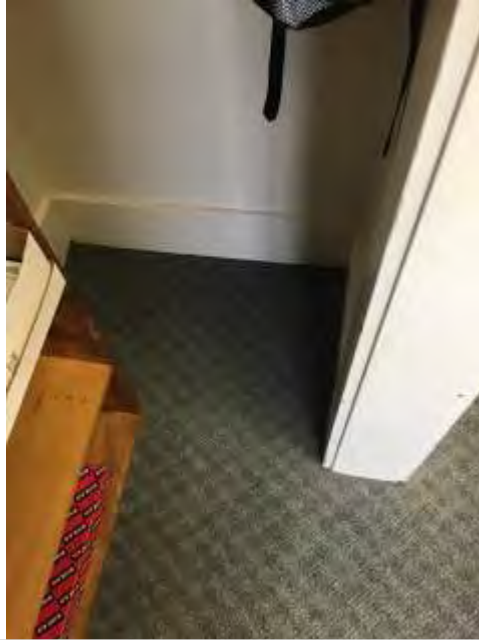
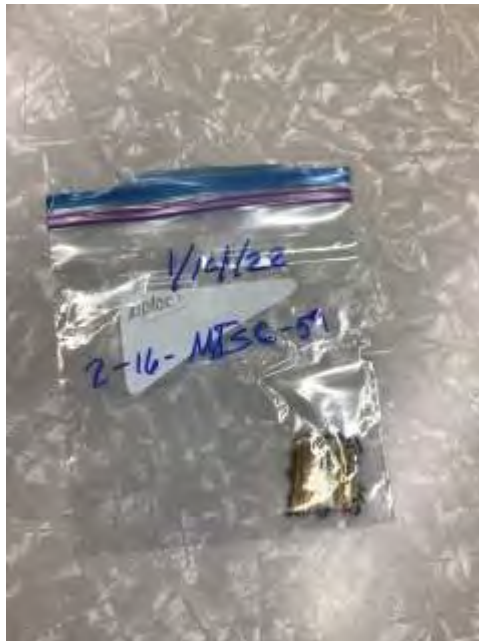
Additional Sample Notes:	
Sample ID:	Sample Type:
2-16-MISC-59	MISC
Sample Location:	Detailed Sample Location:
Classroom 26	North wall of northernmost room
Sample Quantity:	552 SF

Misc Sample Material:	Sample Condition:	Sample Friable?:
Blue carpet with yellow mastic	Damaged or significantly damaged friable miscellaneous ACM	No

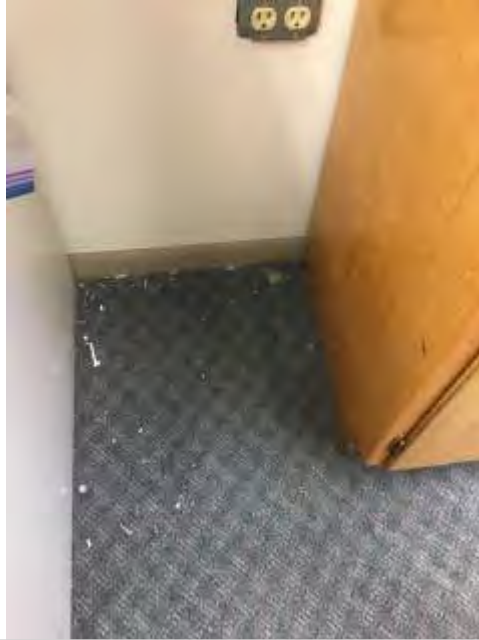
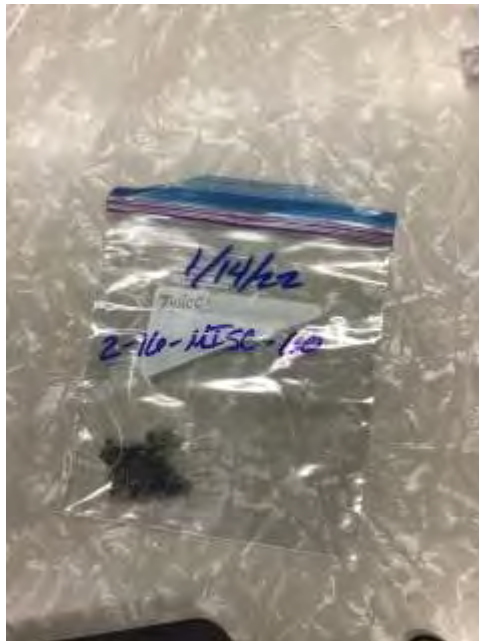
Additional Sample Notes:	
Sample ID:	Sample Type:
2-16-MISC-60	MISC
Sample Location:	Detailed Sample Location:
Classroom 26	South wall of northernmost room
Sample Quantity:	See 2-16-MISC-59

Misc Sample Material:	Sample Condition:	Sample Friable?:
Blue carpet with yellow mastic	Damaged or significantly damaged friable miscellaneous ACM	No

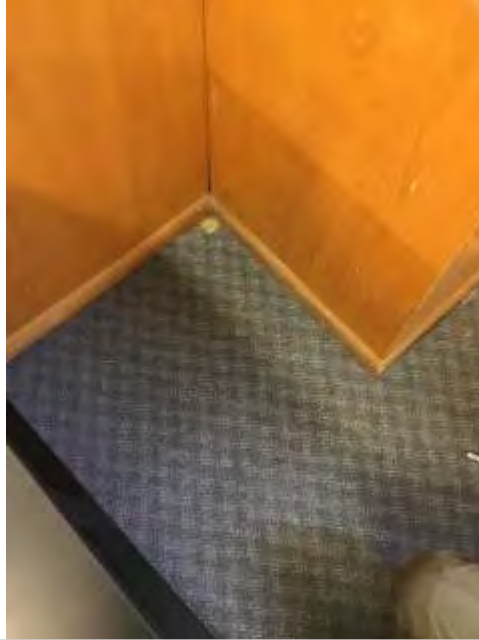
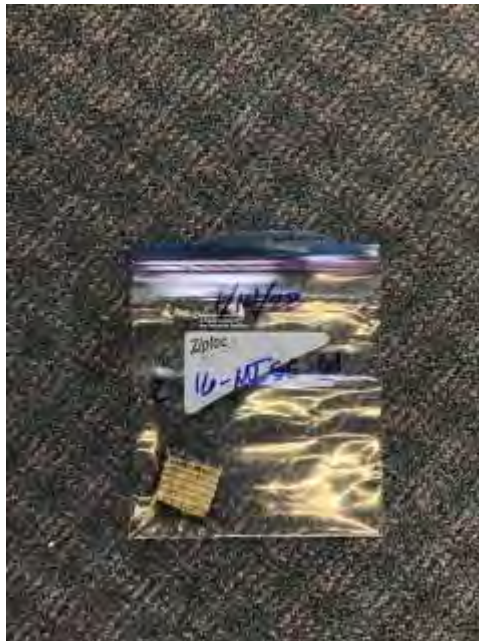
Additional Sample Notes:	
Sample ID:	Sample Type:
2-16-MISC-61	MISC
Sample Location:	Detailed Sample Location:
Classroom 26	Southwest wall of southernmost room
Sample Quantity:	See 2-16-MISC-59

Misc Sample Material:	Sample Condition:	Sample Friable?:
Blue carpet with yellow mastic	Damaged or significantly damaged friable miscellaneous ACM	No

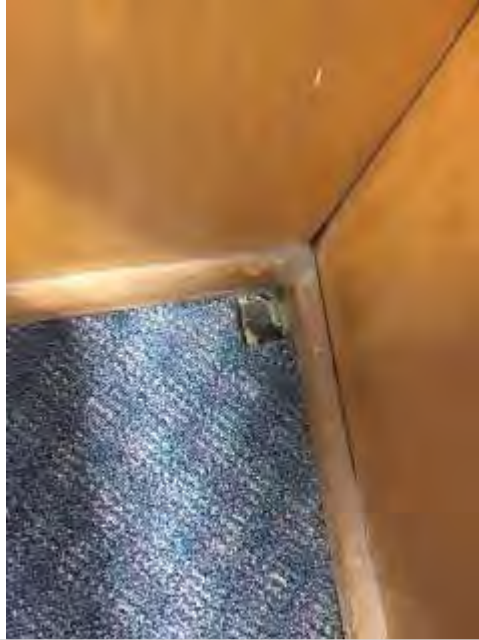
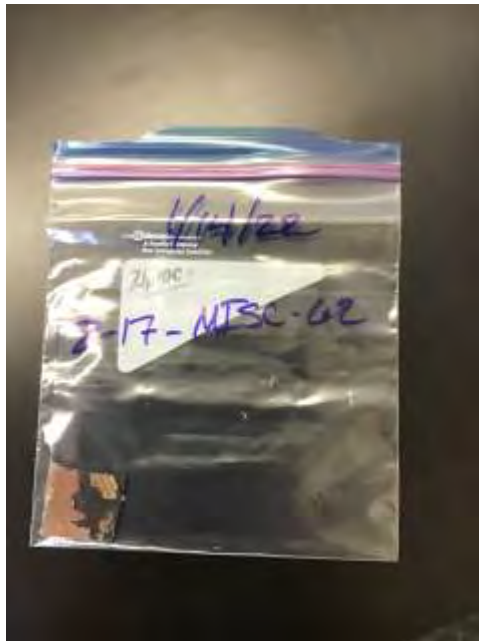
Additional Sample Notes:	
Sample ID:	Sample Type:
2-17-MISC-62	MISC
Sample Location:	Detailed Sample Location:
Classroom 26	Southwest wall of southernmost room
Sample Quantity:	552 SF

Misc Sample Material:	Sample Condition:	Sample Friable?:
Linoleum with black and yellow mastic	Damaged or significantly damaged friable miscellaneous ACM	Yes
