HAZARDOUS BUILDING MATERIALS SURVEY

CONDON GRADE SCHOOL
220 S. EAST STREET
CONDON, OREGON

Prepared for
CITY OF CONDON
May 17, 2022
Project No. M2053.01.002

Prepared by
Maul Foster & Alongi, Inc.
3140 NE Broadway Street, Portland, OR 97232

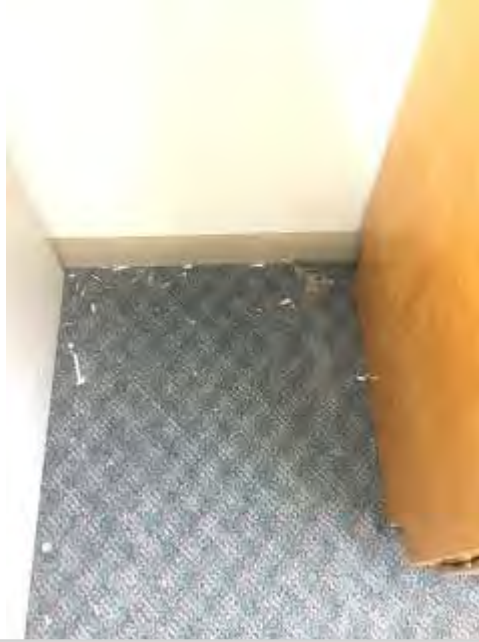
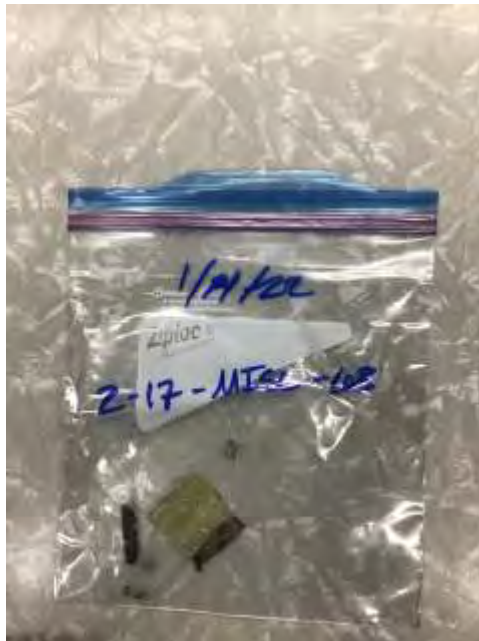
Additional Sample Notes:	
Sample ID:	Sample Type:
2-17-MISC-63	MISC
Sample Location:	Detailed Sample Location:
Classroom 26	South wall of northernmost room
Sample Quantity:	See 2-17-MISC-62

Misc Sample Material:	Sample Condition:	Sample Friable?:
Linoleum with black mastic	Damaged or significantly damaged friable miscellaneous ACM	No

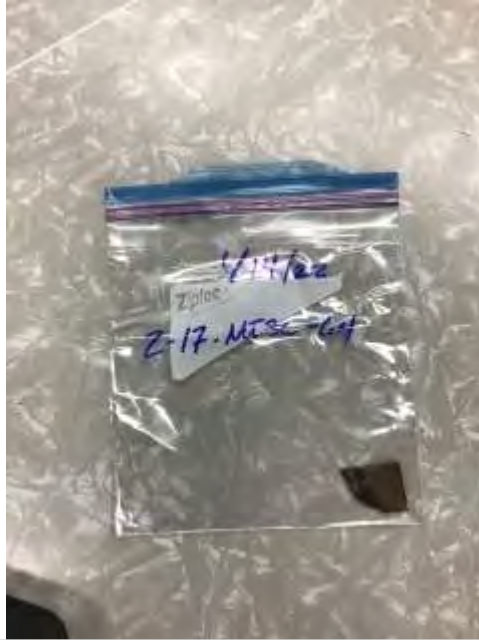
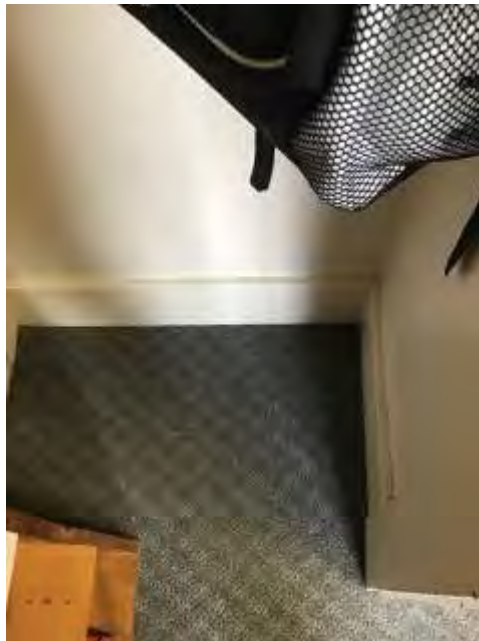
Sample ID:	Sample Type:
2-17-MISC-64	MISC
Sample Location:	Detailed Sample Location:
Classroom 26	North wall of northernmost room
Sample Quantity:	See 2-17-MISC-62

Misc Sample Material:	Sample Condition:	Sample Friable?:
Linoleum with black mastic	Damaged or significantly damaged friable miscellaneous ACM	No

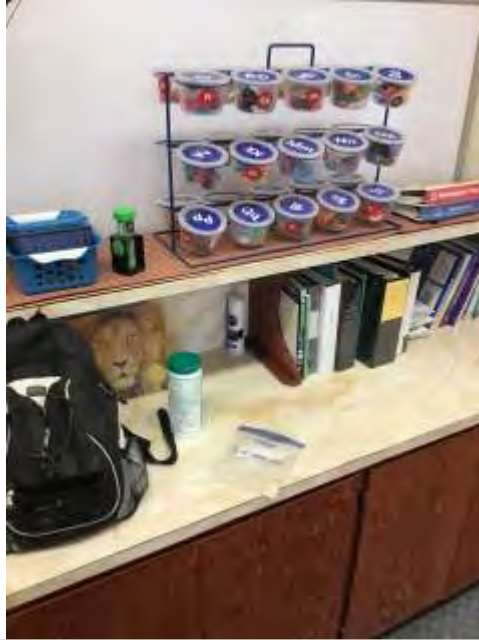
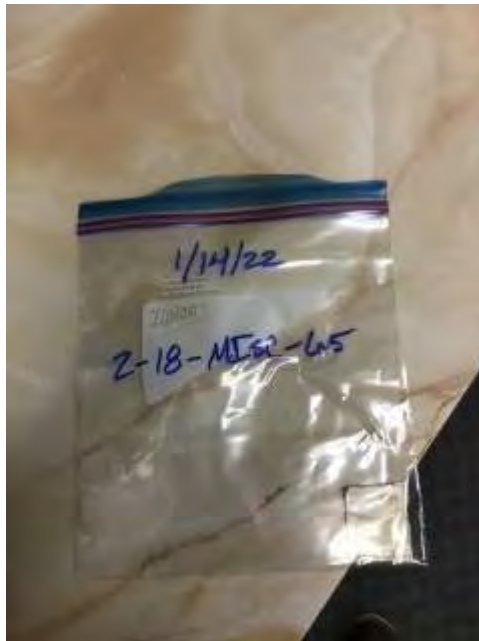
Misc Sample Material:	Sample Condition:	Sample Friable?:
Table top linoleum with tan mastic	Damaged or significantly damaged friable miscellaneous ACM	No

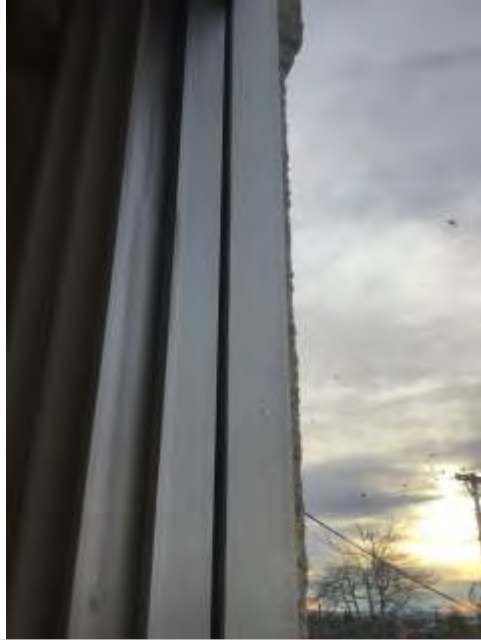
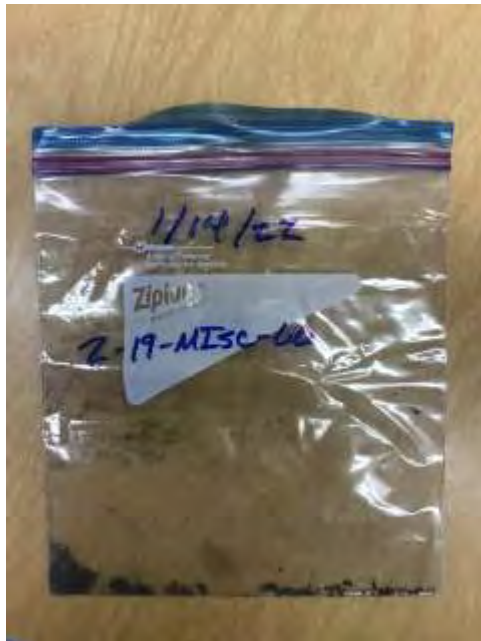
Additional Sample Notes:	
Sample ID:	Sample Type:
2-19-MISC-66	MISC
Sample Location:	Detailed Sample Location:
Classroom 26	Southwest window of southernmost room
Sample Quantity:	500 LF

Misc Sample Material:	Sample Condition:	Sample Friable?:
Black window putty	Damaged or significantly damaged friable miscellaneous ACM	Yes

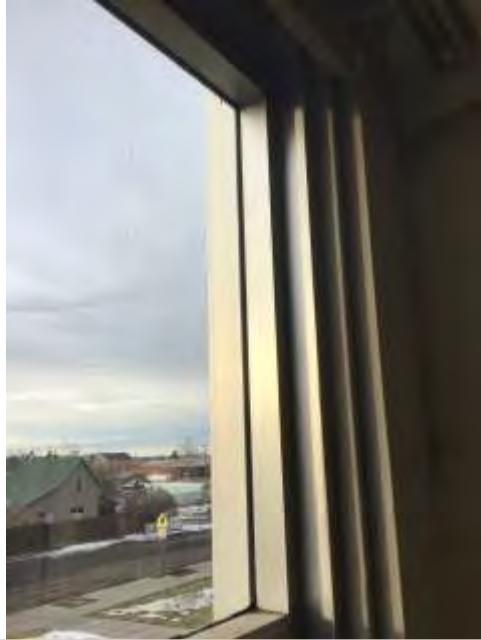
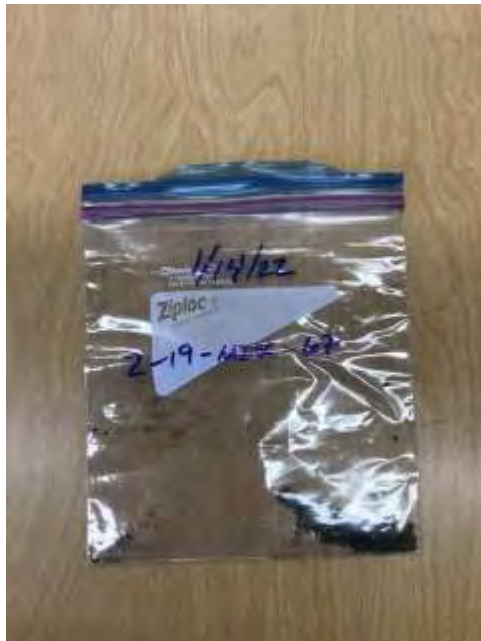
Additional Sample Notes:	
Sample ID:	Sample Type:
2-19-MISC-67	MISC
Sample Location:	Detailed Sample Location:
Classroom 26	Southwest window of southernmost room
Sample Quantity:	See 2-19-MISC-66

Misc Sample Material:	Sample Condition:	Sample Friable?:
Black window putty	Damaged or significantly damaged friable miscellaneous ACM	Yes

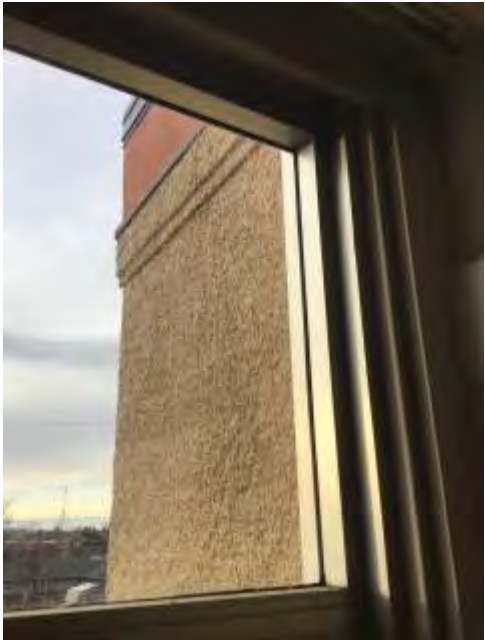
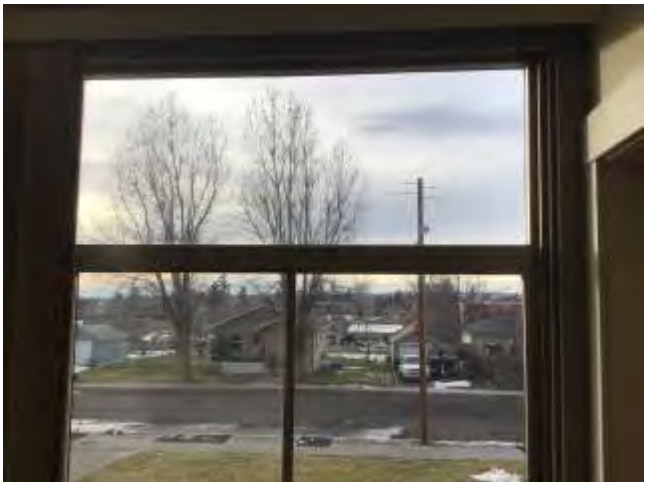
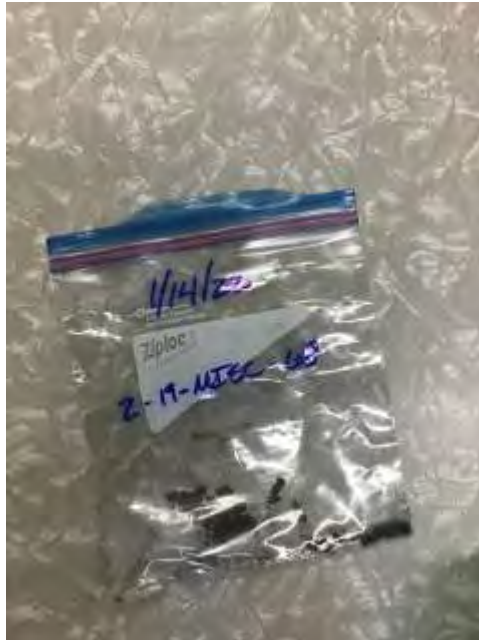
Sample ID:	Sample Type:
2-19-MISC-68	MISC
Sample Location:	Detailed Sample Location:
Classroom 26	Southwest window of northernmost room
Sample Quantity:	See 2-19-MISC-66

Misc Sample Material:	Sample Condition:	Sample Friable?:
Black window putty	Damaged or significantly damaged friable miscellaneous ACM	Yes

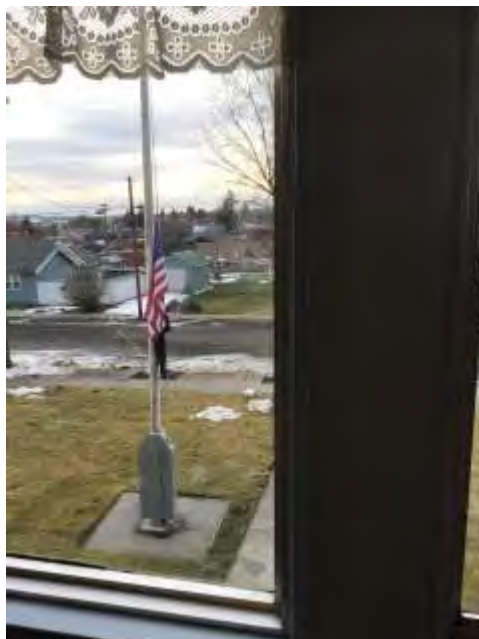
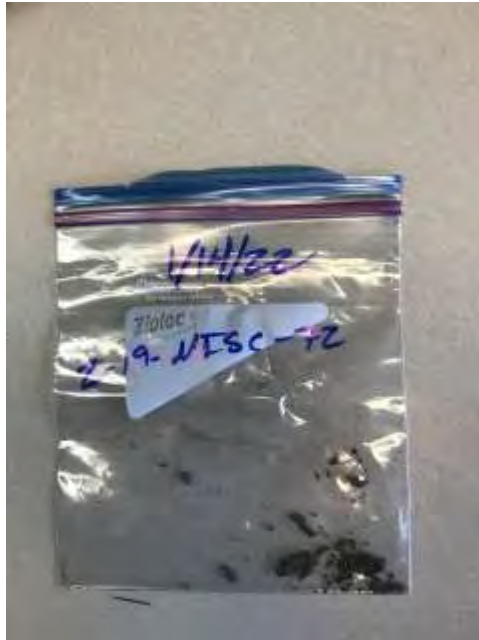
Additional Sample Notes:		
Sample ID:	Sample Type:	
2-19-MISC-72	MISC	
Sample Location:	Detailed Sample Location:	
Counselor's room	West window	
Sample Quantity:	See 2-19-MISC-66	
Misc Sample Material:	Sample Condition:	Sample Friable?:
Black window putty	Damaged or significantly damaged friable miscellaneous ACM	Yes

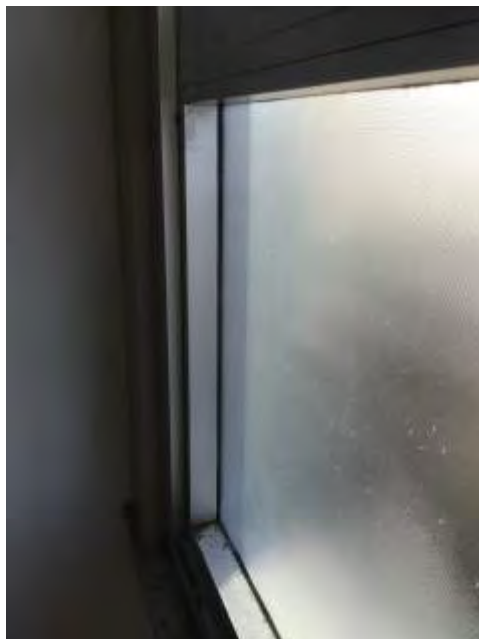
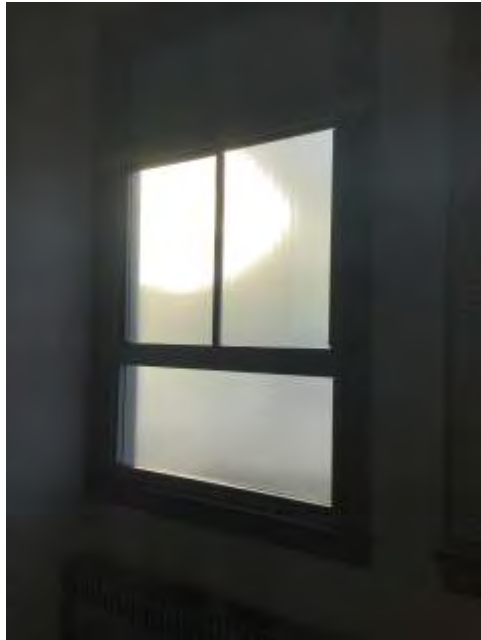
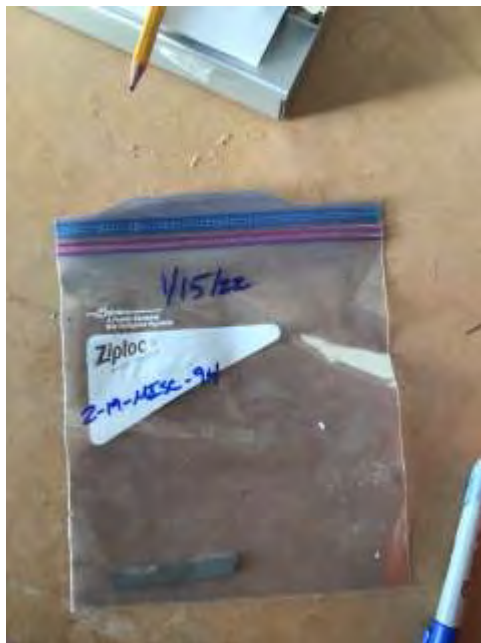
Additional Sample Notes:		
Sample ID:	Sample Type:	
2-19-MISC-94	MISC	
Sample Location:	Detailed Sample Location:	
Stage bathroom	South window pane of shower room	
Sample Quantity:	See 2-19-MISC-66	
Misc Sample Material:	Sample Condition:	Sample Friable?:
Black window putty	Damaged or significantly damaged friable miscellaneous ACM	Yes

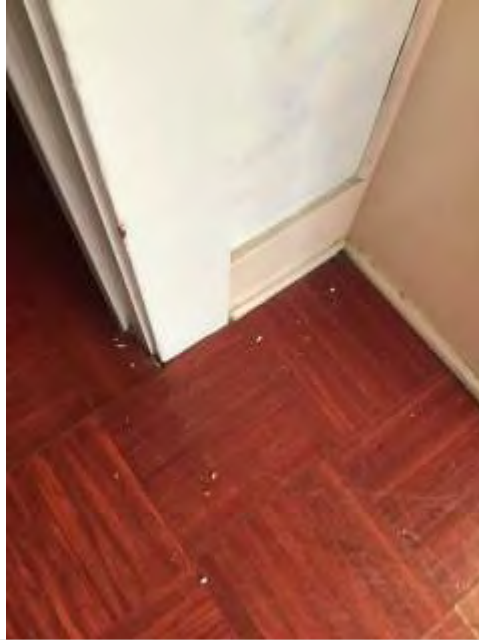
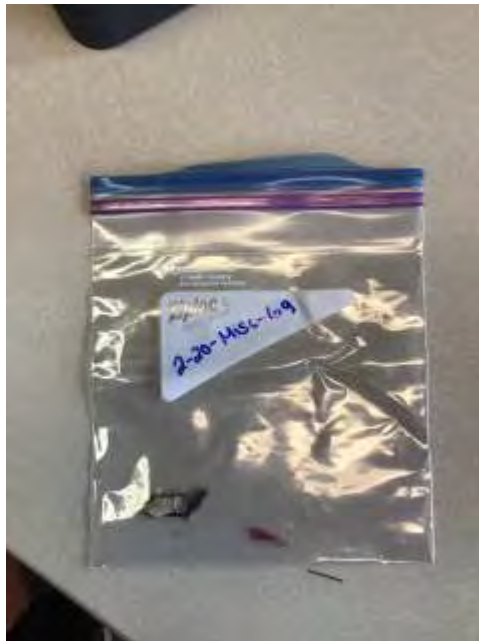
Additional Sample Notes:		
Sample ID:	Sample Type:	
2-20-MISC-69	MISC	
Sample Location:	Detailed Sample Location:	
Counselor's room	East floor near doorway	
Sample Quantity:	222 SF	
Misc Sample Material:	Sample Condition:	Sample Friable?:
9"x9" red vinyl flooring with black mastic	Damaged or significantly damaged friable miscellaneous ACM	Yes
Sample Photo:

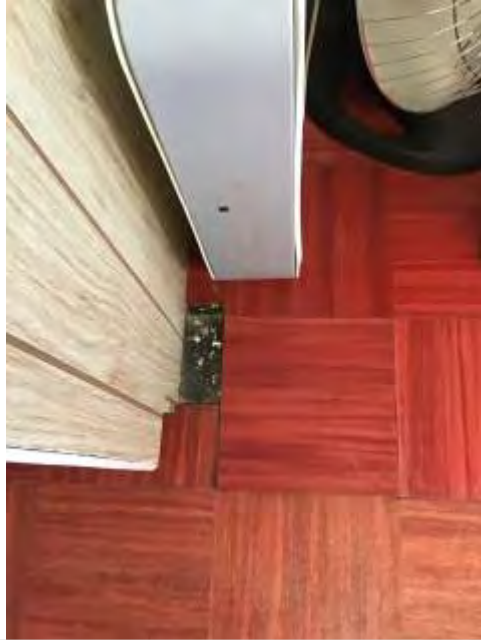
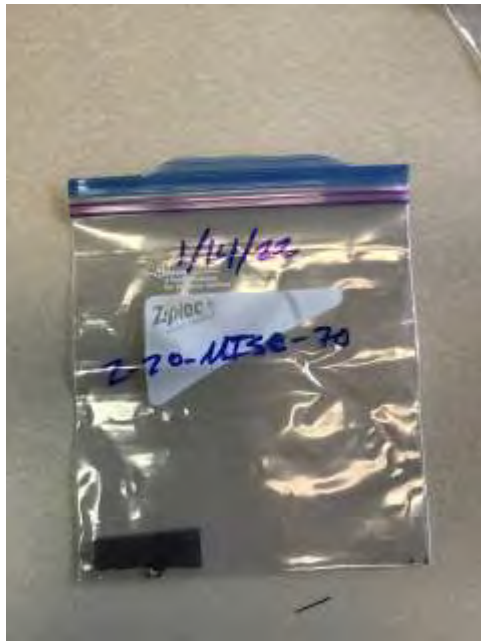
Additional Sample Notes:		
Sample ID:	Sample Type:	
2-20-MISC-70	MISC	
Sample Location:	Detailed Sample Location:	
Counselor's room	East floor near cabinets	
Sample Quantity:	See 2-20-MISC-69	
Misc Sample Material:	Sample Condition:	Sample Friable?:
9"x9" red vinyl flooring with black mastic	Damaged or significantly damaged friable miscellaneous ACM	Yes
Sample Photo:

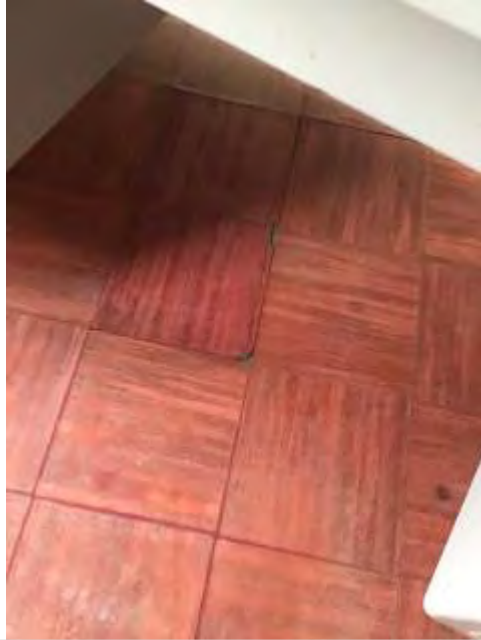
Additional Sample Notes:		
Sample ID:	Sample Type:	
2-20-MISC-71	MISC	
Sample Location:	Detailed Sample Location:	
Counselor's room	Middle of room under desk	
Sample Quantity:	See 2-20-MISC-69	
Misc Sample Material:	Sample Condition:	Sample Friable?:
9"x9" red vinyl flooring with black mastic	Damaged or significantly damaged friable miscellaneous ACM	Yes
Sample Photo:

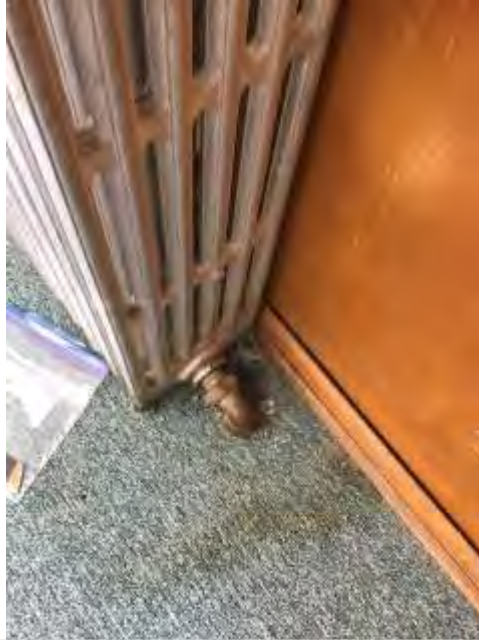
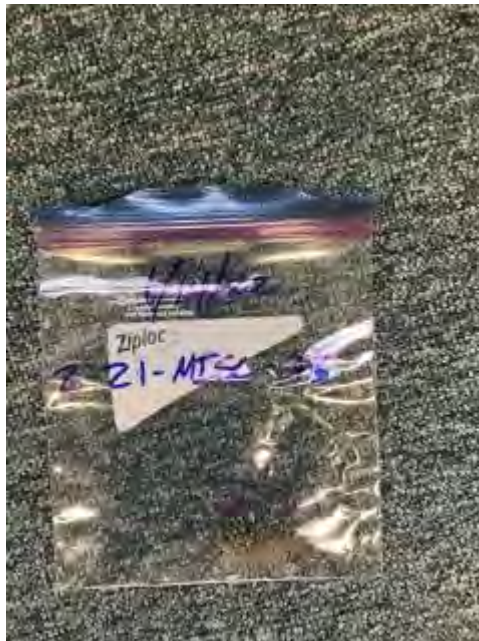
Additional Sample Notes:		
Sample ID:	Sample Type:	
2-21-MISC-73	MISC	
Sample Location:	Detailed Sample Location:	
Classroom 29	Northwest corner of floor near window	
Sample Quantity:	629 SF	
Misc Sample Material:	Sample Condition:	Sample Friable?:
Green and blue carpet with yellow mastic	Damaged or significantly damaged friable miscellaneous ACM	No
Sample Photo:

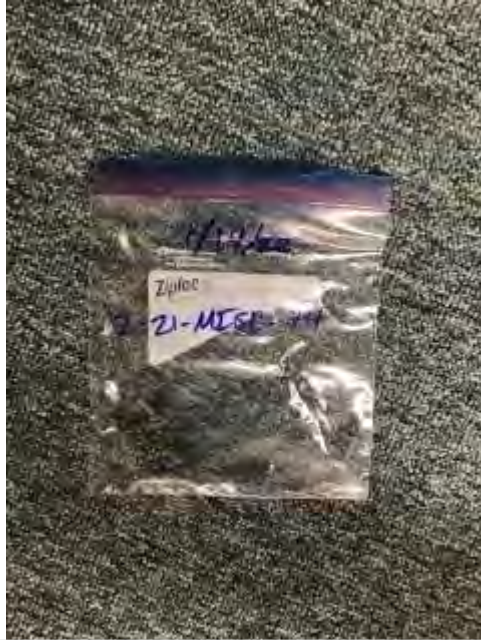
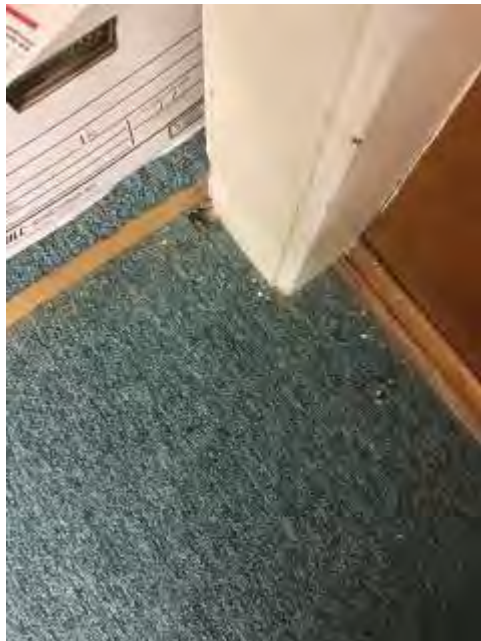
Additional Sample Notes:		
Sample ID:	Sample Type:	
2-21-MISC-74	MISC	
Sample Location:	Detailed Sample Location:	
Classroom 29	Southwest corner of floor near window	
Sample Quantity:	See 2-21-MISC-73	
Misc Sample Material:	Sample Condition:	Sample Friable?:
Green and blue carpet with yellow mastic	Damaged or significantly damaged friable miscellaneous ACM	No
Sample Photo:

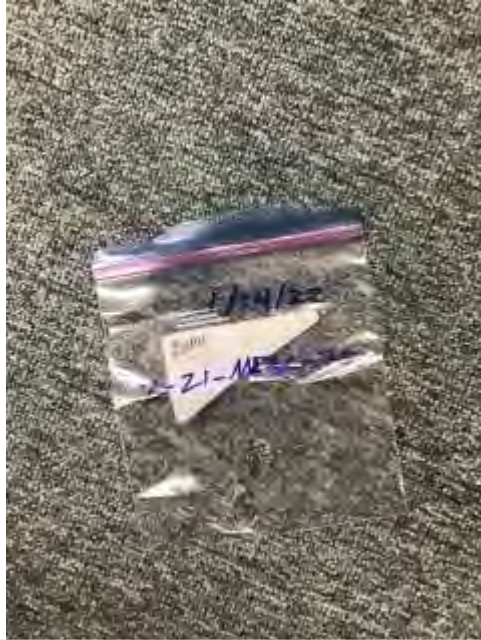
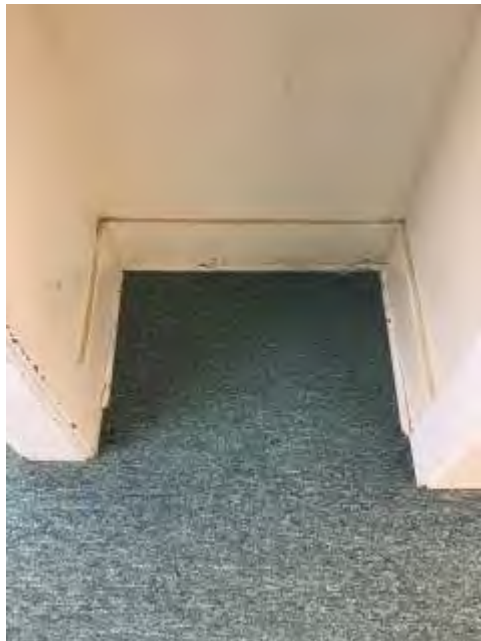
Additional Sample Notes:		
Sample ID:	Sample Type:	
2-21-MISC-75	MISC	
Sample Location:	Detailed Sample Location:	
Classroom 29	Southwest corner outcove	
Sample Quantity:	See 2-21-MISC-73	
Misc Sample Material:	Sample Condition:	Sample Friable?:
Green and blue carpet with yellow mastic	Damaged or significantly damaged friable miscellaneous ACM	No
Sample Photo:

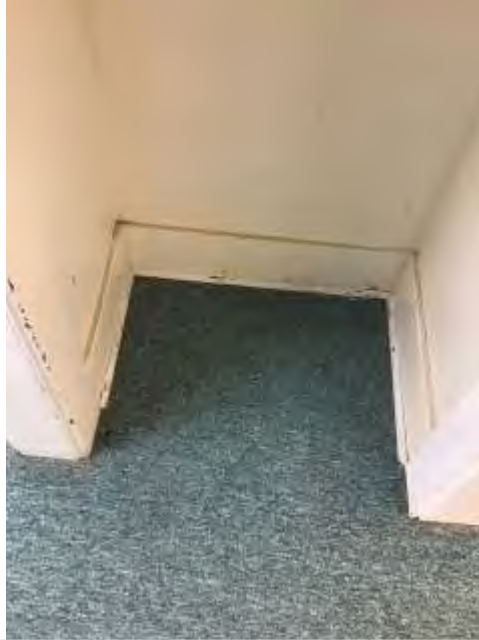
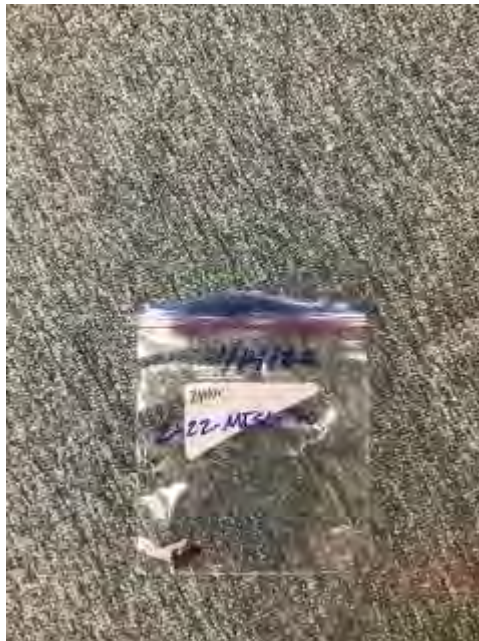
Additional Sample Notes:		
Sample ID:	Sample Type:	
2-22-MISC-76	MISC	
Sample Location:	Detailed Sample Location:	
Classroom 29	Southwest corner outcove	
Sample Quantity:	629 SF	
Misc Sample Material:	Sample Condition:	Sample Friable?:
Linoleum with black and yellow mastic	Damaged or significantly damaged friable miscellaneous ACM	No
Sample Photo:

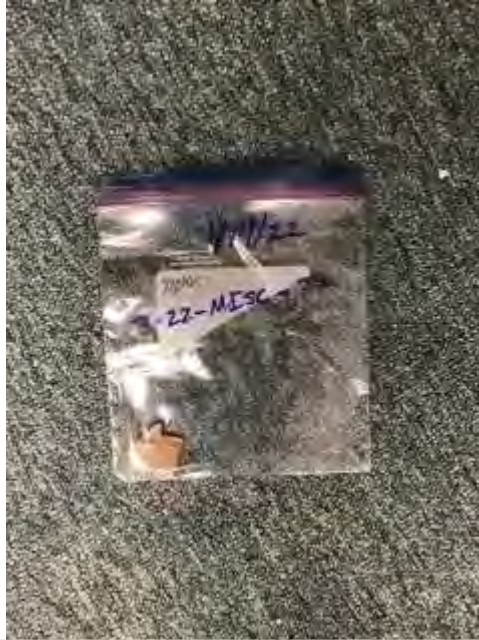
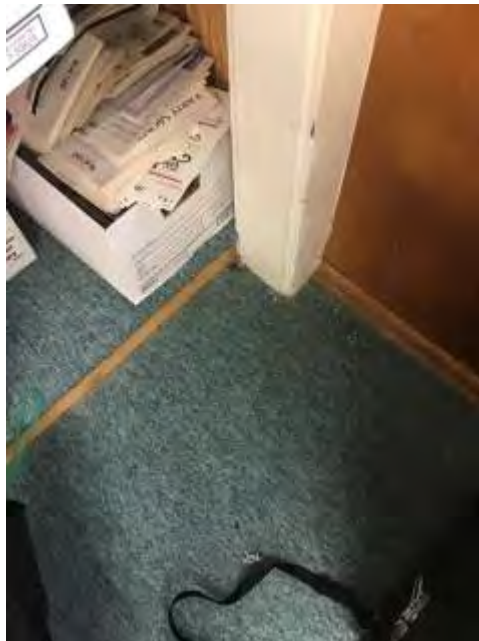
Additional Sample Notes:		
Sample ID:	Sample Type:	
2-22-MISC-77	MISC	
Sample Location:	Detailed Sample Location:	
Classroom 29	Southwest corner of floor near window	
Sample Quantity:	See 2-22-MISC-76	
Misc Sample Material:	Sample Condition:	Sample Friable?:
Linoleum with black and yellow mastic	Damaged or significantly damaged friable miscellaneous ACM	No
Sample Photo:

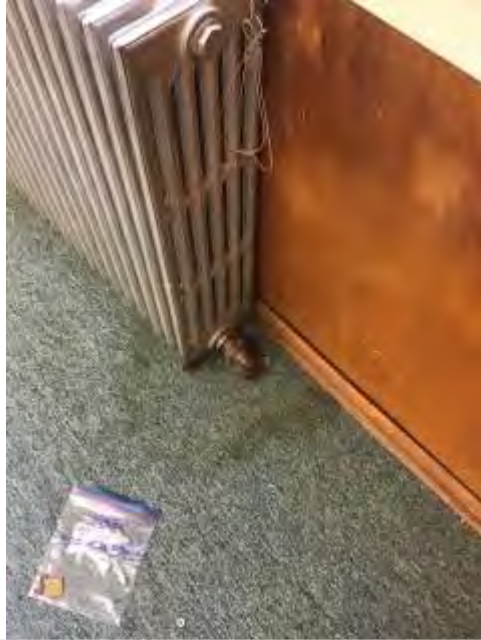
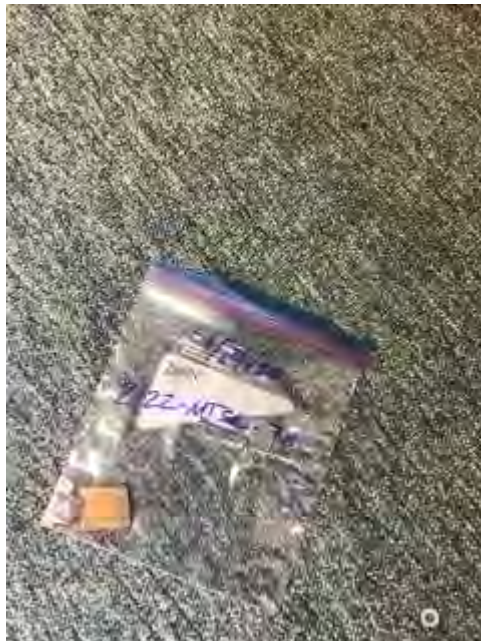
Additional Sample Notes:		
Sample ID:	Sample Type:	
2-22-MISC-78	MISC	
Sample Location:	Detailed Sample Location:	
Classroom 29	Southwest corner of floor near window	
Sample Quantity:	See 2-22-MISC-76	
Misc Sample Material:	Sample Condition:	Sample Friable?:
Linoleum with black and yellow mastic	Damaged or significantly damaged friable miscellaneous ACM	No
Sample Photo:

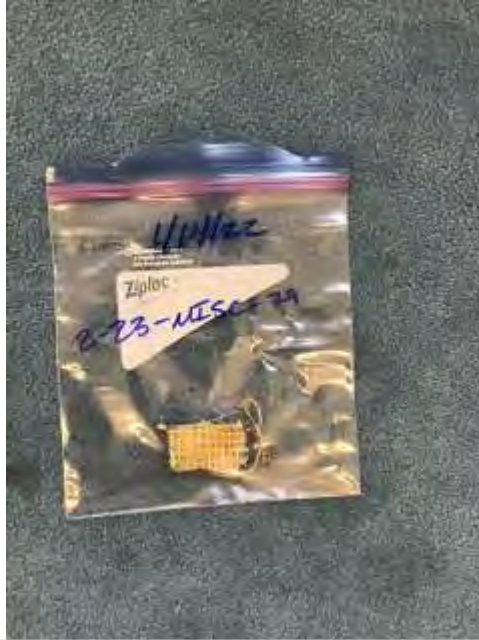
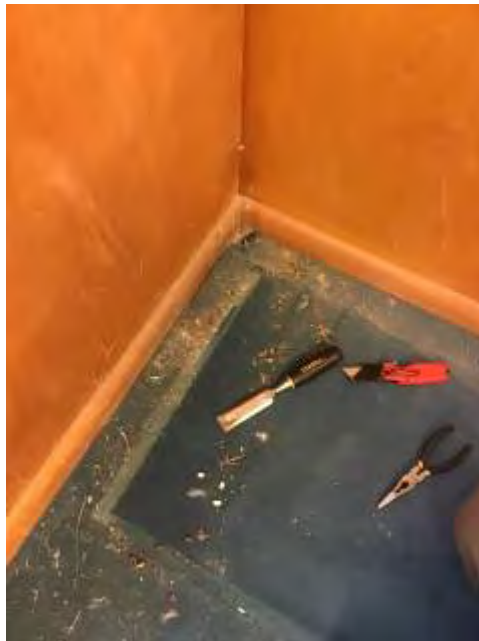
Additional Sample Notes:		
Sample ID:	Sample Type:	
2-23-MISC-79	MISC	
Sample Location:	Detailed Sample Location:	
Classroom 30	Southwest corner floor	
Sample Quantity:	761 SF	
Misc Sample Material:	Sample Condition:	Sample Friable?:
Blue velvet carpet with yellow mastic	Damaged or significantly damaged friable miscellaneous ACM	No
Sample Photo:

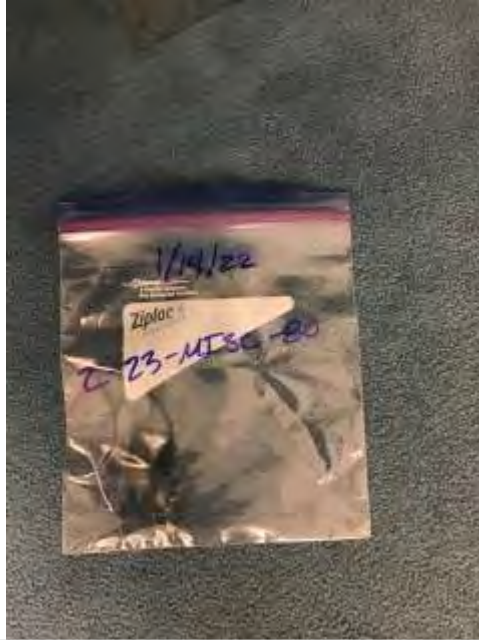
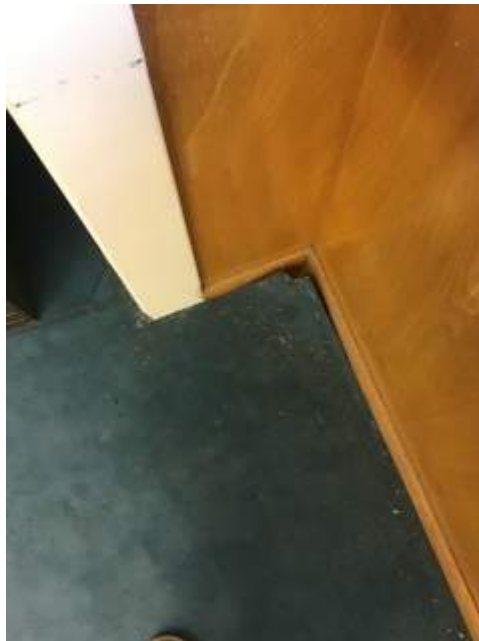
Additional Sample Notes:		
Sample ID:	Sample Type:	
2-23-MISC-80	MISC	
Sample Location:	Detailed Sample Location:	
Classroom 30	Southeast corner floor	
Sample Quantity:	See 2-23-MISC-79	
Misc Sample Material:	Sample Condition:	Sample Friable?:
Blue velvet carpet with yellow mastic	Damaged or significantly damaged friable miscellaneous ACM	No
Sample Photo:

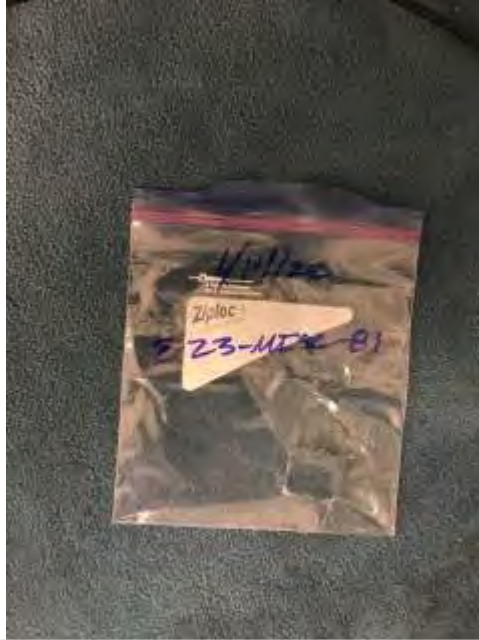
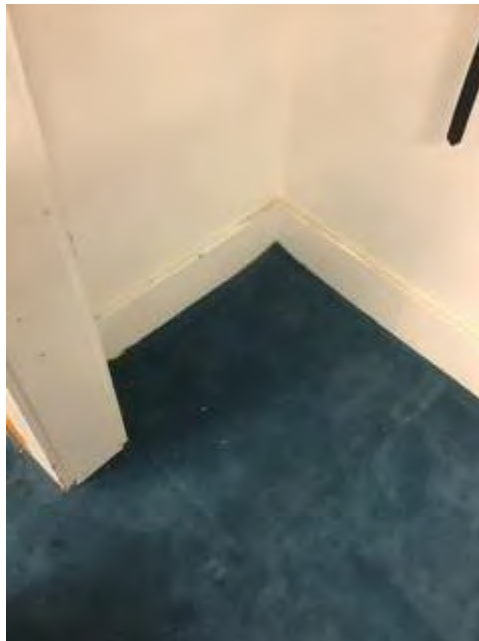
Additional Sample Notes:		
Sample ID:	Sample Type:	
2-23-MISC-81	MISC	
Sample Location:	Detailed Sample Location:	
Classroom 30	Southeast corner	
Sample Quantity:	See 2-23-MISC-79	
Misc Sample Material:	Sample Condition:	Sample Friable?:
Blue velvet carpet with yellow mastic	Damaged or significantly damaged friable miscellaneous ACM	No
Sample Photo:

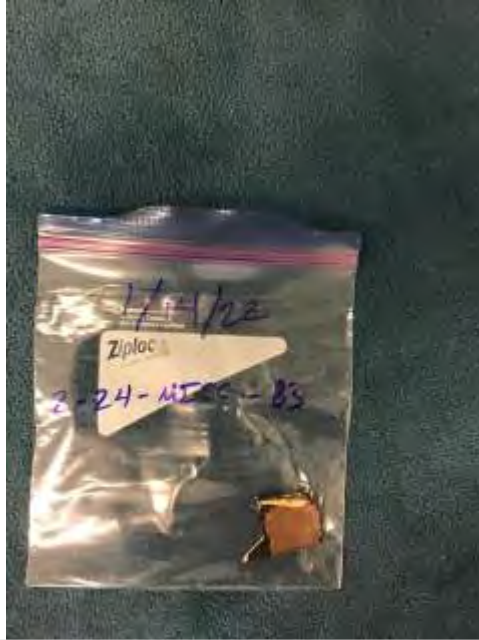
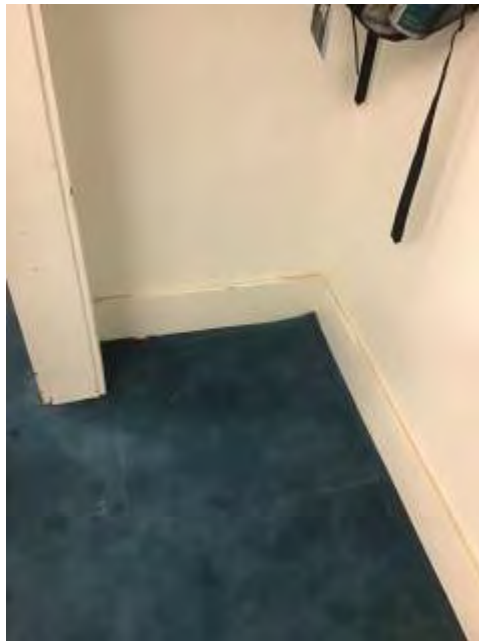
Additional Sample Notes:		
Sample ID:	Sample Type:	
2-24-MISC-83	MISC	
Sample Location:	Detailed Sample Location:	
Classroom 30	Southeast corner	
Sample Quantity:	See 2-24-MISC-82	
Misc Sample Material:	Sample Condition:	Sample Friable?:
Linoleum with black and yellow mastic	Damaged or significantly damaged friable miscellaneous ACM	Yes
Sample Photo:

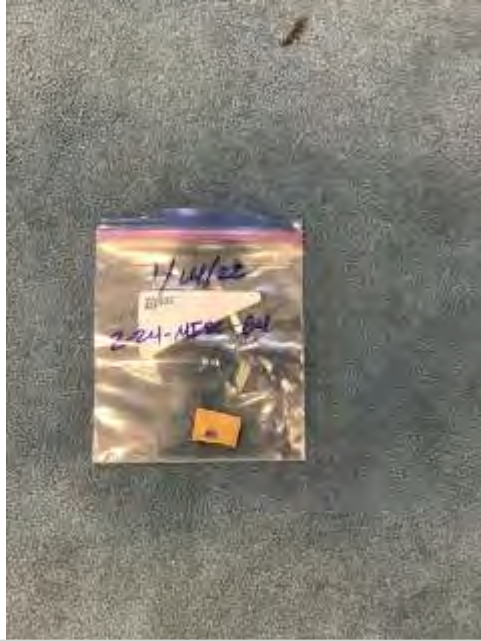
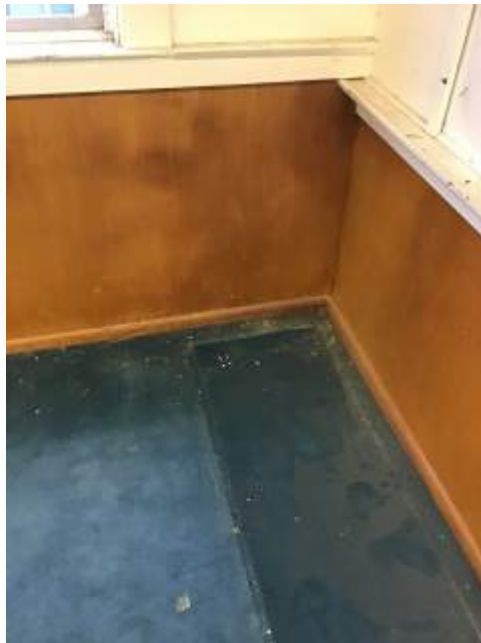
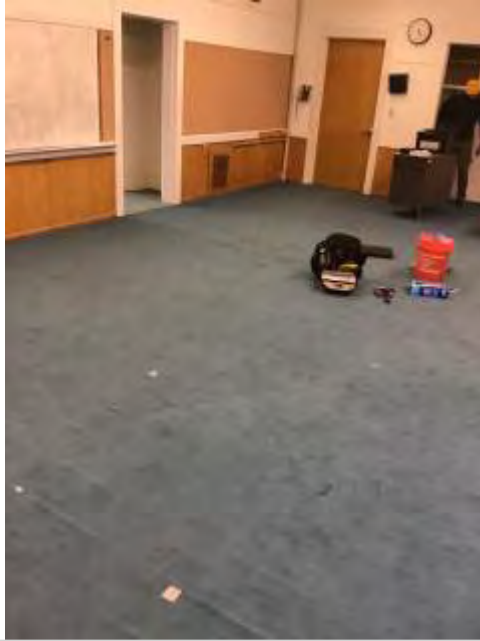
Additional Sample Notes:		
Sample ID:	Sample Type:	
2-24-MISC-84	MISC	
Sample Location:	Detailed Sample Location:	
Classroom 30	Southwest corner	
Sample Quantity:	See 2-24-MISC-82	
Misc Sample Material:	Sample Condition:	Sample Friable?:
Linoleum with black and yellow mastic	Damaged or significantly damaged friable miscellaneous ACM	Yes
Sample Photo:

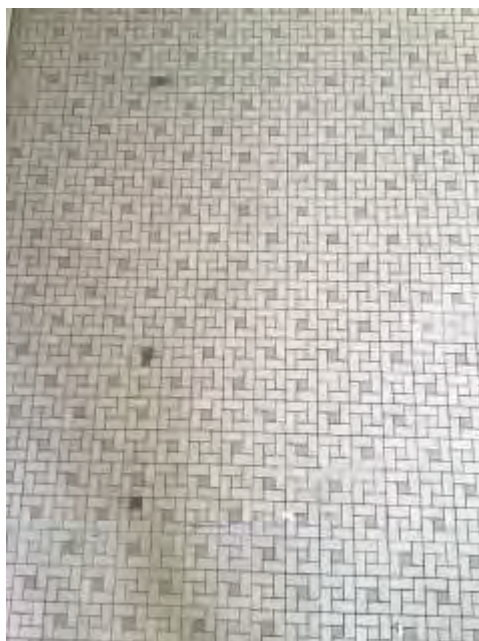
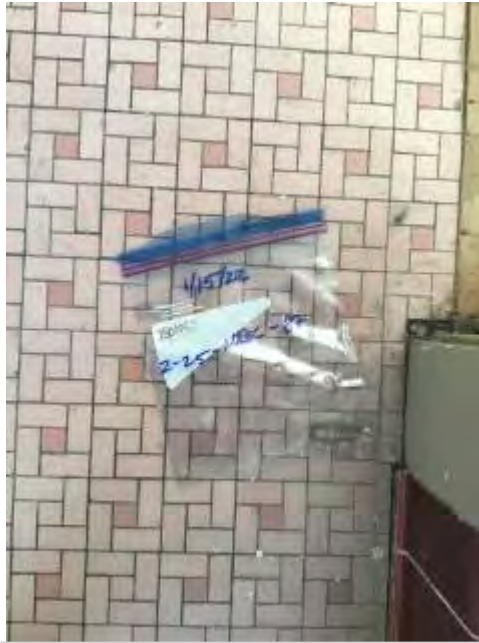
Additional Sample Notes:		
Sample ID:	Sample Type:	
2-25-MISC-88	MISC	
Sample Location:	Detailed Sample Location:	
Stage bathroom	South floor of changing room	
Sample Quantity:	See 2-25-MISC-87	
Misc Sample Material:	Sample Condition:	Sample Friable?:
Pink square tile with gray grout	Damaged or significantly damaged friable miscellaneous ACM	Yes

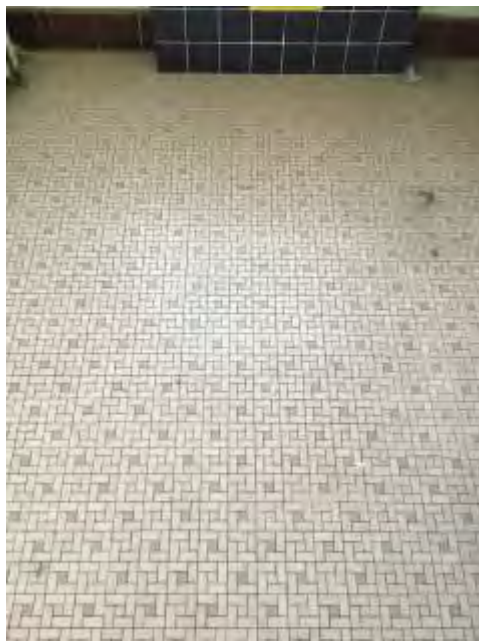
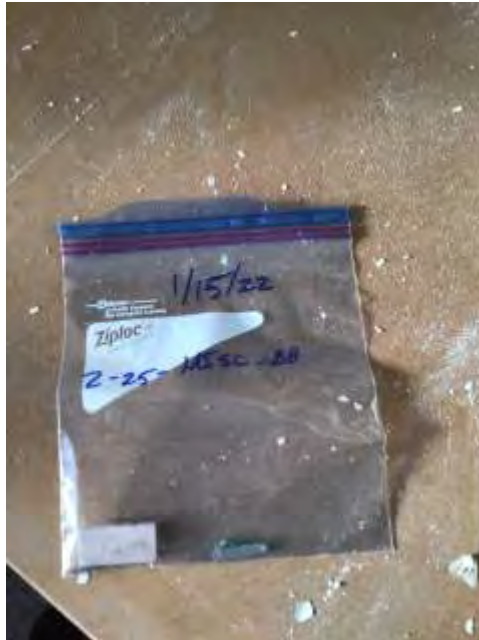
Additional Sample Notes:		
Sample ID:	Sample Type:	
2-25-MISC-89	MISC	
Sample Location:	Detailed Sample Location:	
Stage bathroom	South floor of changing room	
Sample Quantity:	See 2-25-MISC-87	
Misc Sample Material:	Sample Condition:	Sample Friable?:
Pink square tile with gray grout	Damaged or significantly damaged friable miscellaneous ACM	Yes

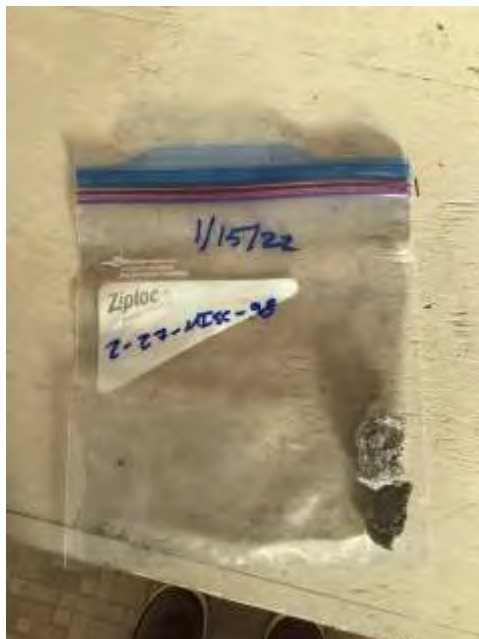
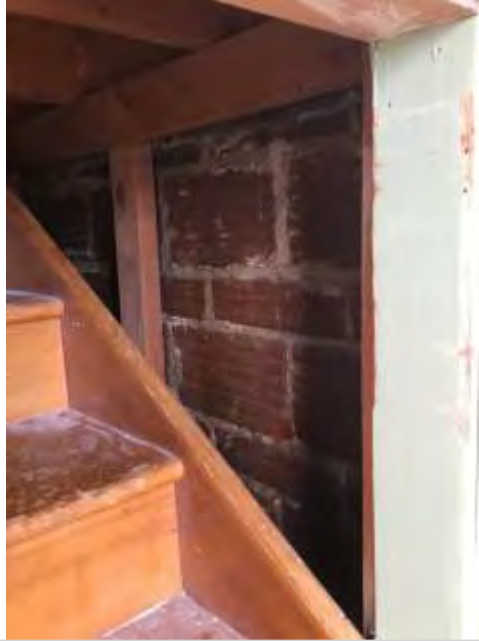
Additional Sample Notes:	Outermost foundation wall appears to be behind walls. No other samples collected due to wall damage and creation of potential friable ACM hazard. Can assume this outermost wall is the length of the older middle section of the school.
---------------------------------	---

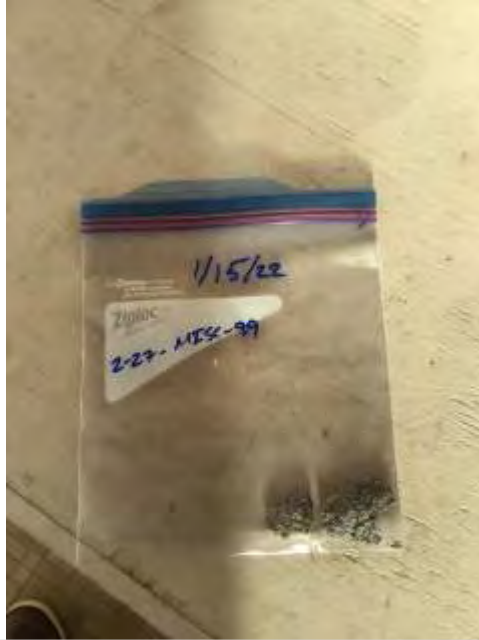
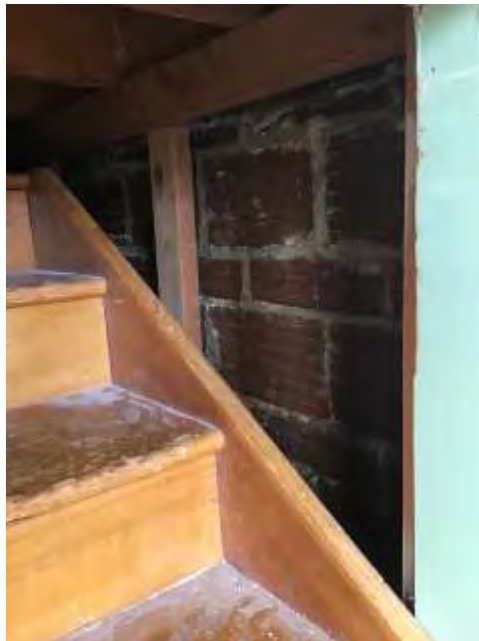
Sample ID:	Sample Type:	
2-27-MISC-99	MISC	
Sample Location:	Detailed Sample Location:	
Stage bathroom	Outermost foundation under gym stage	
Sample Quantity:	See additional notes	
Misc Sample Material:	Sample Condition:	Sample Friable?:
Gray grout	Damaged or significantly damaged friable miscellaneous ACM	Yes

Additional Sample Notes:	Outermost foundation wall appears to be behind walls. No other samples collected due to wall damage and creation of potential friable ACM hazard. Can assume this outermost wall is the length of the older middle section of the school.
---------------------------------	---

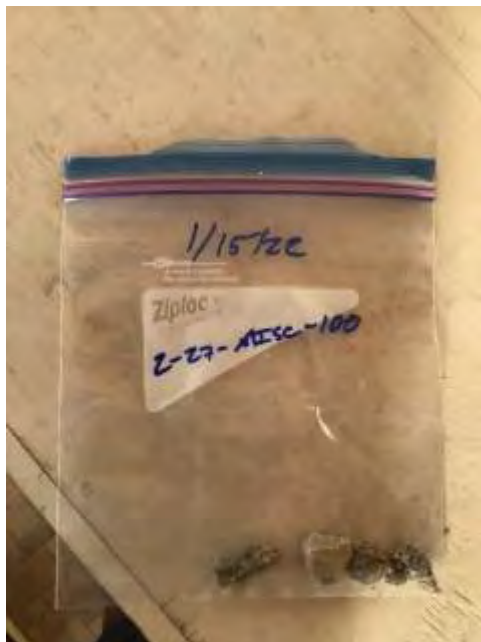
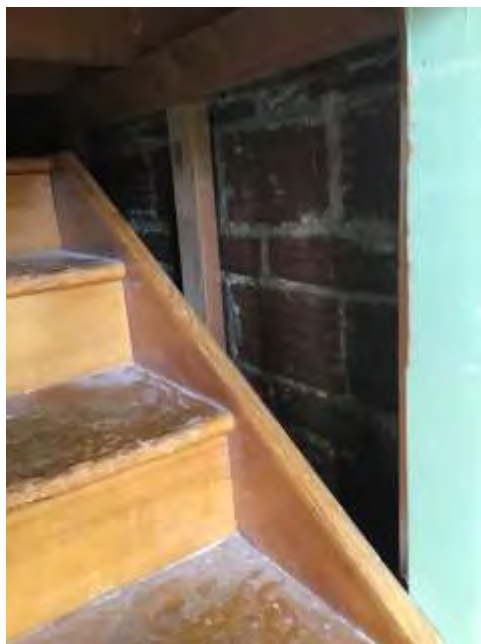
Sample ID:	Sample Type:	
2-27-MISC-100	MISC	
Sample Location:	Detailed Sample Location:	
Stage bathroom	Outermost foundation under gym stage	
Sample Quantity:	See additional notes	
Misc Sample Material:	Sample Condition:	Sample Friable?:

Gray grout	Damaged or significantly damaged friable miscellaneous ACM	Yes
------------	--	-----

Additional Sample Notes:	Outermost foundation wall appears to be behind walls. No other samples collected due to wall damage and creation of potential friable ACM hazard. Can assume this outermost wall is the length of the older middle section of the school.
---------------------------------	---

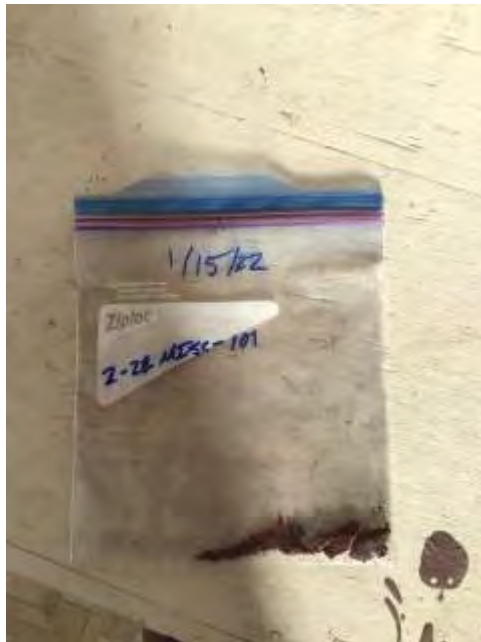
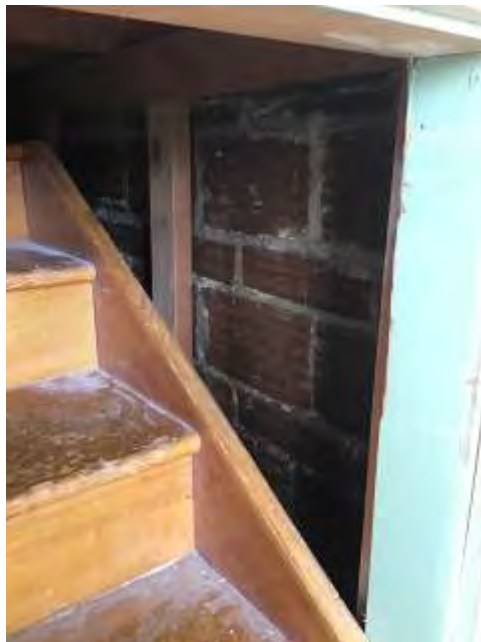
Sample ID:	Sample Type:
2-28-MISC-101	MISC
Sample Location:	Detailed Sample Location:
Stage bathroom	Outermost foundation under gym stage

Sample Quantity:	See additional notes	
Misc Sample Material:	Sample Condition:	Sample Friable?:
Red brick	Damaged or significantly damaged friable miscellaneous ACM	Yes

Additional Sample Notes:	Outermost foundation wall appears to be behind walls. No other samples collected due to wall damage and creation of potential friable ACM hazard. Can assume this outermost wall is the length of the older middle section of the school.
---------------------------------	---

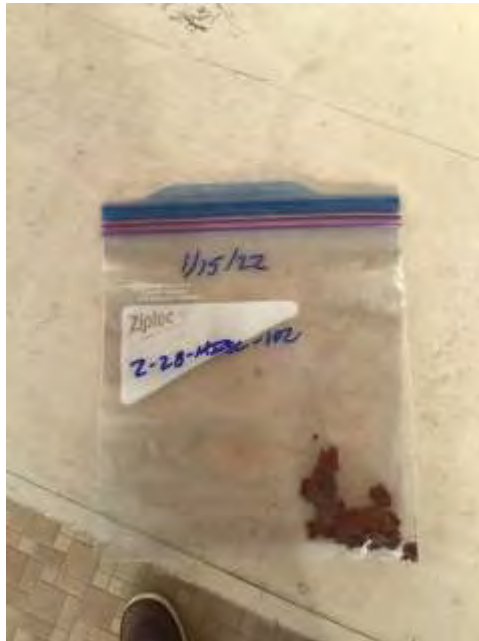
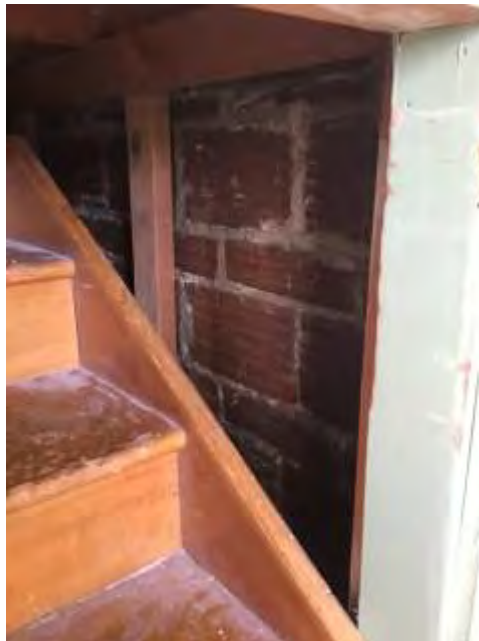
Sample ID:	Sample Type:
2-28-MISC-102	MISC

Sample Location:	Detailed Sample Location:	
Stage bathroom	Outermost foundation under gym stage	
Sample Quantity:	See additional notes	
Misc Sample Material:	Sample Condition:	Sample Friable?:
Red brick	Damaged or significantly damaged friable miscellaneous ACM	Yes

Additional Sample Notes:	Outermost foundation wall appears to be behind walls. No other samples collected due to wall damage and creation of potential friable ACM hazard. Can assume this outermost wall is the length of the older middle section of the school.
---------------------------------	---

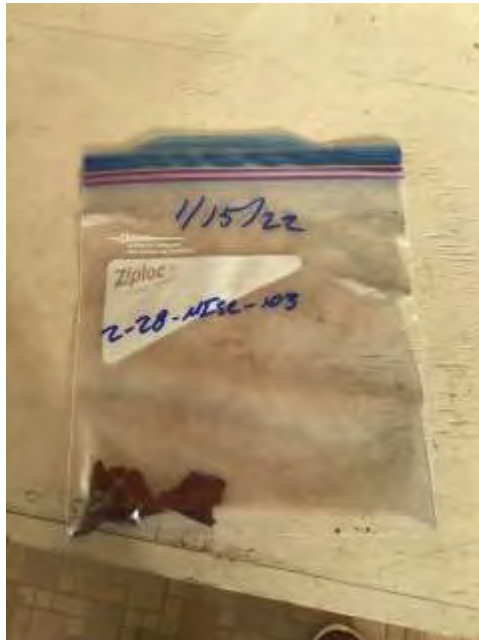
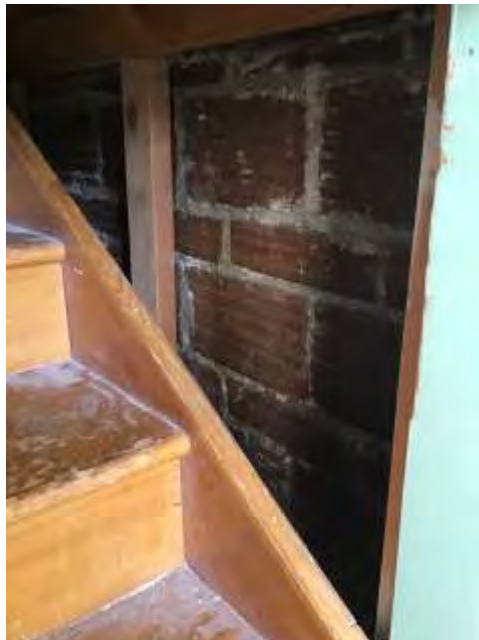
Sample ID:	Sample Type:	
2-28-MISC-103	MISC	
Sample Location:	Detailed Sample Location:	
Stage bathroom	Outermost foundation under gym stage	
Sample Quantity:	See additional notes	
Misc Sample Material:	Sample Condition:	Sample Friable?:
Red brick	Damaged or significantly damaged friable miscellaneous ACM	Yes

Additional Sample Notes:	Outermost foundation wall appears to be behind walls. No other samples collected due to wall damage and creation of potential friable ACM hazard. Can assume this outermost wall is the length of the older middle section of the school.
---------------------------------	---
