HAZARDOUS BUILDING MATERIALS SURVEY

CONDON GRADE SCHOOL
220 S. EAST STREET
CONDON, OREGON

Prepared for
CITY OF CONDON
May 17, 2022
Project No. M2053.01.002

Prepared by
Maul Foster & Alongi, Inc.
3140 NE Broadway Street, Portland, OR 97232

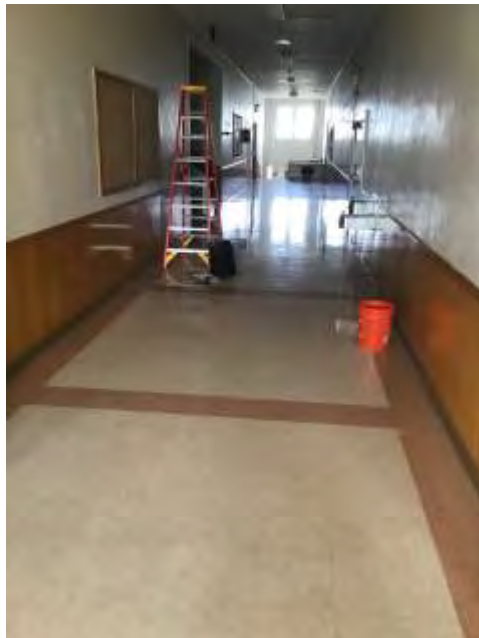
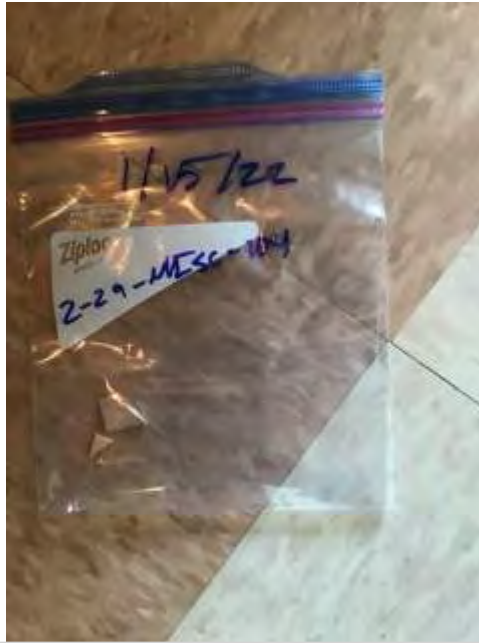
Sample ID:	Sample Type:	
2-29-MISC-104	MISC	
Sample Location:	Detailed Sample Location:	
Hallway	South staircase to stage	
Sample Quantity:	1,074 SF	
Misc Sample Material:	Sample Condition:	Sample Friable?:
12"x12" tan and pink vinyl floor tile with yellow mastic	Damaged or significantly damaged friable miscellaneous ACM	No

Additional Sample Notes:	Plywood under vinyl flooring and above linoleum flooring. Yellow mastic present on top of wood. Handle as same as homogeneous area 29
---------------------------------	---

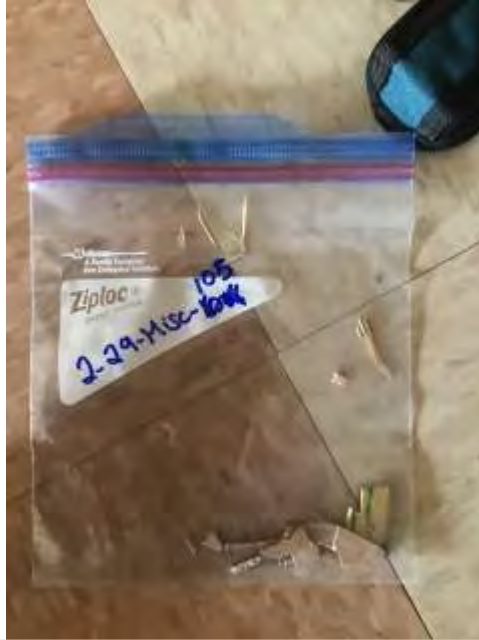
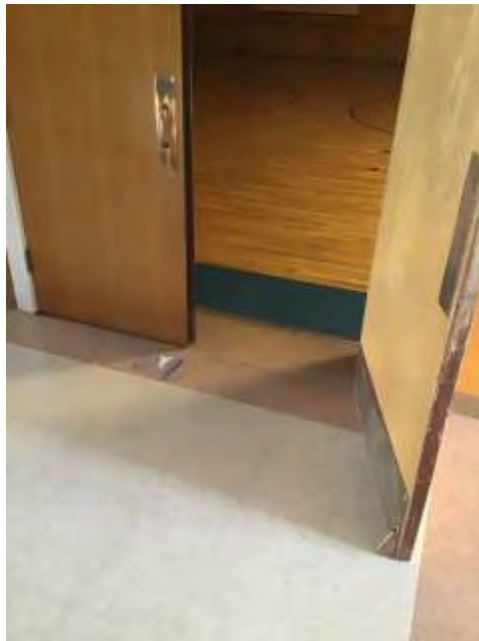
Sample ID:	Sample Type:	
2-29-MISC-105	MISC	
Sample Location:	Detailed Sample Location:	
Hallway	Corner of gym entrance	
Sample Quantity:	See 2-29-MISC-104	
Misc Sample Material:	Sample Condition:	Sample Friable?:
12"x12" tan and pink vinyl floor tile with yellow mastic	Damaged or significantly damaged friable miscellaneous ACM	No

Additional Sample Notes:	Plywood under vinyl flooring and above linoleum flooring. Yellow mastic present on top of wood. Handle as same as homogeneous area 29
---------------------------------	---

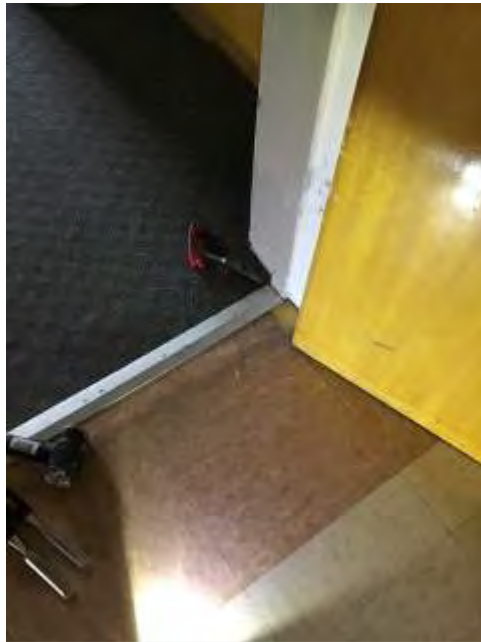
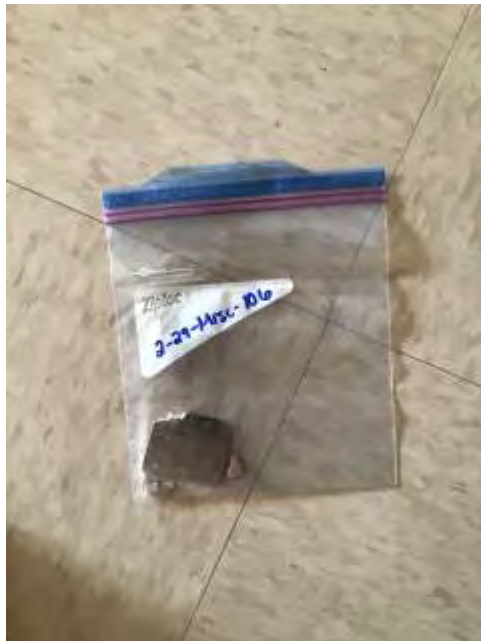
Sample ID:	Sample Type:	
2-29-MISC-106	MISC	
Sample Location:	Detailed Sample Location:	
Hallway	Corner of Classroom 26 entrance	
Sample Quantity:	See 2-29-MISC-104	
Misc Sample Material:	Sample Condition:	Sample Friable?:
12"x12" tan and pink vinyl floor tile with yellow mastic	Damaged or significantly damaged friable miscellaneous ACM	No

Plywood under vinyl flooring and above linoleum flooring. Yellow mastic present on top of wood. Handle as same as homogeneous area 29

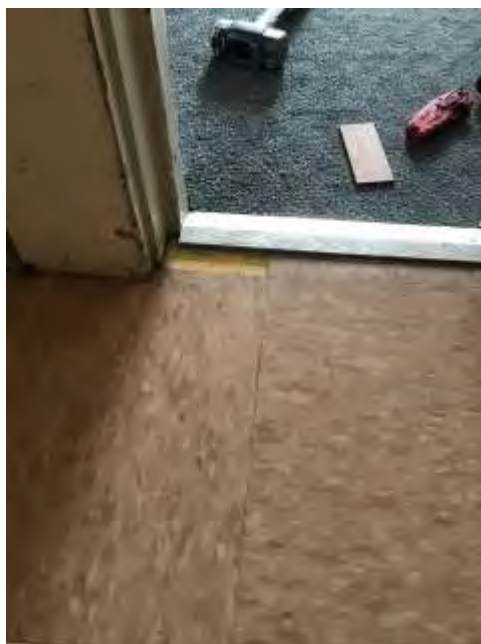
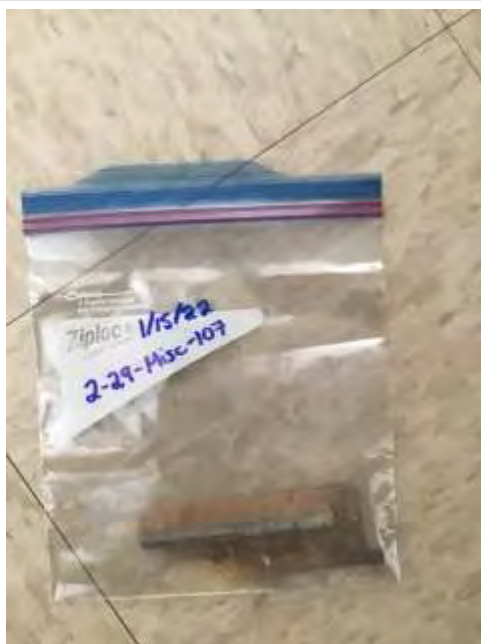
12"x12" tan and pink vinyl floor tile with yellow mastic	Damaged or significantly damaged friable miscellaneous ACM	No
--	--	----

Additional Sample Notes:	Plywood under vinyl flooring and above linoleum flooring. Yellow mastic present on top of wood. Handle as same as homogeneous area 29
---------------------------------	---

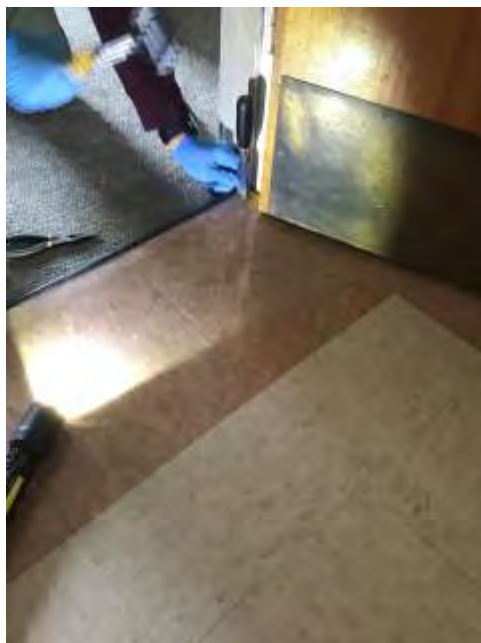
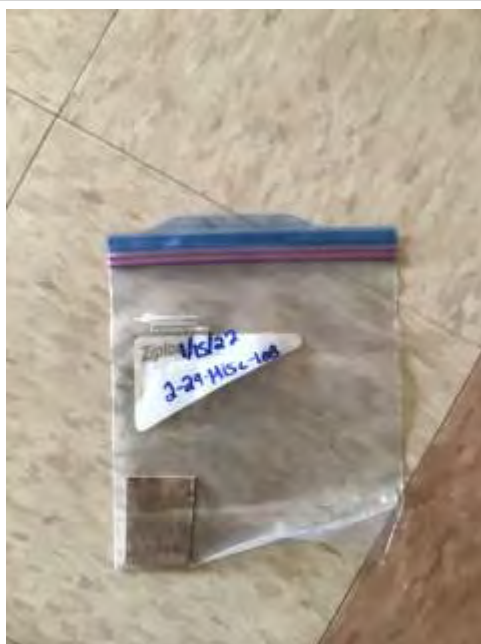
Sample ID:	Sample Type:
2-29-MISC-108	MISC
Sample Location:	Detailed Sample Location:
Hallway	Corner of Classroom Education doorway
Sample Quantity:	See 2-29-MISC-104

Misc Sample Material:	Sample Condition:	Sample Friable?:
12"x12" tan and pink vinyl floor tile with yellow mastic	Damaged or significantly damaged friable miscellaneous ACM	No

Additional Sample Notes:	Plywood under vinyl flooring and above linoleum flooring. Yellow mastic present on top of wood. Handle as same as homogeneous area 29
--------------------------	---

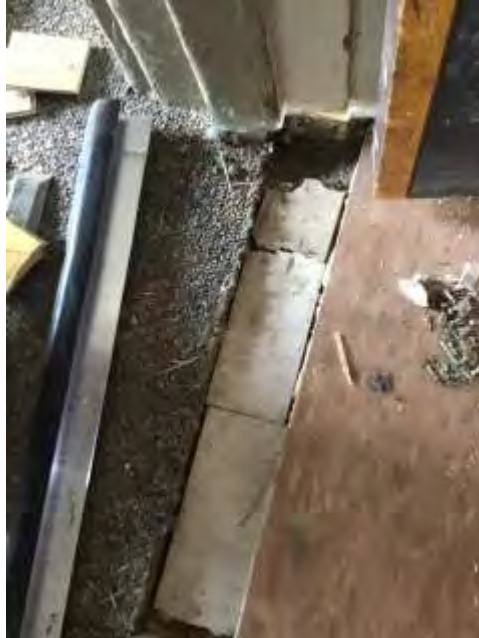
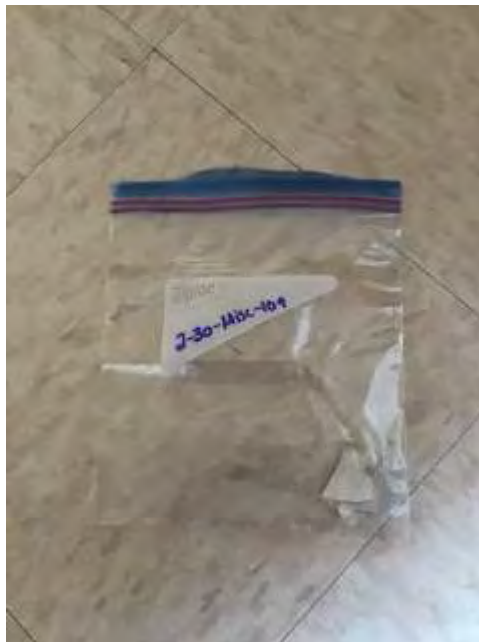
Sample Quantity:	1,073 SF	
Misc Sample Material:	Sample Condition:	Sample Friable?:
Linoleum with black mastic	Damaged or significantly damaged friable miscellaneous ACM	No

Additional Sample Notes:	Linoleum under vinyl tile and wood	
Sample ID:	Sample Type:	
2-30-MISC-110	MISC	
Sample Location:	Detailed Sample Location:	
Hallway	Outside Classroom 25 doorway

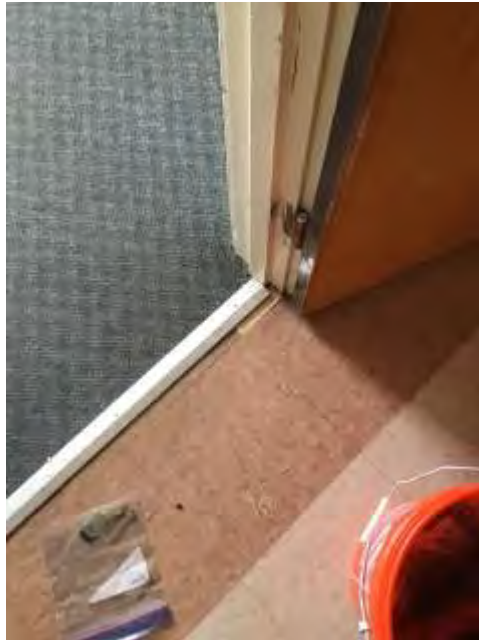
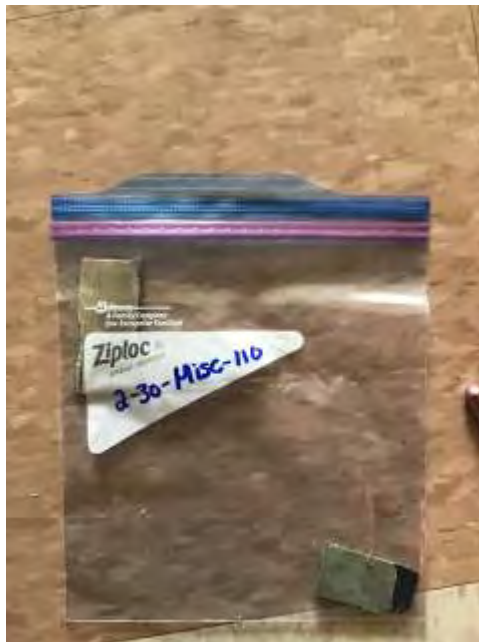
Sample Quantity:	See 2-30-MISC-109	
Misc Sample Material:	Sample Condition:	Sample Friable?:
Linoleum with black mastic	Damaged or significantly damaged friable miscellaneous ACM	No

Additional Sample Notes:	Linoleum under vinyl tile and wood	
Sample ID:	Sample Type:	
2-30-MISC-111	MISC	
Sample Location:	Detailed Sample Location:	
Hallway	Outside Classroom 26 doorway

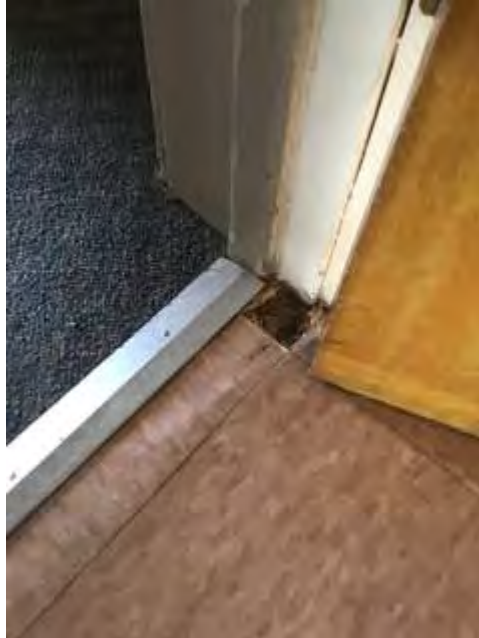
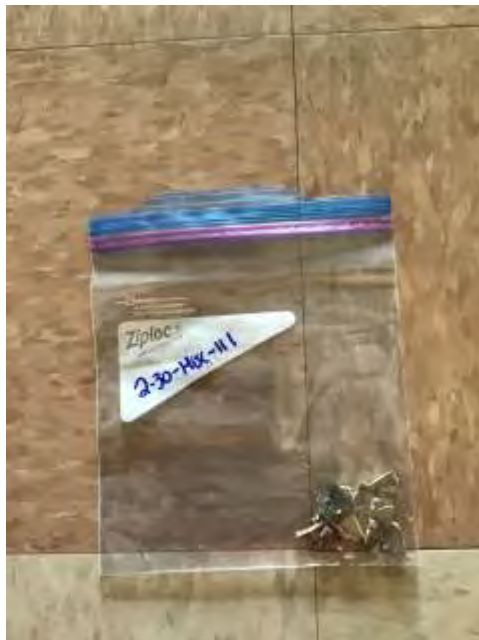
Sample Quantity:	See 2-30-MISC-109	
Misc Sample Material:	Sample Condition:	Sample Friable?:
Linoleum with black mastic	Damaged or significantly damaged friable miscellaneous ACM	No

Additional Sample Notes:	Linoleum under vinyl tile and wood	
Sample ID:	Sample Type:	
2-30-MISC-112	MISC	
Sample Location:	Detailed Sample Location:	
Hallway	Outside gym doorway

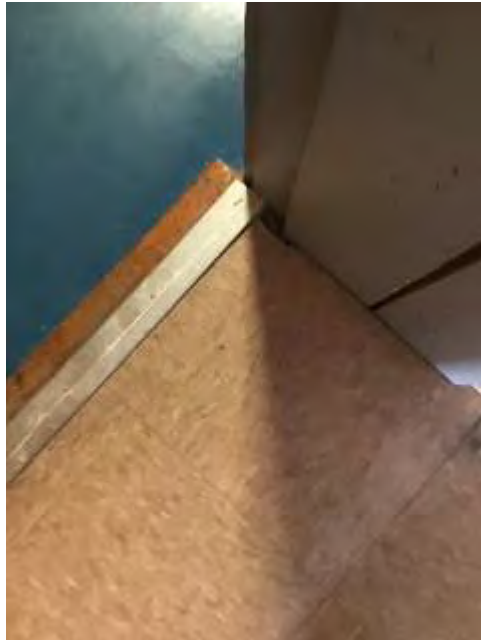
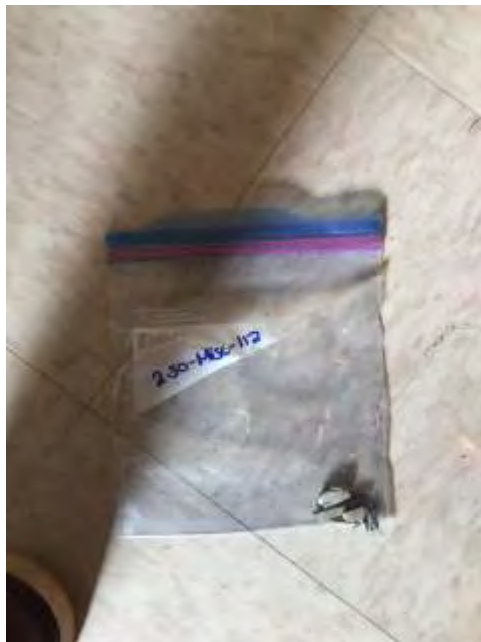
Sample Quantity:	See 2-30-MISC-109	
Misc Sample Material:	Sample Condition:	Sample Friable?:
Linoleum with black mastic	Damaged or significantly damaged friable miscellaneous ACM	No

Additional Sample Notes:	Linoleum under vinyl tile and wood	
Sample ID:	Sample Type:	
2-30-MISC-113	MISC	
Sample Location:	Detailed Sample Location:	
Hallway	Outside stage doorway

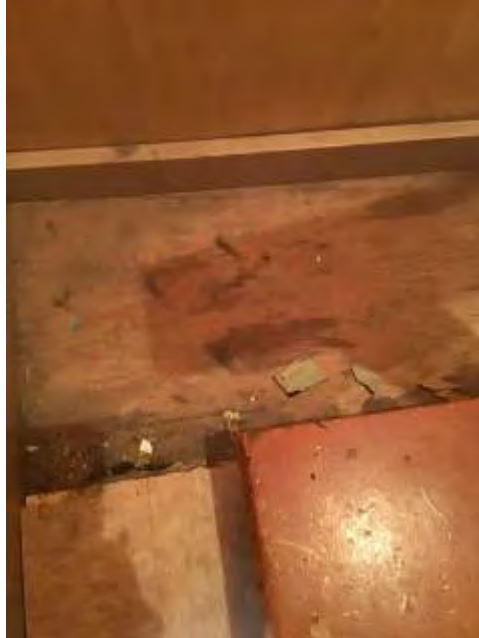
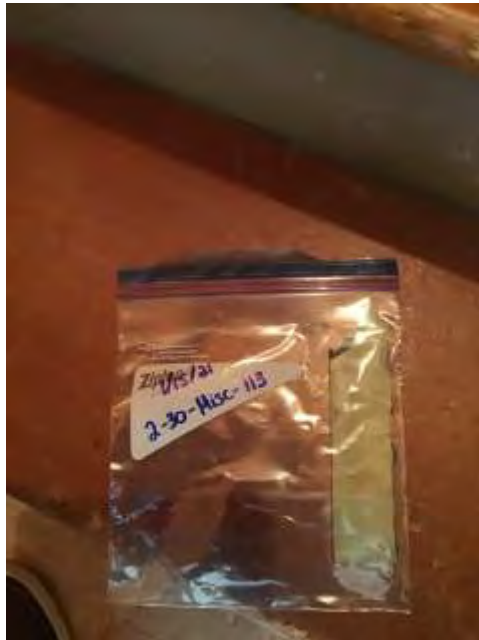
Sample Quantity:	See 2-30-MISC-109	
Misc Sample Material:	Sample Condition:	Sample Friable?:
Linoleum with black mastic	Damaged or significantly damaged friable miscellaneous ACM	No

Additional Sample Notes:	Linoleum under vinyl tile and wood
---------------------------------	------------------------------------

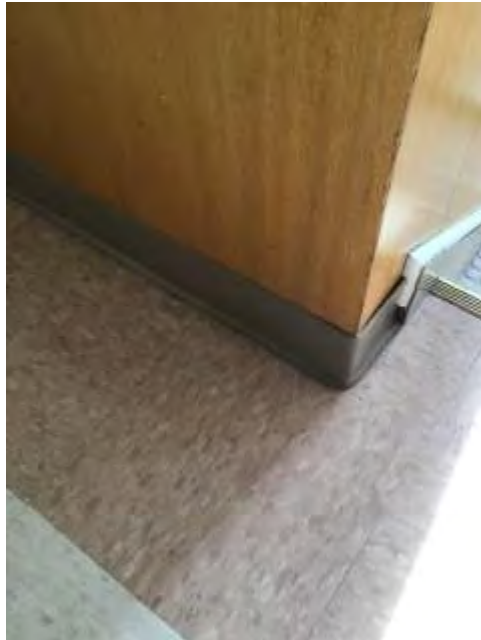
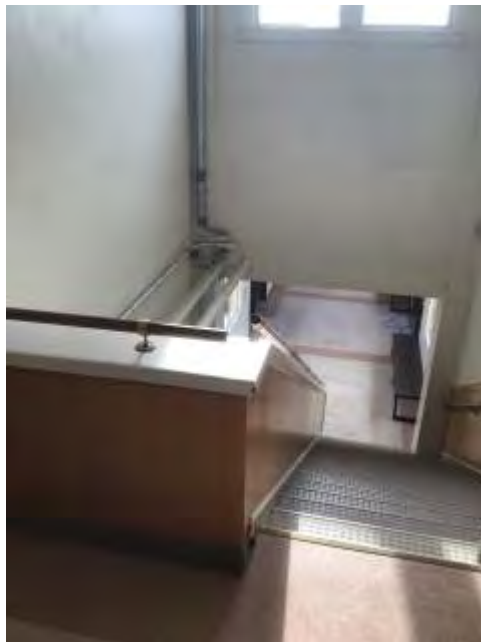
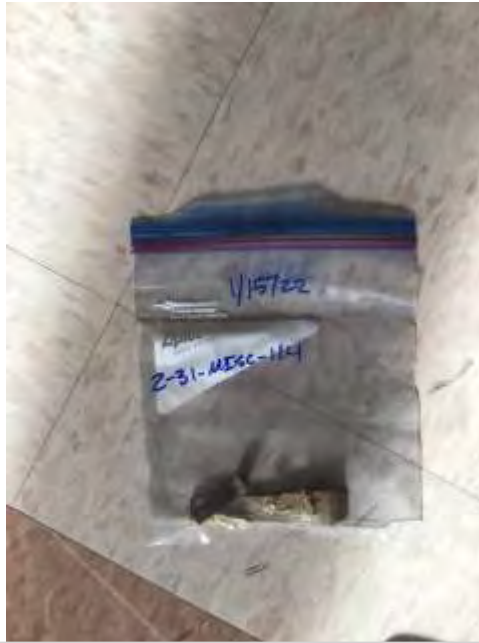
Sample ID:	Sample Type:
2-31-MISC-114	MISC
Sample Location:	Detailed Sample Location:
Hallway	Southeast stairway

Sample Quantity:	214 LF	
Misc Sample Material:	Sample Condition:	Sample Friable?:
Tan base cove with tan mastic	Damaged or significantly damaged friable miscellaneous ACM	No

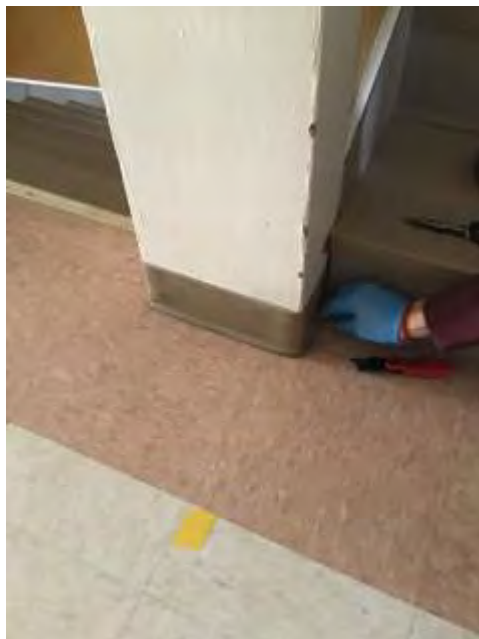
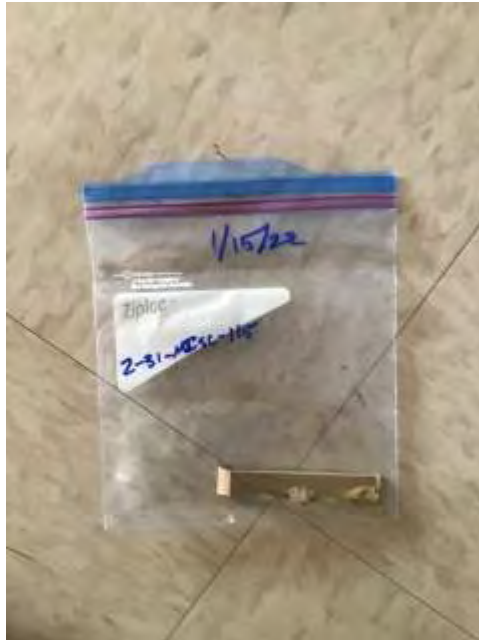
Additional Sample Notes:		
Sample ID:	Sample Type:	
2-31-MISC-115	MISC	
Sample Location:	Detailed Sample Location:	
Hallway	East stairway to counselor's room	
Sample Quantity:	See 2-31-MISC-114	
Misc Sample Material:	Sample Condition:	Sample Friable?:
Tan base cove with tan mastic	Damaged or significantly damaged friable miscellaneous ACM	No

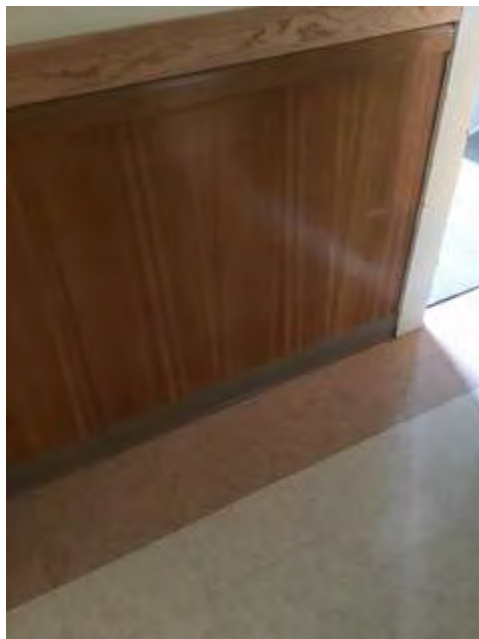
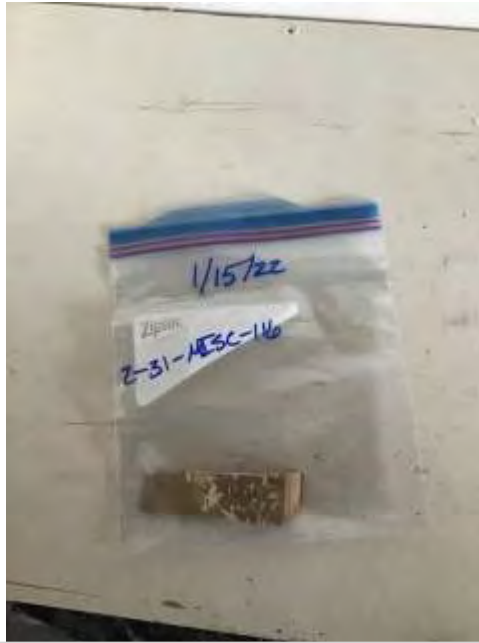
Additional Sample Notes:		
Sample ID:	Sample Type:	
2-31-MISC-116	MISC	
Sample Location:	Detailed Sample Location:	
Hallway	Doorway to Classroom Education	
Sample Quantity:	See 2-31-MISC-114	
Misc Sample Material:	Sample Condition:	Sample Friable?:
Tan base cove with tan mastic	Damaged or significantly damaged friable miscellaneous ACM	No

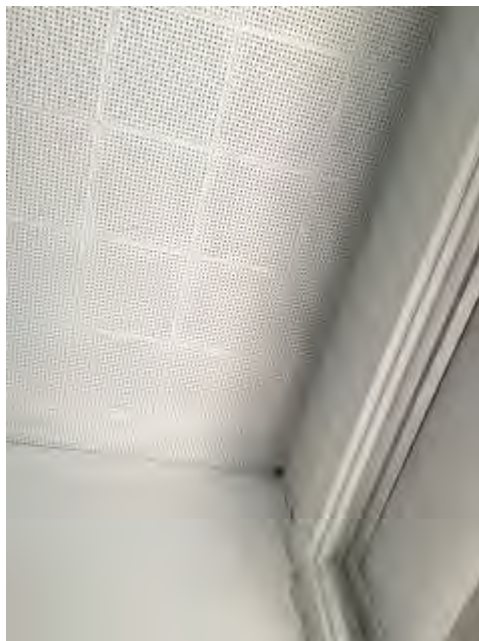
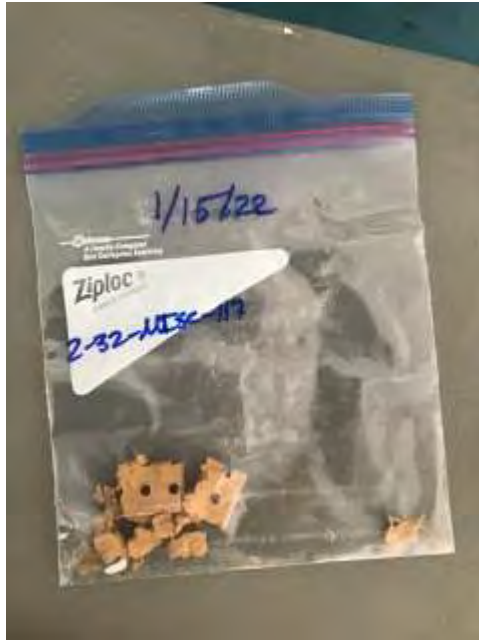
Additional Sample Notes:		
Sample ID:	Sample Type:	
2-32-MISC-117	MISC	
Sample Location:	Detailed Sample Location:	
Classroom 30	Ceiling	
Sample Quantity:	6,928.2 SF	
Misc Sample Material:	Sample Condition:	Sample Friable?:
12"x12" dotted pattern acoustic ceiling tile	Damaged or significantly damaged friable miscellaneous ACM	No

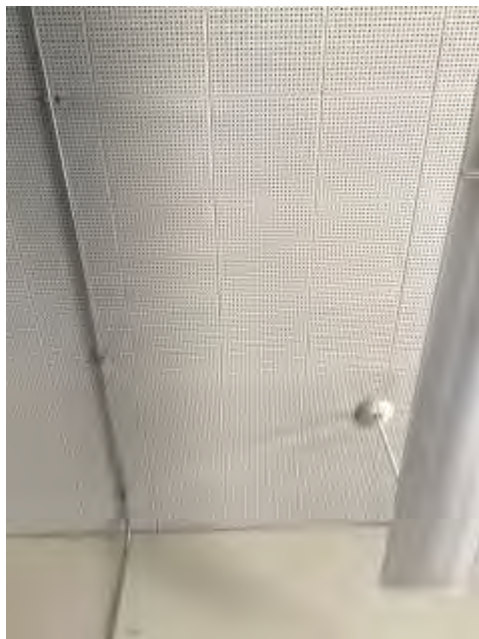
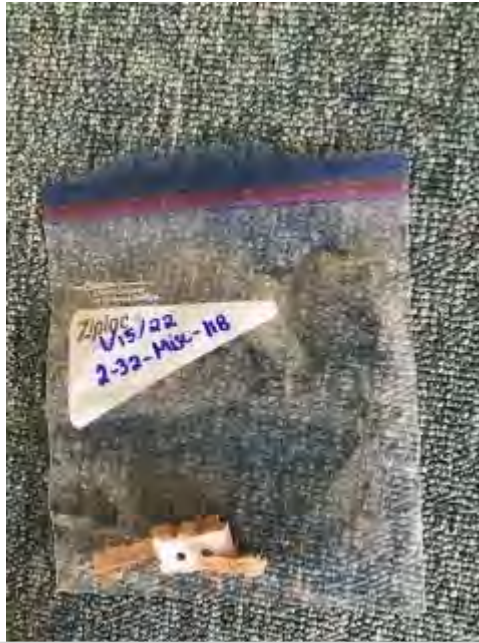
Additional Sample Notes:		
Sample ID:	Sample Type:	
2-32-MISC-118	MISC	
Sample Location:	Detailed Sample Location:	
Classroom 29	Ceiling	
Sample Quantity:	See 2-32-MISC-117	
Misc Sample Material:	Sample Condition:	Sample Friable?:
12"x12" dotted pattern acoustic ceiling tile	Damaged or significantly damaged friable miscellaneous ACM	No

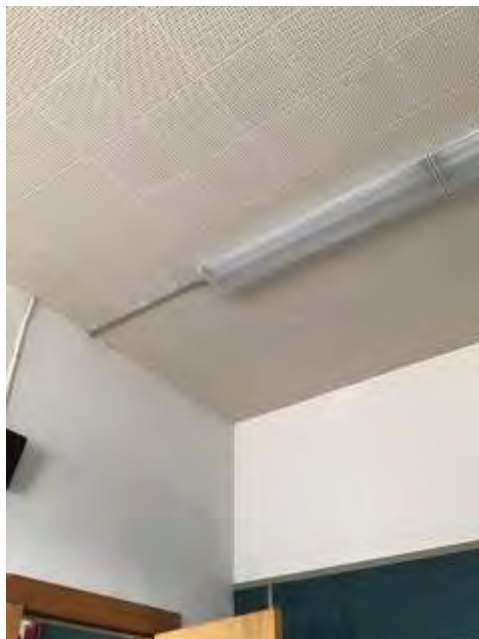
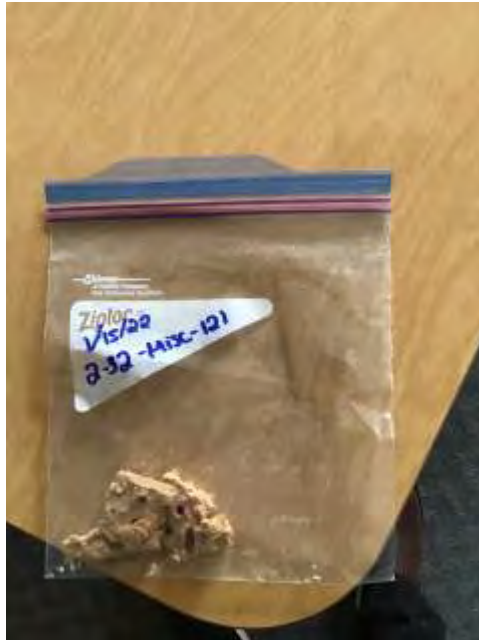
Additional Sample Notes:		
Sample ID:	Sample Type:	
2-32-MISC-121	MISC	
Sample Location:	Detailed Sample Location:	
Hallway	Ceiling of Classroom 26	
Sample Quantity:	See 2-32-MISC-117	
Misc Sample Material:	Sample Condition:	Sample Friable?:
12x12 dotted pattern acoustic ceiling tile	Damaged or significantly damaged friable miscellaneous ACM	No

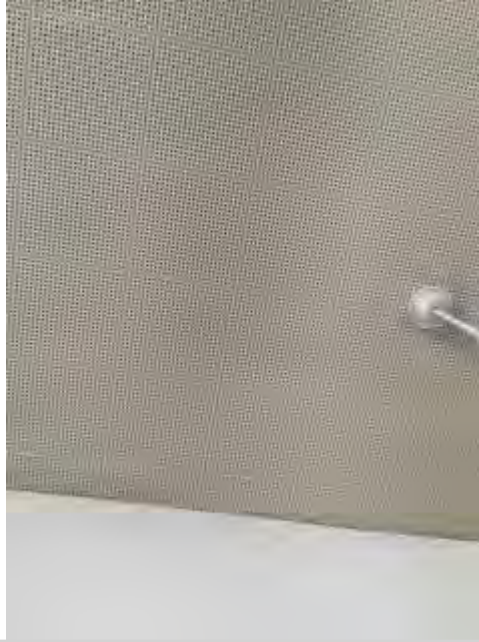
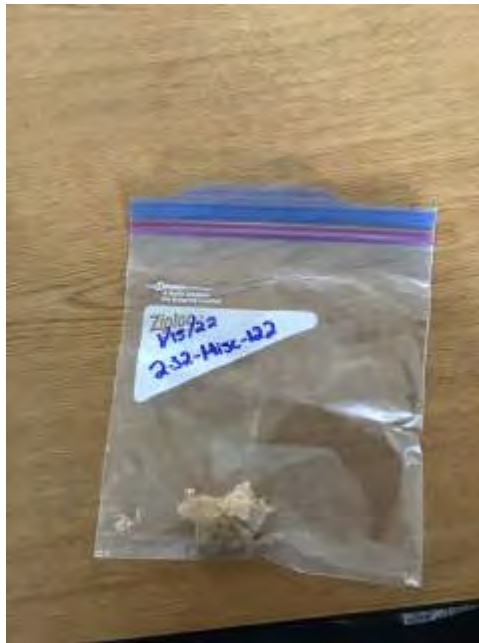
Additional Sample Notes:		
Sample ID:	Sample Type:	
2-32-MISC-122	MISC	
Sample Location:	Detailed Sample Location:	
Hallway	Ceiling of Classroom 24	
Sample Quantity:	See 2-32-MISC-117	
Misc Sample Material:	Sample Condition:	Sample Friable?:
12x12 dotted pattern acoustic ceiling tile	Damaged or significantly damaged; Damaged or significantly damaged friable miscellaneous ACM	No
Sample Photo:

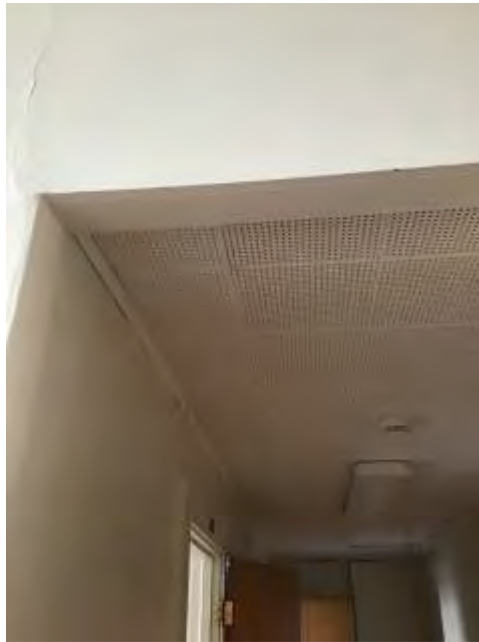
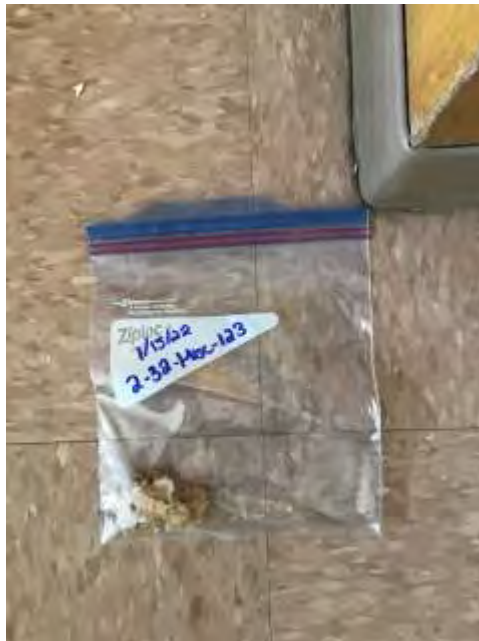
Additional Sample Notes:		
Sample ID:	Sample Type:	
2-32-MISC-123	MISC	
Sample Location:	Detailed Sample Location:	
Hallway	Ceiling of hallway across from Classroom 25	
Sample Quantity:	See 2-32-MISC-117	
Misc Sample Material:	Sample Condition:	Sample Friable?:
12x12 dotted pattern acoustic ceiling tile	Damaged friable surfacing ACM; Damaged or significantly damaged friable miscellaneous ACM	No

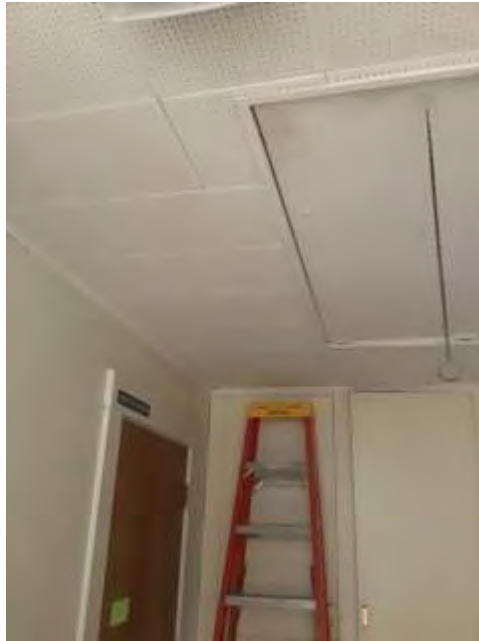
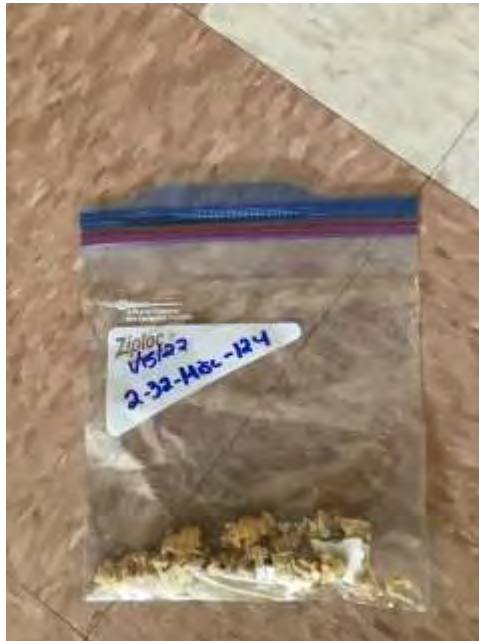
2-32-MISC-124

12x12 dotted pattern acoustic ceiling tile	Damaged friable surfacing ACM; Damaged or significantly damaged friable miscellaneous ACM	No
--	---	----

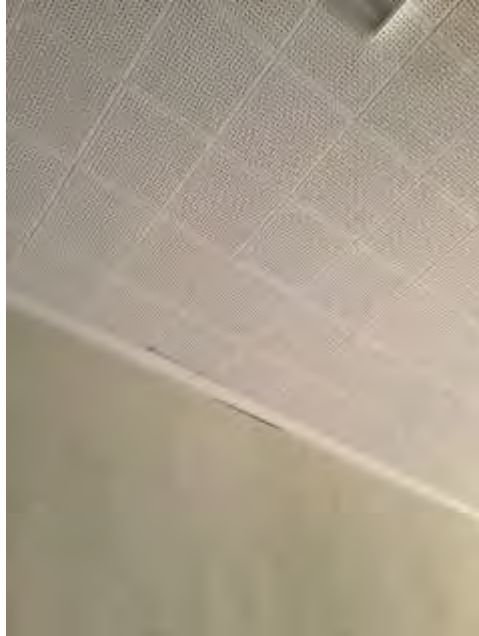
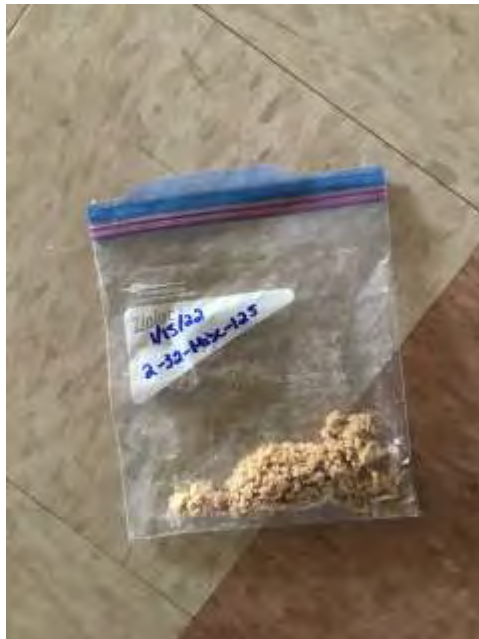
Additional Sample Notes:	
Sample ID:	Sample Type:
2-32-MISC-125	MISC
Sample Location:	Detailed Sample Location:
Hallway	Ceiling across from gym doors
Sample Quantity:	See 2-32-MISC-117

Misc Sample Material:	Sample Condition:	Sample Friable?:
12x12 dotted pattern acoustic ceiling tile	Damaged friable surfacing ACM; Damaged or significantly damaged friable miscellaneous ACM	No

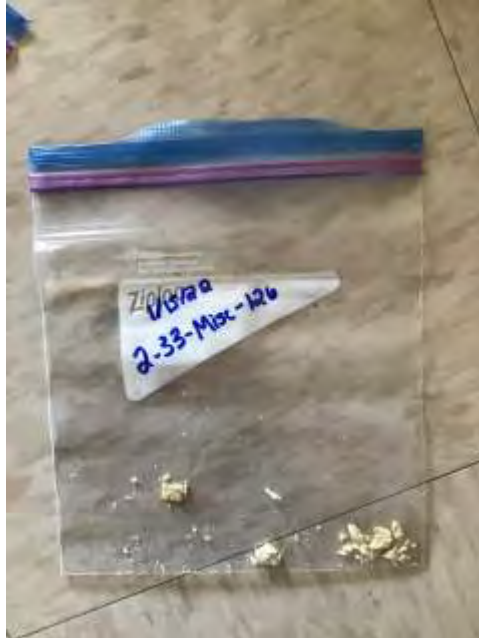
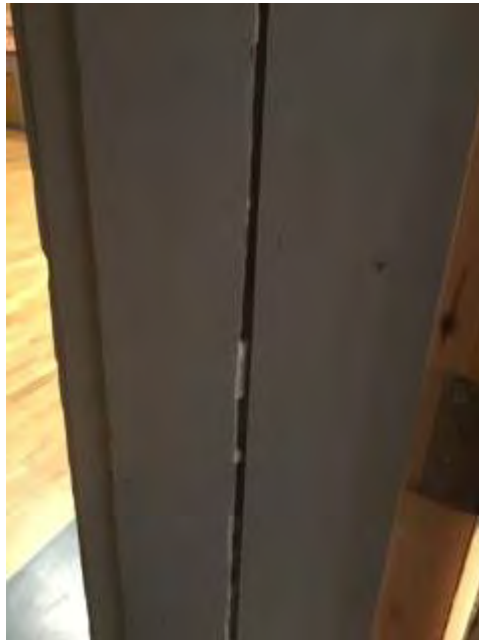
Sample ID:	Sample Type:
2-33-MISC-126	MISC
Sample Location:	Detailed Sample Location:
Gym	Middle doorway in crevices

Sample Quantity:	20 LF	
Misc Sample Material:	Sample Condition:	Sample Friable?:
White caulking material between doors	Damaged or significantly damaged friable miscellaneous ACM	Yes

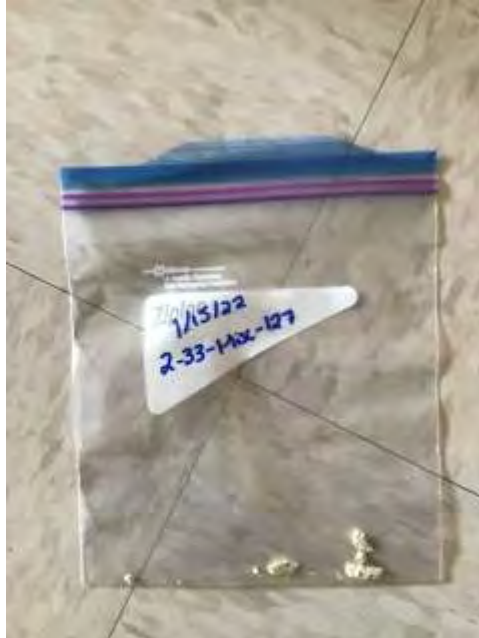
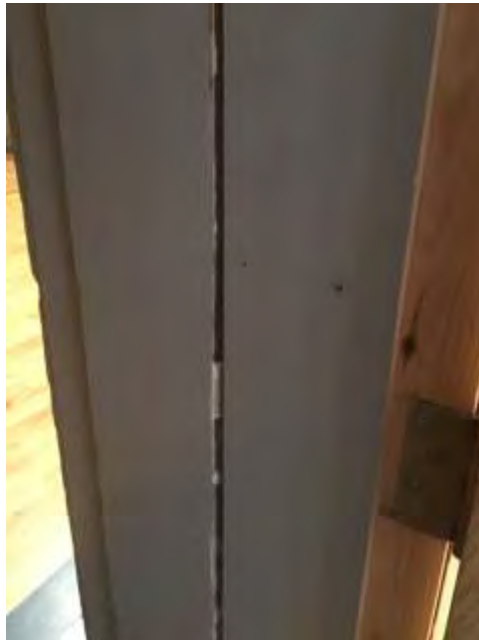
Additional Sample Notes:		
Sample ID:	Sample Type:	
2-33-MISC-127	MISC	
Sample Location:	Detailed Sample Location:	
Gym	Middle doorway in crevices

Sample Quantity:	See 2-33-MISC-126	
Misc Sample Material:	Sample Condition:	Sample Friable?:
White caulking material between doors	Damaged or significantly damaged friable miscellaneous ACM	Yes

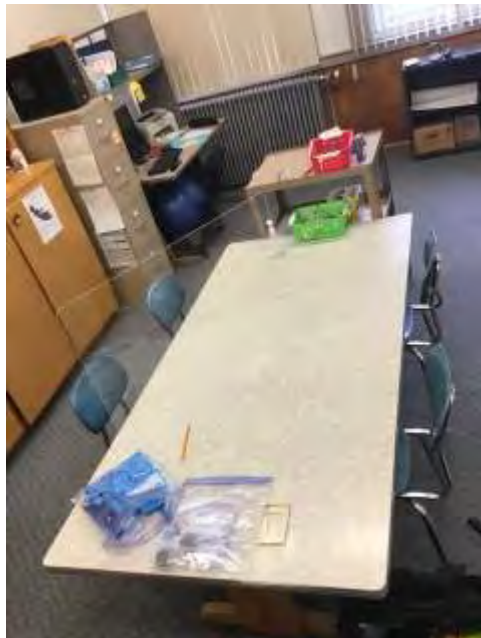
Potential ACM mastic	1 table
Condition:	Additional Fixture Notes:
Good	Did not sample laminate table top due to being in use.

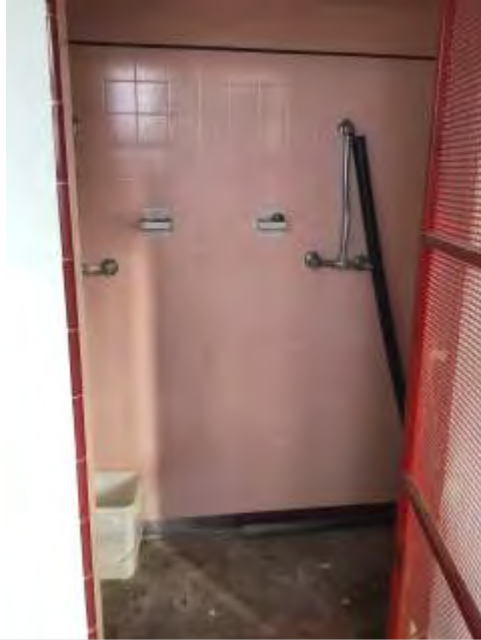
General Fixture Location:	Detailed Fixture Location:
Stage bathroom	Shower
Type of Fixture:	Quantity:
Potential ACM	75 SF
Condition:	Additional Fixture Notes:
Good	Did not collect sample due to shower in apparent use. Sample not collected due to potential creation of friable ACM hazard. Material assumed same as homogeneous area 3.

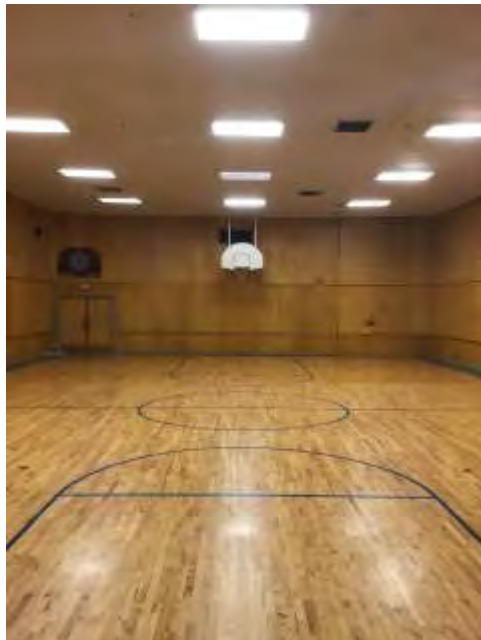
General Fixture Location:	Detailed Fixture Location:
Auditorium	Gym floor
Type of Fixture:	Quantity:
Potential ACM	2,865 SF
Condition:	Additional Fixture Notes:
Good	Due to damage of flooring and the potential to create a friable ACM hazard sample was not collected. If floor is to be removed conduct follow up sampling and ensure no flooring beneath wood.

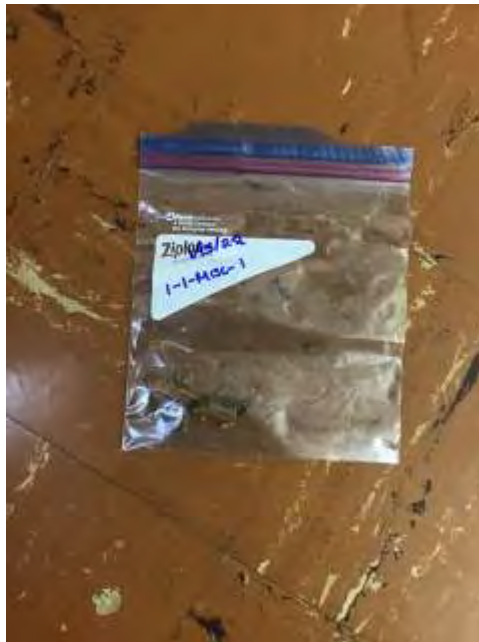
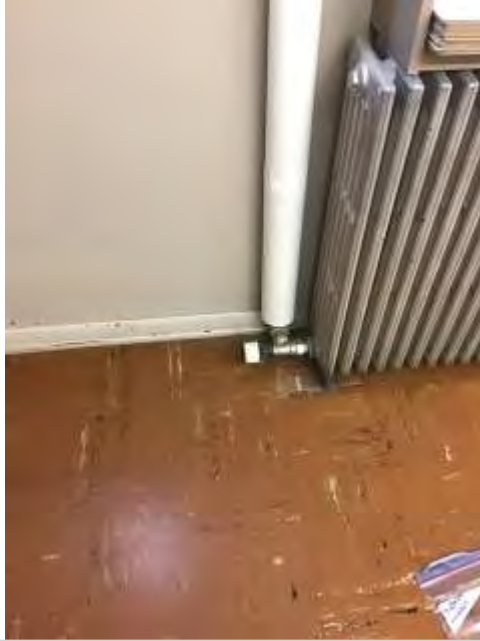
Sample ID:	Sample Type:	
1-1-MISC-1	MISC	
Sample Location:	Detailed Sample Location:	
Classroom 8	Southeast corner of room	
Sample Quantity:	2,111.5 sq. ft.	
Misc Sample Material:	Sample Condition:	Sample Friable?:
9x9 brown and black tile with black mastic		No

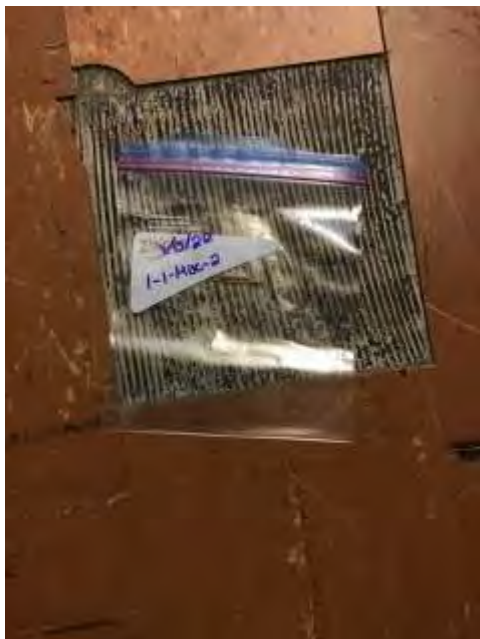
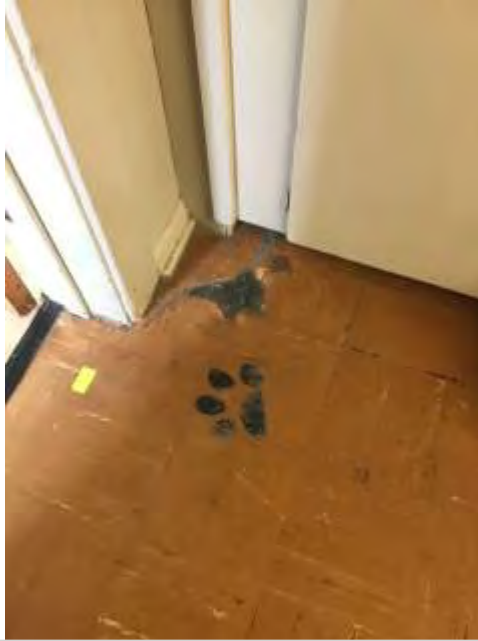
Additional Sample Notes:		
Sample ID:	Sample Type:	
1-1-MISC-2	MISC	
Sample Location:	Detailed Sample Location:	
Classroom 8	Northwest corner of room	
Sample Quantity:	See 1-1-MISC-1	
Misc Sample Material:	Sample Condition:	Sample Friable?:
9x9 brown and black tile with black mastic	Damaged or significantly damaged friable miscellaneous ACM	No

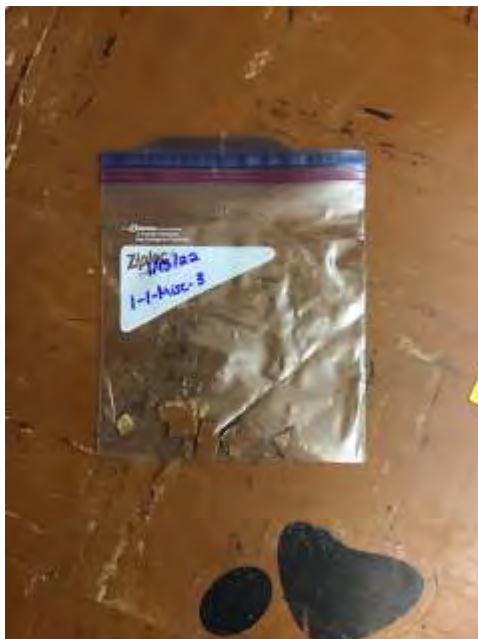
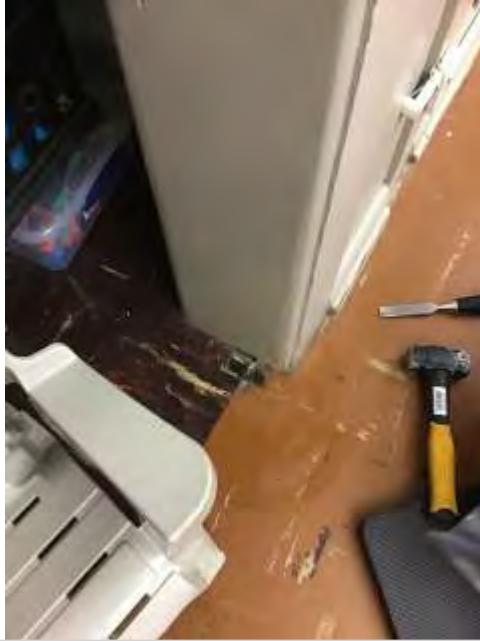
Additional Sample Notes:		
Sample ID:	Sample Type:	
1-1-MISC-3	MISC	
Sample Location:	Detailed Sample Location:	
Classroom 8	North edge of classroom	
Sample Quantity:	See 1-1-MISC-1	
Misc Sample Material:	Sample Condition:	Sample Friable?:
9x9 brown and black tile with black mastic	Damaged or significantly damaged friable miscellaneous ACM	No

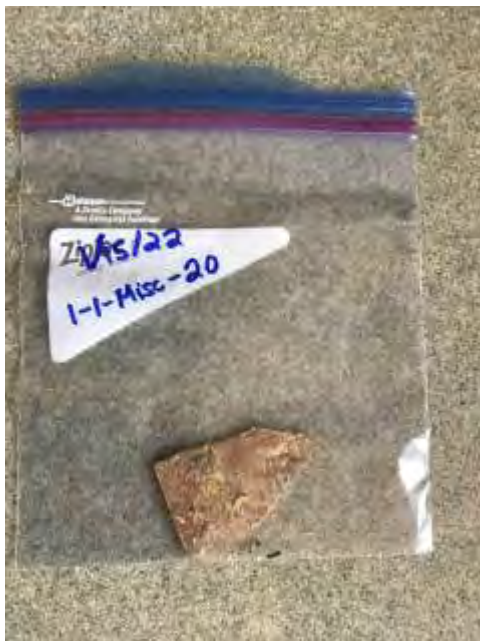
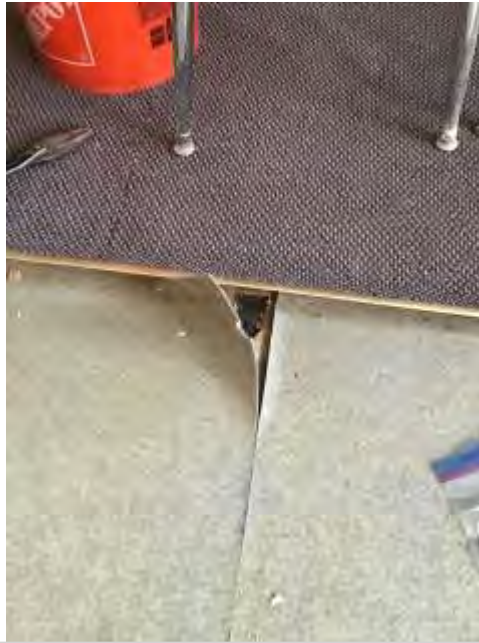
Additional Sample Notes:		
Sample ID:	Sample Type:	
1-1-MISC-20	MISC	
Sample Location:	Detailed Sample Location:	
Classroom 7	Center of room at the boundary between linoleum and carpet	
Sample Quantity:	See 1-1-MISC-1	
Misc Sample Material:	Sample Condition:	Sample Friable?:
9x9 brown and black tile with black mastic	Damaged or significantly damaged friable miscellaneous ACM	No

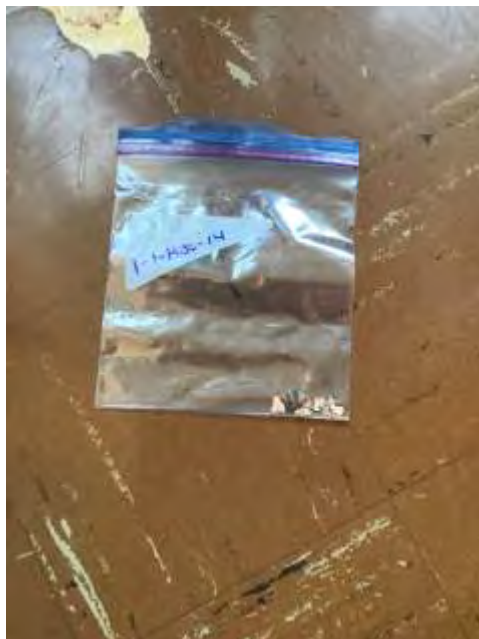
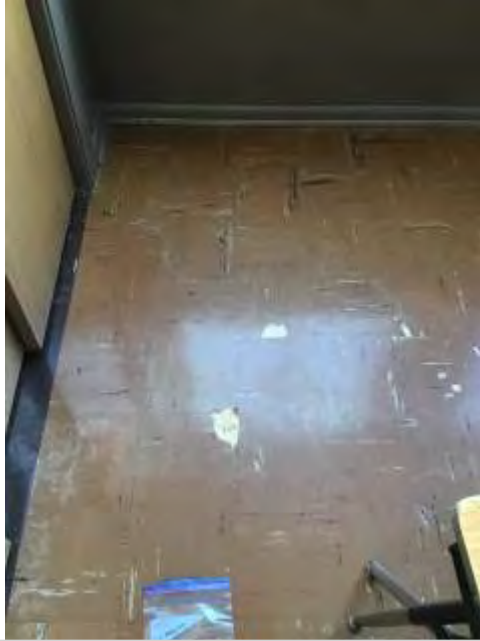
Additional Sample Notes:		
Sample ID:	Sample Type:	
1-1-MISC-14	MISC	
Sample Location:	Detailed Sample Location:	
Classroom 9	Southeast corner of room	
Sample Quantity:	See 1-1-MISC-1	
Misc Sample Material:	Sample Condition:	Sample Friable?:
9x9 brown and black tile with black mastic	Damaged or significantly damaged friable miscellaneous ACM	No

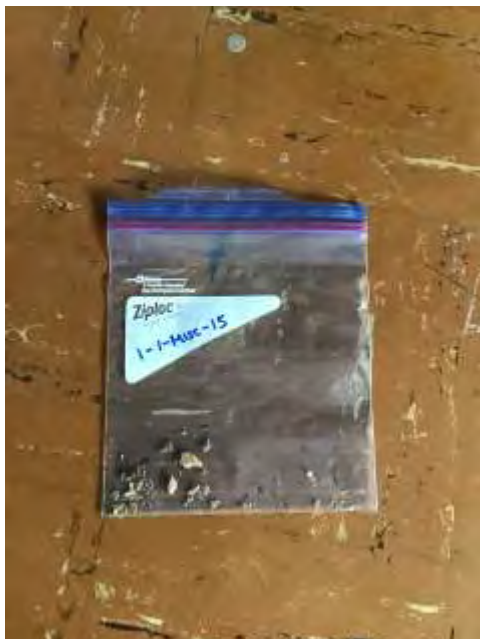
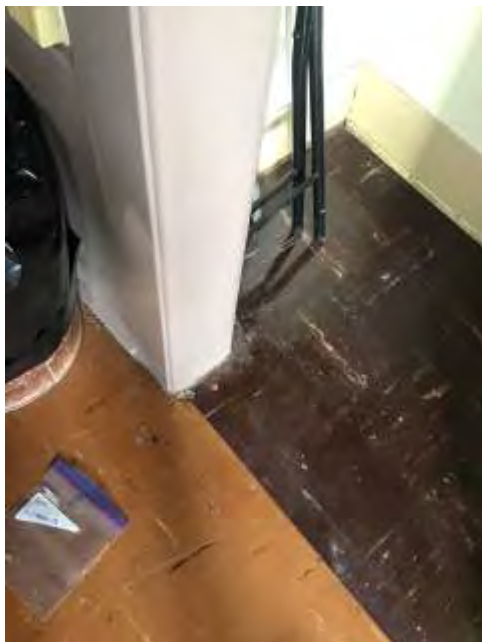
Additional Sample Notes:		
Sample ID:	Sample Type:	
1-1-MISC-15	MISC	
Sample Location:	Detailed Sample Location:	
Classroom 9	East edge of room at closet entrance.	
Sample Quantity:	See 1-1-MISC-1	
Misc Sample Material:	Sample Condition:	Sample Friable?:
9x9 brown and black tile with black mastic	Damaged or significantly damaged friable miscellaneous ACM	No

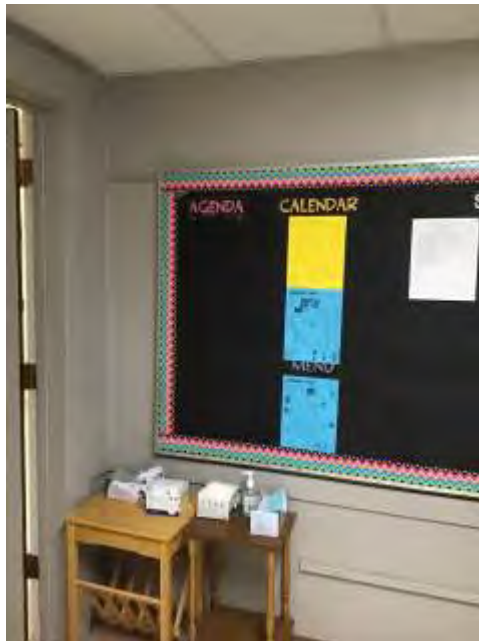
Sample ID:	Sample Type:
1-2-PB-2	PB
Sample Location:	Detailed Sample Location:
Office	Throughout
Sample Quantity:	
Sample Color:	XRF:
Gray	0.18mg/cm2

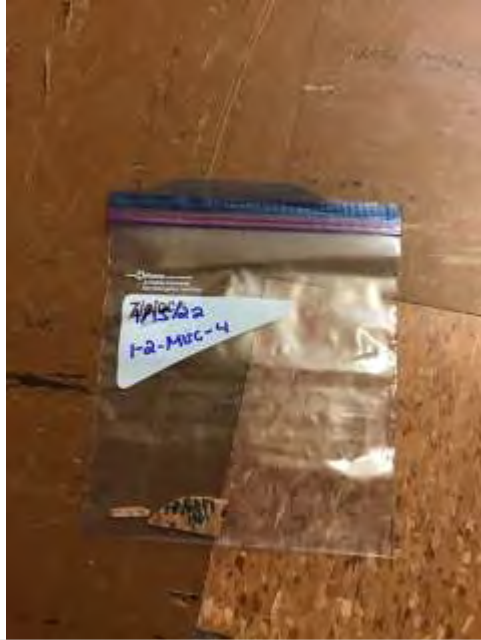
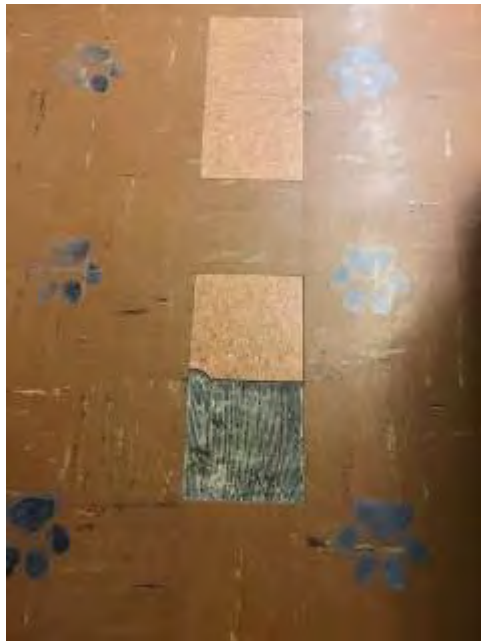
Sample ID:	Sample Type:	
1-2-MISC-4	MISC	
Sample Location:	Detailed Sample Location:	
Classroom 8	Northwest corner of room in entryway	
Sample Quantity:	10 sf	
Misc Sample Material:	Sample Condition:	Sample Friable?:
9x9 spackled tan tile with black mastic	Damaged or significantly damaged friable miscellaneous ACM	No
