HAZARDOUS BUILDING MATERIALS SURVEY

CONDON GRADE SCHOOL
220 S. EAST STREET
CONDON, OREGON

Prepared for
CITY OF CONDON
May 17, 2022
Project No. M2053.01.002

Prepared by
Maul Foster & Alongi, Inc.
3140 NE Broadway Street, Portland, OR 97232

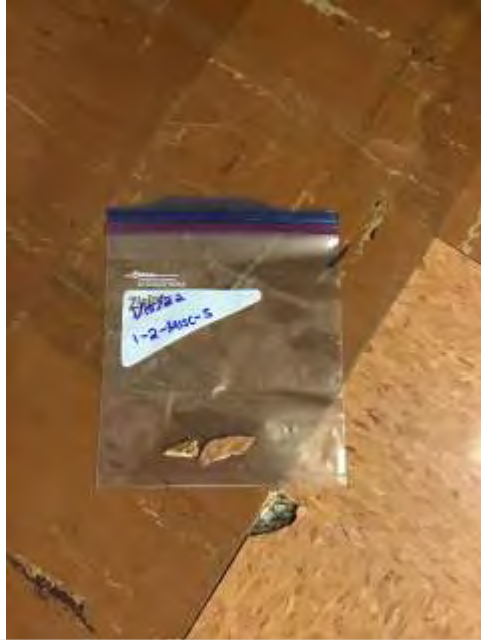
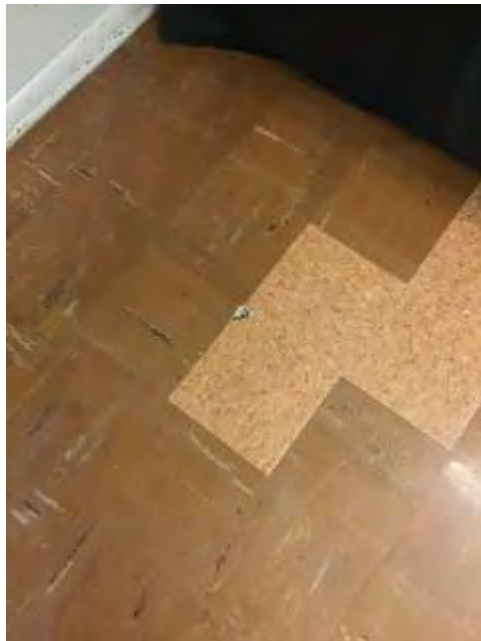
Additional Sample Notes:		
Sample ID:	Sample Type:	
1-2-MISC-5	MISC	
Sample Location:	Detailed Sample Location:	
Classroom 8	West edge of room under carpet	
Sample Quantity:	See 1-2-MISC-4	
Misc Sample Material:	Sample Condition:	Sample Friable?:
9x9 spackled tan tile with black mastic	Damaged or significantly damaged friable miscellaneous ACM	No
Sample Photo:

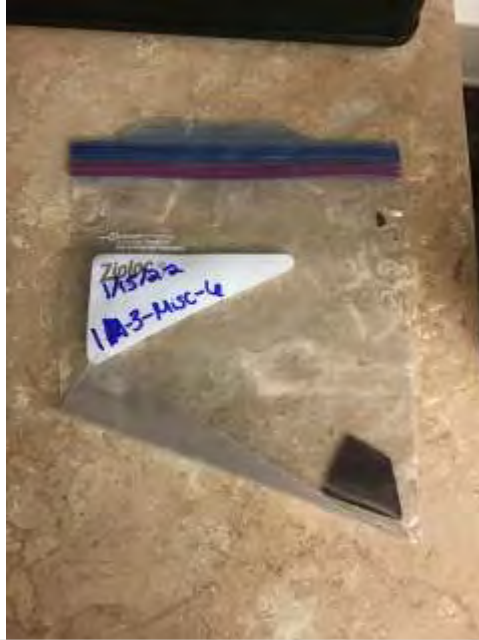
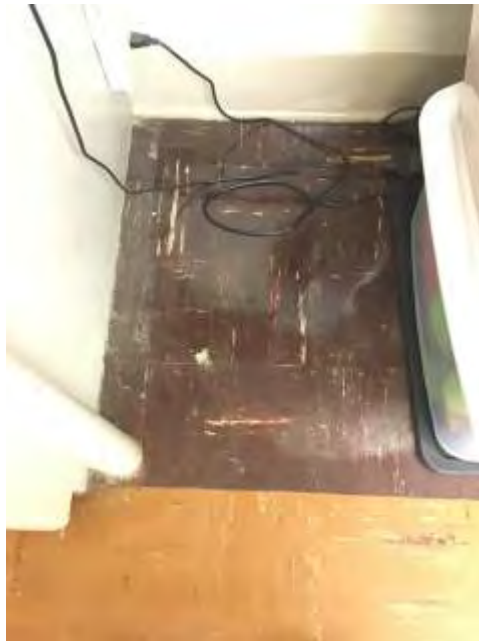
Additional Sample Notes:		
Sample ID:	Sample Type:	
1-3-MISC-6	MISC	
Sample Location:	Detailed Sample Location:	
Classroom 8	Northwest edge of room next to counter	
Sample Quantity:	100.5 SF	
Misc Sample Material:	Sample Condition:	Sample Friable?:
9x9 dark brown tile with black mastic	Damaged or significantly damaged friable miscellaneous ACM	No
Sample Photo:

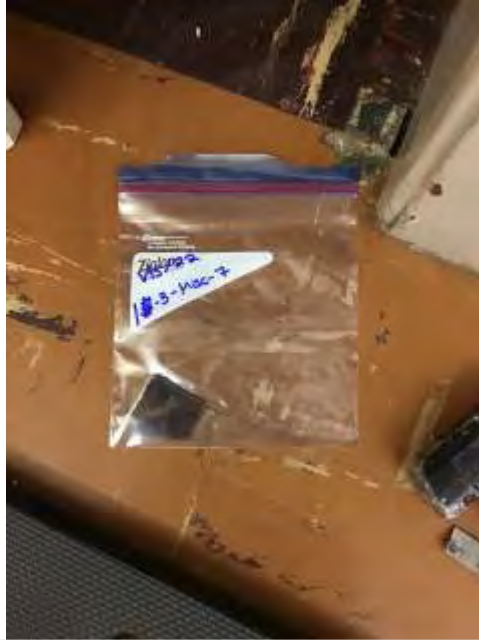
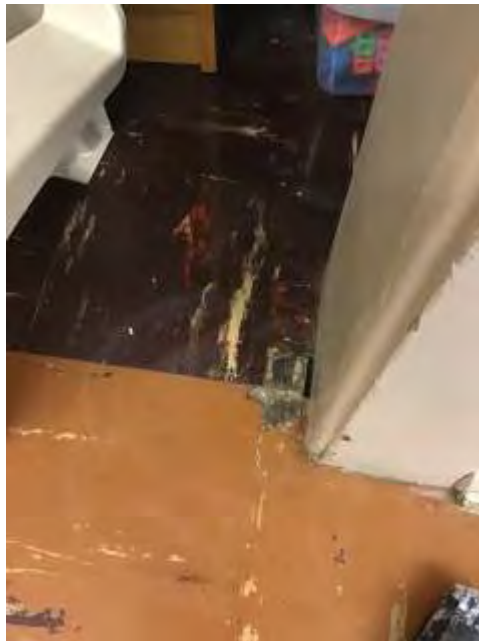
Additional Sample Notes:		
Sample ID:	Sample Type:	
1-3-MISC-7	MISC	
Sample Location:	Detailed Sample Location:	
Classroom 8	North edge of room	
Sample Quantity:	See 1-3-MISC-6	
Misc Sample Material:	Sample Condition:	Sample Friable?:
9x9 dark brown tile with black mastic	Damaged or significantly damaged friable miscellaneous ACM	No
Sample Photo:

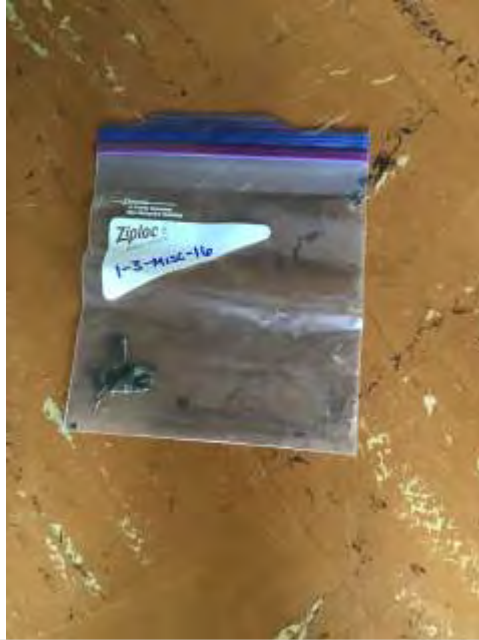
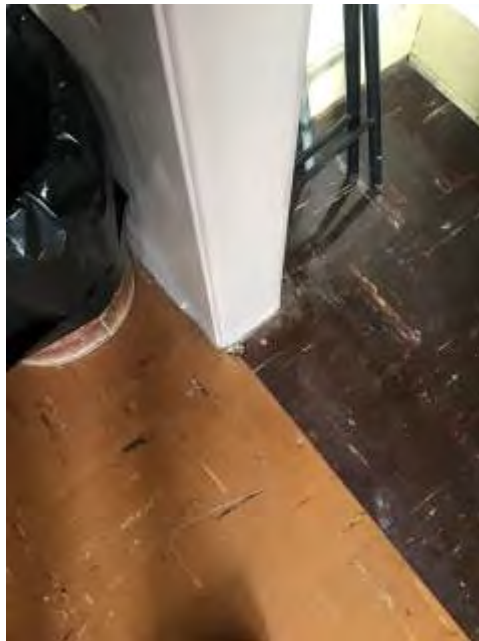
Additional Sample Notes:		
Sample ID:	Sample Type:	
1-3-MISC-16	MISC	
Sample Location:	Detailed Sample Location:	
Classroom 9	East edge of room at closet entrance.	
Sample Quantity:	See 1-3-MISC-6	
Misc Sample Material:	Sample Condition:	Sample Friable?:
9x9 dark brown tile with black mastic	Damaged or significantly damaged friable miscellaneous ACM	No
Sample Photo:

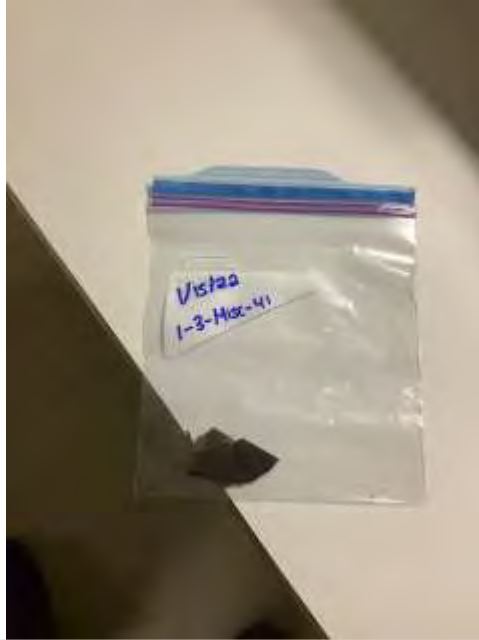
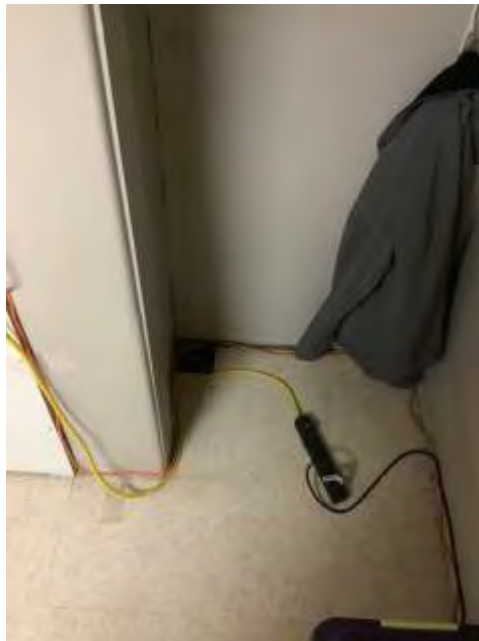
Additional Sample Notes:		
Sample ID:	Sample Type:	
1-3-MISC-41	MISC	
Sample Location:	Detailed Sample Location:	
Office	South edge of main office inside closet cutout	
Sample Quantity:	See 1-3-MISC-6	
Misc Sample Material:	Sample Condition:	Sample Friable?:
9x9 dark brown tile with black mastic	Damaged or significantly damaged friable miscellaneous ACM	No
Sample Photo:

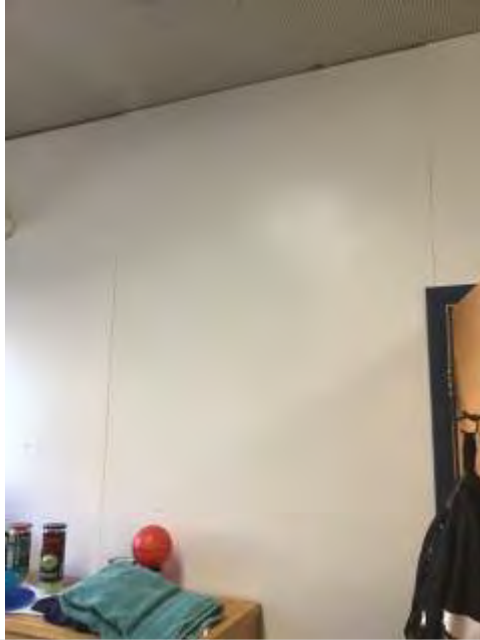
Additional Sample Notes:	
Sample ID:	Sample Type:
1-3-PB-3	PB
Sample Location:	Detailed Sample Location:
Office	Principal's office
Sample Quantity:	710 SF
Sample Color:	XRF:
White	0.04mg/cm2
Sample Photo:

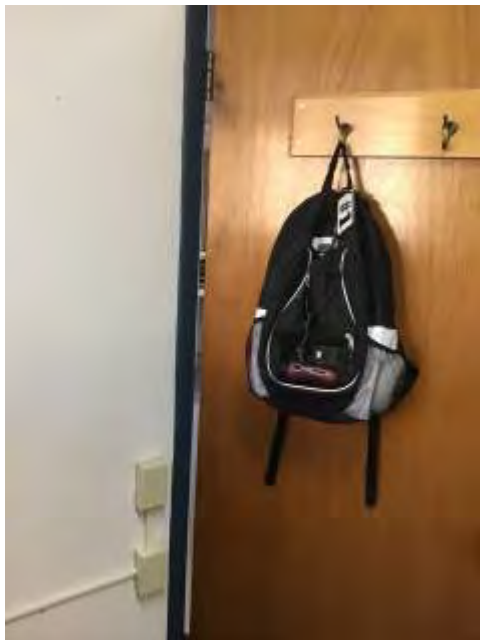
Additional Sample Notes:	
Sample ID:	Sample Type:
1-4-PB-4	PB
Sample Location:	Detailed Sample Location:
Office	Principal's office door frame
Sample Quantity:	
Sample Color:	XRF:
Blue	ND

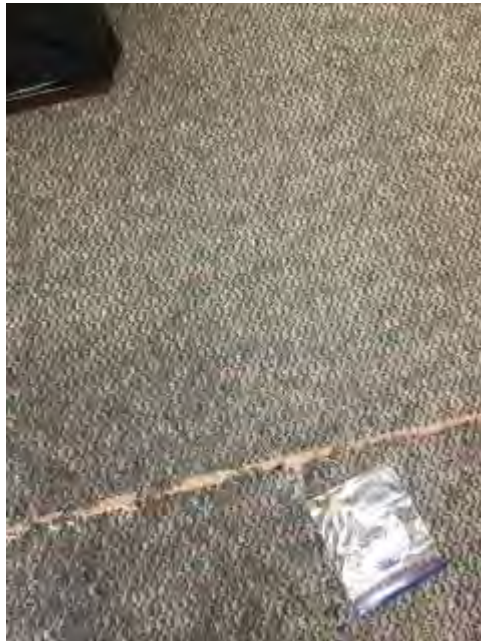
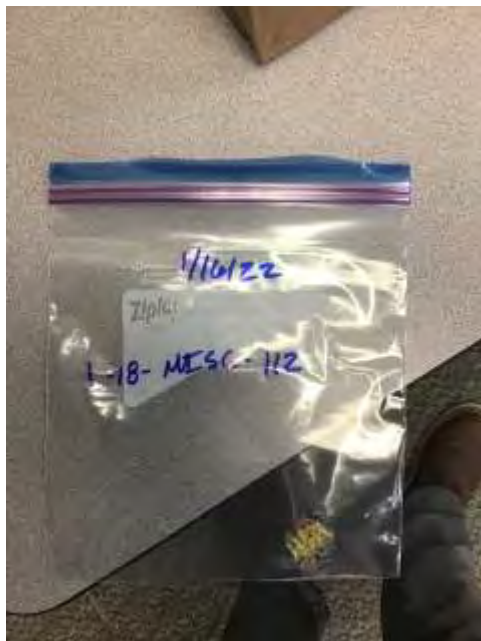
Additional Sample Notes:		
Sample ID:	Sample Type:	
1-4-MISC-112	MISC	
Sample Location:	Detailed Sample Location:	
Computer lab	Middle of floor near entrance	
Sample Quantity:	See 1-4-MISC-8	
Misc Sample Material:	Sample Condition:	Sample Friable?:
Blue green tan patterned carpet with yellow mastic	Damaged or significantly damaged friable miscellaneous ACM	No

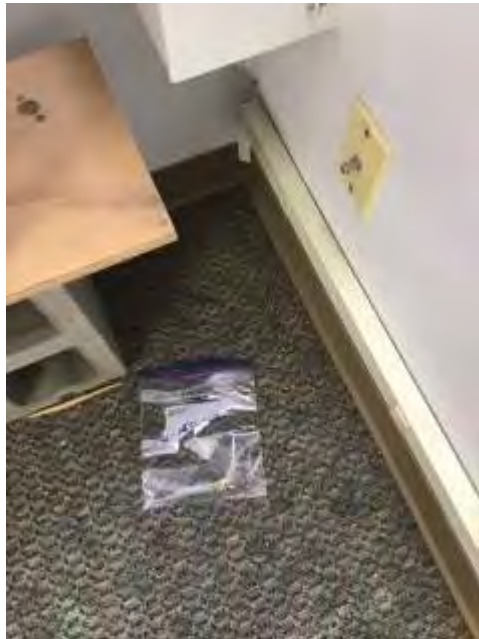
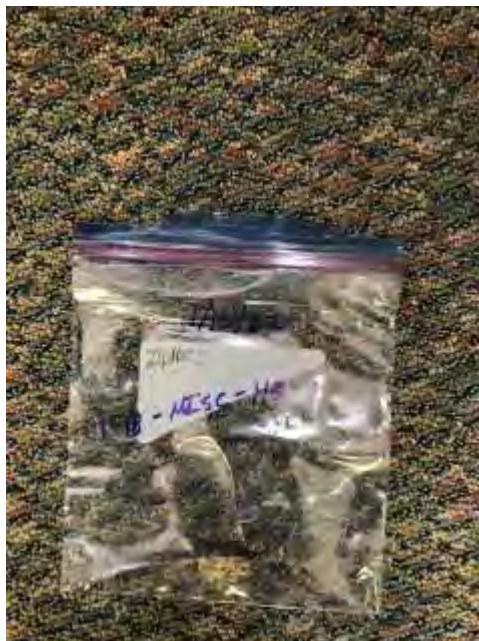
Additional Sample Notes:		
Sample ID:	Sample Type:	
1-4-MISC-113	MISC	
Sample Location:	Detailed Sample Location:	
Computer lab	North corner of office space	
Sample Quantity:	See 1-4-MISC-8	
Misc Sample Material:	Sample Condition:	Sample Friable?:
Blue green tan patterned carpet with yellow mastic	Damaged or significantly damaged friable miscellaneous ACM	No

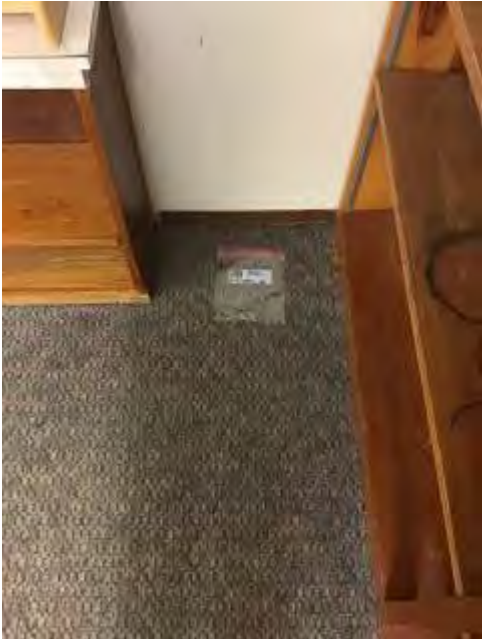
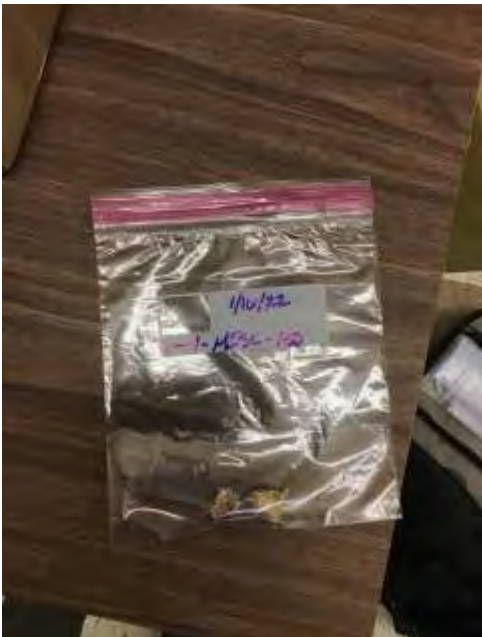
Additional Sample Notes:		
Sample ID:	Sample Type:	
1-4-MISC-150	MISC	
Sample Location:	Detailed Sample Location:	
Library	Northeast corner	
Sample Quantity:	See 1-4-MISC-8	
Misc Sample Material:	Sample Condition:	Sample Friable?:
Blue green tan patterned carpet with yellow mastic	Damaged or significantly damaged friable miscellaneous ACM	No
Sample Photo:

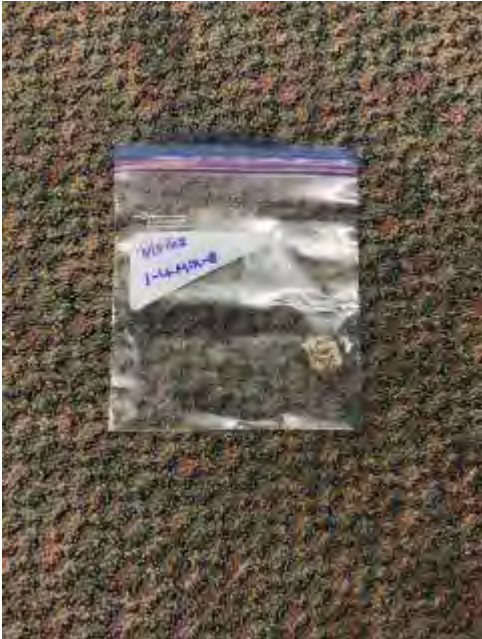
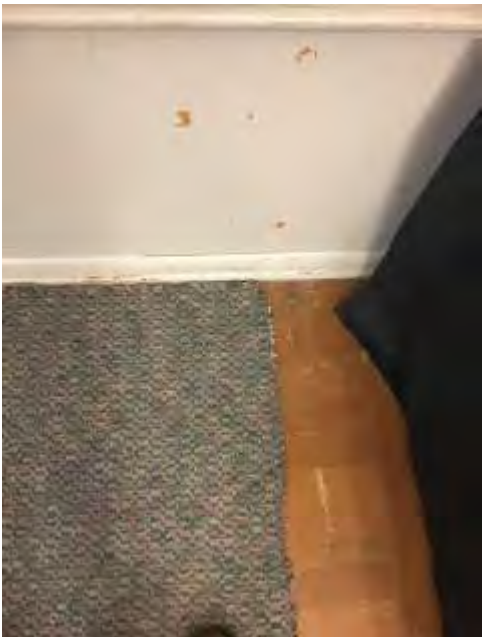
Additional Sample Notes:		
Sample ID:	Sample Type:	
1-4-MISC-8	MISC	
Sample Location:	Detailed Sample Location:	
Classroom 8	Northwest corner of carpet square on west side of room.	
Sample Quantity:	974.5 SF	
Misc Sample Material:	Sample Condition:	Sample Friable?:
Green patterned carpet with yellow mastic	Damaged or significantly damaged friable miscellaneous ACM	No
Sample Photo:

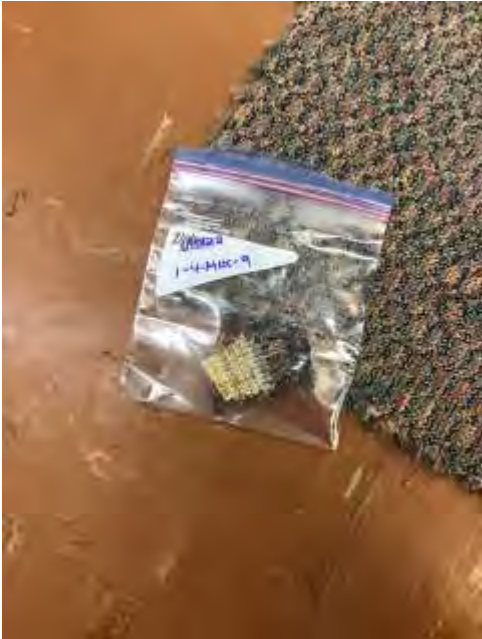
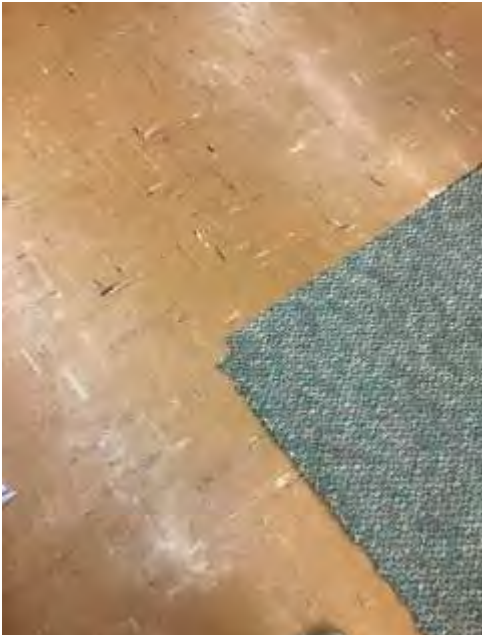
Additional Sample Notes:		
Sample ID:	Sample Type:	
1-4-MISC-9	MISC	
Sample Location:	Detailed Sample Location:	
Classroom 8	Northeast corner of carpet square on west side of room.	
Sample Quantity:	See 1-4-MISC-8	
Misc Sample Material:	Sample Condition:	Sample Friable?:
Green patterned carpet with yellow mastic	Damaged or significantly damaged friable miscellaneous ACM	No
Sample Photo:

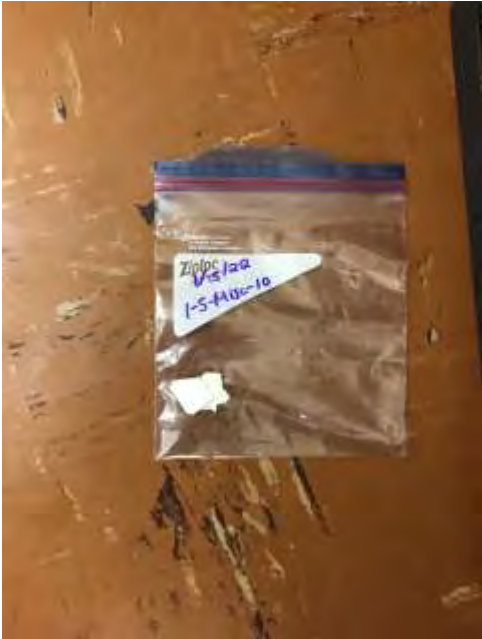
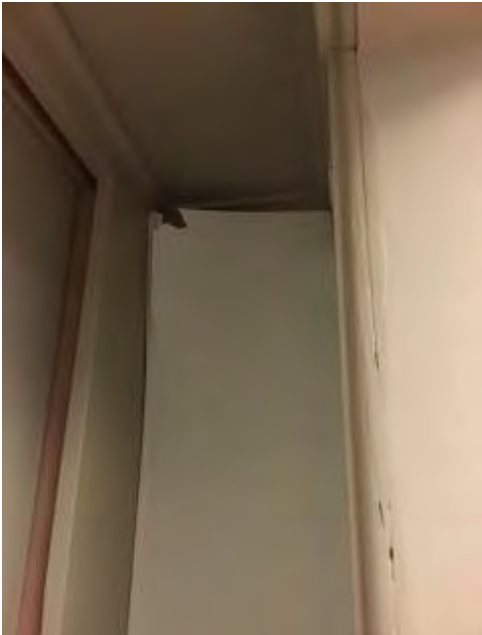
Additional Sample Notes:		
Sample ID:	Sample Type:	
1-5-MISC-10	MISC	
Sample Location:	Detailed Sample Location:	
Classroom 8	East wall of cutout in north wall	
Sample Quantity:	817.5 SF	
Misc Sample Material:	Sample Condition:	Sample Friable?:
White plastic wall covering with orange peel texturing and white mastic	Damaged or significantly damaged friable miscellaneous ACM	No
Sample Photo:

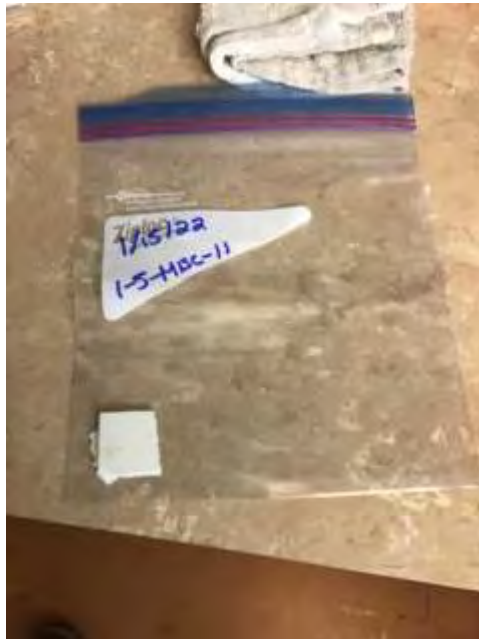
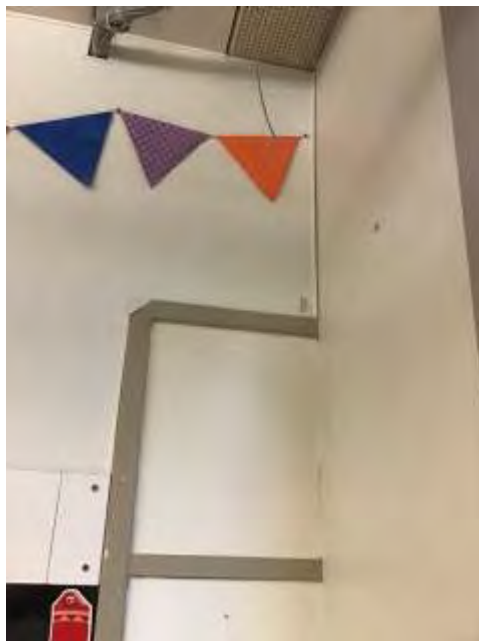
Additional Sample Notes:		
Sample ID:	Sample Type:	
1-5-MISC-11	MISC	
Sample Location:	Detailed Sample Location:	
Classroom 8	Southeast corner of room about 3 feet from ceiling.	
Sample Quantity:	See 1-5-MISC-10	
Misc Sample Material:	Sample Condition:	Sample Friable?:
White plastic wall covering with orange peel texturing and white mastic	Damaged or significantly damaged friable miscellaneous ACM	No

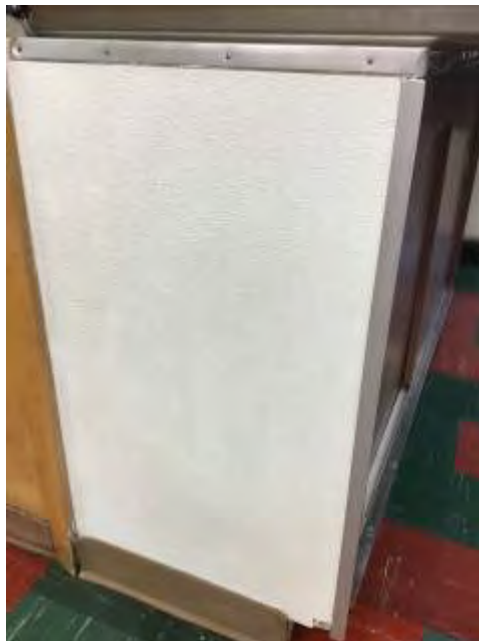
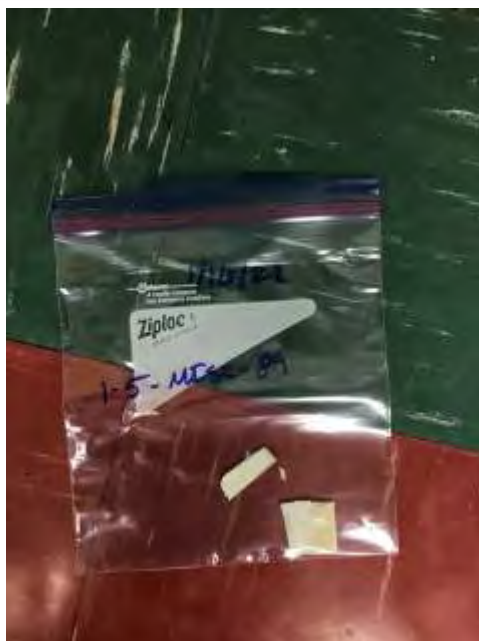
Additional Sample Notes:		
Sample ID:	Sample Type:	
1-5-MISC-89	MISC	
Sample Location:	Detailed Sample Location:	
Cafeteria	North wall near kitchen sink	
Sample Quantity:	See 1-5-MISC-10	
Misc Sample Material:	Sample Condition:	Sample Friable?:
White plastic wall covering with orange peel texturing and white mastic	Damaged or significantly damaged friable miscellaneous ACM	No

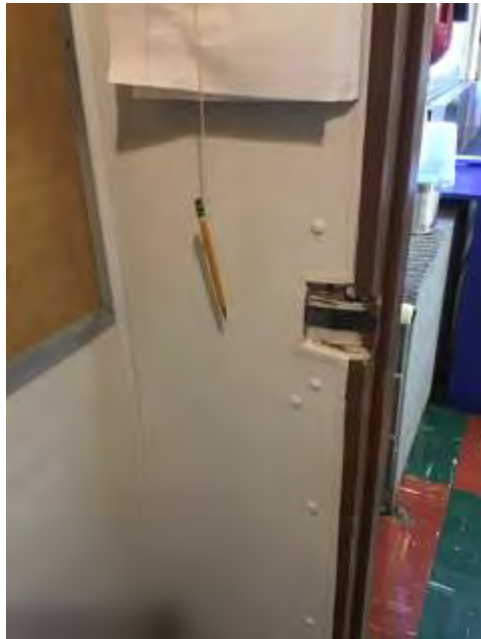
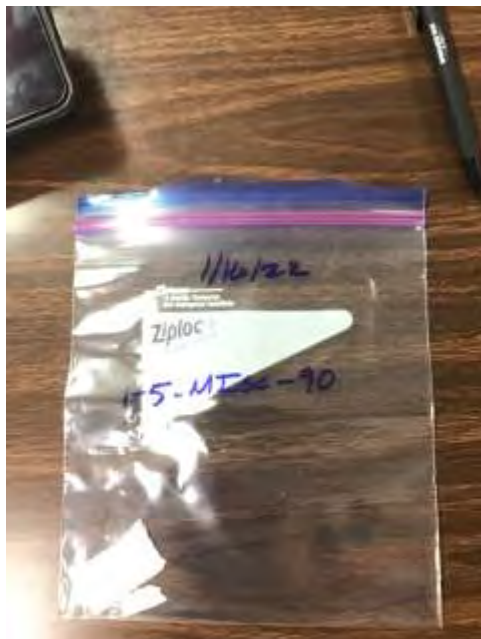
Additional Sample Notes:		
Sample ID:	Sample Type:	
1-5-MISC-90	MISC	
Sample Location:	Detailed Sample Location:	
Cafeteria	North wall of walk in freezer room	
Sample Quantity:	See 1-5-MISC-10	
Misc Sample Material:	Sample Condition:	Sample Friable?:
White plastic wall covering with orange peel texturing and white mastic	Damaged or significantly damaged friable miscellaneous ACM	No

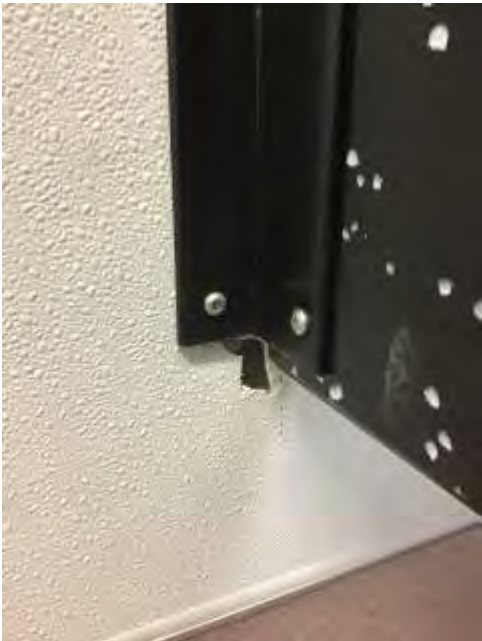
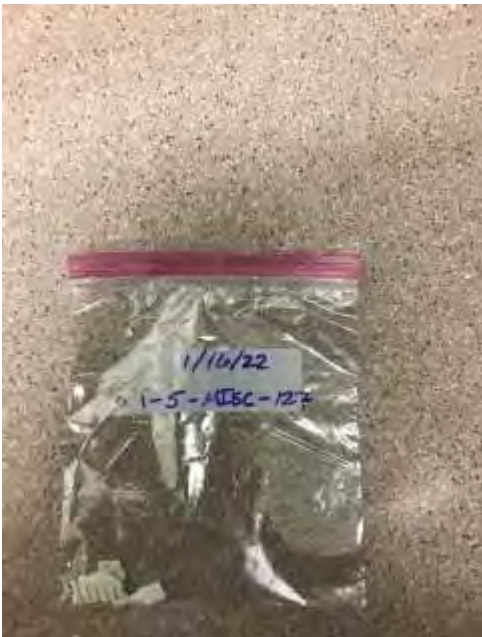
Additional Sample Notes:		
Sample ID:	Sample Type:	
1-5-MISC-127	MISC	
Sample Location:	Detailed Sample Location:	
Girls bathroom	Northeast corner behind toilet	
Sample Quantity:	See 1-5-MISC-10	
Misc Sample Material:	Sample Condition:	Sample Friable?:
White plastic wall covering with orange peel texturing and white mastic	Damaged or significantly damaged friable miscellaneous ACM	No
Sample Photo:

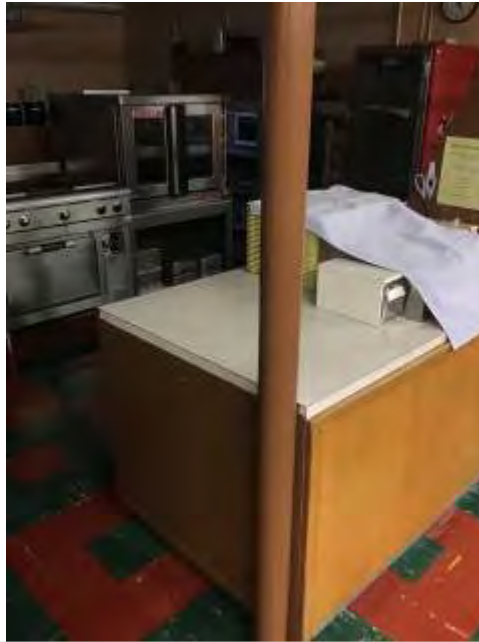
Sample ID:	Sample Type:
1-5-PB-5	PB
Sample Location:	Detailed Sample Location:
Cafeteria	Posts, entrance doors, and window frames
Sample Quantity:	100 LF
Sample Color:	XRF:
Brown	0.82mg/cm2

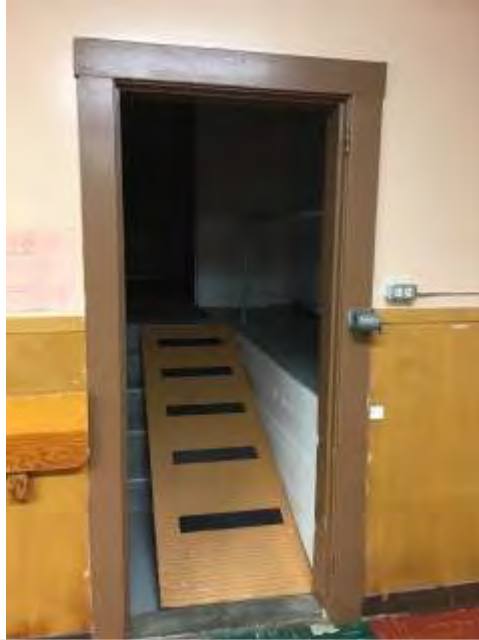
Sample ID:	Sample Type:
1-6-PB-6	PB
Sample Location:	Detailed Sample Location:
Cafeteria	Back storage room doorway
Sample Quantity:	20 LF
Sample Color:	XRF:
Dark brown with light green underneath	8.87mg/cm2

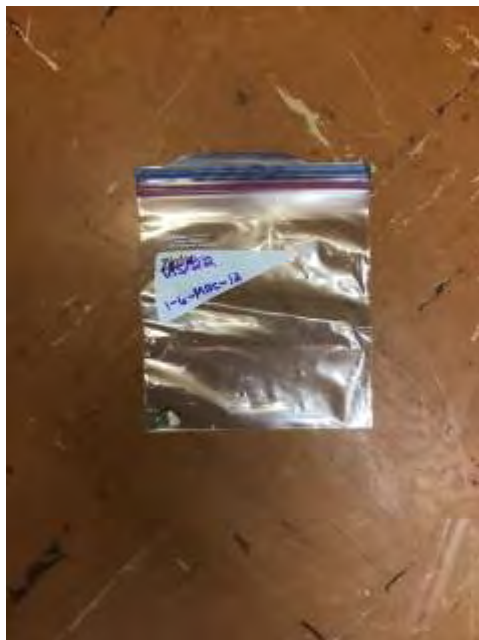
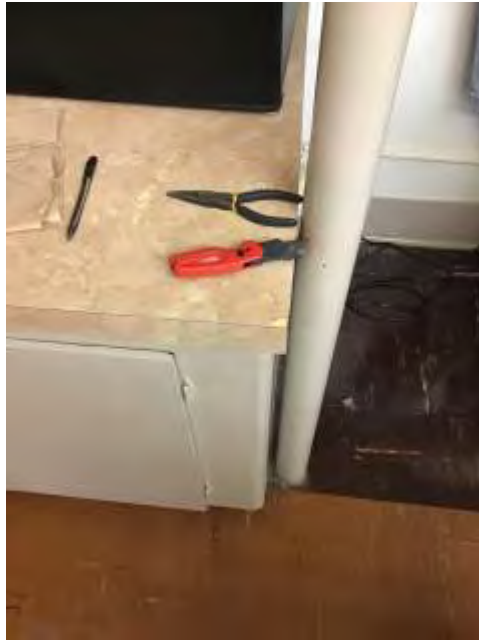
Sample ID:	Sample Type:	
1-6-MISC-12	MISC	
Sample Location:	Detailed Sample Location:	
Classroom 8	Southeast corner of countertop in northwest corner of room.	
Sample Quantity:	28 sf	
Misc Sample Material:	Sample Condition:	Sample Friable?:
Tan vinyl countertop with black mastic	Damaged or significantly damaged friable miscellaneous ACM	No

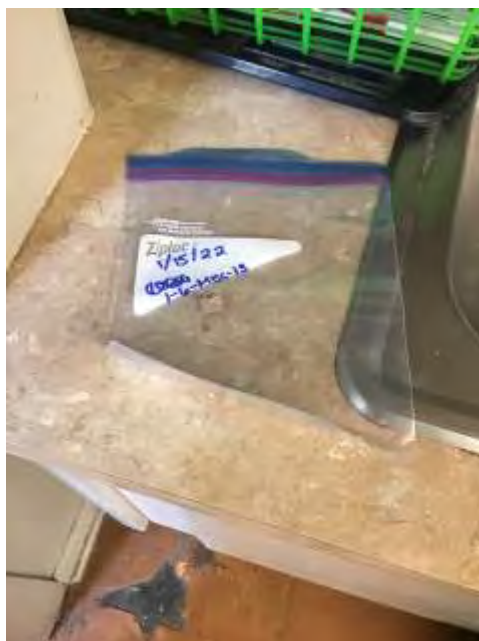
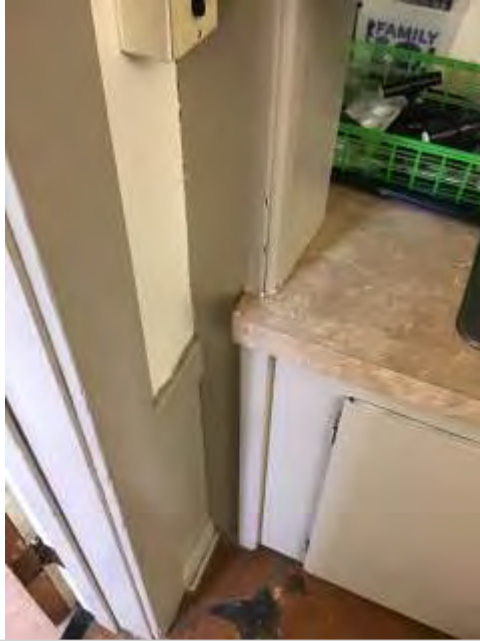
Additional Sample Notes:		
Sample ID:	Sample Type:	
1-6-MISC-13	MISC	
Sample Location:	Detailed Sample Location:	
Classroom 8	Southwest corner of countertop in northwest corner of room.	
Sample Quantity:	See See 1-6-MISC-12	
Misc Sample Material:	Sample Condition:	Sample Friable?:
Tan vinyl countertop with black mastic	Damaged or significantly damaged friable miscellaneous ACM	No

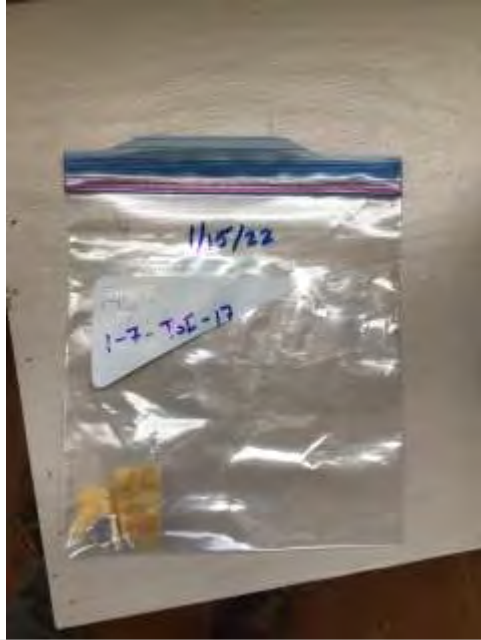
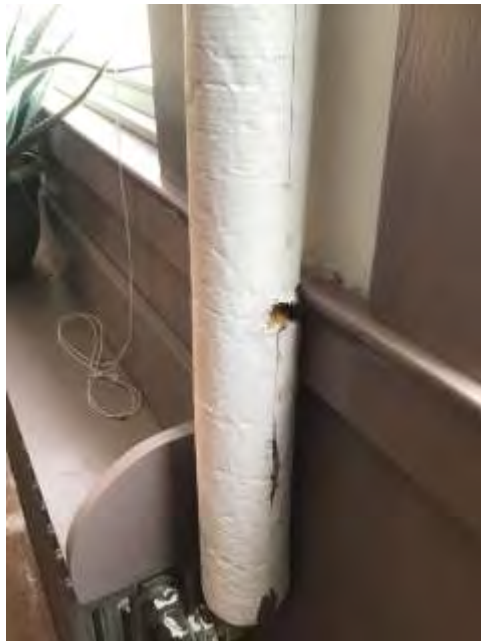
Additional Sample Notes:		
Sample ID:	Sample Type:	
1-7-TSI-17	TSI	
Sample Location:	Detailed Sample Location:	
Classroom 9	South wall of room next to east radiator	
Sample Quantity:	361 LF	
Sample Color:	XRF:	
Misc Sample Material:	Sample Condition:	Sample Friable?:
	Damaged or significantly damaged	Yes
Sample Photo:

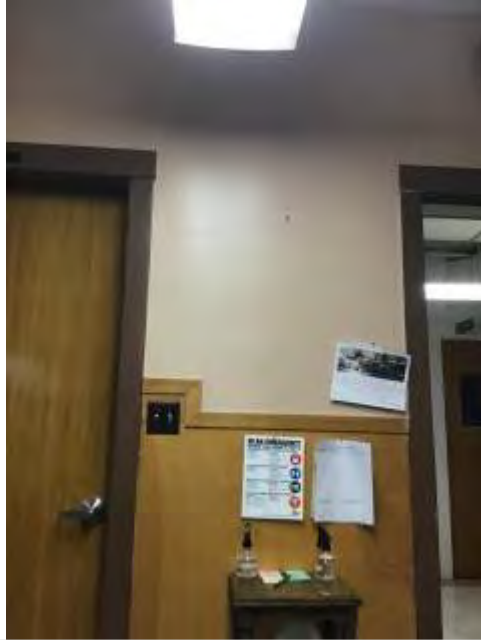
Additional Sample Notes:	White pipe wrap with yellow insulation
Sample ID:	Sample Type:
1-7-PB-7	PB
Sample Location:	Detailed Sample Location:
Cafeteria	Throughout
Sample Quantity:	
Sample Color:	XRF:
Beige	0.11mg/cm2
Sample Photo:

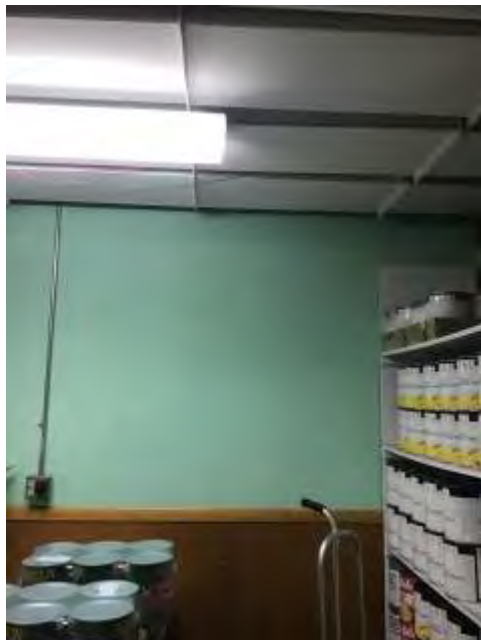
Additional Sample Notes:	
Sample ID:	Sample Type:
1-8-PB-8	PB
Sample Location:	Detailed Sample Location:
Cafeteria	Storage room
Sample Quantity:	
Sample Color:	XRF:
Mint green	ND

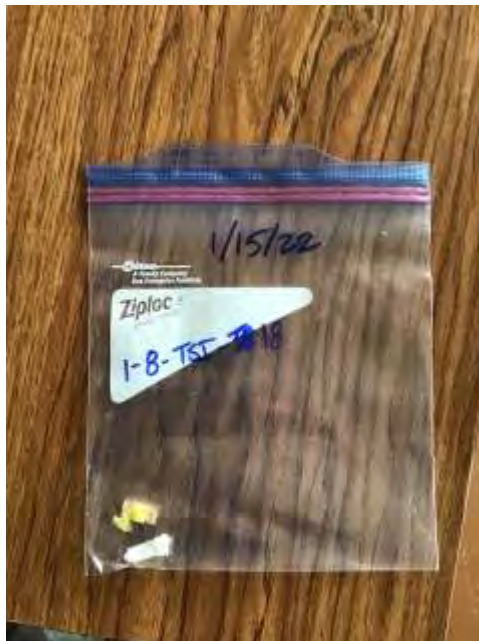
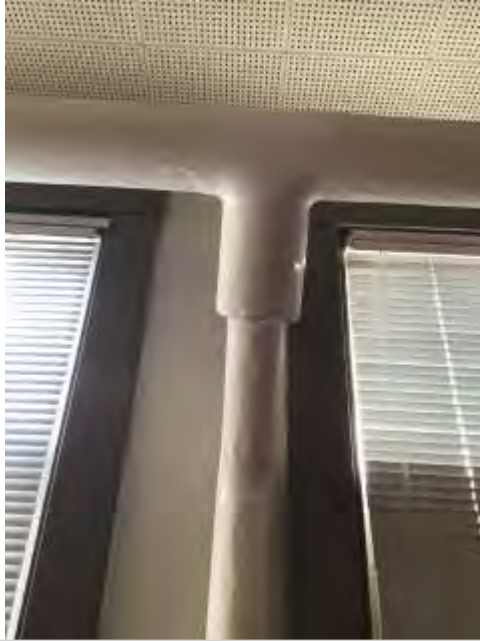
Additional Sample Notes:		
Sample ID:	Sample Type:	
1-8-TSI-18	TSI	
Sample Location:	Detailed Sample Location:	
Classroom 9	Southwest corner of room next to west radiator	
Sample Quantity:	5 LF	
Sample Color:	XRF:	
Misc Sample Material:	Sample Condition:	Sample Friable?:
	Damaged or significantly damaged; Potential ACBM with potential for significant damage	Yes
Sample Photo:

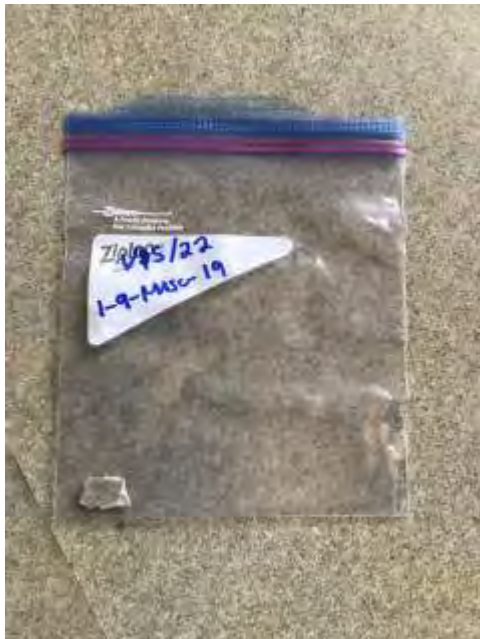
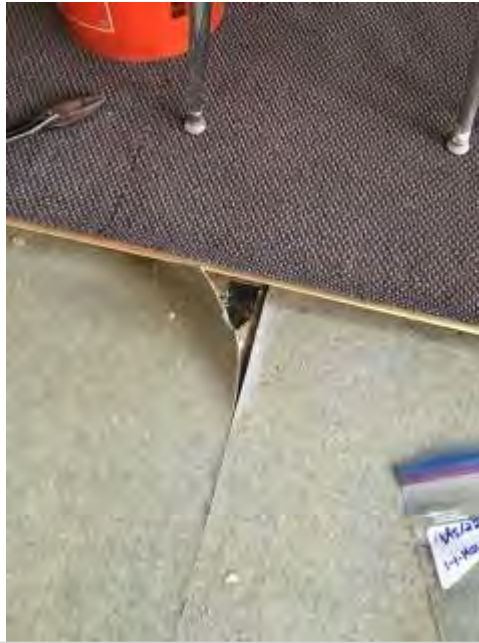
Additional Sample Notes:		White pipe patching material	
Sample ID:		Sample Type:	
1-9-MISC-19		MISC	
Sample Location:		Detailed Sample Location:	
Classroom 7		Center of room at the boundary between the linoleum and carpet	
Sample Quantity:		381 SF	
Misc Sample Material:		Sample Condition:	Sample Friable?:
Green linoleum flooring with yellow tan mastic		Damaged or significantly damaged friable miscellaneous ACM	No

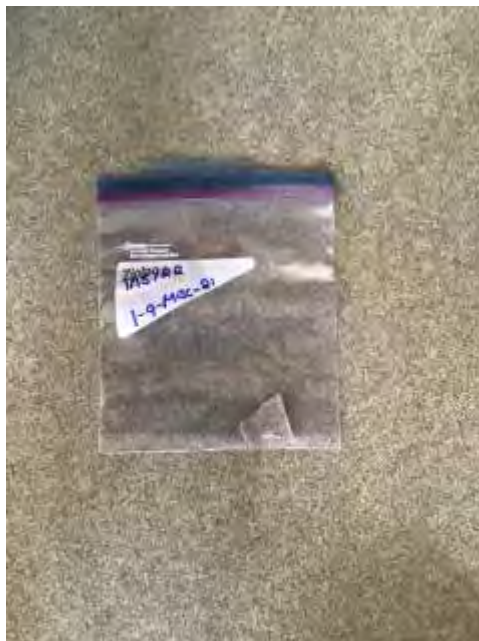
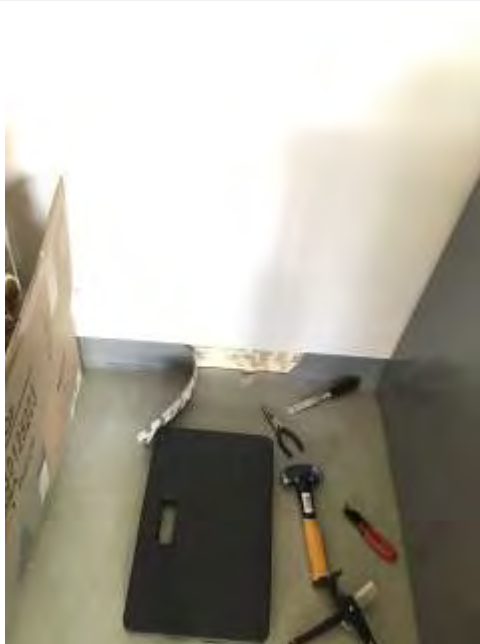
Additional Sample Notes:		
Sample ID:	Sample Type:	
1-9-MISC-21	MISC	
Sample Location:	Detailed Sample Location:	
Classroom 7	East edge of room	
Sample Quantity:	See 1-9-MISC-19	
Misc Sample Material:	Sample Condition:	Sample Friable?:
Green linoleum flooring with yellow tan mastic	Damaged or significantly damaged friable miscellaneous ACM	No

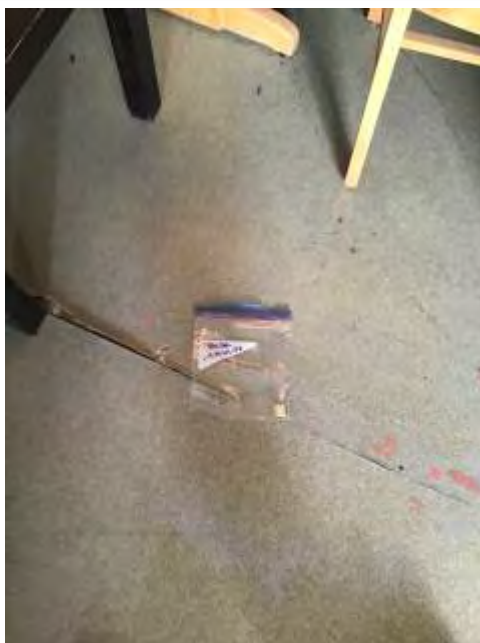
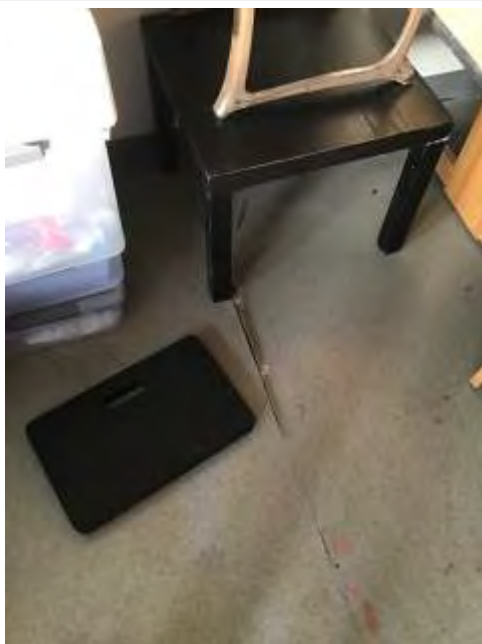
Additional Sample Notes:		
Sample ID:	Sample Type:	
1-9-MISC-22	MISC	
Sample Location:	Detailed Sample Location:	
Classroom 7	North end of room	
Sample Quantity:	See 1-9-MISC-19	
Misc Sample Material:	Sample Condition:	Sample Friable?:
Green linoleum flooring with yellow tan mastic	Damaged or significantly damaged friable miscellaneous ACM	No

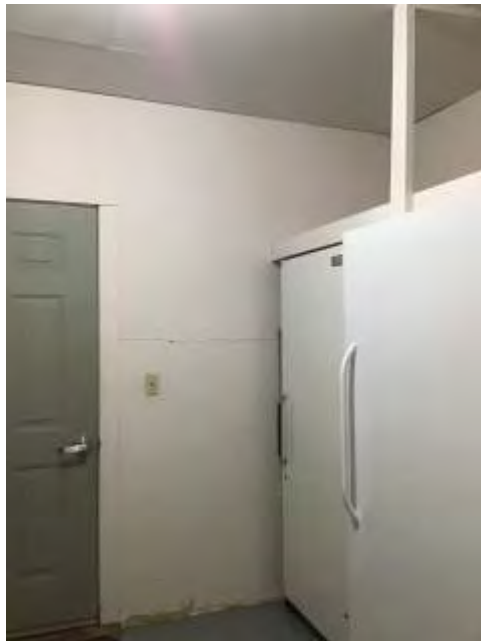
Sample ID:	Sample Type:
1-10-PB-10	PB
Sample Location:	Detailed Sample Location:
Cafeteria	Back storage
Sample Quantity:	
Sample Color:	XRF:
White paint	0.09mg/cm2

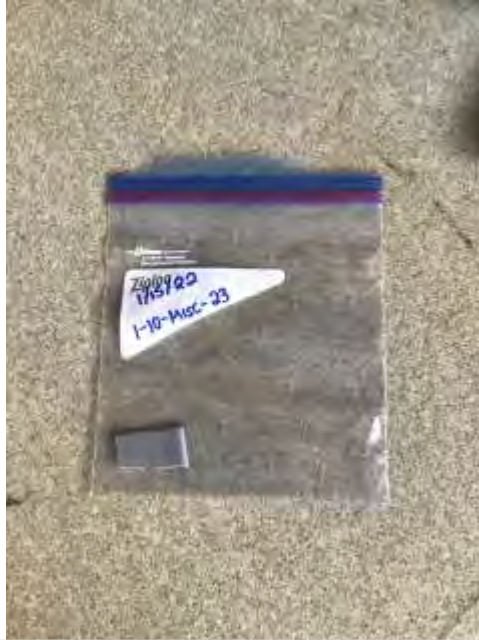
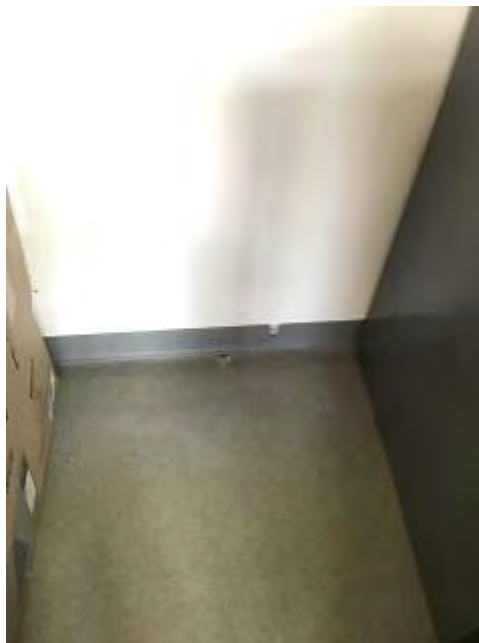
Sample ID:	Sample Type:	
1-10-MISC-23	MISC	
Sample Location:	Detailed Sample Location:	
Classroom 7	East edge of room	
Sample Quantity:	99 LF	
Misc Sample Material:	Sample Condition:	Sample Friable?:
Blue base cove with yellow tan mastic	Damaged or significantly damaged friable miscellaneous ACM	No

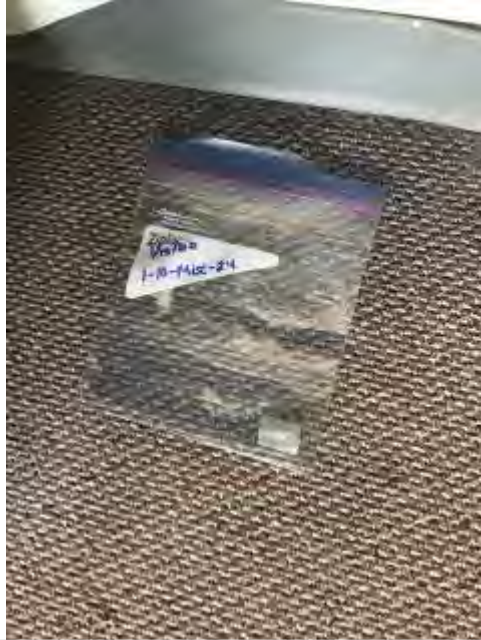
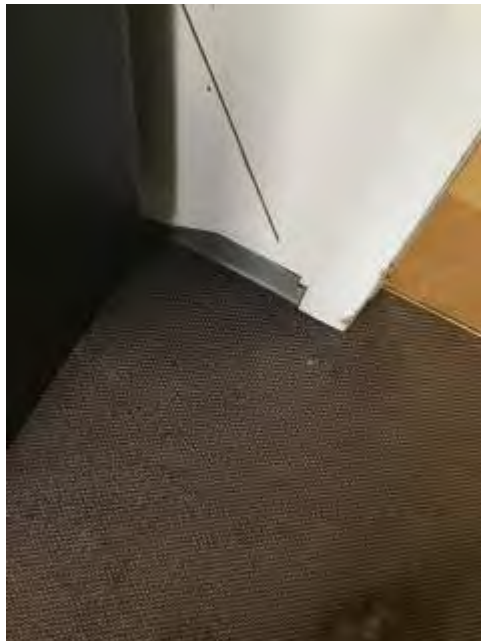
Additional Sample Notes:		
Sample ID:	Sample Type:	
1-10-MISC-24	MISC	
Sample Location:	Detailed Sample Location:	
Classroom 7	Southeast corner of room next to doorway	
Sample Quantity:	See 1-10-MISC-23	
Misc Sample Material:	Sample Condition:	Sample Friable?:
Blue base cove with yellow tan mastic	Damaged or significantly damaged friable miscellaneous ACM	No
Sample Photo:

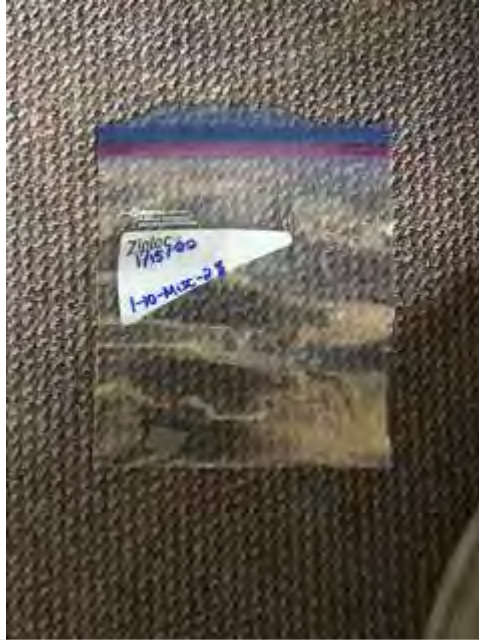
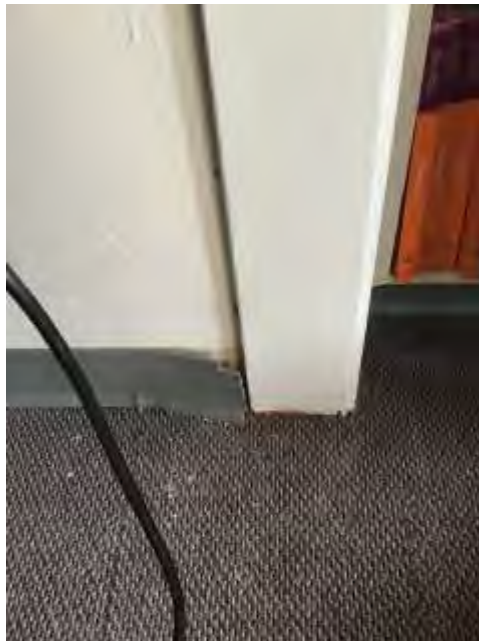
Additional Sample Notes:		
Sample ID:	Sample Type:	
1-10-MISC-25	MISC	
Sample Location:	Detailed Sample Location:	
Classroom 7	South wall of room next to closet	
Sample Quantity:	See 1-10-MISC-23	
Misc Sample Material:	Sample Condition:	Sample Friable?:
Blue base cove with yellow tan mastic	Damaged or significantly damaged friable miscellaneous ACM	No
Sample Photo:

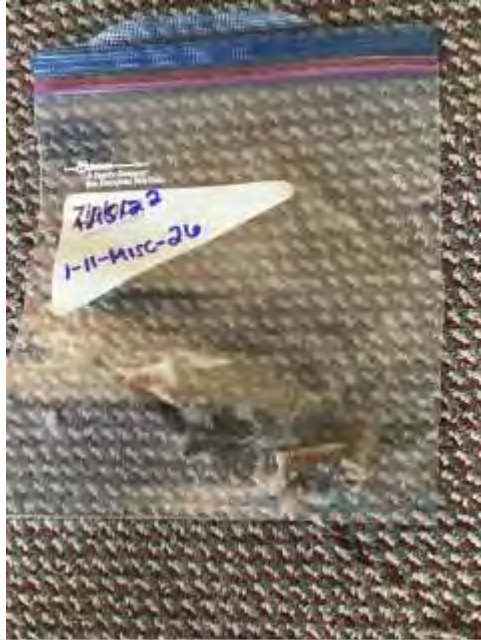
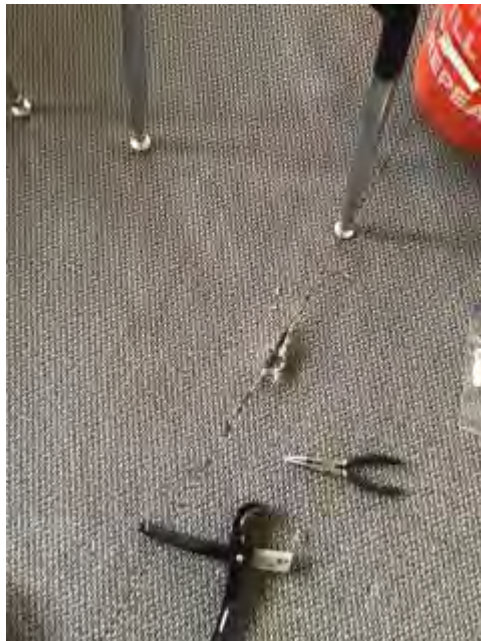
Additional Sample Notes:		
Sample ID:	Sample Type:	
1-11-MISC-26	MISC	
Sample Location:	Detailed Sample Location:	
Classroom 7	Carpet seam in south end of room	
Sample Quantity:	257 SF	
Misc Sample Material:	Sample Condition:	Sample Friable?:
Red green carpet with seam tape and yellow mastic	Damaged or significantly damaged friable miscellaneous ACM	No
Sample Photo:

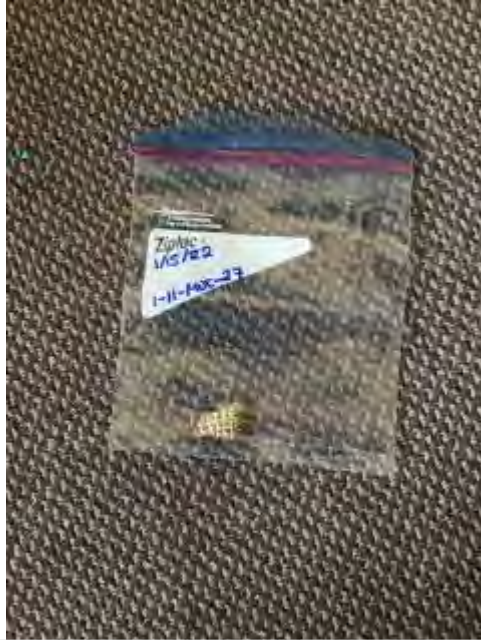
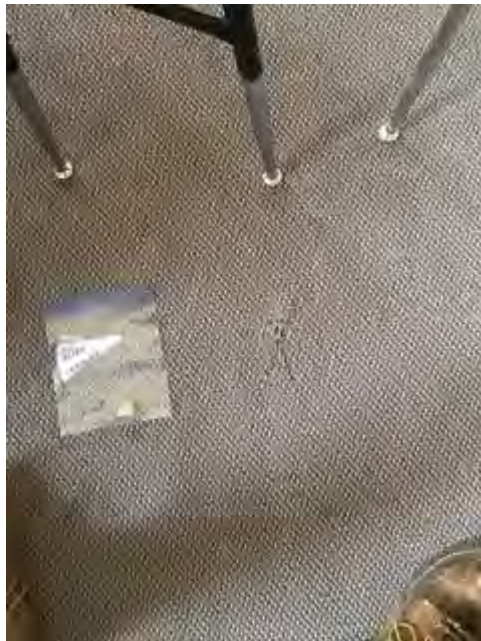
Additional Sample Notes:		
Sample ID:	Sample Type:	
1-11-MISC-27	MISC	
Sample Location:	Detailed Sample Location:	
Classroom 7	South end of room	
Sample Quantity:	See 1-11-MISC-26	
Misc Sample Material:	Sample Condition:	Sample Friable?:
Red green carpet with yellow mastic	Damaged or significantly damaged friable miscellaneous ACM	No
Sample Photo:

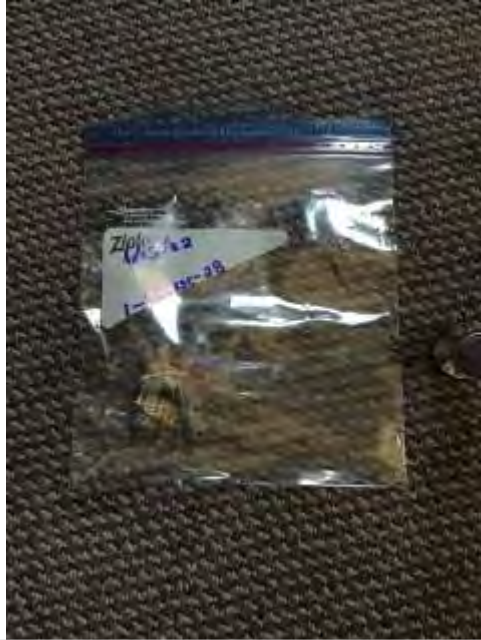
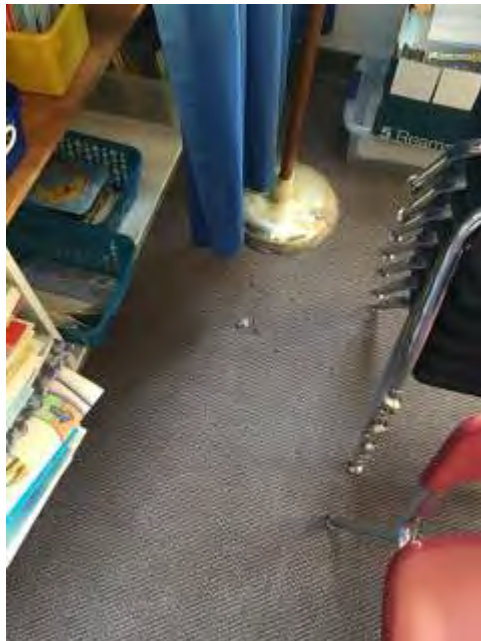
Additional Sample Notes:		
Sample ID:	Sample Type:	
1-11-MISC-28	MISC	
Sample Location:	Detailed Sample Location:	
Classroom 7	Southwest corner of room next to closet	
Sample Quantity:	See 1-11-MISC-26	
Misc Sample Material:	Sample Condition:	Sample Friable?:
Red green carpet with yellow mastic	Damaged or significantly damaged friable miscellaneous ACM	No
Sample Photo:
