HAZARDOUS BUILDING MATERIALS SURVEY

CONDON GRADE SCHOOL
220 S. EAST STREET
CONDON, OREGON

Prepared for
CITY OF CONDON
May 17, 2022
Project No. M2053.01.002

Prepared by
Maul Foster & Alongi, Inc.
3140 NE Broadway Street, Portland, OR 97232

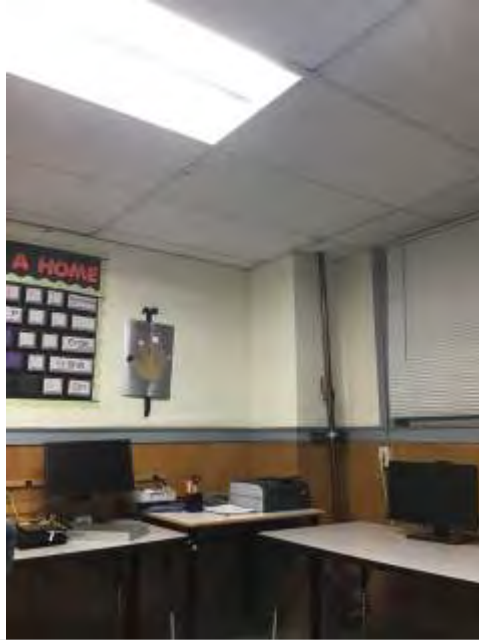
Additional Sample Notes:	
Sample ID:	Sample Type:
1-11-PB-11	PB
Sample Location:	Detailed Sample Location:
Computer lab	Throughout room
Sample Quantity:	
Sample Color:	XRF:
White	0.18mg/cm2
Sample Photo:

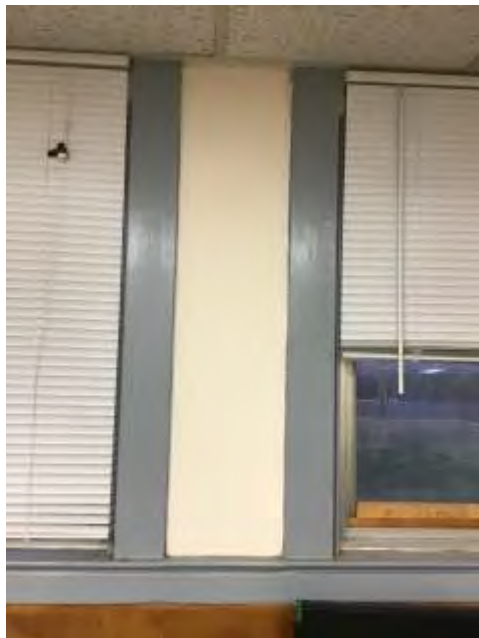
Sample ID:	Sample Type:
1-12-PB-12	PB
Sample Location:	Detailed Sample Location:
Computer lab	Trim throughout
Sample Quantity:	
Sample Color:	XRF:
Sky blue	0.12mg/cm2

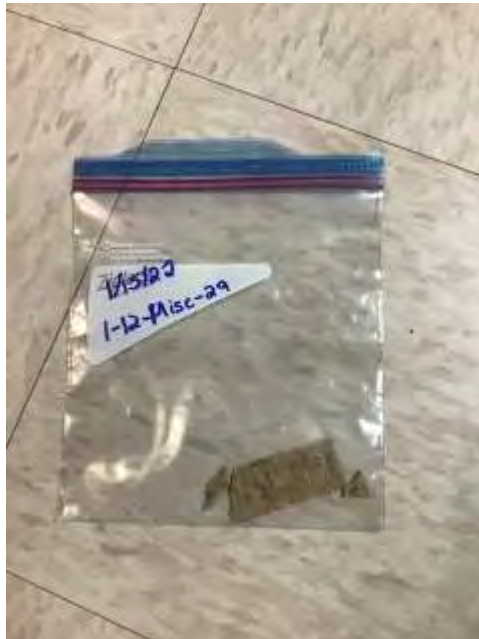
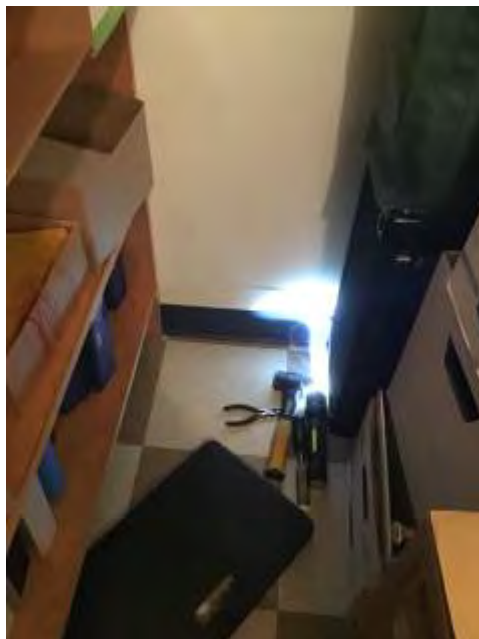
Additional Sample Notes:		
Sample ID:	Sample Type:	
1-12-MISC-29	MISC	
Sample Location:	Detailed Sample Location:	
Supply closet	Southwest corner of closet next to wall	
Sample Quantity:	61.5 SF	
Misc Sample Material:	Sample Condition:	Sample Friable?:
12x12 white and tan floor tiles with yellow mastic	Damaged or significantly damaged friable miscellaneous ACM	No

Additional Sample Notes:	Thin green layer of unknown material beneath mastic. Unable to collect sample of the green layer due to adhesion to concrete beneath.
---------------------------------	---

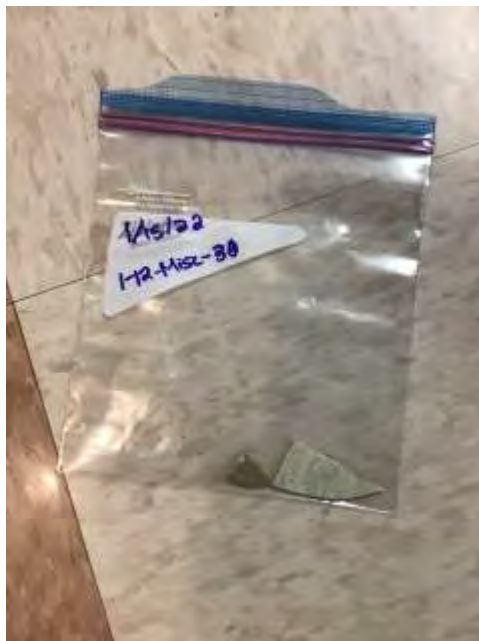
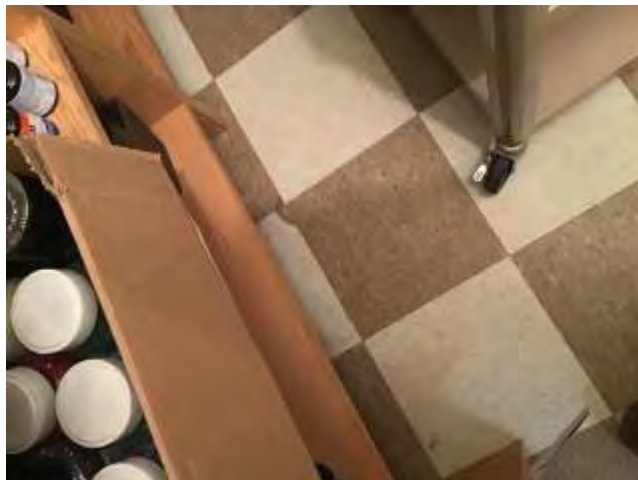
Sample ID:	Sample Type:	
1-12-MISC-30	MISC	
Sample Location:	Detailed Sample Location:	
Supply closet	South edge of closet	
Sample Quantity:	See 1-12-MISC-29	
Misc Sample Material:	Sample Condition:	Sample Friable?:
12x12 white and tan floor tiles with yellow mastic	Damaged or significantly damaged friable miscellaneous ACM	No

Additional Sample Notes:	Thin green layer of unknown material beneath mastic. Unable to collect sample of the green layer due to adhesion to concrete beneath.
---------------------------------	---

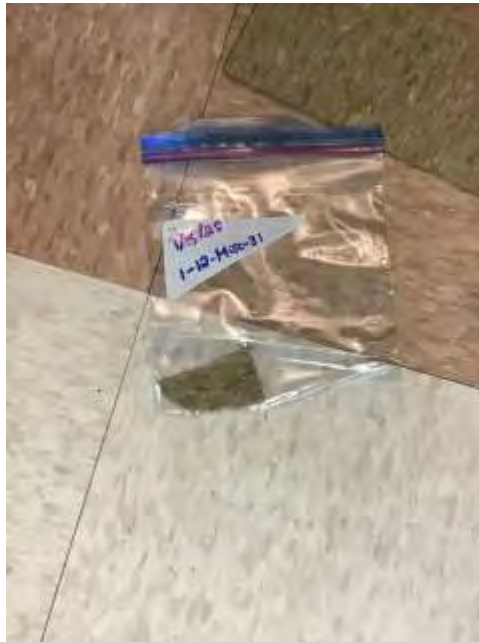
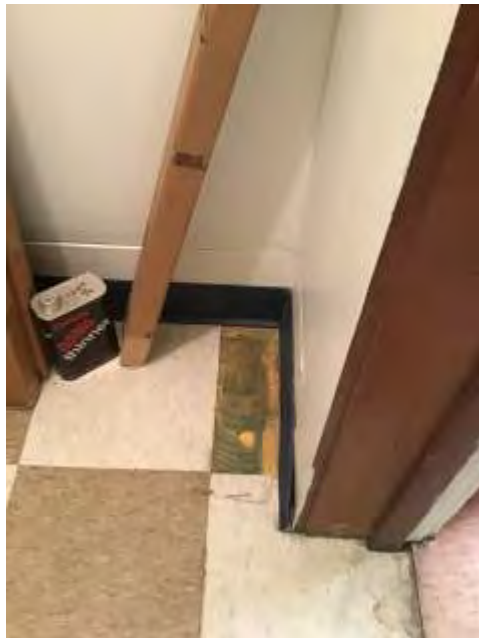
Sample ID:	Sample Type:	
1-12-MISC-31	MISC	
Sample Location:	Detailed Sample Location:	
Supply closet	Northeast corner of closet next to doorway	
Sample Quantity:	See 1-12-MISC-29	
Misc Sample Material:	Sample Condition:	Sample Friable?:
12x12 white and tan floor tiles with yellow mastic	Damaged or significantly damaged friable miscellaneous ACM	No

Additional Sample Notes:	Thin green layer of unknown material beneath mastic. Unable to collect sample of the green layer due to adhesion to concrete beneath.
---------------------------------	---

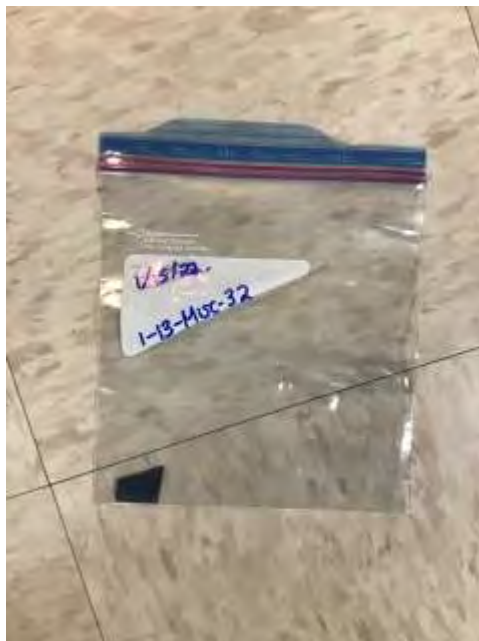
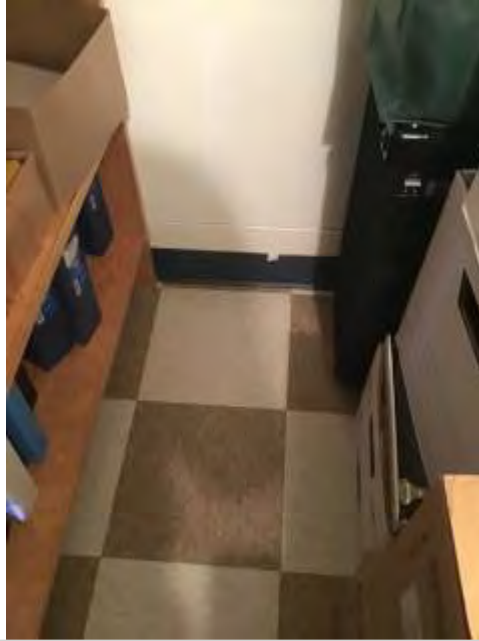
Sample ID:	Sample Type:	
1-13-MISC-32	MISC	
Sample Location:	Detailed Sample Location:	
Supply closet	Southwest corner of closet	
Sample Quantity:	30 LF	
Misc Sample Material:	Sample Condition:	Sample Friable?:
Dark blue base cove with tan mastic	Damaged or significantly damaged friable miscellaneous ACM	No

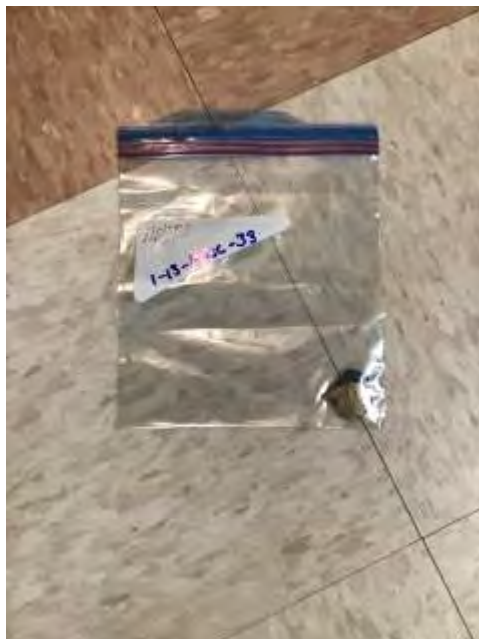
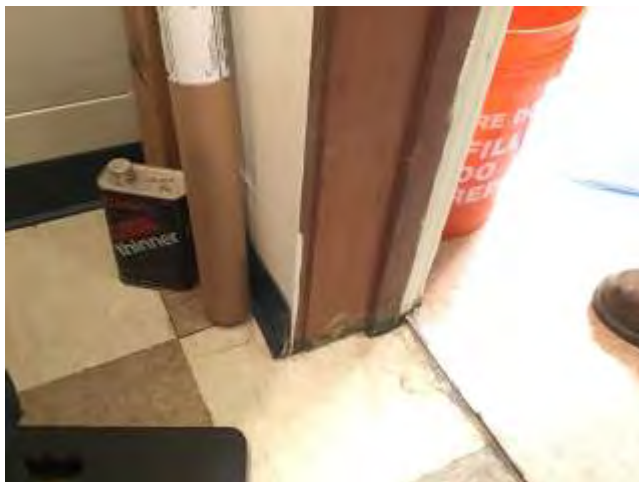
Additional Sample Notes:		
Sample ID:	Sample Type:	
1-13-MISC-33	MISC	
Sample Location:	Detailed Sample Location:	
Supply closet	Northeast corner of closet next to doorway	
Sample Quantity:	See 1-13-MISC-32	
Misc Sample Material:	Sample Condition:	Sample Friable?:
Dark blue base cove with tan mastic	Damaged or significantly damaged friable miscellaneous ACM	No

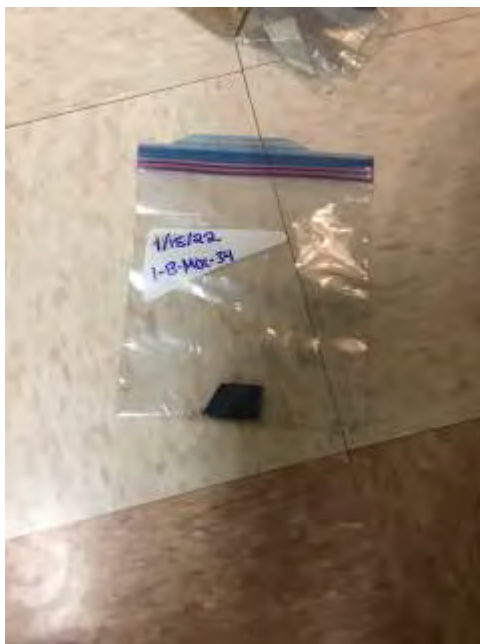
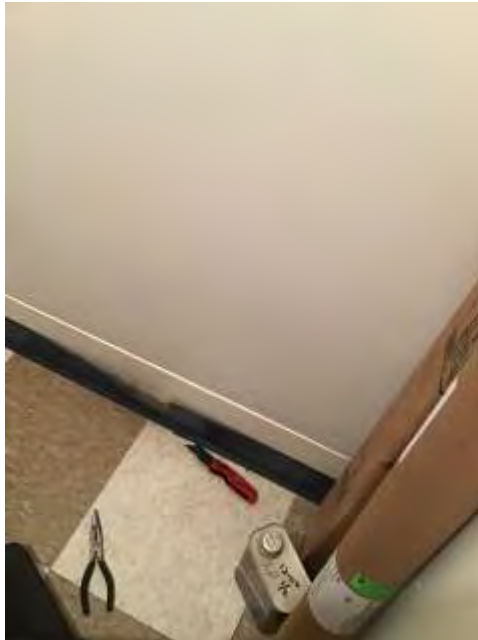
Additional Sample Notes:		
Sample ID:	Sample Type:	
1-13-MISC-34	MISC	
Sample Location:	Detailed Sample Location:	
Supply closet	Northeast corner of closet next to doorway	
Sample Quantity:	See 1-13-MISC-32	
Misc Sample Material:	Sample Condition:	Sample Friable?:
Dark blue base cove with tan mastic	Damaged or significantly damaged friable miscellaneous ACM	No

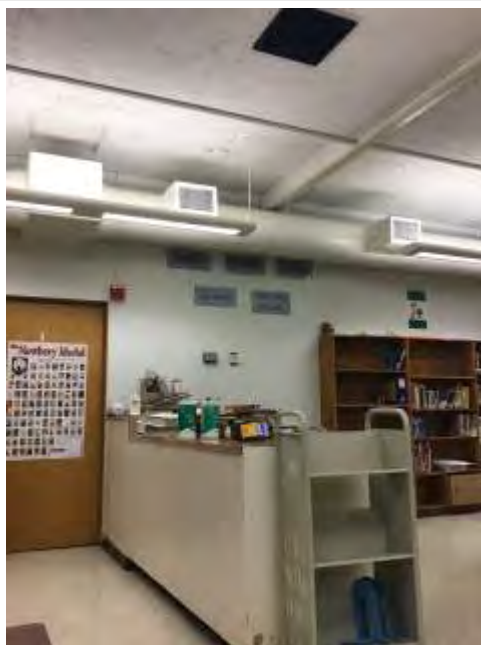
Sample ID:	Sample Type:
1-13-PB-14	PB
Sample Location:	Detailed Sample Location:
Library	Throughout
Sample Quantity:	
Sample Color:	XRF:
White	ND

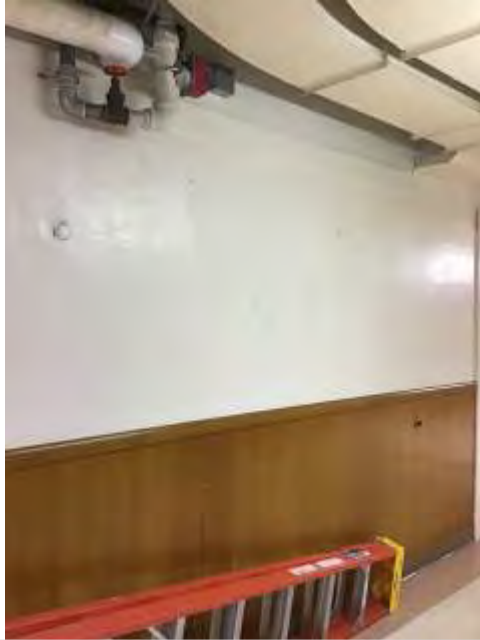
Sample ID:	Sample Type:
1-13-PB-31	PB
Sample Location:	Detailed Sample Location:
Hallway	Walls Throughout
Sample Quantity:	
Sample Color:	XRF:
White	0.21mg/cm2

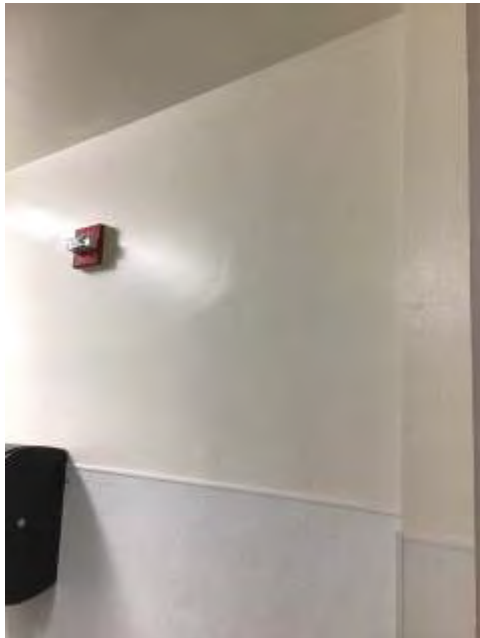
Sample ID:	Sample Type:
1-13-PB-23	PB
Sample Location:	Detailed Sample Location:
Boys bathroom	Walls throughout
Sample Quantity:	
Sample Color:	XRF:
White	0.05mg/cm2

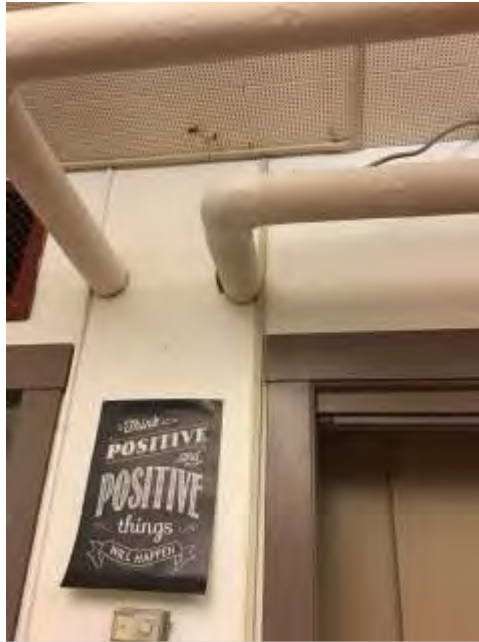
Sample ID:	Sample Type:
1-13-PB-26	PB
Sample Location:	Detailed Sample Location:
Classroom 9	Walls throughout
Sample Quantity:	
Sample Color:	XRF:
White	0.24mg/cm2

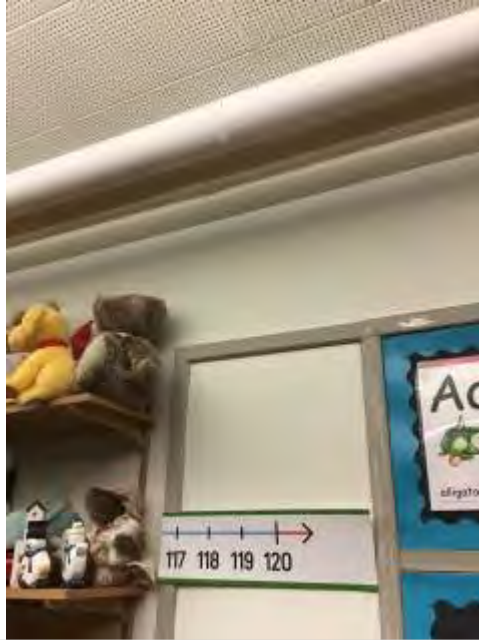
Sample ID:	Sample Type:
1-13-PB-29	PB
Sample Location:	Detailed Sample Location:
Classroom 8	Walls throughout
Sample Quantity:	
Sample Color:	XRF:
White	0.13mg/cm2

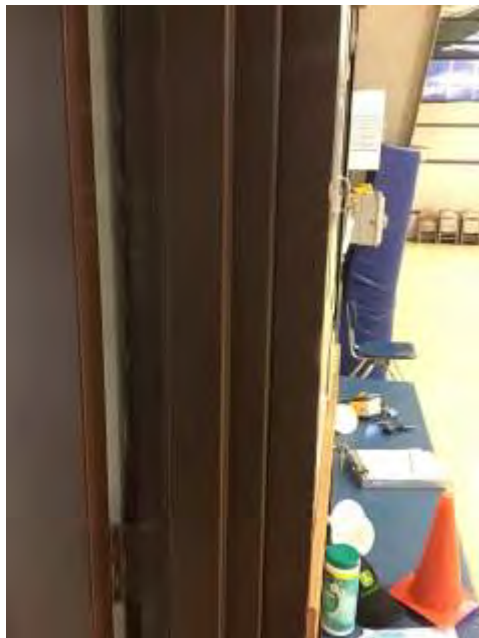
Additional Sample Notes:	
Sample ID:	Sample Type:
1-14-PB-15	PB
Sample Location:	Detailed Sample Location:
Play Shed	Throughout room
Sample Quantity:	
Sample Color:	XRF:
Maroon brown	ND

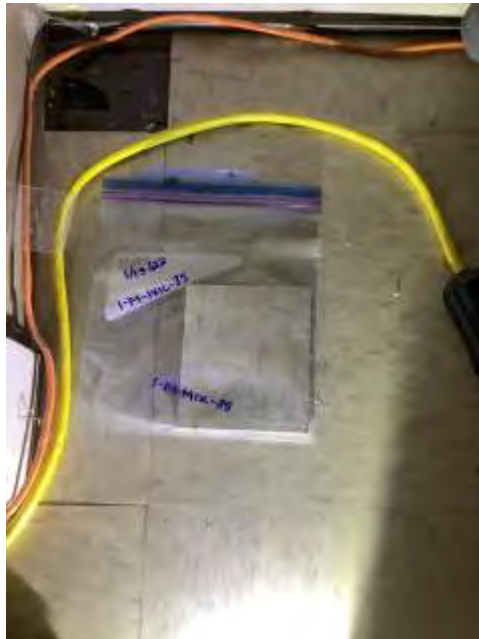
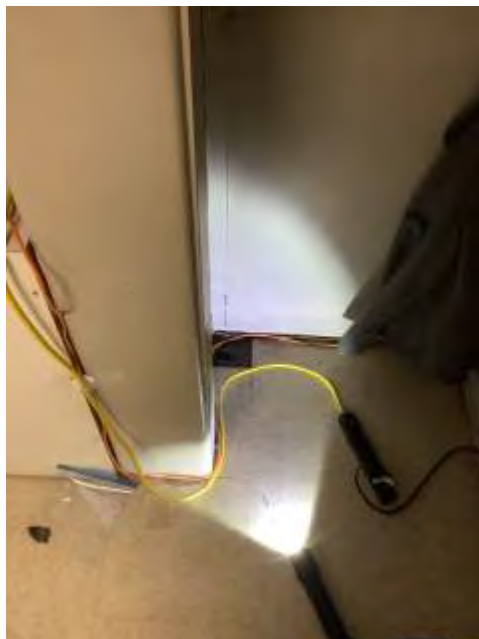
Additional Sample Notes:		
Sample ID:	Sample Type:	
1-14-MISC-35	MISC	
Sample Location:	Detailed Sample Location:	
Office	South edge of main office inside closet cutout	
Sample Quantity:	498 SF	
Misc Sample Material:	Sample Condition:	Sample Friable?:
12x12 light and dark tan floor tiles with yellow mastic	Damaged or significantly damaged friable miscellaneous ACM	No

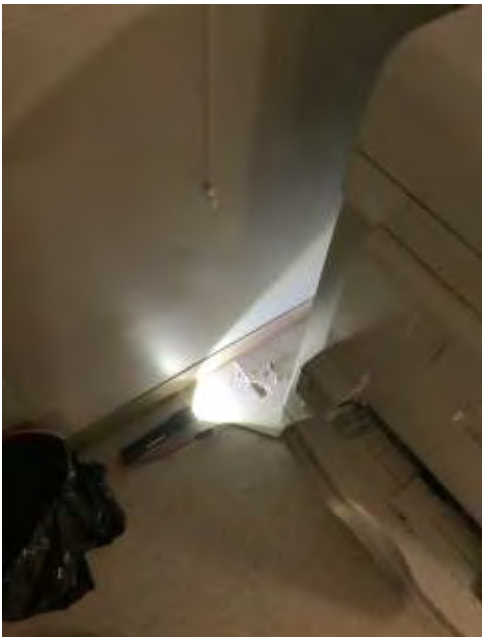
Additional Sample Notes:		
Sample ID:	Sample Type:	
1-14-MISC-36	MISC	
Sample Location:	Detailed Sample Location:	
Office	North edge of main office behind printer	
Sample Quantity:	See 1-14-MISC-35	
Misc Sample Material:	Sample Condition:	Sample Friable?:
12x12 light and dark tan floor tiles with yellow mastic	Damaged or significantly damaged friable miscellaneous ACM	No
Sample Photo:

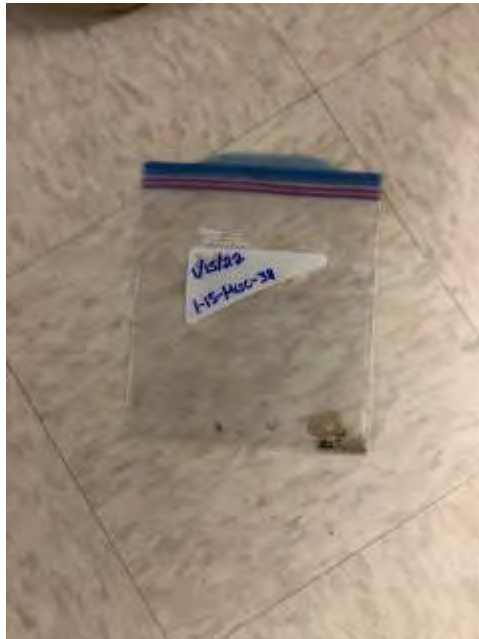
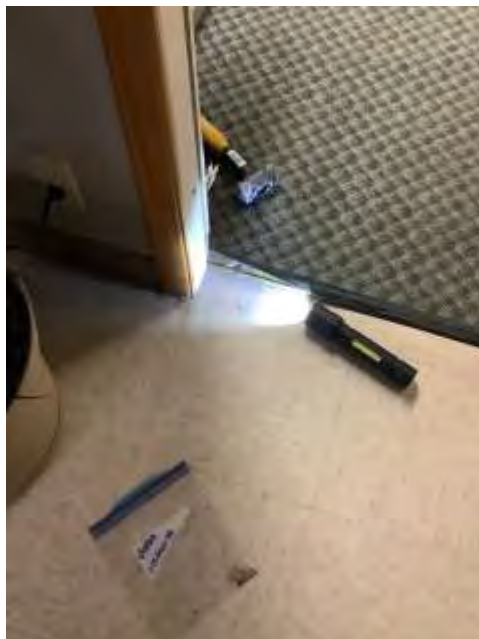
Additional Sample Notes:		
Sample ID:	Sample Type:	
1-15-MISC-38	MISC	
Sample Location:	Detailed Sample Location:	
Office	Doorway between main office and principal's office	
Sample Quantity:	793 SF	
Misc Sample Material:	Sample Condition:	Sample Friable?:
12x12 tan vinyl flooring with black mastic	Damaged or significantly damaged friable miscellaneous ACM	No

Additional Sample Notes:	Flooring is underneath the 12x12 light and dark tan floor tiles and carpet in the office.
---------------------------------	---

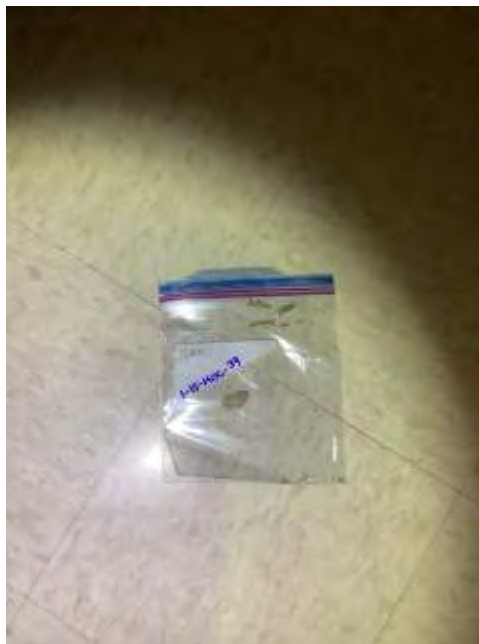
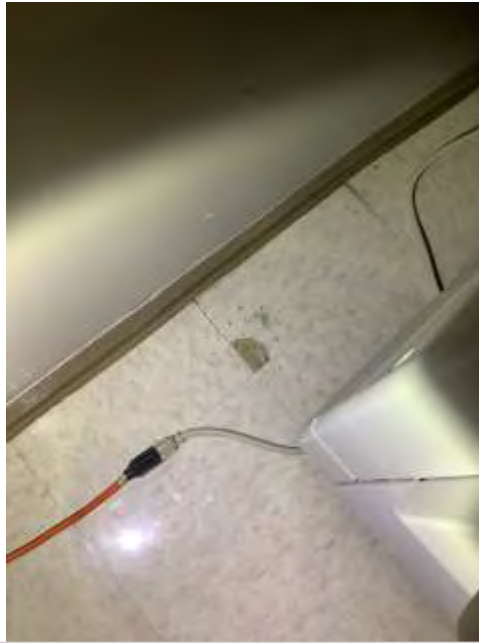
Sample ID:	Sample Type:	
1-15-MISC-39	MISC	
Sample Location:	Detailed Sample Location:	
Office	North edge of main office behind printer	
Sample Quantity:	See 1-15-MISC-38	
Misc Sample Material:	Sample Condition:	Sample Friable?:
12x12 tan vinyl flooring with black mastic	Damaged or significantly damaged friable miscellaneous ACM	No

Additional Sample Notes:	Flooring is underneath the 12x12 light and dark tan floor tiles and carpet in the office.
---------------------------------	---

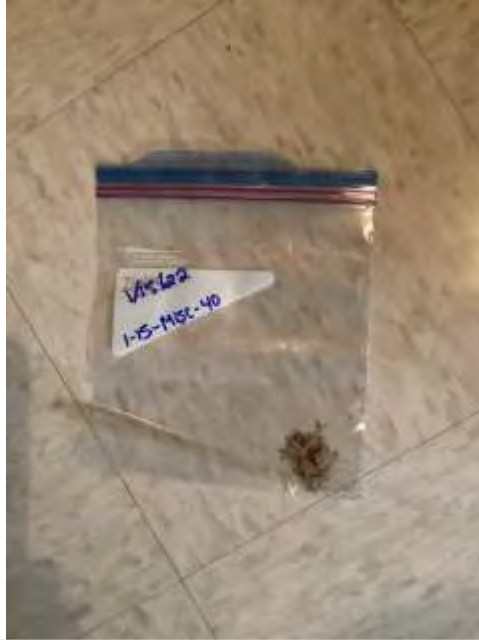
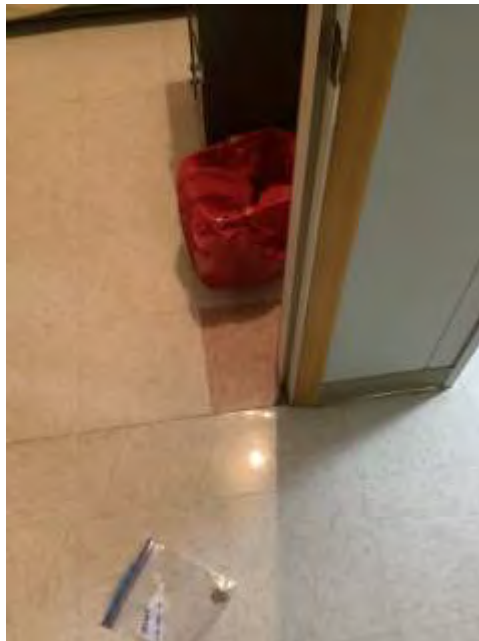
Sample ID:	Sample Type:	
1-15-MISC-40	MISC	
Sample Location:	Detailed Sample Location:	
Office	Doorway between nurse's office and main office	
Sample Quantity:	See 1-15-MISC-38	
Misc Sample Material:	Sample Condition:	Sample Friable?:
12x12 tan vinyl flooring with black mastic	Damaged or significantly damaged friable miscellaneous ACM	No

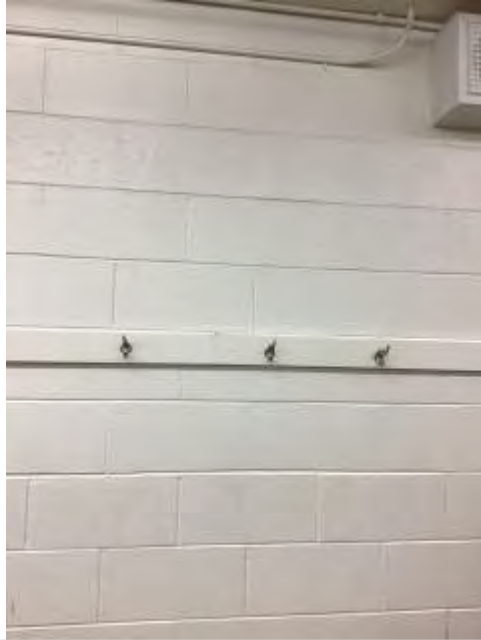
Additional Sample Notes:		Flooring is underneath the 12x12 light and dark tan floor tiles and carpet in the office.
Sample ID:		Sample Type:
1-15-PB-16		PB
Sample Location:		Detailed Sample Location:
Gym		Locker rooms
Sample Quantity:		
Sample Color:		XRF:
White		0.03mg/cm2
Sample Photo:

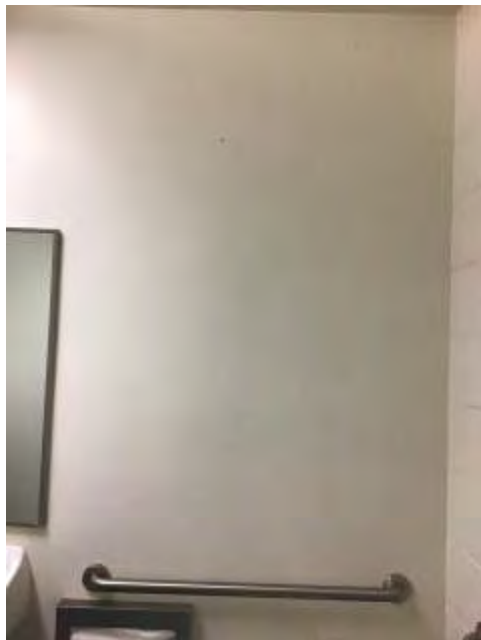
Sample ID:	Sample Type:
1-15-PB-18	PB
Sample Location:	Detailed Sample Location:
Gym	Restroom
Sample Quantity:	
Sample Color:	XRF:
White	ND

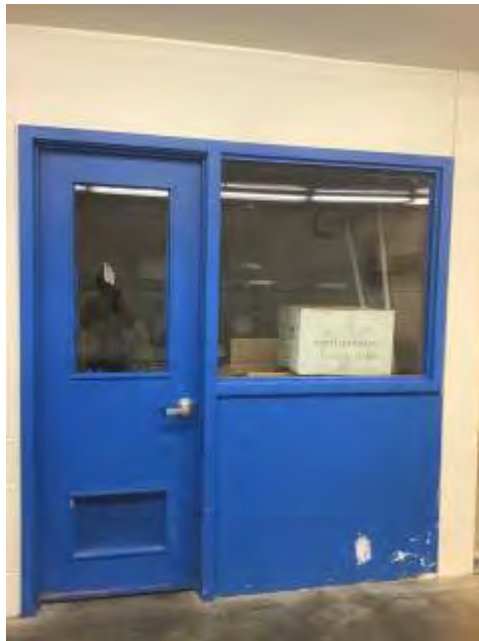
Sample ID:	Sample Type:
1-16-PB-17	PB
Sample Location:	Detailed Sample Location:
Gym	Locker room
Sample Quantity:	
Sample Color:	XRF:
Blue	0.11mg/cm2

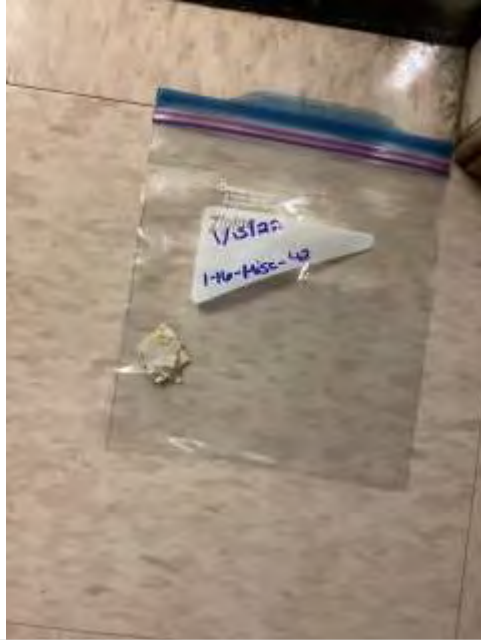
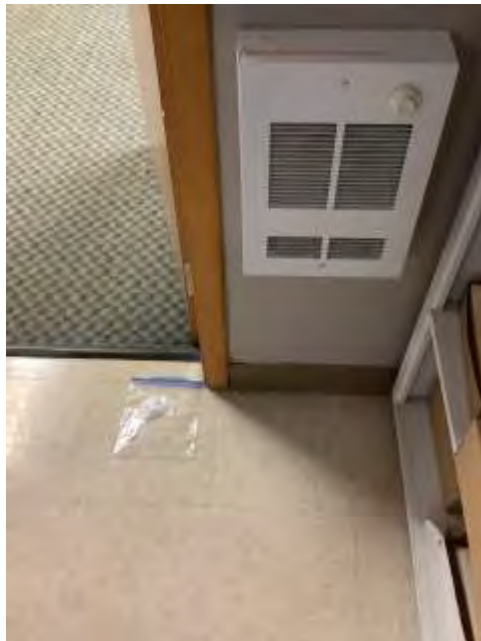
Sample ID:	Sample Type:	
1-16-MISC-42	MISC	
Sample Location:	Detailed Sample Location:	
Office	West wall of main office next to doorway to principal's office	
Sample Quantity:	907.5 SF	
Misc Sample Material:	Sample Condition:	Sample Friable?:
White woven wallpaper with brown fibrous backing and tan mastic	Damaged or significantly damaged friable miscellaneous ACM	No

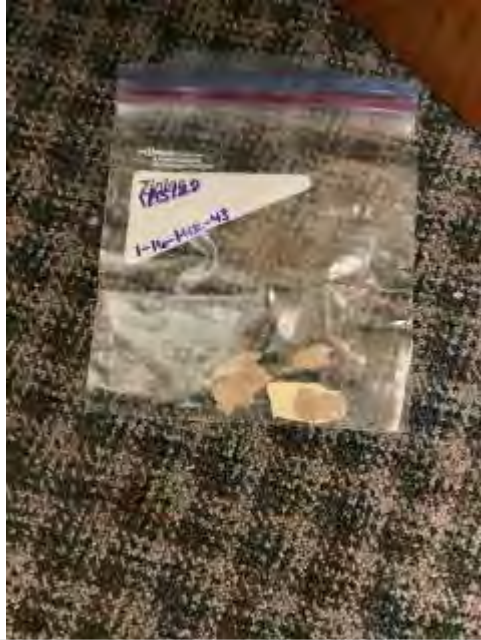
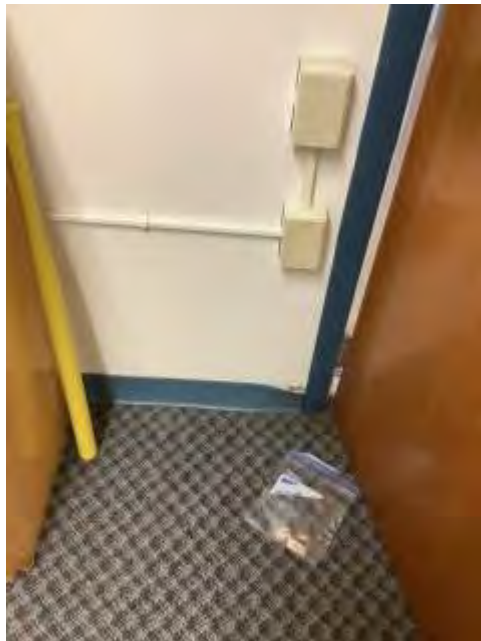
Additional Sample Notes:		Also in computer lab
Sample ID:	Sample Type:	
1-16-MISC-43	MISC	
Sample Location:	Detailed Sample Location:	
Principal's office	East wall of principal's office next to doorway to main office	
Sample Quantity:	See 1-16-MISC-42	
Misc Sample Material:	Sample Condition:	Sample Friable?:
White woven wallpaper with brown fibrous backing and tan mastic	Damaged or significantly damaged friable miscellaneous ACM	No
Sample Photo:

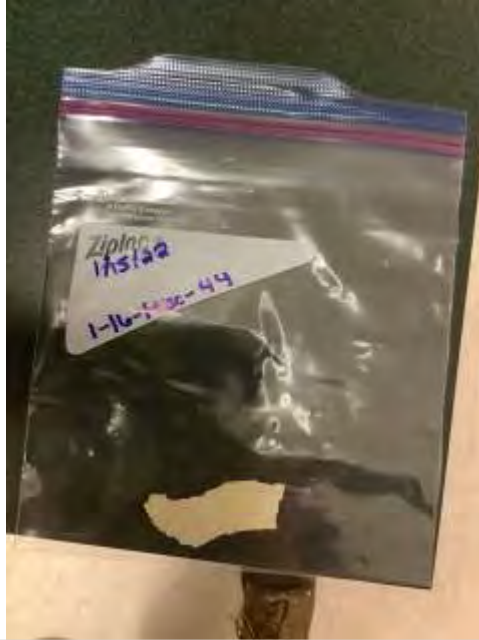
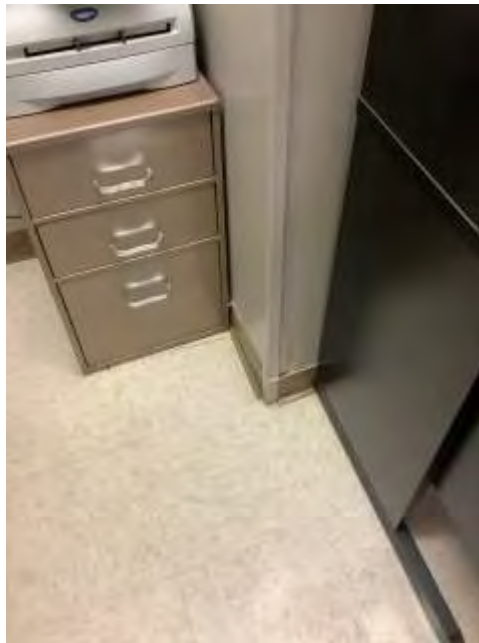
Additional Sample Notes:		
Sample ID:	Sample Type:	
1-16-MISC-44	MISC	
Sample Location:	Detailed Sample Location:	
Office	West wall of main office next to desk near southwest corner	
Sample Quantity:	See 1-16-MISC-42	
Misc Sample Material:	Sample Condition:	Sample Friable?:
White woven wallpaper with brown fibrous backing and tan mastic	Damaged or significantly damaged friable miscellaneous ACM	No
Sample Photo:

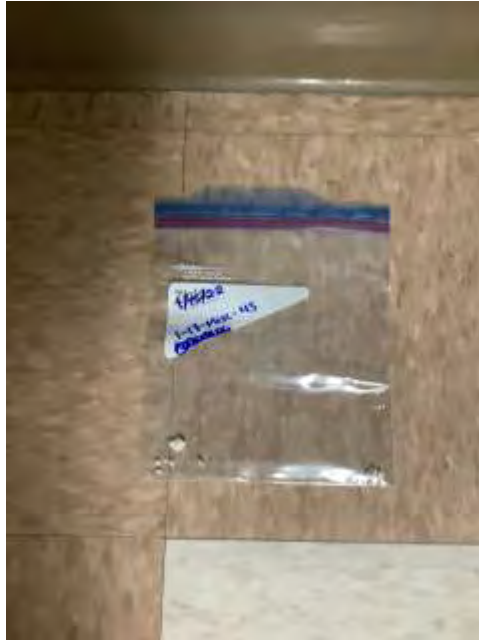
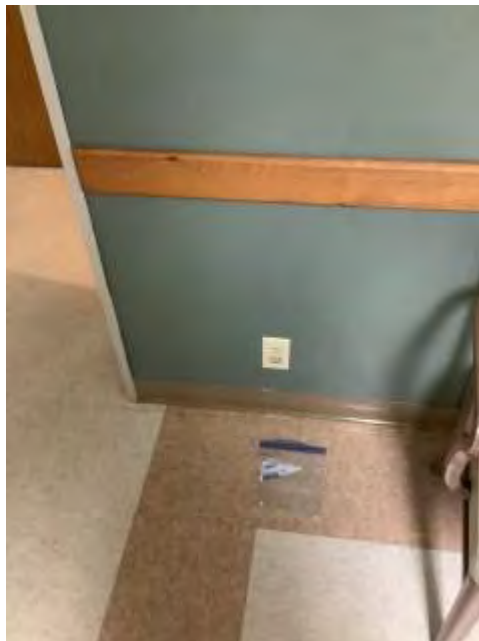
Additional Sample Notes:		
Sample ID:	Sample Type:	
1-17-MISC-45	MISC	
Sample Location:	Detailed Sample Location:	
Office	Outlet on north wall of main office around the corner from doorway to nurse's office	
Sample Quantity:	816.5 SF	
Misc Sample Material:	Sample Condition:	Sample Friable?:
White wallboard	Damaged or significantly damaged friable miscellaneous ACM	No
Sample Photo:

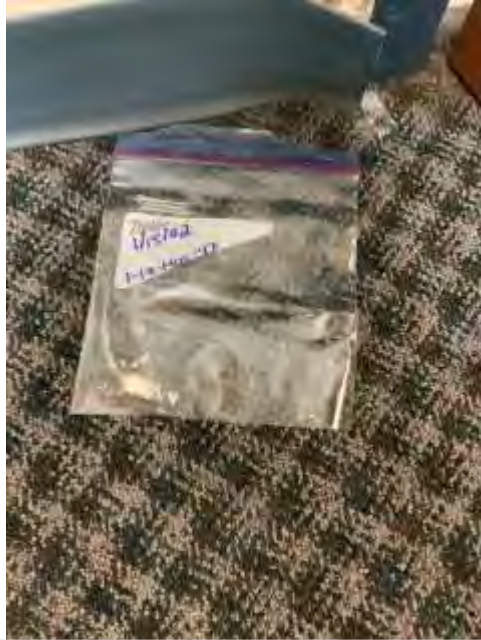
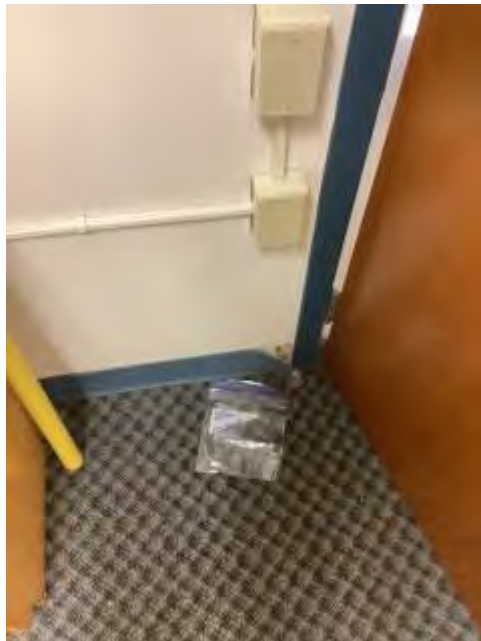
Additional Sample Notes:		
Sample ID:	Sample Type:	
1-17-MISC-47	MISC	
Sample Location:	Detailed Sample Location:	
Principal's office	East wall of principal's office next to doorway to main office	
Sample Quantity:	See 1-17-MISC-45	
Misc Sample Material:	Sample Condition:	Sample Friable?:
White wallboard	Damaged or significantly damaged friable miscellaneous ACM	No
Sample Photo:

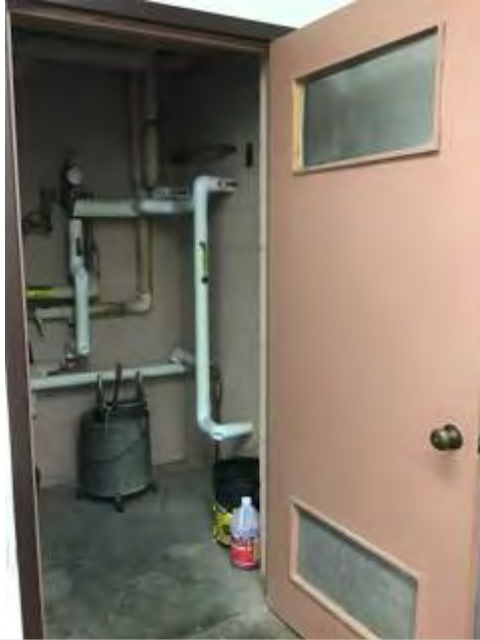
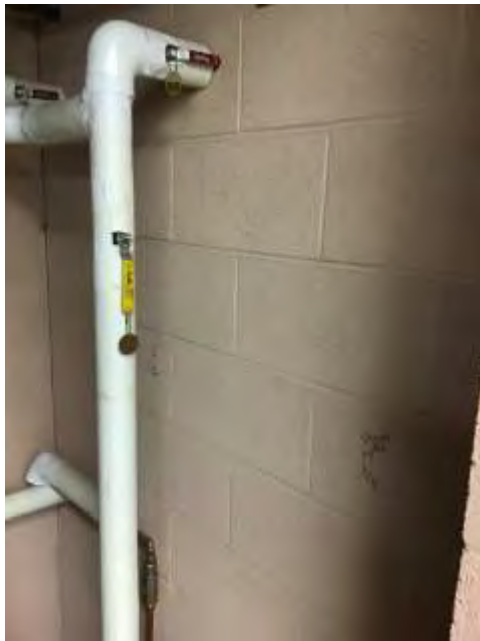
Additional Sample Notes:	
Sample ID:	Sample Type:
1-17-PB-19	PB
Sample Location:	Detailed Sample Location:
Gym	Boys locker room
Sample Quantity:	
Sample Color:	XRF:
Pink	ND
Sample Photo:

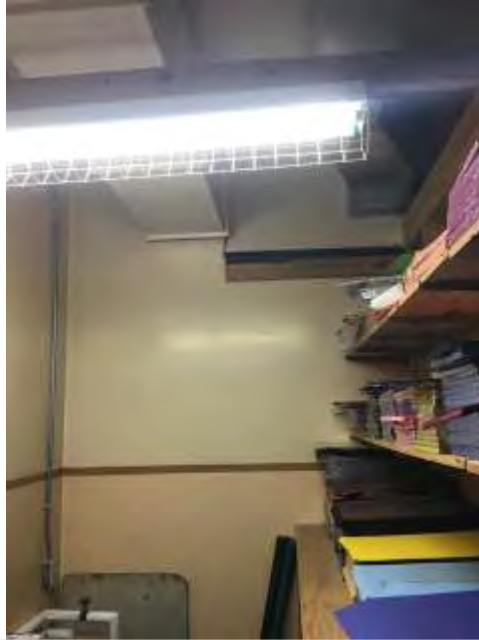
Additional Sample Notes:	
Sample ID:	Sample Type:
1-18-PB-20	PB
Sample Location:	Detailed Sample Location:
Boys restroom	Storage room
Sample Quantity:	
Sample Color:	XRF:
Tan	0.08mg/cm2
Sample Photo:

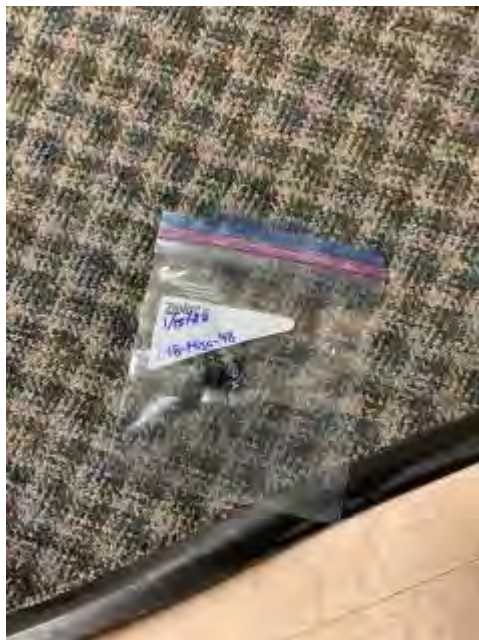
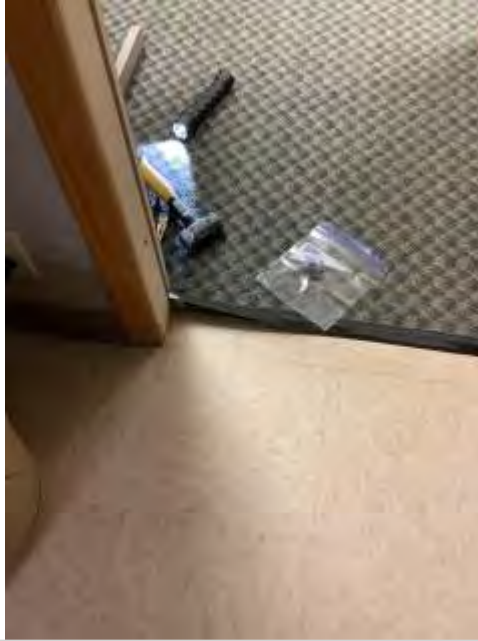
Sample ID:	Sample Type:	
1-18-MISC-48	MISC	
Sample Location:	Detailed Sample Location:	
Principal's office	Doorway between main office and principal's office	
Sample Quantity:	259.1 SF	
Misc Sample Material:	Sample Condition:	Sample Friable?:
Blue green tan patterned carpet with yellow mastic	Damaged or significantly damaged friable miscellaneous ACM	No

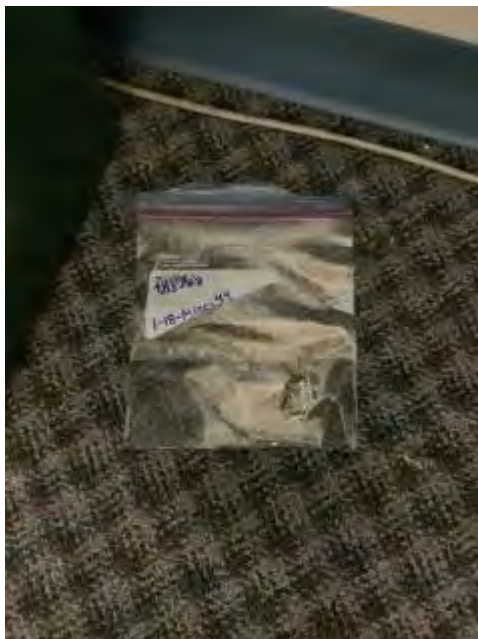
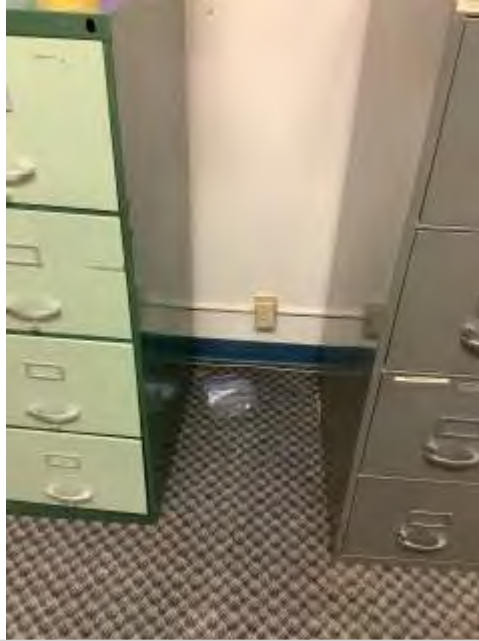
Additional Sample Notes:		
Sample ID:	Sample Type:	
1-18-MISC-49	MISC	
Sample Location:	Detailed Sample Location:	
Principal's office	South edge of principal's office beneath wall outlet	
Sample Quantity:	See 1-18-MISC-48	
Misc Sample Material:	Sample Condition:	Sample Friable?:
Blue green tan patterned carpet with yellow mastic	Damaged or significantly damaged friable miscellaneous ACM	No

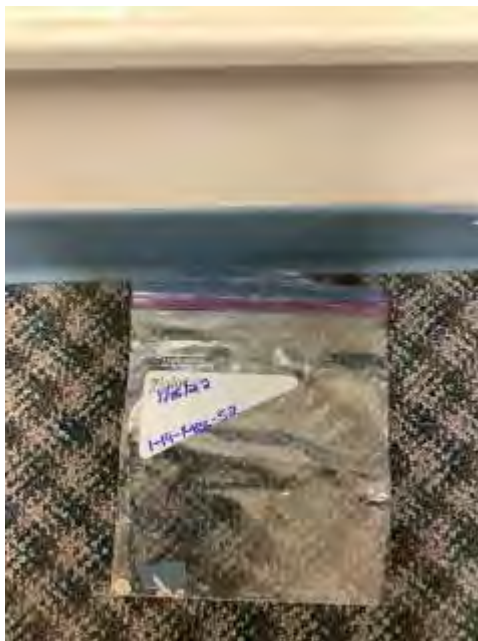
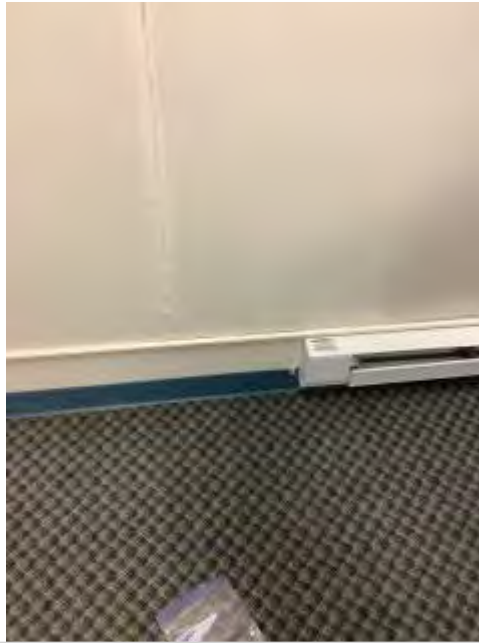
Additional Sample Notes:		
Sample ID:	Sample Type:	
1-19-MISC-52	MISC	
Sample Location:	Detailed Sample Location:	
Principal's office	West wall of principal's office next to wall heater	
Sample Quantity:	See 1-19-MISC-51	
Misc Sample Material:	Sample Condition:	Sample Friable?:
Light blue base cove with tan mastic	Damaged or significantly damaged friable miscellaneous ACM	No

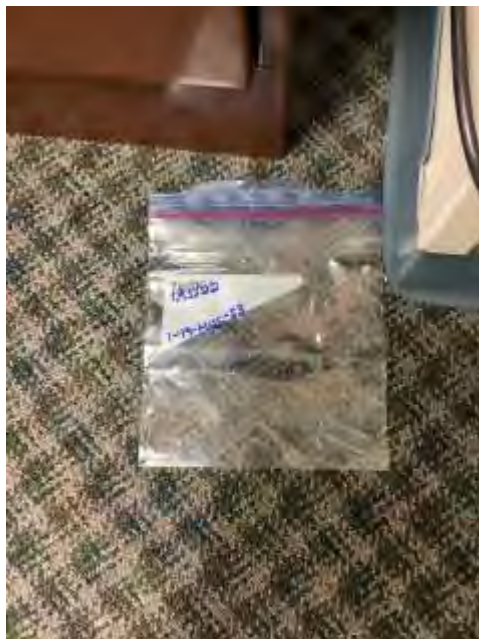
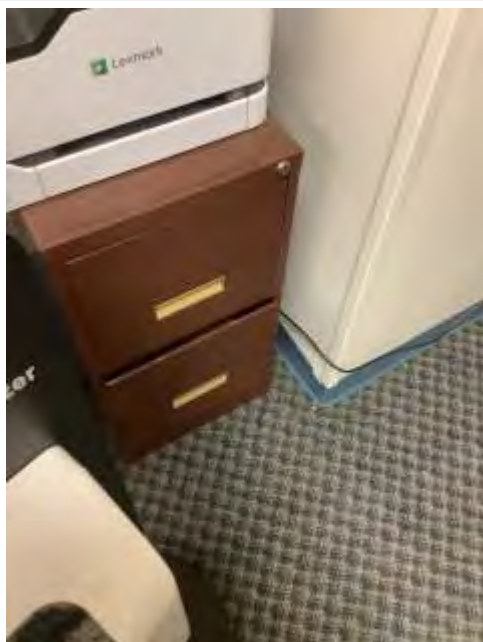
Additional Sample Notes:		
Sample ID:	Sample Type:	
1-19-MISC-53	MISC	
Sample Location:	Detailed Sample Location:	
Principal's office	Southeast corner of principal's office next to file cabinet	
Sample Quantity:	See 1-19-MISC-51	
Misc Sample Material:	Sample Condition:	Sample Friable?:
Light blue base cove with tan mastic	Damaged or significantly damaged friable miscellaneous ACM	No

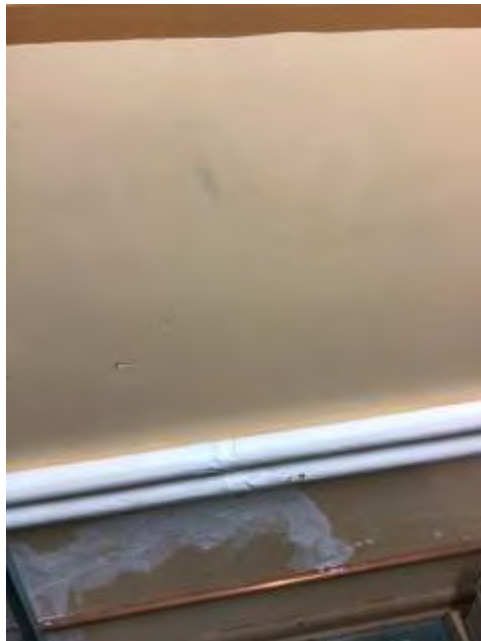
Sample ID:	Sample Type:
1-20-PB-22	PB
Sample Location:	Detailed Sample Location:
Boys restroom	Storage room
Sample Quantity:	
Sample Color:	XRF:
Brown	0.30mg/cm2

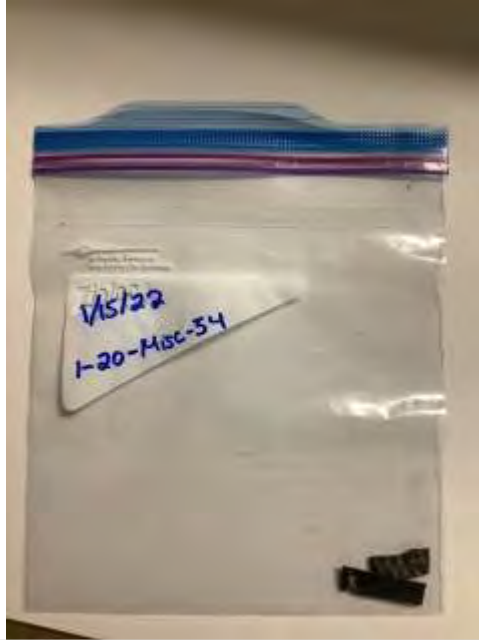
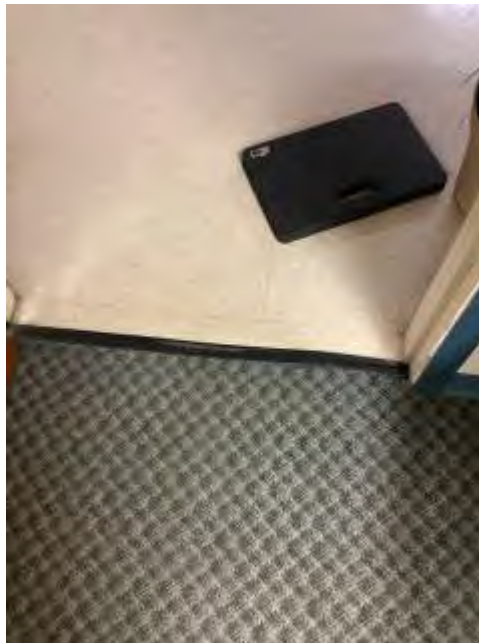
Sample ID:	Sample Type:	
1-20-MISC-54	MISC	
Sample Location:	Detailed Sample Location:	
Principal's office	Doorway between principal's office and the main office	
Sample Quantity:	3.5 LF	
Misc Sample Material:	Sample Condition:	Sample Friable?:
Black transition strip with yellow mastic	Damaged or significantly damaged friable miscellaneous ACM	No

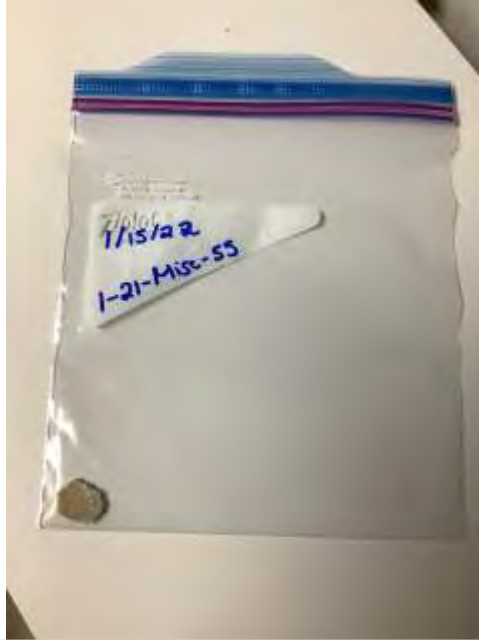
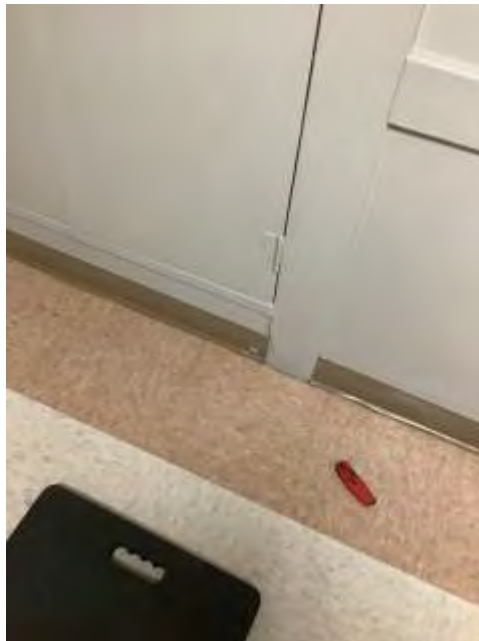
Additional Sample Notes:		
Sample ID:	Sample Type:	
1-21-MISC-55	MISC	
Sample Location:	Detailed Sample Location:	
Office	East wall of main office beneath first aid cabinet doors	
Sample Quantity:	301.4 LF	
Misc Sample Material:	Sample Condition:	Sample Friable?:
Tan base cove with tan mastic	Damaged or significantly damaged friable miscellaneous ACM	No
Sample Photo:

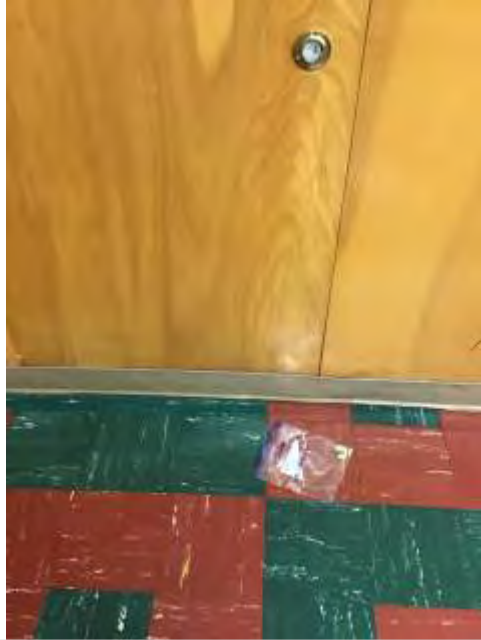
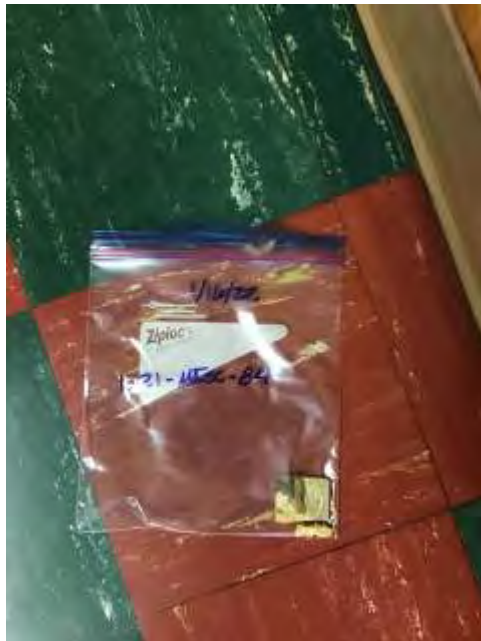
Additional Sample Notes:		
Sample ID:	Sample Type:	
1-21-MISC-84	MISC	
Sample Location:	Detailed Sample Location:	
Cafeteria	Northwest corner behind entrance door	
Sample Quantity:	See 1-21-MISC-55	
Misc Sample Material:	Sample Condition:	Sample Friable?:
Tan base cove with tan mastic	Damaged or significantly damaged friable miscellaneous ACM	No
Sample Photo:

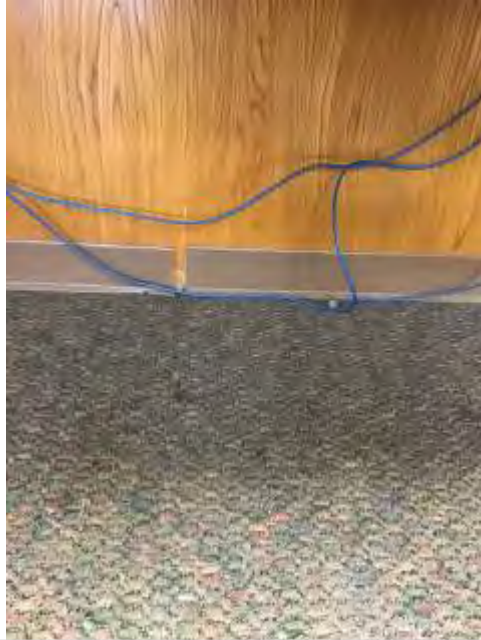
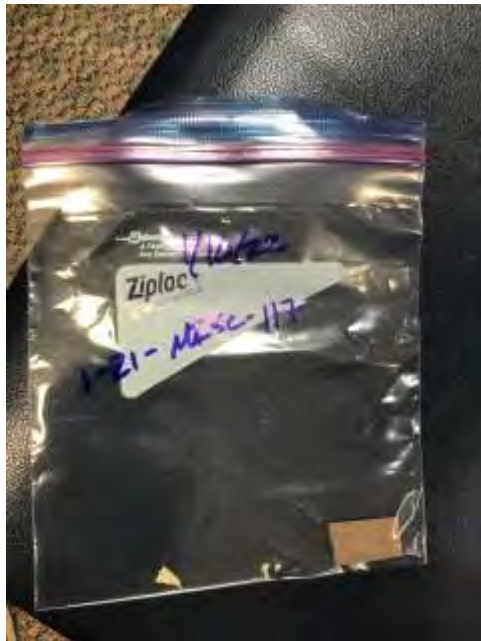
Additional Sample Notes:		
Sample ID:	Sample Type:	
1-21-MISC-117	MISC	
Sample Location:	Detailed Sample Location:	
Computer lab	East corner under desk	
Sample Quantity:	See 1-21-MISC-55	
Misc Sample Material:	Sample Condition:	Sample Friable?:
Tan base cove with tan mastic	Damaged or significantly damaged friable miscellaneous ACM	No
Sample Photo:

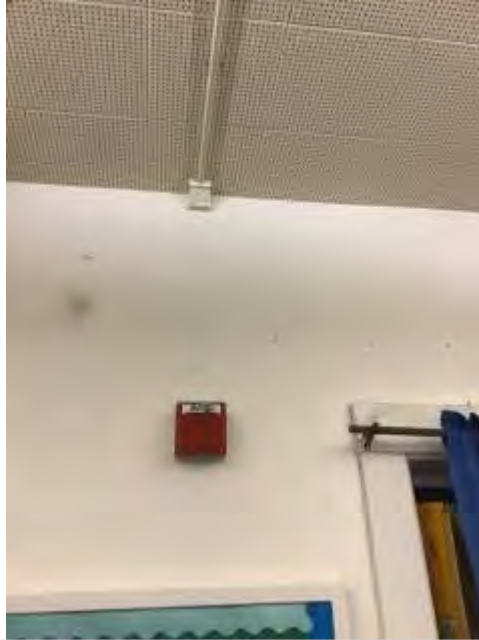
Additional Sample Notes:	
Sample ID:	Sample Type:
1-21-PB-24	PB
Sample Location:	Detailed Sample Location:
Classroom 7	Walls throughout
Sample Quantity:	
Sample Color:	XRF:
White	0.39mg/cm2
Sample Photo:
