HAZARDOUS BUILDING MATERIALS SURVEY

CONDON GRADE SCHOOL
220 S. EAST STREET
CONDON, OREGON

Prepared for
CITY OF CONDON
May 17, 2022
Project No. M2053.01.002

Prepared by
Maul Foster & Alongi, Inc.
3140 NE Broadway Street, Portland, OR 97232

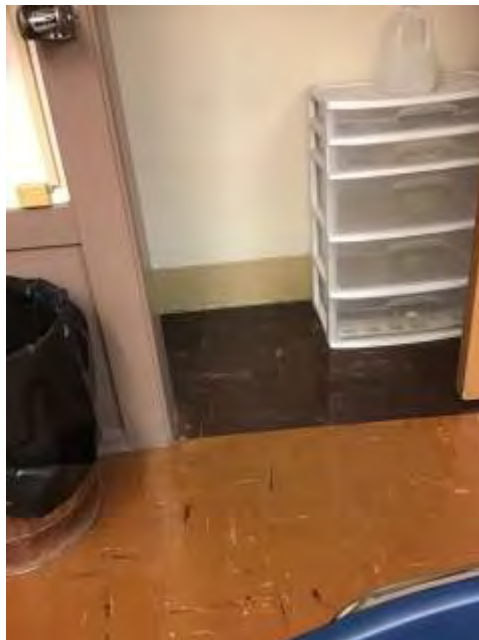
Additional Sample Notes:	
Sample ID:	Sample Type:
1-22-PB-25	PB
Sample Location:	Detailed Sample Location:
Classroom 9	Wood trim in closet
Sample Quantity:	
Sample Color:	XRF:
Tan	0.13mg/cm2

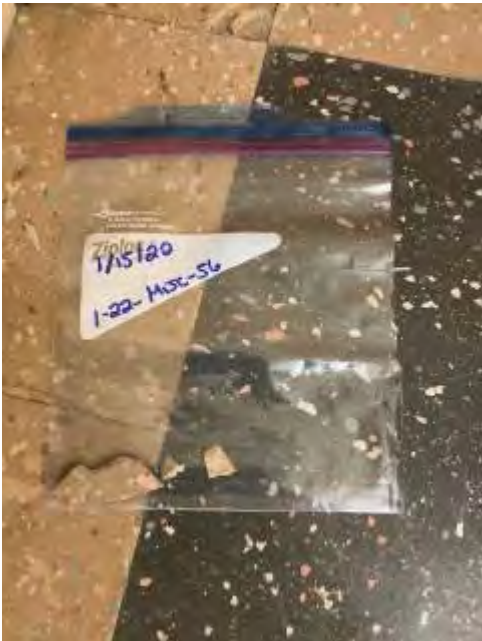
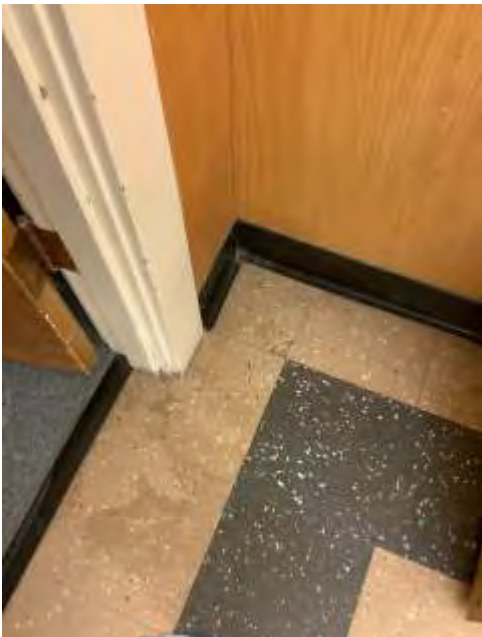
Additional Sample Notes:		
Sample ID:	Sample Type:	
1-22-MISC-56	MISC	
Sample Location:	Detailed Sample Location:	
Faculty lounge	Northwest corner of room next to doorway	
Sample Quantity:	526 SF	
Misc Sample Material:	Sample Condition:	Sample Friable?:
9x9 brown speckled vinyl floor tile with black mastic	Damaged or significantly damaged friable miscellaneous ACM	No
Sample Photo:

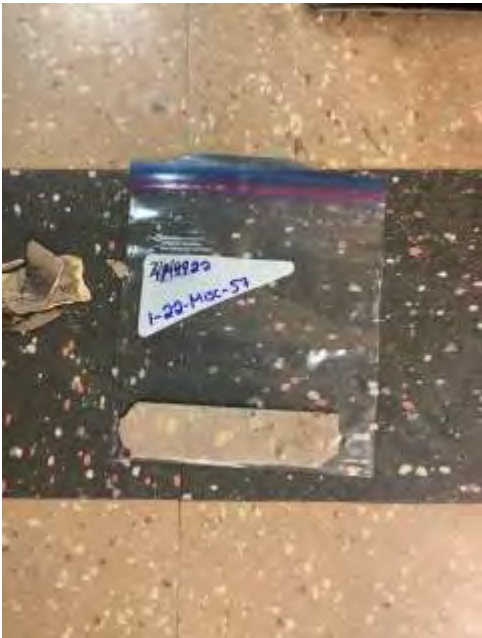
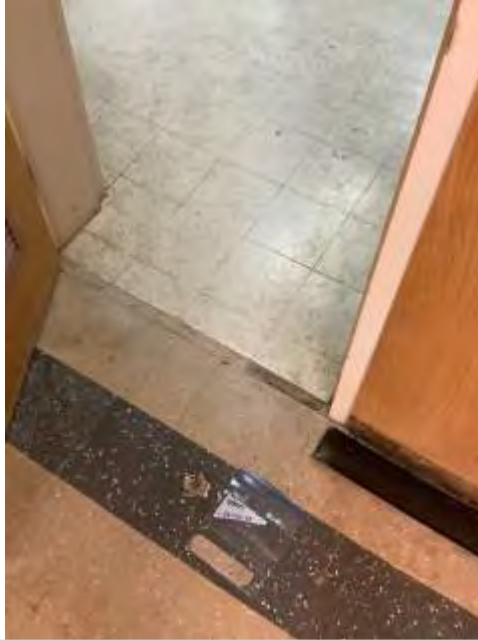
Additional Sample Notes:		
Sample ID:	Sample Type:	
1-22-MISC-57	MISC	
Sample Location:	Detailed Sample Location:	
Faculty lounge	Southeast doorway between lounge and server room	
Sample Quantity:	See 1-22-MISC-56	
Misc Sample Material:	Sample Condition:	Sample Friable?:
9x9 brown speckled vinyl floor tile with black mastic	Damaged or significantly damaged friable miscellaneous ACM; Potential ACBM with potential for damage	No
Sample Photo:

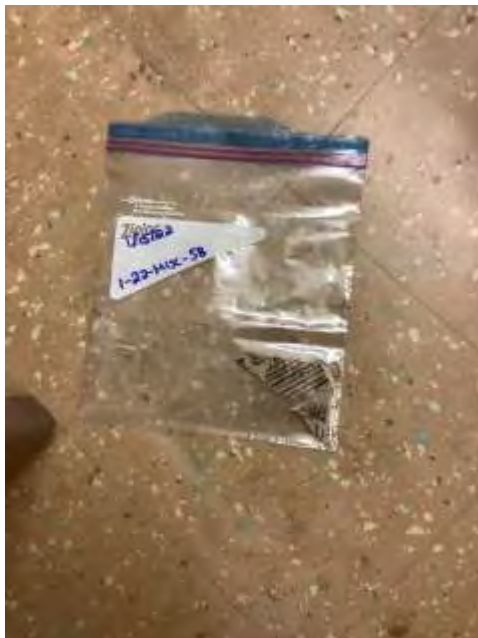
Additional Sample Notes:		
Sample ID:	Sample Type:	
1-22-MISC-58	MISC	
Sample Location:	Detailed Sample Location:	
Faculty lounge	East edge of room next to wall	
Sample Quantity:	See 1-22-MISC-56	
Misc Sample Material:	Sample Condition:	Sample Friable?:
9x9 brown speckled vinyl floor tile with black mastic		No

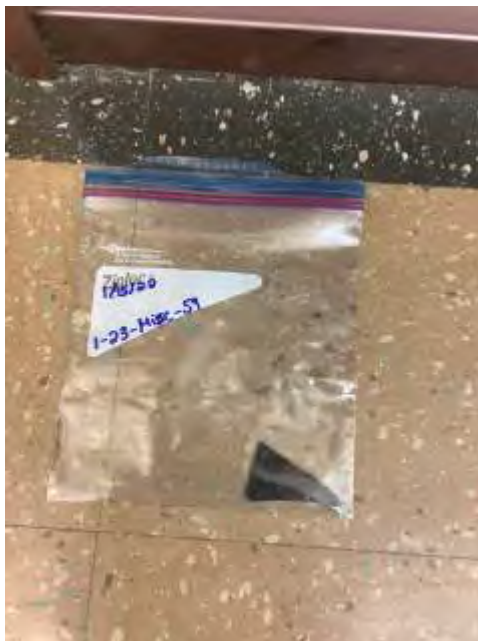
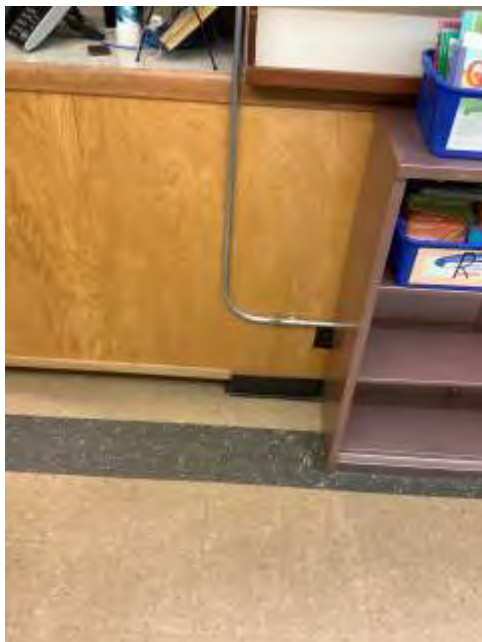
Additional Sample Notes:		
Sample ID:	Sample Type:	
1-23-MISC-59	MISC	
Sample Location:	Detailed Sample Location:	
Faculty lounge	West edge of room in front of tall counter	
Sample Quantity:	88 LF	
Misc Sample Material:	Sample Condition:	Sample Friable?:
9x9 black speckled vinyl floor tile with black mastic	Damaged or significantly damaged friable miscellaneous ACM	No

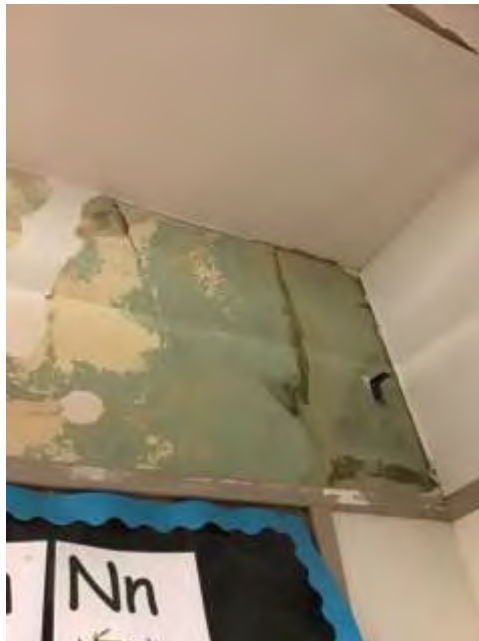
Sample ID:	Sample Type:
1-24-PB-28	PB
Sample Location:	Detailed Sample Location:
Classroom 8	Corner of room
Sample Quantity:	
Sample Color:	XRF:
Light green	0.11mg/cm2

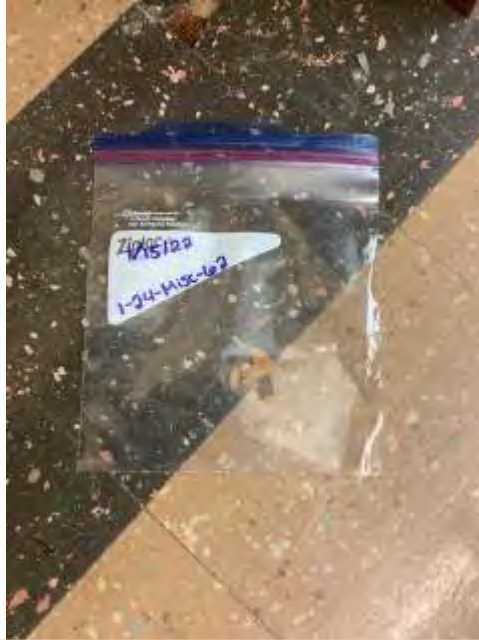
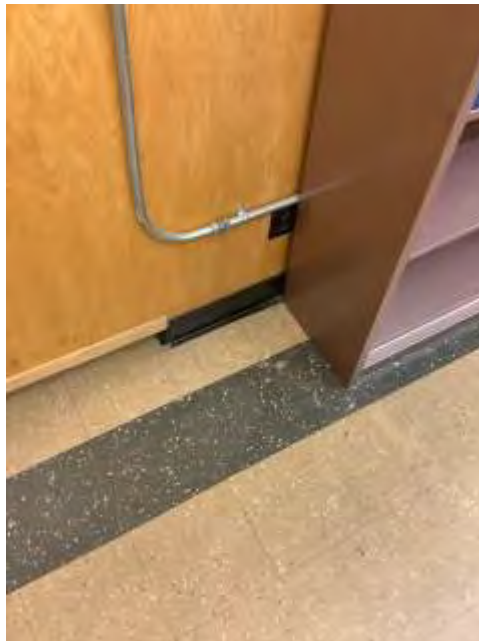
Sample ID:	Sample Type:	
1-24-MISC-62	MISC	
Sample Location:	Detailed Sample Location:	
Faculty lounge	West edge of room in front of tall counter	
Sample Quantity:	526 SF	
Misc Sample Material:	Sample Condition:	Sample Friable?:
Black leveling compound with black mastic	Damaged or significantly damaged friable miscellaneous ACM	No

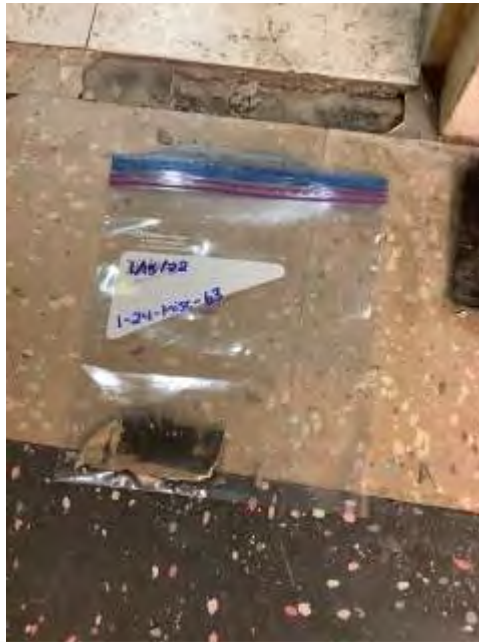
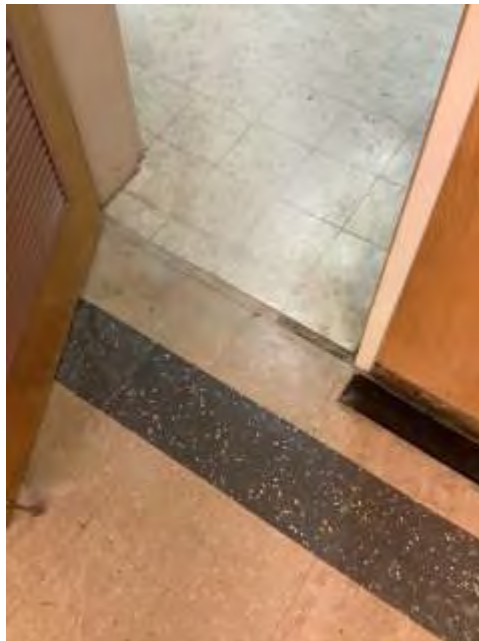
Additional Sample Notes:		
Sample ID:	Sample Type:	
1-24-MISC-63	MISC	
Sample Location:	Detailed Sample Location:	
Faculty lounge	Southeast doorway between lounge and server room	
Sample Quantity:	See 1-24-MISC-62	
Misc Sample Material:	Sample Condition:	Sample Friable?:
Black leveling compound with black mastic	Damaged or significantly damaged friable miscellaneous ACM; Potential ACBM with potential for damage	No

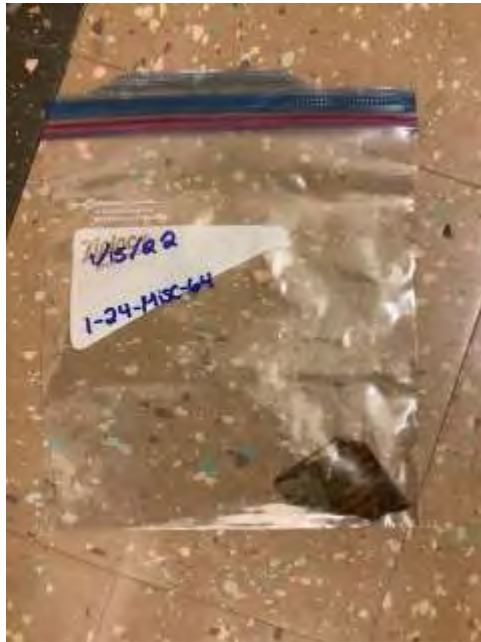
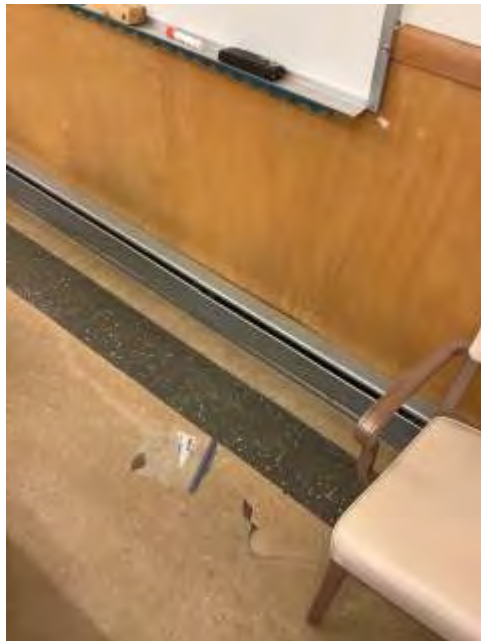
Sample ID:		Sample Type:	
1-24-MISC-64		MISC	
Sample Location:		Detailed Sample Location:	
Faculty lounge		East edge of room next to wall	
Sample Quantity:		See 1-24-MISC-62	
Misc Sample Material:		Sample Condition:	Sample Friable?:
Black leveling compound with black mastic		Damaged or significantly damaged friable miscellaneous ACM	No

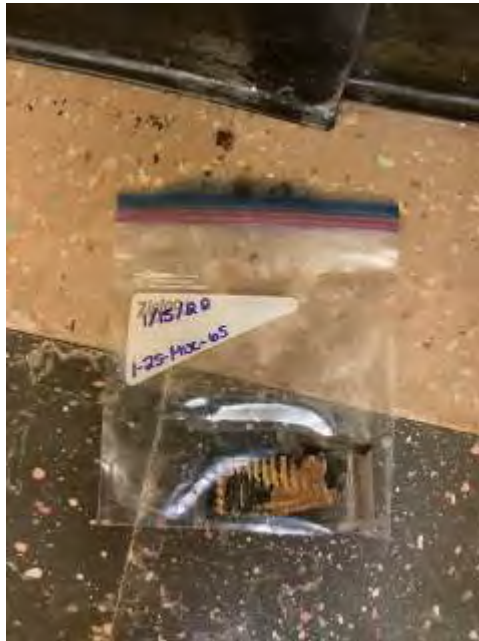
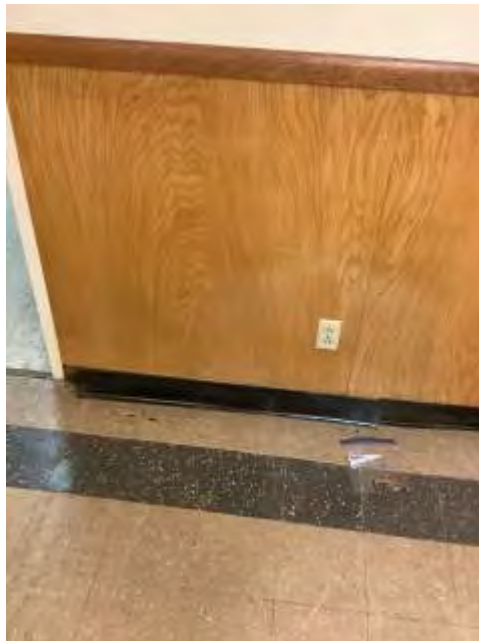
1-25-MISC-65

Black base cove with tan and black mastic	Damaged or significantly damaged friable miscellaneous ACM	No
---	--	----

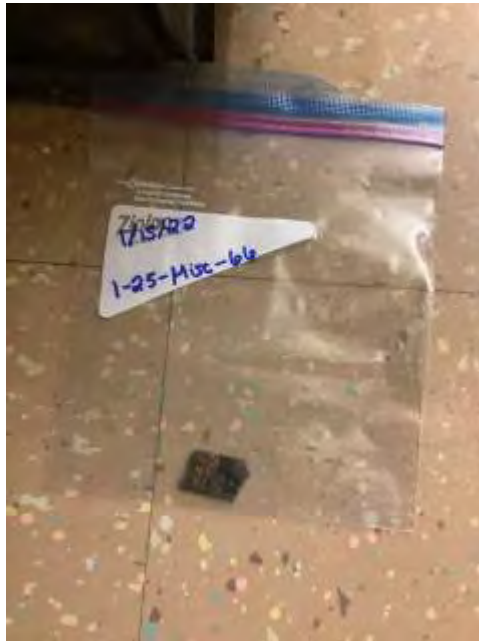
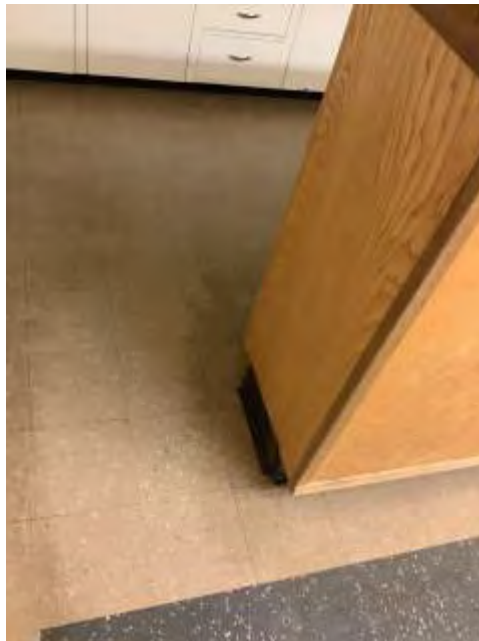
Additional Sample Notes:	Also found in library	
Sample ID:	Sample Type:	
1-25-MISC-66	MISC	
Sample Location:	Detailed Sample Location:	
Faculty lounge	Southwest corner of room on the edge of the tall counter	
Sample Quantity:	See 1-25-MISC-65	
Misc Sample Material:	Sample Condition:	Sample Friable?:

Black base cove with tan and black mastic	Damaged or significantly damaged friable miscellaneous ACM	No
---	--	----

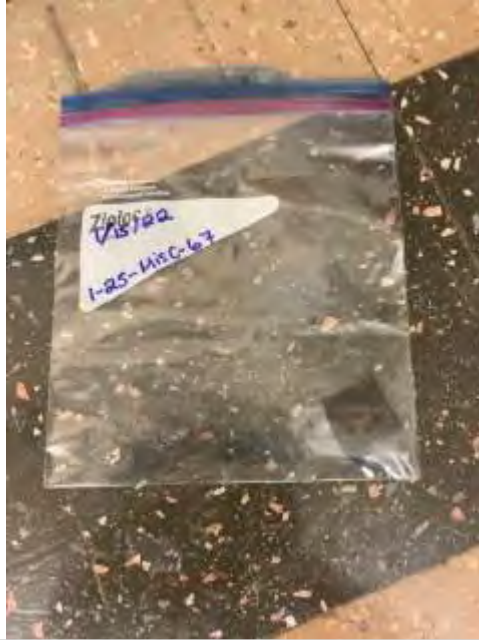
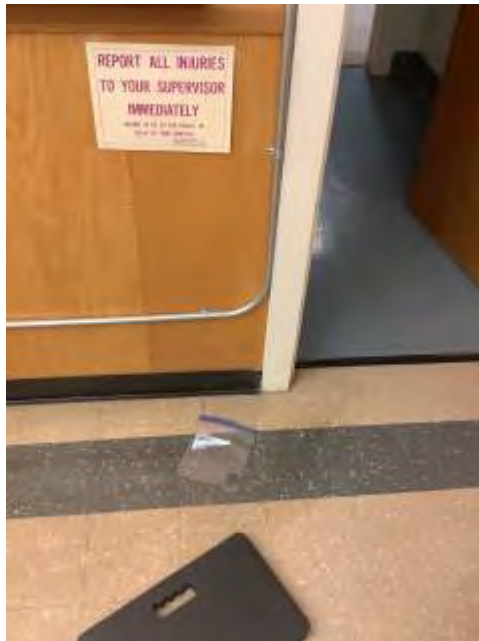
Sample ID:	Sample Type:
1-25-MISC-67	MISC
Sample Location:	Detailed Sample Location:
Faculty lounge	Northwest corner of room next to doorway between faculty lounge and restroom
Sample Quantity:	See 1-25-MISC-65

Misc Sample Material:	Sample Condition:	Sample Friable?:
Black base cove with black mastic	Damaged or significantly damaged friable miscellaneous ACM	No

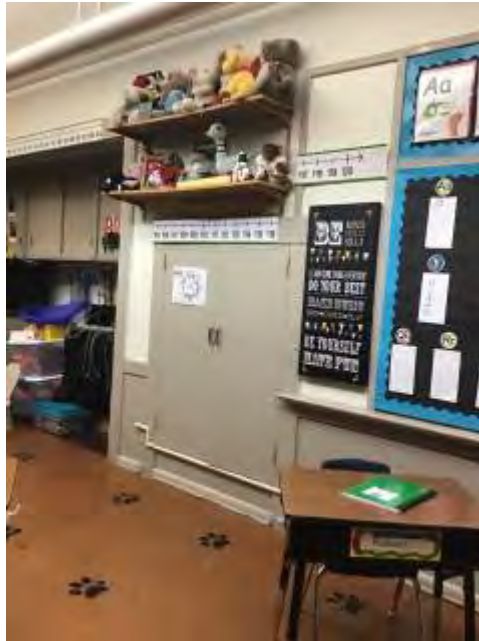
Additional Sample Notes:	Also found in library
Sample ID:	Sample Type:
1-25-PB-30	PB
Sample Location:	Detailed Sample Location:
Classroom 8	Trim throughout
Sample Quantity:

Sample Color:	XRF:
Gray	0.42mg/cm2

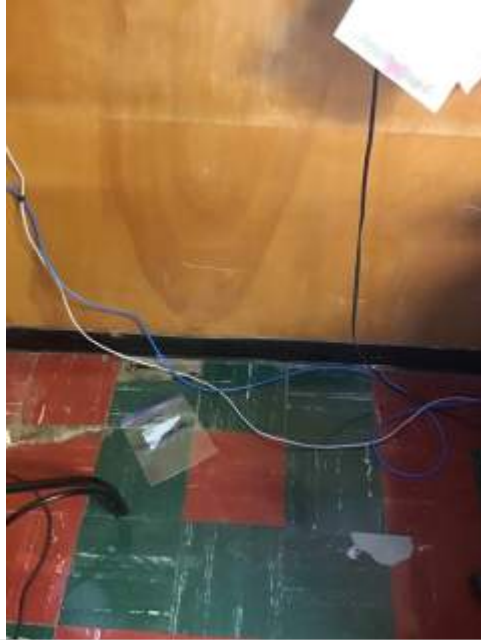
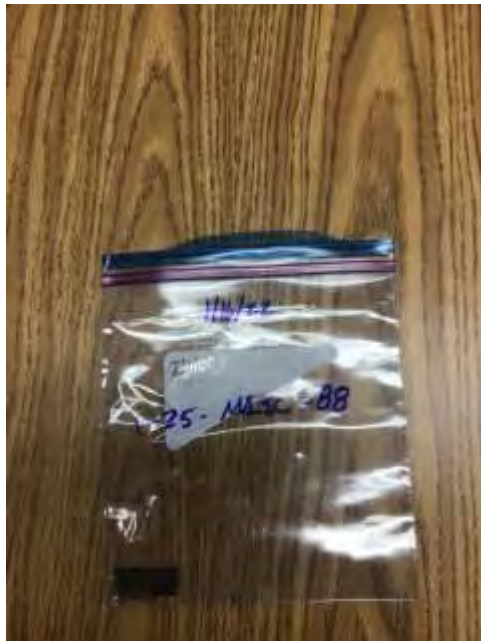
Sample ID:	Sample Type:	
1-25-MISC-88	MISC	
Sample Location:	Detailed Sample Location:	
Cafeteria	East wall behind desk	
Sample Quantity:	See 1-25-MISC-65	
Misc Sample Material:	Sample Condition:	Sample Friable?:
Black base cove with black mastic	Damaged or significantly damaged friable miscellaneous ACM	No

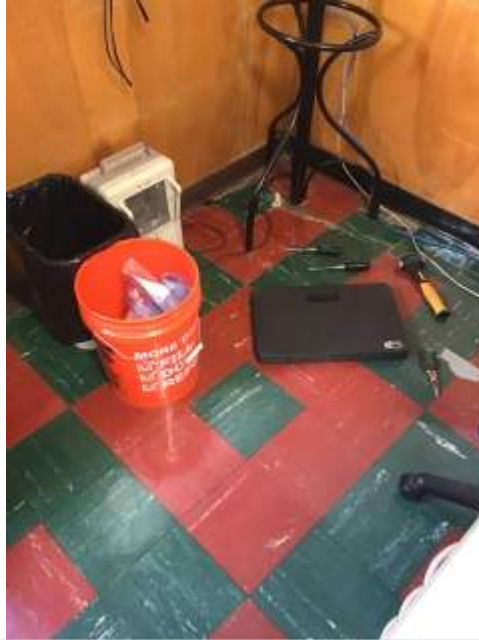
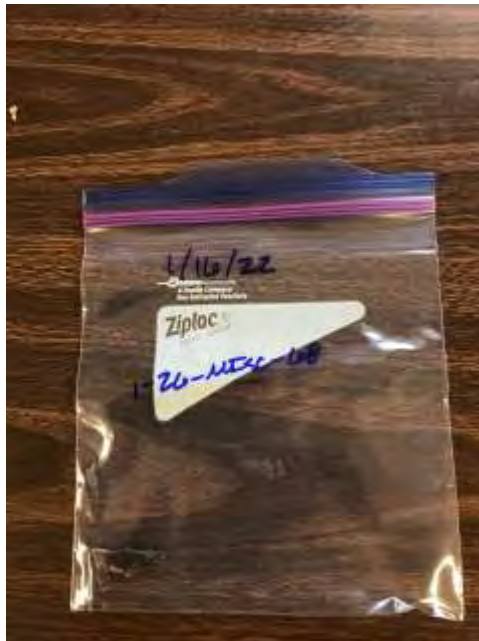
Additional Sample Notes:		
Sample ID:	Sample Type:	
1-26-MISC-68	MISC	
Sample Location:	Detailed Sample Location:	
Cafeteria	Northeast corner of room near desk	
Sample Quantity:	1,432 SF	
Misc Sample Material:	Sample Condition:	Sample Friable?:
9x9 red vinyl floor tile with black mastic	Damaged or significantly damaged friable miscellaneous ACM	No
Sample Photo:

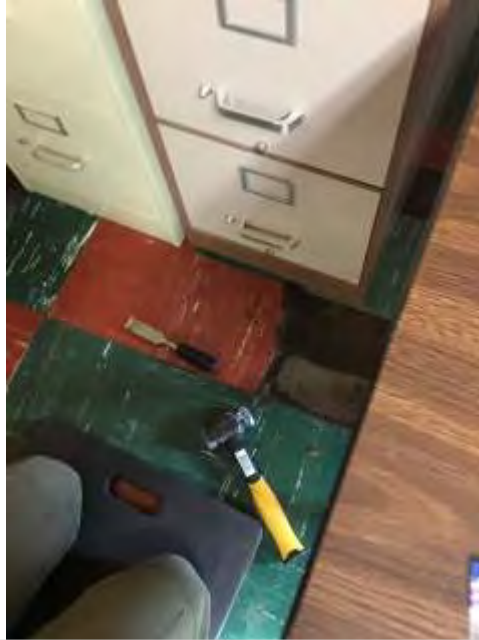
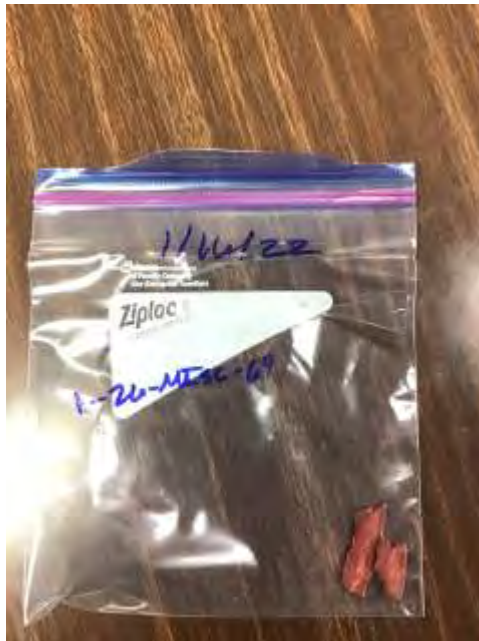
Additional Sample Notes:		
Sample ID:	Sample Type:	
1-26-MISC-69	MISC	
Sample Location:	Detailed Sample Location:	
Cafeteria	Northeast corner of room near filing cabinet	
Sample Quantity:	See 1-26-MISC-68	
Misc Sample Material:	Sample Condition:	Sample Friable?:
9x9 red vinyl floor tile with black mastic	Damaged or significantly damaged friable miscellaneous ACM	No
Sample Photo:

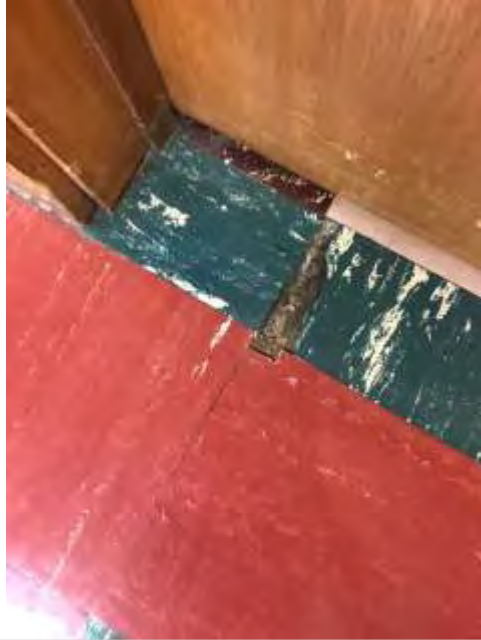
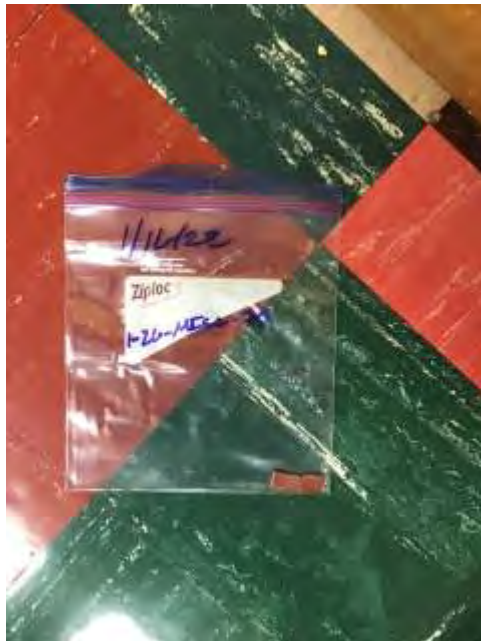
Additional Sample Notes:		
Sample ID:	Sample Type:	
1-26-MISC-70	MISC	
Sample Location:	Detailed Sample Location:	
Cafeteria	Southwest corner of room near door	
Sample Quantity:	See 1-26-MISC-68	
Misc Sample Material:	Sample Condition:	Sample Friable?:
9x9 red vinyl floor tile with black mastic	Damaged or significantly damaged friable miscellaneous ACM	No
Sample Photo:

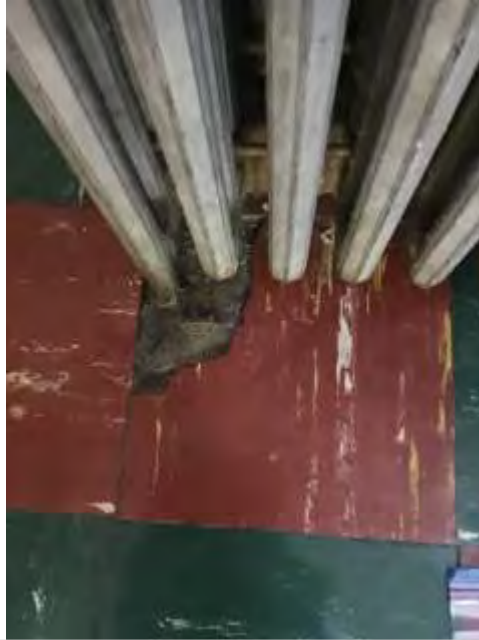
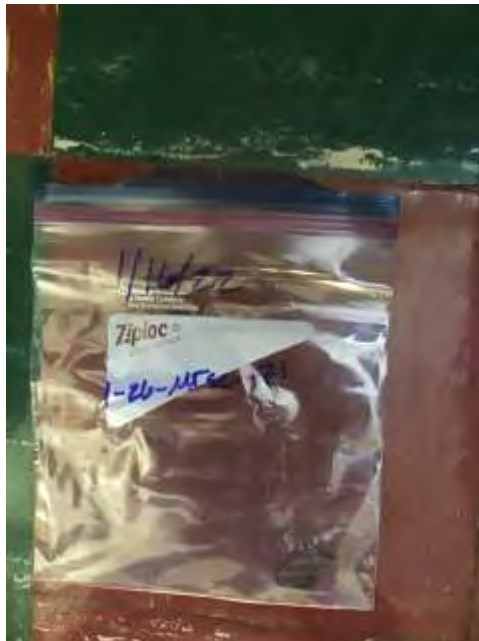
Additional Sample Notes:		
Sample ID:	Sample Type:	
1-26-MISC-71	MISC	
Sample Location:	Detailed Sample Location:	
Cafeteria	Northwest corner of kitchen near freezer	
Sample Quantity:	See 1-26-MISC-68	
Misc Sample Material:	Sample Condition:	Sample Friable?:
9x9 red vinyl floor tile with black mastic	Damaged or significantly damaged friable miscellaneous ACM;Other	No
Sample Photo:

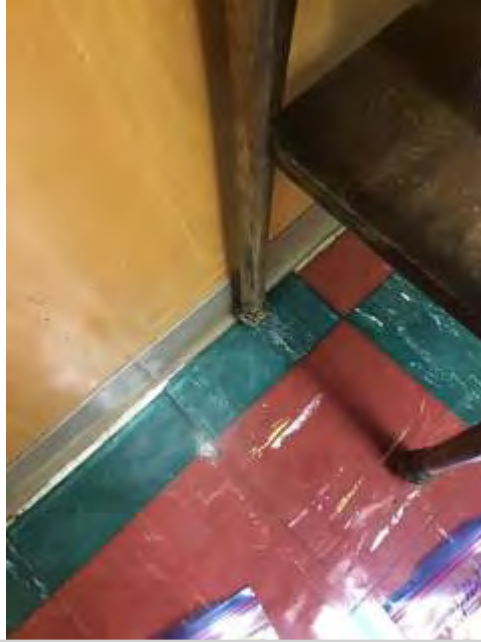
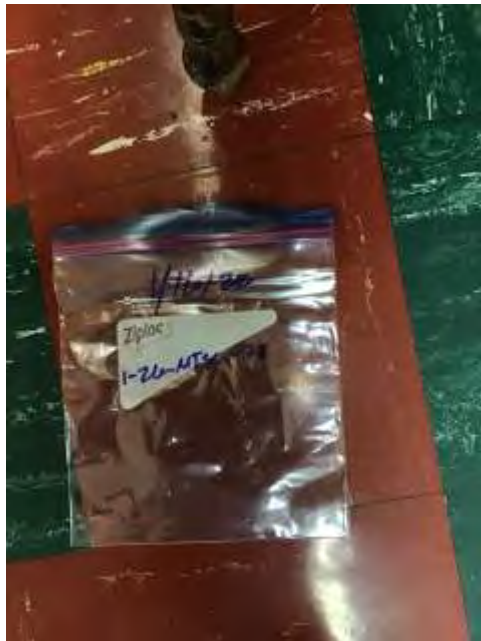
Additional Sample Notes:		
Sample ID:	Sample Type:	
1-26-MISC-72	MISC	
Sample Location:	Detailed Sample Location:	
Cafeteria	Northwest corner of cafeteria near entrance doorway	
Sample Quantity:	See 1-26-MISC-68	
Misc Sample Material:	Sample Condition:	Sample Friable?:
9x9 red vinyl floor tile with black mastic	Damaged or significantly damaged friable miscellaneous ACM	No
Sample Photo:

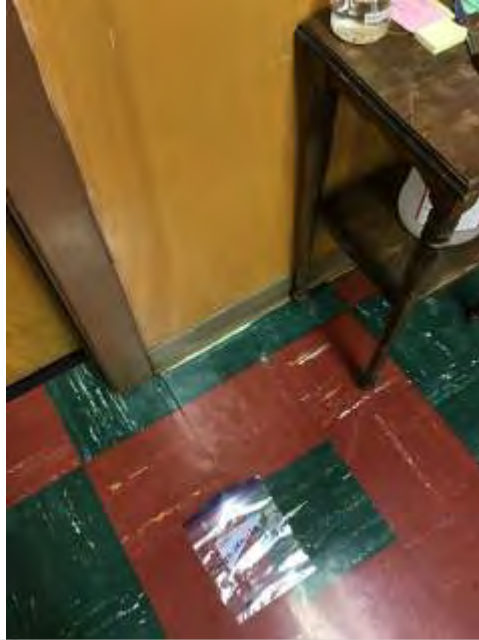
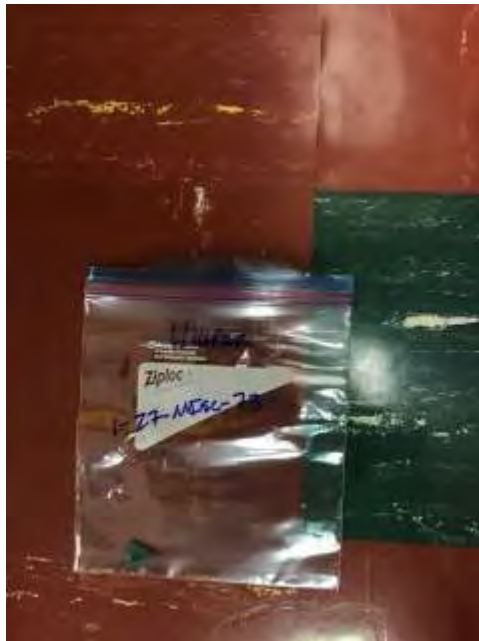
Additional Sample Notes:		
Sample ID:	Sample Type:	
1-27-MISC-73	MISC	
Sample Location:	Detailed Sample Location:	
Cafeteria	Northwest corner of cafeteria near entrance doorway	
Sample Quantity:	1,432 SF	
Misc Sample Material:	Sample Condition:	Sample Friable?:
9x9 green vinyl floor tile with black mastic	Damaged or significantly damaged friable miscellaneous ACM	No
Sample Photo:

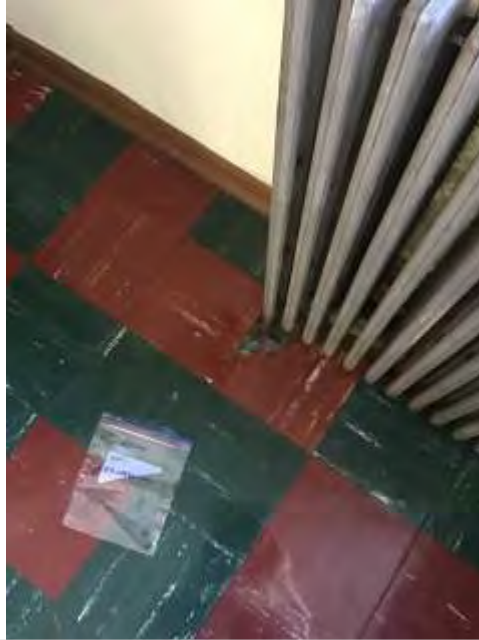
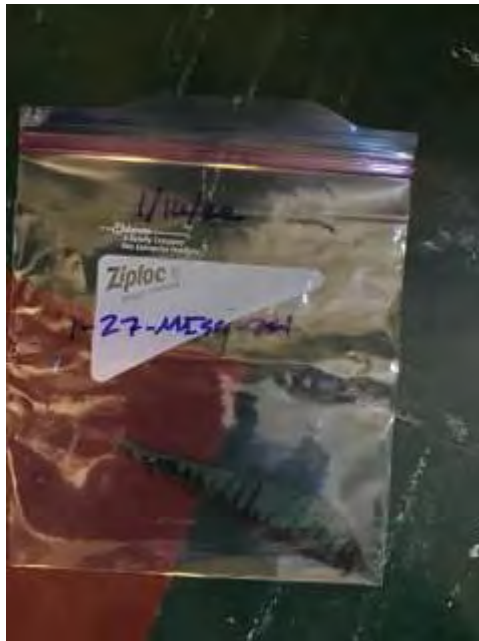
Additional Sample Notes:		
Sample ID:	Sample Type:	
1-27-MISC-74	MISC	
Sample Location:	Detailed Sample Location:	
Cafeteria	Northwest corner of kitchen near freezer	
Sample Quantity:	See 1-27-MISC-73	
Misc Sample Material:	Sample Condition:	Sample Friable?:
9x9 green vinyl floor tile with black mastic	Damaged or significantly damaged friable miscellaneous ACM	No
Sample Photo:

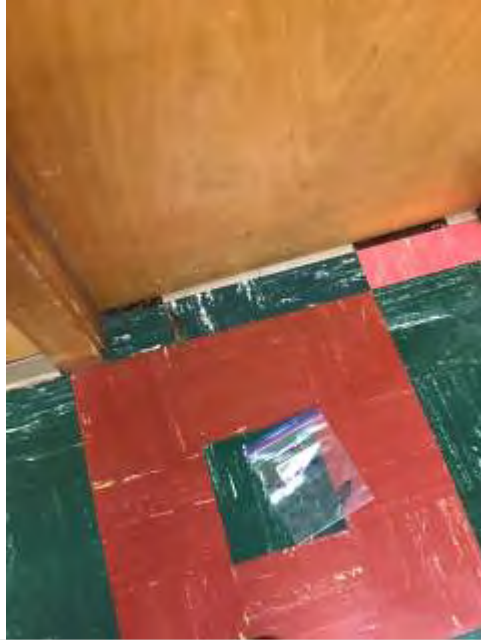
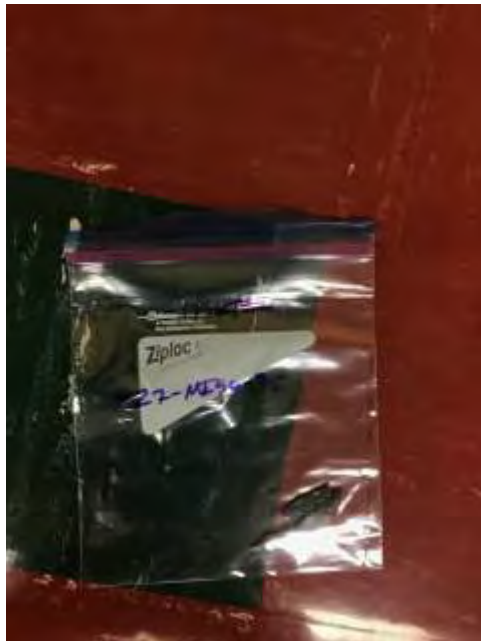
Additional Sample Notes:		
Sample ID:	Sample Type:	
1-27-MISC-75	MISC	
Sample Location:	Detailed Sample Location:	
Cafeteria	Southwest corner of room near door	
Sample Quantity:	See 1-27-MISC-73	
Misc Sample Material:	Sample Condition:	Sample Friable?:
9x9 green vinyl floor tile with black mastic	Damaged or significantly damaged friable miscellaneous ACM	No
Sample Photo:

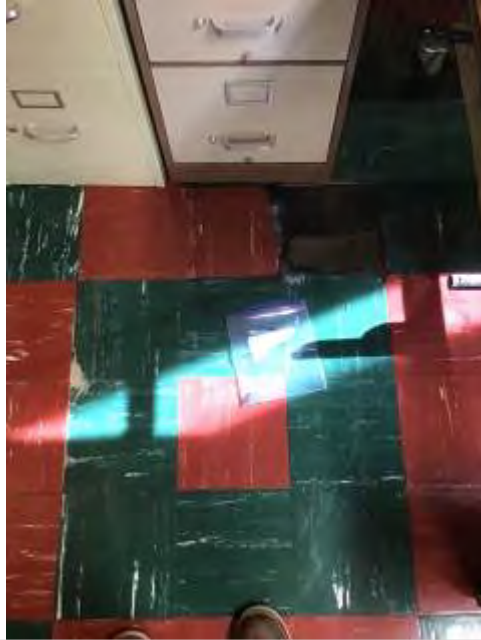
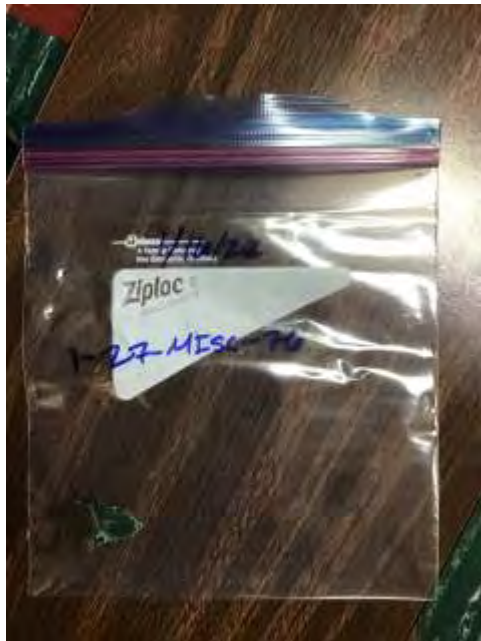
Additional Sample Notes:		
Sample ID:	Sample Type:	
1-27-MISC-76	MISC	
Sample Location:	Detailed Sample Location:	
Cafeteria	Northeast corner of room near filing cabinet	
Sample Quantity:	See 1-27-MISC-73	
Misc Sample Material:	Sample Condition:	Sample Friable?:
9x9 green vinyl floor tile with black mastic	Damaged or significantly damaged friable miscellaneous ACM	No
Sample Photo:

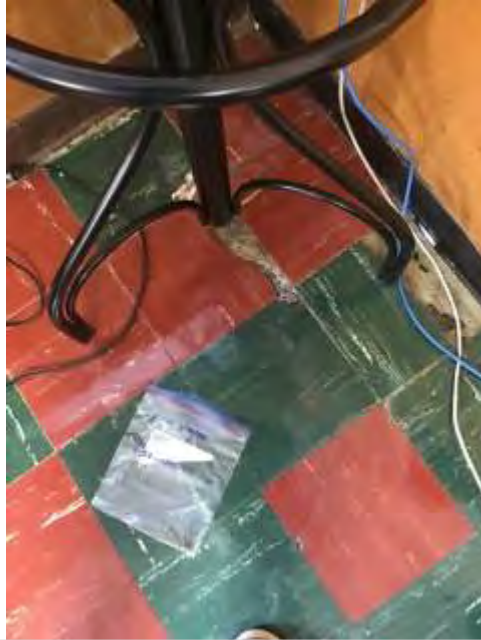
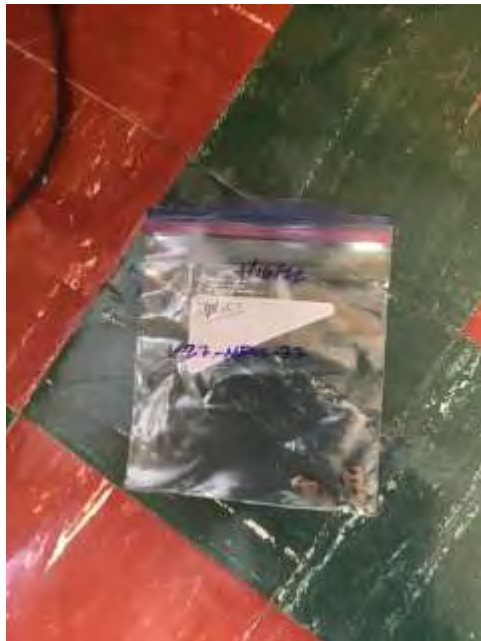
Additional Sample Notes:		
Sample ID:	Sample Type:	
1-27-MISC-77	MISC	
Sample Location:	Detailed Sample Location:	
Cafeteria	Northeast corner of room near desk	
Sample Quantity:	See 1-27-MISC-73	
Misc Sample Material:	Sample Condition:	Sample Friable?:
9x9 green vinyl floor tile with black mastic	Damaged or significantly damaged friable miscellaneous ACM	No
Sample Photo:

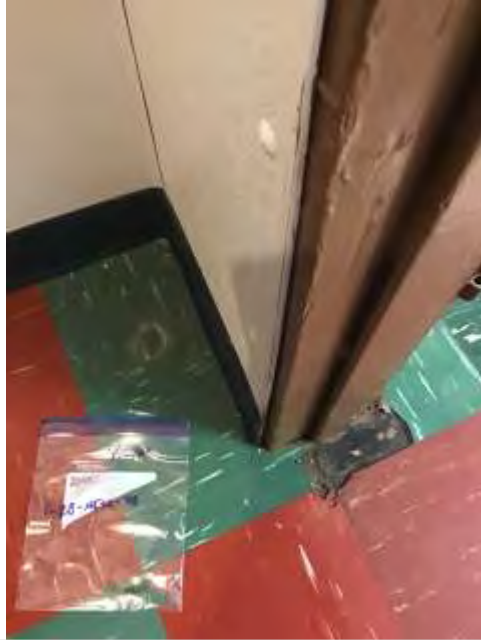
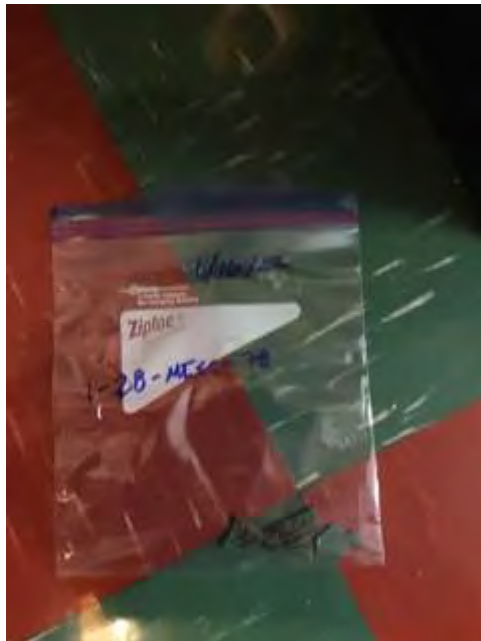
Additional Sample Notes:		
Sample ID:	Sample Type:	
1-28-MISC-78	MISC	
Sample Location:	Detailed Sample Location:	
Cafeteria	Northwest corner of kitchen	
Sample Quantity:	50 tiles	
Misc Sample Material:	Sample Condition:	Sample Friable?:
9x9 light green vinyl tile with black mastic	Damaged or significantly damaged friable miscellaneous ACM	No
Sample Photo:

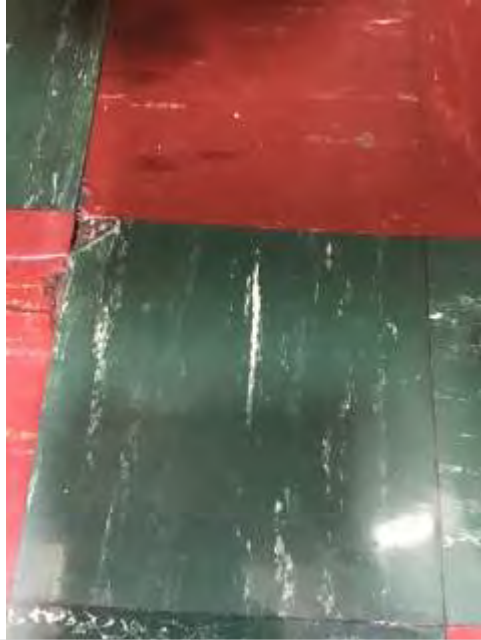
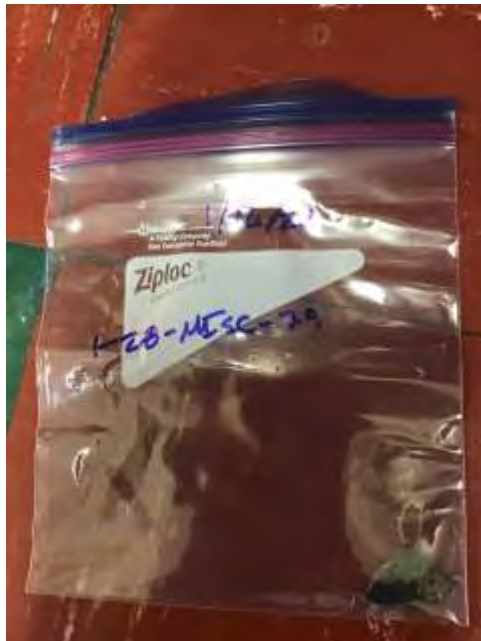
Additional Sample Notes:		
Sample ID:	Sample Type:	
1-28-MISC-79	MISC	
Sample Location:	Detailed Sample Location:	
Cafeteria	Northwest corner of kitchen below sink	
Sample Quantity:	See 1-28-MISC-78	
Misc Sample Material:	Sample Condition:	Sample Friable?:
9x9 light green vinyl tile with black mastic	Damaged or significantly damaged friable miscellaneous ACM	No
Sample Photo:

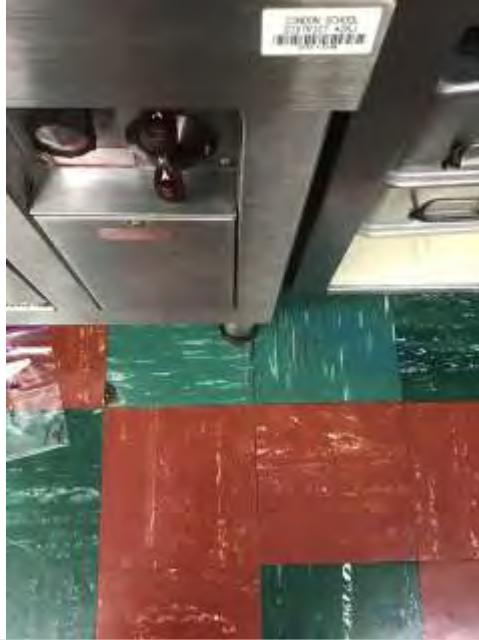
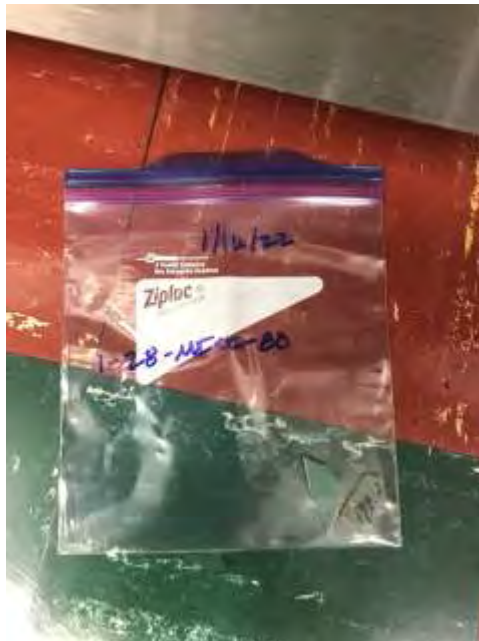
Additional Sample Notes:		
Sample ID:	Sample Type:	
1-28-MISC-80	MISC	
Sample Location:	Detailed Sample Location:	
Cafeteria	Center of kitchen below stove	
Sample Quantity:	See 1-28-MISC-78	
Misc Sample Material:	Sample Condition:	Sample Friable?:
9x9 light green vinyl tile with black mastic	Damaged or significantly damaged friable miscellaneous ACM	No
Sample Photo:

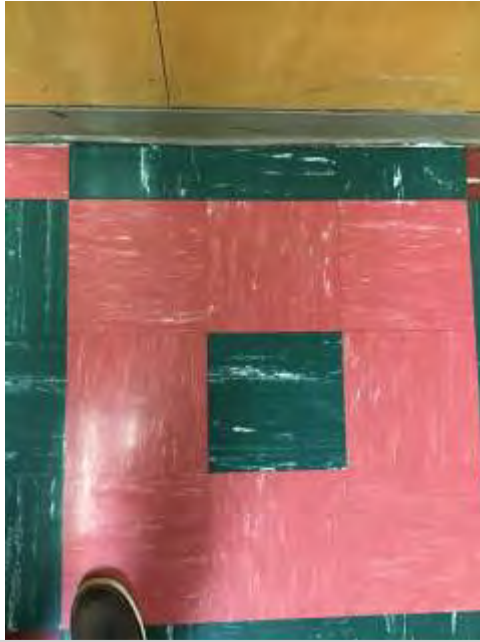
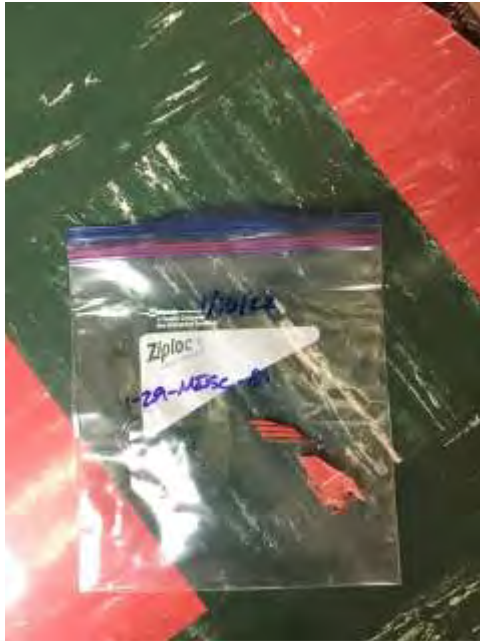
Additional Sample Notes:		
Sample ID:	Sample Type:	
1-29-MISC-81	MISC	
Sample Location:	Detailed Sample Location:	
Cafeteria	Northwest wall near entrance	
Sample Quantity:	30 tiles	
Misc Sample Material:	Sample Condition:	Sample Friable?:
9x9 pink vinyl tile with black mastic	Damaged or significantly damaged friable miscellaneous ACM; Potential ACBM with potential for damage	No

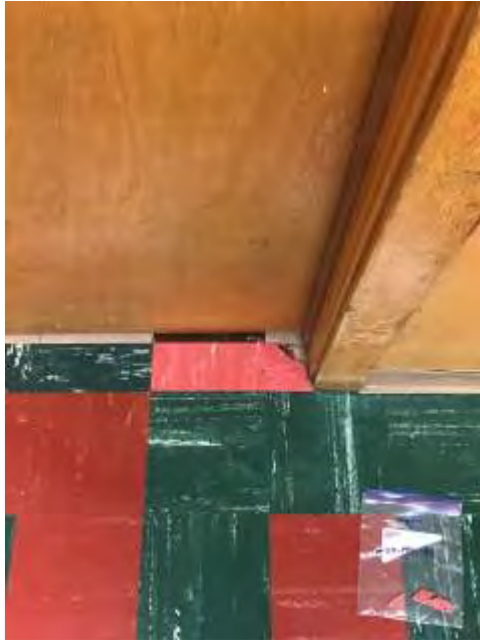
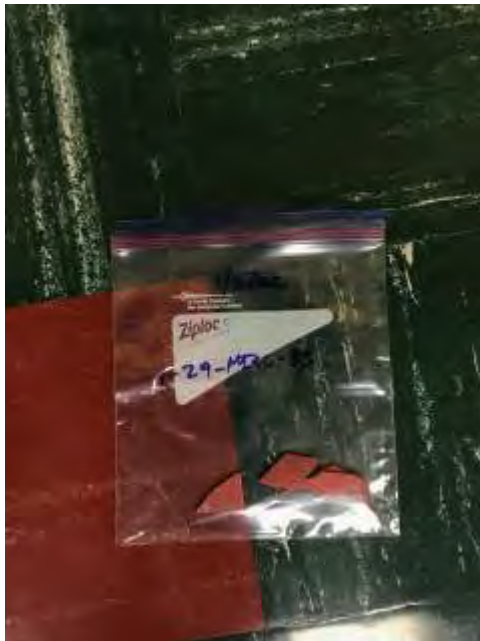
Sample ID:		Sample Type:	
1-29-MISC-83		MISC	
Sample Location:		Detailed Sample Location:	
Cafeteria		West wall near door	
Sample Quantity:		See 1-29-MISC-81	
Misc Sample Material:		Sample Condition:	Sample Friable?:
9x9 pink vinyl tile with black mastic		Damaged or significantly damaged friable miscellaneous ACM	No

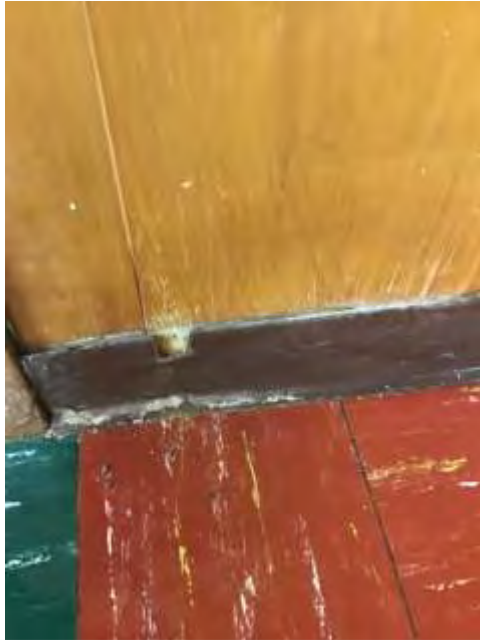
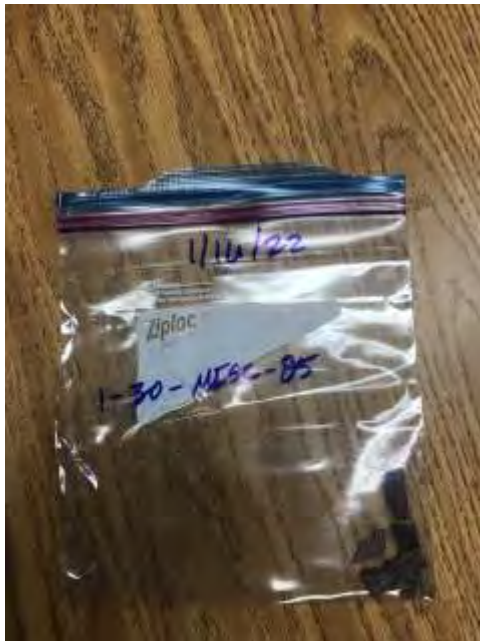
Sample ID:		Sample Type:	
1-30-MISC-85		MISC	
Sample Location:		Detailed Sample Location:	
Cafeteria		Northeast wall near storage room doorway	
Sample Quantity:		43 LF	
Misc Sample Material:		Sample Condition:	Sample Friable?:
Dark brown base cove with yellow mastic		Damaged or significantly damaged friable miscellaneous ACM	No

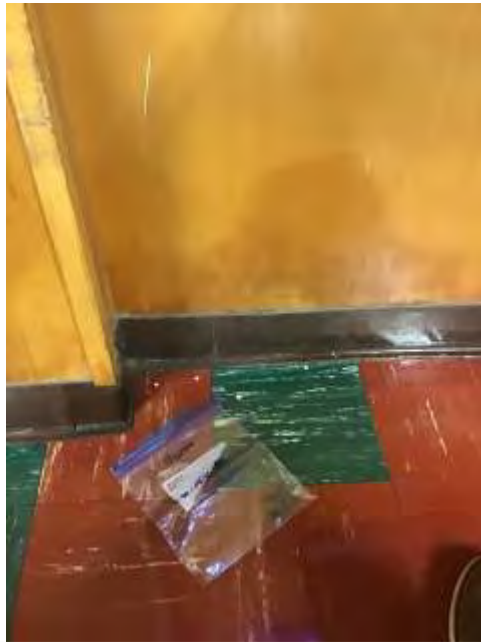
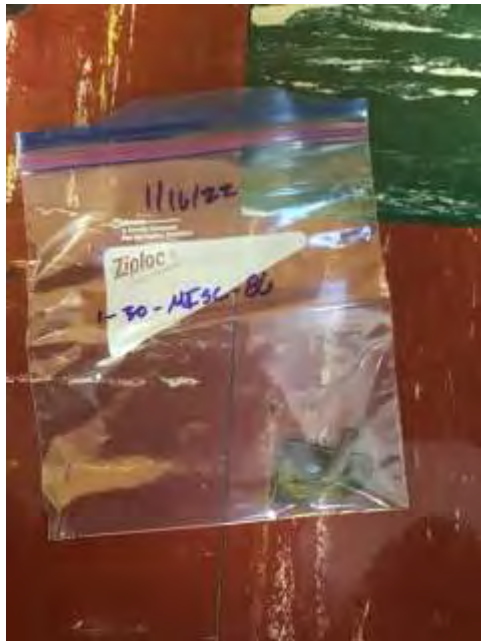
Sample ID:		Sample Type:	
1-30-MISC-86		MISC	
Sample Location:		Detailed Sample Location:	
Cafeteria		East wall near desk	
Sample Quantity:		See 1-30-MISC-85	
Misc Sample Material:		Sample Condition:	Sample Friable?:
Dark brown base cove with yellow mastic		Damaged or significantly damaged friable miscellaneous ACM	No

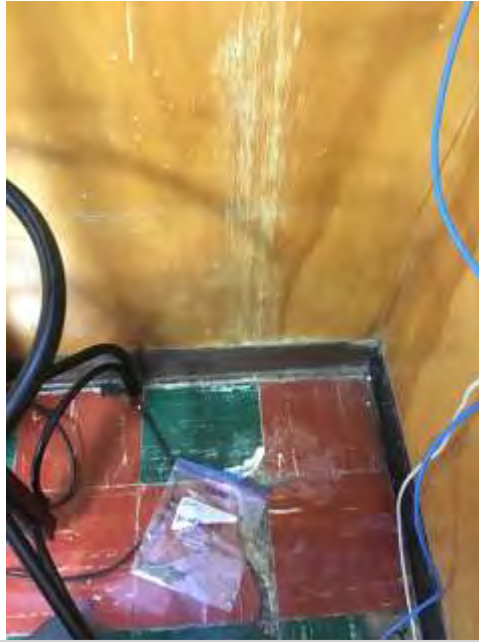
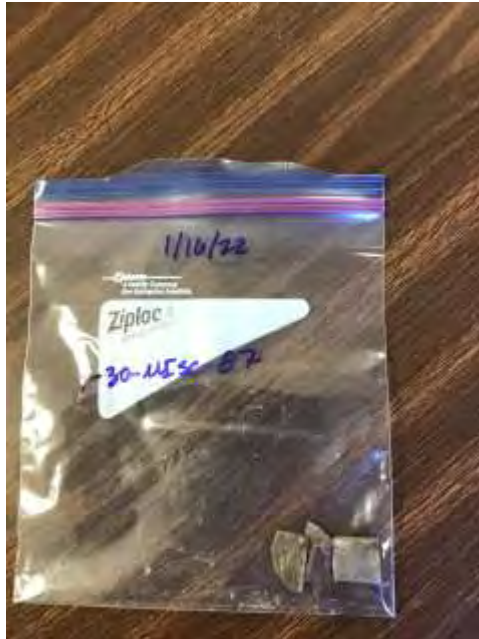
Sample ID:		Sample Type:	
1-30-MISC-87		MISC	
Sample Location:		Detailed Sample Location:	
Cafeteria		East wall behind desk	
Sample Quantity:		See 1-30-MISC-85	
Misc Sample Material:		Sample Condition:	Sample Friable?:
Dark brown base cove with yellow mastic		Damaged or significantly damaged friable miscellaneous ACM	No

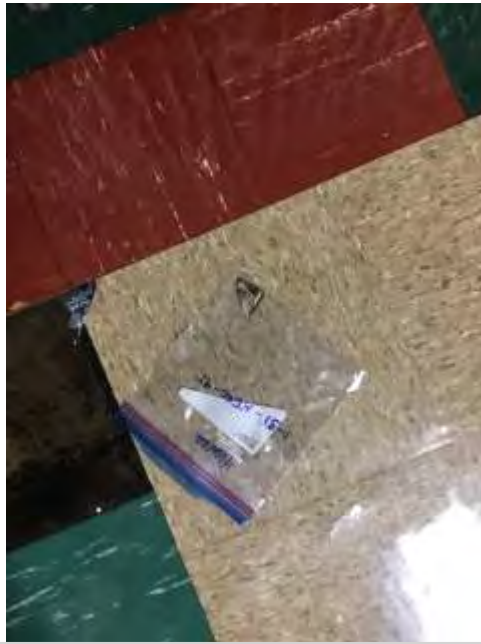
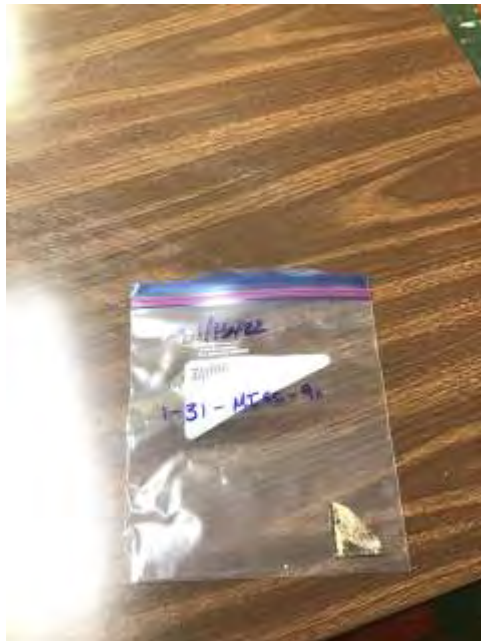
Sample ID:		Sample Type:	
1-31-MISC-91		MISC	
Sample Location:		Detailed Sample Location:	
Cafeteria		East floor near windows	
Sample Quantity:		6 SF	
Misc Sample Material:		Sample Condition:	Sample Friable?:
12x12 tan tile with black mastic		Damaged or significantly damaged friable miscellaneous ACM	No

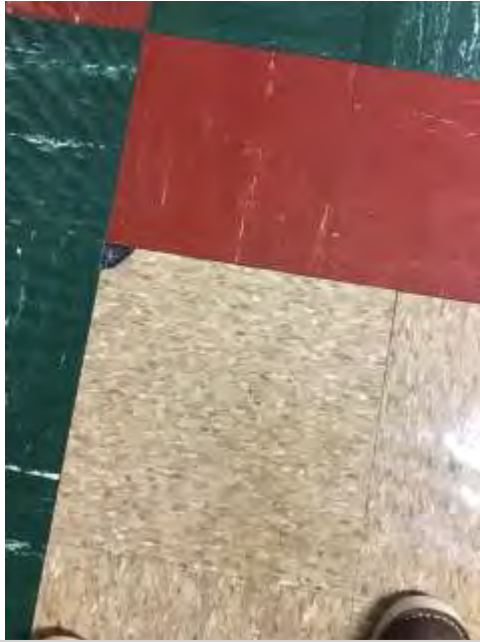
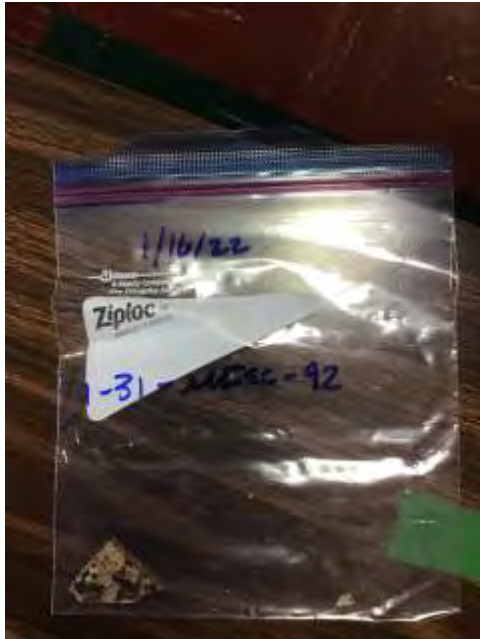
Sample ID:		Sample Type:	
1-31-MISC-92		MISC	
Sample Location:		Detailed Sample Location:	
Cafeteria		East floor near windows	
Sample Quantity:		See 1-31-MISC-91	
Misc Sample Material:		Sample Condition:	Sample Friable?:
12x12 tan tile with black mastic		Damaged or significantly damaged friable miscellaneous ACM	No
