HAZARDOUS BUILDING MATERIALS SURVEY

CONDON GRADE SCHOOL
220 S. EAST STREET
CONDON, OREGON

Prepared for
CITY OF CONDON
May 17, 2022
Project No. M2053.01.002

Prepared by
Maul Foster & Alongi, Inc.
3140 NE Broadway Street, Portland, OR 97232

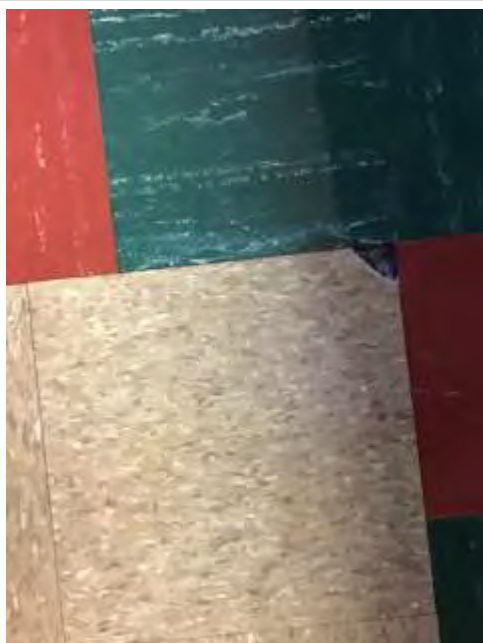
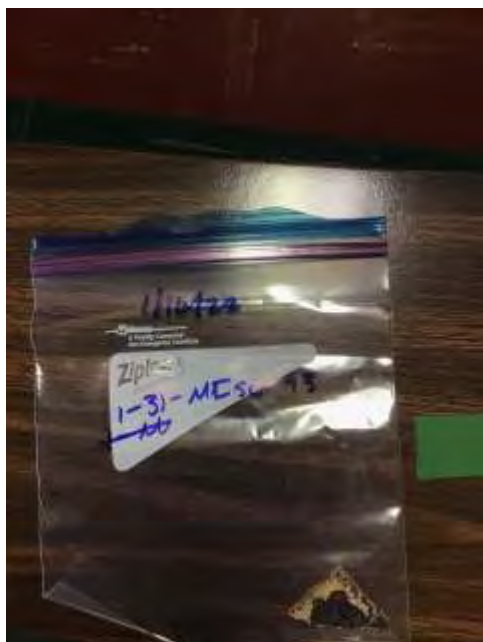
1-31-MISC-93

Damaged or significantly damaged friable miscellaneous ACM

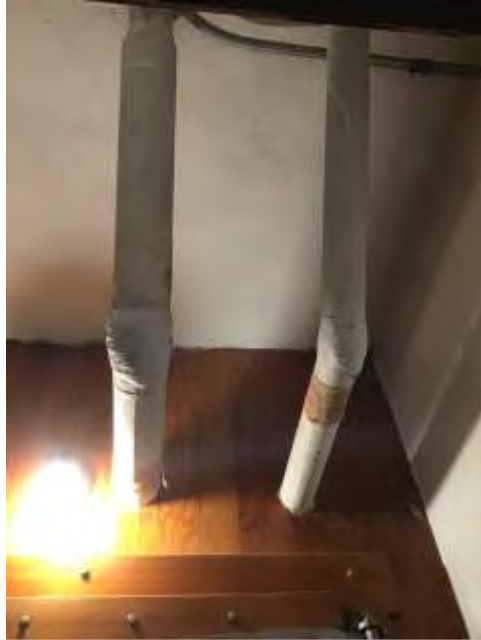
Sample ID:	Sample Type:	
1-32-TSI-95	TSI	
Sample Location:	Detailed Sample Location:	
Cafeteria	Freezer room pipes	
Sample Quantity:		
Sample Color:	XRF:	
Misc Sample Material:	Sample Condition:	Sample Friable?:
	Damaged or significantly damaged	Yes

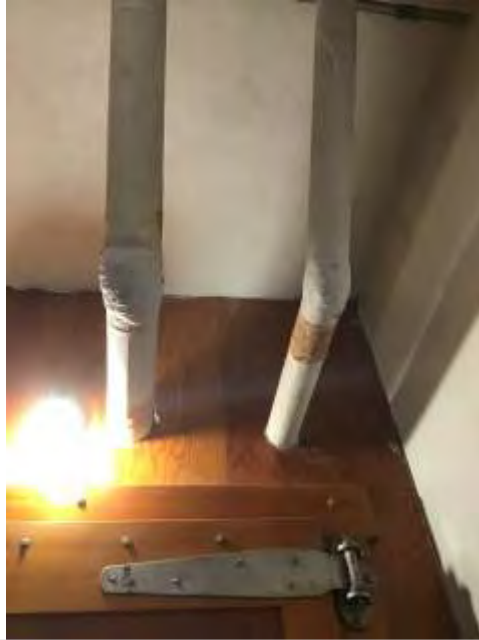
Additional Sample Notes:		
Sample ID:	Sample Type:	
1-32-TSI-96	TSI	
Sample Location:	Detailed Sample Location:	
Cafeteria	Freezer room pipes	
Sample Quantity:		
Sample Color:	XRF:	
Misc Sample Material:	Sample Condition:	Sample Friable?:
	Damaged or significantly damaged	Yes
Sample Photo:

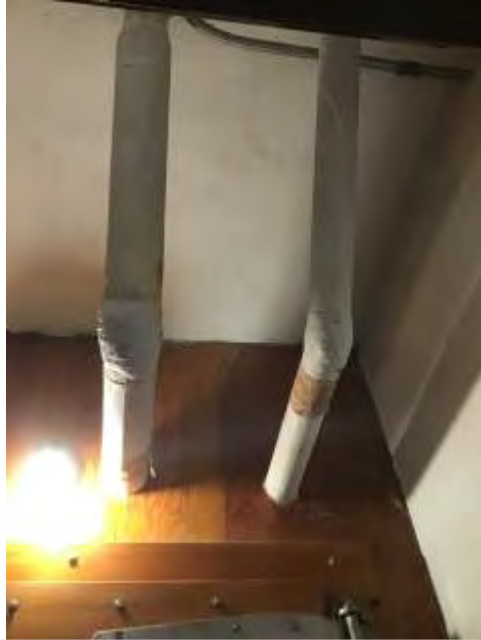
Additional Sample Notes:		
Sample ID:	Sample Type:	
1-33-TSI-97	TSI	
Sample Location:	Detailed Sample Location:	
Cafeteria	Freezer room pipes	
Sample Quantity:		
Sample Color:	XRF:	
Misc Sample Material:	Sample Condition:	Sample Friable?:
	Damaged or significantly damaged	Yes
Sample Photo:

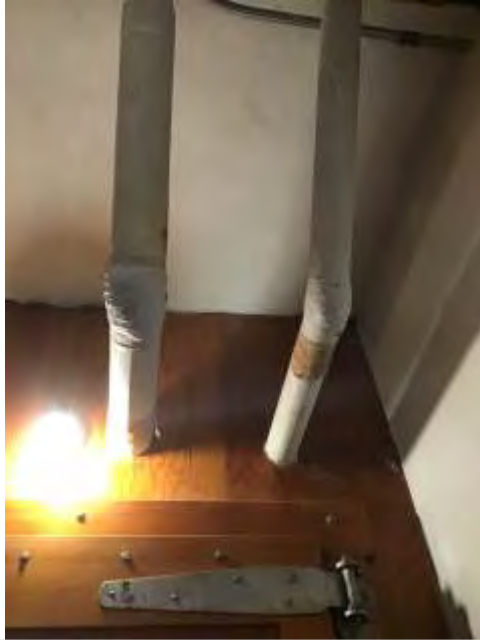
Additional Sample Notes:		
Sample ID:	Sample Type:	
1-33-TSI-98	TSI	
Sample Location:	Detailed Sample Location:	
Cafeteria	Freezer room pipes	
Sample Quantity:		
Sample Color:	XRF:	
Misc Sample Material:	Sample Condition:	Sample Friable?:
	Damaged or significantly damaged	Yes
Sample Photo:

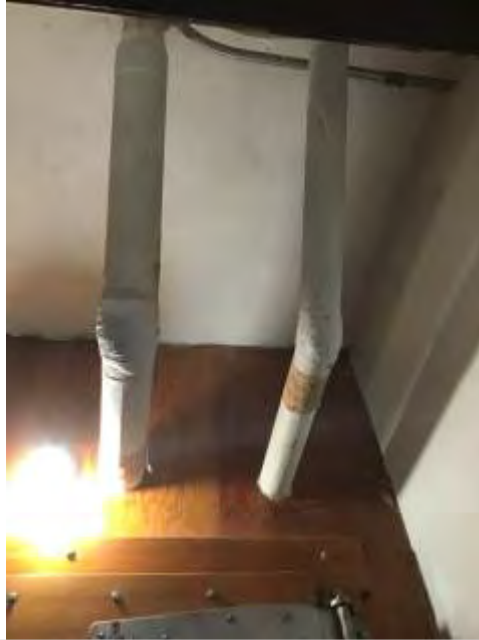
Additional Sample Notes:		
Sample ID:	Sample Type:	
1-33-TSI-99	TSI	
Sample Location:	Detailed Sample Location:	
Cafeteria	Freezer room pipes	
Sample Quantity:		
Sample Color:	XRF:	
Misc Sample Material:	Sample Condition:	Sample Friable?:
	Damaged or significantly damaged	Yes
Sample Photo:

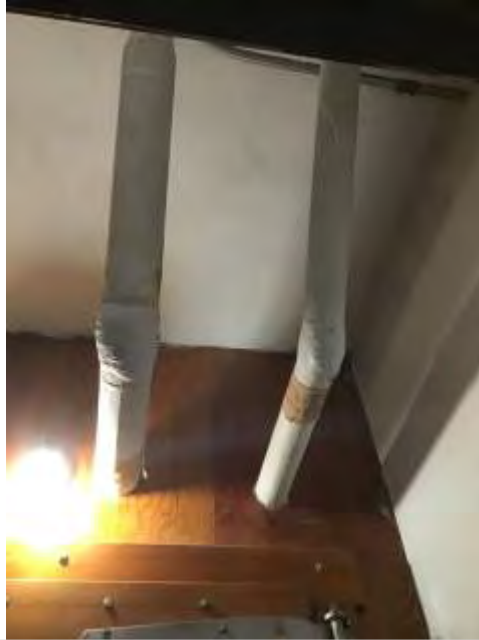
Additional Sample Notes:		
Sample ID:	Sample Type:	
1-34-TSI-100	TSI	
Sample Location:	Detailed Sample Location:	
Cafeteria	Freezer room pipes	
Sample Quantity:		
Sample Color:	XRF:	
Misc Sample Material:	Sample Condition:	Sample Friable?:
	Damaged or significantly damaged	Yes
Sample Photo:

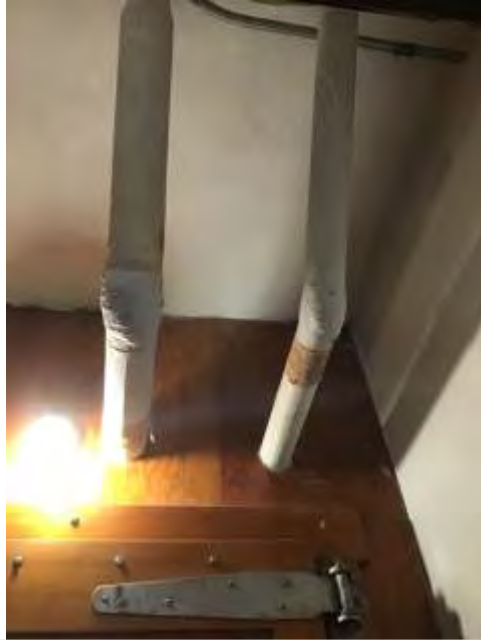
Additional Sample Notes:		
Sample ID:	Sample Type:	
1-34-TSI-101	TSI	
Sample Location:	Detailed Sample Location:	
Cafeteria	Freezer room pipes	
Sample Quantity:		
Sample Color:	XRF:	
Misc Sample Material:	Sample Condition:	Sample Friable?:
	Damaged or significantly damaged	Yes
Sample Photo:

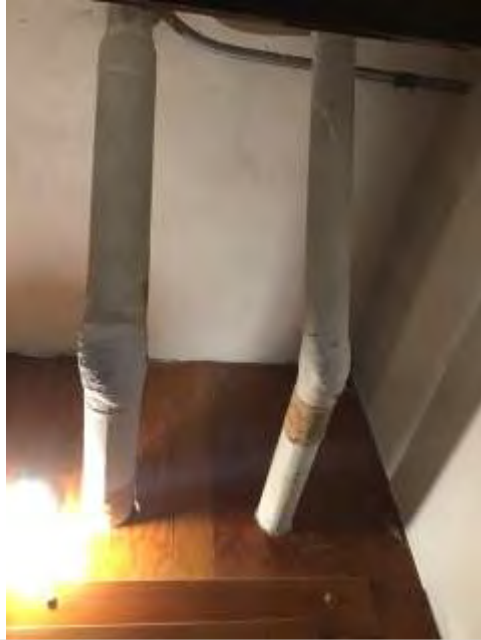
Additional Sample Notes:		
Sample ID:	Sample Type:	
1-34-TSI-102	TSI	
Sample Location:	Detailed Sample Location:	
Cafeteria	Freezer room pipes	
Sample Quantity:		
Sample Color:	XRF:	
Misc Sample Material:	Sample Condition:	Sample Friable?:
	Damaged or significantly damaged	Yes
Sample Photo:

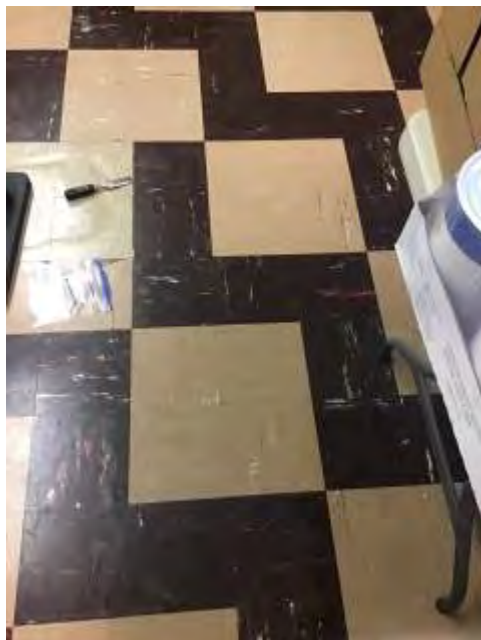
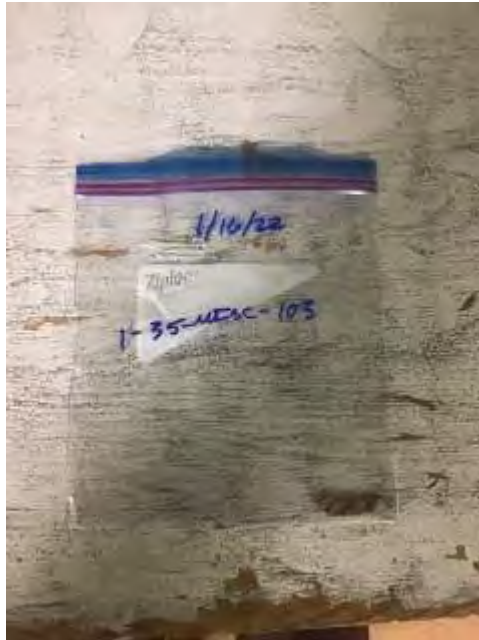
Sample ID:		Sample Type:	
1-35-MISC-103		MISC	
Sample Location:		Detailed Sample Location:	
Cafeteria		Middle of food storage room	
Sample Quantity:		245 SF	
Misc Sample Material:		Sample Condition:	Sample Friable?:
9x9 tan vinyl floor tile with black mastic		Damaged or significantly damaged friable miscellaneous ACM	No

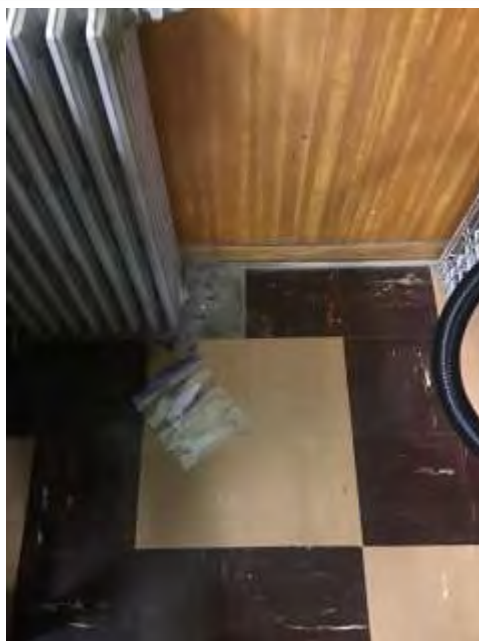
Additional Sample Notes:		
Sample ID:	Sample Type:	
1-35-MISC-104	MISC	
Sample Location:	Detailed Sample Location:	
Cafeteria	Southeast corner of food storage room	
Sample Quantity:	See 1-35-MISC-103	
Misc Sample Material:	Sample Condition:	Sample Friable?:
9x9 tan vinyl floor tile with black mastic	Damaged or significantly damaged friable miscellaneous ACM	No

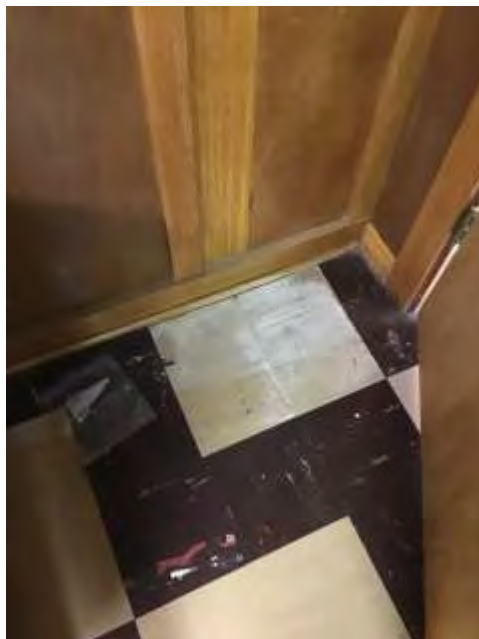
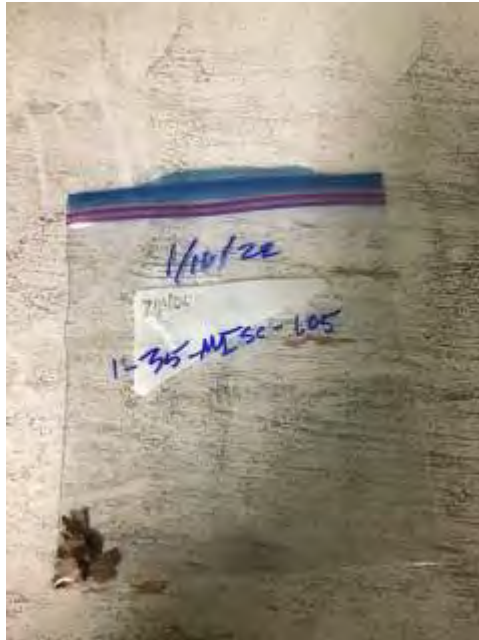
Additional Sample Notes:		
Sample ID:	Sample Type:	
1-35-MISC-105	MISC	
Sample Location:	Detailed Sample Location:	
Cafeteria	Northwest corner of food storage room behind door	
Sample Quantity:	245 SF	
Misc Sample Material:	Sample Condition:	Sample Friable?:
9x9 tan vinyl floor tile with black mastic	Damaged or significantly damaged friable miscellaneous ACM	No

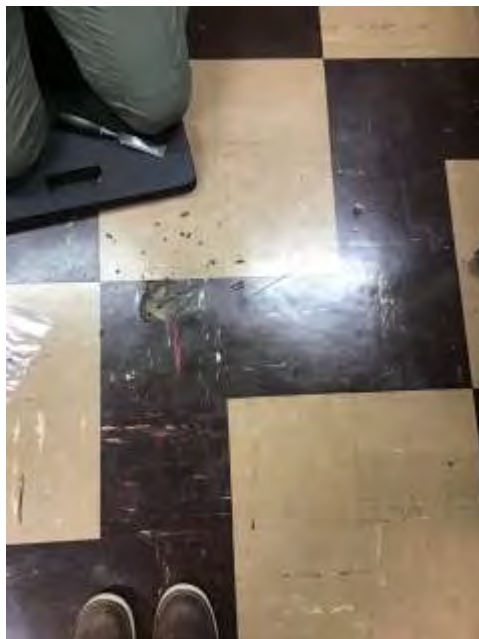
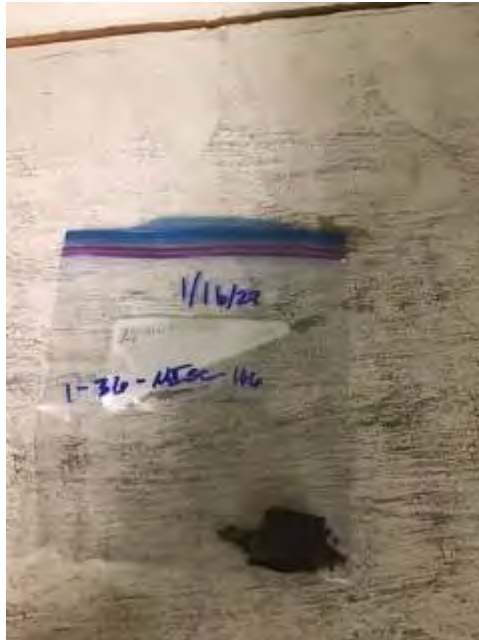
Additional Sample Notes:		
Sample ID:	Sample Type:	
1-36-MISC-106	MISC	
Sample Location:	Detailed Sample Location:	
Cafeteria	Middle of food storage room	
Sample Quantity:	245 SF	
Misc Sample Material:	Sample Condition:	Sample Friable?:
9x9 dark brown vinyl floor tile with black mastic	Damaged or significantly damaged friable miscellaneous ACM	No

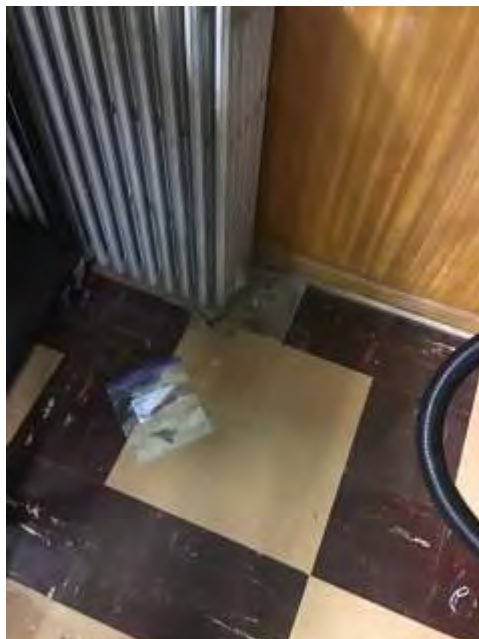
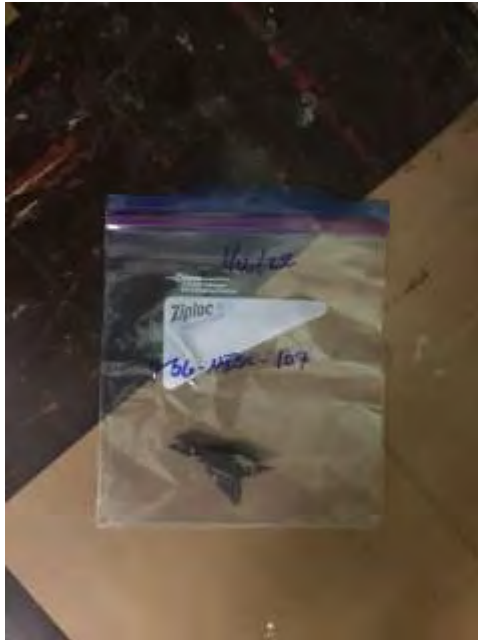
Additional Sample Notes:		
Sample ID:	Sample Type:	
1-36-MISC-107	MISC	
Sample Location:	Detailed Sample Location:	
Cafeteria	Southeast corner of food storage room	
Sample Quantity:	See 1-36-MISC-106	
Misc Sample Material:	Sample Condition:	Sample Friable?:
9x9 dark brown vinyl floor tile with black mastic	Damaged or significantly damaged friable miscellaneous ACM	No

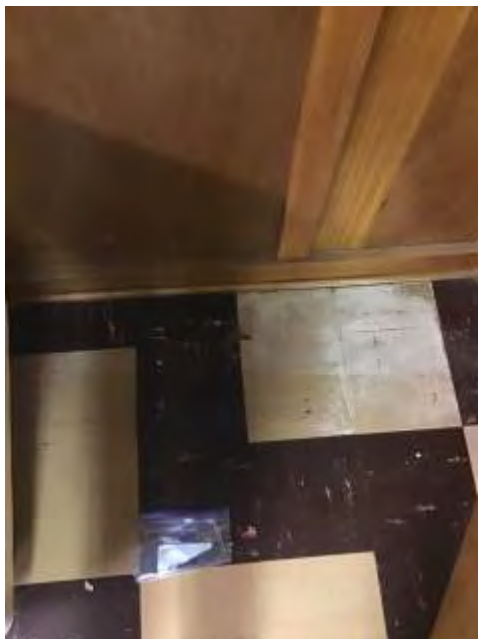
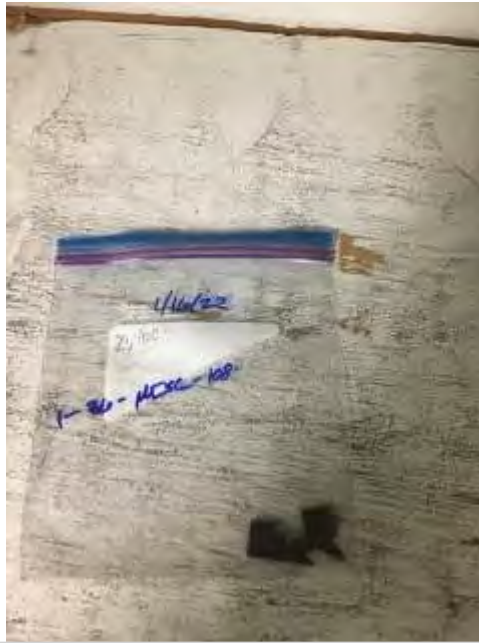
Additional Sample Notes:		
Sample ID:	Sample Type:	
1-36-MISC-108	MISC	
Sample Location:	Detailed Sample Location:	
Cafeteria	Northwest corner of food storage room behind door	
Sample Quantity:	See 1-36-MISC-106	
Misc Sample Material:	Sample Condition:	Sample Friable?:
9x9 dark brown vinyl floor tile with black mastic	Damaged or significantly damaged friable miscellaneous ACM	No

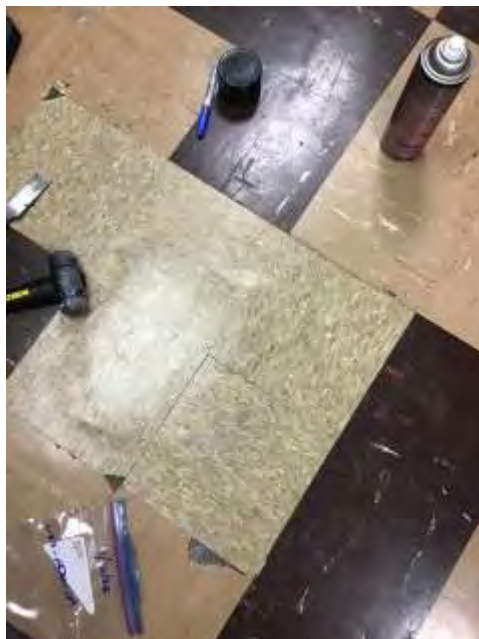
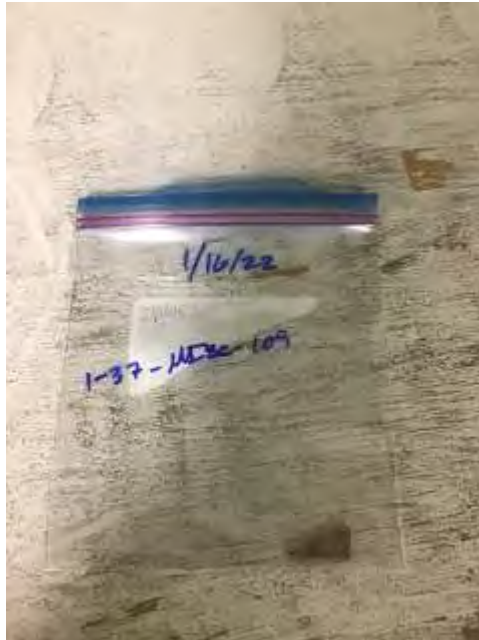
Additional Sample Notes:		
Sample ID:	Sample Type:	
1-37-MISC-109	MISC	
Sample Location:	Detailed Sample Location:	
Cafeteria	Middle of food storage room	
Sample Quantity:	245 SF	
Misc Sample Material:	Sample Condition:	Sample Friable?:
9x9 light spackled vinyl floor tile with Black and Tan mastic	Damaged or significantly damaged friable miscellaneous ACM	No

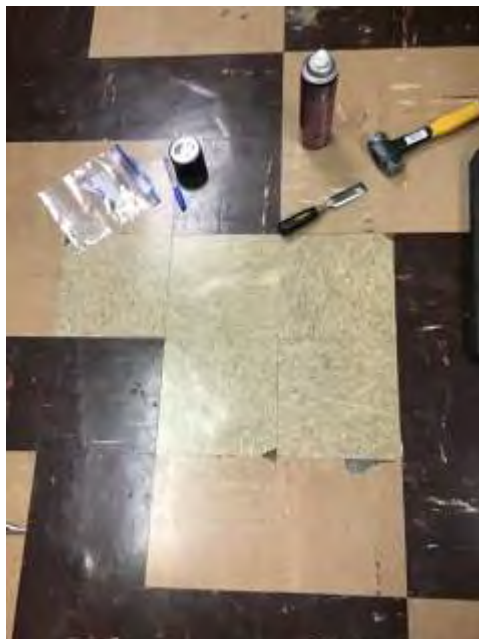
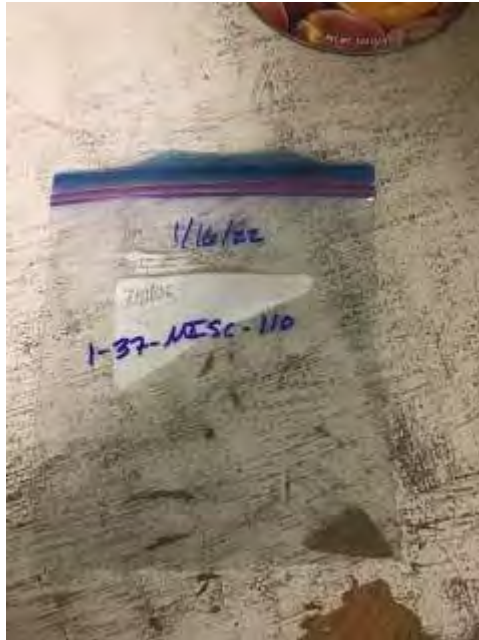
Additional Sample Notes:		
Sample ID:	Sample Type:	
1-37-MISC-110	MISC	
Sample Location:	Detailed Sample Location:	
Cafeteria	Middle of food storage room	
Sample Quantity:	See 1-37-MISC-109	
Misc Sample Material:	Sample Condition:	Sample Friable?:
9x9 light spackled vinyl floor tile with Black and Tan mastic	Damaged or significantly damaged friable miscellaneous ACM	No

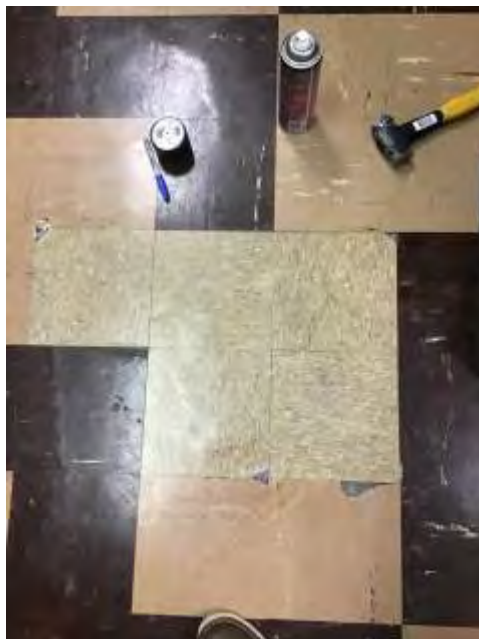
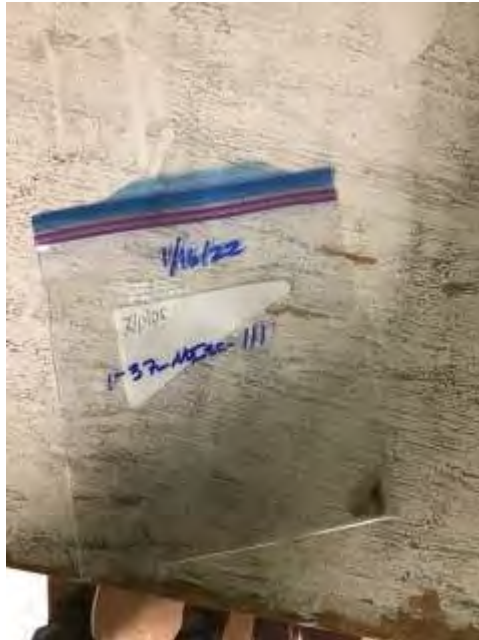
Additional Sample Notes:		
Sample ID:	Sample Type:	
1-37-MISC-111	MISC	
Sample Location:	Detailed Sample Location:	
Cafeteria	Middle of food storage room	
Sample Quantity:	See 1-37-MISC-109	
Misc Sample Material:	Sample Condition:	Sample Friable?:
9x9 light spackled vinyl floor tile with black and tan mastic	Damaged or significantly damaged friable miscellaneous ACM	No

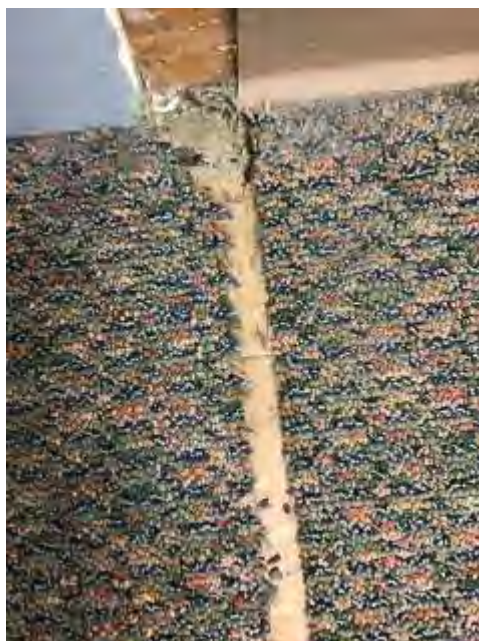
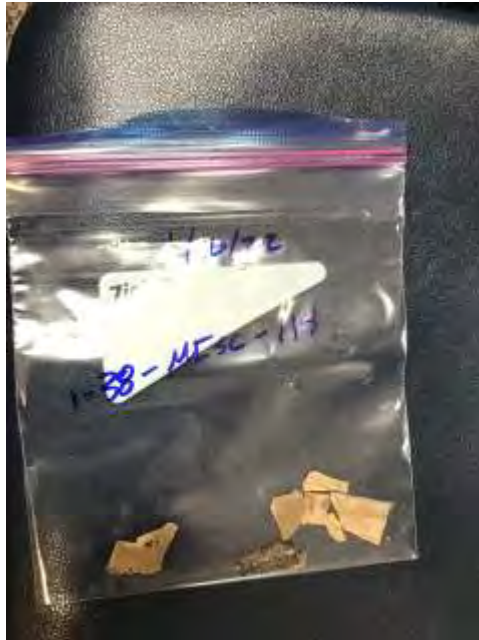
Additional Sample Notes:		
Sample ID:	Sample Type:	
1-38-MISC-114	MISC	
Sample Location:	Detailed Sample Location:	
Computer room	Near doorway	
Sample Quantity:	593.4 SF	
Misc Sample Material:	Sample Condition:	Sample Friable?:
9x9 light tan vinyl floor tile with black mastic	Damaged or significantly damaged friable miscellaneous ACM	No

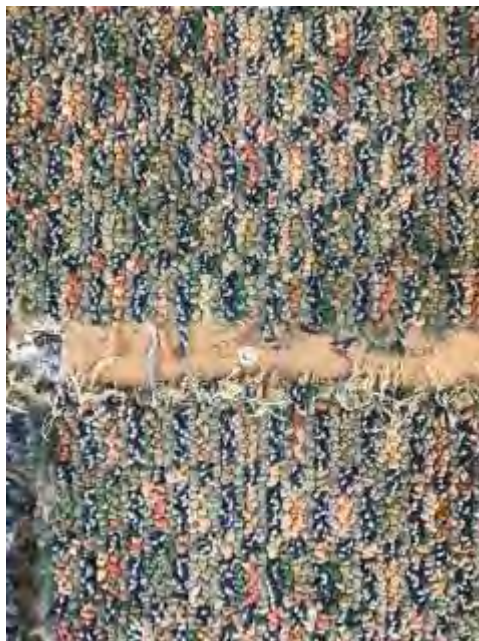
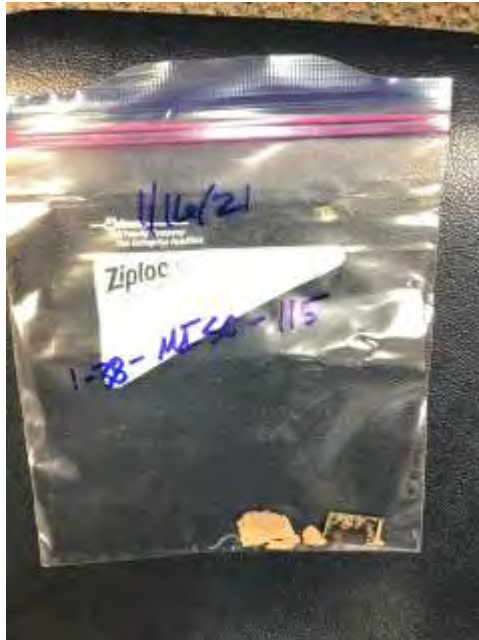
Additional Sample Notes:		
Sample ID:	Sample Type:	
1-38-MISC-115	MISC	
Sample Location:	Detailed Sample Location:	
Computer room	Middle of room near carpet cutout	
Sample Quantity:	See 1-38-MISC-114	
Misc Sample Material:	Sample Condition:	Sample Friable?:
9x9 light tan vinyl floor tile with black mastic	Damaged or significantly damaged friable miscellaneous ACM	No

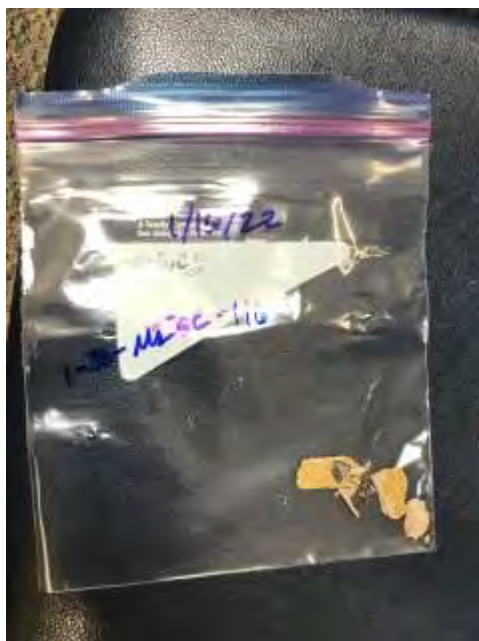
Additional Sample Notes:		
Sample ID:	Sample Type:	
1-38-MISC-116	MISC	
Sample Location:	Detailed Sample Location:	
Computer room	North corner of office space	
Sample Quantity:	See 1-38-MISC-114	
Misc Sample Material:	Sample Condition:	Sample Friable?:
9x9 light tan vinyl floor tile with black mastic	Damaged or significantly damaged friable miscellaneous ACM	No

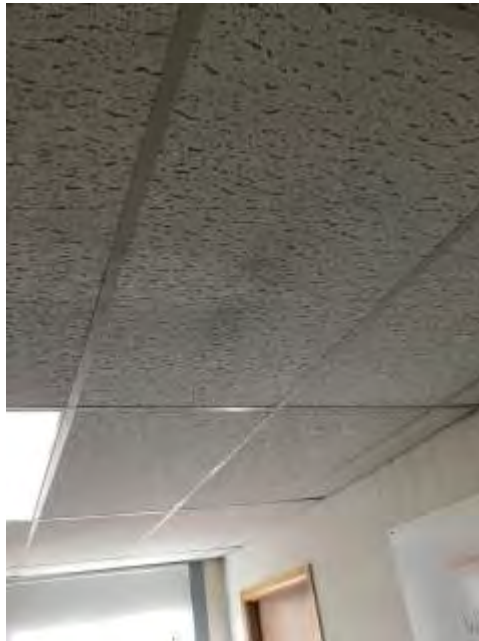
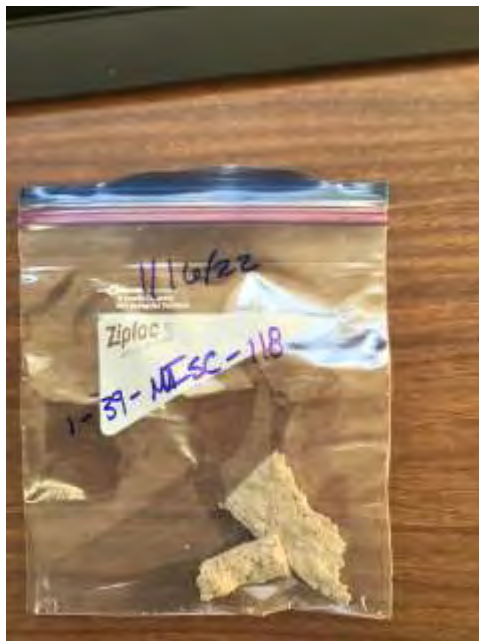
Additional Sample Notes:		
Sample ID:	Sample Type:	
1-39-MISC-118	MISC	
Sample Location:	Detailed Sample Location:	
Computer lab	West corner of computer lab ceiling	
Sample Quantity:	1038 SF	
Misc Sample Material:	Sample Condition:	Sample Friable?:
Stipple pattern drop down ceiling tile	Damaged or significantly damaged friable miscellaneous ACM	Yes

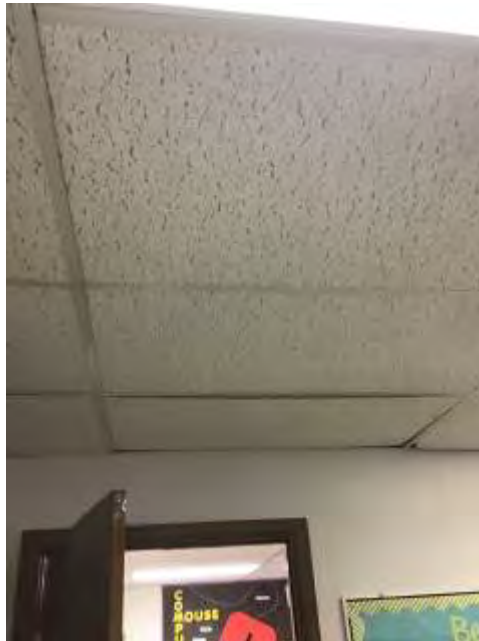
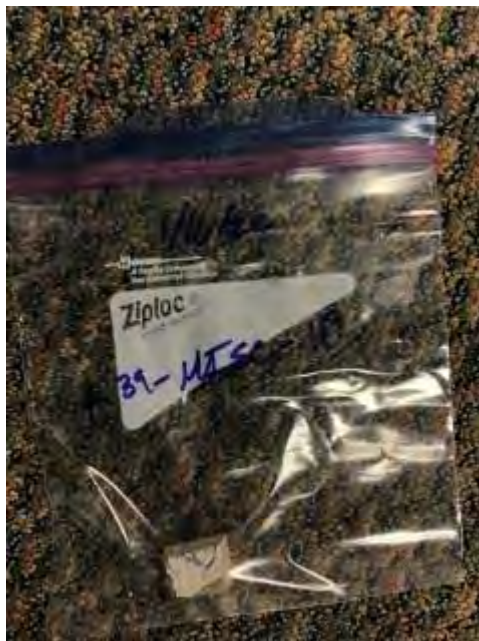
Additional Sample Notes:		
Sample ID:	Sample Type:	
1-39-MISC-119	MISC	
Sample Location:	Detailed Sample Location:	
Computer lab	East corner of office space ceiling	
Sample Quantity:	See 1-39-MISC-118	
Misc Sample Material:	Sample Condition:	Sample Friable?:
Stipple pattern drop down ceiling tile	Damaged or significantly damaged friable miscellaneous ACM	Yes

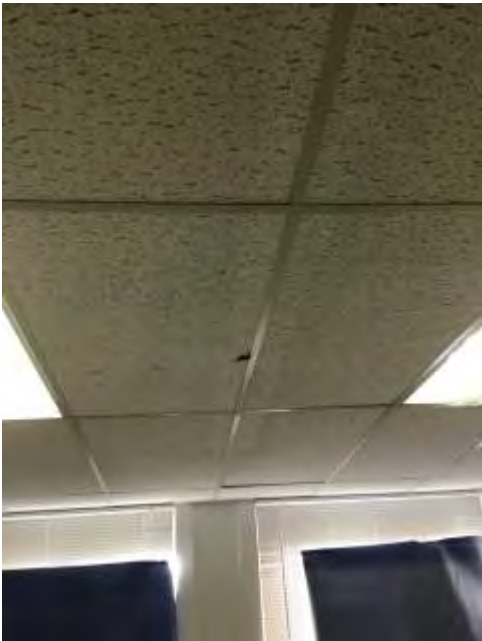
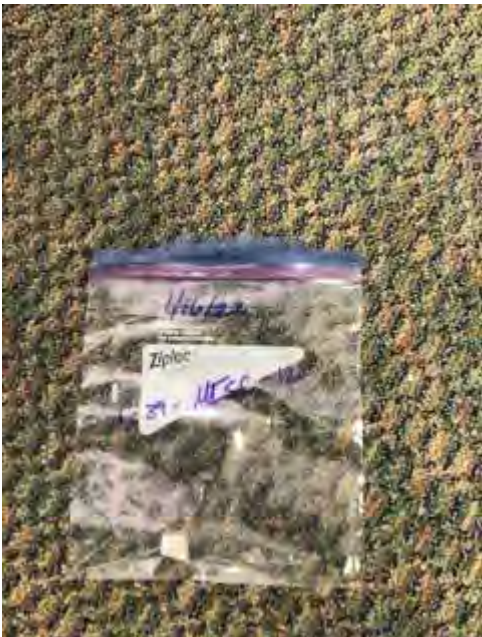
Additional Sample Notes:		
Sample ID:	Sample Type:	
1-39-MISC-120	MISC	
Sample Location:	Detailed Sample Location:	
Computer lab	Middle of office space ceiling	
Sample Quantity:	See 1-39-MISC-118	
Misc Sample Material:	Sample Condition:	Sample Friable?:
Stipple pattern drop down ceiling tile	Damaged or significantly damaged friable miscellaneous ACM	Yes
Sample Photo:

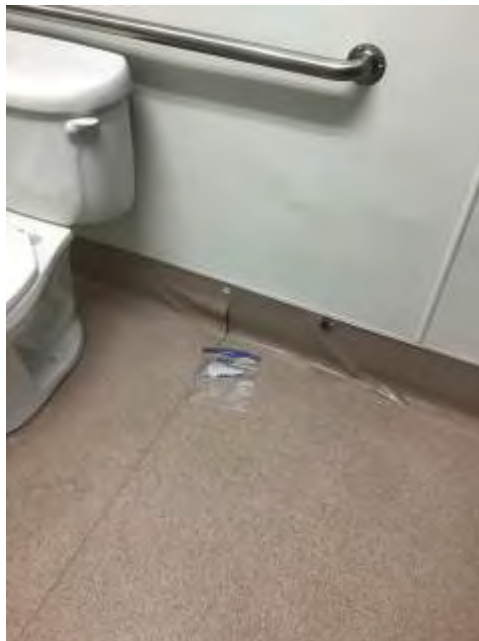
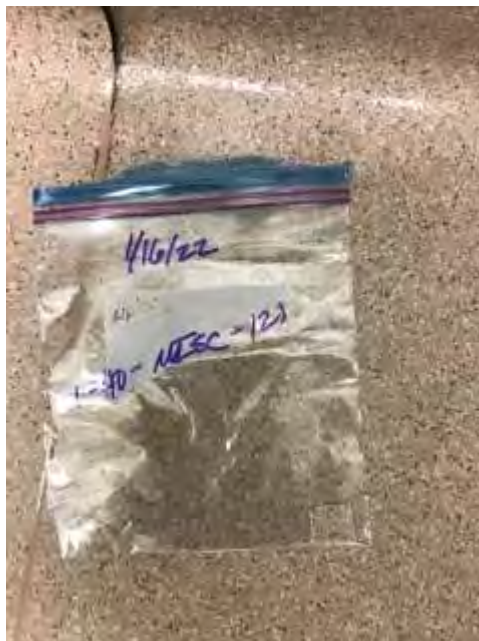
Additional Sample Notes:		
Sample ID:	Sample Type:	
1-40-MISC-121	MISC	
Sample Location:	Detailed Sample Location:	
Girls bathroom	Northeast corner behind toilet	
Sample Quantity:	149 SF	
Misc Sample Material:	Sample Condition:	Sample Friable?:
Pink linoleum with yellow mastic	Damaged or significantly damaged friable miscellaneous ACM	No

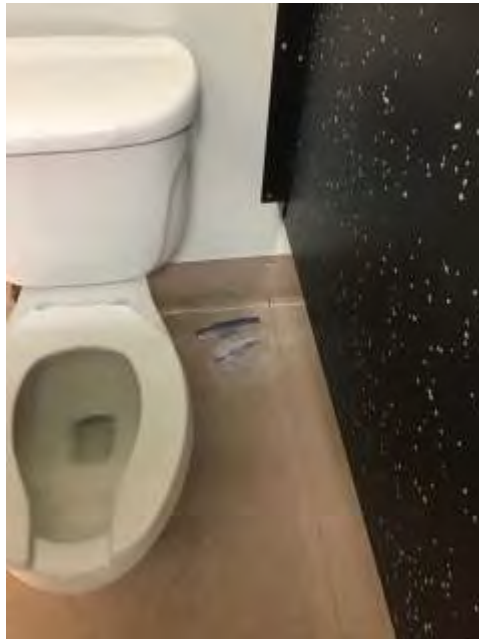
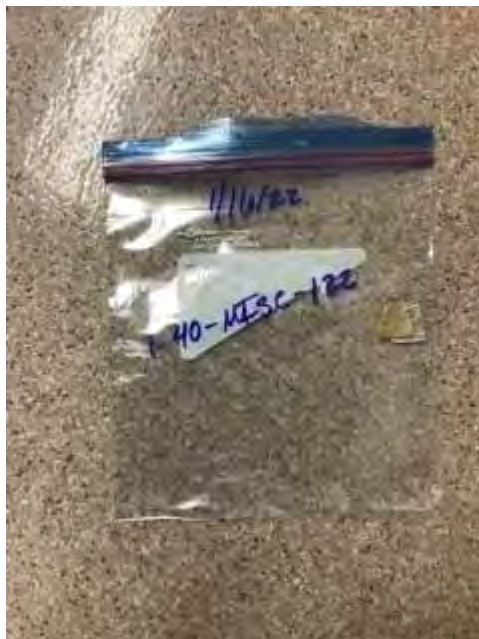
Additional Sample Notes:		
Sample ID:	Sample Type:	
1-40-MISC-122	MISC	
Sample Location:	Detailed Sample Location:	
Girls bathroom	Behind toilet of second stall	
Sample Quantity:	See 1-40-MISC-121	
Misc Sample Material:	Sample Condition:	Sample Friable?:
Pink linoleum with yellow mastic	Damaged or significantly damaged friable miscellaneous ACM	No

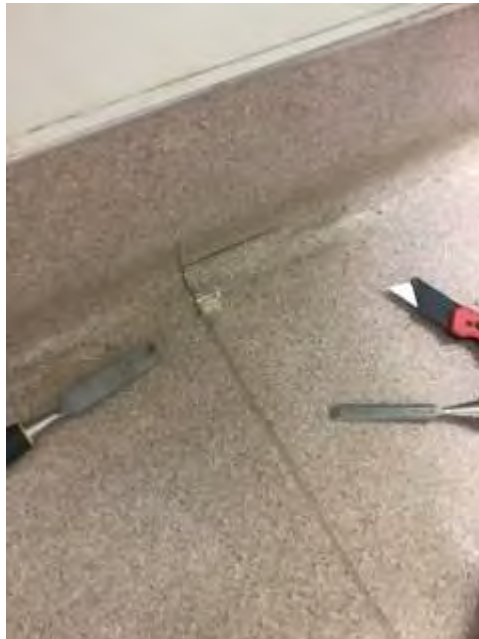
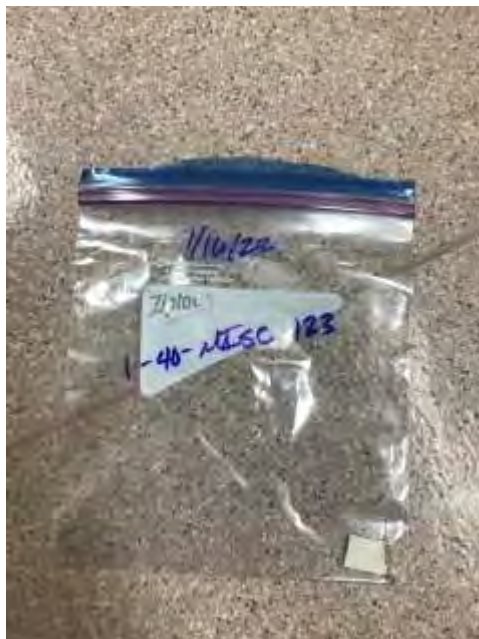
Additional Sample Notes:		
Sample ID:	Sample Type:	
1-40-MISC-123	MISC	
Sample Location:	Detailed Sample Location:	
Girls bathroom	Under sink	
Sample Quantity:	See 1-40-MISC-121	
Misc Sample Material:	Sample Condition:	Sample Friable?:
Pink linoleum with yellow mastic	Damaged or significantly damaged friable miscellaneous ACM	No

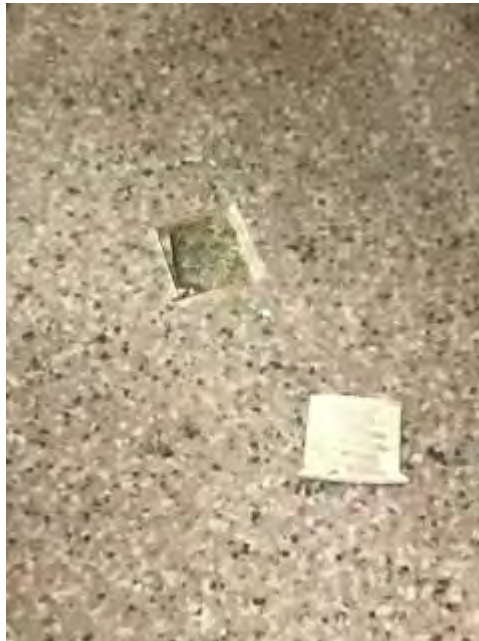
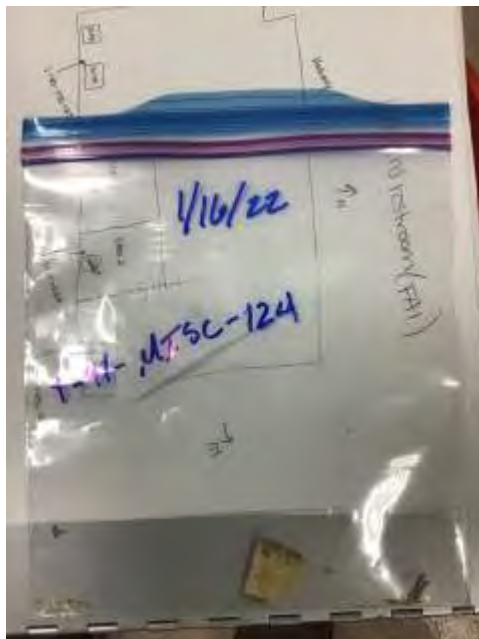
Additional Sample Notes:		
Sample ID:	Sample Type:	
1-41-MISC-124	MISC	
Sample Location:	Detailed Sample Location:	
Girls bathroom	Northeast corner behind toilet	
Sample Quantity:	149 SF	
Misc Sample Material:	Sample Condition:	Sample Friable?:
White vinyl flooring with yellow mastic	Damaged or significantly damaged friable miscellaneous ACM	No

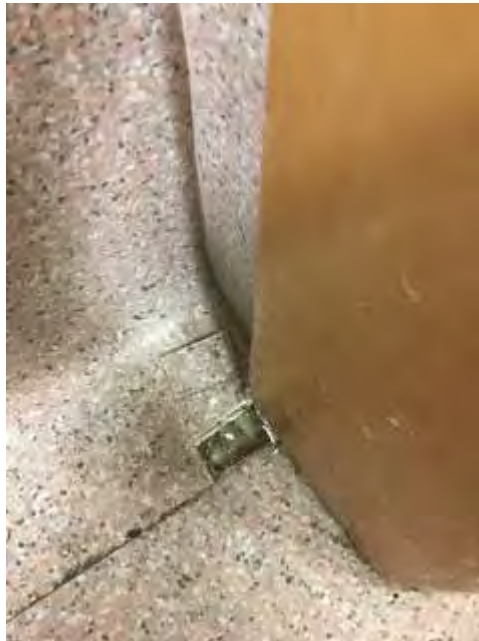
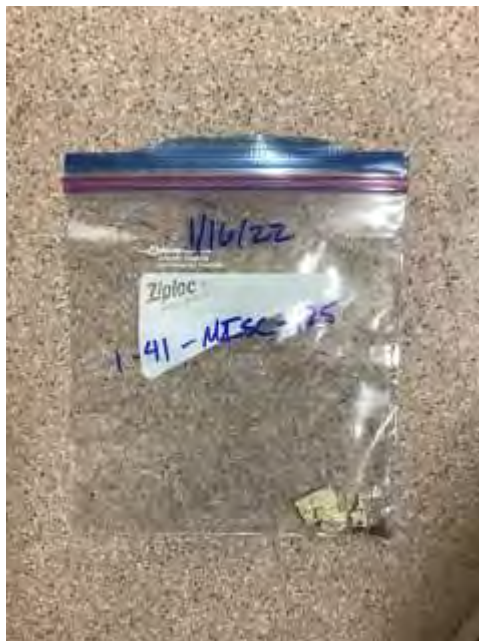
Additional Sample Notes:		Under pink linoleum
Sample ID:	Sample Type:	
1-41-MISC-125	MISC	
Sample Location:	Detailed Sample Location:	
Girls bathroom	Near doorway	
Sample Quantity:	See 1-41-MISC-124	
Misc Sample Material:	Sample Condition:	Sample Friable?:
White vinyl flooring with yellow and black mastic	Damaged or significantly damaged friable miscellaneous ACM;Other	No

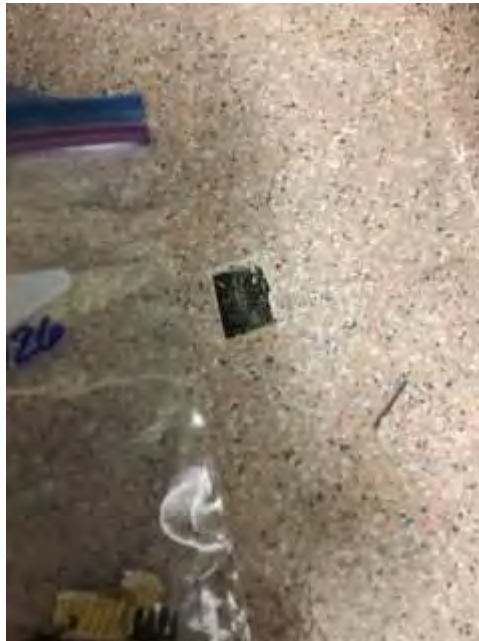
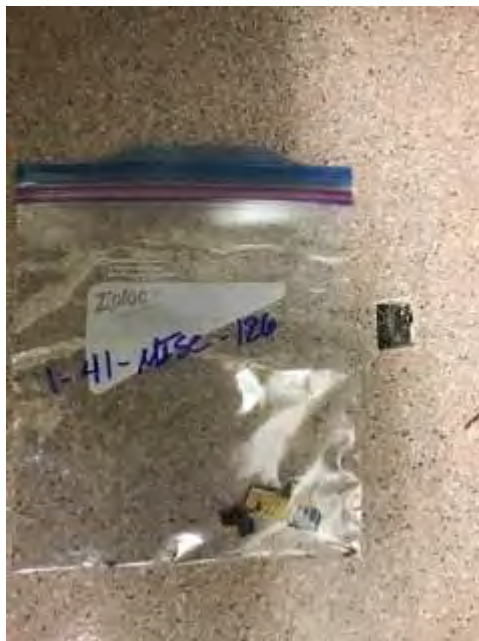
Additional Sample Notes:		Under pink linoleum
Sample ID:	Sample Type:	
1-41-MISC-126	MISC	
Sample Location:	Detailed Sample Location:	
Girls bathroom	Near sinks	
Sample Quantity:	See 1-41-MISC-124	
Misc Sample Material:	Sample Condition:	Sample Friable?:
White vinyl flooring with yellow and black mastic	Damaged or significantly damaged friable miscellaneous ACM	No

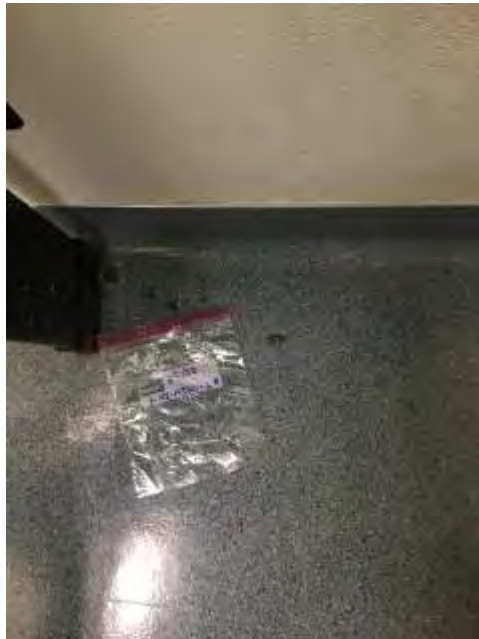
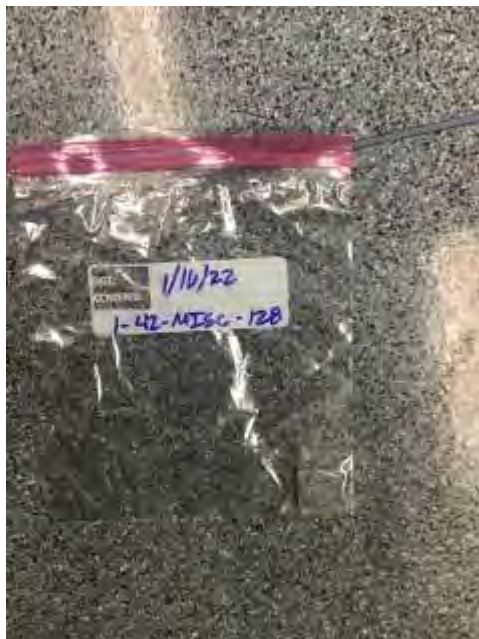
Additional Sample Notes:	Under pink linoleum	
Sample ID:	Sample Type:	
1-42-MISC-128	MISC	
Sample Location:	Detailed Sample Location:	
Boys restroom	Northeast corner behind toilet	
Sample Quantity:	346 SF	
Misc Sample Material:	Sample Condition:	Sample Friable?:
Blue linoleum with yellow mastic	Damaged or significantly damaged friable miscellaneous ACM	No

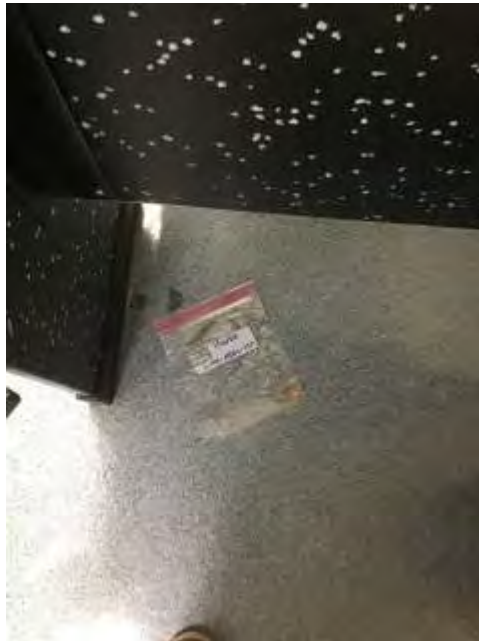
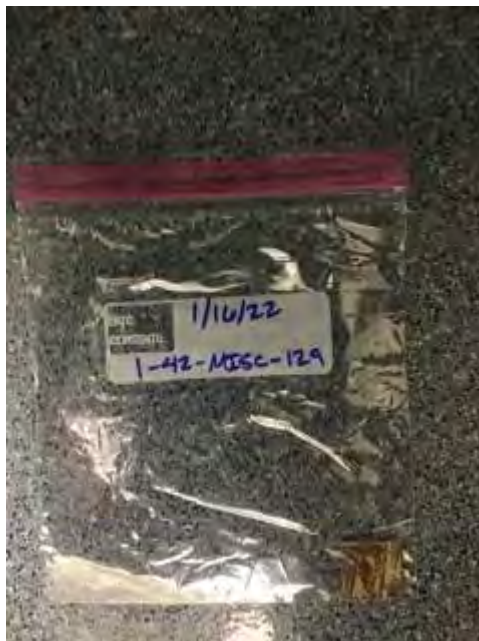
Additional Sample Notes:		
Sample ID:	Sample Type:	
1-42-MISC-129	MISC	
Sample Location:	Detailed Sample Location:	
Boys restroom	Front corner of first bathroom stall leg	
Sample Quantity:	See 1-42-MISC-128	
Misc Sample Material:	Sample Condition:	Sample Friable?:
Blue linoleum with yellow mastic	Damaged or significantly damaged friable miscellaneous ACM	No

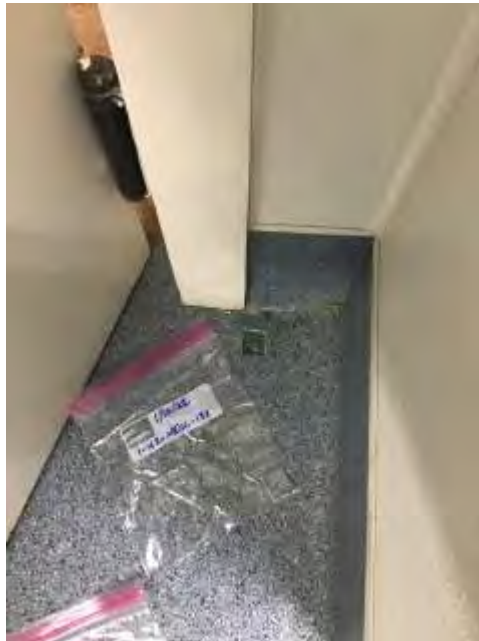
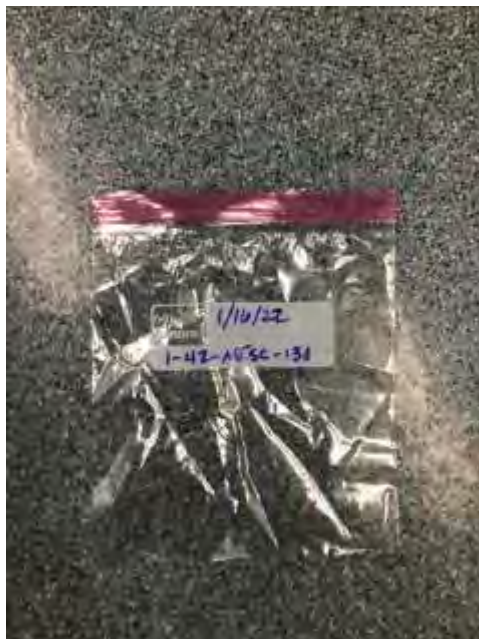
Additional Sample Notes:		
Sample ID:	Sample Type:	
1-42-MISC-130	MISC	
Sample Location:	Detailed Sample Location:	
Boys restroom	Behind door	
Sample Quantity:	See 1-42-MISC-128	
Misc Sample Material:	Sample Condition:	Sample Friable?:
Blue linoleum with yellow mastic	Damaged or significantly damaged friable miscellaneous ACM	No

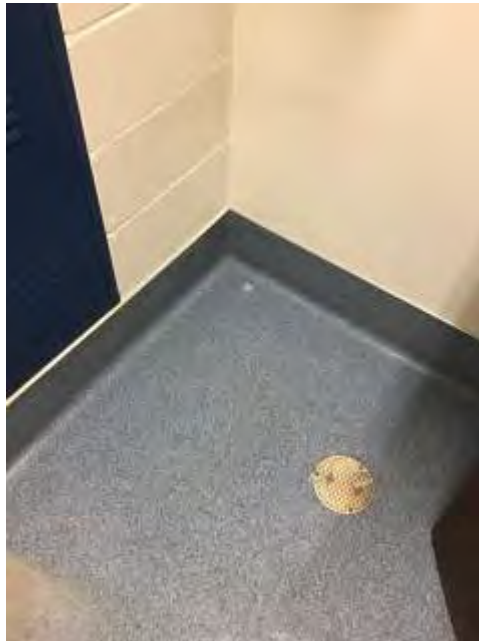
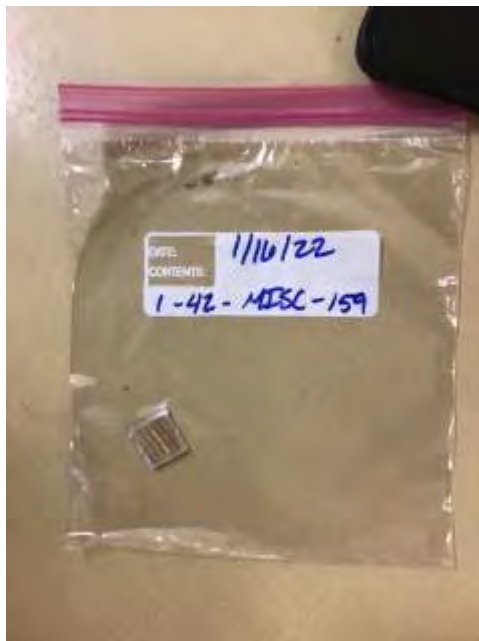
Additional Sample Notes:		
Sample ID:	Sample Type:	
1-42-MISC-159	MISC	
Sample Location:	Detailed Sample Location:	
Gym	Corner of bathroom floor	
Sample Quantity:	346 SF	
Misc Sample Material:	Sample Condition:	Sample Friable?:
Blue linoleum with yellow mastic	Damaged or significantly damaged friable miscellaneous ACM	No

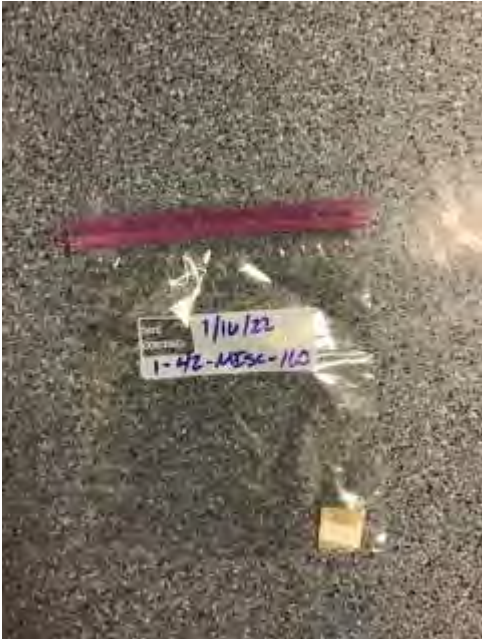
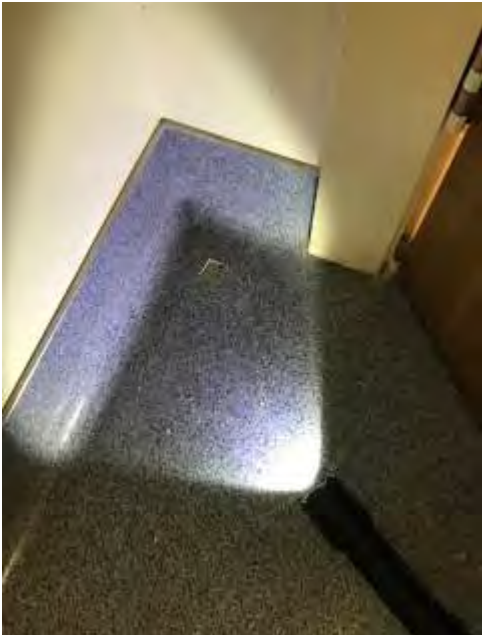
Additional Sample Notes:		
Sample ID:	Sample Type:	
1-42-MISC-160	MISC	
Sample Location:	Detailed Sample Location:	
Faculty	Storage room	
Sample Quantity:	346 SF	
Misc Sample Material:	Sample Condition:	Sample Friable?:
Blue linoleum with yellow mastic	Damaged or significantly damaged friable miscellaneous ACM	No
Sample Photo:

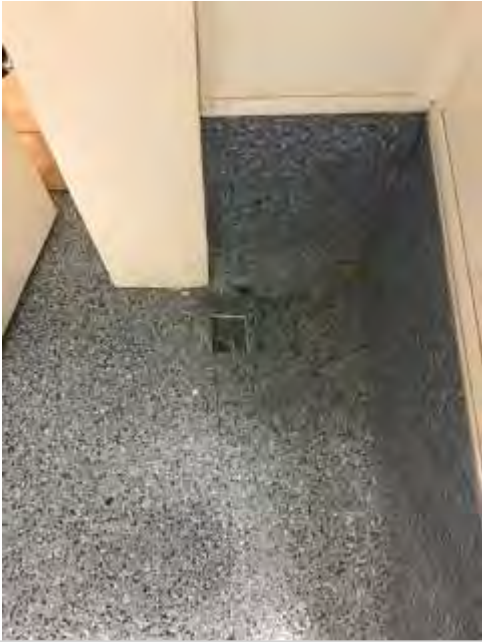
Additional Sample Notes:		
Sample ID:	Sample Type:	
1-43-MISC-131	MISC	
Sample Location:	Detailed Sample Location:	
Boys restroom	Behind door	
Sample Quantity:	250 SF	
Misc Sample Material:	Sample Condition:	Sample Friable?:
9x9 green vinyl tile with black mastic	Damaged or significantly damaged friable miscellaneous ACM	No
Sample Photo:

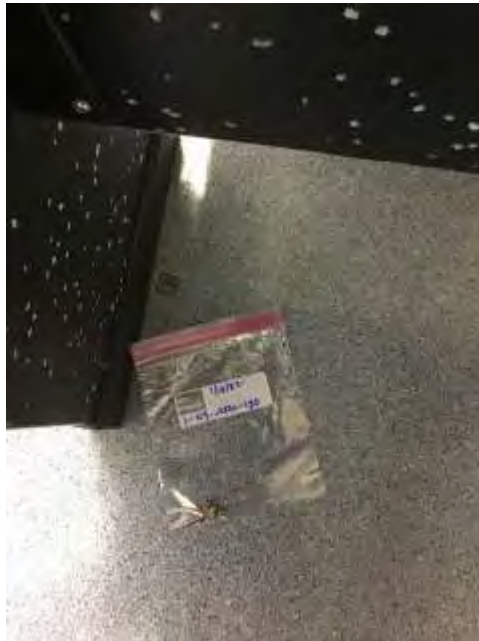
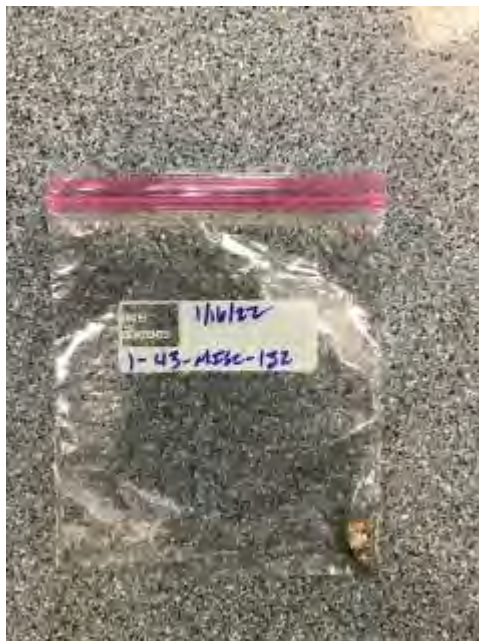
Additional Sample Notes:	Tile under linoleum	
Sample ID:	Sample Type:	
1-43-MISC-132	MISC	
Sample Location:	Detailed Sample Location:	
Boys restroom	Northeast stall behind toilet	
Sample Quantity:	See 1-43-MISC-131	
Misc Sample Material:	Sample Condition:	Sample Friable?:
9x9 green vinyl tile with black mastic	Damaged or significantly damaged friable miscellaneous ACM	No
