HAZARDOUS BUILDING MATERIALS SURVEY

CONDON GRADE SCHOOL
220 S. EAST STREET
CONDON, OREGON

Prepared for
CITY OF CONDON
May 17, 2022
Project No. M2053.01.002

Prepared by
Maul Foster & Alongi, Inc.
3140 NE Broadway Street, Portland, OR 97232

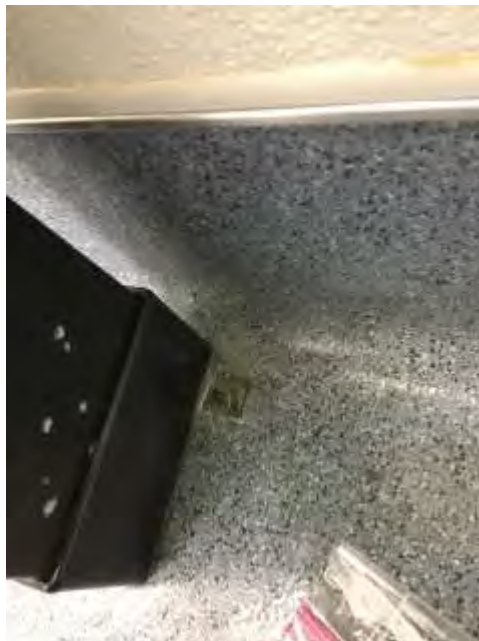
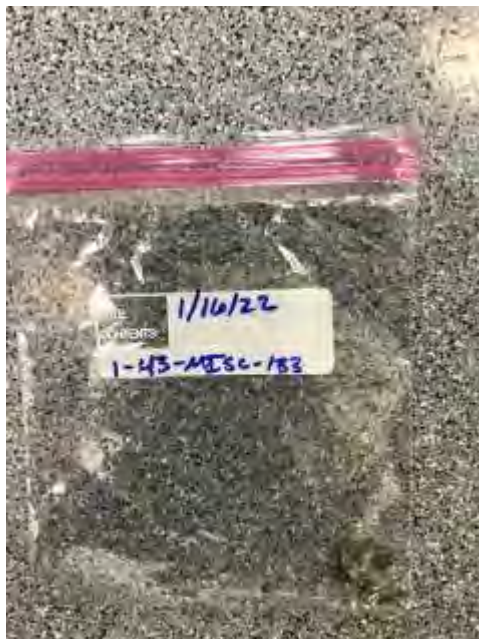
Additional Sample Notes:	Tile under linoleum	
Sample ID:	Sample Type:	
1-43-MISC-133	MISC	
Sample Location:	Detailed Sample Location:	
Boys restroom	Farthest stall from entrance behind toilet	
Sample Quantity:	See 1-43-MISC-131	
Misc Sample Material:	Sample Condition:	Sample Friable?:
9x9 green vinyl tile with black mastic	Damaged or significantly damaged friable miscellaneous ACM	No

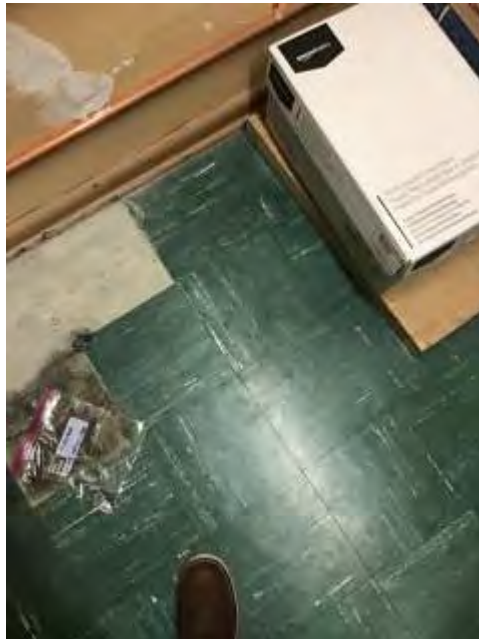
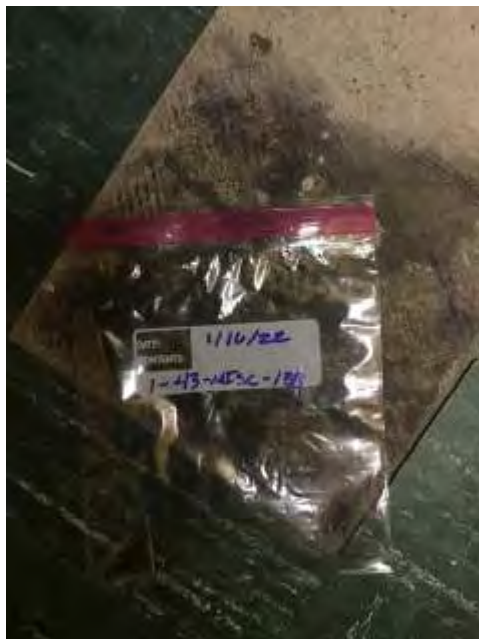
Additional Sample Notes:		Tile under linoleum	
Sample ID:		Sample Type:	
1-43-MISC-138		MISC	
Sample Location:		Detailed Sample Location:	
Boys restroom		North edge of floor in bathroom supply closet	
Sample Quantity:		See 1-43-MISC-131	
Misc Sample Material:		Sample Condition:	Sample Friable?:
9x9 green vinyl tile with black mastic		Damaged or significantly damaged friable miscellaneous ACM	No

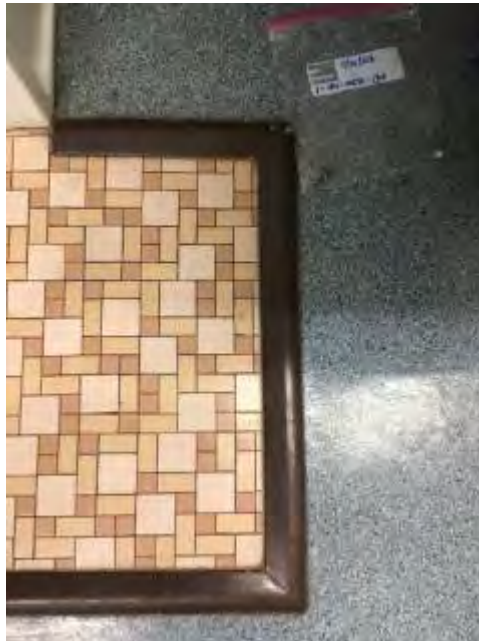
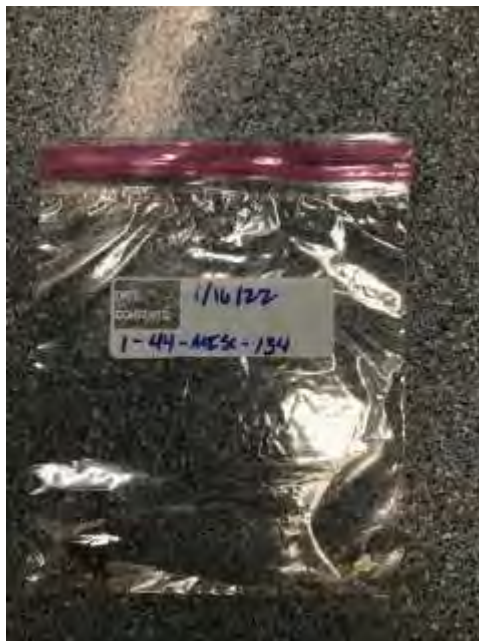
Additional Sample Notes:		Tile under linoleum	
Sample ID:		Sample Type:	
1-44-MISC-134		MISC	
Sample Location:		Detailed Sample Location:	
Boys restroom		Corner closest to sink	
Sample Quantity:		15 LF	
Misc Sample Material:		Sample Condition:	Sample Friable?:
Brown transition strip with yellow mastic		Damaged or significantly damaged friable miscellaneous ACM	No

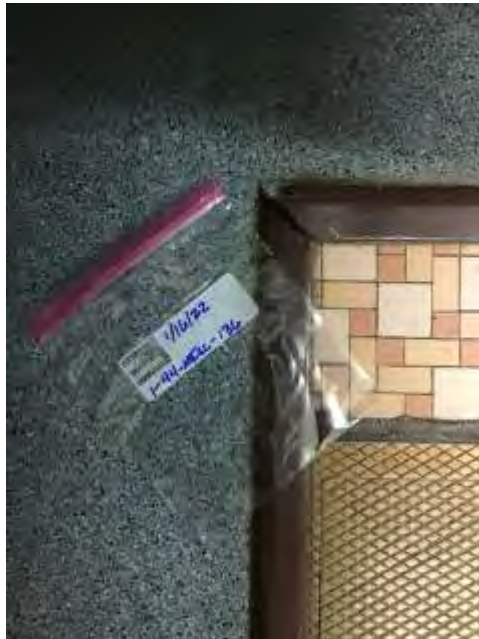
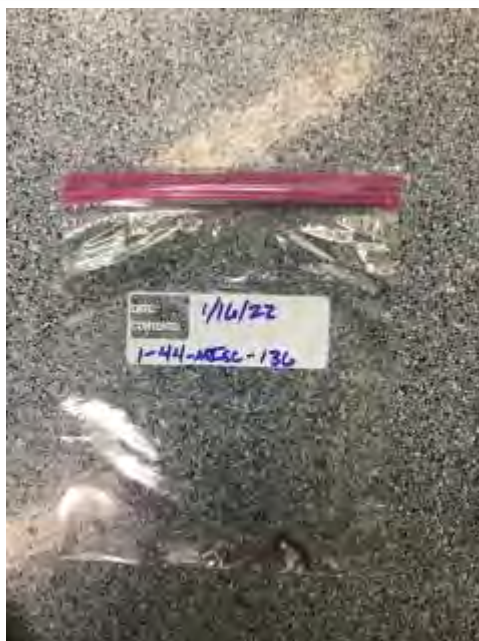
Sample ID:	Sample Type:	
1-44-MISC-136	MISC	
Sample Location:	Detailed Sample Location:	
Boys restroom	Back corner under bathroom stall	
Sample Quantity:	See 1-44-MISC-134	
Misc Sample Material:	Sample Condition:	Sample Friable?:
Brown transition strip with yellow mastic	Damaged or significantly damaged friable miscellaneous ACM	No

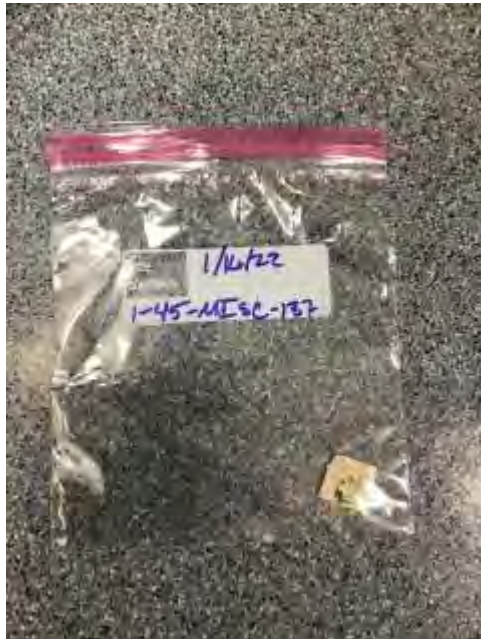
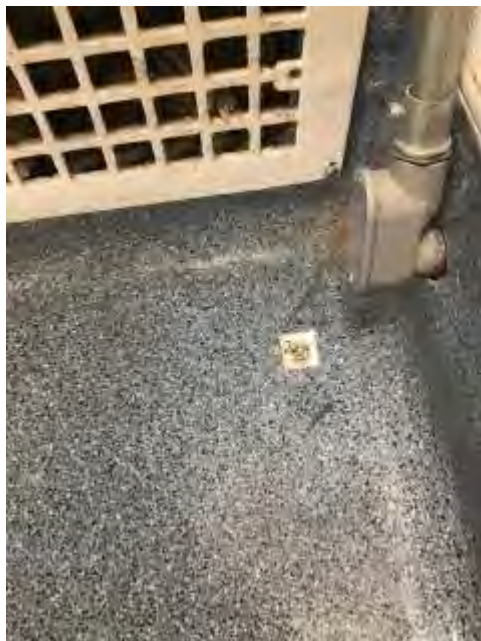
Additional Sample Notes:		
Sample ID:	Sample Type:	
1-45-MISC-137	MISC	
Sample Location:	Detailed Sample Location:	
Boys bathroom	Corner under sink	
Sample Quantity:	20 SF	
Misc Sample Material:	Sample Condition:	Sample Friable?:
White leveling compound with black mastic	Damaged or significantly damaged friable miscellaneous ACM	Yes

Additional Sample Notes:	Only took one sample due to the potential for creating a friable ACM hazard
---------------------------------	---

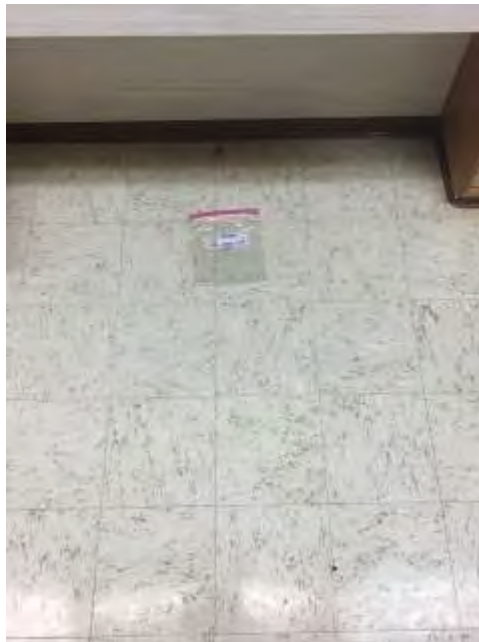
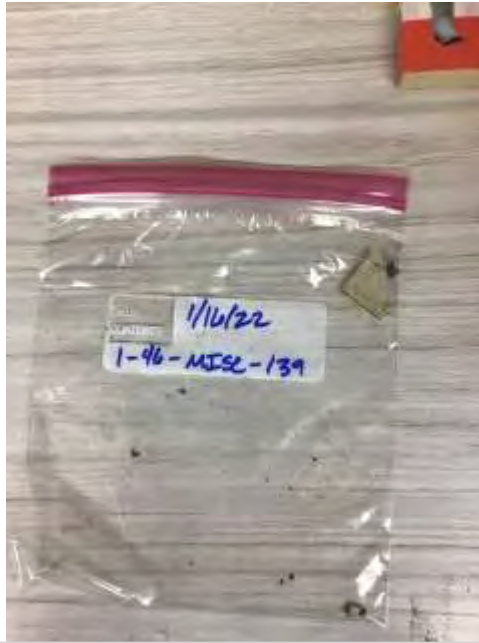
Sample ID:	Sample Type:	
1-46-MISC-139	MISC	
Sample Location:	Detailed Sample Location:	
Library	Storage room under desk	
Sample Quantity:	1,637 SF	
Misc Sample Material:	Sample Condition:	Sample Friable?:
9x9 white vinyl floor tiles with black mastic	Damaged or significantly damaged friable miscellaneous ACM	No

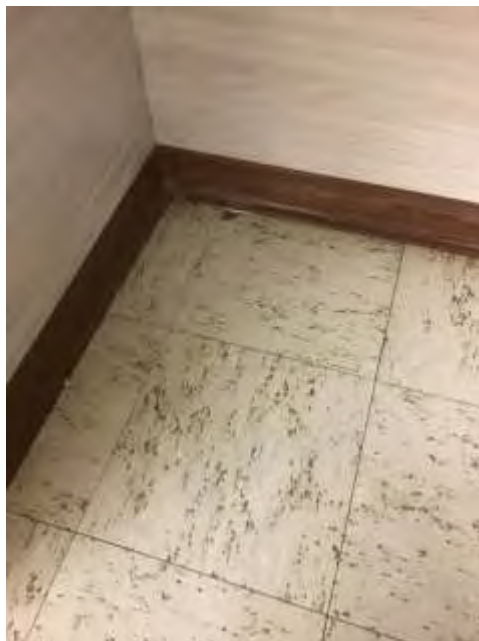
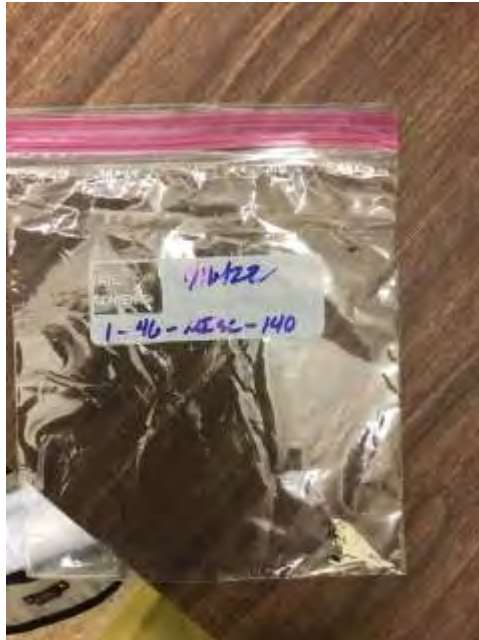
Additional Sample Notes:		
Sample ID:	Sample Type:	
1-46-MISC-140	MISC	
Sample Location:	Detailed Sample Location:	
Library	North wall under printer desk	
Sample Quantity:	See 1-46-MISC-139	
Misc Sample Material:	Sample Condition:	Sample Friable?:
9x9 white vinyl floor tiles with black mastic	Damaged or significantly damaged friable miscellaneous ACM	No

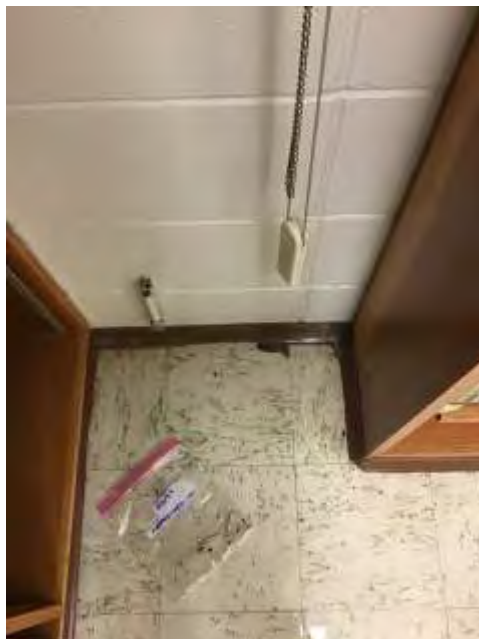
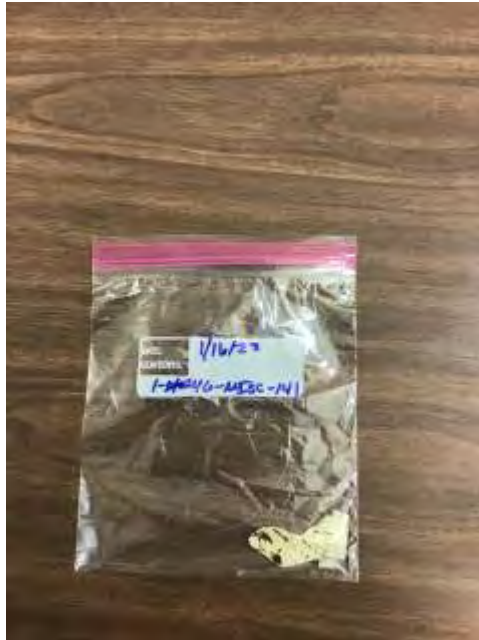
Additional Sample Notes:		
Sample ID:	Sample Type:	
1-46-MISC-141	MISC	
Sample Location:	Detailed Sample Location:	
Library	Southeast corner under TV	
Sample Quantity:	See 1-46-MISC-139	
Misc Sample Material:	Sample Condition:	Sample Friable?:
9x9 white vinyl floor tiles with black mastic	Damaged or significantly damaged friable miscellaneous ACM	No

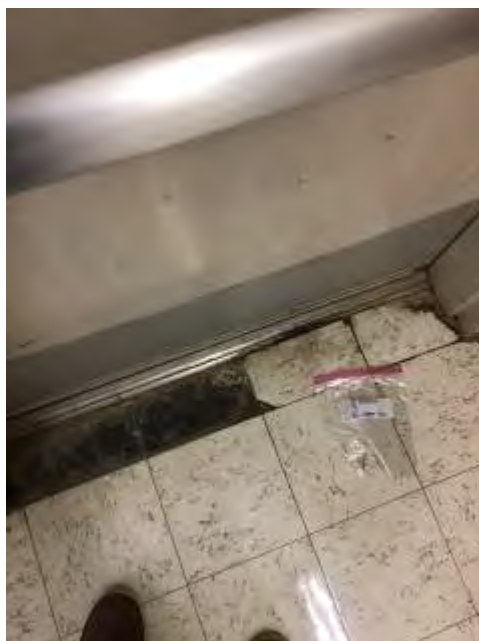
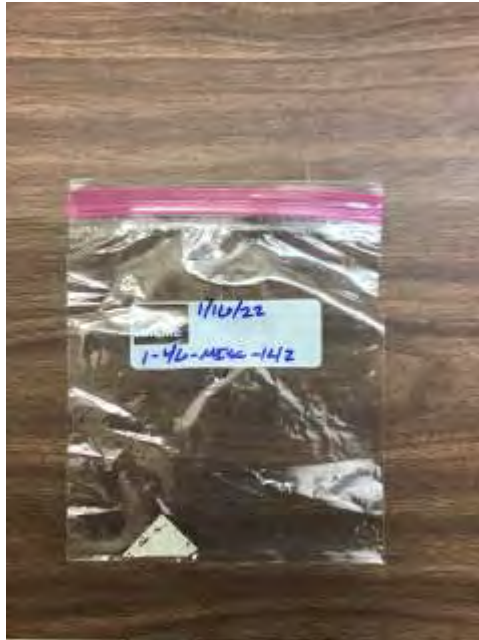
Damaged or significantly damaged friable miscellaneous ACM

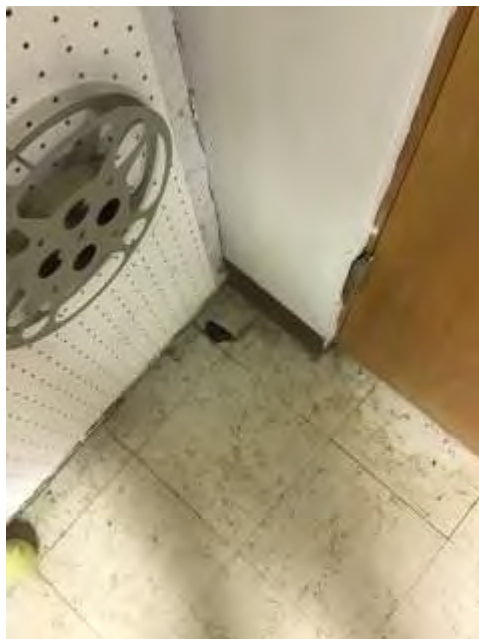
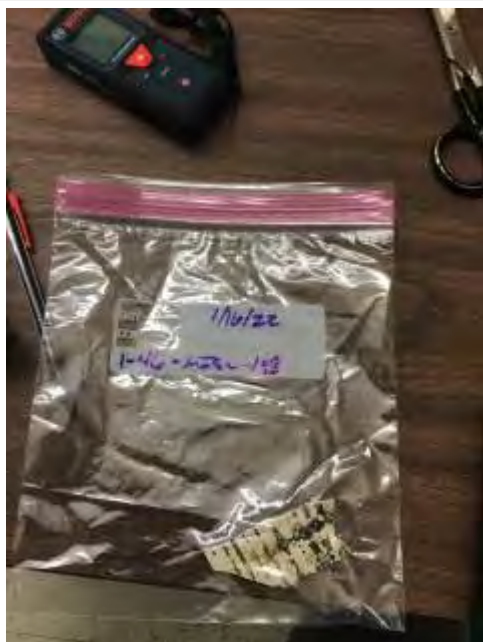
Additional Sample Notes:		
Sample ID:	Sample Type:	
1-46-MISC-143	MISC	
Sample Location:	Detailed Sample Location:	
Library	Behind door of server room	
Sample Quantity:	See 1-46-MISC-139	
Misc Sample Material:	Sample Condition:	Sample Friable?:
9x9 white vinyl floor tiles with black mastic	Damaged or significantly damaged friable miscellaneous ACM	No

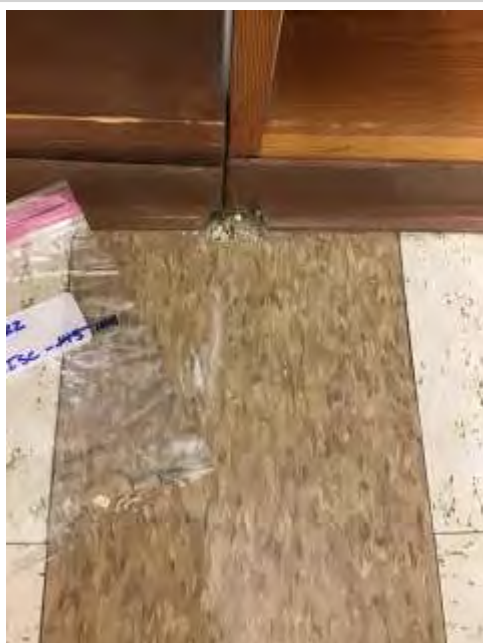
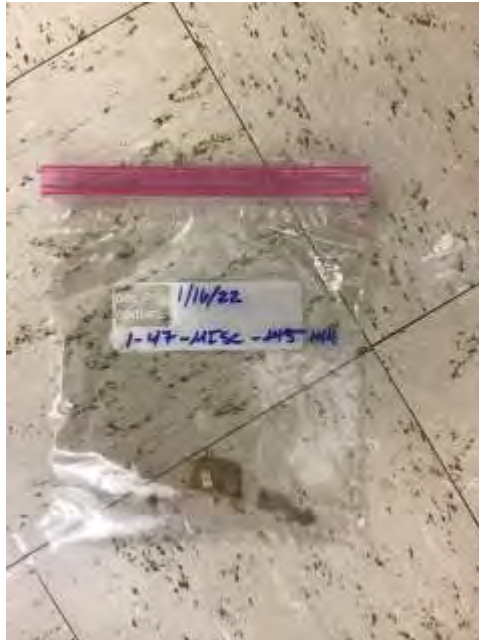
Additional Sample Notes:		
Sample ID:	Sample Type:	
1-47-MISC-144	MISC	
Sample Location:	Detailed Sample Location:	
Library	South end of room near bookshelves	
Sample Quantity:	31.8 LF	
Misc Sample Material:	Sample Condition:	Sample Friable?:
Dark tan vinyl floor tile with yellow and black mastic	Damaged or significantly damaged friable miscellaneous ACM	No

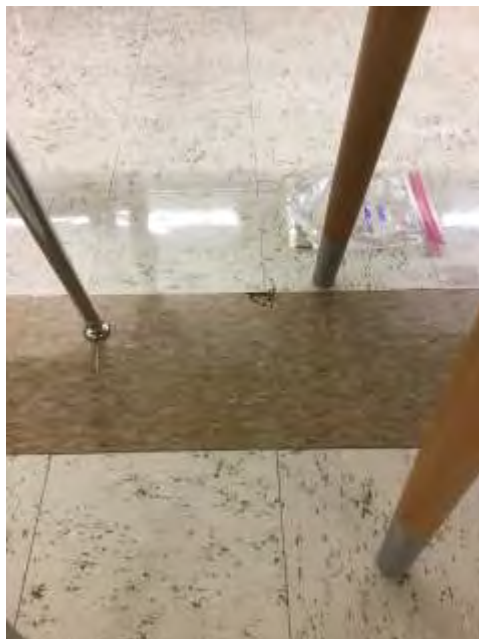
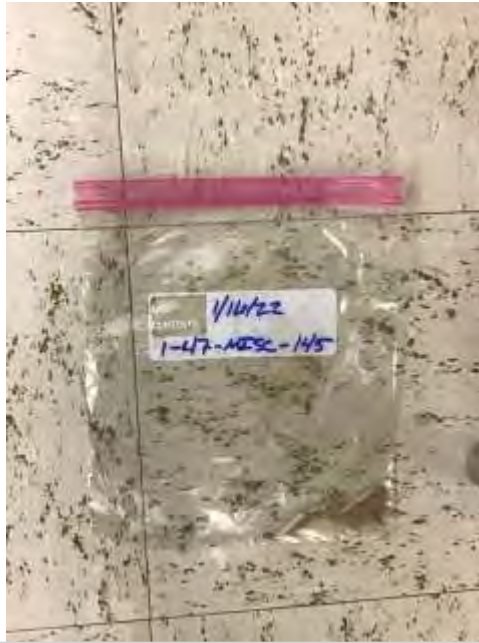
Additional Sample Notes:		
Sample ID:	Sample Type:	
1-47-MISC-145	MISC	
Sample Location:	Detailed Sample Location:	
Library	Middle of room	
Sample Quantity:	See 1-47-MISC-144	
Misc Sample Material:	Sample Condition:	Sample Friable?:
Dark tan vinyl floor tile with yellow and black mastic	Damaged or significantly damaged friable miscellaneous ACM	No

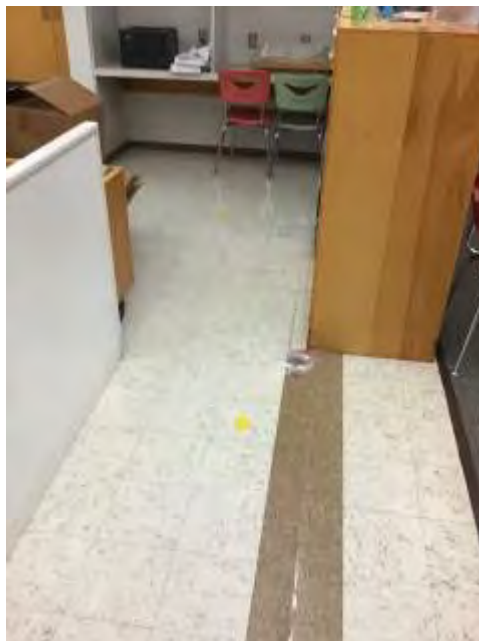
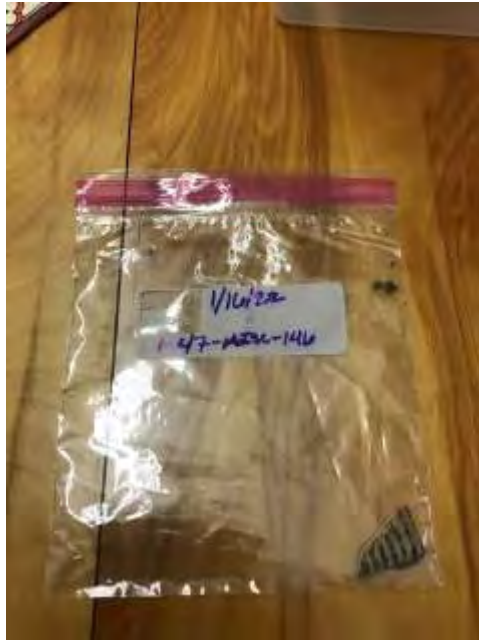
Additional Sample Notes:		
Sample ID:	Sample Type:	
1-47-MISC-146	MISC	
Sample Location:	Detailed Sample Location:	
Library	North end near middle of room	
Sample Quantity:	See 1-47-MISC-144	
Misc Sample Material:	Sample Condition:	Sample Friable?:
Dark tan vinyl floor tile with yellow and black mastic	Damaged or significantly damaged friable miscellaneous ACM	No

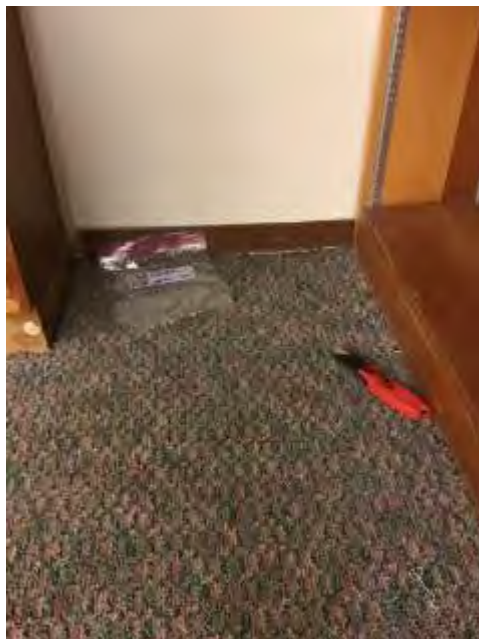
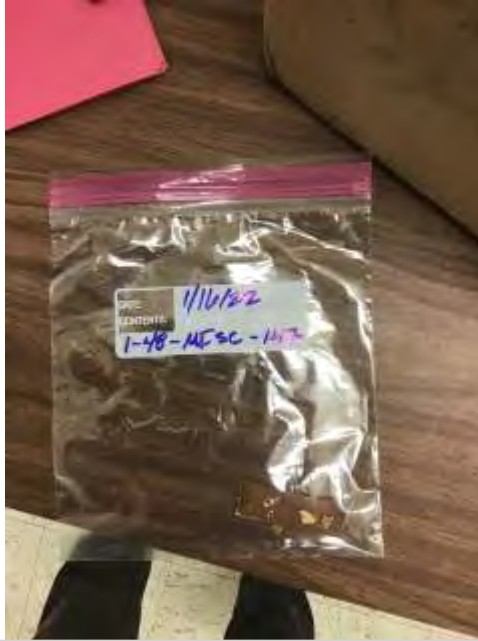
Additional Sample Notes:		
Sample ID:	Sample Type:	
1-48-MISC-147	MISC	
Sample Location:	Detailed Sample Location:	
Library	Northeast corner	
Sample Quantity:	180 LF	
Misc Sample Material:	Sample Condition:	Sample Friable?:
Brown base cove with yellow mastic	Damaged or significantly damaged friable miscellaneous ACM	No

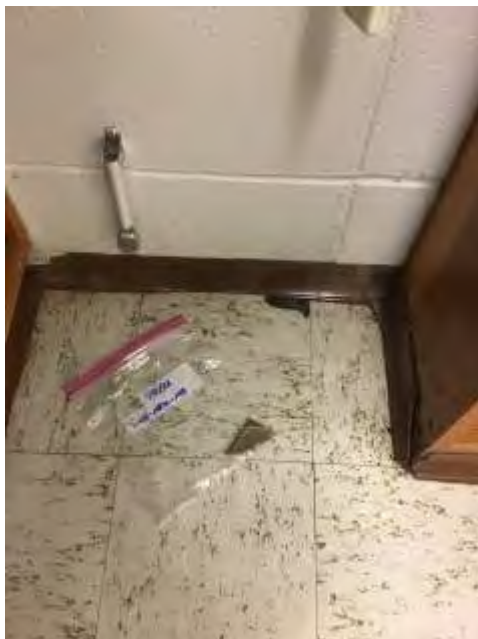
Additional Sample Notes:		
Sample ID:	Sample Type:	
1-48-MISC-148	MISC	
Sample Location:	Detailed Sample Location:	
Library	Southeast corner under TV	
Sample Quantity:	See 1-48-MISC-147	
Misc Sample Material:	Sample Condition:	Sample Friable?:
Brown base cove with yellow mastic	Damaged or significantly damaged friable miscellaneous ACM	No

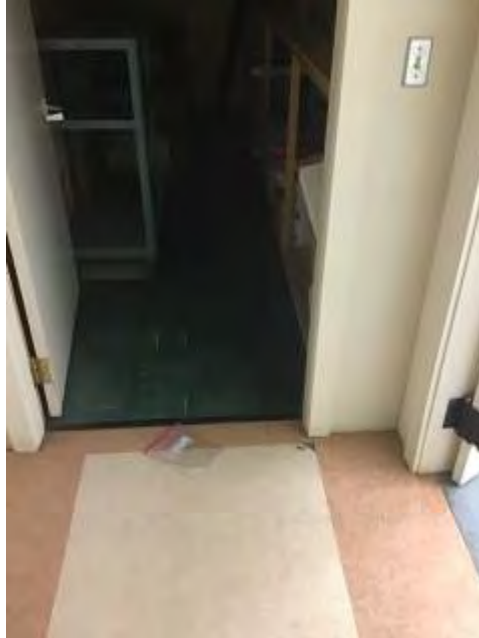
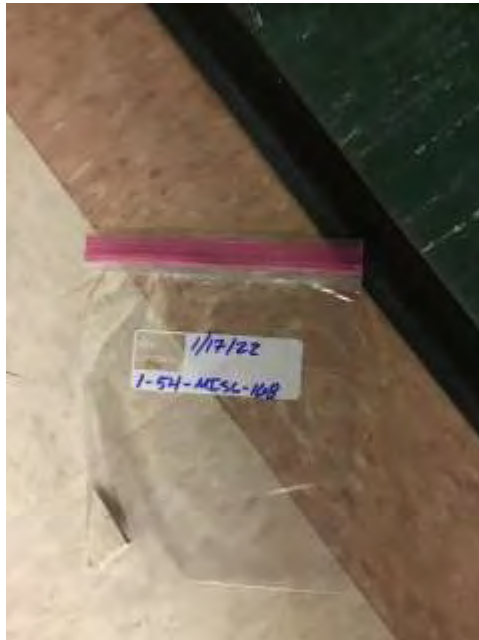
Additional Sample Notes:	
Sample ID:	Sample Type:
1-55-MISC-169	MISC
Sample Location:	Detailed Sample Location:
Hallway	North corner outside girls restroom

Sample Quantity:	1,199 SF	
Misc Sample Material:	Sample Condition:	Sample Friable?:
Tan flooring with black mastic	Damaged or significantly damaged friable miscellaneous ACM	Yes

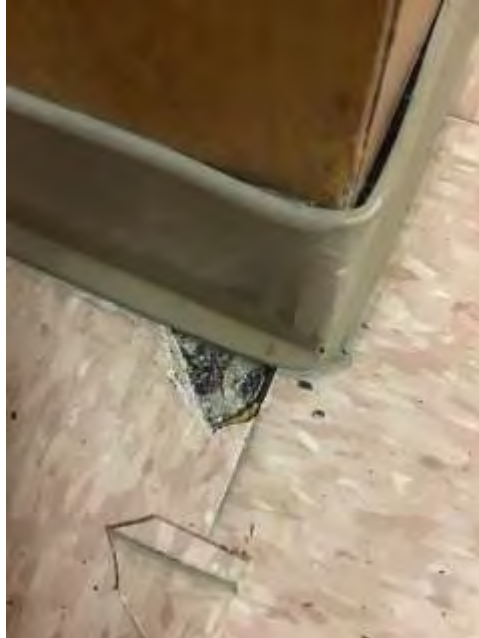
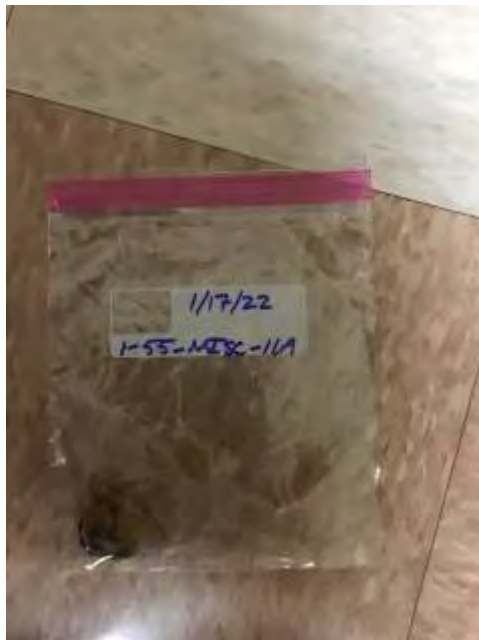
Additional Sample Notes:	Flooring is under 12x12 tan and brown tiles	
Sample ID:	Sample Type:	
1-55-MISC-170	MISC	
Sample Location:	Detailed Sample Location:	
Hallway	North corner outside gym doors

Sample Quantity:	See 1-55-MISC-169	
Misc Sample Material:	Sample Condition:	Sample Friable?:
Tan flooring with black mastic	Damaged or significantly damaged friable miscellaneous ACM	Yes

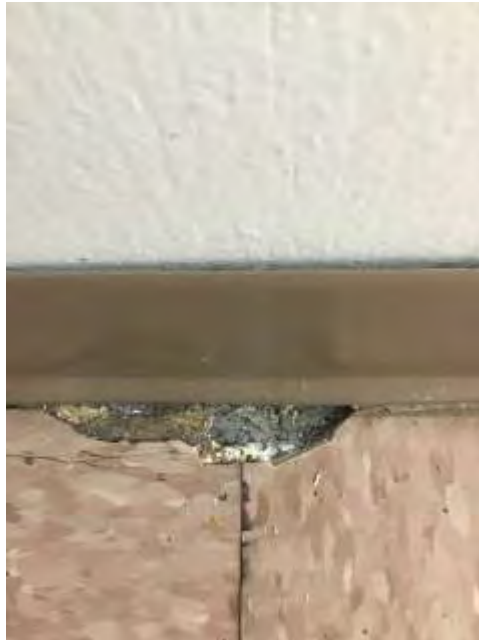
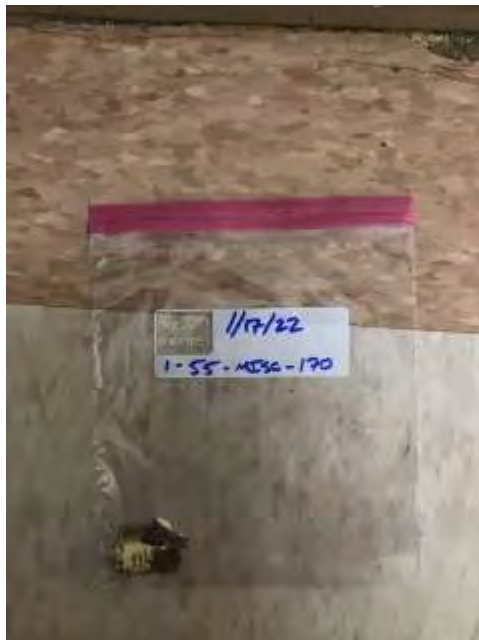
Additional Sample Notes:	Flooring is under 12x12 tan and brown tiles	
Sample ID:	Sample Type:	
1-55-MISC-171	MISC	
Sample Location:	Detailed Sample Location:	
Hallway	Corner outside library doors

Sample Quantity:	See 1-55-MISC-169	
Misc Sample Material:	Sample Condition:	Sample Friable?:
Tan flooring with black mastic	Damaged or significantly damaged friable miscellaneous ACM	Yes

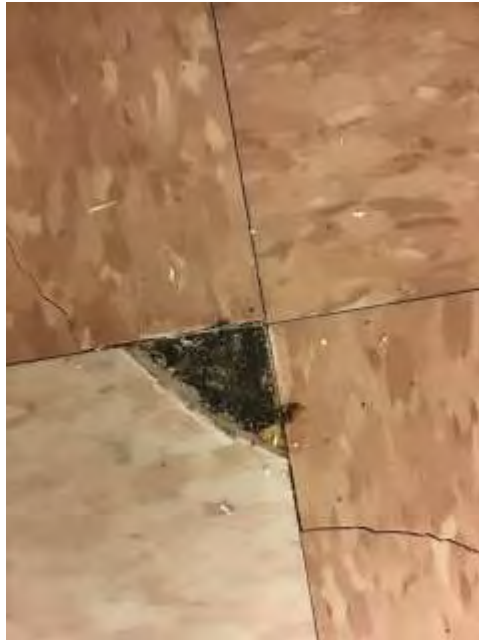
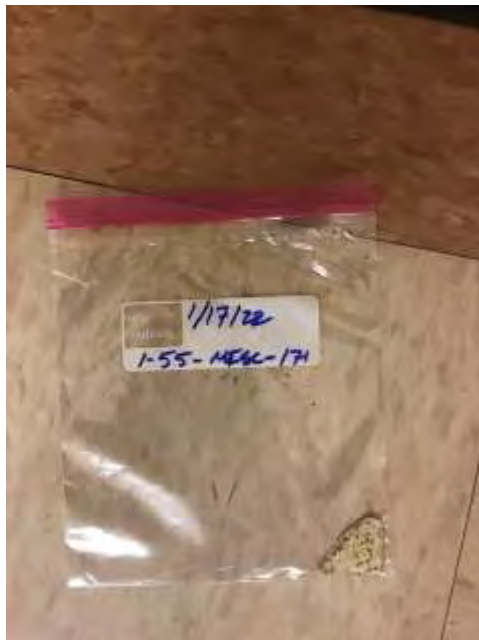
Additional Sample Notes:	Flooring is under 12x12 tan and brown tiles
---------------------------------	---

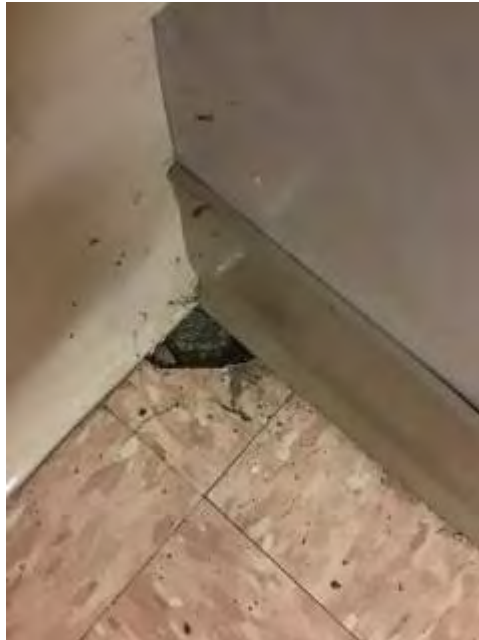
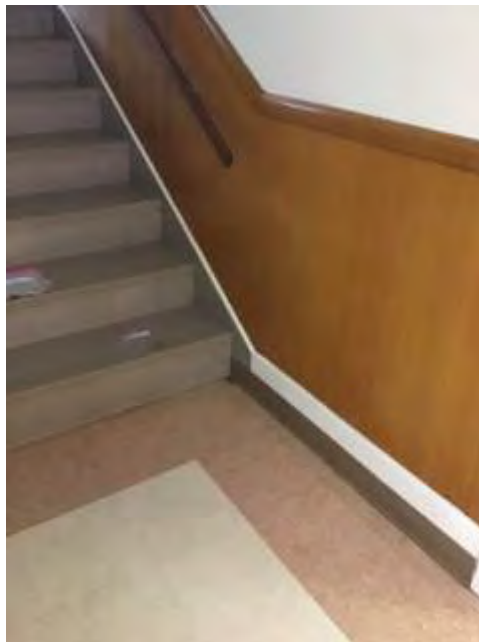
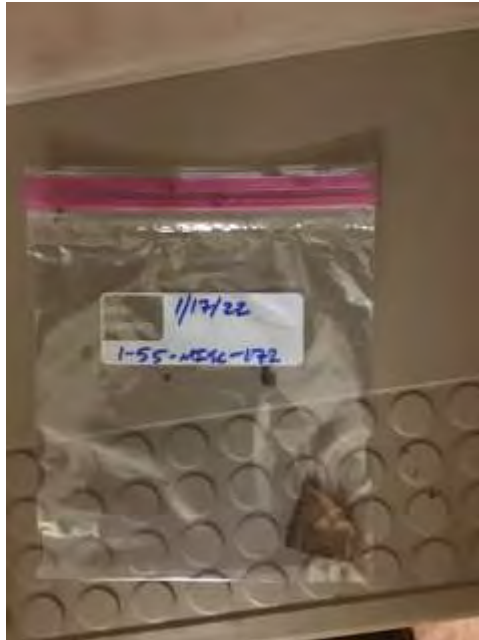
Sample ID:	Sample Type:
1-55-MISC-172	MISC
Sample Location:	Detailed Sample Location:
Hallway	North corner bottom of middle staircase

Sample Quantity:	See 1-55-MISC-169	
Misc Sample Material:	Sample Condition:	Sample Friable?:
Tan flooring with black mastic	Damaged or significantly damaged friable miscellaneous ACM	Yes

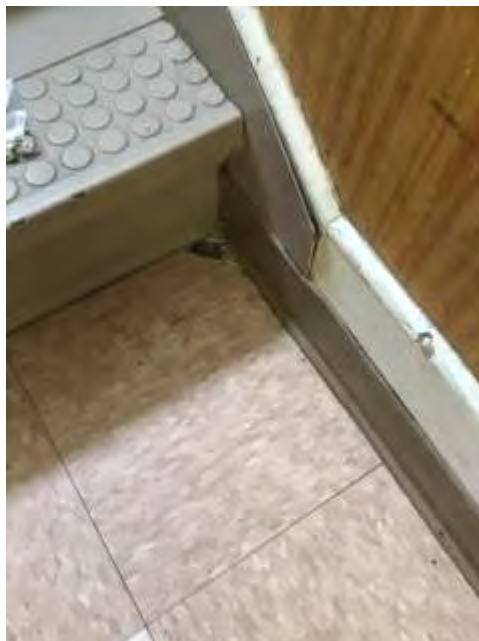
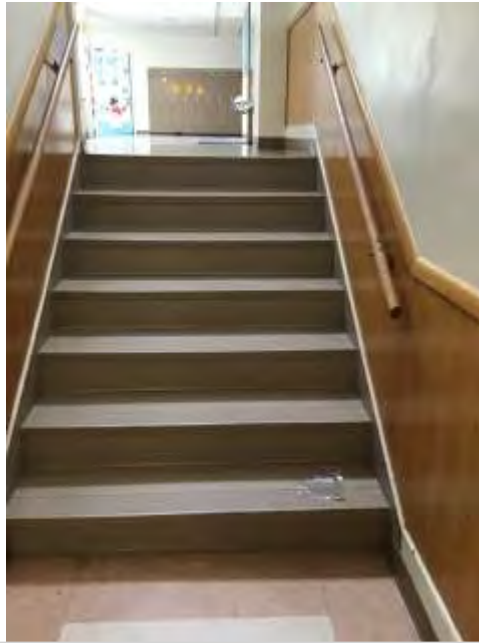
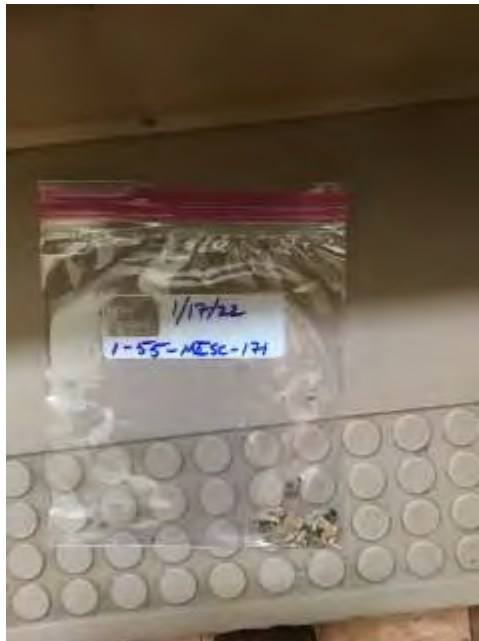
Additional Sample Notes:		Flooring is under 12x12 tan and brown tiles
Sample ID:	Sample Type:	
1-55-MISC-173	MISC	
Sample Location:	Detailed Sample Location:	
Hallway	North corner bottom of north staircase	
Sample Quantity:	See 1-55-MISC-169	
Misc Sample Material:	Sample Condition:	Sample Friable?:
Tan flooring with black mastic	Damaged or significantly damaged friable miscellaneous ACM	Yes

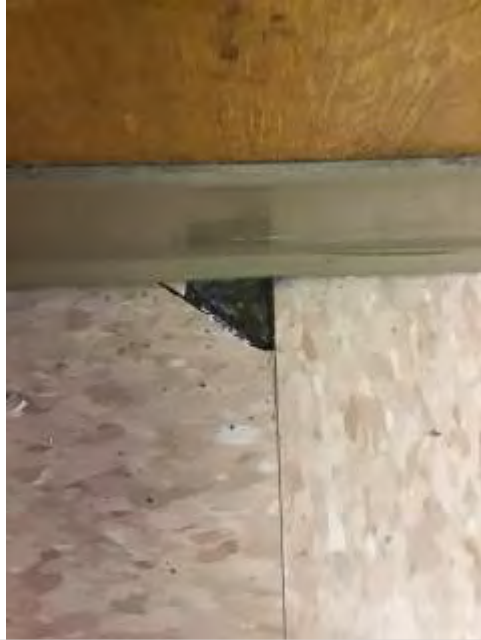
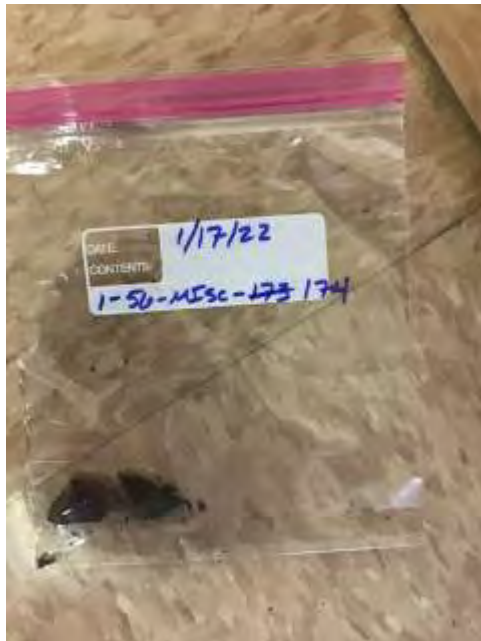
Additional Sample Notes:		Flooring is under 12x12 tan and brown tiles
Sample ID:	Sample Type:	
1-56-MISC-174	MISC	
Sample Location:	Detailed Sample Location:	
Hallway	North corner outside boys restroom	
Sample Quantity:	410 SF	
Misc Sample Material:	Sample Condition:	Sample Friable?:
Dark brown flooring with black mastic	Damaged or significantly damaged friable miscellaneous ACM	Yes
Sample Photo:

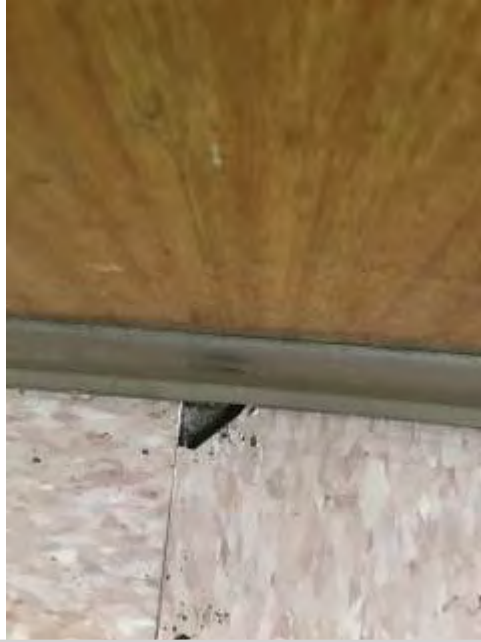
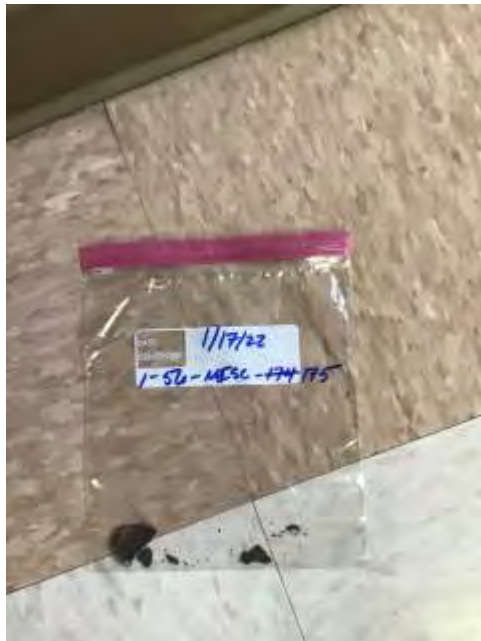
Additional Sample Notes:		Flooring under 12x12 tan and light brown vinyl tiles
Sample ID:	Sample Type:	
1-56-MISC-175	MISC	
Sample Location:	Detailed Sample Location:	
Hallway	Corner outside classroom 8	
Sample Quantity:	See 1-56-MISC-174	
Misc Sample Material:	Sample Condition:	Sample Friable?:
Dark brown flooring with black mastic	Damaged or significantly damaged friable miscellaneous ACM	Yes
Sample Photo:

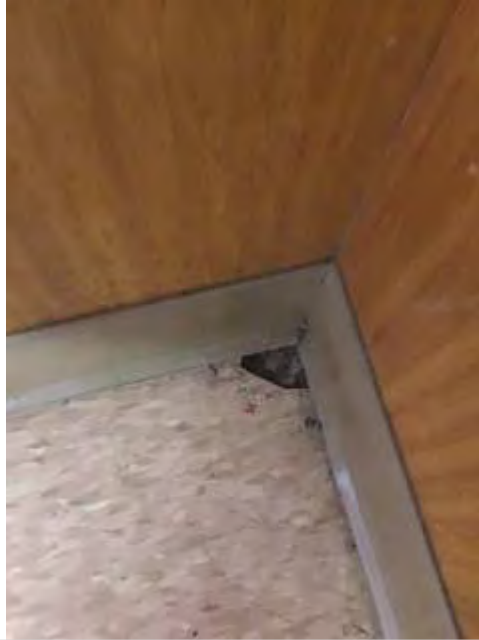
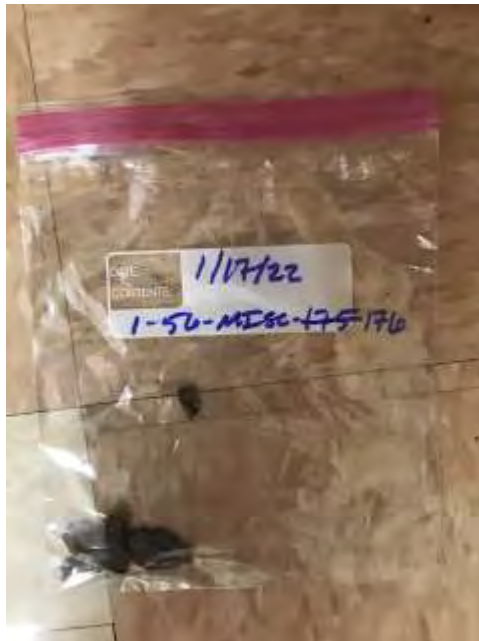
Additional Sample Notes:		Flooring under 12x12 tan and light brown vinyl tiles
Sample ID:	Sample Type:	
1-56-MISC-176	MISC	
Sample Location:	Detailed Sample Location:	
Hallway	Corner outside supply closet	
Sample Quantity:	See 1-56-MISC-174	
Misc Sample Material:	Sample Condition:	Sample Friable?:
Dark brown flooring with black mastic	Damaged or significantly damaged friable miscellaneous ACM	Yes
Sample Photo:

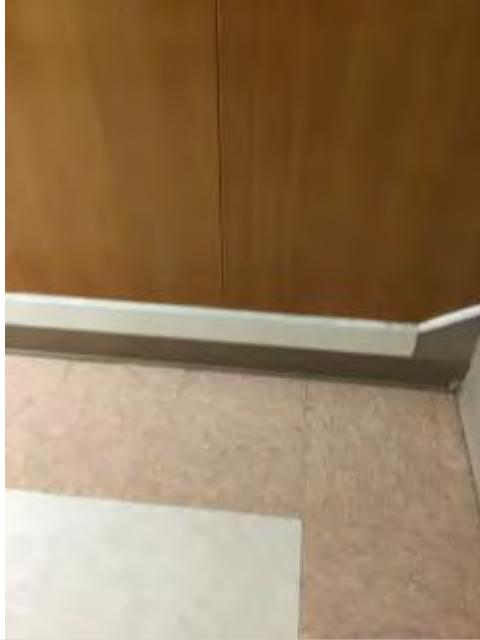
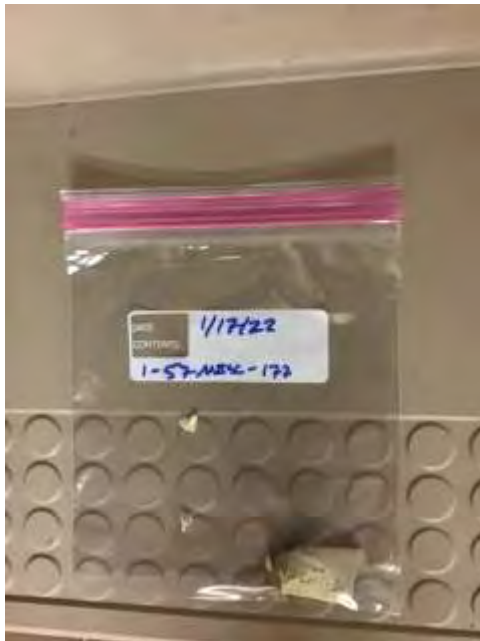
Additional Sample Notes:		Flooring under 12x12 tan and light brown vinyl tiles
Sample ID:	Sample Type:	
1-57-MISC-177	MISC	
Sample Location:	Detailed Sample Location:	
Hallway	South corner on bottom of middle staircase	
Sample Quantity:	385 LF	
Misc Sample Material:	Sample Condition:	Sample Friable?:
Tan base cove with yellow mastic	Damaged or significantly damaged friable miscellaneous ACM	No
Sample Photo:

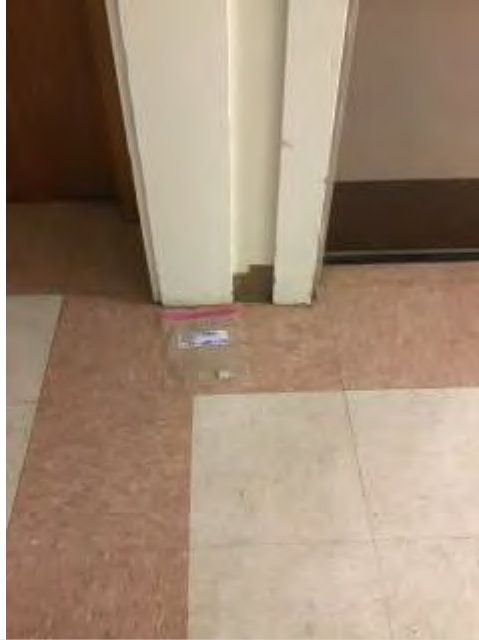
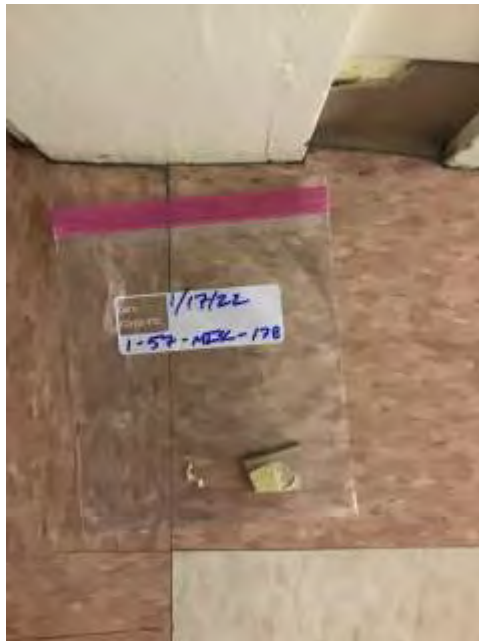
Additional Sample Notes:		
Sample ID:	Sample Type:	
1-57-MISC-178	MISC	
Sample Location:	Detailed Sample Location:	
Hallway	Corner of doorway near boiler room	
Sample Quantity:	See 1-57-MISC-177	
Misc Sample Material:	Sample Condition:	Sample Friable?:
Tan base cove with yellow mastic	Damaged or significantly damaged friable miscellaneous ACM	No
Sample Photo:

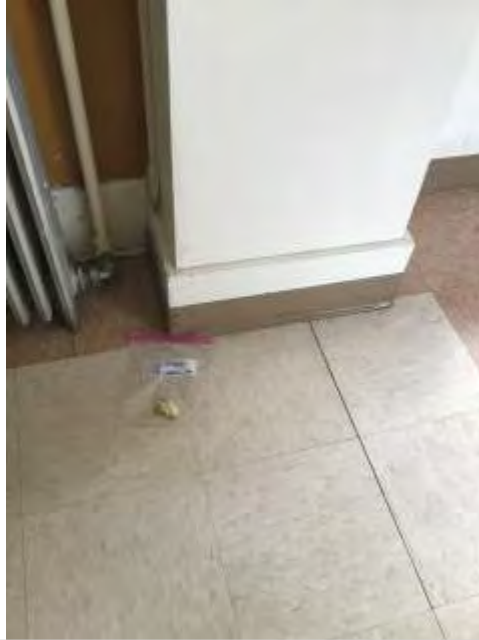
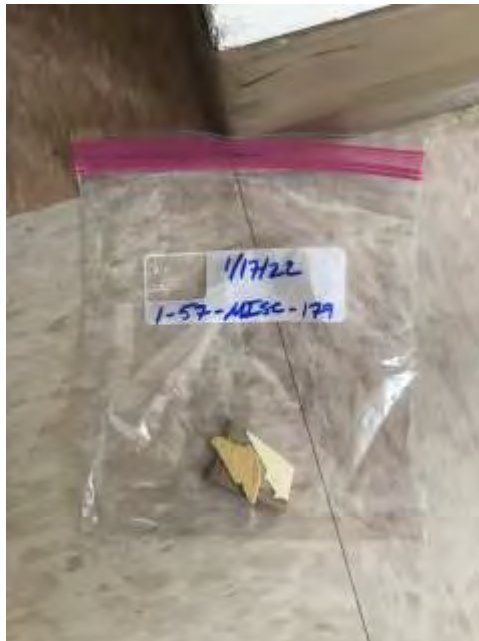
Additional Sample Notes:		
Sample ID:	Sample Type:	
1-57-MISC-179	MISC	
Sample Location:	Detailed Sample Location:	
Hallway	Behind radiator near south staircase	
Sample Quantity:	See 1-57-MISC-177	
Misc Sample Material:	Sample Condition:	Sample Friable?:
Tan base cove with yellow mastic	Damaged or significantly damaged friable miscellaneous ACM	No
Sample Photo:

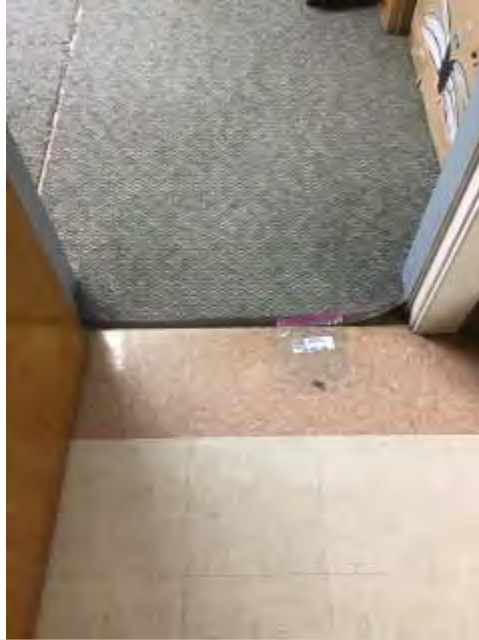
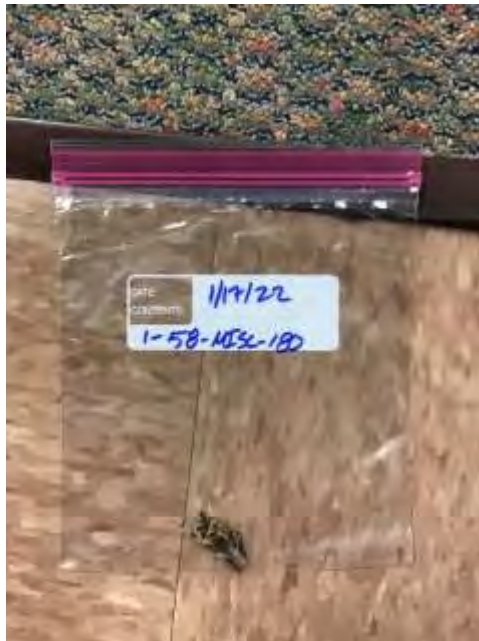
Additional Sample Notes:		
Sample ID:	Sample Type:	
1-58-MISC-180	MISC	
Sample Location:	Detailed Sample Location:	
Hallway	Between hallway and computer lab	
Sample Quantity:	30 LF	
Misc Sample Material:	Sample Condition:	Sample Friable?:
Transition strips with yellow mastic	Damaged or significantly damaged friable miscellaneous ACM	No
Sample Photo:

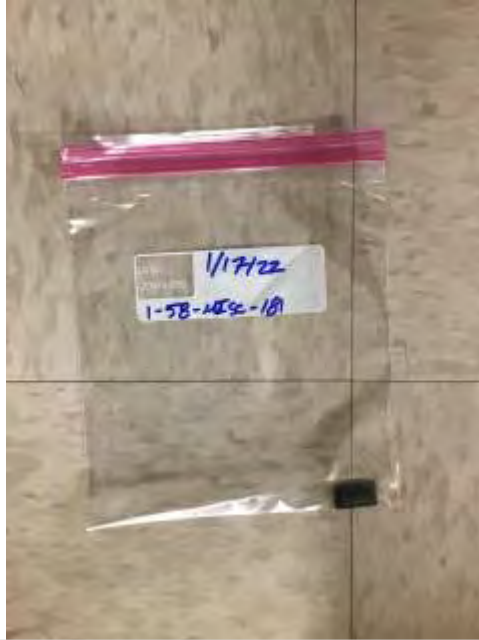
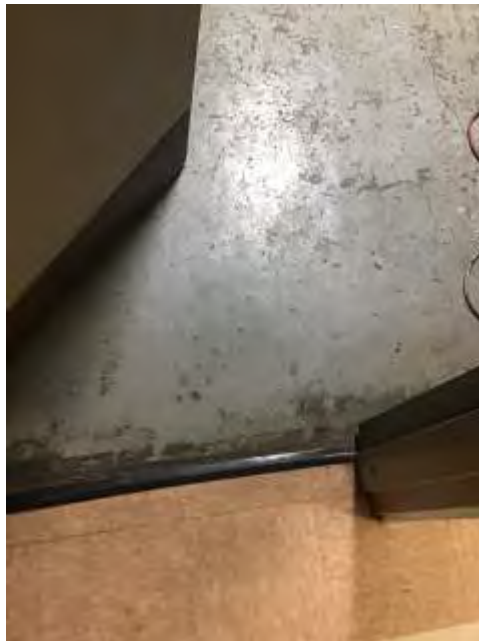
Additional Sample Notes:		
Sample ID:	Sample Type:	
1-58-MISC-181	MISC	
Sample Location:	Detailed Sample Location:	
Hallway	Between hallway and boiler room	
Sample Quantity:	See 1-58-MISC-180	
Misc Sample Material:	Sample Condition:	Sample Friable?:
Transition strips with yellow mastic	Damaged or significantly damaged friable miscellaneous ACM	No
Sample Photo:

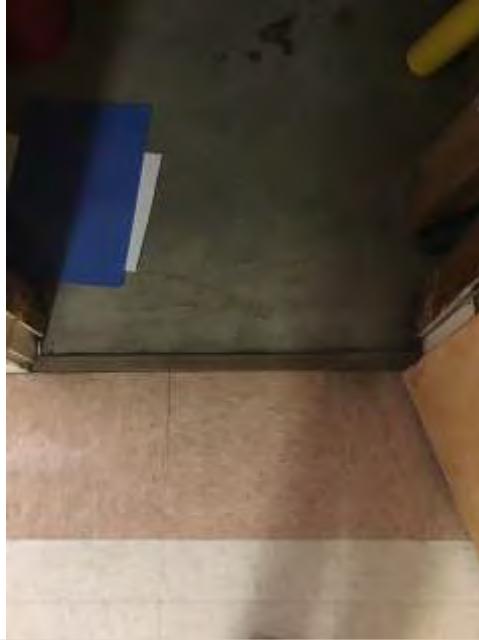
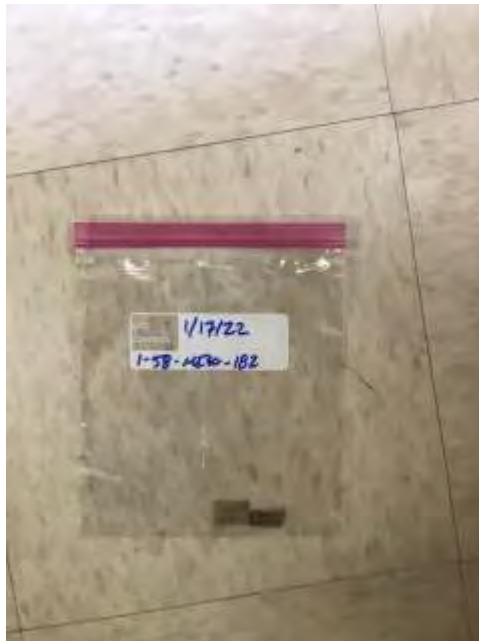
Additional Sample Notes:		
Sample ID:	Sample Type:	
1-58-MISC-182	MISC	
Sample Location:	Detailed Sample Location:	
Hallway	Between hallway and south storage room	
Sample Quantity:	See 1-58-MISC-180	
Misc Sample Material:	Sample Condition:	Sample Friable?:
Transition strips with yellow mastic	Damaged or significantly damaged friable miscellaneous ACM	No
Sample Photo:

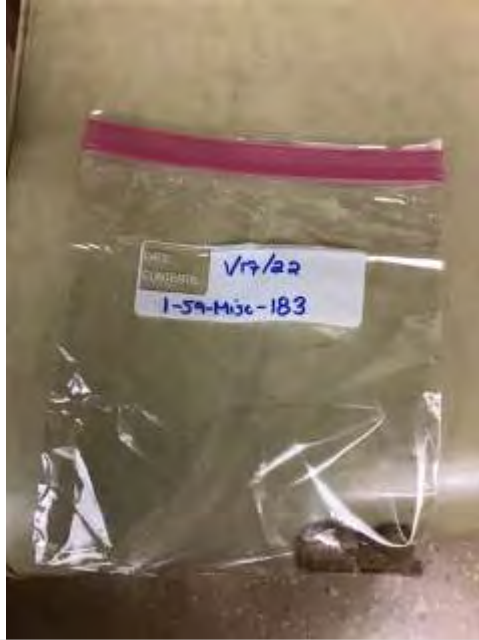
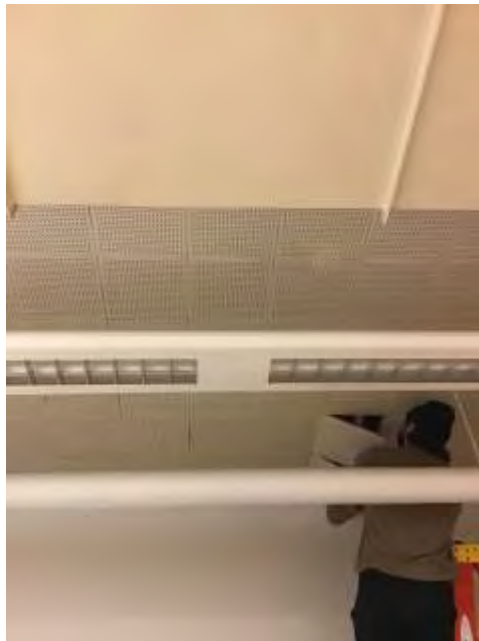
Additional Sample Notes:		
Sample ID:	Sample Type:	
1-59-MISC-183	MISC	
Sample Location:	Detailed Sample Location:	
Faculty	East corner ceiling	
Sample Quantity:	5,000 SF	
Misc Sample Material:	Sample Condition:	Sample Friable?:
9x9 white dotted acoustic ceiling tiles with no mastic	Damaged or significantly damaged friable miscellaneous ACM	Yes
Sample Photo:
