HAZARDOUS BUILDING MATERIALS SURVEY

CONDON GRADE SCHOOL
220 S. EAST STREET
CONDON, OREGON

Prepared for
CITY OF CONDON
May 17, 2022
Project No. M2053.01.002

Prepared by
Maul Foster & Alongi, Inc.
3140 NE Broadway Street, Portland, OR 97232

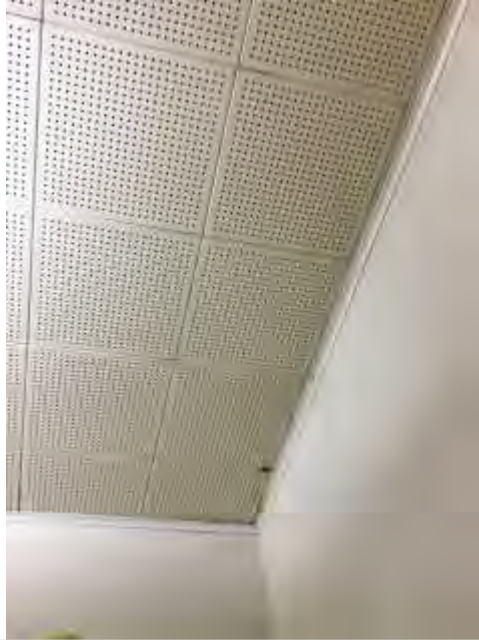
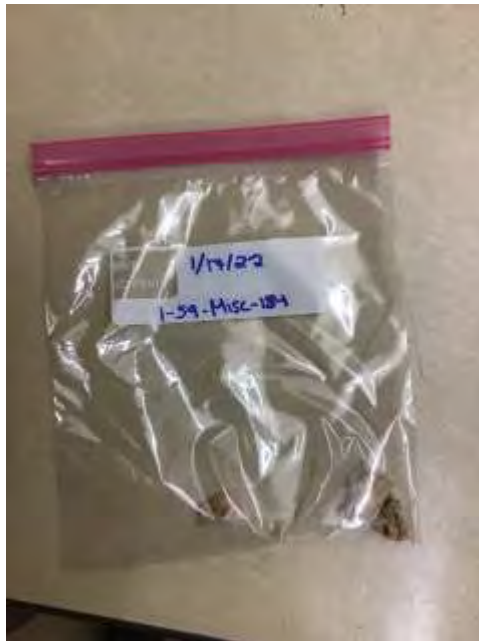
Additional Sample Notes:		
Sample ID:	Sample Type:	
1-59-MISC-184	MISC	
Sample Location:	Detailed Sample Location:	
Faculty	North corner ceiling	
Sample Quantity:	See 1-59-MISC-183	
Misc Sample Material:	Sample Condition:	Sample Friable?:
9x9 white dotted acoustic ceiling tiles with no mastic	Damaged or significantly damaged friable miscellaneous ACM	Yes
Sample Photo:

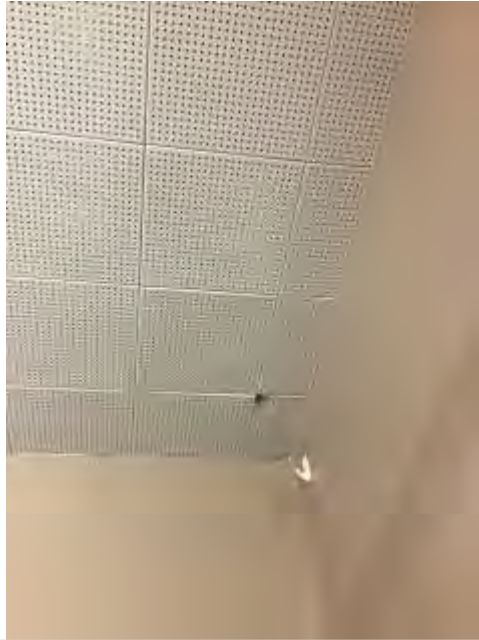
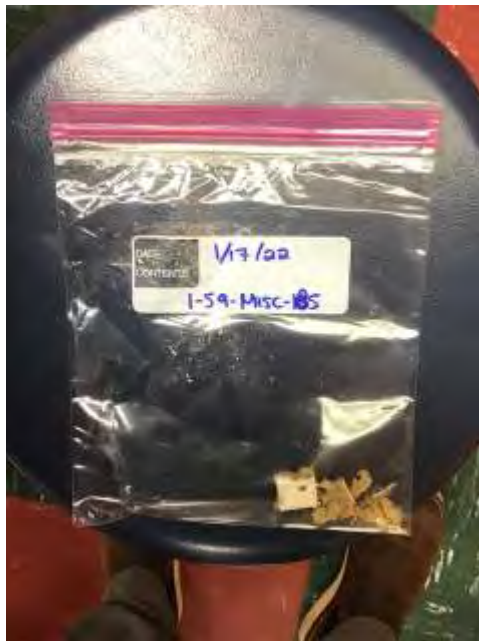
Additional Sample Notes:		
Sample ID:	Sample Type:	
1-59-MISC-185	MISC	
Sample Location:	Detailed Sample Location:	
Cafeteria	Southeast corner ceiling	
Sample Quantity:	See 1-59-MISC-183	
Misc Sample Material:	Sample Condition:	Sample Friable?:
9x9 white dotted acoustic ceiling tiles with no mastic	Damaged or significantly damaged friable miscellaneous ACM	Yes
Sample Photo:

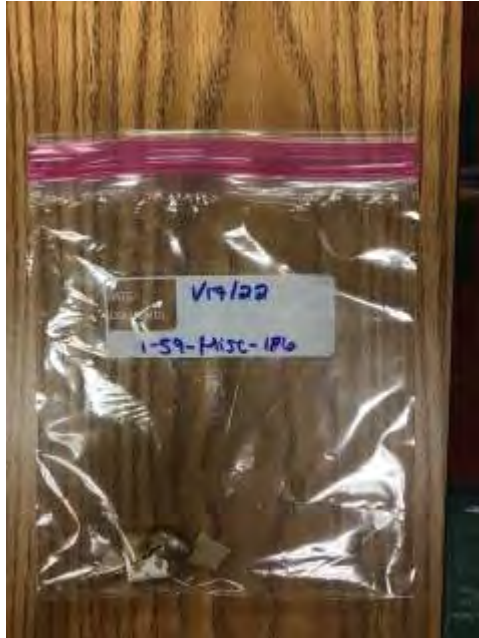
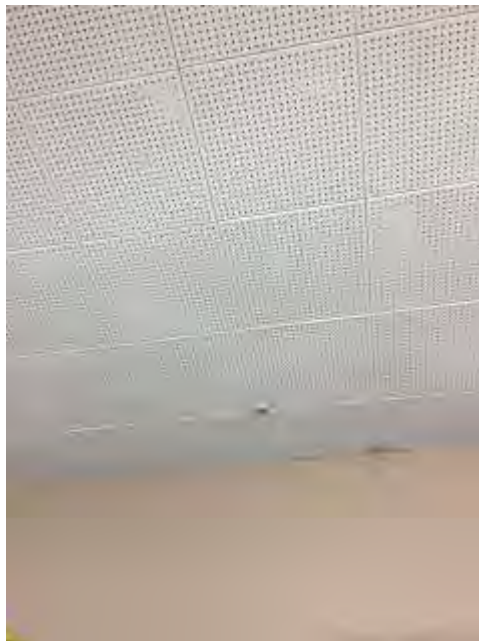
Additional Sample Notes:		
Sample ID:	Sample Type:	
1-59-MISC-186	MISC	
Sample Location:	Detailed Sample Location:	
Cafeteria	East wall ceiling	
Sample Quantity:	See 1-59-MISC-183	
Misc Sample Material:	Sample Condition:	Sample Friable?:
9x9 white dotted acoustic ceiling tiles with no mastic	Damaged or significantly damaged friable miscellaneous ACM	Yes
Sample Photo:

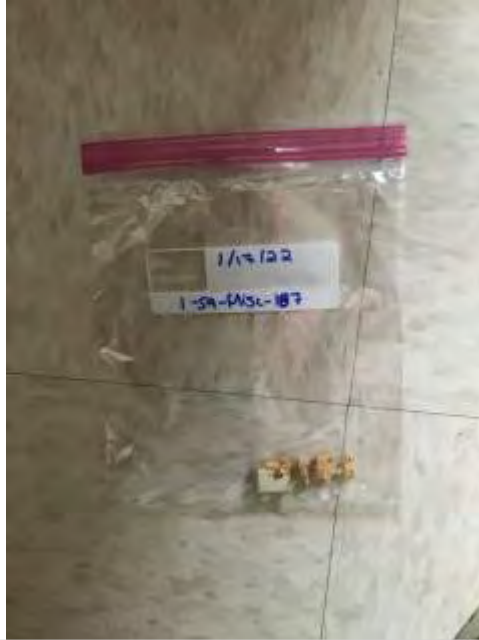
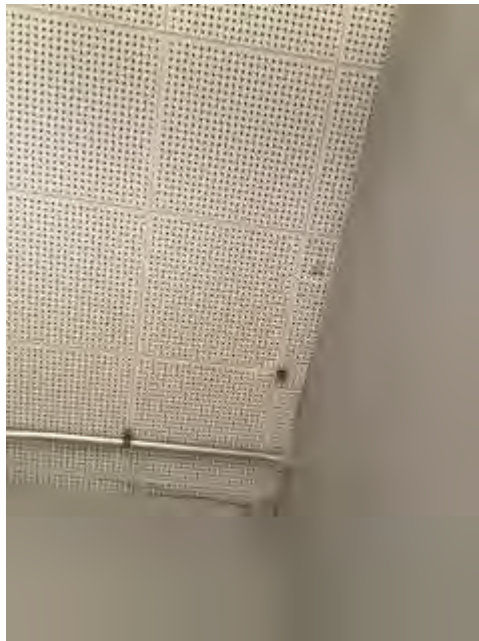
Additional Sample Notes:		
Sample ID:	Sample Type:	
1-59-MISC-187	MISC	
Sample Location:	Detailed Sample Location:	
Office	Nurse's room ceiling	
Sample Quantity:	See 1-59-MISC-183	
Misc Sample Material:	Sample Condition:	Sample Friable?:
9x9 white dotted acoustic ceiling tiles with no mastic	Damaged or significantly damaged friable miscellaneous ACM	Yes
Sample Photo:

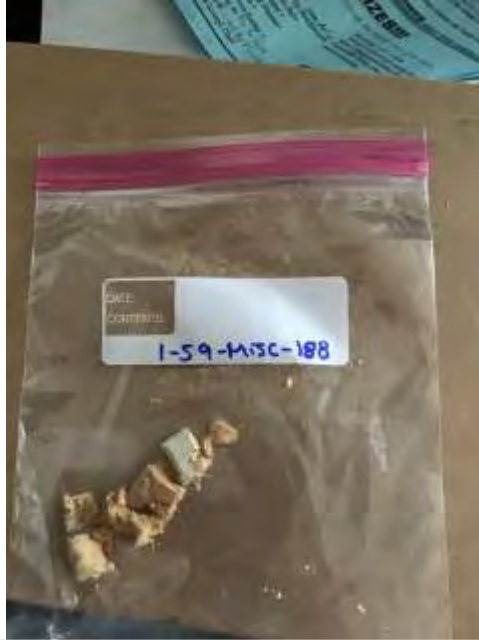
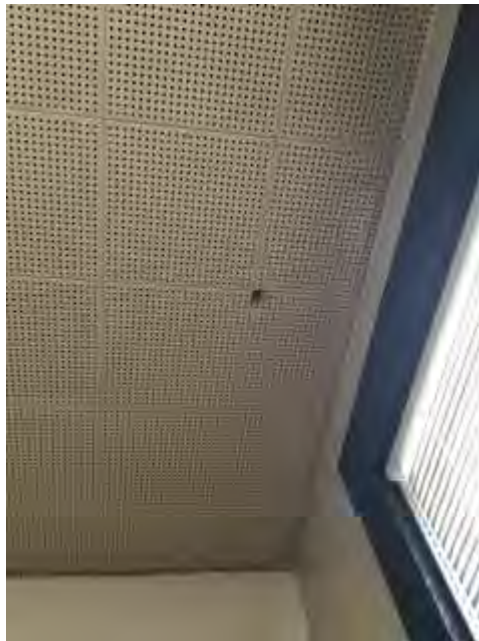
Additional Sample Notes:		
Sample ID:	Sample Type:	
1-59-MISC-188	MISC	
Sample Location:	Detailed Sample Location:	
Office	Principal office northwest corner ceiling	
Sample Quantity:	See 1-59-MISC-183	
Misc Sample Material:	Sample Condition:	Sample Friable?:
9x9 white dotted acoustic ceiling tiles with no mastic	Damaged or significantly damaged friable miscellaneous ACM	Yes
Sample Photo:

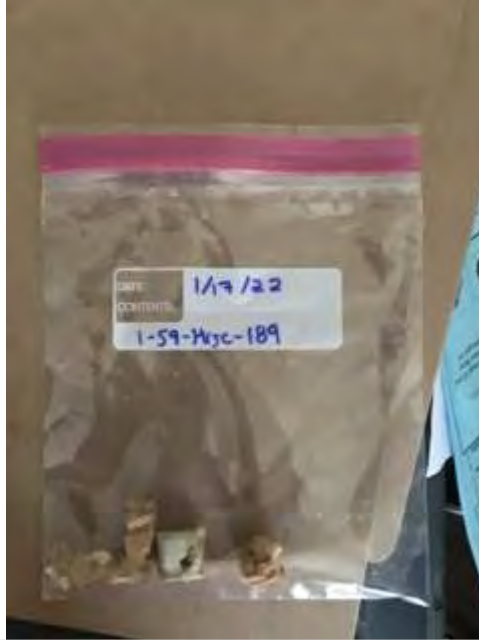
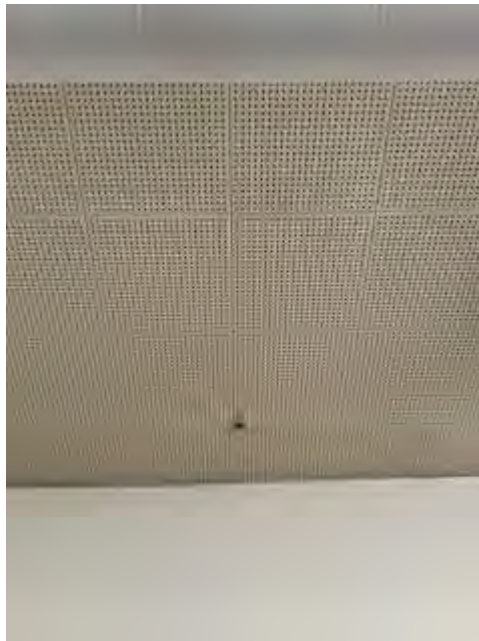
Additional Sample Notes:		
Sample ID:	Sample Type:	
1-59-MISC-189	MISC	
Sample Location:	Detailed Sample Location:	
Office	Principal's office west edge of ceiling	
Sample Quantity:	See 1-59-MISC-183	
Misc Sample Material:	Sample Condition:	Sample Friable?:
9x9 white dotted acoustic ceiling tiles with no mastic	Damaged or significantly damaged friable miscellaneous ACM	Yes
Sample Photo:

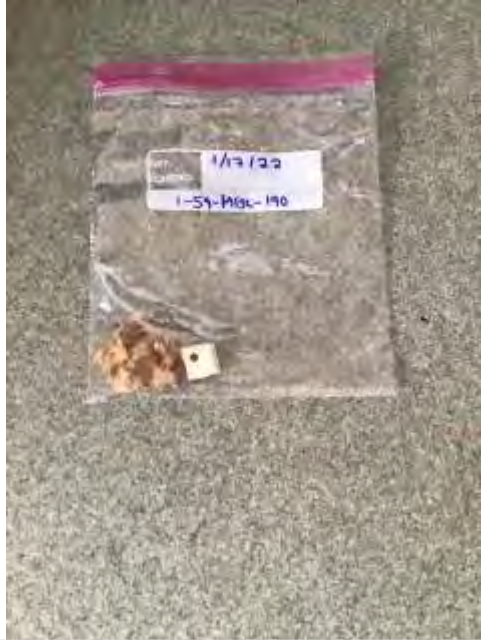
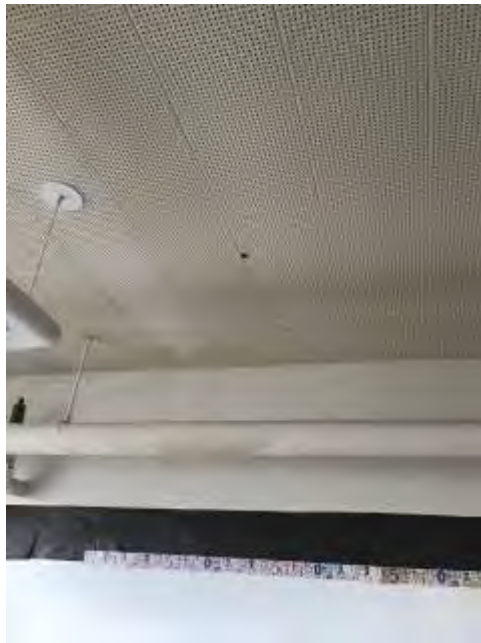
Additional Sample Notes:		
Sample ID:	Sample Type:	
1-59-MISC-190	MISC	
Sample Location:	Detailed Sample Location:	
Classroom 7	North edge of ceiling above pipe	
Sample Quantity:	See 1-59-MISC-183	
Misc Sample Material:	Sample Condition:	Sample Friable?:
9x9 white dotted acoustic ceiling tiles with no mastic	Damaged or significantly damaged friable miscellaneous ACM	No;Yes
Sample Photo:

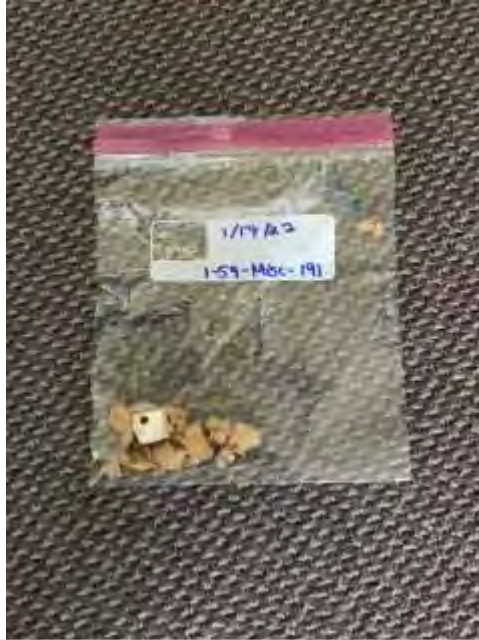
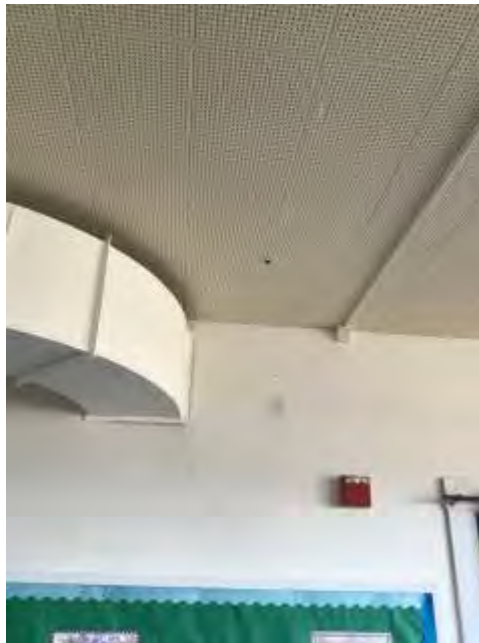
Additional Sample Notes:		
Sample ID:	Sample Type:	
1-59-MISC-191	MISC	
Sample Location:	Detailed Sample Location:	
Classroom 7	South edge of ceiling next to air duct	
Sample Quantity:	See 1-59-MISC-183	
Misc Sample Material:	Sample Condition:	Sample Friable?:
9x9 white dotted acoustic ceiling tiles with no mastic	Damaged or significantly damaged friable miscellaneous ACM	No
Sample Photo:

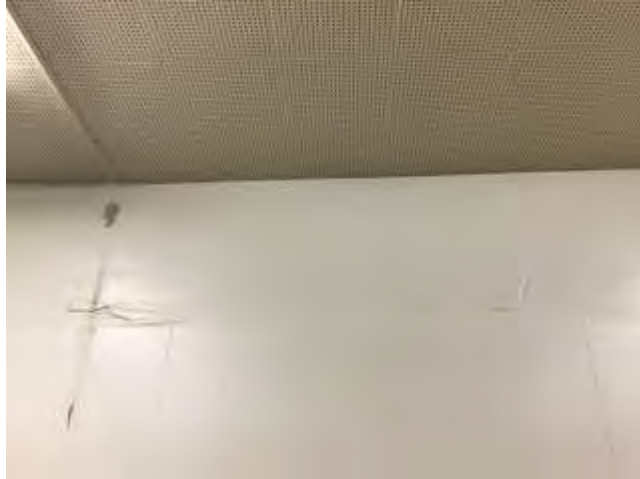
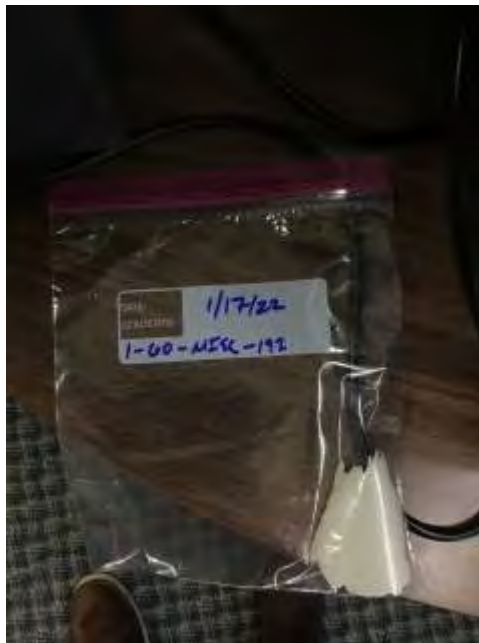
Additional Sample Notes:		
Sample ID:	Sample Type:	
1-60-MISC-192	MISC	
Sample Location:	Detailed Sample Location:	
Office	Northwest wall of principal's office	
Sample Quantity:	34 LF	
Misc Sample Material:	Sample Condition:	Sample Friable?:
White wallpaper with tan mastic	Damaged or significantly damaged friable miscellaneous ACM	No
Sample Photo:

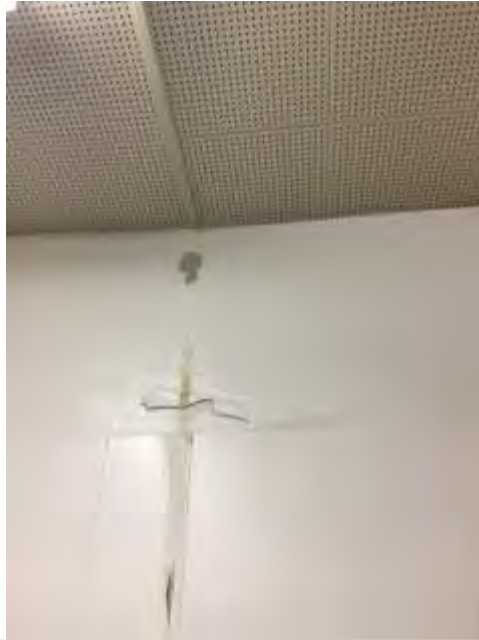
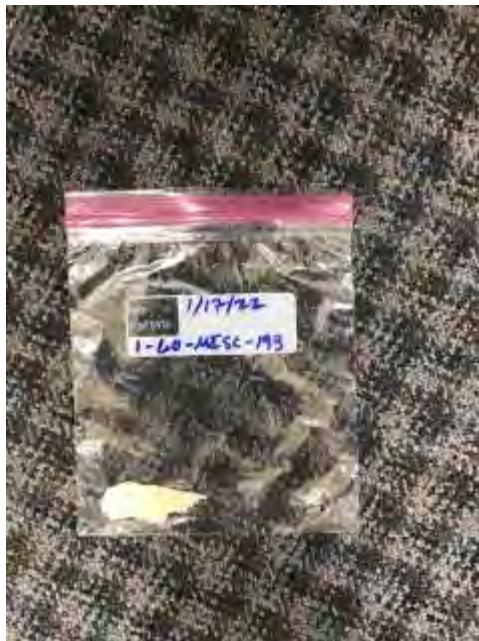
Additional Sample Notes:		
Sample ID:	Sample Type:	
1-60-MISC-193	MISC	
Sample Location:	Detailed Sample Location:	
Office	West wall of principal's office	
Sample Quantity:	See 1-60-MISC-192	
Misc Sample Material:	Sample Condition:	Sample Friable?:
White wallpaper with tan mastic	Damaged or significantly damaged friable miscellaneous ACM	No
Sample Photo:

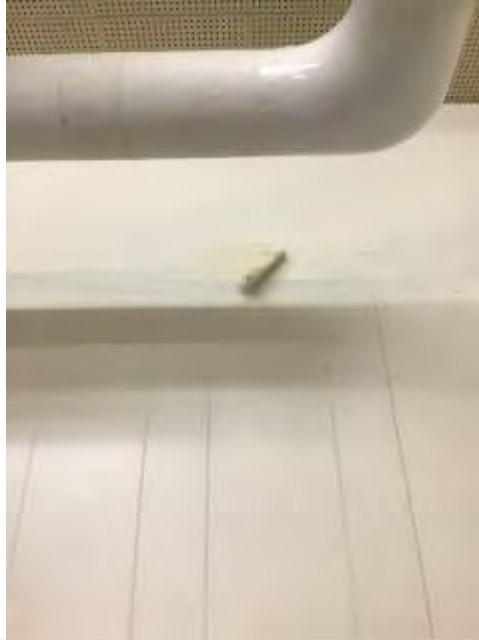
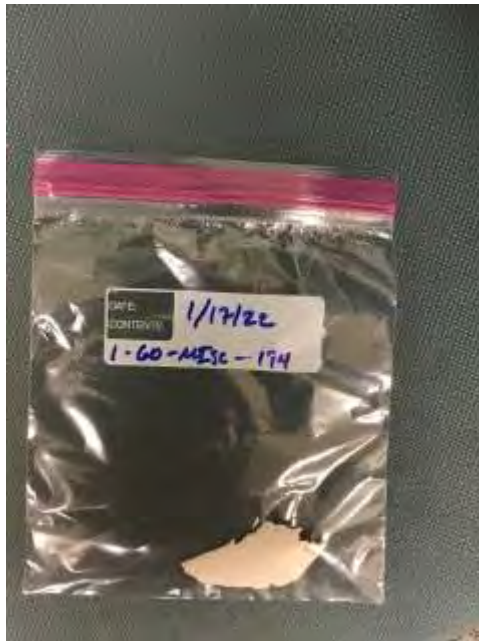
Additional Sample Notes:		
Sample ID:	Sample Type:	
1-60-MISC-194	MISC	
Sample Location:	Detailed Sample Location:	
Office	South wall of principal's office	
Sample Quantity:	See 1-60-MISC-192	
Misc Sample Material:	Sample Condition:	Sample Friable?:
White wallpaper with tan mastic	Damaged or significantly damaged friable miscellaneous ACM	No
Sample Photo:

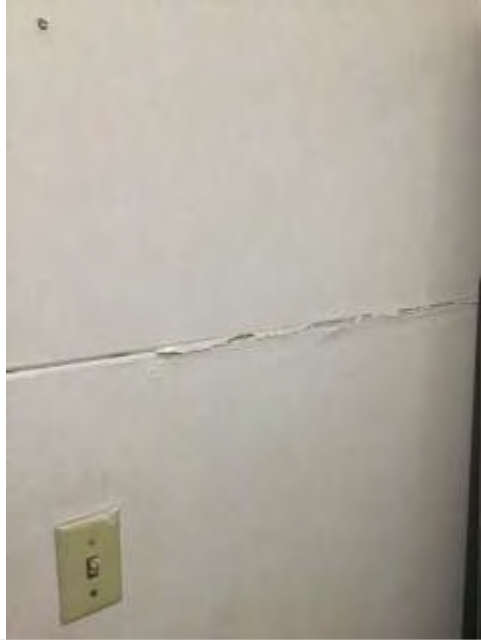
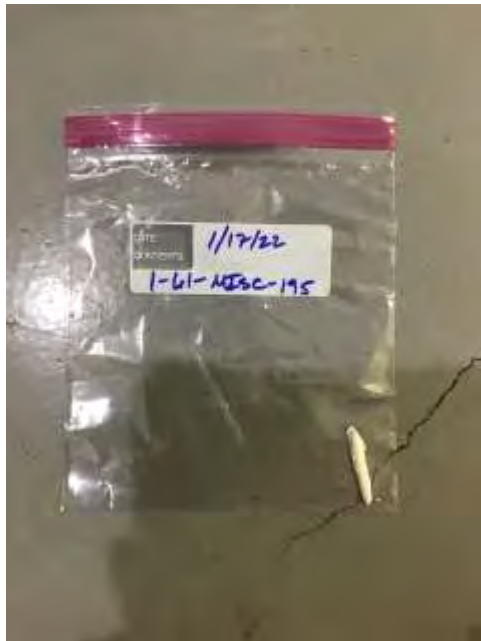
Additional Sample Notes:		
Sample ID:	Sample Type:	
1-61-MISC-195	MISC	
Sample Location:	Detailed Sample Location:	
Cafeteria	Back storage room	
Sample Quantity:	177 SF	
Misc Sample Material:	Sample Condition:	Sample Friable?:
White woven wallpaper with yellow mastic	Damaged or significantly damaged friable miscellaneous ACM	No
Sample Photo:

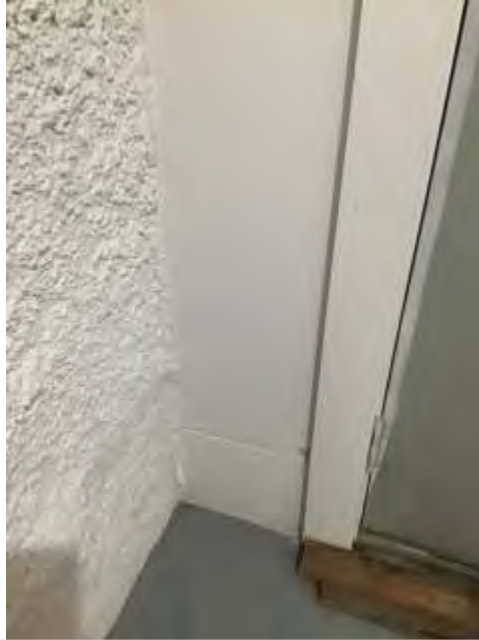
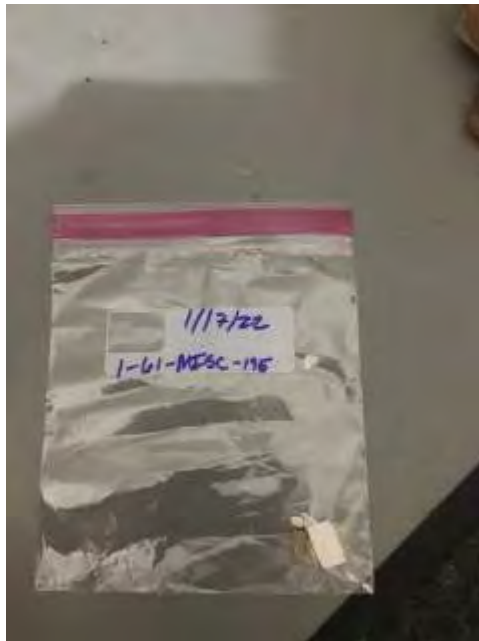
Additional Sample Notes:		
Sample ID:	Sample Type:	
1-61-MISC-196	MISC	
Sample Location:	Detailed Sample Location:	
Cafeteria	Back storage room	
Sample Quantity:	See 1-61-MISC-195	
Misc Sample Material:	Sample Condition:	Sample Friable?:
White woven wallpaper with yellow mastic	Damaged or significantly damaged friable miscellaneous ACM	No
Sample Photo:

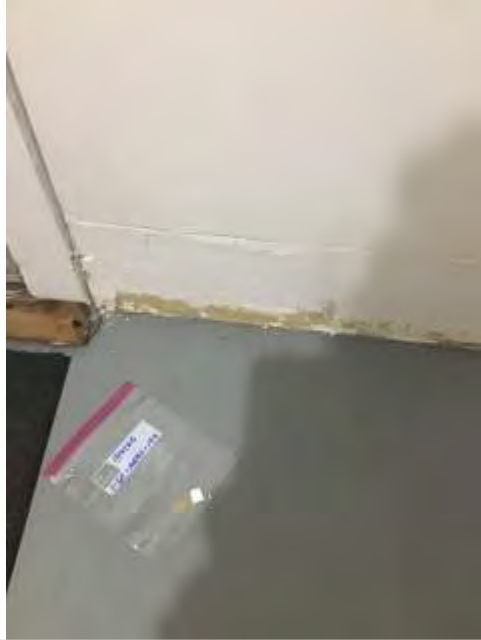
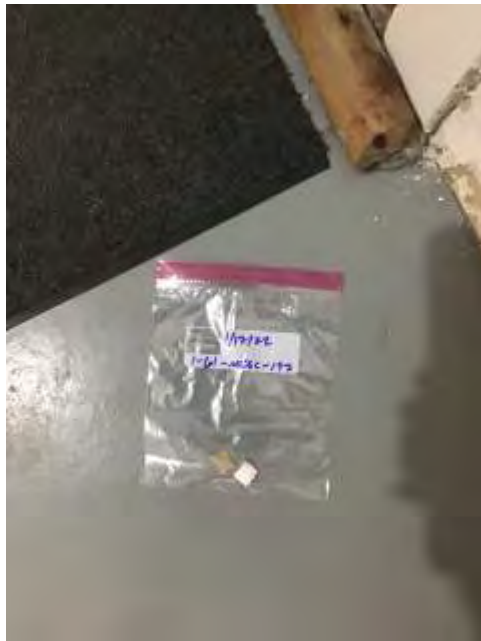
Additional Sample Notes:		
Sample ID:	Sample Type:	
1-61-MISC-197	MISC	
Sample Location:	Detailed Sample Location:	
Cafeteria	Back storage room	
Sample Quantity:	See 1-61-MISC-195	
Misc Sample Material:	Sample Condition:	Sample Friable?:
White woven wallpaper with yellow mastic	Damaged or significantly damaged friable miscellaneous ACM	No
Sample Photo:

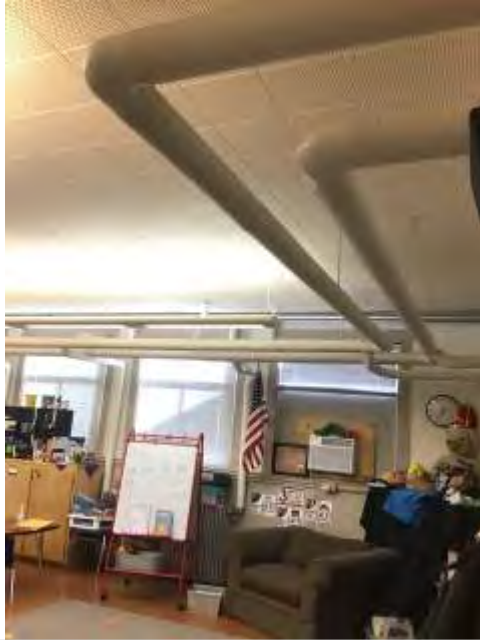
General Fixture Location:	Detailed Fixture Location:
Classroom 8	Throughout ceiling of room.
Type of Fixture:	Quantity:
Potential Asbestos containing TSI	240 LF
Condition:	Additional Fixture Notes:
Severely damaged

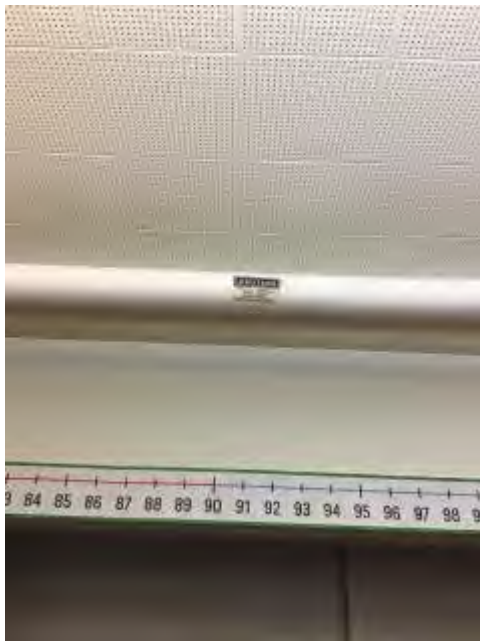
General Fixture Location:	Detailed Fixture Location:
Classroom 8	Along north edge of classroom ceiling
Type of Fixture:	Quantity:
Asbestos containing TSI	60 LF
Condition:	Additional Fixture Notes:
Good

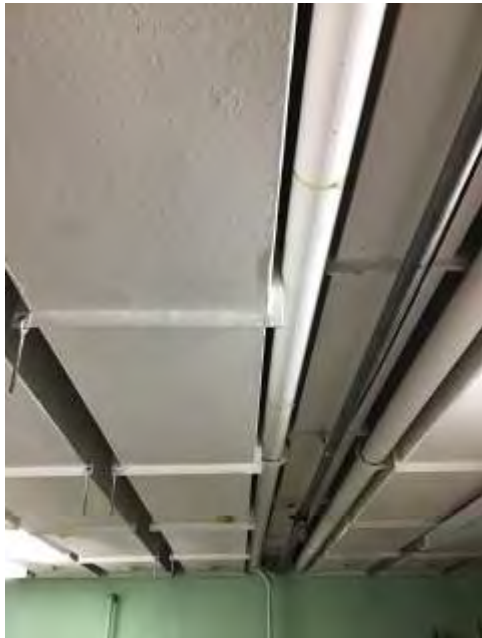
General Fixture Location:	Detailed Fixture Location:
Cafeteria	In food storage room HVAC
Type of Fixture:	Quantity:
ACM	7 HVAC ducts
Condition:	Additional Fixture Notes:
Poor	Each duct is approximately 18.4 feet long by 1.3 feet wide. Ducts appear to be coated on all sides.

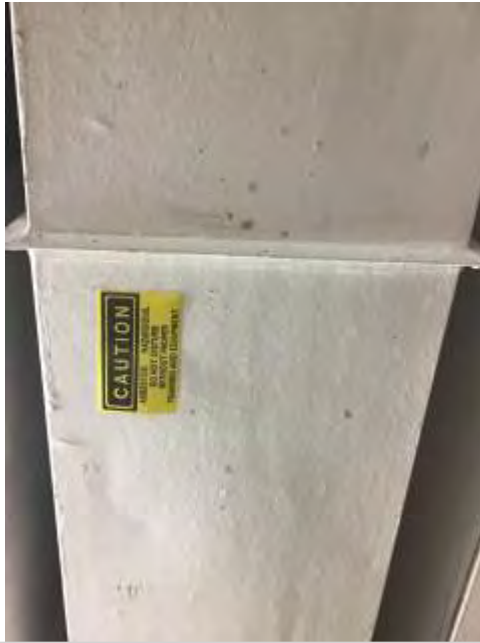
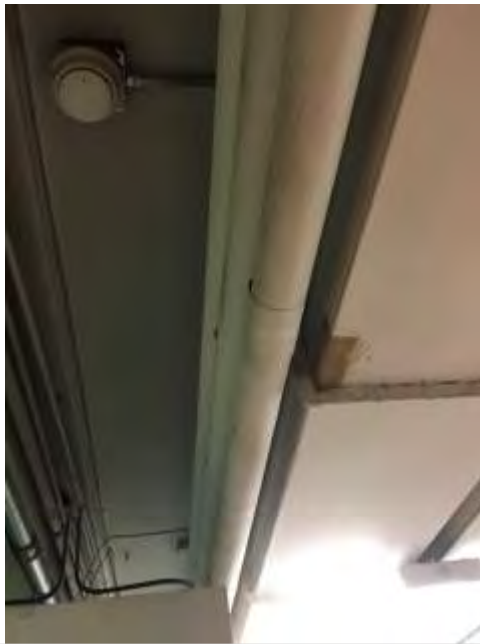
3 wrapped pipes.

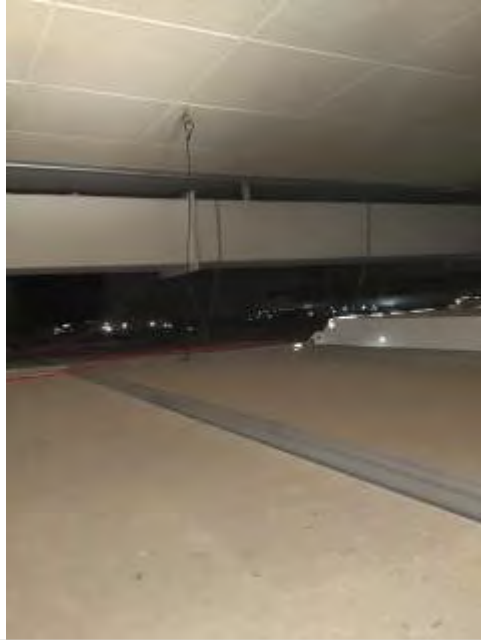
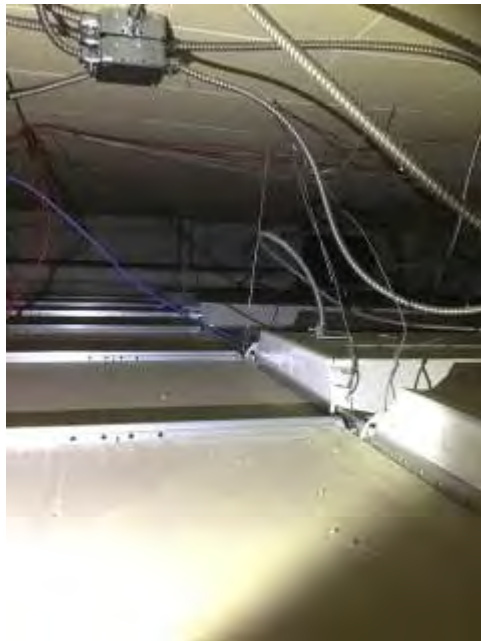
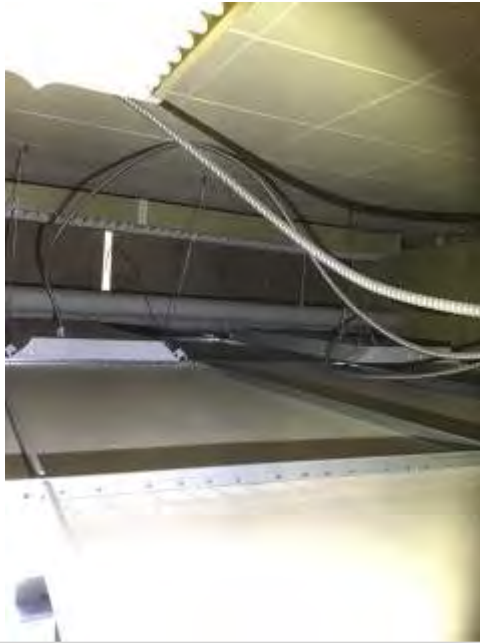
Other Material Tracking	
General Fixture Location:	Detailed Fixture Location:
Computer lab and office	Above drop down ceiling
Type of Fixture:	Quantity:
ACM	
Condition:	Additional Fixture Notes:
Good	Asbestos containing HVAC duct above ceiling, as well as 9x9 dotted pattern acoustic ceiling tiles
Other Material Photo:

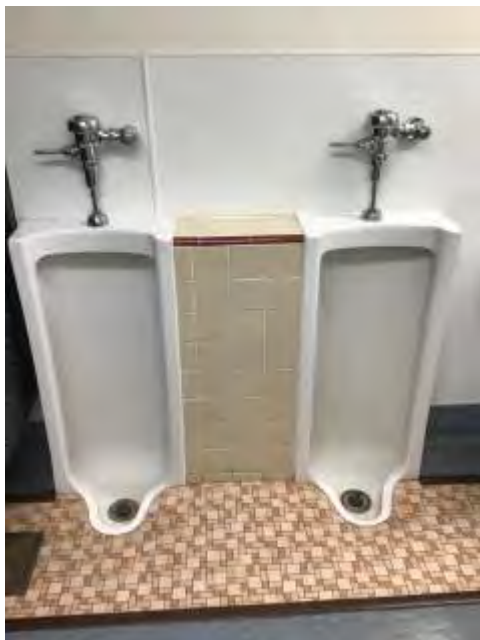
General Fixture Location:	Detailed Fixture Location:
Boys bathroom	Surrounding urinal
Type of Fixture:	Quantity:
Potential ACM	50 SF
Condition:	Additional Fixture Notes:
Other	Potential ACM. However, sample not collected due to bathroom being heavily occupied and creating a potential friable ACM hazard. Assume grout and tile is the same as functional area 2

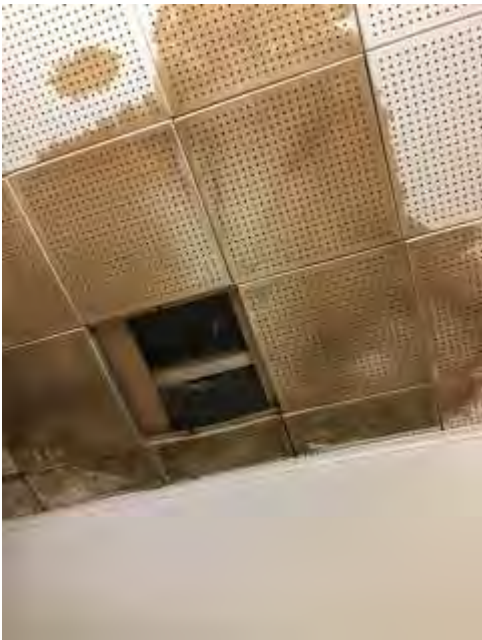
Other Material Tracking	
General Fixture Location:	Detailed Fixture Location:
Faculty	Above ceiling tiles
Type of Fixture:	Quantity:
Potential ACM	Unknown
Condition:	Additional Fixture Notes:
Severely damaged	Black fibrous installation above ceiling tile. Did not collect sample due to extreme friability and being in an active area with high potential to be ACM.

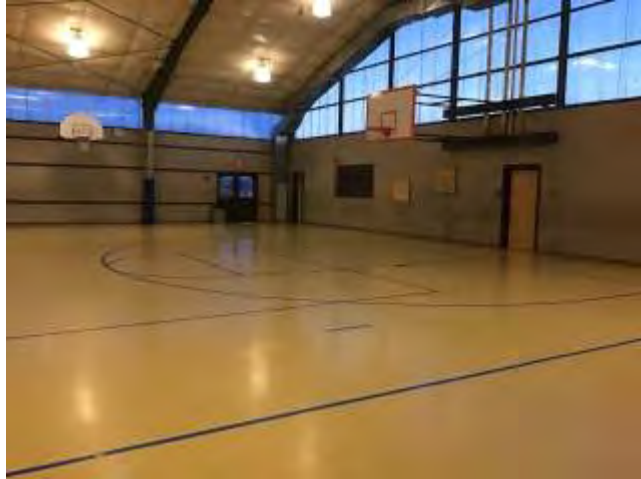
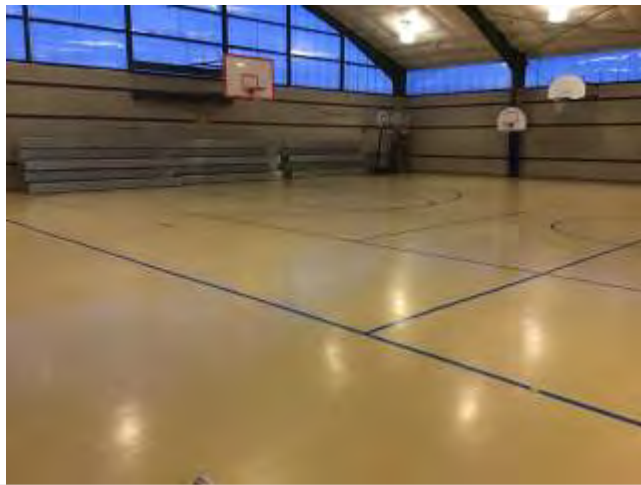
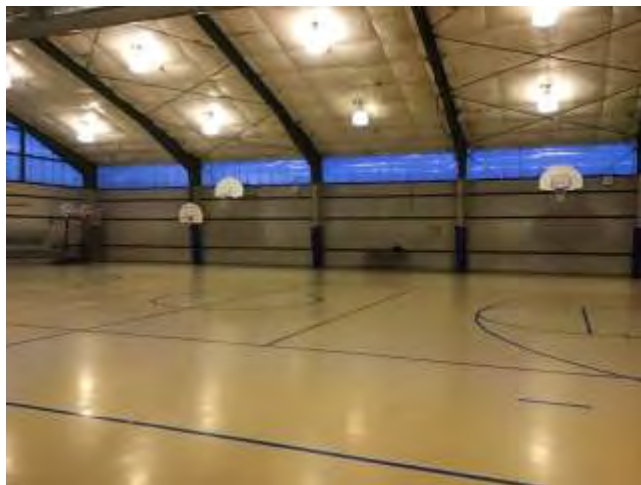
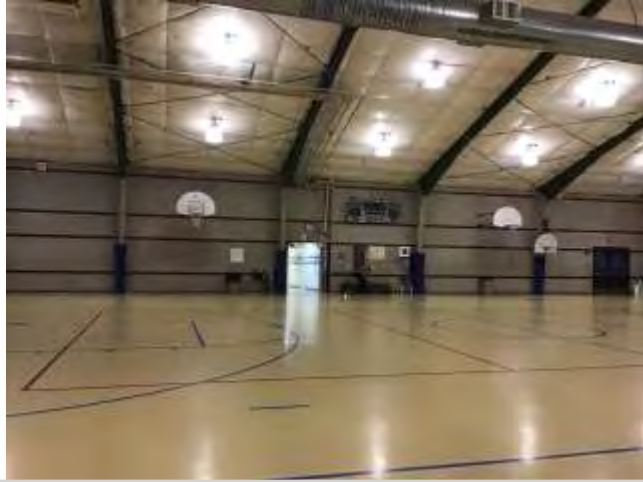
Other Material Tracking	
General Fixture Location:	Detailed Fixture Location:
Gym	Gym flooring
Type of Fixture:	Quantity:
	7,927.33 SF
Condition:	Additional Fixture Notes:
Good	Potential mercury containing flooring. Conduct a mercury vapor assessment or TCLP sampling to further inform.

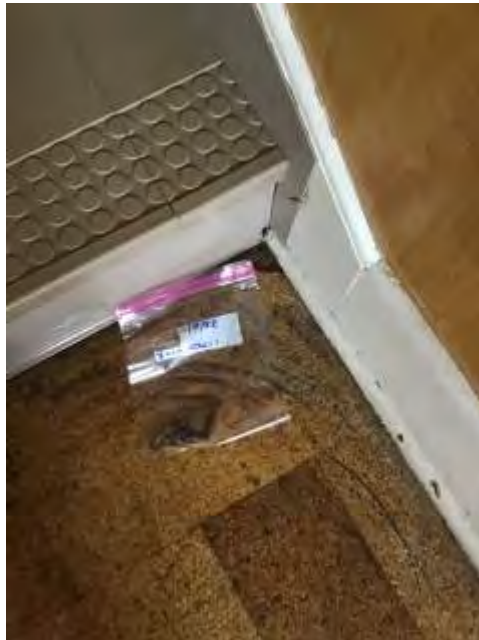
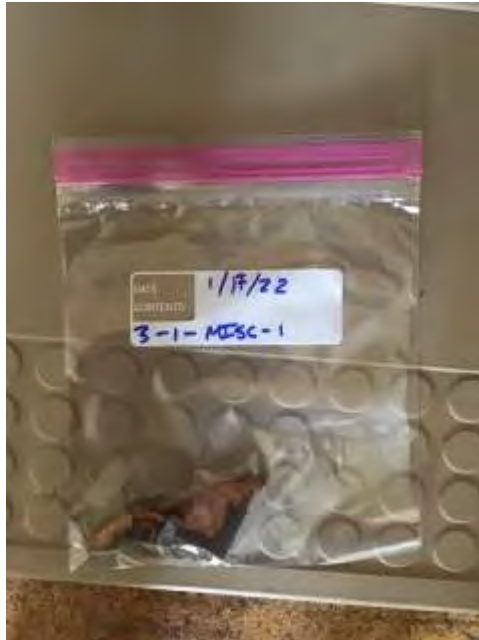
Sample ID:	Sample Type:	
3-1-MISC-1	MISC	
Sample Location:	Detailed Sample Location:	
Entrance	North corner of entrance landing near stairs	
Sample Quantity:	103 SF	
Misc Sample Material:	Sample Condition:	Sample Friable?:
Brown vinyl tile with black mastic	Damaged or significantly damaged friable miscellaneous ACM	No

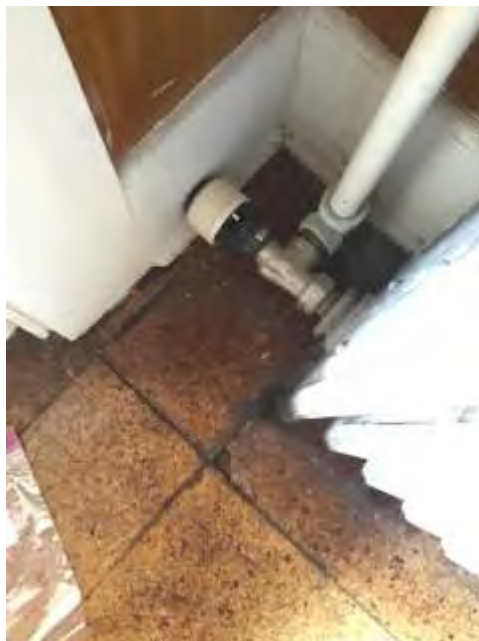
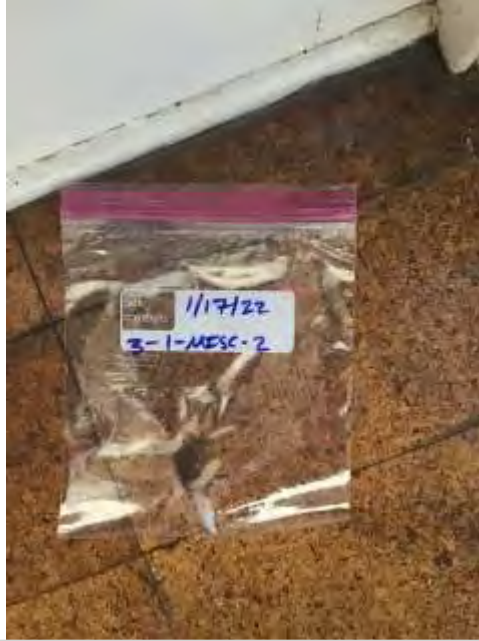
Additional Sample Notes:		
Sample ID:	Sample Type:	
3-1-MISC-2	MISC	
Sample Location:	Detailed Sample Location:	
Entrance	Northeast corner of entrance landing near radiator	
Sample Quantity:	See 3-1-MISC-1	
Misc Sample Material:	Sample Condition:	Sample Friable?:
Brown vinyl tile with black mastic	Damaged or significantly damaged friable miscellaneous ACM	No

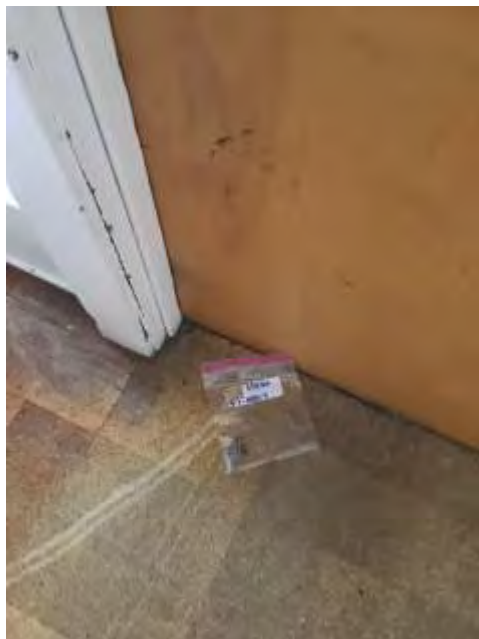
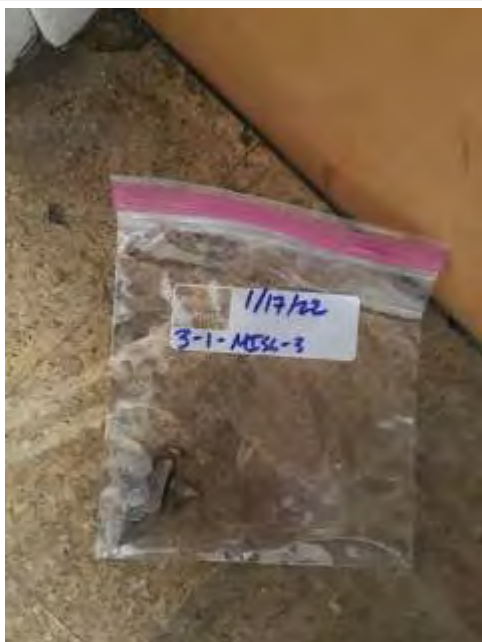
Additional Sample Notes:		
Sample ID:	Sample Type:	
3-1-MISC-3	MISC	
Sample Location:	Detailed Sample Location:	
Entrance	Corner of entrance landing door	
Sample Quantity:	See 3-1-MISC-1	
Misc Sample Material:	Sample Condition:	Sample Friable?:
Brown vinyl tile with black mastic	Damaged or significantly damaged friable miscellaneous ACM	No

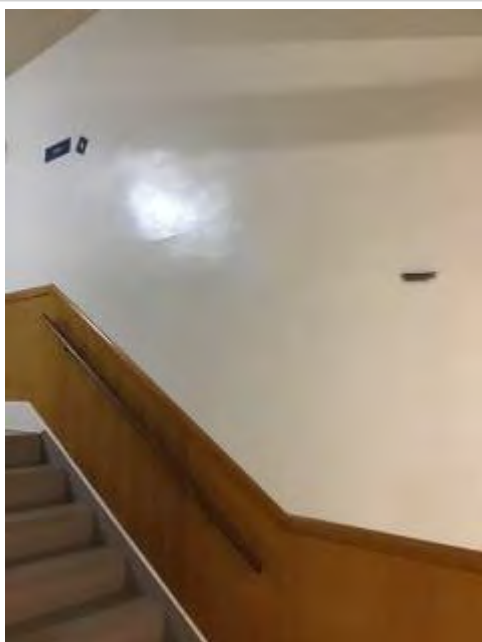
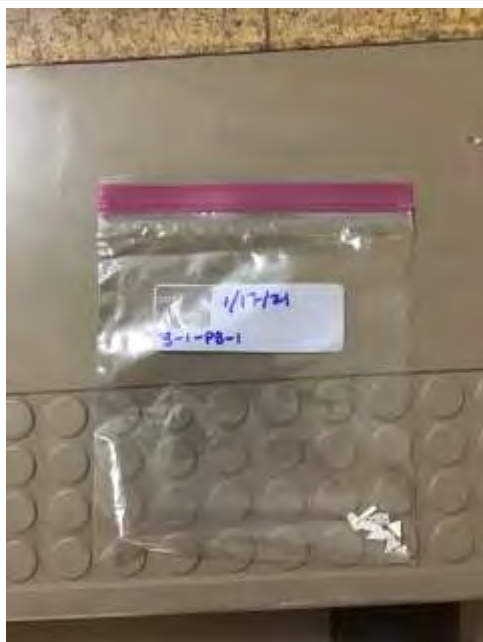
White	0.13mg/cm2
-------	------------

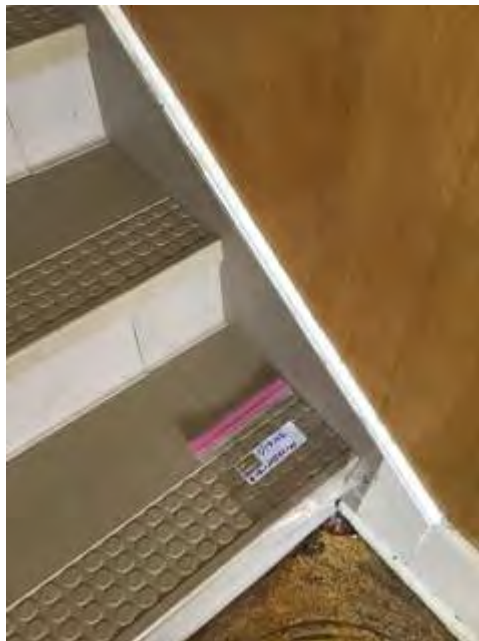
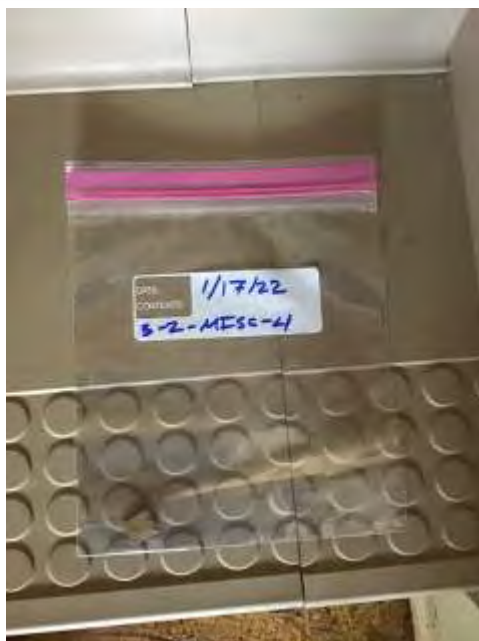
Additional Sample Notes:		
Sample ID:	Sample Type:	
3-2-MISC-4	MISC	
Sample Location:	Detailed Sample Location:	
Entrance	Northeast corner of stairs	
Sample Quantity:	317.3 SF	
Misc Sample Material:	Sample Condition:	Sample Friable?:
Tan rubber stair treads with tan and yellow mastic	Damaged or significantly damaged friable miscellaneous ACM	No

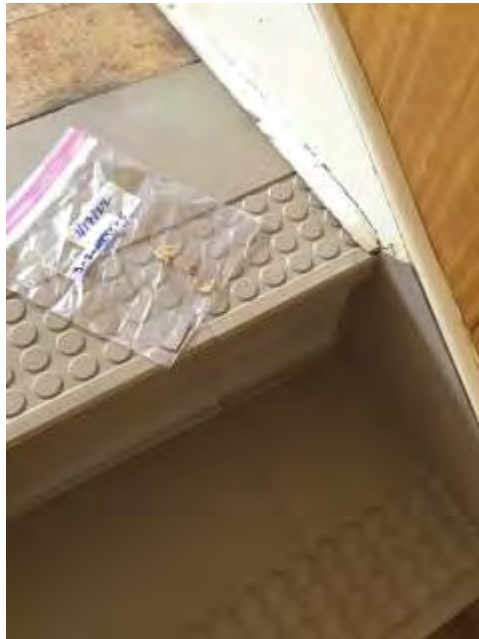
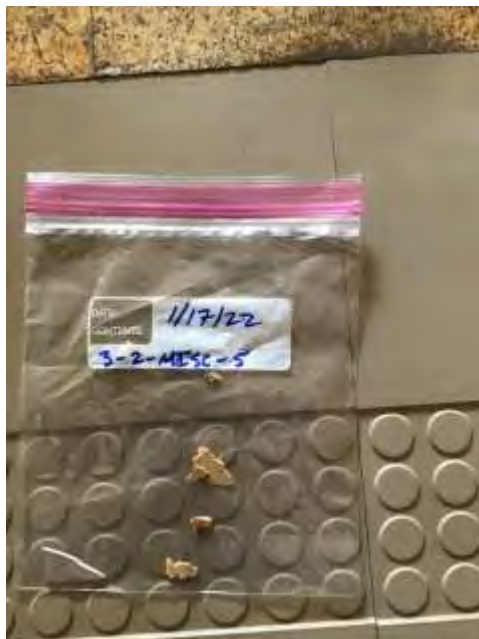
Additional Sample Notes:		
Sample ID:	Sample Type:	
3-2-MISC-5	MISC	
Sample Location:	Detailed Sample Location:	
Entrance	Corner of bottom stairs	
Sample Quantity:	See 3-2-MISC-4	
Misc Sample Material:	Sample Condition:	Sample Friable?:
Tan rubber stair treads with tan and yellow mastic	Damaged or significantly damaged friable miscellaneous ACM	No

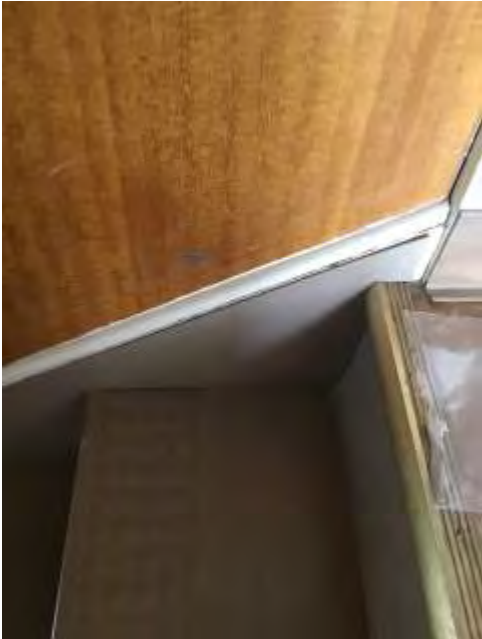
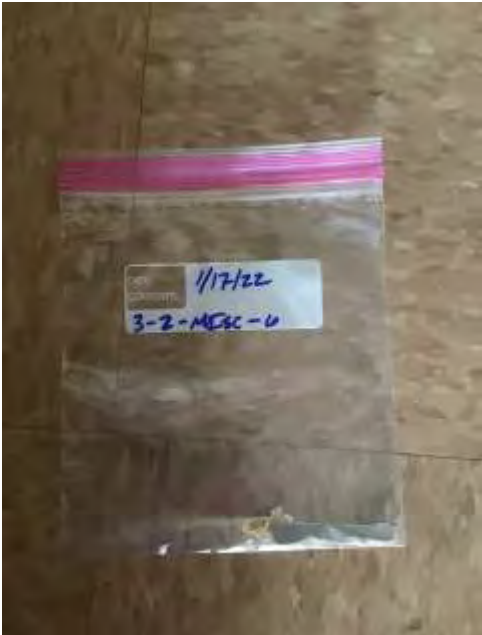
Additional Sample Notes:		
Sample ID:	Sample Type:	
3-2-MISC-6	MISC	
Sample Location:	Detailed Sample Location:	
Entrance	Top of entrance stairway leading up	
Sample Quantity:	See 3-2-MISC-4	
Misc Sample Material:	Sample Condition:	Sample Friable?:
Tan rubber stair treads with tan and yellow mastic	Damaged or significantly damaged friable miscellaneous ACM	No
Sample Photo:

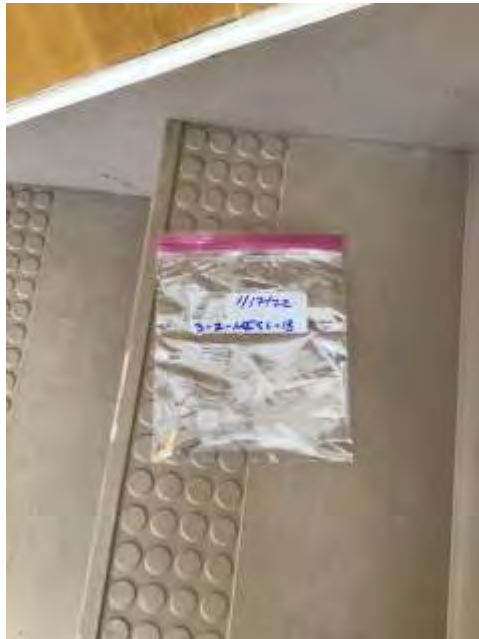
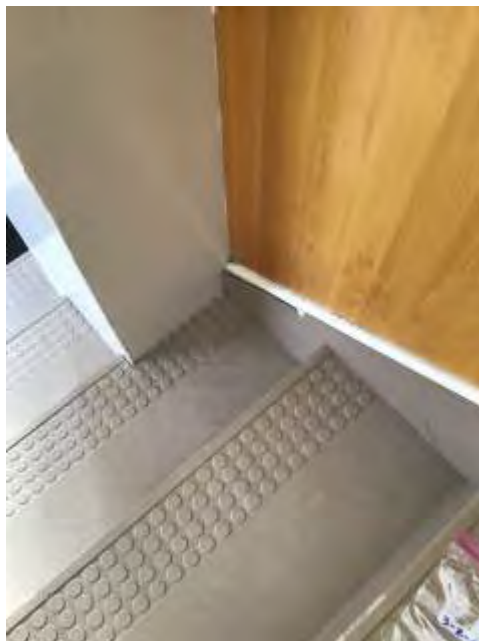
Additional Sample Notes:		
Sample ID:	Sample Type:	
3-2-MISC-13	MISC	
Sample Location:	Detailed Sample Location:	
South staircase	Corner of bottom stairs	
Sample Quantity:	See 3-2-MISC-4	
Misc Sample Material:	Sample Condition:	Sample Friable?:
Tan rubber stair treads with tan and yellow mastic	Damaged or significantly damaged friable miscellaneous ACM	No

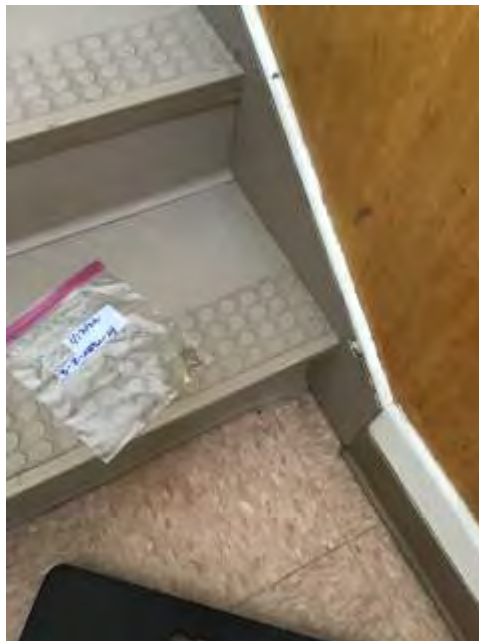
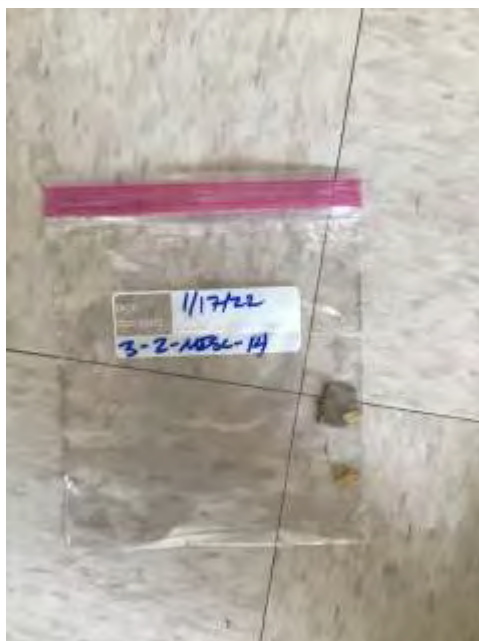
Additional Sample Notes:		
Sample ID:	Sample Type:	
3-2-MISC-14	MISC	
Sample Location:	Detailed Sample Location:	
North staircase	Corner of bottom stairs	
Sample Quantity:	See 3-2-MISC-4	
Misc Sample Material:	Sample Condition:	Sample Friable?:
Tan rubber stair treads with tan and yellow mastic	Damaged or significantly damaged friable miscellaneous ACM	No

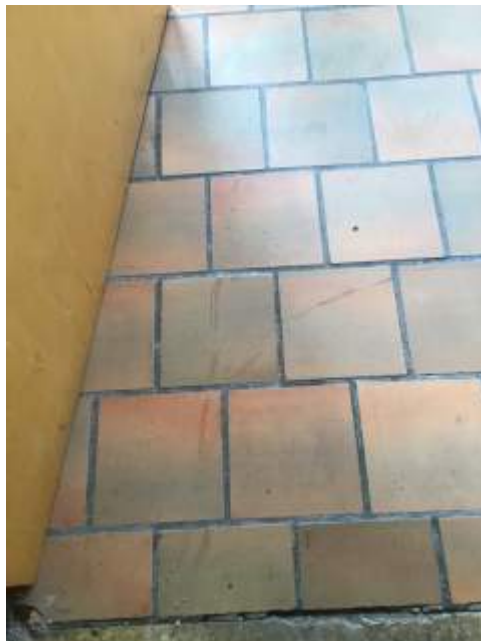
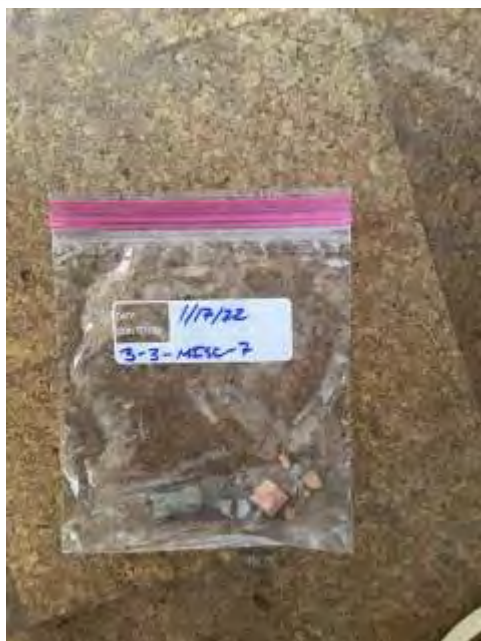
Additional Sample Notes:		
Sample ID:	Sample Type:	
3-3-MISC-7	MISC	
Sample Location:	Detailed Sample Location:	
Entrance	Entrance landing between the second set of double doors	
Sample Quantity:	97 SF	
Misc Sample Material:	Sample Condition:	Sample Friable?:
Red brick flooring and gray grout	Damaged or significantly damaged friable miscellaneous ACM	Yes

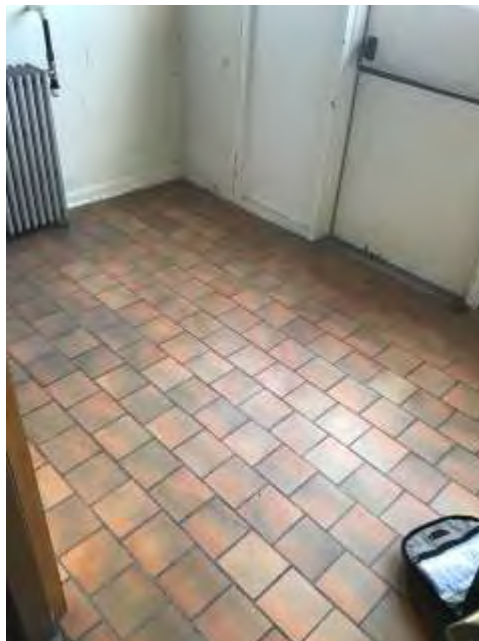
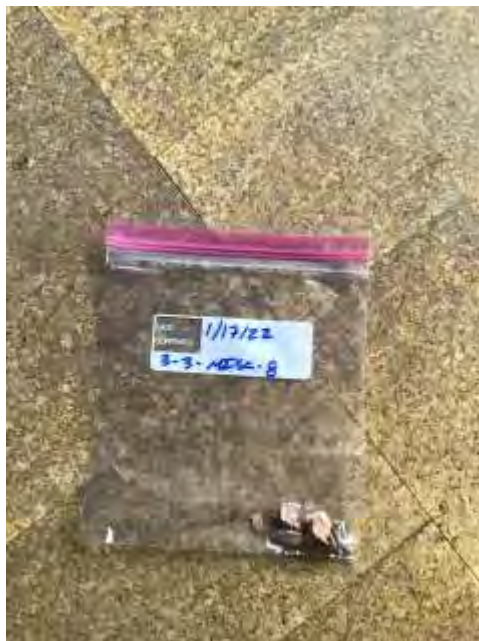
Additional Sample Notes:		
Sample ID:	Sample Type:	
3-3-MISC-8	MISC	
Sample Location:	Detailed Sample Location:	
Entrance	Entrance landing between the second set of double doors	
Sample Quantity:	See 3-3-MISC-7	
Misc Sample Material:	Sample Condition:	Sample Friable?:
Red brick flooring and gray grout	Damaged or significantly damaged friable miscellaneous ACM	Yes
