HAZARDOUS BUILDING MATERIALS SURVEY

CONDON GRADE SCHOOL
220 S. EAST STREET
CONDON, OREGON

Prepared for
CITY OF CONDON
May 17, 2022
Project No. M2053.01.002

Prepared by
Maul Foster & Alongi, Inc.
3140 NE Broadway Street, Portland, OR 97232

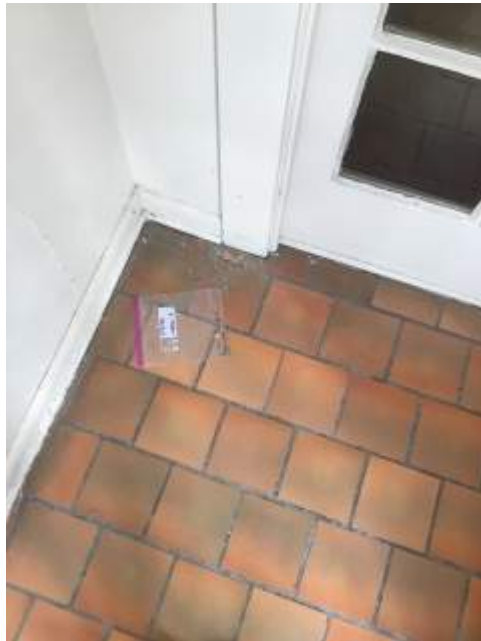
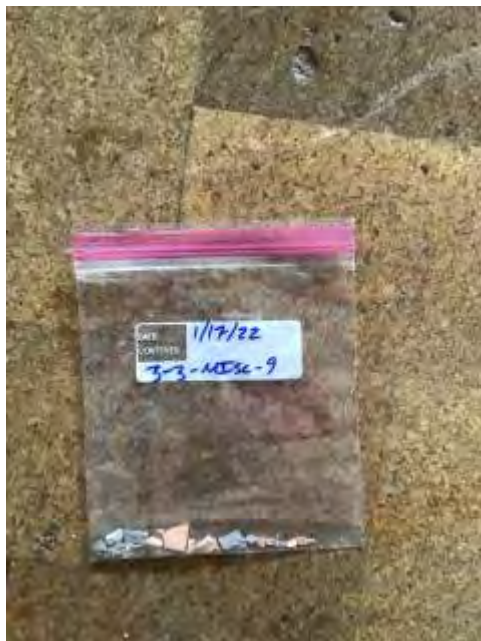
Additional Sample Notes:		
Sample ID:	Sample Type:	
3-3-MISC-9	MISC	
Sample Location:	Detailed Sample Location:	
Entrance	Entrance landing corner behind second set of doors	
Sample Quantity:	See 3-3-MISC-7	
Misc Sample Material:	Sample Condition:	Sample Friable?:
Red brick flooring and gray grout	Damaged or significantly damaged friable miscellaneous ACM	Yes

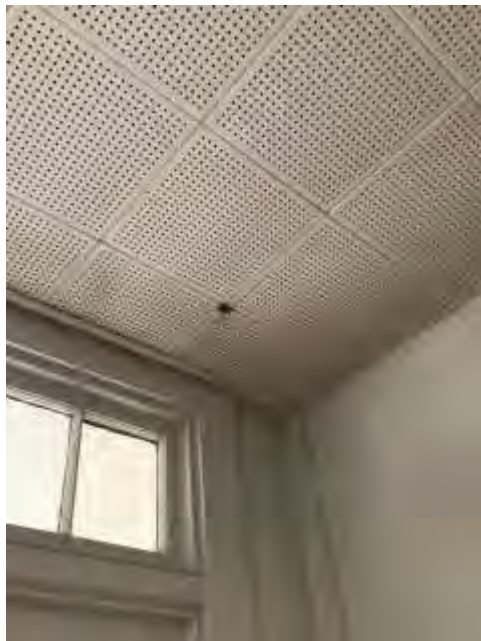
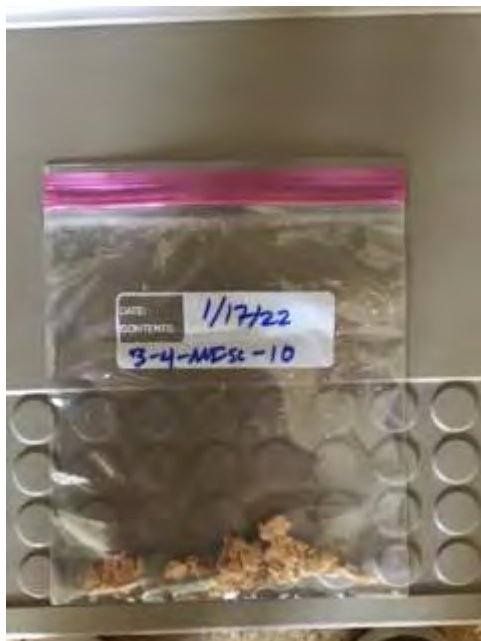
Additional Sample Notes:		
Sample ID:	Sample Type:	
3-4-MISC-10	MISC	
Sample Location:	Detailed Sample Location:	
Entrance	North corner near doors	
Sample Quantity:	201 SF	
Misc Sample Material:	Sample Condition:	Sample Friable?:
9"x9" white dotted acoustic ceiling tiles	Damaged or significantly damaged friable miscellaneous ACM	Yes

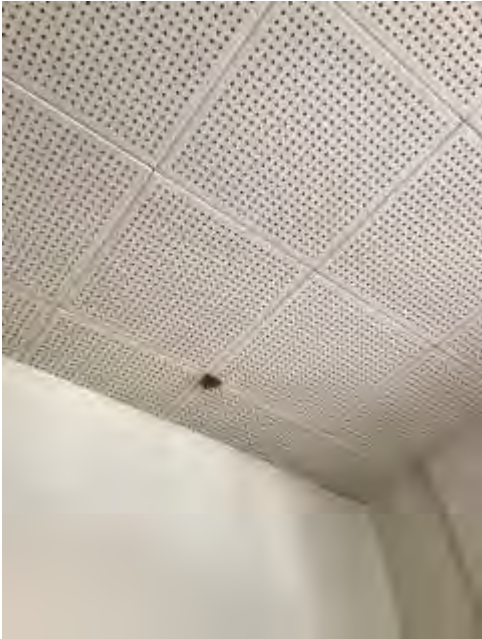
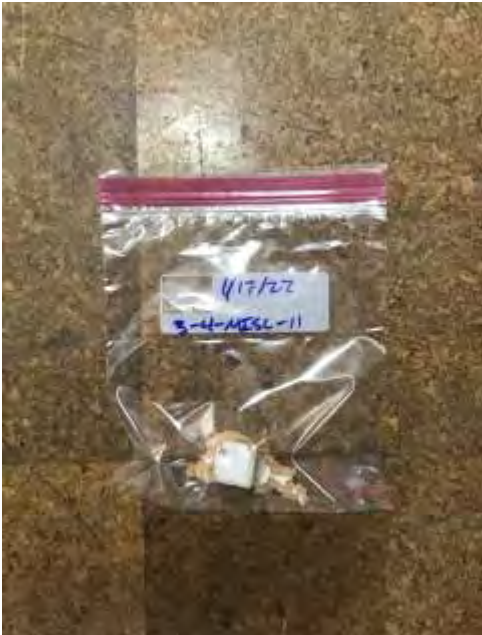
Additional Sample Notes:		
Sample ID:	Sample Type:	
3-4-MISC-11	MISC	
Sample Location:	Detailed Sample Location:	
Entrance	South corner near doors	
Sample Quantity:	See 3-4-MISC-10	
Misc Sample Material:	Sample Condition:	Sample Friable?:
9"x9" white dotted acoustic ceiling tiles	Damaged or significantly damaged friable miscellaneous ACM	Yes
Sample Photo:

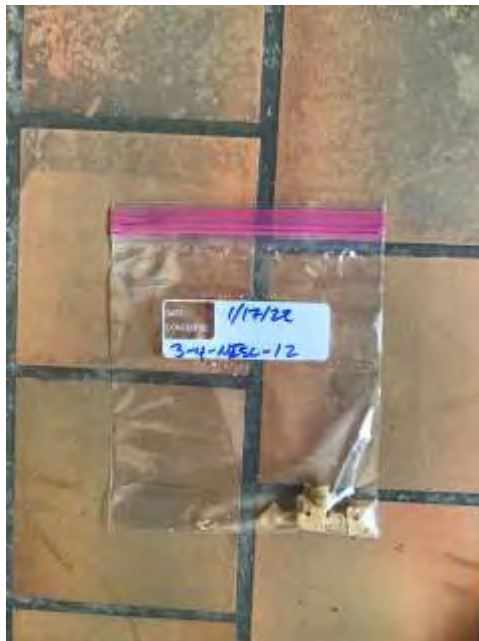
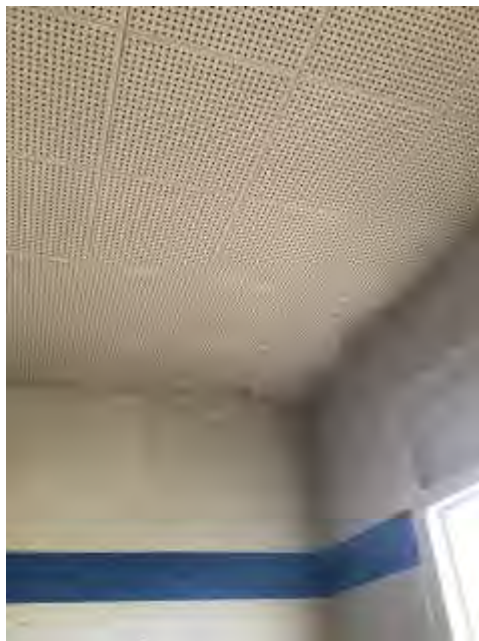
Additional Sample Notes:		
Sample ID:	Sample Type:	
3-4-MISC-12	MISC	
Sample Location:	Detailed Sample Location:	
Entrance	South corner near first set of doors	
Sample Quantity:	See 3-4-MISC-10	
Misc Sample Material:	Sample Condition:	Sample Friable?:
9"x9" white dotted acoustic ceiling tiles	Damaged or significantly damaged friable miscellaneous ACM	Yes

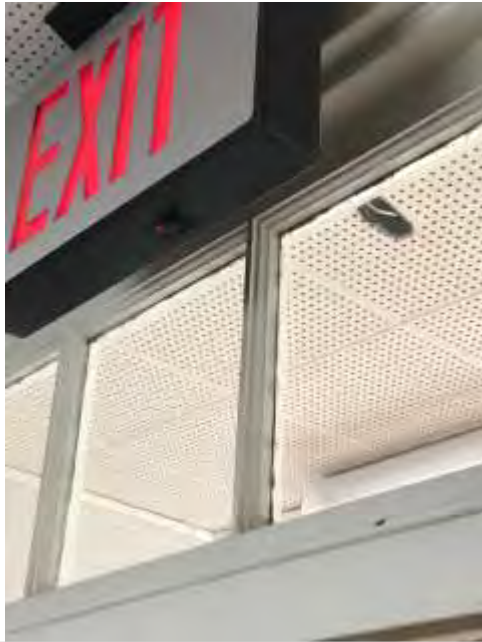
Other Material Tracking	
General Fixture Location:	Detailed Fixture Location:
Entrance	Single window panes
Type of Fixture:	Quantity:
Black mastic on single pane windows	20 LF
Condition:	Additional Fixture Notes:
Poor	Could not get sample without damaging window.

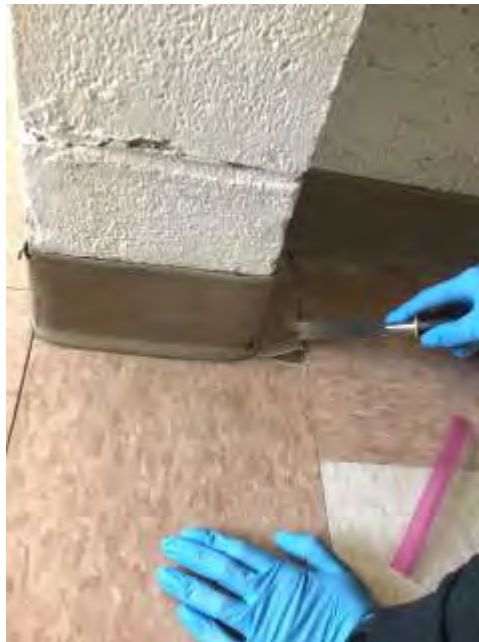
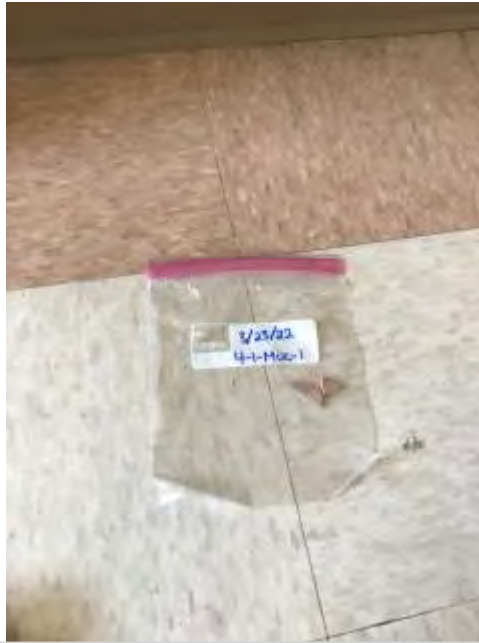
Sample ID:	Sample Type:	
4-1-MISC-1	MISC	
Sample Location:	Detailed Sample Location:	
South wing hallway	Northwest corner	
Sample Quantity:	2000 square feet	
Misc Sample Material:	Sample Condition:	Sample Friable?:
Beige 12"x12" tile with yellow mastic	Potential ACBM with potential for damage	No

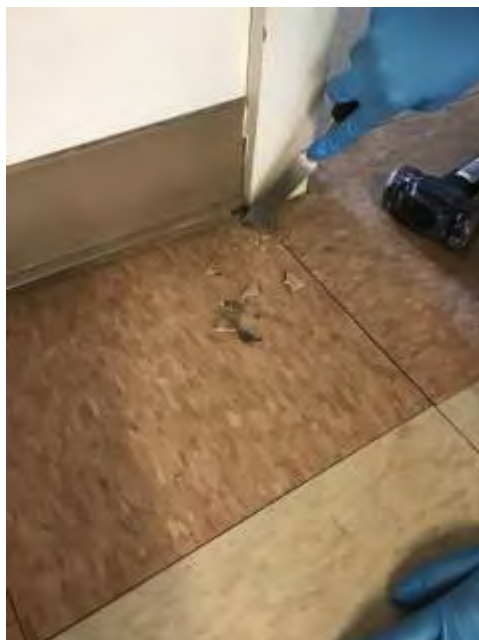
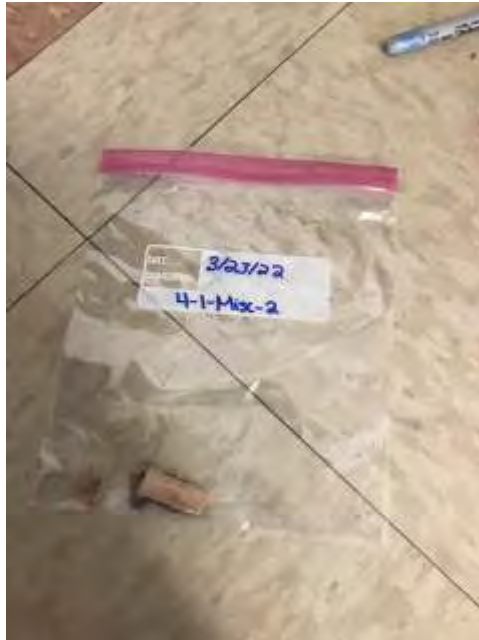
Additional Sample Notes:		
Sample ID:	Sample Type:	
4-1-MISC-2	MISC	
Sample Location:	Detailed Sample Location:	
South wing hallway	Southwest corner	
Sample Quantity:	See 4-1-MISC-1	
Misc Sample Material:	Sample Condition:	Sample Friable?:
Beige 12"x12" tile with yellow mastic	Potential ACBM with potential for damage	No

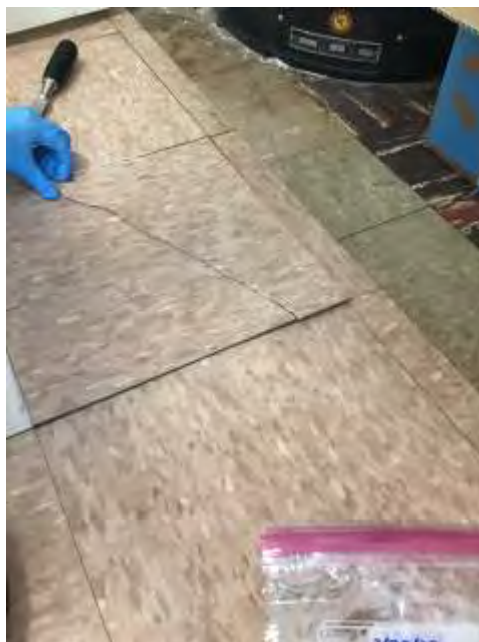
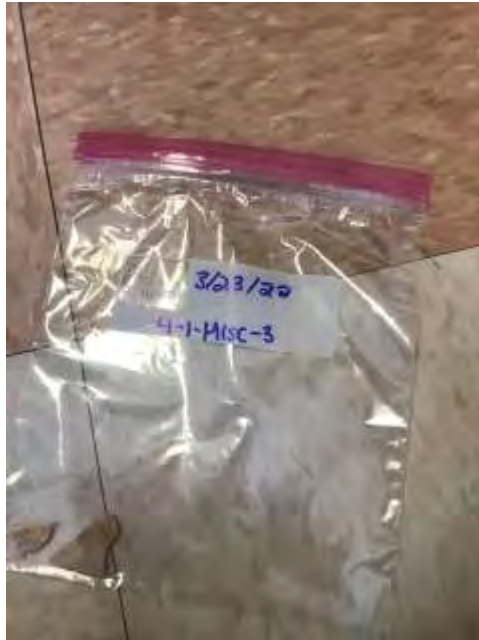
Additional Sample Notes:		
Sample ID:	Sample Type:	
4-1-MISC-3	MISC	
Sample Location:	Detailed Sample Location:	
South wing hallway	West closet	
Sample Quantity:	See 4-1-MISC-1	
Misc Sample Material:	Sample Condition:	Sample Friable?:
Beige 12"x12" tile with yellow mastic	Potential ACBM with potential for damage	No

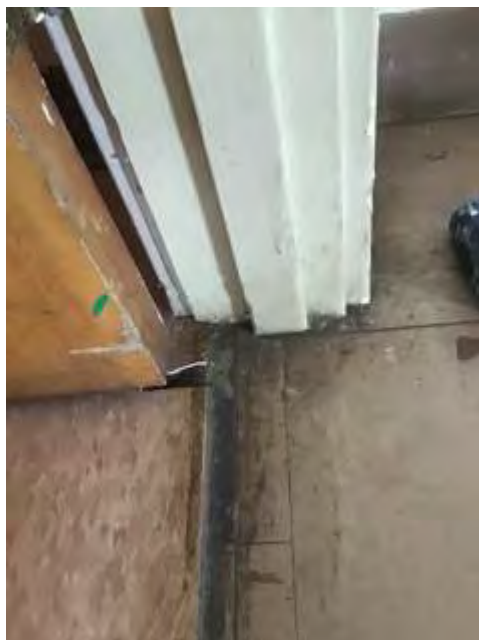
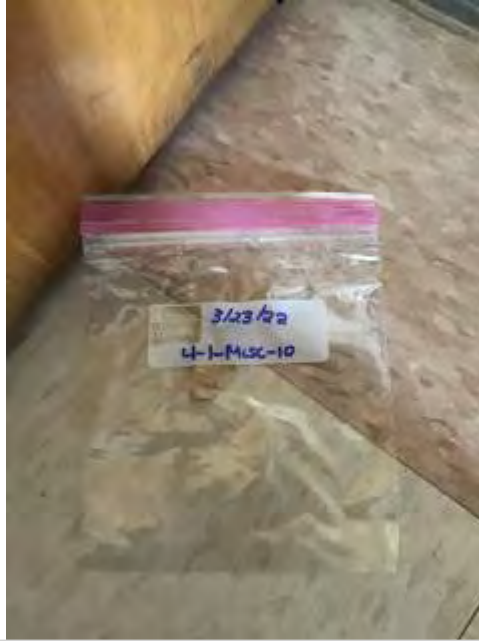
Additional Sample Notes:		White leveling compound	
Sample ID:		Sample Type:	
4-1-MISC-10		MISC	
Sample Location:		Detailed Sample Location:	
South wing hallway		Southeast corner	
Sample Quantity:		See 4-1-MISC-1	
Misc Sample Material:		Sample Condition:	Sample Friable?:
Beige 12"x12" tile with yellow mastic		Potential ACBM with potential for damage	No

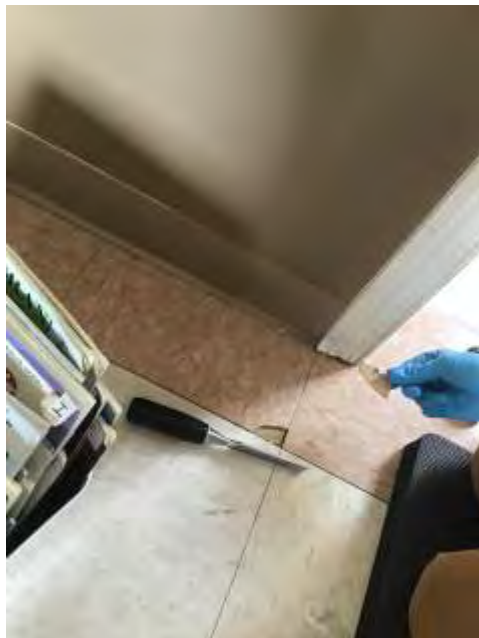
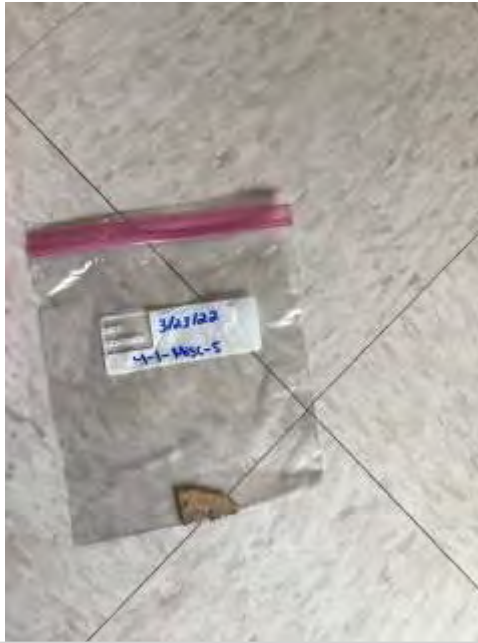
Additional Sample Notes:		
Sample ID:	Sample Type:	
4-1-MISC-5	MISC	
Sample Location:	Detailed Sample Location:	
South wing hallway	Northeast corner	
Sample Quantity:	See 4-1-MISC-1	
Misc Sample Material:	Sample Condition:	Sample Friable?:
Beige 12"x12" tile with yellow mastic	Potential ACBM with potential for damage	No

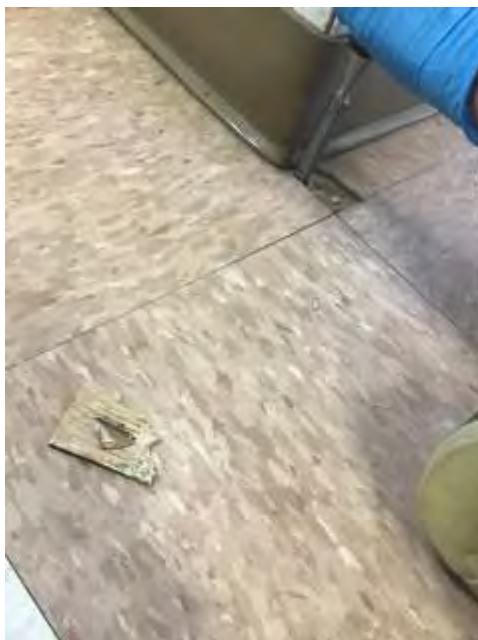
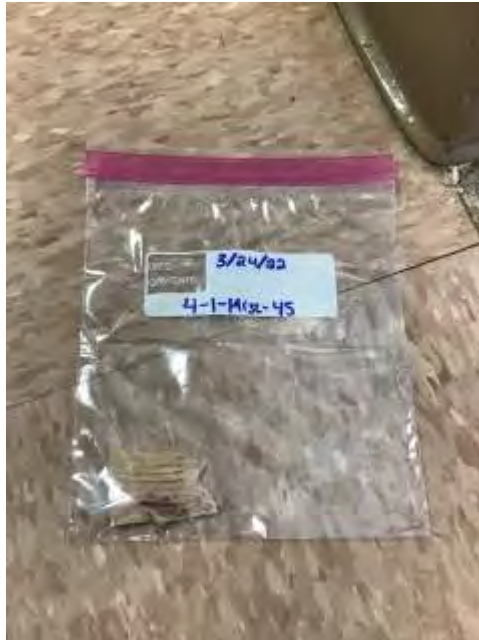
Sample ID:	Sample Type:	
4-1-MISC-45	MISC	
Sample Location:	Detailed Sample Location:	
North wing hallway	Center	
Sample Quantity:	See 4-1-MISC-1	
Misc Sample Material:	Sample Condition:	Sample Friable?:
Beige 12"x12" tile with yellow mastic	Potential ACBM with potential for damage	No

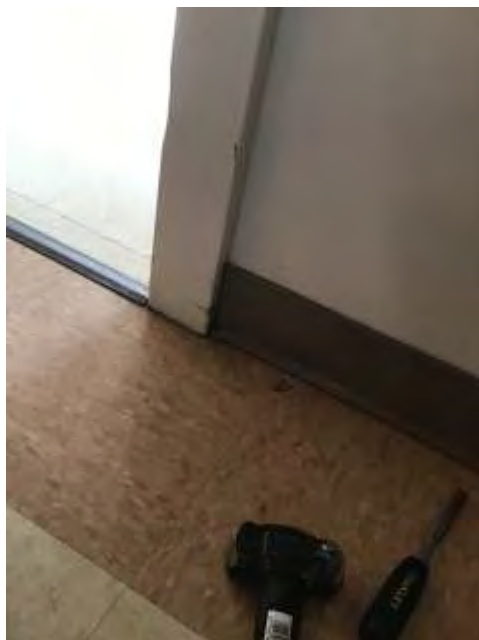
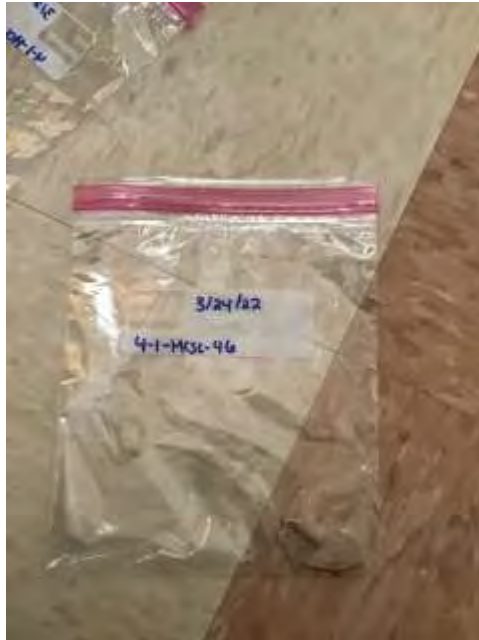
Additional Sample Notes:		With remnant black mastic.
Sample ID:	Sample Type:	
4-1-MISC-46	MISC	
Sample Location:	Detailed Sample Location:	
North wing hallway	Northeast	
Sample Quantity:	See 4-1-MISC-1	
Misc Sample Material:	Sample Condition:	Sample Friable?:
Beige 12"x12" tile with yellow mastic	Potential ACBM with potential for damage	No

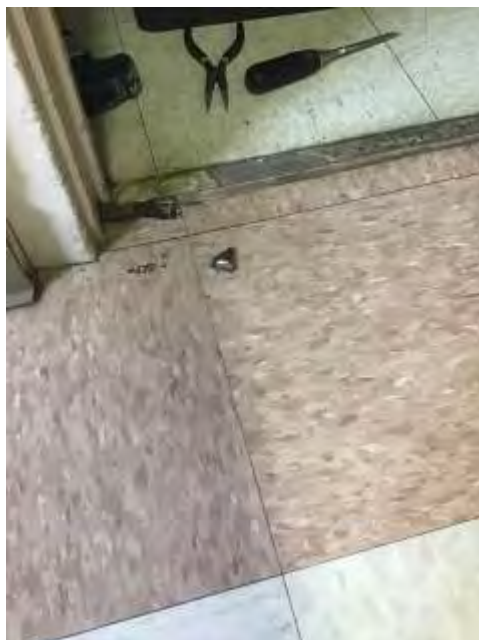
Additional Sample Notes:		
Sample ID:	Sample Type:	
4-1-MISC-47	MISC	
Sample Location:	Detailed Sample Location:	
North wing hallway	Northwest	
Sample Quantity:	See 4-1-MISC-1	
Misc Sample Material:	Sample Condition:	Sample Friable?:
Beige 12"x12" tile with yellow mastic	Potential ACBM with potential for damage	No

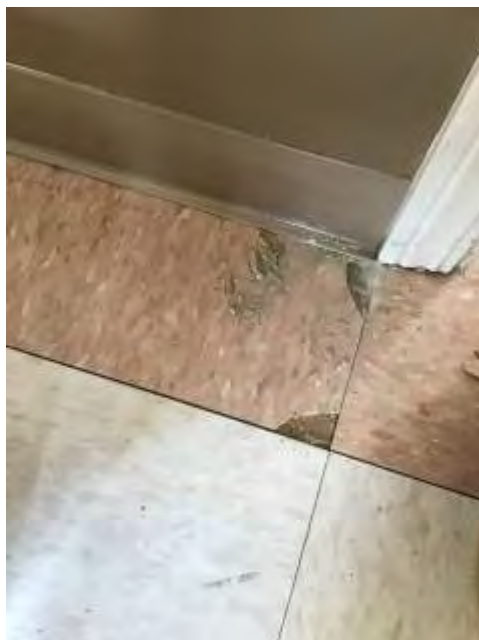
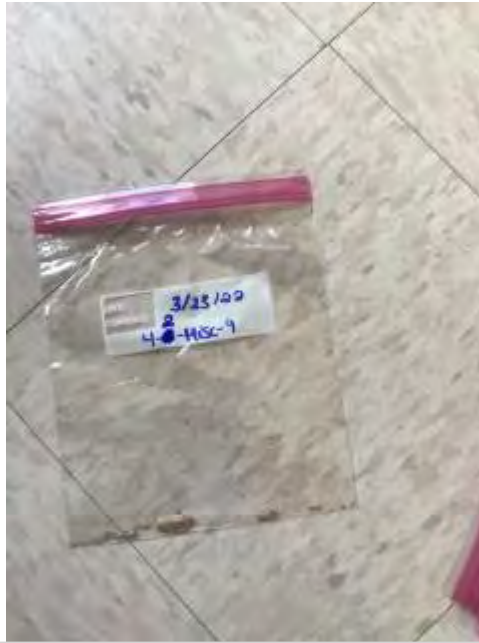
Sample ID:		Sample Type:	
4-2-MISC-9		MISC	
Sample Location:		Detailed Sample Location:	
South wing hallway		Northeast corner	
Sample Quantity:		250 square feet	
Misc Sample Material:		Sample Condition:	Sample Friable?:
Brown leveling compound with black mastic		Potential ACBM with potential for damage	No

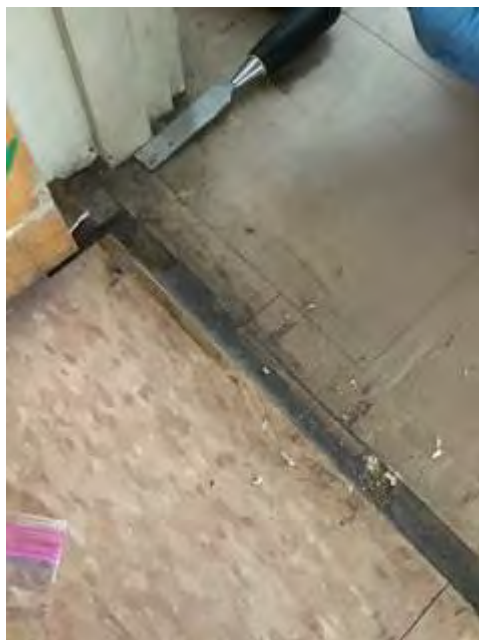
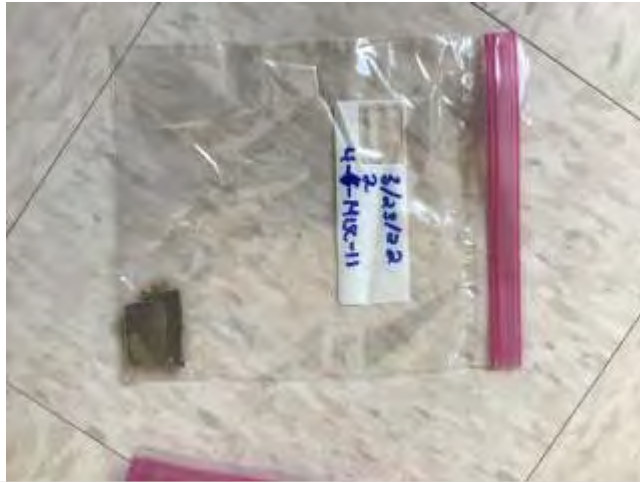
Additional Sample Notes:		Under hallway flooring.
Sample ID:	Sample Type:	
4-2-MISC-11	MISC	
Sample Location:	Detailed Sample Location:	
South wing	Southeast corner	
Sample Quantity:	See 4-2-MISC-9	
Misc Sample Material:	Sample Condition:	Sample Friable?:
Brown leveling compound with black mastic	Potential ACBM with potential for damage	No

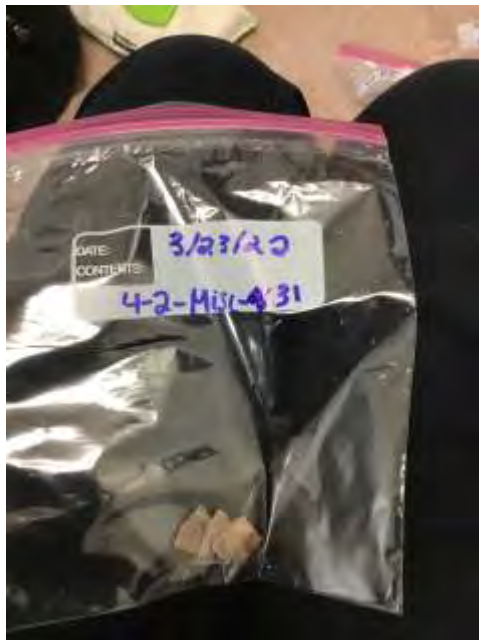
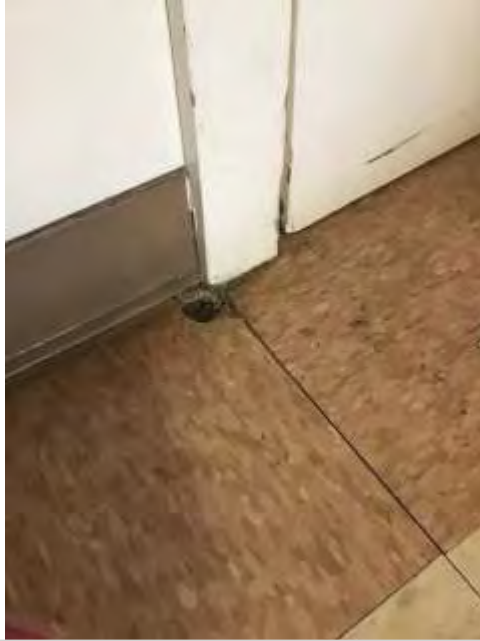
Additional Sample Notes:		Under hallway flooring.
Sample ID:	Sample Type:	
4-2-MISC-31	MISC	
Sample Location:	Detailed Sample Location:	
South wing hallway	Southwest corner	
Sample Quantity:	See 4-2-MISC-9	
Misc Sample Material:	Sample Condition:	Sample Friable?:
Brown leveling compound with black mastic	Potential ACBM with potential for damage	No

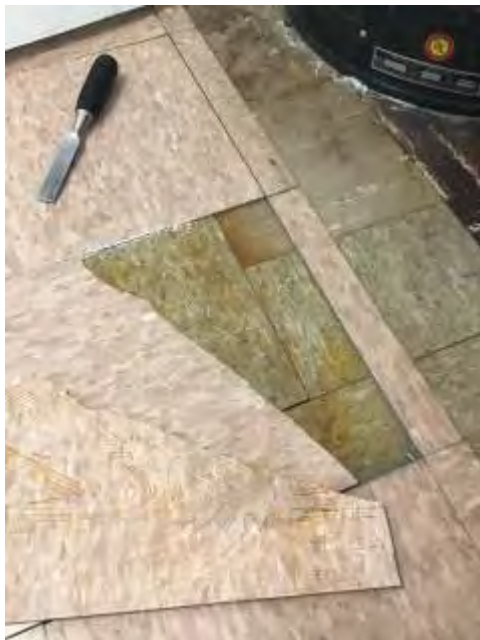
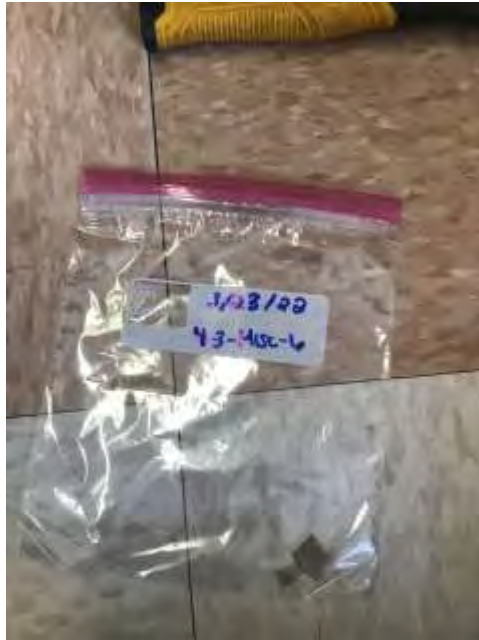
Additional Sample Notes:		Under hallway flooring.
Sample ID:	Sample Type:	
4-3-MISC-6	MISC	
Sample Location:	Detailed Sample Location:	
South wing hallway	West closet	
Sample Quantity:	1100 square feet	
Misc Sample Material:	Sample Condition:	Sample Friable?:
9"x9" oatmeal tile with black mastic	Potential ACBM with potential for damage	No

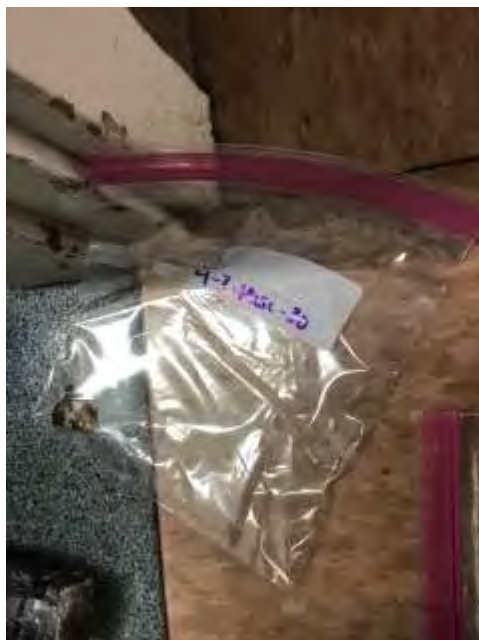
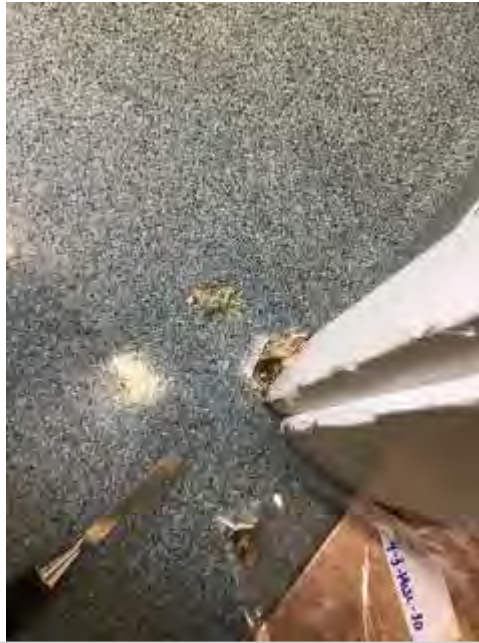
Additional Sample Notes:		Under hallway flooring.
Sample ID:	Sample Type:	
4-3-MISC-30	MISC	
Sample Location:	Detailed Sample Location:	
South wing	Southwest boys bathroom	
Sample Quantity:	See 4-3-MISC-6	
Misc Sample Material:	Sample Condition:	Sample Friable?:
9"x9" oatmeal tile with black mastic		No

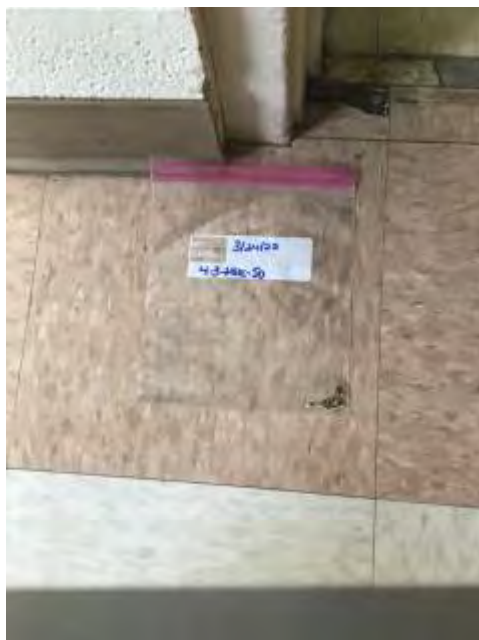
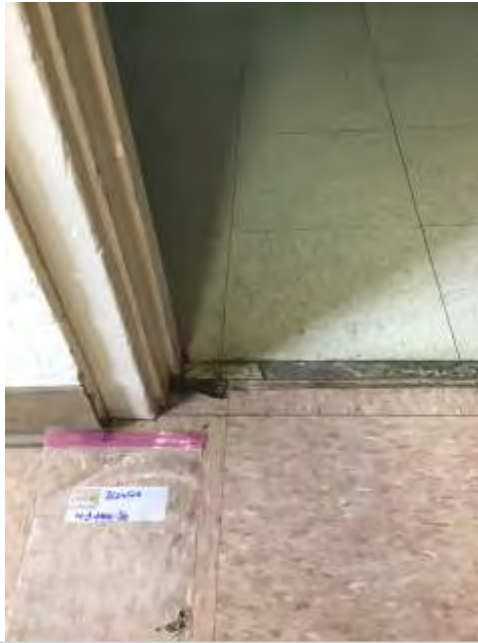
Additional Sample Notes:		Under linoleum flooring
Sample ID:	Sample Type:	
4-3-MISC-50	MISC	
Sample Location:	Detailed Sample Location:	
North wing hallway	Northwest	
Sample Quantity:	See 4-3-MISC-6	
Misc Sample Material:	Sample Condition:	Sample Friable?:
9"x9" oatmeal tile with black mastic	Potential ACBM with potential for damage	No

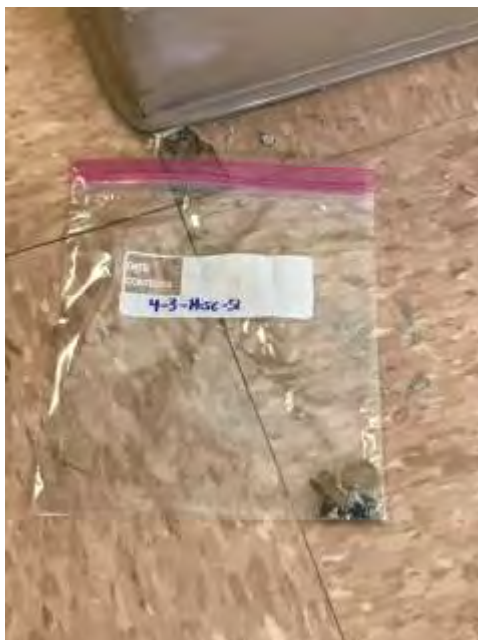
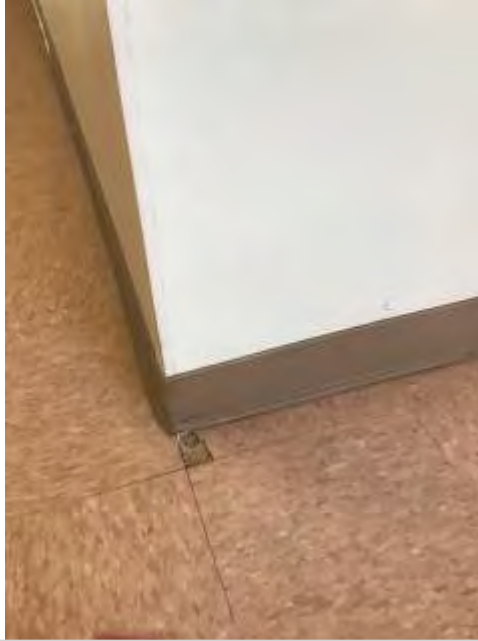
Additional Sample Notes:		
Sample ID:	Sample Type:	
4-3-MISC-51	MISC	
Sample Location:	Detailed Sample Location:	
North wing hallway	Center	
Sample Quantity:	See 4-3-MISC-6	
Misc Sample Material:	Sample Condition:	Sample Friable?:
9"x9" oatmeal tile with black mastic	Potential ACBM with potential for damage	No

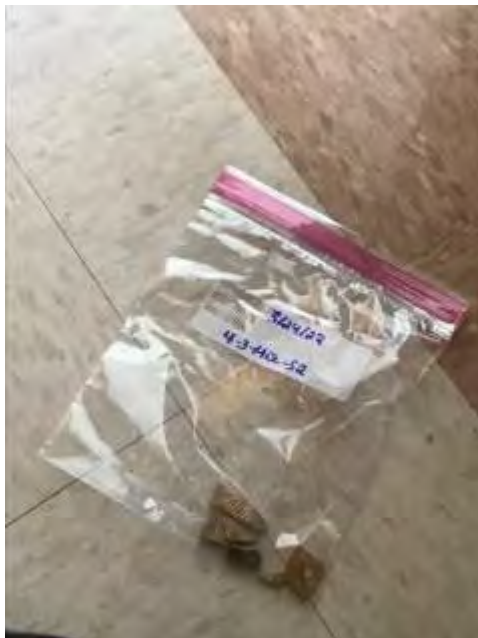
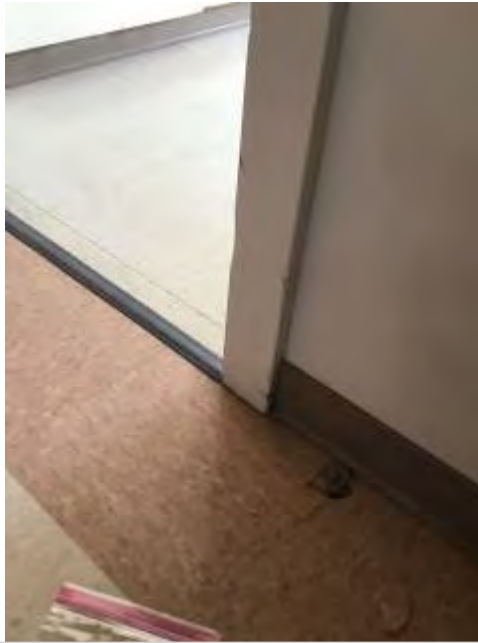
Additional Sample Notes:		
Sample ID:	Sample Type:	
4-3-MISC-52	MISC	
Sample Location:	Detailed Sample Location:	
North wing hallway	Northeast	
Sample Quantity:	See 4-3-MISC-6	
Misc Sample Material:	Sample Condition:	Sample Friable?:
9"x9" oatmeal tile with black mastic	Potential ACBM with potential for damage	No

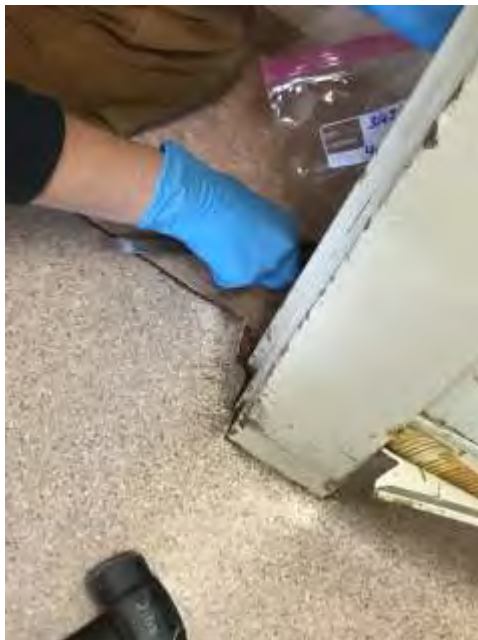
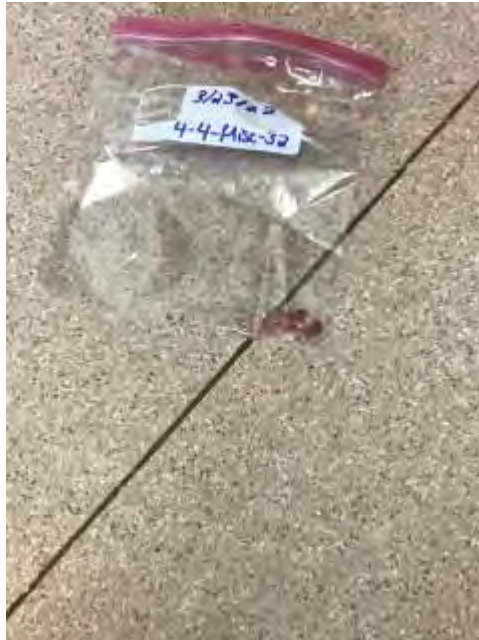
Sample ID:	Sample Type:	
4-4-MISC-32	MISC	
Sample Location:	Detailed Sample Location:	
South wing	Southeast girls bathroom	
Sample Quantity:	See 4-4-MISC-7	
Misc Sample Material:	Sample Condition:	Sample Friable?:
Maroon 9"x9" tile with black mastic	Potential ACBM with potential for damage	No

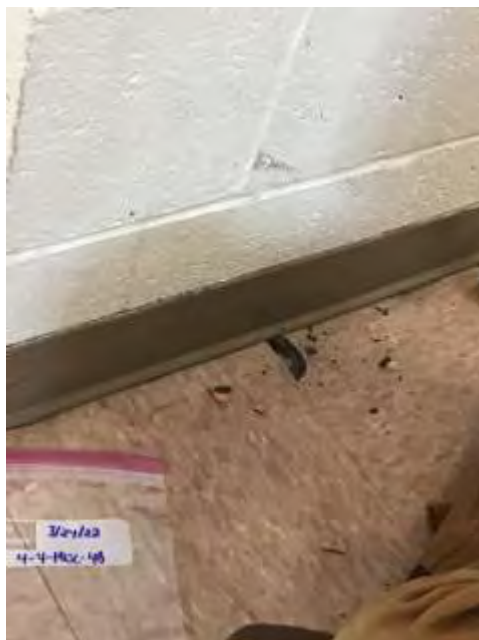
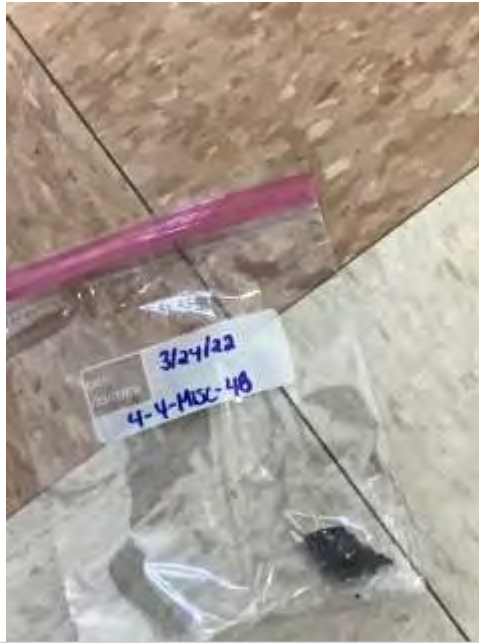
Additional Sample Notes:		Under linoleum flooring.
Sample ID:	Sample Type:	
4-4-MISC-48	MISC	
Sample Location:	Detailed Sample Location:	
North wing hallway	Center	
Sample Quantity:	See 4-4-MISC-7	
Misc Sample Material:	Sample Condition:	Sample Friable?:
Maroon 9"x9" tile with black mastic	Potential ACBM with potential for damage	No

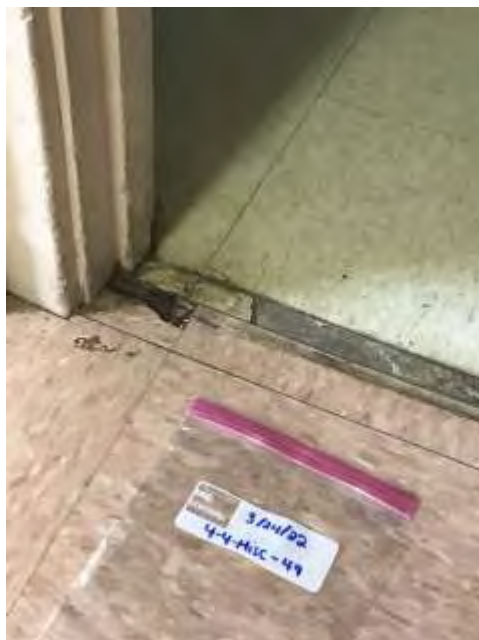
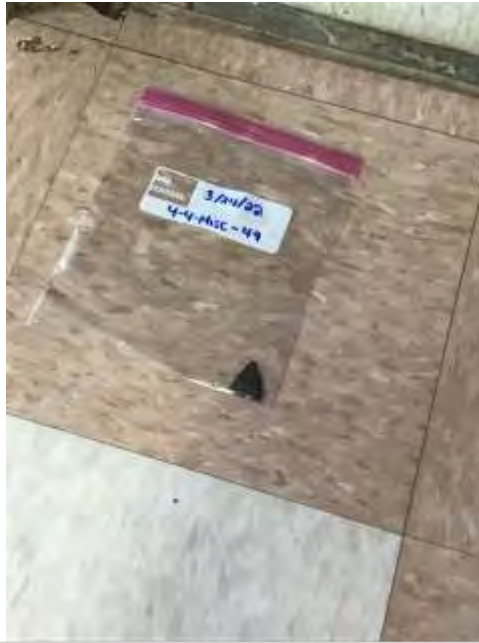
Potential ACBM with potential for damage

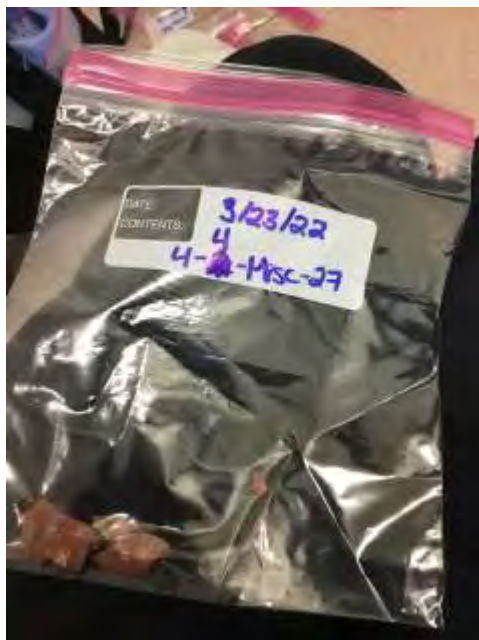
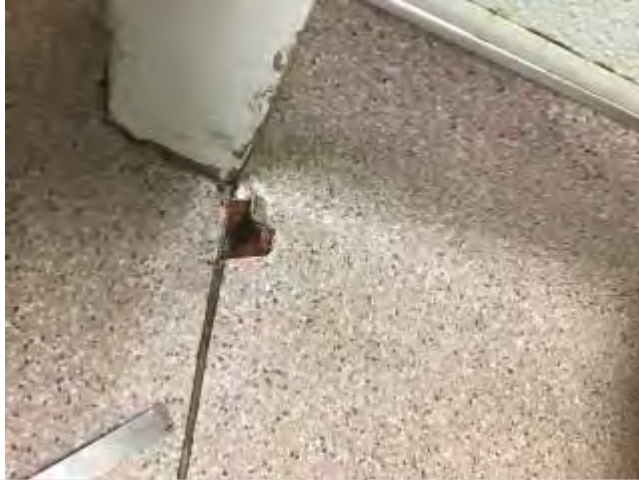
Sample ID:
4-4-MISC-27

Potential ACBM with potential for damage

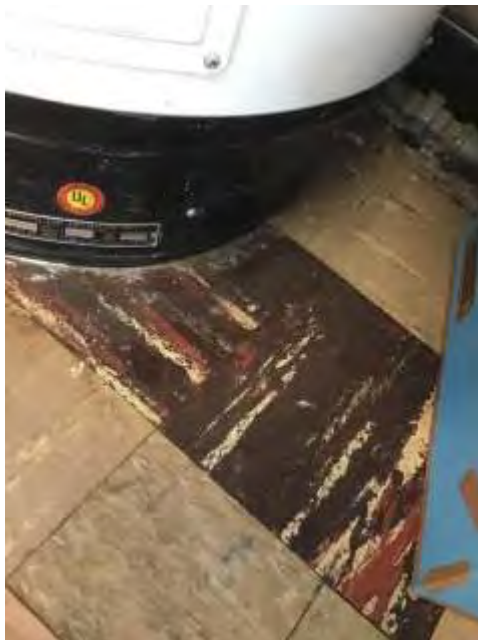
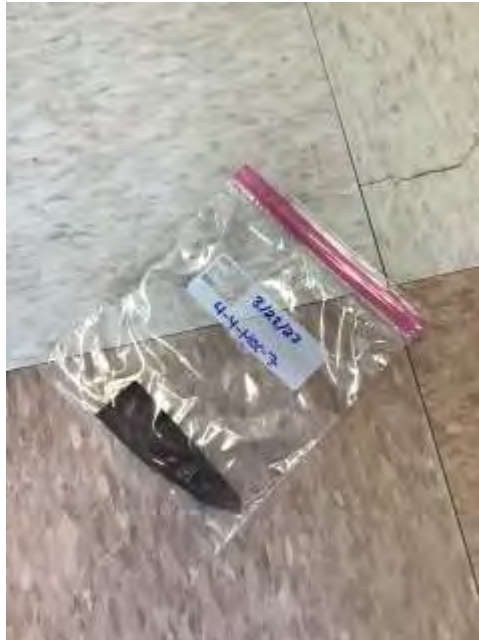
Additional Sample Notes:		Under linoleum flooring.	
Sample ID:		Sample Type:	
4-4-MISC-7		MISC	
Sample Location:		Detailed Sample Location:	
South wing hallway		West closet	
Sample Quantity:		1358 square feet	
Misc Sample Material:		Sample Condition:	Sample Friable?:
Maroon 9"x9" tile with black mastic		Potential ACBM with potential for damage	No

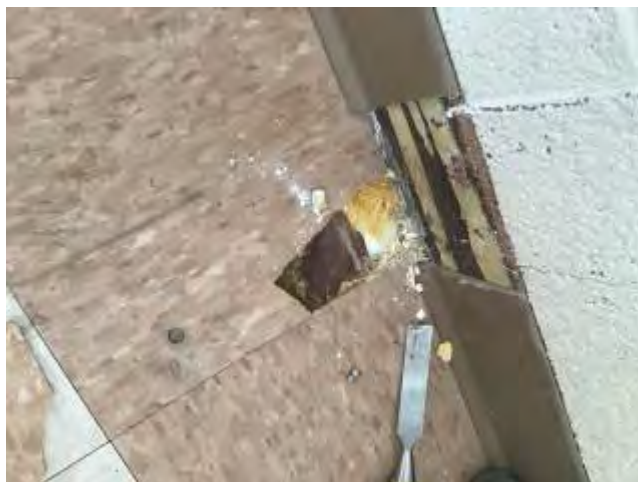
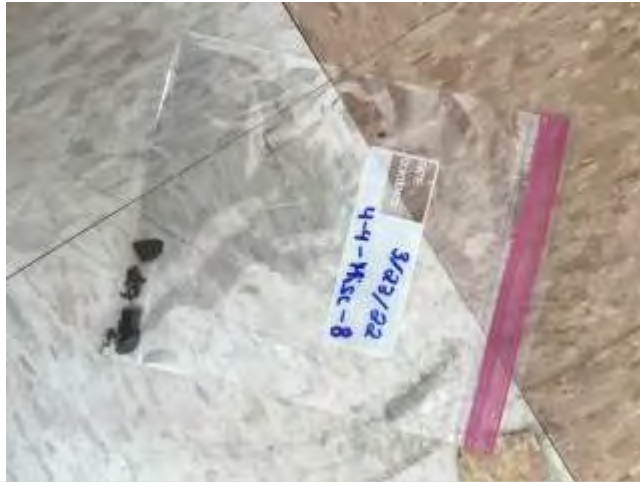
Sample ID:	Sample Type:	
4-4-MISC-8	MISC	
Sample Location:	Detailed Sample Location:	
South wing hallway	Center	
Sample Quantity:	See 4-4-MISC-7	
Misc Sample Material:	Sample Condition:	Sample Friable?:
Maroon 9"x9" tile with black mastic	Potential ACBM with potential for damage	No

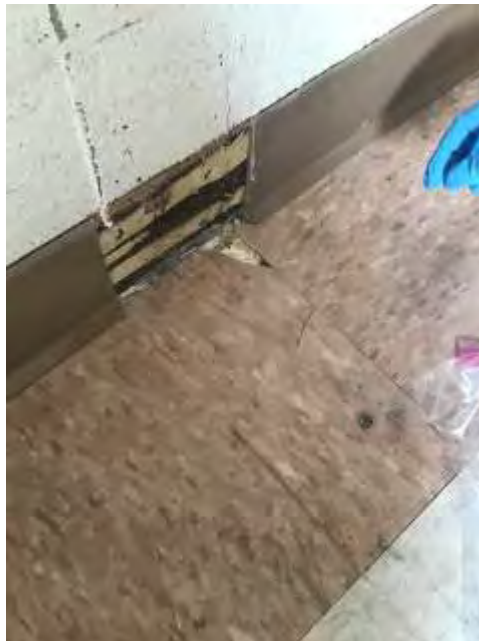
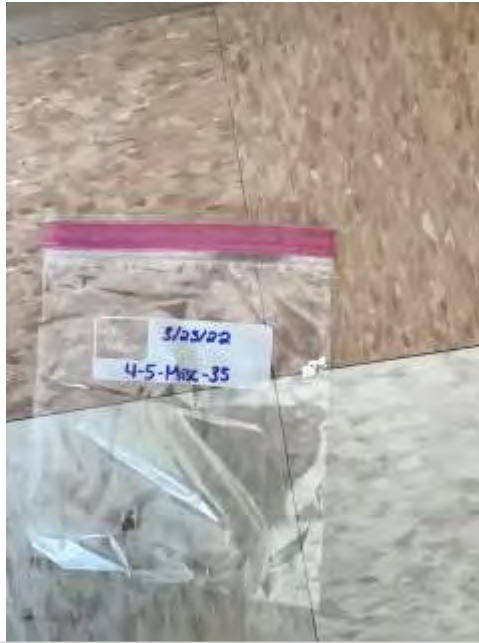
Additional Sample Notes:		Under hallway flooring.
Sample ID:	Sample Type:	
4-5-MISC-35	MISC	
Sample Location:	Detailed Sample Location:	
South wing hallway	Center	
Sample Quantity:	300 square feet	
Misc Sample Material:	Sample Condition:	Sample Friable?:
White leveling compound	Damaged or significantly damaged friable miscellaneous ACM	Yes

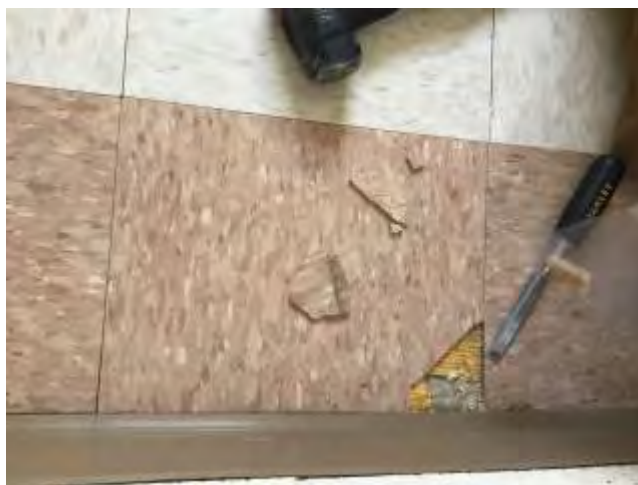
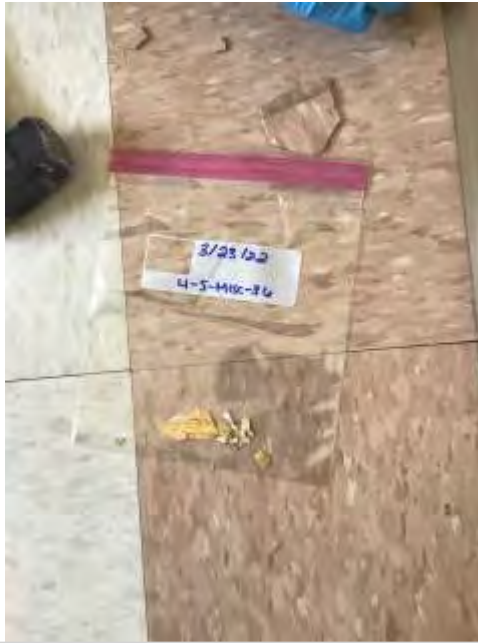
Damaged or significantly damaged friable
miscellaneous ACM

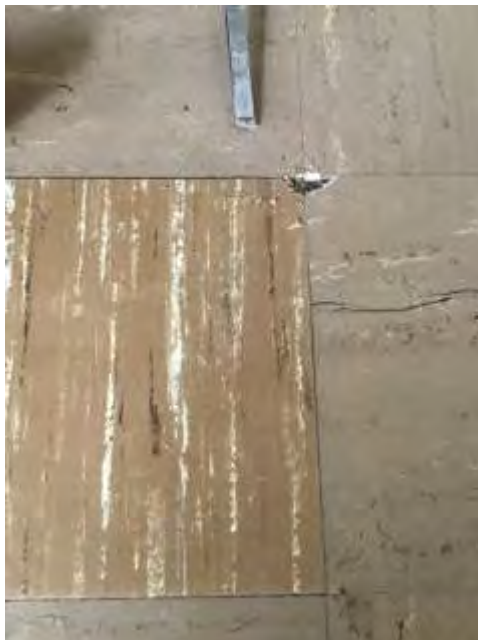
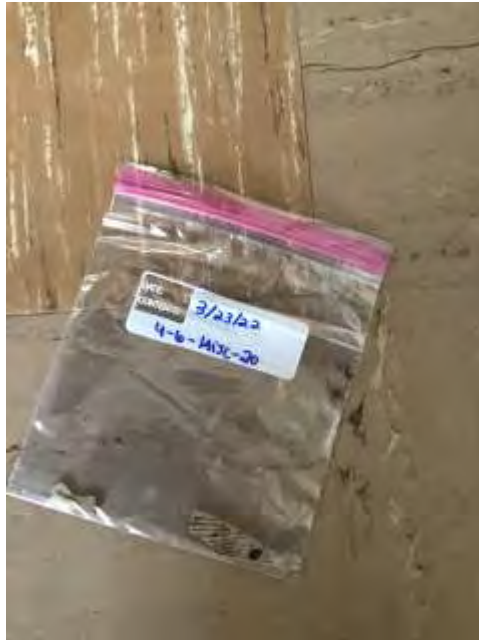
Additional Sample Notes:		
Sample ID:	Sample Type:	
4-6-MISC-20	MISC	
Sample Location:	Detailed Sample Location:	
South wing	Classroom 11	
Sample Quantity:	See 4-6-MISC-12	
Misc Sample Material:	Sample Condition:	Sample Friable?:
9"x9" classroom tile with black mastic	Potential ACBM with potential for damage	No

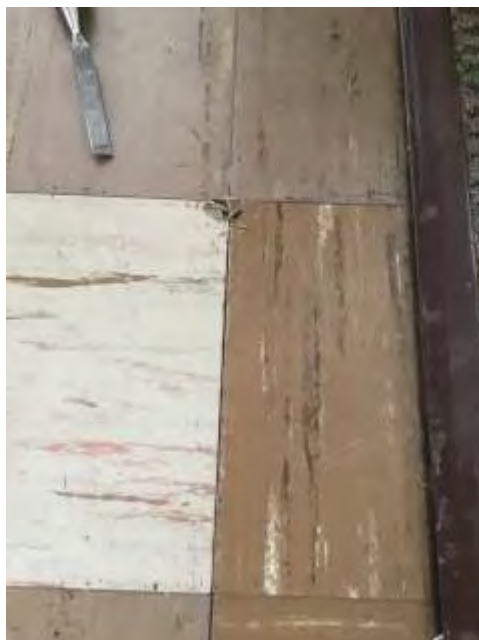
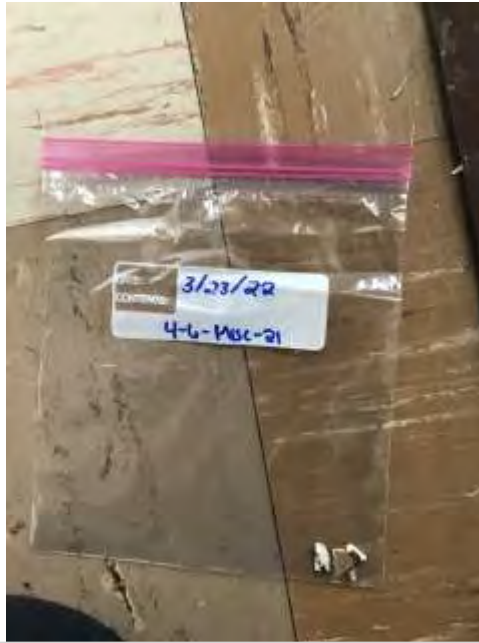
Additional Sample Notes:		
Sample ID:	Sample Type:	
4-6-MISC-21	MISC	
Sample Location:	Detailed Sample Location:	
South wing	Classroom 11	
Sample Quantity:	See 4-6-MISC-12	
Misc Sample Material:	Sample Condition:	Sample Friable?:
9"x9" classroom tile with black mastic	Potential ACBM with potential for damage	No

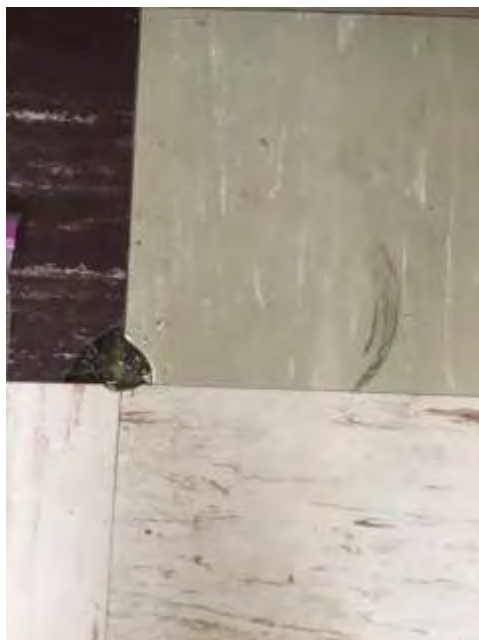
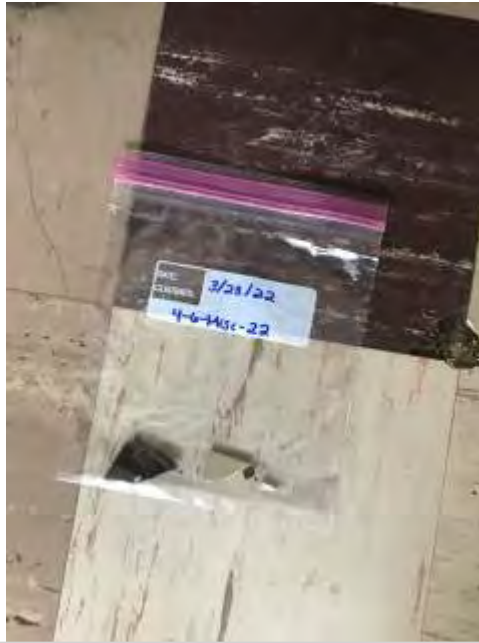
Additional Sample Notes:		
Sample ID:	Sample Type:	
4-6-MISC-22	MISC	
Sample Location:	Detailed Sample Location:	
South wing	Classroom 10	
Sample Quantity:	See 4-6-MISC-12	
Misc Sample Material:	Sample Condition:	Sample Friable?:
9"x9" classroom tile with black mastic	Potential ACBM with potential for damage	No

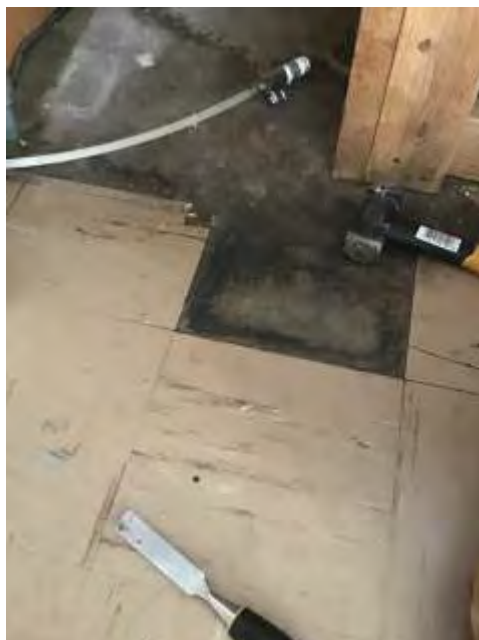
Additional Sample Notes:		
Sample ID:	Sample Type:	
4-6-MISC-12	MISC	
Sample Location:	Detailed Sample Location:	
South wing	Classroom 13	
Sample Quantity:	3600 square feet	
Misc Sample Material:	Sample Condition:	Sample Friable?:
9"x9" classroom tile with black mastic	Potential ACBM with potential for damage	No

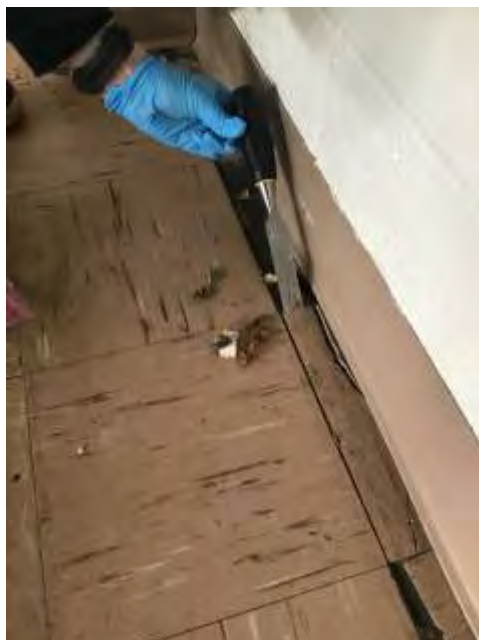
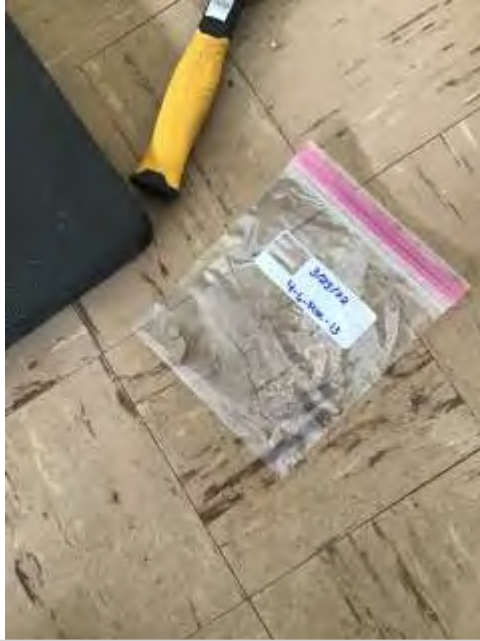
Additional Sample Notes:		
Sample ID:	Sample Type:	
4-6-MISC-13	MISC	
Sample Location:	Detailed Sample Location:	
South wing	Classroom 12	
Sample Quantity:	See 4-6-MISC-12	
Misc Sample Material:	Sample Condition:	Sample Friable?:
9"x9" classroom tile with black mastic	Potential ACBM with potential for damage	No
