HAZARDOUS BUILDING MATERIALS SURVEY

CONDON GRADE SCHOOL
220 S. EAST STREET
CONDON, OREGON

Prepared for
CITY OF CONDON
May 17, 2022
Project No. M2053.01.002

Prepared by
Maul Foster & Alongi, Inc.
3140 NE Broadway Street, Portland, OR 97232

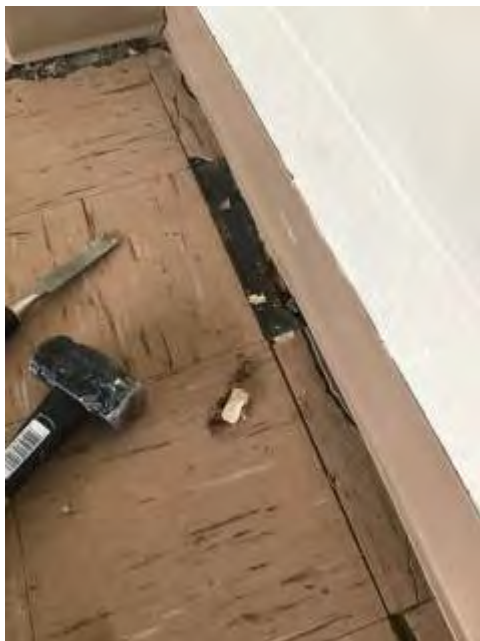
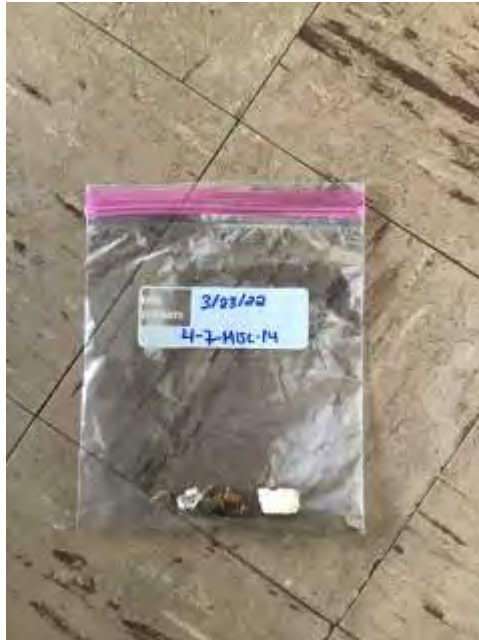
Additional Sample Notes:		
Sample ID:	Sample Type:	
4-7-MISC-14	MISC	
Sample Location:	Detailed Sample Location:	
South wing	Classroom 12	
Sample Quantity:	5 square feet	
Misc Sample Material:	Sample Condition:	Sample Friable?:
Brown fibrous material with black mastic	Damaged or significantly damaged friable miscellaneous ACM	Yes

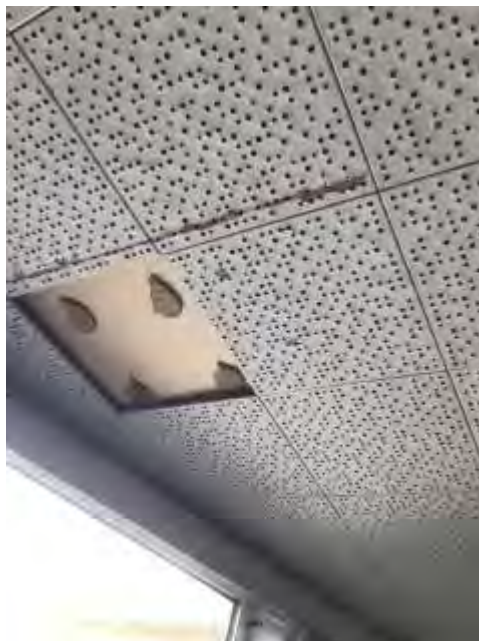
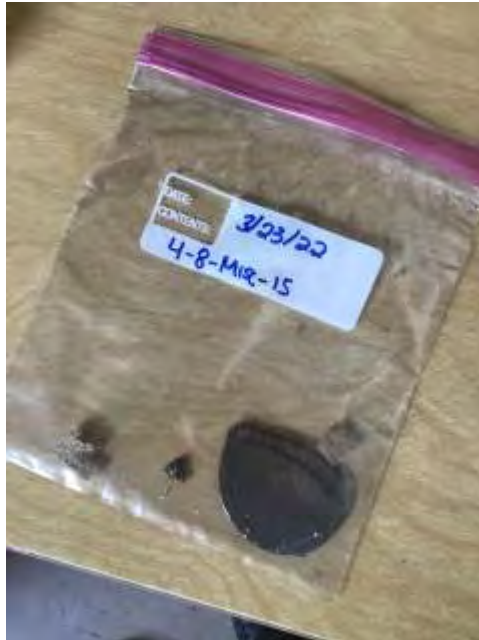
Additional Sample Notes:		Under classroom flooring.
Sample ID:	Sample Type:	
4-8-MISC-15	MISC	
Sample Location:	Detailed Sample Location:	
South wing	Classroom 12	
Sample Quantity:	7800 square feet	
Misc Sample Material:	Sample Condition:	Sample Friable?:
Stipple pattern 12"x12" acoustic ceiling tile with black glue dots	Damaged or significantly damaged friable miscellaneous ACM	Yes

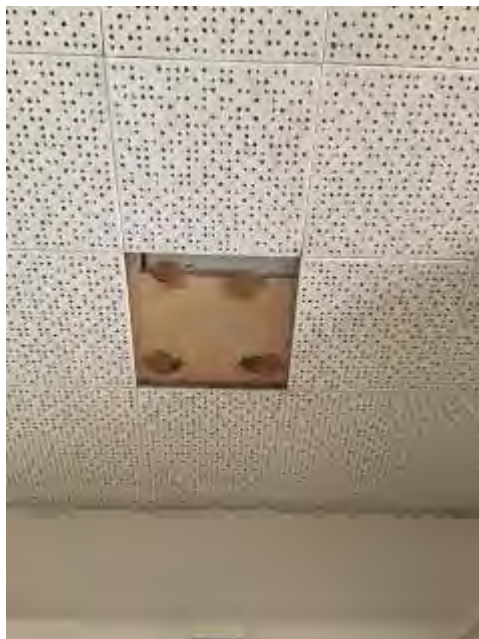
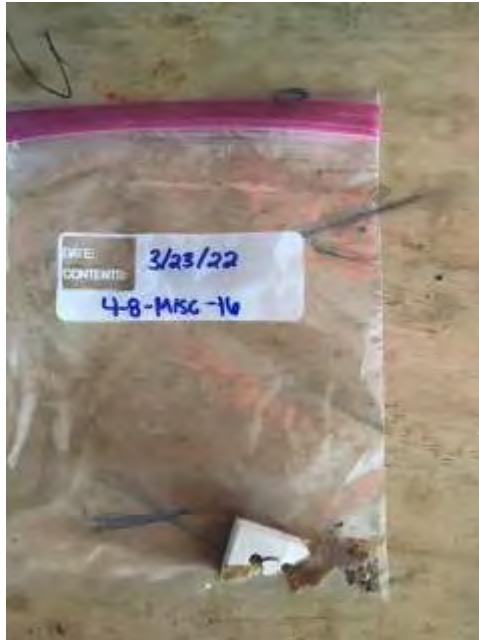
Additional Sample Notes:		
Sample ID:	Sample Type:	
4-8-MISC-16	MISC	
Sample Location:	Detailed Sample Location:	
South wing hallway	Southeast, entrance classroom 12	
Sample Quantity:	See 4-8-MISC-15	
Misc Sample Material:	Sample Condition:	Sample Friable?:
Stipple pattern 12"x12" acoustic ceiling tile with black glue dots	Damaged or significantly damaged friable miscellaneous ACM	Yes

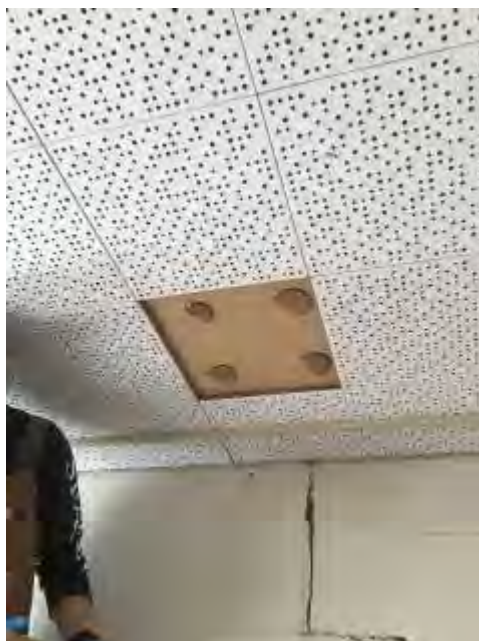
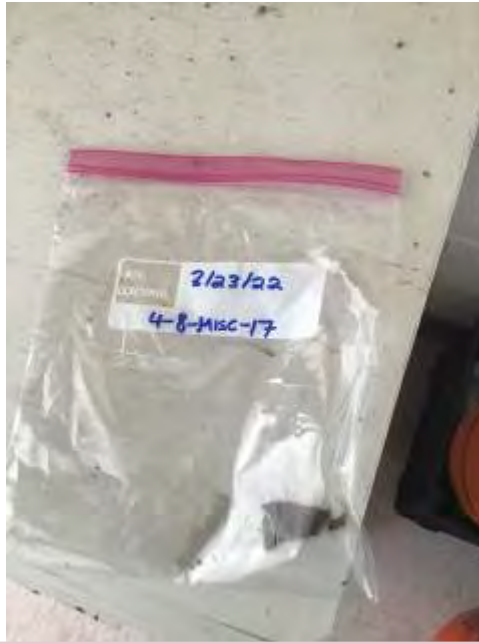
Additional Sample Notes:		
Sample ID:	Sample Type:	
4-8-MISC-17	MISC	
Sample Location:	Detailed Sample Location:	
South wing hallway	Center	
Sample Quantity:	See 4-8-MISC-15	
Misc Sample Material:	Sample Condition:	Sample Friable?:
Stipple pattern 12"x12" acoustic ceiling tile with black glue dots	Damaged or significantly damaged friable miscellaneous ACM	Yes

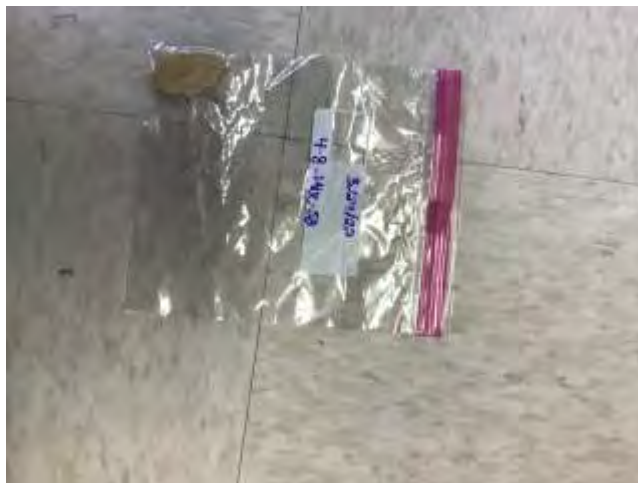
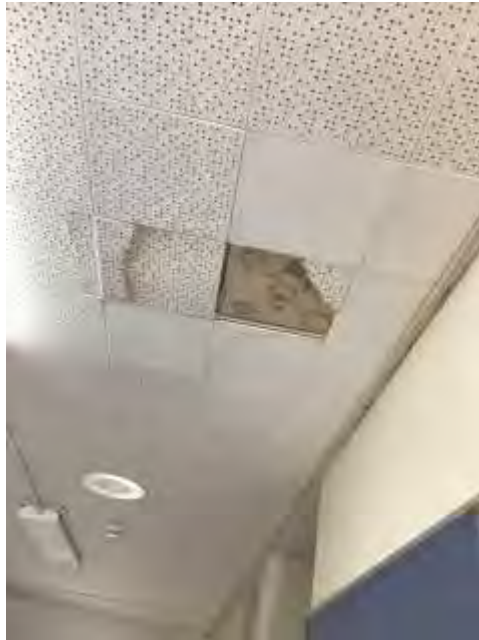
Additional Sample Notes:		
Sample ID:	Sample Type:	
4-8-MISC-58	MISC	
Sample Location:	Detailed Sample Location:	
North wing hallway	Northeast	
Sample Quantity:	See 4-8-MISC-15	
Misc Sample Material:	Sample Condition:	Sample Friable?:
Stipple pattern 12"x12" acoustic ceiling tile with black glue dots	Damaged or significantly damaged friable miscellaneous ACM	Yes

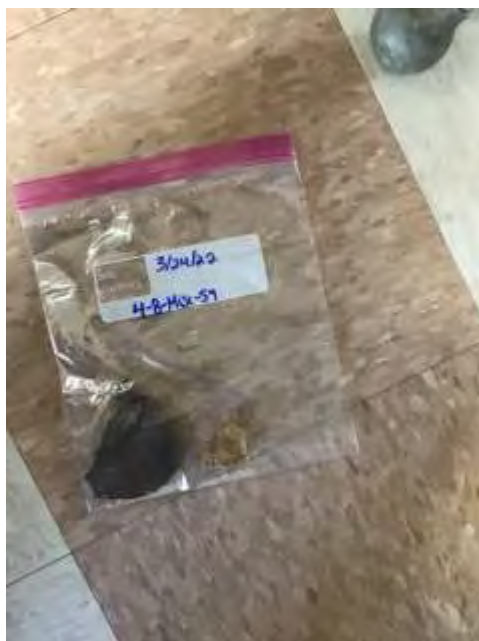
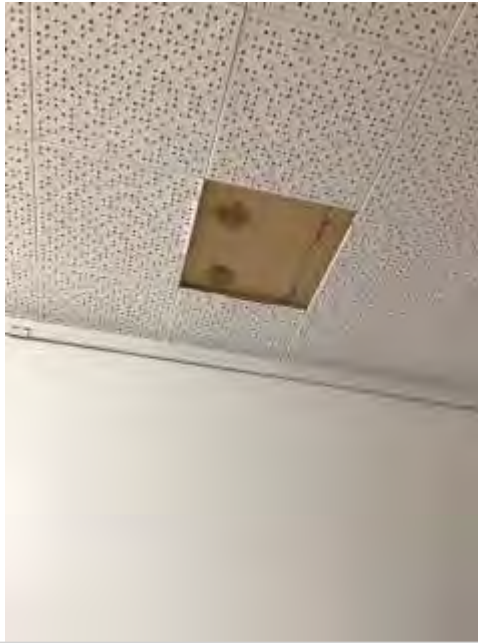
Additional Sample Notes:		With tan glue dot.
Sample ID:	Sample Type:	
4-8-MISC-59	MISC	
Sample Location:	Detailed Sample Location:	
North wing hallway	Northeast	
Sample Quantity:	See 4-8-MISC-15	
Misc Sample Material:	Sample Condition:	Sample Friable?:
Stipple pattern 12"x12" acoustic ceiling tile with black glue dots	Damaged or significantly damaged friable miscellaneous ACM	Yes

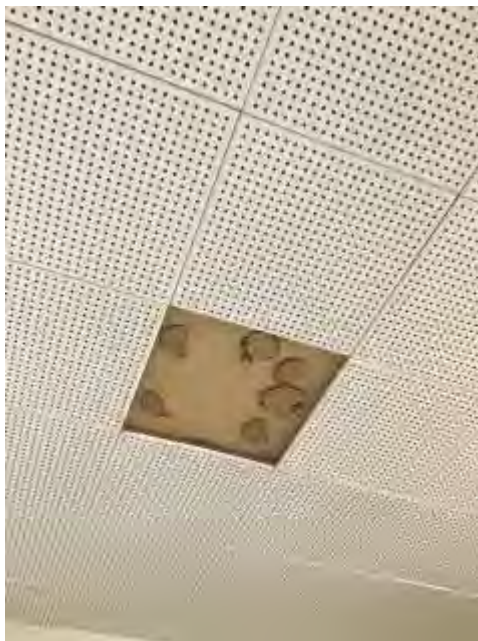
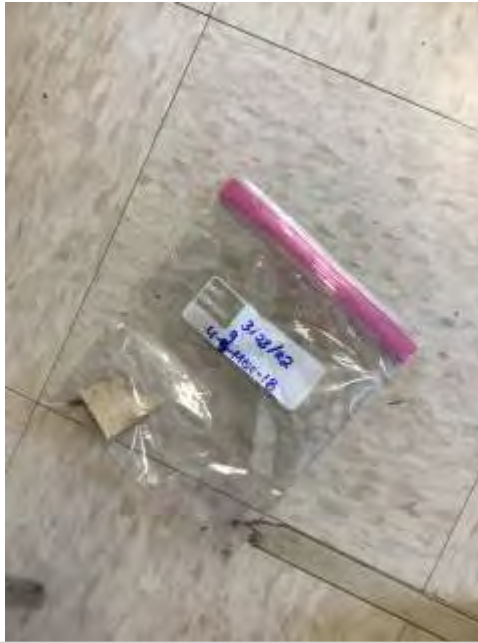
Additional Sample Notes:		With tan glue dot.
Sample ID:	Sample Type:	
4-9-MISC-18	MISC	
Sample Location:	Detailed Sample Location:	
South wing hallway	Southwest corner	
Sample Quantity:	2500 square feet	
Misc Sample Material:	Sample Condition:	Sample Friable?:
Gridded stipple pattern 12"x12" acoustic ceiling tile with brown glue dots	Damaged or significantly damaged friable miscellaneous ACM	Yes

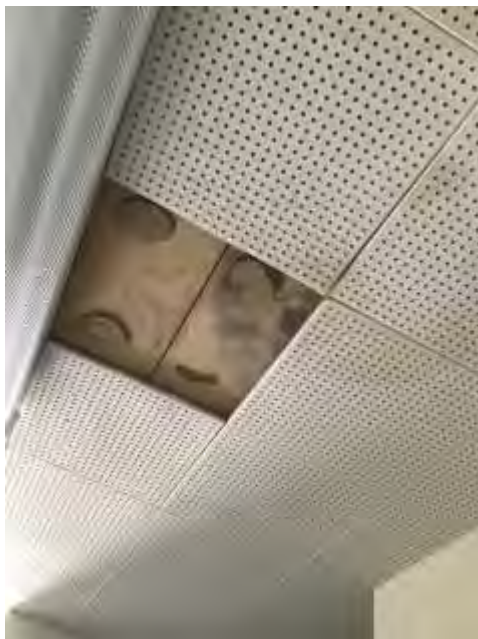
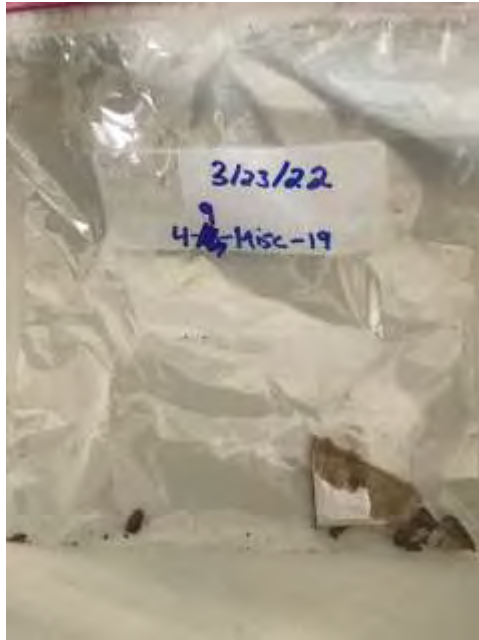
Additional Sample Notes:		
Sample ID:	Sample Type:	
4-9-MISC-19	MISC	
Sample Location:	Detailed Sample Location:	
South wing	Southwest boys bathroom	
Sample Quantity:	See 4-9-MISC-18	
Misc Sample Material:	Sample Condition:	Sample Friable?:
Gridded stipple pattern 12"x12" acoustic ceiling tile with brown glue dots	Damaged or significantly damaged friable miscellaneous ACM	Yes

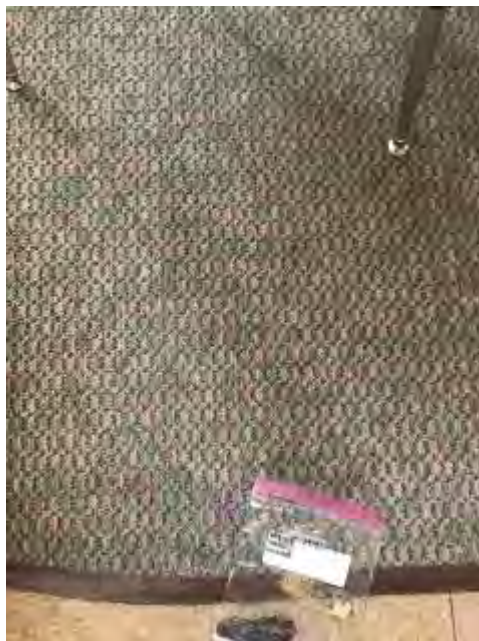
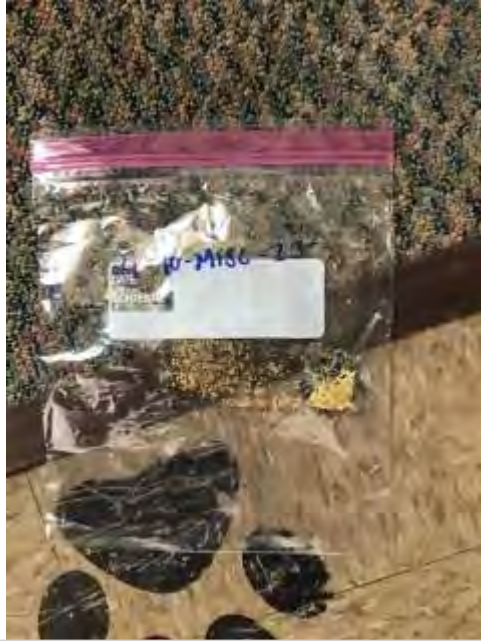
Additional Sample Notes:		
Sample ID:	Sample Type:	
4-10-MISC-23	MISC	
Sample Location:	Detailed Sample Location:	
South wing	Classroom 11	
Sample Quantity:	740 square feet	
Misc Sample Material:	Sample Condition:	Sample Friable?:
Green carpet with yellow mastic	Damaged or significantly damaged friable miscellaneous ACM	No

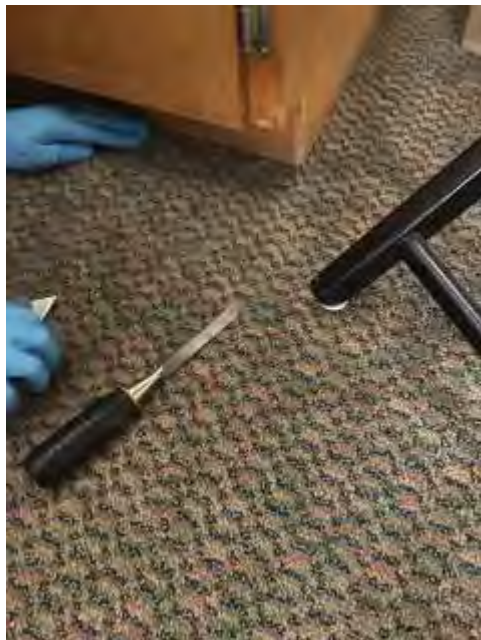
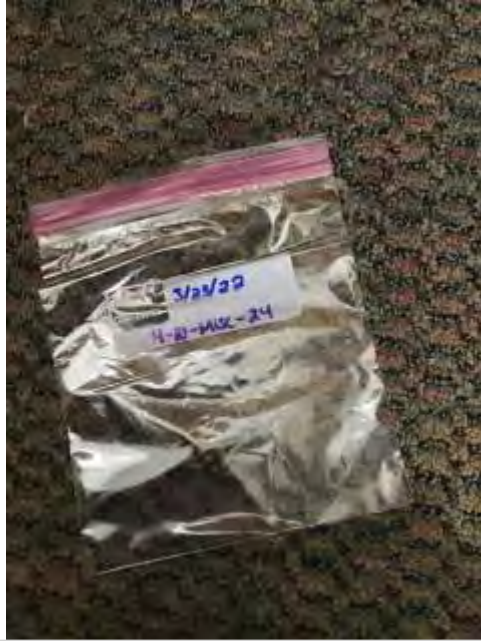
Additional Sample Notes:		
Sample ID:	Sample Type:	
4-10-MISC-24	MISC	
Sample Location:	Detailed Sample Location:	
South wing	Classroom 10	
Sample Quantity:	See 4-10-MISC-23	
Misc Sample Material:	Sample Condition:	Sample Friable?:
Green carpet with yellow mastic	Potential ACBM with potential for damage	No

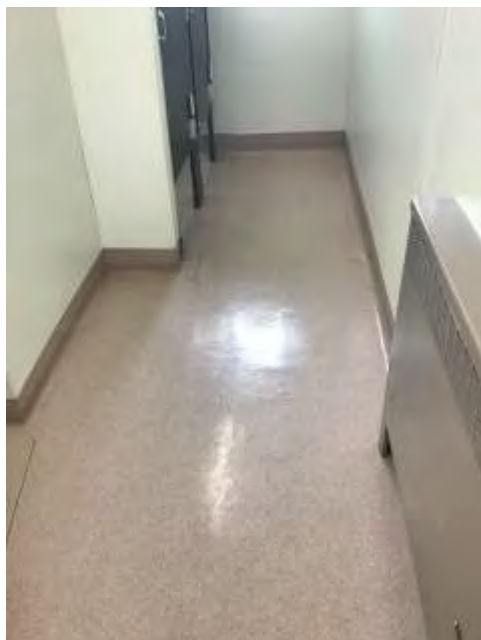
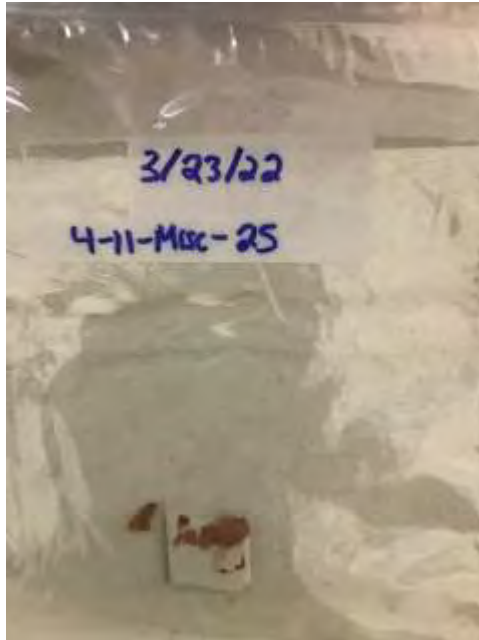
Sample ID:	Sample Type:	
4-11-MISC-25	MISC	
Sample Location:	Detailed Sample Location:	
South wing	Southwest girls bathroom	
Sample Quantity:	340 square feet	
Misc Sample Material:	Sample Condition:	Sample Friable?:
Pink linoleum with yellow mastic	Potential ACBM with potential for damage	No

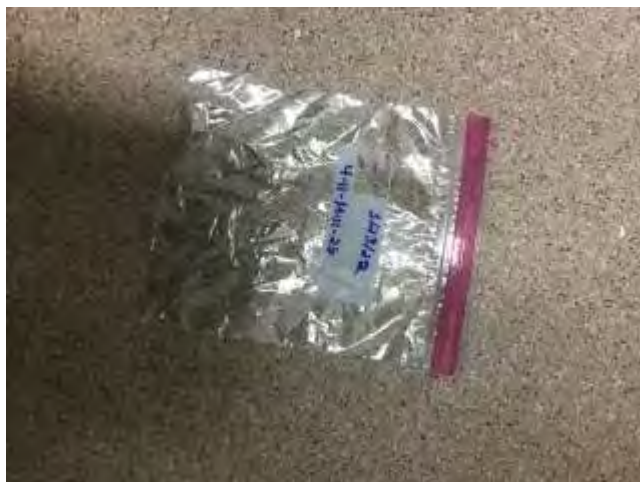
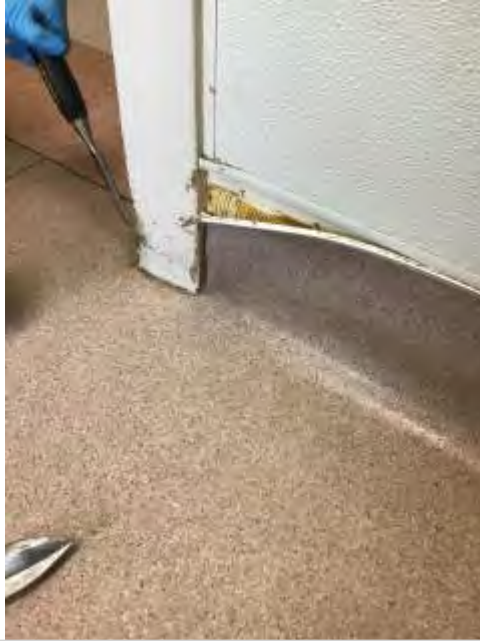
Additional Sample Notes:		
Sample ID:	Sample Type:	
4-11-MISC-26	MISC	
Sample Location:	Detailed Sample Location:	
South wing	Southeast girls bathroom	
Sample Quantity:	See 4-11-MISC-25	
Misc Sample Material:	Sample Condition:	Sample Friable?:
Pink linoleum with yellow mastic	Potential ACBM with potential for damage	No

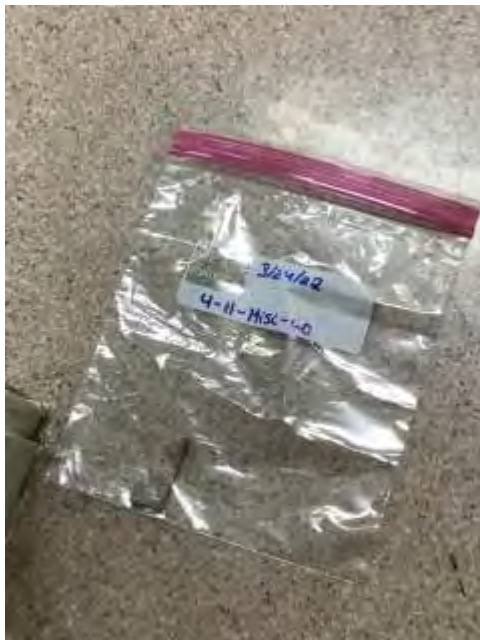
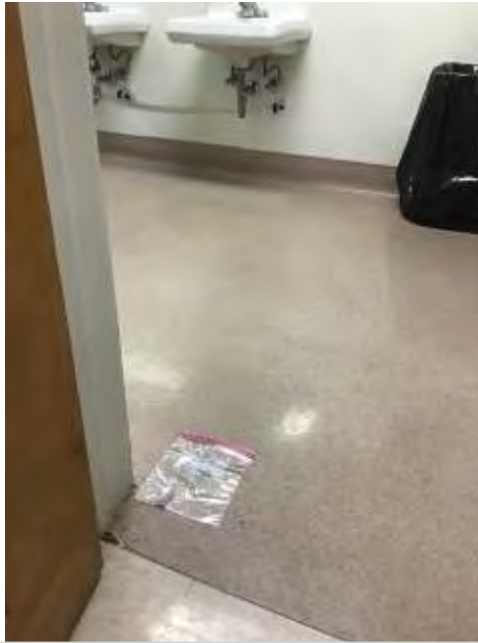
Additional Sample Notes:		
Sample ID:	Sample Type:	
4-11-MISC-60	MISC	
Sample Location:	Detailed Sample Location:	
North wing	Girls bathroom	
Sample Quantity:	See 4-11-MISC-25	
Misc Sample Material:	Sample Condition:	Sample Friable?:
Pink linoleum with yellow mastic	Potential ACBM with potential for damage	No

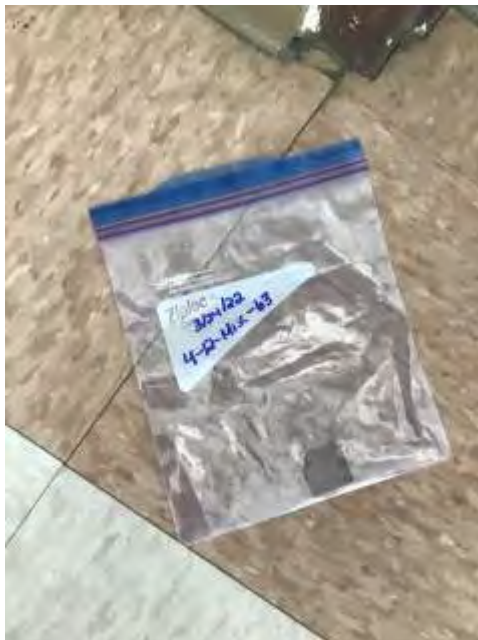
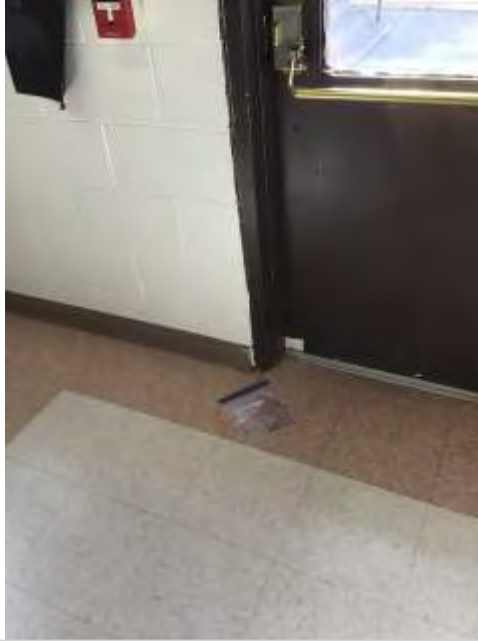
Additional Sample Notes:		
Sample ID:	Sample Type:	
4-12-MISC-63	MISC	
Sample Location:	Detailed Sample Location:	
North wing hallway	Northwest	
Sample Quantity:	See 4-12-MISC-37	
Misc Sample Material:	Sample Condition:	Sample Friable?:
Brown base cove with tan mastic	Potential ACBM with potential for damage	No

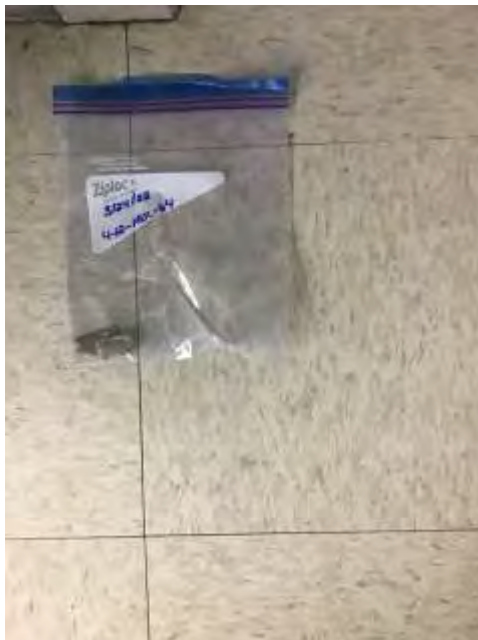
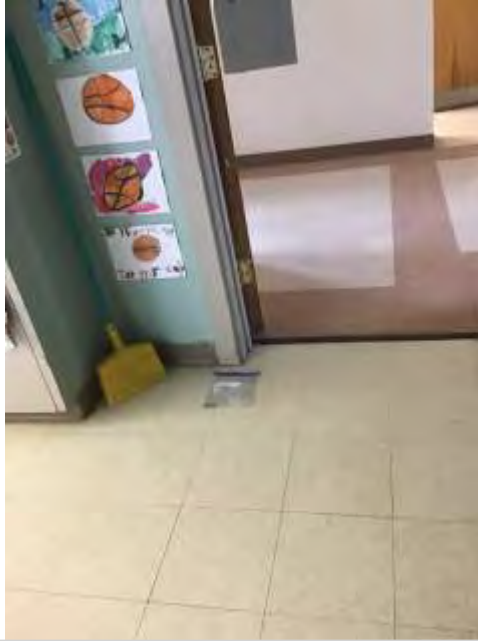
Additional Sample Notes:		
Sample ID:	Sample Type:	
4-12-MISC-64	MISC	
Sample Location:	Detailed Sample Location:	
North wing	Classroom 22	
Sample Quantity:	See 4-12-MISC-37	
Misc Sample Material:	Sample Condition:	Sample Friable?:
Brown base cove with tan mastic	Potential ACBM with potential for damage	No

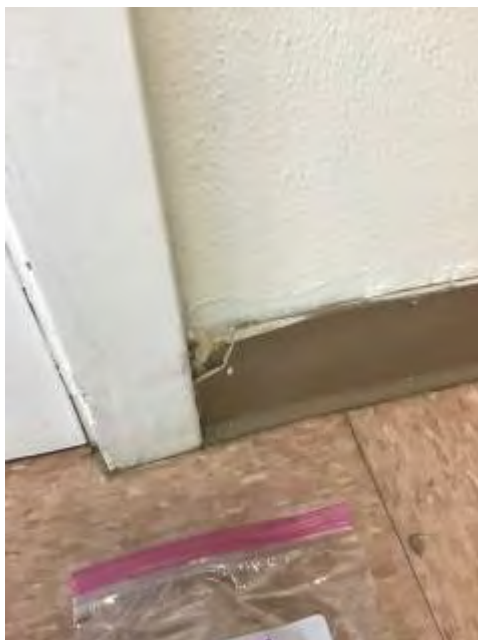
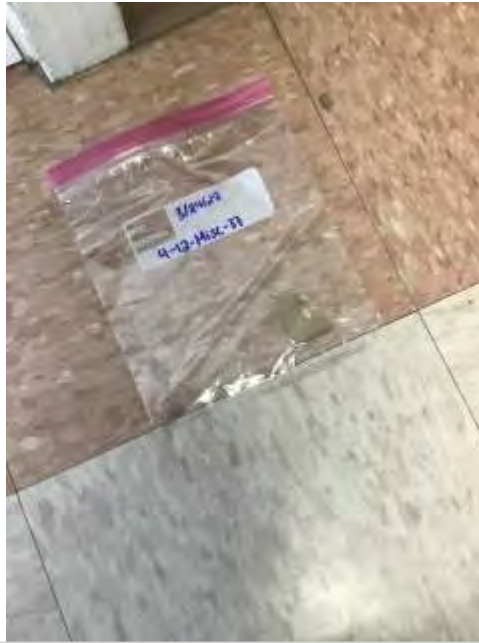
Additional Sample Notes:		
Sample ID:	Sample Type:	
4-12-MISC-37	MISC	
Sample Location:	Detailed Sample Location:	
South wing hallway	Southwest	
Sample Quantity:	1260 linear feet	
Misc Sample Material:	Sample Condition:	Sample Friable?:
Brown base cove with tan mastic	Potential ACBM with potential for damage	No

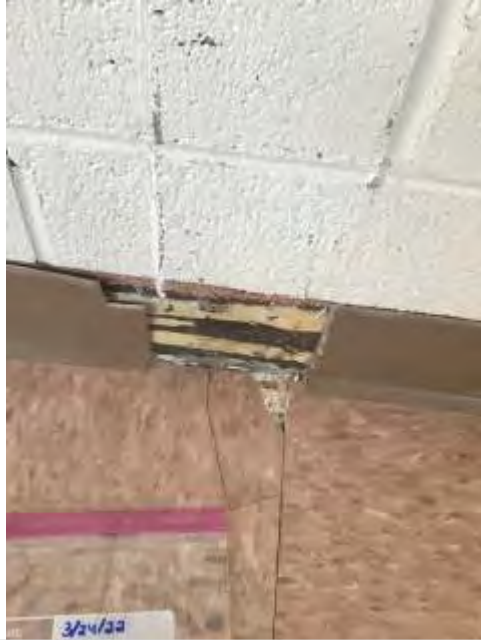
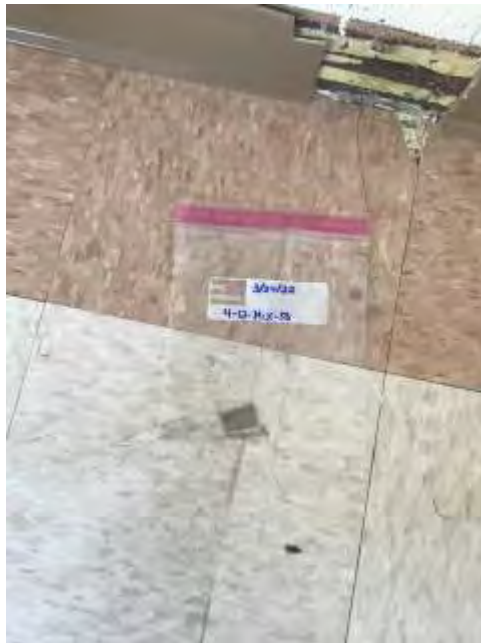
Additional Sample Notes:		
Sample ID:	Sample Type:	
4-12-MISC-38	MISC	
Sample Location:	Detailed Sample Location:	
South wing Hallway	Center	
Sample Quantity:	See 4-12-MISC-37	
Misc Sample Material:	Sample Condition:	Sample Friable?:
Brown base cove with tan mastic	Potential ACBM with potential for damage; Potential ACBM with potential for significant damage	No
Sample Photo:

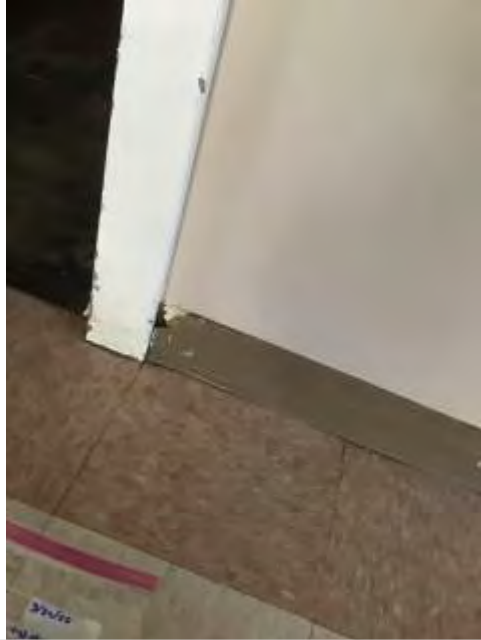
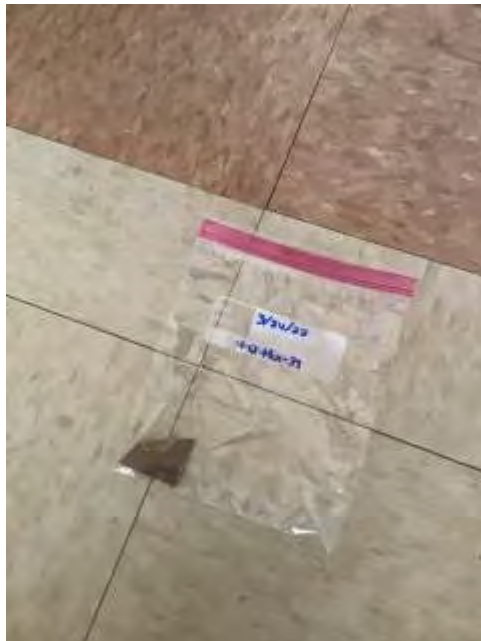
Additional Sample Notes:		
Sample ID:	Sample Type:	
4-12-MISC-39	MISC	
Sample Location:	Detailed Sample Location:	
South wing hallway	Southeast	
Sample Quantity:	See 4-12-MISC-37	
Misc Sample Material:	Sample Condition:	Sample Friable?:
Brown base cove with tan mastic	Potential ACBM with potential for damage	No
Sample Photo:

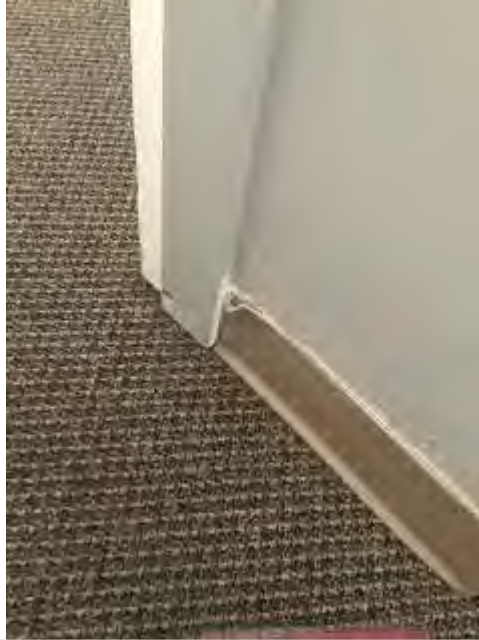
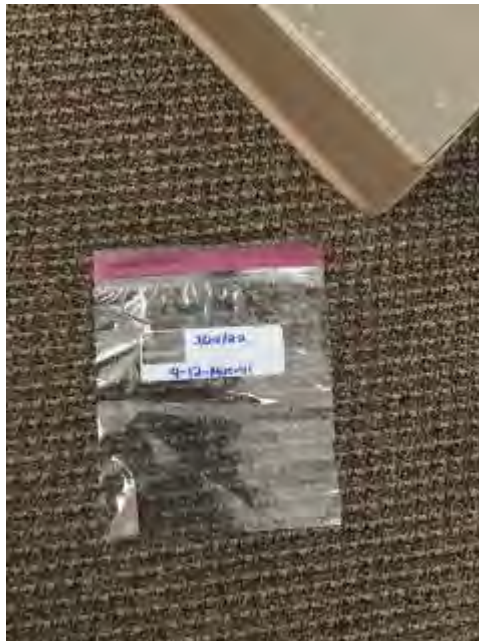
Additional Sample Notes:		
Sample ID:	Sample Type:	
4-12-MISC-41	MISC	
Sample Location:	Detailed Sample Location:	
Southwing	Classroom 12	
Sample Quantity:	See 4-12-MISC-37	
Misc Sample Material:	Sample Condition:	Sample Friable?:
Brown base cove with tan mastic	Potential ACBM with potential for damage	No
Sample Photo:

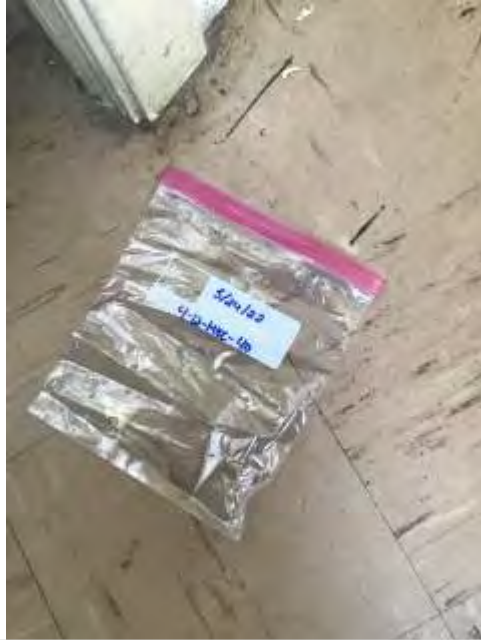
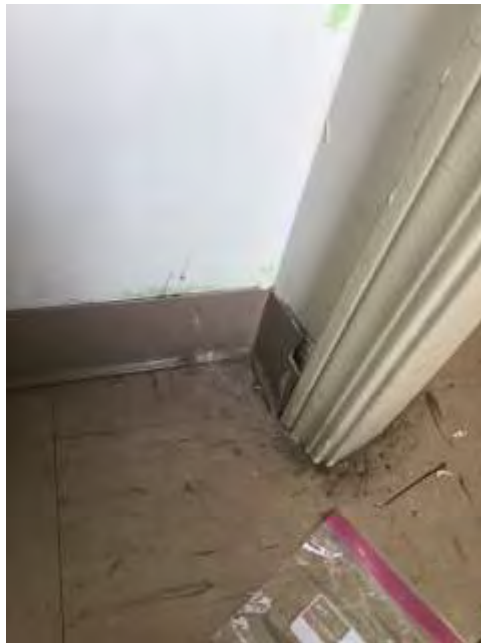
Additional Sample Notes:		
Sample ID:	Sample Type:	
4-12-MISC-40	MISC	
Sample Location:	Detailed Sample Location:	
South wing	Classroom 13	
Sample Quantity:	See 4-12-MISC-37	
Misc Sample Material:	Sample Condition:	Sample Friable?:
Brown base cove with tan mastic	Potential ACBM with potential for damage	No
Sample Photo:

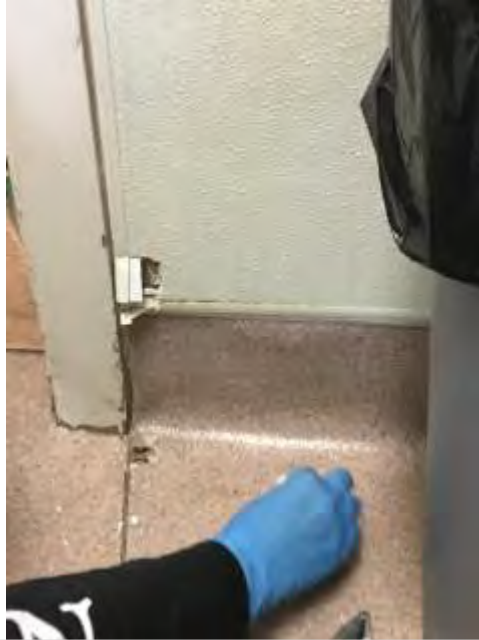
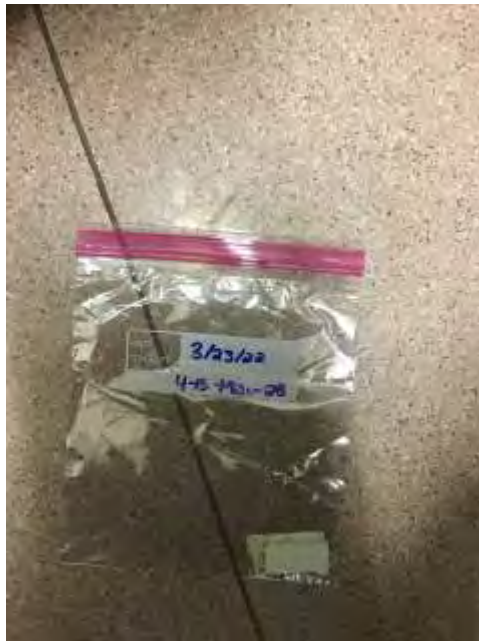
Additional Sample Notes:		
Sample ID:	Sample Type:	
4-13-MISC-28	MISC	
Sample Location:	Detailed Sample Location:	
South wing	Southwest girls bathroom	
Sample Quantity:	1350 square feet	
Misc Sample Material:	Sample Condition:	Sample Friable?:
White plastic wallboard with yellow and tan mastic	Potential ACBM with potential for damage	No
Sample Photo:

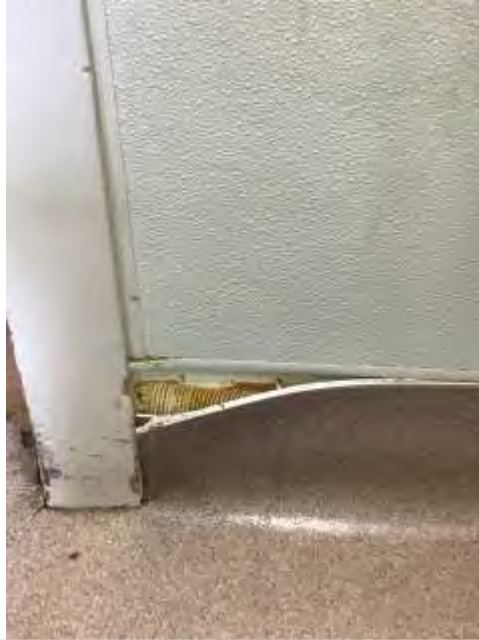
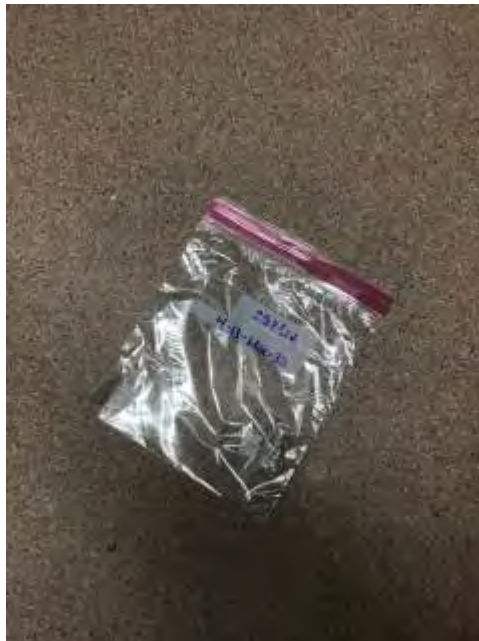
Additional Sample Notes:		
Sample ID:	Sample Type:	
4-13-MISC-33	MISC	
Sample Location:	Detailed Sample Location:	
South wing	Southeast girls bathroom	
Sample Quantity:	See 4-13-MISC-28	
Misc Sample Material:	Sample Condition:	Sample Friable?:
White plastic wallboard with yellow and tan mastic	Potential ACBM with potential for damage	No
Sample Photo:

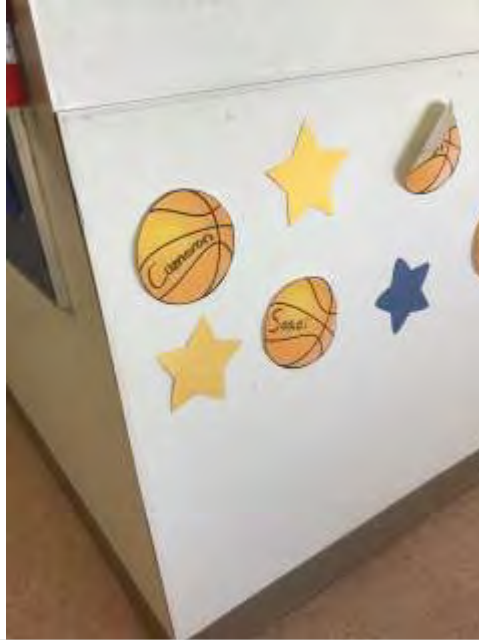
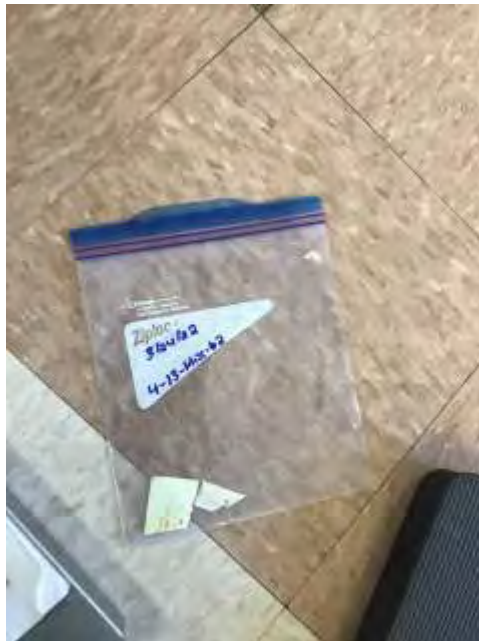
Sample ID:		Sample Type:	
4-13-MISC-62		MISC	
Sample Location:		Detailed Sample Location:	
North wing hallway		Center	
Sample Quantity:		See 4-13-MISC-28	
Misc Sample Material:		Sample Condition:	Sample Friable?:
White plastic wallboard with yellow and tan mastic		Potential ACBM with potential for damage	No

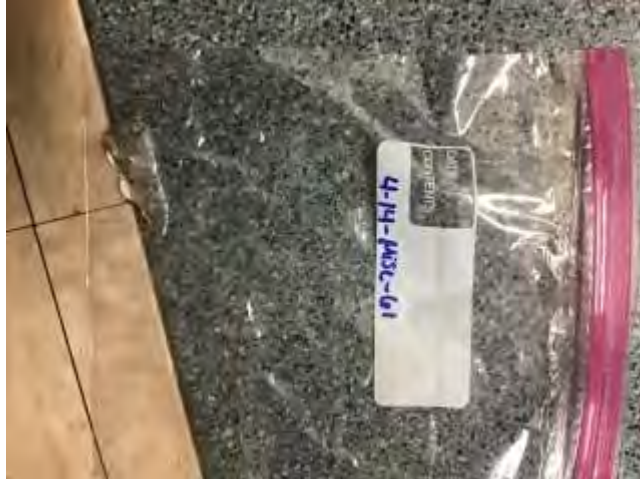
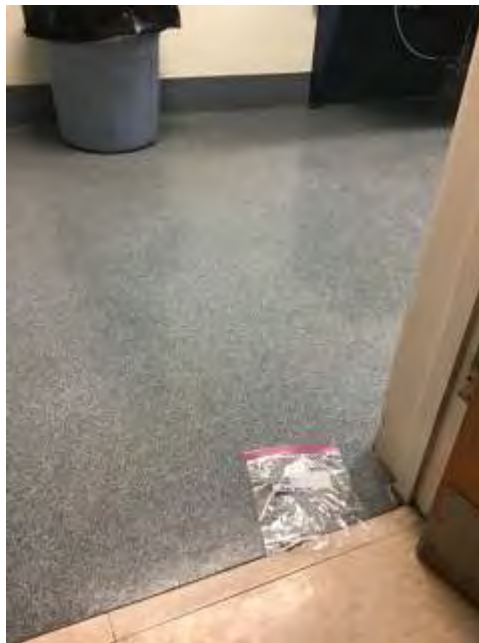
Additional Sample Notes:		
Sample ID:	Sample Type:	
4-14-MISC-61	MISC	
Sample Location:	Detailed Sample Location:	
North wing	Boys bathroom	
Sample Quantity:	See 4-14-MISC-29	
Misc Sample Material:	Sample Condition:	Sample Friable?:
Blue linoleum with yellow mastic	Potential ACBM with potential for damage	No
Sample Photo:

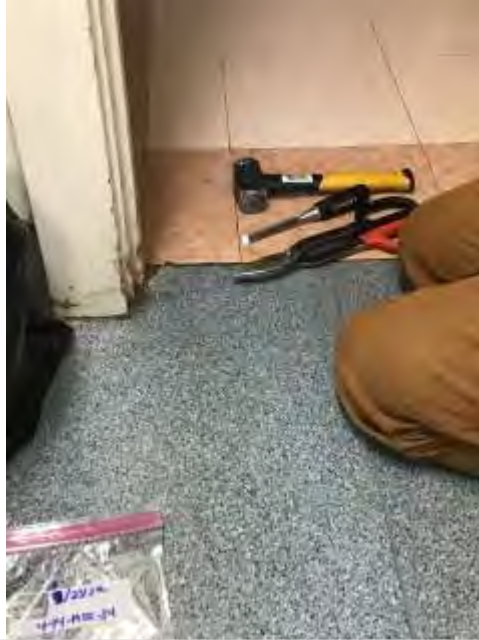
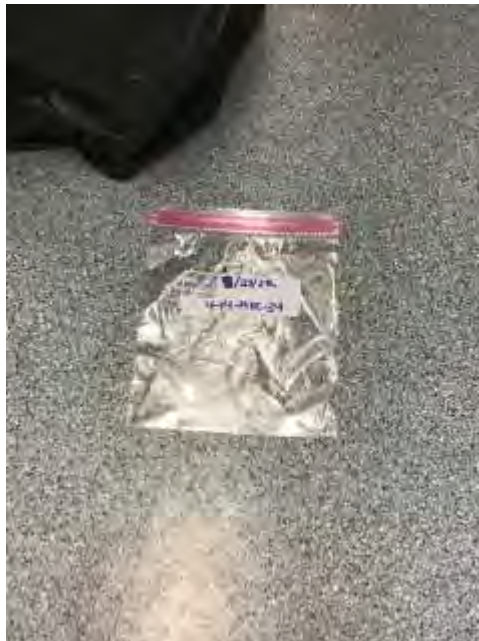
Sample ID:		Sample Type:	
4-14-MISC-34		MISC	
Sample Location:		Detailed Sample Location:	
South wing		Southeast boys bathroom	
Sample Quantity:		See 4-14-MISC-29	
Misc Sample Material:		Sample Condition:	Sample Friable?:
Blue linoleum with yellow mastic		Potential ACBM with potential for damage	No

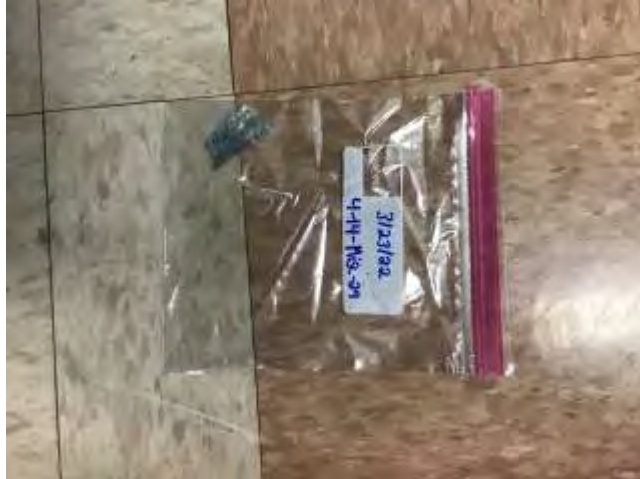
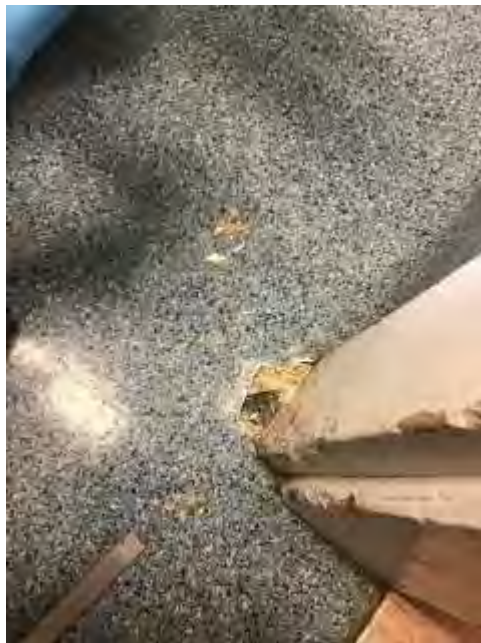
Additional Sample Notes:		Maroon flooring underneath (HA4)
Sample ID:	Sample Type:	
4-14-MISC-29	MISC	
Sample Location:	Detailed Sample Location:	
South wing	Southwest boys bathroom	
Sample Quantity:	340 square feet	
Misc Sample Material:	Sample Condition:	Sample Friable?:
Blue linoleum with yellow mastic	Potential ACBM with potential for damage	No
Sample Photo:

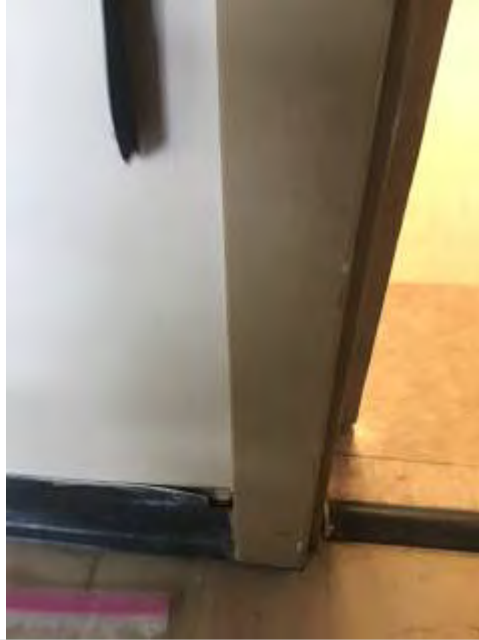
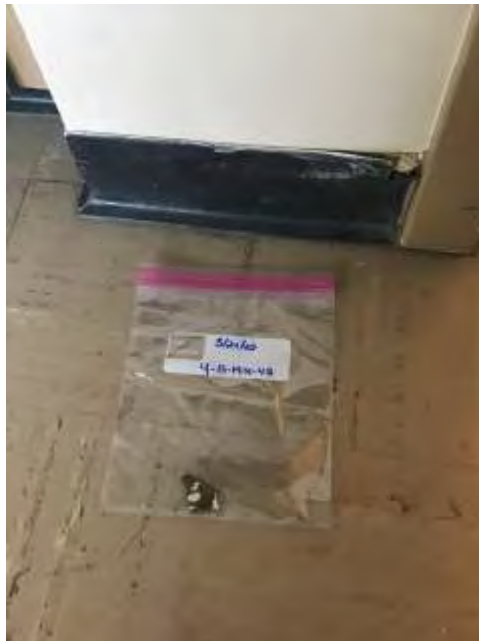
Sample ID:	Sample Type:	
4-15-MISC-42	MISC	
Sample Location:	Detailed Sample Location:	
South wing	Classroom 10	
Sample Quantity:	270 linear feet	
Misc Sample Material:	Sample Condition:	Sample Friable?:
Black base cove with black mastic	Potential ACBM with potential for damage	No

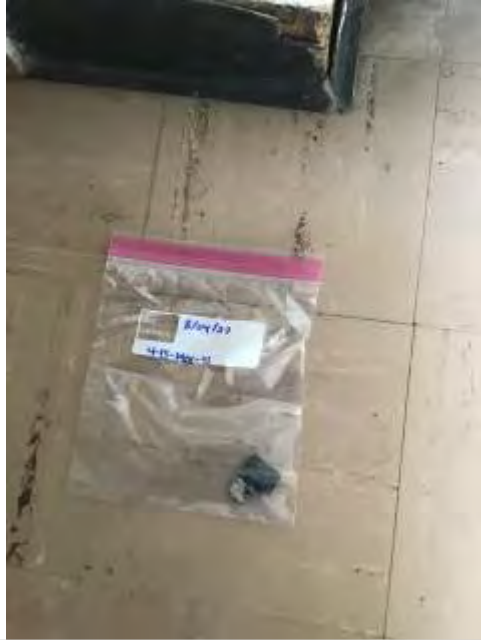
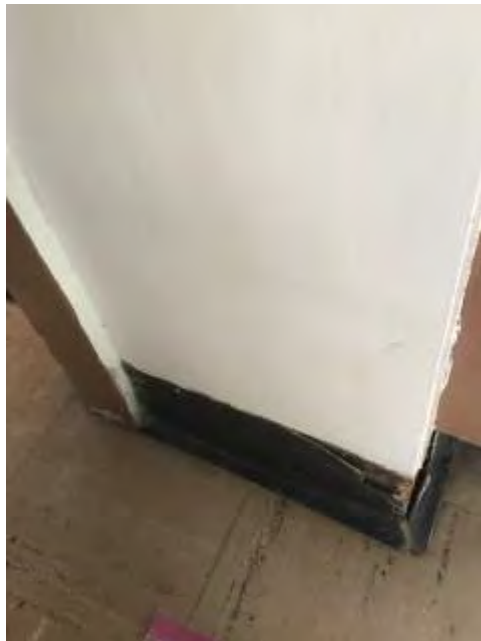
Additional Sample Notes:		
Sample ID:	Sample Type:	
4-15-MISC-43	MISC	
Sample Location:	Detailed Sample Location:	
South wing	Classroom 11	
Sample Quantity:	See 4-15-MISC-42	
Misc Sample Material:	Sample Condition:	Sample Friable?:
Black base cove with black mastic	Potential ACBM with potential for damage	No
Sample Photo:

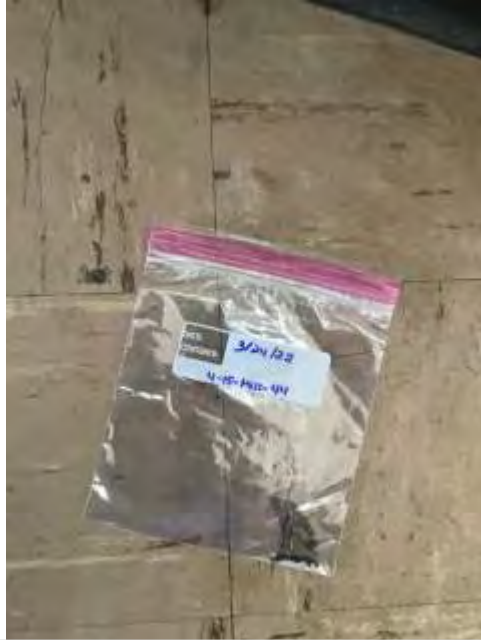
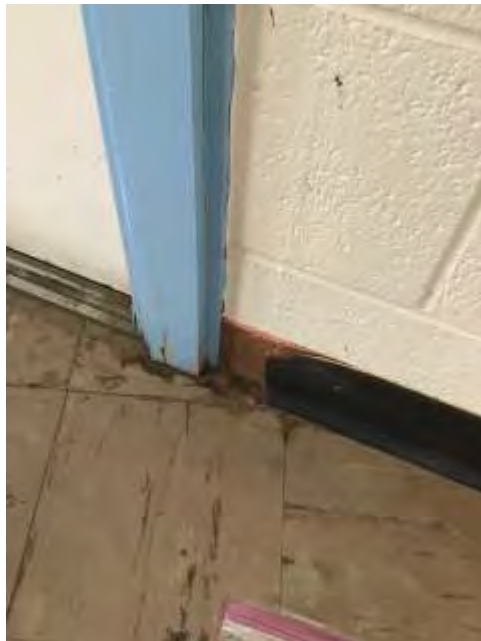
Additional Sample Notes:		
Sample ID:	Sample Type:	
4-15-MISC-44	MISC	
Sample Location:	Detailed Sample Location:	
South wing	Classroom 12	
Sample Quantity:	See 4-15-MISC-42	
Misc Sample Material:	Sample Condition:	Sample Friable?:
Black base cove with black mastic	Potential ACBM with potential for damage	No
Sample Photo:

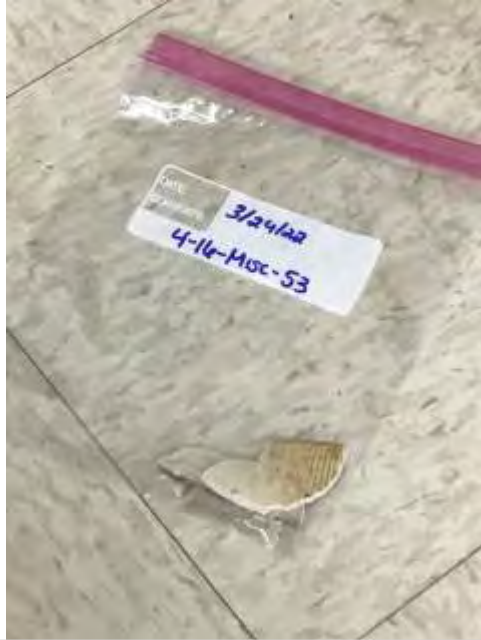
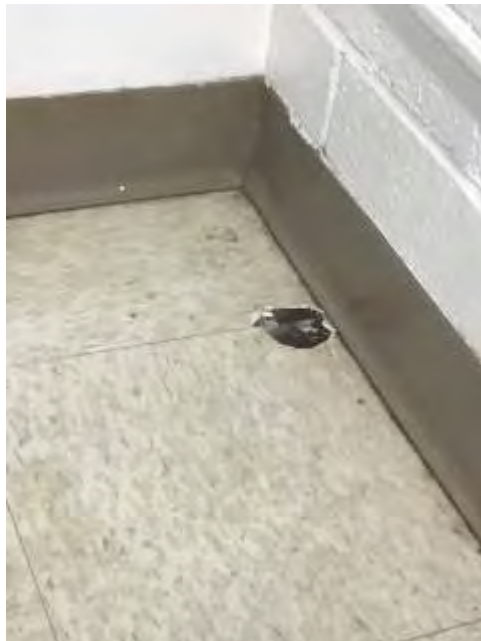
Additional Sample Notes:		
Sample ID:	Sample Type:	
4-16-MISC-53	MISC	
Sample Location:	Detailed Sample Location:	
North wing	Classroom 21	
Sample Quantity:	3310 square feet	
Misc Sample Material:	Sample Condition:	Sample Friable?:
White 12"x12" tile with black mastic	Potential ACBM with potential for damage	No
Sample Photo:

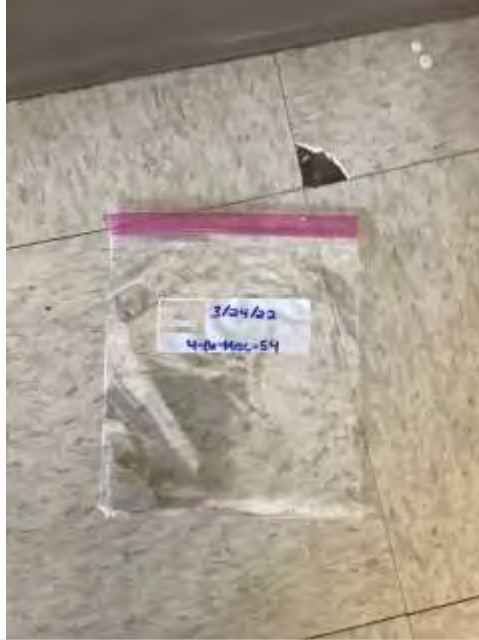
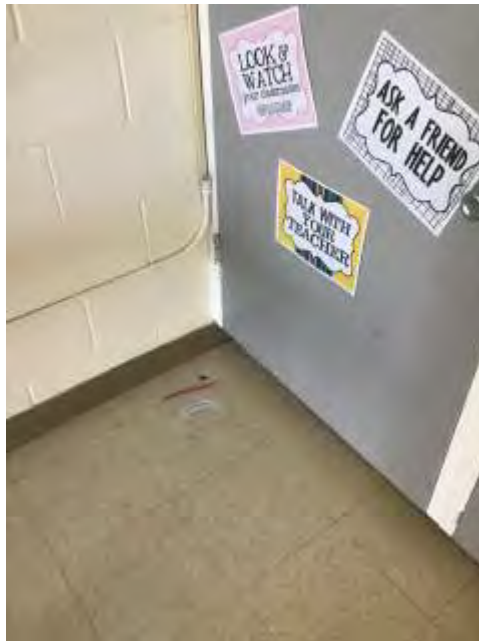
Additional Sample Notes:		
Sample ID:	Sample Type:	
4-16-MISC-54	MISC	
Sample Location:	Detailed Sample Location:	
North wing	Classroom 21	
Sample Quantity:	See 4-16-MISC-53	
Misc Sample Material:	Sample Condition:	Sample Friable?:
White 12"x12" tile with black mastic	Potential ACBM with potential for damage	No
Sample Photo:

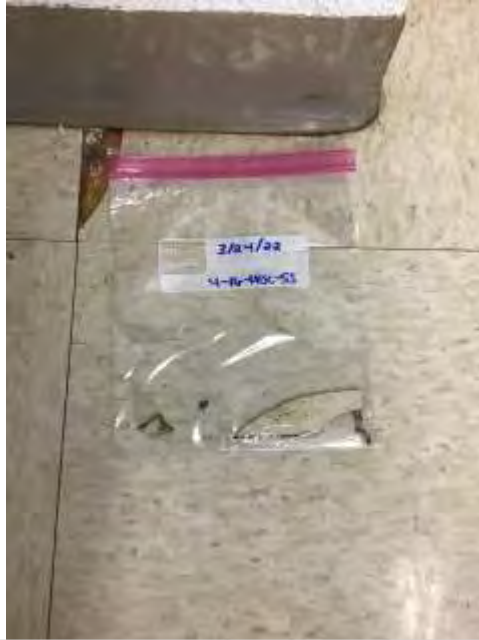
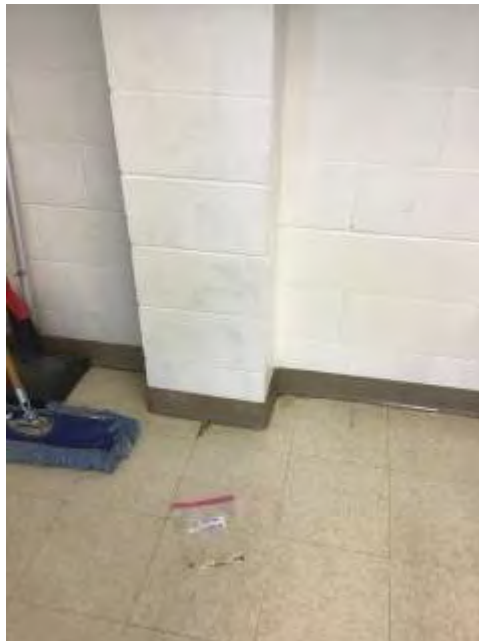
Additional Sample Notes:		
Sample ID:	Sample Type:	
4-16-MISC-55	MISC	
Sample Location:	Detailed Sample Location:	
North wing	Classroom 20	
Sample Quantity:	See 4-16-MISC-53	
Misc Sample Material:	Sample Condition:	Sample Friable?:
White 12"x12" tile with black mastic	Potential ACBM with potential for damage	No
Sample Photo:
