HAZARDOUS BUILDING MATERIALS SURVEY

CONDON GRADE SCHOOL
220 S. EAST STREET
CONDON, OREGON

Prepared for
CITY OF CONDON
May 17, 2022
Project No. M2053.01.002

Prepared by
Maul Foster & Alongi, Inc.
3140 NE Broadway Street, Portland, OR 97232

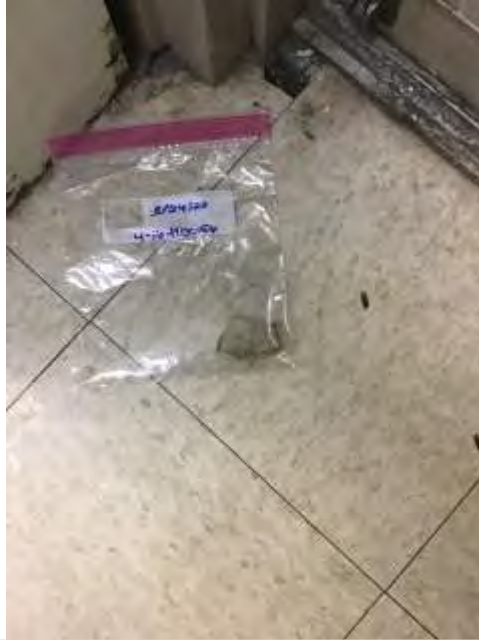
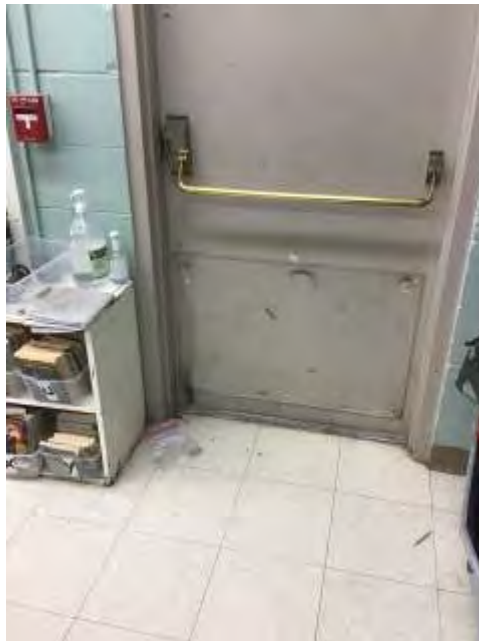
Additional Sample Notes:		
Sample ID:	Sample Type:	
4-16-MISC-56	MISC	
Sample Location:	Detailed Sample Location:	
North wing	Classroom 22	
Sample Quantity:	See 4-16-MISC-53	
Misc Sample Material:	Sample Condition:	Sample Friable?:
White 12"x12" tile with black mastic	Potential ACBM with potential for damage	No
Sample Photo:

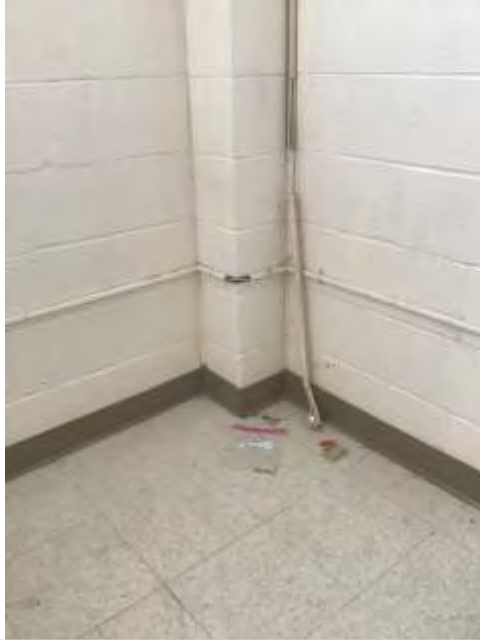
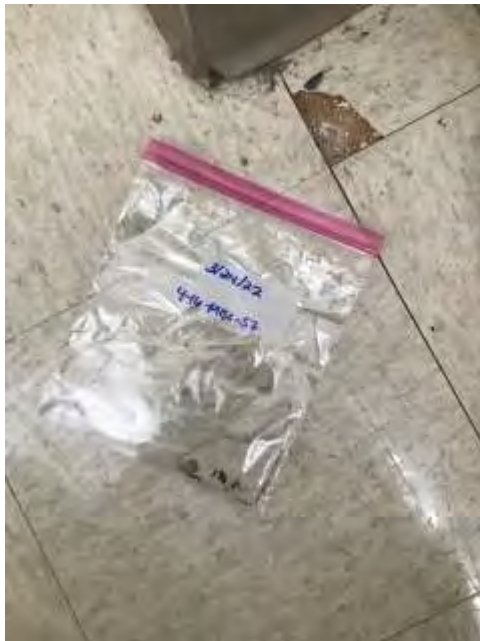
Additional Sample Notes:		
Sample ID:	Sample Type:	
4-16-MISC-57	MISC	
Sample Location:	Detailed Sample Location:	
North wing	Classroom 23	
Sample Quantity:	See 4-16-MISC-53	
Misc Sample Material:	Sample Condition:	Sample Friable?:
White 12"x12" tile with black mastic	Potential ACBM with potential for damage	No
Sample Photo:

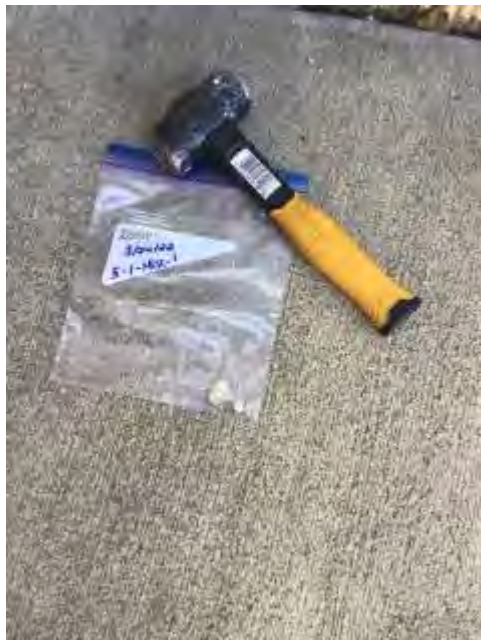
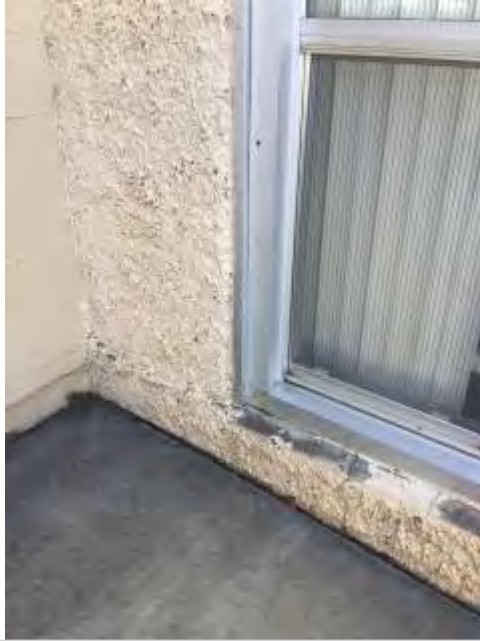
Sample ID:	Sample Type:	
5-1-MISC-1	MISC	
Sample Location:	Detailed Sample Location:	
West exterior	North side of main wing	
Sample Quantity:	9000 square feet	
Misc Sample Material:	Sample Condition:	Sample Friable?:
Tan stucco	Damaged or significantly damaged friable miscellaneous ACM	Yes

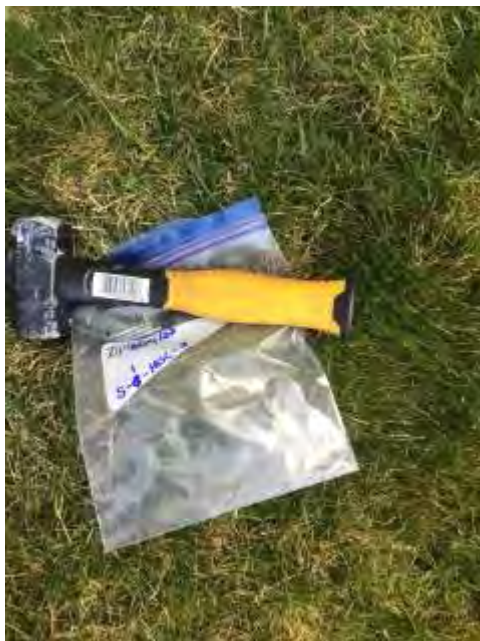
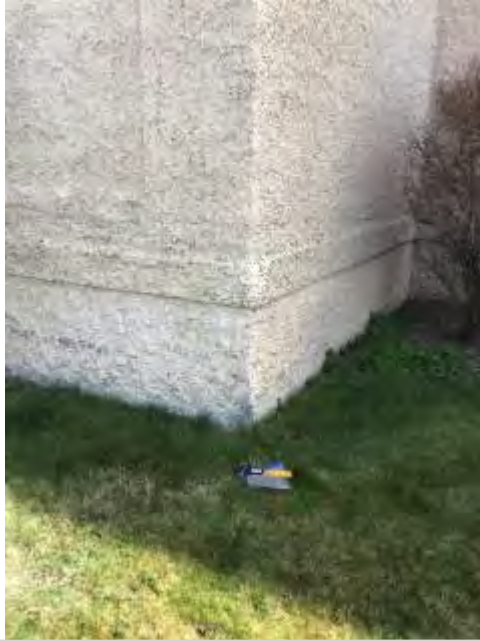
Additional Sample Notes:		
Sample ID:	Sample Type:	
5-1-MISC-2	MISC	
Sample Location:	Detailed Sample Location:	
West exterior	North of main entrance	
Sample Quantity:	See 5-1-MISC-1	
Misc Sample Material:	Sample Condition:	Sample Friable?:
Tan stucco	Damaged or significantly damaged friable miscellaneous ACM	Yes

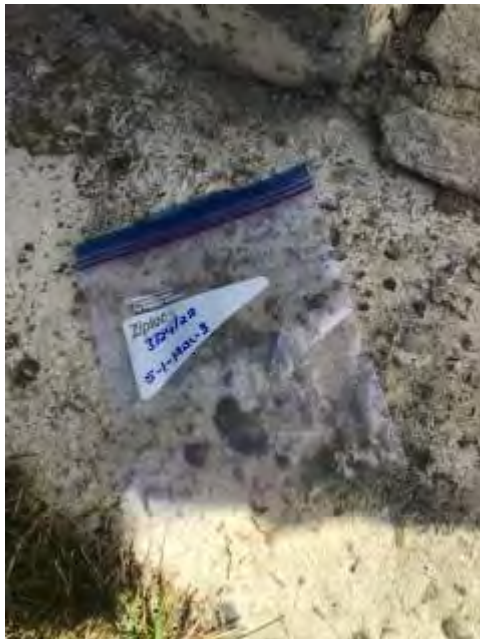
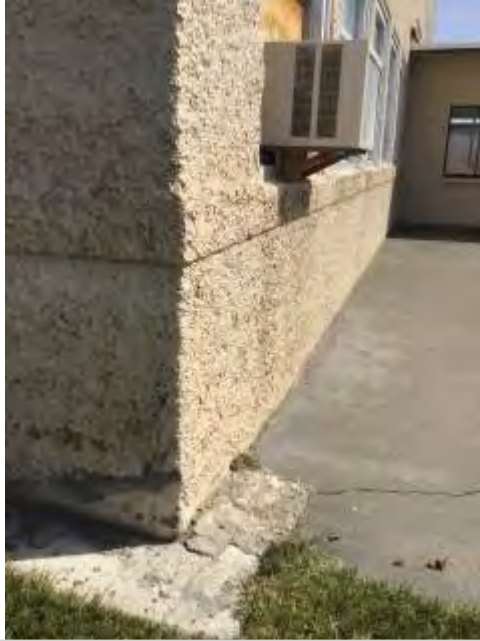
Additional Sample Notes:		
Sample ID:	Sample Type:	
5-1-MISC-3	MISC	
Sample Location:	Detailed Sample Location:	
West exterior	Southwest corner of main wing	
Sample Quantity:	See 5-1-MISC-1	
Misc Sample Material:	Sample Condition:	Sample Friable?:
Tan stucco	Damaged or significantly damaged friable miscellaneous ACM	Yes

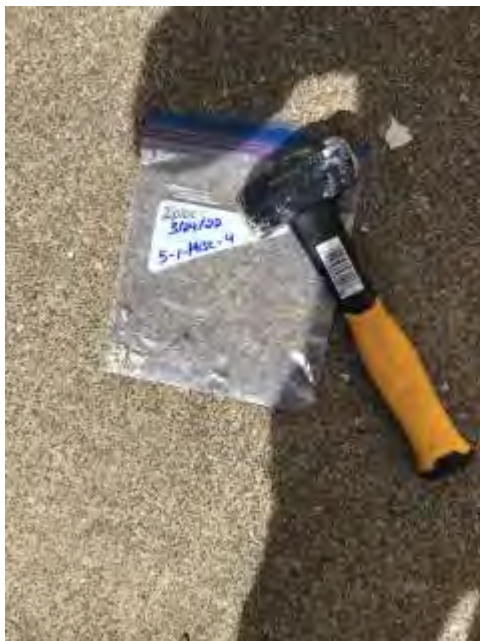
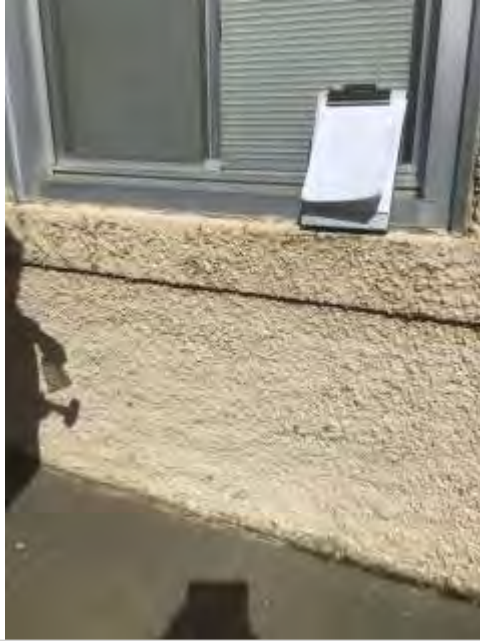
Additional Sample Notes:		
Sample ID:	Sample Type:	
5-1-MISC-4	MISC	
Sample Location:	Detailed Sample Location:	
South exterior	Southeast wall	
Sample Quantity:	See 5-1-MISC-1	
Misc Sample Material:	Sample Condition:	Sample Friable?:
Tan stucco	Damaged or significantly damaged friable miscellaneous ACM	Yes

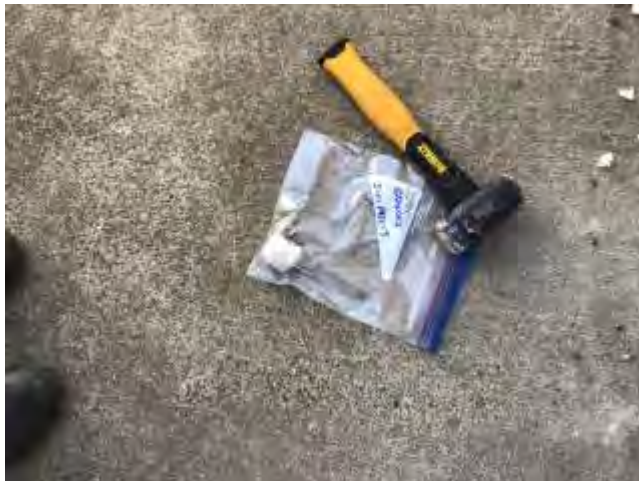
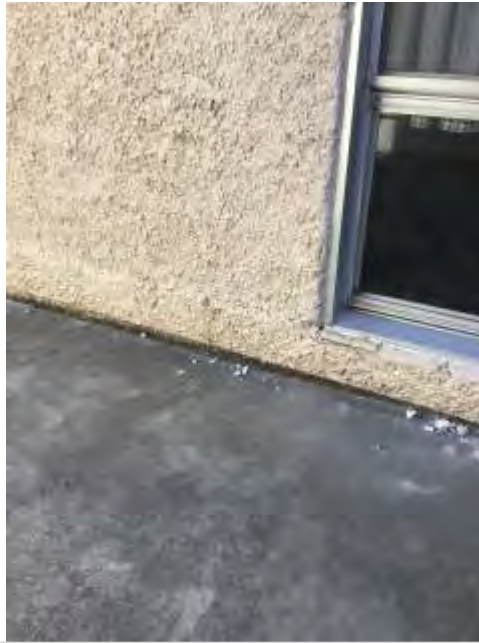
Additional Sample Notes:		
Sample ID:	Sample Type:	
5-1-MISC-5	MISC	
Sample Location:	Detailed Sample Location:	
East exterior	North side	
Sample Quantity:	See 5-1-MISC-1	
Misc Sample Material:	Sample Condition:	Sample Friable?:
Tan stucco	Damaged or significantly damaged friable miscellaneous ACM	Yes
