YOUR INSPECTION REPORT

Downtown
Calgary, AB

Saturday, June 21, 2014

RE: Report No. 1008, v.0
Downtown
Calgary, AB

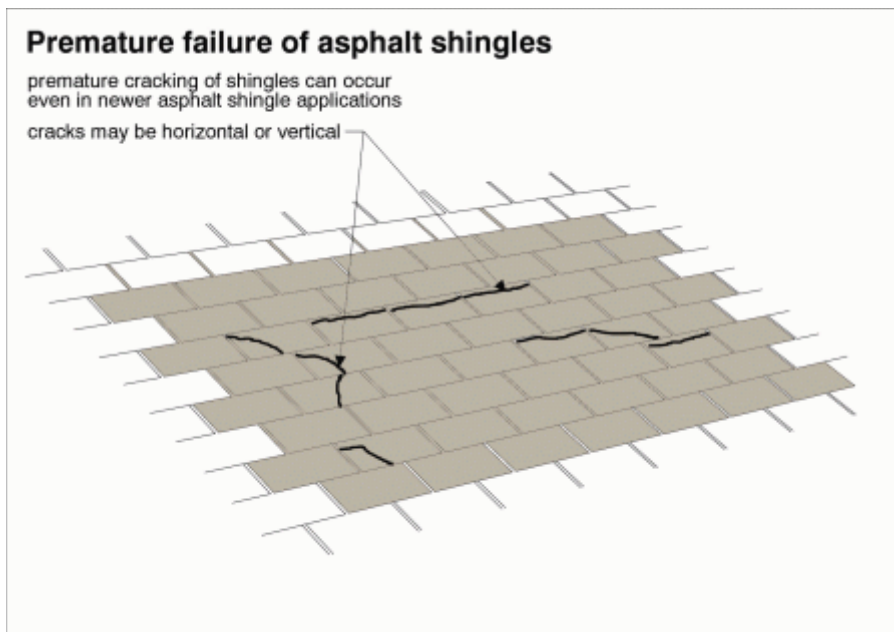
1. Cracked

1. Condition: • [Cracked](#)

Implication(s): Chance of water damage to contents, finishes and/or structure

Task: Monitor

Time: Ongoing

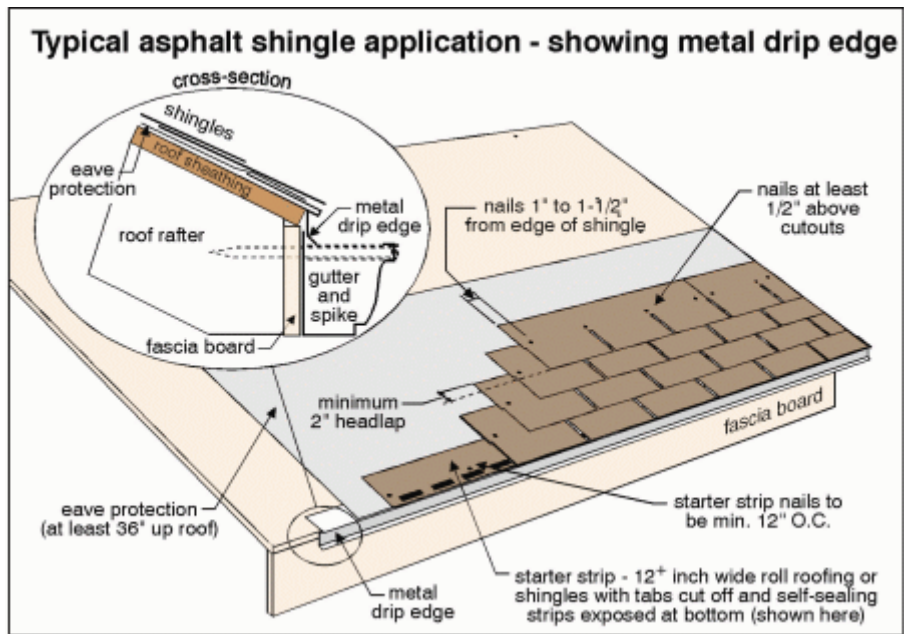
2. Missing, loose or torn

2. Condition: • [Missing, loose or torn](#)

a section of roof cover torn by tree branches, cutting back the tree branches to avoid further damages.

Implication(s): Chance of water damage to contents, finishes and/or structure

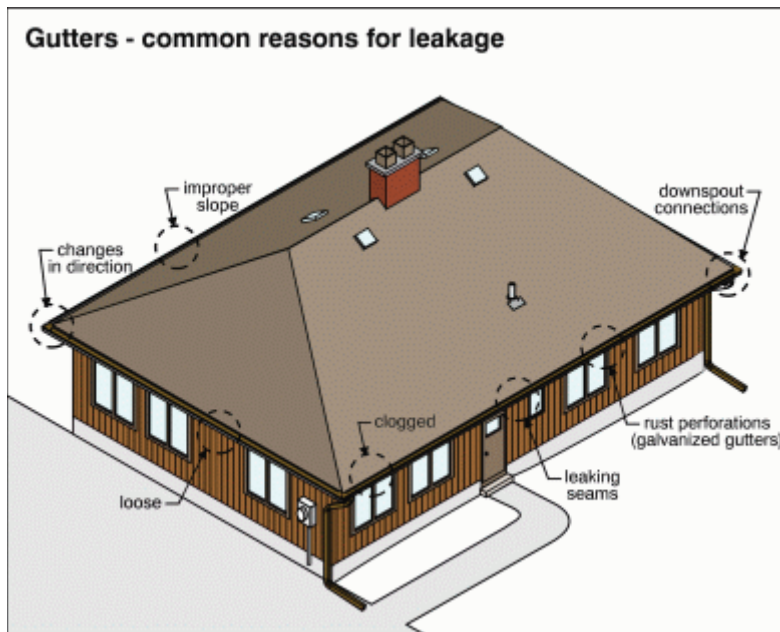
4. Loose or damaged

4. Condition: • [Loose or damaged](#)

Implication(s): Chance of water damage to contents, finishes and/or structure

Task: Repair or replace

Time: Less than 1 year

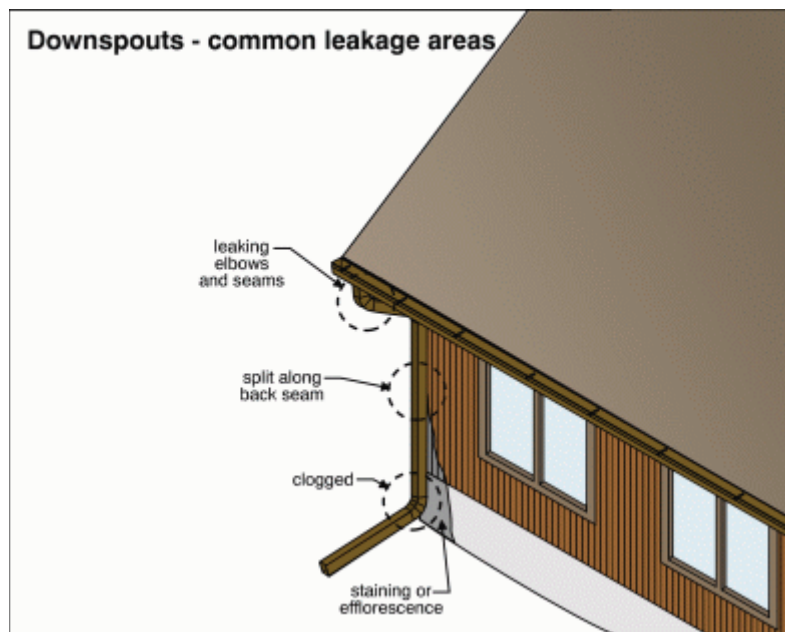
5. leak

5. Condition: • [Leak](#)

Implication(s): Chance of water damage to contents, finishes and/or structure

Task: Repair or replace

Time: Less than 1 year

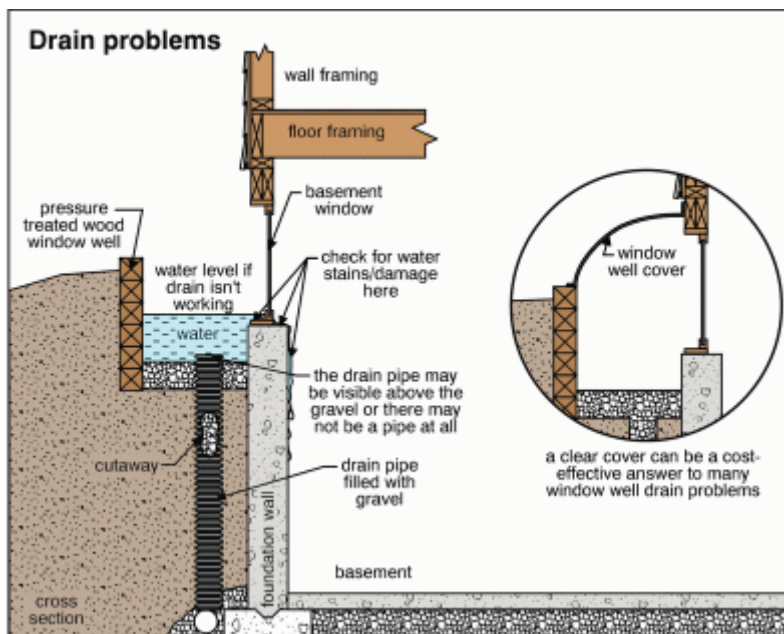
7. Condition: • [Missing](#)

Implication(s): Chance of water damage to contents, finishes and/or structure | Material deterioration

Task: Improve

Time: Less than 3 years

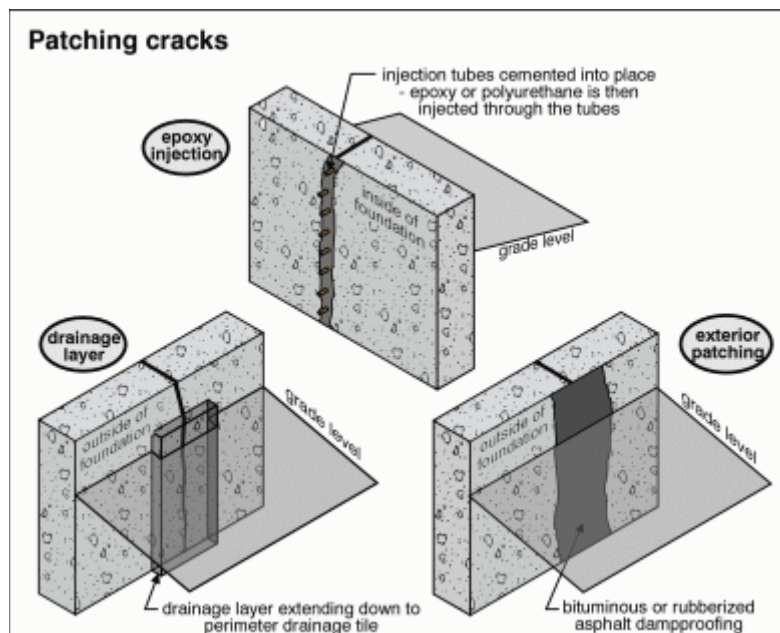
11. Condition: • Typical minor cracks

Task: Monitor; Patching as needed.

Time: Ongoing
