DEPARTMENT OF REGULATORY
AND ECONOMIC RESOURCES

MINIMUM INSPECTION PROCEDURAL GUIDELINES
FOR BUILDING ELECTRICAL RECERTIFICATION

- a. Name on Title: Village at Dadeland Condominiums (B)
- b. Street Address: 7320 SW 82nd St. Miami, Florida 33143
- c. Legal Description: Village at Dadeland Condominiums
- d. Owner's Name: Village at Dadeland Condominiums
- e. Owner's Mailing Address: 7320 SW 82nd St. Miami, Florida 33143
- f. Folio Number of Property on which Building is Located: 30-4035-047-XXXX
- g. Building Code Occupancy Classification: R2 - Residential
- h. Present Use: Condominium, Residential
- i. General Description, Type of Construction, Size, Number of Stories, and Special Features

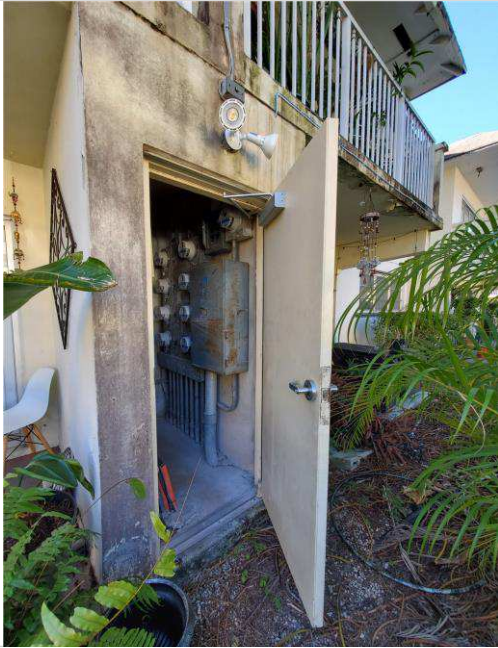
Photo 1 – Village of Dadeland Condominium Association

Existing Electrical Room – 1st FL
No Storage Permitted

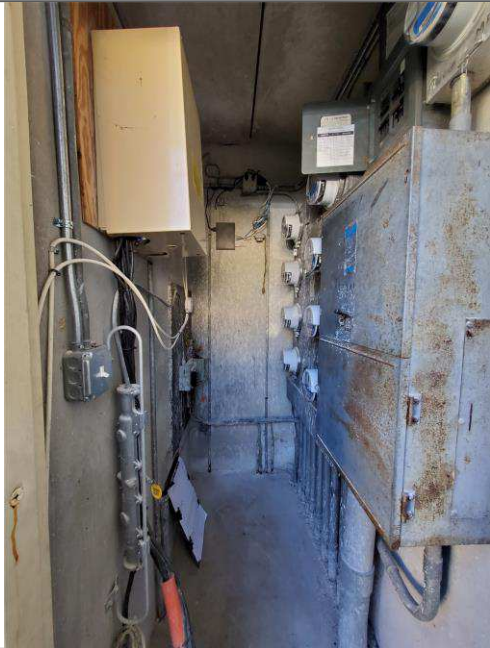
Photo 2 – Village of Dadeland Condominium Association

Existing Electrical Room – 1st FL
Main Switches for Apartments,
Meters, and Gutter.

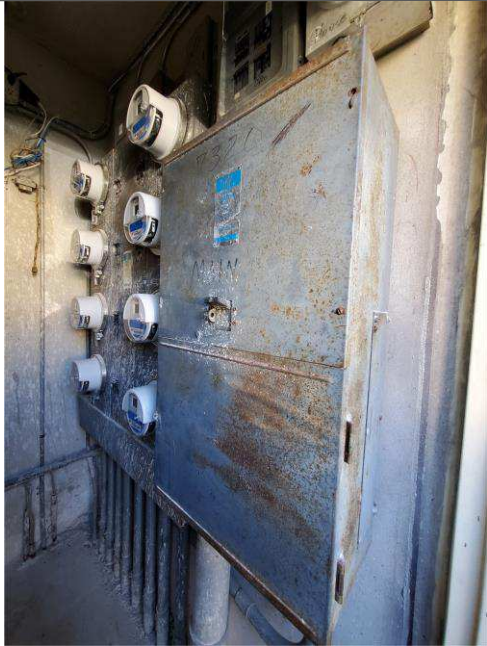
Photo 3 – Village of Dadeland Condominium Association

Existing Electrical Room – 1st FL
Main Disconnect and Meter
Stacks

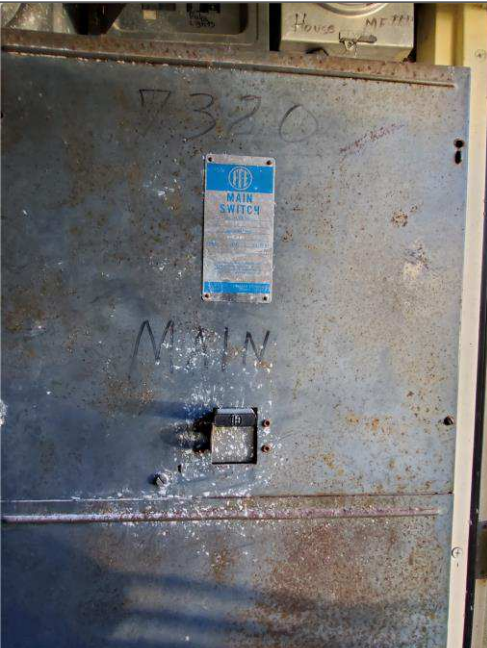
Photo 4 – Village of Dadeland Condominium Association

Existing Electrical Room – 1st FL
400A Main Disconnect

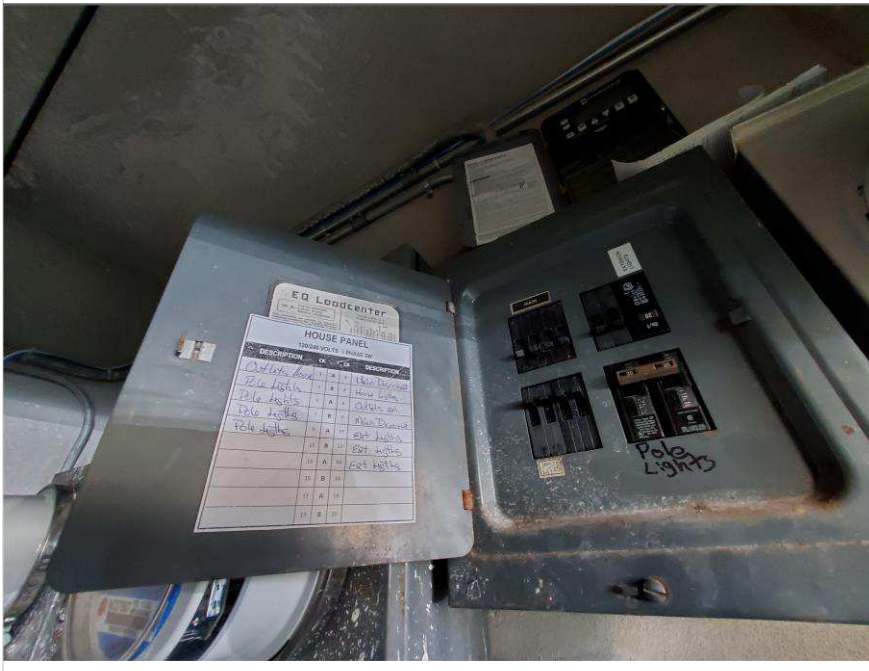
Photo 6 – Village of Dadeland Condominium Association

Existing Electrical Room – 1st FL
House Main Distribution Panel
Board and Breakers - oxidized
50 year old electrical
components.

Covered Name Plate Rating.

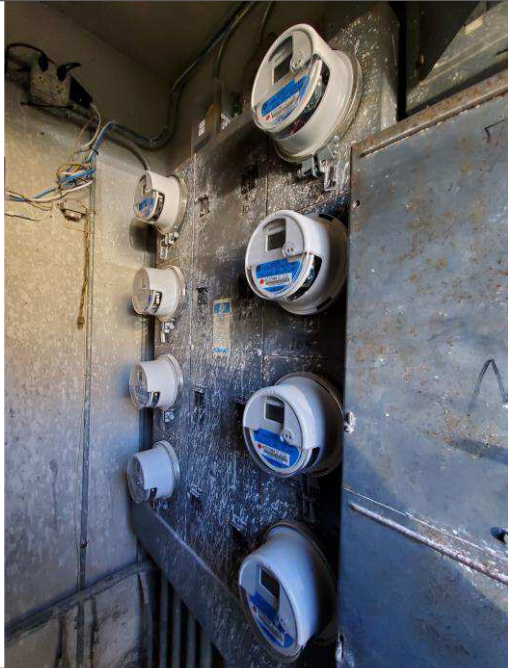
Photo 7 – Village of Dadeland Condominium Association

Existing Electrical Room – 1st FL
Apartment Meters and Main
Gutter

Old and oxidized meter stacks.

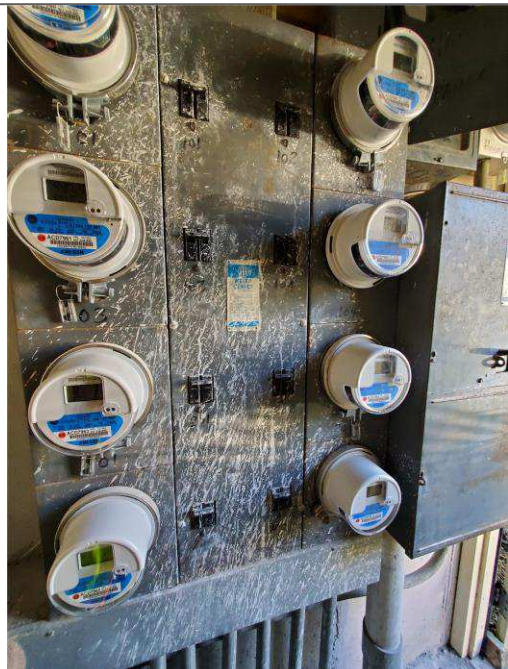
Photo 8 – Village of Dadeland Condominium Association

Existing Electrical Room – 1st FL
Apartment Meters and Main
Gutter

Old and oxidized meter stacks.

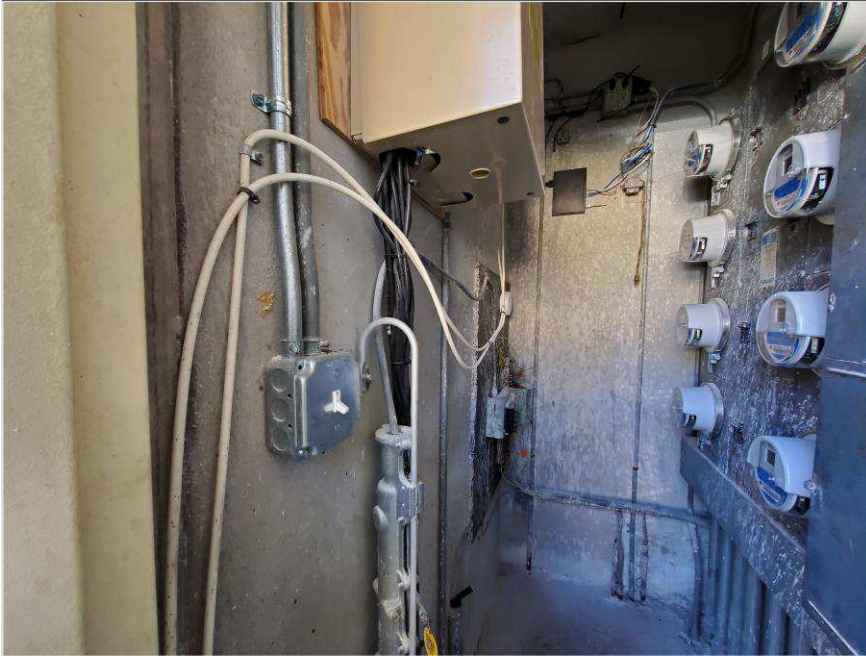
Photo 9 – Village of Dadeland Condominium Association

Existing Electrical Room – 1st FL
Apartment Meters and Main
Gutter

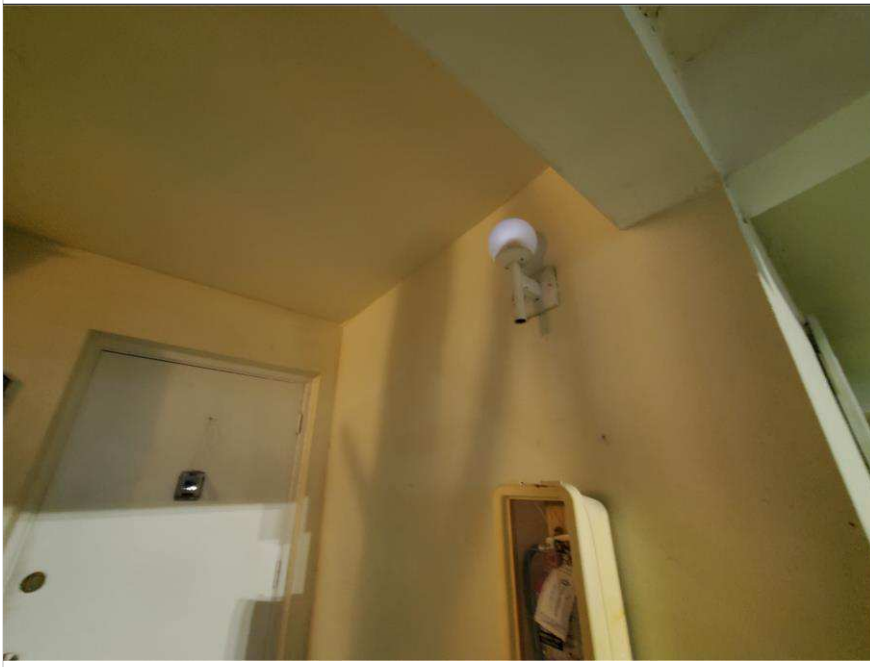
Photo 14 – Village of Dadeland Condominium Association

Parking – Poorly Illuminated
Exterior lights not functional.

Comments: Open parking areas have low illumination levels creating unsafe conditions and security concerns. Additional lighting is required to illuminate the parking walking surfaces for safety and security purposes. Parking light mounted on building is out - Repairs Required.

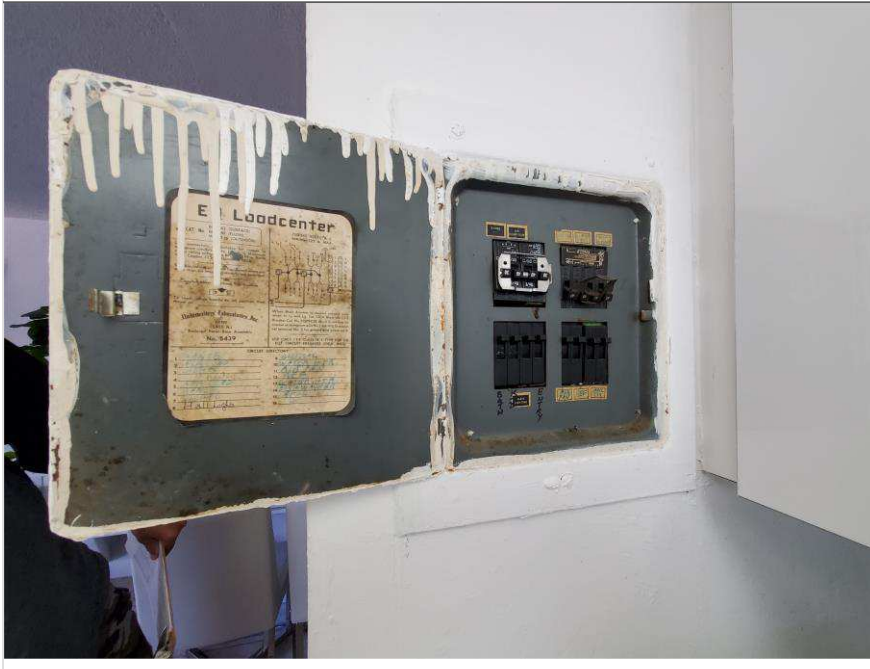
Photo 15 – Village of Dadeland Condominium Association

Apartments – Old Electrical Panels

8. Not all balcony and/or patio outlets are WP type, Repairs Required.
9. Electrical Panels in the apartments have considerable oxidation and are to be replaced.

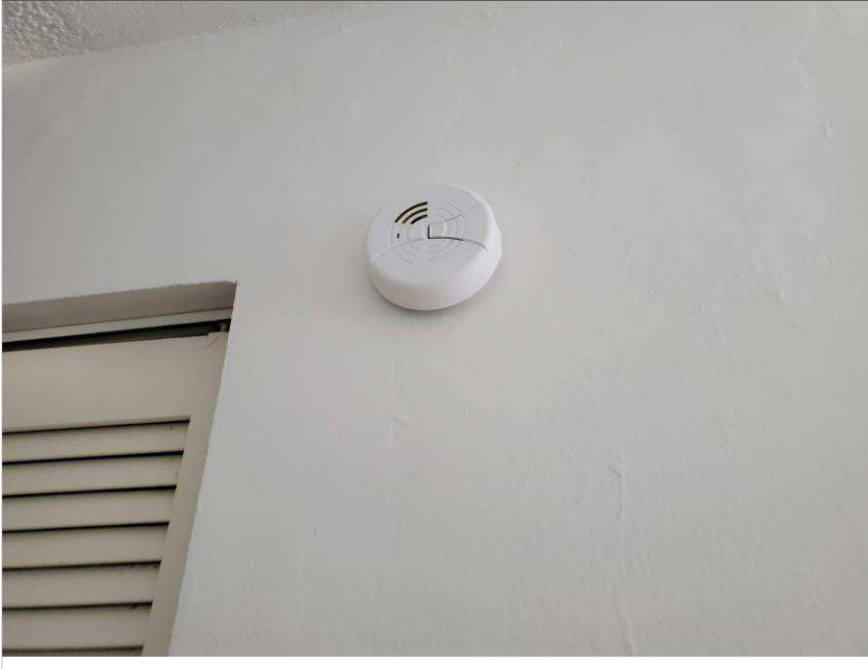
Photo 19 – Village of Dadeland Condominium Association

Apartments – Smoke Detectors

Old Smoke Detectors to be replaced.

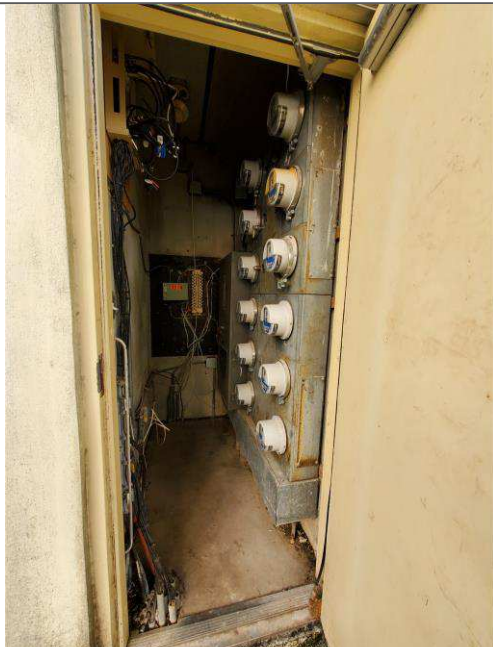
Photo 2 – Village of Dadeland Condominium Association

Existing Electrical Room - 1st FL
Main Switches for Apartments,
Meters, and Gutter.

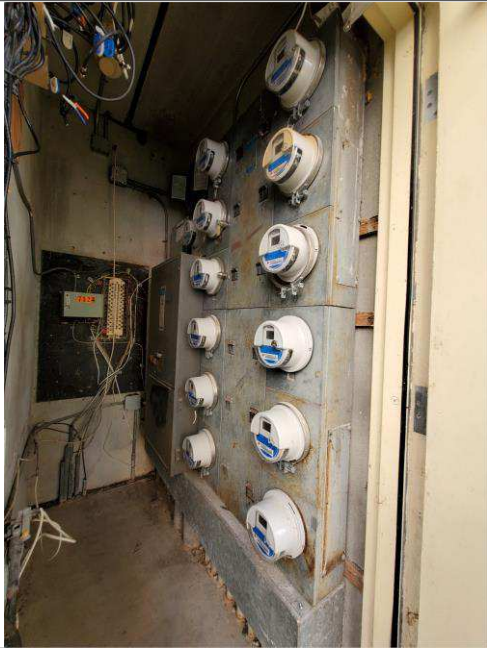
Photo 3 – Village of Dadeland Condominium Association

Existing Electrical Room - 1st FL
Main Disconnect and Meter
Stacks

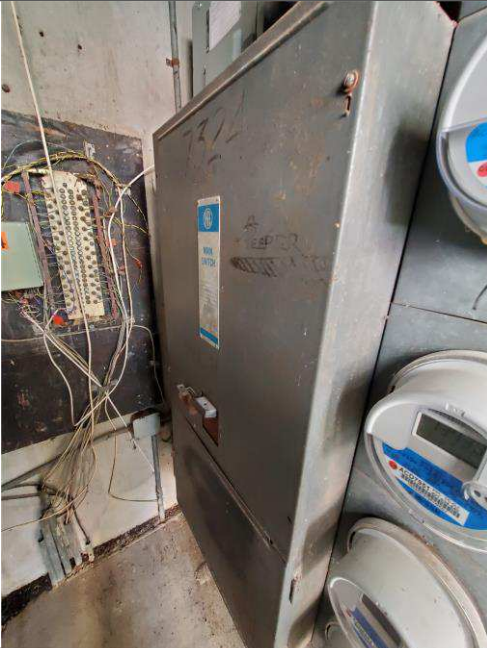
Photo 4 – Village of Dadeland Condominium Association

Existing Electrical Room - 1st FL
Building Main Disconnect -
considerably oxidized.
50 year old electrical
component.

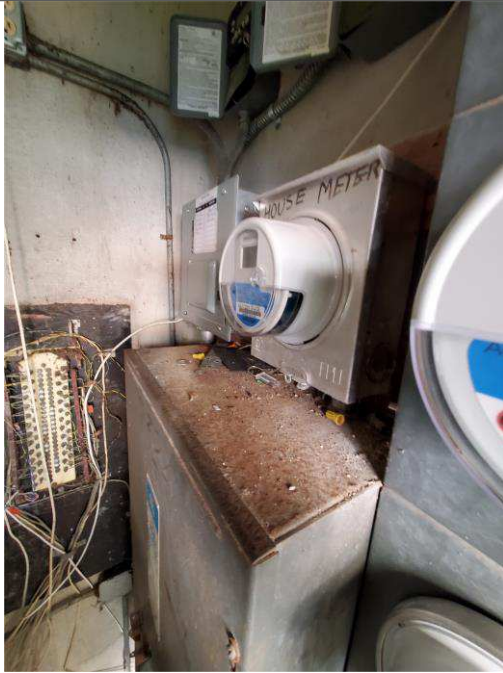
Photo 5 – Village of Dadeland Condominium Association

Existing Electrical Room - 1st FL
Building Main Disconnect (top
view) - considerably oxidized.
50 year old electrical
component.

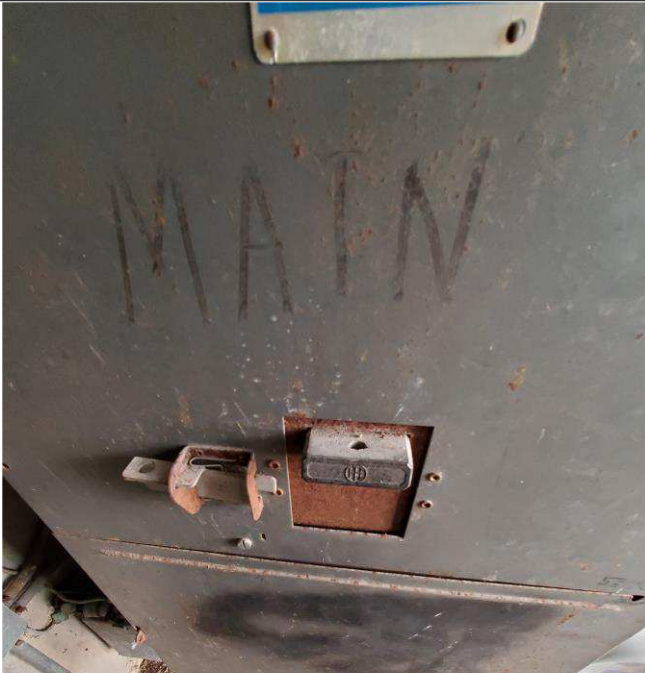
Photo 6 – Village of Dadeland Condominium Association

Existing Electrical Room - 1st FL
Building Main Disconnect (front
view)-oxidized.
50 year old electrical
component.

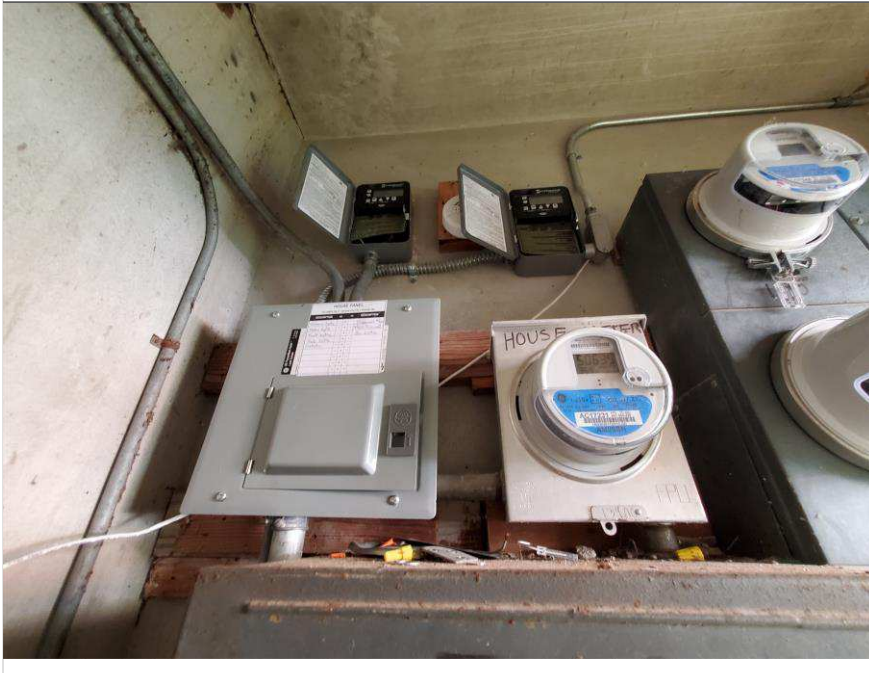
Photo 7 – Village of Dadeland Condominium Association

Existing Electrical Room - 1st FL
House Main Meter and Panel
Board

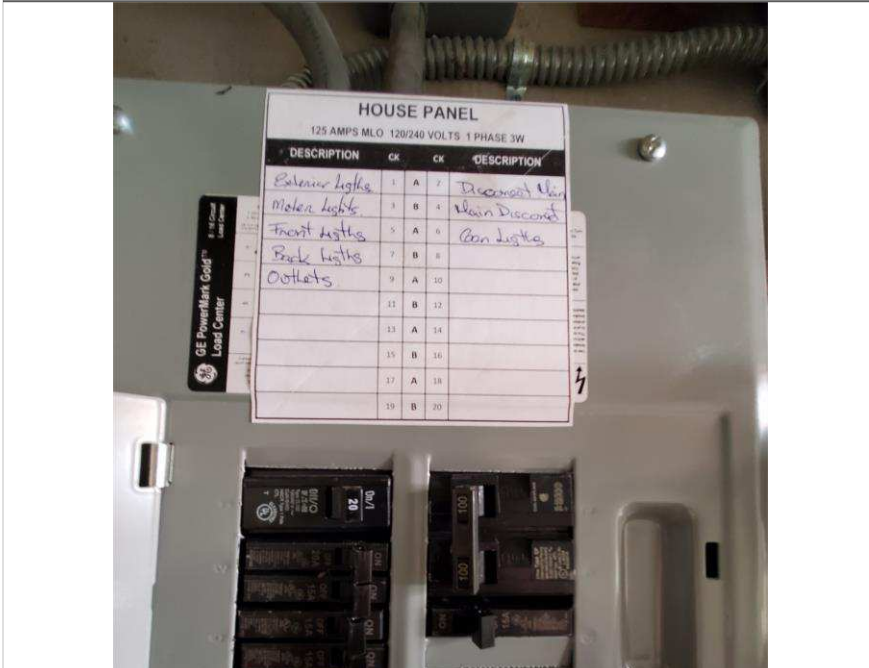
Photo 8 – Village of Dadeland Condominium Association

Existing Electrical Room - 1st FL
House Main Distribution Panel
Board and Breakers

Name Plate Rating Covered.

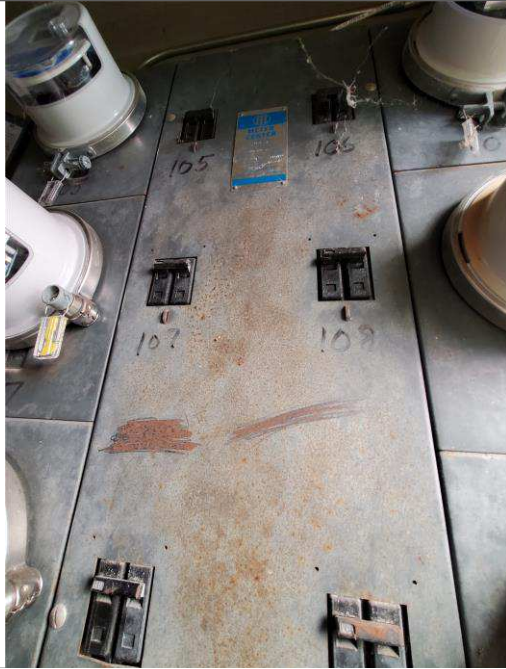
Photo 9 – Village of Dadeland Condominium Association

Existing Electrical Room - 1st FL
Apartment Meters and switches

Old and oxidized meter stacks.

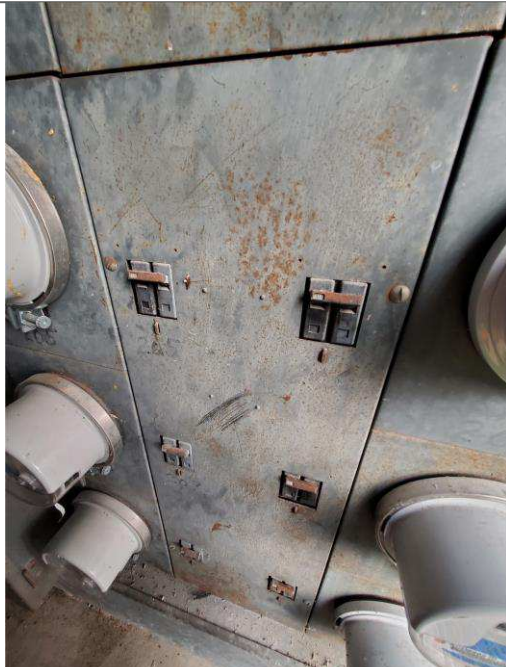
Photo 10 – Village of Dadeland Condominium Association

Existing Electrical Room - 1st FL
Apartment Meters and Main
Gutter

Old and oxidized meter stacks
and breakers.

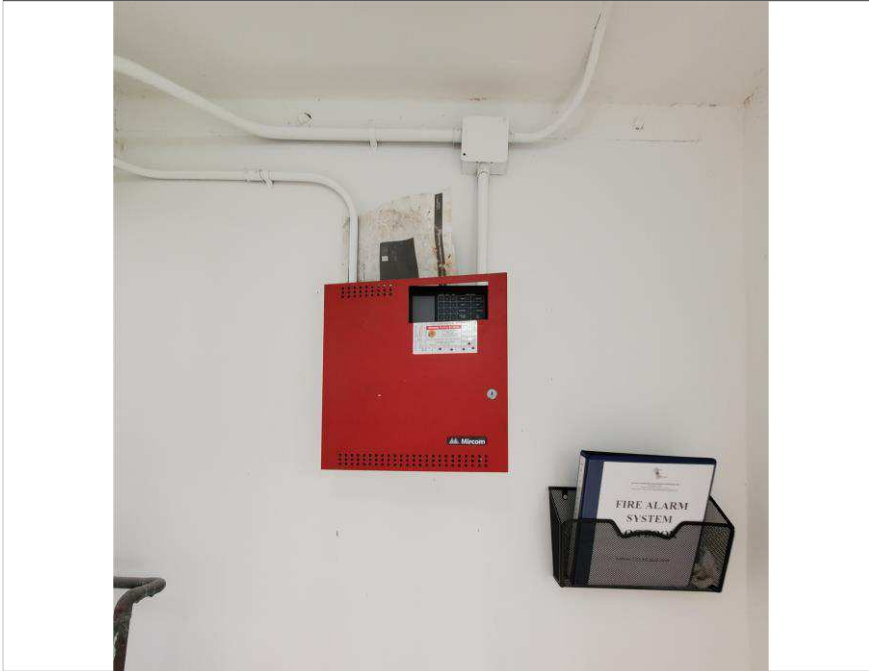
Photo 15 – Village of Dadeland Condominium Association

Laundry/Water heater room:
Fire Alarm Panel

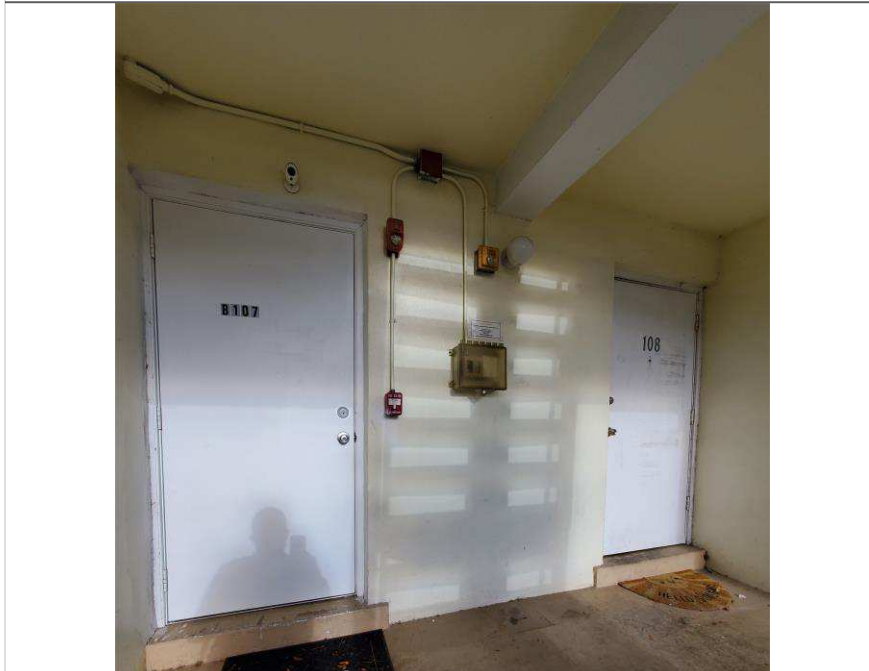
Photo 17 – Village of Dadeland Condominium Association

Level 1:

Fire Alarm - Old and Weathered
Fire Alarm Devices and Control
Center

Old Strobe Horn/Strobe Device
and Pull Stations

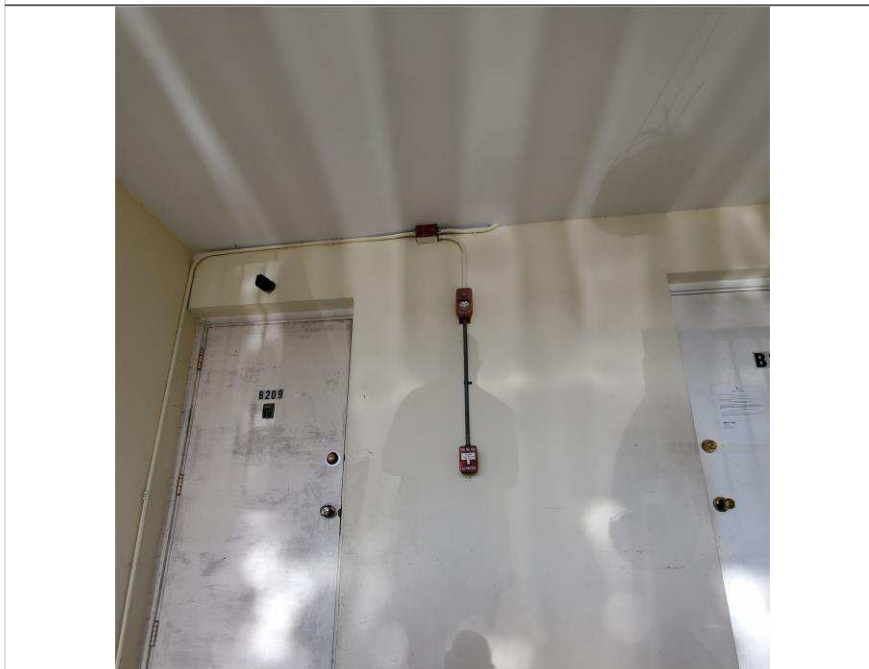
Photo 18 – Village of Dadeland Condominium Association

Level 2

Fire Alarm - Old and Weathered
Fire Alarm Devices and Control
Center

Old Strobe Horn/Strobe Device
and Pull Stations

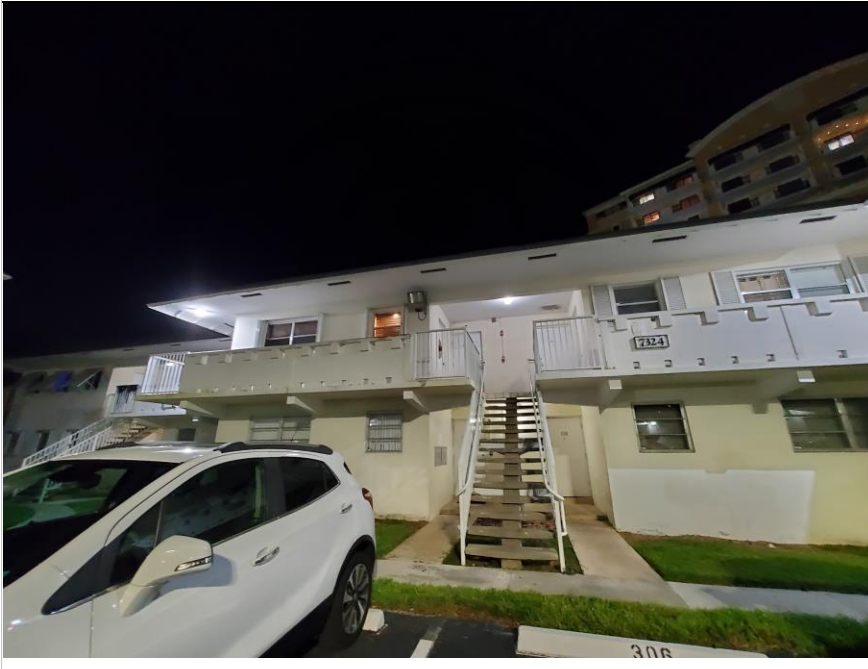
Photo 19 – Village of Dadeland Condominium Association

Parking:
Poorly Illuminated
Exterior lights not functional.

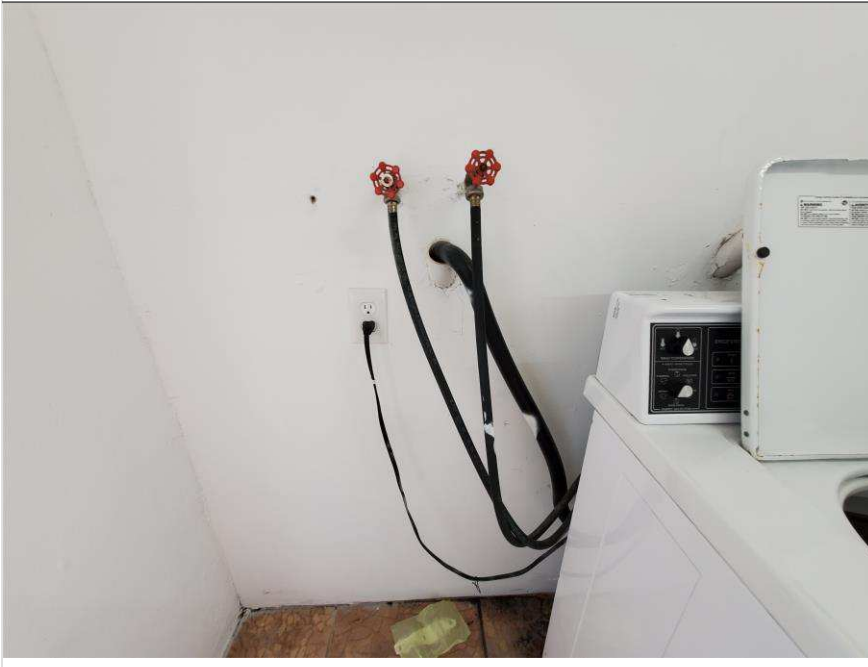
Photo 20 – Village of Dadeland Condominium Association

Laundry Room - Outlets are not
GFCI type.

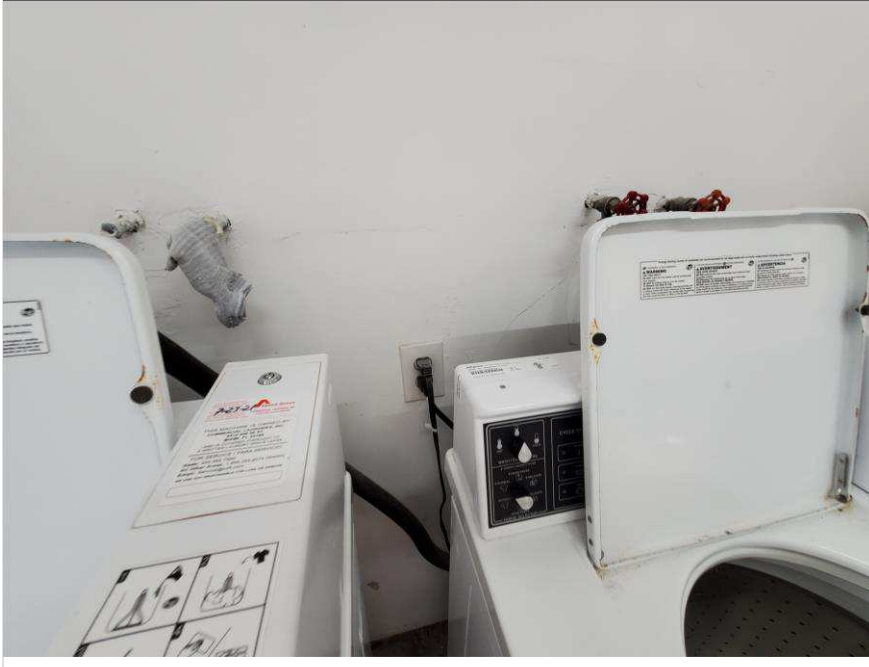
Photo 21 – Village of Dadeland Condominium Association

Laundry Room - Outlets are not GFCI type.

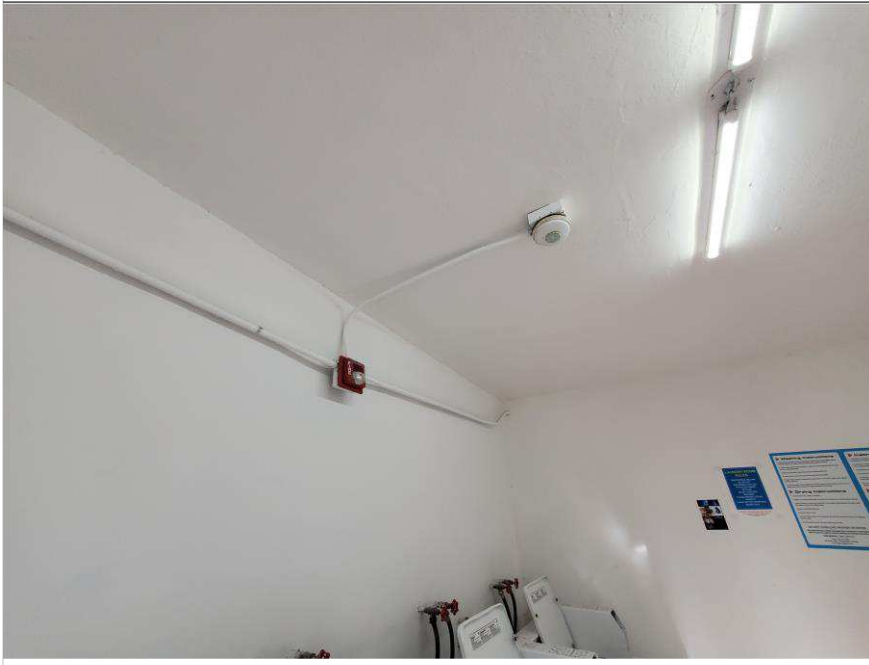
Photo 22 – Village of Dadeland Condominium Association

Laundry Room:
Old smoke detector

Comments: All old smoke detectors to be replaced. Smoke detectors to be installed and maintained in all .
main electric rooms. Apartments - Not all apartments have smoke detectors in the living room, hallways,
and/or bedrooms. As observed in Units B108, B210 all other units to be verified for compliance.

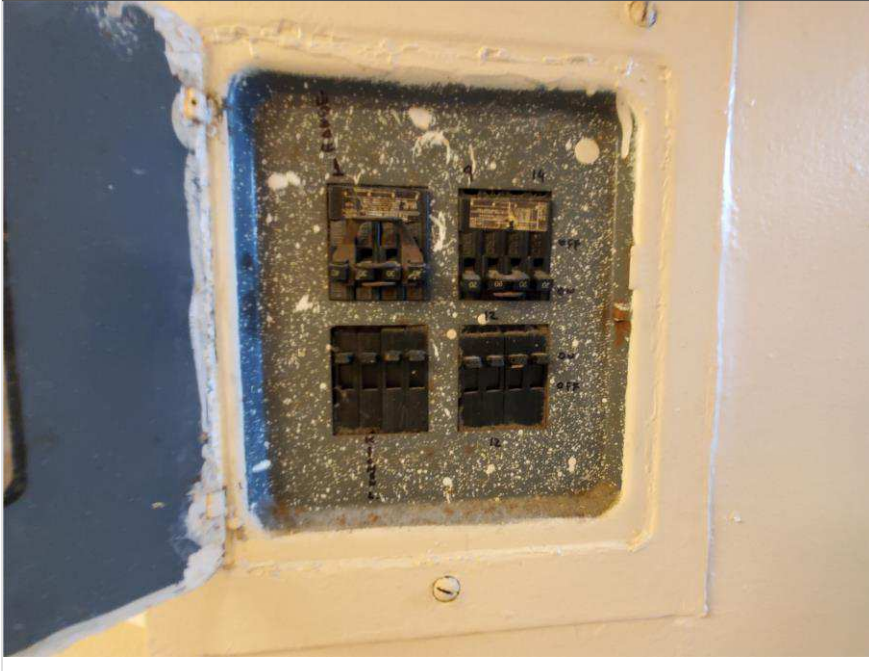
Photo 23 – Village of Dadeland Condominium Association

Apartments - Old Electrical
Panels

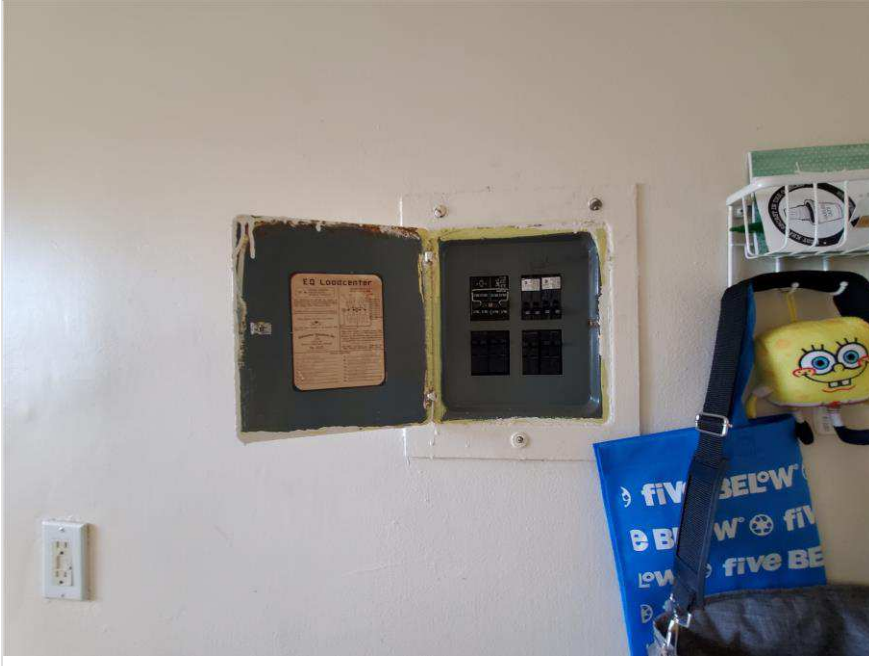
Photo 24 – Village of Dadeland Condominium Association

Apartments - Old Electrical
Panels

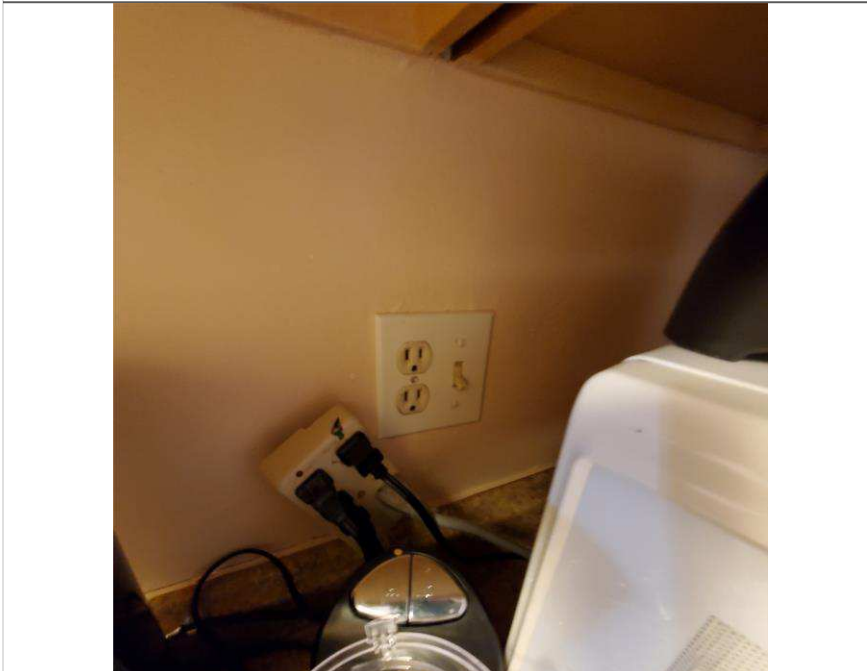
Photo 25 – Village of Dadeland Condominium Association

Apartments - Kitchen outlets
not GFCI type

3. Unit B210 - Kitchen outlets are not GFCI type, Repairs Required
4. All Kitchen Island Outlets are to be GFCI type, Repairs Required
5. Electrical outlets that have an open ground and/or are hot are to be repaired.

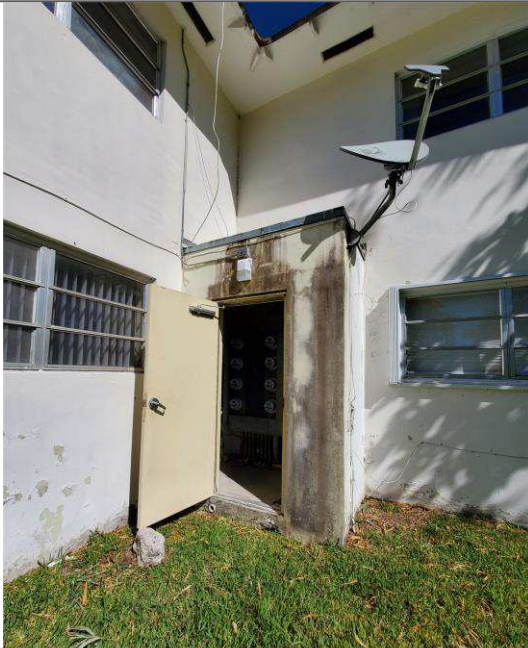
Photo 1 – Village of Dadeland Condominium Association

Existing Electrical Room - 1st FL
No storage permitted.

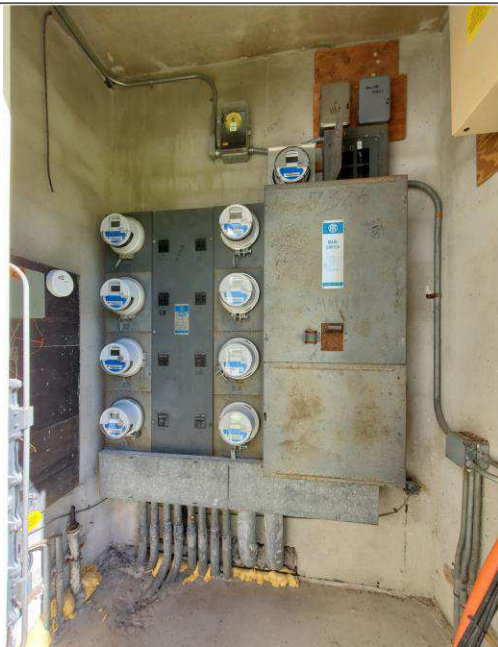
Photo 2 – Village of Dadeland Condominium Association

Existing Electrical Room - 1st FL
Main Switches for Apartments,
Meters, and Gutter.

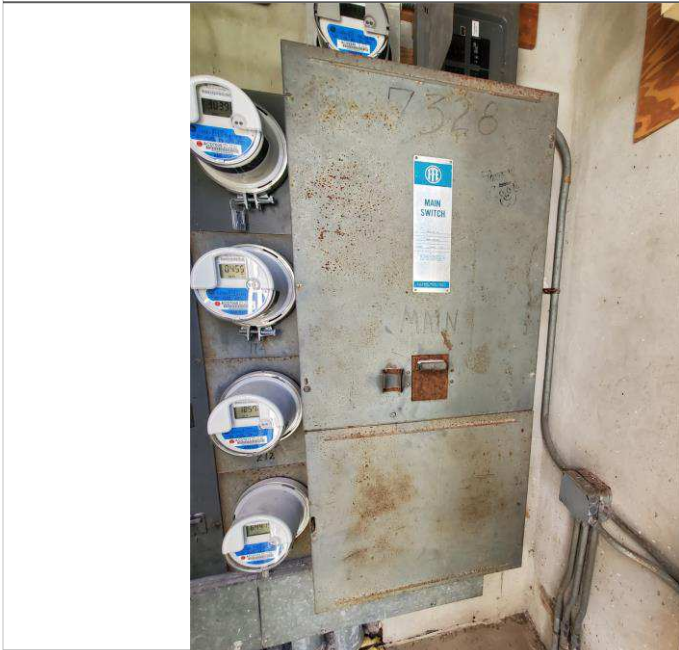
Photo 3 – Village of Dadeland Condominium Association

Existing Electrical Room - 1st FL
Main Building Disconnect
considerably oxidized.
50 year old electrical
component.

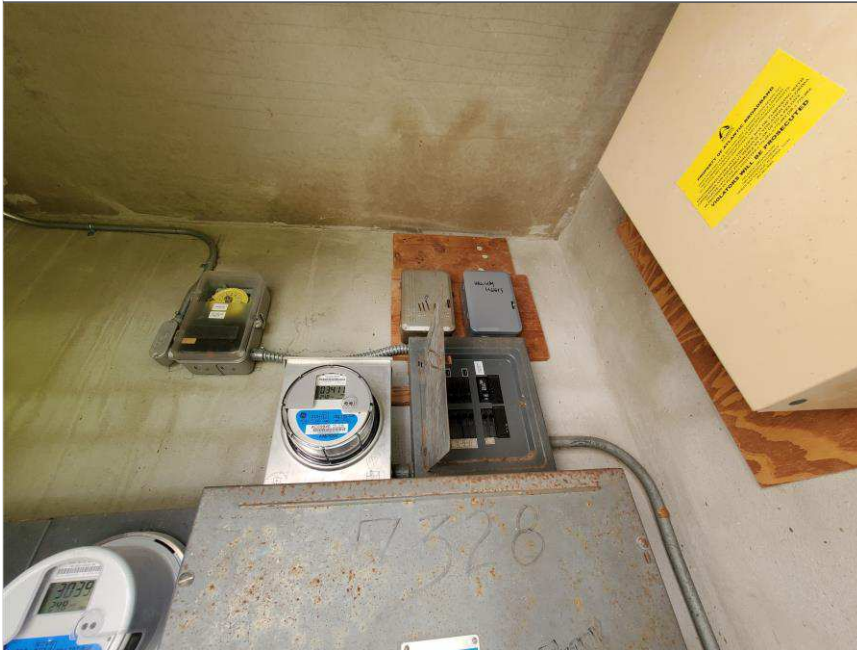
Photo 4 – Village of Dadeland Condominium Association

Existing Electrical Room - 1st FL
House Main Meter and Panel
Board oxidized.
50 year old electrical
component.

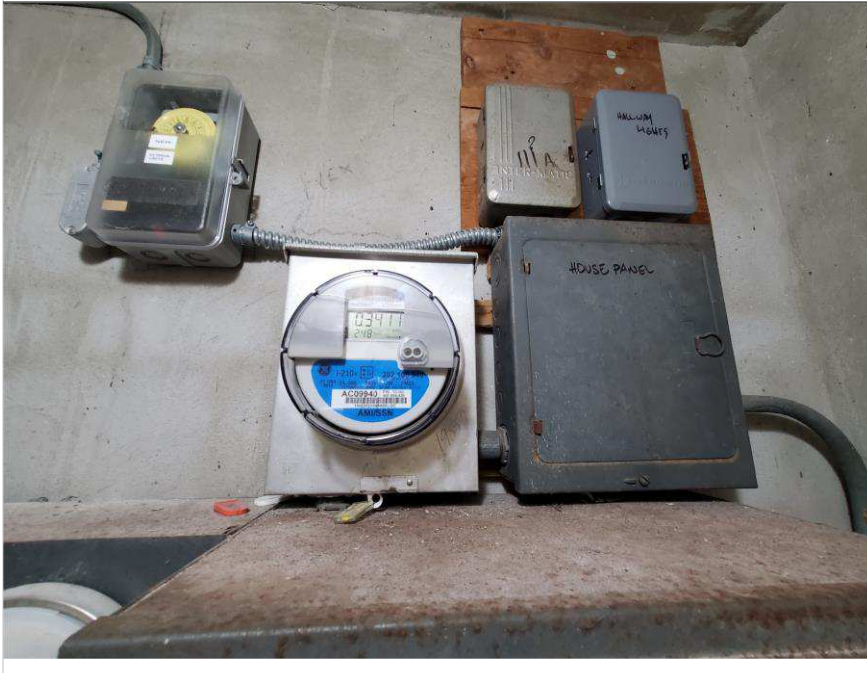
Photo 5 – Village of Dadeland Condominium Association

Existing Electrical Room - 1st FL
House Main Meter and Panel
Board are oxidized.
50 year old electrical
component.

Oxidized time clock

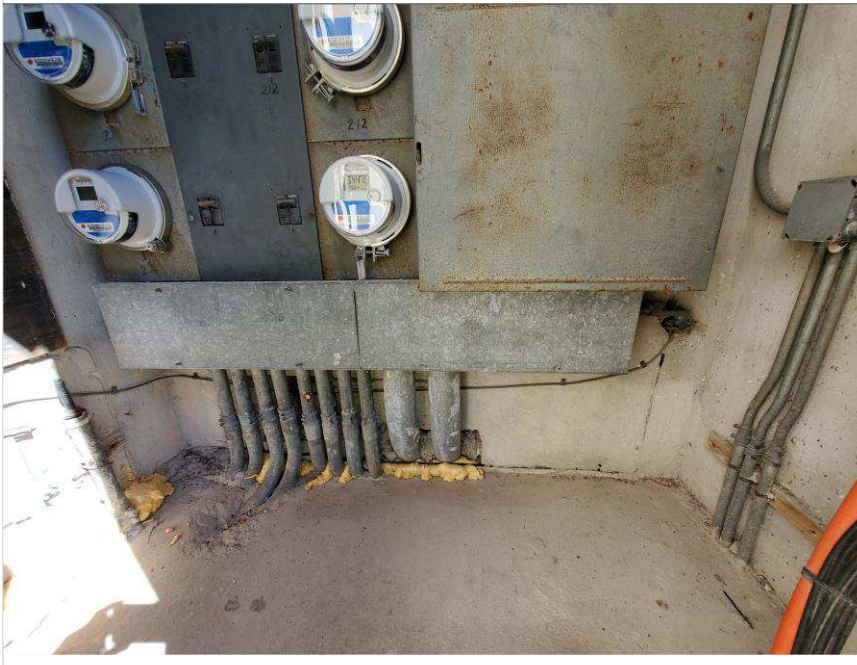
Photo 8 – Village of Dadeland Condominium Association

Existing Electrical Room - 1st FL
Apartment Meters, Main
Switches and Gutter.

Old and oxidized meter stacks.

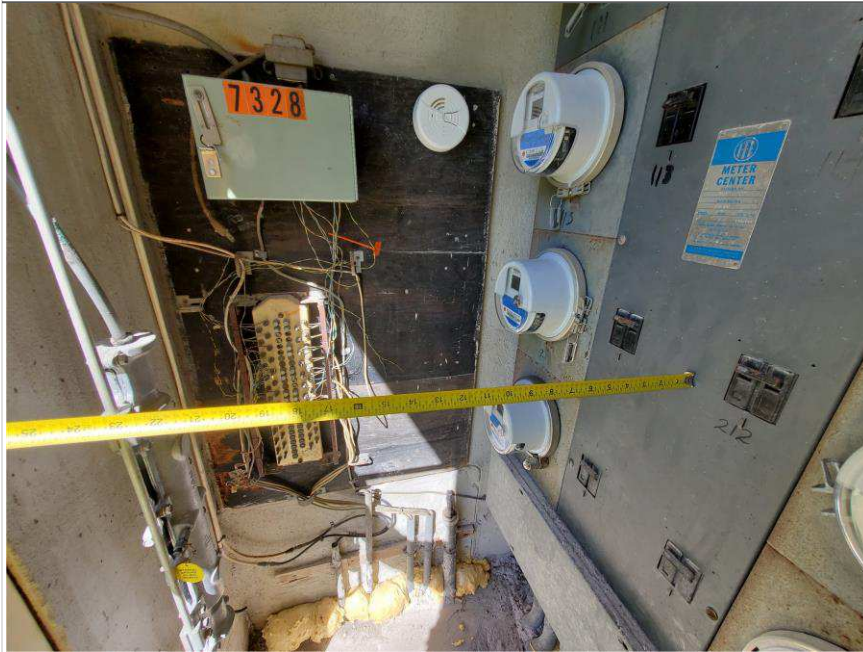
Photo 9 – Village of Dadeland Condominium Association

Existing Electrical Room - 1st FL
Apartment Meters, Main
Switches and Gutter.

Old and oxidized meter stacks.

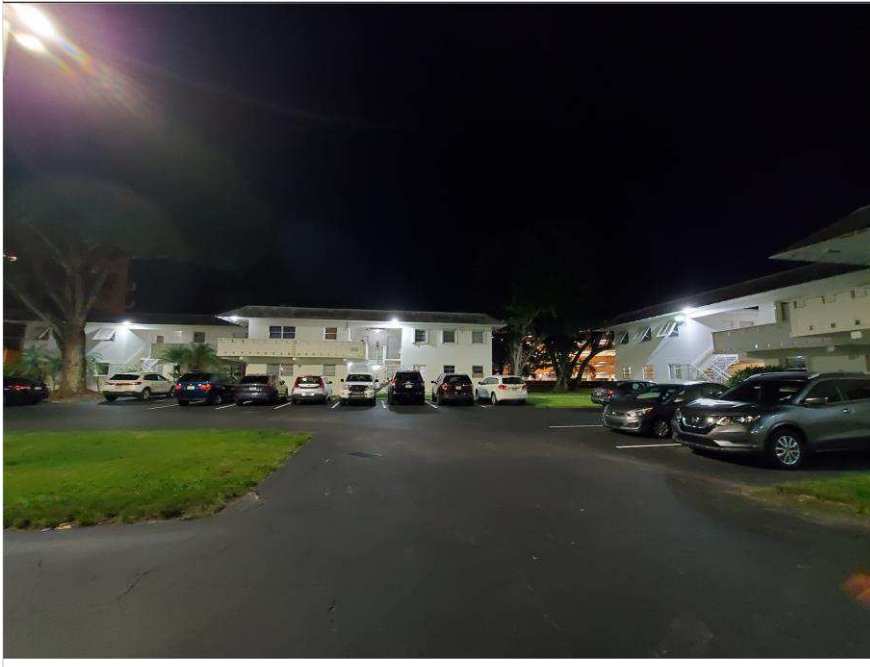
Photo 14 – Village of Dadeland Condominium Association

Parking - Poorly Illuminated
Exterior light not functional.

No light fixture over section of
the catwalk.

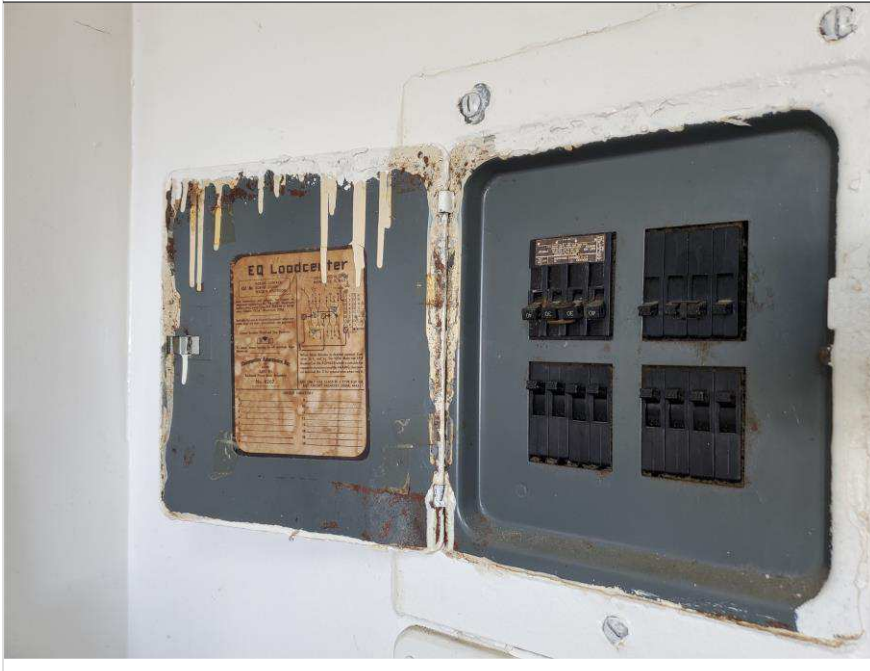
Photo 15 – Village of Dadeland Condominium Association

Apartments - Old Electrical
Panels

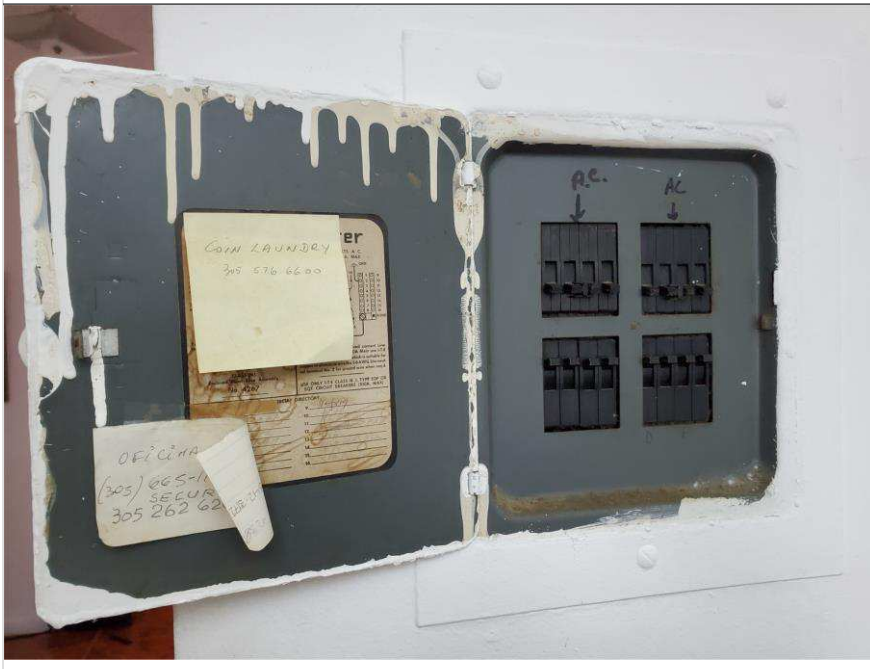
Photo 16 – Village of Dadeland Condominium Association

Apartments - Old Electrical
Panels

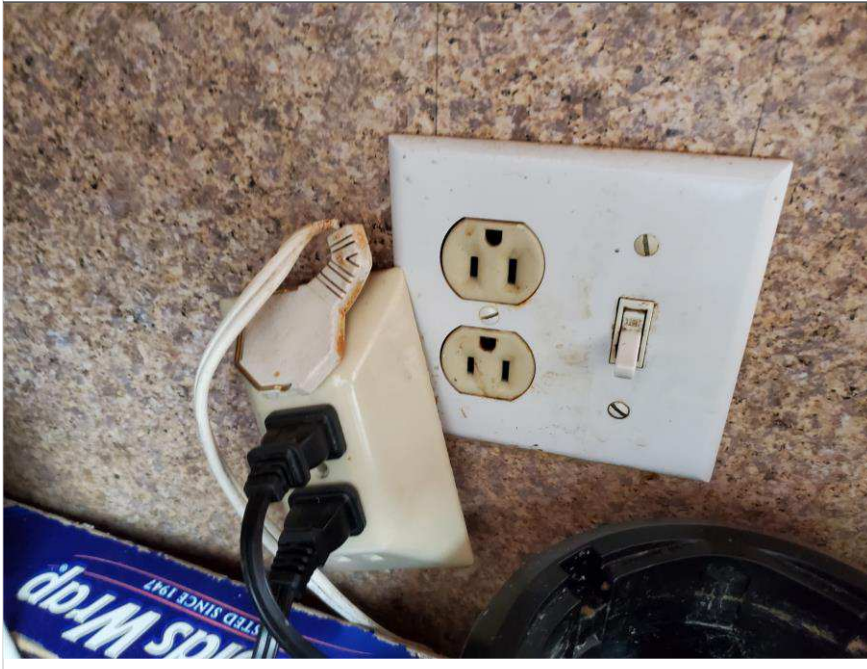
Photo 17 – Village of Dadeland Condominium Association

Apartments - Kitchen outlets
not GFCI type.

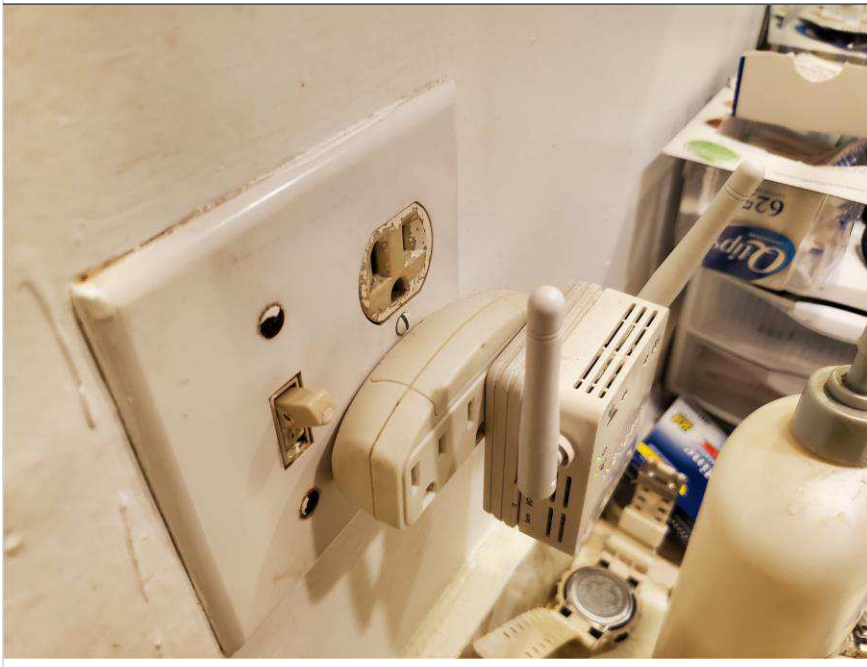
Photo 18 – Village of Dadeland Condominium Association

Apartments - Bathroom outlets
not GFCI type.

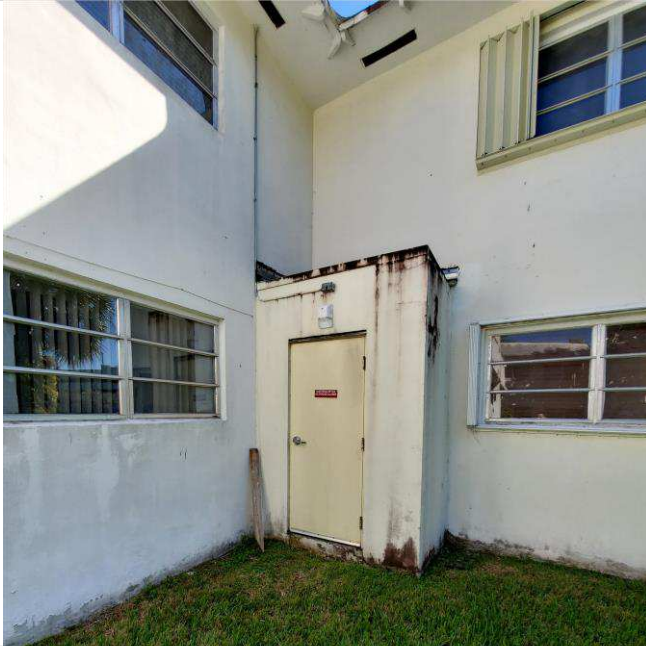
Photo 1 – Village of Dadeland Condominium Association

Existing Electrical Room - 1st FL
No storage permitted.
