DEPARTMENT OF REGULATORY
AND ECONOMIC RESOURCES

MINIMUM INSPECTION PROCEDURAL GUIDELINES
FOR BUILDING ELECTRICAL RECERTIFICATION

- a. Name on Title: Village at Dadeland Condominiums (B)
- b. Street Address: 7320 SW 82nd St. Miami, Florida 33143
- c. Legal Description: Village at Dadeland Condominiums
- d. Owner's Name: Village at Dadeland Condominiums
- e. Owner's Mailing Address: 7320 SW 82nd St. Miami, Florida 33143
- f. Folio Number of Property on which Building is Located: 30-4035-047-XXXX
- g. Building Code Occupancy Classification: R2 - Residential
- h. Present Use: Condominium, Residential
- i. General Description, Type of Construction, Size, Number of Stories, and Special Features

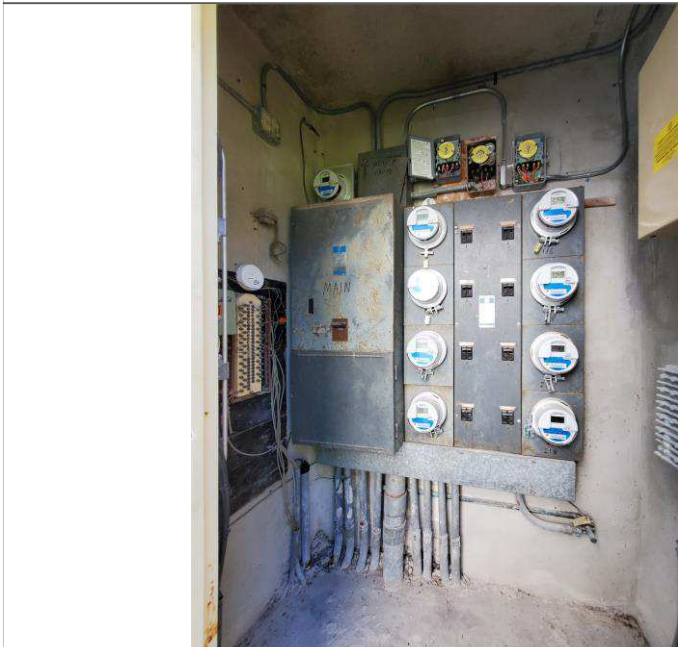
Photo 2 – Village of Dadeland Condominium Association

Existing Electrical Room - 1st FL
Main Switches for Apartments,
Meters, and Gutter.

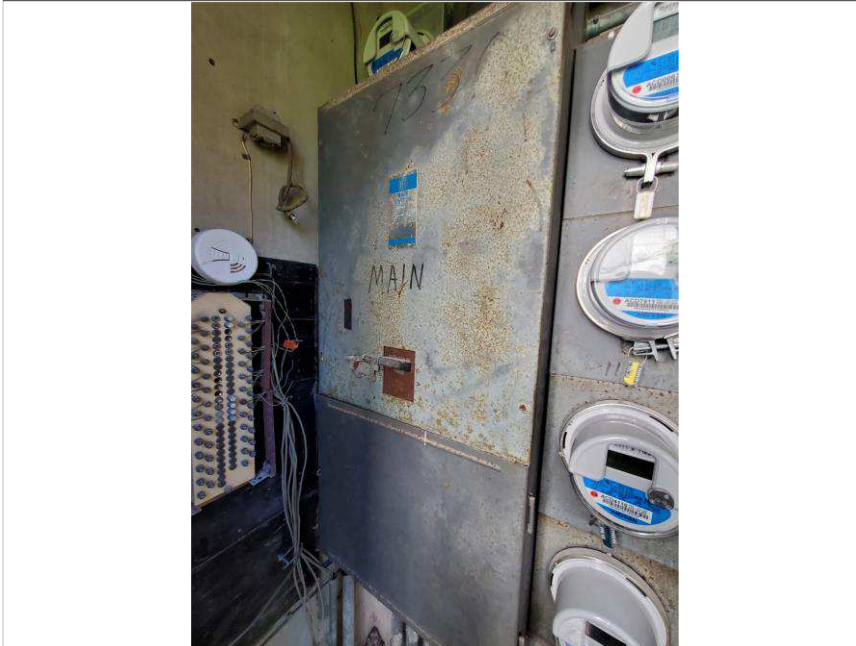
Photo 3 – Village of Dadeland Condominium Association

Existing Electrical Room - 1st FL
Building Main Disconnect
considerably oxidized.
50 year old electrical
component.

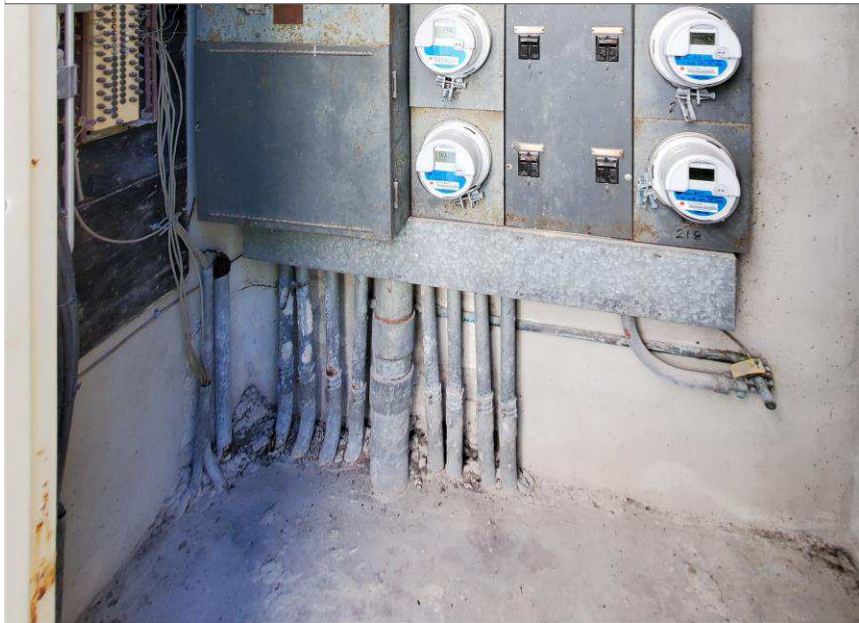
Photo 8 – Village of Dadeland Condominium Association

Existing Electrical Room - 1st FL
Apartment Meters and Main
Gutter

Old and oxidized meter stacks.

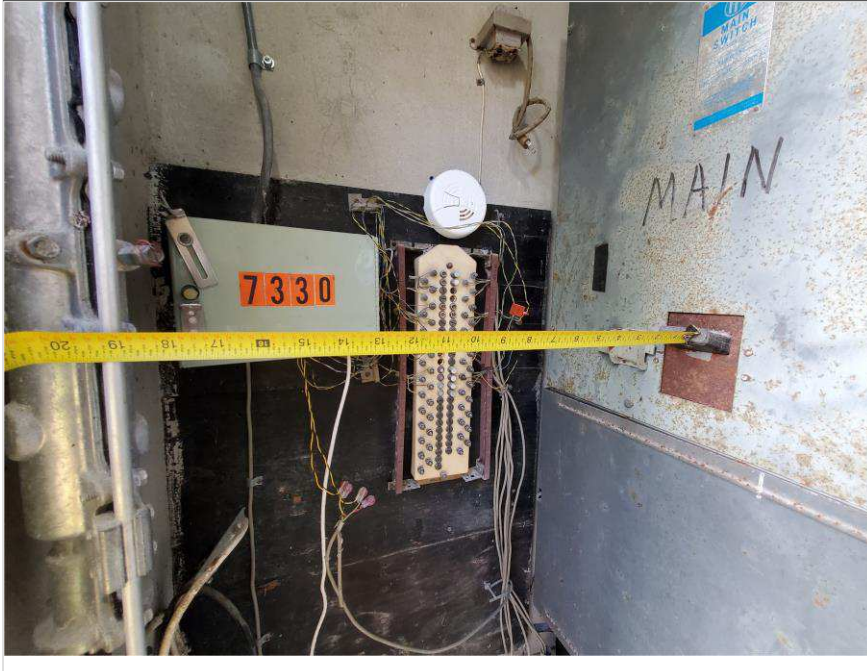
Photo 9 – Village of Dadeland Condominium Association

Existing Electrical Room - 1st FL

Insufficient clearance at meters and Main Disconnect Switch.

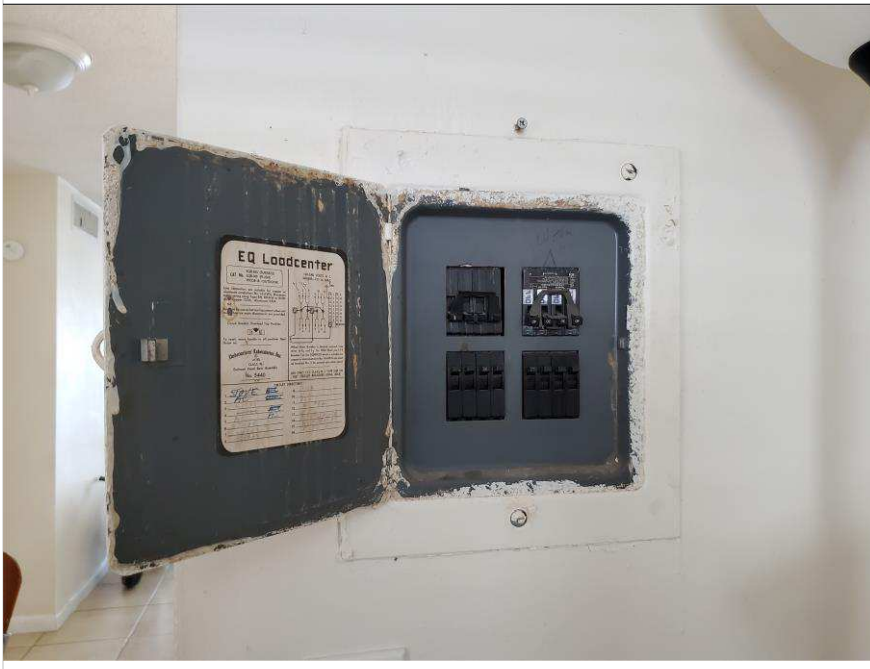
Photo 14 – Village of Dadeland Condominium Association

Apartments - Old Electrical
Panels

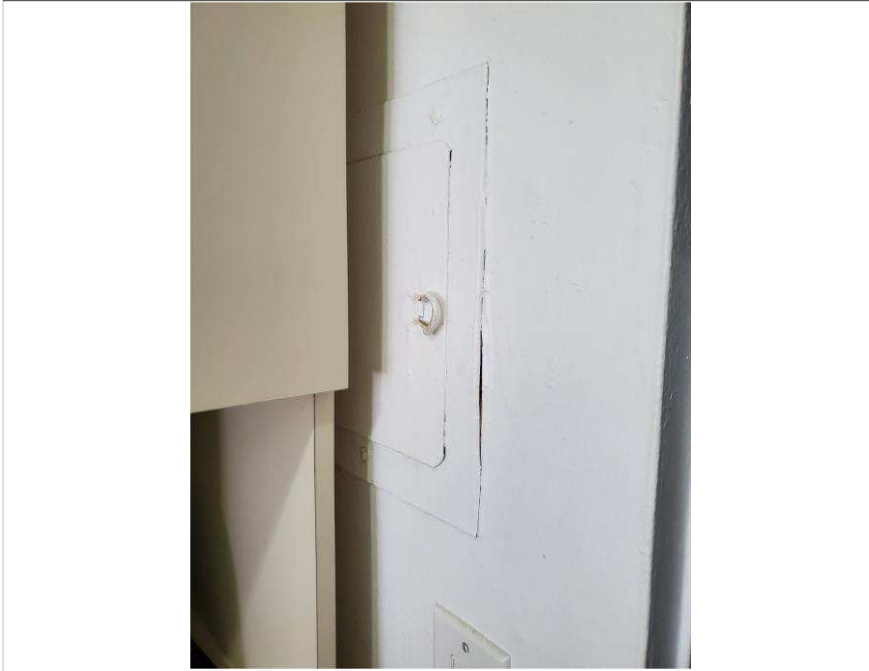
Photo 15 – Village of Dadeland Condominium Association

Apartments - Old Electrical Panels

Panel is not accessible as it is blocked by cabinet/shelves.

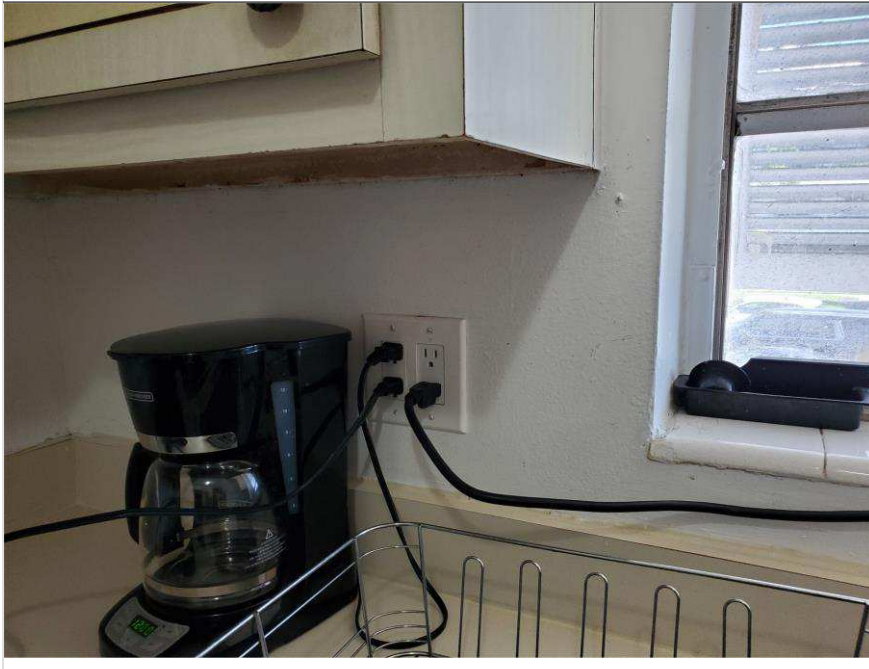
Photo 16 – Village of Dadeland Condominium Association

Apartments - Kitchen outlets not GFCI type.

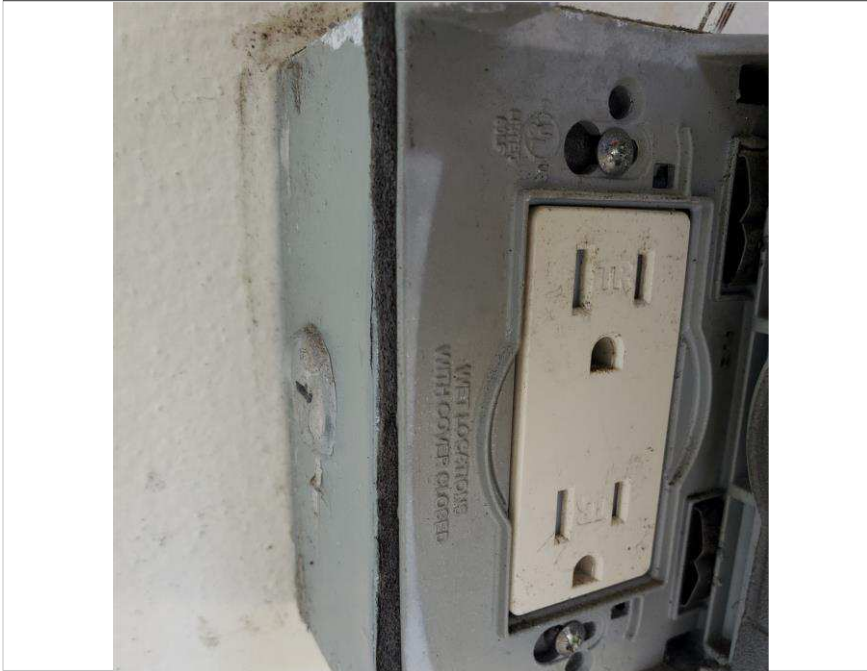
Photo 17 – Village of Dadeland Condominium Association

Apartments - Balcony/Patio outlets not GFCI type.
