FULL RESERVE STUDY

3300 Park Avenue Condominium Association, Inc.

Bridgeport, Connecticut

June 7, 2016

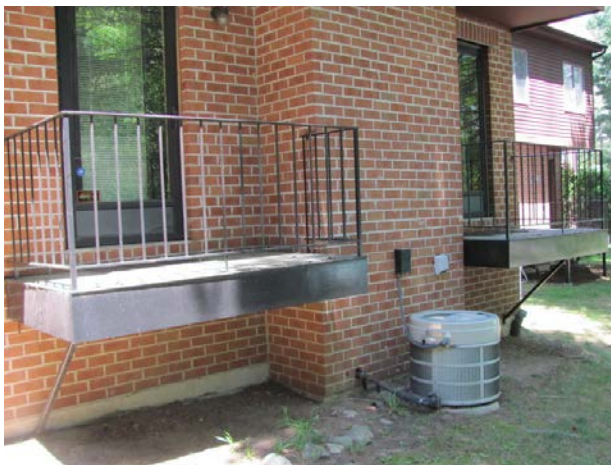
Balconies and Bridges, Metal - The Association is responsible for eight balconies at Building 1, two balconies at Building 2 and two bridges connecting Units 8 and 9 to the garage. The balconies and bridges comprise 510 square feet of decking and 190 linear feet of railings. The balconies and bridges are original and in fair condition. The finishes are in poor condition at an unknown age. We note rust throughout the balconies and isolated areas of significant corrosion.

Metal balconies

replacement of the decks and railings and capital repairs to the structures, by 2025. We depict this information on Line Items 1.100 and 1.105 of *Reserve Expenditures*.

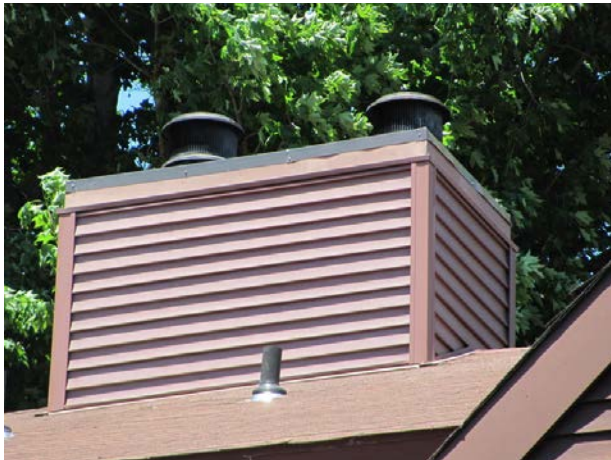
Chimney Caps, Aluminum - 3300 Park Avenue maintains nine aluminum chimney caps. The chimney caps were replaced in 2015 and 2016 and are in good overall condition based on our visual inspection from the ground. The exception is one chimney cap at Building 1 which is original and in poor condition.

Typical newer chimney cap

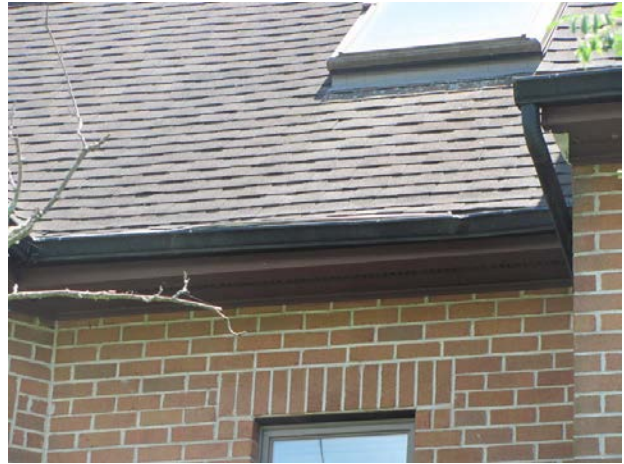
Deflected gutter at Building 3

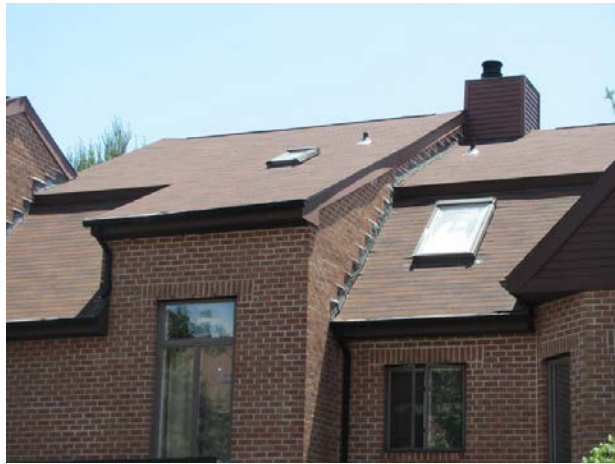
Replaced roofs at Building 1

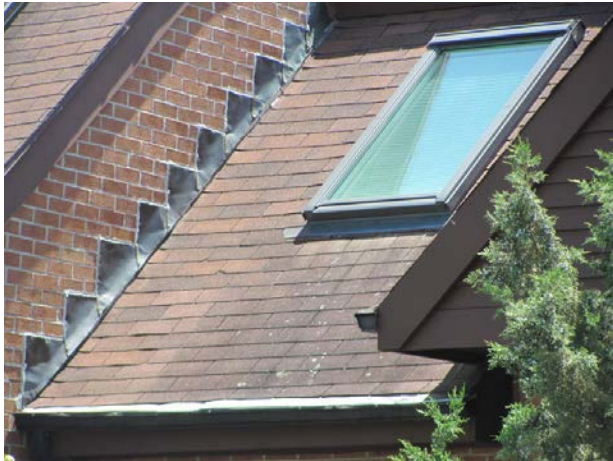
Our visual inspection from the ground notes granular loss at shingles, and lifted and weathered shingles.

Cupped and weathered shingles at Building 1

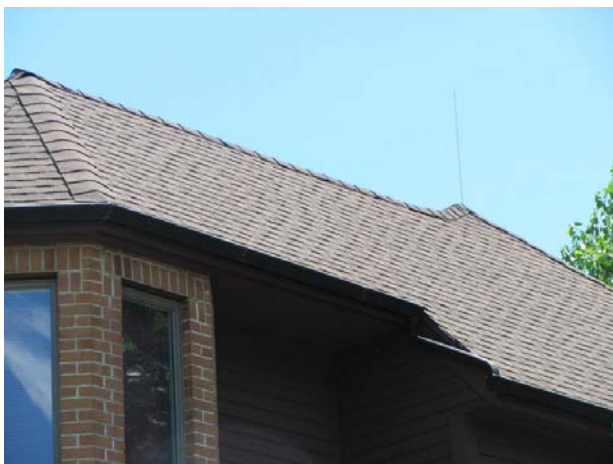
Laminate shingles at Building 3

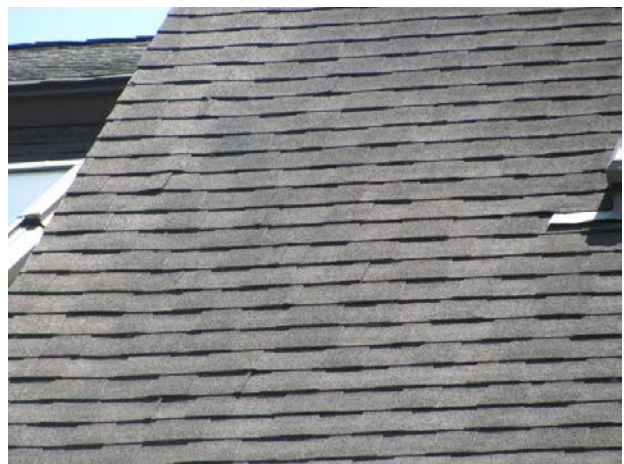
Weathering evident at shingles at Building 3

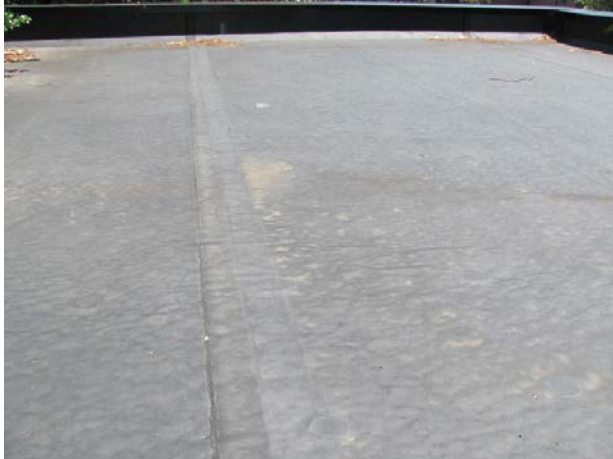
Roofs, EPDM - The 13 garage roofs at 3300 Park Avenue consist of 69 squares of ethylene propylene diene monomer (EPDM) roofing. The roofs were replaced from approximately 2003 to 2015, and vary from good to fair condition. Management does not report

a history of leaks. Our visual inspection notes evidence of standing water. However, we were unable to visually inspect each roof at the time of our inspection.

EPDM roof at garage

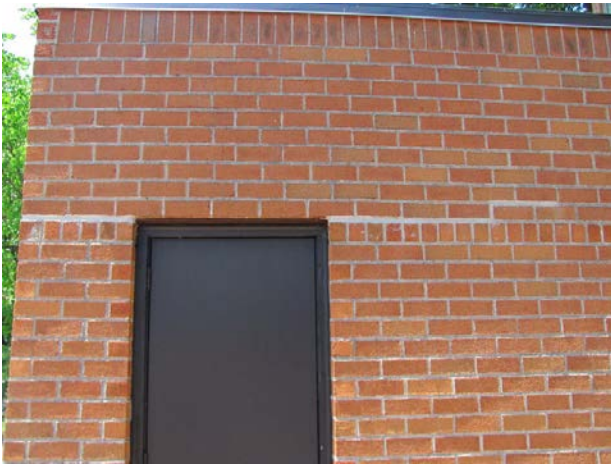
Recent mortar repairs at garage

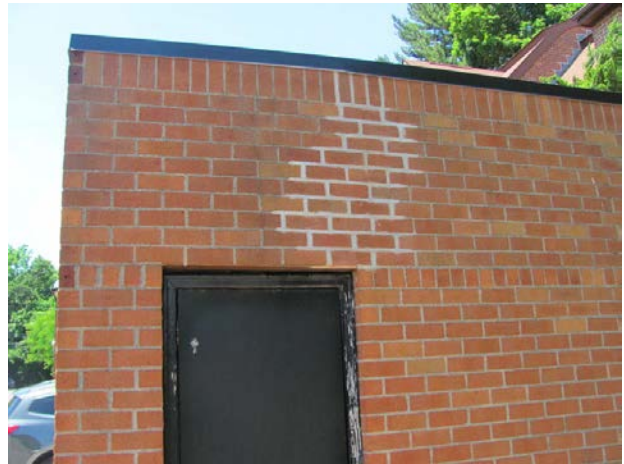
Recent mortar repairs at garage

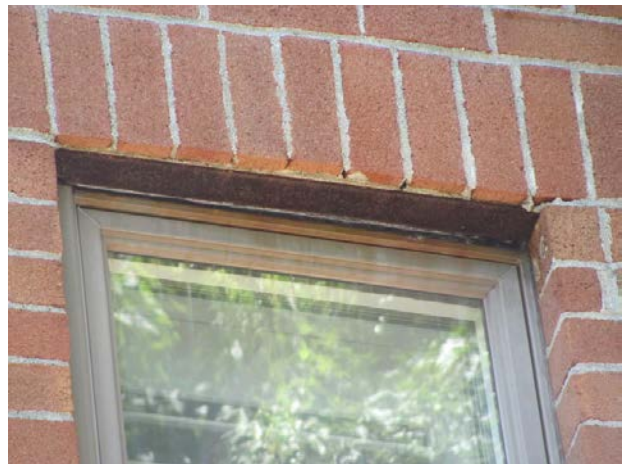
- Moderate amount of previous repairs evident
- Efflorescence is visible
- Lintels exhibit rust
- Masonry exhibits cracks
- No spalled masonry is evident
- Mortar deterioration is evident

Lintel detail

We also recommend inspection, repair and replacement of the steel lintels. Lintels are structural supports or beams above windows and doors. Fatigued lintels also allow the direct penetration of storm water into the wall assembly. These inspections should locate areas of rust on the lintels and cracks or other structural damage to the walls around lintels. The contractor should remove any areas of rust, prime and paint these lintels. Paint protects and maximizes the remaining useful life of the lintels and therefore the exterior wall systems. Structural damage can eventually lead to costly replacements of lintels and surrounding wall systems. The following diagram details a metal lintel and weep system:

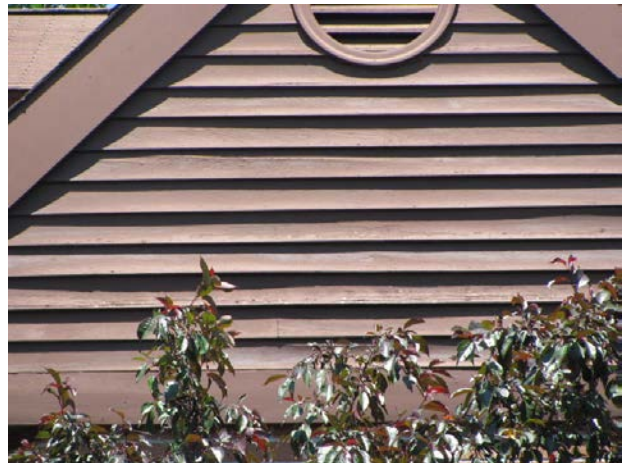
Faded paint finish at south facing elevation

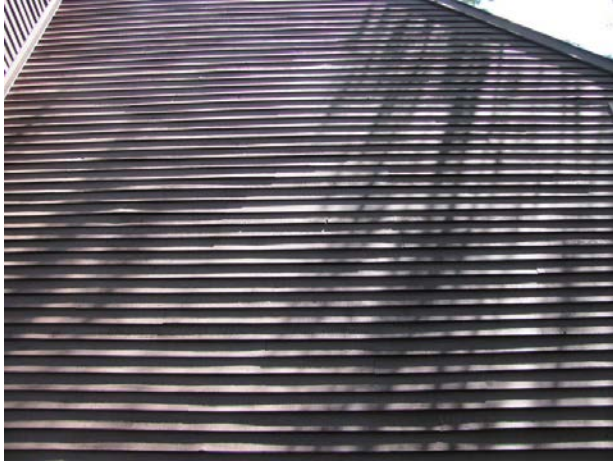
soffit and fascia. The siding is primarily original and in fair overall condition. The siding exhibits loose pieces, wood rot, and warped and weathered siding.

Wood siding

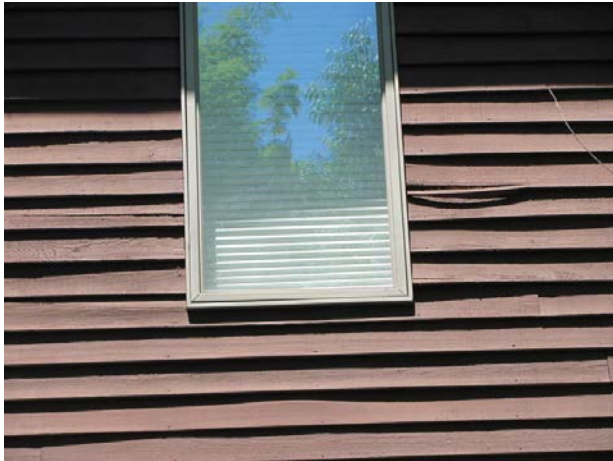
Split wood siding

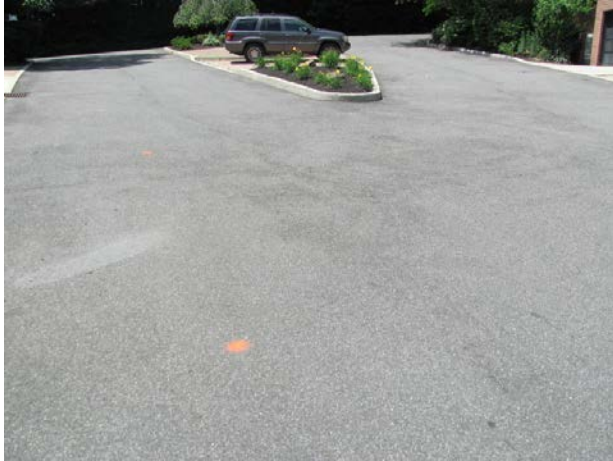
overall condition. We note isolated cracks and deterioration adjacent to catch basins and manholes.

Asphalt pavement street

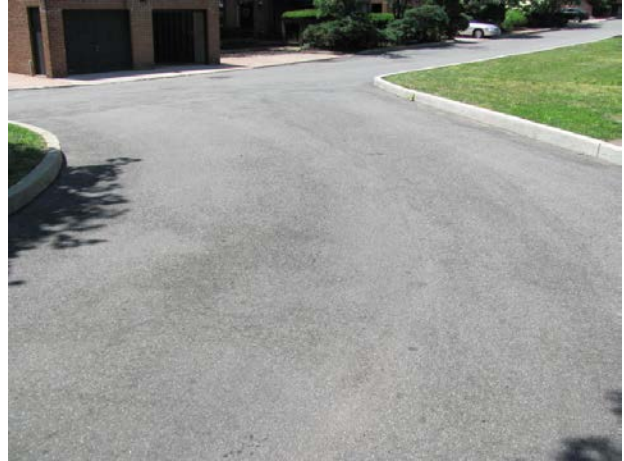
Asphalt pavement street

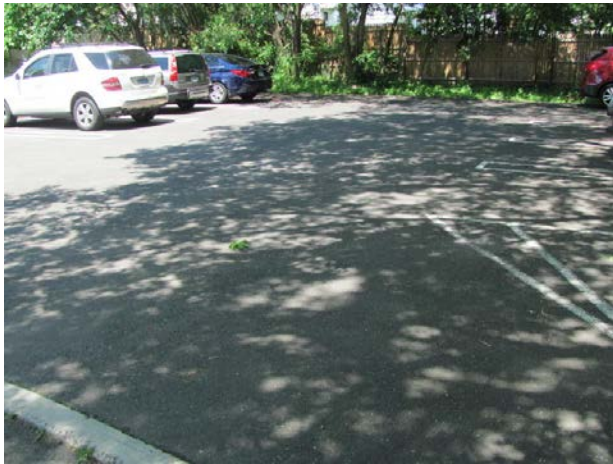
Asphalt pavement parking area

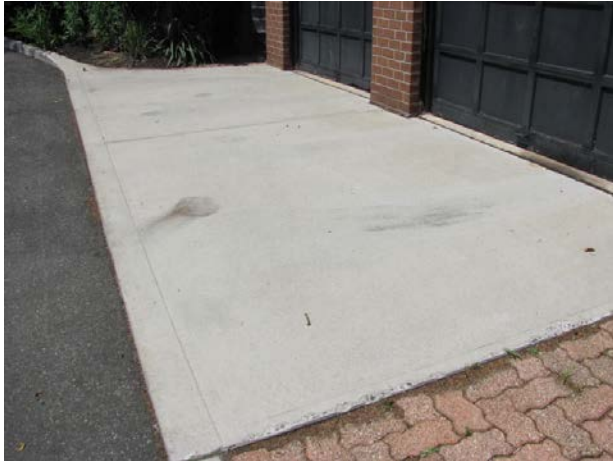
Concrete Driveways - Concrete driveways of varying sizes and configurations allow for access to the individual residences throughout the Association. The driveways were all replaced in approximately 2012 or 2013, are in good overall condition and comprise approximately 3,250 square feet. We note isolated cracks and spalled concrete.

Concrete driveway

Expenditures notes our estimate of future costs and anticipated times of replacements. We base our estimate of replacement on five-inch thick, 3,000 PSI concrete with 6x6 - W1.4xW1.4 steel reinforcing mesh.

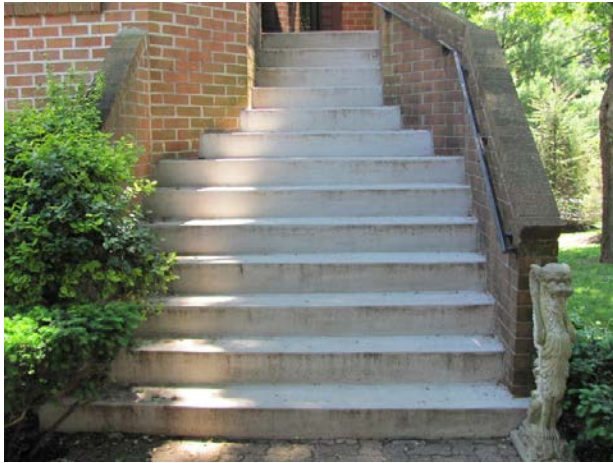
Concrete Stairs and Stoops - The units at the property are accessed either by cast on ground concrete stairs or concrete stoops. The 250 stairs comprise 1,500 linear feet of nose, and stoops and landings comprise 1,100 square feet. The stairs and stoops vary significantly from good to poor condition. We note significant concrete spalls and deterioration at a limited number of units.

Newer concrete stairs

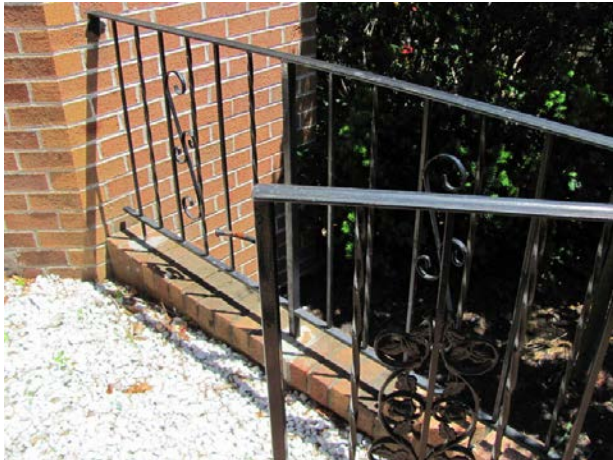
Fences and Handrails, Steel - Approximately 240 linear feet of steel fences and 280 linear feet of steels handrails are found at the front of the units. The fences and handrails are original and in fair condition. We note rust and corrosion, and loose connections.

Steel fence

Fences and handrails of this type have a long useful life but are not maintenance free. Periodic maintenance should include periodic applications of protective paint finish to the steel surfaces and partial replacement of deteriorated sections as needed. Steel components at grade and key structural connections are especially prone to failure if not thoroughly maintained. Secure and rust free fasteners and connections will prevent premature deterioration. We recommend paint applications periodically funded through the operating budget and we anticipate a useful life of up to 35 years for the fences and handrails. We anticipate a phased replacement beginning by 2020 and concluding by 2022. We depict this information on Line Item 4.245 of *Reserve Expenditures*.

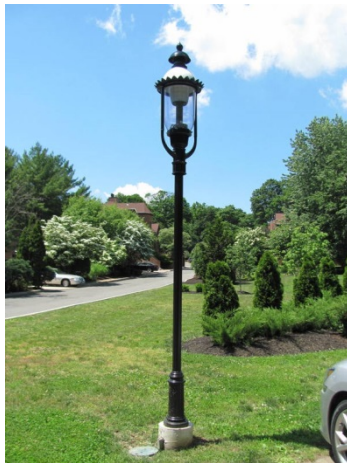
Light Poles and Fixtures - The Association uses three metal light fixtures atop metal poles and four bollard light fixtures to illuminate the property. These elements were replaced in 2015, are in good condition and have useful lives of 20- to 25-years.

Light pole and fixture

The Association should anticipate the need for replacement by 2038. We note this information on Line Item 4.560 of *Reserve Expenditures*.

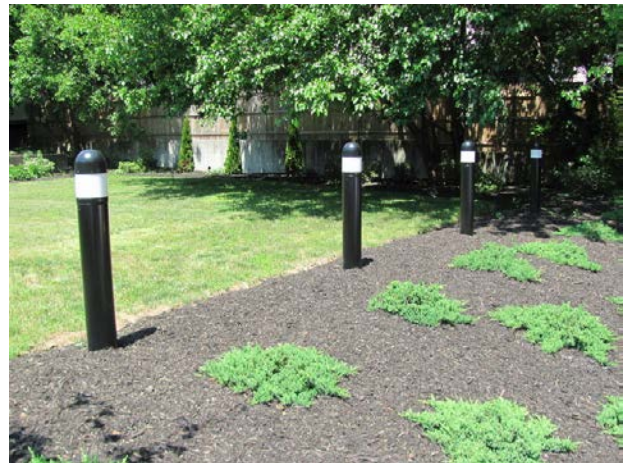
Bollard light fixtures

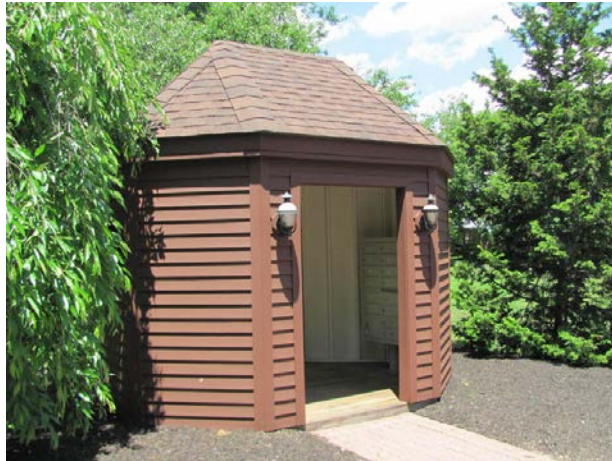
Mailbox Stations and Shelter Renovation - The Association maintains two metal mailbox stations at one shelter that contain the 26 individual mailboxes. The mailbox stations and shelter were replaced in 2008, are in good condition and have a useful life of up to 25 years.

Mailbox shelter

The Association should anticipate renovations of the shelter in conjunction with replacement of the mailbox stations. These renovations may include replacement of the asphalt shingle roof, and partial replacement of the wood siding and deck. 3300 Park Avenue should also budget for replacement of the mailbox stations by 2030. We depict this information on Line Item 4.600 of *Reserve Expenditures*. The Association should verify the new mailboxes meet the specifications of the *United States Postal Service*. The Association should budget for interim repairs and paint finishes through the operating budget.

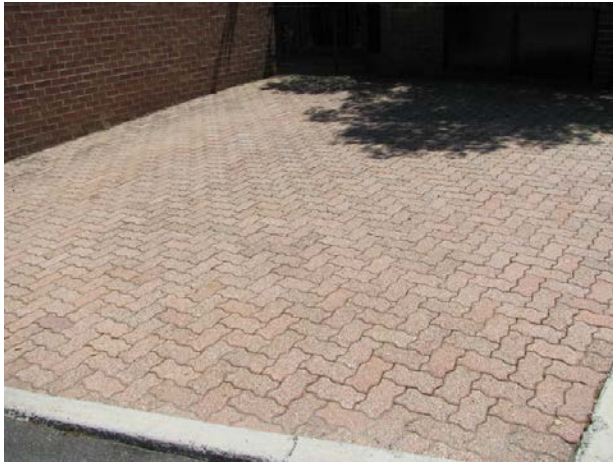
Pavers, Masonry - The front entrance walkways and parking areas utilize approximately 16,500 square feet of interlocking herringbone pattern masonry pavers. This quantity excludes the pool deck which is included on a separate line item. This quantity also excludes the rear patios which are maintained by homeowners. The pavers vary significant in age and condition. The Association historically completes partial resetting and replacements on an as needed basis, and recently completed partial resetting in 2015. We note several areas of settlement and organic growth.

Masonry pavers

Masonry pavers have a long functional useful life. However, over time, the negative effects of inclement weather, erosion, snow removal equipment and vehicle traffic will create isolated areas of deterioration. We advise the Association budget for complete resetting of the pavers with partial replacement of up to eighty percent (80%) every 15- to 20-years. We include a phased allowance for this work beginning by 2020 and concluding by 2035. A subsequent phased activity is likely beginning by 2040. We depict this information on Line Item 4.620 of *Reserve Expenditures*. We suggest the Association conduct interim resetting and replacement of minor areas of pavers as normal maintenance, funded from the operating budget.

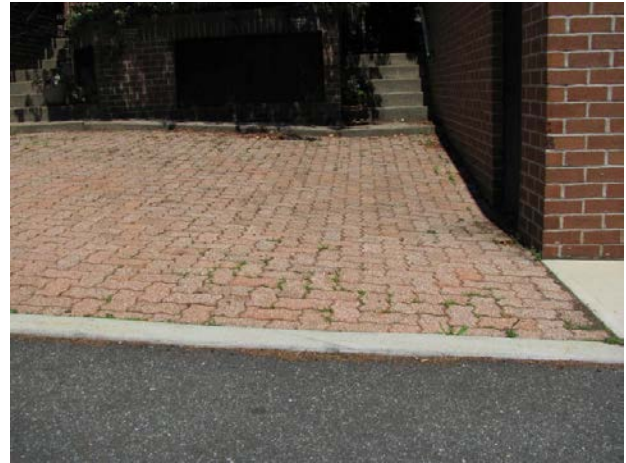
Settlement evident and organic growth at Unit 34

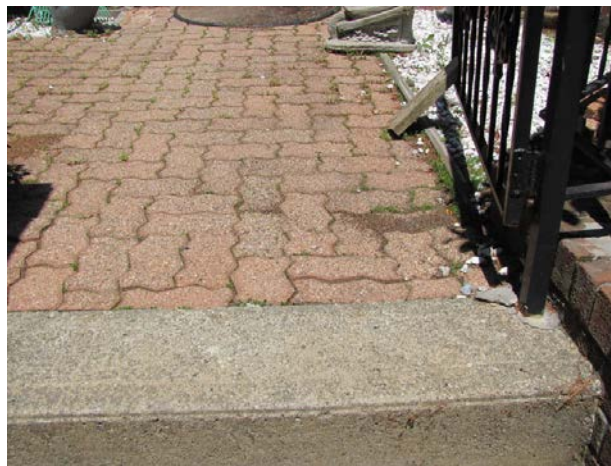
Settlement at walkway

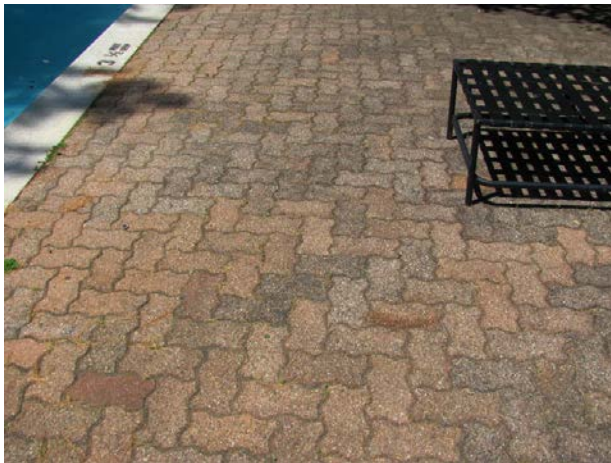
Deck, Pavers - Brick pavers surround the pool and comprise approximately 1,650 square feet. The deck is likely original and in fair condition. The Association completes partial resetting and replacements as needed, and most recently completed partial resetting of the pavers in 2015. We note organic growth and settlement.

Brick pavers

The useful life of deck pavers is 25- to 30-years with the benefit of interim resetting and repairs funded through the operating budget. Inadequate subsurface preparation, poor finishing techniques, soil movement and water infiltration underneath the deck can cause significant settlement and cracks in the pavers. The pool deck should also be free of trip hazards for the safety of residents and their guests. We recommend the Association budget for replacement of the deck pavers by 2021. However, the time and cost may vary. We include this information on Line Item 6.200 of *Reserve Expenditures*.

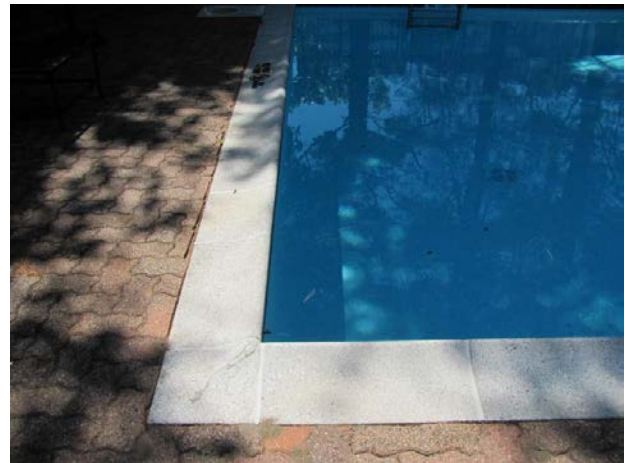
Newer coping

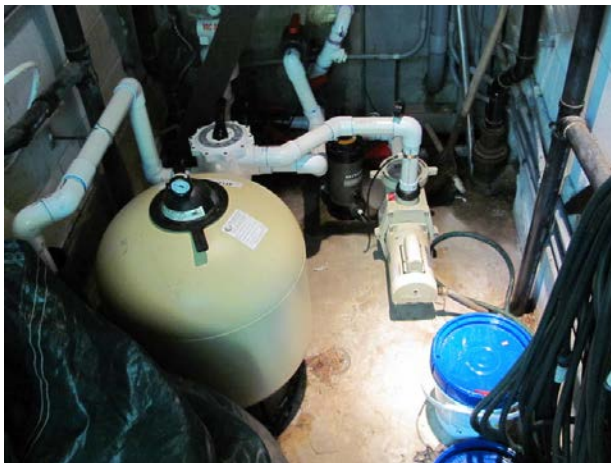
The pool mechanical equipment was replaced in 2016 with the exception of the pool heater replaced in 2011 and they are reported in satisfactory operational condition.

Pool mechanical equipment

Pool mechanical equipment has a useful life of up to 15 years. Failure of the pool mechanical equipment as a single event is unlikely. We recommend the Association anticipate replacement of up to fifty percent (50%) of the pool mechanical equipment by 2024 and by 2029, and every 13 years thereafter. We consider interim replacement of motors and minor repairs as normal maintenance. We note this information on Line Item 6.600 of *Reserve Expenditures*.

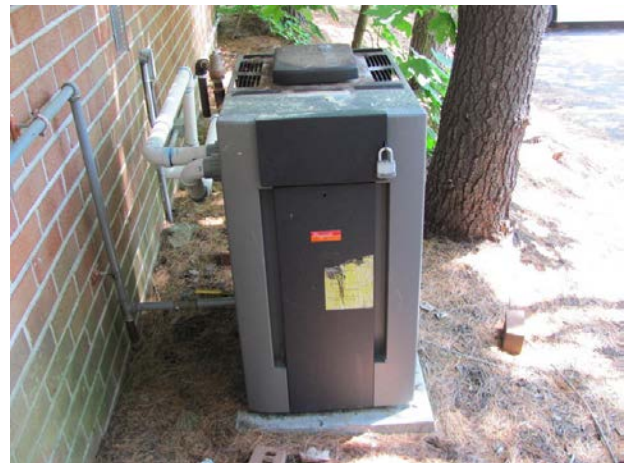
Pool heater

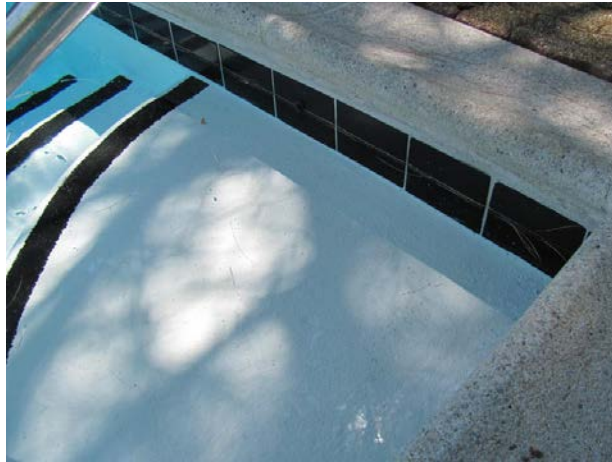
Pool Finish, Plaster - The pool wall and floor surfaces have a plaster finish of 580 square feet based on the horizontal surface area. The Association sand blasted and applied two coats of epoxy paint over the existing plaster finish in 2016. The age of the plaster is unknown.

Pool finish in good condition

This type of pool finish deteriorates with time and requires periodic maintenance and replacement. We recommend the Association anticipate the need to replace the finish and conduct related repairs every 8- to 12-years to maintain the integrity of the pool structure. Removal and replacement provides the opportunity to inspect the pool structure and to allow for partial repairs of the underlying concrete surfaces as needed. We recommend the Association budget for the following by 2022 and every 10 years thereafter except when structure replacement occurs:

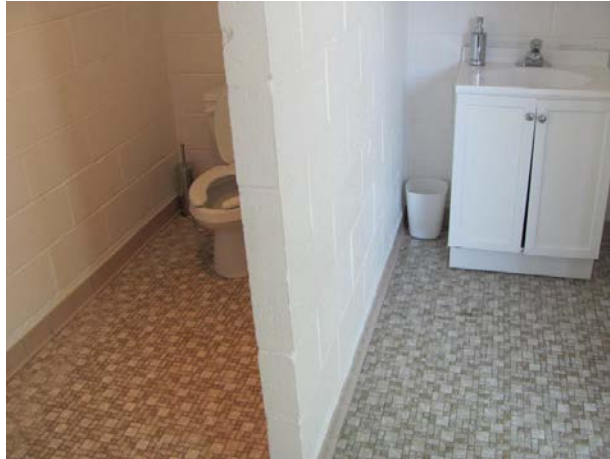
The components vary in age and are in fair overall condition. We note missing tiles.

Rest room

The useful life of rest room components varies up to 25 years. Periodic renovations are an astute practice to maintain a positive overall appearance of the Association. We recommend the Association budget for a renovation by 2020 and again by 2045. We note this information on Line Item 6.811 of *Reserve Expenditures*. The Association should verify the rest room renovations comply with the Americans with Disabilities Act.
