# Property Inspection Report

XXXX Xxxx Street, San Diego 92XXX

Report Number: 15XXXX0319A Xxxx 1881sf 1985 Slab Pool

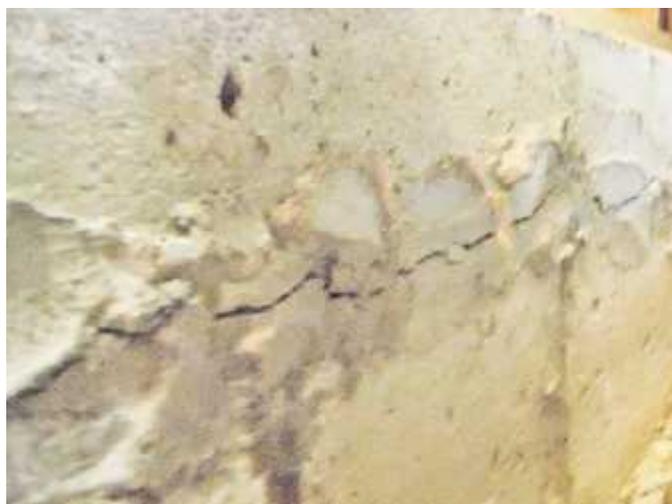
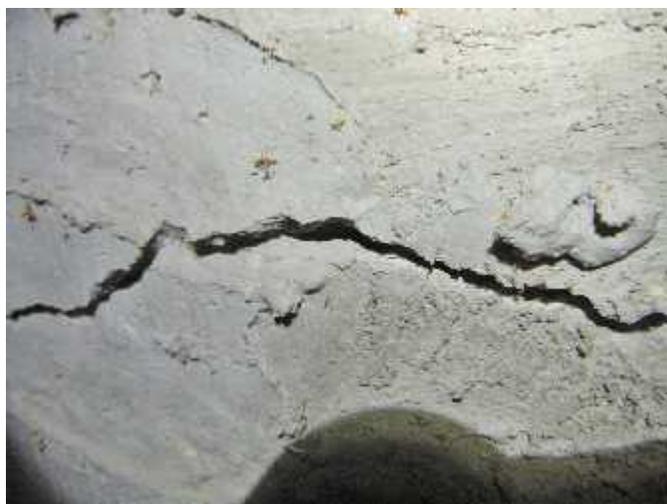
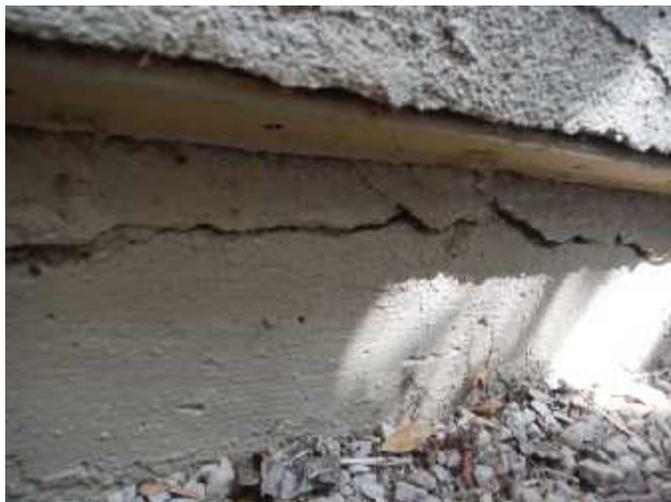
##### *Horizontal Foundation Stemwall Crack with Patch and Cracked Again:*

The south perimeter foundation stemwall was discovered to contain a horizontally crack approximately 6-feet long. The south interior foundation stemwall has been patched from what appears to be a horizontal metal rebar corroded and expanded. The west 6-feet of the horizontal patching has cracked again through the previously patched stemwall material. There is a horizontal crack on the south exterior foundation stemwall that was not previously patched.

\* The reoccurring horizontal cracking indicates that there has been movement under the previous patching consistent with metal horizontal metal support (rebar) continuing to corrode and expand. The horizontal cracking that has not been patched, and cracking through the patching material on the foundation stemwalls will allow moisture in through the cracks and in contact with the stemwall interior metal support is a **NOT FUNCTIONING PROPERLY – MATERIAL DEFECT CONDITION.**

*Recommend Further Evaluation Before Removal of Pre-Purchase Investigative Contingency:* It is recommended that a qualified and experienced Foundation Contractor specializing in foundation repairs should provide a cost estimate for removing all damaged patching material on the foundation stemwall exposing the length of

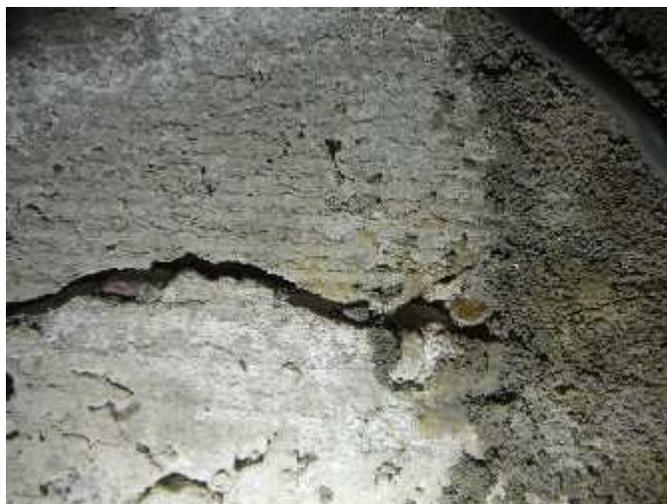
The north wing of the kitchenette popout walls has a horizontal crack. This area of the kitchenette popout section of the east perimeter foundation and building wall was not previously patched.

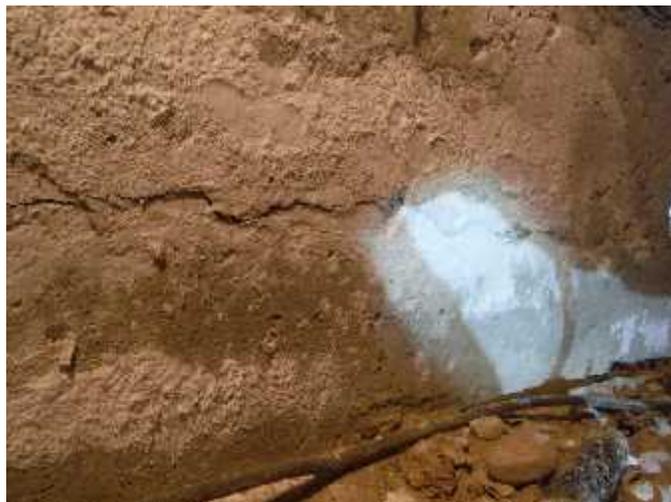
The south foundation stemwall east of the subarea crawlspace entry contains a horizontal crack that was not previously patched or repaired but is now cracked.

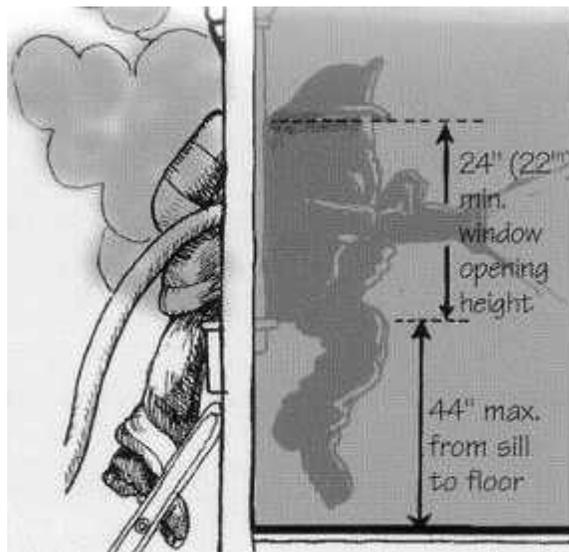
### ***Upper Bedroom Egress Window Latch Too High:***

There are two latches installed in the master bedroom, the upstairs southwest bedroom, the upstairs northwest bedroom, and the downstairs bedroom sliding egress (emergency exit and rescue) windows to provide more security and a tighter seal when the window is latched closed.

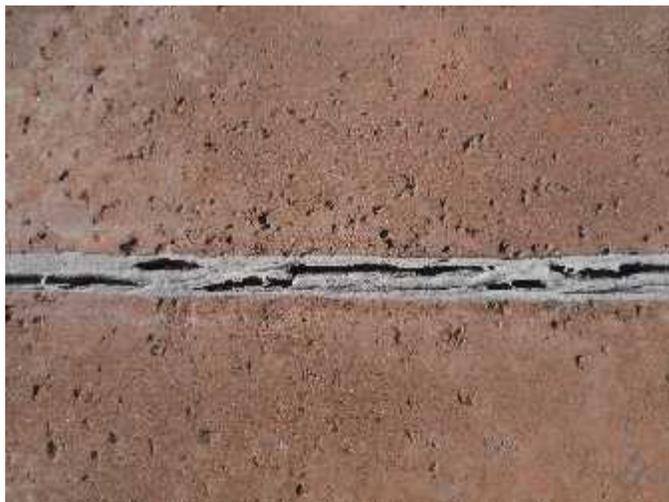
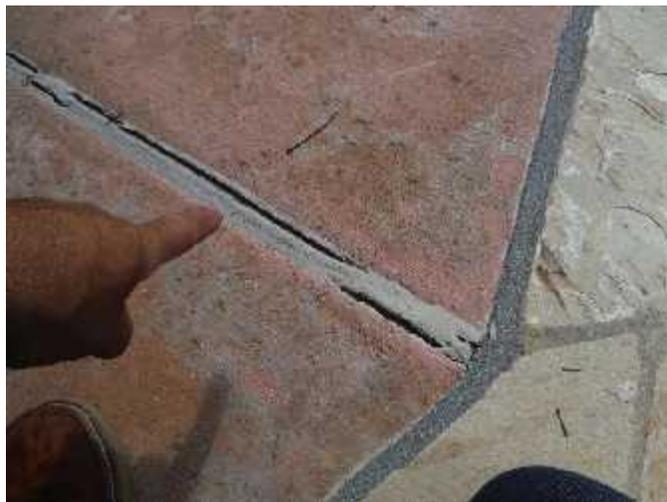
\* The separating and deteriorated elastomeric sealant between sections of the pool / spa surrounding concrete decking will allow moisture under the concrete decking which can cause the soil to expand eventually pushing the concrete decking upward. The separating and deteriorated elastomeric sealant is a patent **END OF SERVICE LIFE CONDITION**.

**Recommendation:** It is recommended that a qualified and experienced Exterior Coating Specialist Contractor remove and then reapply new elastomeric sealant between the sections of the pool and spa perimeter poured-in-place concrete flatwork decking.

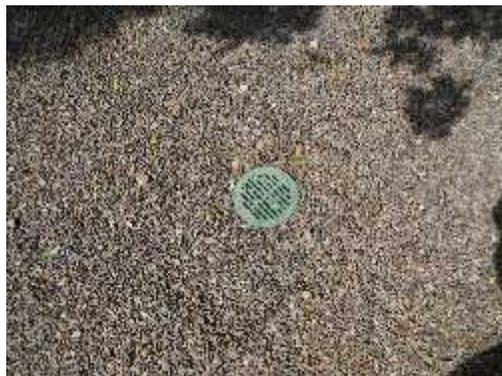
***Landing Drain Opening Observed but the Interior Condition and Termination are Not Accessible and Unknown:***

There is what appears to be a drain opening at the landing outside the garage west exterior door. The drain opening is missing in cover and no termination could be discovered for any drain piping from the exterior door landing.

\* Empirically, exterior surface drain piping eventually clogs with debris and roots seeking water and do not function as expected. It is beyond the capacity of Asset Inspection & Consulting Services during a Property Inspection to test or verify the continuity or fouling of the subterranean drain piping that is connected to the surface drain openings and the interior condition or proper function of the subterranean drainage system is an **UNKNOWN CONDITION AND DEFERRED**.

**Recommendations:** It is recommended that the Seller be requested to disclose the history of the subterranean drain piping and surface drain

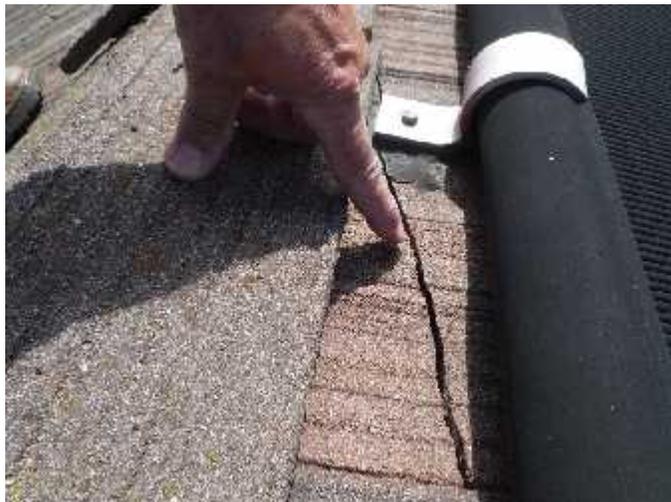
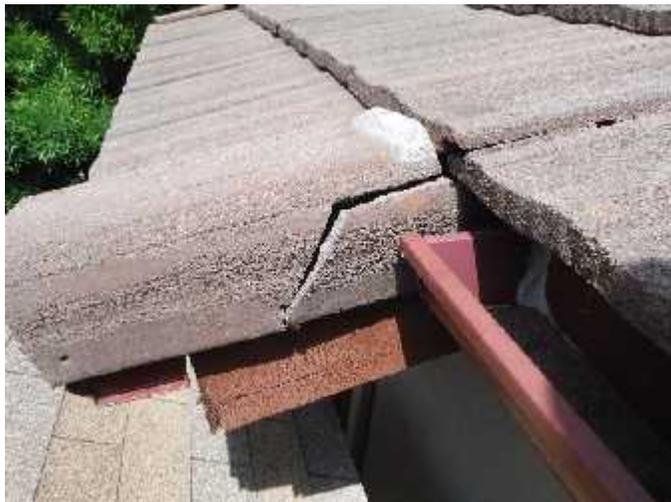
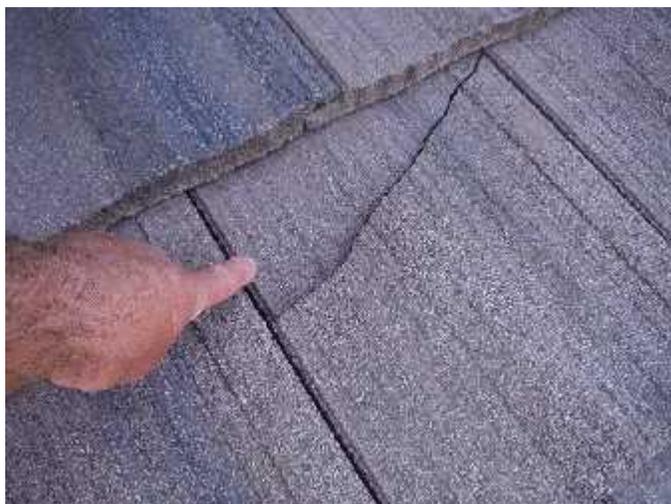
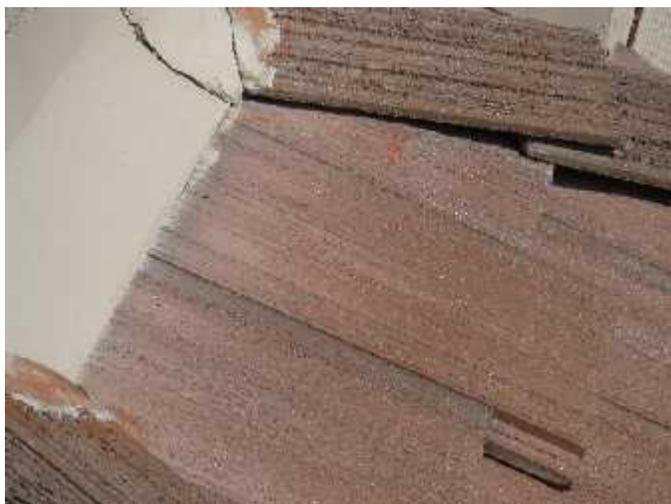
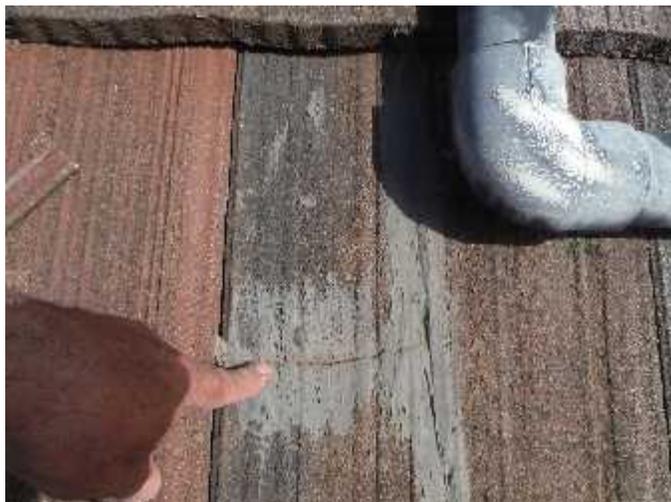
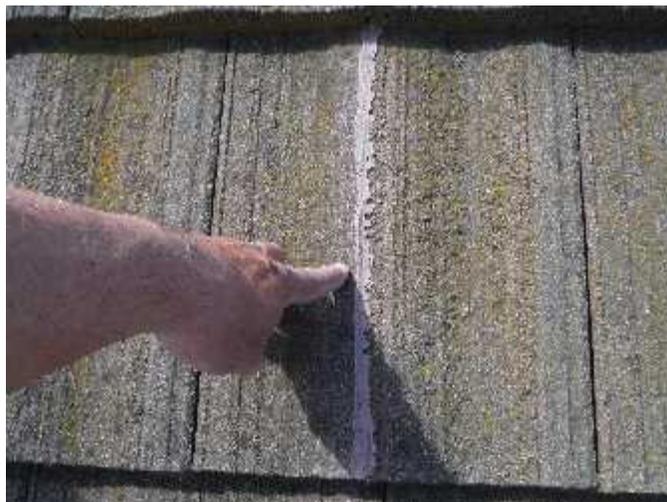
*Multiple Broken Tiles and Multiple Broken Tiles that has been Glued Together and Slipped Tiles:*

There are multiple broken concrete roof tiles on the south roof slope and on the garage roof slope. There are also roof tiles on the north and south slopes that were observed to have been glued together after having been broken completely across the face of the concrete tile. And on the east lower slope there is a roof tile that is displaced and slipping down the roof slope.

\* Minimum building standards find that roof tiles that are cracked or broken completely across the face of the tile in either direction shall be replaced. The gluing together of a broken (completely across the face of the tile) concrete roof tile is prohibited by building standards. Slipped roof tiles will continue to displace below the row of tiles and eventual expose the paper underlayment. The broken, glued together, and displaced tiles are a patent **NOT FUNCTIONING PROPERLY CONDITION**.

**Recommendation:** It is recommended that a qualified and experienced C-39 Roofing Contractor examine all roof slopes for displaced tiles, broken tiles, glue together tiles, and all penetration flashings to provide a cost estimate for all repairs discovered.

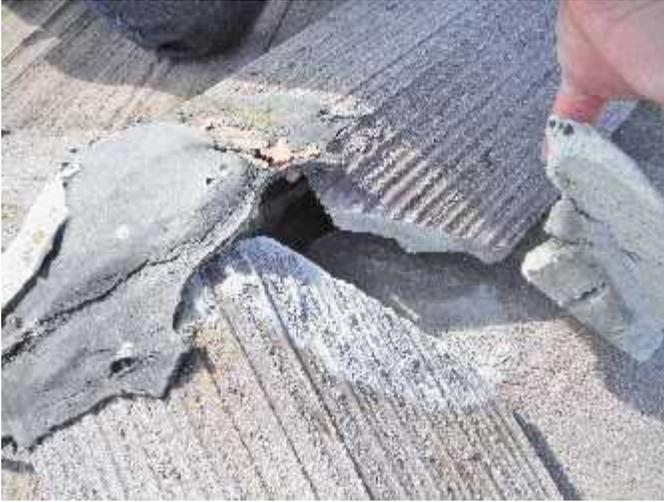
\* The deteriorated mortar on the end of the roof ridge is allowing moisture under the tile roof covering and onto wood the tile was meant to protect. The deteriorated ridge end mortar is an **END OF SERVICE LIFE CONDITION**.

**Recommendation:** It is recommended that a qualified and experienced C-39 Roofing Contractor replace the mortar with ridge tiles meant for the configuration or replace the deteriorated mortar with fresh mortar. The ridge end mortar should be examined every 3 to 5 years for any separation between the concrete mortar and the concrete tile roof members.

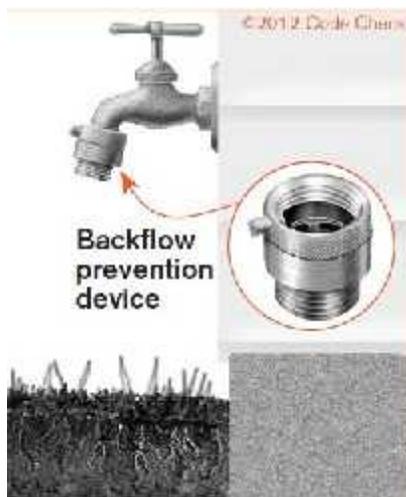
\* Modern safety standards require anti-siphon protection to be installed on all hose bib faucets to prevent cross-contamination of the potable water supply with water from attached hoses, and the lack of exterior hose bib faucet anti-siphon protection for the hose bib faucets does not meet minimum building standards, and is a potential **SAFETY HAZARD CONDITION**.

**Recommendation:** It is recommended that Maintenance Personnel attach hose bib faucet anti-siphon devices on all hose bib faucets before attaching a garden hose.

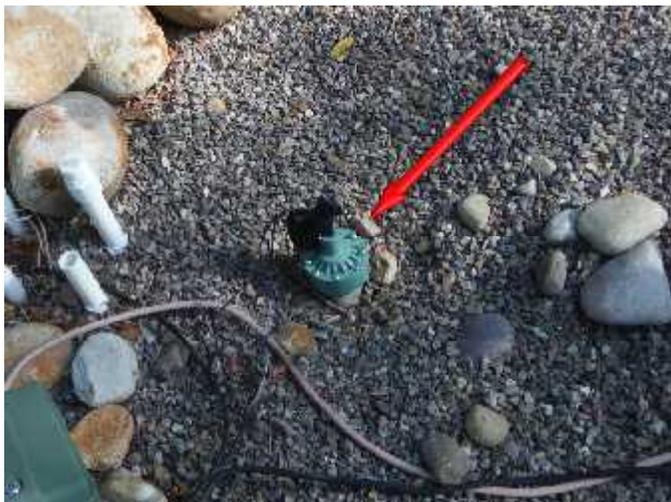
***Sprinkler Valve without Anti-Siphon Protection:***

The sprinkler water supply control valve located on the northeast rear yard is without protection to prevent irrigated water from back-siphoning into the potable water system of the dwelling either by an airgap separation, back-siphoning device or an anti-siphon valve.

\* The lack of back-siphoning protection for the sprinkler control valve does not meet minimum safety standards and is a **SAFETY HAZARD CONDITION**.

**Recommendation:** It is recommended that a qualified and experienced C-36 Plumbing Contractor familiar with the required anti-siphon protection for sprinkler control valves should install back-siphoning device for the sprinkler control valve.

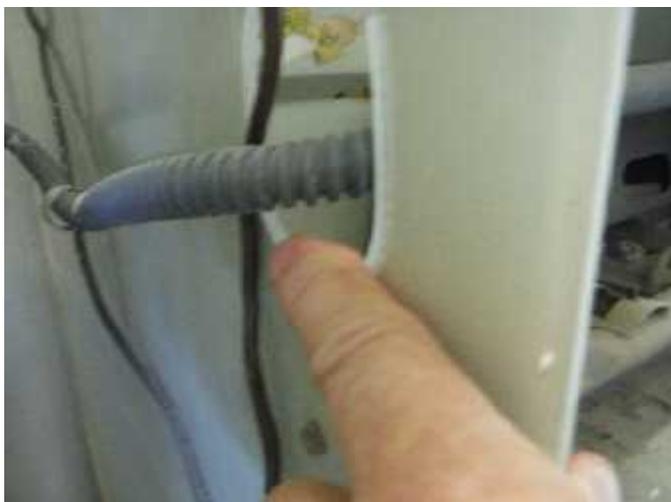
### *Flexible Gas Connector Passes through the Sidewall of the Furnace Appliance Metal Housing:*

The furnace flexible gas connector has been installed passing through the left sidewall of the furnace appliance. The flexible gas connector is not a modern, safe stainless-steel gas flex connector.

\* During the operation of the furnace the furnace fan will vibrate the furnace and the metal edge of the furnace appliance sidewall could rub against the flexible gas connector which could damage and rupture the gas flex connector. During a seismic event the movement of the furnace could rupture the flexible gas connector spilling gas into the interior of the dwelling. Minimum building standards prohibit a flexible gas connector from passing through the sidewall of an appliance and the existing configuration is a **SAFETY HAZARD CONDITION**.

**Recommendation:** It is recommended that a qualified and experienced C-36 Plumbing Contractor replace the existing gas flex connector for the central furnace with a

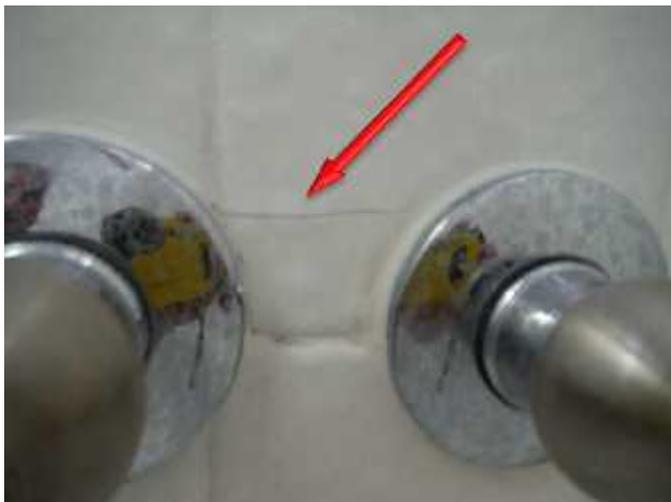
##### ***Cracked Tile within Shower Enclosure:***

The master bathroom shower enclosure has a cracked tile on the north wall between the shower valve handles.

\* The purpose of the ceramic tile is to keep water out of the substrate inside the shower enclosure walls. The cracked shower enclosure tile could begin to allow moisture to get under the tile enclosure and is a **NOT FUNCTIONING PROPERLY CONDITION**.

**Recommendation:** It is recommended that a qualified and experienced C-54 Tile Contractor evaluate the cracked tile within the shower enclosure to determine if moisture is migrating through the cracked ceramic tile and provide a cost estimate for replacing the tiles as necessary.

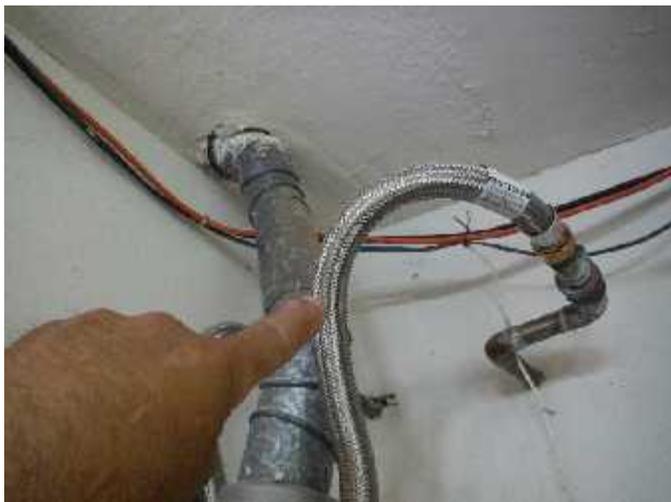
***Water Heater Hot and Cold Water Lines are Not Insulated:***

The water heater hot and cold water pipes and connectors are not insulated within 15-inches of water heater.

\* The lack of insulation on the hot and cold water lines allows heat to dissipate directly from the warmer upper portion of the tank lowering the efficiency of the heated water. The lack of insulation on the water heater water lines, as required by the manufacturer and minimum building standards, is a patent **NOT FUNCTIONING PROPERLY CONDITION**.

**Recommendation:** It is recommended that Maintenance Personnel install tubular insulation around the hot and cold water lines within 15-inches of the water heater tank as required by the manufacturer’s installation instructions and minimum building standards.

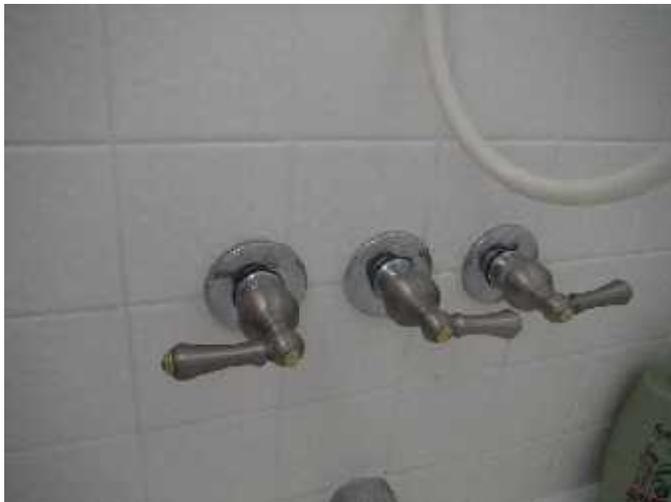
### *Shower 3-Handled Valves:*

Consistent with the era of construction the master bathroom and the downstairs shower faucet valves are 3-handled valve (hot and cold with shower diverter) configurations.

\* The 3-handled shower faucet valves do not offer single-valve thermal protection like modern single-stem faucets offer and is an **END OF SERVICE LIFE CONDITION**.

**Recommendation:** It is recommended that a qualified and experienced C-36 Plumbing Contractor specializing in the replacement of 3-handled shower faucet valves provide a cost estimate for replacing both 3-handled bathtub / shower faucet valves with modern, thermally-controlled and pressure-balanced, single-stem shower valves, including any repairs to the shower enclosure walls and all proper shower enclosure trim plates.

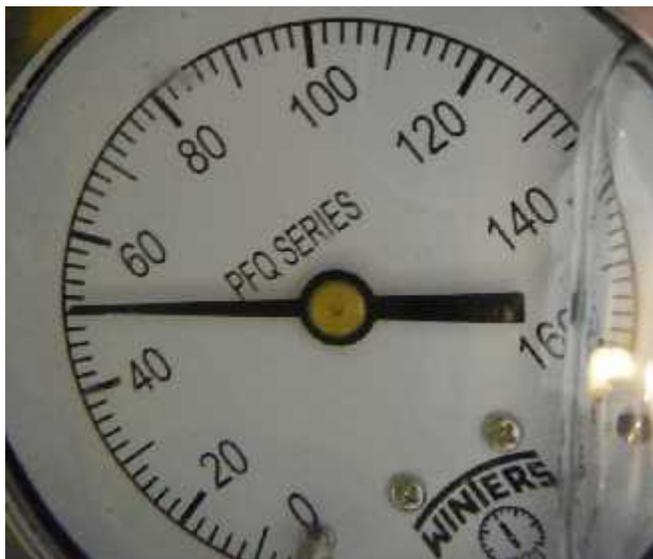
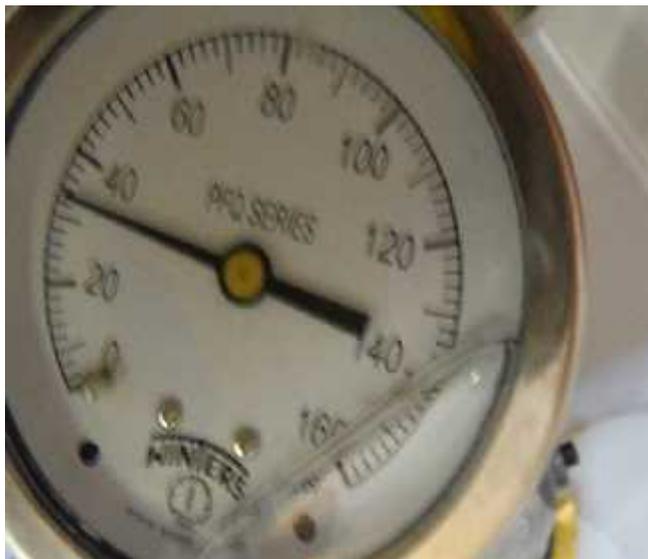
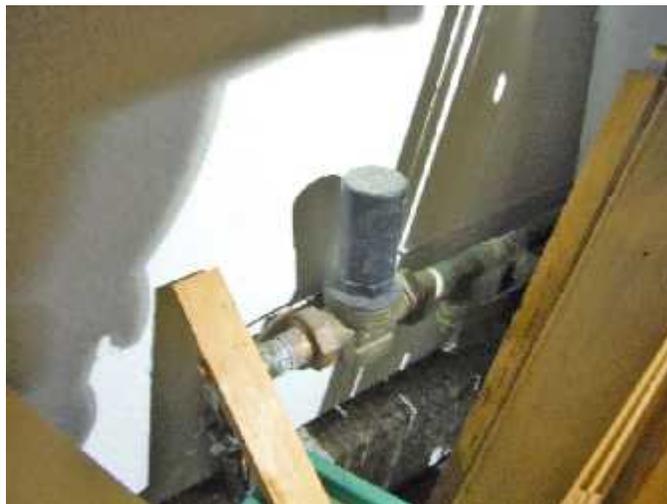
### *Significant Water Pressure Drop when One Faucet is Turned On and Volume Drop with Multiple Fixtures Turned On:*

The water pipe supply pressure was 51-psig. When one sink fixture was turned on the water pressure dropped from 51-psig to 33-psig. When all water fixtures were on there was a significant reduction in water volume observed at the fixtures.

\* The water supply volume reduction with multiple faucets on, and the water pressure drop with only one faucet turned on indicates that the pressure regulator is not opening adequately when there is a demand for more volume as the regulator is designed to function. With the water volume drop with multiple fixtures on and the significant water pressure drop in the pressure regulator when one faucet is turned on is the pressure regulator device nearing an **END OF SERVICE LIFE CONDITION**.

**Recommendation:** It is recommended that a qualified and experienced C-36 Plumbing Contractor replace the existing water pressure regular when the existing pressure regulator fails with excessive water pressure or the general use of multiple faucets indicate a substantial reduction in water volume.

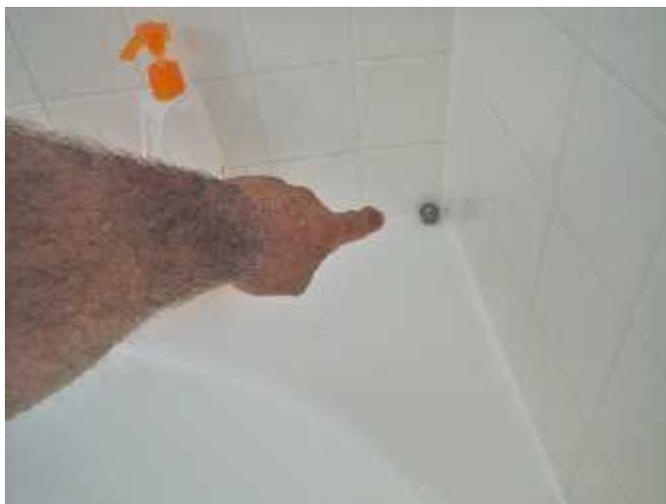
### *Bathtub Rim not Sloped Properly to Drain into Tub Vessel:*

The master bathroom and downstairs hallway bathroom bathtub rims do not slope properly to drain into the bathtub vessel allowing shower water to stand on the bathtub rim where it intersects with the shower enclosure walls.

\* With water sitting on the bathtub rim there is potential for moisture to migrate under the shower enclosure walls and come in contact with the wall materials behind the shower enclosure walls. The improperly sloped bathtub rim does not meet minimum installation requirements for draining all shower spray to the bathtub vessel drain and is a **MAINTENANCE DEFICIENCY CONDITION**.

**Recommendations:** It is recommended that Maintenance Personnel remove all deteriorated grouting material, clear loose debris from the joint between the bathtub rim and the bottom edge of the shower enclosure walls, and then apply new matching grout.

-> It is recommended that Maintenance Personnel maintain the grouting at the bathtub rim to shower enclosure wall connections and wipe any standing water off the bathtub rim after use to control corrosion to the bathtub rim surface and moisture intrusion behind the shower enclosure walls.

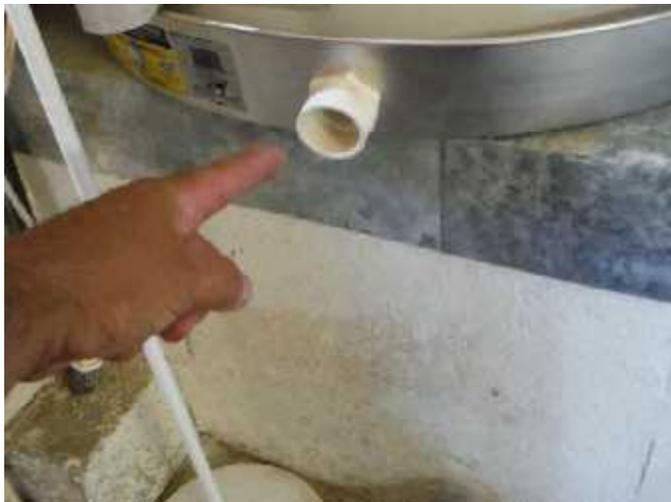
### *Water Heater Drain Pan is Not Piped Away from the Drywall Base Stand:*

The water heater drain pan is not piped away from drywall base stand allowing water draining out of the pan to saturate the lower drywall material.

\* The lack of a drain piping extending down to the garage floor and away from the drywall covered water heater stand is a **MAINTENANCE DEFICIENCY CONDITION**.

**Recommendation:** It is recommended that Maintenance Personnel extend the drain piping to the garage floor with a 90-degree elbow install at the bottom end aimed so that any water would flow away from the water heater drywall stand.

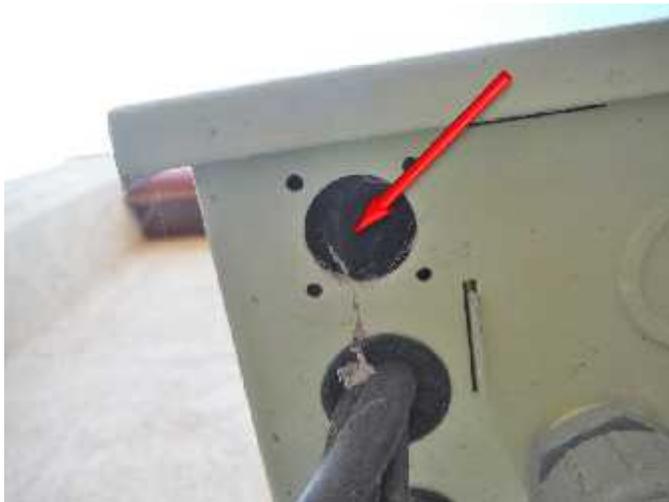
\* The open knockout in the bottom of the accessible electrical panel box can allow access into the inner electrical panel components which are electrically energized and could be inadvertently accessed by someone interfacing with the electrical panel. The open knockout in the electrical panel exterior box does not meet minimum safety requirements and is a patent **SAFETY HAZARD CONDITION**.

**Recommendation:** It is recommended that a qualified and experienced C-10-Electrical Contractor close the unused opening in the pool equipment electrical panel box equivalent to the original knockout.

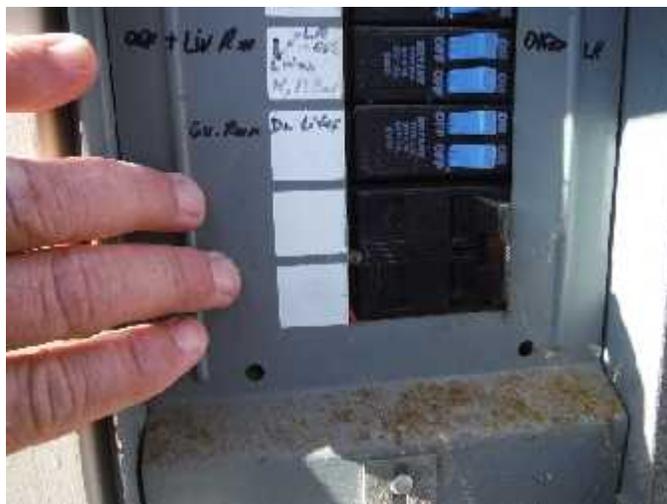
### *Circuits in Main Electrical Panel are Not All Labeled for Identification:*

The main electrical panel circuits are not all permanently marked labeling each circuit's use from all other circuits in the panel.

\* The lack of labeling for each circuit's use will inhibit repair and emergency access when shutting off a specific electrical circuit. The lack of labeling for each electrical circuit's use does not meet minimum modern building and safety standards, and is a patent **SAFETY HAZARD CONDITION**.

**Recommendation:** It is recommended that a qualified and experienced C-10-Electrical Contractor evaluate each circuit in the main electrical panel and permanently label each circuit's use from all other circuits in the electrical panel.

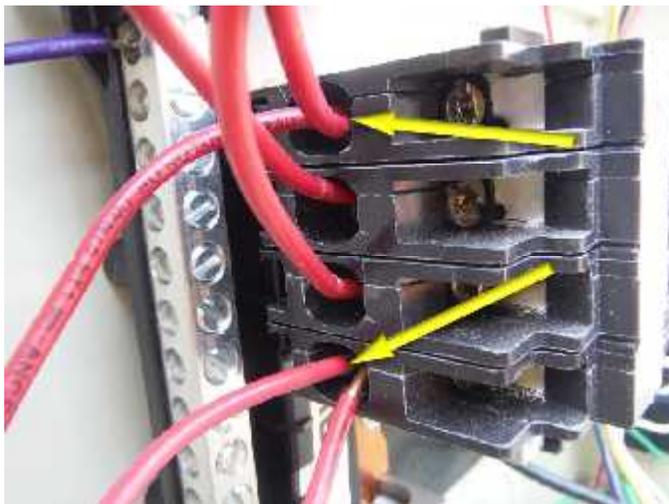
circuit breaker.

\* The circuit breakers are not listed for multiple wire connections and are not constructed to evenly clamp down on both wires creating a separation between the improperly added second circuit wire and the breaker connecting clamp where electricity would have to arch over the separation in the wire connection to complete the circuit. The potential arching of electricity in the loose connection from the added circuit wire can overheat the breaker connection and cause fires. The two circuit wires in the single circuit breaker lug screw is a **SAFETY HAZARD CONDITION**.

**Recommendation:** It is recommended that a qualified and experienced C-10-Electrical Contractor provide for a single connection for each circuit wire connected to their

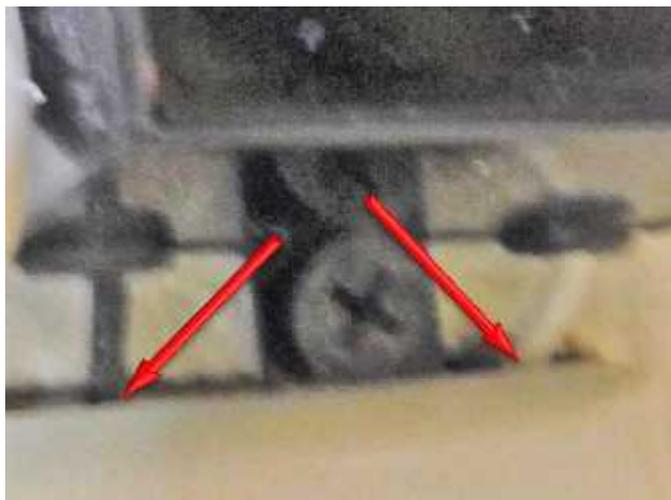
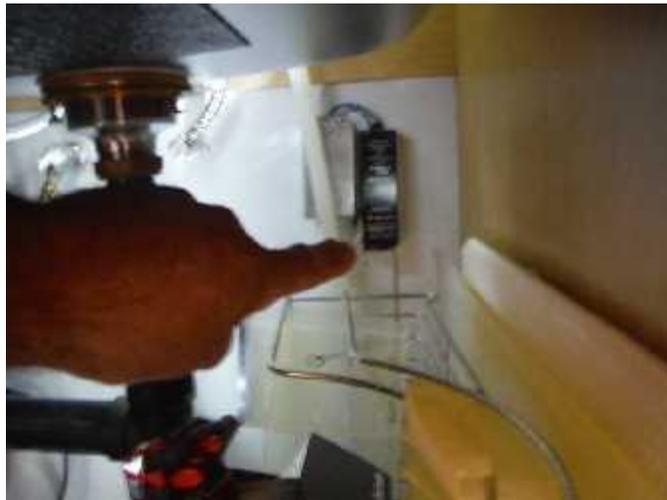
\* Electrical conductors are required to be enclosed in sheathing or conduit for the protection of the wire insulation. The exposed conductors feeding the lighting transformer should have been run in a cord or conduit protection until into the transformer body, does not meet minimum safety standards and is a **SAFETY HAZARD CONDITION**.

**Recommendation:** It is recommended that a qualified and experienced C-10 Electrical Contractor reconnect the lighting transformer supply wiring through a cord or conduit from junction-box cover.

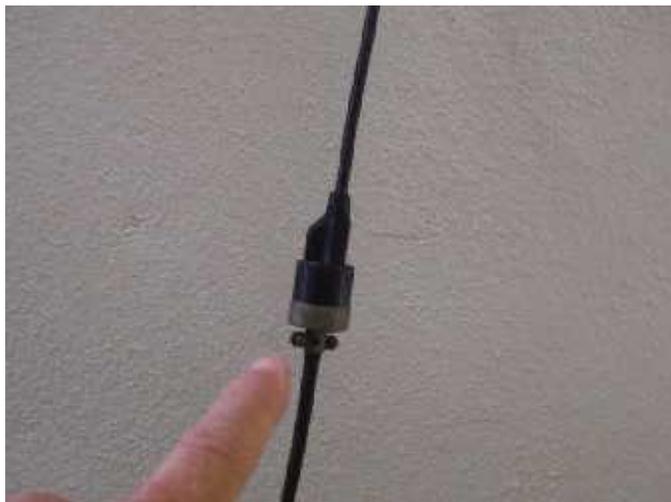
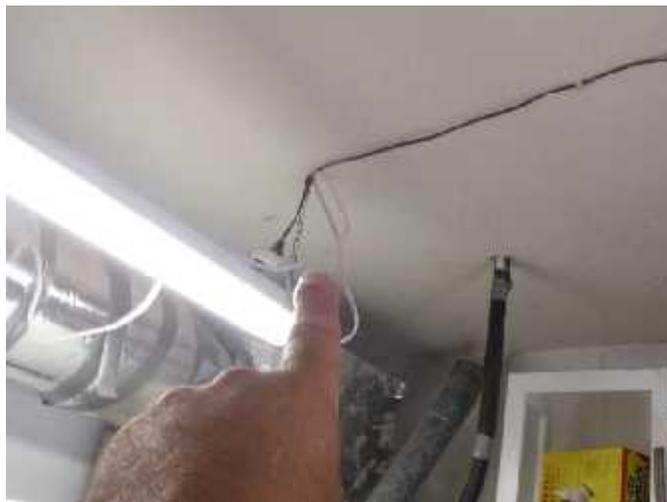
### *Extension Cords Being Used for Permanent Wiring:*

There is an extension cord being used as permanent wiring for the garage door opener. There is another extension cord are being used for permanent wiring of the garage interior lights.

\* The use of extension cords for permanent wiring does not meet minimum building standards because the wiring within the extension cord is smaller than the house wiring which can increase the temperature of the extension wiring with potentially horrific event. The use of extension cords is for intermittent use only and not for permanent wiring. The use of extension cords for permanent wiring is a **SAFETY HAZARD CONDITION**.

**Recommendation:** It is recommended that a qualified and experienced C-10 Electrical Contractor remove all extension cords being used as permanent wiring and install properly sized and connected circuit wiring for the garage lights and garage door opener.

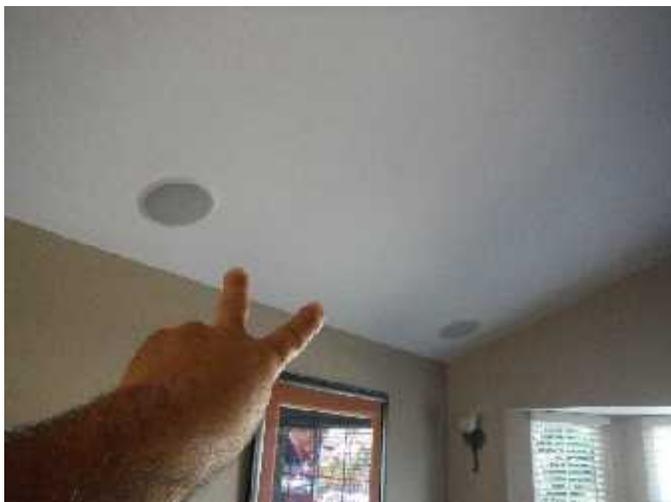
**Speakers for Sound System Observed and Not Examined:**

Speakers for a sound system have been installed in the living room ceiling.

\* The speakers and any sound system were not tested or operated by Asset Inspection & Consulting Services who has no knowledge concerning sound systems. The interior speakers are an **UNKNOWN CONDITION AND DEFERRED.**

**Recommendations:** It is recommended that the Seller be requested to disclose the operation of the music speakers, the location of the sound system connections, provide all manufacturer operation / installation instructions, and disclose manufacturer warranty periods.

-> If disclosure from the Seller is not forthcoming then it is recommended that the Buyer (Client) contact several Music System vendors to evaluate the existing system

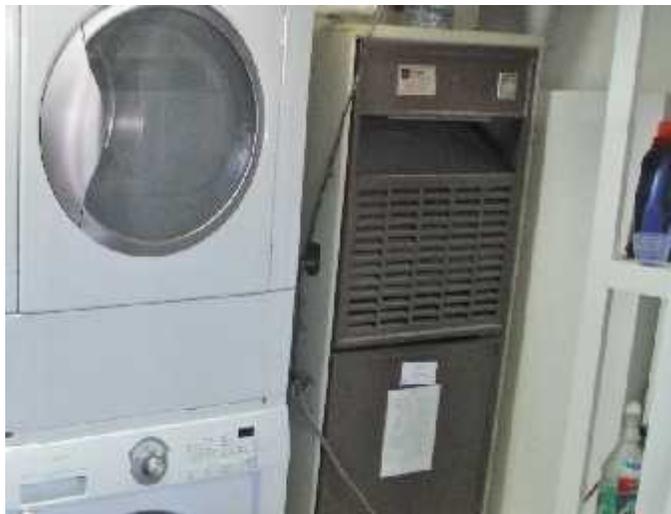
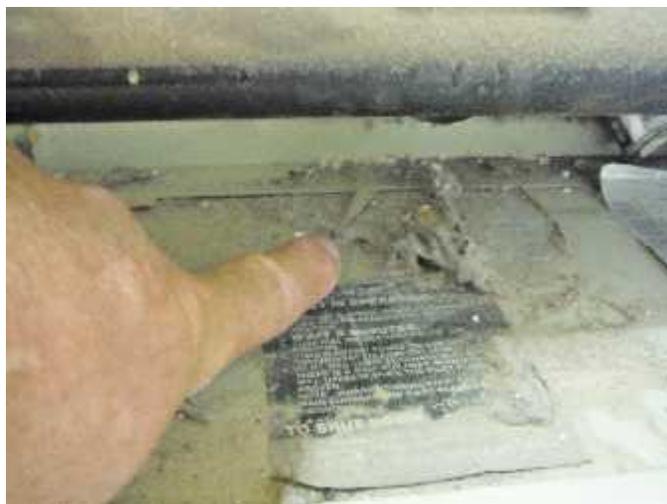
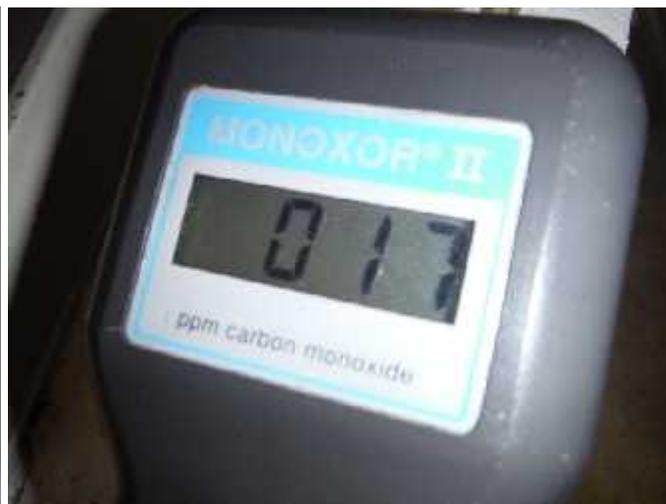
*Furnace is Older and Cannot be Relied Upon to Continue To Function Safely:*

The central forced-air furnace is original, older, has exceeded its expected service life, and even if the furnace was completely serviced and repaired it cannot be relied upon to continue to function safely or operate as intended. The draft diverter was detected with 17 ppm Carbon Monoxide and the burner area was detected with 23 ppm Carbon Monoxide. The furnace interior is very dirty.

\* Consistent with the year the furnace was built the furnace is very inefficient allowing a large percentage of the Btu consumption to escape out the furnace flue. Consistent with the year the furnace was built the furnace appliance components, heat exchanger, gas valve, and limit safety switch, are all past their service life and cannot be relied upon to function safely. The older central forced-air furnace is an **END OF SERVICE LIFE - MATERIAL DEFECT CONDITION**.

*Recommend Further Evaluation Before Removal of Pre-Purchase Investigative Contingency:* It is recommended that a qualified and experienced C-20 HVAC Contractor should be evaluated the entire forced-air furnace system and provide a cost estimate for servicing and for the replacement of the furnace system with a safe, modern, energy efficient furnace prior to the Client's (Buyer) acceptance and removal of pre-purchase investigative contingency time periods as defined in the property purchase agreement.

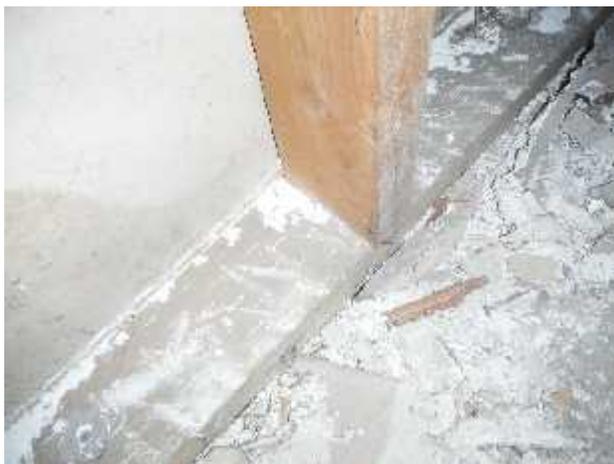
***Open Framing at Return Air Grill Drawing Air From Wall Framing:***

Consistent with the era of construction there are open holes and gaps through the return-air plenum wall framing that are drawing unfiltered and unconditioned air into the central heating and cooling system and then into the living spaces of the dwelling. The return-air plenum is full of debris.

\* Drawing unfiltered air into the forced-air conditioned air stream adds pollutants directly into the interior of the dwelling and the equipment interior heat-exchanger. The open holes and gaps through the return-air wall framing does not meet minimum building and safety standards and is a **NOT FUNCTIONING PROPERLY CONDITION**.

**Recommendation:** It is recommended that a qualified and experienced C-20 HVAC Contractor remove all debris and then properly seal and insulate the return-air ducting located under the furnace spaces to at least minimum building standards.

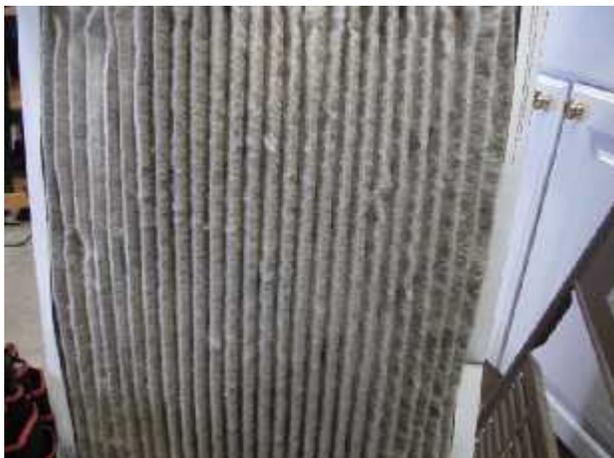
***Conditioned Air-Filter Condition:***

The air-filtration filter for the forced-air handle is located in the fan compartment which is the bottom furnace compartment.

\* The dirty air-filter will inhibit air flow to the furnace heat-exchanger causing the heat-exchanger metal to overheat air filter is an **END OF SERVICE LIFE CONDITION**.

**Recommendation:** It is recommended that Maintenance Personnel replace the air-filter at change of ownership of the property and that the air filter be changed at least twice a year or more often if there are pets in the dwelling, or there is central cooling, or if the home is continuously being occupied throughout the day.

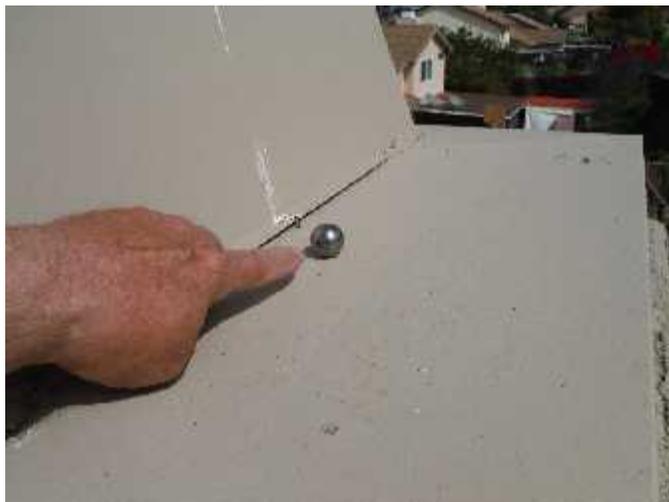
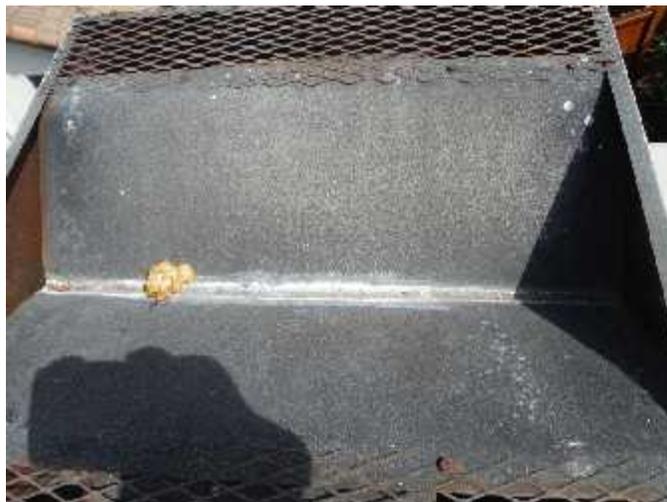
\* Water is held around the flue penetration and eventually will corrode the sheet-metal cap allowing moisture into the chimney chase structure to damage the fireplace components. The improperly sloped chimney termination cap is a **NOT FUNCTIONING PROPERLY CONDITION**.

**Recommendation:** It is recommended that a qualified and experienced Fireplace Contractor specializing in prefabricated fireplaces should correct the improperly sloped chimney termination cap.

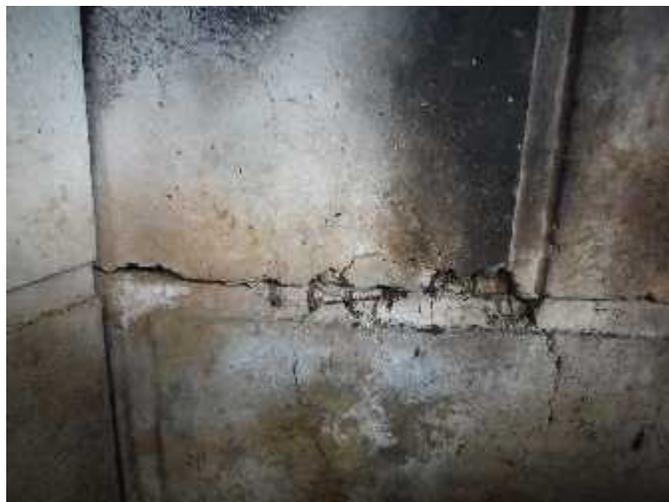
### *Firebox Rear Refractory Plate is Excessively Damaged:*

The firebox rear refractory plate wall for the family room fireplace is cracked horizontally.

\* The cracked refractory plates are no longer functioning as initially intended. The cracked refractory plates are a **NOT FUNCTIONING PROPERLY CONDITION**.

**Recommendations:** It is recommended that a qualified and experienced Fireplace Contractor specializing in prefabricated fireplaces examine the firebox protective refractory plate walls and repair all damaged refractory wall plating.

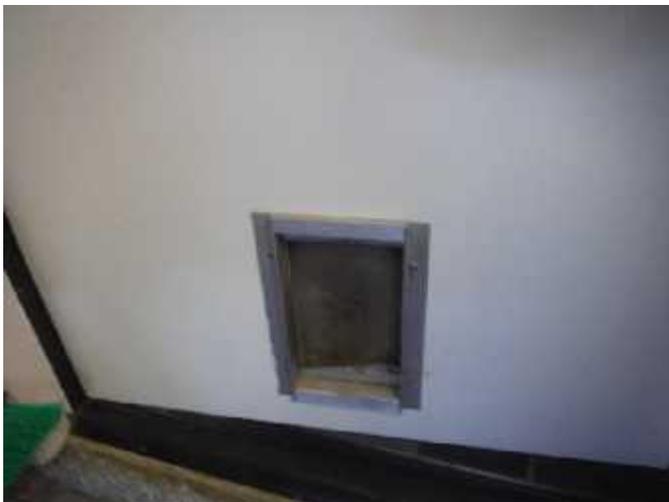
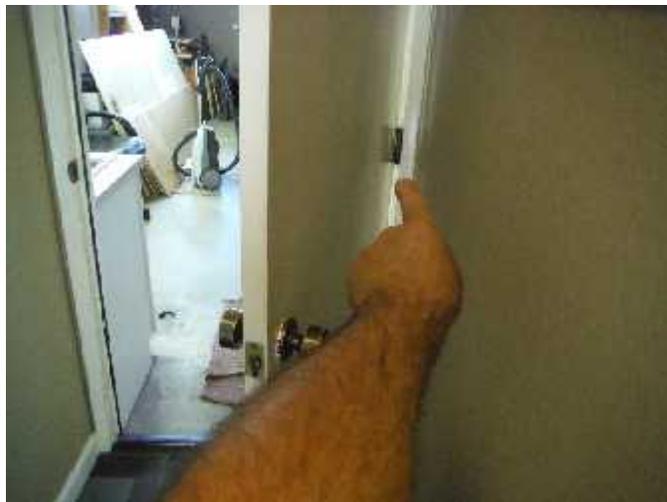
### *Pet-Door Installed in Fire-Rated Door:*

The integrity of the fire-rated door is negated by the pet door installed through the garage to the interior door. The fire-rated door has one self-closing hinge spring that has been disconnected and no longer self-closes and latches shut.

\* The damaged fire-rated door would provide oxygen to a garage interior fire thus spreading the fire into the interior of the dwelling. The modified fire-rated door is a patent **SAFETY HAZARD CONDITION**. The lack of 2-spring hinges required for self-closing and self-latching the fire-rated door between the attached garage and the dwelling interior does not meet minimum safety standards and is a patent **SAFETY HAZARD CONDITION**.

**Recommendation:** It is recommended that a qualified and experienced C-6 Carpentry Contractor specializing in hanging fire-rated doors should replace the existing doors passing through the fire-resistant barrier separation between the dwelling interior and the attached garage with doors that are fire-rated (solid-core 1 3/8-inch door or a honeycomb-core steel door) that self-closes and self-latches when released from any open position.

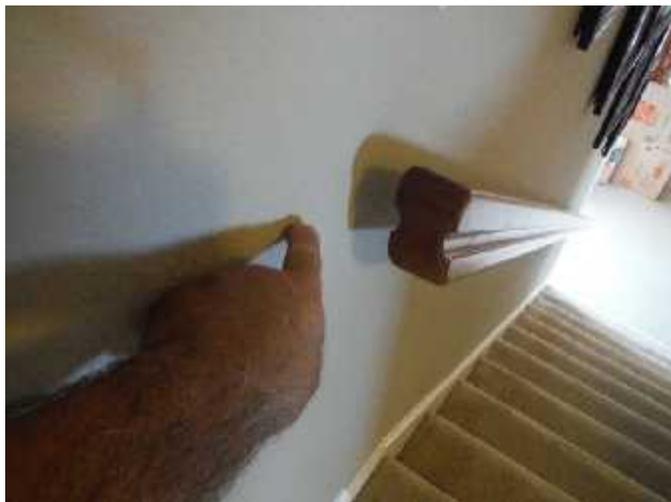
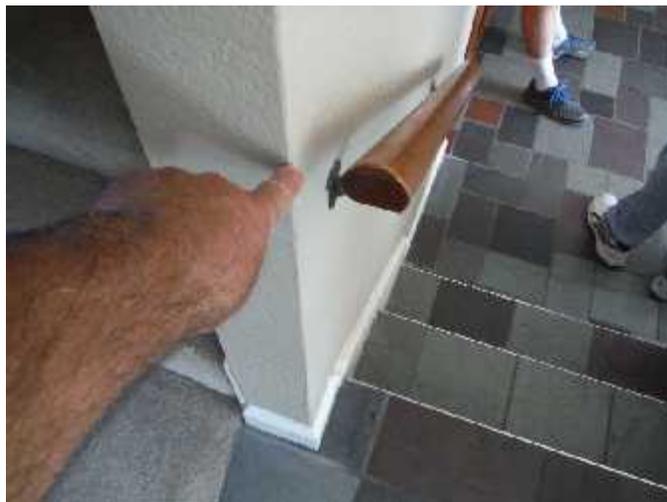
\* With the handrail end projecting outward a sleeve can get caught in the exposed handrail end - causing a trip hazard. The exposed handrail end does not meet minimum safety standards and are a patent **SAFETY HAZARD CONDITION**.

**Recommendation:** It is recommended that a qualified and experienced Carpentry Contractor specializing in stair construction should repair the exposed handrail ends so that they turn back to the wall or newel post.

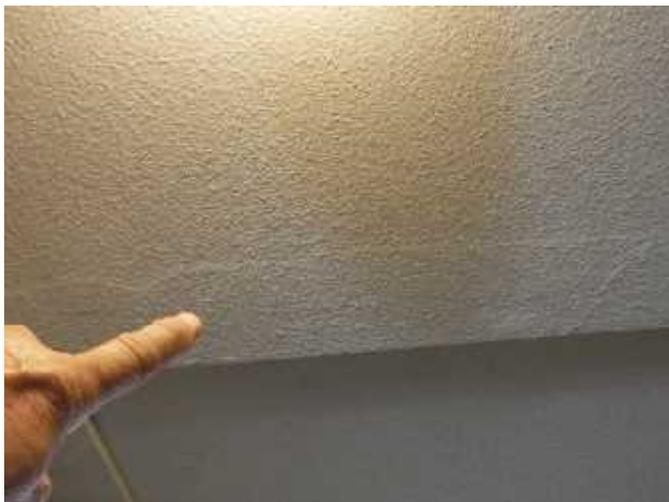
##### ***Substandard Ceiling Patch and Re-Texturing to Attic Access Hatch:***

The upstairs hallway attic access hatch had experienced a repair that included patching the ceiling surface around the attic access hatch. The quality of the ceiling patch is amateurish and without minimum workmanlike standards.

\* The improperly installed interior ceiling patch around the attic access hatch is a **NOT FUNCTIONING PROPERLY CONDITION**.

**Recommendation:** It is recommended that a qualified and experienced D-9 Drywall Contractor properly patch and float the ceiling surface to match the texture of the surrounding ceiling texture.
