# Property Inspection Report

XXXX Xxxx Street, San Diego 92XXX

Report Number: 15XXXX0319A Xxxx 1881sf 1985 Slab Pool

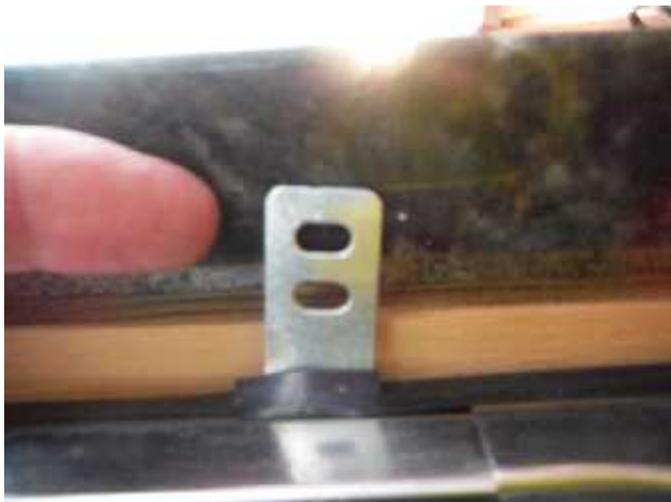
### *Dishwasher Not Connected to Cabinet:*

The built-in dishwasher appliance is not properly or adequately secured to the cabinet structure needed to prevent the dishwasher from tipping forward when weight is applied to the open dishwasher door.

- \* The built-in dishwasher needing to be secured to the cabinet structure is a **NOT FUNCTIONING PROPERLY CONDITION**.

**Recommendation:** It is recommended that Maintenance Personnel properly attach the dishwasher appliance to the kitchen countertop structure so that the dishwasher appliance is fixed in place.

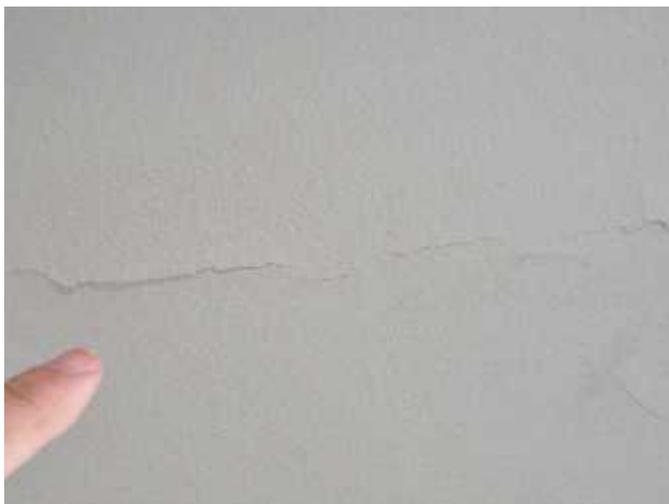
#### ***Ceiling Staining Discovered in Garage Ceiling but Tested Dry:***

Water stains and cracking drywall texture were discovered in the garage ceiling drywall. The moisture staining was tested and tested dry.

\* The lack of confirmation as to the history of the staining in the garage ceiling is an **UNKNOWN CONDITION AND DEFERRED**.

**Recommendation:** It is recommended that the Seller be requested to disclose the history of all roof leak repairs. It is recommended that the Seller be requested to provide documentation concerning insurance claims, dates of repairs performed, and Contractor receipts (with warranty periods) concerning the extent of repair(s), with dates.

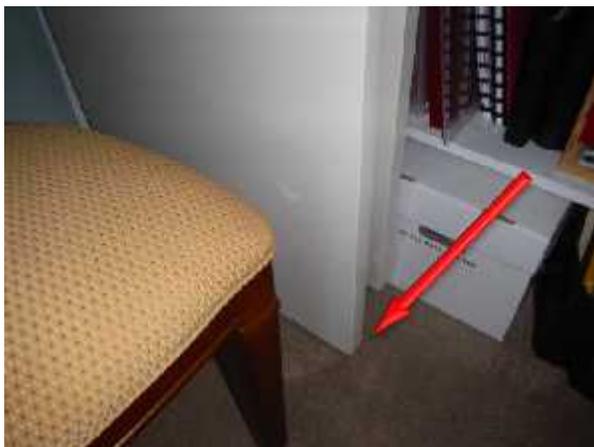
*Closet Door Floor-Guide is Missing:*

The upstairs northwest bedroom closet bypass doors are missing the bottom-rail floor-guide.

\* The lack of functioning floor-guide for bedroom bypass closet doors allows the doors to protrude or bind from swinging outward or inward during their operation and is a **MAINTENANCE DEFICIENCY CONDITION**.

**Recommendation:** It is recommended that Maintenance Personnel install closet by-pass floor-guides for all missing or damaged guides.

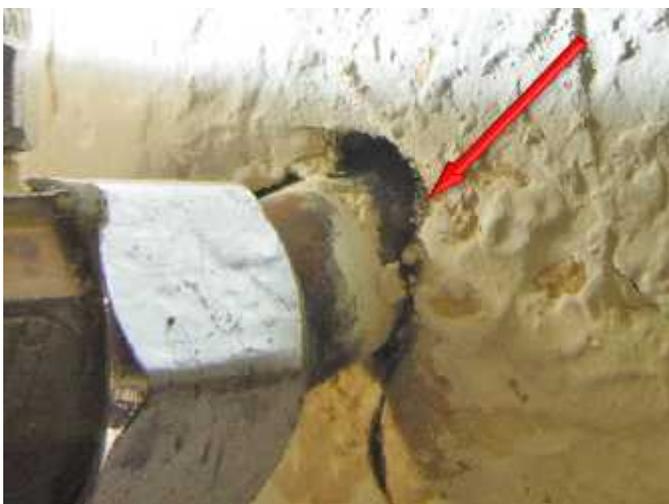
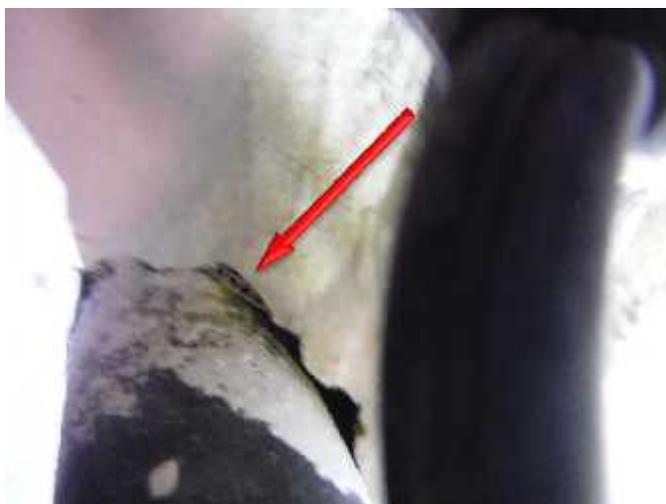
*Gap in Wall around Plumbing Penetrations need Sealing:*

The wall under the master bedroom bathroom left sink and the downstairs wet-bar sink(hot and cold water piping) needs the annular gap around the plumbing penetrations sealed.

\* The open annular gap around wall penetrations under sinks can provide an opening for insect infestation or transfer of air from the interior of the wall space and the interior of the dwelling. The open annular gap around wall penetrations under sinks is a **MAINTENANCE DEFICIENCY CONDITION**.

**Recommendation:** It is recommended that Maintenance Personnel seal all gaps around the plumbing wall penetrations to control insect infestation and any transfer of air from the interior wall space.

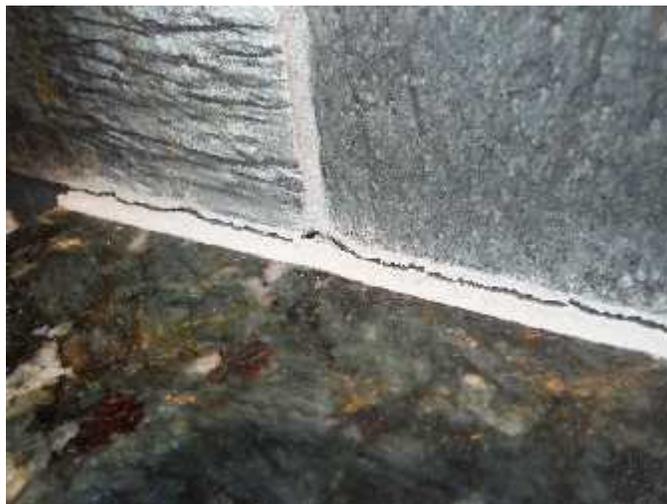
### *Kitchen and Bathroom Countertop Separation Needs Caulking:*

The kitchen countertop, the master bathroom sink countertop, and the upstairs hallway bathroom have separated where the countertop intersects with the countertop backsplash.

\* The open gap can allow moisture behind the countertop surface material into the cabinet / wall substrate which can swell from moisture saturation. The open separation between the bathroom countertop and backsplash material is a **MAINTENANCE DEFICIENCY CONDITION**.

**Recommendation:** It is recommended that Maintenance Personnel remove all loose separated caulking material, clean, and then re-apply caulking to completely seal the separation between the countertop and backsplash surfaces to control moisture intrusion under the countertop materials.

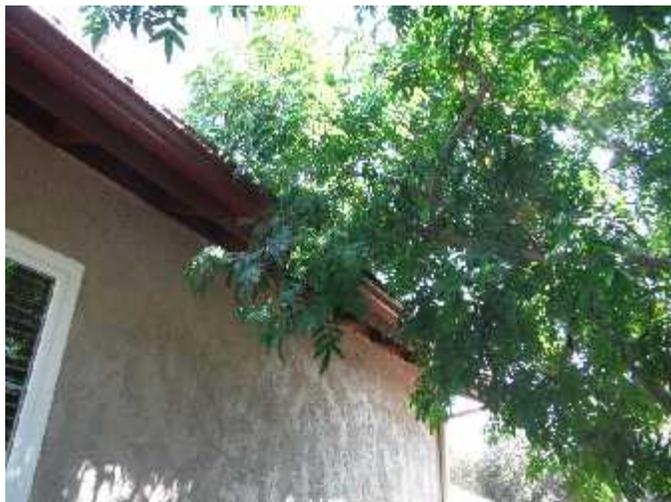
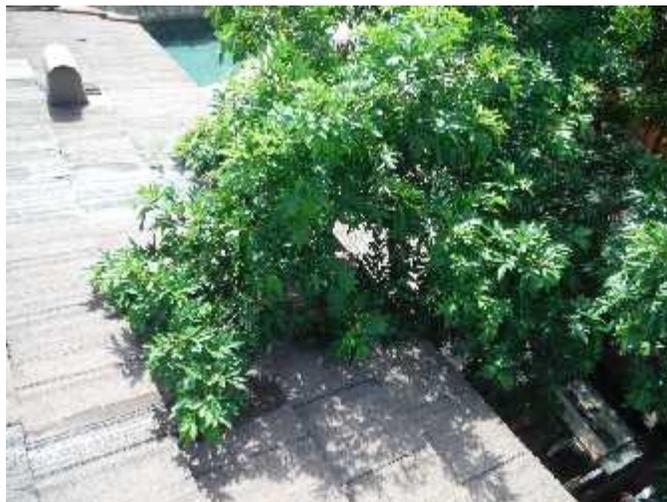
\* Vegetation extending over the building roof is continuously depositing leaf and branch debris onto this building's roof covering. Vegetation in contact with the building wall siding and trim will constantly convey moisture and contact abrasion to the building materials and is a **NOT FUNCTIONING PROPERLY CONDITION**.

**Recommendation:** It is recommended that a qualified and experienced C-27 Landscaping Contractor evaluate all the vegetation on the property and provide a cost estimate for trimming and removal of all vegetation in contact with the building and those excessively close to the building structure.

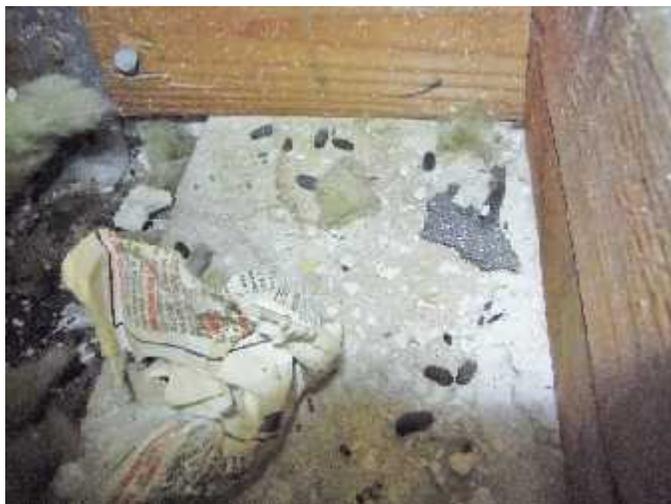
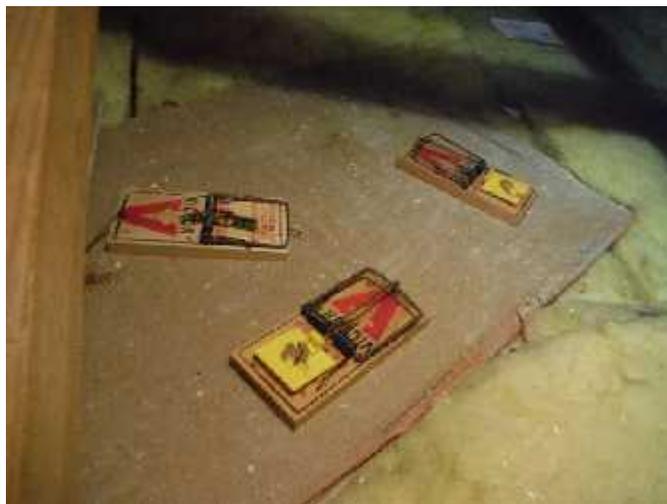
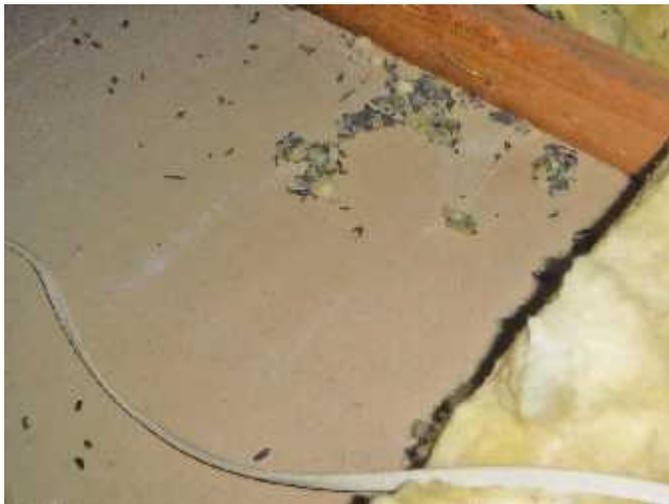
**Evidence of Vermin Infestation – Rodent Bodies and Droppings Observed:**

There is evidence of vermin infestation on the interior of the dwelling. Rodent droppings, rodent traps, and a dead body of a rodent was discovered in the attic crawlspace area.

\* The evaluation of rodent infestation is beyond the capacity of Asset Inspection & Consulting Services to evaluate and therefore an **UNKNOWN CONDITION AND DEFERRED**. The infestation by rodents is a **SAFETY HAZARD CONDITION**.

**Recommendations:** It is recommended that the Seller be requested to disclose the history of any rodent infestation and all treatments with dates of action the Contractor receipts for all work performed.

-> It is recommended that the Client (Buyer) contact a qualified and experienced Agricultural Pest Inspector to completely evaluate the dwelling and garage interiors for eliminating all rodent infestation and the sealing of the

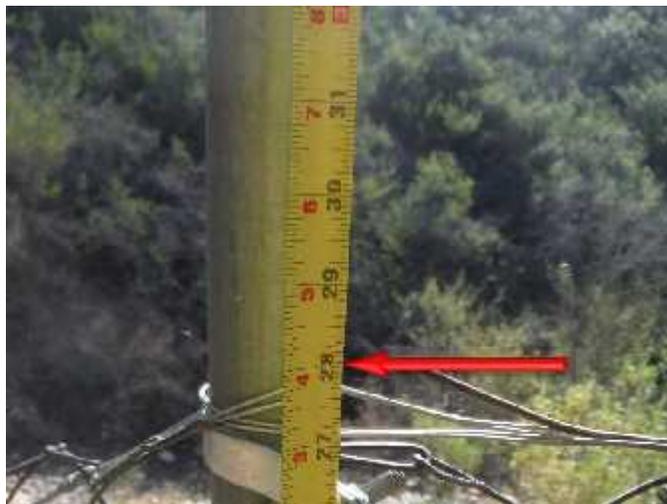
##### ***Barrier Fencing Less than 60-Inches:***

The east property perimeter safety barrier fencing for the pool with spa yard is less than 60-inch high.

\* The minimum California safety building code requires safety barrier fencing for pools with spas to be a minimum of 60-inch high from grade level (on both sides of the fencing) and completely around the yard with the pool with spa in order to control unsupervised access to the pool or spa waters, which, historically have had horrific consequences. The less than minimum 60-inch high safety barrier fencing is a **SAFETY HAZARD CONDITION**.

**Recommendation:** It is recommended that a qualified and experienced C-13 Fencing Contractor familiar with the City of San Diego pool and spa barrier fencing requirements should re-configure the less than 60-inches high safety barrier perimeter fencing to the correct height for safety.

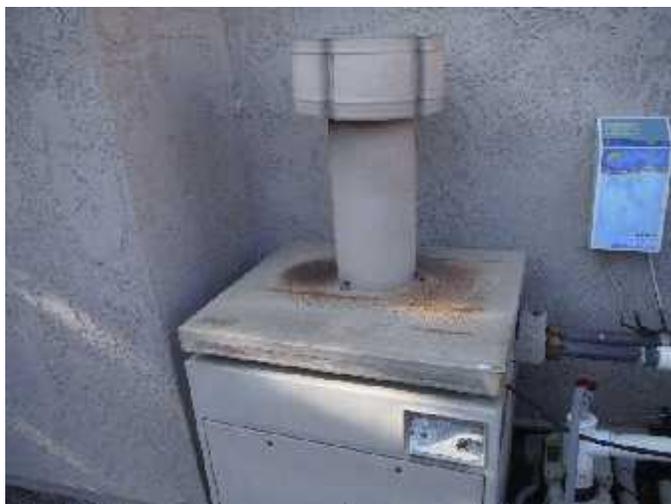
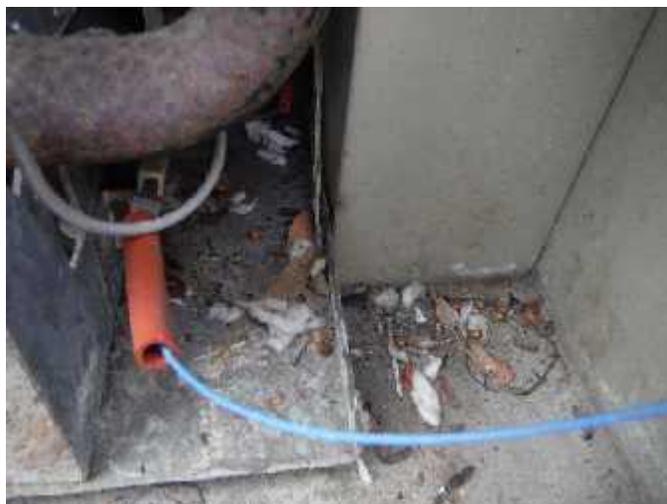
##### ***Pool / Spa Natural Gas Water Heater did Not Respond to a Call for Heating:***

The pool and spa natural-gas fueled water heater did not respond to a call for heat and did not function as intended. There is rodent nesting material in the burn chamber that is flammable

\* The reason for the pool / spa water heater to not function as intended is not self-evident but there is rodent nesting material in the burn chamber of the water heater. The operation of the natural-gas pool / spa water heater is an **UNKNOWN CONDITION AND DEFERRED**.

**Recommendation:** It is recommended that a qualified and experienced D-35 Pool and Spa Maintenance Contractor should completely evaluate and discover the reason why the pool / spa natural-gas heater did not respond to repeated call for heating.

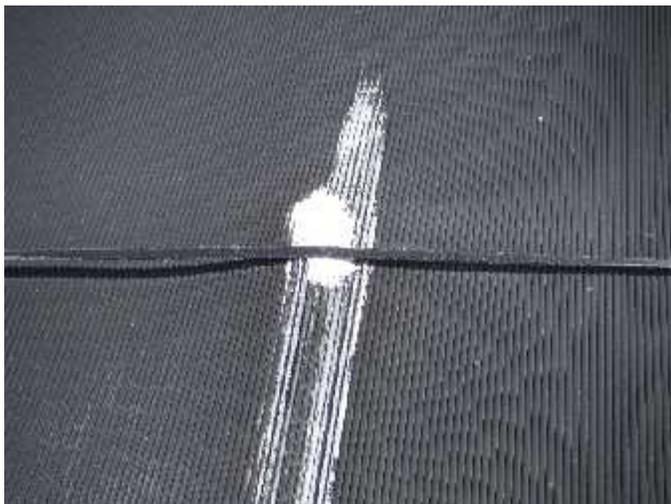
\* The patched solar pool and spa water panel is an **UNKNOWN CONDITION AND DEFERRED.**

**Recommendations:** The quality or materials making up the solar pool / spa water heating panel patch is beyond the abilities of Asset Inspection & Consulting Services to evaluate. It is recommended that the Seller be requested to disclose the history concerning the patch on the pool / spa solar panel, complete with Contractors receipts, timeline and warranty periods for the work performed

-> If disclosure is not forthcoming then it is recommended to contact the Manufacturer of the water-heater solar equipment and requesting a service-representative evaluate the repair patch to the solar panel.

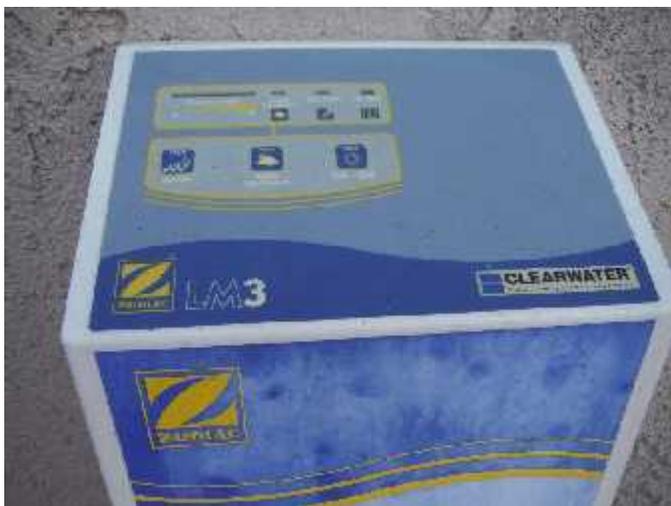
### *Salt Water Chlorinators:*

The pool and spa water is being treated with a salt water chlorinator manufactured by Clearwater model number LM3-24

\* The maintenance and service of the salt water chlorinator are an **UNKNOWN CONDITION AND DEFERRED.**

**Recommendation:** It is recommended that the Seller be requested to provide all salt water chlorinator manufacturer installation, maintenance and service instructions. If no manufacturer installation, maintenance and service instructions are forthcoming then it is recommended that a qualified and experienced D-35 Pool and Spa Maintenance Contractor should evaluate the pool / spa salt water chlorinator equipment to provide a cost estimate for the proper care and maintenance of the salt water chlorinator equipment.
