Treasure State Acres Road Maintenance Plan

DRAFT 2015 REPORT

**Lewis & Clark County
Public Works Department
and
Treasure State Acres Homeowners Assoc.**

Robert Peccia & Associates
Helena & Kalispell, Montana
RPA Project: 14513.000

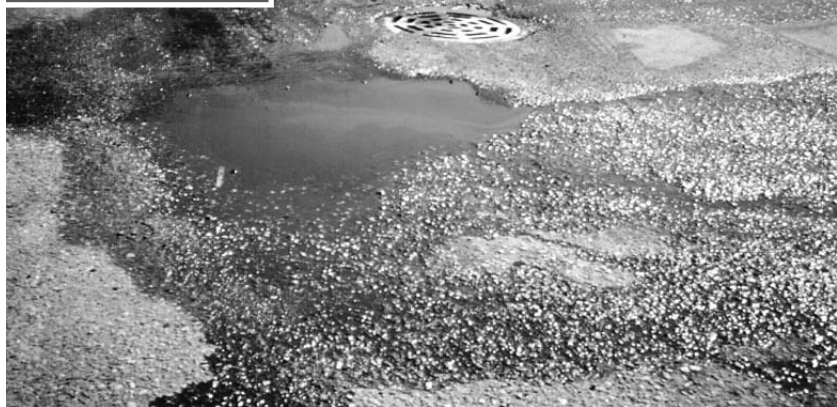
Pavement settlement causes ponding in this poor parking lot inlet.

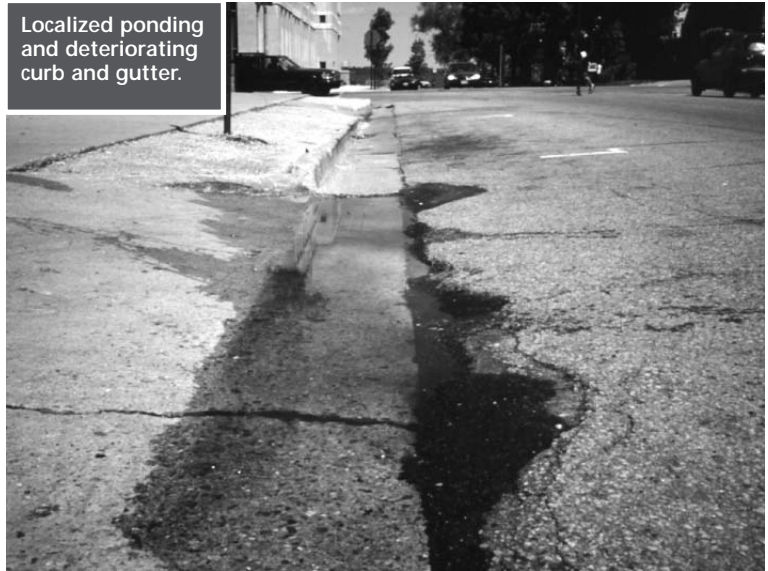
Localized ponding and deteriorating curb and gutter.

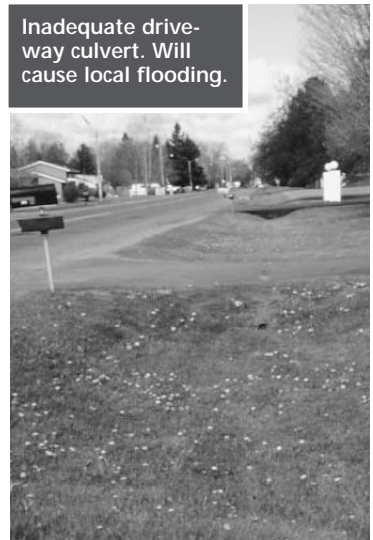
Inadequate driveway culvert. Will cause local flooding.

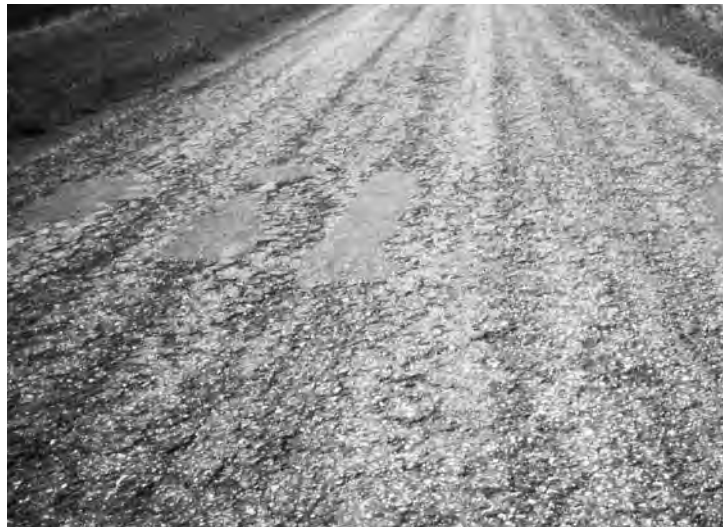
◀ Severe raveling and loss of surface material.

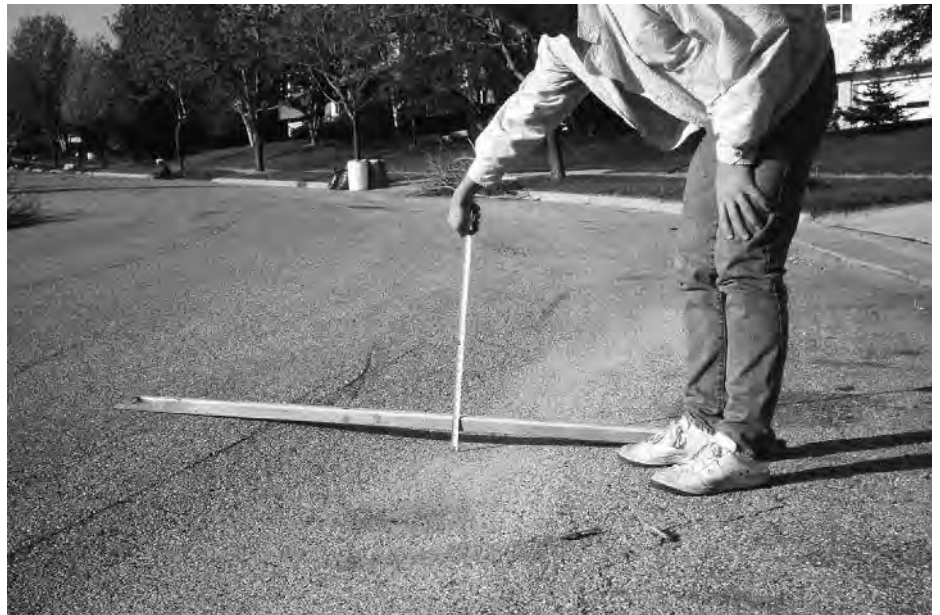
► Severe settling from utility trench.

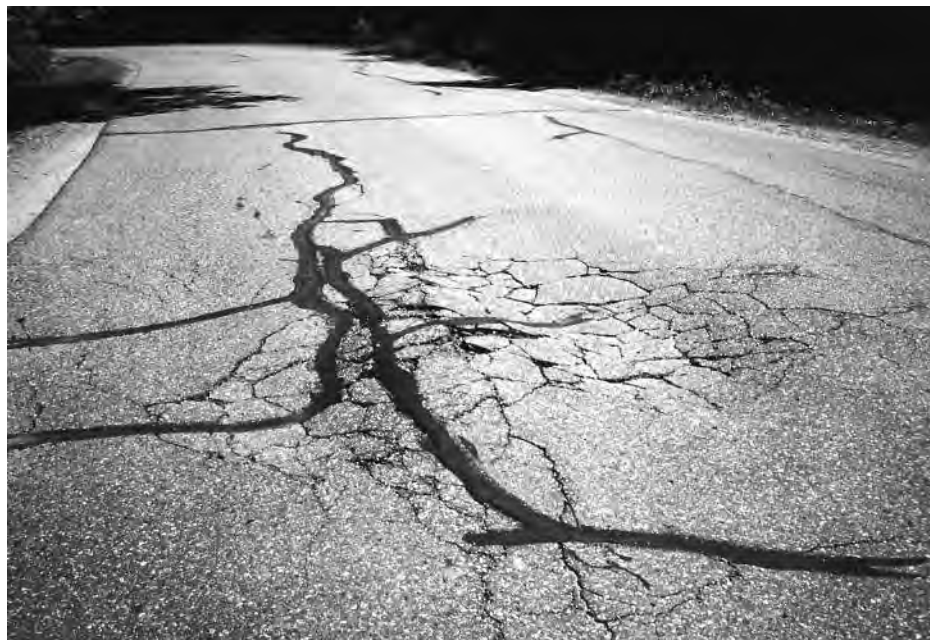
► Frost heave damage from spring break-up.

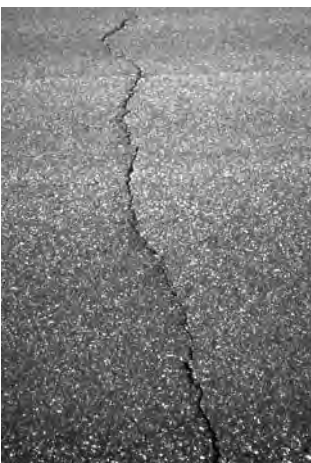
▲ Tight cracks less than 1/4" in width.

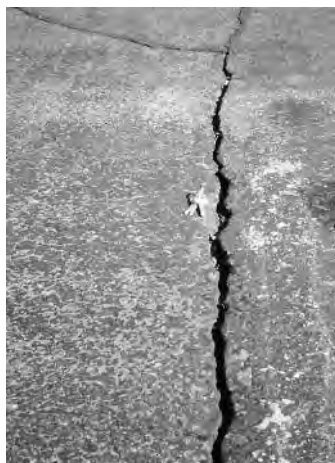
▲ Open crack – 1/2" or more in width.

Prevent water intrusion and damage by sealing cracks which are more than 1/4" wide.

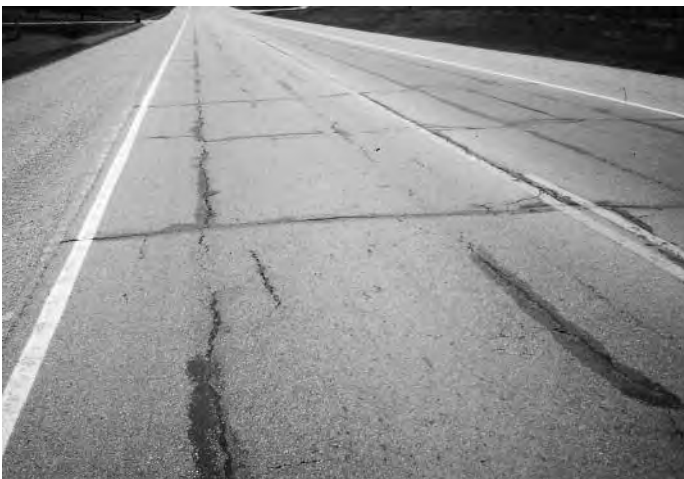
▼ Load-related cracks in wheel path.

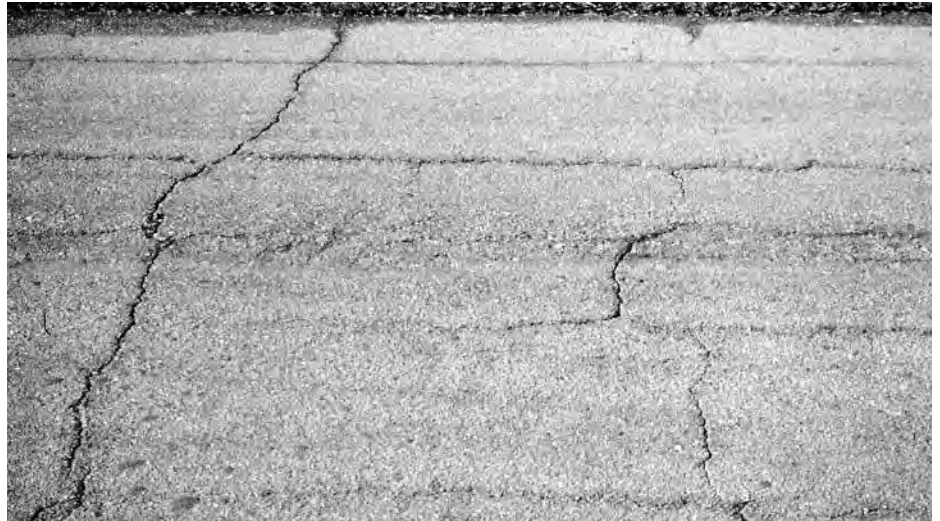
▼ Block cracking with open cracks.

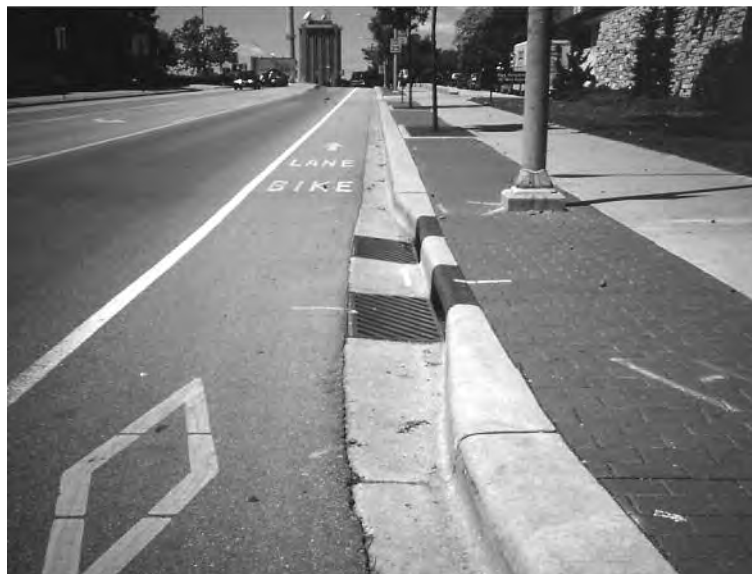
Urban drainage.
RATING:
Excellent
