RE: SCEAP Grant EPG-104-16

Please find enclosed the Facility Plan for wastewater treatment and collection system improvements serving the City of Fair Grove, Missouri, for your review.

Gregory S. Perkins, P.E.
Senior Consultant/Project Manager
TREKK Design Group, LLC

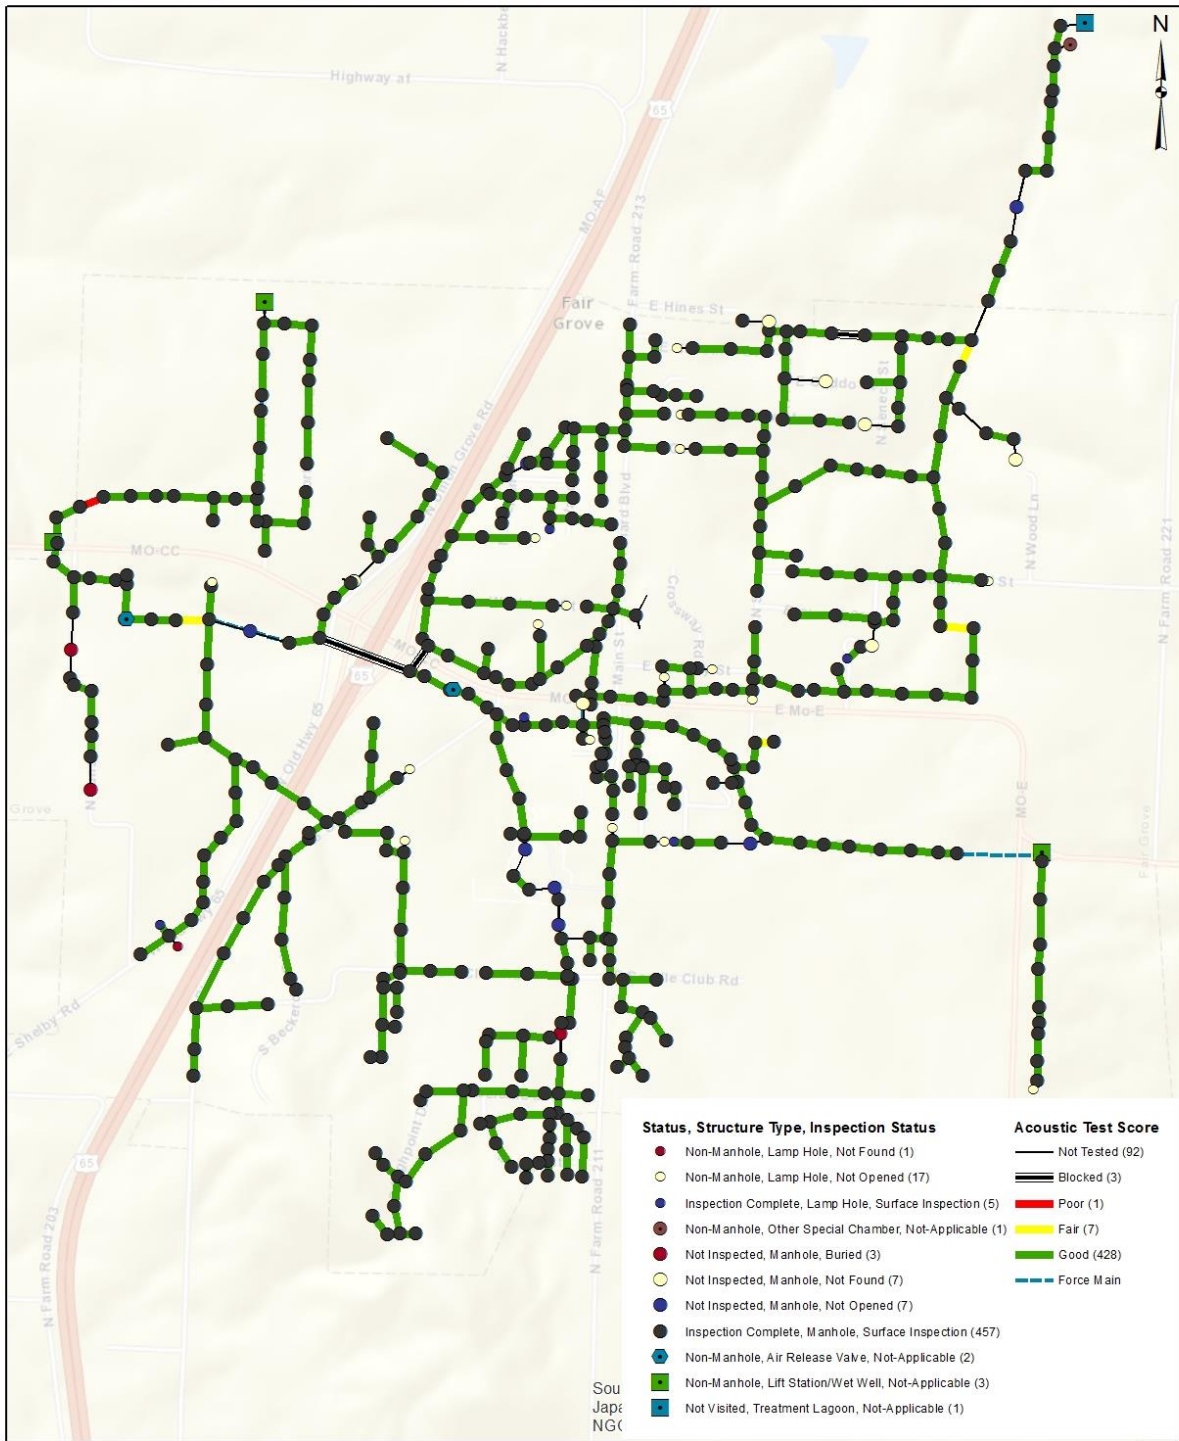
Figure 2-7: Acoustic Sounding & Manhole Inspection Results

Acoustic sounding was performed prior to flow monitoring and smoke testing to ensure lines would be free and clear for smoke to pass through cleanly. The acoustic sounding results can also prioritize maintenance for lines that need to be cleaned and televised. Acoustic sounding results along with manhole status for the study area are shown in Figure 2-7. Table 2-3 illustrates the amount of acoustic testing performed in the City. Not all pipe segments were tested due to lack of access to the manhole structures. A large map showing Manhole Inspections and Acoustic Sounding Results is available in Appendix B.

Acoustic Sounding Score	Total Segments	Total Sewer Footages	% Totals
Blocked	3	1,556.8	1.5%
Poor	1	241.4	0.23%
Fair	7	1,413.7	1.4%
Good	428	100,218.1	96.9%

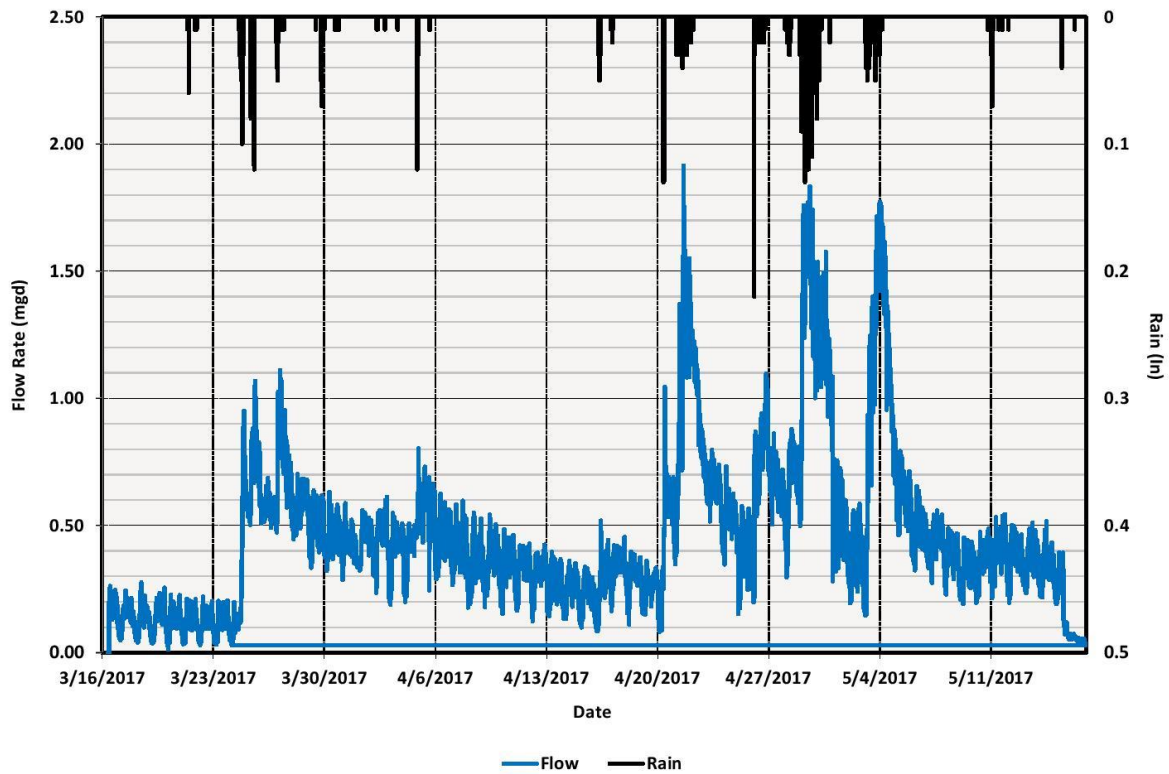
Fair Grove, MO Flow Monitoring: Site: 16-035_1 Manhole: SW-017

Study Area Basin ID	Flow Total (Million Gallons)	ADDF (MGD)	ADDF Projected (Million Gallons)	I&I as % of Total Flow	Peaking Factor*	Instantaneous Peak Flow (MGD)	Peak Hourly Flow (Gallons/Hour)
All Except Northeast basin	29.65	0.12	7.04	76.27%	15.77	1.92	59,292

*DNR considers a peaking factor greater than 2.5 to be excessive I&I.

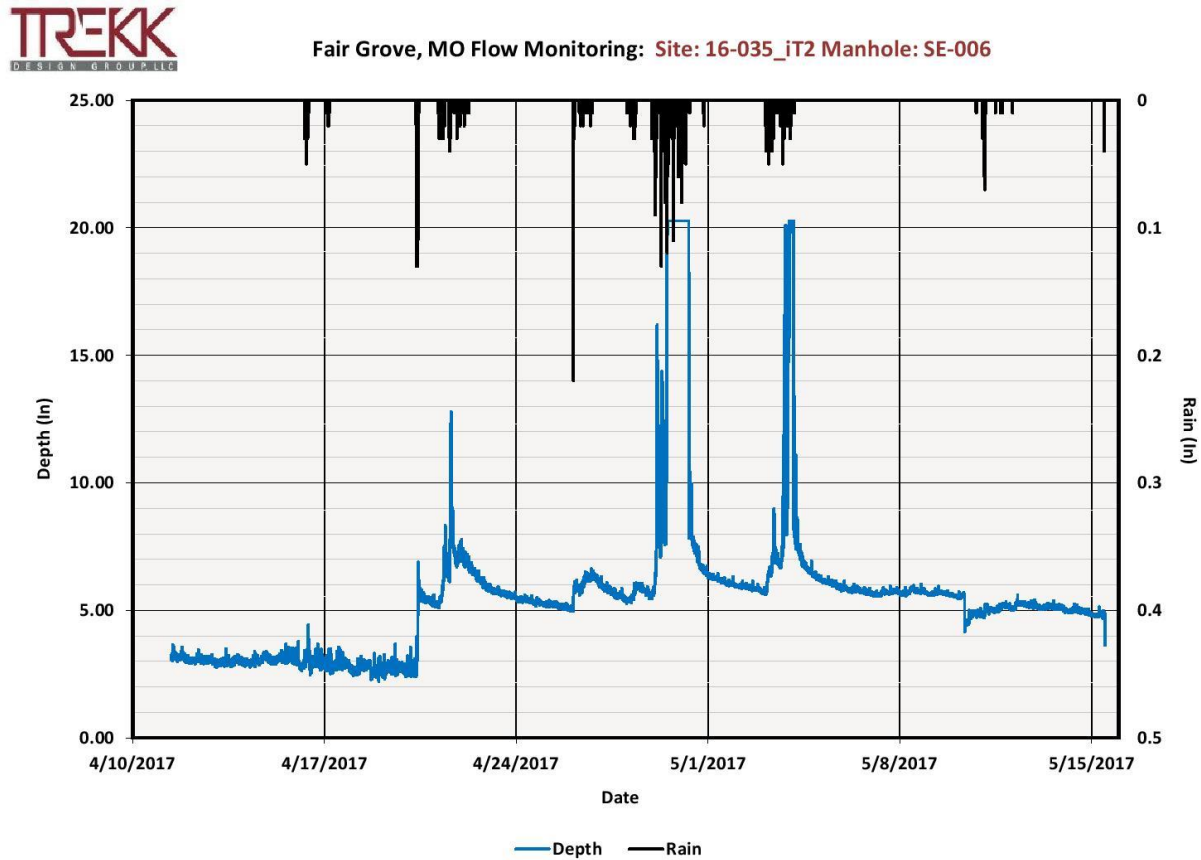
Figure 2-11: iTracker2 Level Graph

iTracker 2 was installed in manhole SE-006. Data from iTracker2 and iTracker4 provided the best case for large amounts of I&I that may be identifiable via smoke testing. Both sites seem to have more inflow than infiltration suggesting direction connections to the sanitary sewer. The level graph is provided in Figure 2-11.

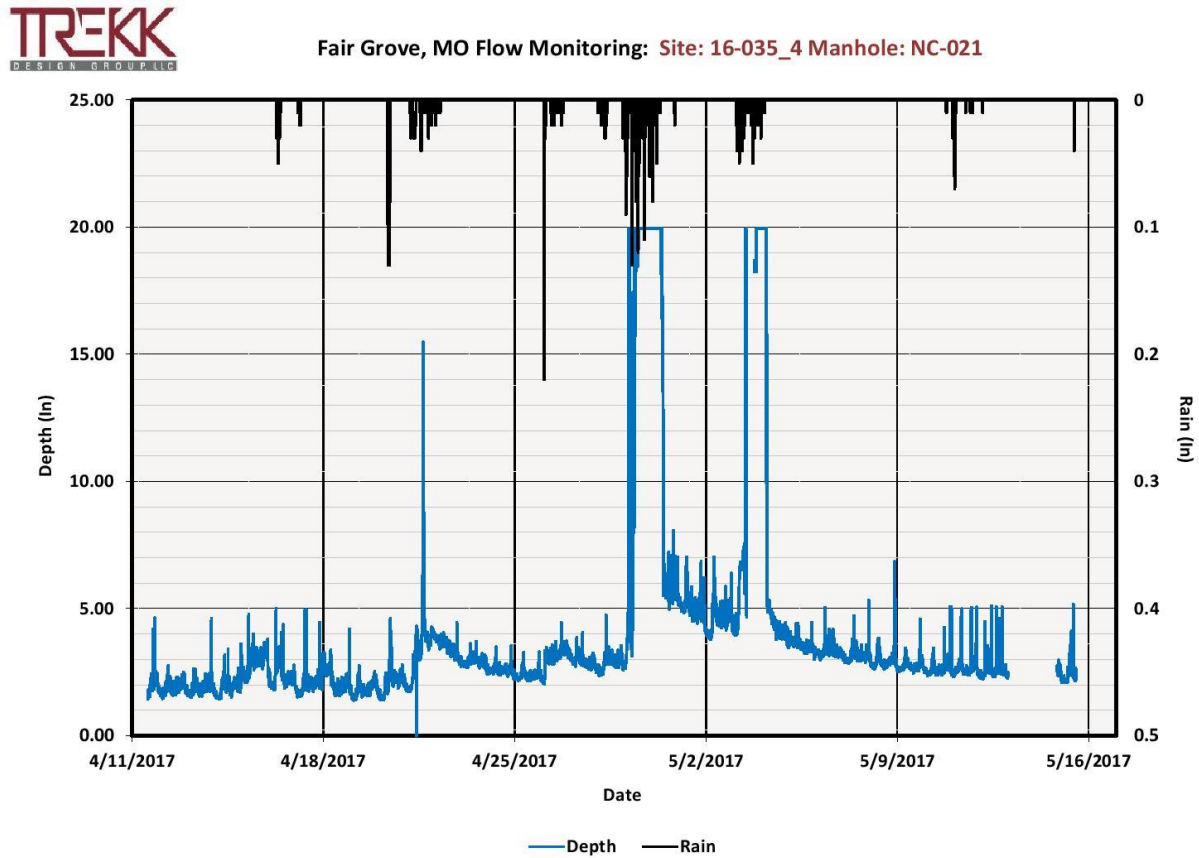
Figure 2-13: iTracker4 Level Graph

iTracker 4 was installed in manhole NC-021. Data from iTracker2 and iTracker4 provided the best case for large amounts of I&I that may be identifiable via smoke testing. Both sites seem to have more inflow than infiltration suggesting direction connections to the sanitary sewer. It appears that this site experienced surcharged conditions during significant rain events while the iTrackers were installed. The level graph is provided in Figure 2-13.

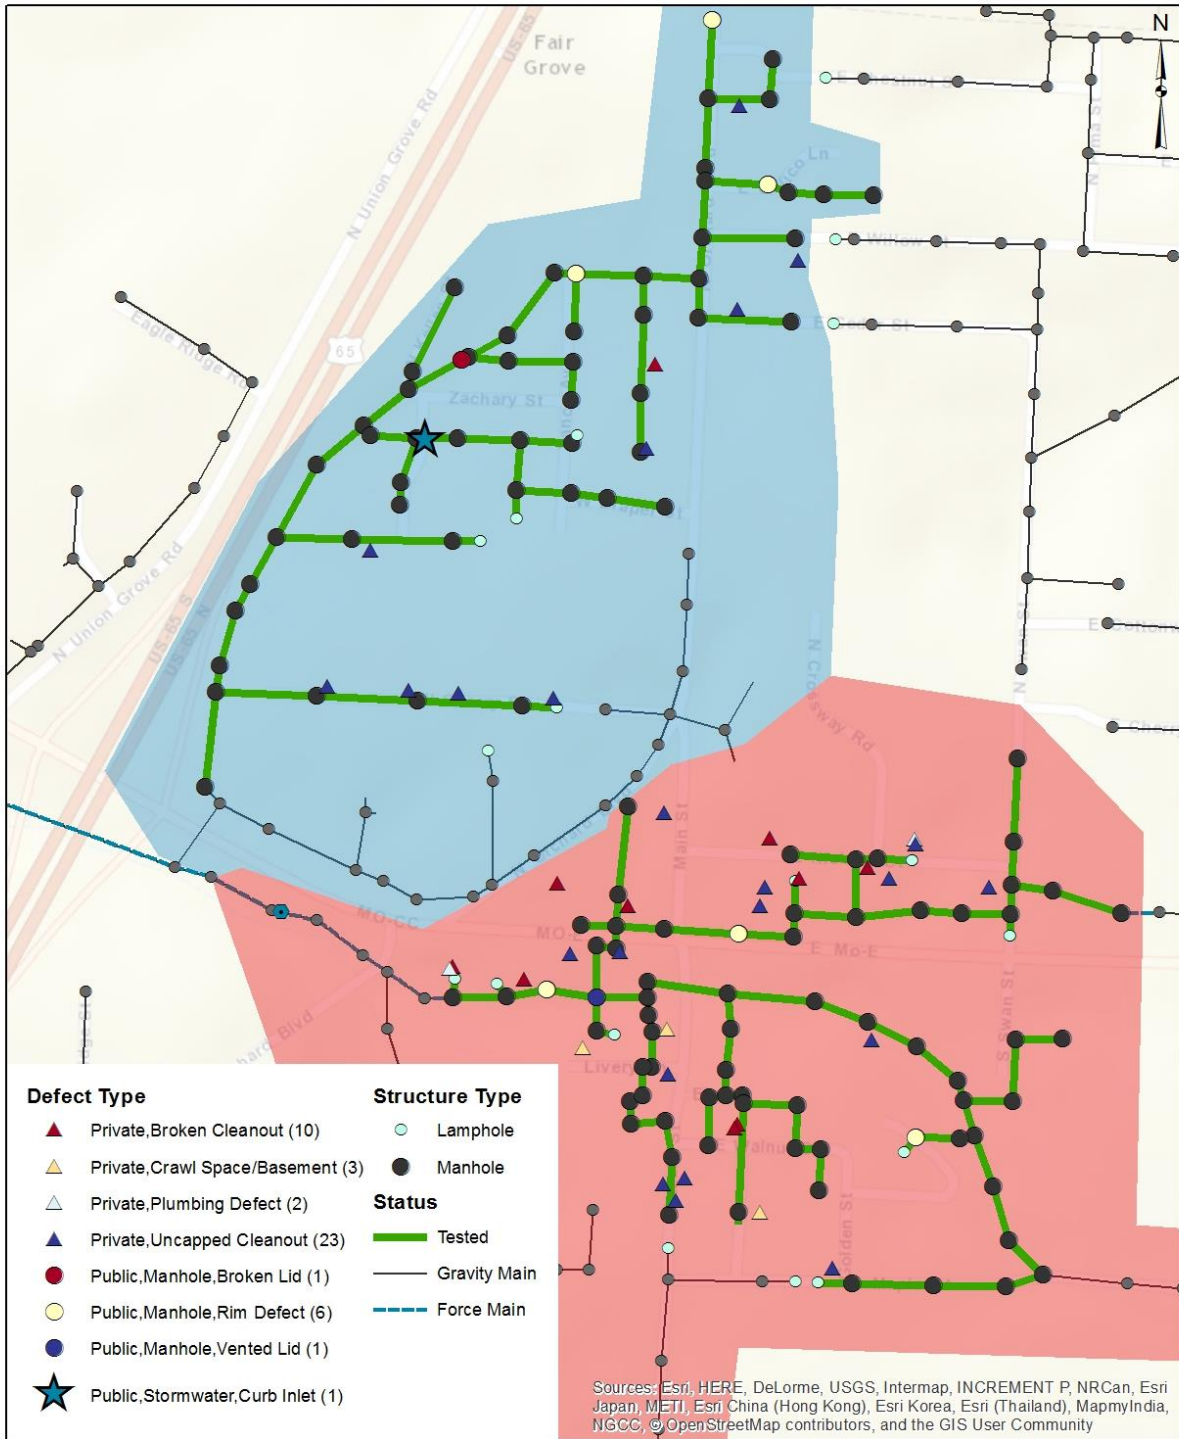
Figure 2-16: Smoke Testing Defect Summary

- Smoke Testing results: The North Central and South East basins were smoke tested and a total of 47 smoke defects were found. There were 38 private sector defects, primarily consisting of cleanout defects, and 9 public sector defects consisting of 8 manhole defects.

Table 2-9 shows the number of defects in the private sector was higher than those found in the public sector. Due to the shallower depth of the service laterals and surface exposure of cleanouts to outdoor activities, it is not uncommon to see a higher number of private sector defects. Additionally, due to their lower construction cost, repairs to private sector defects are typically less expensive than public sector defects. Line segments exhibiting smoke from public sources, other than manholes, may need to be included in a future CCTV inspection program. Additionally, service laterals that exhibit smoke may also be included in the CCTV inspection program.

Smoke Testing is recommended to identify and confirm directly connected sources of I/I on both private property and the City owned portion of the system. Smoke testing is performed by injecting, through the vaporization of oil, into an isolated line segment with a high-capacity blower. The use of oil, instead of smoke bombs, allows for continuous smoke production while field crews canvass the area and conduct a perimeter check of all buildings in close proximity for evidence of smoke. It is recommended to smoke test the remaining 90,350 LF of the collection system that was not tested during this project.
