Pfeifer Home Inspection  
Indianapolis, IN 46236  
317-340-1734  
pfeiferhomeinspect@gmail.com  
License #HI01700103

# Home Inspection Report

Jane Doe  
123 fake street  
Indianapolis, Indiana 46562

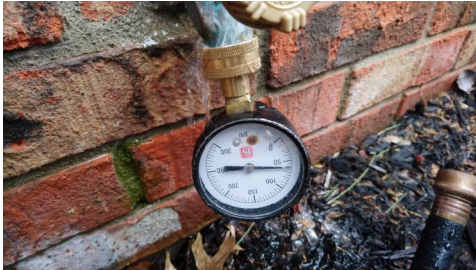
Hose Bibbs: 60PSI was measured - We tested the exterior hose bibb's water pressure and it met the acceptable limit. A typical homes water pressure usually measures between 40-80PSI. All of the hose bibbs around the home were functioning as expected as well.

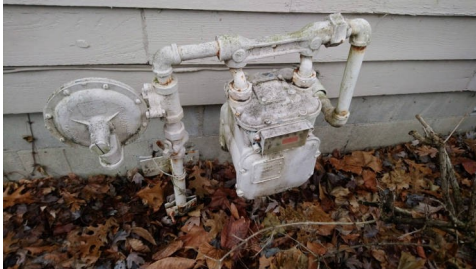
Gas Meter: Exterior surface mount at side of home - The exterior gas meter was inspected with no visible sign of any leaks. No code violations were noticed as well.

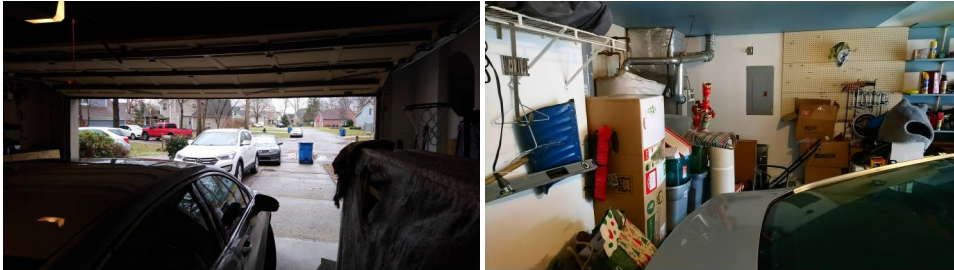
1. Type of Structure: Attached Car Spaces: 2
2. Acceptable Garage Doors: Metal - We tested the operation of the garage door and everything functioned properly. The door opened and closed without any issues. Additionally, we tested the auto reverse sensors at the bottom of the track and they reversed properly.

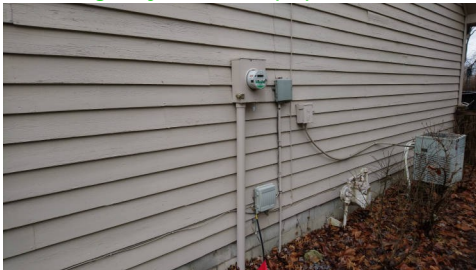
1. Service Size Amps: 200 Volts: 110-240 VAC
2. Acceptable Service: Copper - The service entrance is up to code with no imperfections. No water appears to be entering any of the equipment.

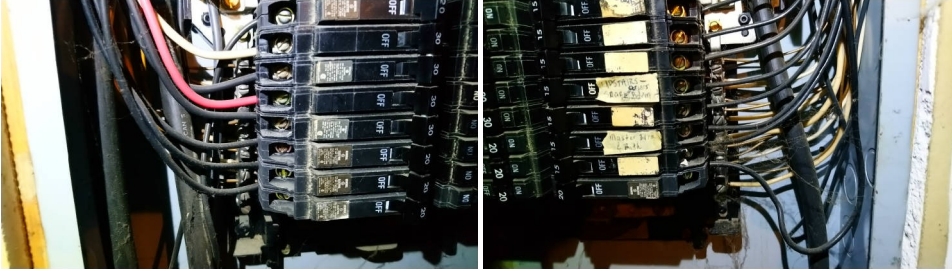
Manufacturer: (continued)

- Garage Electric Panel Manufacturer: Per code, all knockouts need to be properly covered if removed from the panel. If not, it presents a shock hazard as someone could accidentally stick a finger in the panel. We found one open knockout in the panel needing addressed. The rest of the panel is up to code. All neutral wires were isolated on both bus bars. All wiring is the right size for the attached breaker. A qualified contractor will need to evaluate for the correct repairs.

3. Defective Manufacturer: Per code, all knockouts need to be properly covered if removed from the panel. If not, it presents a shock hazard as someone could accidentally stick a finger in the panel. We found one open knockout in the panel needing addressed. The rest of the panel is up to code. All neutral wires were isolated on both bus bars. All wiring is the right size for the attached breaker. A qualified contractor will need to evaluate for the correct repairs.

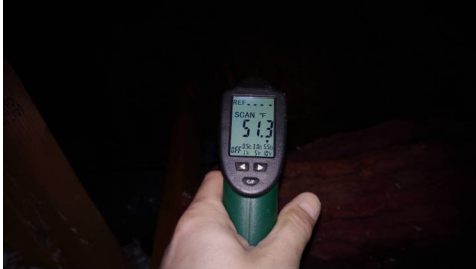
3. Acceptable Ventilation: 51 degrees in the attic - The temperature in the attic was at a typical temperature for the current conditions outside. No ventilation issues were noticed in the attic.

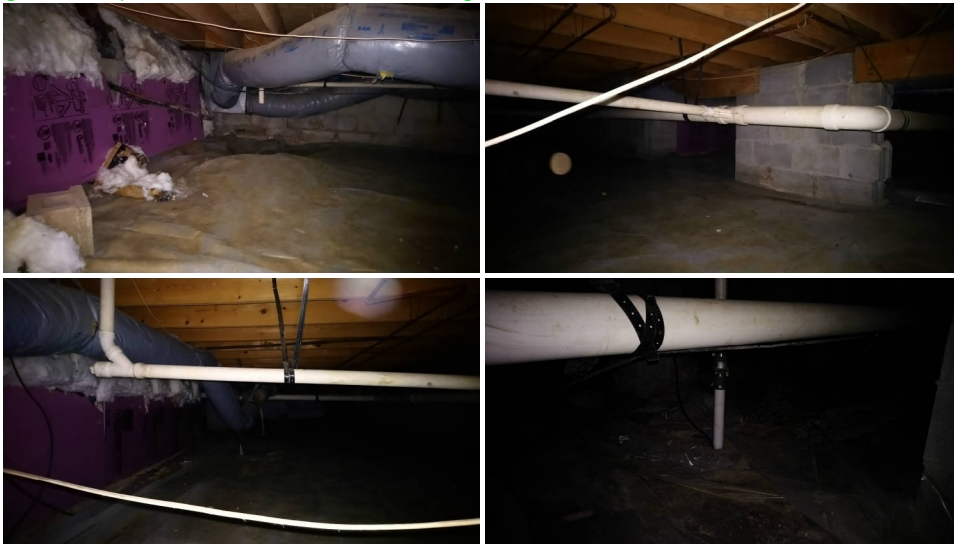
1. Method of Inspection: In the crawl space
2. Acceptable Access: Metal door - After reviewing the entire crawlspace it was dry and ventilating good with no moisture present. A vapor barrier runs across the entire length of the crawl to help prevent moisture build up. No active leaks or previous leaks were noted as well. The cement block foundation is in good shape as no additional cracking or lateral movement was found.

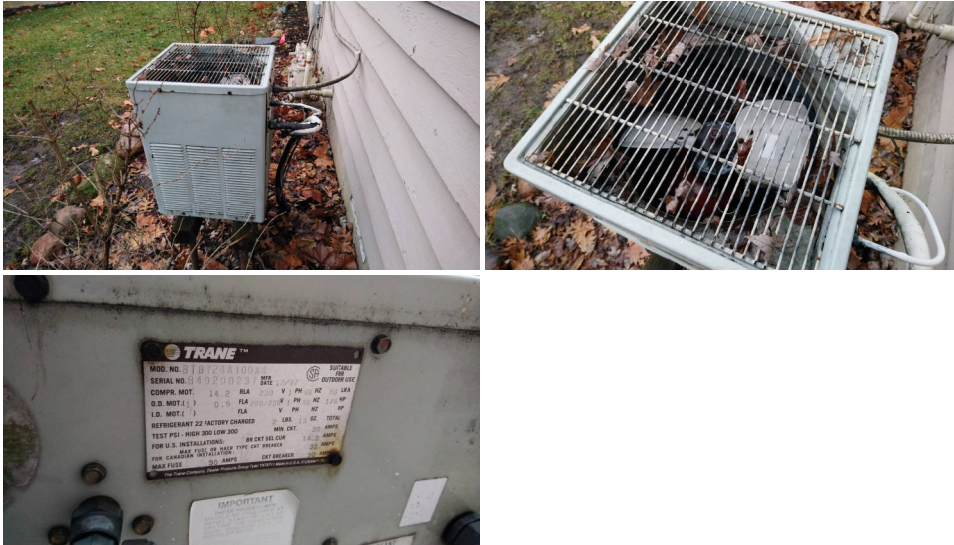
1. Marginal A/C System Operation: Due to the temperature outside the AC unit was not tested, however were able to review the exterior of the unit. The suction line was correctly insulated from the home to the unit. We did observe leaves inside of the unit needing cleaned out. With that said, the unit is from 1987 and at end of the typical life expectancy.

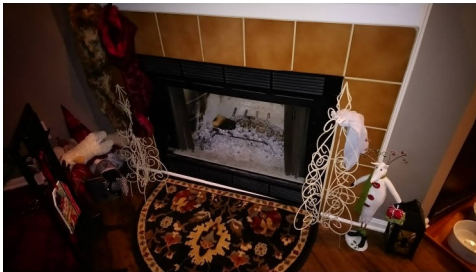
1. Acceptable Fireplace Construction: Brick - The wood fireplace is in good condition and free of any cracking. We tested the damper and were able to open/close the valve as expected. We recommend having the flue cleaned when moving into a new home.

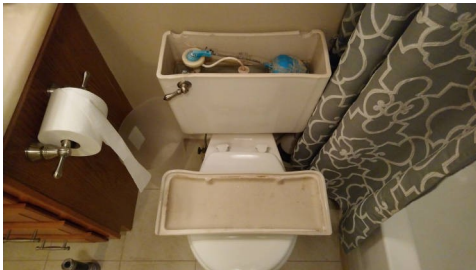
5. Acceptable Toilets: 1 1/2 Gallon Tank - The toilet was functioning correctly during the inspection. We inspected the supply lines to the toilet and did not find any leaks at all. Additionally, we felt around the bottom of the toilet and no leaks were discovered.

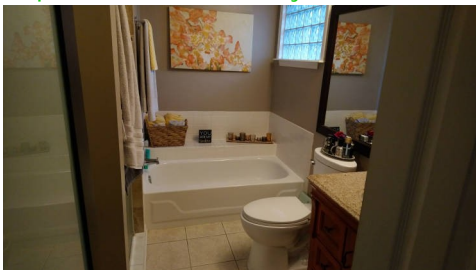
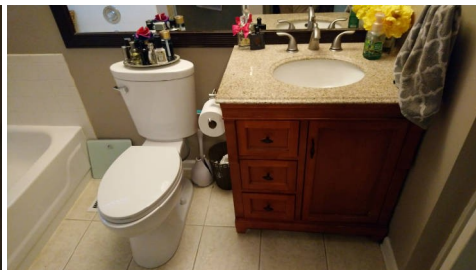
6. Acceptable Walls: Paint - We inspected all of the walls in this room and did not see any major holes or imperfections in the drywall.

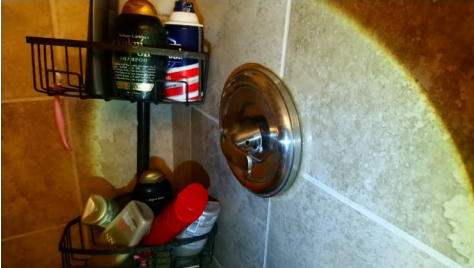
6. Master Bathroom Shower/Surround: We attempted to test the shower surround however no water came out when the handle was turned. It's possible a shut off valve was engaged at the time of our inspection. A qualified contractor will need to evaluate the shower to determine the correct repair.

Shower/Surround: We attempted to test the shower surround however no water came out when the handle was turned. It's possible a shut off valve was engaged at the time of our inspection. A qualified contractor will need to evaluate the shower to determine the correct repair.

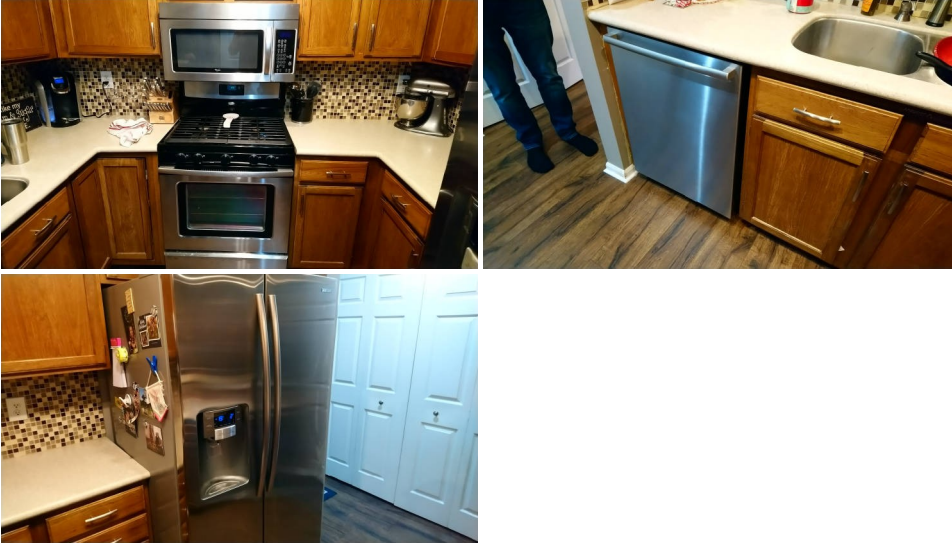
1. Acceptable Cooking Appliances: Range, Fridge, and Dishwasher - All appliances were tested and in working condition during our inspection.

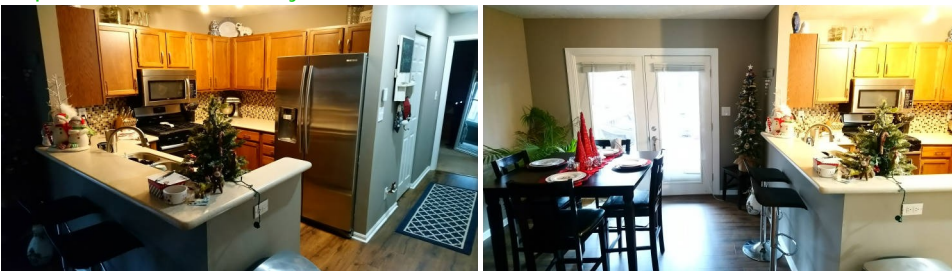
3. Acceptable Walls: Paint - We inspected all of the walls in this room and did not see any major holes or imperfections in the drywall.

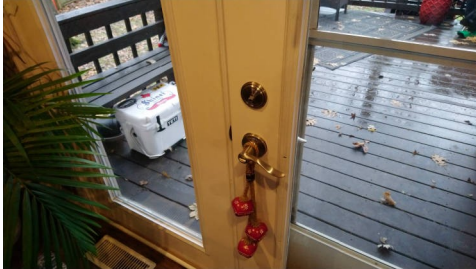
Doors: (continued)

7. 1st Floor Kitchen Doors: Metal - The deadbolt on the back door will need to be replaced by a qualified contractor. The inside lever to open/lock the deadbolt is missing. The rest of the hardware on the back door was functioning as expected. We opened and closed the door without any issues.

4. Defective Doors: Metal - The deadbolt on the back door will need to be replaced by a qualified contractor. The inside lever to open/lock the deadbolt is missing. The rest of the hardware on the back door was functioning as expected. We opened and closed the door without any issues.

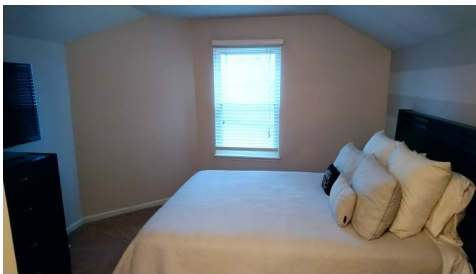
1. Acceptable Walls: Paint - All of the walls are in good condition in this room. No large holes or imperfections were noticed.

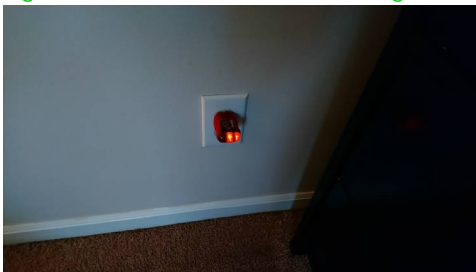
3. Acceptable Electrical: 110 VAC - All outlets were tested in this room and in working condition. The outlets were tight to the wall and not moving.

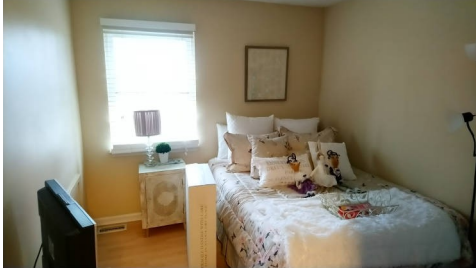
4. Acceptable Walls: Paint - We inspected all of the walls in this room and did not see any major holes or imperfections in the drywall.

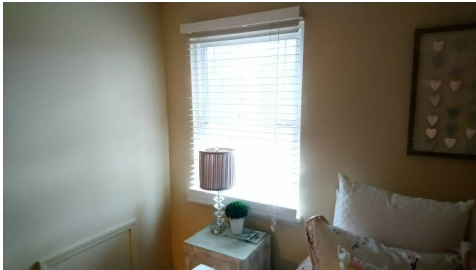
5. Acceptable Windows: Vinyl single hung - All of the windows in this room were tested and operating normally. All panes and seals were still intact inside of the windows.

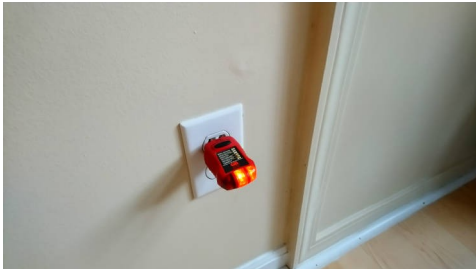
6. Acceptable Electrical: 110 VAC - All outlets were tested in this room and in working condition. The outlets were tight to the wall and not moving.

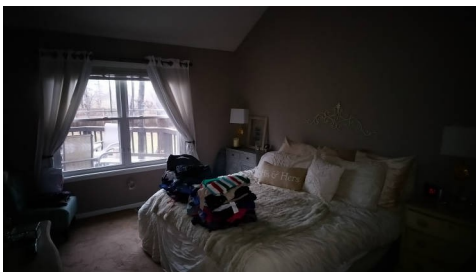
7. Acceptable Walls: Paint - All of the walls are in good condition in this room. No large holes or imperfections were noticed.

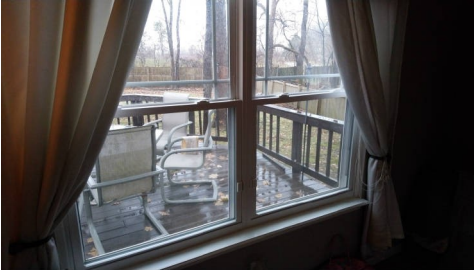
8. Acceptable Windows: Vinyl single hung - All of the windows in this room were tested and operating normally. All panes and seals were still intact inside of the windows.

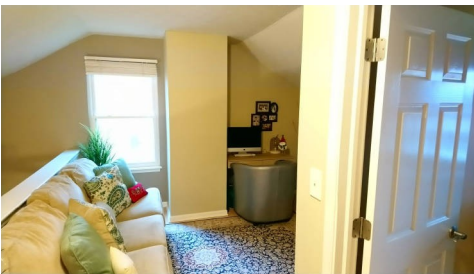
1. Acceptable Walls: Paint - All of the walls are in good condition in this room. No large holes or imperfections were noticed.

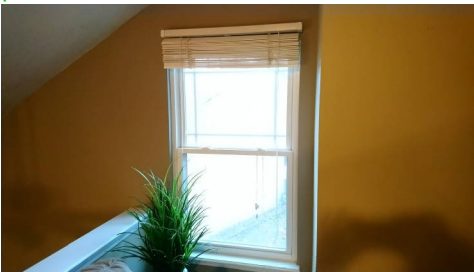
2. Acceptable Windows: Vinyl single hung - All of the windows in this room were tested and operating normally. All panes and seals were still intact inside of the windows.

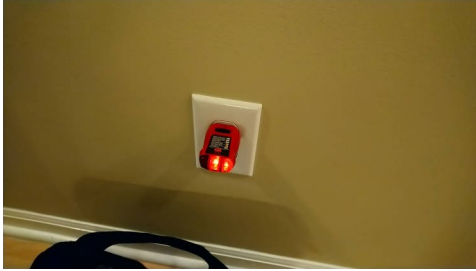
Electrical: (continued)

10. 2nd floor loft Living Space Electrical: 110 VAC - The outlet in the 2nd floor hallway appears to be loose. As we inserted our electrical tester we received an indication of loose wiring. Upon inserting the tester all the way everything tested fine. Typically when this happens the wiring is loose and needs to be tightened.

3. Marginal Electrical: 110 VAC - The outlet in the 2nd floor hallway appears to be loose. As we inserted our electrical tester we received an indication of loose wiring. Upon inserting the tester all the way everything tested fine. Typically when this happens the wiring is loose and needs to be tightened.

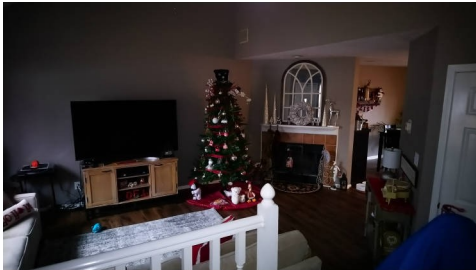
4. Acceptable Walls: Paint - We inspected all of the walls in this room and did not see any major holes or imperfections in the drywall.

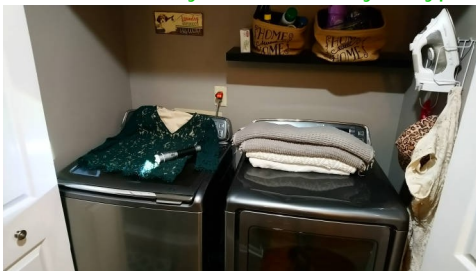
1. Acceptable Walls: Paint - In the laundry room we did review the walls for any holes or imperfections. We did not test the laundry machine as you typically need a load of clothes to do so.

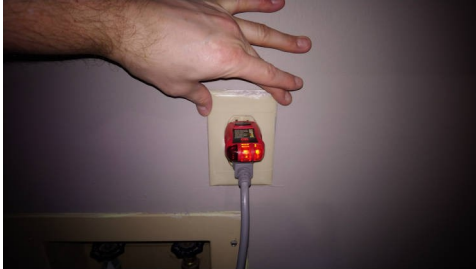
2. Acceptable Electrical: 110 VAC - All outlets were tested in this room and in working condition. The outlets were tight to the wall and not moving.
