Home Inspection Report

123 Main Street, Anytown, NY 12866

Inspection Date:

Wednesday, April 5, 2023

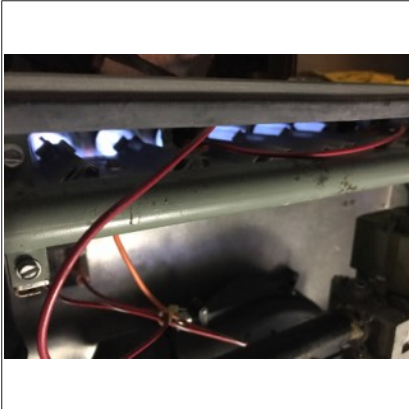
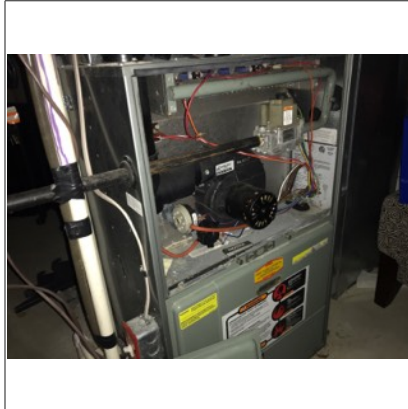
System type • **Forced Air Furnace**
• **Manufacturer: Bryant**
• **Model Number: 350MAV0360ADKA**
• **Serial Number: 4799A01525**
• **Manufactures Date: 1999**

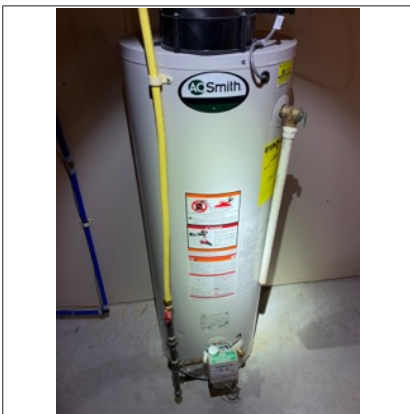
Interior supply piping •Copper
 •Plastic
Waste system •Public Sewer System
Drain / waste / vent piping •Plastic
 •Copper
 •Cast Iron
Water heater •**Power Source: Electric**
 •**Storage Capacity (in gallons):40**
 •**Manufacturer:AO Smith**
 •**Location:Basement**
 •**Manufactures Date: 2012**

- Water heaters have a typical life expectancy of 7 to 12 years. The existing unit has passed this age range. It would be wise to budget for a new unit. One cannot predict with certainty when replacement will become necessary.

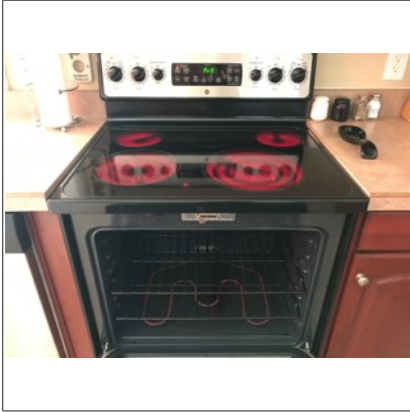
Electric range unit •The installation of an anti-tip bracket is recommended to safely secure an oven to the floor to provide extra protection when excess force is applied to an open oven door.
