DEPARTMENT OF REGULATORY  
AND ECONOMIC RESOURCES

MINIMUM INSPECTION PROCEDURAL GUIDELINES  
FOR BUILDING ELECTRICAL RECERTIFICATION

- a. Name on Title: Village at Dadeland Condominiums (A)
- b. Street Address: 7300 SW 82nd St. Miami, Florida 33143
- c. Legal Description: Village at Dadeland Condominiums
- d. Owner's Name: Village at Dadeland Condominiums
- e. Owner's Mailing Address: 7300 SW 82nd St. Miami, Florida 33143
- f. Folio Number of Property on which Building is Located: 30-4035-047-XXXX
- g. Building Code Occupancy Classification: R2 - Residential
- h. Present Use: Condominium, Residential
- i. General Description, Type of Construction, Size, Number of Stories, and Special Features

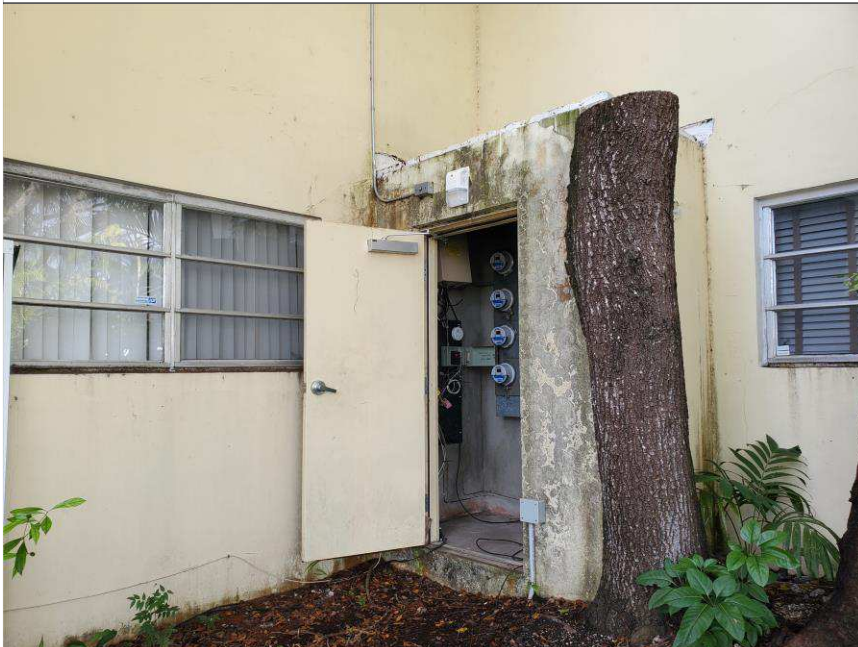
Photo 2 – Village of Dadeland Condominium Association

Existing Electrical Room - 1<sup>st</sup> FL  
Main Switches for Apartments,  
Meters, and Gutter.

Electrical Room enclosure to be  
watertight.  
Tree stump to be removed.

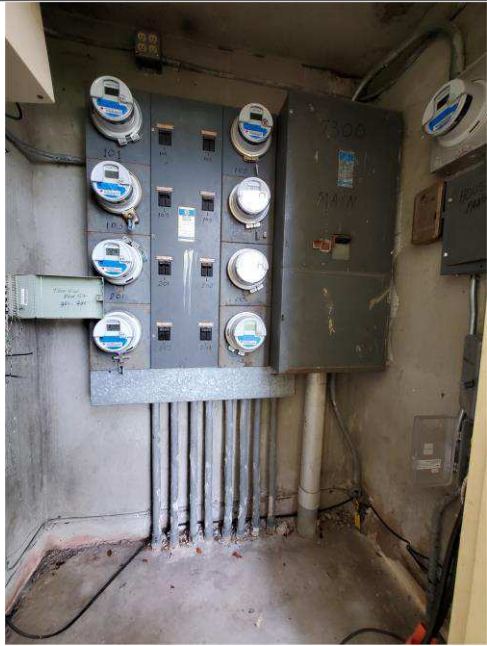
Photo 3 – Village of Dadeland Condominium Association

Existing Electrical Room - 1st FL  
Main Disconnect and Meter  
Stacks

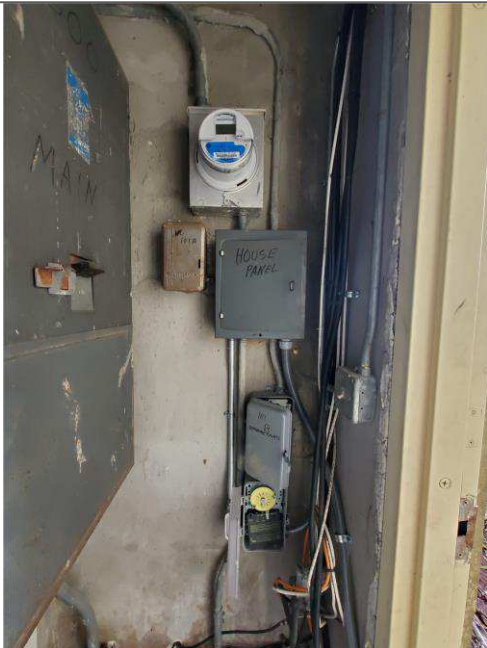
Photo 4 – Village of Dadeland Condominium Association

Existing Electrical Room - 1st FL  
House Panel Board and Meter.  
50 year old electrical  
component.

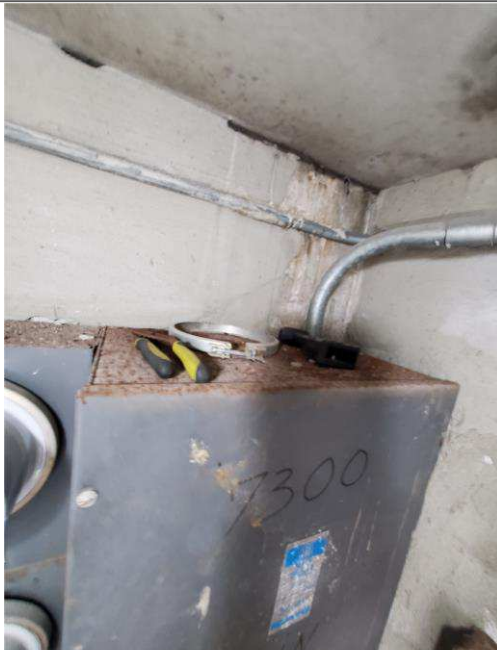
Photo 7 – Village of Dadeland Condominium Association

Existing Electrical Room - 1st FL  
House Panel Board and Meter  
are corroded.

50 year old electrical  
component.

Possible moisture intrusion  
from main electric room roof.

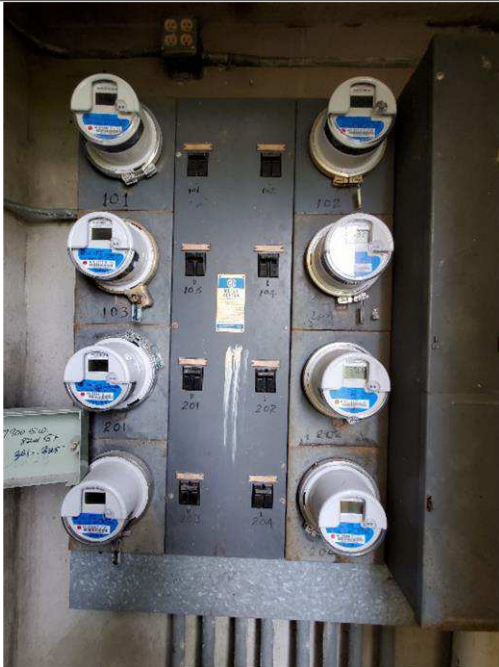
Photo 13 – Village of Dadeland Condominium Association

Existing Electrical Room - 1st FL  
Apartment Meters, Main  
Switches and Gutter.

Old and corroded meter stacks.

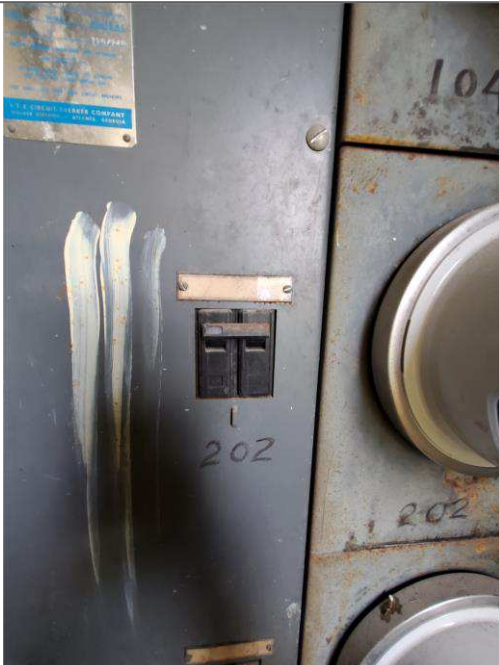
Photo 14 – Village of Dadeland Condominium Association

Existing Electrical Room - 1st FL  
Apartment Meters and Main  
Switch

Old and corroded meter stacks.

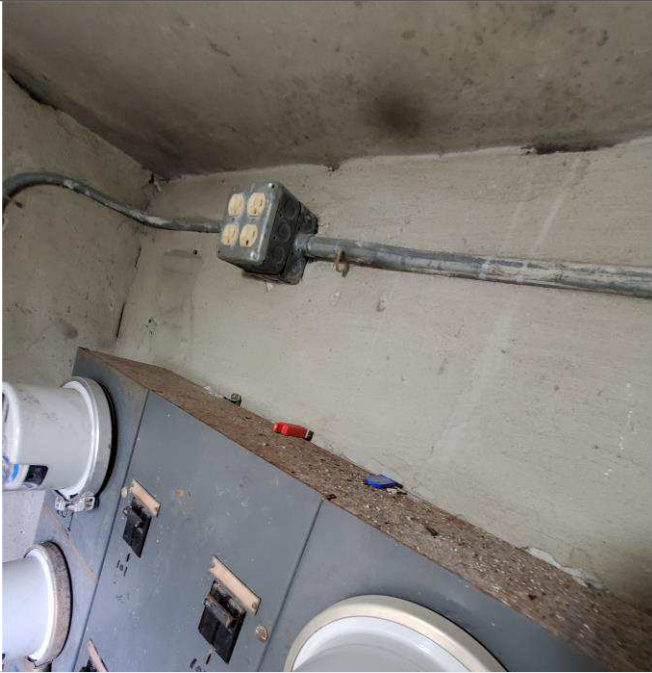
Photo 15 – Village of Dadeland Condominium Association

Existing Electrical Room - 1st FL  
Apartment Meters - Top View

Old and corroded meter stacks.

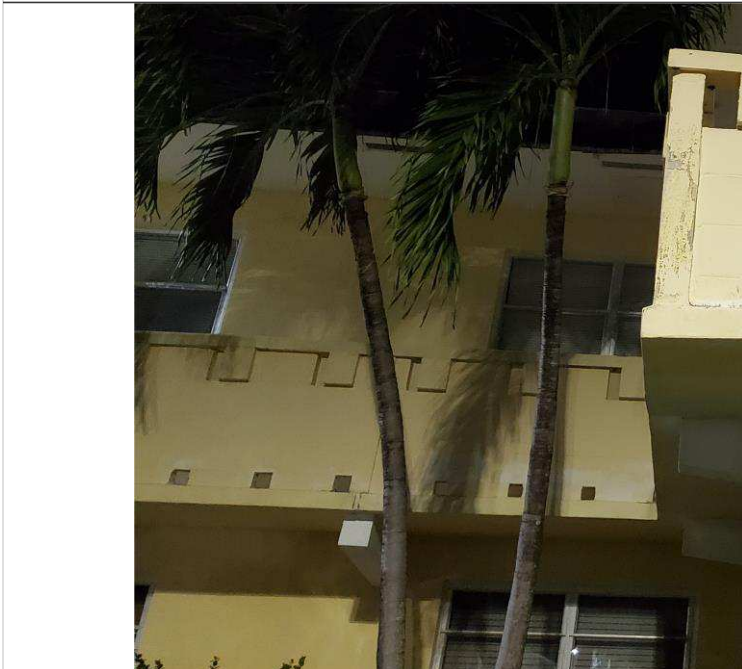
Photo 20 – Village of Dadeland Condominium Association

Points of Egress  
Poorly illuminated catwalks  
Exterior lights not functional.

No light fixture over section of the catwalk.

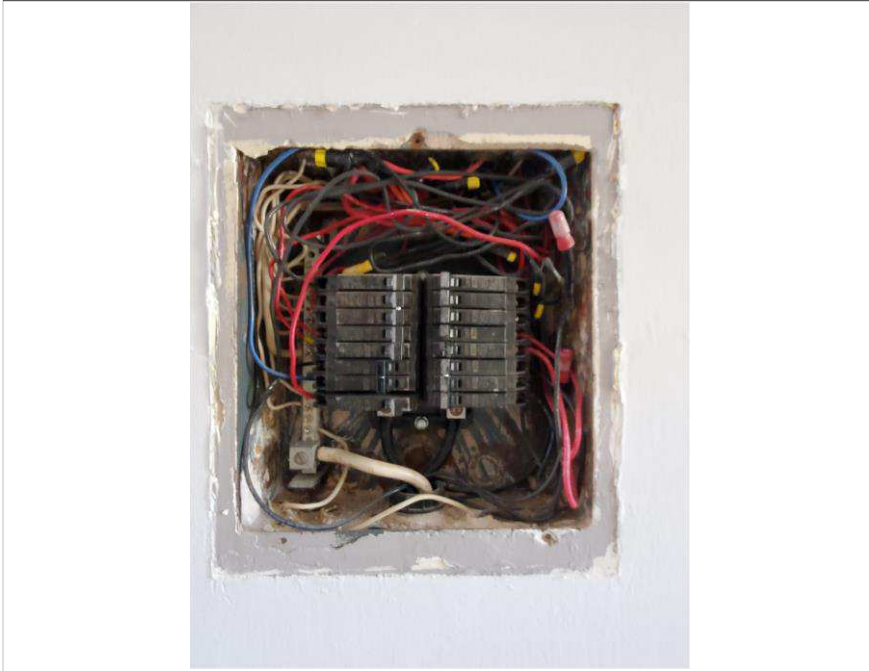
Photo 21 – Village of Dadeland Condominium Association

Apartments - Old Electrical  
Panels

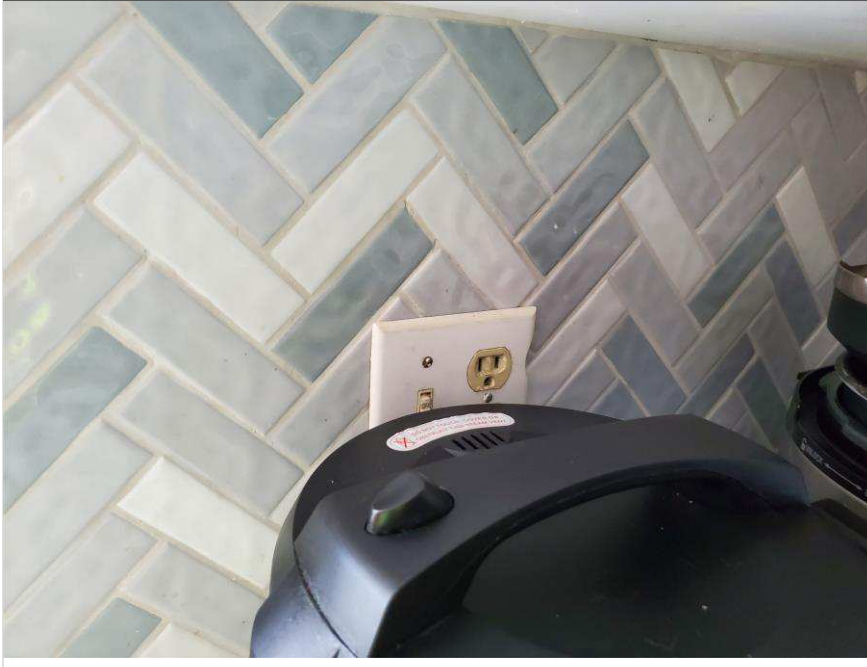
Photo 23 – Village of Dadeland Condominium Association

Apartments - Kitchen outlets  
not GFCI type.

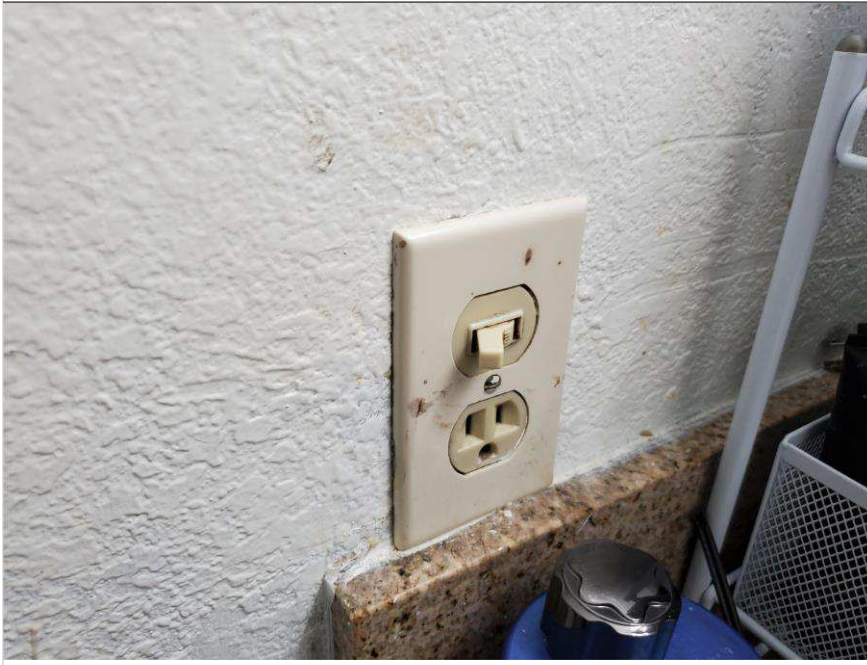
Photo 24 – Village of Dadeland Condominium Association

Apartments - Bathroom outlets  
not GFCI type.

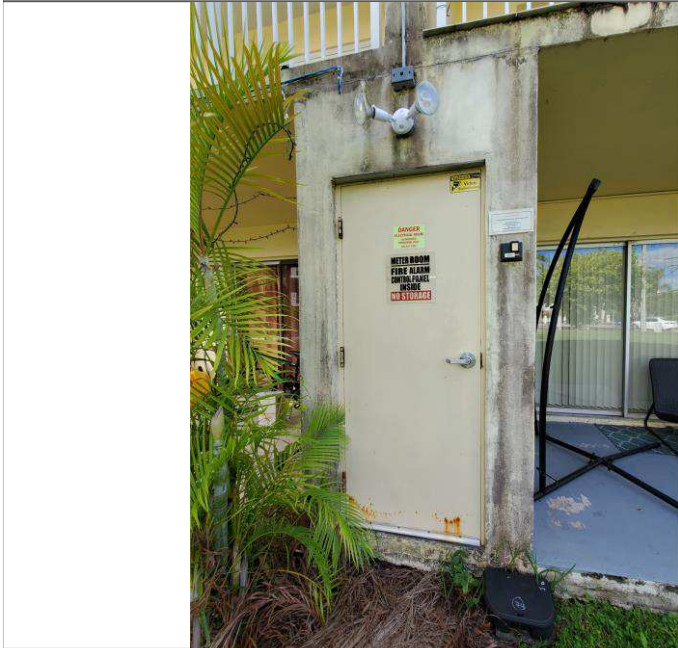
Photo 1 – Village of Dadeland Condominium Association

Existing Electrical Room - 1st FL  
Provide sign with Building  
Number

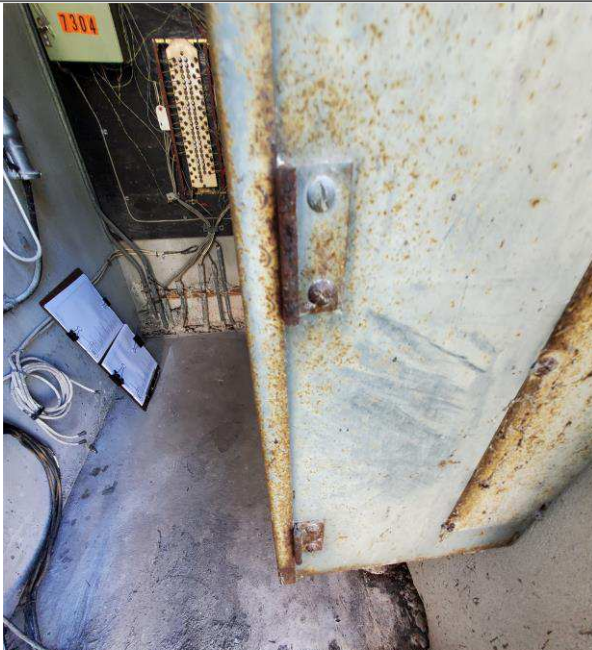
Photo 7 – Village of Dadeland Condominium Association

Existing Electrical Room - 1<sup>st</sup> FL  
Building Main Disconnect – Side  
View - corroded 50 year old  
electrical components.

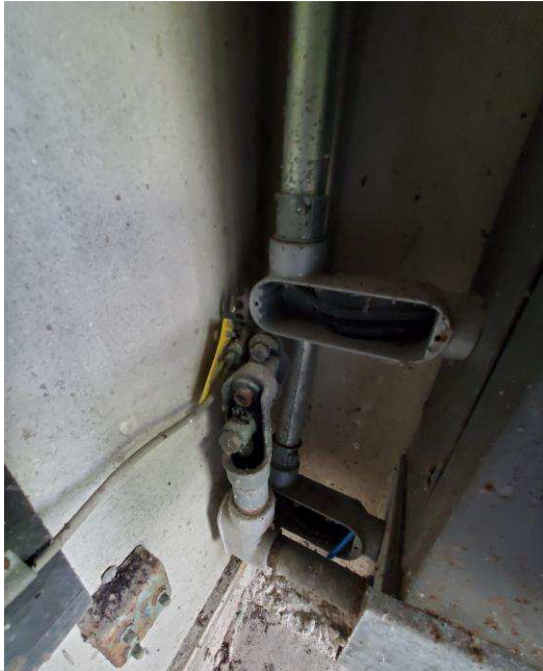
Photo 11 – Village of Dadeland Condominium Association

Existing Electrical Room - 1st FL  
Main Distribution – Grounding

Grounding resistance to be  
Tested to determine if repairs  
and /or maintenance are  
required.

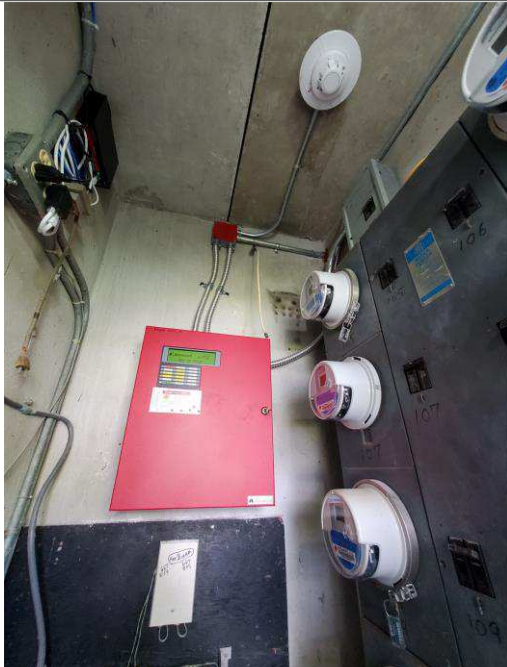
Photo 13 – Village of Dadeland Condominium Association

Comments: Fire Alarm panel located in Main Electric Room - Insufficient clearances - Repairs Required

Existing Electrical Room - 1st FL  
Fire Alarm Panel

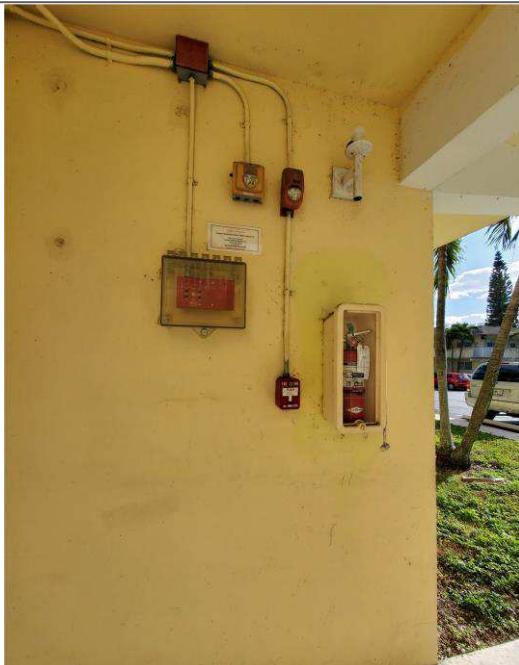
Photo 14 – Village of Dadeland Condominium Association

Level 1  
Fire Alarm - Old and Weathered  
Fire Alarm Devices and Control  
Center

Old Strobe Horn/Strobe Device

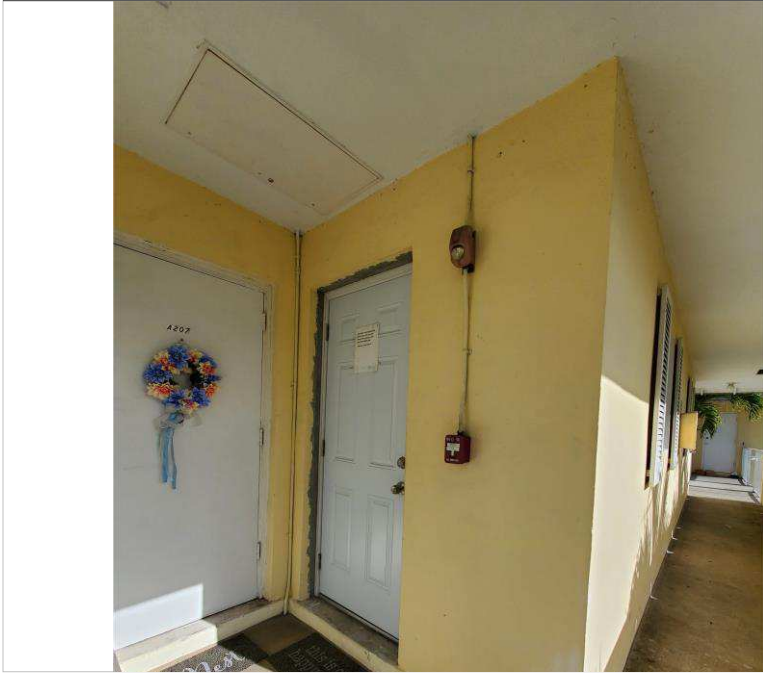
Photo 15 – Village of Dadeland Condominium Association

Level 2

Fire Alarm - Old and Weathered  
Fire Alarm Devices and Control  
Center

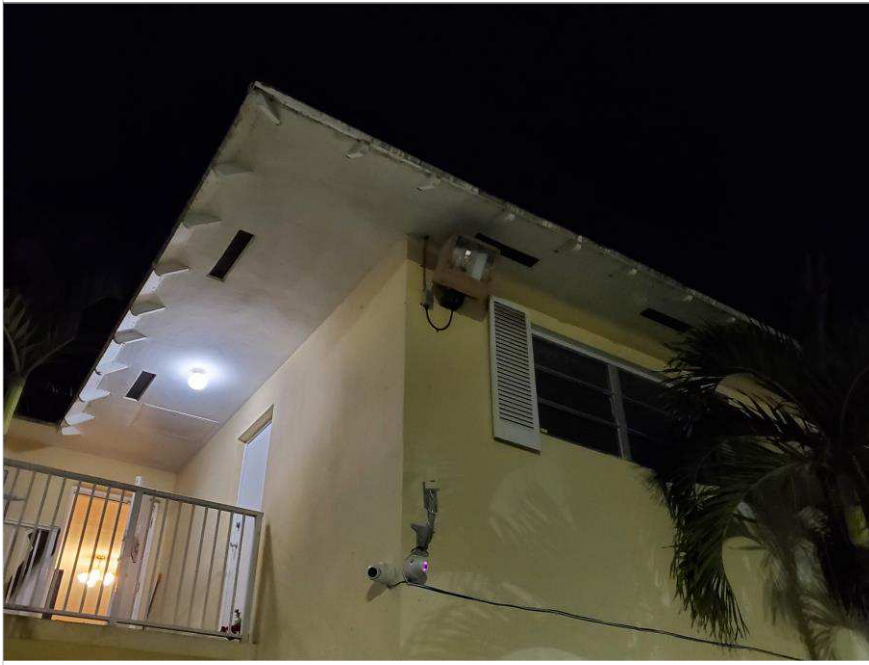
Photo 18 – Village of Dadeland Condominium Association

Parking - Poorly Illuminated Parking Areas

Parking Light is out or not functioning.

Exterior light not functional

Comments: Open parking areas have low illumination levels creating unsafe conditions and security concerns. Additional lighting is required to illuminate the parking walking surfaces for safety and security purposes. Parking light mounted on building is out - Repairs Required.

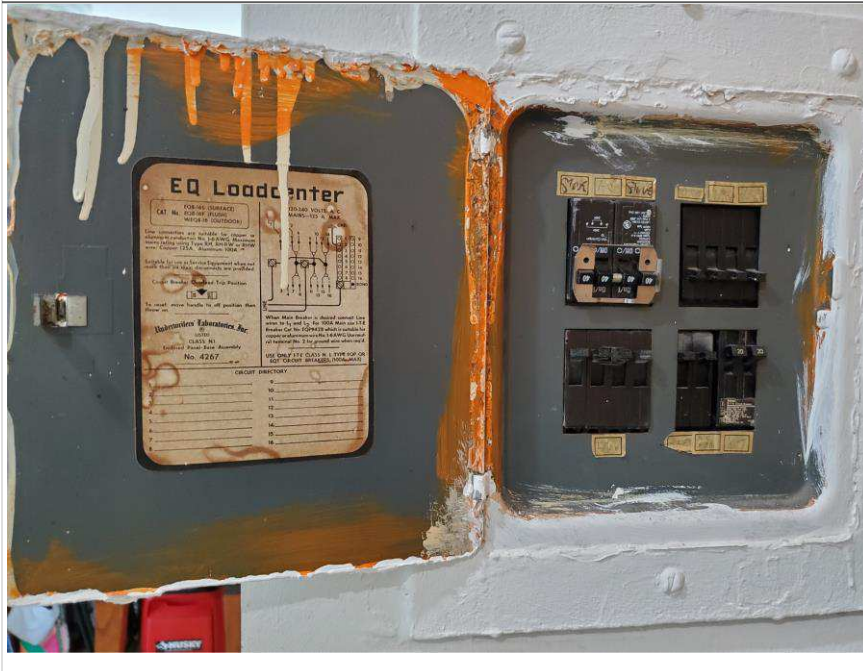
Photo 19 – Village of Dadeland Condominium Association

Apartments - Old Electrical  
Panels

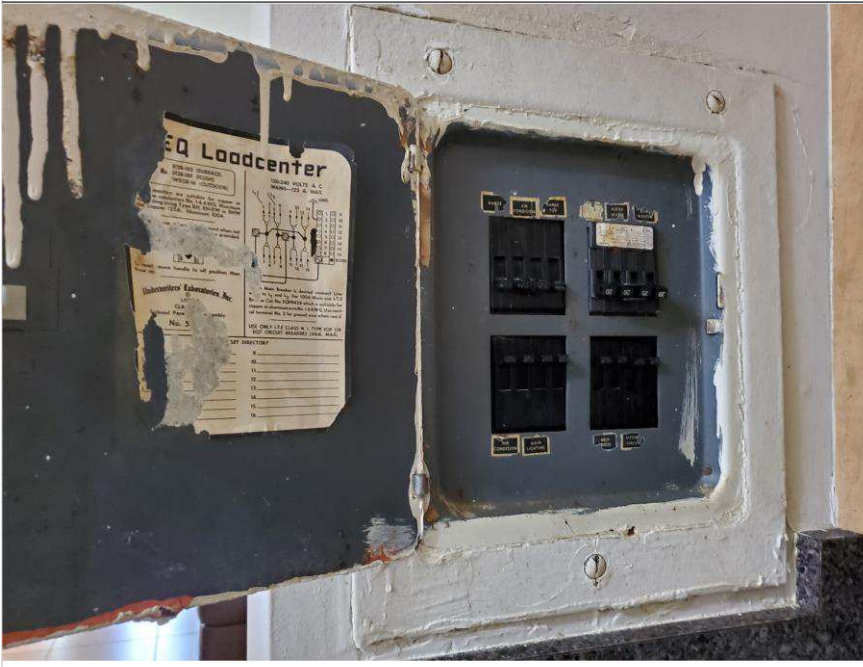
Photo 20 – Village of Dadeland Condominium Association

Apartments - Old Electrical  
Panels

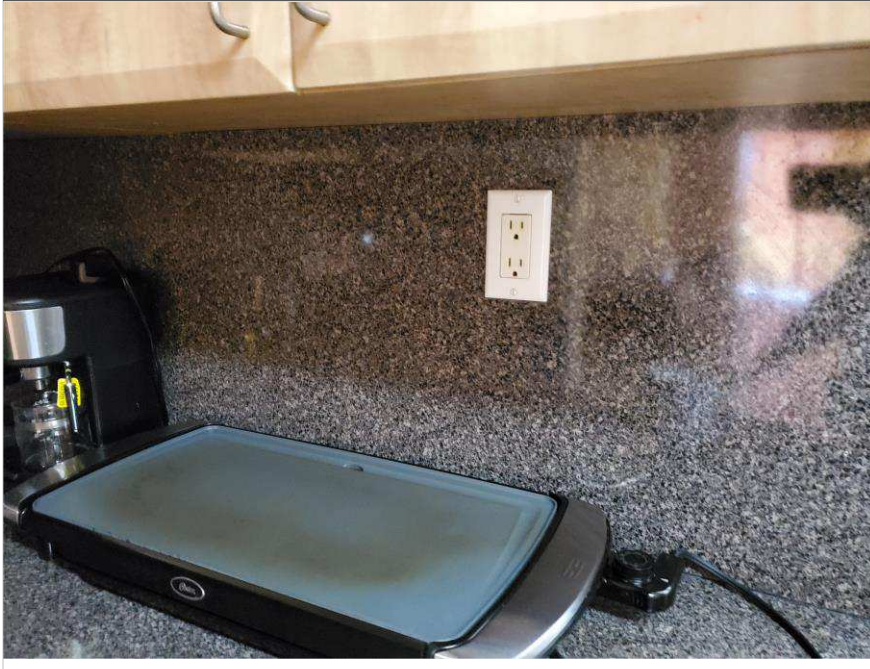
Photo 21 – Village of Dadeland Condominium Association

Apartments - Kitchen Outlets  
Not GFCI type.

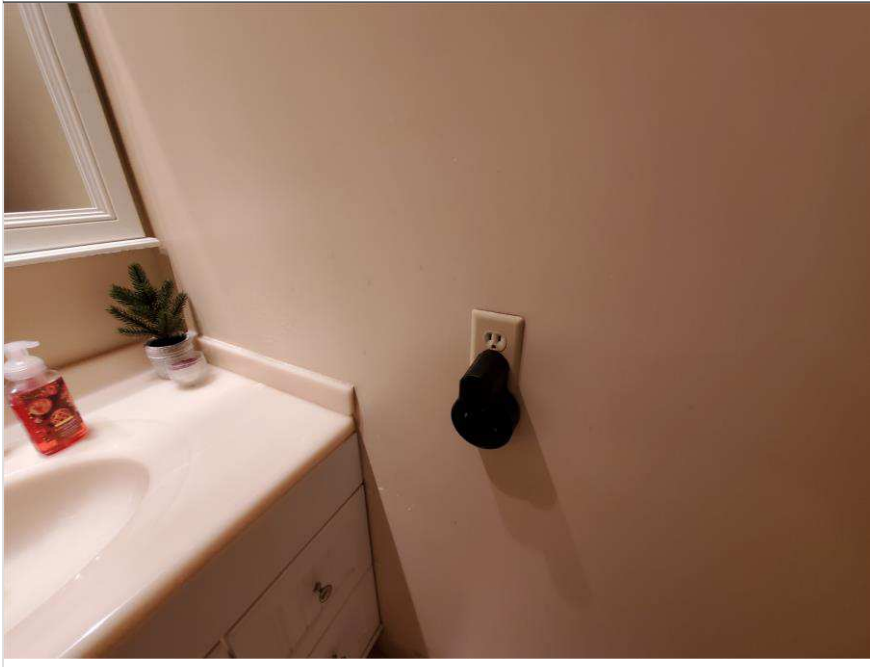
Photo 22 – Village of Dadeland Condominium Association

Apartments - Bathroom Outlets  
not GFCI type.

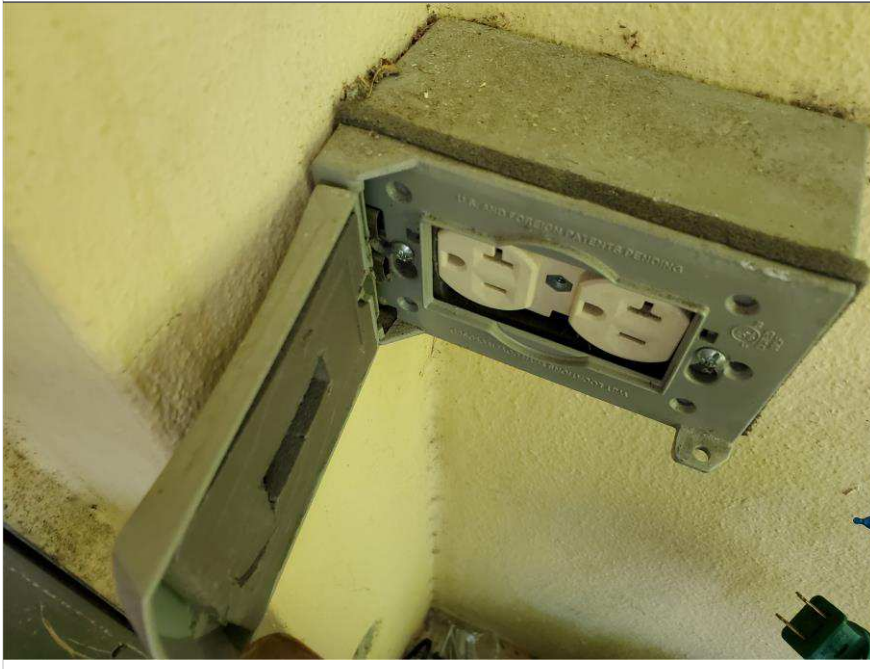
Photo 23 – Village of Dadeland Condominium Association

Apartments - Balcony Outlets  
not GFCI type.

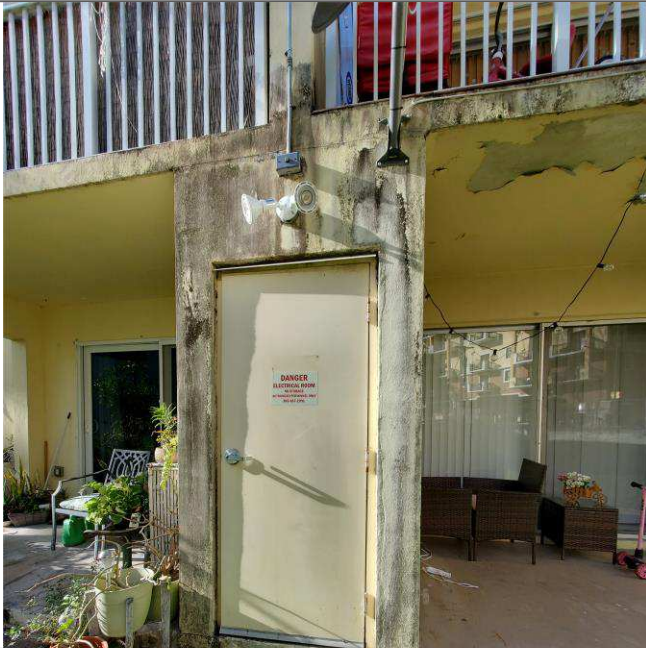
Photo 1 – Village of Dadeland Condominium Association

Existing Electrical Room - 1st FL  
No Storage Permitted

Building Number sign is missing.

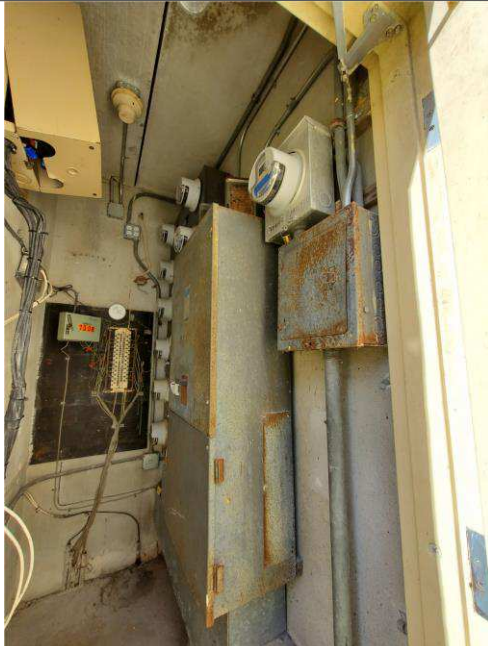
Photo 3 – Village of Dadeland Condominium Association

Existing Electrical Room - 1st FL  
Main Disconnect and Meter  
Stacks

Old smoke detector.

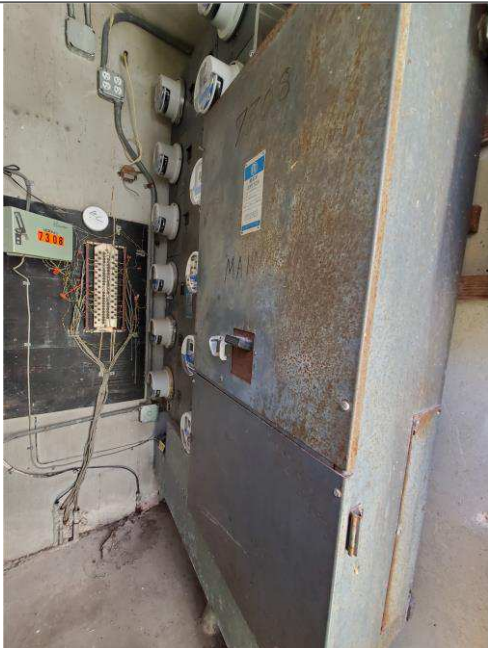
Photo 4 – Village of Dadeland Condominium Association

Existing Electrical Room - 1st FL  
Building Main Disconnect is  
corroded.

50 year old electrical  
component.

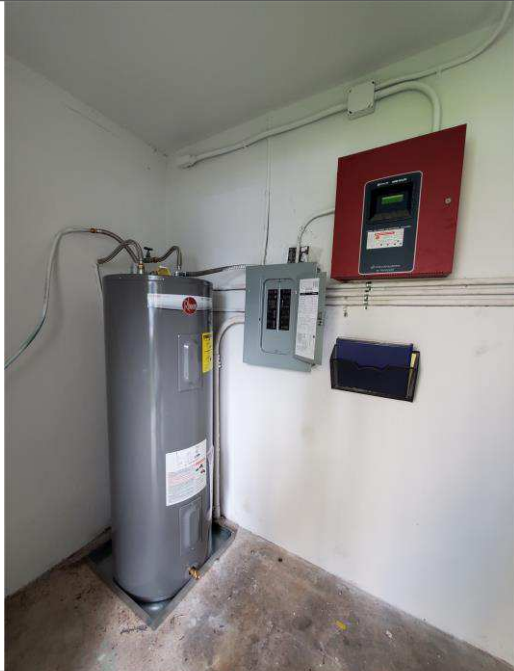
Photo 15 – Village of Dadeland Condominium Association

1st FL - Laundry/Water Heater  
Room  
Fire Alarm Panel

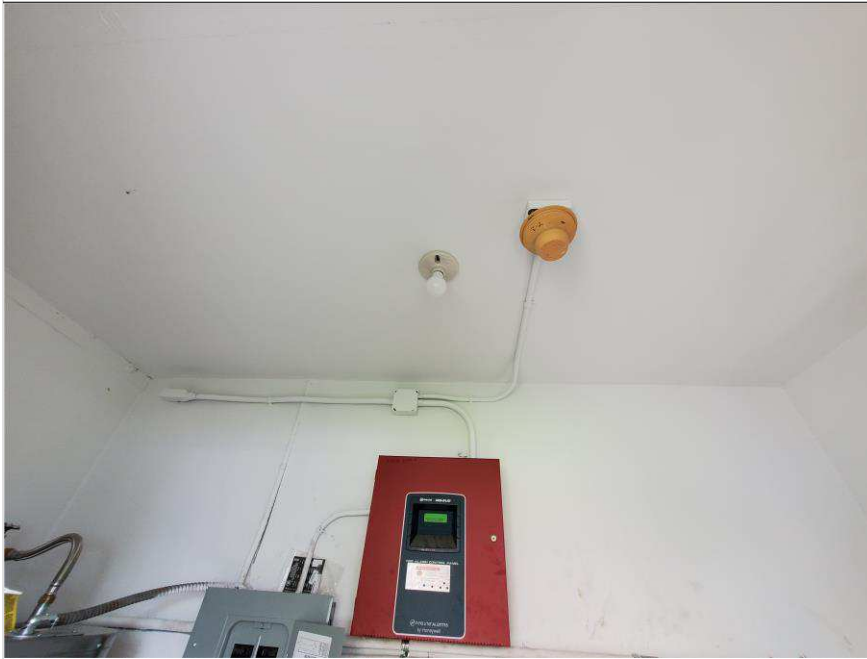
Photo 16 – Village of Dadeland Condominium Association

1st FL - Laundry/Water Heater  
Room  
Old and Fire Alarm Devices

Old Smoke Alarm Device

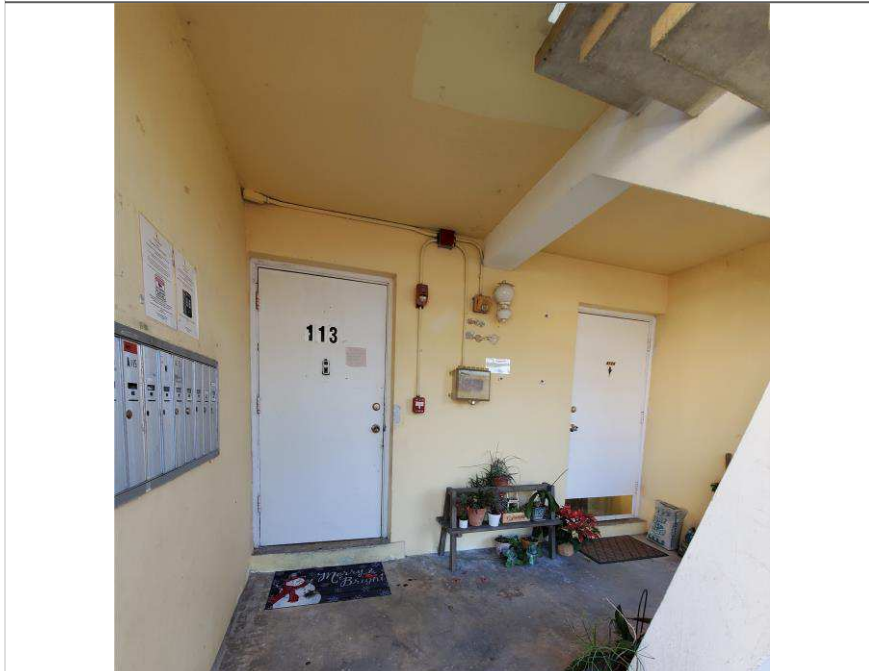
Photo 17 – Village of Dadeland Condominium Association

Level 1

Fire Alarm - Old and Weathered  
Fire Alarm Devices and Control  
Center

Old Strobe Horn/Strobe Device  
and Pull Stations

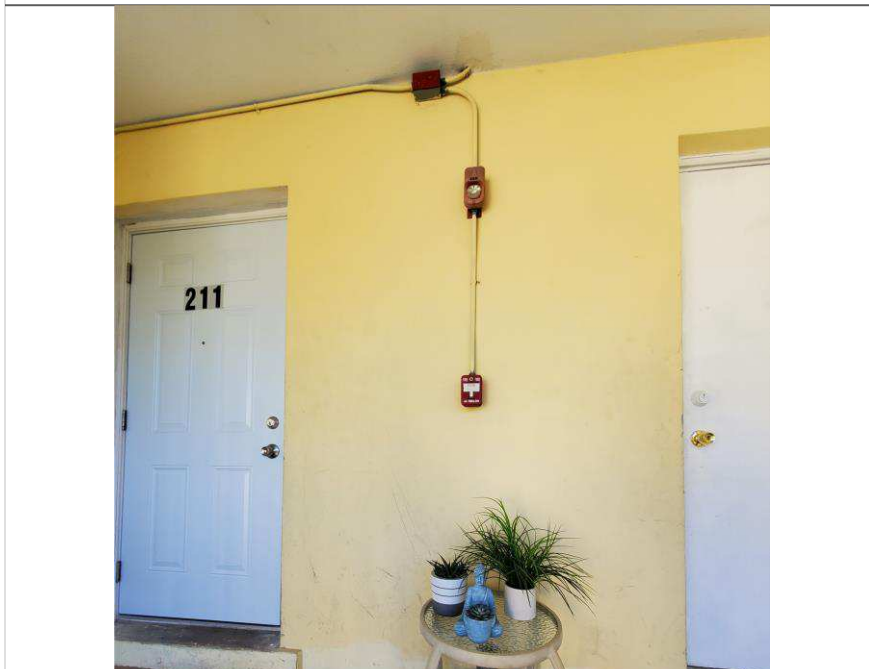
Photo 18 – Village of Dadeland Condominium Association

Level 2

Fire Alarm - Old and Weathered  
Fire Alarm Devices and Control  
Center

Old Strobe Horn/Strobe Device  
and Pull Stations

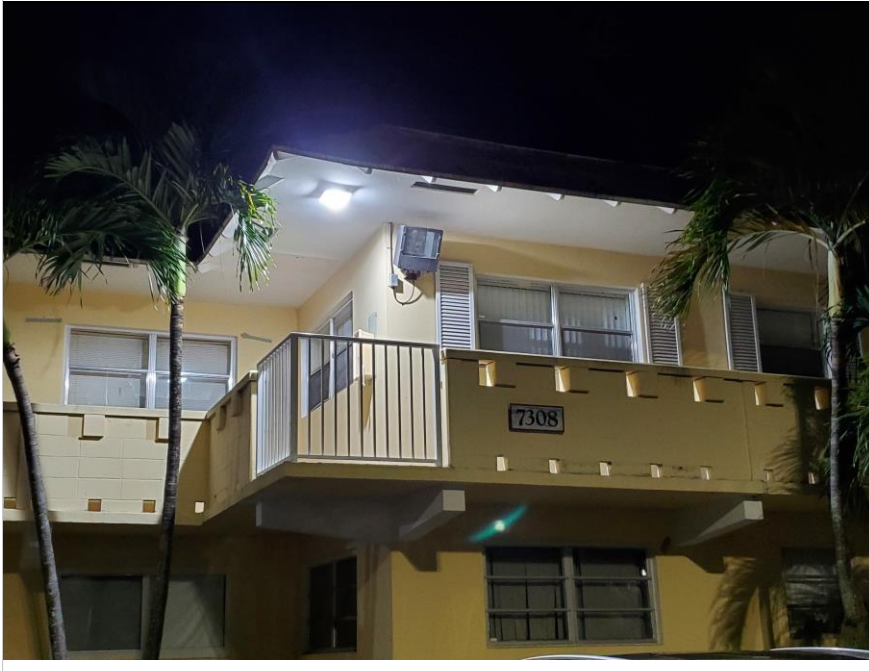
Photo 19 – Village of Dadeland Condominium Association

Points of Egress/Parking

Poorly illuminated points of egress.

Exterior lights not functional

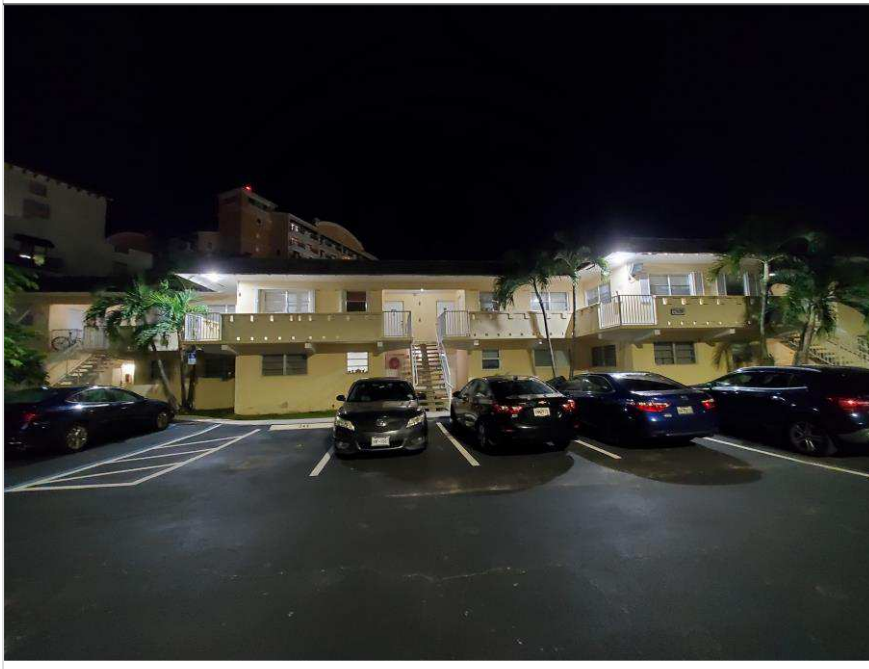
Photo 20 – Village of Dadeland Condominium Association

Parking

Poorly illuminated sidewalks and parking areas.

Exterior lights not functional.

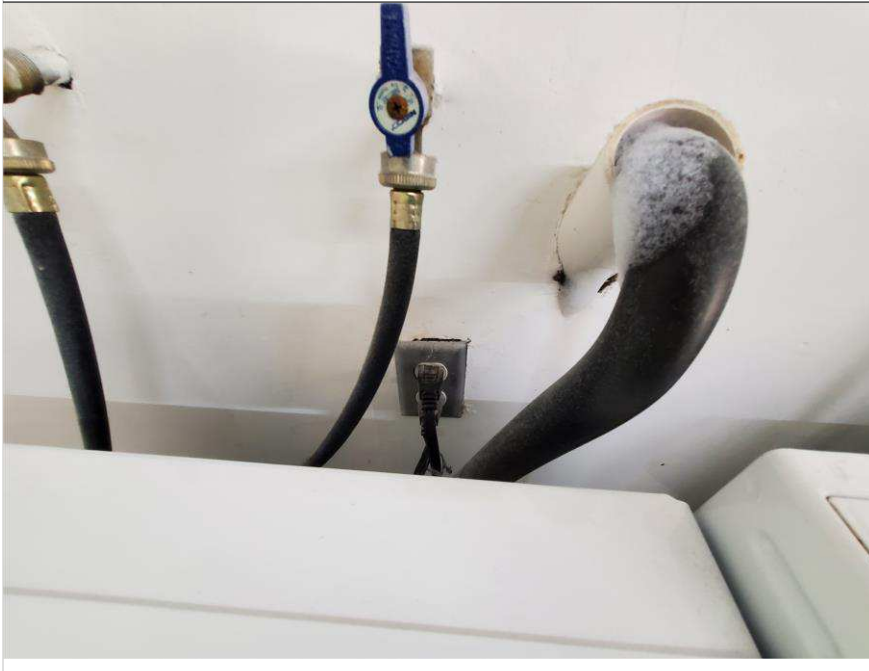
Photo 21 – Village of Dadeland Condominium Association

Laundry Room - Outlets are not GFCI type.

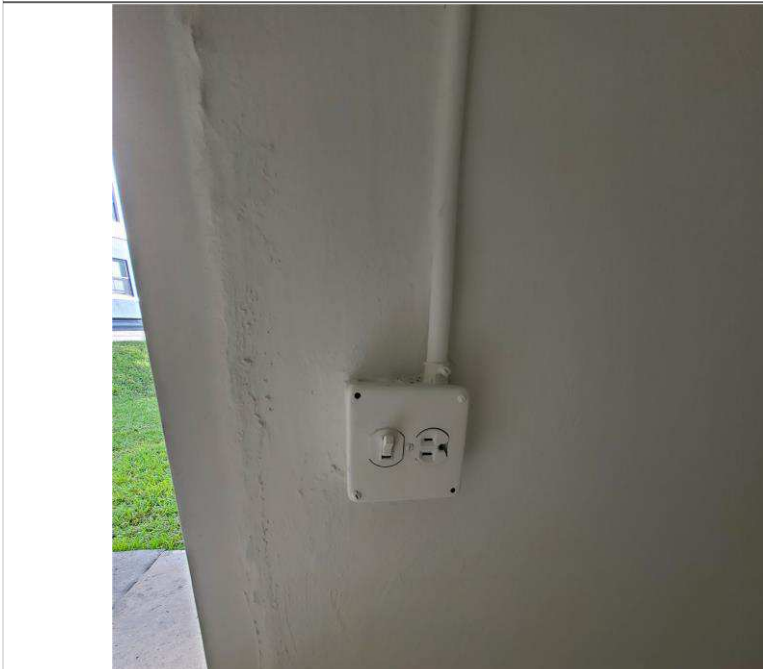
Photo 22 – Village of Dadeland Condominium Association

Laundry Room - Water Heater Room

Outlet is not a GFCI type.

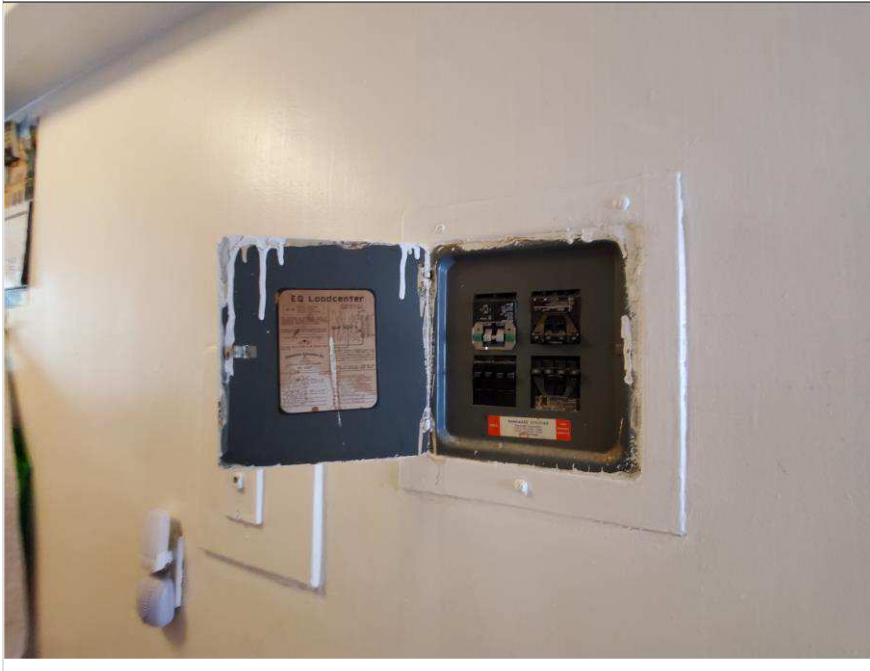
Photo 23 – Village of Dadeland Condominium Association

Apartments - Old Electrical  
Panels

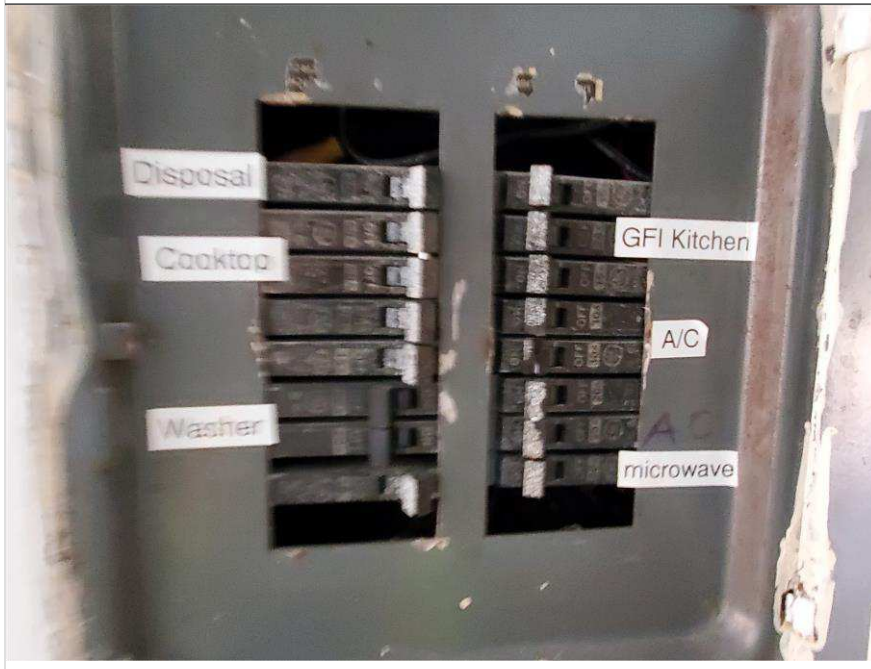
Photo 24 – Village of Dadeland Condominium Association

Apartments - Old Electrical  
Panels

Open breaker slots to be closed.

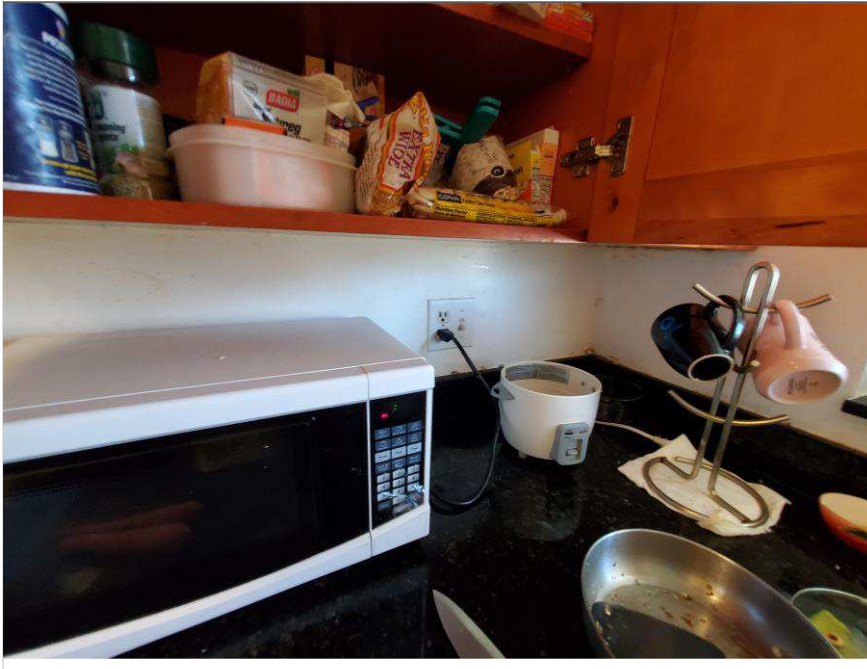
Photo 25 – Village of Dadeland Condominium Association

Apartments - Kitchen outlets  
not GFCI type.

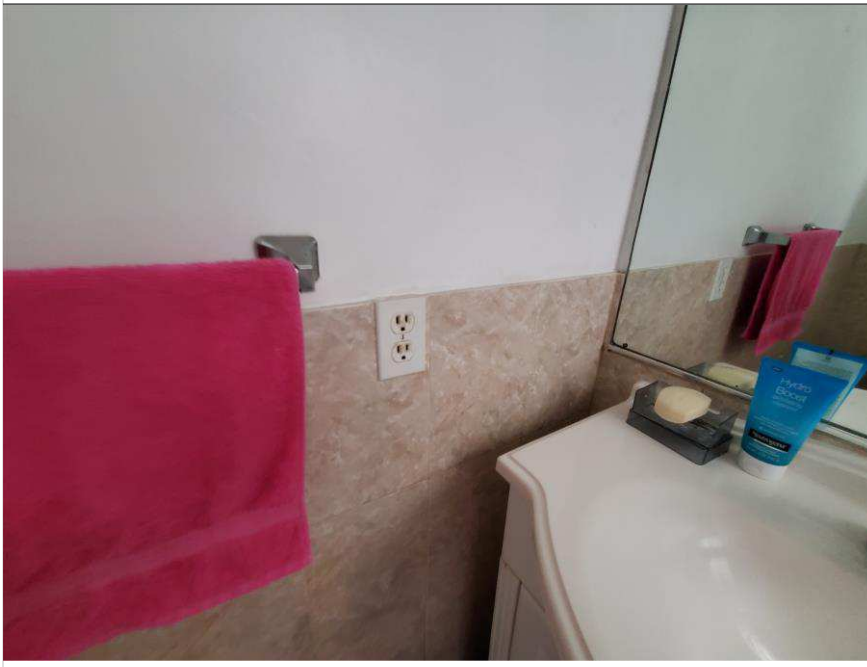
Photo 26 – Village of Dadeland Condominium Association

Apartments - Bathroom Outlets  
not GFCI type.

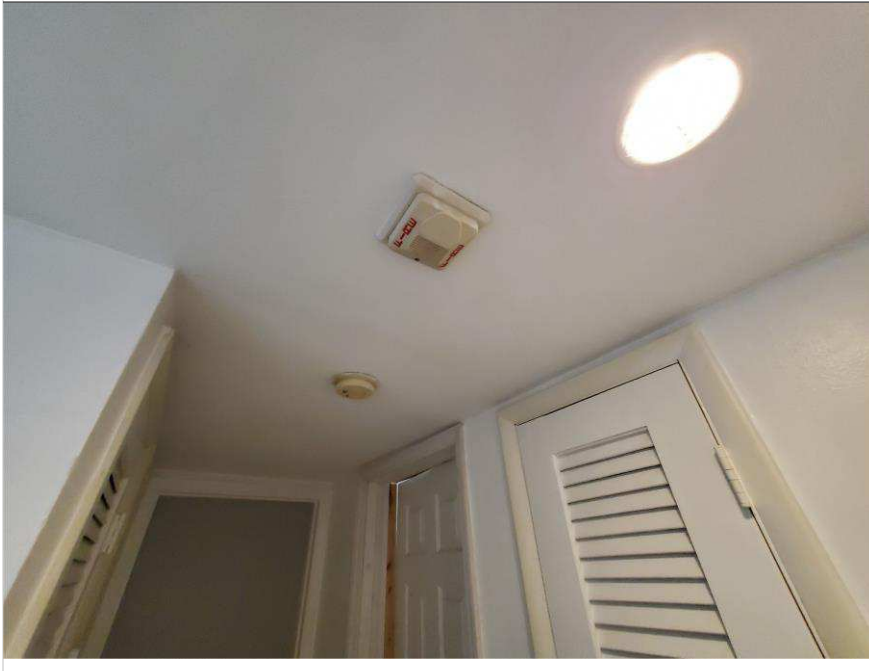
Photo 27 – Village of Dadeland Condominium Association

Apartments - Old Smoke Detectors

Old Smoke Detectors to be replaced.

Old Fire Alarm devices that have exceeded their useful life to be replaced.

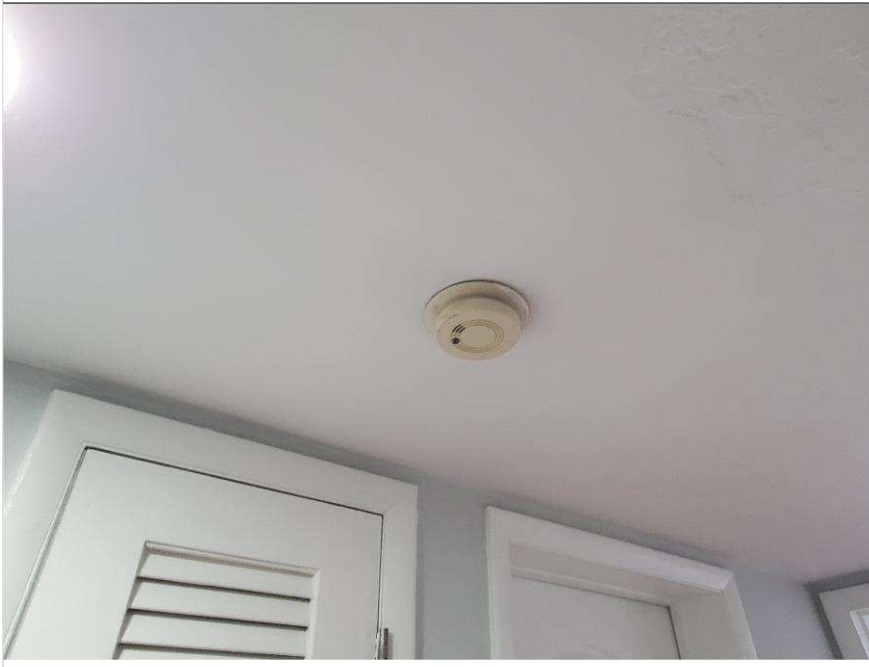
Photo 28 – Village of Dadeland Condominium Association

Apartments - Old Smoke Detectors

Old Smoke detectors to be replaced.

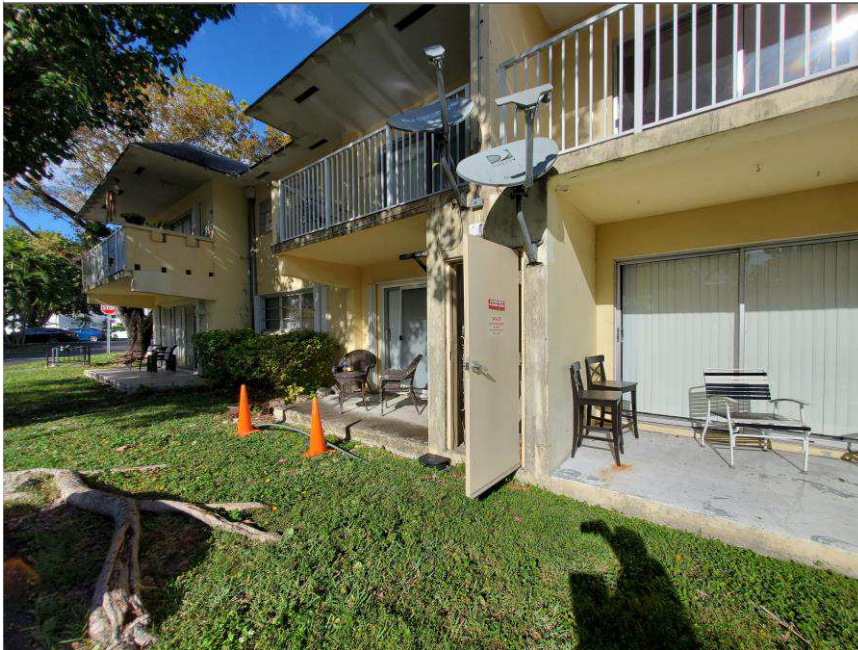
Photo 1 – Village of Dadeland Condominium Association

Existing Electrical Room - 1st FL  
No Storage Permitted

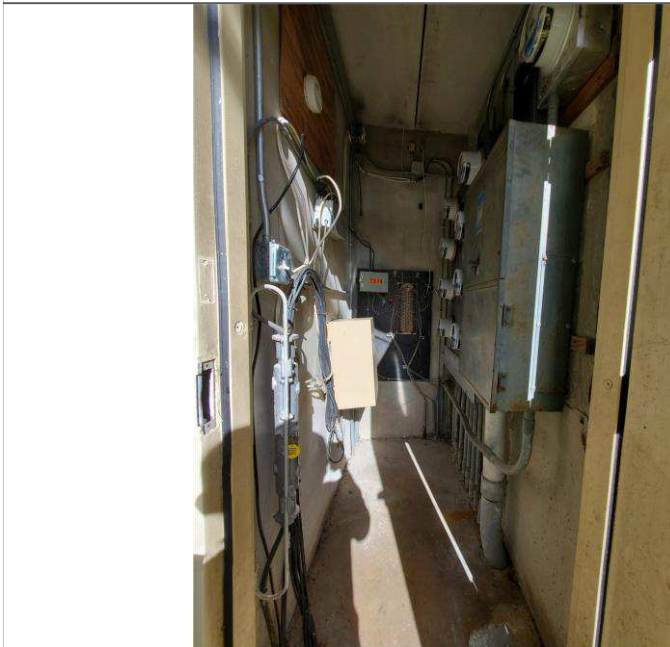
Photo 2 – Village of Dadeland Condominium Association

Existing Electrical Room - 1<sup>st</sup> FL  
Main Switches for Apartments,  
Meters, and Gutter.

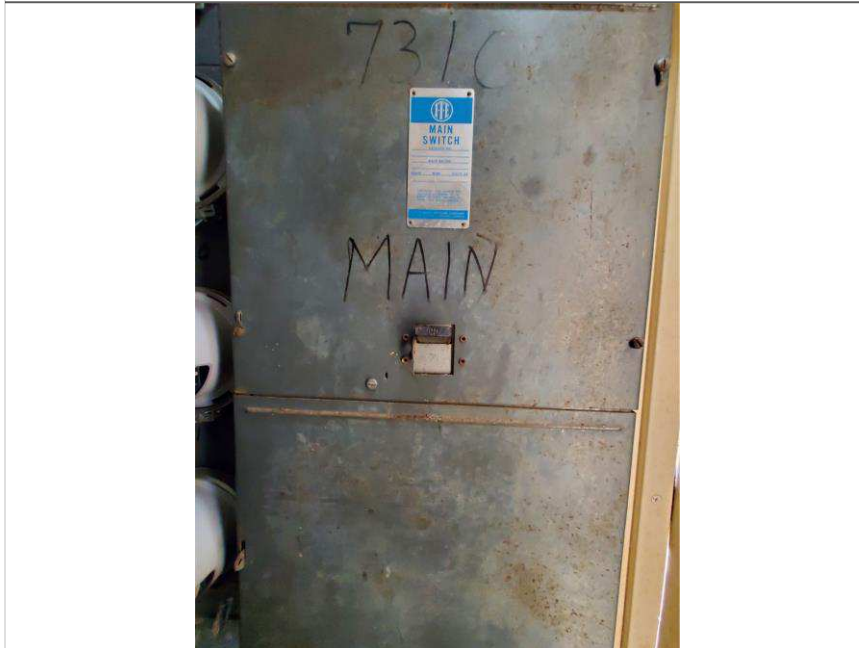
Photo 3 – Village of Dadeland Condominium Association

Existing Electrical Room - 1st FL  
Main Disconnect
