DEPARTMENT OF REGULATORY  
AND ECONOMIC RESOURCES

MINIMUM INSPECTION PROCEDURAL GUIDELINES  
FOR BUILDING ELECTRICAL RECERTIFICATION

- a. Name on Title: Village at Dadeland Condominiums (A)
- b. Street Address: 7300 SW 82nd St. Miami, Florida 33143
- c. Legal Description: Village at Dadeland Condominiums
- d. Owner's Name: Village at Dadeland Condominiums
- e. Owner's Mailing Address: 7300 SW 82nd St. Miami, Florida 33143
- f. Folio Number of Property on which Building is Located: 30-4035-047-XXXX
- g. Building Code Occupancy Classification: R2 - Residential
- h. Present Use: Condominium, Residential
- i. General Description, Type of Construction, Size, Number of Stories, and Special Features

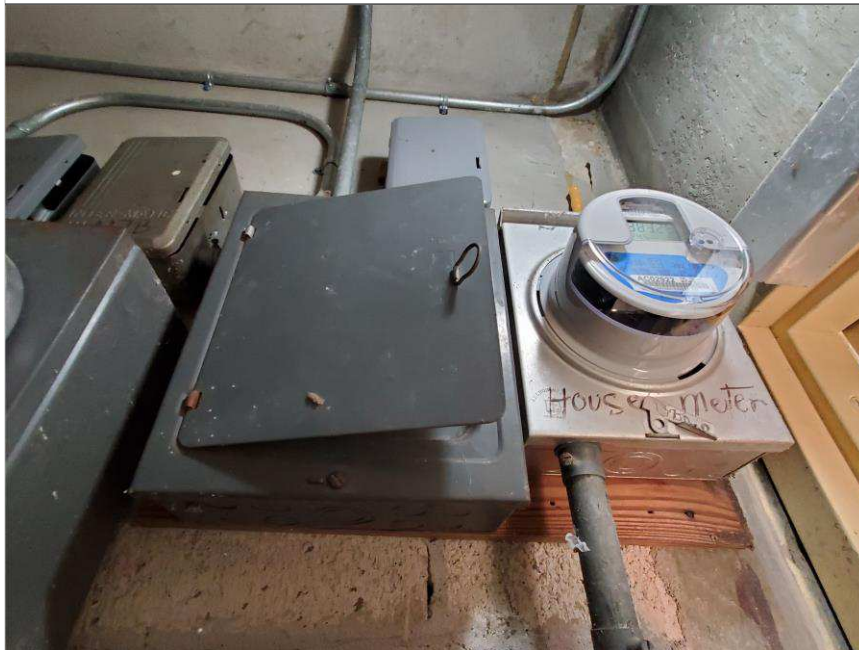
Photo 4 – Village of Dadeland Condominium Association

Existing Electrical Room - 1st FL  
House Meter and Panel Board.  
50 year old electrical  
component.

Oxidized time clock

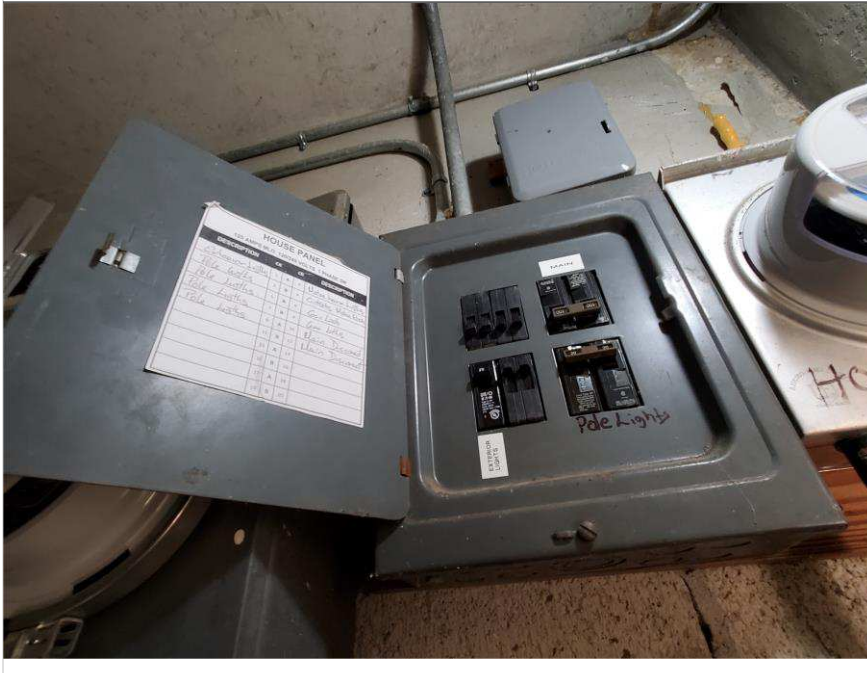
Photo 5 – Village of Dadeland Condominium Association

Existing Electrical Room - 1st FL  
House Panel Board and breakers  
are oxidized.

50 year old electrical  
components.

Missing Name Plate Rating.

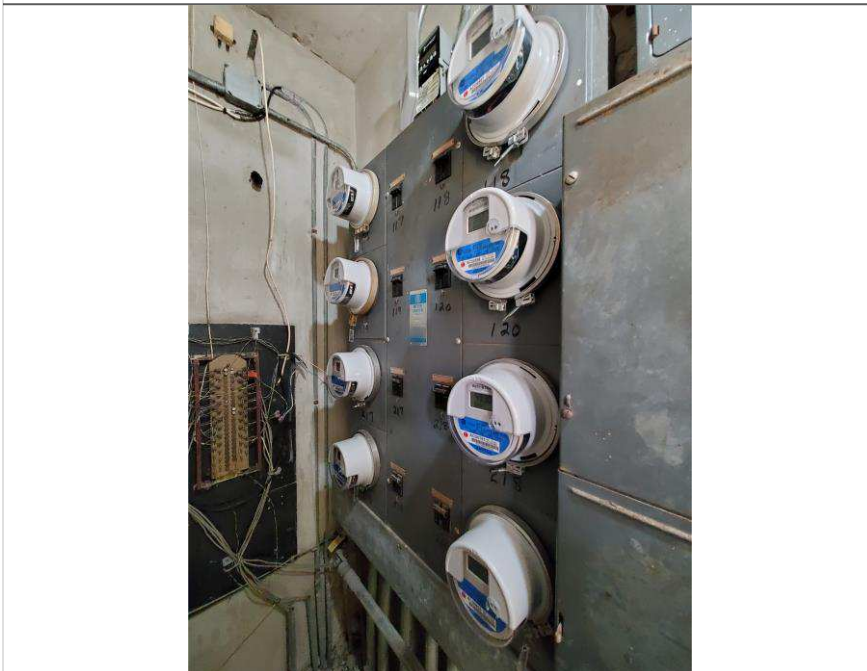
Photo 6 – Village of Dadeland Condominium Association

Existing Electrical Room - 1st FL  
Apartment Meters, Main  
Switches and Gutter

Old and corroded meter stacks.

Time clocks are installed too  
high.

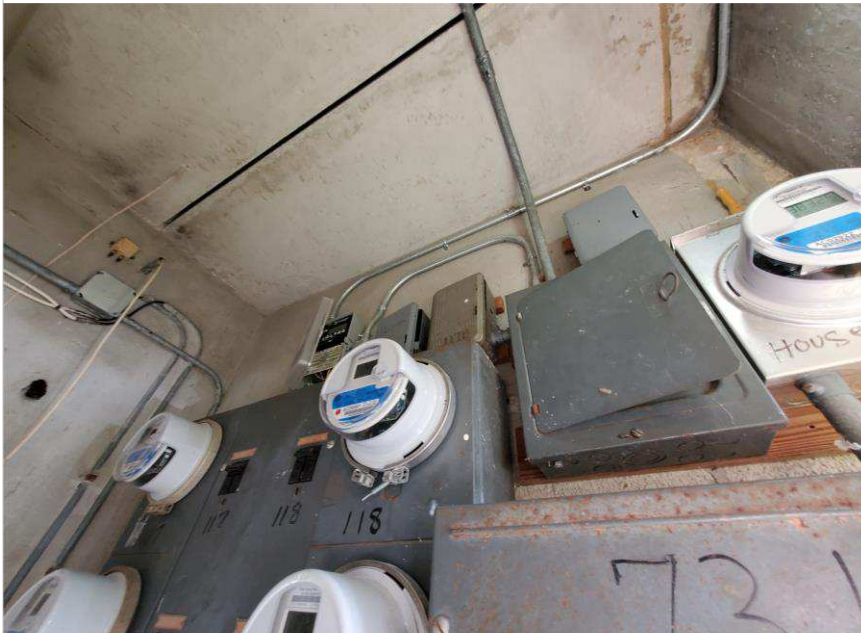
Photo 7 – Village of Dadeland Condominium Association

Existing Electrical Room - 1st FL  
Apartment Meters

Old and corroded meter stacks.

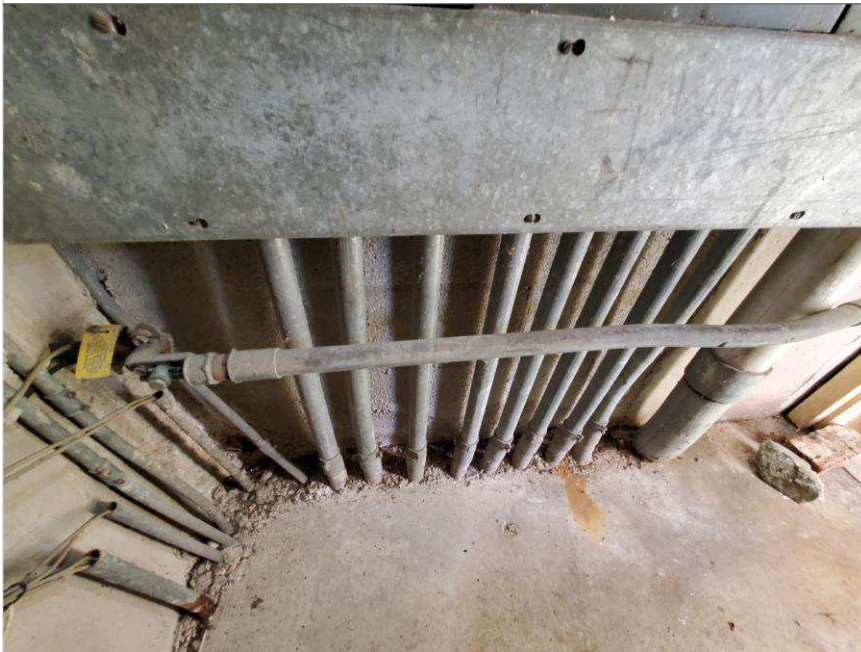
Photo 8 – Village of Dadeland Condominium Association

Existing Electrical Room - 1st FL  
Main Gutter

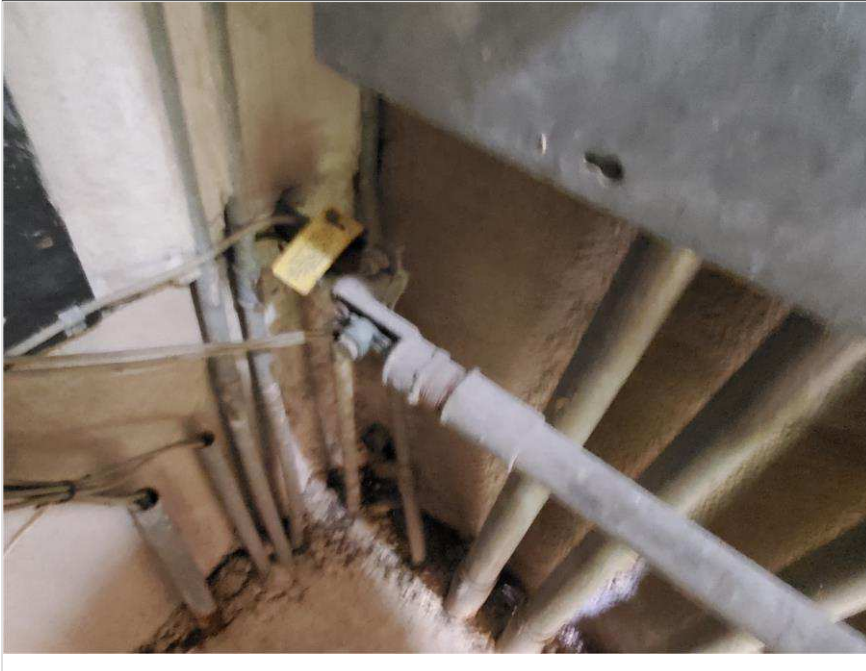
Photo 9 – Village of Dadeland Condominium Association

Comments: Observed corrosion and/or section loss at the ground bars. We recommend that grounding resistance to be tested by an electrician and repaired/replaced if necessary.

Existing Electrical Room - 1st FL  
Main Distribution - Grounding

Grounding resistance to be tested to determine if repairs and/or maintenance are required.

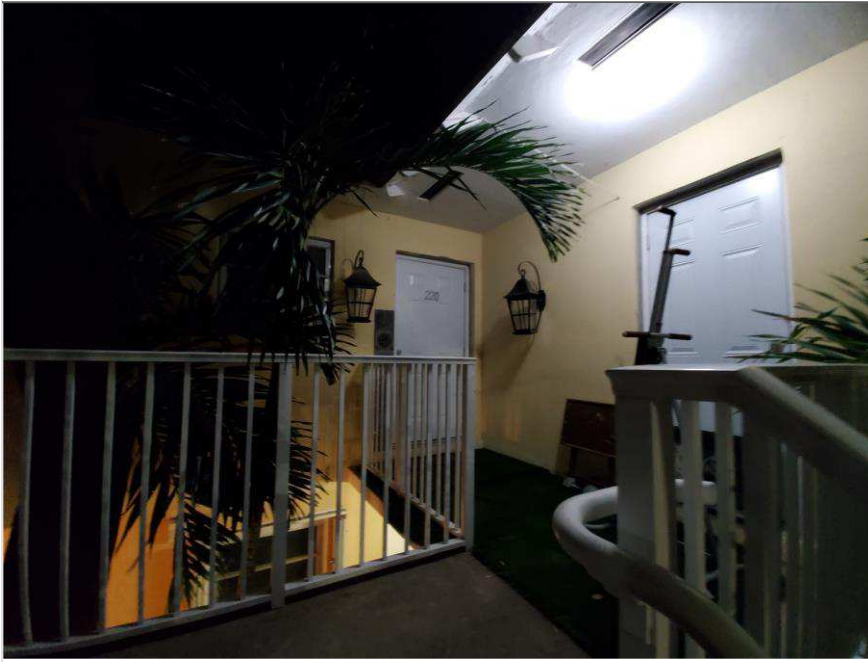
Photo 13 – Village of Dadeland Condominium Association

Comments: Light out at catwalk - Repairs Required

Points of Egress - Poorly illuminated Catwalks  
Exterior lights not functional.

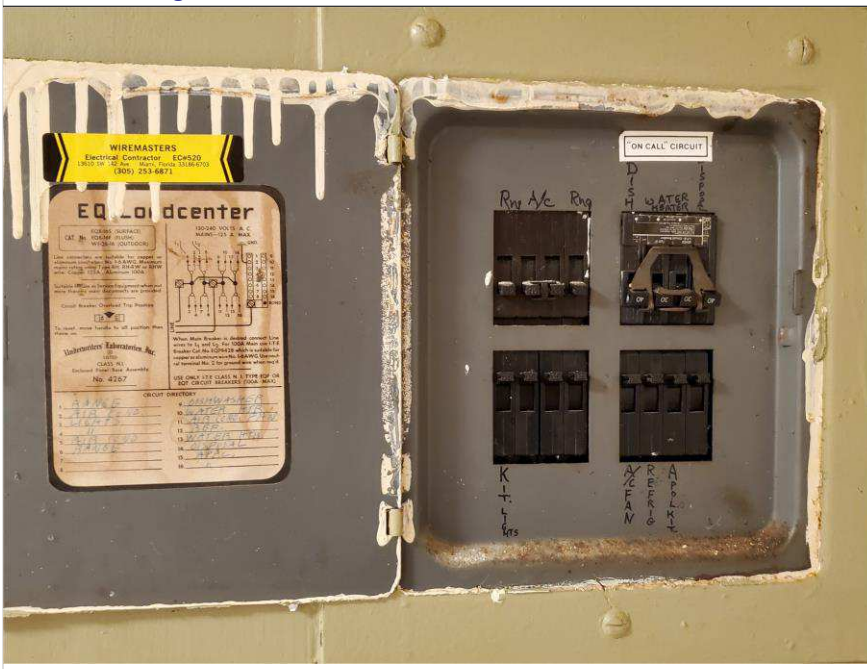
Photo 14 – Village of Dadeland Condominium Association

Apartments - Old Electrical Panels

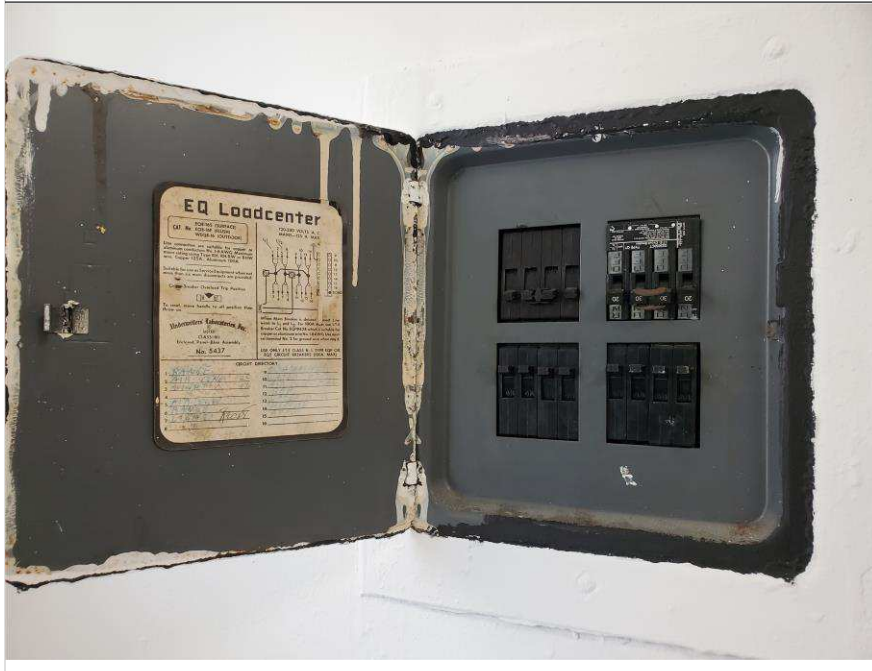
Photo 15 – Village of Dadeland Condominium Association

Apartments - Old Electrical Panels

Old oxidized breaker to be replaced.

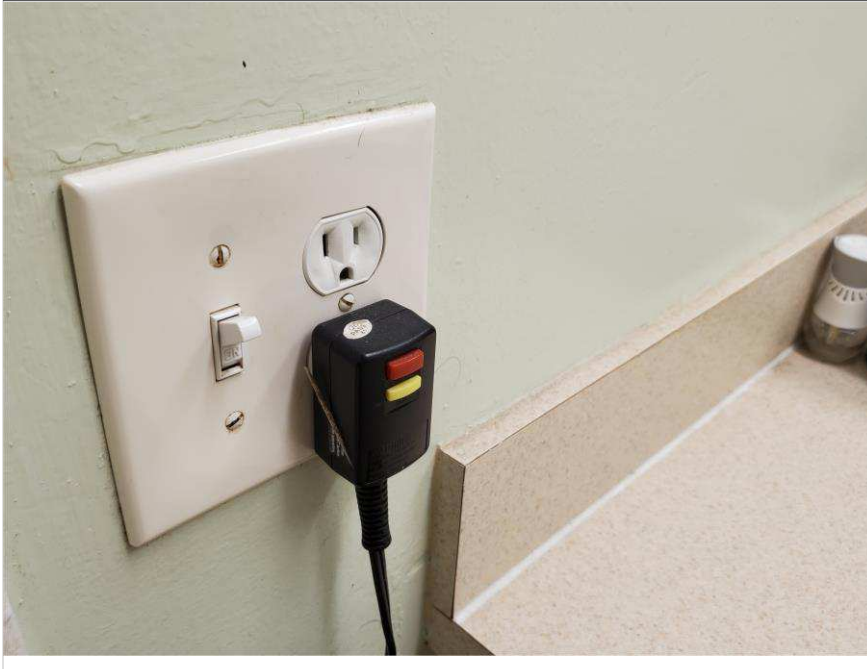
Photo 17 – Village of Dadeland Condominium Association

Apartments - Bathroom Outlets  
not GFCI type.

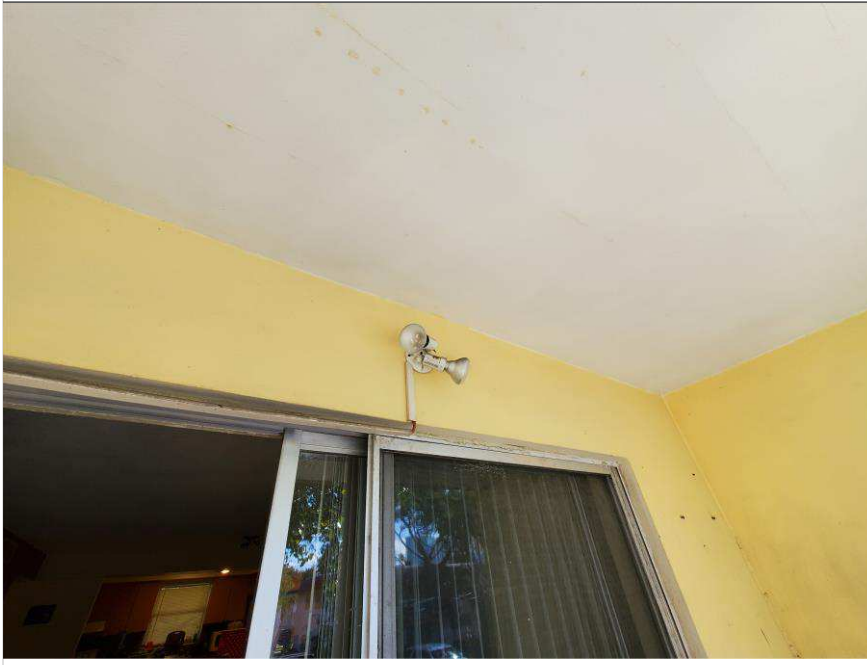
Photo 18 – Village of Dadeland Condominium Association

Apartments -  
Balcony/Patio light fixture is  
incorrectly wired.

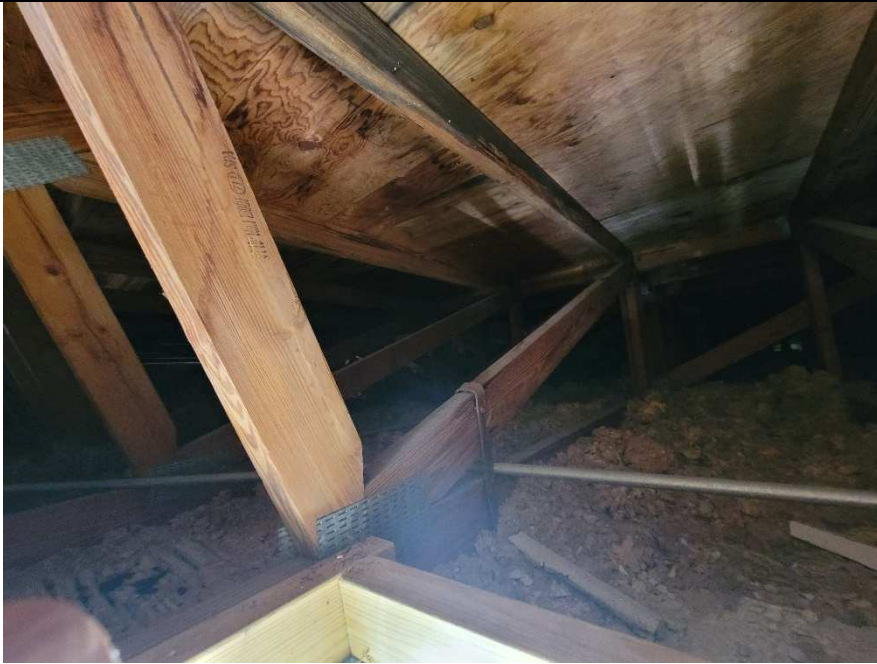
Photo #5:

Where accessible the roof structure was observed and found to be in fair condition.

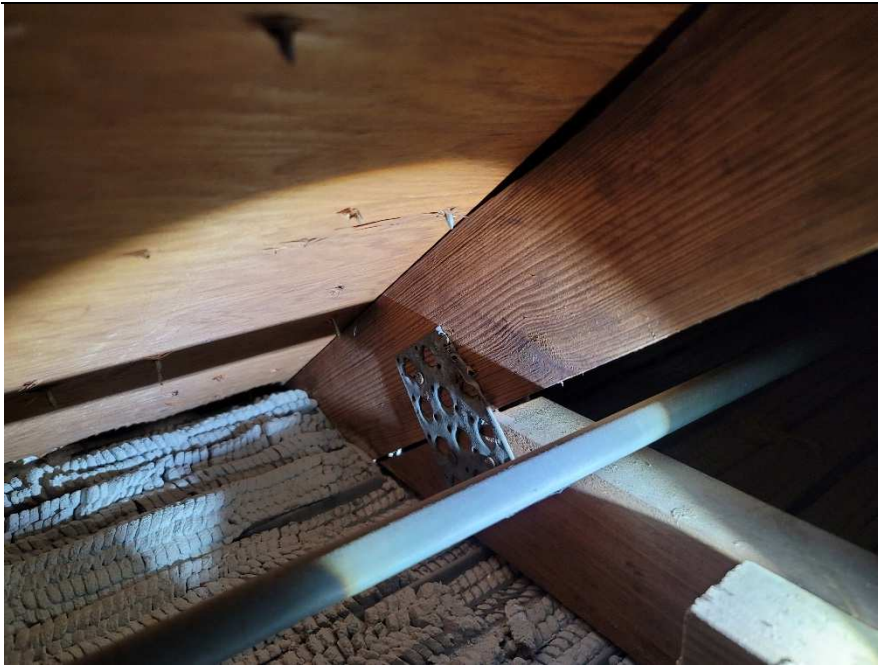
Photo #5:

Where accessible the roof structure was observed and found to be in fair condition.

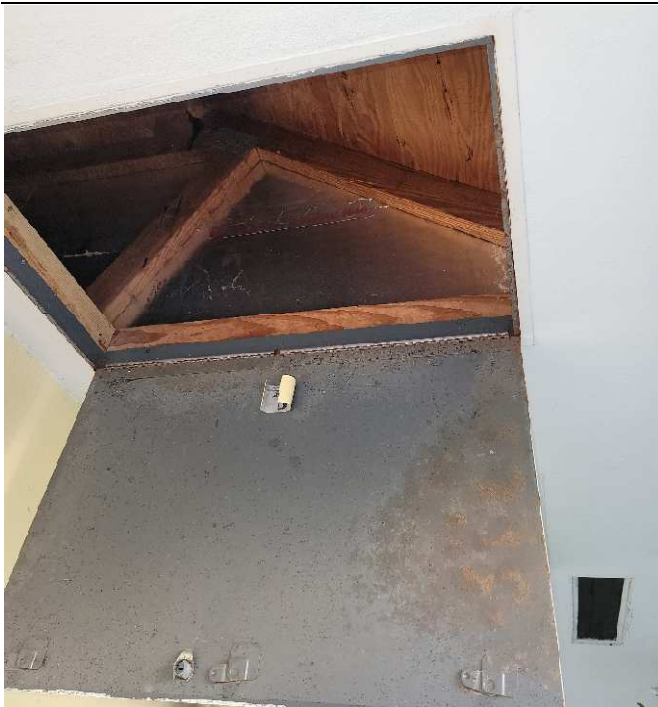
Photo #2:

Where accessible the roof structure was observed and found to be in fair condition

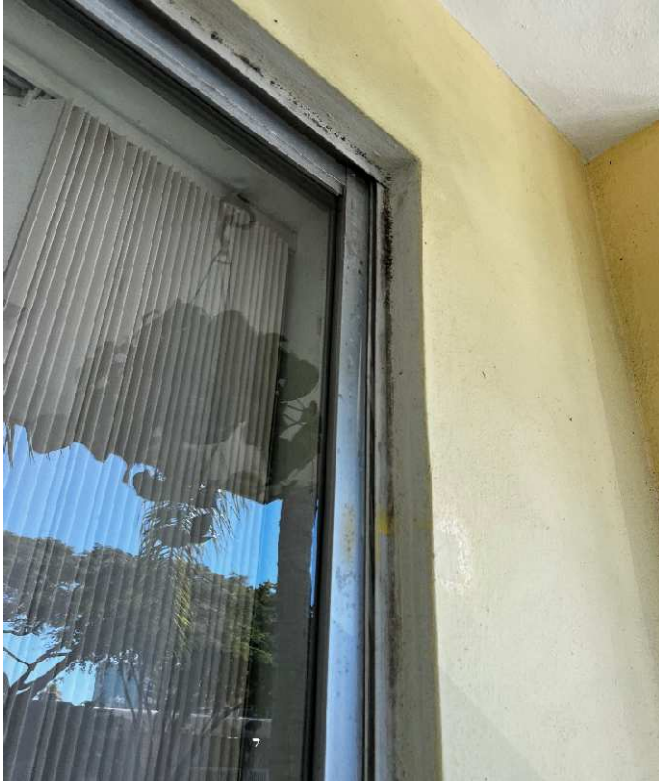
Photo #5:

Expired/ nonexistent sealant joint.
