TALCO
Home Inspection

Inspection Report

202 Scarborough Beach Road
Richmond KY 40475

Date: 3/14/2018	Time: 10:00 AM till 02:00 PM	Report ID: 180314KNUE
Property: 202 Scarborough Beach Road Richmond KY 40475	Customer: Ms. Sharon Anthony	Real Estate Professional:

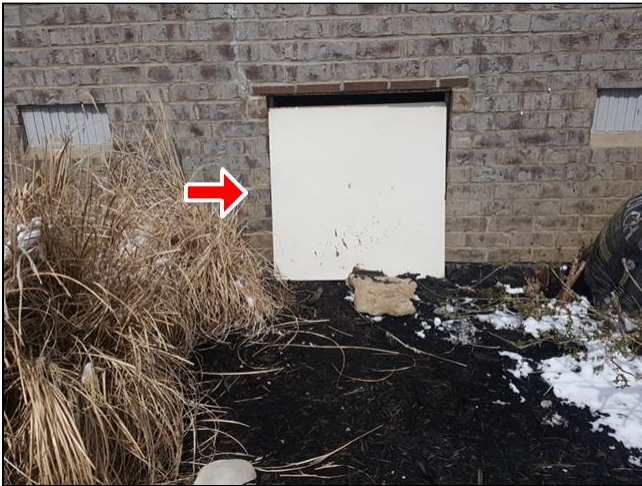
1.0 Item 1(Picture)

1.0 Access to the crawlspace is located at the rear left side of the home.

For safety, recommend a lock be installed on the crawlspace access door to prevent a child entering which could result in a injury or death occurring.

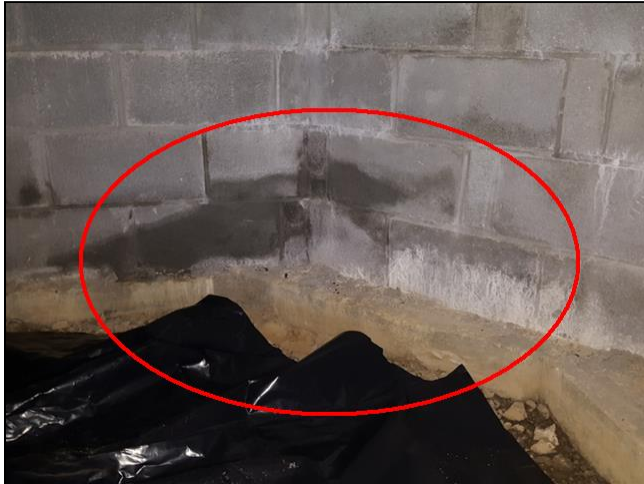
1.1 Item 1(Picture)

1.1 Efflorescence was found on the bottom courses of the block walls at the crawlspace at the rear right corner of the home which indicates moisture is in contact with the masonry. The white chemical deposits (Efflorescence) are caused by water evaporation from the exterior. This does not necessarily indicate that water intrusion is occurring in the crawlspace. I recommend checking the gutters and the downspout drain lines for proper operation. Also, a water proofing paint could be applied to the interior side of the block if necessary. Efflorescence is found on many homes without water intrusion occurring inside the home. But, it should alert you to the possibility that future steps may be needed.

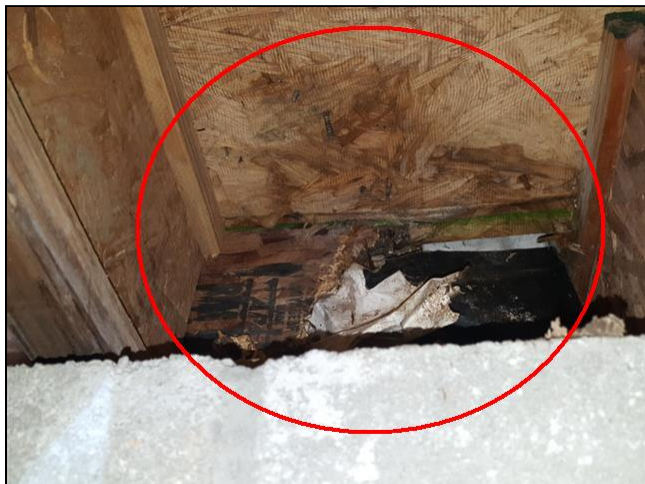
1.4 Item 1(Picture)

1.4 The band board is damp and partially missing in the crawlspace below the rear entry door area. It appears that water leakage has been occurring near the door frame which shows signs of previous repairs. I cannot determine if water leakage may still occur in this area. Water intrusion if not corrected can lead to other problems including mold and cause excessive moisture to floor system that can lead to deterioration and increased repair cost. Replacement of the missing band board maybe needed to support the sub floor in this area. Recommend a qualified contractor further evaluate to determine if water leakage is still occurring and to repair damaged area in the crawlspace.

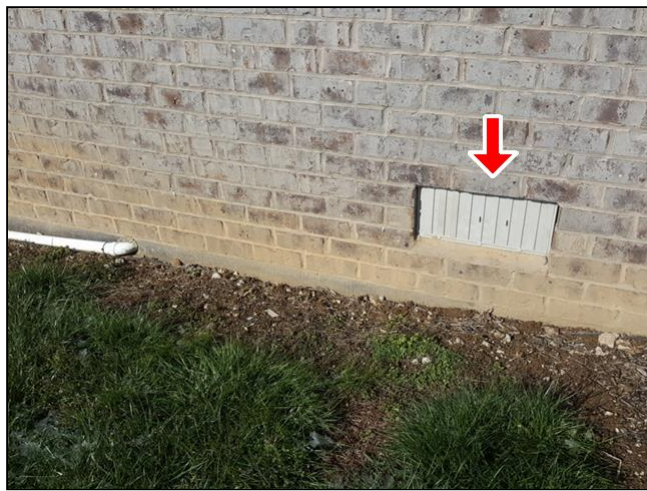
1.8 Item 2(Picture) left side of home

1.8 The vents have been sealed up in the crawl space. However the crawlspace has not been prepared encapsulation. Though there was no condensation noted at the time of the inspection, it is possible to have a dry crawlspace that is prepared for no ventilation however certain steps are required for this to be achieved. High humidity within the crawl could be experienced during certain times of the year which can cause condensation to form or cause joists to sag over time. Recommend this area be monitored during the seasons to see if condensation is occurring in the crawlspace and if so a qualified contractor should be consulted to eliminate cause. The vents may need to be opened. I would still recommend a qualified crawlspace contractor further evaluate the crawl to determine if other measures are required due to no ventilation. Opinions vary on whether or not your crawlspace should be ventilated.

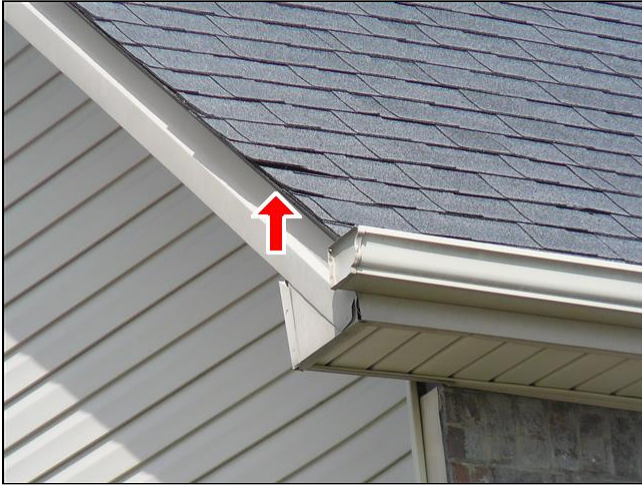
2.0 Item 1(Picture)

2.0 (1) The shingles on the roof at the rear of the home where indicated by the photo(s) are starting to lift and may not be secured correctly. The sealant of the shingle tab maybe failing. Shingle damage or roof leakage can occur at these areas. They are also at risk to be blown off by high winds. If the shingle is raised by more than 1/2" the nails should be reseted to prevent water entry under the shingles. Recommend a qualified roofing contractor repair as needed.

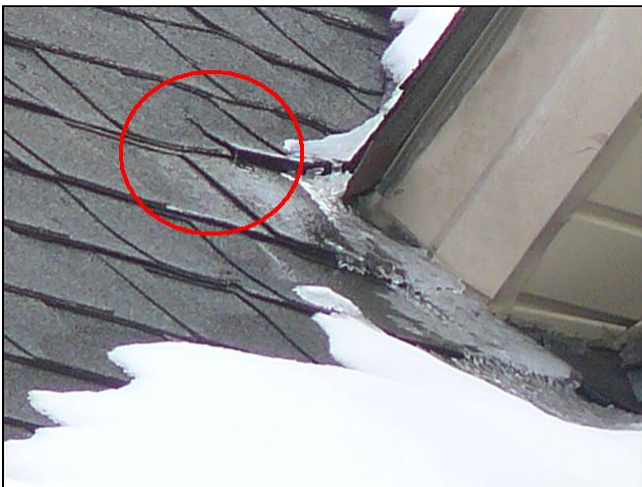
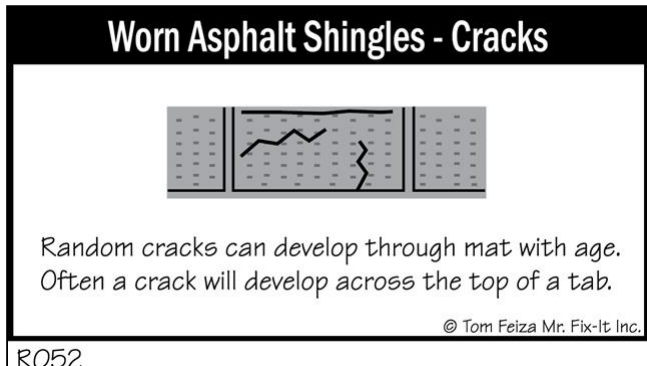
2.0 Item 4(Picture)

2.0 (2) The damaged shingle on the right hand side of the garage roof needs to be replaced or repaired before a water leak develops. This area also has excess water draining in this area due to the roof intersection. Also a diverter flashing maybe needed. The area below in the bonus room attic was wet at the time of the inspection indicating a roof leak is experienced in this area. It may not be caused by the cracked shingle. Strongly recommend a qualified roofing contractor further investigate this area to determine where leak is occurring and repair as needed prior to closing. Water leakage in an attic can cause mold to occur and deteriorate the roof structure.

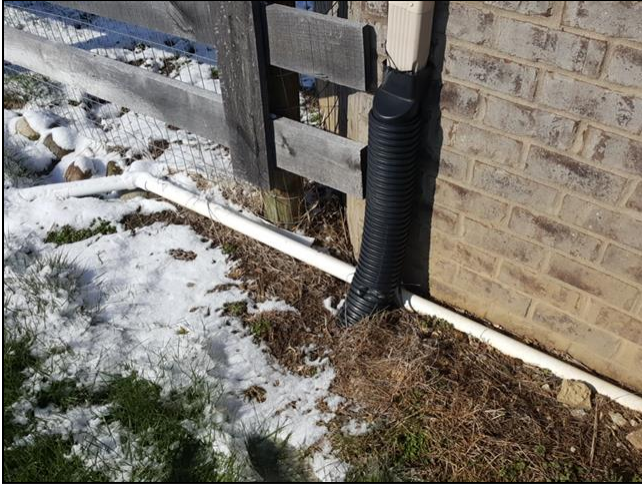
2.3 Item 3(Picture) rear right corner of home

2.3 (2) Downspouts that discharge below grade level should be monitored. If they are ever suspected to be clogged or disconnected below grade, they should be redirected to discharge at least 10 feet from the building or into a storm sewer system. Foundation leakage adjacent to a downspout is an indication of a problem below grade.

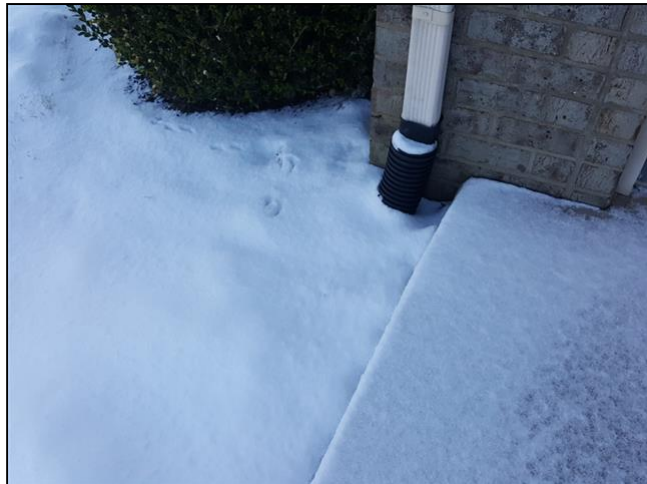
2.3 Item 6(Picture) front left corner of garage

2.3 (3) Recommend the downspout extension(s) be attached to the downspout at the where indicated in the photos by placing a screw at the top and bottom where it connects to the downspout to ensure the extension(s) does not pull away from the downspout(s). Failing to do this may create future problems to the foundation around the home due to soil erosion and water entering the crawlspace which may result in the foundation settlement if the extension detaches from the downspout.

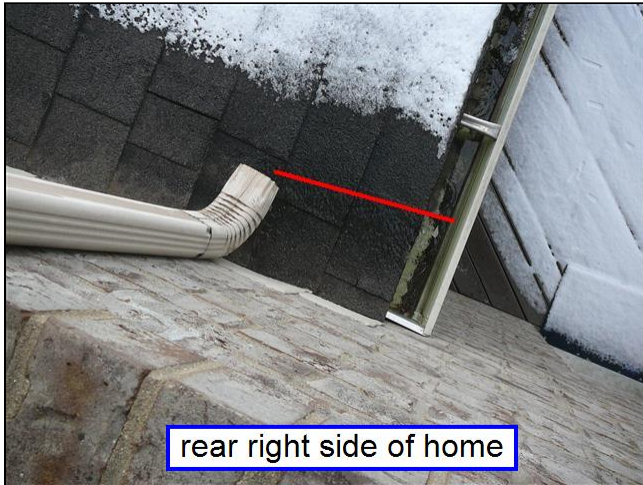
2.3 Item 13(Picture)

2.3 (4) Recommend the downspout(s) that discharge onto the roof be extended to discharge water directly into the gutter below. This condition, if left unattended, can result in premature deterioration and staining of the roofing material under the end of the downspout. The excessive discharge of storm water onto roof from downspout also puts stress on building materials designed to prevent water entry into the structure of home. Recommend correcting all around the home as needed using a qualified gutter installer.

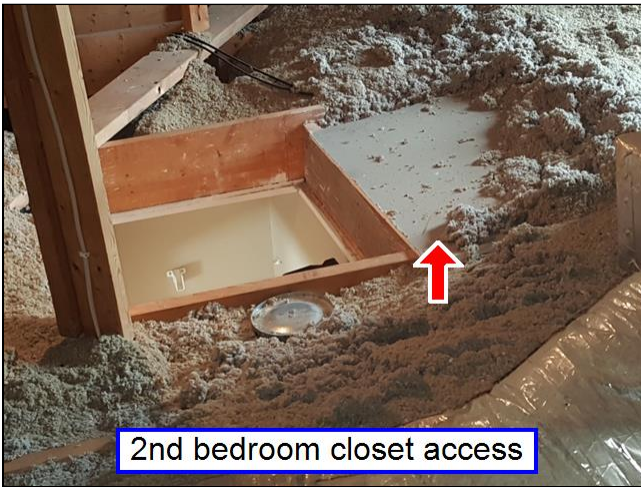
2.4 Item 3(Picture)

2.4 (2) Recommend the attic access hatch be insulated to prevent air and heat loss for energy conservation.

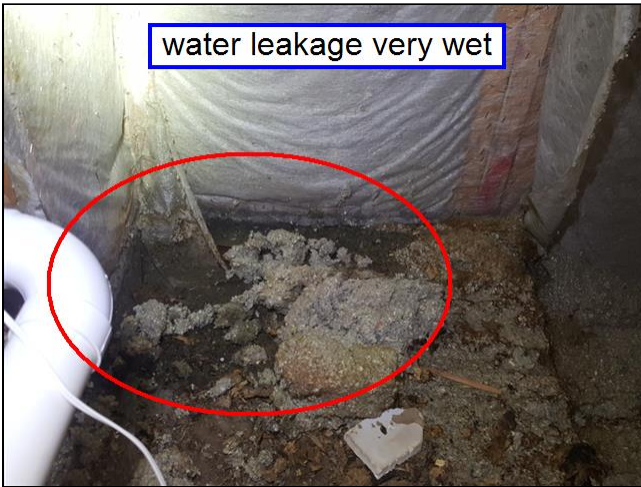
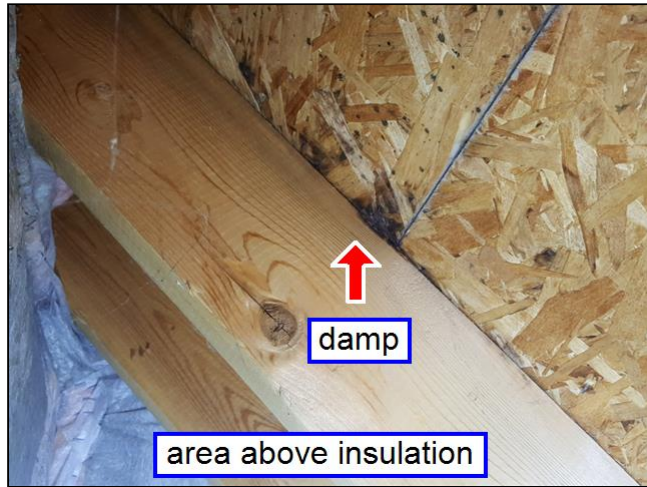
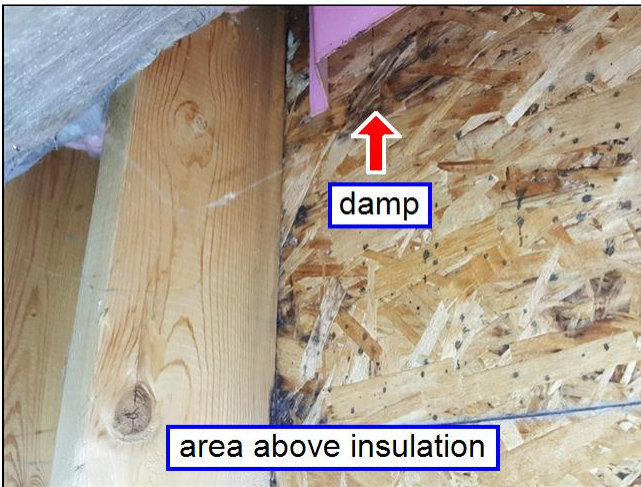
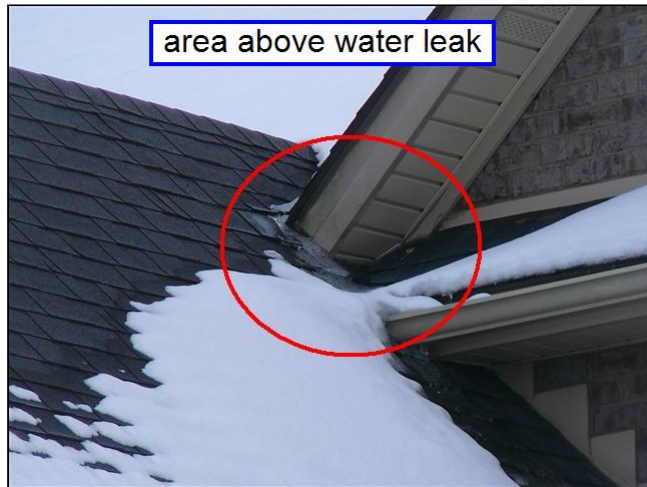
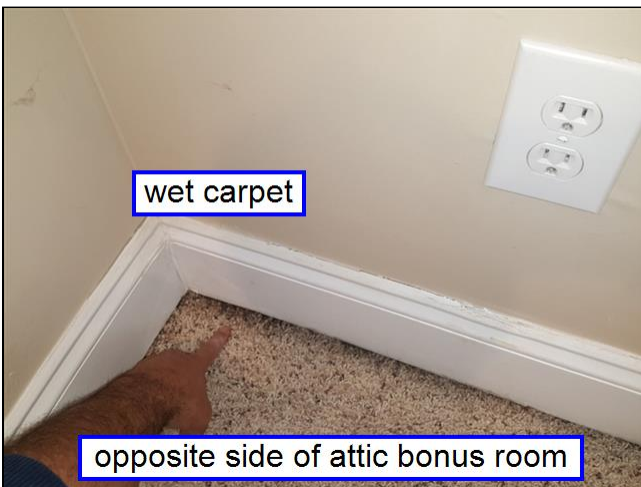
2.5 (1) There is a water leak in the bonus room attic above where the garage and house roof intersects. The insulation and floor was wet at the time of the inspection. The damage to the structure in this area does not appear significant to require replacing at this time. The wet insulation should be removed and replaced where needed to prevent mold from occurring. If not corrected roof leakage can cause deterioration of the buildings structure and materials which will result in increased repair costs later on if not corrected. Strongly recommend a qualified roofing contractor further evaluate to determine where leakage is occurring and repair/correct as needed prior to closing. Other trades maybe needed if there is hidden damage that could not be seen.

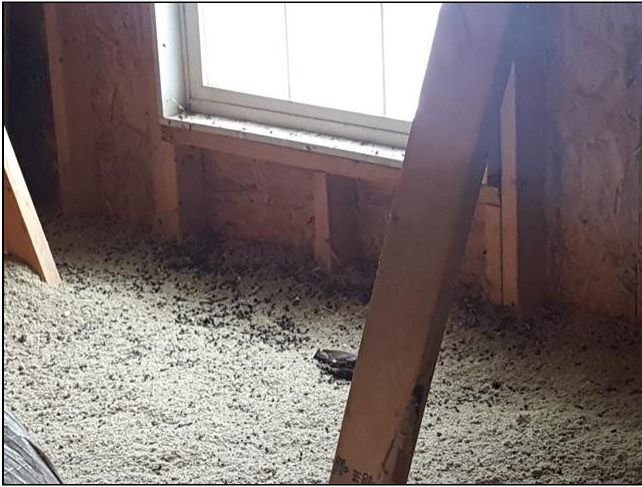
2.5 Item 6(Picture)

2.5 (2) Excessive dead flies were found near the window in the attic at the front of the home. Recommend a qualified pest control contractor evaluate the attic area to determine where they are entering from and seal openings/correct as needed. They maybe entering from the gable vents which are missing screens.

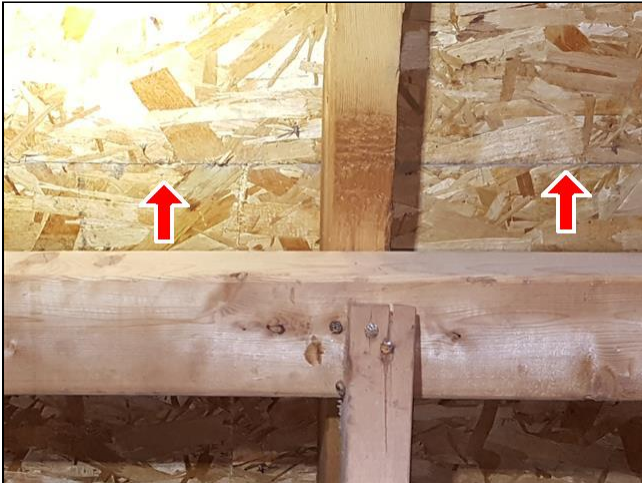
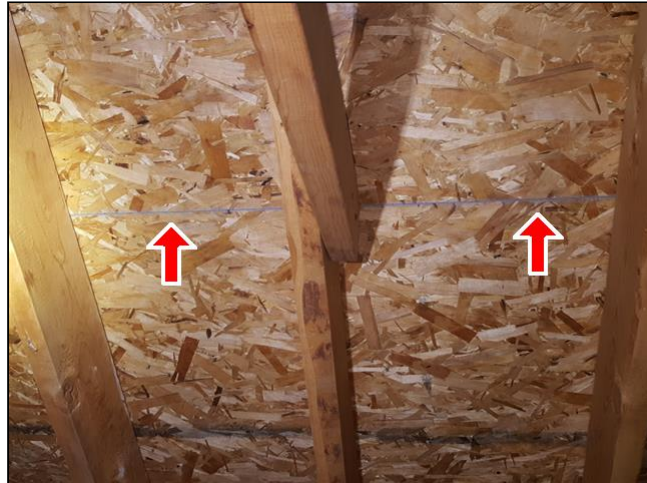
2.5 (3) There is no 1/8" spacing or ply clips at the ends, joins or sides of the roof sheathing as is recommended. Without this space the edges of the sheathing could raise if moisture enters and expands the sheathing. The raised areas could then be easily seen as the shingles conform to the surface of the roof sheathing on the outside. No problems were found at time of inspection. If this condition appears and is bothersome the shingles will need to be removed and the sheathing replaced or if possible a relief joint cut at the edges of the sheathing by a qualified roofing contractor. At the moment this is not a high priority. Strongly recommend that when a new roof is installed that this be done then.

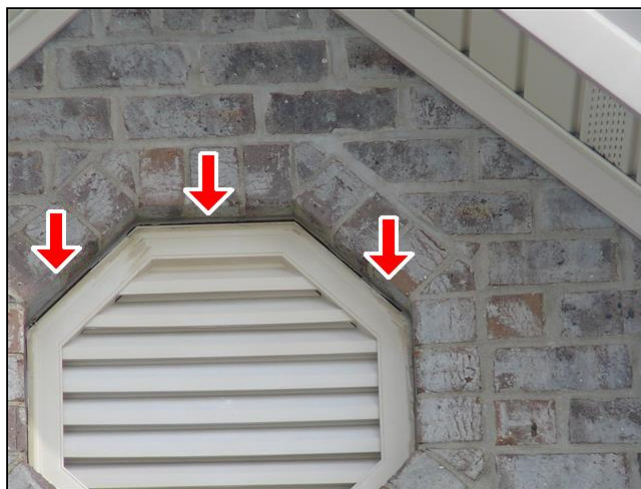
2.6 Item 2(Picture)

2.6 Recommend the gap between the gable vent and the brick siding at the right side of the home be sealed with caulk to prevent insects and water intrusion into the attic. Water intrusion could lead to deterioration of the wall framing. [Choosing the right caulk](#)

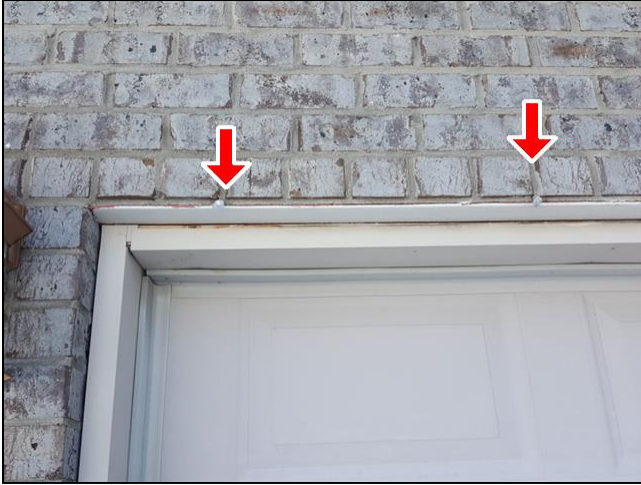
3.0 Item 1(Picture) above garage

3.0 Rope protruding out of the brick siding are known as weep holes. These pieces of rope should not be pulled out. They will deteriorate over time, however they should have been trimmed after house was built. Weep holes are openings close to the bottom of brick mortar joints that allow drainage. They are also recommended over door and window openings. This is for your information.

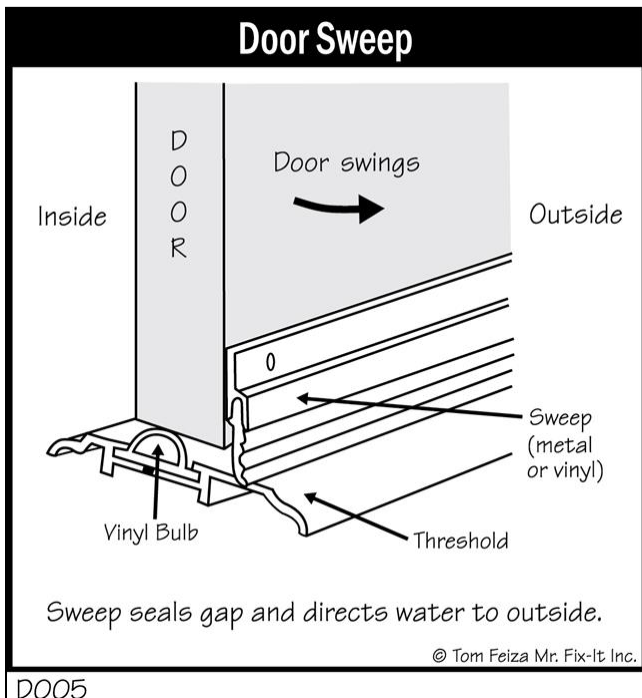
3.3 Item 1(Picture)

3.3 I would recommend a door sweep be installed at the rear door of the home to ensure water intrusion does not occur. This is for your information

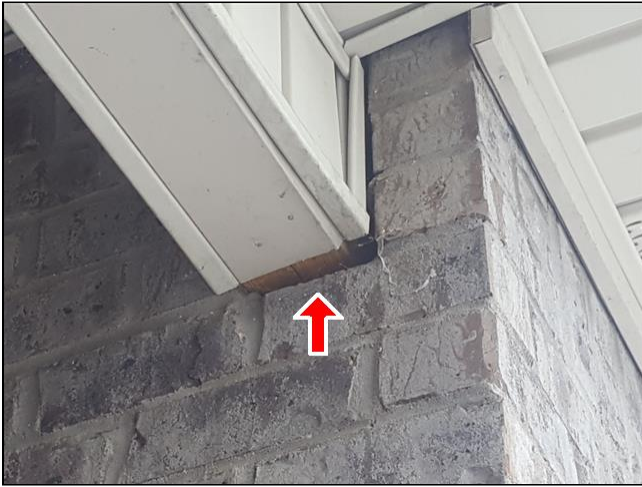
3.5 Item 1(Picture)

3.5 Recommend sealing the gap between the porch roof support beam and brick wall under the front porch to prevent water intrusion and insects entering the gap to prevent possible deterioration of the support beam. A general contractor is recommended for repair and correction.

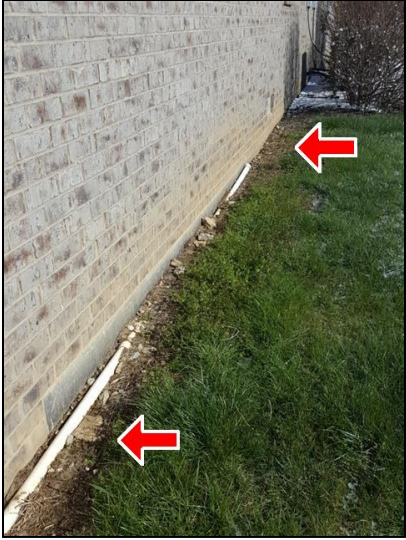
3.10 There are depressions in the soil around the foundation perimeter at the left side of the home. Recommend filling all depressions and re-grading the soil so the soil slopes away from the home around the foundation to ensure water pooling does not occur in these areas. Water pooling could lead to to crawlspace leakage.

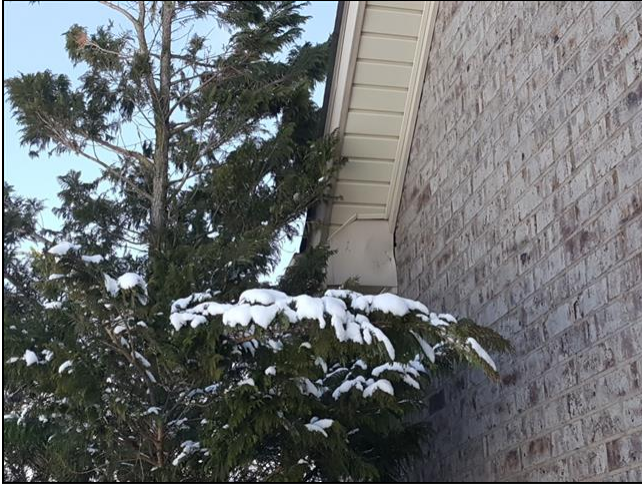
3.11 Item 1(Picture)

3.11 (1) The tree limbs that are in contact or hanging near the roof at the front right corner of the home should be trimmed to prevent damage to the shingles and from scraping on the roof surface. They will also clog gutters which will cause water run off problems around the home. Recommend cutting back tree branches as needed.

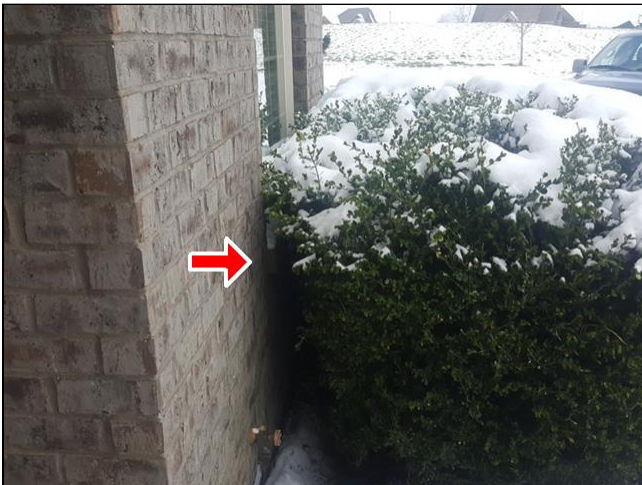
3.11 Item 2(Picture) front right side of home

3.11 (2) The vegetation is overgrown at the front right side of the home where indicated in the photo(s). Recommend that all bushes, shrubs and trees where applicable be kept neatly trimmed and away from the foundation, wall siding, and window frames to prevent damage to the home and allow proper venting and inspection of house. A 6" clearance is recommended.

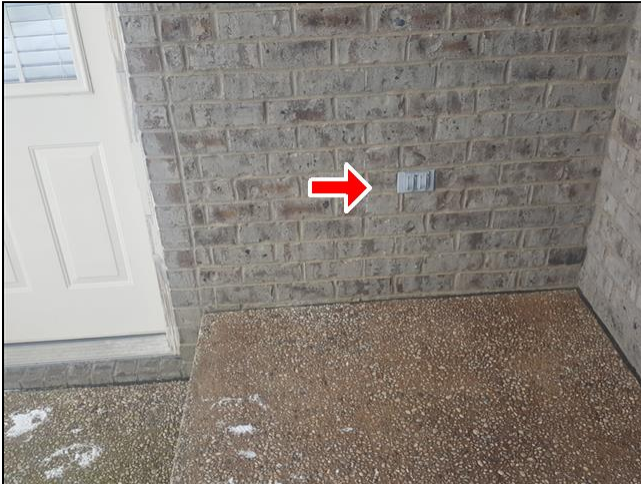
3.13 Item 1(Picture)

3.13 (1) The exterior outlet at the front porch is GFCI protected. The reset switch is located at the garage of the home. This is for your information.

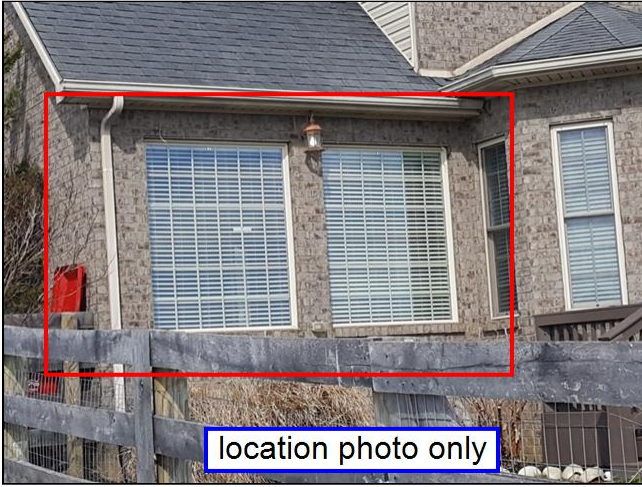
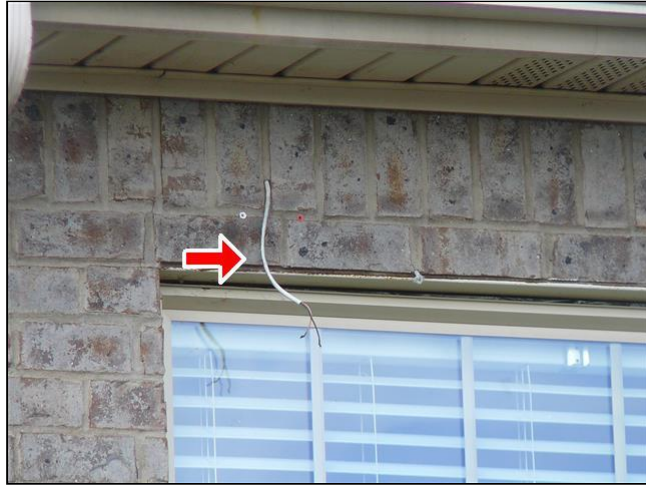
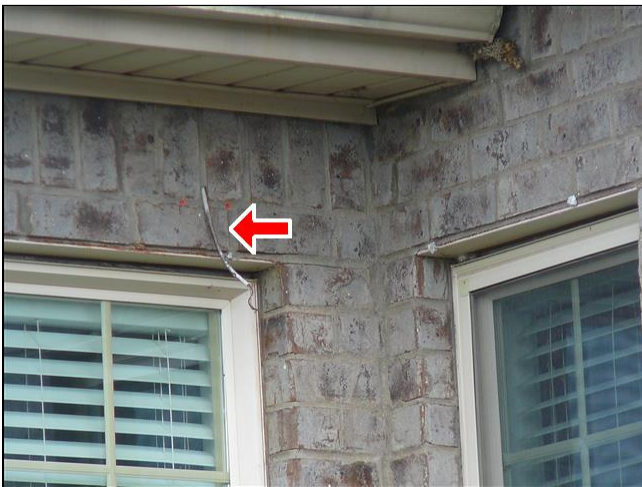
3.13 (3) There is exposed electrical wiring from the wall above the living room window where indicated in the photos. Wires should not be exposed to weather or exposed. This is a safety issue. The wiring can be damaged which could cause a short or if touched cause an electric shock resulting in a death. Exposed wires should be UF and protected in conduit leading to the source. Recommend a qualified electrician further investigate, then repair and/or correct as needed prior to closing. These wires maybe for speakers or lighting. I could not determine.

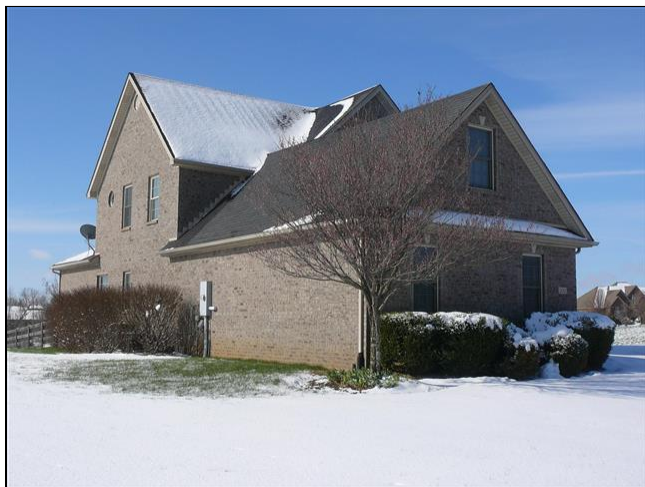
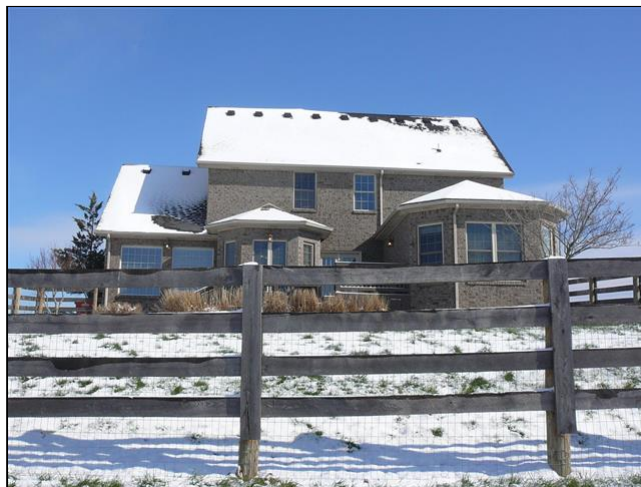
3.14 Due to the exterior of the home is partially covered with snow at the time of the inspection we were unable to properly examine and inspect some of and/or all the components related to this section. You may wish to have these areas be reinspected prior to closing by a home inspector once the snow coverage has gone.

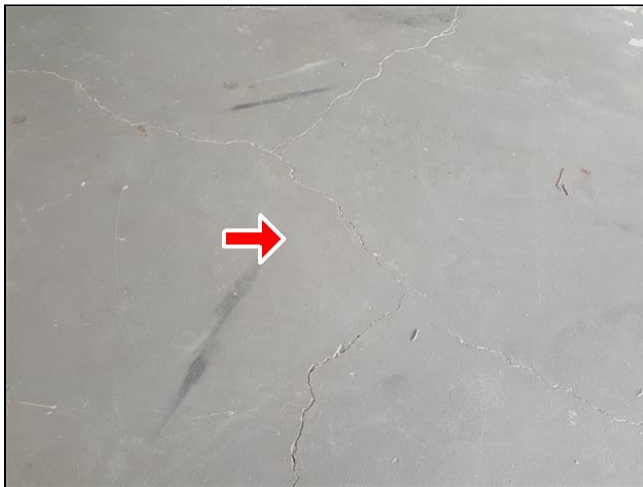
4.2 Item 1(Picture)

4.2 (1) The garage flooring has typical cracks in areas highlighted in photos. These cracks do not appear significant and seem typical. Cracks that are usually 1/8 inch or wider are need for concern. The cracks are usually the result of shrinkage and/or settling of the slab. Also this crack maybe due to freezing soil underneath placing upward pressure on the slab. Recommend these cracks be sealed then apply an epoxy coating on the floor to ensure water intrusion does not occur. It is recommended that you monitor annually after repairs. If these cracks should reoccur a masonry contractor who is familiar with foundation repair should be consulted. [Caulk for Concrete Cracks](#) This is for your information.

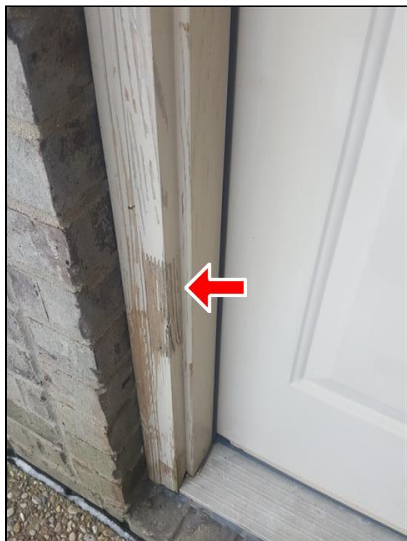
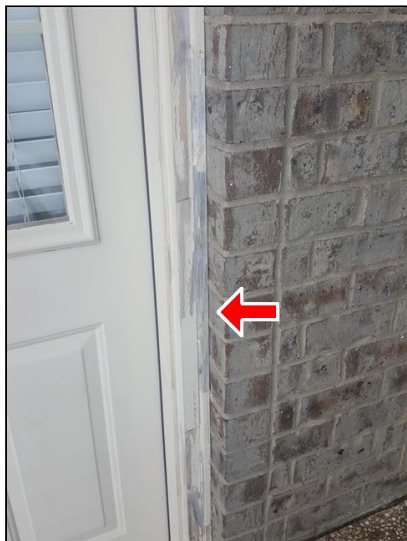
4.6 The exterior entry door to the garage is weathered/has missing paint and needs prep and paint (exterior) around the door frame to prevent water intrusion. Deterioration may occur via wood rot if not painted. Recommend prep and paint as needed.

As an additional note you may wish to consider wrapping the door frames with metal wrapping. This will ensure frames are sealed and not exposed to the weather. It will eliminate the need for maintenance in regards to painting wooden frames so that moisture will not penetrate.

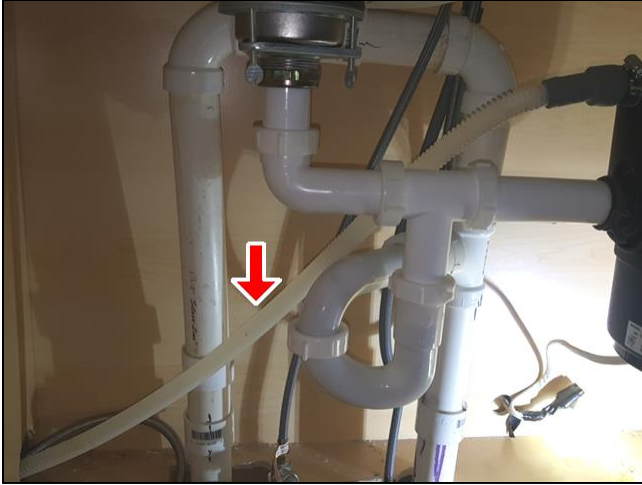
5.2 Item 1(Picture)

5.2 The dishwasher drain hose did not perform a loop to create a trap under the sink. The current recommendations for the dishwasher drain lines are for them to be installed as close to the bottom of the countertop as possible. This creates a water blockage to prevent sewer gases entering the house through the dishwasher. Recommend repair or replace as necessary.

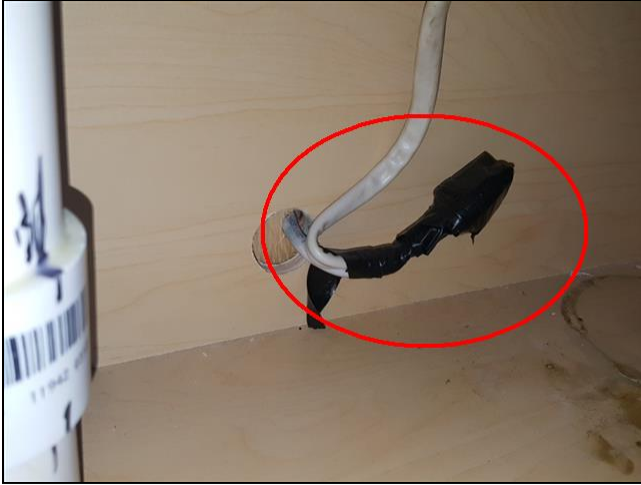
5.3 Item 1(Picture)

5.3 (1) Wires terminated with twist caps and sealed with insulation tape under the sink for the disposal unit should be enclosed in a junction box and fitted with a cover to prevent a person tampering with connections. This is a safety issue. Also, if a water leak was to occur, this could result in a short and a possible fire develop under the sink. Recommend a licensed electrician repair as needed to prevent accidental electric shocks.

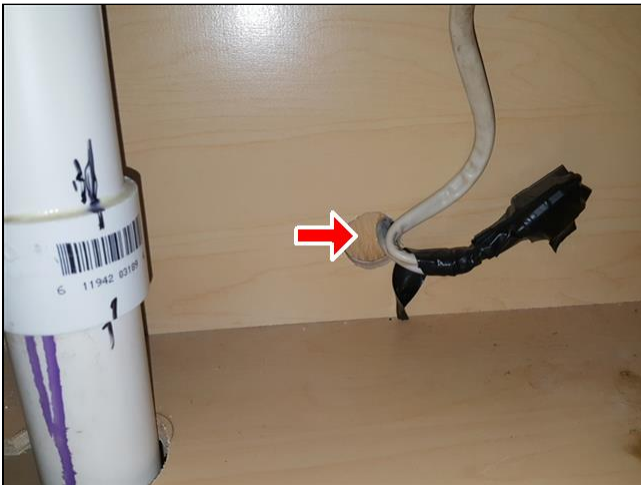
5.3 Item 2(Picture)

5.3 (2) The outlet is obstructed by the panelling under the kitchen sink. Could not determine how the disposer is connected. This is hazardous if repair work is needed on the disposer. The only easy means of cutting power to the disposer is via the electrical panel box. Recommend a qualified electrician repair as needed for your safety.

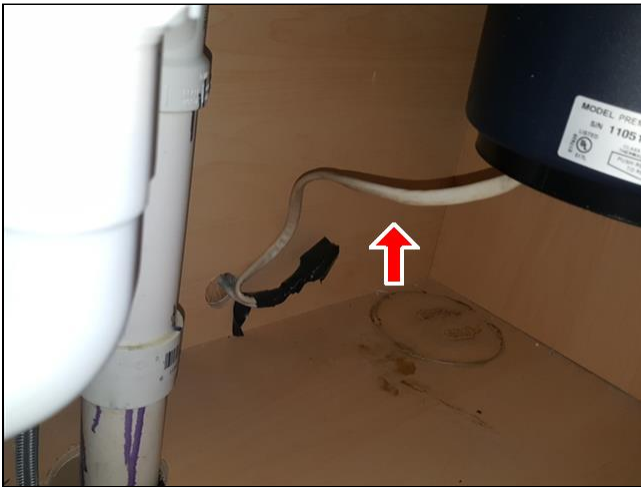
5.3 Item 3(Picture)

5.3 (3) Unprotected electrical wiring under the kitchen sink for the disposer is susceptible to being damage and should be relocated or protected by a rigid conduit. Recommend a qualified electrician repair as needed for safety of the occupants.

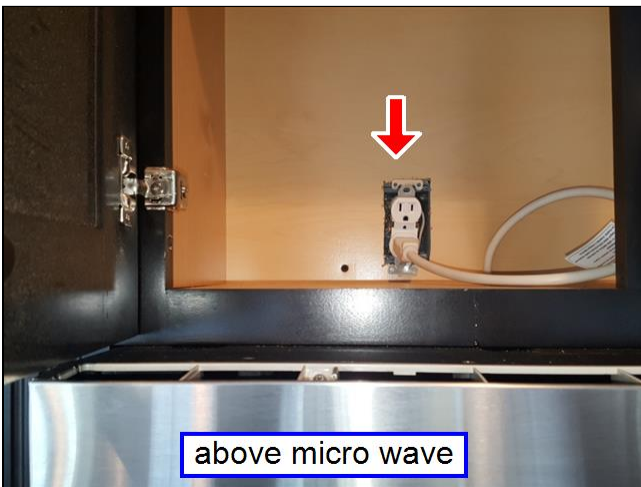
5.9 Item 1(Picture)

5.9 (3) The outlet(s) in the kitchen where indicated in the photo(s) is missing a cover-plate. The outlet was not tested. All missing covers should be installed to prevent touching the sides of the devices to prevent an electric shock which can cause an injury or death. Electrical issues are considered a hazard until repaired, and this is considered to be unsafe. A qualified licensed electrical contractor should correct as needed prior to moving in.

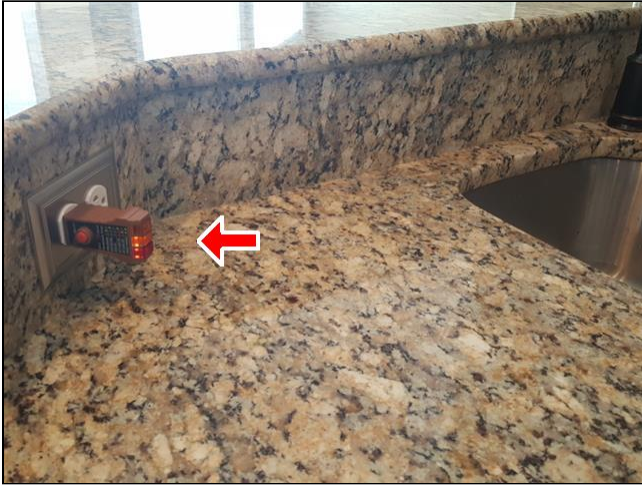
5.9 Item 2(Picture)

5.9 (4) The GFCI outlet (Ground Fault Circuit Interrupt) at the kitchen where indicated in the photo(s) is improperly wired with the hot and neutral wires reversed. This is extremely dangerous and a potential shock hazard. You **CAN BE SHOCKED** causing a possible death when the switch to the appliance is off when plugged into the outlet. Recommend a qualified licensed electrician repair as needed for safety prior to moving.

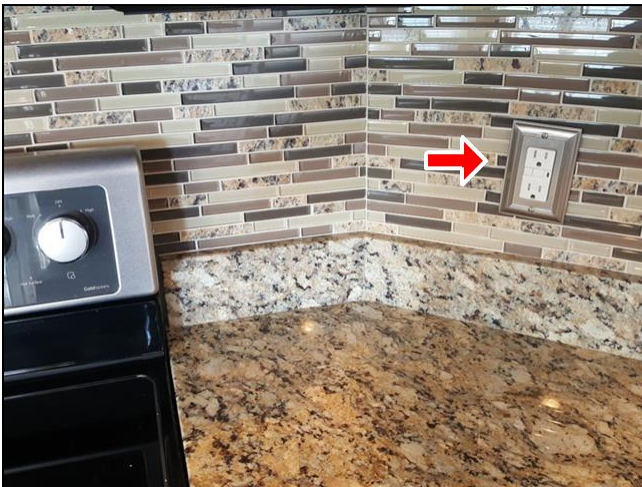
5.9 Item 3(Picture)

5.9 (5) The outlet(s) in the kitchen where indicated in the photo(s) are/is loose at the wall or in the outlet box. Electrical issues are considered a hazard until repaired. This is a safety issue that needs to be corrected due to an electric shock or fire from loose connections could occur if not repaired. Recommend a qualified licensed electrical contractor correct as needed.

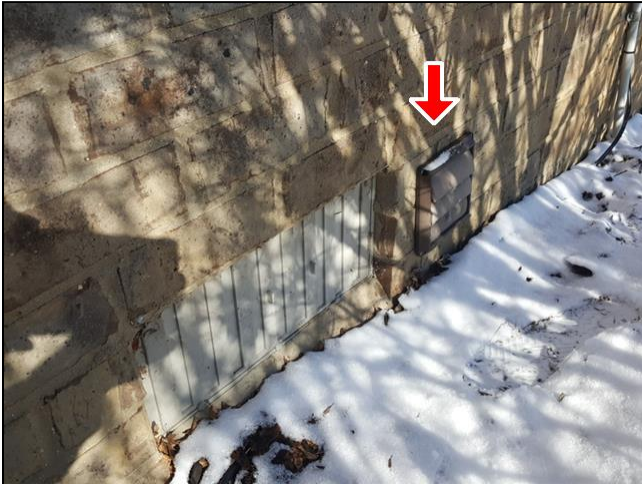
5.10 Item 1(Picture)

5.10 (1) The exterior port for the dryer vent pipe is located on the left side of the home. (see photo for location) This is for your information.

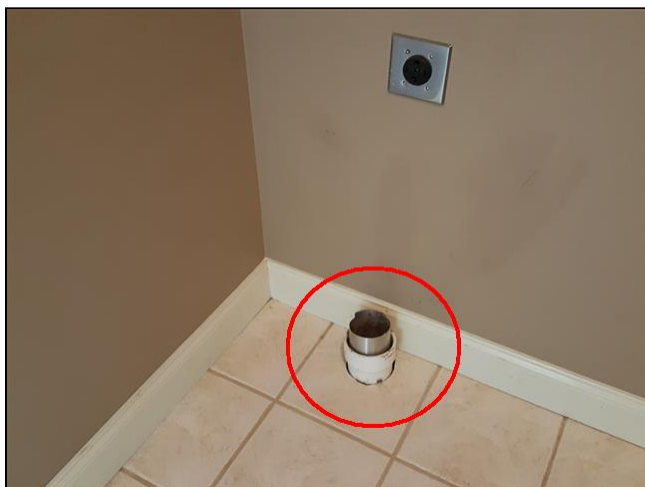
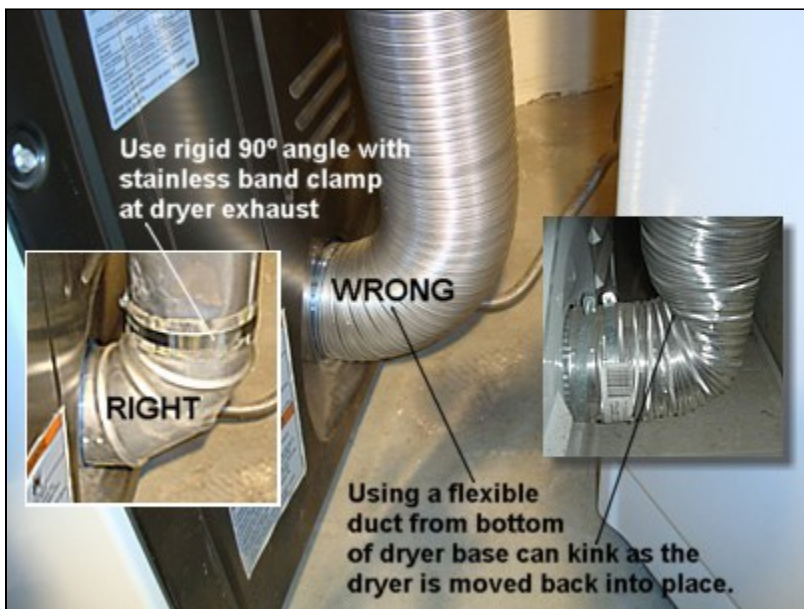
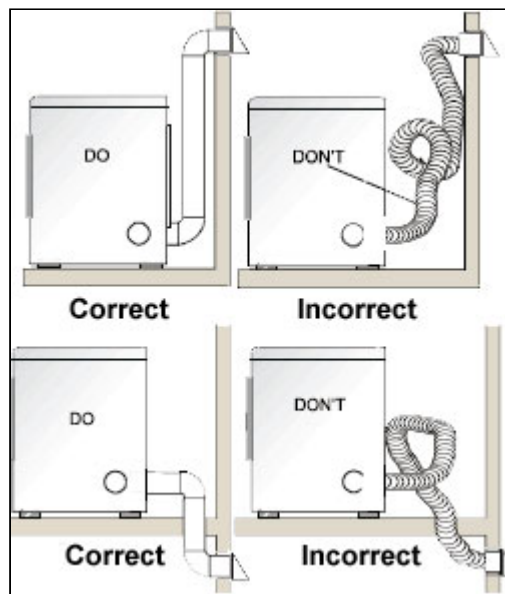
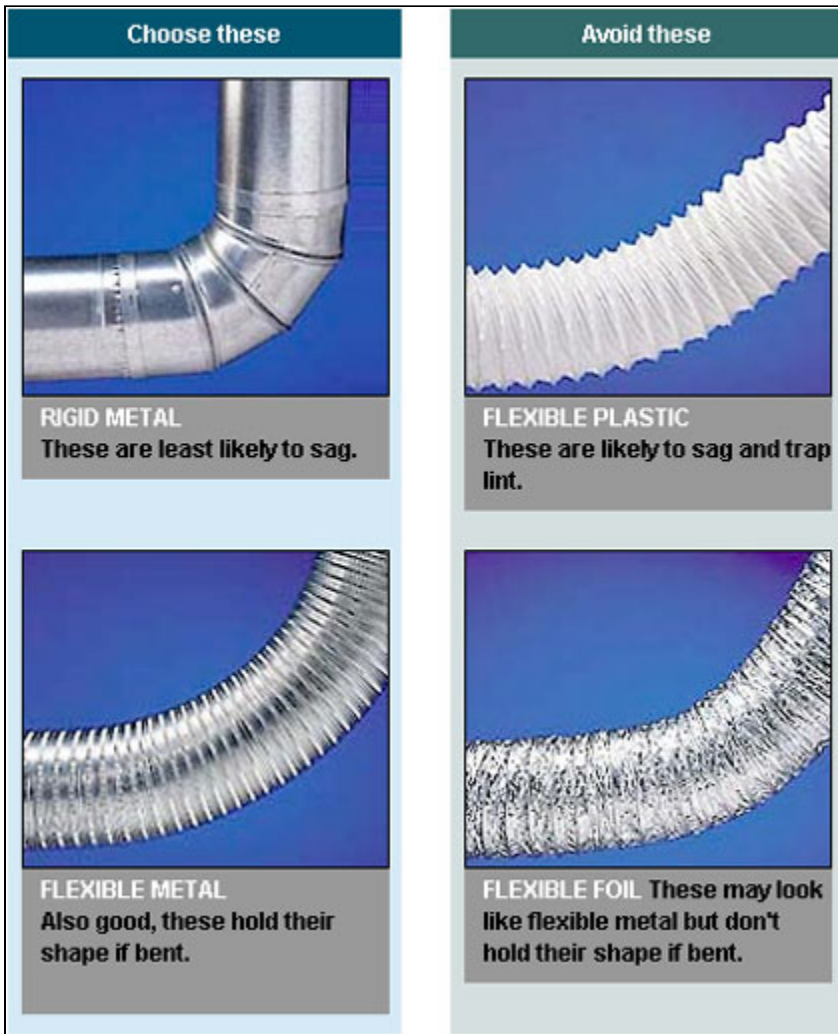
5.10 (2) When installing your dryer do not use flexible foil piping. The current recommendations are for dryer vents to be heavy flexible or solid metal to help prevent crushing and damage from fires. Dryer lint fires are reported to be the third leading cause of fires. Exhaust ducts should be constructed of minimum 0.016 inch thick rigid metal ducts, having smooth interior surfaces with joints running in the direction of air flow. Exhaust ducts shall not be connected with sheet metal screws or fastening means which extend into the duct. All dryer vents should be disconnected and cleaned twice a year. This is a very common cause of fires. This is for your information.

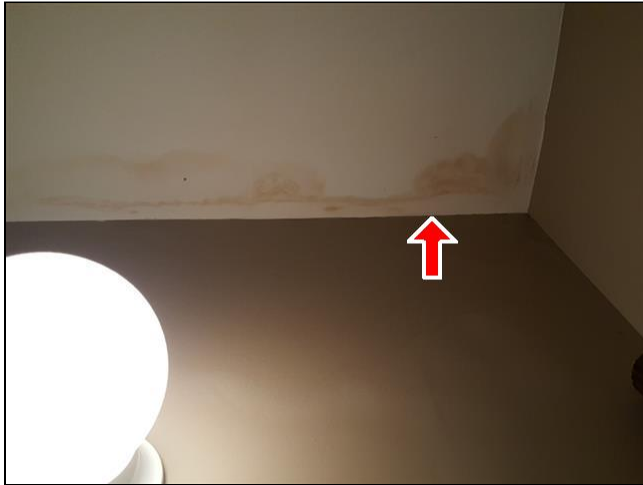
6.0 Item 2(Picture)

6.0 (3) The drywall at the ceiling in the hallway closet above the roof intersection reveals an old water stain indicating a leak did or still exists where indicated by the photo(s). Although there was no leaking or elevated moisture content found at this time, I could not determine how the stain existed. Perhaps ask the owner of the home to explain cause of the stain. Inspections are limited and destructive inspections are excluded. Recommend cleaning the drywall then monitor this area to see if a leak is active and if a leak does exist, recommend further investigation and repair as needed. The repair work will likely involve the removal of the covering in order to determine where the leak is coming from and if it still exists. The extent of the damage cannot be realized until the covering is removed.

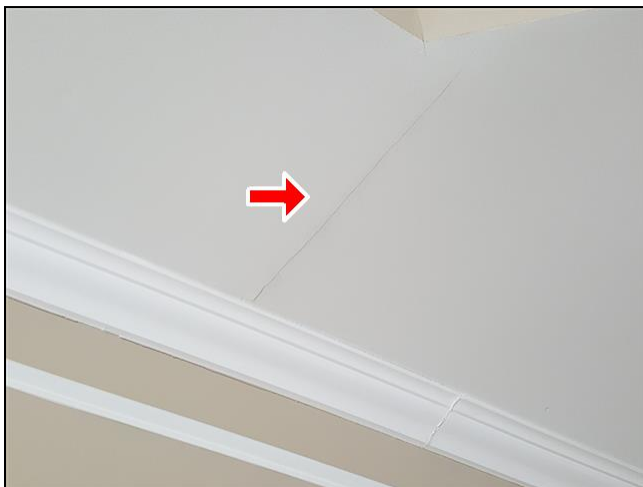
6.0 Item 4(Picture)

6.0 (4) The cracks in the ceiling in the Master bedroom (see photos for location) appear to be common settlement cracks. Cracks larger than 1/16" are of concern only. Minor settlement of the home has occurred due to the age of the home and from perhaps framing shrinkage. Cracks of this nature are also caused by moisture, changing temperature, or framing shrinkage due to a lack of ventilation of vaulted ceilings. Recommend repairing cracks then paint and monitor. If cracks reappear and become larger than 1/8" then would recommend a structural engineer further investigate to determine cause and suggest repairs.

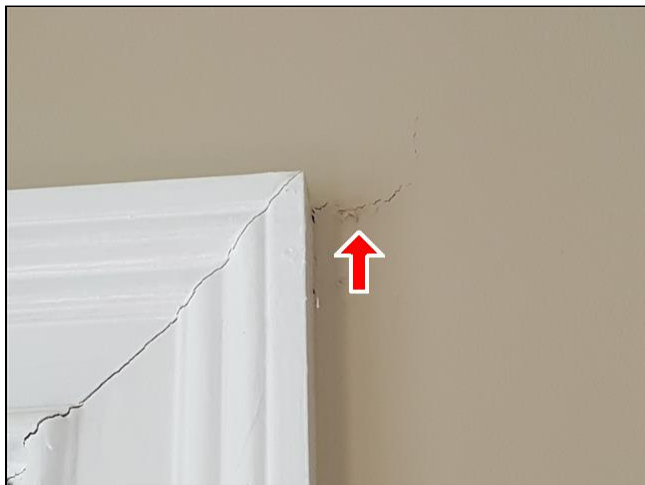
6.1 (1) The crack(s) noted on the walls near the corners of the door frames in the home, (see photos for location) are common minor settlement diagonal crack(s). Cracks larger than 1/8" are of concern only. Minor settlement of the home has occurred. All the doors in the related room(s) do open and close without rubbing on door jambs. This damage is considered to be cosmetic and a small repair issue for your information. Recommend prep prime and paint as needed.

6.1 Item 1(Picture) dining room window

Note: After repairs, these areas should be monitored and if cracks reappear and become greater than 1/8 inch wide, then further evaluation is recommended by a qualified contractor to determine cause and repairs. (structural members are not visible)

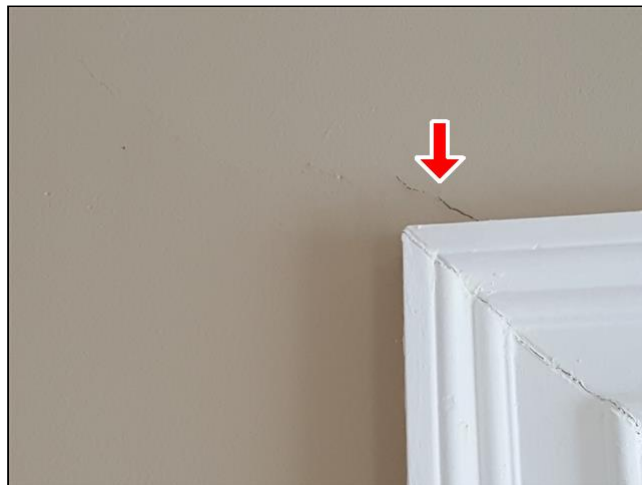
6.1 Item 2(Picture) 2nd bedroom

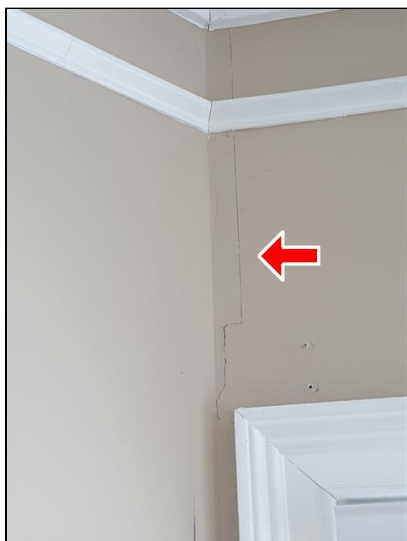
6.1 (2) The crack(s) noted on the wall where indicated in the photo at the master bedroom, (see photos for location) are common minor settlement vertical crack(s). Cracks larger than 1/8" wide are of concern only. Minor settlement of the home has occurred due to the age of the home and from perhaps via framing shrinkage. This damage is considered to be cosmetic and a small repair issue for your information. Recommend prep prime and paint as needed.

6.1 Item 3(Picture) master bedroom

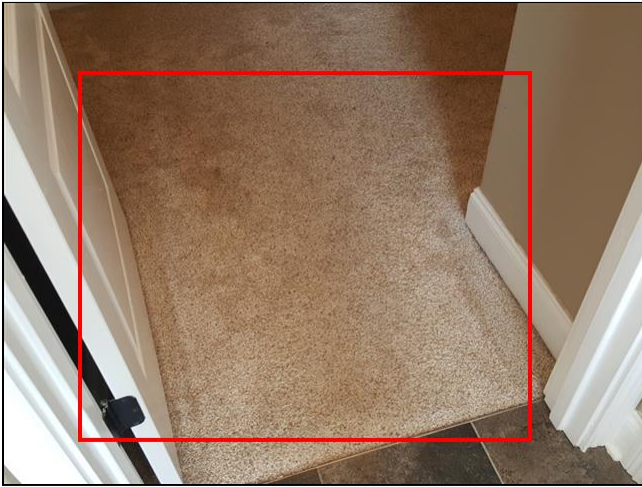
6.2 Item 1(Picture)

6.2 (1) The floor squeaks in the master bedroom closet as indicated in the photo(s) (nuisance only). This is for your information and is of no concern from a structural perspective. A qualified carpenter should know how to eliminate or reduce squeaks in the flooring. This will likely involve the removal of the floor covering to repair the squeak in the floor. Repair as desired.

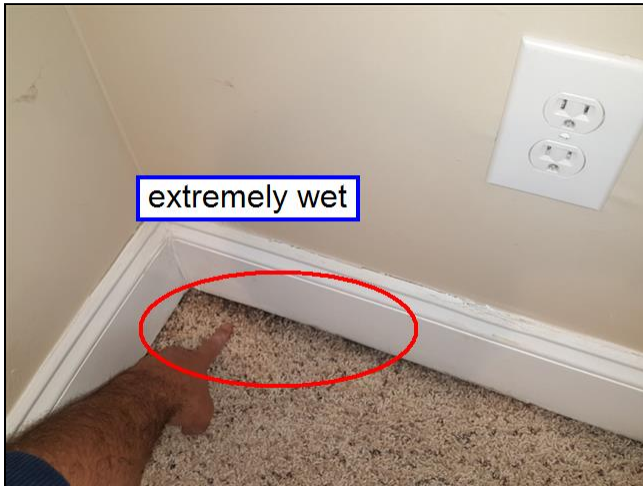
6.2 Item 5(Picture)

6.2 (2) The carpet is wet in the bonus room near the entry door from a water leak in the attic. See note 2.5(1) and 2.0(2) for recommendation and repairs.
