TALCO
Home Inspection

Inspection Report

202 Scarborough Beach Road
Richmond KY 40475

Date: 3/14/2018	Time: 10:00 AM till 02:00 PM	Report ID: 180314KNUE
Property: 202 Scarborough Beach Road Richmond KY 40475	Customer: Ms. Sharon Anthony	Real Estate Professional:

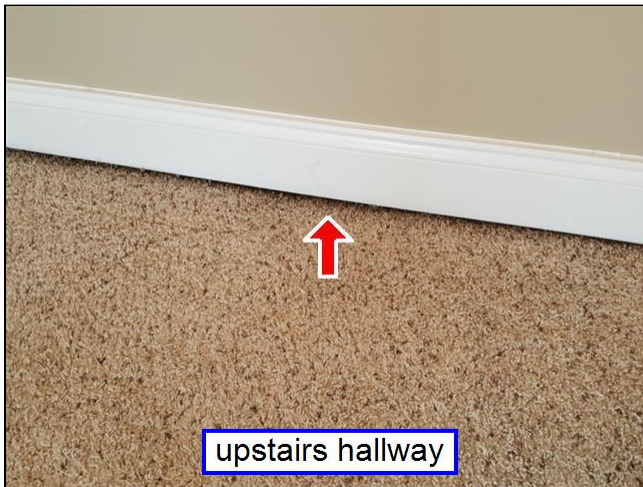
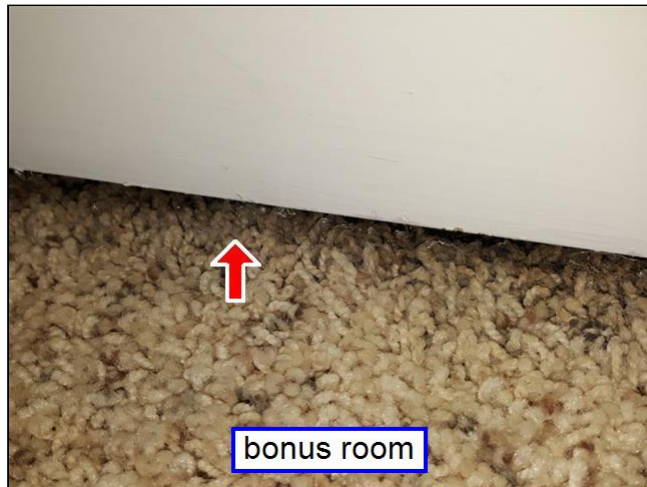
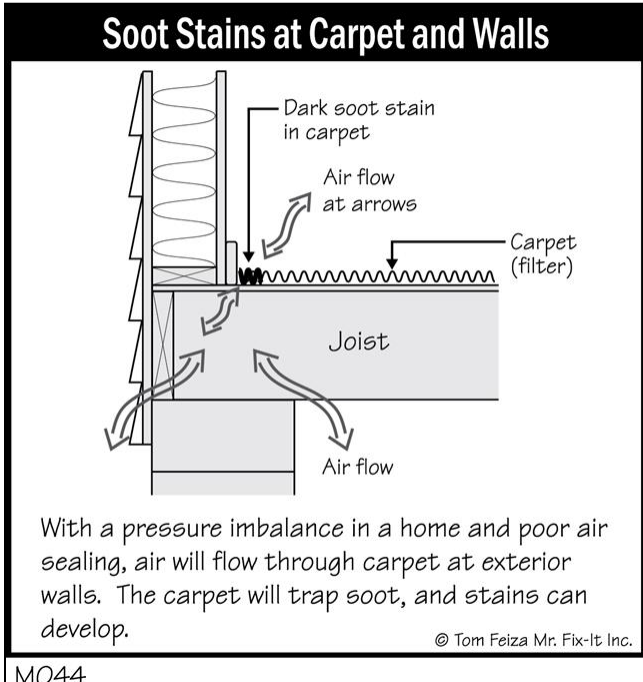
6.2 (3) The black stain along the edge of the carpet in the bonus room and near the upstairs hallway are soot stains (filtration soiling). Filtration soiling occurs as a result of air being forced into the room or space at a higher rate than it can escape from the same area, via the ventilation system and/or gaps between the carpet and the wall trim and under closed doors. As the air is forced through these gaps, it passes through the carpet, which acts as a filter to the air. Any pollutants in the air are trapped by the carpet and turn the carpet gray or black in that area. Common pollutants that can contribute to the problem include smoke from cigarettes and candles, cooking oils, fireplace ash, and dust. Recommend a qualified contractor seal the air gaps between the carpet and baseboard trim.

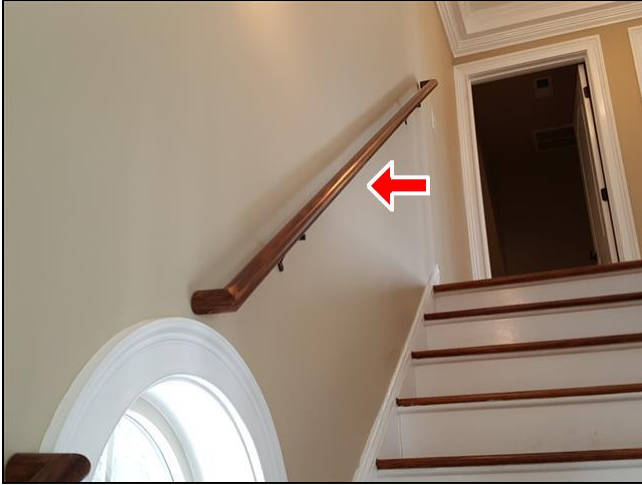
6.3 Item 1(Picture)

6.3 The stair case rail on the on the left side is unstable and not secured properly. This is extremely dangerous and is a safety concern. It may fail under a medium or heavy force or if someone was pushed against or was leaning on the railing. For your safety it should be strengthened and secured. Recommend a qualified contractor repair as needed before closing.

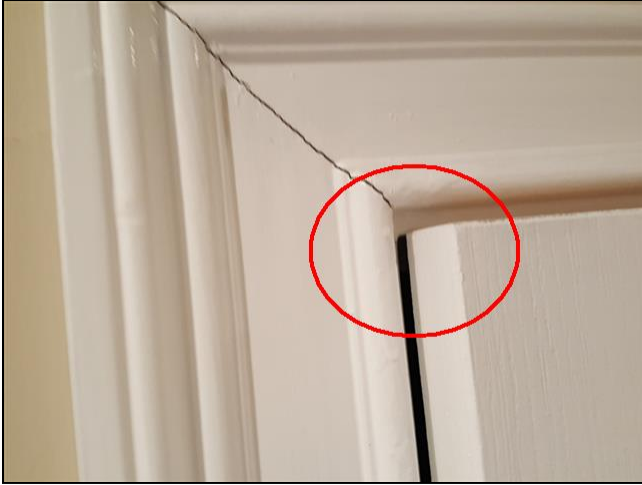
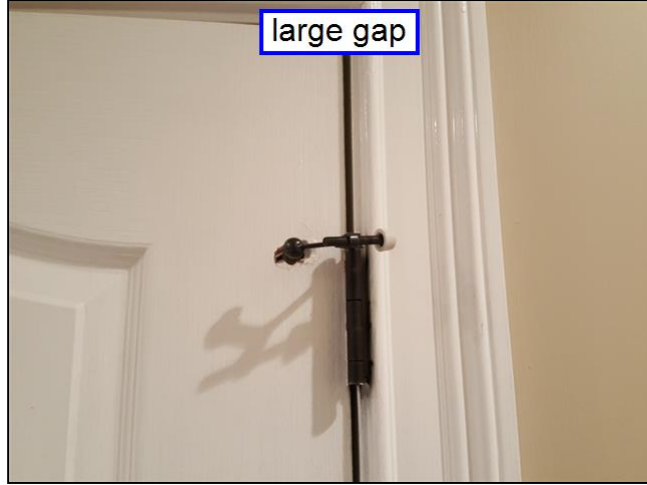
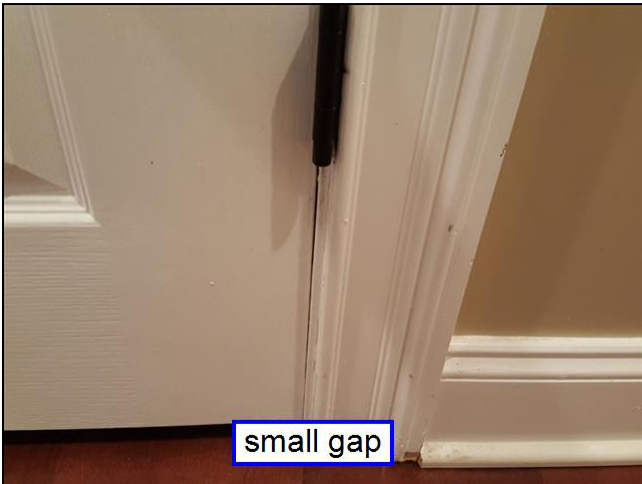
6.4 (1) The doors where indicated in the photos hits the door jamb at the top and does not close shut. Sometimes correcting the door opening can require the door trim to be removed and painting touch up, and/or door hinges may need reseating to ensure correct closure of the door. Recommend a general contractor repair as needed.

6.4 Item 1(Picture) hallway closet

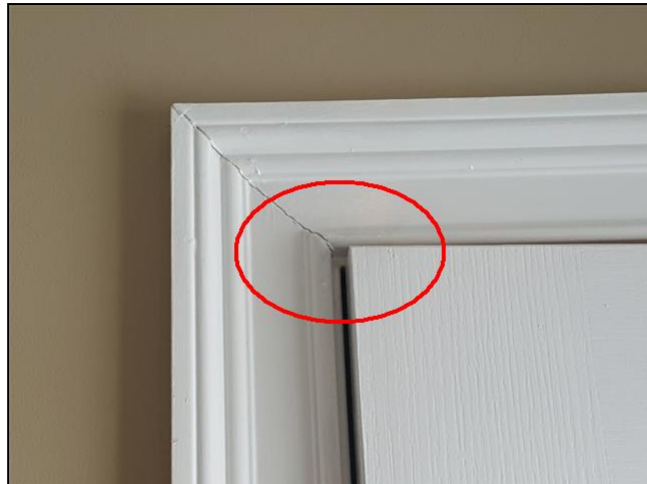
6.4 Item 4(Picture) 3rd bedroom closet

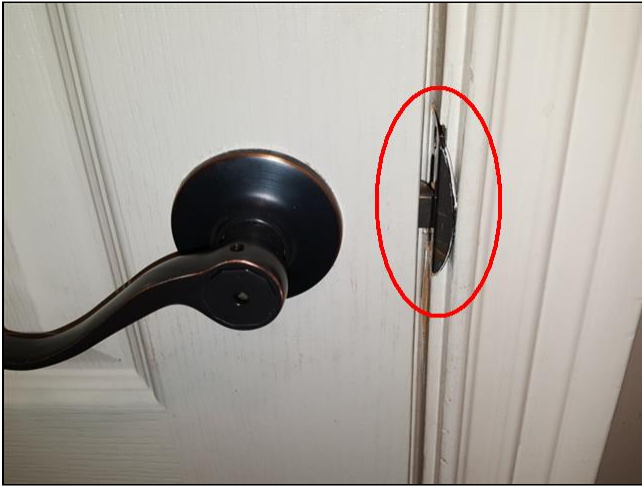
6.4 (2) The door knob hardware is not latching in the rooms where indicated in the photo. It requires an adjustment. The strike plate may need to be adjusted or trimmed to be able to lock/close the door. Recommend repair as needed.

6.4 Item 5(Picture) washer dryer room

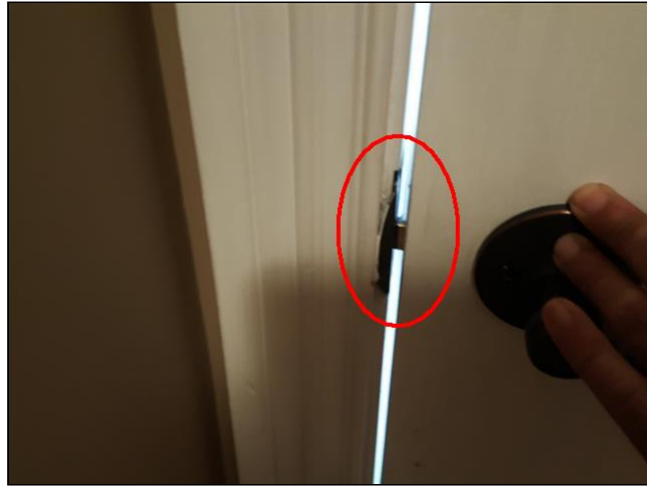
6.4 Item 6(Picture) master bedroom closet

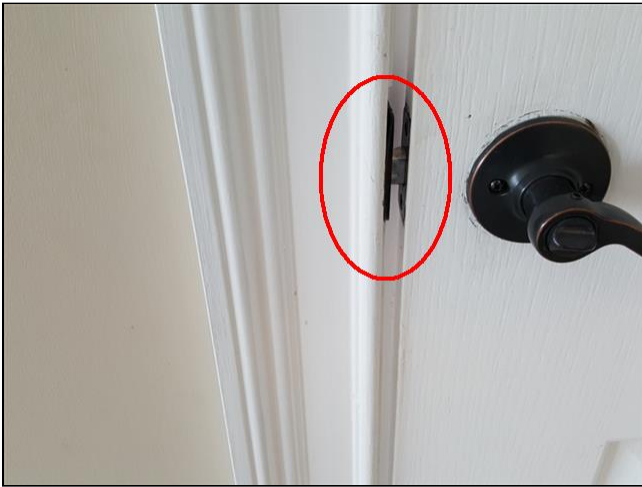
6.4 Item 7(Picture) master bedroom

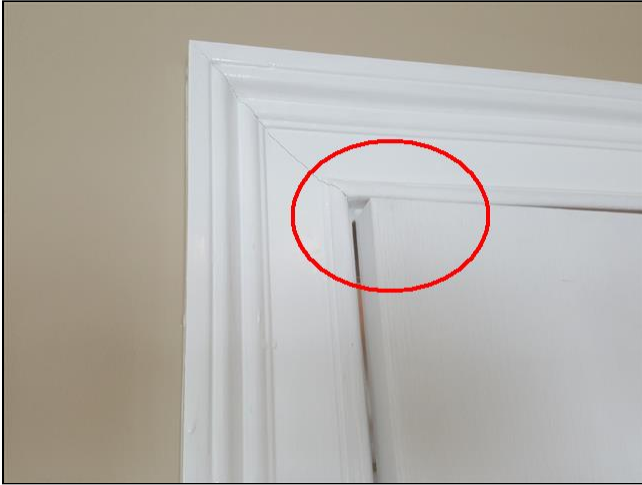
6.4 Item 9(Picture)

6.4 (3) The entry door in the 3rd Bedroom where indicated in the photo does close properly, however it rubs at the door jamb when closing where indicated in photos. This is a maintenance issue and is for your information. Sometimes correcting the door opening can require the door trim to be removed then touch up painting or doors will need to be rehung or trimmed down. Recommend a qualified contractor repair as needed.

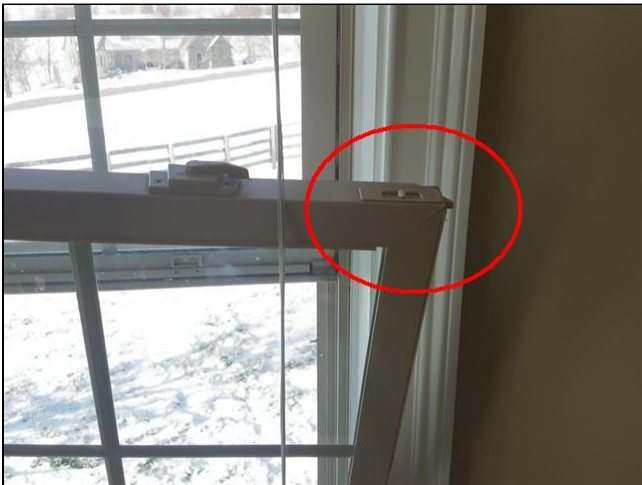
6.5 Item 1(Picture)

6.5 (1) The window pulls out of the frame when the tilt feature is used in the Master Bedroom on the right side at the bottom of window. The window is loose in the frame however it does open and close correctly. This is a maintenance issue. Recommend a qualified window installer repair as needed. There may be a warranty in effect on these windows. Inquire from the owner as to any possible warranties.

This is a potential safety issue as the window may drop which could result in an injury of a person when tilted for cleaning.

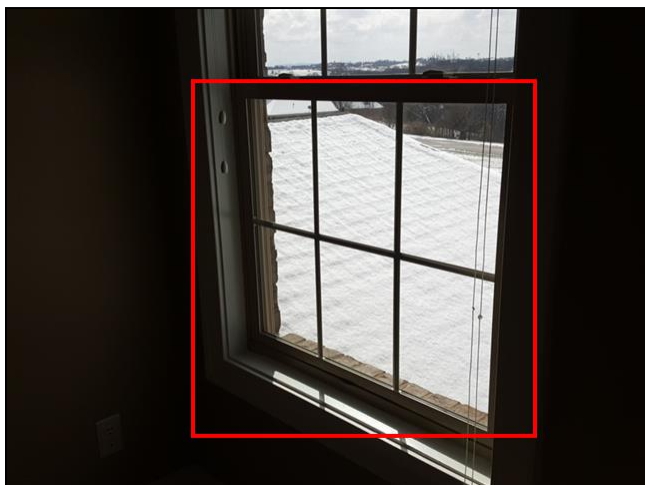
6.5 Item 3(Picture) 2nd bedroom

6.5 (3) The windows in the 2nd and 3rd bedroom where indicated in the photos are missing screens. Recommend these be installed to prevent insects entering the home when the window is opened. Replace as needed.

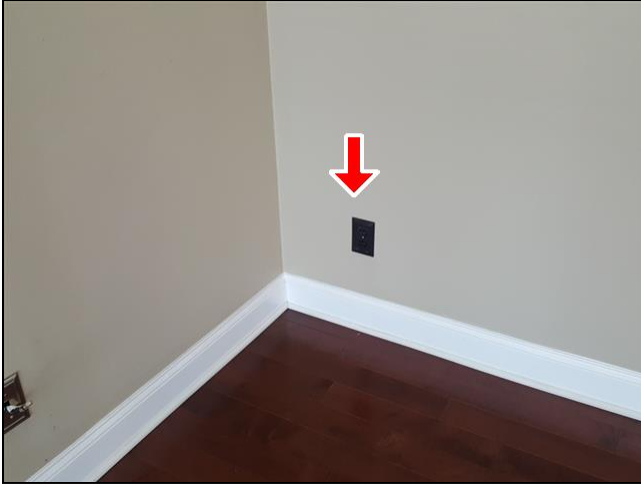
6.7 Item 1(Picture) living room

6.7 (1) The outlet(s) where indicated in the photo(s) are/is loose at the wall or in the outlet box. Electrical issues are considered a hazard until repaired. This is a safety issue that needs to be corrected due to an electric shock or fire from loose connections could occur if not repaired. Recommend a qualified licensed electrical contractor correct as needed.

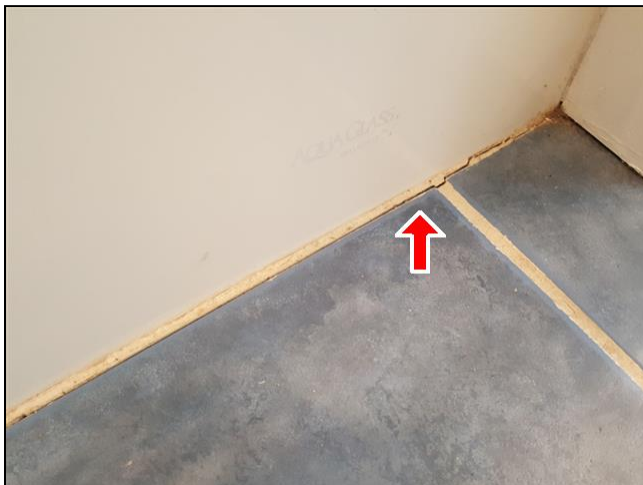
7.0 Item 1(Picture)

7.0 The tile floor covering has cracked grout in the 2nd bathroom between the floor and the tub enclosure. These openings need to be sealed to prevent possible water intrusion in the event a water leak occurs in the bathroom. Water intrusion can lead to deterioration of the sub floor and may cause the tiles to come loose. Recommend a qualified contractor repair as needed. Then it would be advisable to install a molding strip and/or trim between the floor and tub.

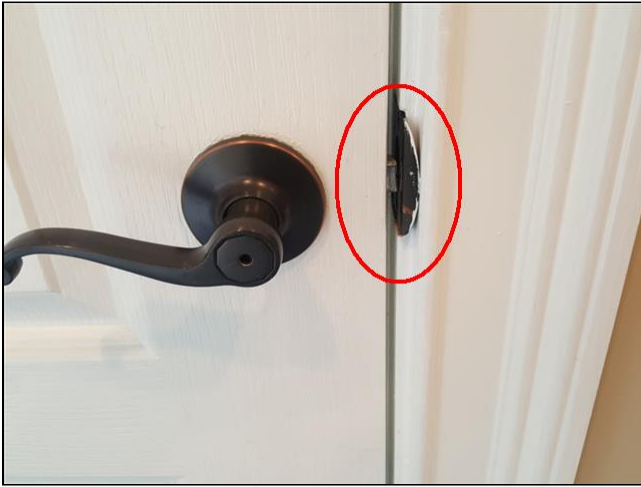
7.2 Item 1(Picture)

7.2 The door knob hardware is not latching in the 2nd bathroom where indicated in the photo. It requires an adjustment. The strike plate may need to be adjusted or trimmed to be able to lock/close the door. Recommend repair as needed.

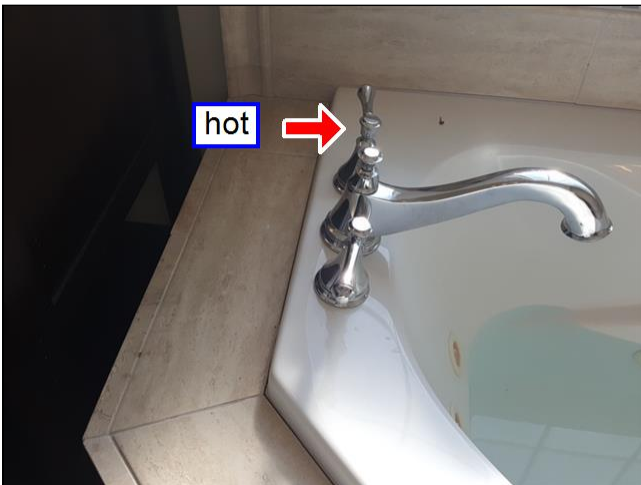
7.4 Item 1(Picture)

7.4 (1) The hot and cold water lines are connected in reverse from there normal positions in the Master bathroom at the jacuzzi tub. This could result in scalding burns of a person or child and is a safety issue. Recommend they be changed to the accepted normal locations with the cold water valve on the right side of the fixture. Recommend a licensed plumber correct as needed.

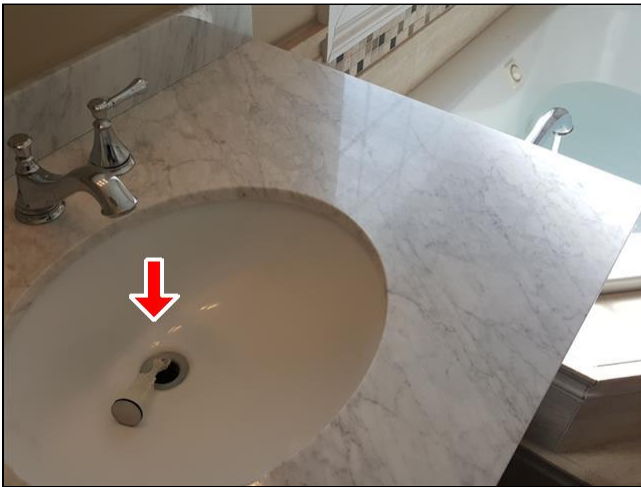
7.4 Item 2(Picture)

7.4 (2) The drain control stopper is not connected at the sink and does not function in the master bathroom. Recommend correcting to allow easy use of the drain lever and to ensure it functions properly. Repair or correct as needed.

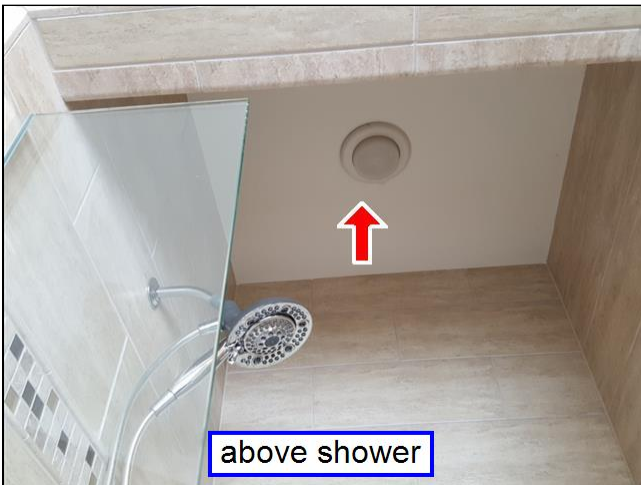
7.6 Item 1(Picture)

7.6 (3) The light fixture does not work above the shower and the jacuzzi (try bulb first) at the master bathroom. This is for your information.

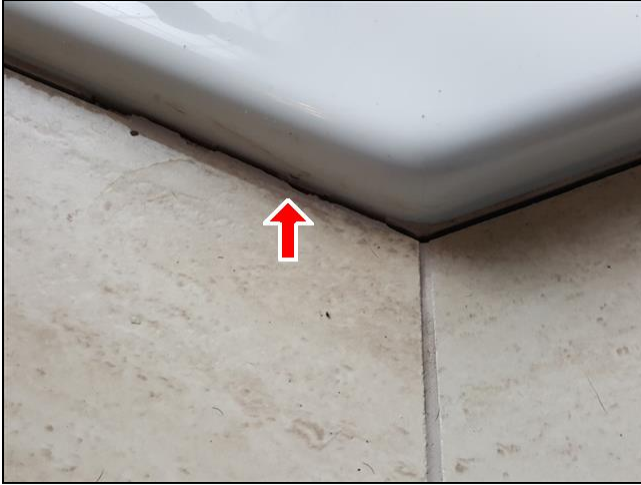
7.8 Item 3(Picture)

7.8 (2) Cracked grout around the jacuzzi enclosure should be sealed and replaced with new grout to prevent water entry behind the finished materials. If the grout is damaged and not properly repaired it could allow water entry. Water entry can damage the walls, framing or loosen the tiles and cause mold growth. A qualified contractor should be able to make any repairs that are needed.

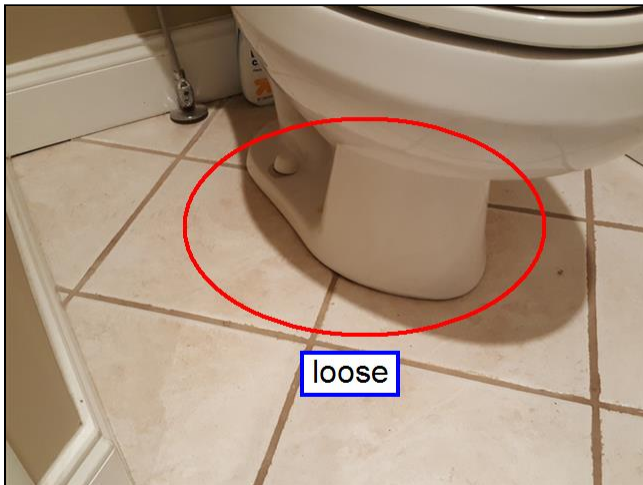
7.9 Item 1(Picture)

7.9 The toilet tank base is loose at the floor in the half bath. The screws may need tightening to secure the toilet base to the floor to prevent a water leak between the toilet and the drain line connection. If tightening the screws at the base of the toilet does not secure the toilet, repairs may involve re-setting the toilet on a new wax seal and/or repairs to the floor may be required. Recommend a qualified licensed plumber repair or correct as needed.

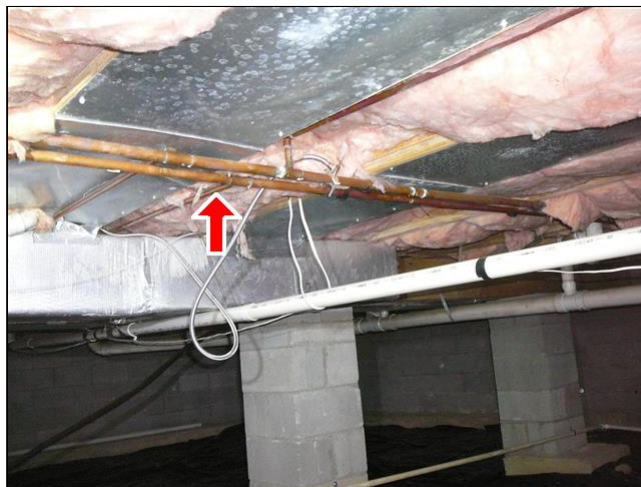
8.1 Item 2(Picture)

8.1 (2) Recommend insulating the water supply pipes underneath in the crawlspace (hot and cold) to ensure pipes do not freeze in winter which may cause a serious plumbing leak in the crawlspace, and to prevent heat loss of water when hot water is flowing into home. This will improve efficiency. This is for your information.

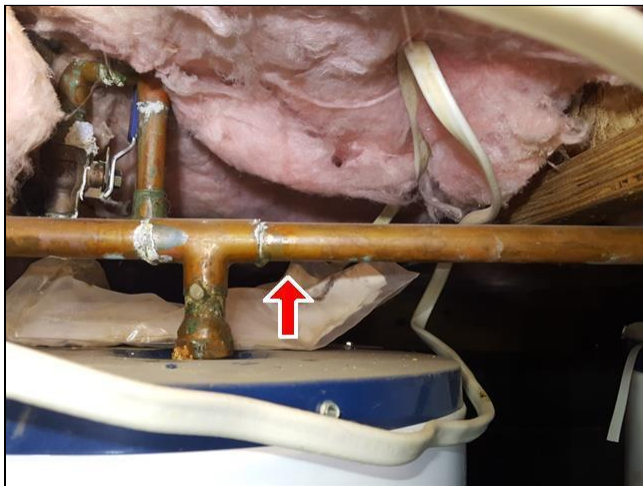
8.3 Item 2(Picture)

8.3 (2) Recommend insulating the water pipes leading into the water heater (hot and cold) to ensure pipes do not freeze in winter which may cause a serious plumbing leak in the crawlspace or harm the water heater, and to prevent heat loss of water when hot water is flowing into the home. This will improve efficiency.

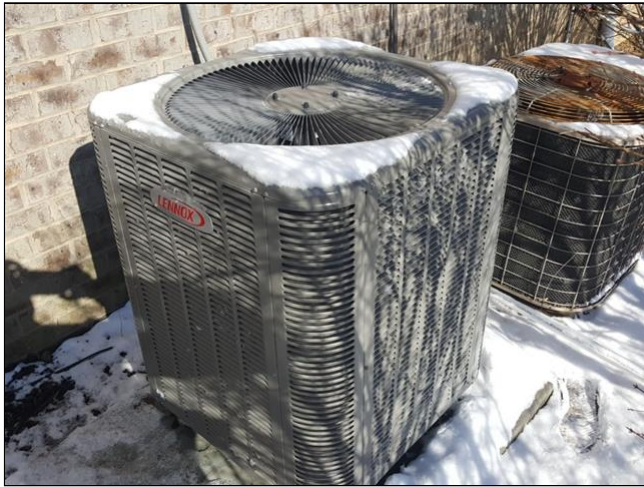
heat pump/left side of home

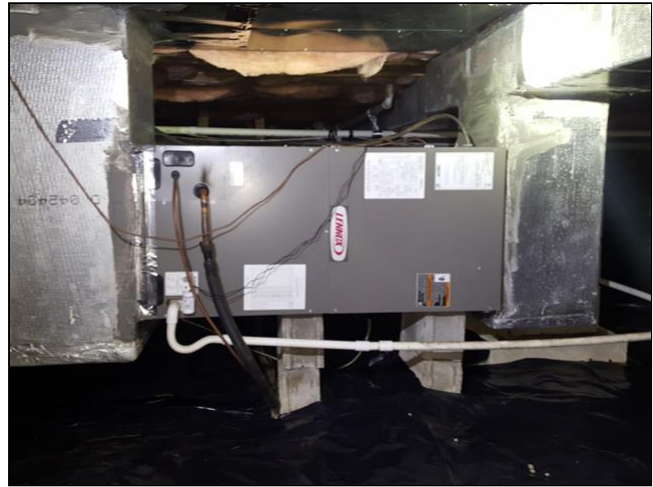
air handler/crawlspace

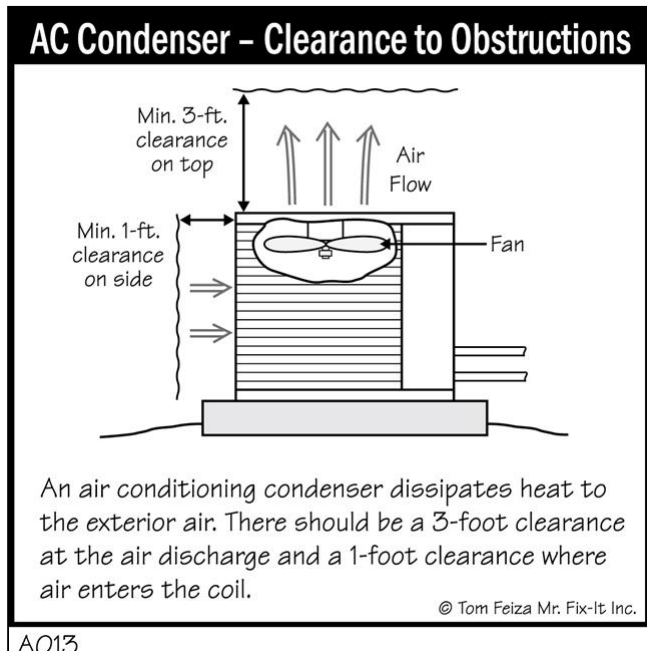
10.0.A Item 2(Picture) Unit Clearance

10.0.A (2) Vegetation in the vicinity of the outdoor unit of the Heat Pump should be cut back to prevent obstruction of the airflow. This can damage to the unit via running hot ,shorten it's life expectancy, and cause it to run inefficient. Recommend removing all the vegetation surrounding the unit so that the fins are not obstructed.

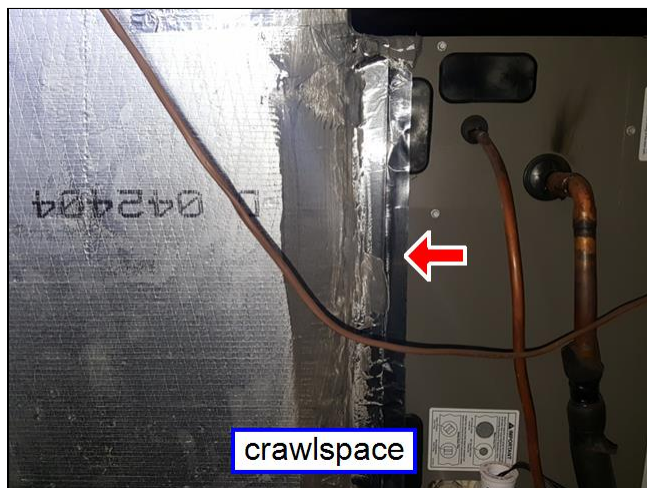
10.1.A Item 1(Picture)

The filter was not inspected due to the access cover is very difficult to open without damaging the unit and perhaps re-sealing the cover. The cover should be easily accessible and removed so that filter can be changed on a regular basis. Recommend a qualified HVAC correct as needed prior to moving in.

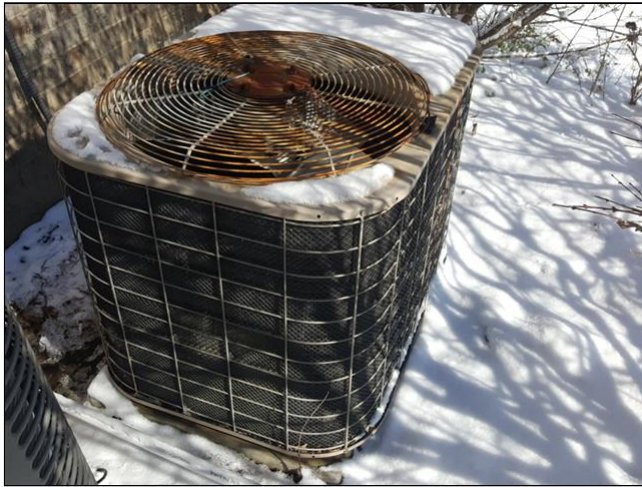
heat pump/left side of home

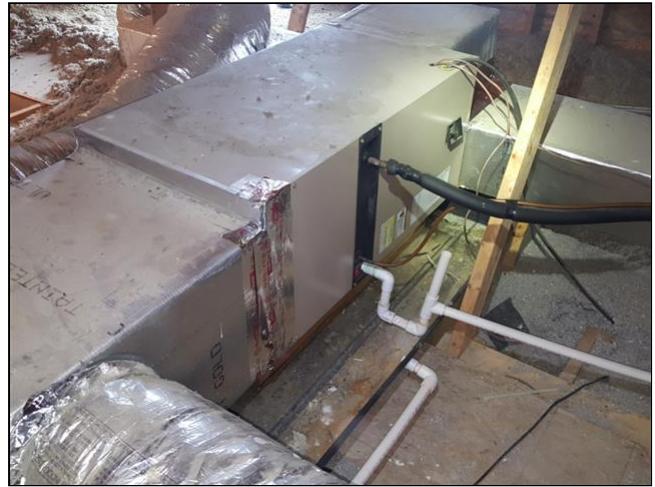
air handler/attic

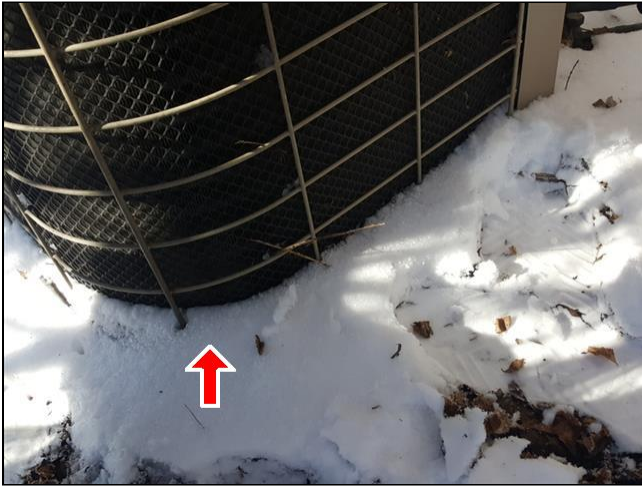
10.0.B Item 1(Picture)

10.0.B (3) The heat pump should be raised of the ground for better efficiency and proper drainage. Blocked fins via snow coverage can harm the unit and increase energy costs. Recommend a qualified HVAC contractor correct if desired. Ensure that when a new unit is installed that this is done on the new installation.

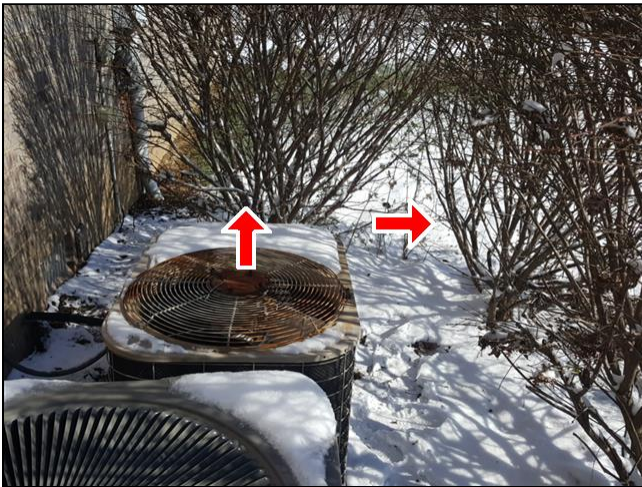
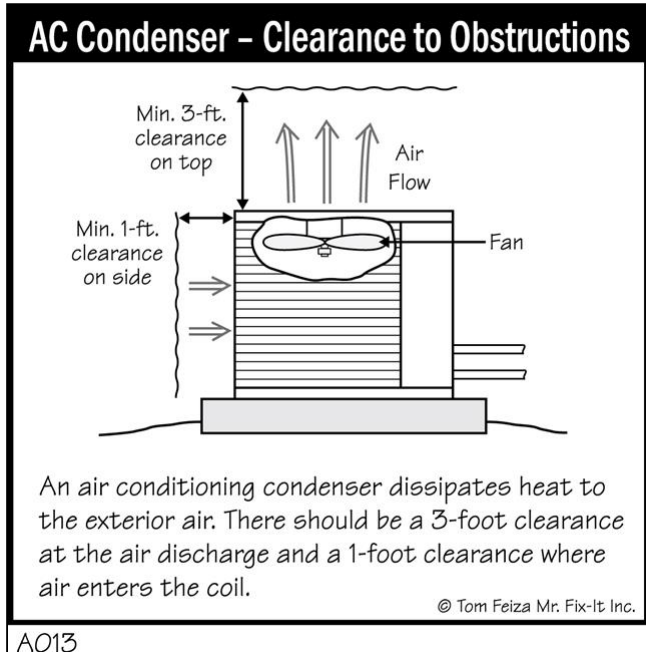
10.0.B (4) Vegetation in the vicinity of the outdoor unit of the Heat Pump should be cut back to prevent obstruction of the airflow. This can damage to the unit via running hot ,shorten it's life expectancy, and cause it to run inefficient. Recommend removing all the vegetation surrounding the unit so that the fins are not obstructed.

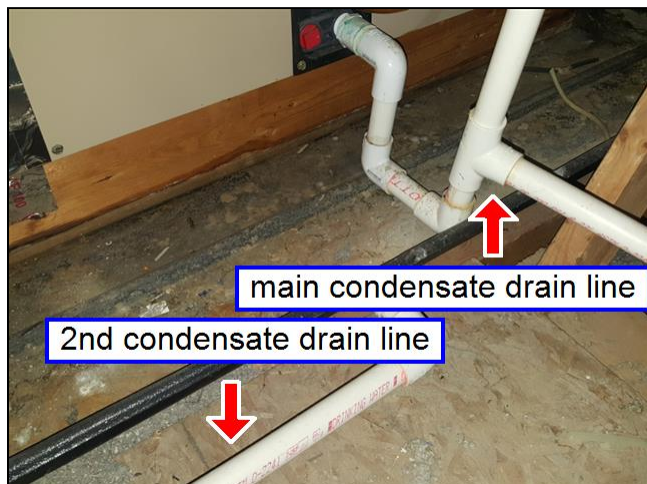
10.0.B Item 4(Picture)

10.0.B (5) The Air Handler in the attic has a condensate drip tray under the unit. In the event that the condensate drain line malfunctions or water overflows into the tray below, the additional condensate line will drain the water to the outside from the drain pan. Recommend that you check the drain pan each quarter to see if there is any water in the pan and install an Aqua guard condensate shut off switch as an additional safe guard in the event that both condensate drain lines are clogged. A qualified HVAC contractor is recommended for this install. This will ensure that the unit shuts down when the unit is leaking water and that water will not leak in the attic. This is for your information.

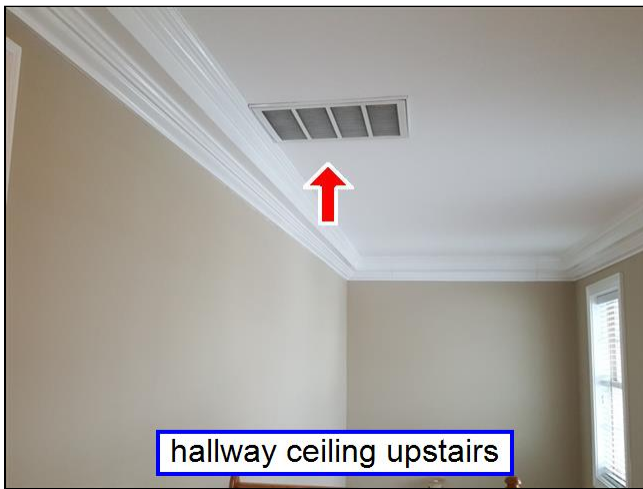
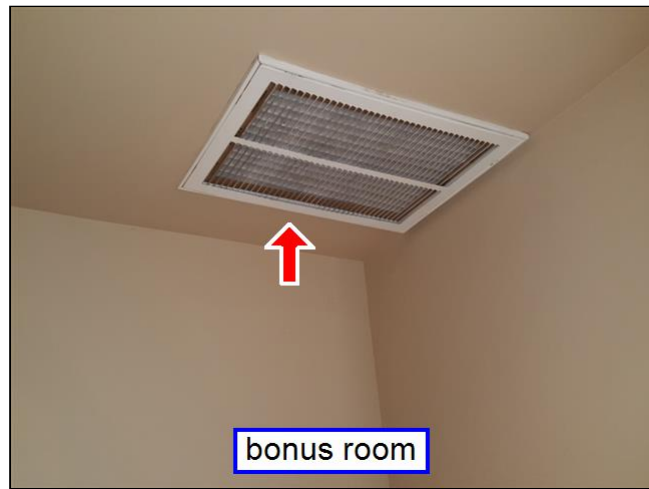
10.1.B (1) Filter location (see photo). The arrow on the filter should always point towards the blower.

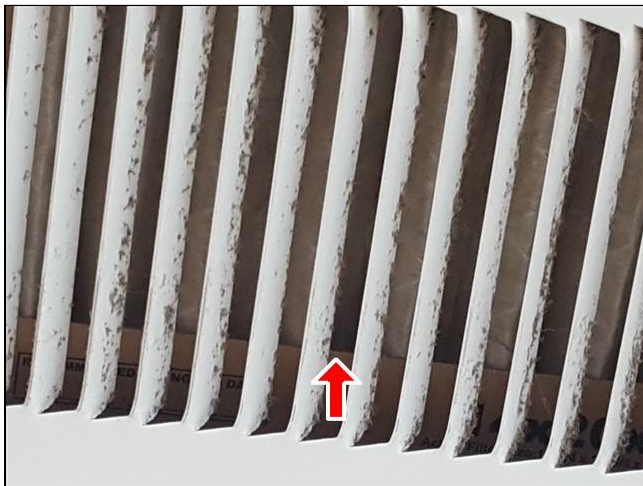
10.1.B (2) The filter is extremely dirty at the return register in the ceiling upstairs which reduces the efficiency of the HVAC system and shortens its life. Your filter is designed to keep airborne dirt from clogging your blower. If the filter itself gets clogged, then the system cannot move enough air, and it won't perform efficiently. Filters should be checked once a month or according to manufacturers recommendations and replaced as needed. Recommend the filters be replaced now.

10.1.B Item 3(Picture) hallway ceiling upstairs

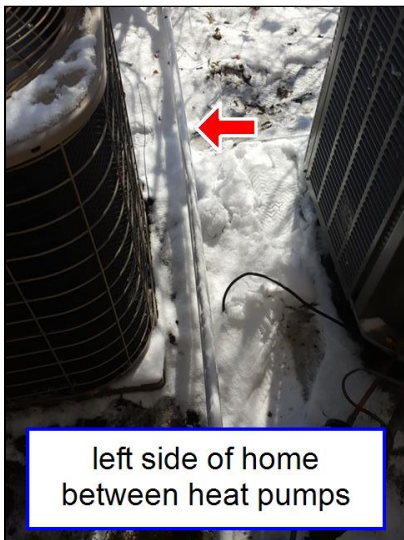
10.3.B Item 1(Picture)

10.3.B (1) Location of the condensate drain line to exterior. (see photo)

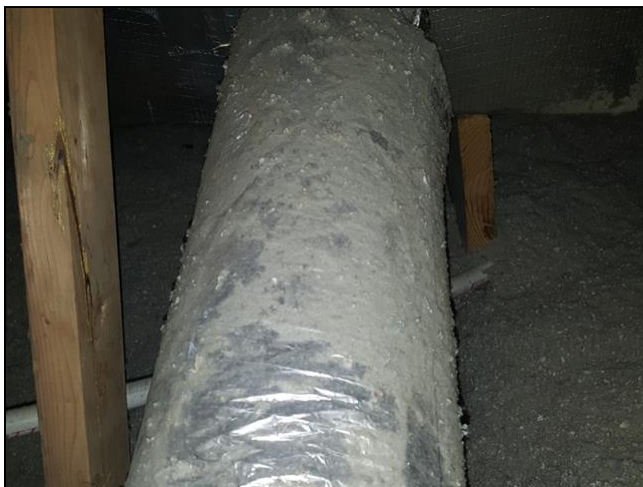
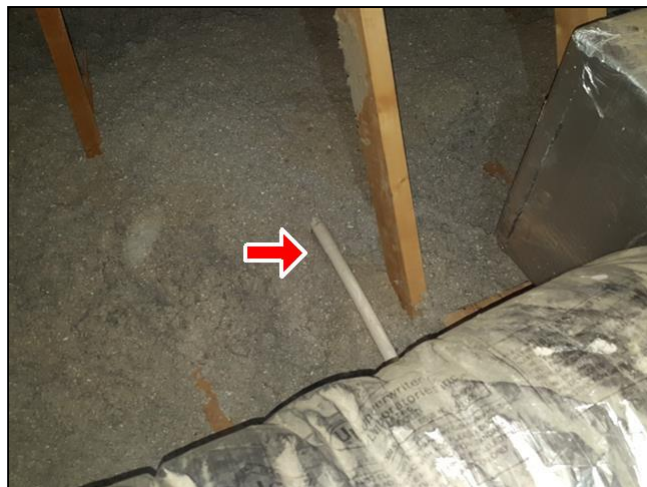
10.3.B (2) Could not locate where the 2nd condensate drain line exits. Recommend asking the owner for location and/or consult a HVAC contractor upon further inspection of both units. The drain line may be connected directly to the drainage system in the home.

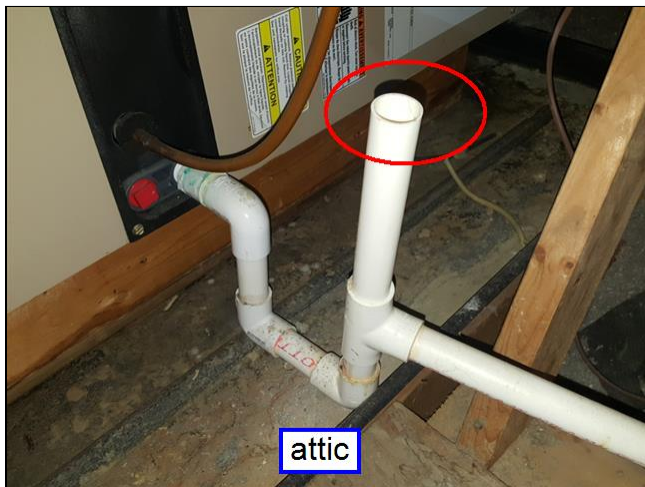
10.3.B Item 4(Picture)

10.3.B (3) The vent stack for the condensate drain line in the attic is incorrectly installed and is missing a cap. The vent pipe should be installed after the trap and have the top capped off. The current installation can cause the condensate not to drain and fail. Recommend a qualified HVAC contractor repair as needed.

Note: this may have been the reason for water stains in the drain pan.

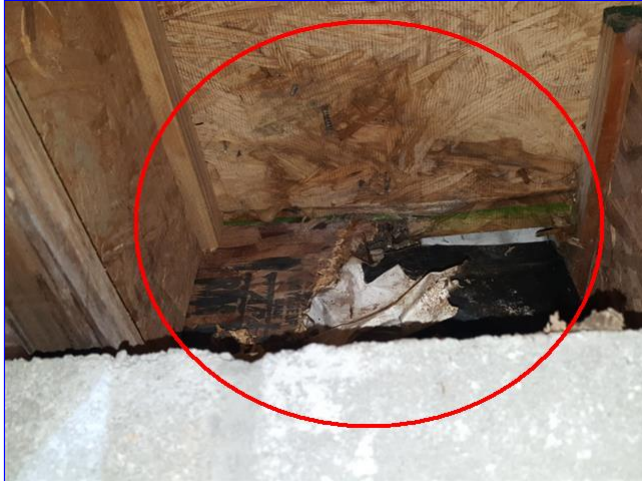
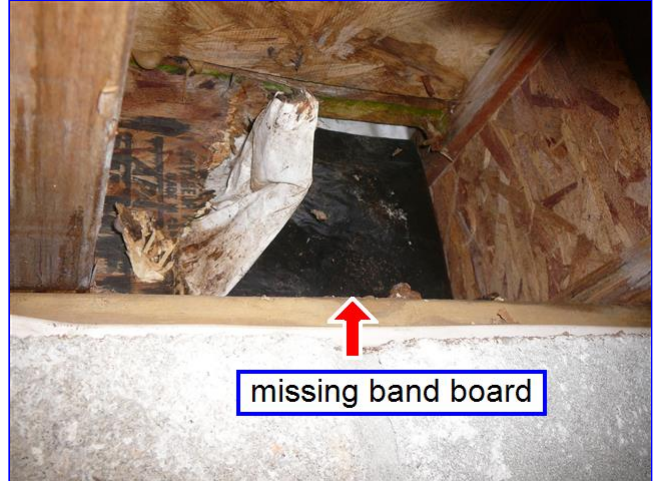
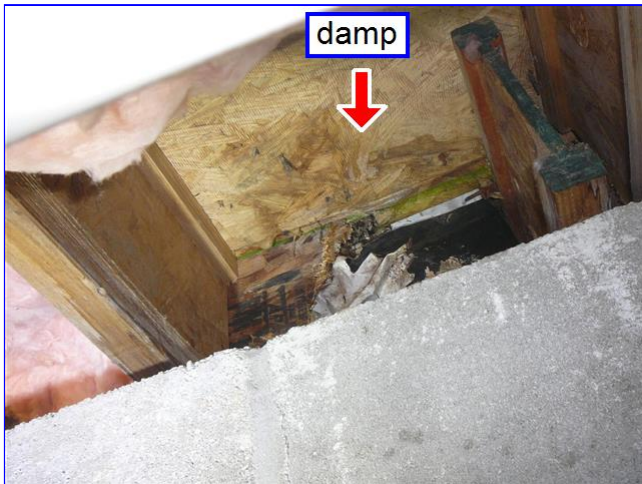
The band board is damp and partially missing in the crawlspace below the rear entry door area. It appears that water leakage has been occurring near the door frame which shows signs of previous repairs. I cannot determine if water leakage may still occur in this area. Water intrusion if not corrected can lead to other problems including mold and cause excessive moisture to floor system that can lead to deterioration and increased repair cost. Replacement of the missing band board maybe needed to support the sub floor in this area. Recommend a qualified contractor further evaluate to determine if water leakage is still occurring and to repair damaged area in the crawlspace.

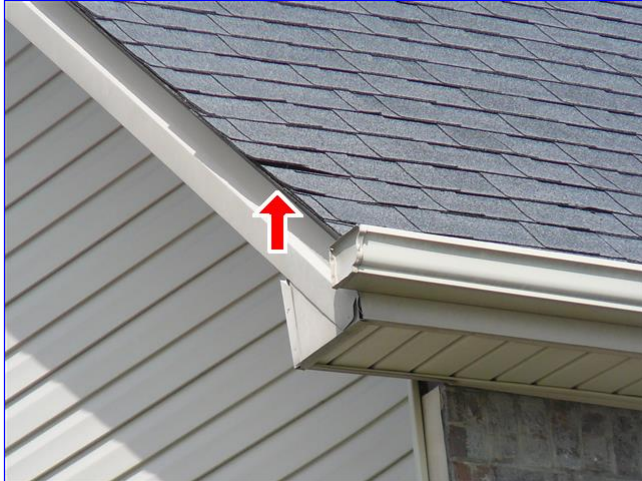
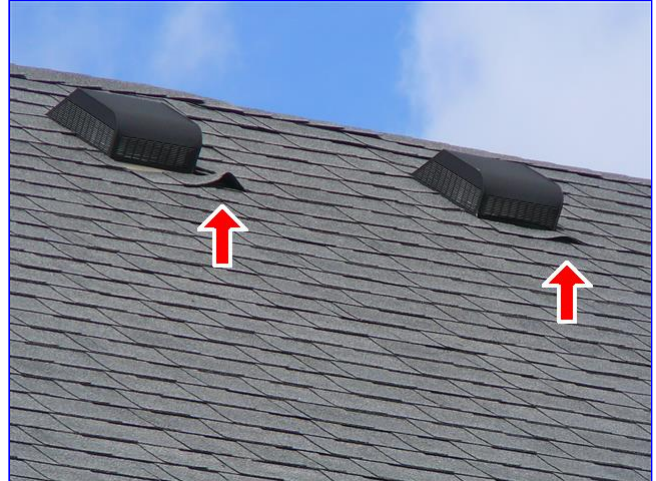
(1) The shingles on the roof at the rear of the home where indicated by the photo(s) are starting to lift and may not be secured correctly. The sealant of the shingle tab maybe failing. Shingle damage or roof leakage can occur at these areas. They are also at risk to be blown off by high winds. If the shingle is raised by more than 1/2" the nails should be reseated to prevent water entry under the shingles. Recommend a qualified roofing contractor repair as needed.

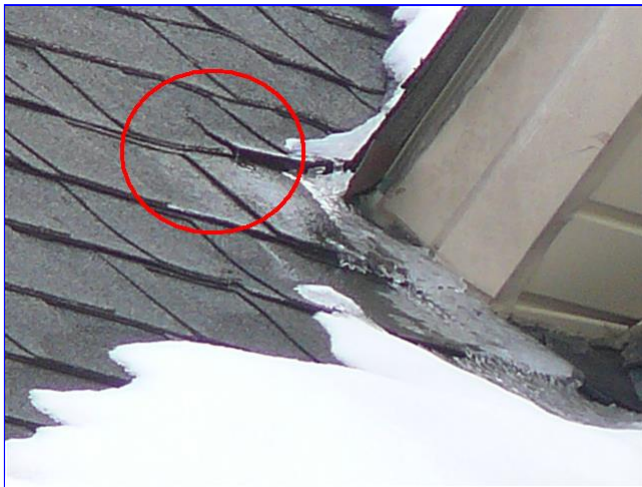
2.0 Item 3(Picture)

(2) The damaged shingle on the right hand side of the garage roof needs to be replaced or repaired before a water leak develops. This area also has excess water draining in this area due to the roof intersection. Also a diverter flashing maybe needed. The area below in the bonus room attic was wet at the time of the inspection indicating a roof leak is experienced in this area. It may not be caused by the cracked shingle. Strongly recommend a qualified roofing contractor further investigate this area to determine where leak is occurring and repair as needed prior to closing. Water leakage in an attic can cause mold to occur and deteriorate the roof structure.

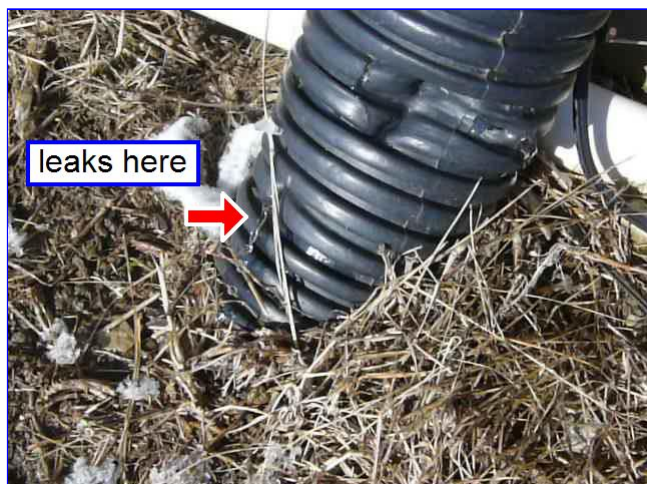
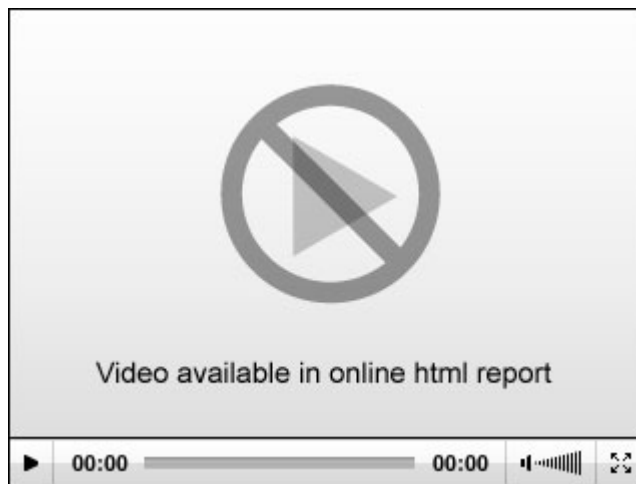
(1) The downspout extension is cracked and leaks at the rear right corner of the home. This can cause crawlspace leakage, settlement of the foundation wall and possible soil erosion near the foundation perimeter. Recommend repair or replacement as needed by a general contractor.

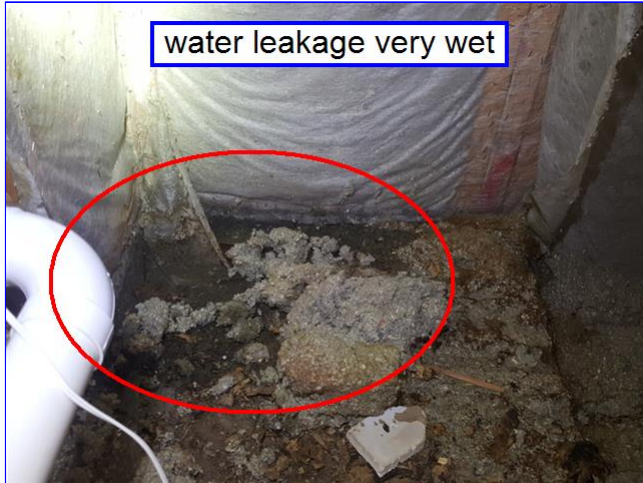
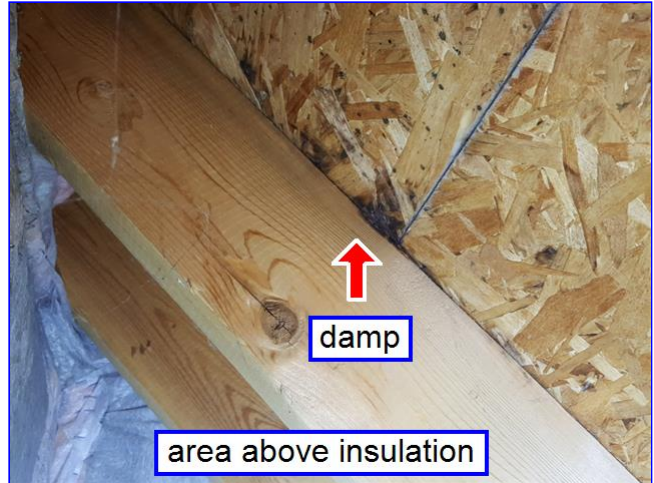
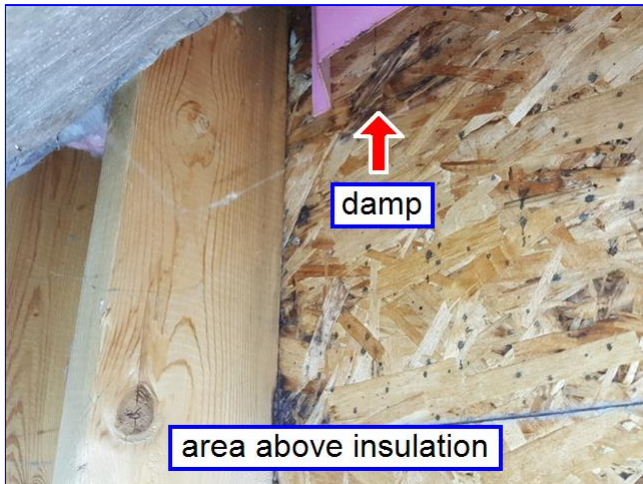
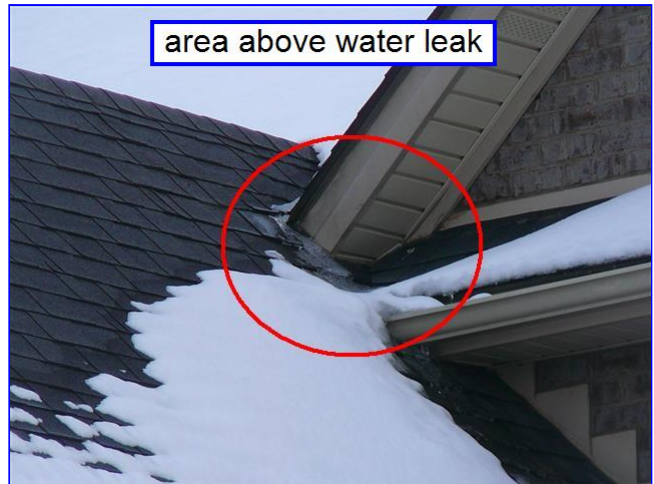
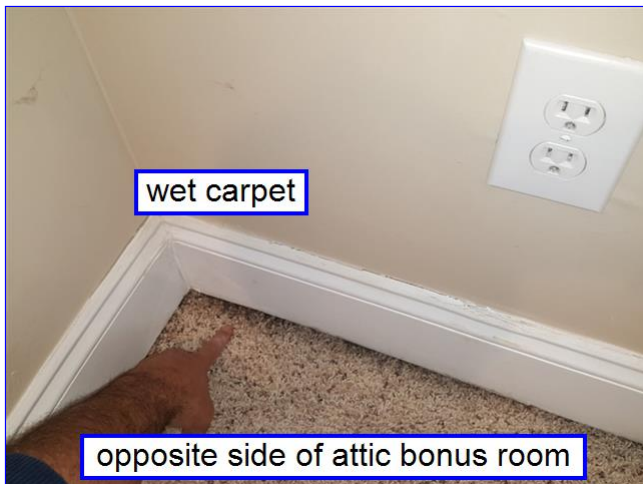
(1) There is a water leak in the bonus room attic above where the garage and house roof intersects. The insulation and floor was wet at the time of the inspection. The damage to the structure in this area does not appear significant to require replacing at this time. The wet insulation should be removed and replaced where needed to prevent mold from occurring. If not corrected roof leakage can cause deterioration of the buildings structure and materials which will result in increased repair costs later on if not corrected. Strongly recommend a qualified roofing contractor further evaluate to determine where leakage is occurring and repair/correct as needed prior to closing. Other trades maybe needed if there is hidden damage that could not be seen.

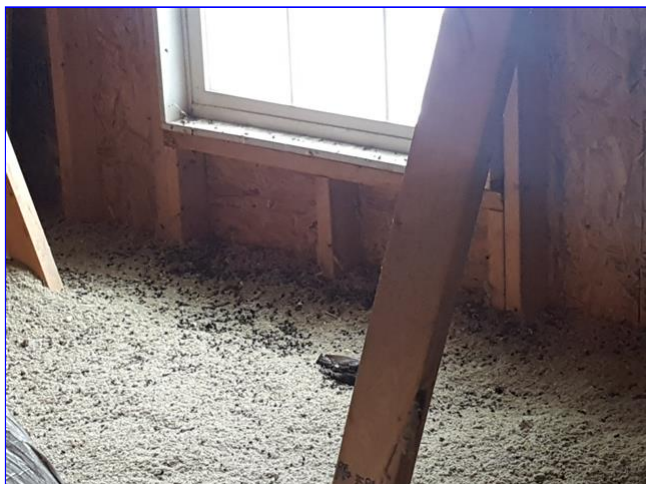
2.5 Item 6(Picture)

(2) Excessive dead flies were found near the window in the attic at the front of the home. Recommend a qualified pest control contractor evaluate the attic area to determine where they are entering from and seal openings/correct as needed. They maybe entering from the gable vents which are missing screens.

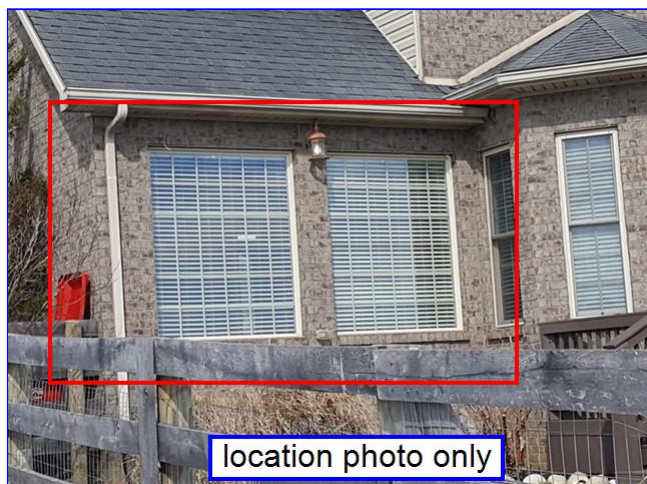
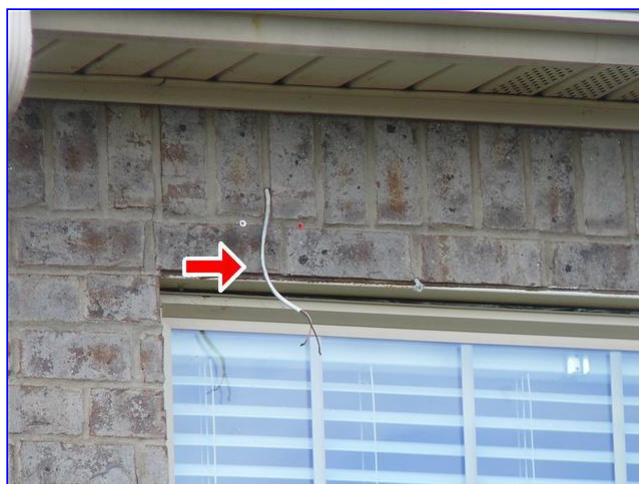
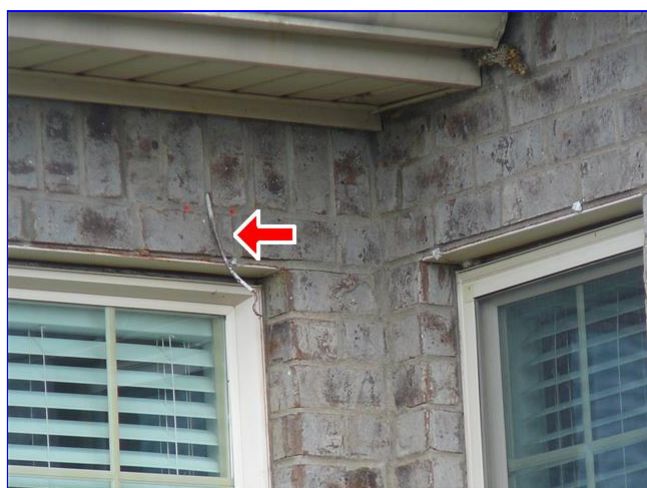
(3) There is exposed electrical wiring from the wall above the living room window where indicated in the photos. Wires should not be exposed to weather or exposed. This is a safety issue. The wiring can be damaged which could cause a short or if touched cause an electric shock resulting in a death. Exposed wires should be UF and protected in conduit leading to the source. Recommend a qualified electrician further investigate, then repair and/or correct as needed prior to closing. These wires maybe for speakers or lighting. I could not determine.
