TALCO
Home Inspection

Inspection Report

202 Scarborough Beach Road
Richmond KY 40475

Date: 3/14/2018	Time: 10:00 AM till 02:00 PM	Report ID: 180314KNUE
Property: 202 Scarborough Beach Road Richmond KY 40475	Customer: Ms. Sharon Anthony	Real Estate Professional:

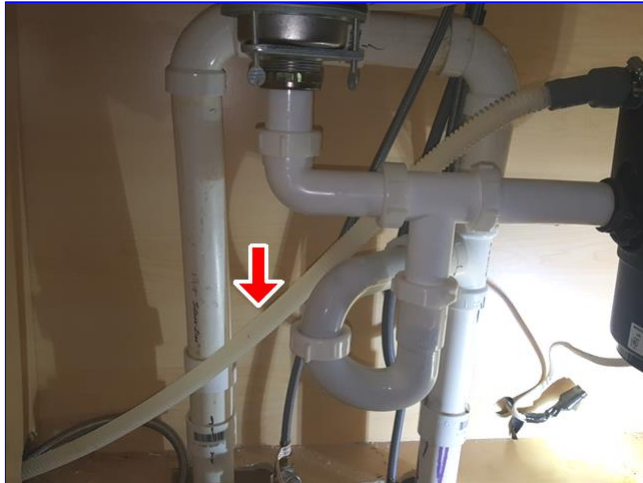
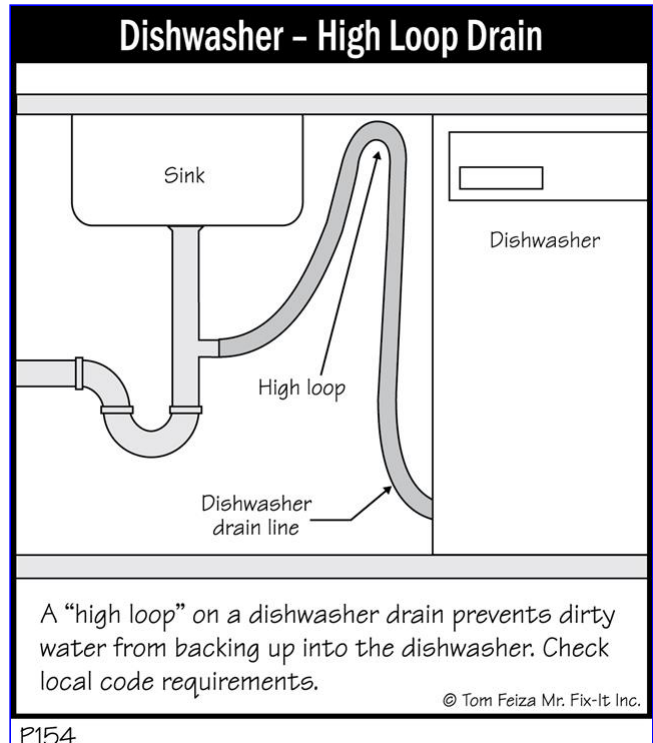
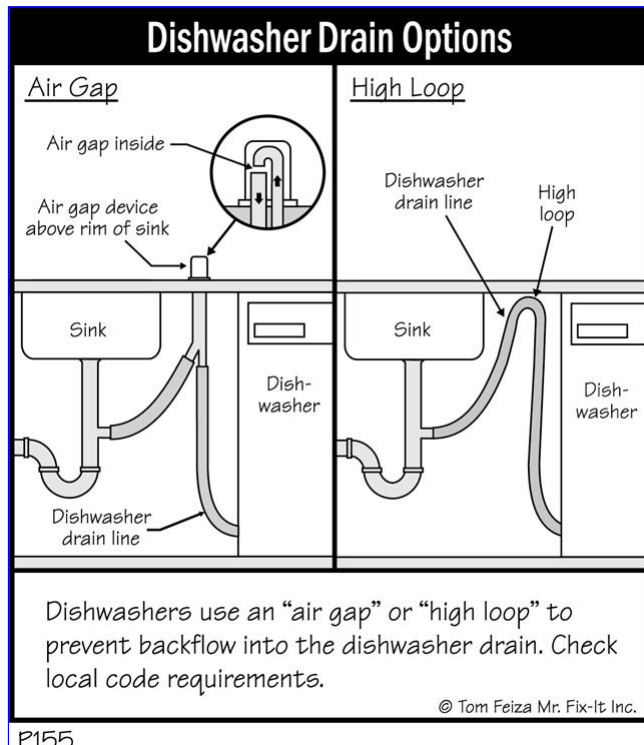
The dishwasher drain hose did not perform a loop to create a trap under the sink. The current recommendations for the dishwasher drain lines are for them to be installed as close to the bottom of the countertop as possible. This creates a water blockage to prevent sewer gases entering the house through the dishwasher. Recommend repair or replace as necessary.

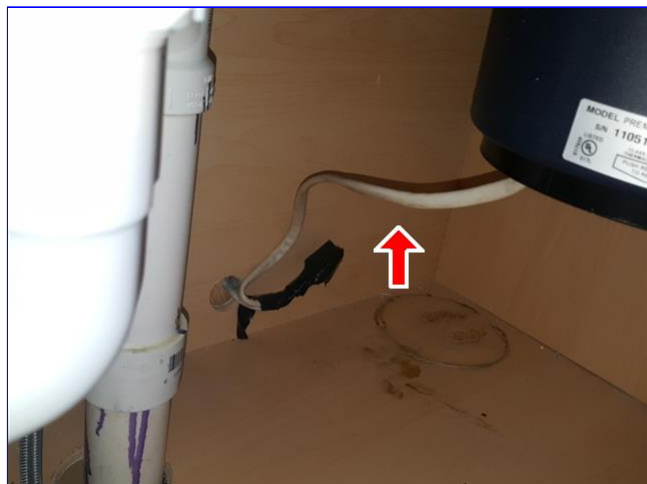
5.3 Item 3(Picture)

(3) Unprotected electrical wiring under the kitchen sink for the disposer is susceptible to being damage and should be relocated or protected by a rigid conduit. Recommend a qualified electrician repair as needed for safety of the occupants.

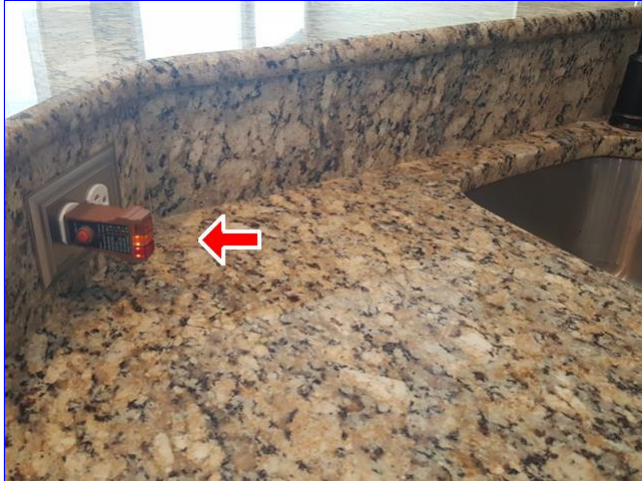
5.9 Item 2(Picture)

(4) The GFCI outlet (Ground Fault Circuit Interrupt) at the kitchen where indicated in the photo(s) is improperly wired with the hot and neutral wires reversed. This is extremely dangerous and a potential shock hazard. You **CAN BE SHOCKED** causing a possible death when the switch to the appliance is off when plugged into the outlet. Recommend a qualified licensed electrician repair as needed for safety prior to moving.

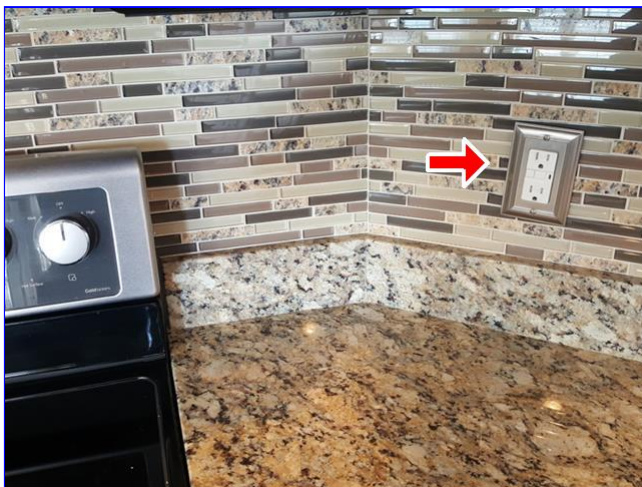
5.9 Item 3(Picture)

(5) The outlet(s) in the kitchen where indicated in the photo(s) are/is loose at the wall or in the outlet box. Electrical issues are considered a hazard until repaired. This is a safety issue that needs to be corrected due to an electric shock or fire from loose connections could occur if not repaired. Recommend a qualified licensed electrical contractor correct as needed.

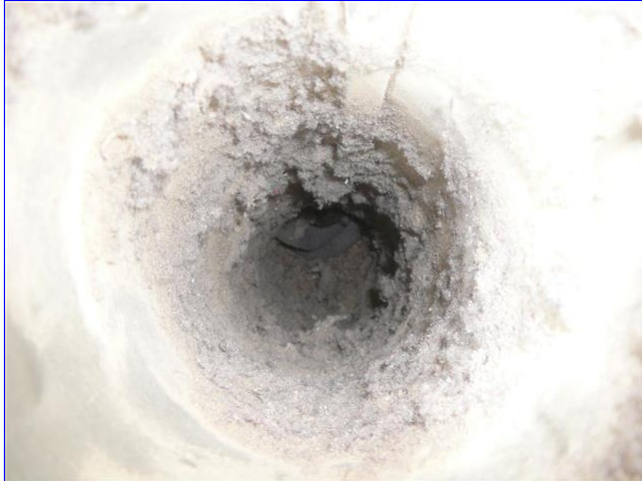
5.10 Item 6(Picture)

(3) The dryer vent pipe has a large build up of lint inside. This is restricting the flow and may cause a back-draft. This can cause a fire to occur due to excessive heat build up in the vent pipe. Also your dryer runs longer, putting more wear and tear on it and therefore cutting the machines life in half. Strongly recommend cleaning the dryer vent for safety before moving in and operating dryer.

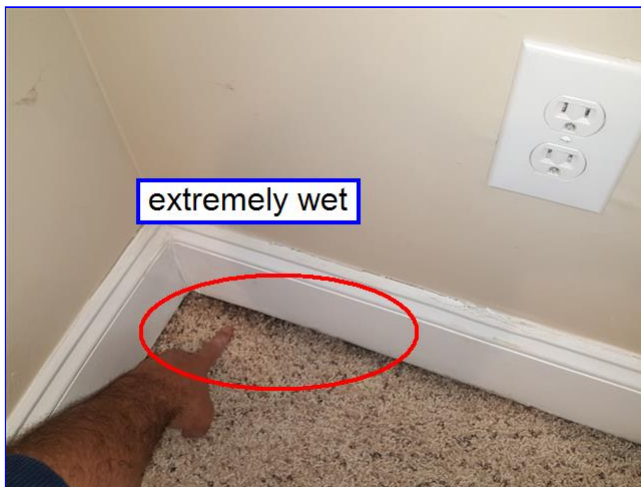
6.2 Item 5(Picture)

(2) The carpet is wet in the bonus room near the entry door from a water leak in the attic. See note 2.5(1) and 2.0(2) for recommendation and repairs.

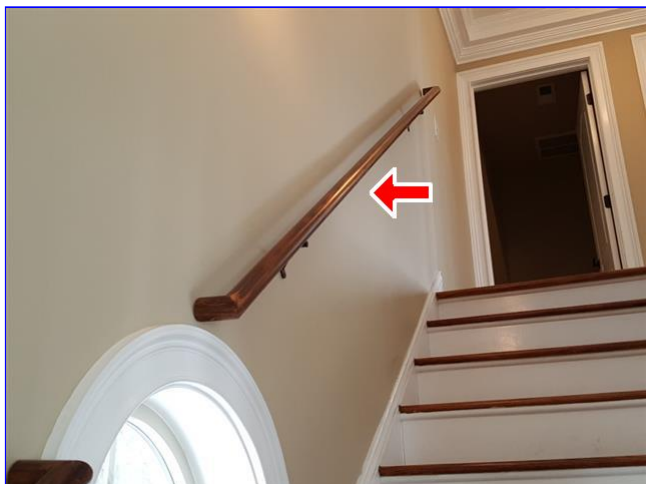
6.3 Item 1(Picture)

The stair case rail on the on the left side is unstable and not secured properly. This is extremely dangerous and is a safety concern. It may fail under a medium or heavy force or if someone was pushed against or was leaning on the railing. For your safety it should be strengthened and secured. Recommend a qualified contractor repair as needed before closing.

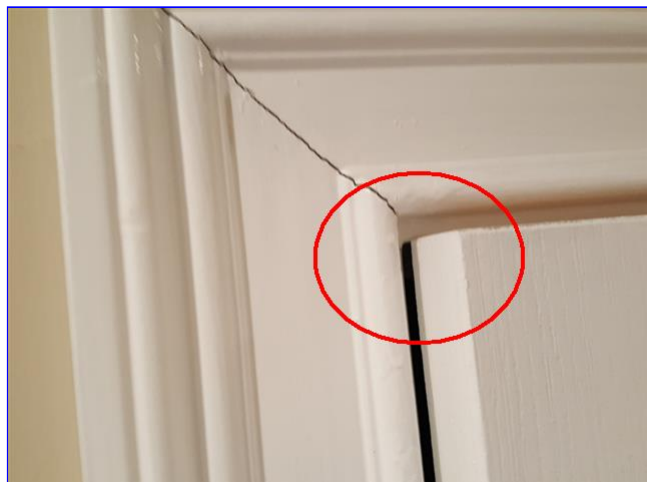
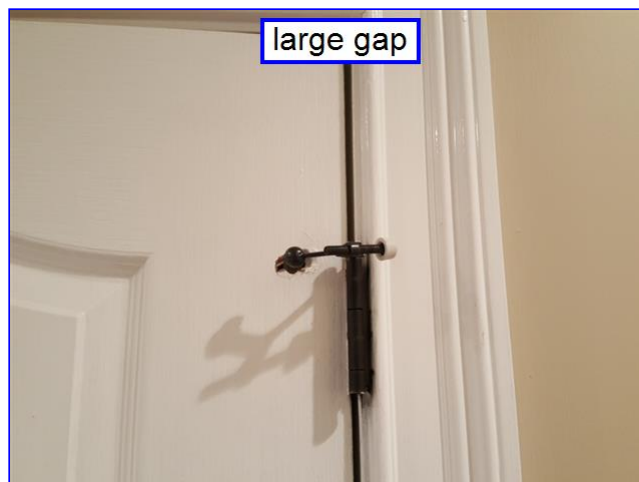
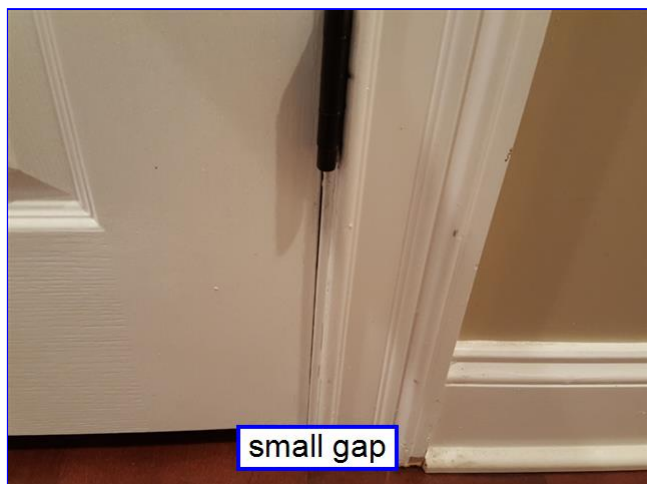
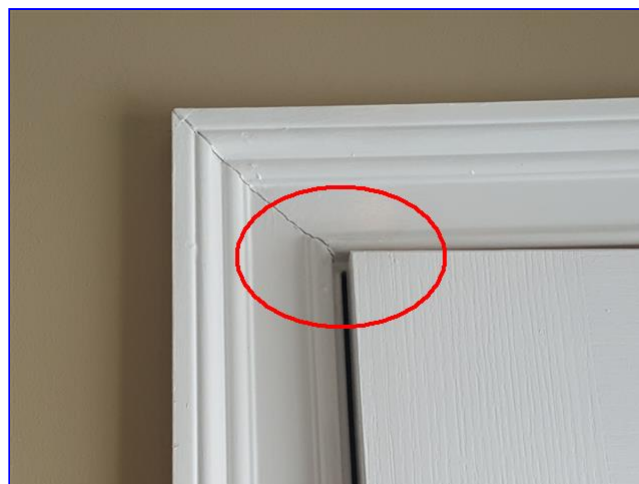
(1) The doors where indicated in the photos hits the door jamb at the top and does not close shut. Sometimes correcting the door opening can require the door trim to be removed and painting touch up, and/or door hinges may need reseating to ensure correct closure of the door. Recommend a general contractor repair as needed.

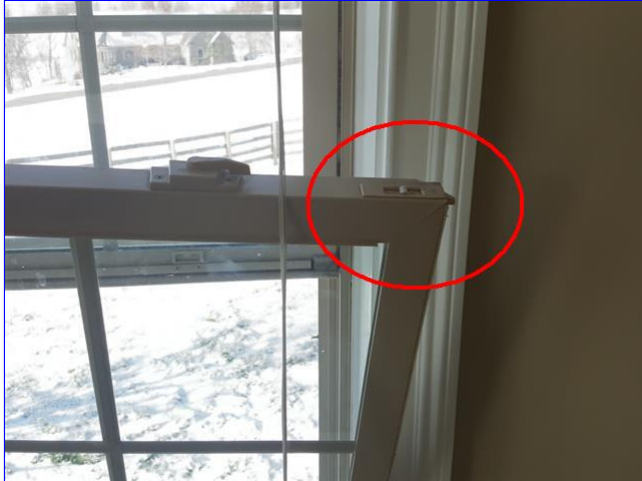
6.5 Item 1(Picture)

(1) The window pulls out of the frame when the tilt feature is used in the Master Bedroom on the right side at the bottom of window. The window is loose in the frame however it does open and close correctly. This is a maintenance issue. Recommend a qualified window installer repair as needed. There may be a warranty in effect on these windows. Inquire from the owner as to any possible warranties.

This is a potential safety issue as the window may drop which could result in an injury of a person when tilted for cleaning.

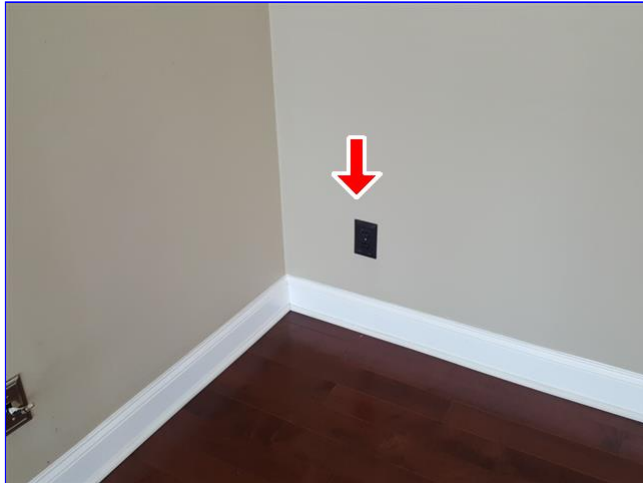
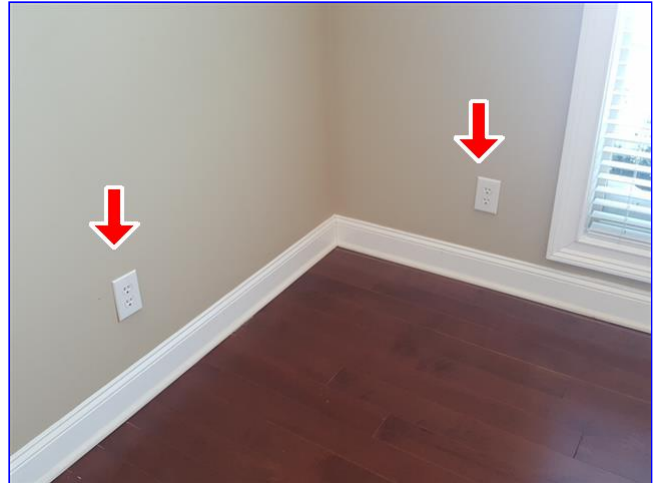
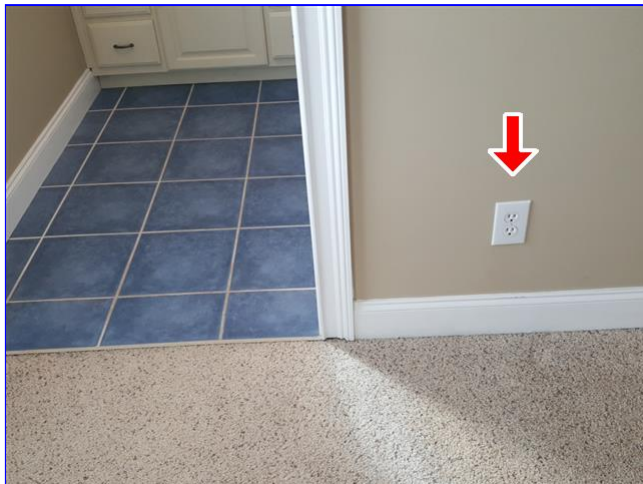
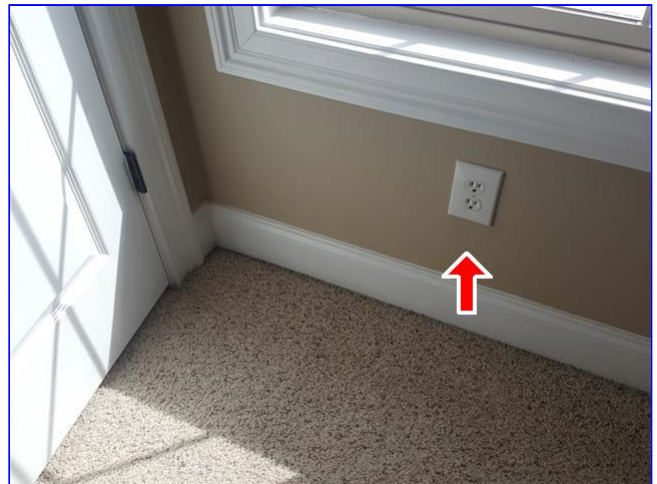
(1) The outlet(s) where indicated in the photo(s) are/is loose at the wall or in the outlet box. Electrical issues are considered a hazard until repaired. This is a safety issue that needs to be corrected due to an electric shock or fire from loose connections could occur if not repaired. Recommend a qualified licensed electrical contractor correct as needed.

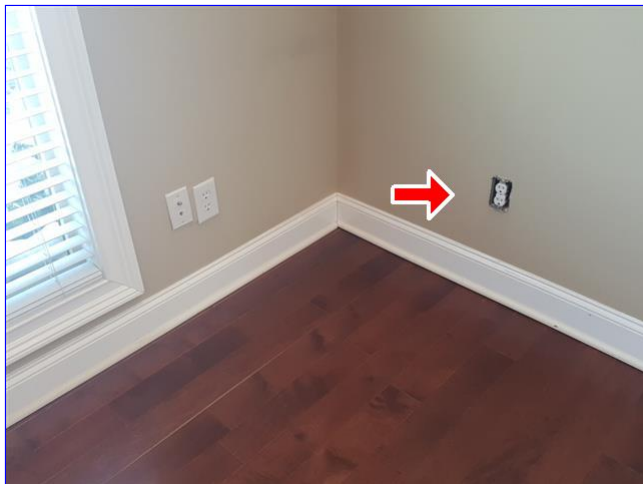
6.7 Item 5(Picture) sitting room

(2) The outlet(s) in the sitting room where indicated in the photo(s) is missing a cover-plate. All missing covers should be installed to prevent touching the sides of the devices to prevent an electric shock which can cause an injury or death. Electrical issues are considered a hazard until repaired, and this is considered to be unsafe. A qualified licensed electrical contractor should correct as needed prior to moving in.

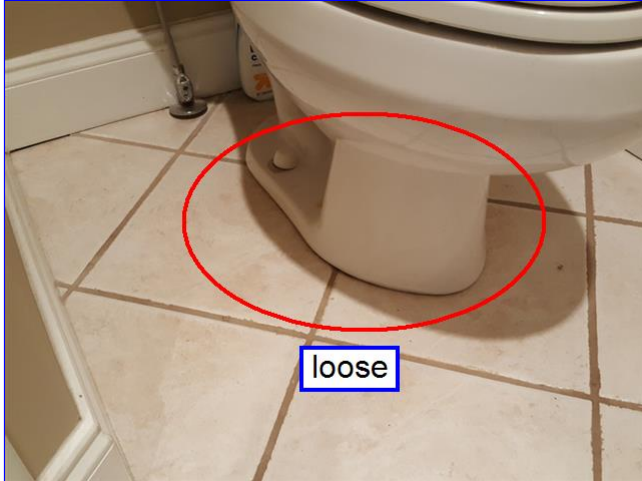
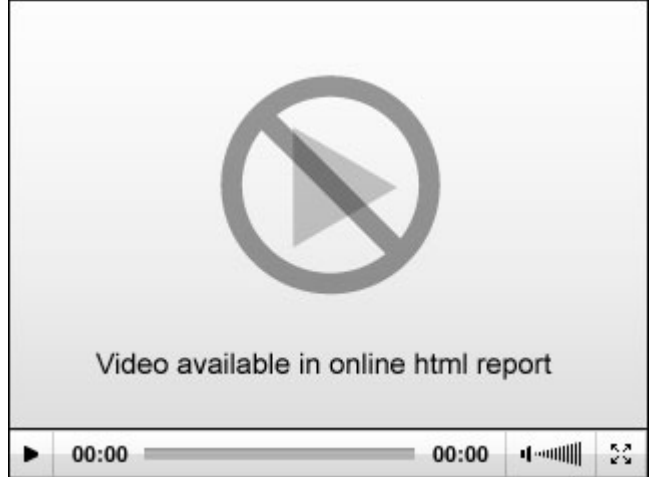
The toilet tank base is loose at the floor in the half bath. The screws may need tightening to secure the toilet base to the floor to prevent a water leak between the toilet and the drain line connection. If tightening the screws at the base of the toilet does not secure the toilet, repairs may involve re-setting the toilet on a new wax seal and/or repairs to the floor may be required. Recommend a qualified licensed plumber repair or correct as needed.

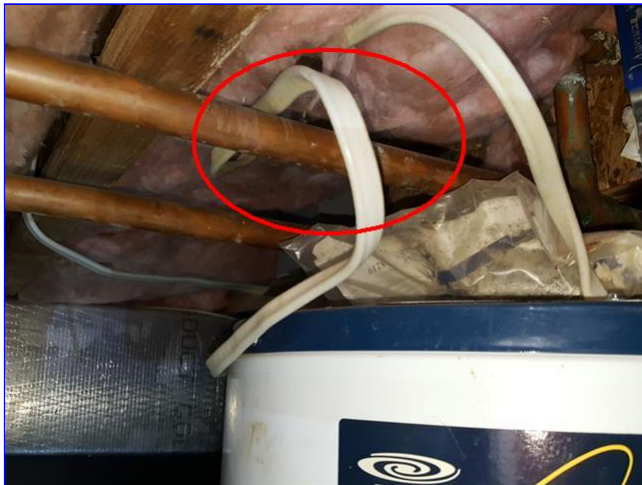
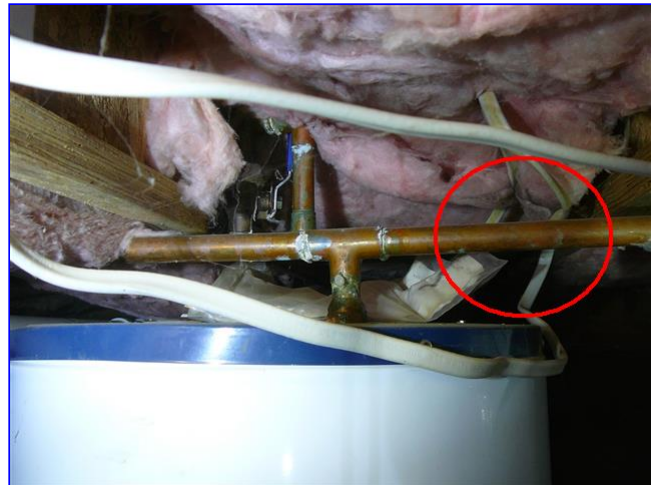
(5) Electric lines running across the top of the water heater should be protected in a conduit and/or secured to joists to protect the wire jacket from damage. The electrical wire may contact the hot water line which can melt the insulation which can lead to an energized wire. The wiring for the water heater should be in a conduit and have a romex connector connecting it to the water heater. This is a safety issue as an injury or death could occur from an electrical shock. Recommend a licensed electrical contractor correct, repair or replace as necessary.

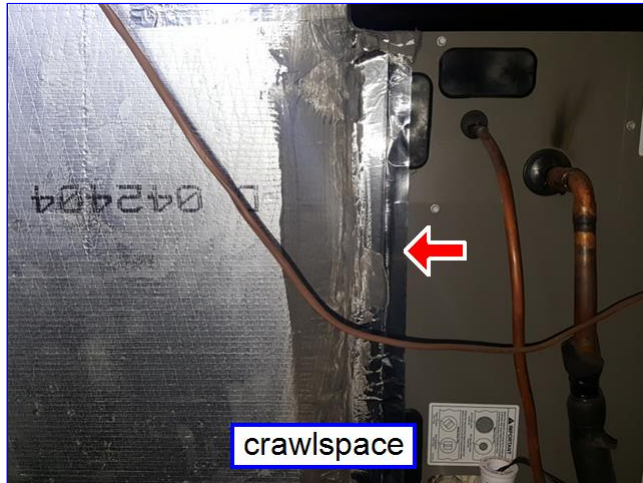
10.1.A Item 1(Picture)

The filter was not inspected due to the access cover is very difficult to open without damaging the unit and perhaps re-sealing the cover. The cover should be easily accessible and removed so that filter can be changed on a regular basis. Recommend a qualified HVAC correct as needed prior to moving in.

Note: The filter ensures clean air is distributed within the home and also protects equipment from small debris entering which can lead to problems with the unit and duct work.

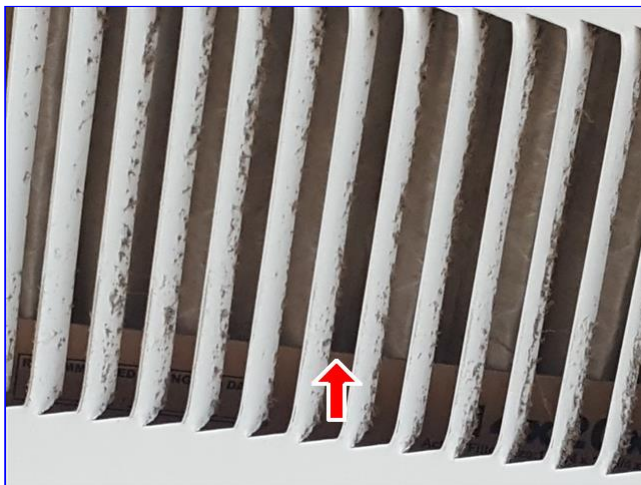
10.1.B Item 3(Picture) hallway ceiling upstairs

(2) The filter is extremely dirty at the return register in the ceiling upstairs which reduces the efficiency of the HVAC system and shortens it's life. Your filter is designed to keep airborne dirt from clogging your blower. If the filter itself gets clogged, then the system cannot move enough air, and it won't perform efficiently. Filters should be checked once a month or according to manufacturers recommendations and replaced as needed. Recommend the filters be replaced now.

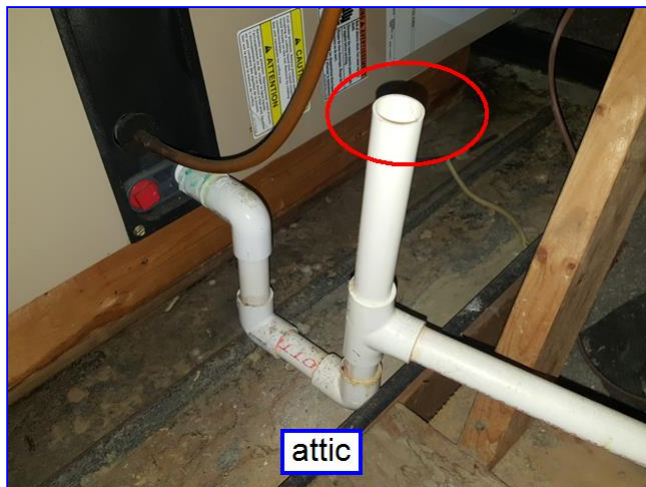
10.3.B Item 4(Picture)

(3) The vent stack for the condensate drain line in the attic is incorrectly installed and is missing a cap. The vent pipe should be installed after the trap and have the top capped off. The current installation can cause the condensate not to drain and fail. Recommend a qualified HVAC contractor repair as needed.

Note: this may have been the reason for water stains in the drain pan.

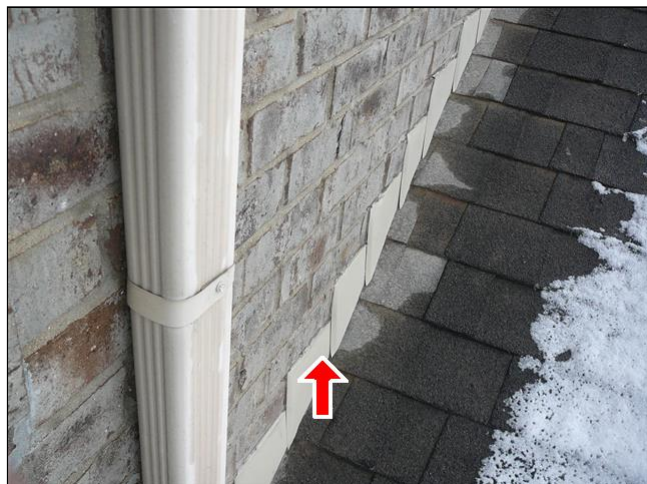
2.1 Item 1(Picture)

(2) There are some gaps in the step flashings around the home, and they should be sealed to prevent water entering behind the flashing which can lead to water leaks in the attic and wall cavity which can cause deterioration of the roof and wall structure. Recommend sealing gaps with caulk as needed.

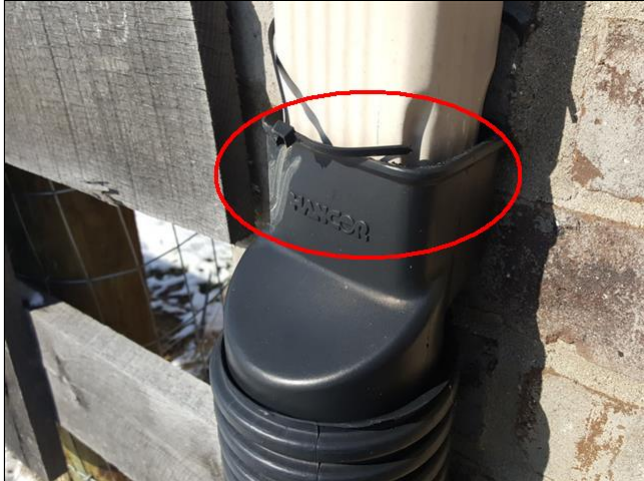
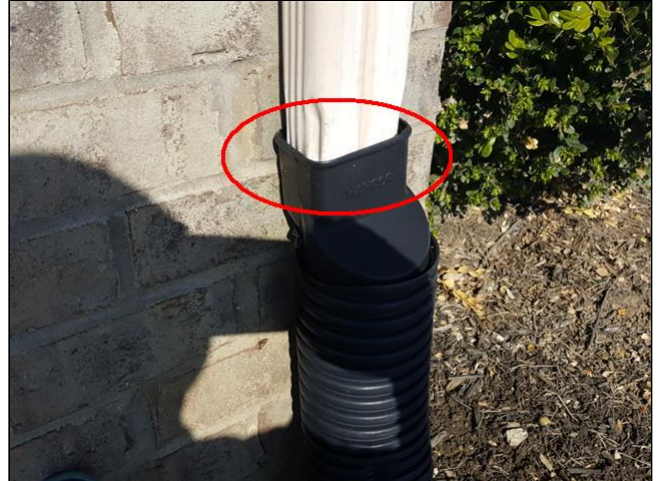
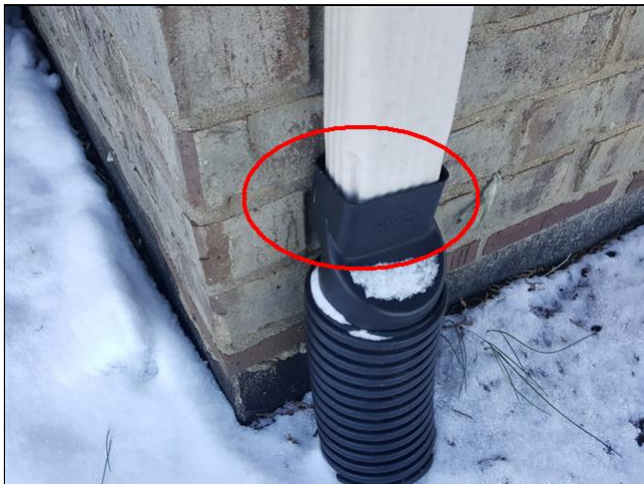
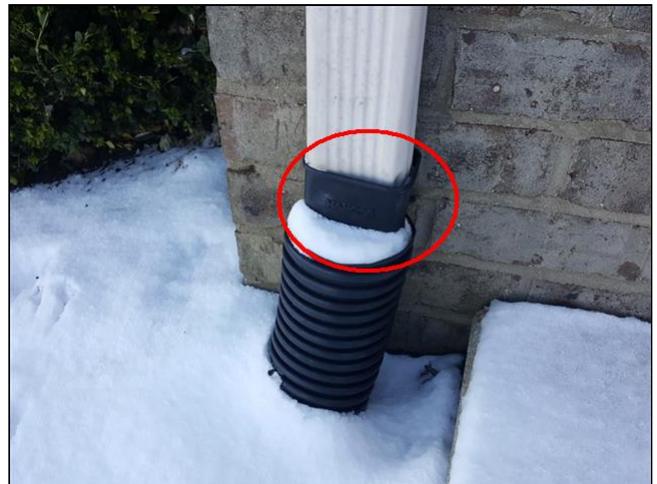
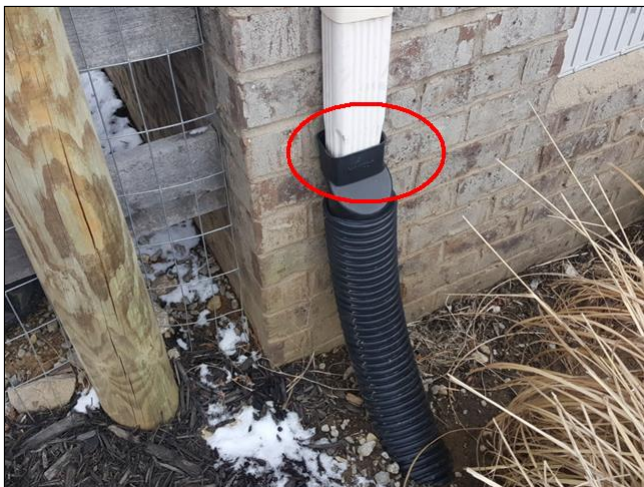
(3) Recommend the downspout extension(s) be attached to the downspout at the where indicated in the photos by placing a screw at the top and bottom where it connects to the downspout to ensure the extension(s) does not pull away from the downspout(s). Failing to do this may create future problems to the foundation around the home due to soil erosion and water entering the crawlspace which may result in the foundation settlement if the extension detaches from the downspout.

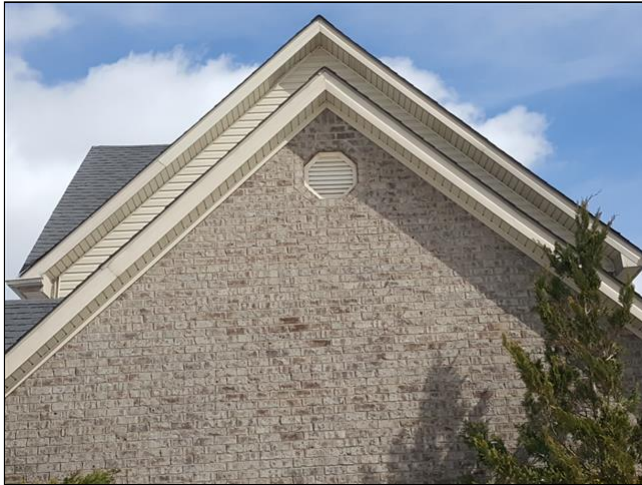
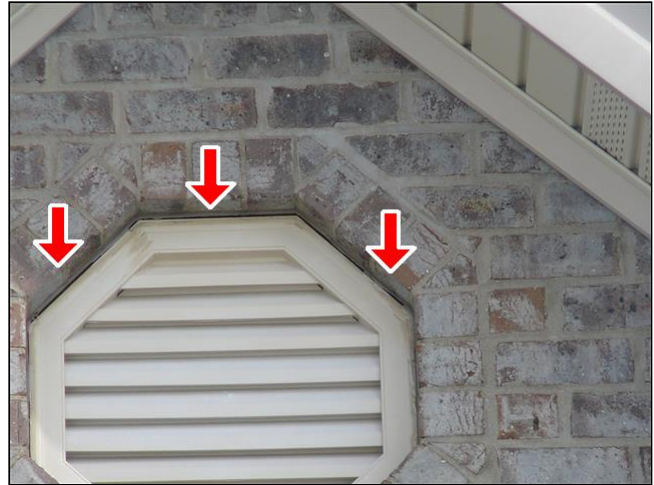
Recommend the gap between the gable vent and the brick siding at the right side of the home be sealed with caulk to prevent insects and water intrusion into the attic. Water intrusion could lead to deterioration of the wall framing. [Choosing the right caulk](#)

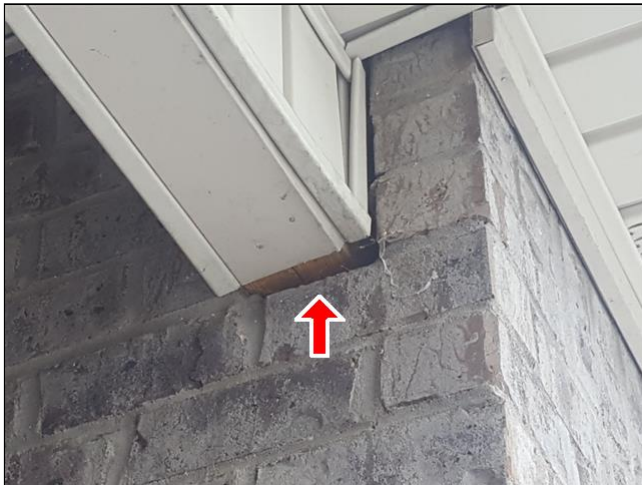
3.5 Item 1(Picture)

Recommend sealing the gap between the porch roof support beam and brick wall under the front porch to prevent water intrusion and insects entering the gap to prevent possible deterioration of the support beam. A general contractor is recommended for repair and correction.

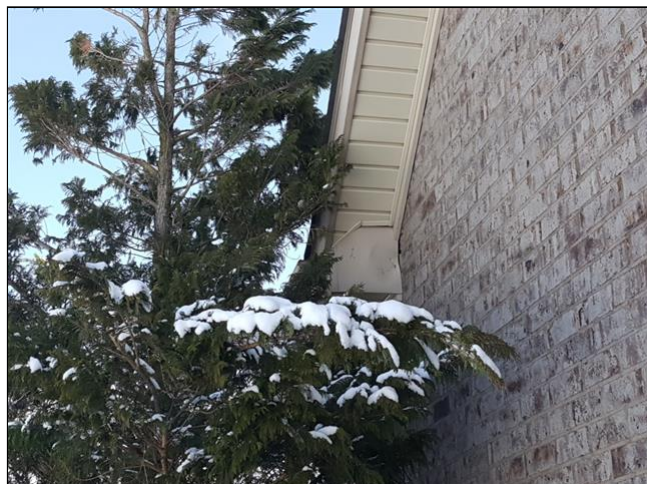
3.11 Item 1(Picture)

(1) The tree limbs that are in contact or hanging near the roof at the front right corner of the home should be trimmed to prevent damage to the shingles and from scraping on the roof surface. They will also clog gutters which will cause water run off problems around the home. Recommend cutting back tree branches as needed.

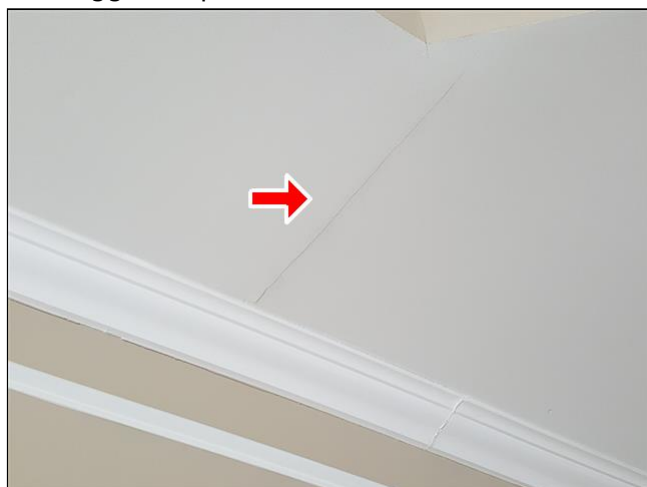
6.0 Item 4(Picture)

(4) The cracks in the ceiling in the Master bedroom (see photos for location) appear to be common settlement cracks. Cracks larger than 1/16" are of concern only. Minor settlement of the home has occurred due to the age of the home and from perhaps framing shrinkage. Cracks of this nature are also caused by moisture, changing temperature, or framing shrinkage due to a lack of ventilation of vaulted ceilings. Recommend repairing cracks then paint and monitor. If cracks reappear and become larger than 1/8" then would recommend a structural engineer further investigate to determine cause and suggest repairs.

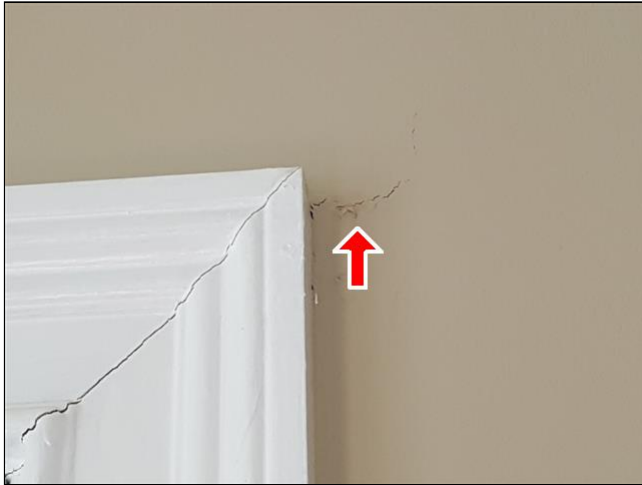
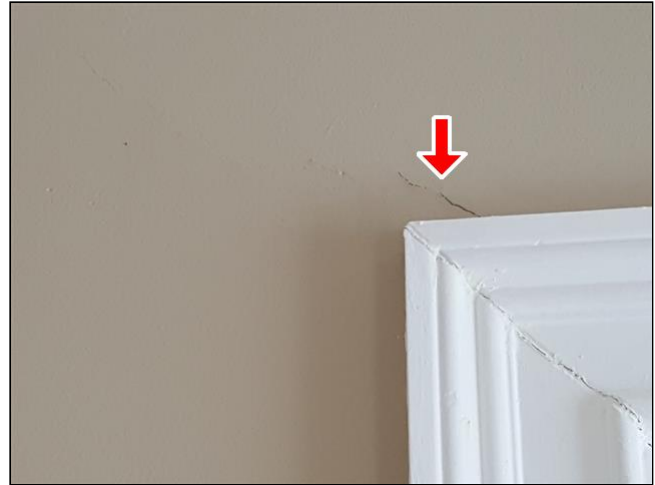
(1) The crack(s) noted on the walls near the corners of the door frames in the home, (see photos for location) are common minor settlement diagonal crack(s). Cracks larger than 1/8" are of concern only. Minor settlement of the home has occurred. All the doors in the related room(s) do open and close without rubbing on door jambs. This damage is considered to be cosmetic and a small repair issue for your information. Recommend prep prime and paint as needed.

Note: After repairs, these areas should be monitored and if cracks reappear and become greater than 1/8 inch wide, then further evaluation is recommended by a qualified contractor to determine cause and repairs. (structural members are not visible)

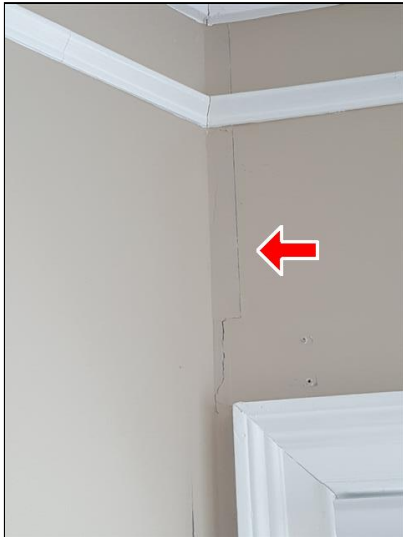
6.1 Item 3(Picture) master bedroom

(2) The crack(s) noted on the wall where indicated in the photo at the master bedroom, (see photos for location) are common minor settlement vertical crack(s). Cracks larger than 1/8" wide are of concern only. Minor settlement of the home has occurred due to the age of the home and from perhaps via framing shrinkage. This damage is considered to be cosmetic and a small repair issue for your information. Recommend prep prime and paint as needed.

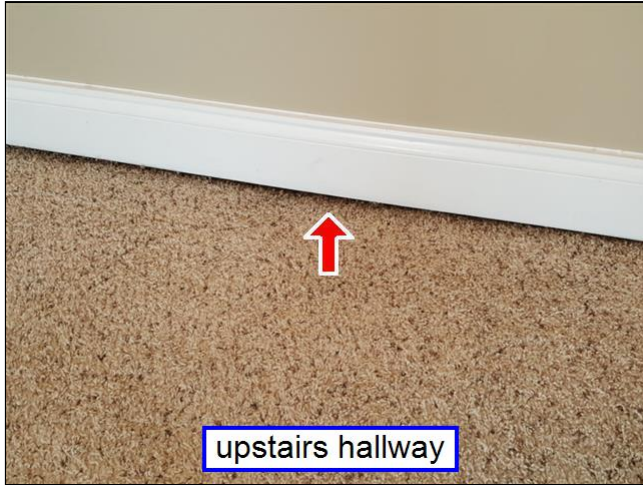
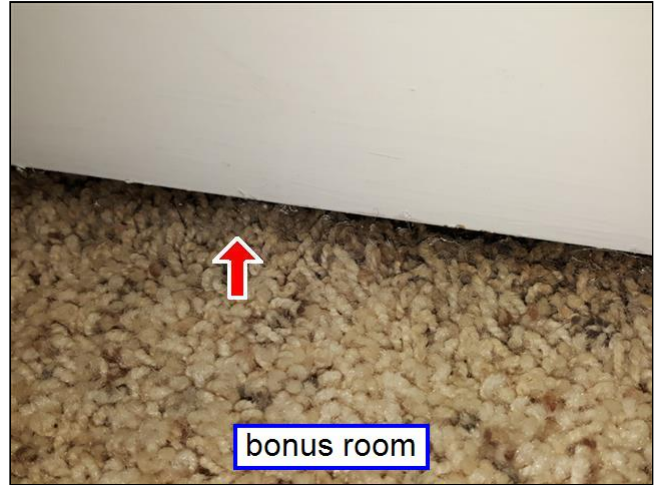
(3) The black stain along the edge of the carpet in the bonus room and near the upstairs hallway are soot stains (filtration soiling). Filtration soiling occurs as a result of air being forced into the room or space at a higher rate than it can escape from the same area, via the ventilation system and/or gaps between the carpet and the wall trim and under closed doors. As the air is forced through these gaps, it passes through the carpet, which acts as a filter to the air. Any pollutants in the air are trapped by the carpet and turn the carpet gray or black in that area. Common pollutants that can contribute to the problem include smoke from cigarettes and candles, cooking oils, fireplace ash, and dust. Recommend a qualified contractor seal the air gaps between the carpet and baseboard trim.

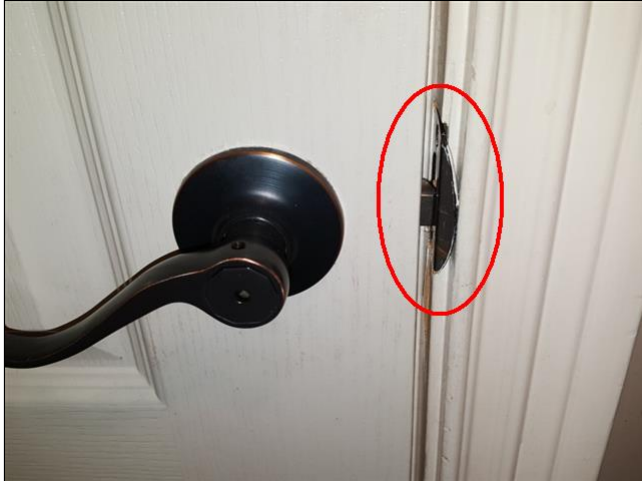
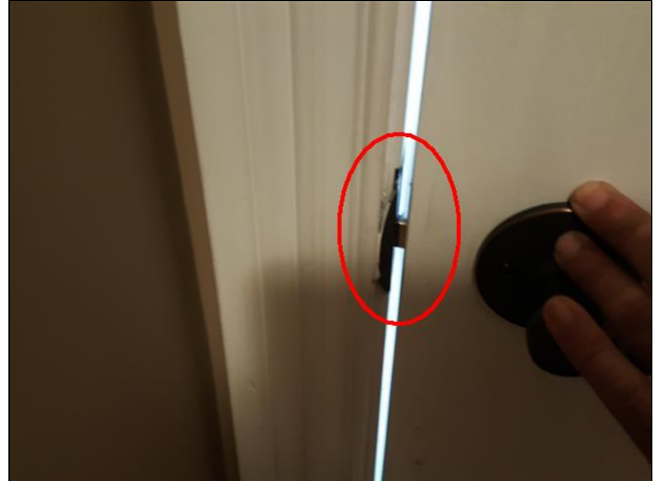
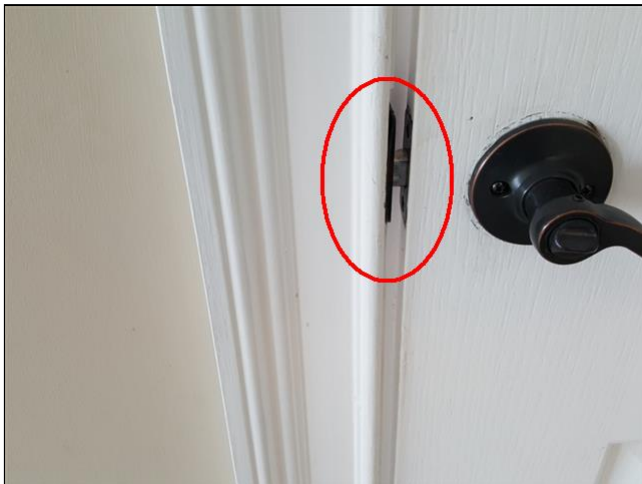
(2) The door knob hardware is not latching in the rooms where indicated in the photo. It requires an adjustment. The strike plate may need to be adjusted or trimmed to be able to lock/close the door. Recommend repair as needed.

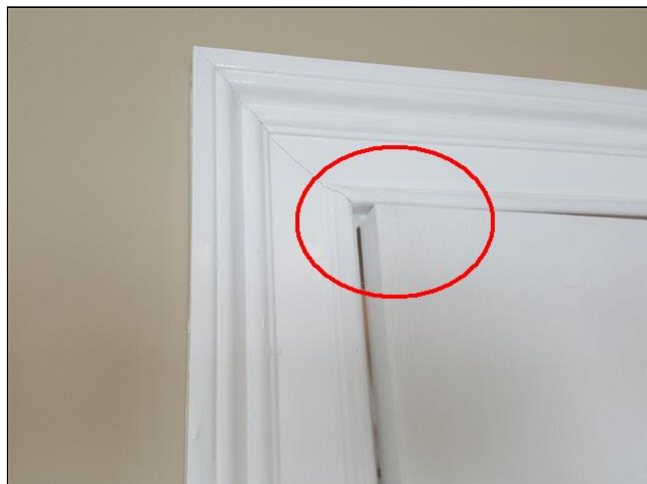
6.4 Item 9(Picture)

(3) The entry door in the 3rd Bedroom where indicated in the photo does close properly, however it rubs at the door jamb when closing where indicated in photos. This is a maintenance issue and is for your information. Sometimes correcting the door opening can require the door trim to be removed then touch up painting or doors will need to be rehung or trimmed down. Recommend a qualified contractor repair as needed.

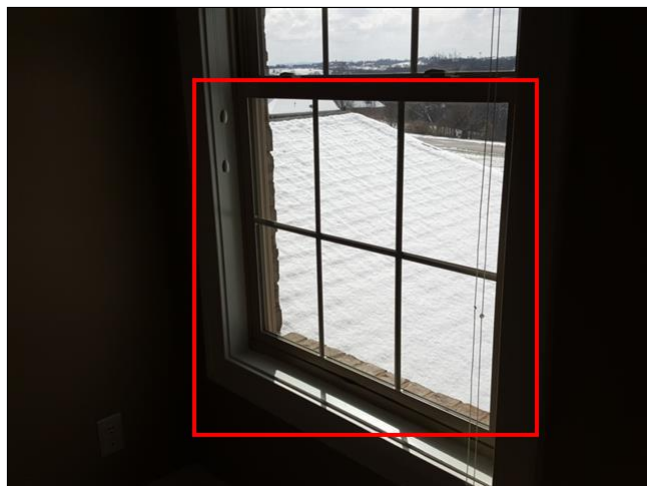
6.5 Item 3(Picture) 2nd bedroom

(3) The windows in the 2nd and 3rd bedroom where indicated in the photos are missing screens. Recommend these be installed to prevent insects entering the home when the window is opened. Replace as needed.

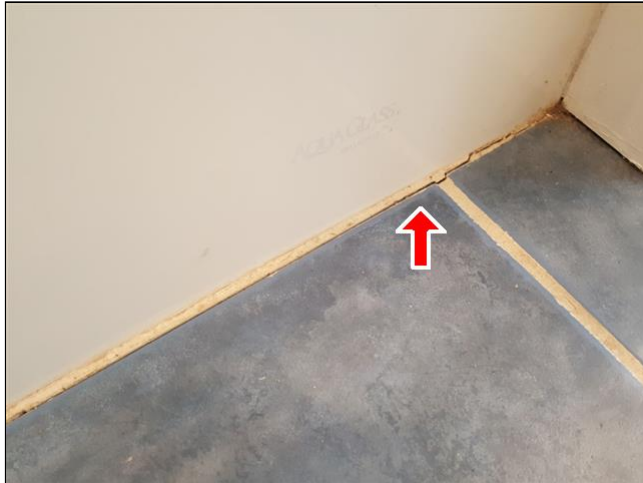
7.0 Item 1(Picture)

The tile floor covering has cracked grout in the 2nd bathroom between the floor and the tub enclosure. These openings need to be sealed to prevent possible water intrusion in the event a water leak occurs in the bathroom. Water intrusion can lead to deterioration of the sub floor and may cause the tiles to come loose. Recommend a qualified contractor repair as needed. Then it would be advisable to install a molding strip and/or trim between the floor and tub.

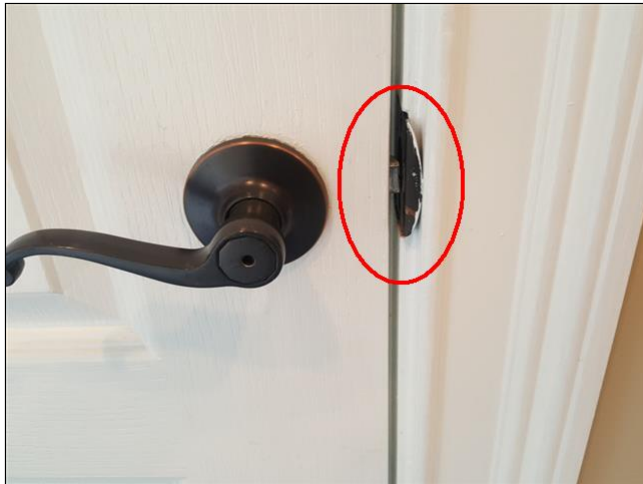
7.2 Item 1(Picture)

The door knob hardware is not latching in the 2nd bathroom where indicated in the photo. It requires an adjustment. The strike plate may need to be adjusted or trimmed to be able to lock/close the door. Recommend repair as needed.

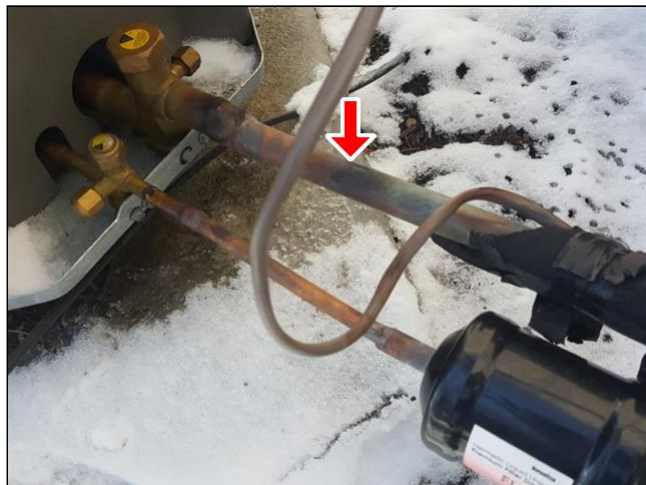
10.3.A Item 2(Picture)

(2) Missing/Damaged foam insulation was found on the exterior large suction line for the Heat Pump compressor. This insulation is to maintain or stabilize the temperature of the cooling system. The outside temperature can influence this gas and cause efficiency fluctuations of the unit.

Replacement of the insulation where needed will help maintain efficiency of the compressor and/or can cause energy loss and condensation. Recommend installing a new sleeve, this will help maintain efficiency of the compressor.
