All Valley Home Inspections

Inspection reference: Sample Report

Confidential Inspection Report

645 Rock Lane

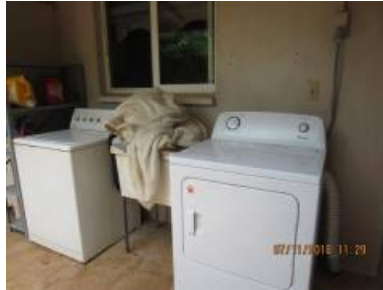
Laundry provisions were located at the exterior laundry closet of the building. A 240 volt receptacle was present at the laundry area for an electric clothes dryer. The provisions for the laundry appliances i.e.(supply valves, drains, gas supply, electric supply and dryer venting) if present, were observed to be in generally acceptable condition except for the following:

Laundry Conditions

Monitor: The washer and or dryer have some rust on the units. We recommend that the rust be monitored with correction as necessary.

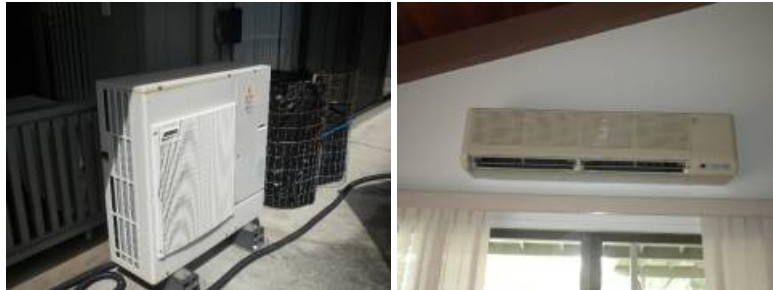
Repair: The air conditioning unit was not producing an acceptable air temperature differential in the room. We recommend a qualified mechanical contractor be retained to evaluate the cooling/heating system further and make repairs as necessary.

Air conditioning was provided by one or more mini split system(s). The compressor for the cooling system was located at the exterior right side of the building.

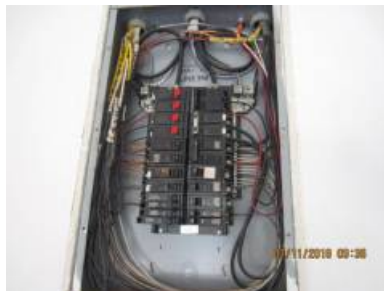
Repair: More than one wire at the subpanel was installed at a breaker or fuse which was designed for the installation of only one wire. This "double tapping" cannot insure that both wires, installed under a screw designed to carry only one wire, receive the same amount of pressure from the screw. Because positive connection for all the wires under the screw may not be the same there is a possibility of arcing or gapping. This arcing can result in dangerous resistance and heat buildup within the circuit, and is considered an improper electrical trade practice. We recommend elimination of all double tapping, for an increased margin of electrical safety.

An additional distribution panel, or sub panel was located in the hall bathroom.

The subpanel was in acceptable condition with circuitry installed and protected in an acceptable manner except for the following:

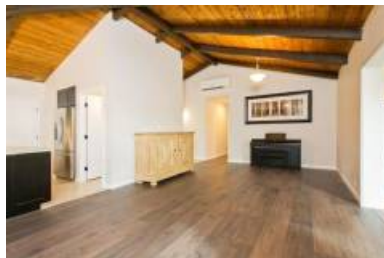
The finished walls and ceilings inside of the building appeared to be a combination of drywall, and wood/paneling. The interior walls and ceiling surfaces were observed to be in generally acceptable condition except for the following:

Ceiling & Wall Conditions

Consult Seller: There appeared to be patching and/or repairs to the finished wall surface in the hall bathroom. We recommend that the seller be consulted for additional information as to the reason for the repairs.

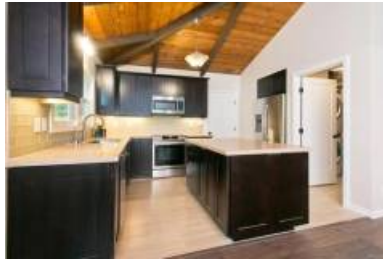
The cabinets and countertops were observed to be in generally acceptable condition except for the following:

Counter Top Condition

Repair: The caulking for the backsplash is in need of repair or replacement. We recommend that caulking be installed and/or gaps filled to prevent possible water intrusion at the wall areas.
