Supplemental  
Report on the  
functional and  
physical adequacy  
of Baldwin's three  
existing fire station  
facilities

May 10, 2022

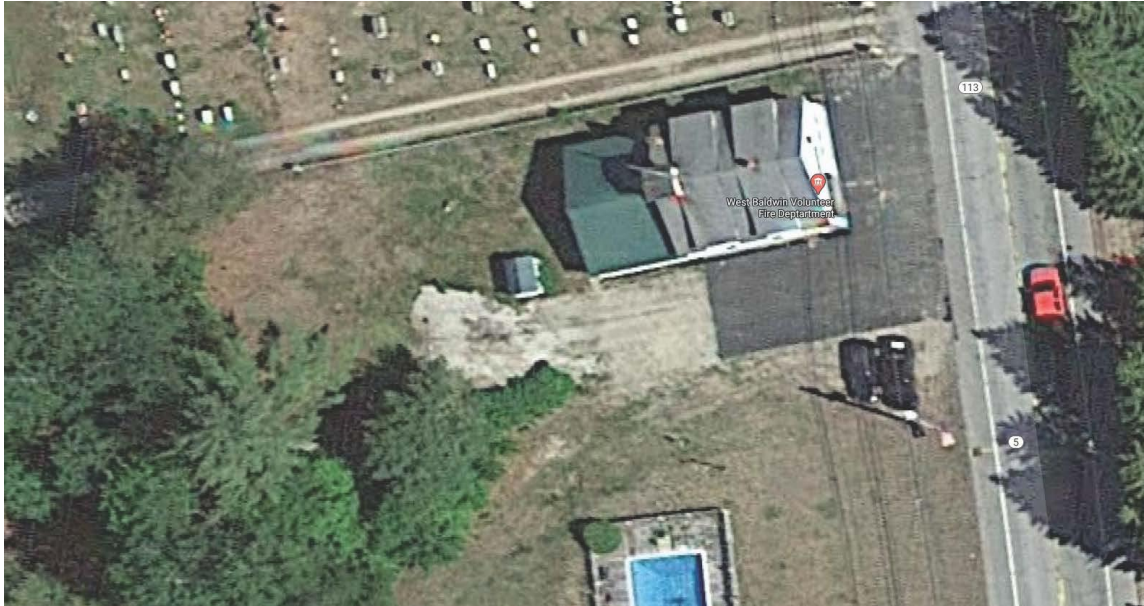
*Site Plan West Baldwin Fire Station, West Baldwin, Maine*

There is a short apron in front of the building of approximately 20' and a paved/gravel parking area to the side for approximately 5-6 cars. Because of the lot shape and setbacks limiting the building width to 35', a new building cannot exceed two bay doors facing the road. There is not enough turning room to face the doors to the side. Given all the requirements, building a new building or an addition is not feasible even if we obtained numerous variances and relief from these ordinances.

The site is inadequate for a fire station. There is no apron room to maneuver trucks to back into the station without turning on the busy road. The width of the site is completely inadequate especially for any new construction with the state cemetery setback. Most apparatus doors today are 14' x 14'. There is barely room to accommodate two doors if they were enlarged. There is currently parking for four to five cars at the side of the building. That could be expanded to the rear of the site if required.

The facility at West Baldwin is grossly inadequate to service the fire protection needs of Baldwin into the future. Because the site is so small, any renovation, expansion, or new construction on the site is impossible without the addition of adjacent land. We would recommend that the town dispose of the facility when a better facility is available.

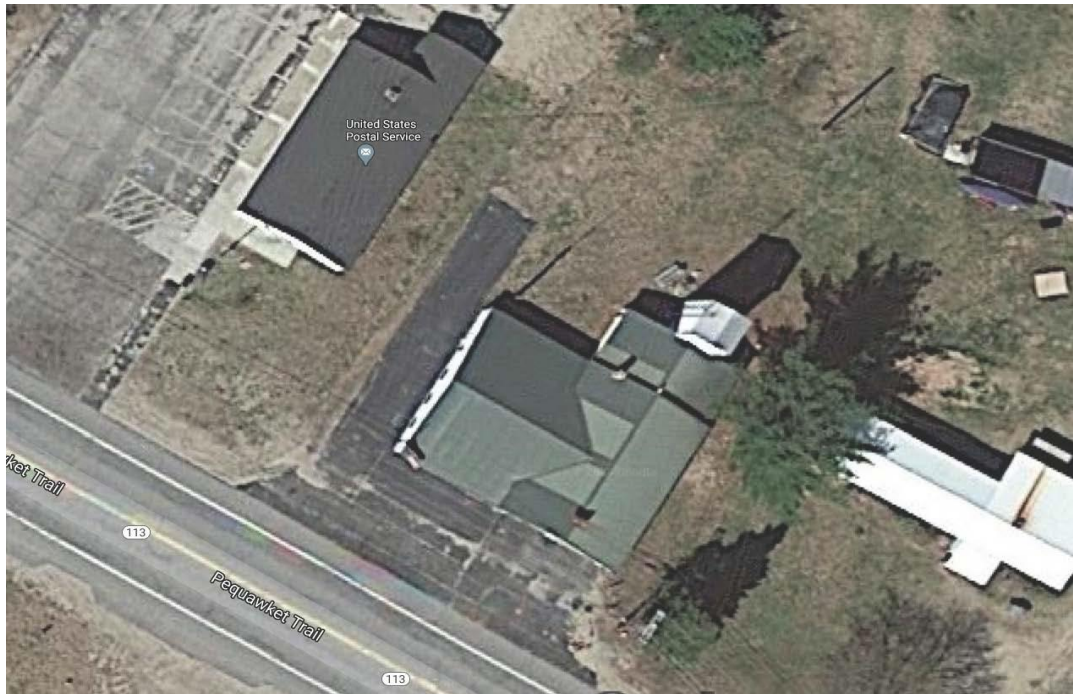
*Site Plan East Baldwin Fire Station, East Baldwin, Maine*

The East Baldwin (District 1) is located at 209 Pequawket Trail (Route 113), which is the main thoroughfare through the Town. The information available on the site is conflicting. GIS information shows a site of 0.82 acres. However, tax maps show a much smaller site (see the portion of Tax Map 1a below). It is also unclear if the fire station on this site shares the site with the Post Office Building. It is assumed that due to multiple buildings on this site, the tax map information is most likely correct, and that the GIS information has not been updated. This area is zoned VC (Village Center). In this zone, there is a minimum lot size of 2 acres, and a 200' minimum road frontage requirement. In addition, there is a front setback of 100', side setbacks of 10' and a rear setback of 25'. It also appears that a portion of the rear of the building is over the site lot line. Given all the requirements, building a new building or an addition would require numerous variances and relief from these ordinances.

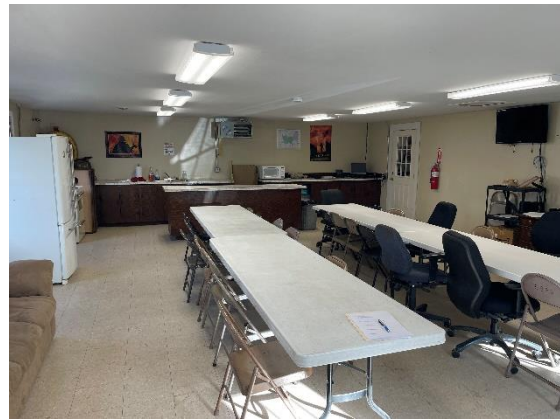
The building is missing many essential functions even if it were able to continue to operate as a 100% volunteer station which is unlikely as volunteer departments continue to decline. There is no decontamination area, no workroom, no storage, no turnout gear locker area, no offices, no showers, no generator, and no sleeping rooms to house paid staff if needed. Similar to West Baldwin, the station is essentially just a garage for apparatus.

*East Baldwin Fire Station, dayroom*

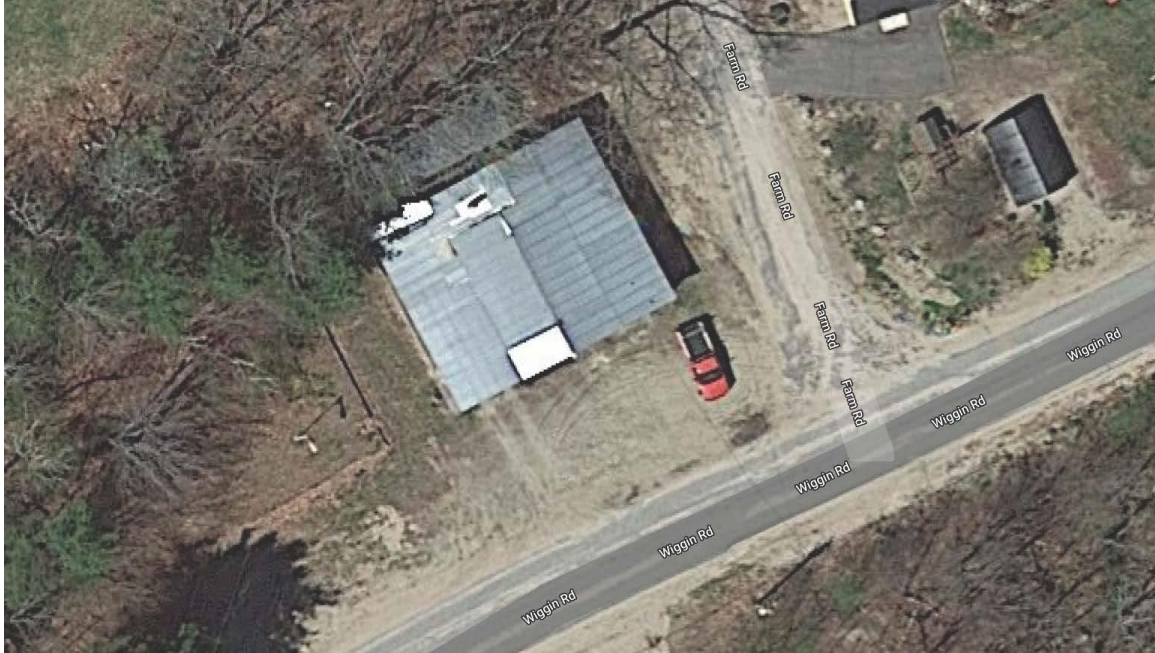
*Site Plan North Baldwin Fire Rescue Station, Baldwin, Maine*

The North Baldwin station(District 2) is located at the corner of Wiggin Road and Farm Road. The site is currently leased by the town. The site is extremely small at approximately 6,500 square feet. This area is zoned R (Rural). In this zone, there is a minimum lot size of 2 acres, and a 200' minimum road frontage requirement. In addition, there is a front setback of 100', side setbacks of 10' and a rear setback of 25'. Given all the requirements, building a new building or an addition would require numerous variances and relief from these ordinances.
